Closure Plan Update/Annual Environmental Management Report

Canyon Coal Mine (MLs 1464 and 1471)

01 July 2012 – 30 June 2013

**Whitehaven Coal Mining Limited
Mine Closure Progress Report
for the
Canyon Coal Mine
(MLs 1464 and 1471)**

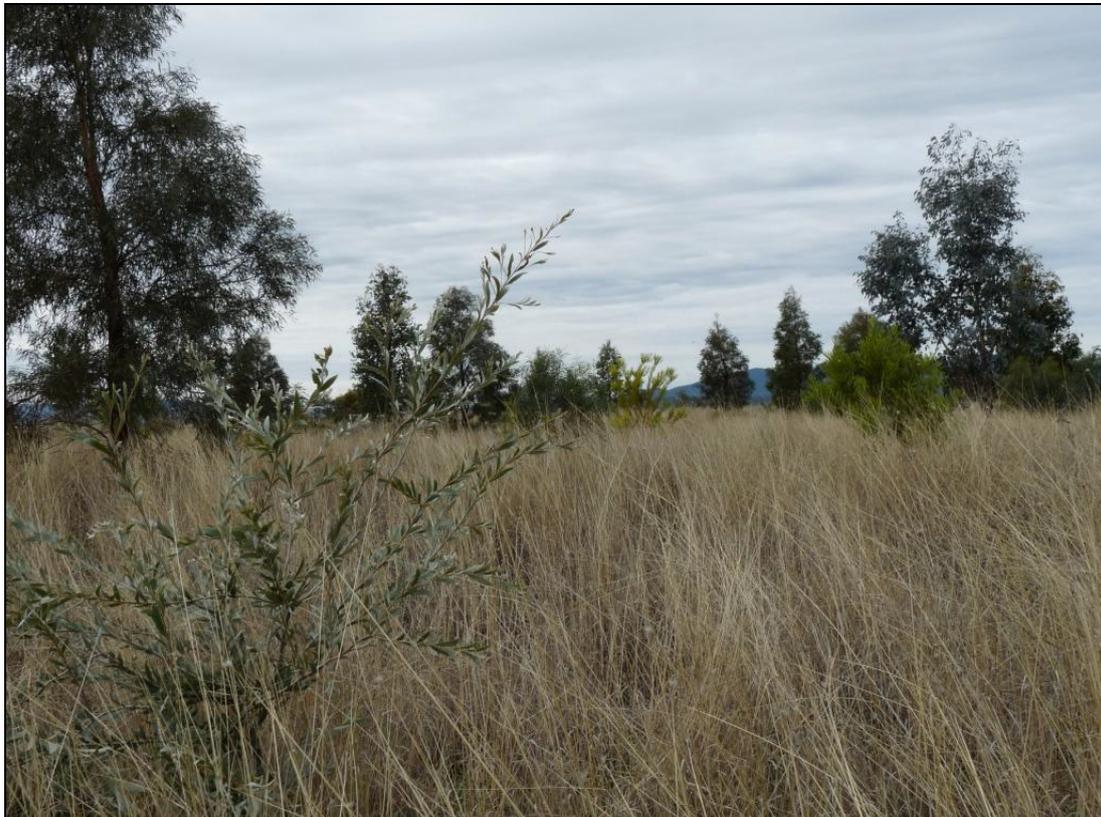
Plate 1 – Infill Understorey Plantings, Zone 2(d) Native Vegetation

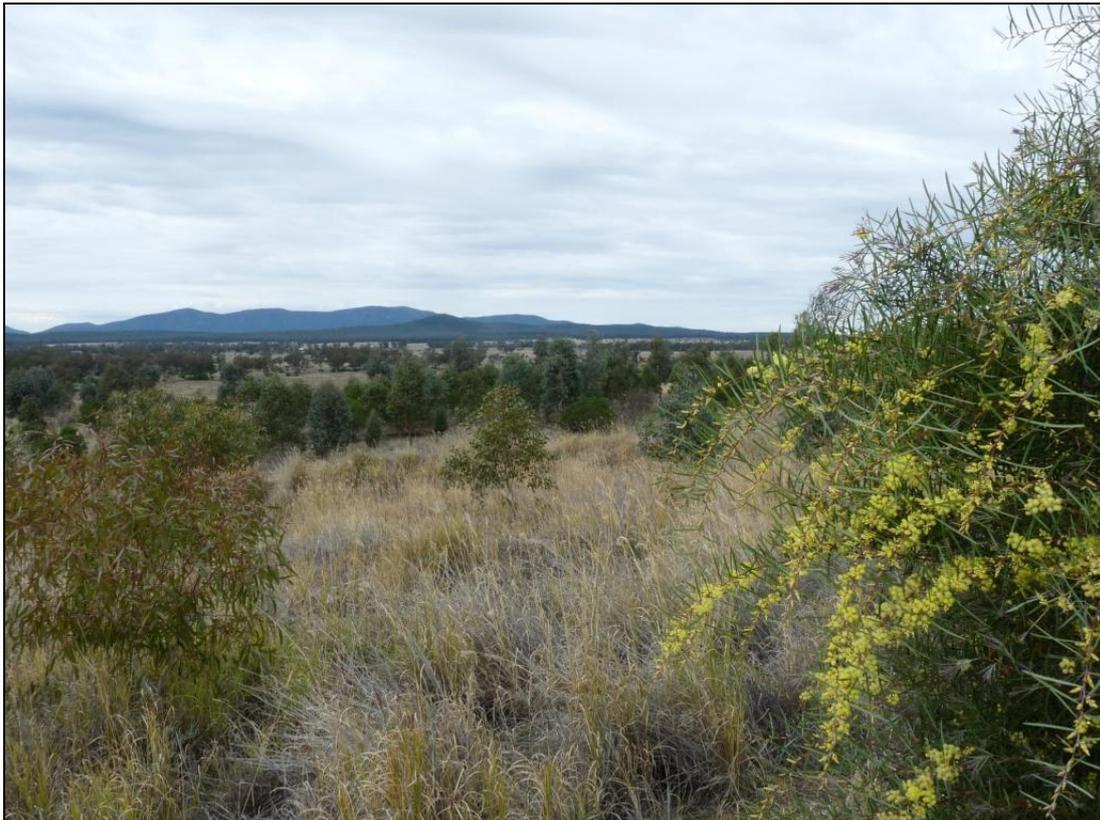
Plate 2 - Zone 2(d) Native Vegetation

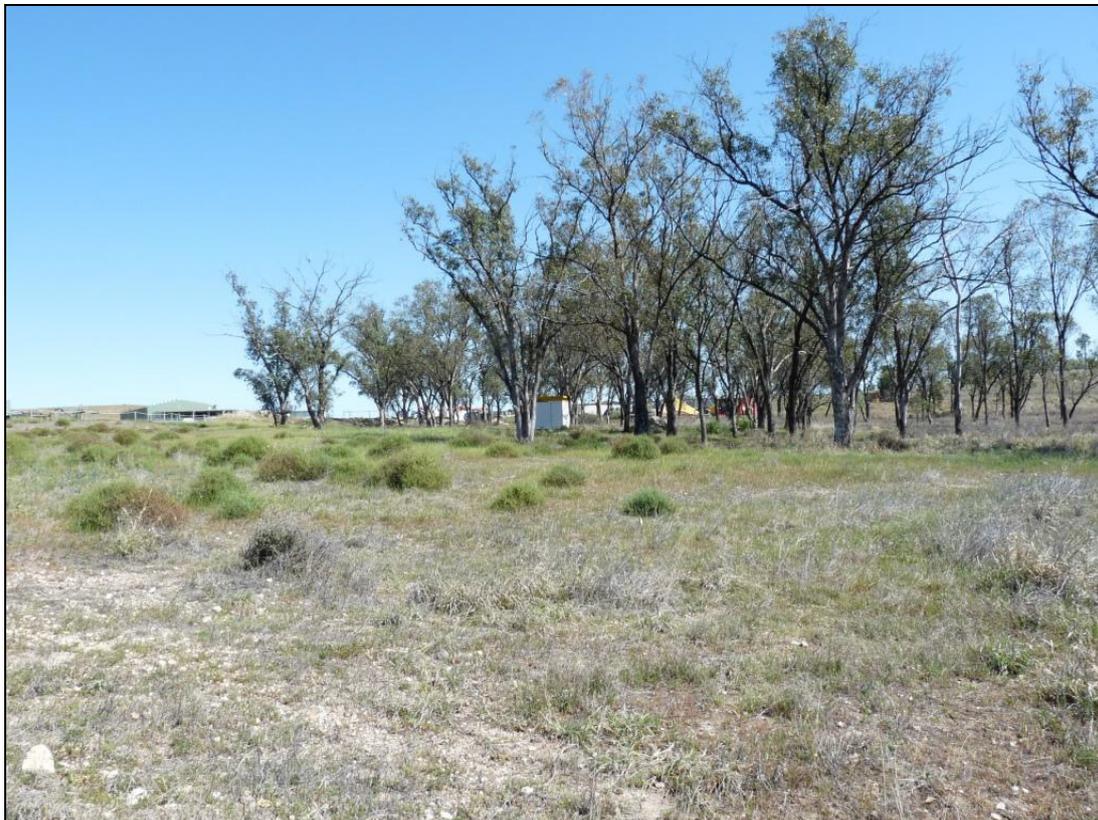
The crib and office facilities were removed in August 2010 with the exception of the toilet block, which is used by the environmental team and contractors associated with closure activities. The area, including the car park, was then topsoiled and seeded. Additionally, a small waterway was constructed to slowly drain away runoff into storage dams to the east of this area. The former Orica hardstand is yet to be rehabilitated, as it currently provides a useful safe stopping area for haul trucks on the passing haul road.

Plate 3 - Zone 1(a) - Former Office and Crib Facilities

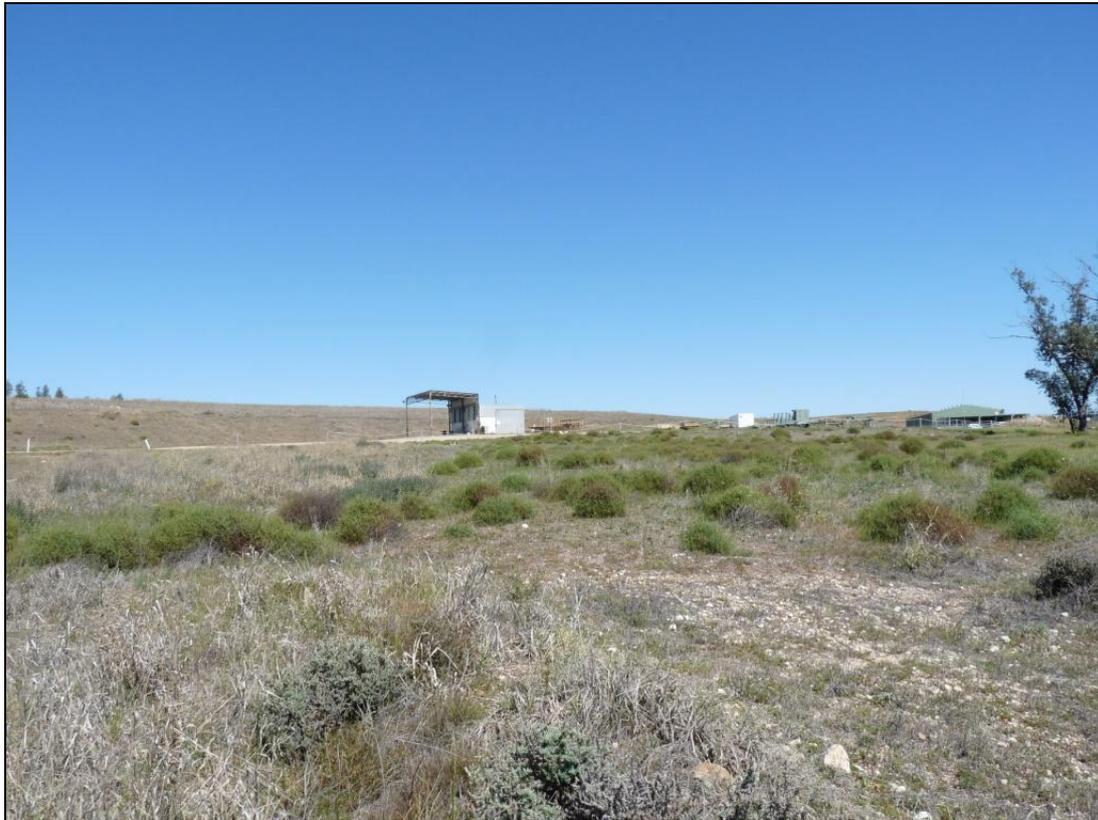
In mid 2010, the two 50,000L diesel storage tanks were removed from the bunded area which had a capacity of 240,000L. The bunded area, which also contained stored oils, incorporated a clay over plastic over clay liner to minimise the potential of soil contamination in the event of a spill. Pipes and lockable valves were in place to enable removal of spills and rainwater from the area.

Analysis of the soil samples was conducted by ALS Laboratory Group Environmental Division in Sydney. Results of the sampling indicated that in two locations the levels of C10 – C36 Fractions of Hydrocarbons (Diesels and Lubricating Oils) exceeded the threshold concentrations for sensitive land use set in the NSW EPA Guidelines for Assessing Service Station Sites (2004). Heavy metals analysis indicated all samples were well within threshold limits.

Based on these results, the contaminated material was excavated and disposed of within a designated bunded area in September 2010 for future bioremediation. Following excavation of this material it was noted that contamination was present at greater depths than first identified. Subsequently, additional soil samples were collected to a depth of 2.5m, along with a resample of the two locations within the pit, to ensure all contaminated material was removed. Results of these sites found that contaminated material had been removed from all but one area (2 samples within the one large pit).

Plate 4 - Zone 1(b) - Workshop, Fuel Farm and Hardstand Area

Wet weather hampered the continuation of remediation of the fuel storage area. When conditions permitted, the additional contaminated soil was excavated and stored in the bunded area onsite for bioremediation. Once bioremediated, the soil was disposed of offsite as general waste.

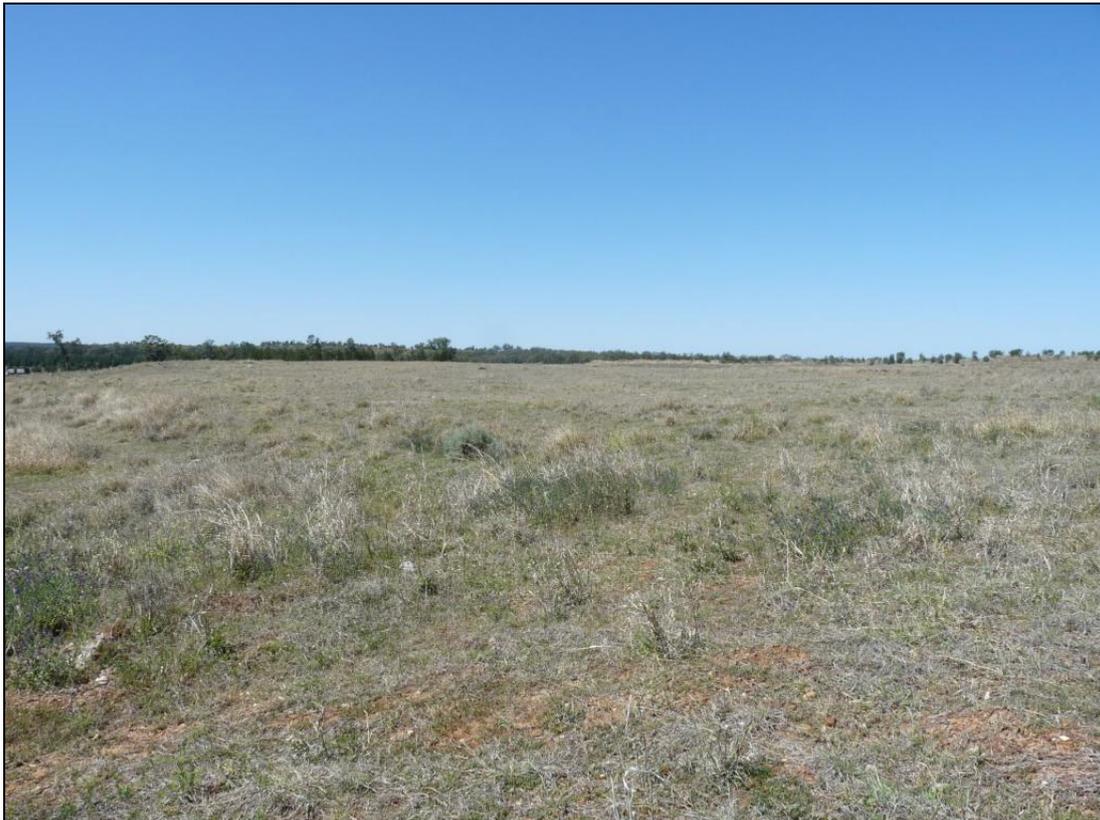
The removal of coal loader and associated infrastructure was completed in September 2010, with the loadout bin being commissioned at Whitehaven's Sunnyside Coal Mine. The ROM pad and ROM facilities area totalled 7.5 ha and was reshaped, stabilised with contours and waterways for drainage, top-soiled and seeded with a summer pasture mix. The waterway spills into a rehabilitated area to the south of the pad that is designed to slowly drain runoff into the final void. This area has also been top-soiled and seeded with a summer pasture mix for prevention of erosion. Further planting of native trees in clump formations was undertaken in November 2011.

Plate 5 - Zone 1(c) - ROM Pad and Coal Loading Facilities

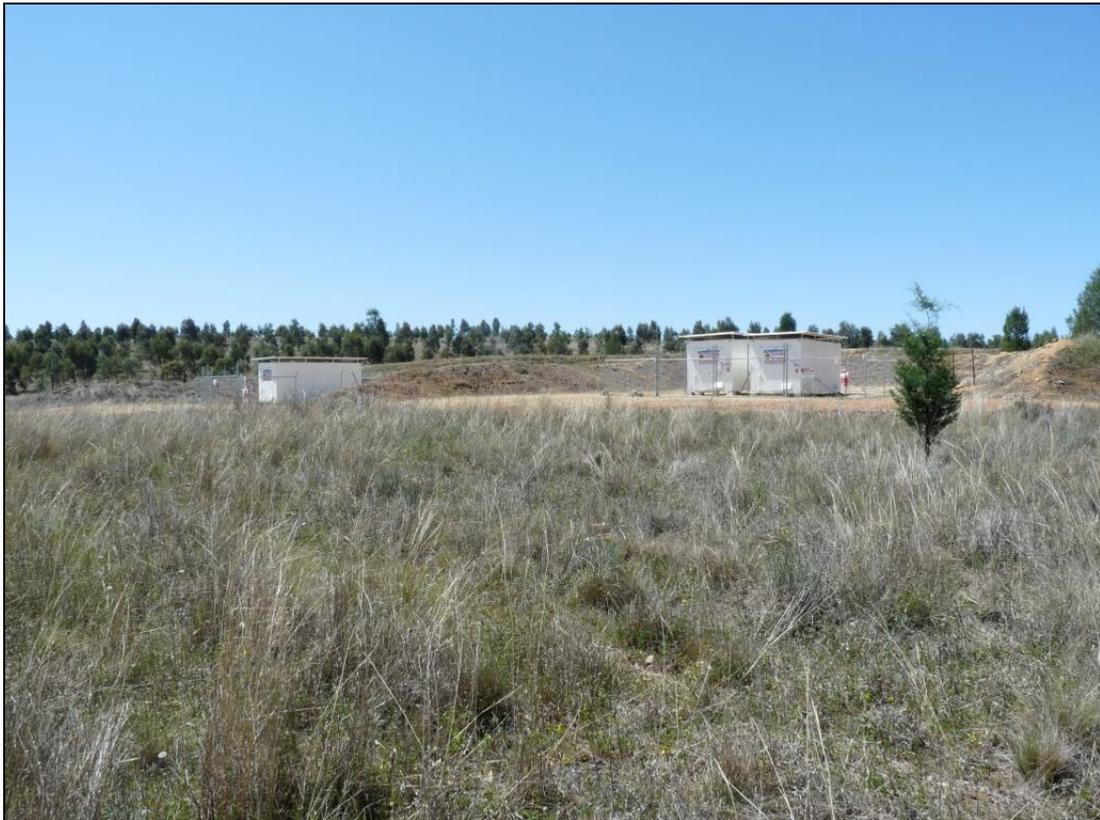
The explosives magazine is still currently used by blasting contractor Orica Mining Services. Whitehaven plans to leave the magazine in its current location for the foreseeable future as it provides a secure area which is isolated from the general public.

Plate 6 - Zone 1(d) - Explosives Magazine

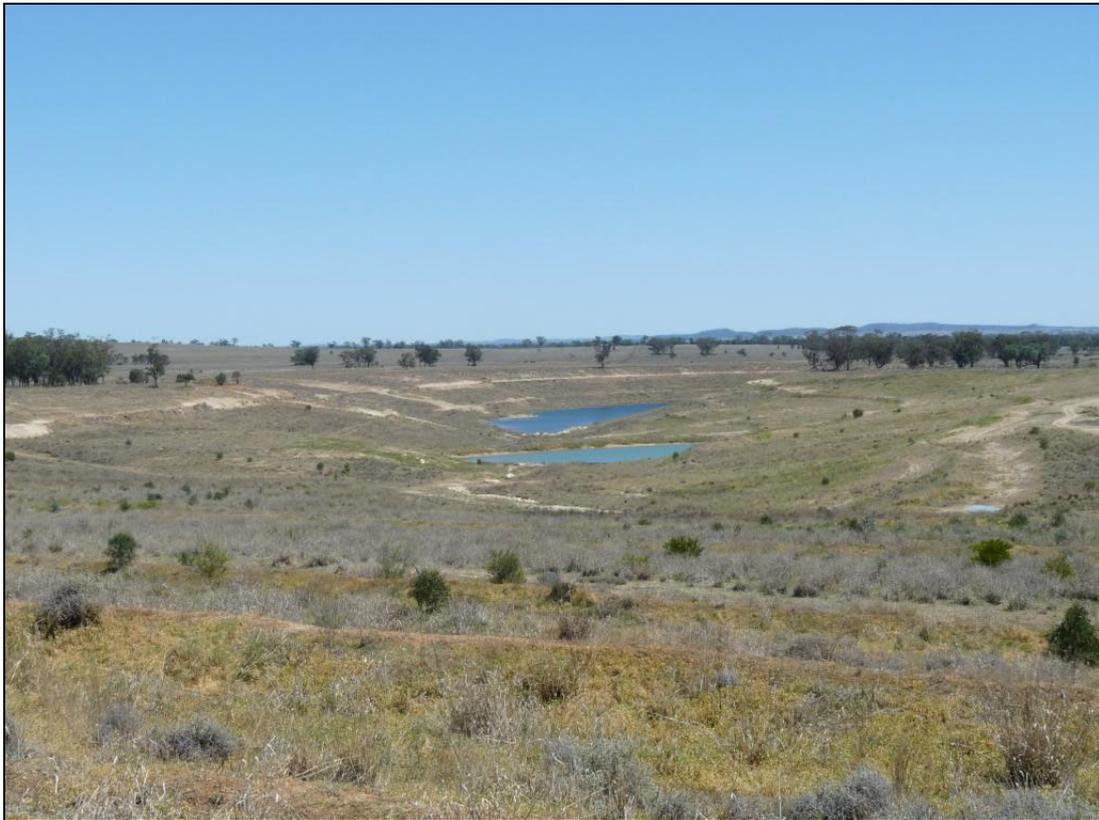
Although a summer cover crop consisting of predominately Japanese Millet was present in the void area, the intensity of rainfall events over late December 2009 and early January 2010 (a total of 184.6mm fell from the 22/12/09 – 3/1/10) resulted in numerous instances of gully erosion through contour banks and dam walls within the void. The major areas affected included the southern side of the void with three small instances of gully erosion through contours, and one small instance on the northern side of the void. A large channel was also eroded through the dam wall which was acting as a water velocity control structure in the lower void. These areas were further affected by 180.8 mm of rainfall over the following months of February and March 2010, creating major damage to the first void dam to the east with a large channel cut through the dam wall. In total an area of around 0.5ha was affected by erosion in the void.

As discussed previously, heavy rains in early 2012 resulted in new erosion on the southern face of the void. The area was remediated in late 2012 by Wards Earthmoving. Whilst works like this will occur as required, at this stage progression to final rehabilitation of the void have been delayed due to the pending Vickery Coal Project which will ultimately result in the Canyon void being backfilled with waste rock from the Vickery Project. Plate 16 and Plate 17 show the final void in mid 2013.

Plate 14 - Zone 3 - Final Void (Photo 1)

Remediation work began in May 2010 with dozer contractors patching the problematic areas and reseeded with a winter cover crop consisting of predominately Rye Corn to further stabilise the soil. Major work occurred on the dam entering the void (to the east) with the wall filled and enlarged to incorporate a new rock lined spillway turfed with kikuyu grass. This work has prevented further instances of channelling through the dam wall and slowed water entering the void from the east, therefore reducing the chances of gully erosion through the lower water structures to the west. Works on the southern side of the void were also undertaken and included shaping and seeding of steeper slopes that were previously left due to access issues.

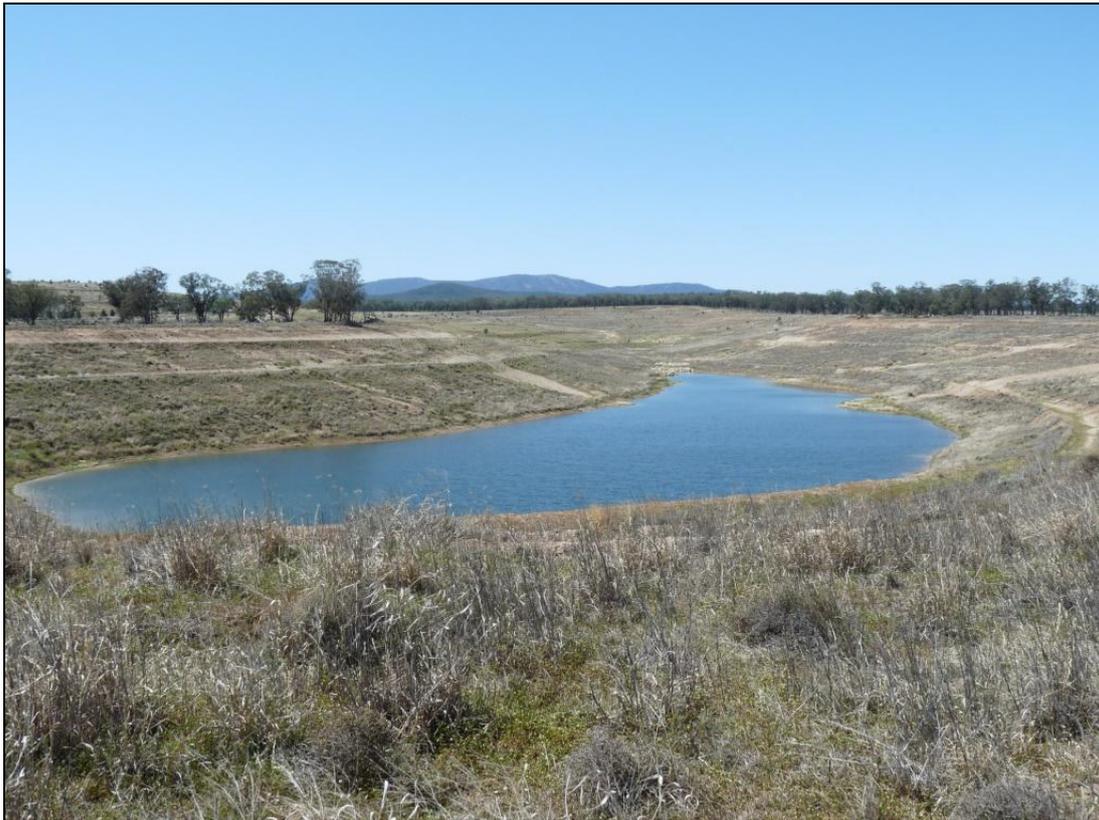
Plate 15 - Zone 3 - Final Void (Photo 2)

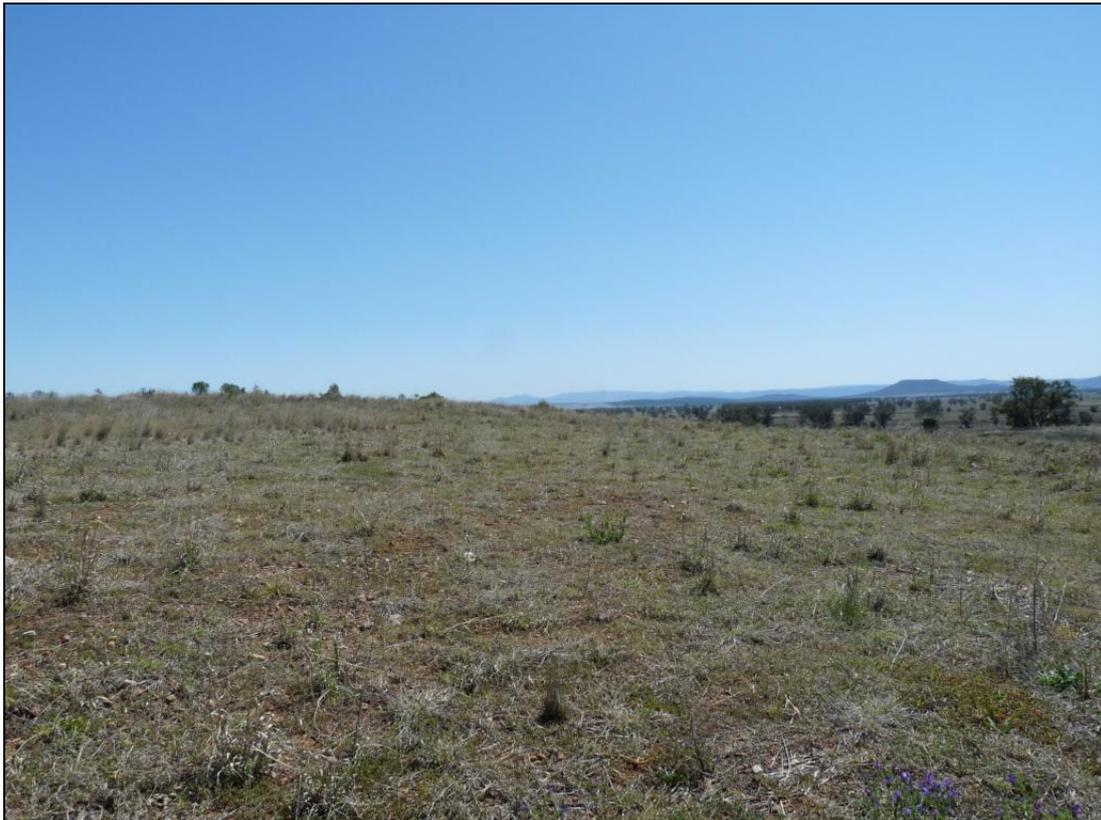
Both reject emplacement 1 (north), Plate 16, and 2 (south), Plate 17, areas have been filled, reshaped, top-soiled and seeded with summer pasture mix during September 2010. Planting of native trees was undertaken in November 2011 with additional planting in February 2013.

Plate 16 - Zone 5(a) - Emplacement Area 1

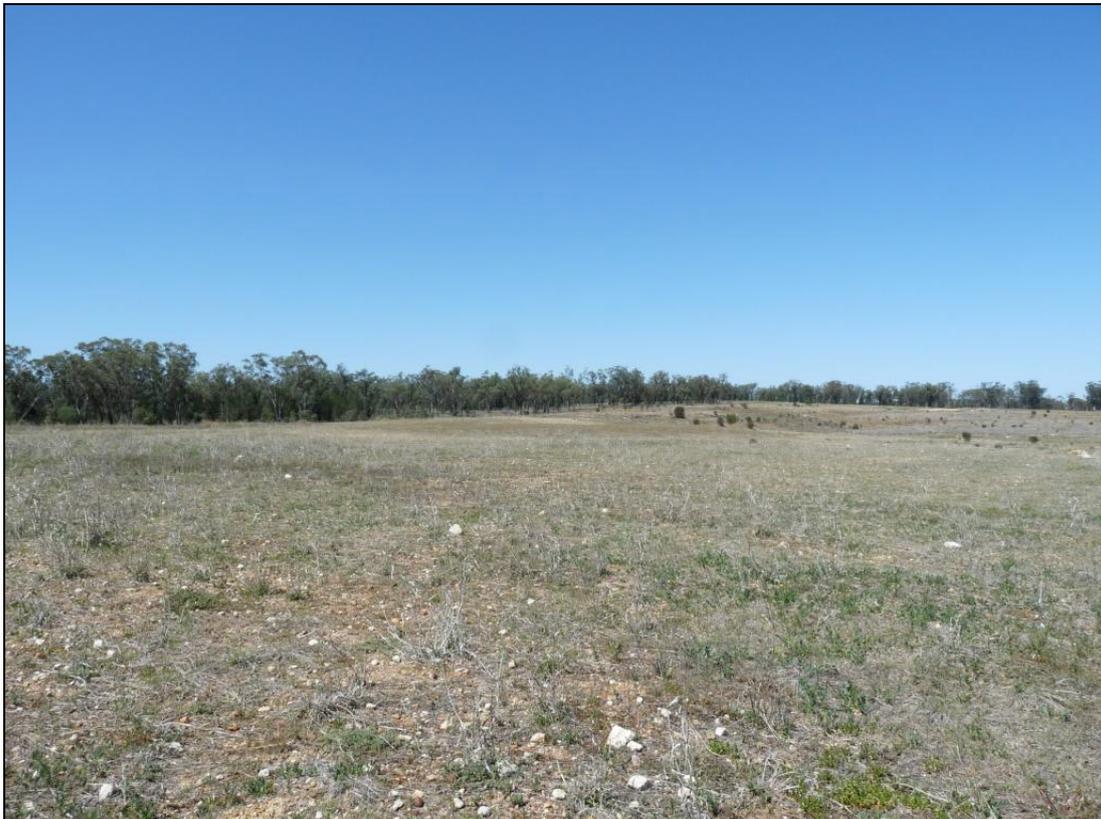
Plate 17 - Zone 5(b) - Emplacement Area 2

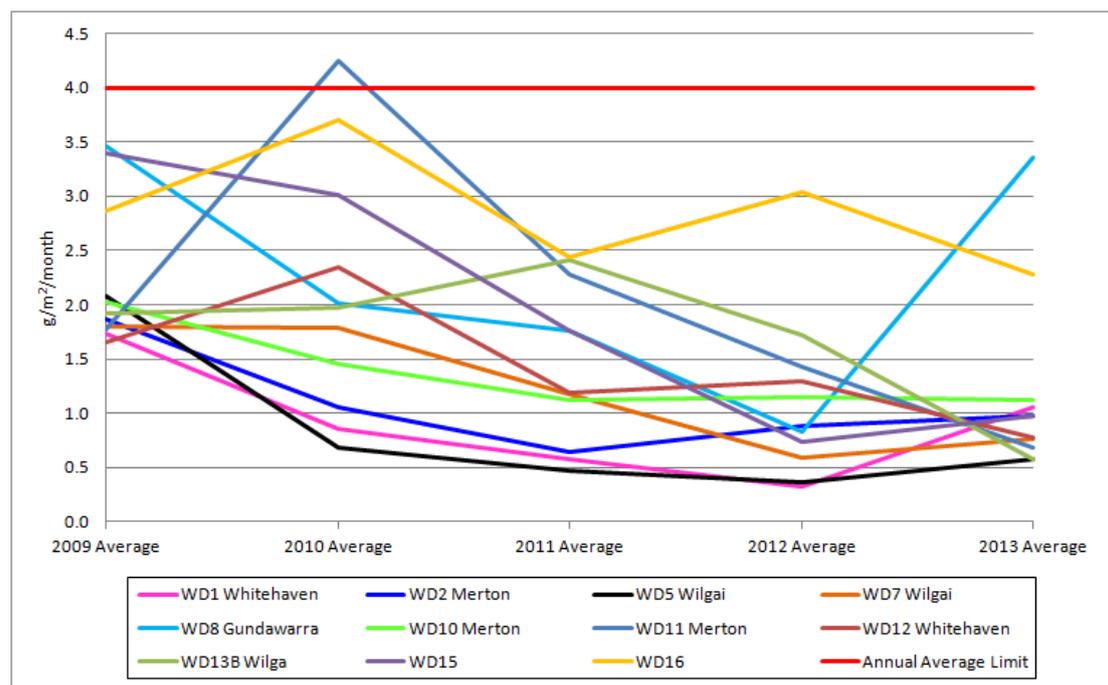
Figure 1 - Annual Average Deposited Dust Results

Figure 1 shows the annual average for each monitoring point since July 2009, compared with the consent limit of $4\text{g/m}^2/\text{month}$. It should be noted that September 2009 results have been excluded from the graphed data for all monitoring locations as these results were skewed by regional bushfires. December 2010 and January 2011 deposited dust results have also been excluded from WD-13B Womboola as they were highly anomalous with results from that monitoring location during other months as well as results from other monitoring locations during December and January.

The graph shows that all monitoring locations have remained below the annual average criteria of $4\text{g/m}^2/\text{month}$ since mining ceased in mid 2009. The overall trend of the data shows that deposited dust levels are generally remaining at low levels around the Canyon site and are continuing to fall as a consequence of established groundcover across all rehabilitated areas.

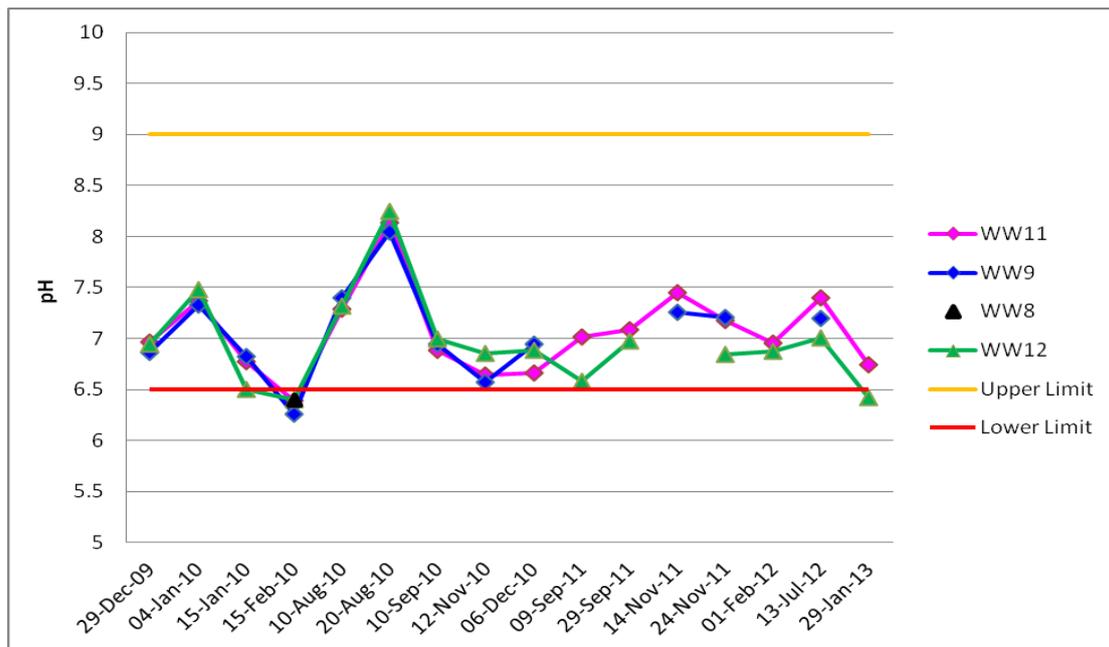
Figure 2 - Wet Weather Discharge pH (2009 - 2013)

Figure 2 shows that discharge from WW9 on the 13th July 2012, as well as ambient flows upstream and downstream of Canyon, remained within the pH thresholds of 6.5 – 8. The downstream monitoring location (WW12) recorded a pH level slightly below the threshold in January 2013. This is not believed to be associated with Canyon as no wet weather discharge was recorded.

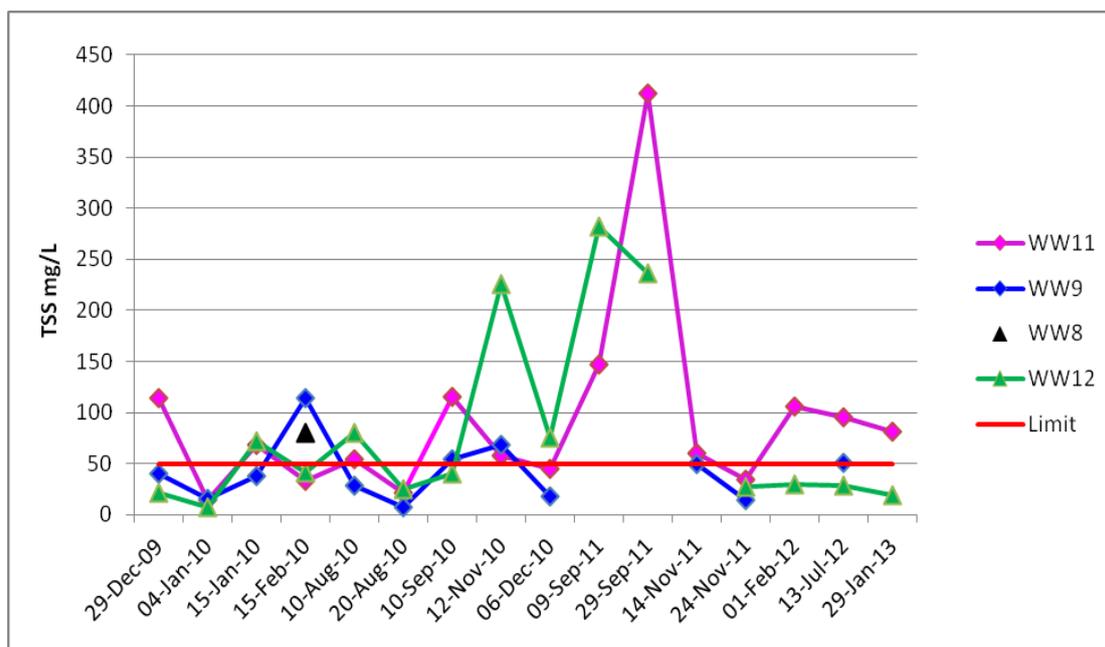
Figure 3 - Wet Weather Discharge TSS (2009 - 2013)

The discharge from WW9 on the 13th July 2012 recorded a TSS level of 51mg/L. Whilst this is 1mg/L above the threshold of 50mg/L, it is noteworthy that the upstream monitoring location returned a TSS level of approximately 100mg/L. The elevated result at the upstream monitoring location is likely a result of farming practices and the unsealed Hoad Lane and is in no way influenced by the Canyon site. Figure 3 also shows that the ambient flows in January 2013, where discharge from site was not recorded, again exceeded the 50mg/L limit at the upstream monitoring location. On both occasions the TSS level was well below 50mg/L at the downstream monitoring location (WW12).

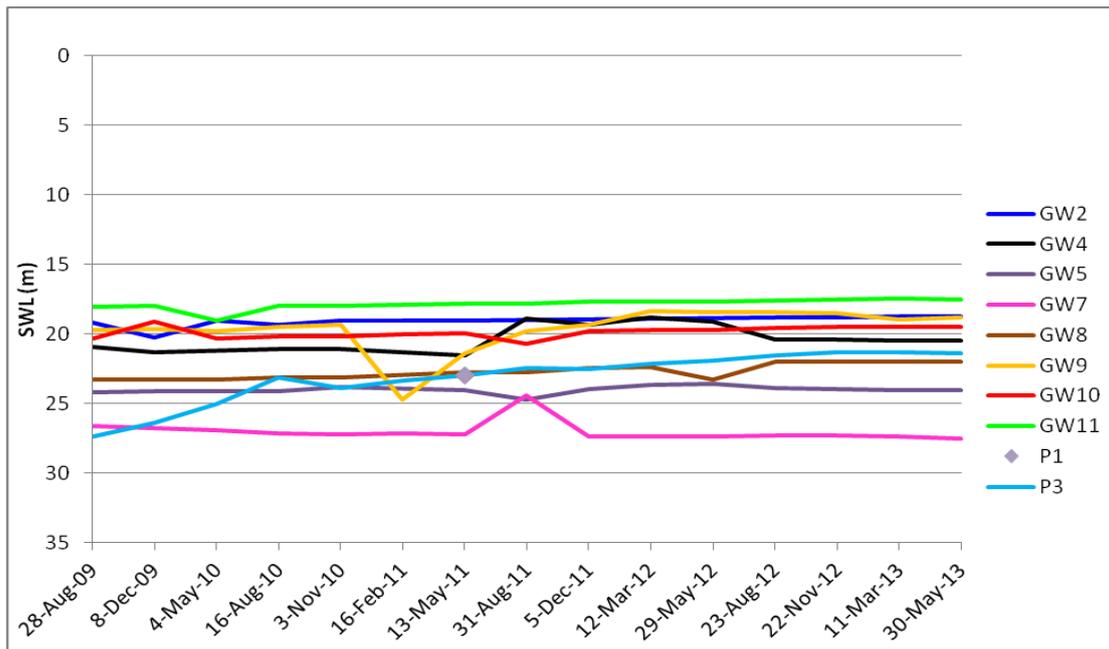
Figure 4 - Standing Water Level (2009 - 2013)

Figure 4 shows the SWL at all monitoring locations has remained very consistent throughout the last 12 months. Any variations in SWL at this stage are considered to be influenced by non-mining activities or seasonal variation.

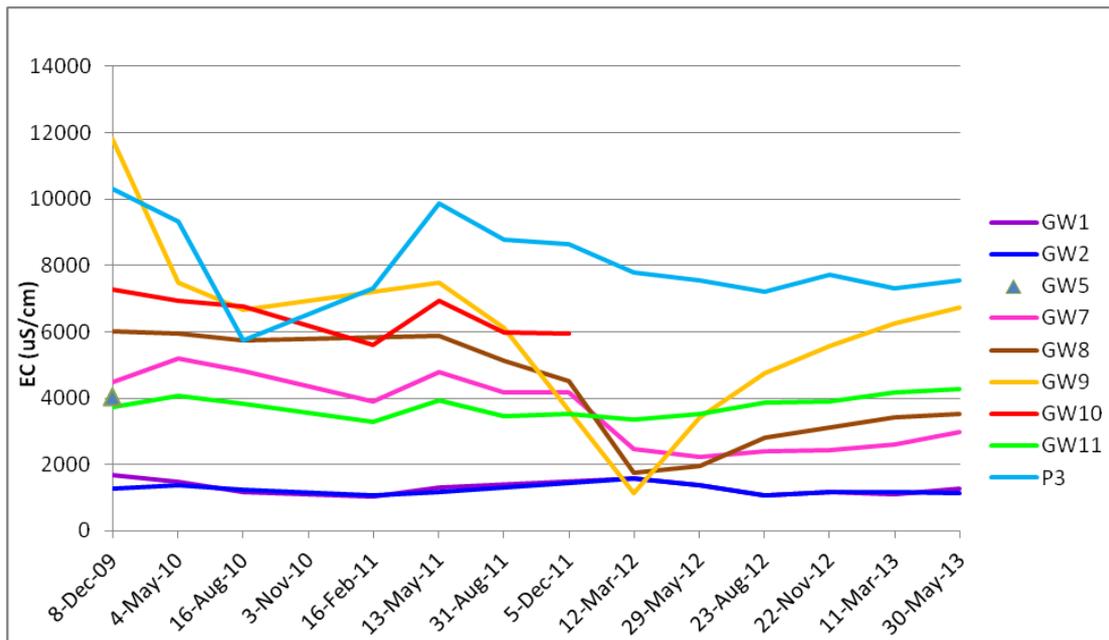
Figure 5 - Groundwater Electrical Conductivity (2009 - 2013)

Figure 5 shows a drop in EC levels since mine closure at some monitoring locations, however there has been a trend of increasing EC levels (particularly at GW7, GW8, GW9 and GW11) in the last twelve months. This may be attributable to the reduced rainfall compared to the previous few years. Ongoing EC trends will continue to be monitored for identification of long term trends.
