**Closure Plan Update/Annual
Environmental Management Report**

**Canyon Coal Mine
(MLs 1464 and 1471)**

01 July 2013 – 30 June 2014

**Whitehaven Coal Mining Limited
Mine Closure Progress Report
for the
Canyon Coal Mine
(MLs 1464 and 1471)**

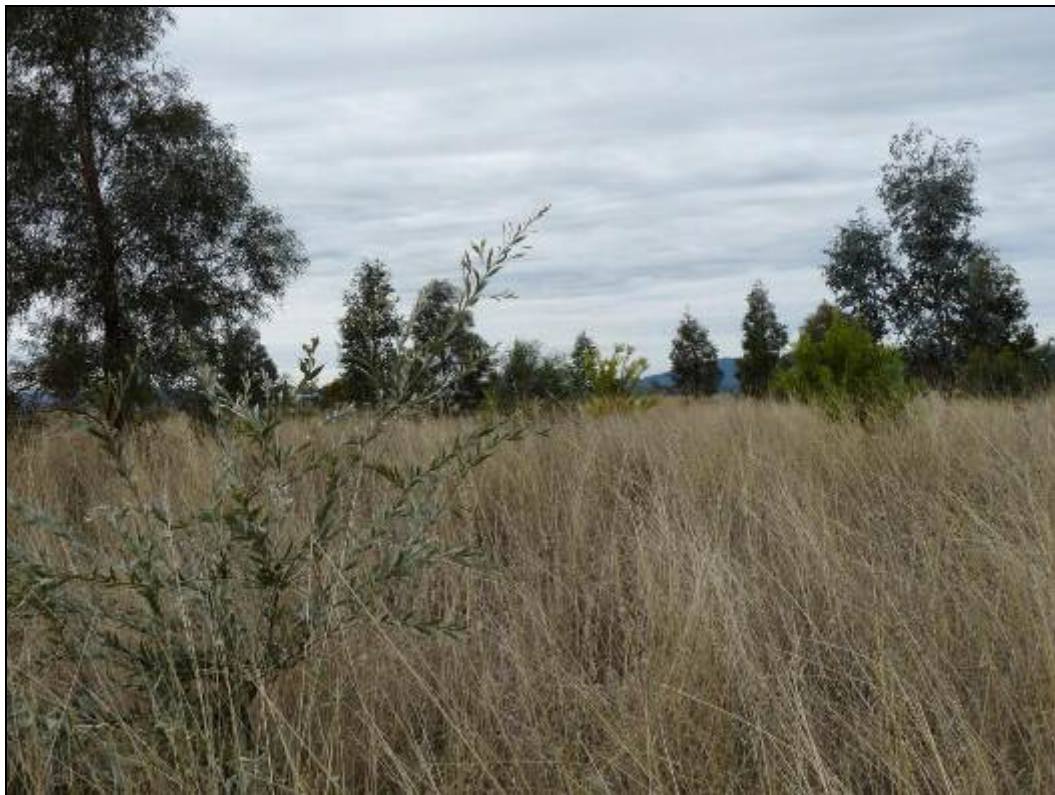
Plate 1 – Infill Understory Plantings, Zone 2(d) Native Vegetation

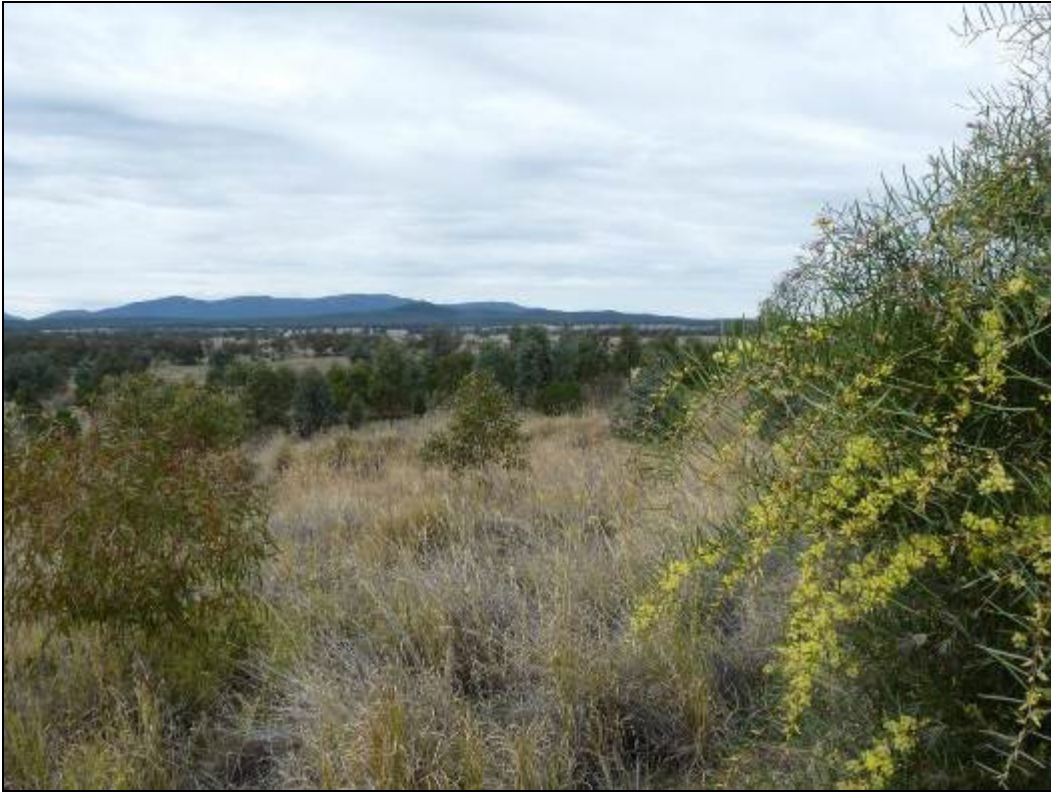
Plate 2 - Zone 2(d) Native Vegetation

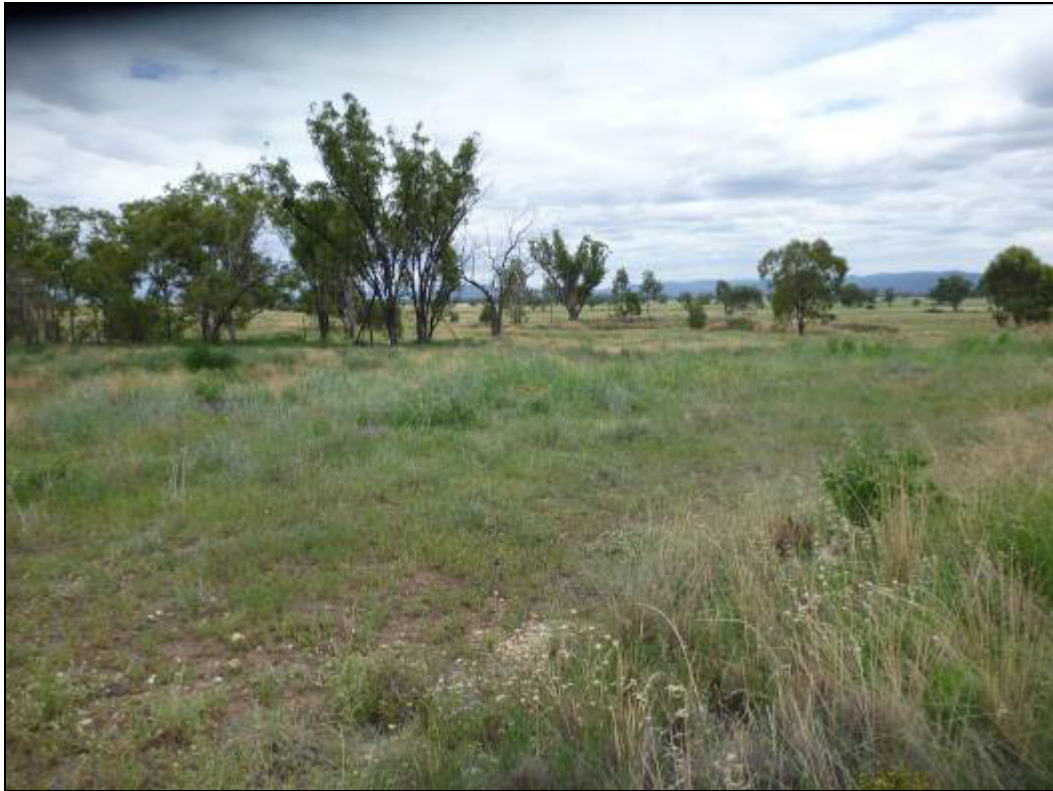
The crib and office facilities were removed in August 2010 with the exception of the toilet block, which is used by the environmental team and contractors associated with closure activities. The area, including the car park, was then topsoiled and seeded. Additionally, a small waterway was constructed to slowly drain away runoff into storage

dams to the east of this area. The former Orica hardstand is yet to be rehabilitated, as it currently provides a useful safe stopping area for haul trucks on the passing haul road.

Plate 3 - Zone 1(a) - Former Office and Crib Facilities

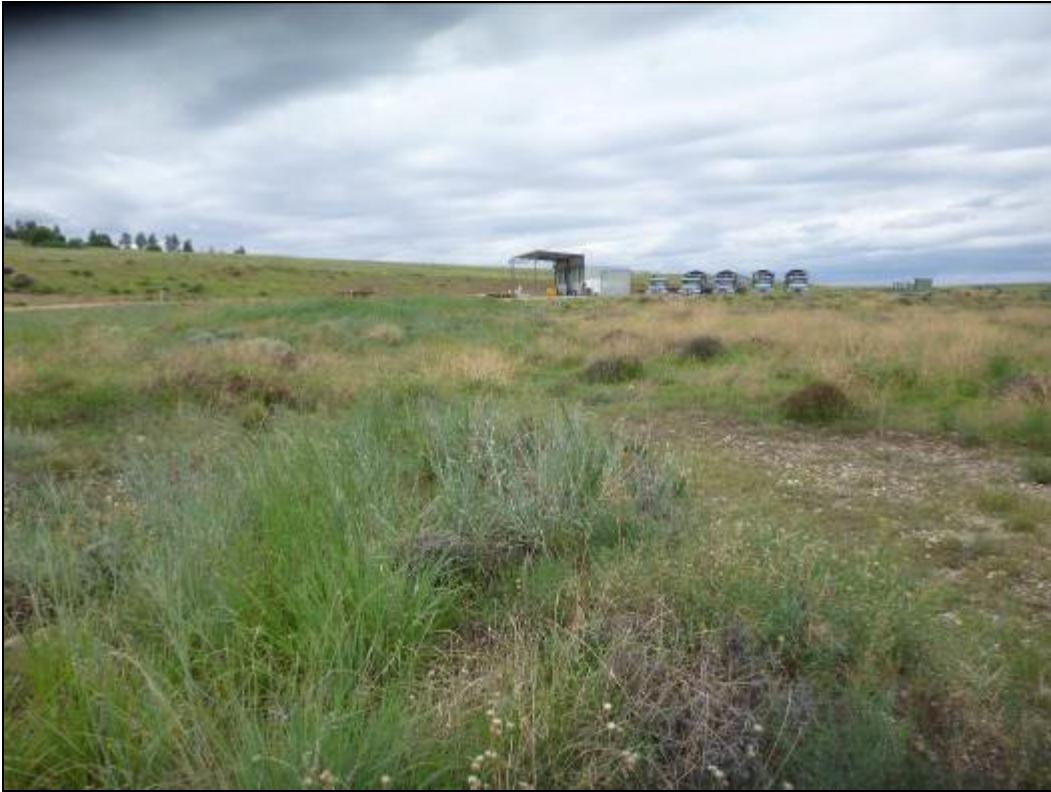
In mid 2010, the two 50,000L diesel storage tanks were removed from the bunded area which had a capacity of 240,000L. The bunded area, which also contained stored oils, incorporated a clay over plastic over clay liner to minimise the potential of soil contamination in the event of a spill. Pipes and lockable valves were in place to enable removal of spills and rainwater from the area.

On 18th August 2010, soil testing for hydrocarbon contamination was conducted around the old fuel storage area which comprised collecting soil samples from 8 separate pits. Soil samples were taken at the surface, 1m and 2m intervals from pits dug out by a backhoe. Four pits were located around the fuel storage area, one within the storage area and the remaining three down slope of the site to determine whether there has been any soil contamination away from the direct location. These samples were tested for total metals, recoverable metals and total petroleum hydrocarbons.

Analysis of the soil samples was conducted by ALS Laboratory Group Environmental Division in Sydney. Results of the sampling indicated that in two locations the levels of C10 – C36 Fractions of Hydrocarbons (Diesels and Lubricating Oils) exceeded the threshold concentrations for sensitive land use set in the NSW EPA Guidelines for

Assessing Service Station Sites (2004). Heavy metals analysis indicated all samples were well within threshold limits.

The former workshop has been decommissioned to the basic structure, as a potential agricultural shed for future land use on the site. The hardstand and storage area has had all mining related stores removed. The wash down sump has had an oil and grease analysis completed, with results indicating all parameters within compliance levels.

Plate 4 - Zone 1(b) - Workshop, Fuel Farm and Hardstand Area

Based on these results, the contaminated material was excavated and disposed of within a designated bunded area in September 2010 for future bioremediation. Following excavation of this material it was noted that contamination was present at greater depths than first identified. Subsequently, additional soil samples were collected to a depth of 2.5m, along with a resample of the two locations within the pit, to ensure all contaminated material was removed. Results of these sites found that contaminated material had been removed from all but one area (2 samples within the one large pit).

Wet weather hampered the continuation of remediation of the fuel storage area. When conditions permitted, the additional contaminated soil was excavated and stored in the bunded area onsite for bioremediation. Once bioremediated, the soil was disposed of offsite as general waste.

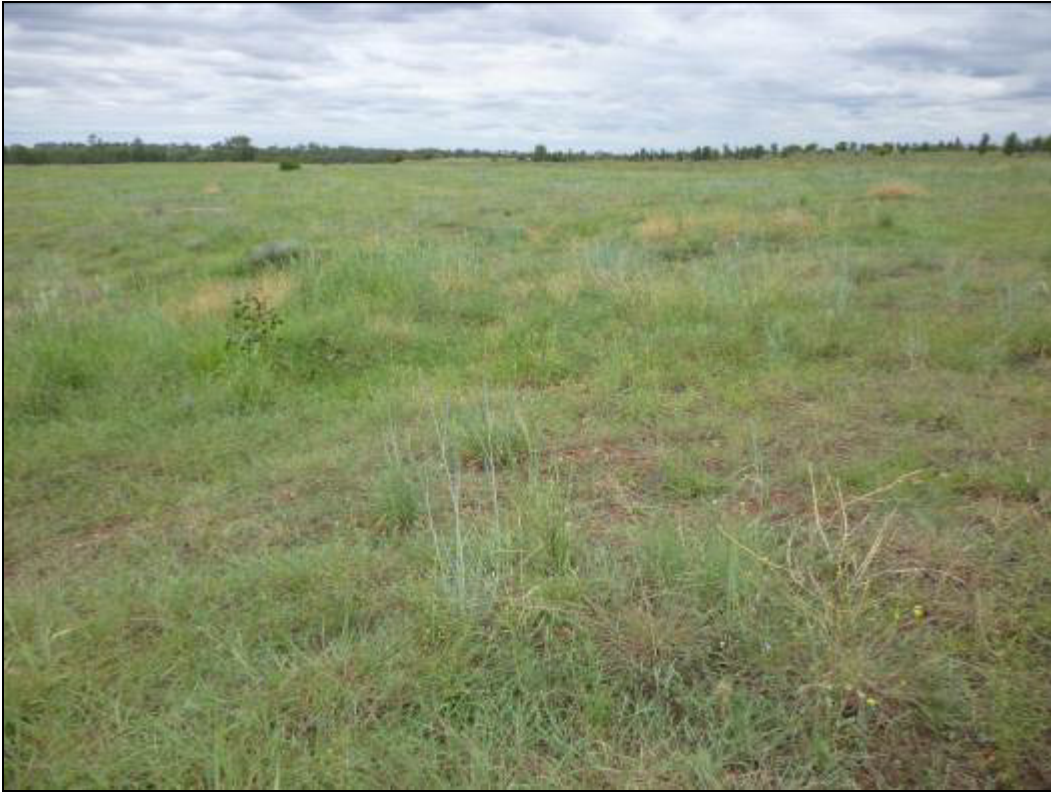
The removal of coal loader and associated infrastructure was completed in September 2010, with the loadout bin being commissioned at Whitehaven's Sunnyside Coal Mine. The ROM pad and ROM facilities area totalled 7.5 ha and was reshaped, stabilised with contours and waterways for drainage, top-soiled and seeded with a summer pasture mix. The waterway spills into a rehabilitated area to the south of the pad that is designed to slowly drain runoff into the final void. This area has also been top-soiled and seeded with a summer pasture mix for prevention of erosion. Further planting of native trees in clump formations was undertaken in November 2011.

Plate 5 - Zone 1(c) - ROM Pad and Coal Loading Facilities

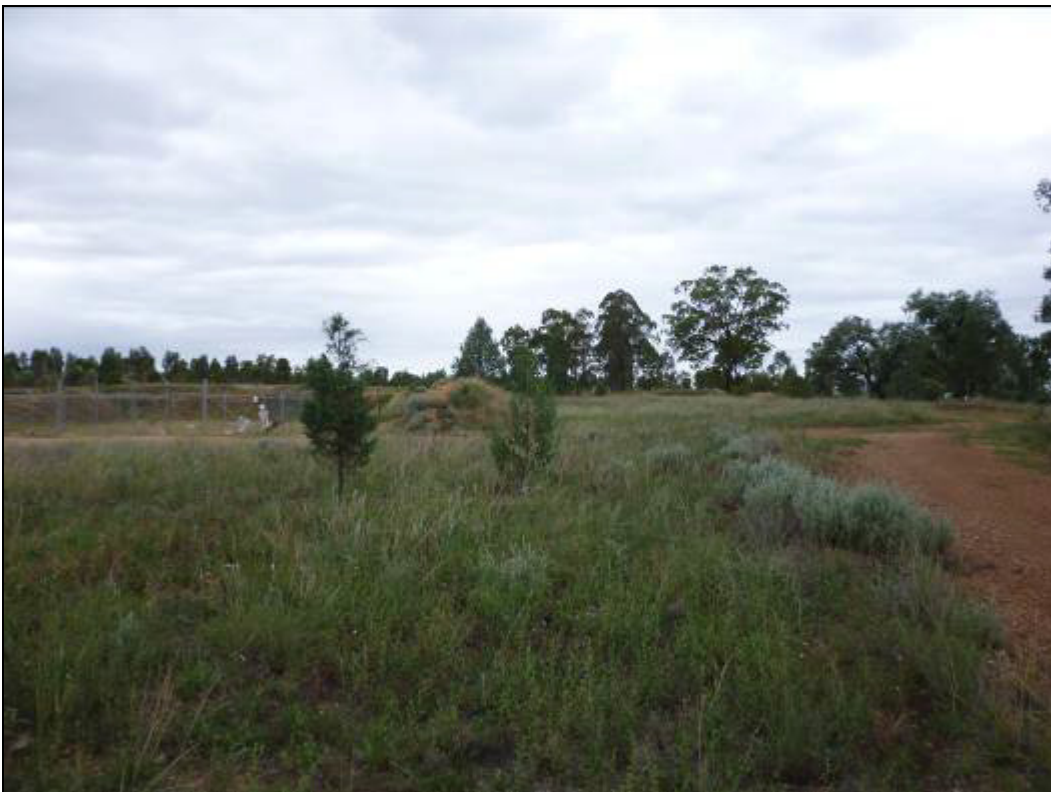
The explosives magazine has been partially rehabilitated with the removal of blast storage containers. Fence removal and reshaping/seeding of area is still to occur.

Plate 6 - Zone 1(d) - Explosives Magazine

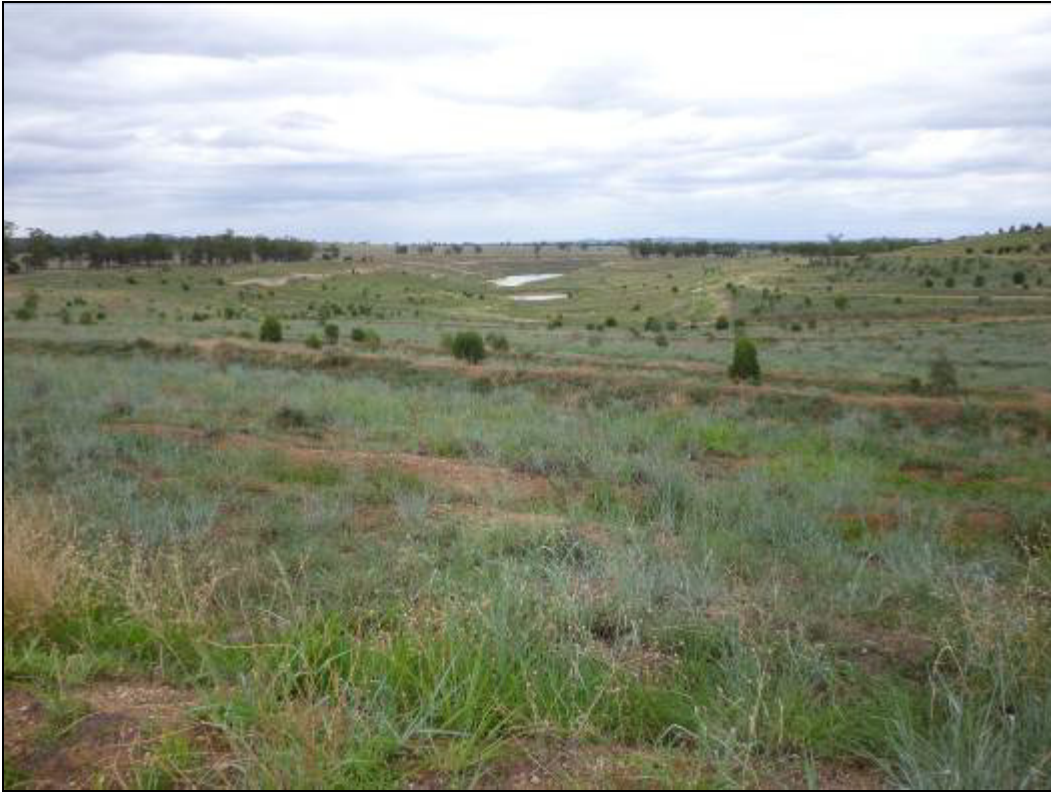
Although a summer cover crop consisting of predominately Japanese Millet was present in the void area, the intensity of rainfall events over late December 2009 and early January 2010 (a total of 184.6mm fell from the 22/12/09 – 3/1/10) resulted in numerous instances of gully erosion through contour banks and dam walls within the void. The major areas affected included the southern side of the void with three small instances of gully erosion through contours, and one small instance on the northern side of the void. A large channel was also eroded through the dam wall which was acting as a water velocity control structure in the lower void. These areas were further affected by 180.8 mm of rainfall over the following months of February and March 2010, creating major damage to the first void dam to the east with a large channel cut through the dam wall. In total an area of around 0.5ha was affected by erosion in the void.

As discussed previously, heavy rains in early 2012 resulted in new erosion on the southern face of the void. The area was remediated in late 2012 by Wards Earthmoving. Whilst works like this will occur as required, at this stage progression to final rehabilitation of the void have been delayed due to the pending Vickery Coal Project which will ultimately result in the Canyon void being backfilled with waste rock from the Vickery Project. Plate 14 and Plate 15 show the final void in January 2014.

Plate 14 - Zone 3 - Final Void (Photo 1)

Remediation work began in May 2010 with dozer contractors patching the problematic areas and reseeding with a winter cover crop consisting of predominately Rye Corn to further stabilise the soil. Major work occurred on the dam entering the void (to the east) with the wall filled and enlarged to incorporate a new rock lined spillway turfed with kikuyu grass. This work has prevented further instances of channelling through the dam wall and slowed water entering the void from the east, therefore reducing the chances of gully erosion through the lower water structures to the west. Works on the southern side of the void were also undertaken and included shaping and seeding of steeper slopes that were previously left due to access issues.

Earthen mounds were installed in June 2010 within the void to provide an alternative to rip-lines and were anticipated to be incorporated into future tree planting campaigns. Mounds also provide further stability within the void slope acting as smaller intermediate contours between larger contours, catching water runoff and therefore providing moisture to developing tubestock.

The approximate 35.9 ha of the void was re-seeded in September 2010 with a summer pasture mix to provide further stability on void slopes. The seed mix consisted of 250kg of Japanese Millet, 50kg Bambatsi Panic, 50kg Purple Pigeon Grass and 50kg Premier Digit Grass, which equates to approximately 11kg/ha of pasture. The new crop was required to replace the annual winter species crop and was particularly important in the prevention of erosion of slopes during summer storms.

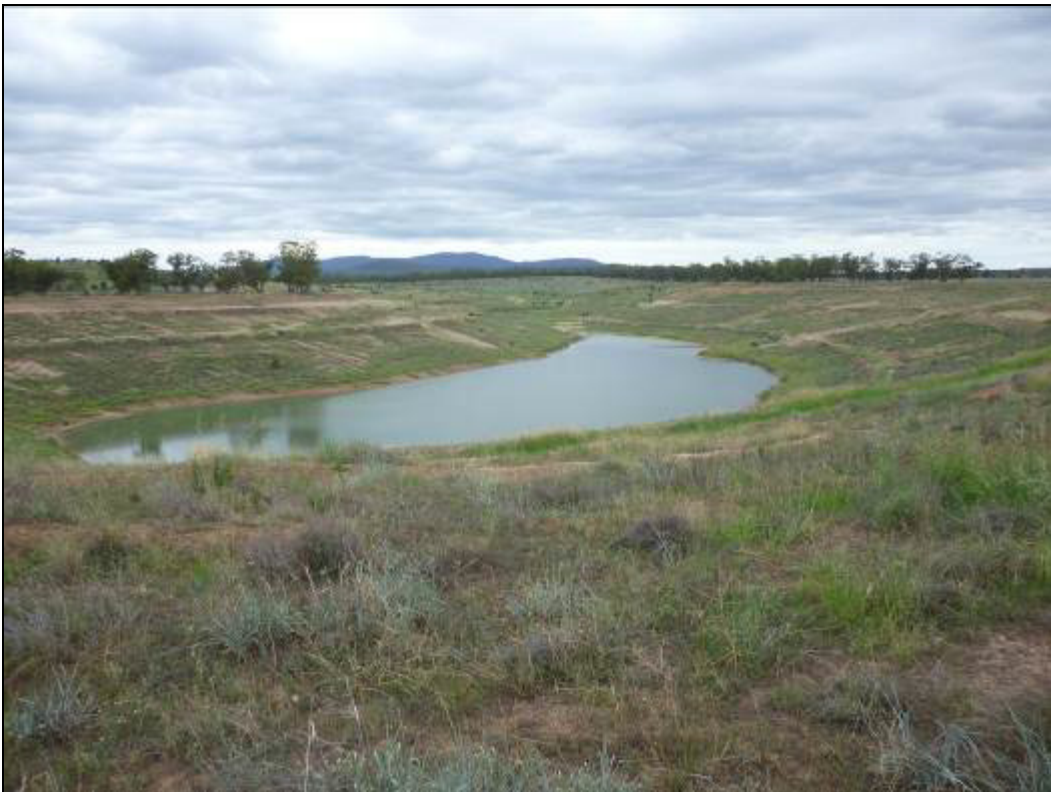
Plate 15 - Zone 3 - Final Void (Photo 2)

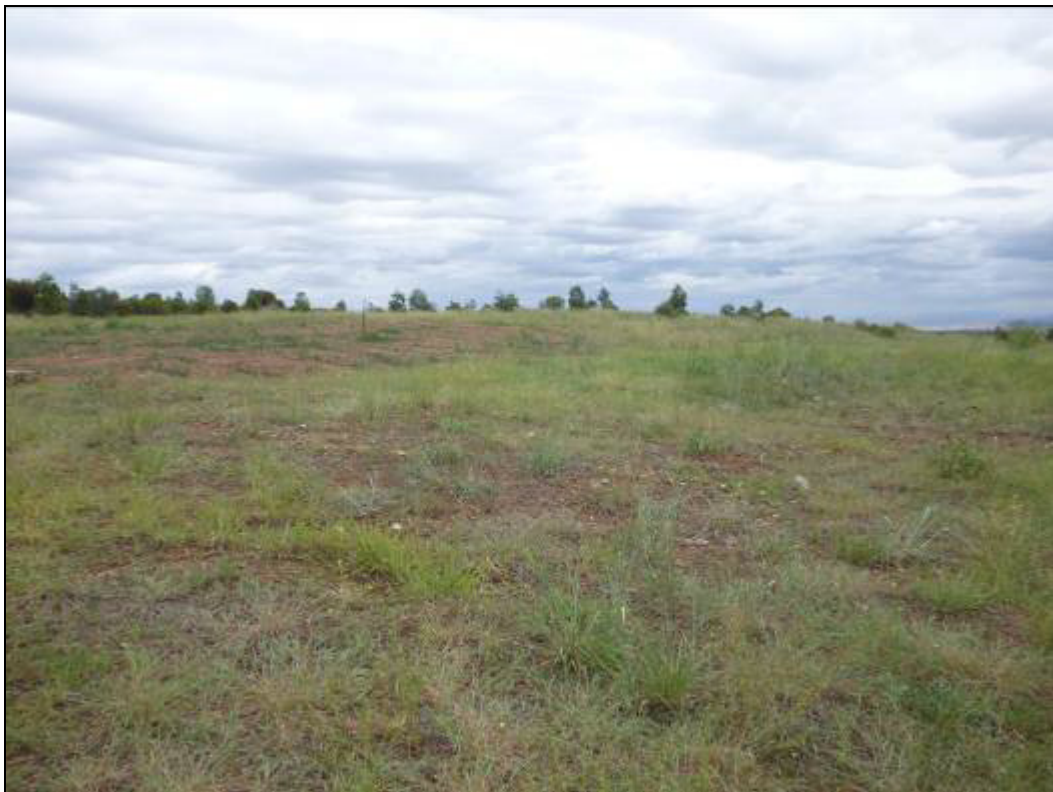
Both reject emplacement 1 (north), Plate 16, and 2 (south), Plate 17, areas have been filled, reshaped, top-soiled and seeded with summer pasture mix during September 2010.

Plate 16 - Zone 5(a) - Emplacement Area 1

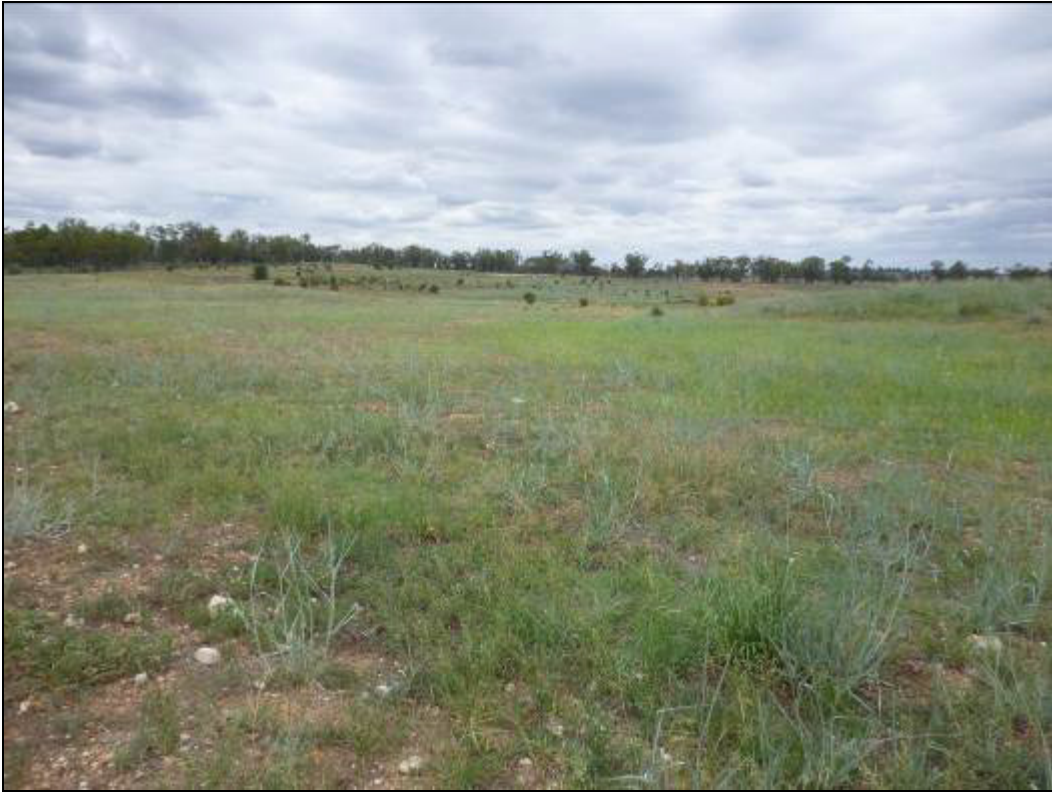
Plate 17 - Zone 5(b) - Emplacement Area 2

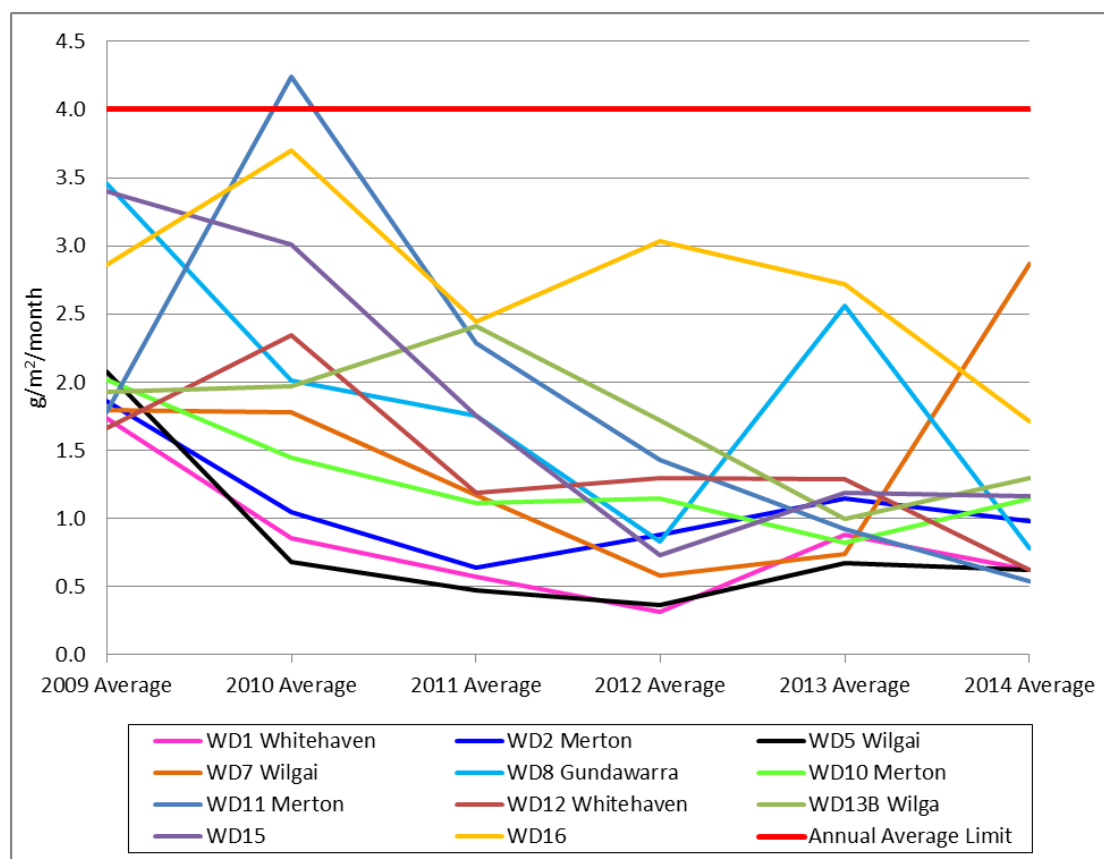
Figure 1 - Annual Average Deposited Dust Results

Figure 1 shows the annual average for each monitoring point since July 2009, compared with the consent limit of $4\text{g/m}^2/\text{month}$. It should be noted that September 2009 results have been excluded from the graphed data for all monitoring locations as these results were skewed by regional bushfires. December 2010 and January 2011 deposited dust results have also been excluded from WD-13B Womboola as they were highly anomalous with results from that monitoring location during other months as well as results from other monitoring locations during December and January.

The graph shows that all monitoring locations have generally remained below the annual average criteria of $4\text{g/m}^2/\text{month}$ since mining ceased in mid 2009. The overall trend of the data shows that deposited dust levels are generally remaining at low levels around the Canyon site and are continuing to fall as a consequence of established groundcover across all rehabilitated areas.

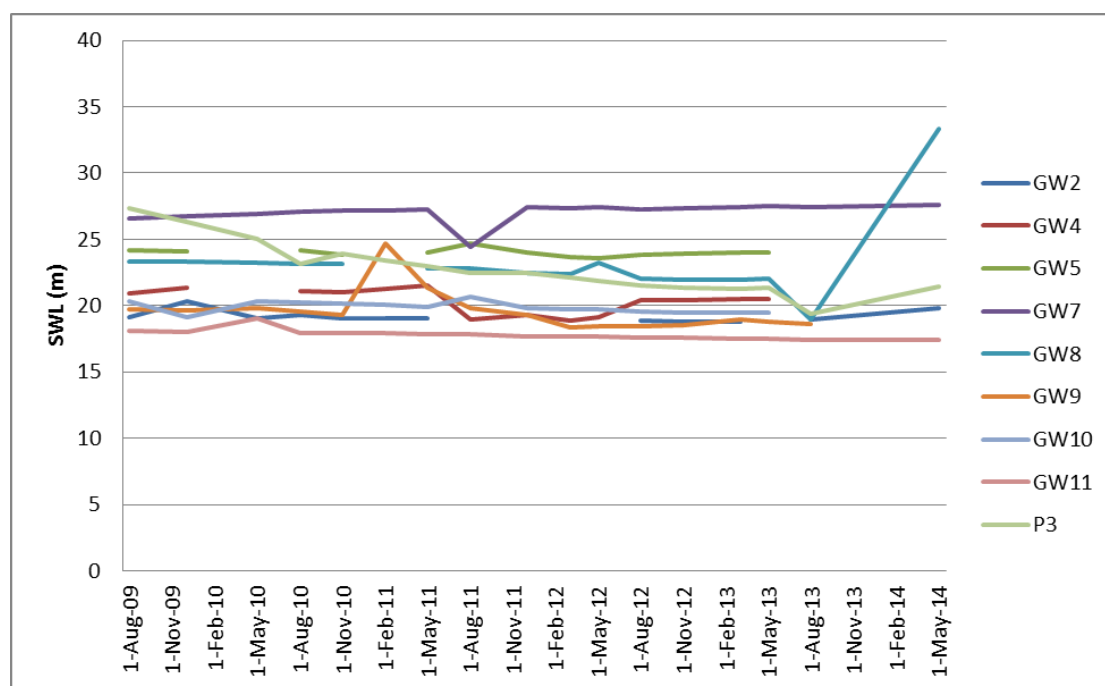
Figure 2 - Standing Water Level (2009 - 2014)

Figure 2 shows the SWL at all monitoring locations, with the exception of GW8, has remained very consistent throughout the period July 2013 to June 2014. Any variations in SWL at this stage are considered to be influenced by non-mining activities or seasonal variation.

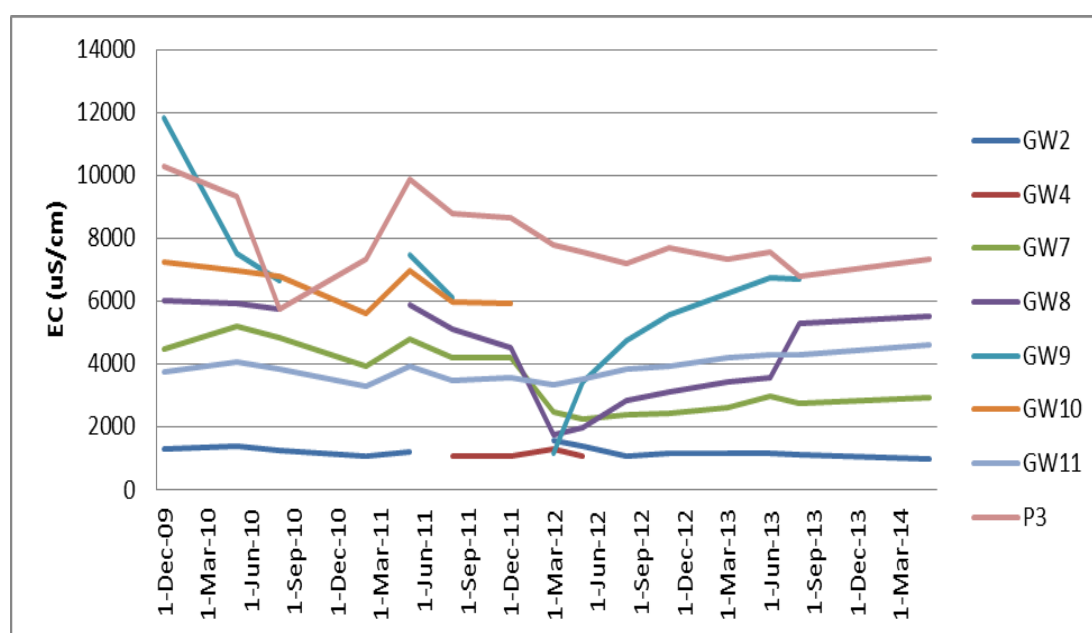
Figure 3 - Groundwater Electrical Conductivity (2009 - 2014)

Figure 3 shows a drop in EC levels since mine closure at some monitoring locations, however there has been a continued trend of increasing EC levels (particularly at GW7, GW8, and GW11) in the last twelve months. This may be attributable to the reduced rainfall compared to the previous few years. Ongoing EC trends will continue to be monitored for identification of long term trends.
