## Environmental Event Report

### Narrabri Underground Mine Stage 3 Extension Project

### Surface Water Trigger Investigation Report – May 2026

Narrabri Coal Operations Pty Ltd

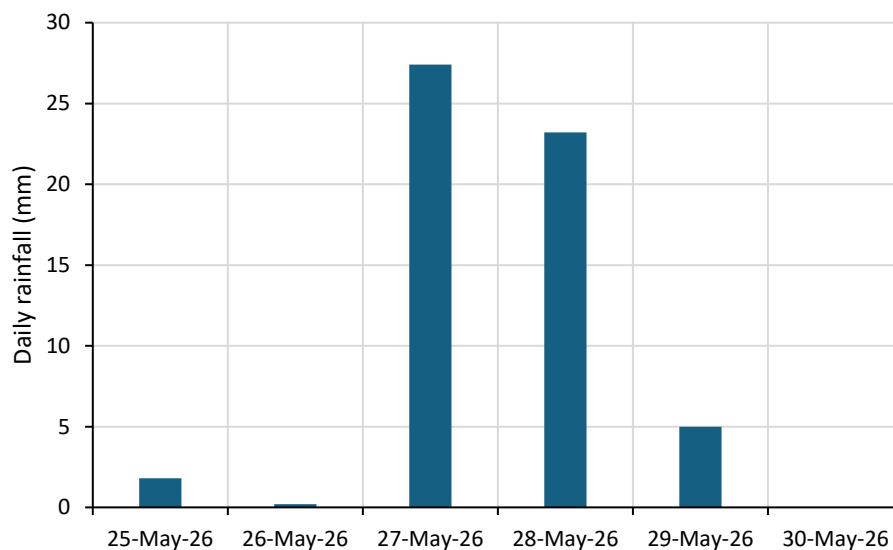
**Figure 2.1 – Daily rainfall totals – site rainfall station**

Sub-daily rainfall is recorded at the NCO AWS. The daily rainfall totals that fell in the period around the exceedance is presented in Figure 2.1, which shows that the total recorded rainfall that fell over the period between 25 and 29 May 2026 was 57.6 mm. This confirms that the 5-day rainfall event trigger (38.4 mm) was exceeded prior to the exceedance on 29 May 2026.

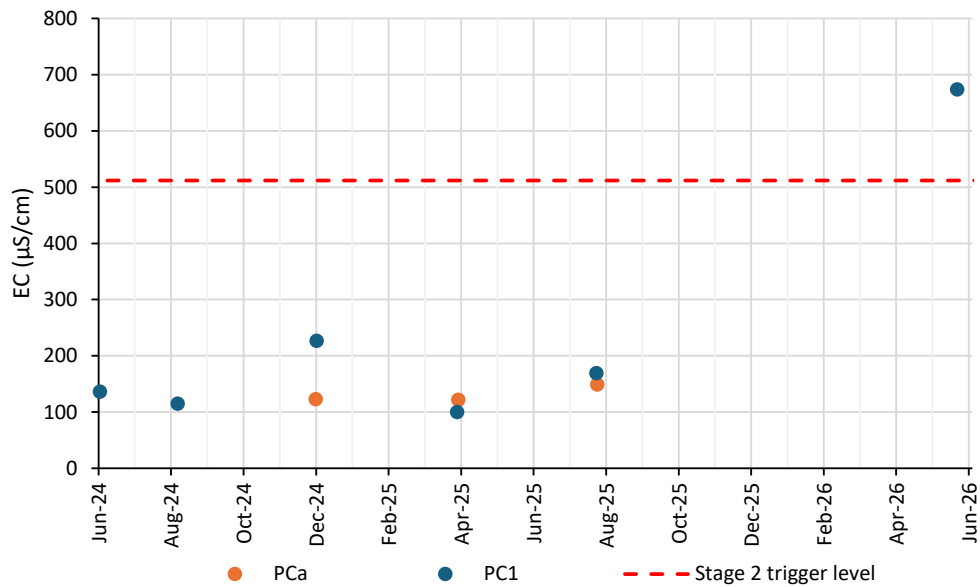
**Figure 2.2 – Long-term Electrical Conductivity readings in Pine Creek**

Figure 2.2 shows the long-term EC levels recorded at PC1 and PCa (located on Pine Creek upstream of the mine, but on a different streamline than PC1) across the last 2 years. Figure 2.3 shows the long-term TOC levels at PC1 and PCa. The LW101 panel has been subsided during the full 2-year period of record. The following is of note:

- **Electrical conductivity:**
  - The EC levels in Pine Creek are generally low in the 2 years prior to the May 2026 flow event, consistently below 230  $\mu\text{S}/\text{cm}$  across PC1 and PCa.

- The PC1 May 2026 reading appears to be elevated compared to the historical trend, appearing to be somewhat anomalous.
  - The recorded PC1 and PCa EC levels are generally similar across the 2 year period of record in instances where both PC1 and PCa samples were collected.

- **Electrical conductivity:**
  - **“First flush” conditions:** The May 2026 rainfall was the first significant rainfall event since December 2025. This allowed contaminants to naturally accumulate within the creek catchments during the dry period. The flows after the prolonged dry period (referred to as the “first flush”) typically collect the accumulated contaminants and may cause a brief spike in downstream concentrations. It is likely that first flush conditions during the May 2026 flow event contributed to the elevated readings at PC1 and KC1DS.

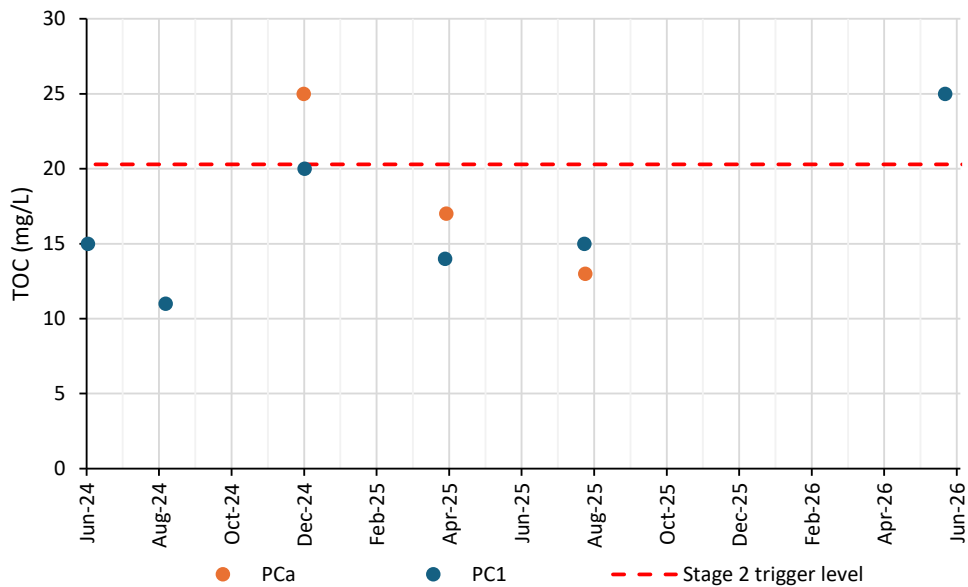
**Figure 2.3 – Long-term Total Organic Carbon readings in Pine Creek**

- No reading was collected at PCa in May 2026.
- **Total organic carbon:**
  - The TOC levels in Pine Creek range between 9 mg/L and 25 mg/L in the 2 years prior to the May 2026 flow event. The highest reading (25 mg/L) in the past 2 years was recorded at PCa in December 2024.

- The PC1 May 2026 reading appears to be within the range of typical values observed in Pine Creek.
  - The recorded PC1 and PCa TOC levels are generally similar across the 2 year period of record in instances where both PC1 and PCa samples were collected.

- **Total organic carbon:**
  - **Consistent with historical trends:** The TOC levels at PC1 and KC1DS recorded on 29 May 2026 are generally consistent with the historically recorded levels in Pine Creek and Kurrajong Creek, respectively.

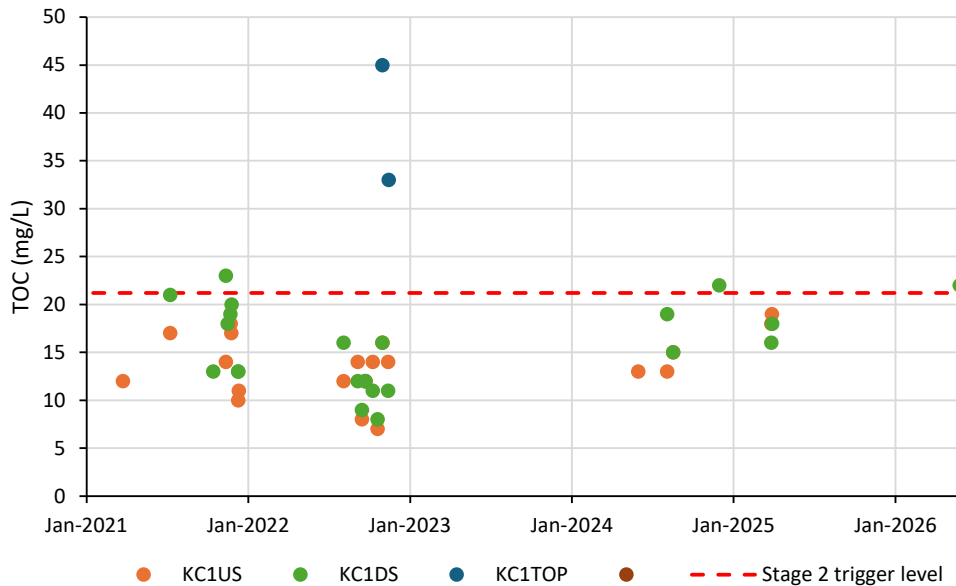
**Figure 2.4 – Long-term Total Organic Carbon readings in Kurrajong Creek**

Figure 2.2 shows the long-term TOC levels recorded at KC1DS, KC1US and KC1TOP across the last 5 years. The following is of note:

- The TOC levels in Kurrajong Creek range between 2 mg/L and 45 mg/L in the 5 years prior to the May 2026 flow event. The highest reading (45 mg/L) in the past 5 years was recorded at KC1TOP in November 2022.
- The KC1DS May 2026 reading appears to be within the range of typical values observed in Kurrajong Creek.

- The recorded KC1US and KC1DS TOC levels are generally similar across the 5 year period of record in instances where both upstream and downstream samples were collected. The KC1TOP readings appear to be elevated in comparison to the KC1US and KC1DS readings.
- No readings were collected at KC1US or KC1TOP in May 2026.
