Annual Review Rocglen Coal Mine

Name of operation	Rocglen Coal Mine
Name of operator	Whitehaven Coal Mining Pty Ltd
Development consent/project approval number	PA 10_0015
Name of holder of development consent/project approval	Whitehaven Coal Mining Pty Ltd
Mining lease number	ML 1620, ML 1662
Name of holder of mining lease	Whitehaven Coal Mining Pty Ltd
Water licence number	WAL29461 and WAL 36758
Name of holder of water licence	Whitehaven Coal Mining Pty Ltd
MOP start date	31 March 2019
MOP end date	30 March 2022
Annual review start date	1 st January 2020
Annual review end date	31 st December 2020
	1

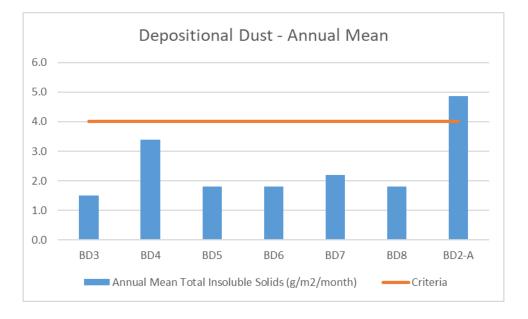
Figure 3 - Annual average depositional dust

A review of the above, shows that the annual average limit for deposited dust was below the set criteria at all sites except BD2-A (Penryn). High dust insoluble solid readings of readings of 30 and 14.6 g/m²/month were recorded in January and February 2020 respectively. The high reading were due to regional dust storms and bushfires as well as large number of sheep in the paddock with the monitor. January had an ash content of 26.4%.

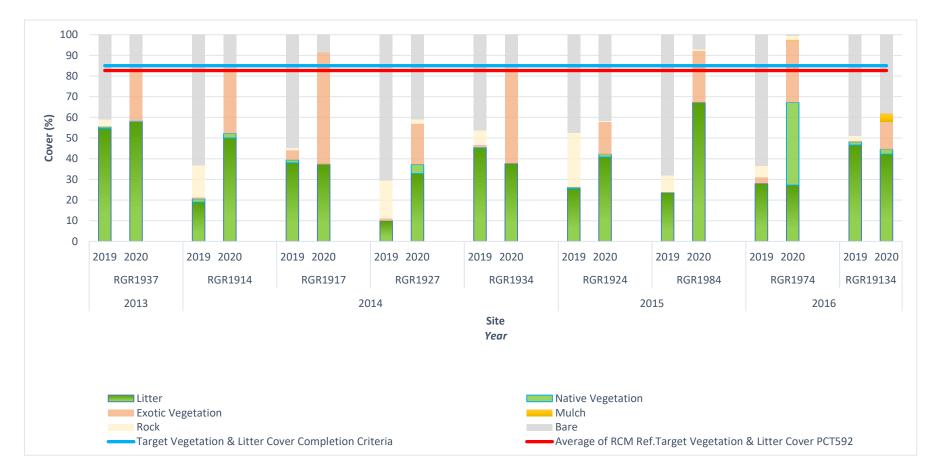
Figure 16 Average Percentage Cover of Groundcover Components within each Woodland Domain Rehabilitation Year at Rocglen Coal Mine, comparing the 2019 and 2020 Monitoring Seasons.

Native vegetation, leaf litter and mulch are collectively termed "vegetative surface cover" (CMOP tbl 18 & 26). The completion criteria state that vegetative surface cover is to be greater than 85% (CMOP tbl 18). As exotic vegetation is at odds with the Woodland Domain objective, only the combined contribution of litter and native vegetation was assessed as contributing to the cover target. This minimum target is very close to the average across the 2020 analogue site average of 82.6% (±2.9%—**Figure 16**).

Among rehabilitation sites assessed in 2020, vegetative surface cover (excluding living exotic vegetation) ranged between 37.6% (±4.1%) at the 2014 site RGR1934, and 67.2% (±6.4%) at the 2015 site RGR1984 (**Figure 16**). This latter site also saw the greatest year-to-year increase (43.6%). All other sites saw increases in vegetative surface cover also, apart from the 2014 sites RGR1917 which remained similar to 2019, and RGR1934 which decreased by 8.8%. All values were below the minimum completion criteria value of 85%.

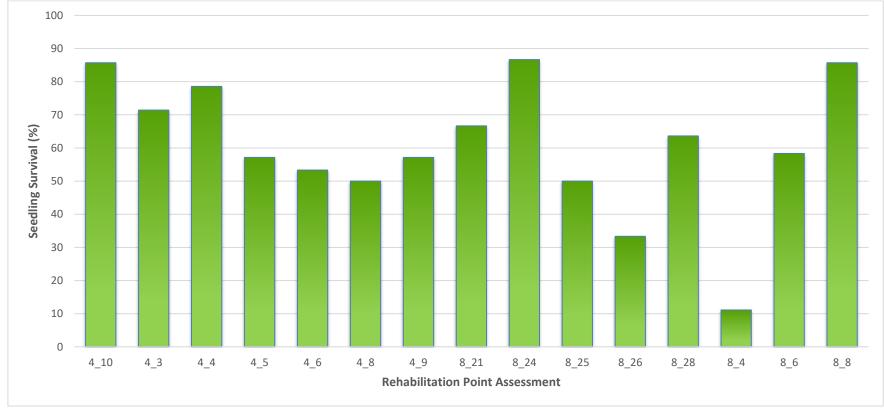
Figure 20 Seedling Survival Estimates based on RPAs within the Woodland Domain at Rocglen Mine

The RPA methodology (Aspect Ecology 2020a) was modified to incorporate an assessment of tree seedling survival. This methodology was applied to areas of the conservation domain planted with seedlings in 2020. Seedling survival was estimated to be at or above 50% for all 2020 plantings, with the highest being at 87% and the overall average survival estimated at 61% (Error! Reference source not found.).

The RPA methodology (Aspect Ecology 2020a) indicated that 42% of the areas represented by RPA sites did not require any treatment at this stage (**Table 6.2.2b**). For close to a half the locations, supplementary plantings of tree seedlings is recommended. Slightly over 10% of areas were deemed to be failing and therefore ploughing and reseeding is warranted.
