Goonbri Creek Stream Condition Survey Report

ARRAWONGA COAL PROJECT

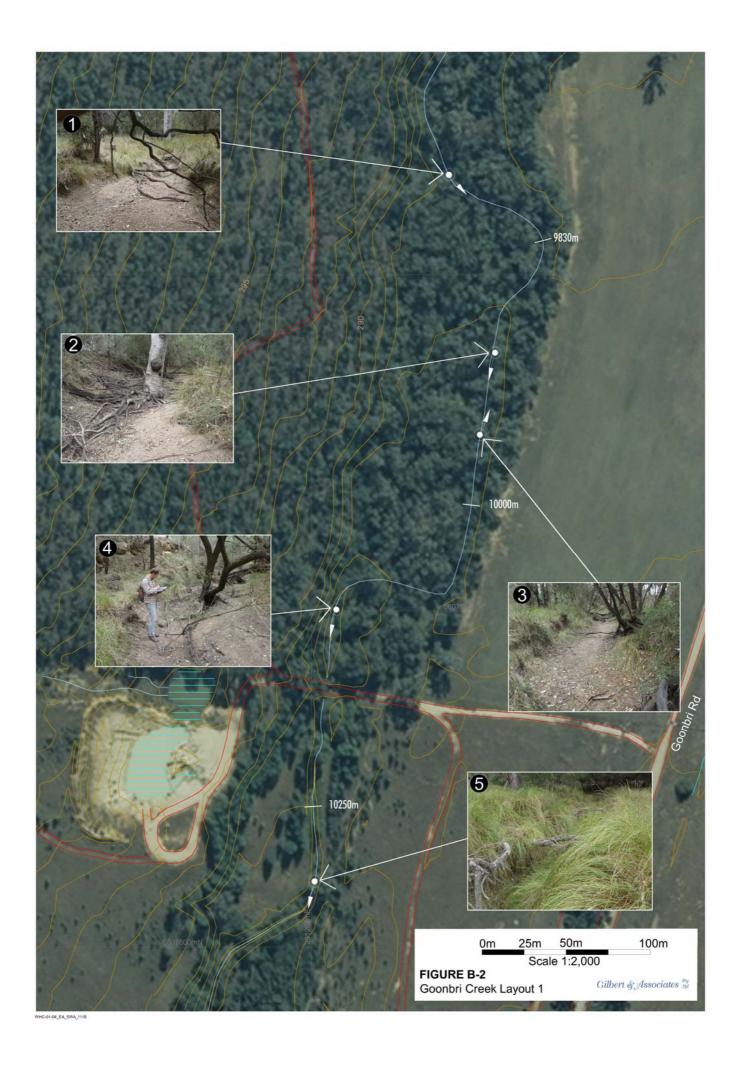
Reach	Plan Form of Channel	Channel Geomorphology	Channel Geometry	Bed Materials	Vegetation Community	Other Vegetation	Adjacent Land Use	Photo Number	Comments
I	Low sinuosity, relatively straight	Relatively stable, some lateral erosion evident	CWT - 6.8m LBH - 1m RBH - 1m CWB - 2.5m	Gravelly sandy bed	Forest with vegetation community predominantly composed of White Cypress Pine and Narrow-leaved Ironbark	Sedge grasses on both banks	State Forest	1	Incised channel with exposed roots
I	Low sinuosity, relatively straight with gradual bend	Relatively stable, some lateral erosion evident	CWT - 7m LBH - 3m RBH - 1.2m CWB - 3m	Gravelly sandy bed	Forest with vegetation community predominantly composed of White Cypress Pine and Narrow-leaved Ironbark	Sedge grass grows in hummocks on RB Open pasture above LB	State Forest	2	V shaped channel
I	Low sinuosity, relatively straight with gradual bend	Relatively stable, some lateral erosion evident	LBH - 1m RBH - 3m with 4m terrace CWB - 1.8m	Sand prevailing	Forest with vegetation community predominantly composed of White Cypress Pine and Narrow-leaved Ironbark	Sedge grasses on both banks Open pasture above RB	State Forest	3	Incised channel with exposed roots exposed bedrock escarpment with 3m terrace on RB

I	Low sinuosity, relatively straight with gradual bend	Bedrock on RB confining channel	Not measured, refer photo 4	Silty gravel with many exposed roots	Forest with vegetation community predominantly composed of White Cypress Pine and Narrow-leaved Ironbark	Tussock grass present in clumps on both banks and also in floodplain	State Forest	4	Incised channel with exposed roots
II	Low sinuosity, relatively straight with gradual bend	Relatively stable, some lateral erosion evident as slumping on edges of channel	CWT - 3m LBH - 1.8m RBH - 1.8m CWB - 1m	Silty sand bed with sand sheets between small bars	Predominantly open grassland with scattered stands of Blakely's Red Gum - Yellow Box - Rough-barked Apple - Belah - Paperbark vegetation community	Sedge grasses on both banks and floodplain	Past agricultural land with some regrowth	5	-

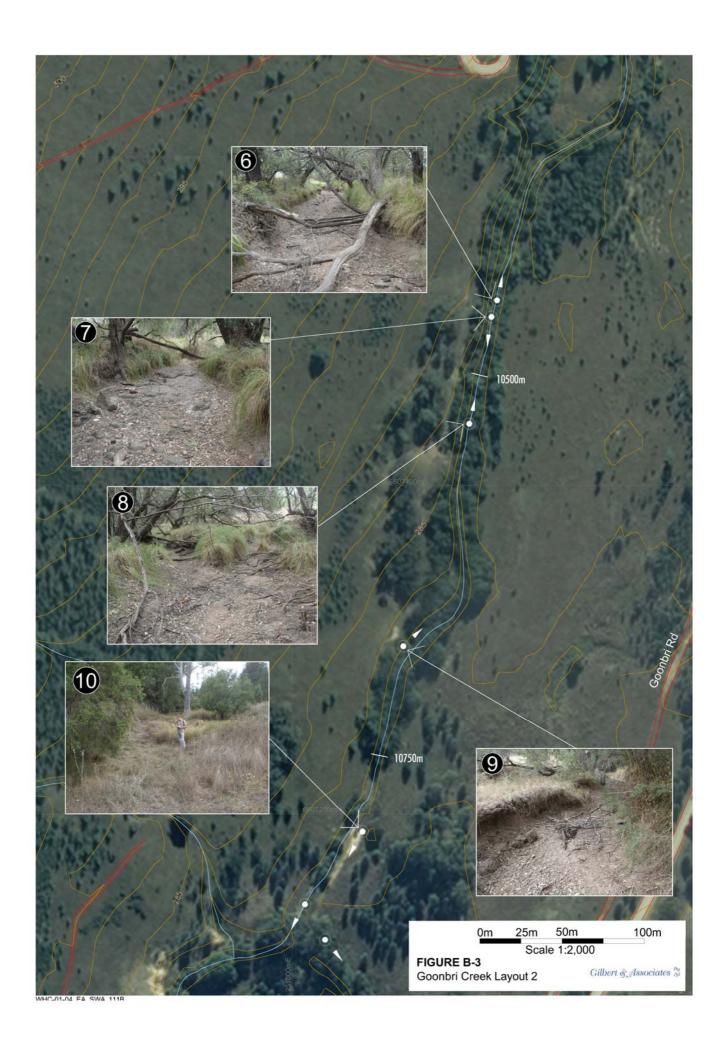
Reach	Plan Form of Channel	Channel Geomorphology	Channel Geometry	Bed Materials	Vegetation Community	Other Vegetation	Adjacent Land Use	Photo Number	Comments
II	Low sinuosity, relatively straight with gradual development of slight meanders	Lateral erosion and undercutting evident	CWT - 9.5m LBH - 2m RBH - 1.6m CWB - 3.1m Terrace - 10m length and 3m height	Cobbles and boulders on a sandy gravelly bed.	Predominantly open grassland with scattered stands of Blakely's Red Gum - Yellow Box - Rough-barked Apple - Belah - Paperbark vegetation community	Tufts and hummocks of Sedge grasses on both banks	Past agricultural land with some regrowth	6	Exposed roots on side of channel and in bed testament to continual bank and channel erosion
II	Relatively straight channel with bifurcated channel around island	Erosion and undercutting of banks evident	Incised channel on either side of island. Island 1.5m high LBH - 1.7m RBH - 3m	Exposed, jointed conglomerate sandstone bedrock in channel with some cobbles and sandy gravel present	Predominantly open grassland with scattered stands of Blakely's Red Gum - Yellow Box - Rough-barked Apple - Belah - Paperbark vegetation community	Tufts and hummocks of Sedge grasses on both banks Island timbered with grasses present	Past agricultural land with some regrowth	7	Continuing occurrence of exposed roots in channel bottom and banks.

II	Bifurcated channel rejoins main channel with continuing low sinuosity	Erosion and undercutting of banks evident	Left channel: LBH - 1m RBH - 1m CWB - 2m Island: 1.5m high and 15m long Right channel: LBH - 1.2m RBH - 1.2m CWB - 1.5m	Gravelly bed	Predominantly open grassland with scattered stands of Blakely's Red Gum - Yellow Box - Rough-barked Apple - Belah - Paperbark vegetation community	Tufts and hummocks of Sedge grasses on both banks	Past agricultural land with some regrowth	8	Exposed roots, leaf litter, felled trees from erosion and undercutting of banks and debris in channel
II	Straight channel with low sinuosity	Undulating channel with scour holes and undercutting of banks and some chute and pool formation	Not measured, refer photo 9	Sand and silt bed with large gravel present	Predominantly open grassland with scattered stands of Blakely's Red Gum - Yellow Box - Rough-barked Apple - Belah - Paperbark vegetation community	Tufts and hummocks of Sedge grasses on both banks	Past agricultural land with some regrowth	9	Gravel and sand bars between scour holes

II	Straight channel anabranch, now superseded by new more incised flow path	Evidence of past bank undercutting visible	Not measured, refer photo 10	Mixed alluvial sediments	Predominantly open grassland with scattered stands of Blakely's Red Gum - Yellow Box - Rough-barked Apple - Belah - Paperbark vegetation community	Tufts and hummocks of Sedge grasses on both banks and in channel	Past agricultural land with some regrowth	10	Dense vegetation in and around old channel which is now an anabranch to the new main channel

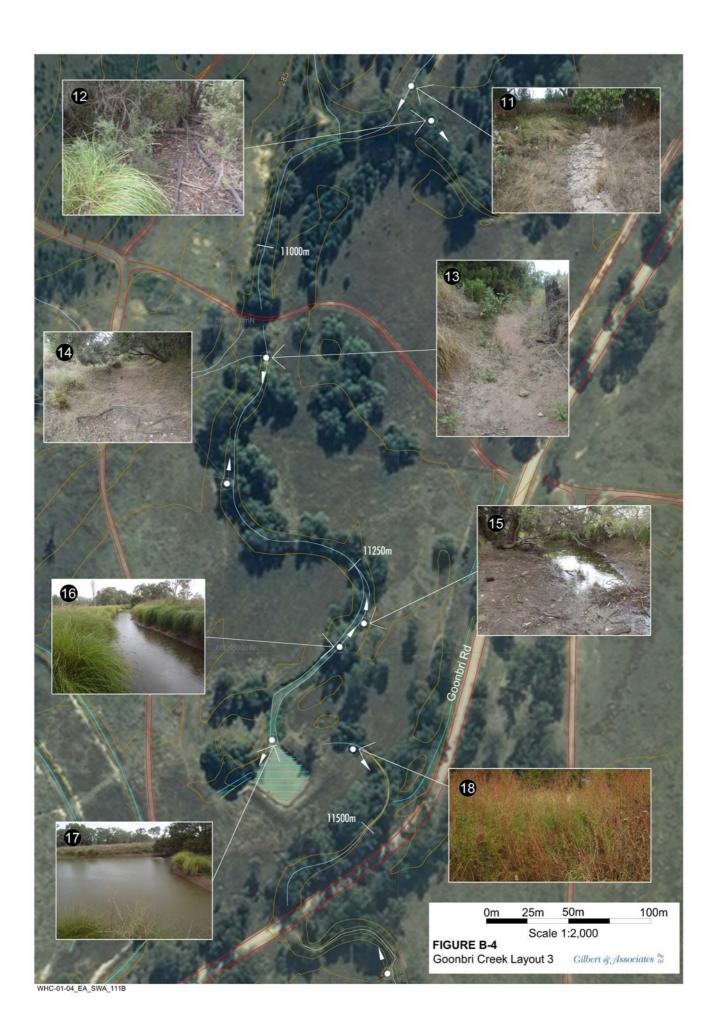
Reach	Plan Form of Channel	Channel Geomorphology	Channel Geometry	Bed Materials	Vegetation Community	Other Vegetation	Adjacent Land Use	Photo Number	Comments
II	Relatively straight, incised in sections	Minor erosion of banks visible	LBH - 0.6m RBH - 0.6m CWB - 1.5m	Exposed rock bed with soil	Predominantly open grassland with scattered stands of Blakely's Red Gum - Yellow Box - Rough-barked Apple - Belah - Paperbark vegetation community	Hummocks of tussock grass present in channel and on open outflow above channel	Past agricultural land with some regrowth	11	New channel supersedes old in smaller flow events
II	Straight with some erratic meanders	Laterally stable	Not measured, refer photo 12	Alluvials mostly covered with grassy regrowth.	Predominantly open grassland with scattered stands of Blakely's Red Gum - Yellow Box - Rough-barked Apple - Belah - Paperbark vegetation community	Hummocks of tussock grass present in channel and on open outflow above channel	Past agricultural land with some regrowth	12	Within treed sections bed is choked with branches and detritus, suggesting no recent flows New channel supersedes old in smaller flow events

II	Straight channel with moderate sinuosity and low amplitude of meandering present	Undulating channel with scour holes and undercutting of banks and some chute and pool formation.	CWT - 5.5m LBH - 1.8m RBH - 2m CWB - 1.6m	Silty with some sand in scour	Predominantly open grassland with scattered stands of Blakely's Red Gum - Yellow Box - Rough-barked Apple - Belah - Paperbark vegetation community	Hummocks of tussock grass present in channel and on open outflow above channel	Past agricultural land with some regrowth	13	More scour holes evident with increased distance downstream
II	Straight channel with a low amplitude meander	Pools and scour holes evident	Not measured, refer photo 14	Pool with gravelly bed, and a silty matrix	Predominantly open grassland with scattered stands of Blakely's Red Gum - Yellow Box - Rough-barked Apple - Belah - Paperbark vegetation community	Hummocks of tussock grass present in channel and on open outflow above channel	Past agricultural land with some regrowth	14	Alternating pools and scour holes in this section of creek

II	Asymmetrical channel with long straight pool	Pools and scour holes evident	CWT - 4m LBH - 1m RBH - 1m	Silty	Predominantly open grassland with scattered stands of Blakely's Red Gum - Yellow Box - Rough-barked Apple - Belah - Paperbark vegetation community	Thick tusks of Sedge grasses populate channel margin Trees in floodplain	Past agricultural land with some regrowth	15	Alternating long pools and silty bars
II	Symmetrical channel, relatively straight with pool	Long Pool, undercutting present	Not measured, refer photo 16	Silt matrix	Predominantly open grassland with scattered stands of Blakely's Red Gum - Yellow Box - Rough-barked Apple - Belah - Paperbark vegetation community	Sedge grass overhanging into pool, scattered Eucalypt species in floodplain	Past agricultural land with some regrowth	16	Alternating long pools and silty bars
II	Straight channel into farm dam	Long Pool, minor undercutting present	Not measured, refer photo 17	Silty	Secondary Grassland vegetation community	Sedge grasses on banks of farm dam	Past agricultural land with some regrowth	17	-

II	Channel modified due to farm dam spillway	Stable channel, section laterally unconfined	N/a no defined channel	Alluvials	Predominantly open grassland with scattered stands of Blakely's Red Gum - Yellow Box - Rough-barked Apple - Belah - Paperbark vegetation community	Various dense, tall grasses and herbaceous plants	Past agricultural land with some regrowth	18	Channel difficult to discern, area prone to flood out

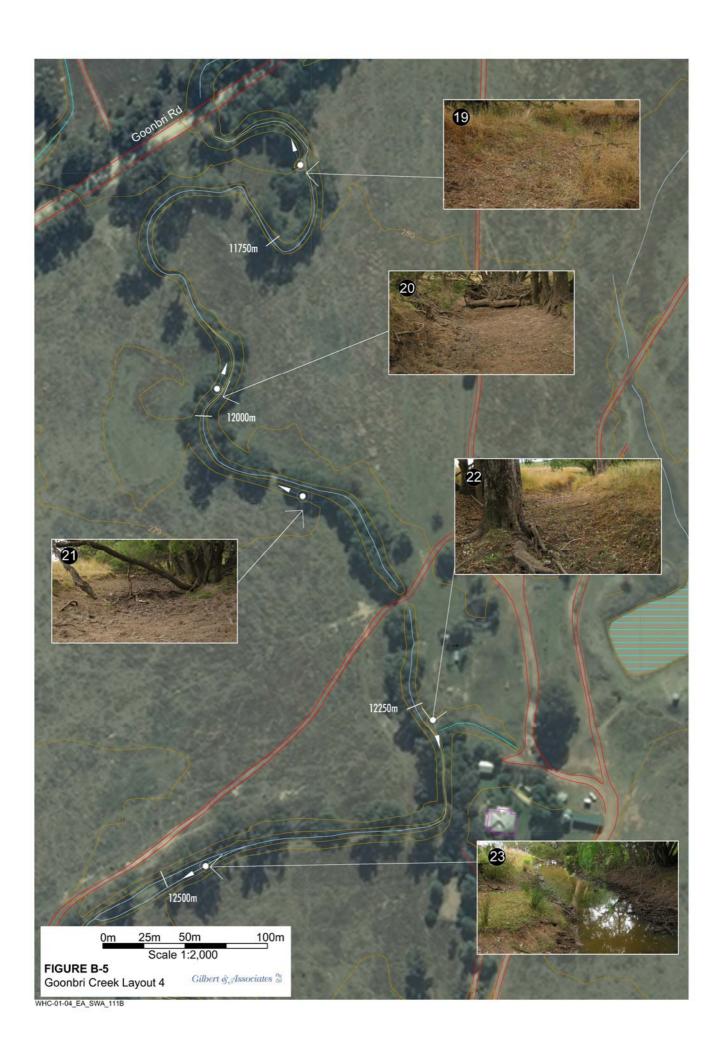
Reach	Plan Form of Channel	Channel Geomorphology	Channel Geometry	Bed Materials	Vegetation Community	Other Vegetation	Adjacent Land Use	Photo Number	Comments
Ш	Symmetrical channel with fully developed meanders and high sinuosity	Alternating scour holes and sandy bars, potential for continued channel expansion at meander	CWT - 9.5m (including terrace) LBH - 1.3m RBH - 2m CWB - 2m	Silty	Predominantly open grassland with scattered stands of Blakely's Red Gum - Yellow Box - Rough-barked Apple - Belah - Paperbark vegetation community	Cluster of various trees scattered alongside channel	Active cropping and pastures	19	In active paddock
Ш	Moderate sinuosity with meanders, asymmetrical channel with secondary bank on RB	Relatively laterally stable due to tree roots, some adjustment of channel possible	LBH - 1.6m RBH - 1.0m CWB - 2.7m Terrace 6.5m long and secondary RBH 1.3m	Silty	Predominantly open grassland with scattered stands of Blakely's Red Gum - Yellow Box - Rough-barked Apple - Belah - Paperbark vegetation community	Cluster of various trees in channel	Active cropping and pastures	20	-

III	Relatively straight and asymmetrical channel with slight bending of channel	Relatively laterally stable due to tree roots, some adjustment of channel possible	CWT - 6.8m LBH - 1.3m RBH - 1.2m CWB - 3.4m	Silty	Predominantly open grassland with scattered stands of Blakely's Red Gum - Yellow Box - Rough-barked Apple - Belah - Paperbark vegetation community	Cluster of various trees as mentioned above in channel	Active cropping and pastures	21	Increased proportion and size of erosion and depositional features within paddock areas
Ш	Moderate sinuosity with meandering, undulating channel with alternating scours/pools and deposition bars/riffles	Minor undercutting of banks present, scour holes and bed erosion visible	Not measured, refer photo 22	Silty	Predominantly open grassland with scattered stands of Blakely's Red Gum - Yellow Box - Rough-barked Apple - Belah - Paperbark vegetation community	Tall clusters of trees in riparian zone, native Plains grasses in outflow plain	Active cropping and pastures	22	Close to farm homestead

III	Symmetrical channel with straight channel sections with long pools	Stable channel with pool in long scour hole	Not measured, refer photo 23	Silty	Predominantly open grassland with scattered stands of Blakely's Red Gum - Yellow Box - Rough-barked Apple - Belah - Paperbark vegetation community	Trees lining channel, native Plains grass in outflow plain	Active cropping and pastures	23	Pool approximately 50m in length

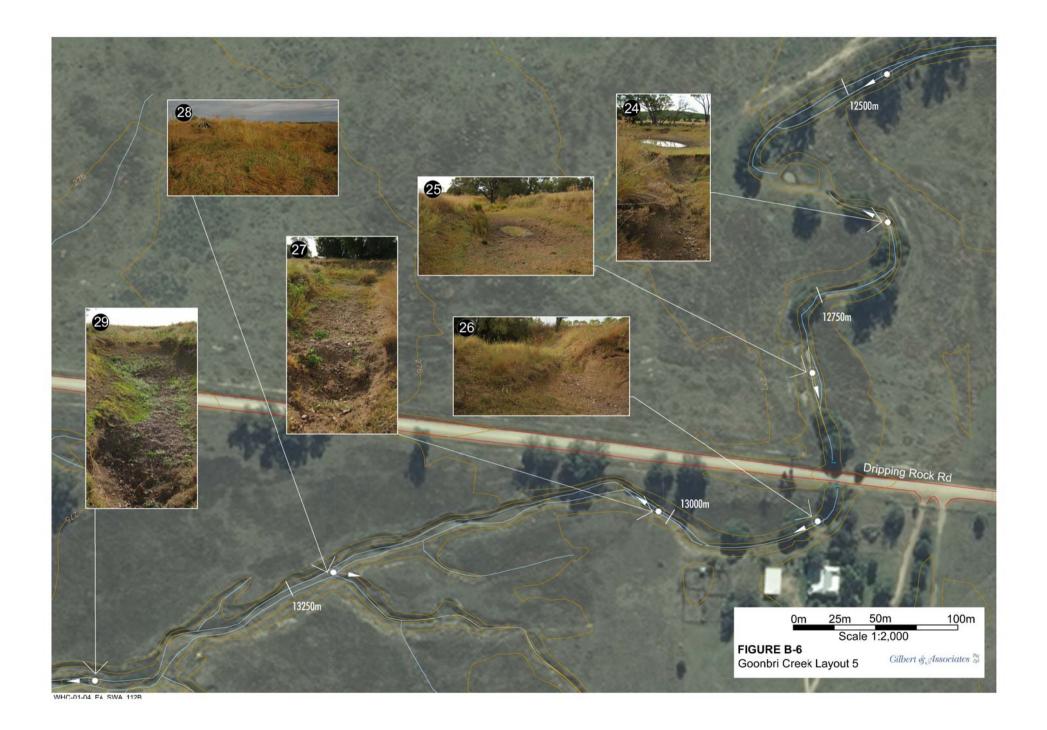
Reach	Plan Form of Channel	Channel Geomorphology	Channel Geometry	Bed Materials	Vegetation Community	Other Vegetation	Adjacent Land Use	Photo Number	Comments
III	Defined meanders with large amplitude	Laterally active section with bank erosion and deep localised scour holes present-	Not measured, refer photo 24	Mainly sandy silt, and cobbles on top of silt at high points	Secondary Grassland vegetation community	Open paddock with native Plains grass colonisation	Active cropping and pastures	24	Defined scour holes in this section of creek
III	Relatively straight with a symmetrical channel	Undulating channel with scour holes and undercutting of banks and some chute and pool formation.	Not measured, refer photo 25	Grassy bed in channel	Secondary Grassland vegetation community	Open paddock with native Plains grass colonisation	Active cropping and pastures	25	Alternating scour holes and deposition bars

III	Asymmetrical creek channel with moderate sinuosity	Laterally active section with deep scour holes and chutes between	Not measured, refer photo 26	Cobbles over sandy matrix	Secondary Grassland vegetation community	Open paddock with native Plains grass colonisation	Active cropping and pastures	26	Stable sloping RB, LB is terraced
III	Symmetrical channel approaching moderate amplitude meander	Minor undercutting of banks present, scour holes and bed erosion visible	CWT - 4.6m LBH - 2m RBH - 2m CWB - 2.3m	Sand with cobbles in scour hole	Secondary Grassland vegetation community	Open paddock with native Plains grass colonisation	Active cropping and pastures	27	Larger stones and cobbles in scour depressions
111	Low sinuosity, relatively straight with gradual development of slight meanders	Deep section of channel with slumping and scours visible	Not measured, refer photo 29	Grassy bed with sand and cobbles	Secondary Grassland vegetation community	Open paddock with native Plains grass colonisation	Active cropping and pastures	28	-

III	Asymmetrical creek channel with moderate sinuosity and bank terraces	Laterally inactive section, however deep alternating scour holes and bars	Pool/scour complex - 15m long, 7m width, 1.8m depth	Sandy silty with stones and some cobbles in scour	Secondary Grassland vegetation community	Open paddock with native Plains grass colonisation	Active cropping and pastures	29	-

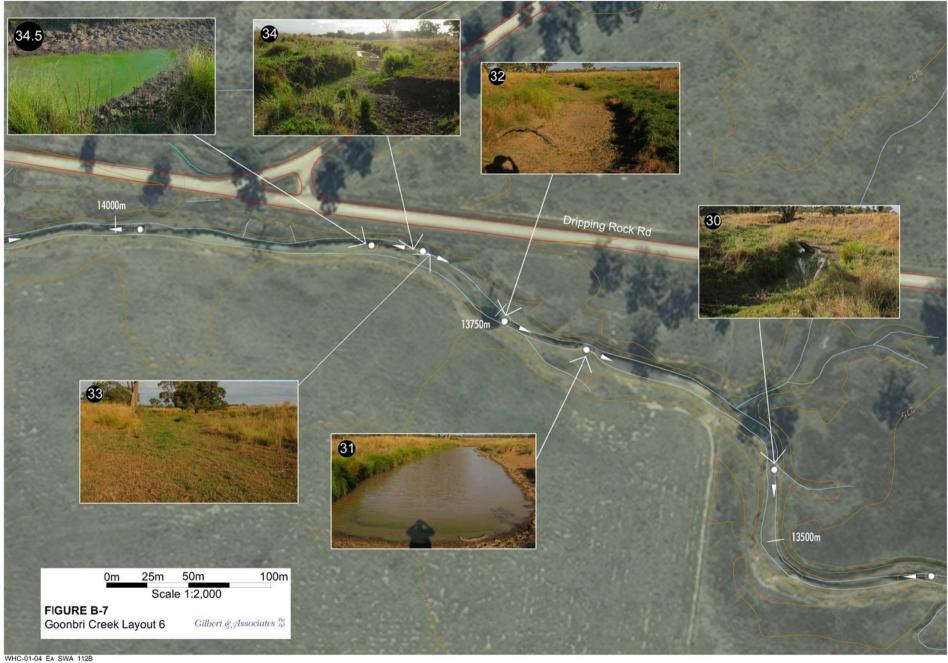
Reach	Plan Form of Channel	Channel Geomorphology	Channel Geometry	Bed Materials	Vegetation Community	Other Vegetation	Adjacent Land Use	Photo Number	Comments
III	Symmetrical channel approaching moderate amplitude meander	Minor erosion of banks, deep scour holes visible	CWT - 13.5m RBH - 1.3m LBH - 1.5m CWB - 5.8m	Sandy with Silt	Secondary Grassland vegetation community	Open paddock with native Plains grass colonisation on banks and clumps of tall Sedge grasses in channel	Active cropping and pastures	30	Pond in scour hole
III	Reasonably symmetrical straight channel	Erosion and slumping on RB	Pond - 30m long, 12-15m width	Silt	Secondary Grassland vegetation community	Open paddock with native Plains grass colonisation on banks and clumps of tall Sedge grasses in channel	Active cropping and pastures	31	Featureless floodplain in paddock
III	Reasonably symmetrical straight channel	Moderate lateral stability above scour hole	Not measured, refer photo 32	Silt	Secondary Grassland vegetation community	Open paddock with native Plains grass colonisation on banks and clumps of tall Sedge grasses in channel	Active cropping and pastures	32	-

III	Low sinuosity, relatively straight with gradual development of slight meanders	Undercutting of banks visible, channel stable with grass colonisation on bars	Not measured, refer photo 33	Grassy	Secondary Grassland vegetation community	Open paddock with native Plains grass colonisation on banks and clumps of tall Sedge grasses in channel	Active cropping and pastures	33	Featureless floodplain in paddock
III	Low sinuosity, relatively straight with gradual development of slight meanders	Undercutting of banks and resultantly moderate lateral stability	Not measured, refer photo 34	Predominantly silty with grass cover	Secondary Grassland vegetation community	Open paddock with native Plains grass colonisation on banks and clumps of tall Sedge grasses in channel	Active cropping and pastures	34	-
III	Low sinuosity, relatively straight with gradual development of slight meanders	Undercutting of banks and resultantly moderate lateral stability	Not measured - refer photo 34.5	Predominantly silty	Secondary Grassland vegetation community	Open paddock with native Plains grass colonisation on banks and clumps of tall Sedge grasses in channel	Active cropping and pastures	34.5	Pool possibly eutropic with algae on surface and at depth

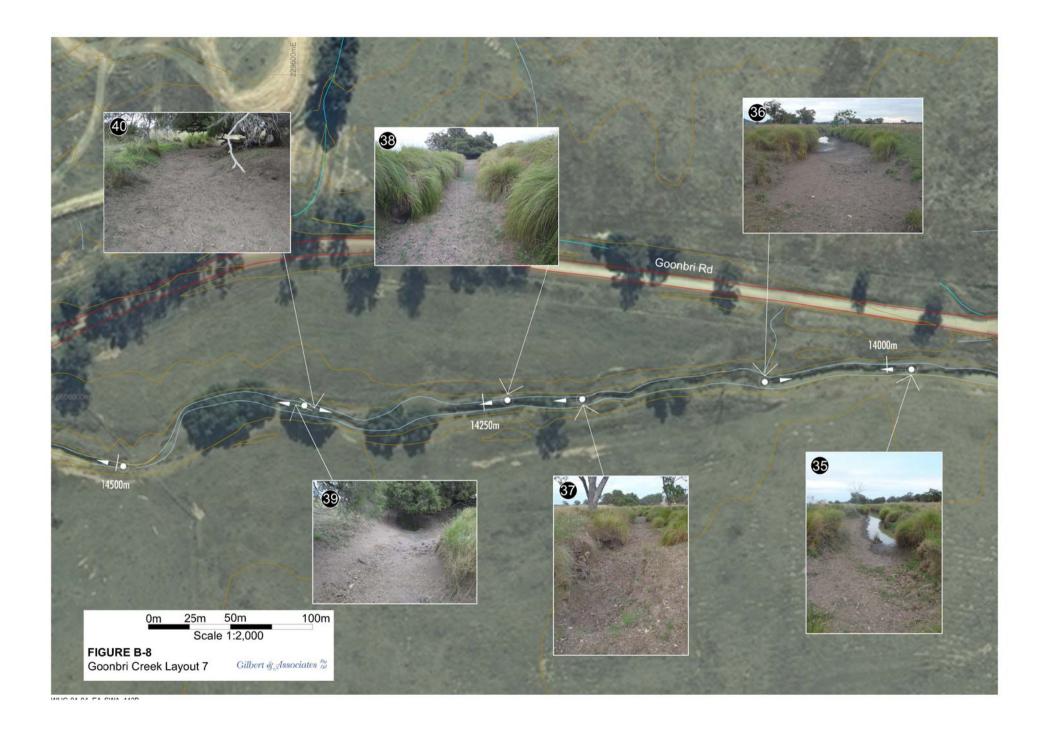
Reach	Plan Form of Channel	Channel Geomorphology	Channel Geometry	Bed Materials	Vegetation Community	Other Vegetation	Adjacent Land Use	Photo Number	Comments
IV	Low sinuosity, relatively straight with gradual development of slight meanders	Trench-like erosion with undercutting of banks and moderate lateral stability	Not measured, refer photo 35	Silty with Sand and stones	Secondary Grassland vegetation community	Sedges, tall native Plains grasses in paddock	Non active, re-colonised pasture	35	Persistent grasses growing on margin of channel aiding in lateral stability
IV	Low sinuosity, relatively straight with gradual development of slight meanders	Trench-like erosion with undercutting of banks and moderate lateral stability	Not measured, refer photo 36	Silty bed with some sand	Secondary Grassland vegetation community	Sedges, tall native Plains grasses in paddock	Non active, re-colonised pasture	36	Persistent grasses growing on margin of channel aiding in lateral stability D/S grassy hummocks and levee on left bank

IV	Low sinuosity, with slight channel undulation	Slight undercutting of banks	Not measured, refer photo 37	Sandy channel	Secondary Grassland vegetation community	Sedges, tall native Plains grasses in paddock	Non active, re-colonised pasture	37	Featureless floodplain continues Tusks of grasses on channel banks
IV	Straight channel	Trench-like erosion with grasses aiding in lateral stability	CWT - 7m LBH - 1.4m RBH - 1.4m CWB - 2.8m	Sandy bed with stones and some cobbles	Secondary Grassland vegetation community	Sedges, tall native Plains grasses in paddock	Non active, re-colonised pasture	38	Persistent grasses growing on margin of channel aiding in lateral stability
IV	Channel diverted around copse of trees	Little undercutting and erosion	Not measured, refer photo 39	Sandy bed with stones	Predominantly open grassland with scattered stands of Blakely's Red Gum - Yellow Box - Rough-barked Apple - Belah - Paperbark vegetation community	Sedges, tall native Plains grasses in paddock, native trees in channel	Non active, re-colonised pasture	39	Trees adjacent to channel adding cohesion to banks

IV	Channel diverted around copse of trees	Little undercutting and erosion	Not measured, refer photo 40	Sandy bed with stones	Predominantly open grassland with scattered stands of Blakely's Red Gum - Yellow Box - Rough-barked Apple - Belah - Paperbark vegetation community	Sedges, tall native Plains grasses in paddock, native trees in channel	Non active, re-colonised pasture	40	Trees adjacent to channel adding cohesion to banks

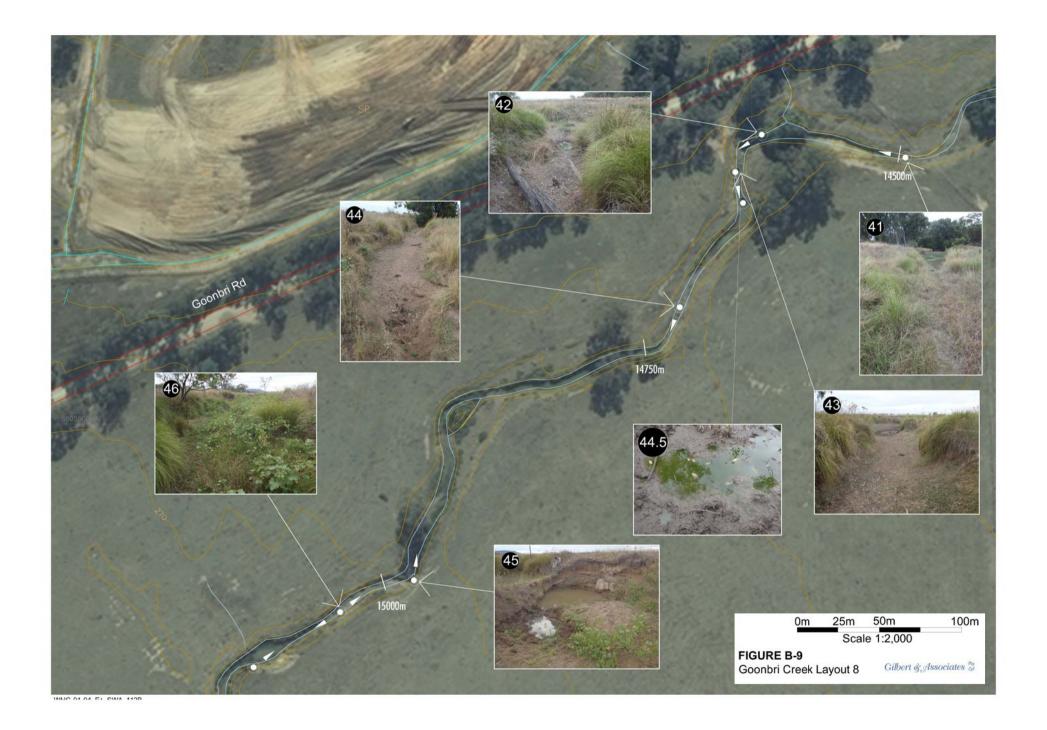
Reach	Plan Form of Channel	Channel Geomorphology	Channel Geometry	Bed Materials	Vegetation Community	Other Vegetation	Adjacent Land Use	Photo Number	Comments
IV	Symmetrical channel, low sinuosity, relatively straight with gradual development of slight meanders	Undercutting of banks with moderate lateral stability	Large permanent pool, 20m long and 4-5m width	Silt	Secondary Grassland vegetation community	Abundance of aquatic plants in pond, typical tall Sedge grasses on channel banks and native Plains grass on overbank floodplain	Non active, re-colonised pasture	41	-
IV	Somewhat symmetrical channel, sharp left hand bend against high bank	Scour holes evident	Not measured, refer photo 42	Sandy with gravel	Secondary Grassland vegetation community	Hummocks of Sedge grasses on edges of channel, overbank featureless floodplain dominated by tall native Plains grass	Non active, re-colonised pasture	42	Complex scour holes prevalent in entire reach

IV	Sinuous channel with large amplitude meander , high bank on RB	Scour holes evident	CWT - 11m LBH - 1.2m RBH - 1.2m high bank 2.2m CWB - 3.5m	Silty sand with gravel present	Secondary Grassland vegetation community	Hummocks of Sedge grasses on edges of channel, overbank featureless floodplain dominated by tall native Plains grass	Non active, re-colonised pasture	43	-
IV	Symmetrical channel, relatively straight, approaching a bend.	Scour holes evident	CWT - 12m LBH - 1m RBH - 1m CWB - 2.4m Terrace above main channel has total width of 21m	Silty sand with gravel present	Secondary Grassland vegetation community	Hummocks of Sedge grasses on edges of channel, overbank featureless floodplain dominated by tall native Plains grass	Non active, re-colonised pasture	44	Channel geometry measured at riffle in channel between scour holes
IV	Symmetrical channel, relatively straight, approaching a bend.	Scour holes evident	CWT - 12m LBH - 1m RBH - 1m CWB - 2.4m Terrace above main channel has total width of 21m	Silty sand with gravel present	Secondary Grassland vegetation community	Hummocks of Sedge grasses on edges of channel, overbank featureless floodplain dominated by tall native Plains grass	Non active, re-colonised pasture	44.5	Still pool in bed. Pool with green algae present and some fish still alive

IV	Relatively straight channel with slight meander	Deep undercutting of banks visible, slumping of both banks and large scour holes present	Not measured, refer photo 45	Silt in pool with sand and gravel deposition present	Secondary Grassland vegetation community	Hummocks of Sedge grasses on edges of channel, overbank featureless floodplain dominated by tall native Plains grass, some unidentified herbaceous growth in channel	Non active, re-colonised pasture	45	Large plunge pool at bend in gully
IV	Relatively straight section of symmetrical channel	Trench-like erosion with undercutting of banks and low lateral stability	CWT - 7m LBH - 2m RBH - 2m CWB - 2m	Sandy, gravelly bed	Secondary Grassland vegetation community	Abundance of aquatic plants in pond, typical tall Sedge grasses on channel banks and native Plains grasses on overbank floodplain	Non active, re-colonised pasture	46	-

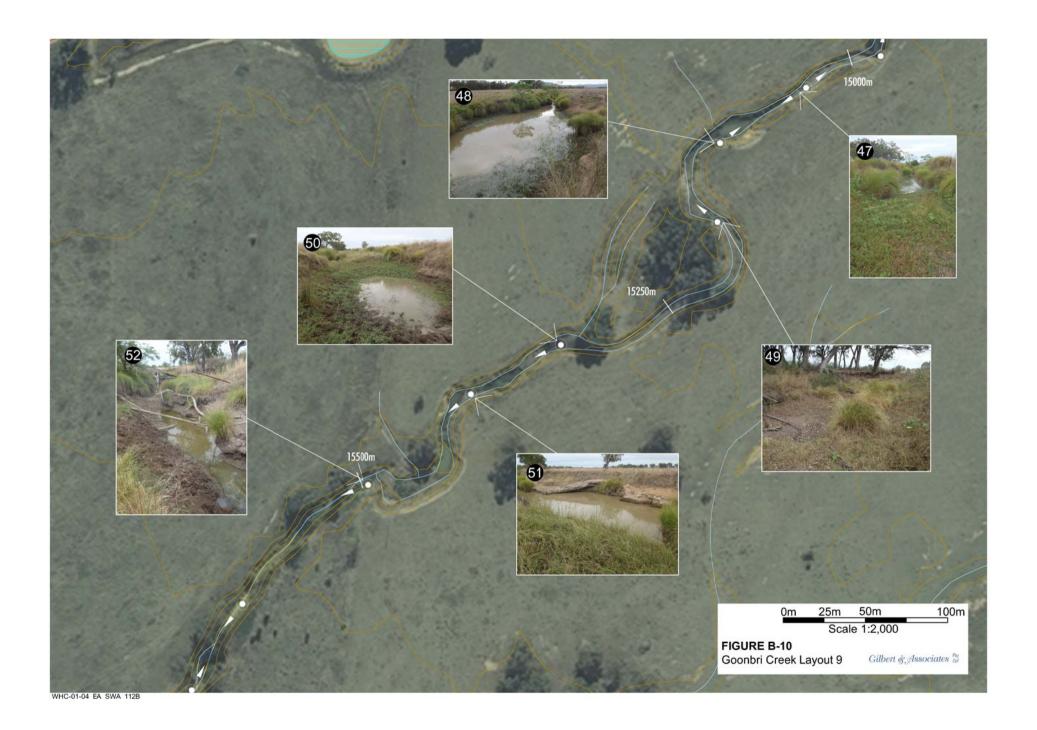
Reach	Plan Form of Channel	Channel Geomorphology	Channel Geometry	Bed Materials	Vegetation Community	Other Vegetation	Adjacent Land Use	Photo Number	Comments
IV	Relatively straight section of channel	Trench-like channel with undercutting of banks and low lateral stability, pools located in larger scour holes	CWT - 7m LBH - 2m RBH - 2m CWB - 2m	Sandy gravelly bed on bars	Vegetation community primarily composed of Poplar Box - Pilliga Box - White Cypress Pine	Abundance of aquatic plants in pond, typical tall Sedge grasses on channel banks and native Plains grass on overbank floodplain	Non active, re-colonised pasture	47	Typical trench-like gully formation continues with featureless floodplain of native Plains grass above
IV	Relatively straight, low sinuosity section of channel	Scour holes present	Tear drop shaped pool about 20m length and 15m width	Unknown - Inundated	Secondary Grassland vegetation community	Abundance of aquatic plants in pond, typical tall Sedge grasses on channel banks and native Plains grass on overbank floodplain	Non active, re-colonised pasture	48	Permanent pool

IV	Large meanders present in featureless floodplain,	Obvious undercutting on outside of meander with slumping of bank and scour holes in channel	Not measured, refer photo 49	Sandy banks and channel bed	Secondary Grassland vegetation community	Scattered tufts of Sedge grass, tall grasses and small clumps of trees	Non active, re-colonised pasture	49	-
IV	Relatively straight section of channel with a typical undulating channel surrounded by flat floodplain	Low bank stability with slumping visible, and ponding in large scour holes	Not measured, refer photo 50	Silty sand on bed, sand with some weakly cohesive conglomerate strata on channel sides	Secondary Grassland vegetation community	Abundance of aquatic plants in pond, typical tall Sedges on channel banks and various tall grasses on overbank floodplain	Non active, re-colonised pasture	50	Permanent pools in scour holes
IV	Meandering present in featureless floodplain, reasonably symmetrical trench- like channel	Bedrock controlled planform on RB	Not measured, refer photo 51	Sandy banks with conglomerate bedrock on banks	Secondary Grassland vegetation community	Sedges growing within gully channel and various tall grasses in floodplain	Non active, re-colonised pasture	51	-

IV	Relatively straight section of channel, with a symmetrically eroding channel	Erosion evident	Not measured, refer photo 52	Silty bed, banks with conglomerate bedrock interspersed with alluvial sand	Secondary Grassland vegetation community	Sedges growing within gully channel and various tall grasses in floodplain	Non active, re-colonised pasture	52	Permanent pools in scour holes Note exposed rock strata on RB contributing to a controlled RB planform

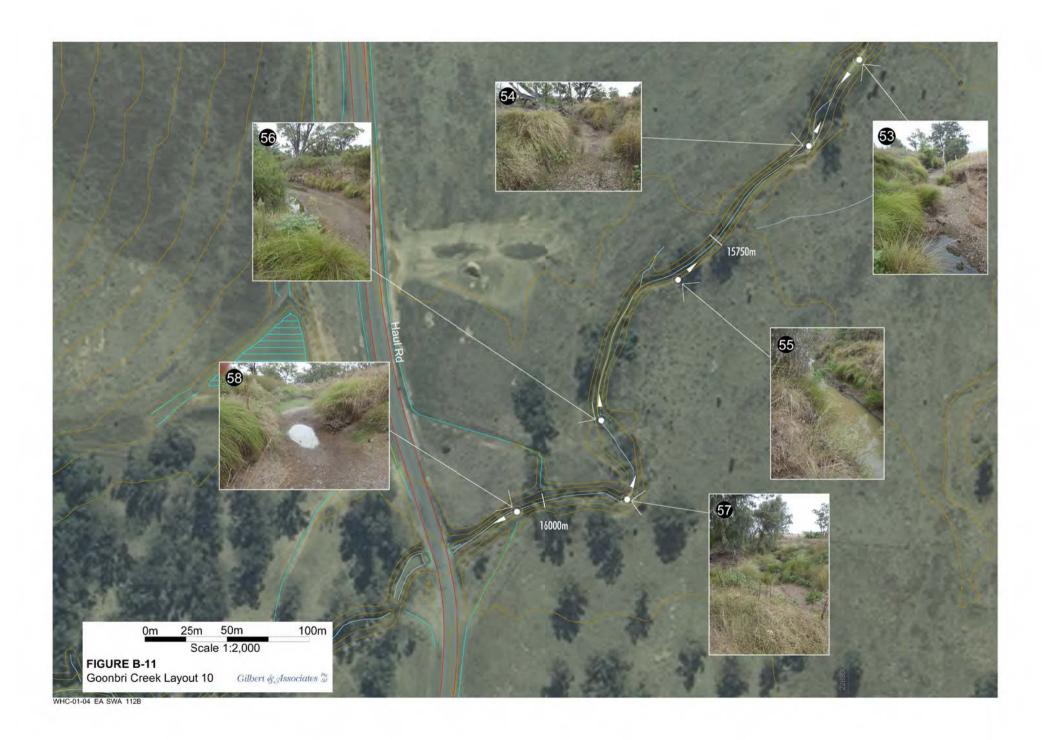
Reach	Plan Form of Channel	Channel Geomorphology	Channel Geometry	Bed Materials	Vegetation Community	Other Vegetation	Adjacent Land Use	Photo Number	Comments
IV	Relatively straight section of channel	Symmetrically eroding channel. Note exposed conglomerate strata on RB contributing to a controlled RB planform	Not measured, refer photo 53	Sandy gravelly bed with conglomerates consisting of gravels in bank zones	Secondary Grassland vegetation community	Sedges growing within gully channel and various tall grasses in floodplain	Non active, re-colonised pasture	53	Chunks of dirt and conglomerate have recently calved off side of steep channels
IV	Straight section of channel	Laterally unstable with evidence of recent slumping and also fallen trees	Not measured, refer photo 54	Sandy gravelly bed with some cobbles present	Secondary Grassland vegetation community	Sedges growing within gully channel and various tall grasses in floodplain, some unidentified herbaceous plants in channel	Non active, re-colonised pasture	54	-

IV	Straight section of channel	Laterally unstable with evidence of recent slumping	Not measured, refer photo 55	Sandy and gravelly where not inundated	Secondary Grassland vegetation community	Sedges growing within gully channel and various tall grasses in floodplain, bushes a few metres tall are scattered above gully banks	Non active, re-colonised pasture	55	-
IV	Large meander in channel just upstream of Haul Road	Incised channel with evidence of lateral instability in recent flow events	Not measured, refer photo 56	Silty sand in channel bed where not inundated	Secondary Grassland vegetation community	Sedges growing within gully channel and various tall grasses in floodplain, bushes a few metres tall are scattered above gully banks	Non active, re-colonised pasture	56	-
IV	Large meander in channel just upstream of Haul Road	Incised channel with evidence of lateral instability in recent flow events, also large felled tree resultantly turned into log jam	Not measured, refer photo 57	Silty sand and gravel in channel bed where inundated	Secondary Grassland vegetation community	Sedges growing within gully channel and various tall grasses in floodplain, overgrown vegetation in section of gully just U/S of haul road	Non active, re-colonised pasture	57	Some herbaceous plants growing in channel

IV	Straight section of channel just U/S of culvert under Haul Road	Heavily vegetated with tusks of tall Sedges and other grasses providing lateral stability to channel	Not measured, refer photo 58	Silty sand and gravel in channel bed	Secondary Grassland vegetation community	Sedges growing on bed margins and various tall grasses in upper channel and in floodplain	Non active, re-colonised pasture	58	20m U/S of Haul Road
