## WINCHESTER SOUTH PROJECT

Environmental Impact Statement

# **Winchester South Project EIS**

## **Aquatic Ecology and Stygofauna, Additional Information**

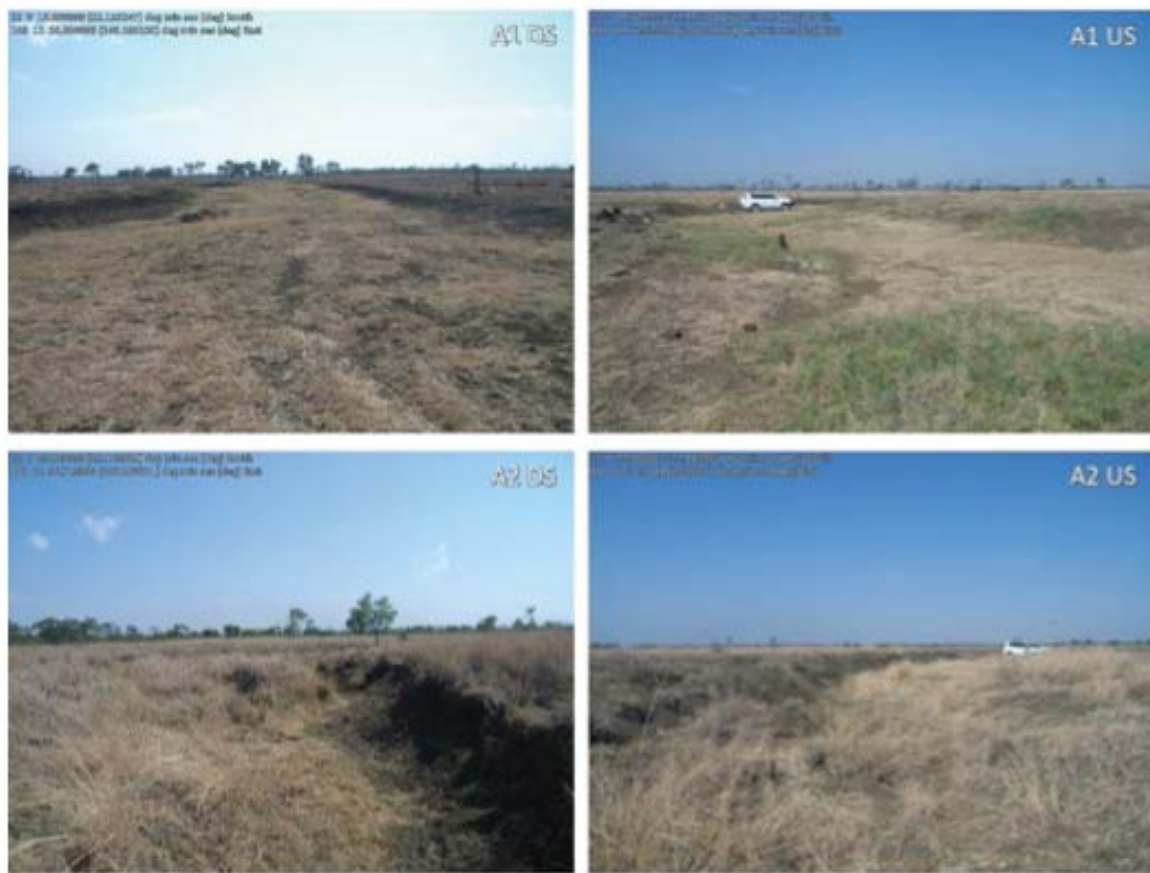
Figure 6.2 Sites A1 (U3) and A2 (from Geomorphology Assessment; Fluvial Systems 2020)

Sites A1 (U3) and A2 appear as drainage features, with no visible standing water (Figure 6.2 and Figure 6.3). The drainage feature appears to form a channel that funnels immediate localised rainfall, but that would not likely provide flow beyond the duration of a rain event. Vegetation appears to be terrestrial grasses, with no aquatic plants. Site A1 upstream appears to consist of broken sections of a depression. This section of the waterway is not a waterway providing for fish passage.

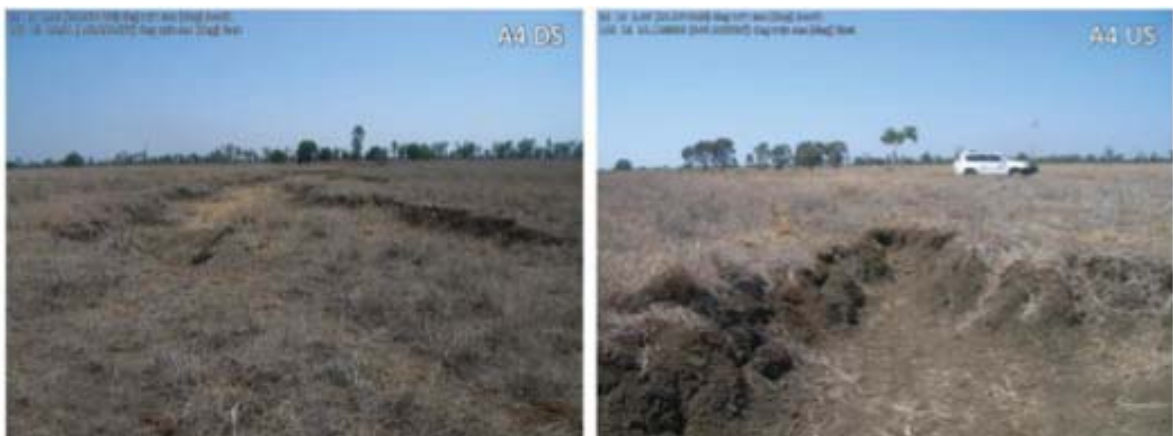
Figure 6.5 Site A4 (from Geomorphology Assessment; Fluvial Systems 2020)

The depression does not appear that it would provide adequate flow to provide for fish passage, or habitat opportunities.

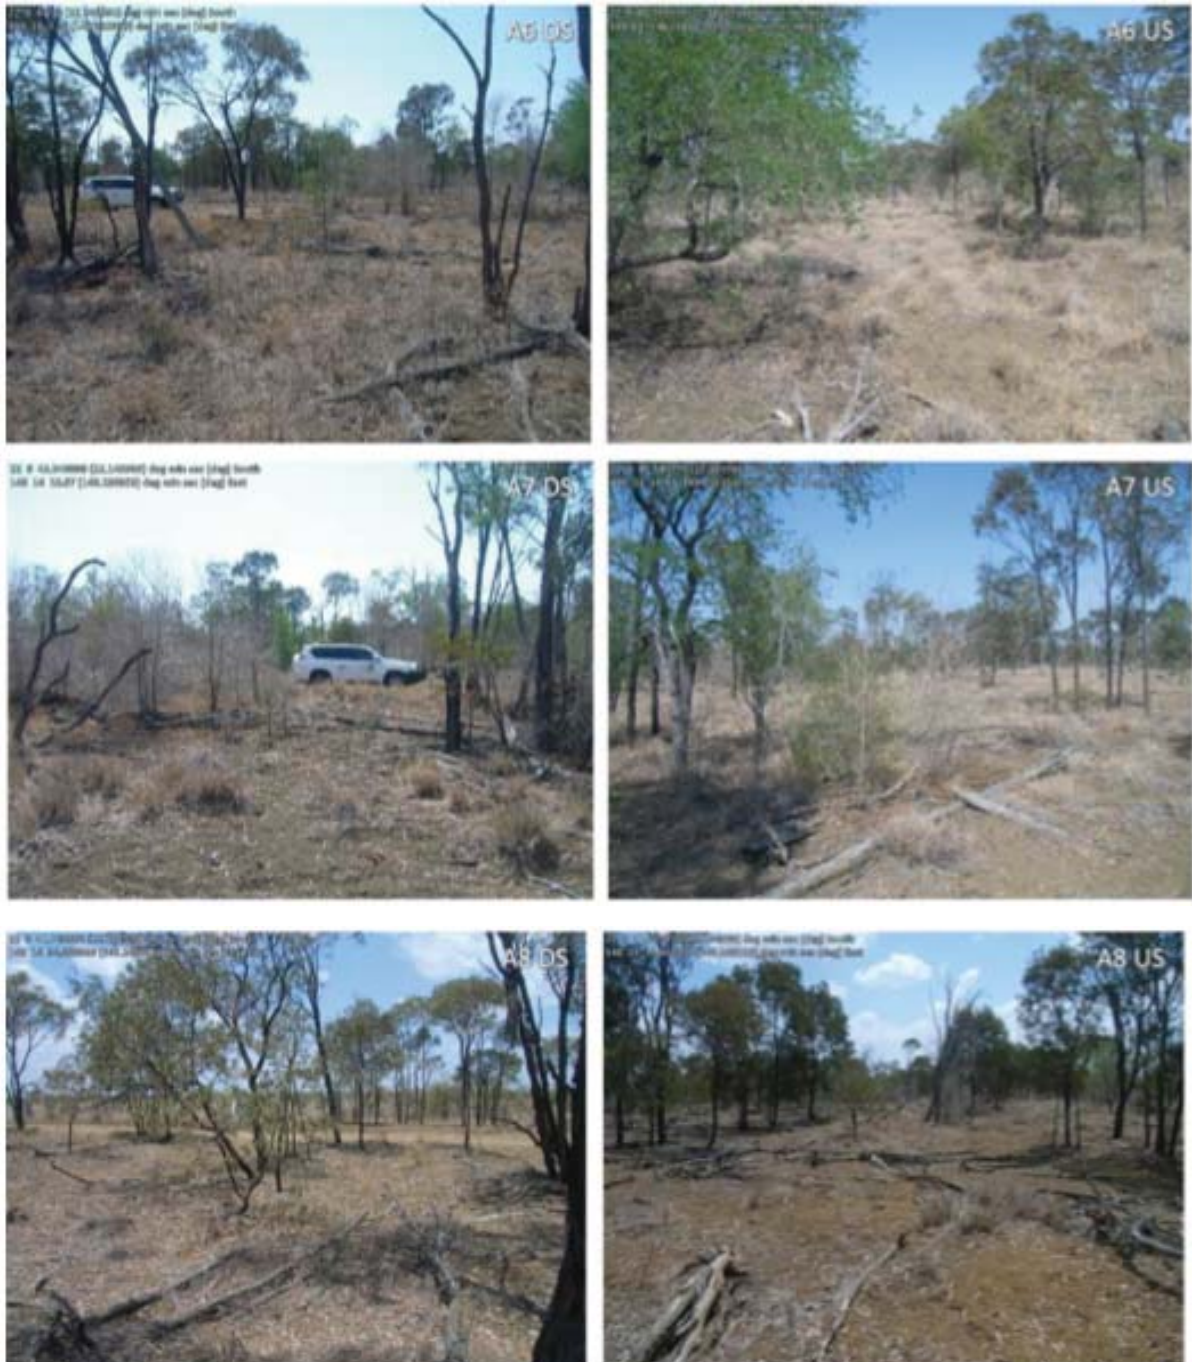
Figure 6.7 Sites A6, A7, and A8 (from Geomorphology Assessment; Fluvial Systems 2020)

The mapped feature from Site A6 through to Site A8 does not exhibit any of the qualities of a waterway as defined by DAF, and as such, is not considered a waterway providing for fish passage.

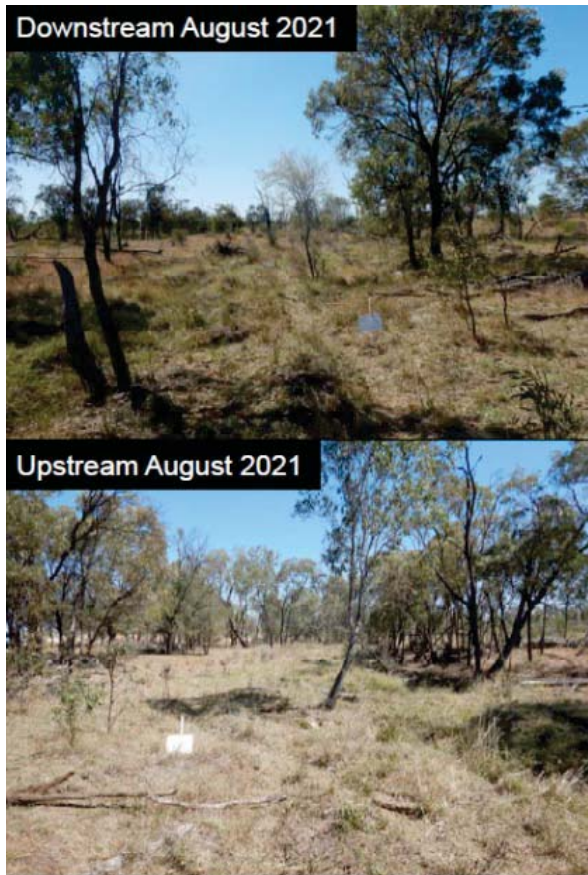
Figure 6.9 Site D5 (from site inspections; Whitehaven Coal 2021)

The mapped feature does not exhibit the qualities of a waterway as defined by DAF, and as such, is not considered a waterway providing for fish passage. This was confirmed during our recent field assessment (see Appendix B).

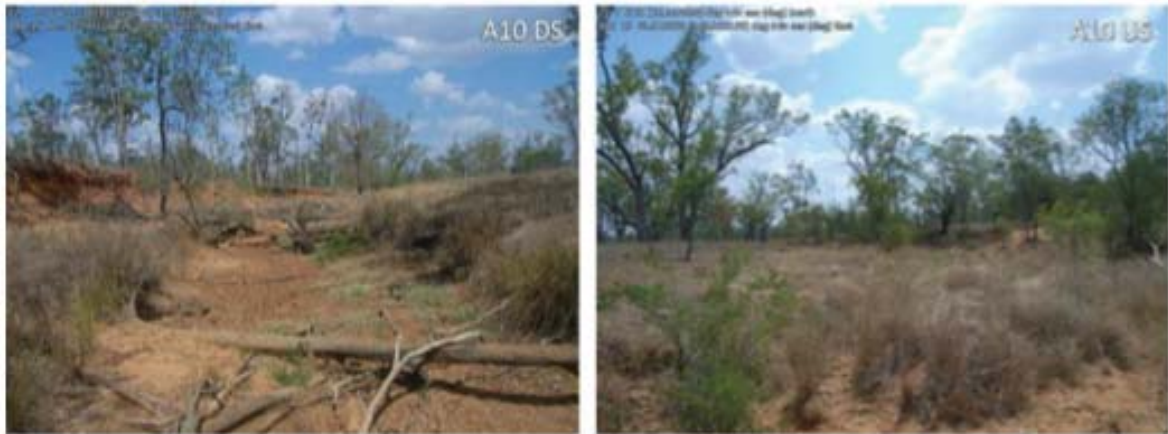
Figure 6.10 Site A10 (from Geomorphology Assessment; Fluvial Systems 2020)

The mapped feature at Site A10 exhibits qualities of a waterway as defined by DAF, and may be considered a waterway providing for fish passage.

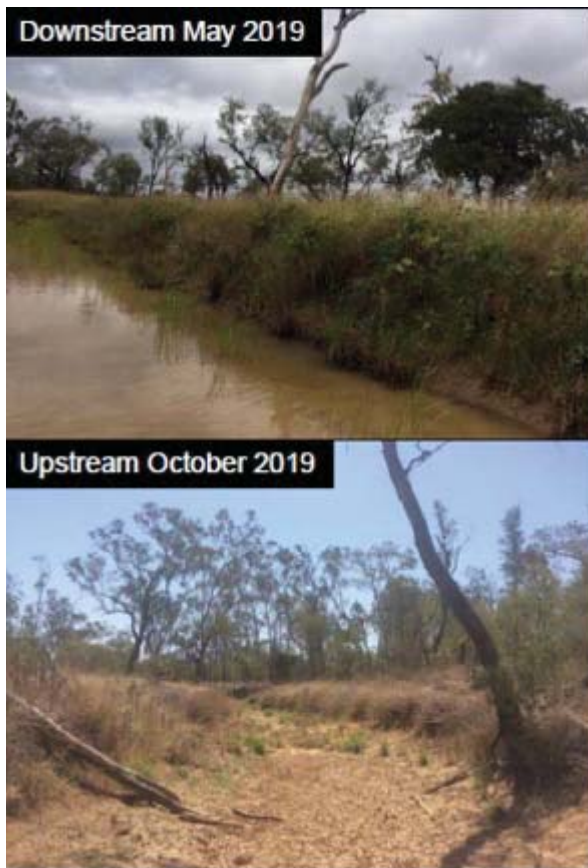
Figure 6.11 Site U1 (from site inspections; Whitehaven Coal 2021)

The mapped feature at Site U1 exhibits qualities of a waterway providing for fish passage, as defined by DAF.

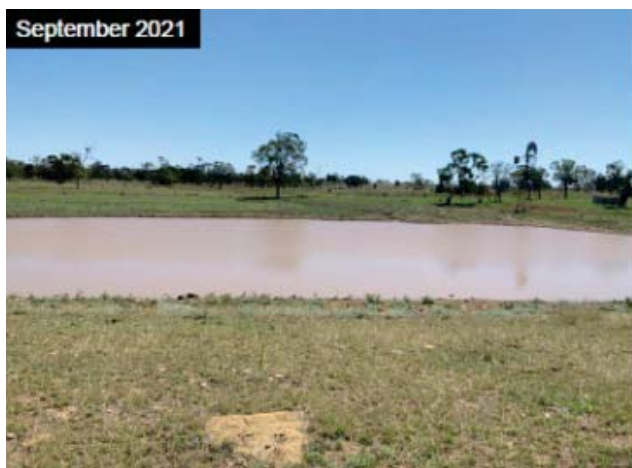
Figure 6.15 Site 7 dam, located at the upstream limit of the central unnamed waterway (from site inspections; Whitehaven Coal 2021)

While the dam may provide suitable fish habitat, the high dam walls likely act as a barrier to fish passage and restrict connectivity to any potential habitat opportunities upstream and downstream. Further, our assessment indicates a lack of fish passage opportunities immediately downstream of Site 7 (see description of Sites 6 and 5, below).

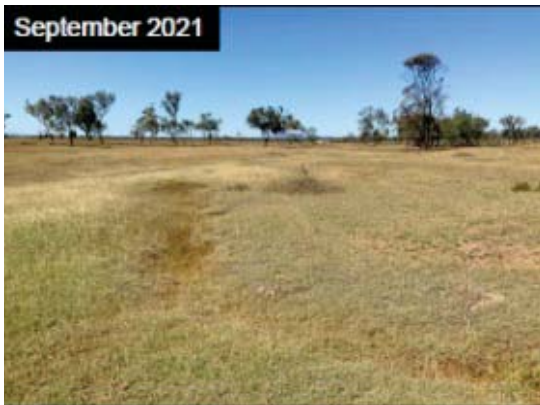
Figure 6.18 Site 6 (Photo from site inspections; Whitehaven Coal 2021)

The mapped feature at Sites 6 and 5 do not exhibit any of the qualities of a waterway as defined by DAF; and as such, are not considered to be waterways providing for fish passage.

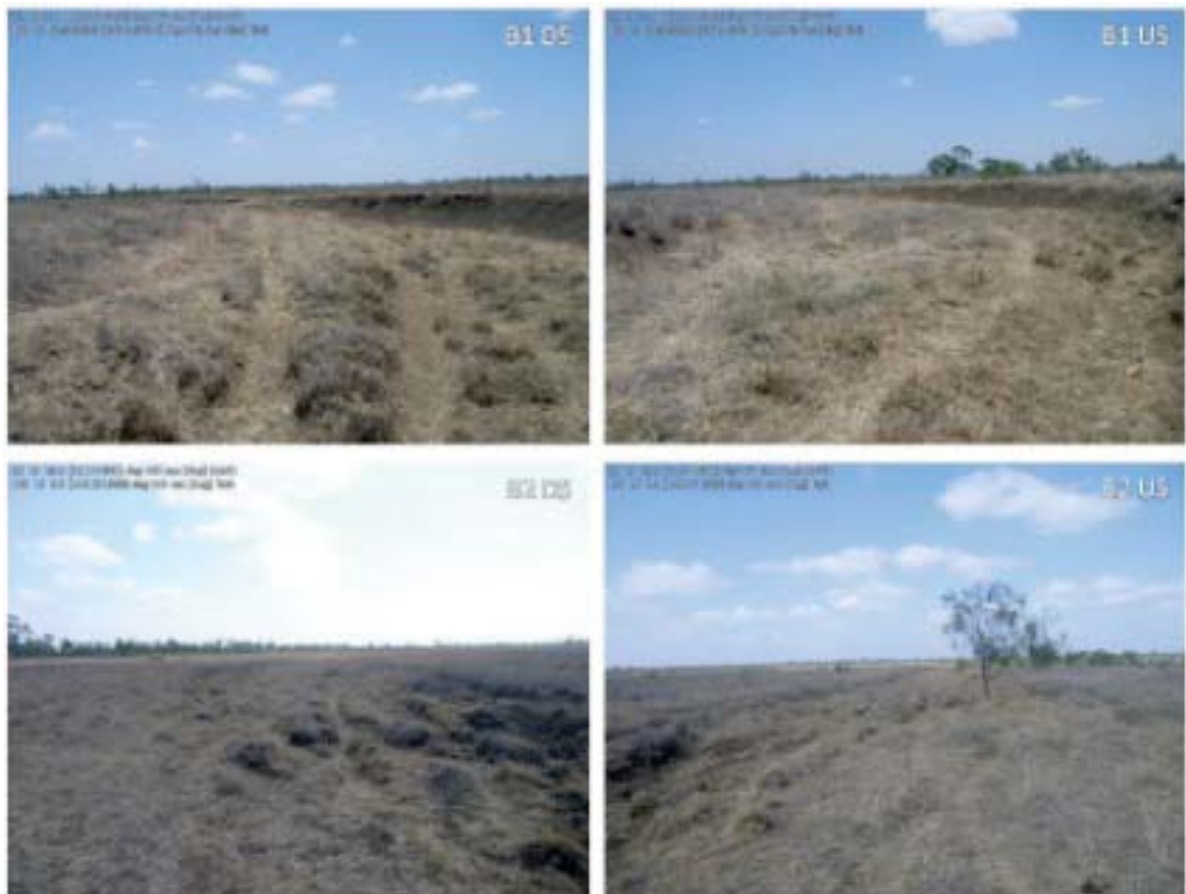
Figure 6.20 Sites B1 and B2 (from Geomorphology Assessment; Fluvial Systems 2020)

Due to the lack of a channel with defined bed and banks, no riparian vegetation, and a lack of fish habitat and connectivity for fish passage, Sites B1 and B2 are not considered a waterway providing for fish passage.

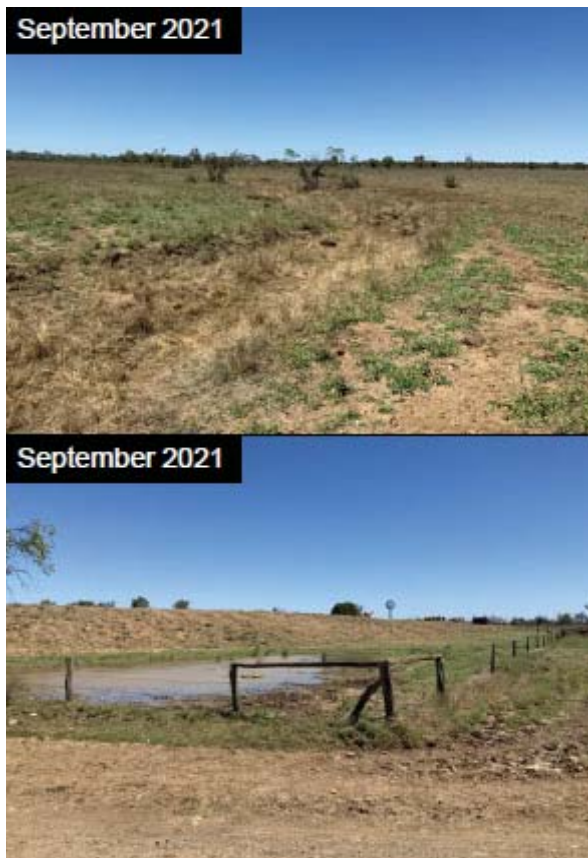
Figure 6.22 Site 1 (Photo from site inspections; Whitehaven Coal 2021)

There appears to be a drainage depression, or gully, leading to the small pool of water. The depression is not holding water and appears to contain terrestrial vegetation. The banks of this drainage feature do not appear to be continuous or well defined. The drainage depression would not likely provide adequate flow other than in times of localised rainfall. Due to the lack of a channel with continuously defined bed and banks, no riparian vegetation, and insufficient flow to maintain aquatic ecological processes, Site 1 is not considered a waterway providing for fish passage.

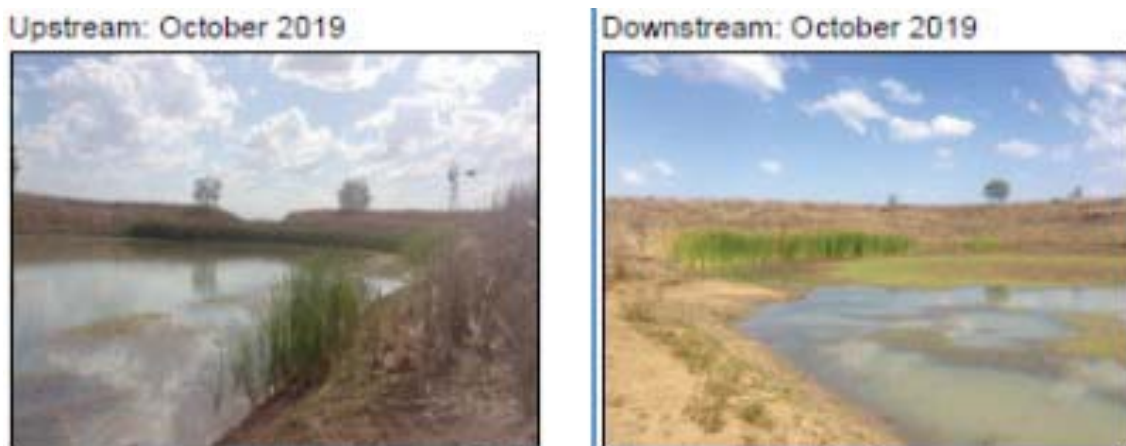
Figure 6.23 Site FD2 (Photo from EIS; ESP 2021)

Our assessment found Site FD2 is a large, constructed dam. The dam walls are approximately 4 m in height, and act to restrict connectivity to upstream and downstream reaches. Aquatic plants are present in the dam. Additionally, fish have been captured during previous fish surveys at this site (see Section 3.2.1 for details). While the dam provides suitable fish habitat, the high dam walls act as a barrier, creating a lack of connectivity upstream and downstream.

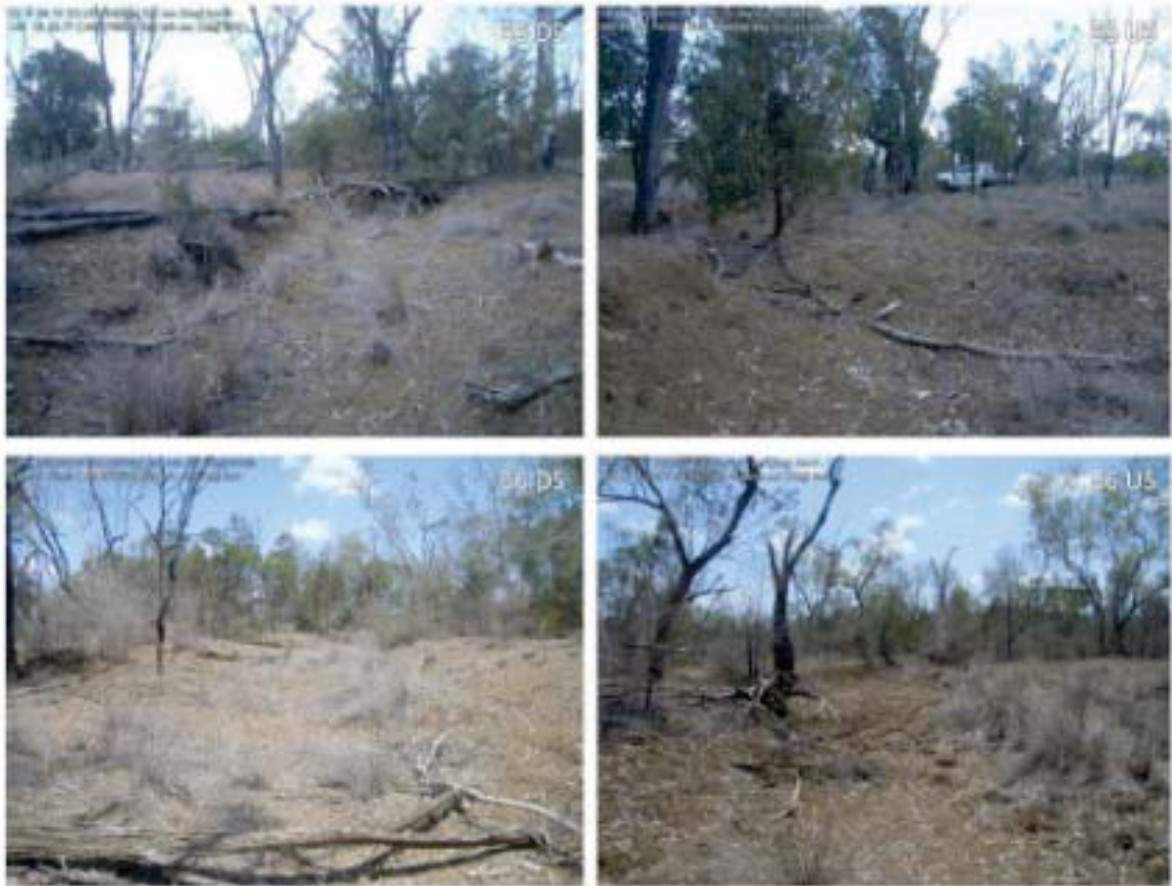
Figure 6.25 Sites B5 and B6 (Photos from Geomorphology Assessment; Fluvial Systems 2020)

Our assessment found Sites B5 and B6 are drainage depressions, or gullies, lacking the features of a waterway providing for fish passage (Figure 6.25). The drainage feature presents as a slight depression forming a gully that likely directs overland flows for a short duration. The drainage feature does not provide fish passage or habitat opportunities, and does not appear to have an unbroken, continuous defined bed and banks. This section of the mapped feature would not provide adequate flow beyond an immediate rainfall event. Terrestrial vegetation can be seen growing across the feature.

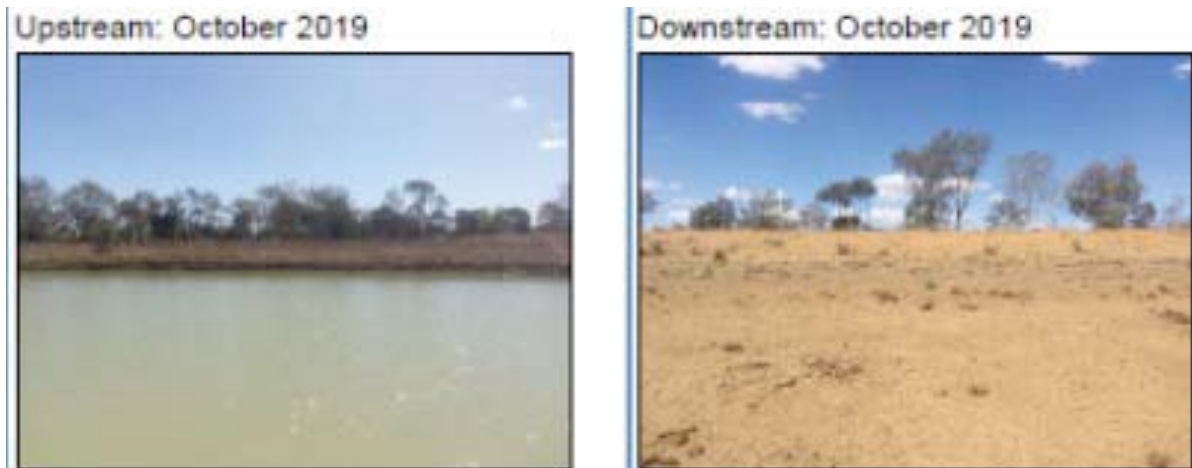
Figure 6.26 Site FD3, constructed dam (Photos from EIS; ESP 2021)

While the dam may provide fish habitat opportunities, the relatively steep, high dam walls act as a barrier to fish passage, reducing connectivity upstream and downstream.

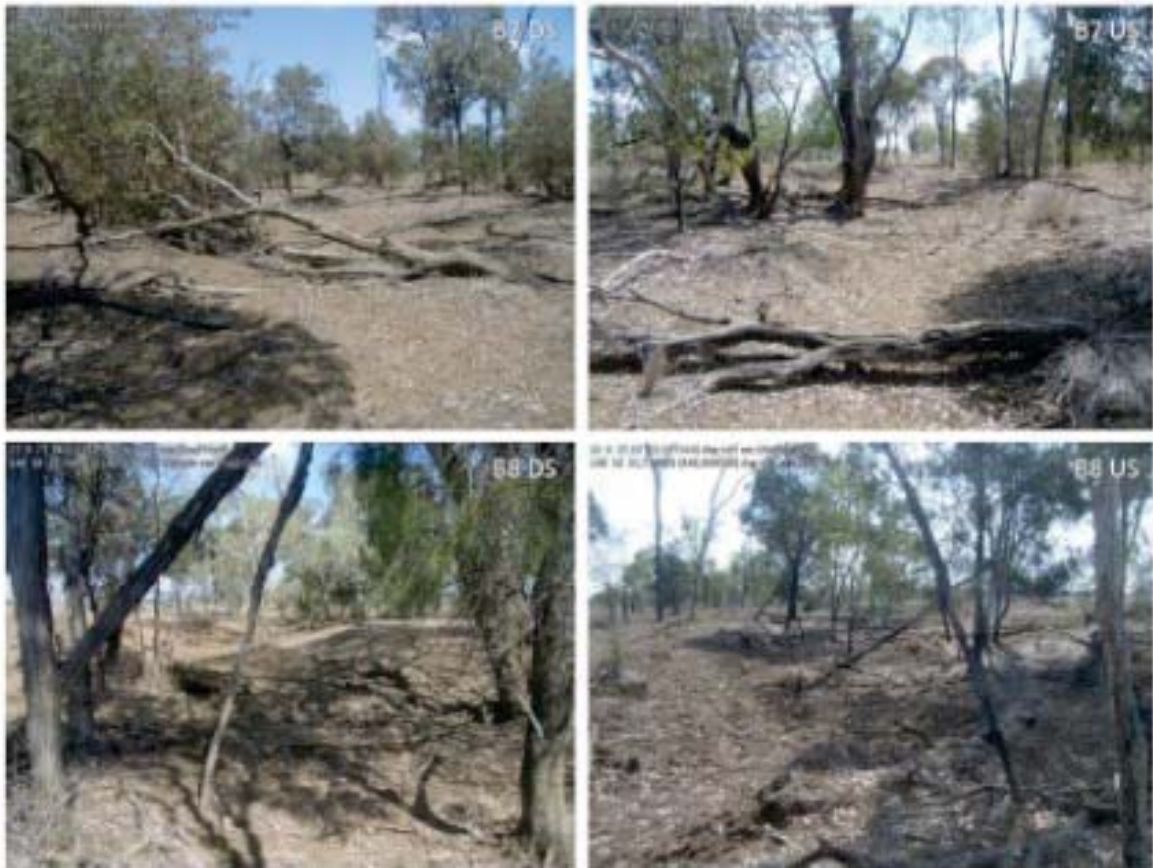
Figure 6.27 Site B7 and B8 (Photos from Geomorphology Assessment; Fluvial Systems 2020)

Due to the lack of a channel with no continuous defined bed and banks, no riparian vegetation, lack of fish habitat or passage opportunities, Sites B7, B8 and U2 are not considered a waterway providing for fish passage.

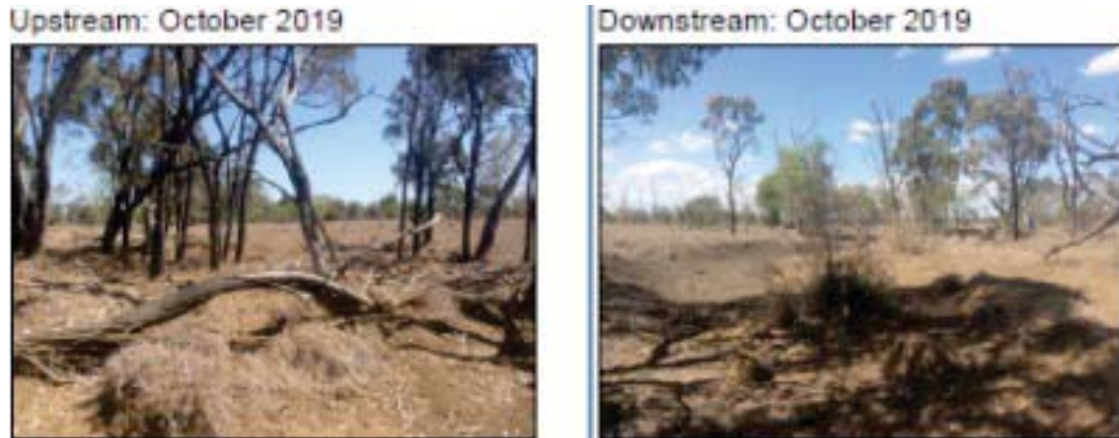
Figure 6.30 Site U7, showing upstream and downstream in October 2019 (Photos from EIS; ESP 2021)

The drainage feature likely directs intermittent, localised flows, and would not provide extended or persistent flows outside of a localised rainfall event. The drainage feature would likely not provide fish passage or habitat opportunities outside of an immediate localised rainfall event.
