# **Closure Plan Update/Annual Environmental Management Report**

**Canyon Coal Mine  
(MLs 1464 and 1471)**

**01 July 2011 – 30 June 2012**

**Whitehaven Coal Mining Limited**  
**Mine Closure Progress Report**  
**for the**  
**Canyon Coal Mine**  
**(MLs 1464 and 1471)**

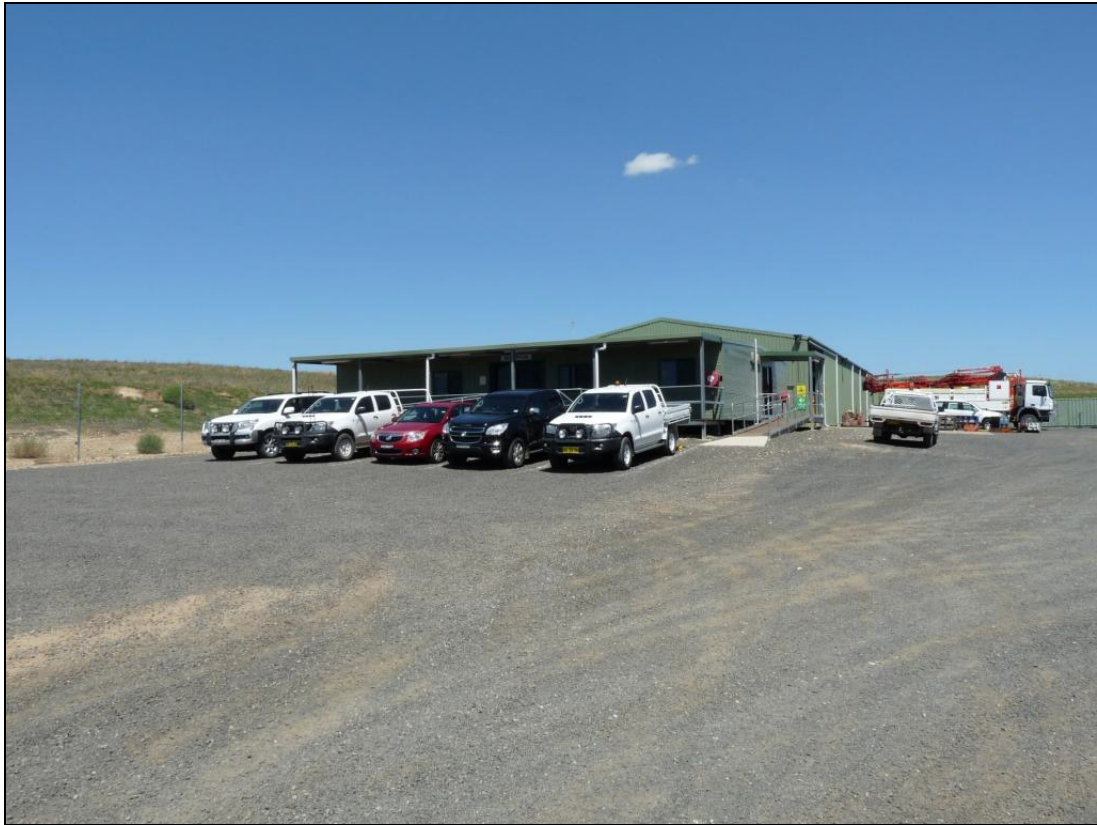
**Plate 1 - Maintenance Facility Buildings**

For the purposes of the commitments provided in the original Closure Plan, works in this domain have been completed. However, following submission of the Closure Plan Whitehaven sought approval from Narrabri Shire Council (NSC) for construction of offices, a storage shed and hardstand areas for a centralised maintenance storage area for Whitehaven's open cut mines (Plate 1 and Plate 2). Consent was issued by NSC in mid 2011 and the final occupation certificate was issued in early 2012. The Maintenance Facility will remain for the foreseeable future and therefore may need to be excised from the Canyon ML at the time of relinquishment.

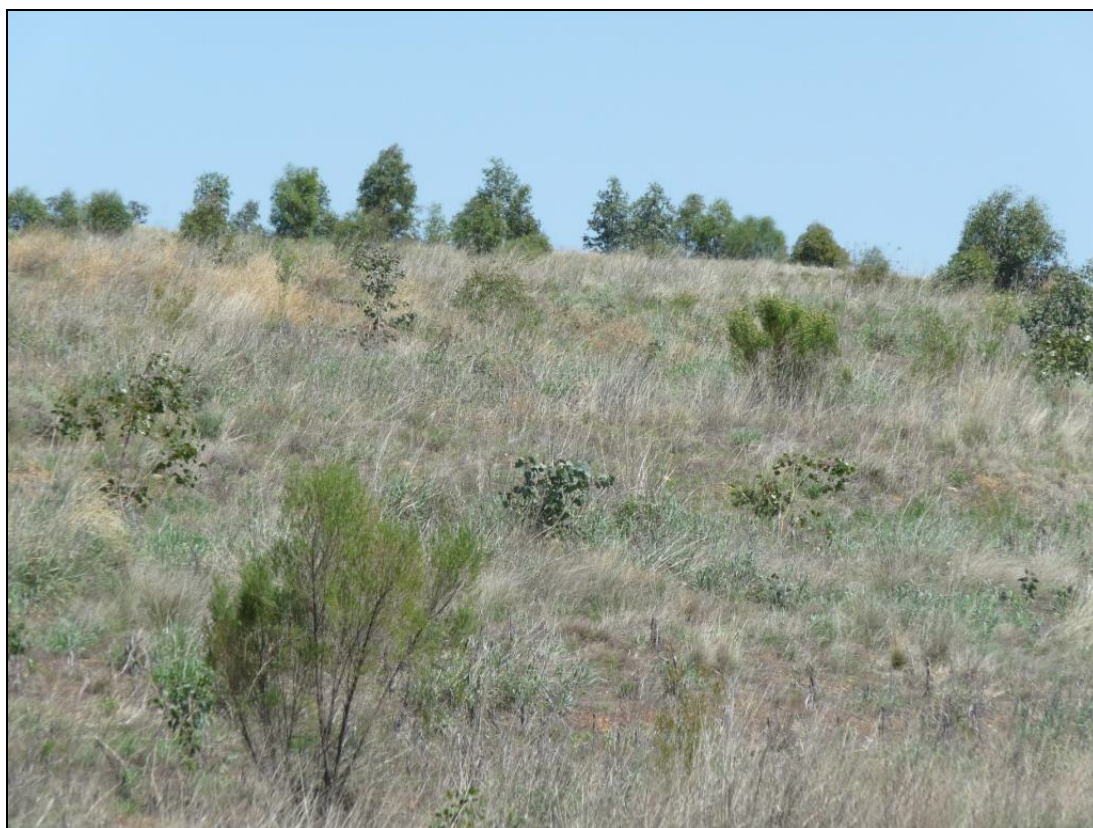
**Plate 3 - Revegetation Near Former Coal Bin**

The removal of coal loader and associated infrastructure was completed in September 2010, with the loadout bin being commissioned at Whitehaven's Sunnyside Coal Mine. The ROM pad and ROM facilities area totalled 7.5 ha and was reshaped, stabilised with contours and waterways for drainage, top-soiled and seeded with a summer pasture mix. The waterway spills into a rehabilitated area to the south of the pad that is designed to slowly drain runoff into the final void. This area has also been top-soiled and seeded with a summer pasture mix for prevention of erosion. Further planting of native trees in clump formations was undertaken in November 2011 (Plate 3).

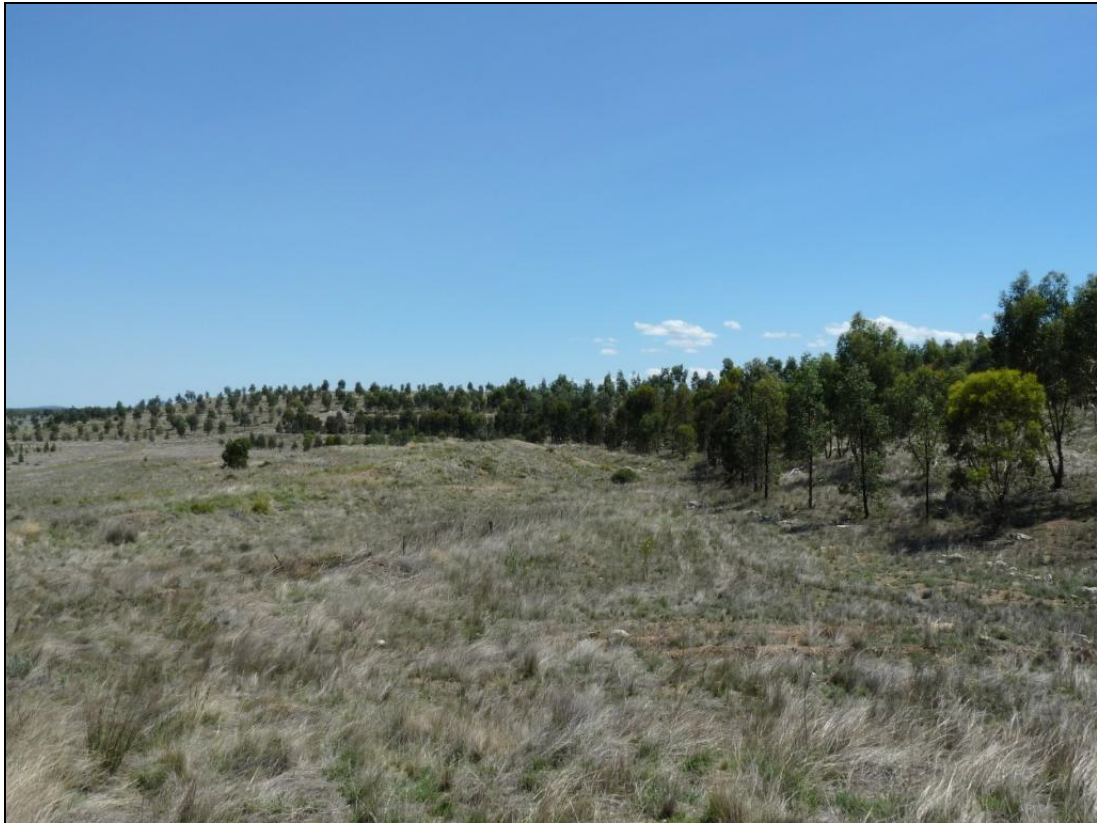
**Plate 4 - Established Revegetation on Western Slope (2c)**

Plate 4 to Plate 7 show the progress of rehabilitation across the native vegetation rehabilitation zones while Table 1 provides a summary of the number and type of species planted during the period July 2009 to November 2011.

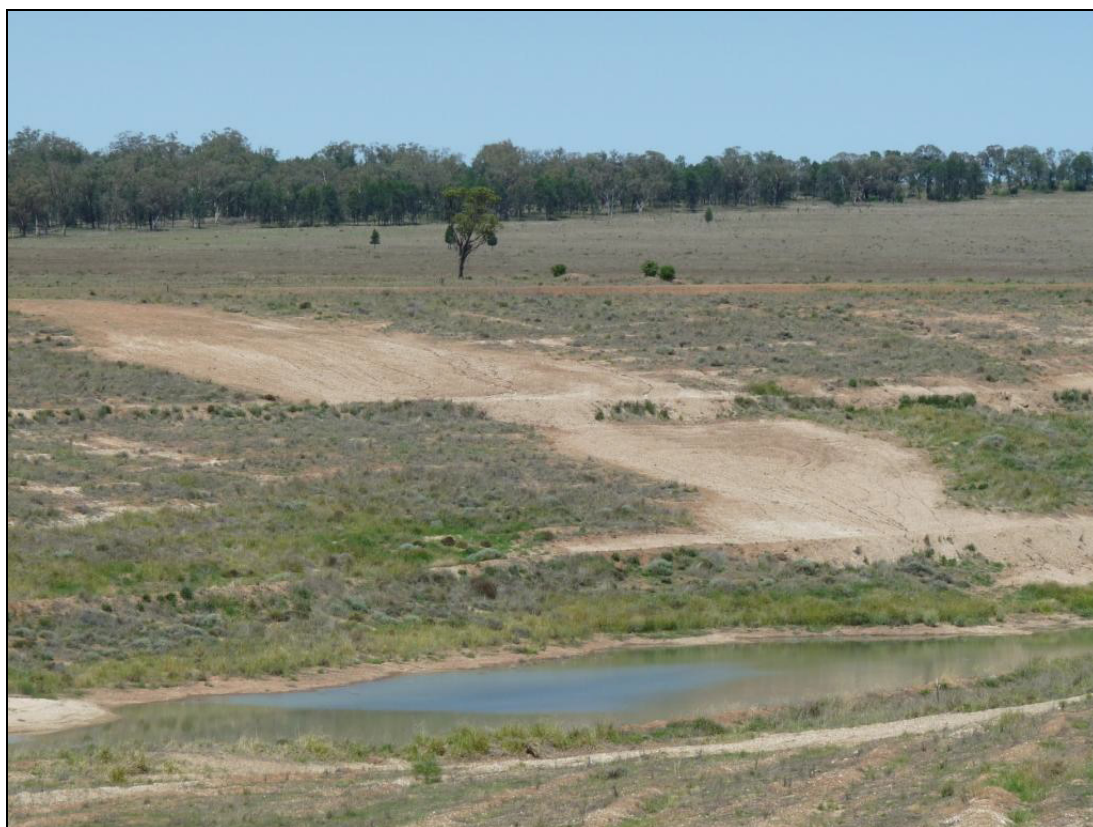
**Plate 8 - Repair Works to Void, 2012**

As discussed previously, heavy rains in early 2012 resulted in new erosion on the southern face of the void. The area was remediated in late 2012 by Wards Earthmoving (Plate 8). Whilst works like this will occur as required, at this stage progression to final rehabilitation of the void have been delayed due to the pending Vickery Coal Project which will ultimately result in the Canyon void being backfilled with waste rock from the Vickery Project.

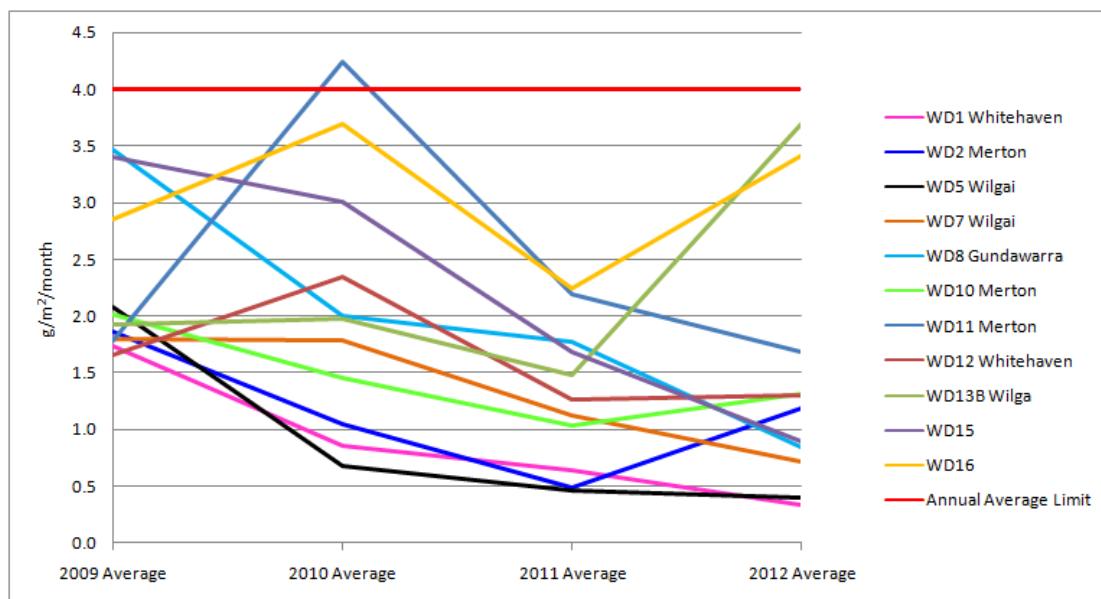
Figure 1 - Annual Average Deposited Dust Results

Air quality is monitored monthly, with the intention of staged removal of monitoring points on relinquishment of area. Results are shown in Figure 1.

Figure 1 shows the annual average for each monitoring point since July 2009, compared with the consent limit of  $4\text{g/m}^2/\text{month}$ . It should be noted that September 2009 results have been excluded from the graphed data for all monitoring locations as these results were skewed by regional bushfires. December 2010 and January 2011 deposited dust results have also been excluded from WD-13B Womboola as they were highly anomalous with results from that monitoring location during other months as well as results from other monitoring locations during December and January.

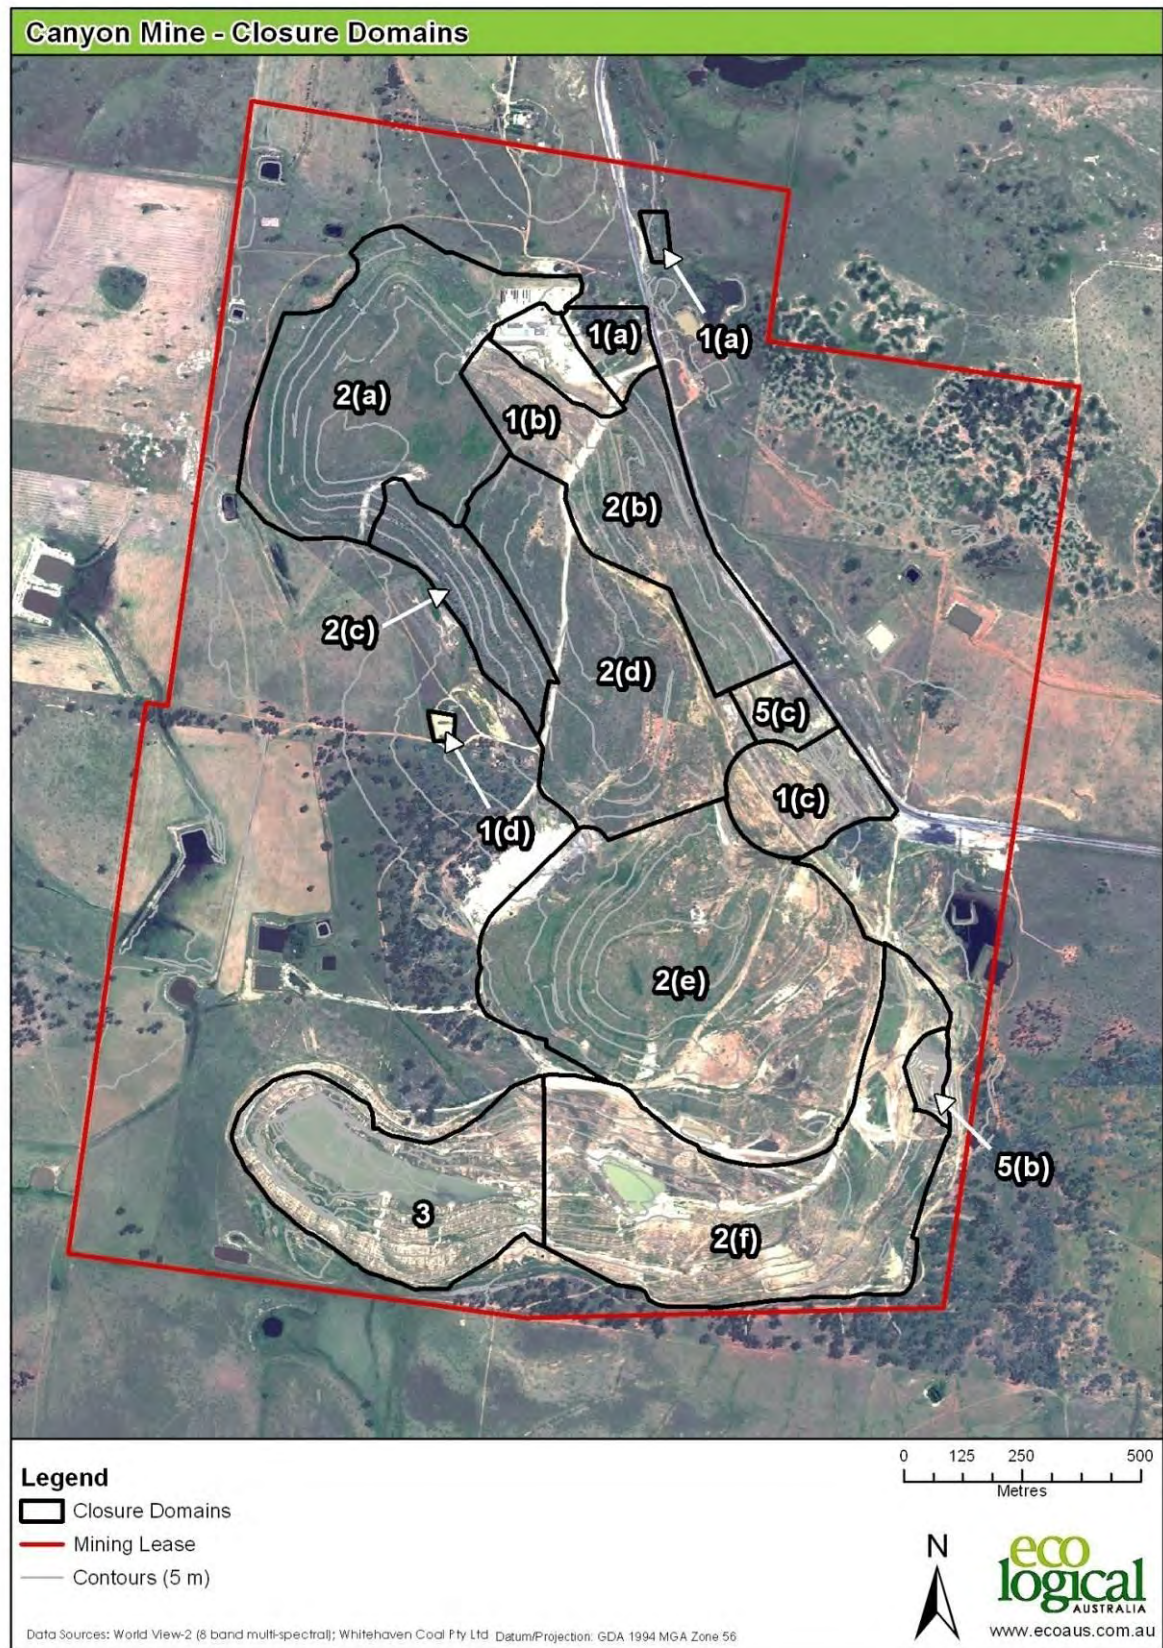
Figure 3-2: Closure domains

Five primary closure domains were created for the final landscape (**Table 3-4; Figure 3-2**). Closure domains were chosen to reflect the prior land use and/or rehabilitation type.

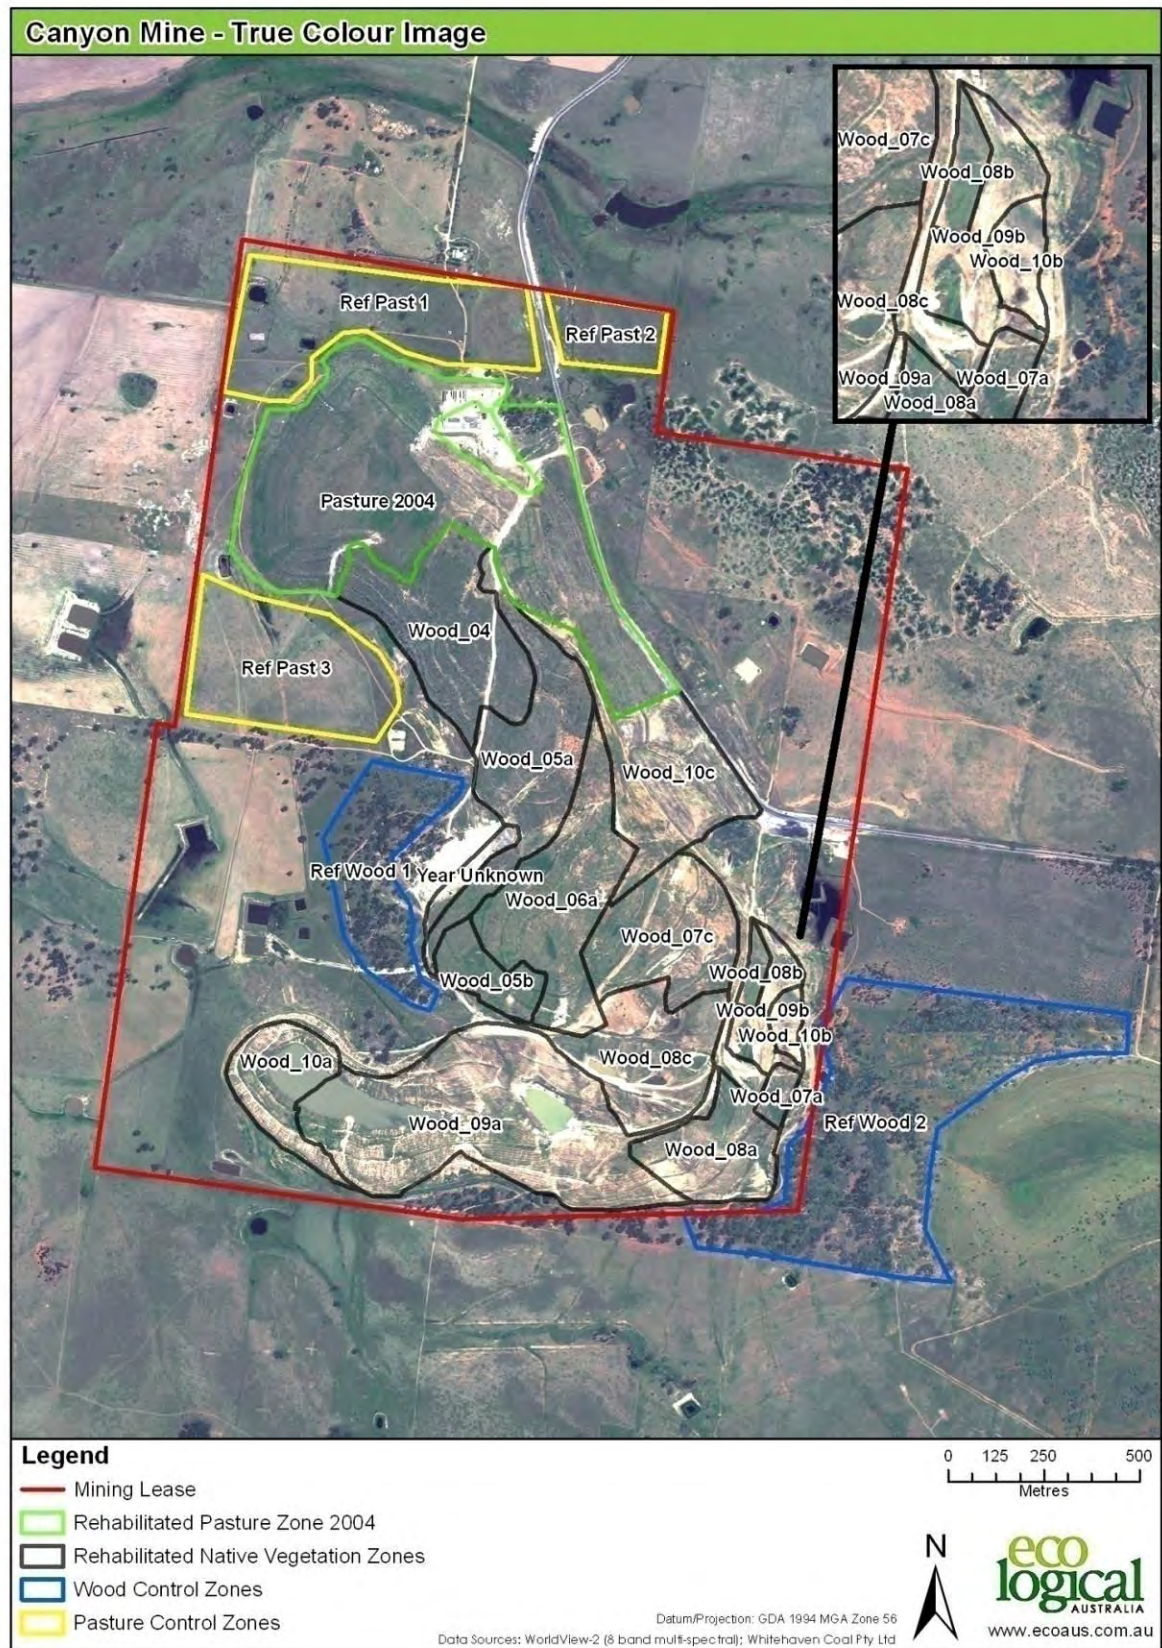
Figure 6-1: Canyon Mine - True Colour Image

The combination of true colour, false colour and NDVI image visualisation products gives an indication of the extent and condition of each land cover type in the area (**Figure 6-1**; **Figure 6-2** and **Figure 6-3**). These images show a pattern of revegetation which is consistent with the rehabilitation zones, i.e. those areas which were planted during 2004 to 2006 indicate greater vegetation cover than those areas rehabilitated since 2007. Infrastructure such as roads and dams are evident.

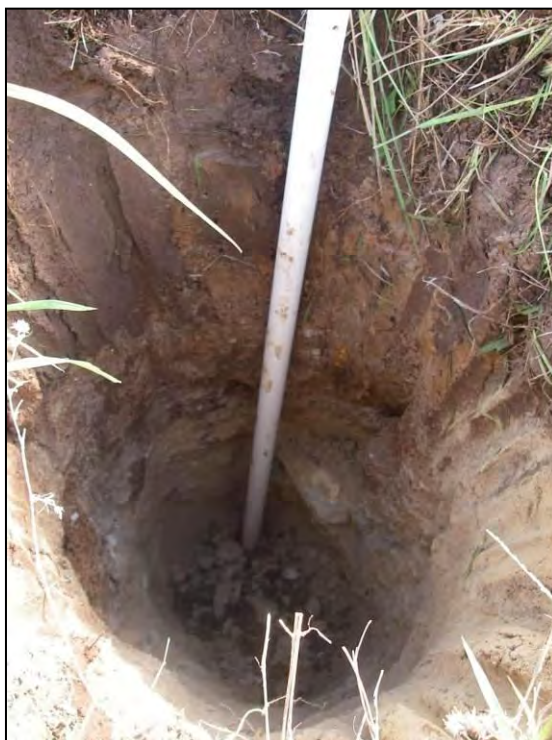
Soil Pit 1 Woodland Rehabilitation Zone (north) (E: 229364; N: 6596274)

HORIZON AND DEPTH	SOIL DESCRIPTION
1: 0 – 0.15 m	Light clay-clayey gravel (wet) with fine-medium gravels (1-5 mm) Grass roots throughout
2: 0.15 – 0.60 m	0.15-0.60 m Sandy clay loam-light clay (lower gravel content than A1) Light chocolate Amount of roots decreases with depth
3: 0.60 – 0.95 m	Sandy clay-gravel mixture (dark grey) with coarse gravels No roots present Mine overburden encountered at 0.95 m

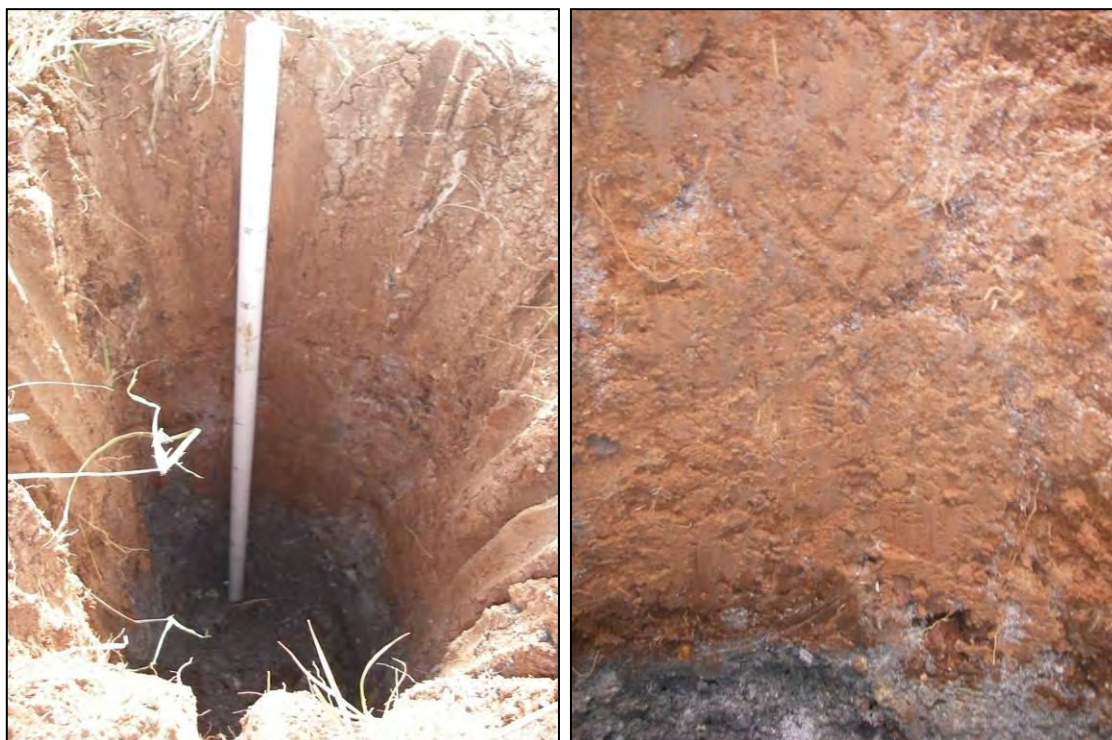
## Soil Pit 2 Woodland Rehabilitation Zone (mid) (E: 229569; N: 6595820)

HORIZON AND DEPTH	SOIL DESCRIPTION
1: 0 – 0.70 m	Medium clay with fine gravels (chocolate) Large portion gravels (up to 50%) 1-5 mm diameter Roots present
2: 0.70 – 0.80 m	Medium-heavy clay (brown-chocolate) with fine-medium gravels (approx 10-20%) No roots
3: 0.80 -1.00 m	Sandy clay-gravel mixture (dark grey) Coarse gravels and cobbles (size increases with depth)

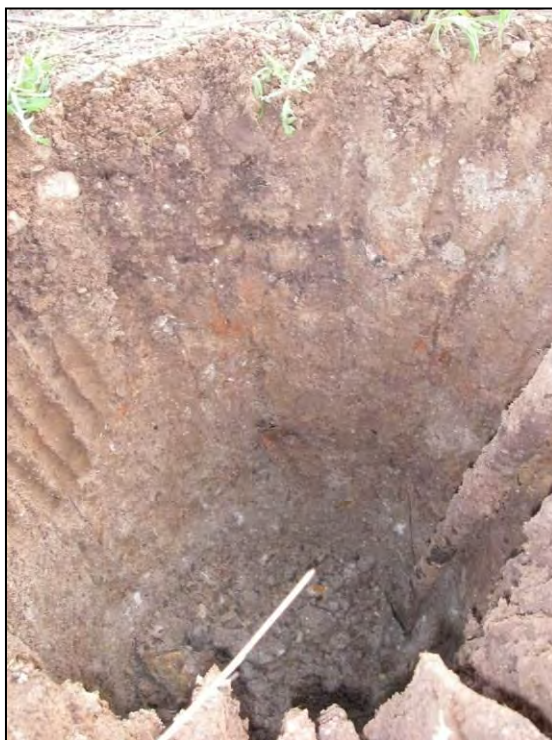
## Soil Pit 3 Woodland Rehabilitation Zone (south) (E: 229377; N: 6595302)

HORIZON AND DEPTH	SOIL DESCRIPTION
1: 0 – 0.25 m	Medium clay with fine gravels (chocolate) Roots throughout horizon
2: 0.25 – 0.55 m	Medium-heavy clay (dark brown-chocolate) Fine-medium gravels (approx 5-10%) No roots
3: 0.55 – 0.80 m	Sandy clay-gravel mixture (light grey-light brown) with gravel and rock chip fragments Mine overburden encountered at 0.80 m

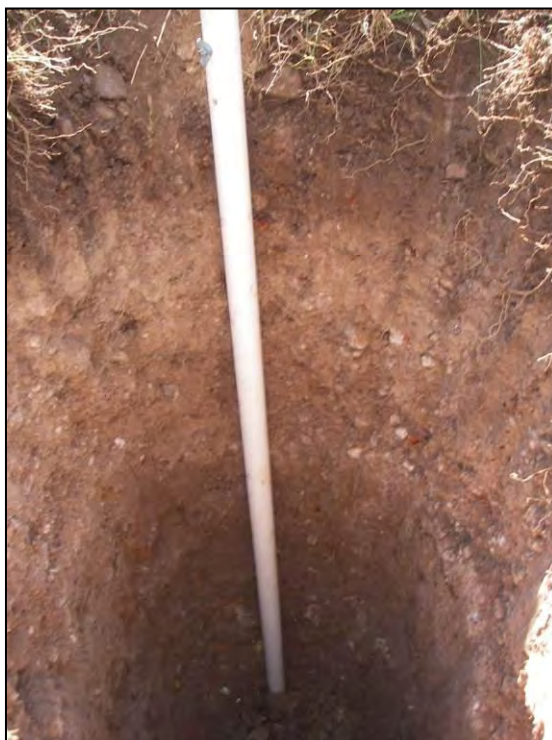
## Soil Pit 4 Woodland Control (north) (E: 229048; N: 6595871)

HORIZON AND DEPTH	SOIL DESCRIPTION
1: 0 – 0.20 m	Sandy loam - sandy clay loam (dark brown) 10-20% gravels (10-15 mm) Root activity throughout horizon
2: 0.20 – 0.50 m	Sandy loam - sandy clay loam (light red-brown) 15-25% gravels (5-20 mm) Roots present but less than above horizon
3: 0.50 – 0.60 m	Heavy clay (chocolate-dark brown) 10-20% gravels (10-15 mm) Few roots
4: 0.60 – 0.75 m	Horizon boundary Sandy clay loam-light clay (dark chocolate) 20-30% gravels up to 25 mm Roots present
5: 0.75 – 1.00 m	Medium-heavy clay (chocolate) Some tree roots present

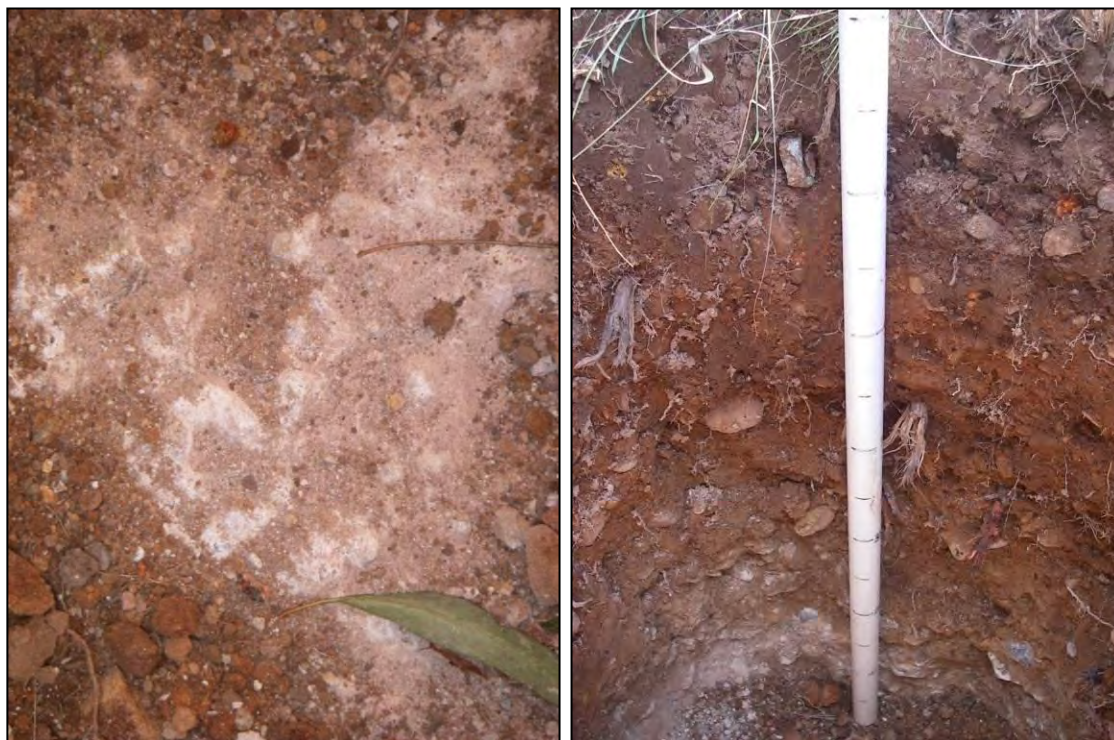
## Soil Pit 5 Woodland Control (south) (E: 230102; N: 6595019)

HORIZON AND DEPTH	SOIL DESCRIPTION
1: 0 – 0.15 m	Light clay with coarse gravels (chocolate-grey) (10mm- 70 mm) Roots present (grass and tree species)
2: 0.15 – 0.35 m	Sandy loam (light grey) with medium gravels Roots present
3: 0.35 – 0.60 m	Sandy loam (light grey) with medium to coarse gravels Rock fragments up to 150 mm Tree roots present
4: 0.60 – 0.85 m	Gravel-sand-silt mixture with predominantly coarse gravels

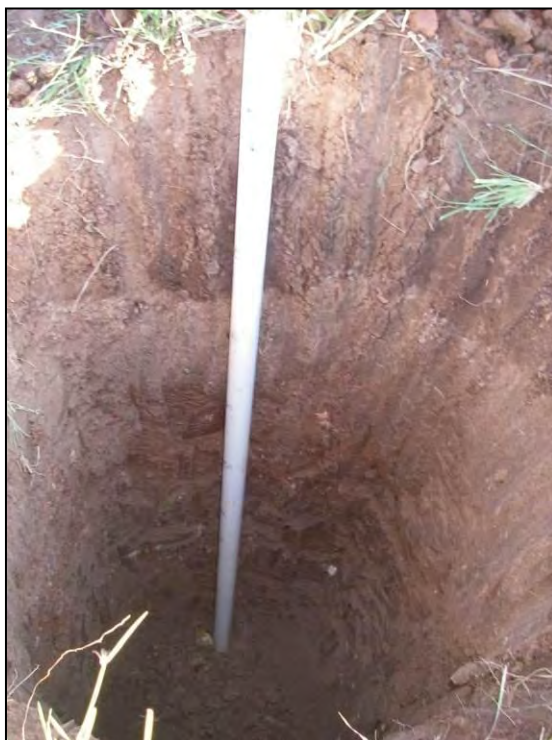
## Soil Pit 6 Pasture Control (south) (E: 229678; N: 6596283)

HORIZON AND DEPTH	SOIL DESCRIPTION
1: 0 – 0.20 m	Sandy clay loam-light clay No gravels Roots present
2: 0.20 – 0.40 m	Medium-heavy clay with fine gravel Roots throughout profile
3: 0.40 – 0.60 m	Gravel seam with more than 50% fine gravel (dark red-brown)
4: 0.60 – 1.00 m	Light clay (red-brown) Much less gravel, mottled No roots

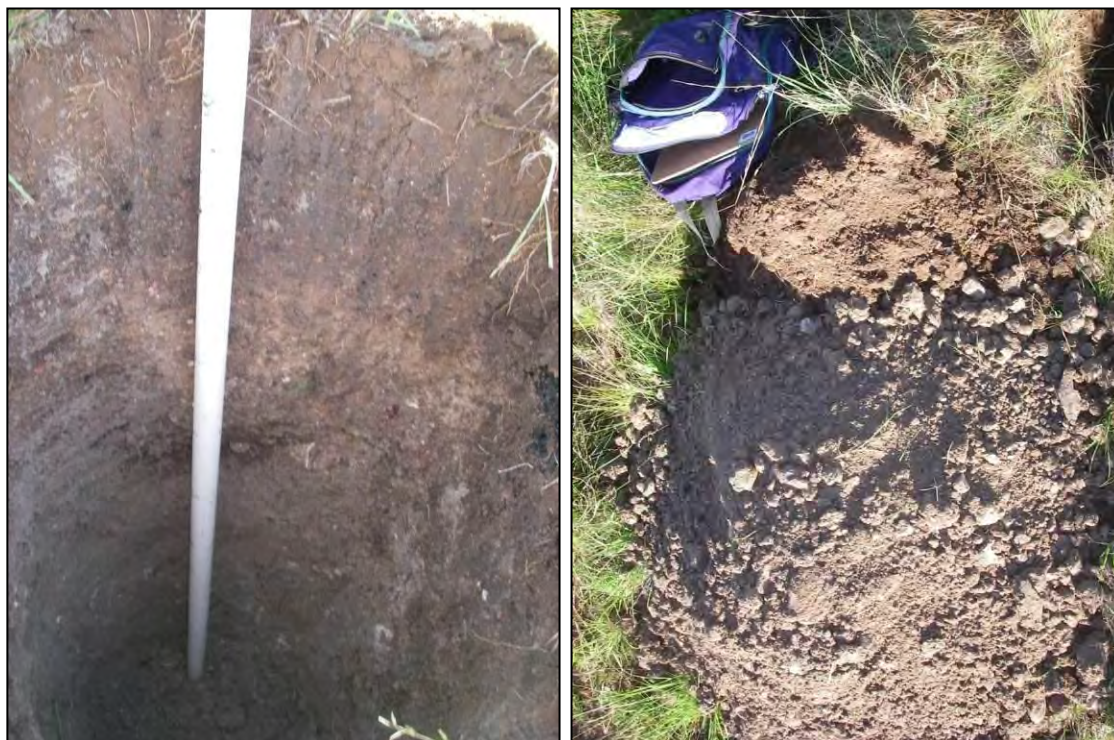
## Soil Pit 7 Pasture Control (north) (E: 229028; N: 6597192)

HORIZON AND DEPTH	SOIL DESCRIPTION
1: 0 – 0.20 m	Light-medium clay (chocolate) with some fine-coarse gravel Roots throughout profile
2: 0.20 – 0.40	Light -medium clay (light chocolate) with coarse gravels Roots throughout profile but decreases with depth Transitional boundary
3: 0.40 – 1.00	Heavy clay (grey) with small amounts of gravel Roots to depth of 75 cm only

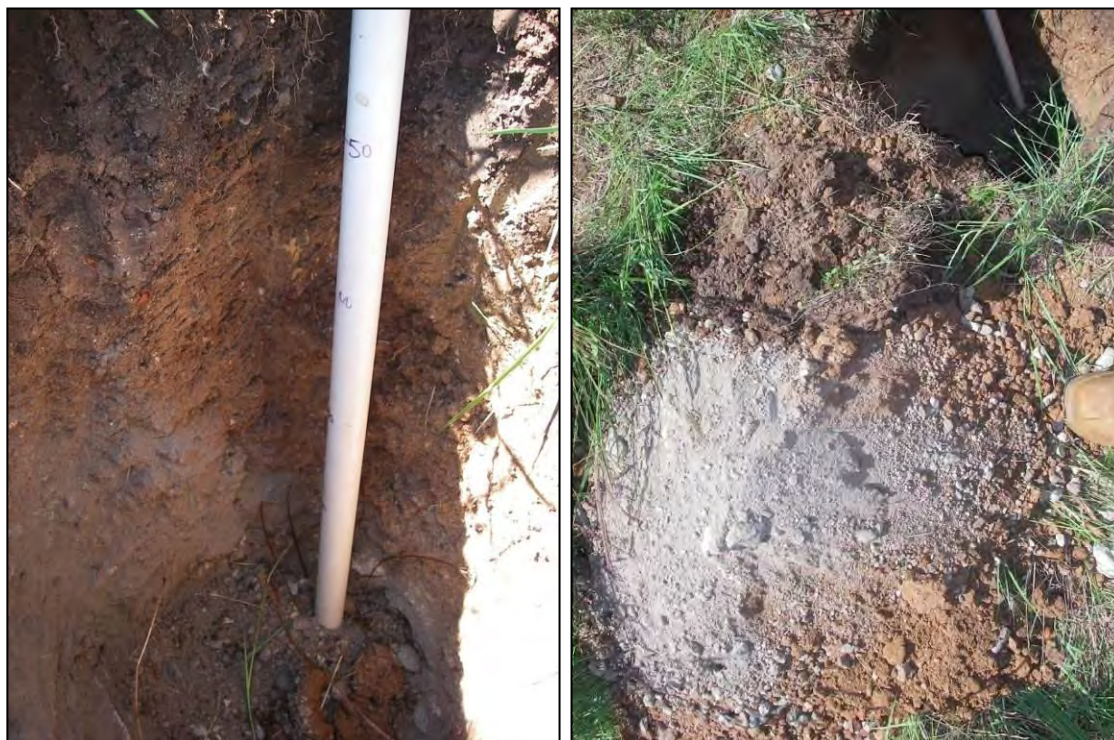
## Soil Pit 8 Pasture Rehabilitation Zone (E: 228961; N: 6597001)

HORIZON AND DEPTH	SOIL DESCRIPTION
1: 0 – 0.15 m	Medium-heavy clay (dark chocolate) with high portion of fine gravel Roots throughout depth of profile
2: 0.15 – 0.60 m	Medium clay (dark brown) with fine-medium gravels Roots to depth of 45cm and decrease with depth
3: 0.60 – 1.00 m	Gravel-sand-clay mixture (mine overburden) (grey) Coarse gravels increasing in size and abundance with depth No roots

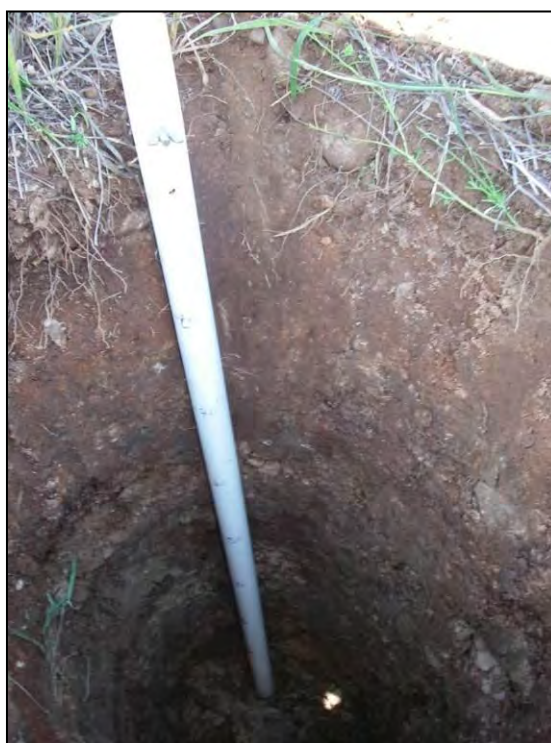
## Soil Pit 9 Pasture Rehabilitation Zone (E: 229020; N: 6595752)

HORIZON AND DEPTH	SOIL DESCRIPTION
1: 0 – 0.40 m	Sandy loam-light clay (dark red-chocolate) with high proportion of fine gravel Roots to 35 cm (although sparse after 20 cm depth)
2: 0.40 – 0.60 m	Light-medium clay (chocolate-light grey) High proportion of fine gravels (thin gravel seams) No roots
3: 0.60 – 1.00 m	Medium-heavy clay (dark red-chocolate) Little to no gravels No roots
