WHC\_REP\_NAR\_END OF PANEL REPORT LW102

# LW102

# END OF PANEL REPORT

# NARRABRI MINE

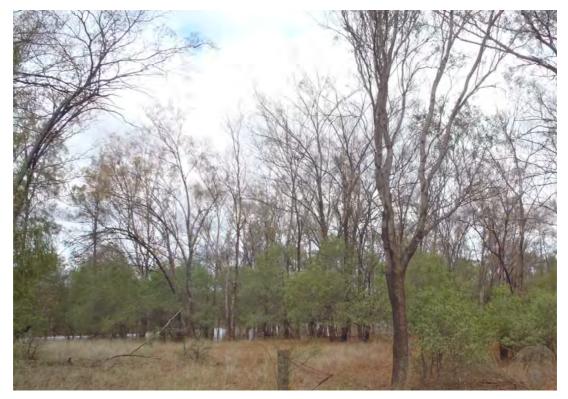
Photo 1: Ponding at LW102 within a Tributary of Pine Creek

Water ponding has been observed in LW102 in two tributaries of Pine Creek, refer to Photo 1 and Photo 2, immediately upstream of the ponding area reported for LW101. The ponding in the tributaries of Pine Creek was predicted to occur in the Stage 2 Longwall Project Environmental Assessment for the Narrabri Mine.

The mine is currently developing a management procedure for the ponding area to formalise the current process of pumping water downstream from the ponding area. Water quality samples are collected monthly from the ponded water. The results are monitored to ensure parameters are not increasing above the baseline levels in the ponded water as this may affect the soils in the area. The results indicate water quality parameters, including pH, EC, TSS, Oil & Grease, and turbidity, are within the range of background levels for the mining area. Baseline information was collected for soils in the ponding area of LW101 as part of the monitoring requirements outlined in the Extraction Plan. This includes electrical conductivity and soil moisture distribution mapping using EM31/38 sensors. Should the ponding of water impact the soils the mine will investigate additional options for management which may include a diversion drain to minimise the level of ponding.

For the ponding of water in the tributaries in LW102 it is expected that the system will naturally re-adjust to changes as a result of subsidence to reach a dynamic equilibrium. Maximum gradient change measured along the reach between LW101 and LW102 is 5.47%. Small reaches of the creek have increased or decreased in gradient at the upstream and downstream extent of ponding but the channel bed appears stable (as relative to the natural system). Monitoring required by the Land Management Plan, developed as part of the Extraction Plan, noted that no remediation works are recommended for the area of ponding within LW101.

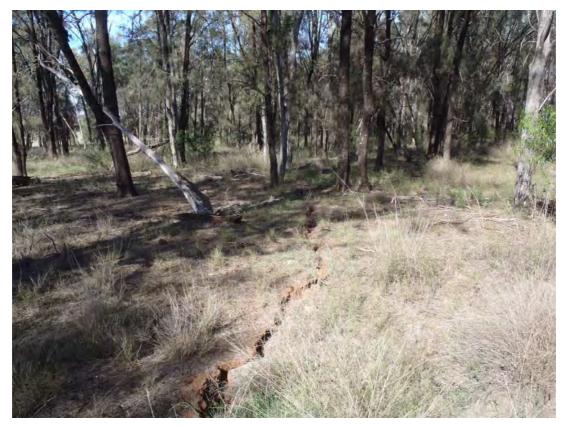
Photo 3: Surface Crack in LW102

Informal visual observations in the subsidence area were undertaken as part of general duties in addition to the formal inspections of Greylands Road, required by the Extraction Plan, undertaken when undermining the road. Surface cracks observed were typically 50mm to 100mm wide with some cracks widths up to 200 mm (refer to Photo 3). The cracks were within the predicted range. LW102 was not ploughed and seeded as was undertaken in LW101 during its extraction as very little rainfall and hot conditions over the summer period meant very little soil moisture was available for seed propagation. Ploughing and seeding will be undertaken above LW102 when conditions improve.

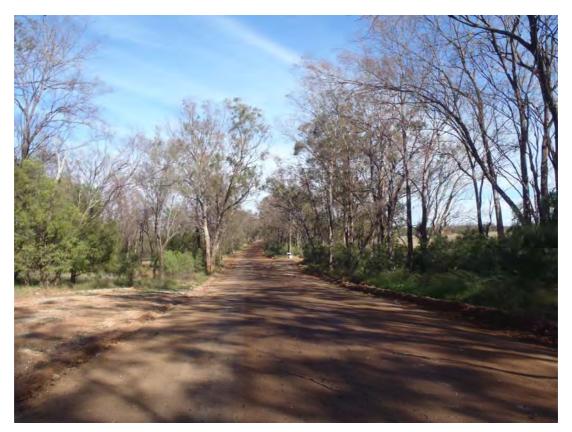
Photo 4: Greylands Road above LW102

As reported previously, large trees have been impacted by subsidence above LW101 and LW102. Although to a lesser extent in LW102 (refer to Photo 4) given the trees are smaller than those that occur above LW101. In late October 2013, a Senior Botanist supervised the excavation of two recently dead trees along Greylands Road within LW101; a Grey Box approximately 12 m tall (dbh 30 cm) and White Cypress Pine (*Callitris glaucophylla*,

Daily inspections during active subsidence were undertaken as outlined in the GRMP and the Built Features Management Plan, part of the Extraction Plan. In accordance with the GRMP, Greylands Road was inspected by NSC and closed prior to undermining. Following mining, Narrabri Mine undertook remediation works in the form of stabilising the surface of the road with gravel (refer to Photo 4). The road remains closed to the general public.

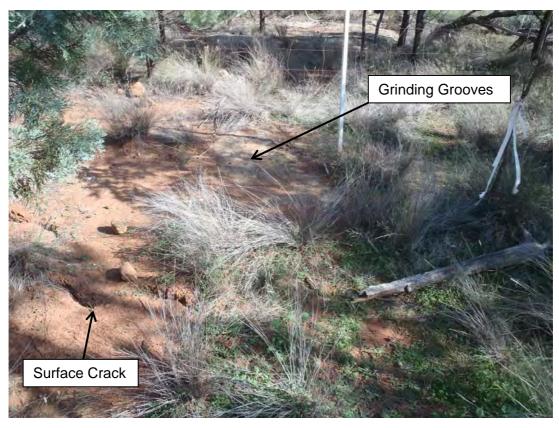
Photo 5: Grinding Grooves on Sandstone Floaters in LW102

Fifteen previously identified cultural heritage sites are located above LW102 being Sites 16-19 and 22-27. Four previously identified cultural heritage sites are located above the chain pillars between LW101 and LW102 being Sites 32-34 and between LW102 and LW103 chain pillars being Sites 28 and 122. Sites 17, 25 and 26 are isolated artefacts. Sites 16, 18-19, 22-24 and 27 are artefacts scatters including up to 18 artefacts (Site 19) located adjacent to the ephemeral creek. Site 122 comprises 6 grinding grooves on 3 sandstone platforms. It was predicted that no impacts would occur to the grinding grooves as they were considered to be located on sandstone floaters. The grinding grooves were not disturbed by subsidence (refer to Photo 5). The artefacts will be subject to further investigation to determine the extent of impacts following subsidence, if any, and then additional management measures may be introduced as required. This could include temporary salvage of artefacts as recommended by the Aboriginal Stakeholders for the mine.
