WHC_REP_NAR_END OF PANEL REPORT LW104

END OF PANEL REPORT

NARRABRI MINE

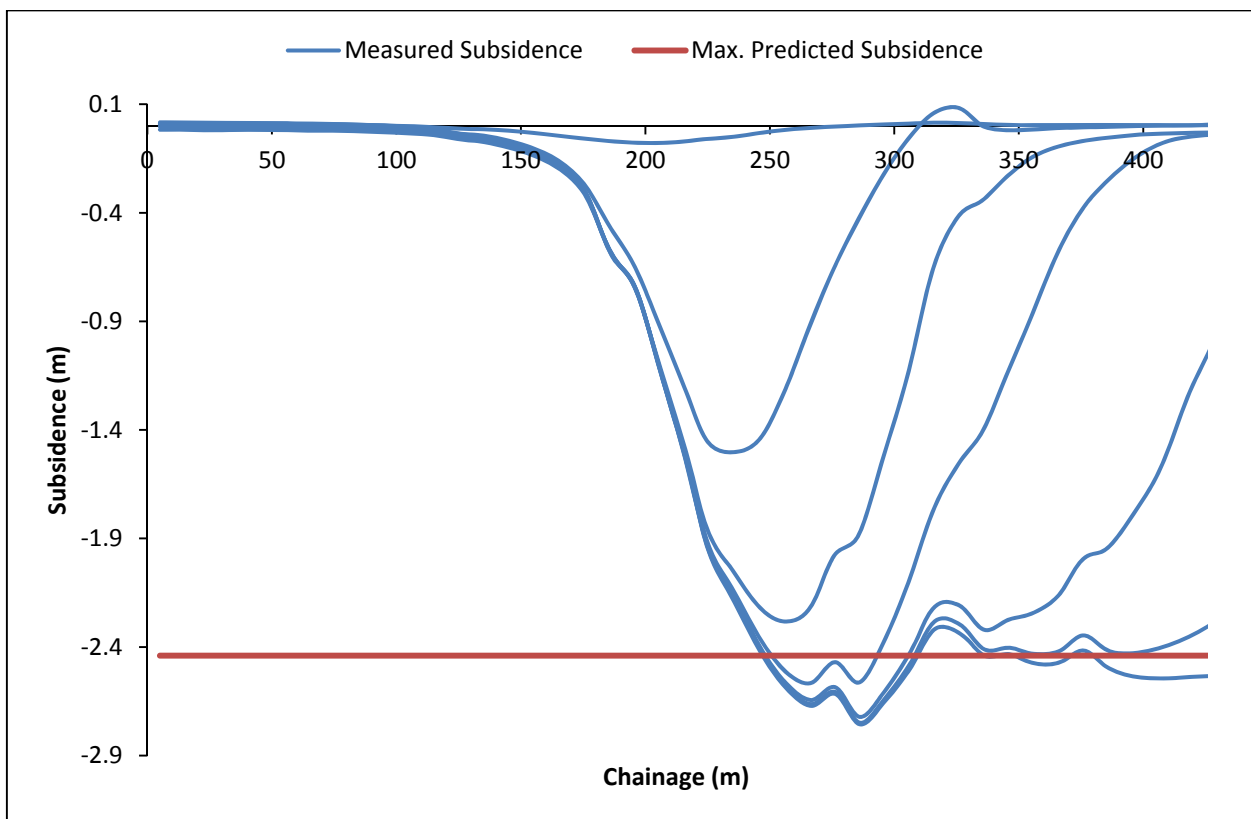
Figure 2: LW104 (North) Subsidence

- The maximum subsidence measurements for the northern and southern monitoring lines in LW104 were within +/- 15% of the predicted value of 2.44 m with a maximum measured value of 2.756 m, refer to Figure 2 and Figure 3.

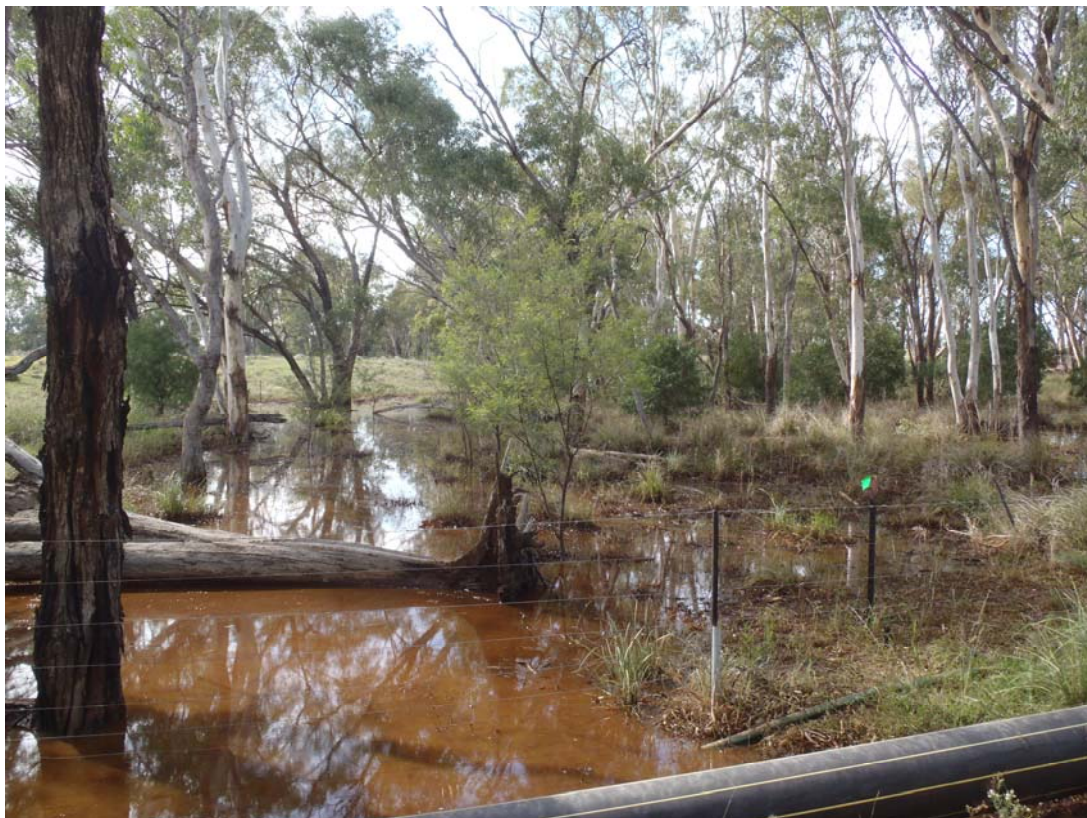
Water ponding has been observed in LW104 in Pine Creek, refer to Photo 1. The ponding was predicted to occur in the Stage 2 Longwall Project Environmental Assessment for the

Narrabri Mine, and is generally limited to within the banks of the ephemeral creeks, although some out of bank ponding has occurred.

Photo 1: Ponding at LW104 within Pine Creek

For the ponding of water in LW104 it is expected that the system will naturally re-adjust to changes as a result of subsidence to reach a dynamic equilibrium. Maximum gradient change measured along Pine Creek is 3.29%. Small reaches of the creek have increased or decreased in gradient at the upstream and downstream extent of ponding but the channel bed appears stable (relative to the natural system). Some trees are stressed as a result of water ponding

The mine is continuing the current management measures for the larger ponding area in LW101 of pumping water downstream. Water quality samples are collected monthly from the ponded water. The results are monitored to ensure parameters are not increasing above the baseline levels in the ponded water as this may affect the soils in the area. The results indicate water quality parameters, including pH, EC, TSS, Oil & Grease, and turbidity, are within the range of background levels for the mining area. Baseline information was collected for soils in the ponding area of LW101 as part of the monitoring requirements outlined in the Extraction Plan, including electrical conductivity and soil moisture distribution mapping using EM31/38 sensors. A ponding management plan is being developed and should be provided to DRE and OEH by the end of December 2015 for comment.

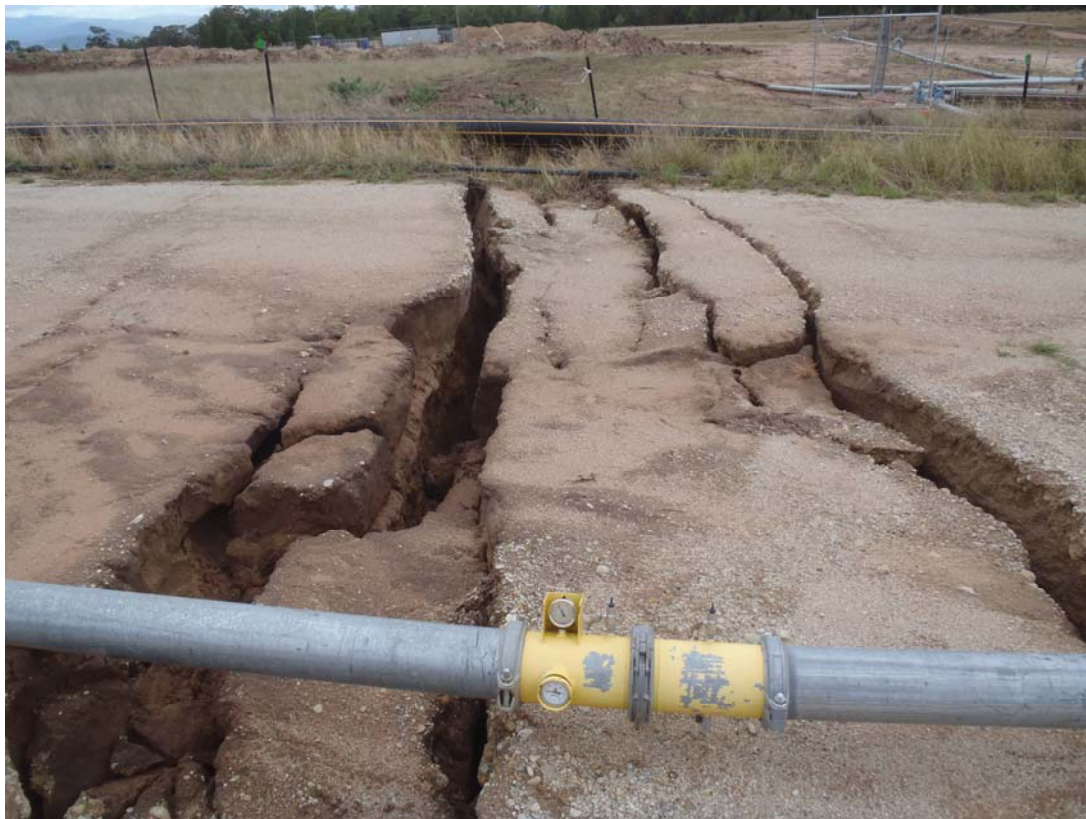
Informal visual observations in the subsidence area were undertaken as part of general duties, in addition to the formal inspections of Greylands Road, required by the Extraction Plan when undermining the road. Surface cracks observed were typically 50mm to 100mm wide with some cracks widths up to 200 mm (refer to Photo 2). The cracks were within the predicted range. No ploughing has been undertaken in LW104 and only limited ploughing has occurred in LW102 as below average rainfall and mild conditions over the extraction period meant very little soil moisture was available for seed propagation, refer to Photo 3. Additional ploughing and seeding will be undertaken above LW104 when conditions improve.

Photo 2: Surface Crack in LW104

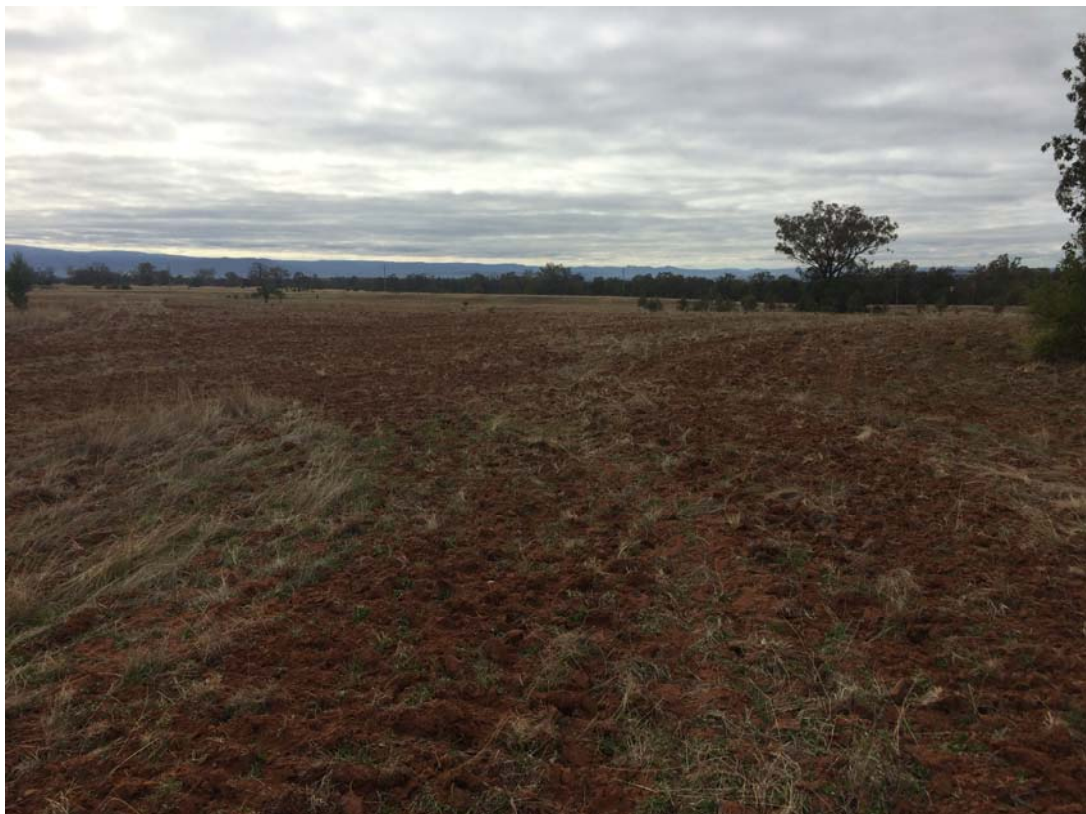
Photo 3: Ploughing Above LW102

No areas of LW104 were ploughed and only limited areas of land over LW102 were ploughed during the extraction of LW104, refer to Section 4.2.1. No other areas of agricultural utilisation were impacted during the extraction of LW104 as the ponding that occurs in Pine Creek is generally limited to within the creek banks.

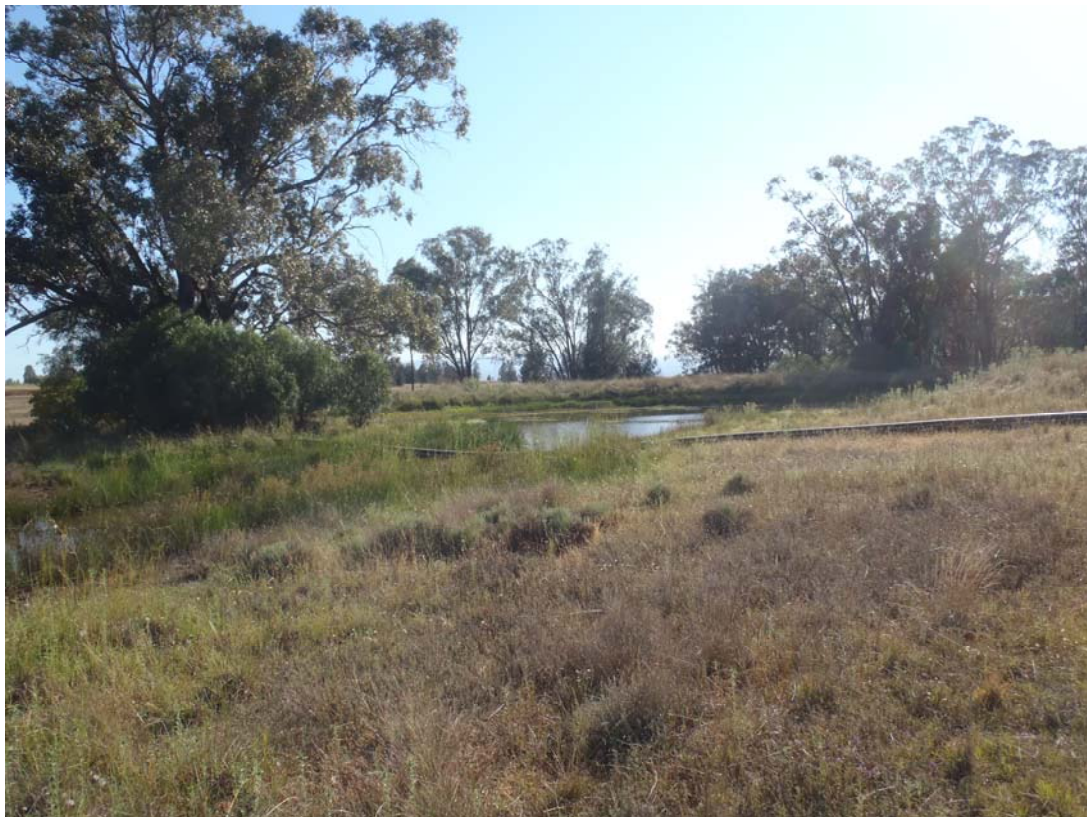
Two small farms dam were undermined in LW104. Rainfall in late August 2015 at the mine refilled these dams refer to Photo 4. Subsidence has not impacted on the function of these dams.

Photo 4: Farm Dam above LW104

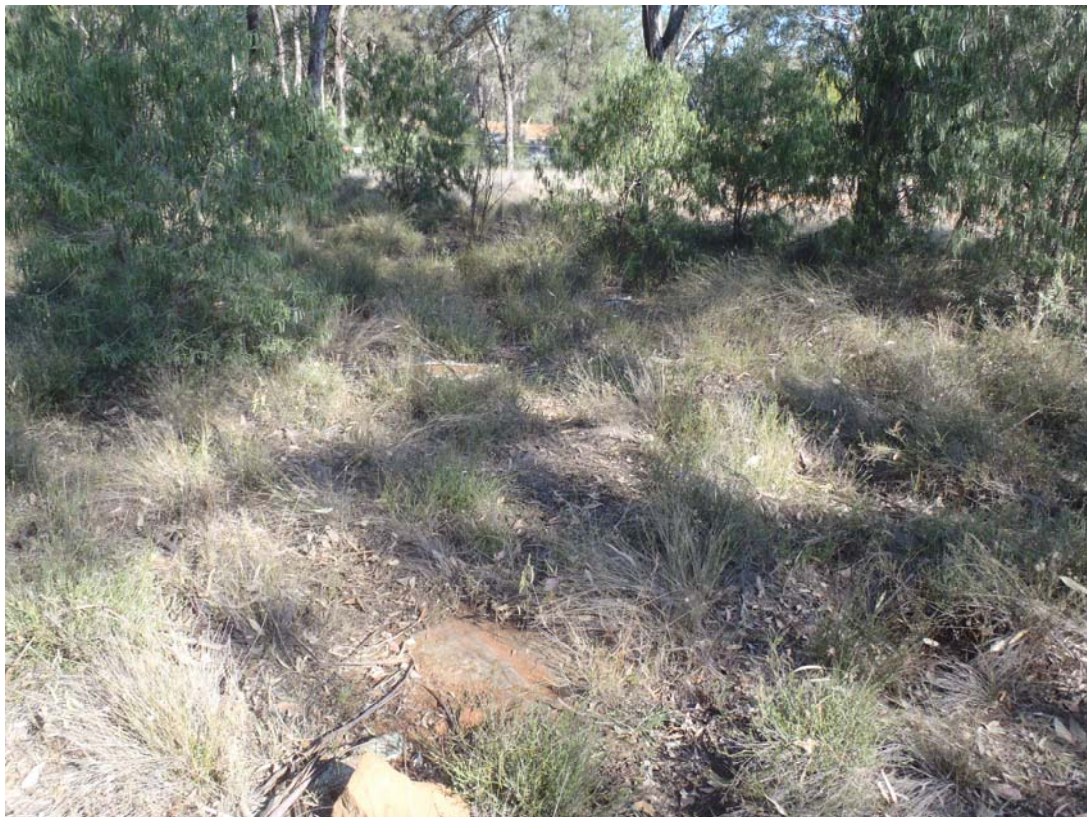
Ten previously identified cultural heritage sites are located above LW104 being Sites 10b, 37-42 and 133-135. Site 10b is a grinding groove site that lies above the chain pillar between LW104 and LW105. Sites 37, 134 and 135 are isolated artefacts. Sites 38-42 and 133 are artefacts scatters. Sites 10b, 38 and 39 are listed as being of high archaeological significance. All sites are located adjacent to the ephemeral creeks. The Extraction Plan developed for LW101 to LW105 outlines that the artefact scatters and isolated artefacts occur on actively degrading surfaces and it is assumed that most of the artefacts have already been displaced by slope-wash, stock movement, land clearance, ploughing, harrowing and vehicular traffic. There would be very few artefacts in their original depositional context or provenance and the direct impact of subsidence (vertical or horizontal displacement) is likely to be minimal. The plan outlines that the main impact may occur as a result of subsidence remediation works.

The sites outlined above have not been impacted by subsidence apart from vertical displacement and as described above, the artefacts are considered unlikely to be located in their original positions. Photo 5 is of Site 10b which was not predicted to be impacted by subsidence as it is located on sandstone floaters and although there is cracking in the immediate vicinity of Site 10b it remains unaffected. This site will be reassessed following the extraction of LW105. Sites 38 and 39 have not been affected apart from vertical displacement. The mine will engage representatives from the Registered Aboriginal Parties (RAPs) to be present during site remediation works that may impact upon sites previously identified at the mine.

Photo 5: Site 10b, Grinding Grooves, located on the chain pillar between LW104 & LW105
