**WHC\_REP\_NAR\_END OF PANEL REPORT LW105**

## END OF PANEL REPORT

### NARRABRI MINE

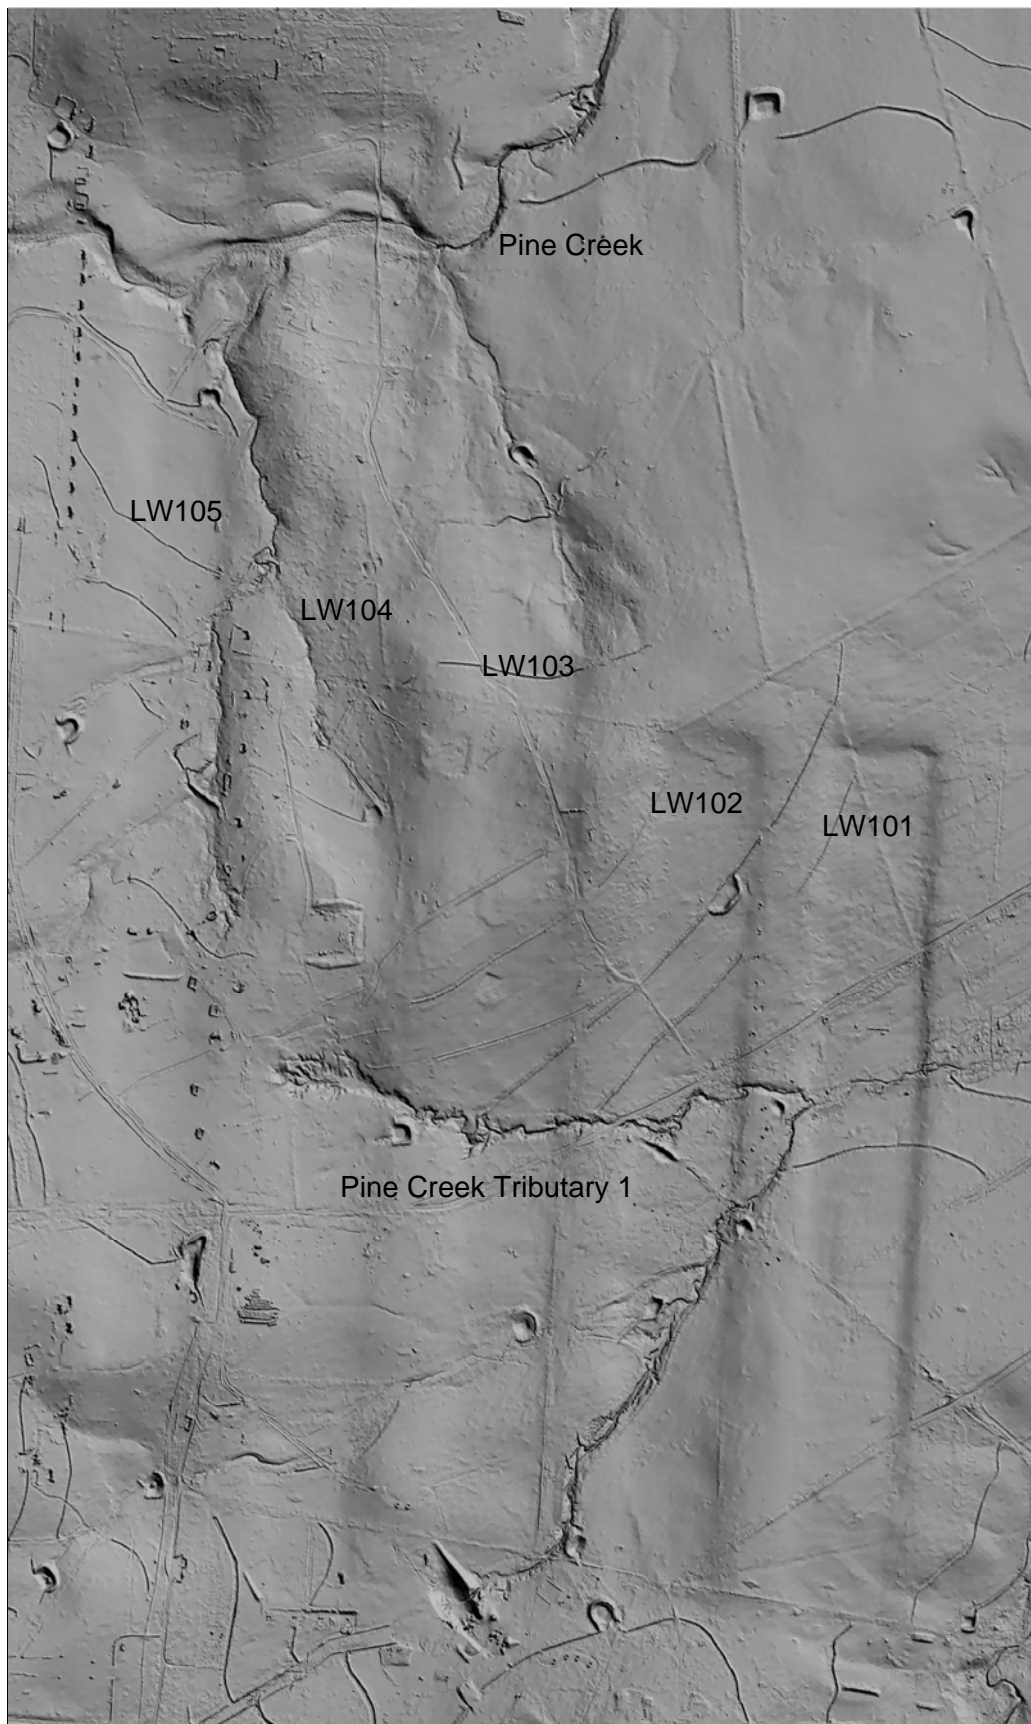
**Figure 1: ALS Survey Image of LW101-LW105, May 2016**

Aerial Laser Scanning (ALS) surveys have been conducted at Narrabri Mine as they are considered to provide a more thorough understanding of subsidence development. The intention is to phase out the longitudinal monitoring with ALS surveys should it prove to be an adequate monitoring technique. To date, Narrabri Mine has completed seven surveys: November 2008 (baseline), 31 December 2012, 25 July 2013, 2 December 2013, 3 October 2014, 25 March 2015 and 6 May 2016. The May 2016 survey imagery is included as Figure 1.

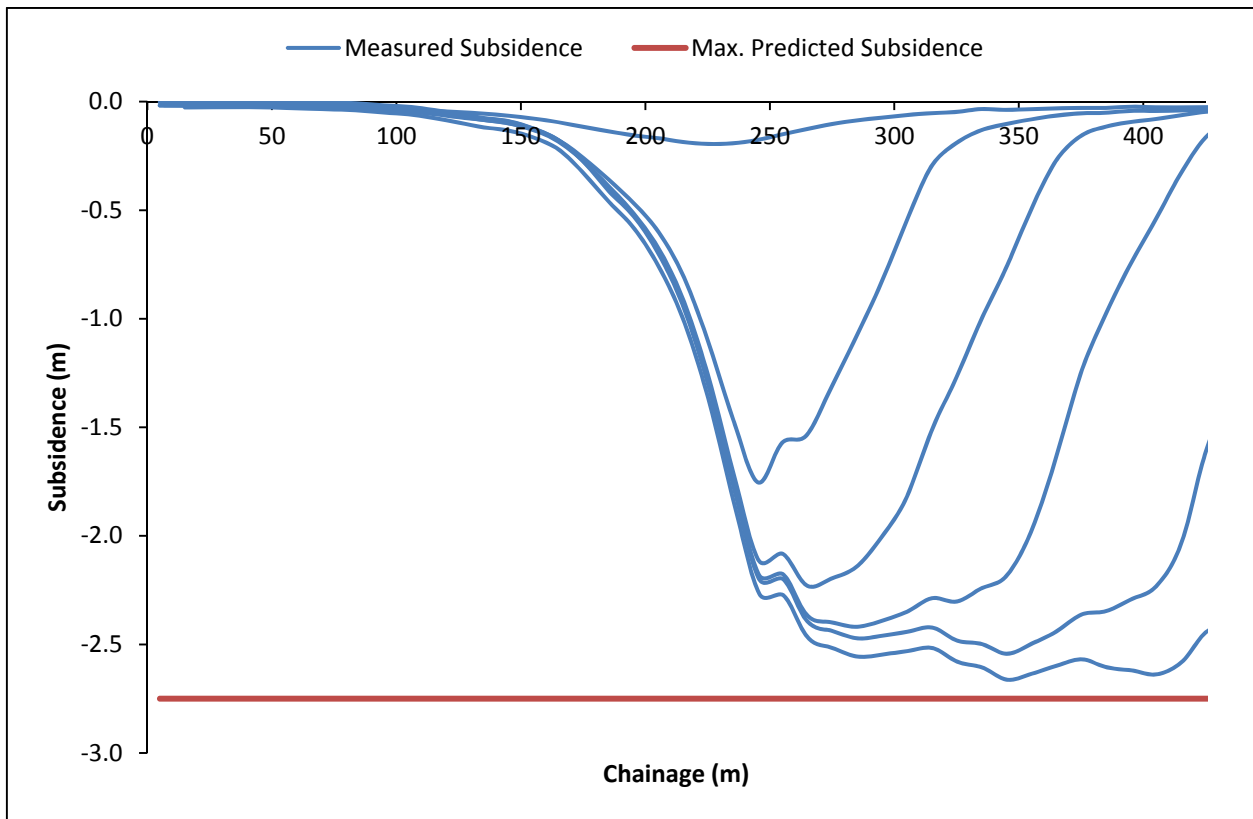
Figure 2: LW105 (North) Subsidence

- The maximum subsidence measurements for the northern and southern monitoring lines in LW105 were within the predicted value of 2.75 m with a maximum measured value of 2.663 m, refer to Figure 2 and Figure 3.

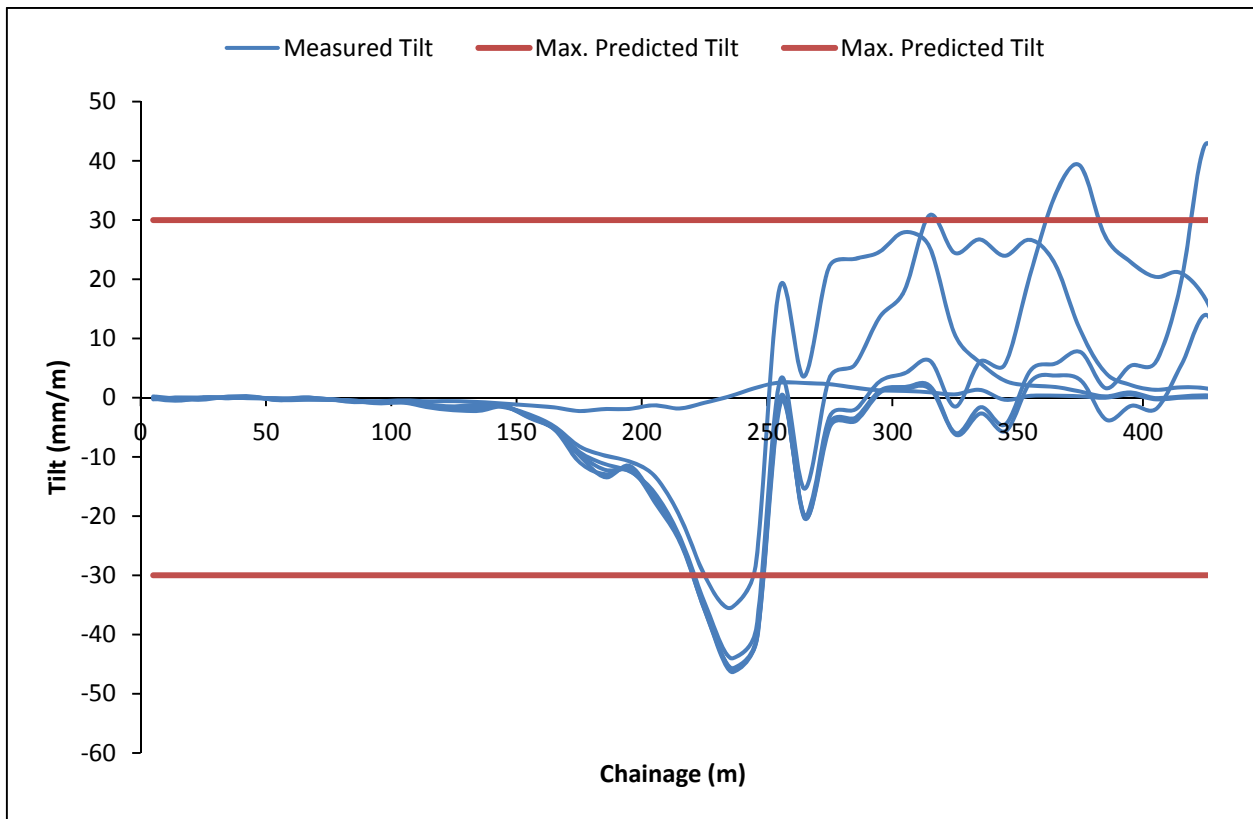
Figure 4: LW105 (North) Tilt

- The maximum tilt measurements recorded for LW105 exceeded the maximum predicted value of 30 mm/m, refer to Figure 4 and Figure 5. However, 97% of all values were within the predicted range.

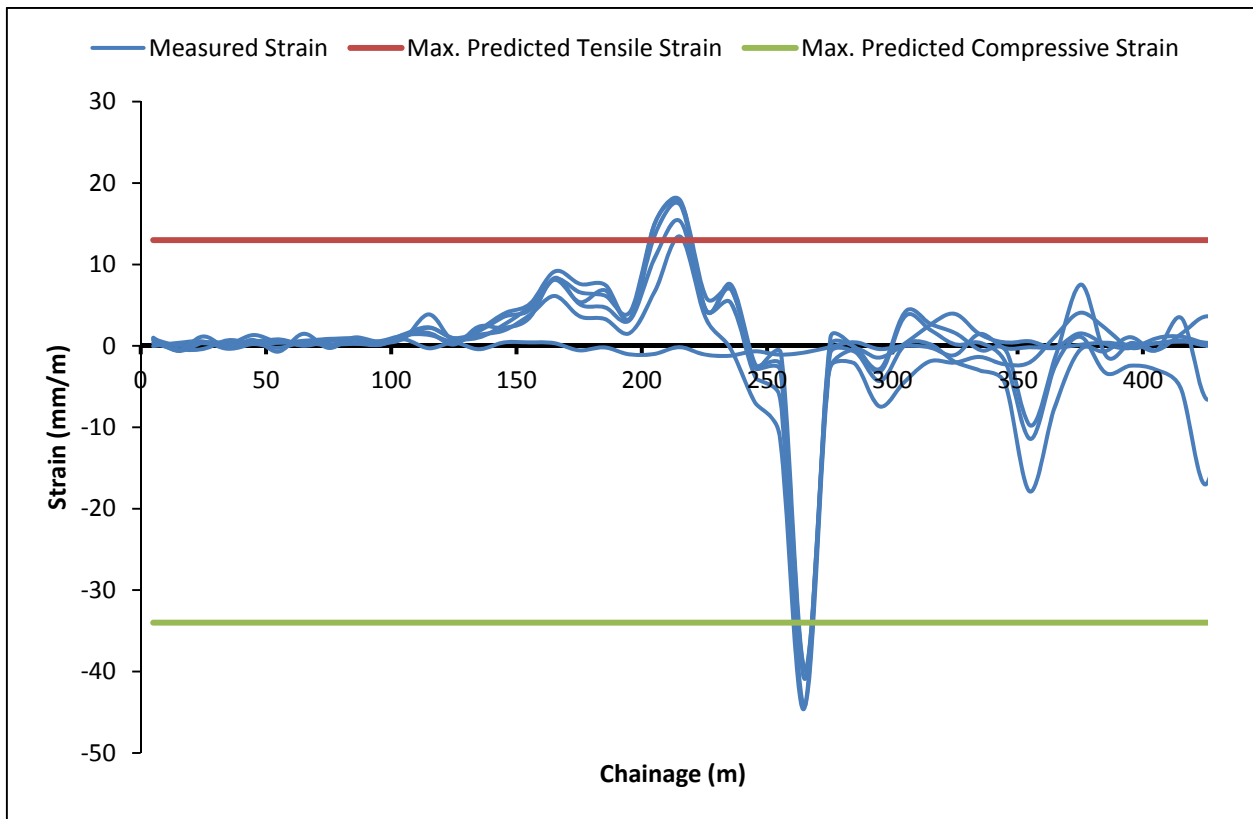
Figure 6: LW105 (North) Strain

- The maximum tensile strain measurements for LW105 exceeded the range of predicted values of 6.5 mm/m (smooth profile) and 13 mm/m (discontinuous or crack affected profiles), refer to Figure 6 and Figure 7. However, 98% of the recorded values were within the predicted range.

- The maximum compressive strain measurements for LW105 exceeded the range of the predicted values of 17 mm/m (smooth profile) and 34 mm/m (discontinuous or crack affected profiles), refer to Figure 6 and Figure 7. However, 99% of the recorded values were within the predicted range.

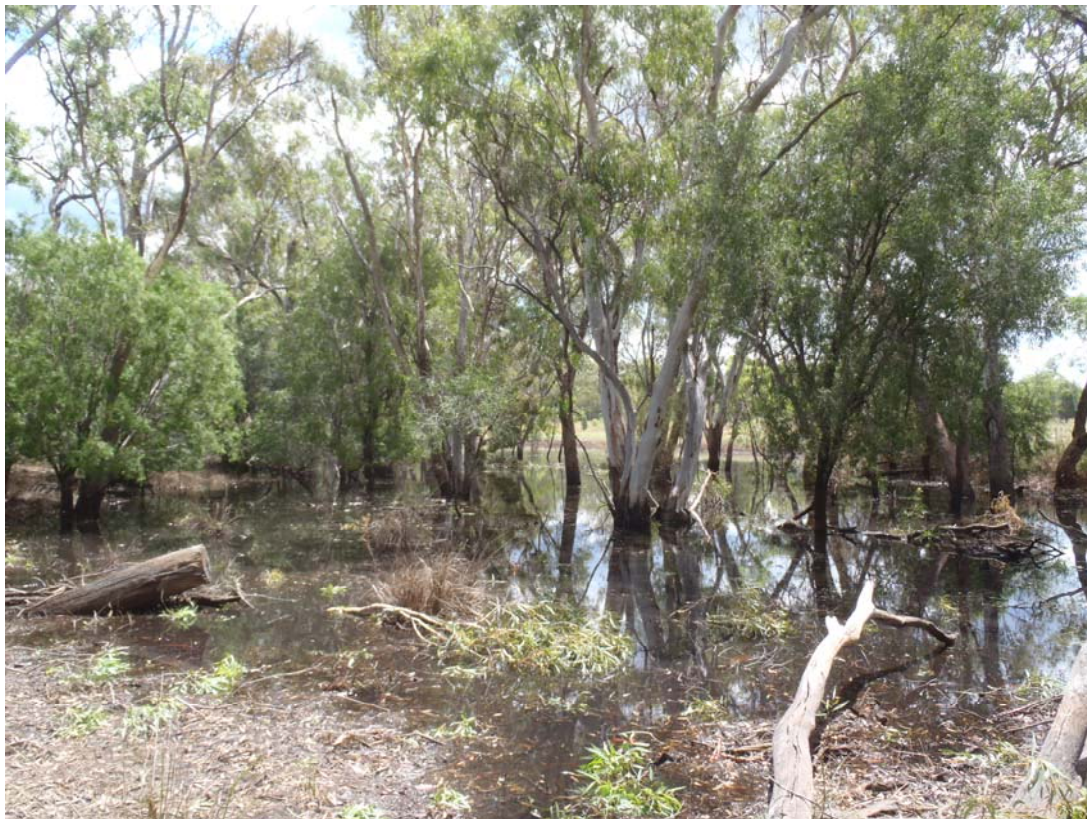
Water ponding has been observed in LW105 in Pine Creek, refer to Photo 1. The ponding was predicted to occur in the Environmental Assessment for the Narrabri Mine, and is generally limited to within the banks of the ephemeral creeks, although some out of bank ponding has occurred.

**Photo 1: Ponding at LW105 within Pine Creek**

For the ponding of water in LW105 it is expected that the system will naturally re-adjust to changes as a result of subsidence to reach a dynamic equilibrium. Maximum gradient change measured along Pine Creek is 4.54%. Small reaches of the creek have increased or decreased in gradient at the upstream and downstream extent of ponding but the channel bed appears stable (relative to the natural system). Some trees are stressed as a result of water ponding

The mine is continuing the current management measures for ponding areas at the mine which is pump the water downstream. Water quality samples are collected monthly from the ponded water. The results are monitored to ensure parameters are not increasing above the baseline levels in the ponded water as this may affect the soils in the area. The results indicate water quality parameters, including pH, EC, TSS, Oil & Grease, and turbidity, are within the range of background levels for the mining area.

A ponding management plan is being developed, with OEH attending site during August 2016 to view the ponding and proposed management measures first hand. Finalising the plan will depend on comments made by OEH following this visit which are yet to be received.

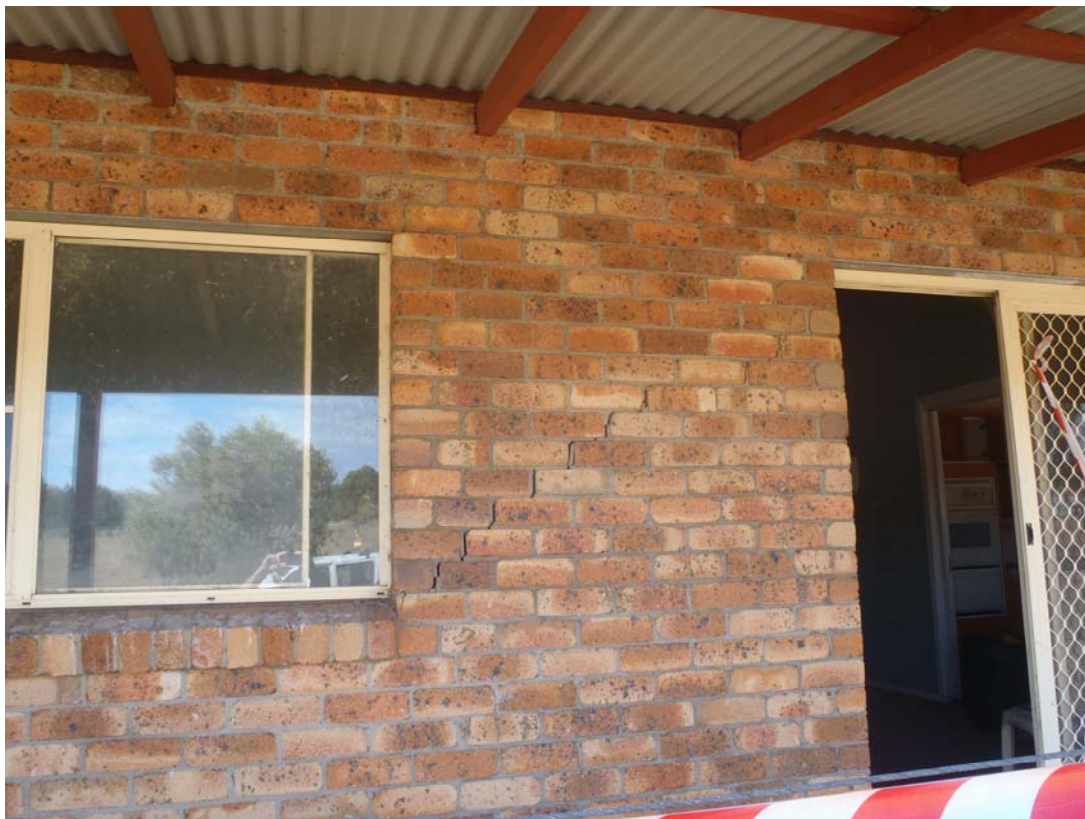
One mine-owned house on the “Barton Hedge” property was undermined during the extraction of LW105. The house was vacated prior to undermining with access restricted as required by the Extraction Plan. The house will be assessed to determine its future use. Some damage was noted, i.e. cracking of brick work and sagging roof, refer to Photo 2. Subsidence at the house was measured to be 2.22m.

**Photo 2: Damaged brick work “Barton Hedge”**

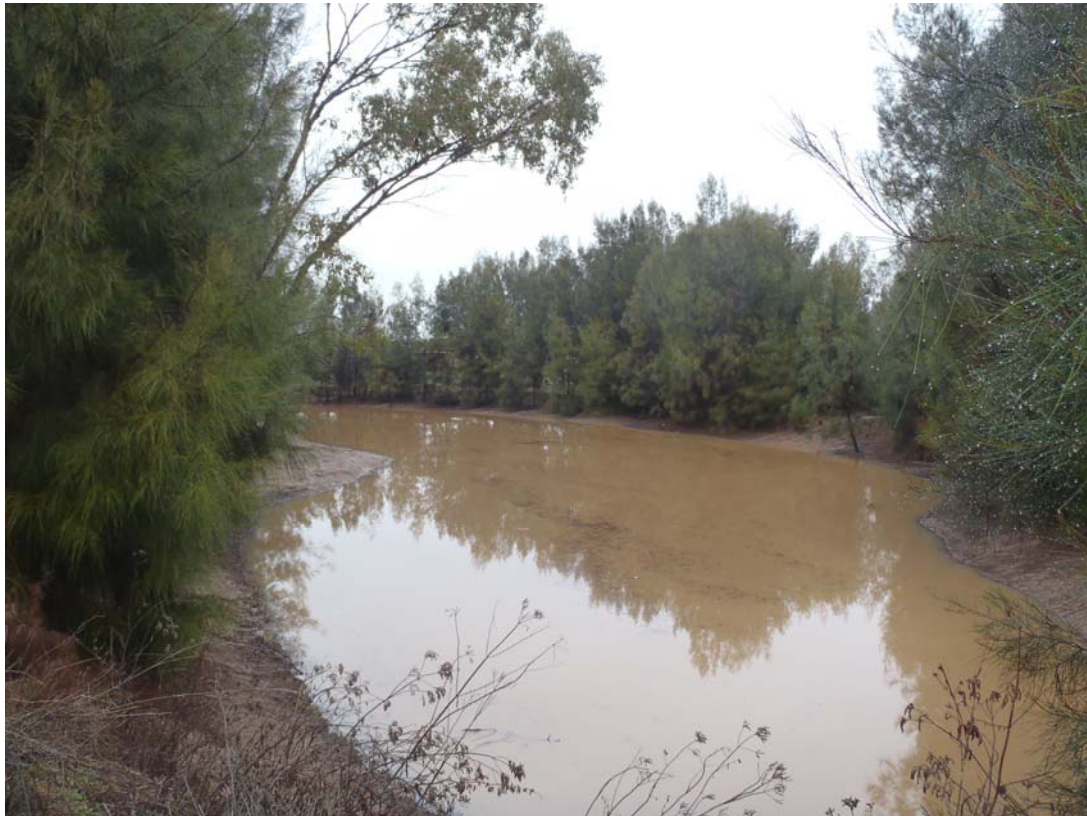
Two small farms dam were undermined in LW105. Rainfall in late August 2016 at the mine refilled these dams refer to Photo 3. Subsidence has not impacted on the function of these dams.

**Photo 3: Farm Dam above LW105 following rainfall**

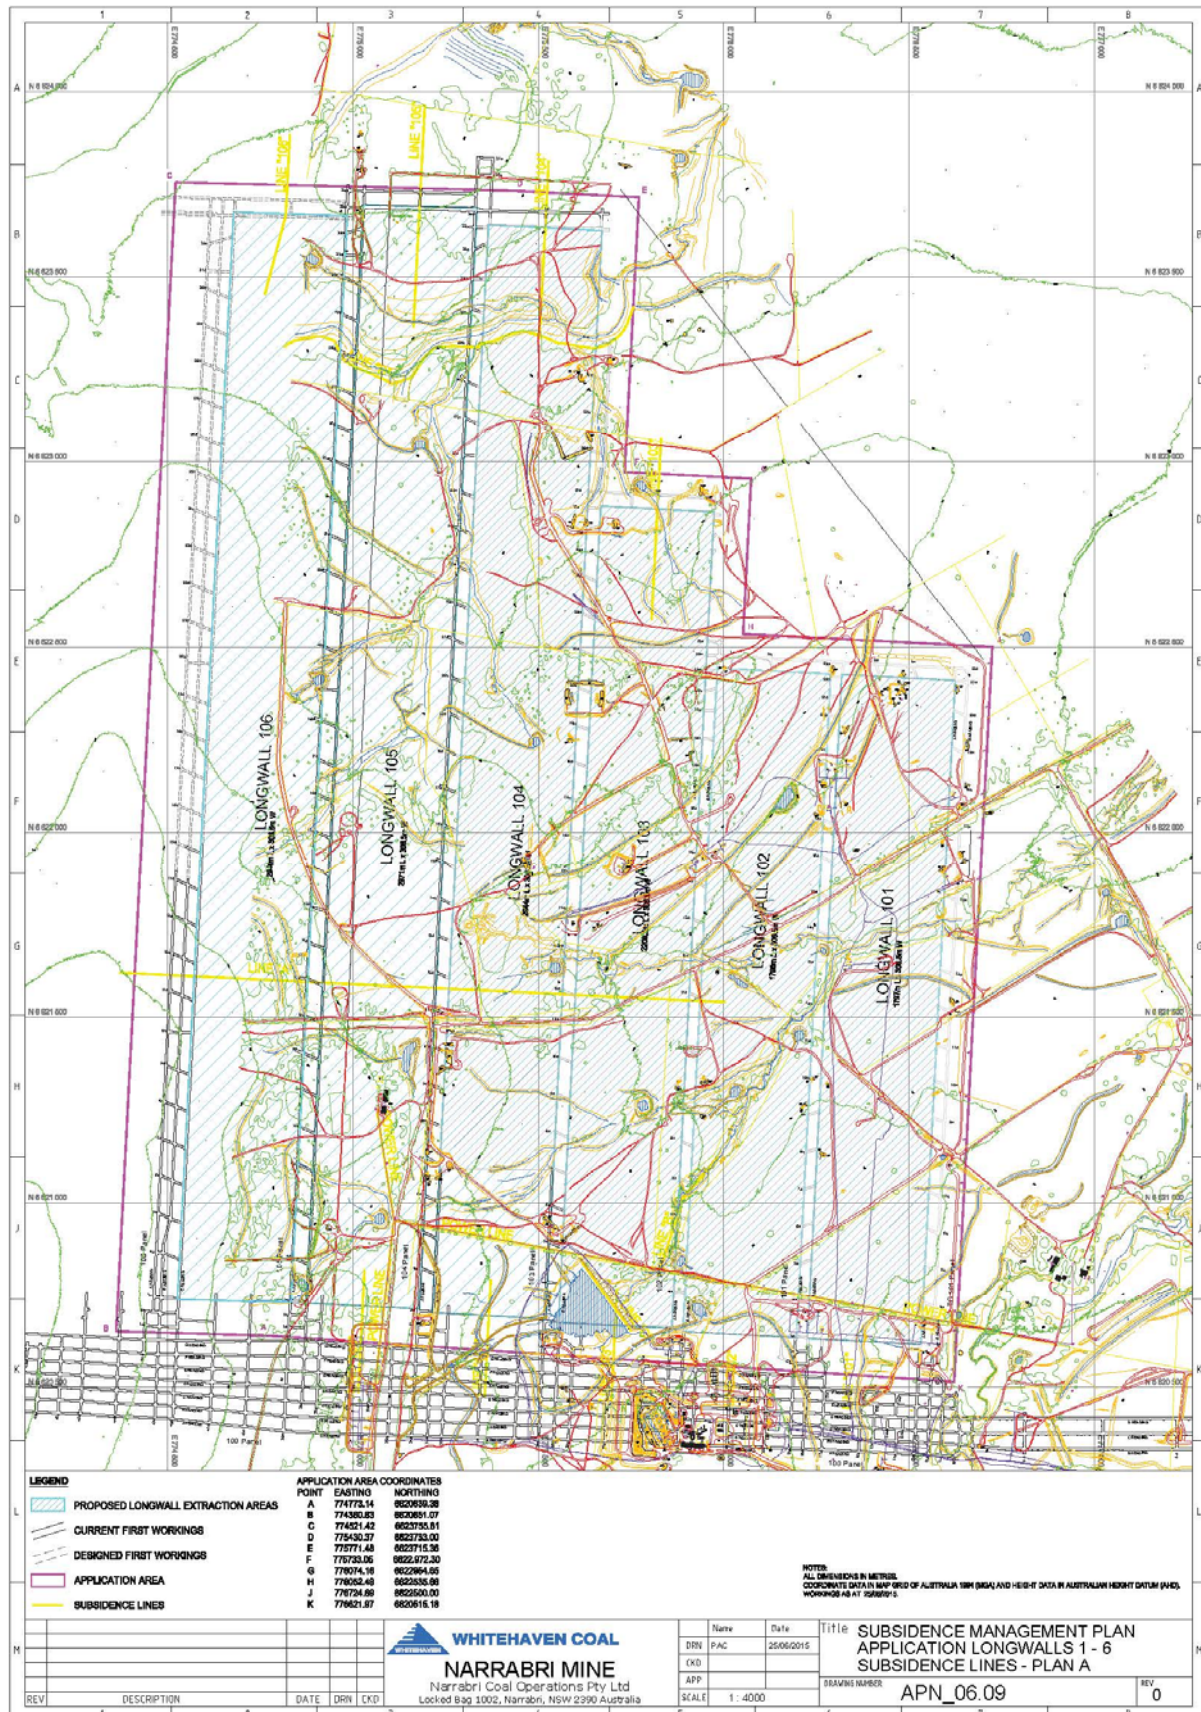
### Attachment 2: Narrabri Mine Subsidence Monitoring Lines LW101 to LW105

Narrabri Mine has established a subsidence monitoring program, required as part of the Extraction Plan for Longwall Panels LW101 to LW105, to quantify subsidence parameters and to identify subsidence related impacts to environmental and built features. Subsidence monitoring results are reported to the Principal Subsidence Engineer at the Division of Resources and Energy (DRE). The subsidence monitoring program consists of the following elements and is presented as Attachment 2:

- A transverse subsidence line across longwall panels LW101 to LW105;
- A full-length longitudinal line over LW101 and LW102 with reduced monitoring extending over the starting and finishing point of each remaining longwall block (LW103 – LW105);
- A survey line along the riparian management zone of Pine Creek and Pine Creek Tributary No.1;
- Four additional survey cross lines perpendicular to Pine Creek Tributary No 1 to establish lateral movement impacts; and
- Survey markers on the 11kV power poles for monitoring of tilt and strain to poles over LW101 to LW104.

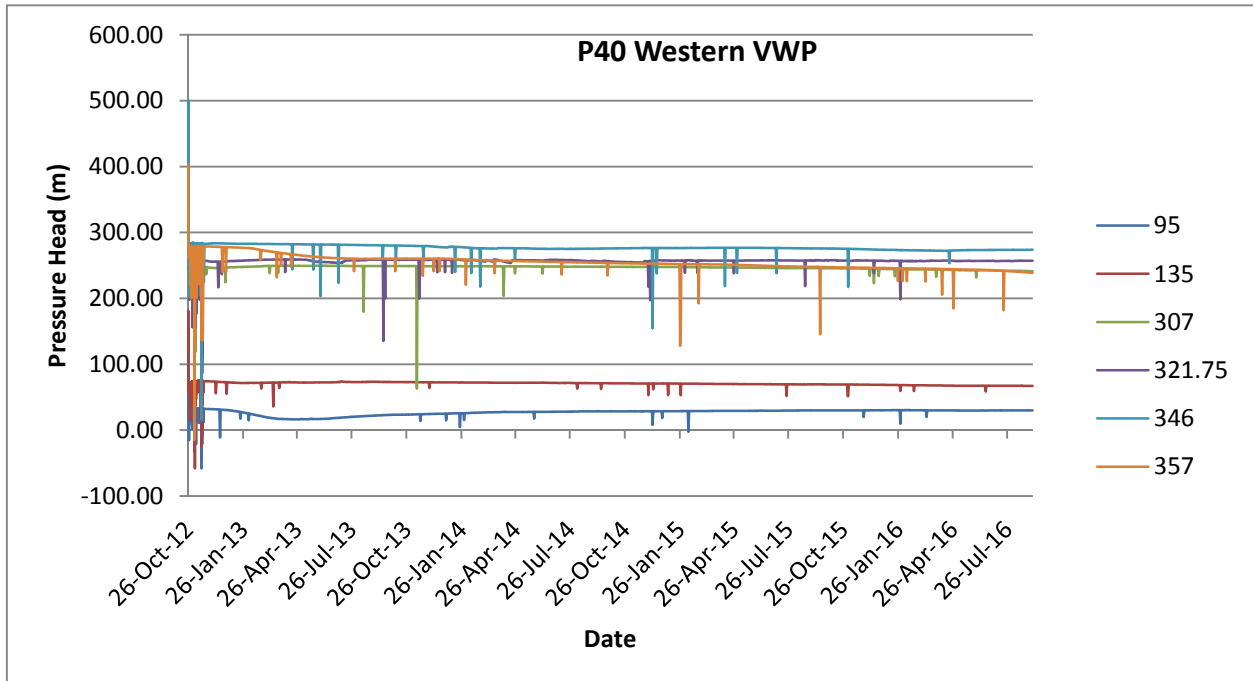
Figure 1: P40 Monitoring Results

- Multi-level vibrating wires P40, P44, P45 and P46 were installed in 2012. The lower depths in P40 at 346 m and 357 m (Hoskissons Seam and Arkarula Formation) show mining effects. Also, P44 at depth 134 m (Digby Formation) shows a decline in the water level due to mining from 225 mAHD in August 2012 to 218 mAHD in August 2014. The Napperby and Pamboola Formations are unaffected at this location.

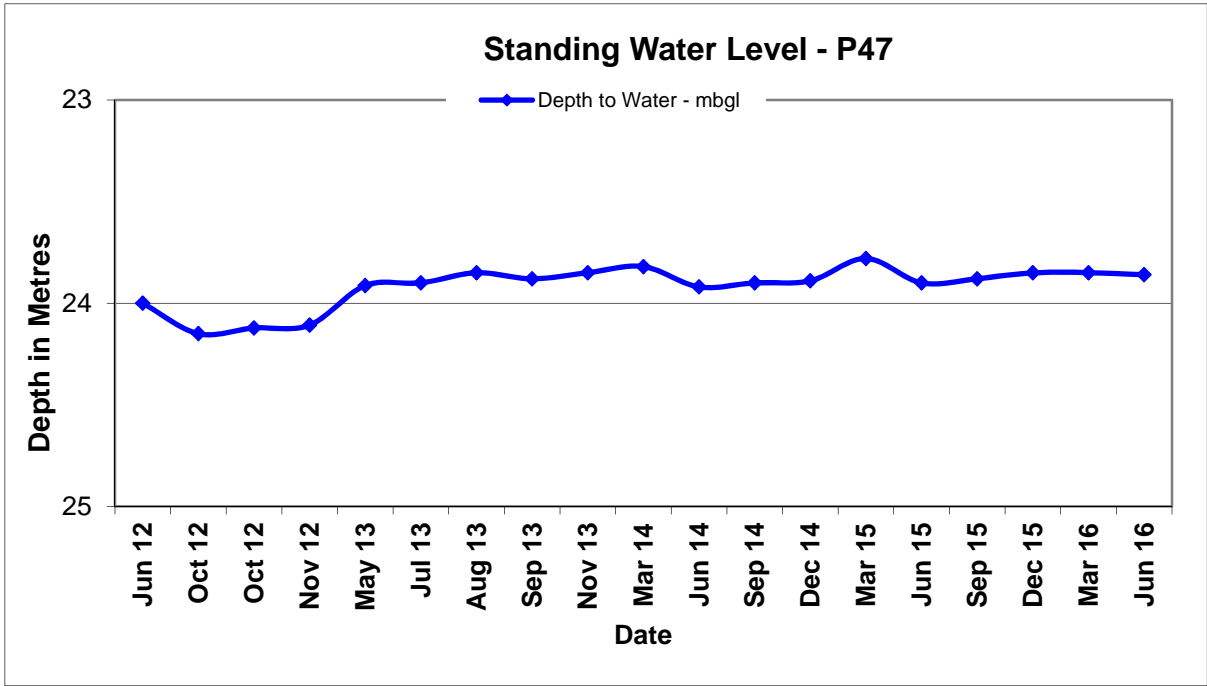
Figure 5: P47 Monitoring Results

The eleven VWP's include four life-of-mine groundwater monitoring wells that have been installed as required by the Water Management Plan for the Longwall Project. P39A&B,

P43 and P47 are life-of-mine standpipe piezometer targeting the Garrawilla Volcanics, Watermark and alluvium on and surrounding the mine. There are two more VWP's to be installed as part of the life-of-mine monitoring program.
