**Narrabri Mine Community Consultative Committee Meeting #48****Date:** Tuesday 04<sup>th</sup> March 2020**Time:** 5:00pm**Location:** Narrabri Mine office

**Mine Progress Report (01 December 2019 – 29 February 2020)**

## 4. ENVIRONMENTAL MONITORING REPORT

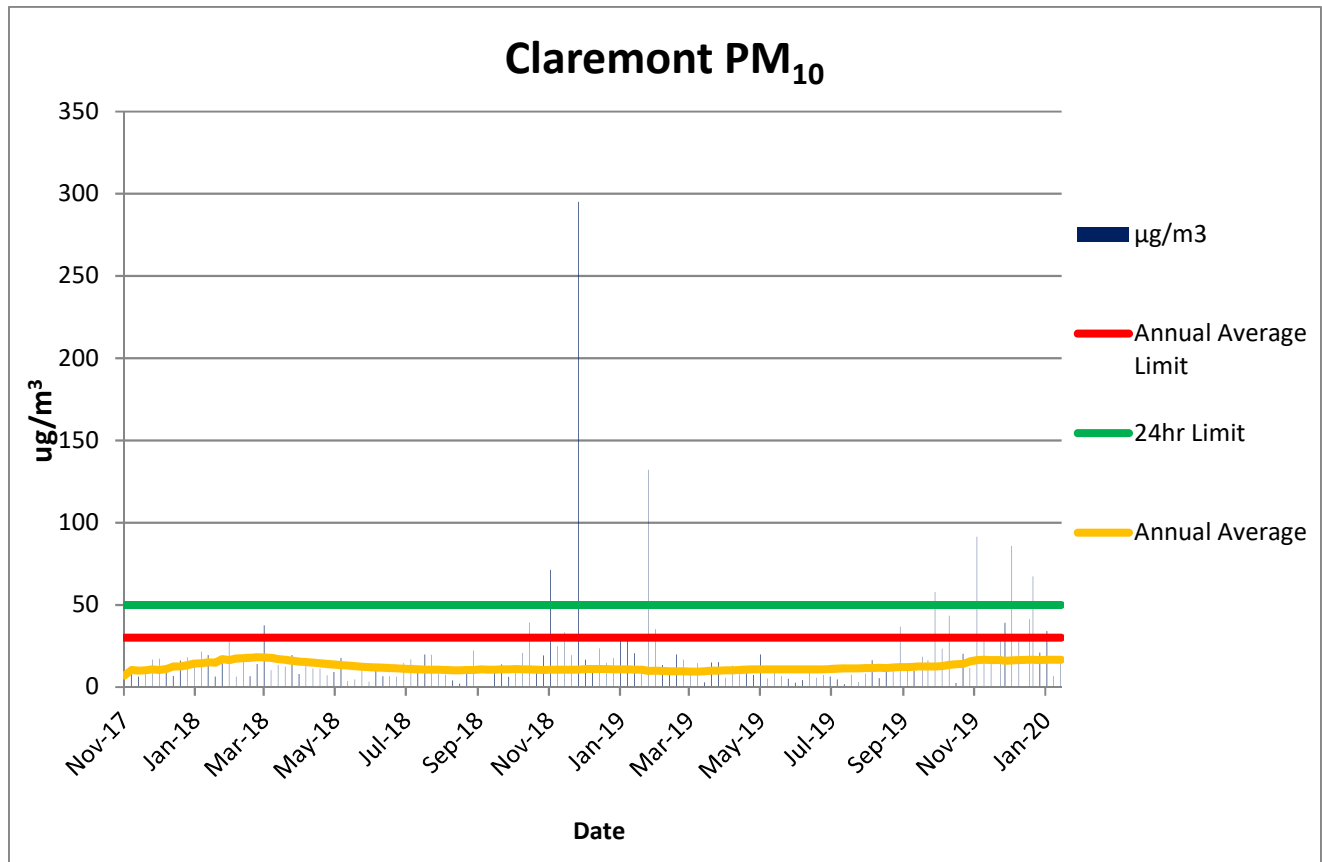
**Figure 1:** Claremont PM<sub>10</sub> HVAS results. Samples are collected over a 24 hour period once every week, with a (24hr) compliance limit of 50.0ug/m<sup>3</sup>.

The Claremont HVAS is returning an annual average of 16.65 µg/m<sup>3</sup>, which is below the annual average limit of 30 µg/m<sup>3</sup>.

Since the previous CCC meeting there has been an exceedance of the 24 hour limit of 50.0 µg/m<sup>3</sup> on the 9<sup>th</sup> of January 2020 (result of 67.3 µg/m<sup>3</sup>) due to poor regional air quality across NSW. The exceedance was reported to the regulator.

- **PM10 AIR QUALITY-** NCO recorded exceedances at monitoring locations Claremont (on 09/01/20) and Turrabaa (09/01/20). Results attributed to poor regional air quality. Both exceedances have been reported to the Department of Planning (DPI&E).
- **QUARTERLY NOISE MONITORING-** Attended noise monitoring was undertaken on the 18th, 19th and 20th of December 2019 in accordance with mine approvals. Compliance was achieved at all locations during all time periods.
- **SURFACE WATER MONITORING:** No discharges. Creek flow events as a result of rainfall were sampled as required.
- **WATER LICENSING:** Namoi River General Security water orders placed due to recent river flow event. Discussed Mine Dewatering and water treatment usage processes and figures. JS mentioned it would be a good idea to include more detail on this graph for future meetings.

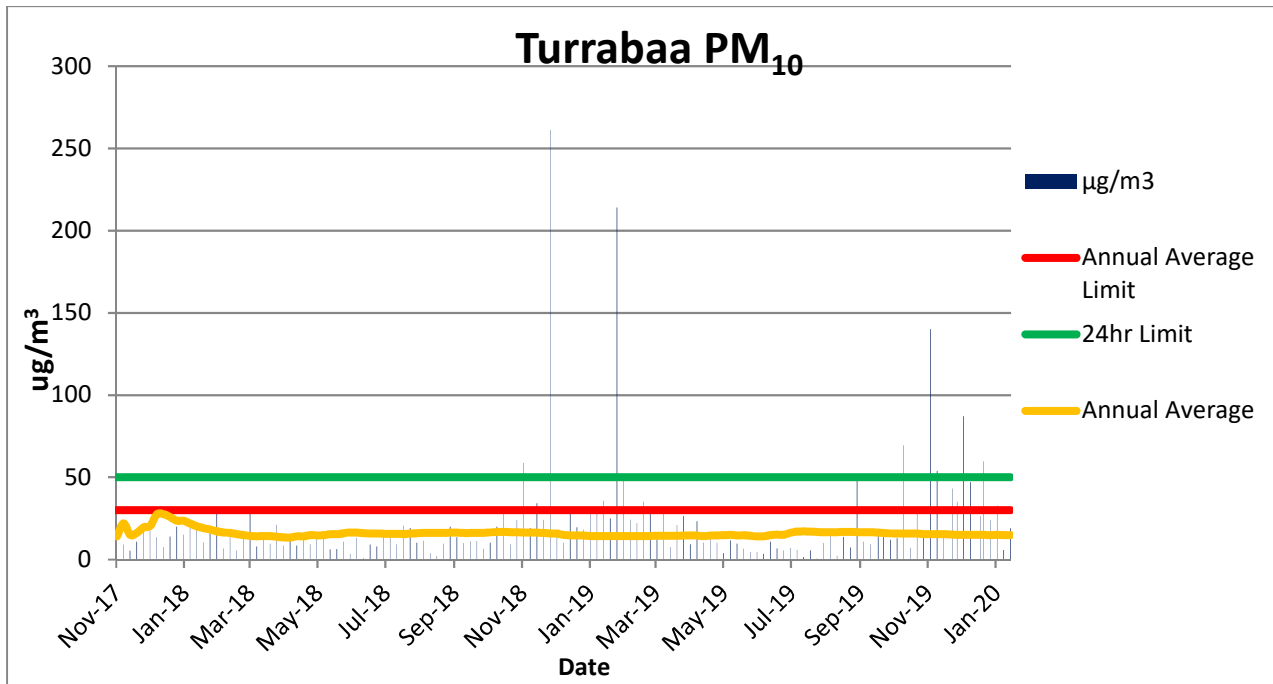
**Figure 2:** Turrabaa PM10 High Volume Air Sampler results. Samples are collected over a 24 hour period once every week, with a (24hr) compliance limit of 50.0  $\mu\text{g}/\text{m}^3$ .

The Turrabaa HVAS is returning an annual average of 14.88  $\mu\text{g}/\text{m}^3$ , which is below the annual average limit of 30  $\mu\text{g}/\text{m}^3$ .

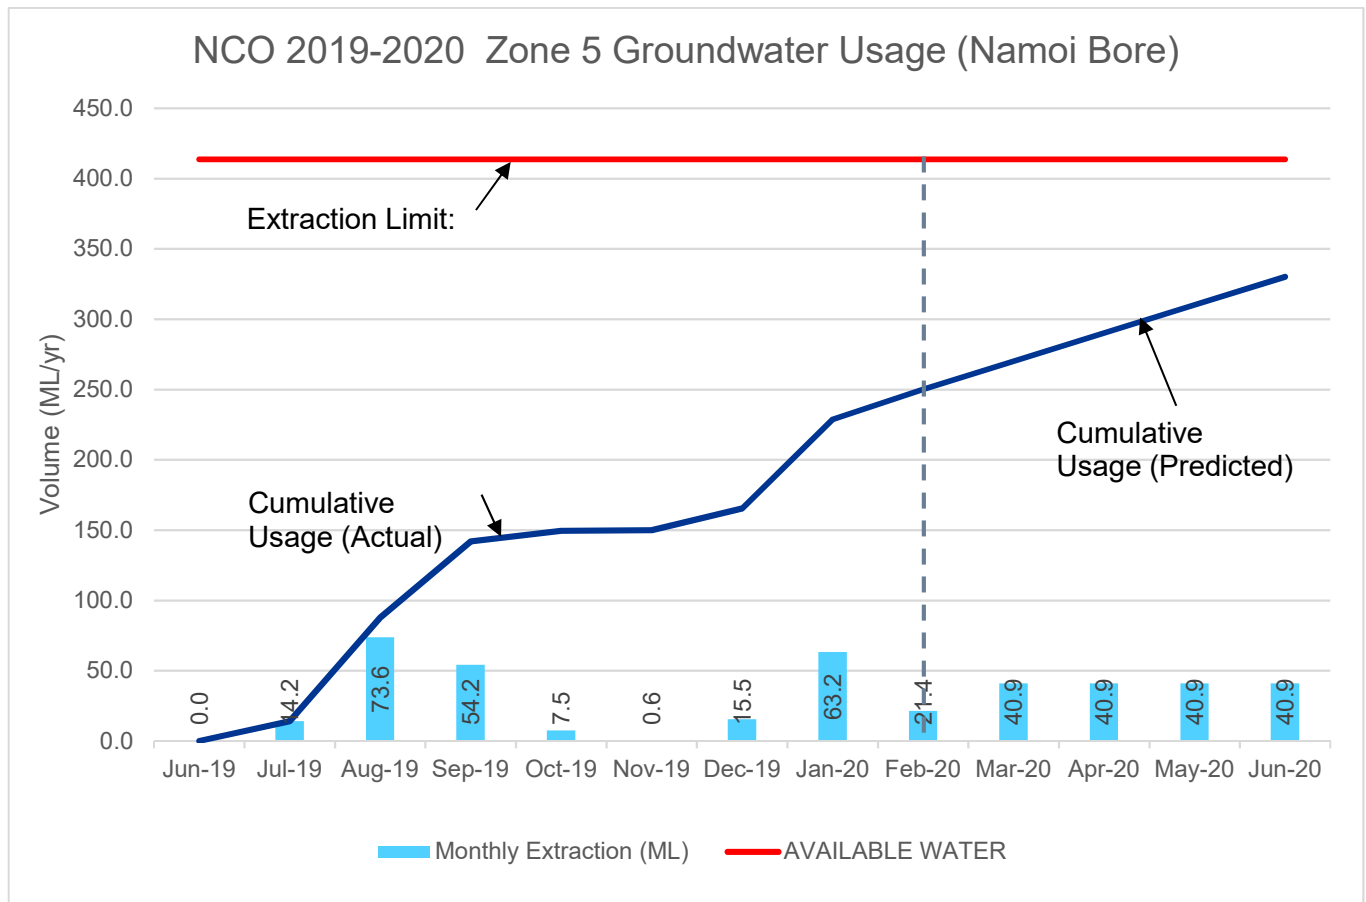
Figure 4: Zone 5 licenced groundwater usage from the Namoi Bore over the Financial Year.

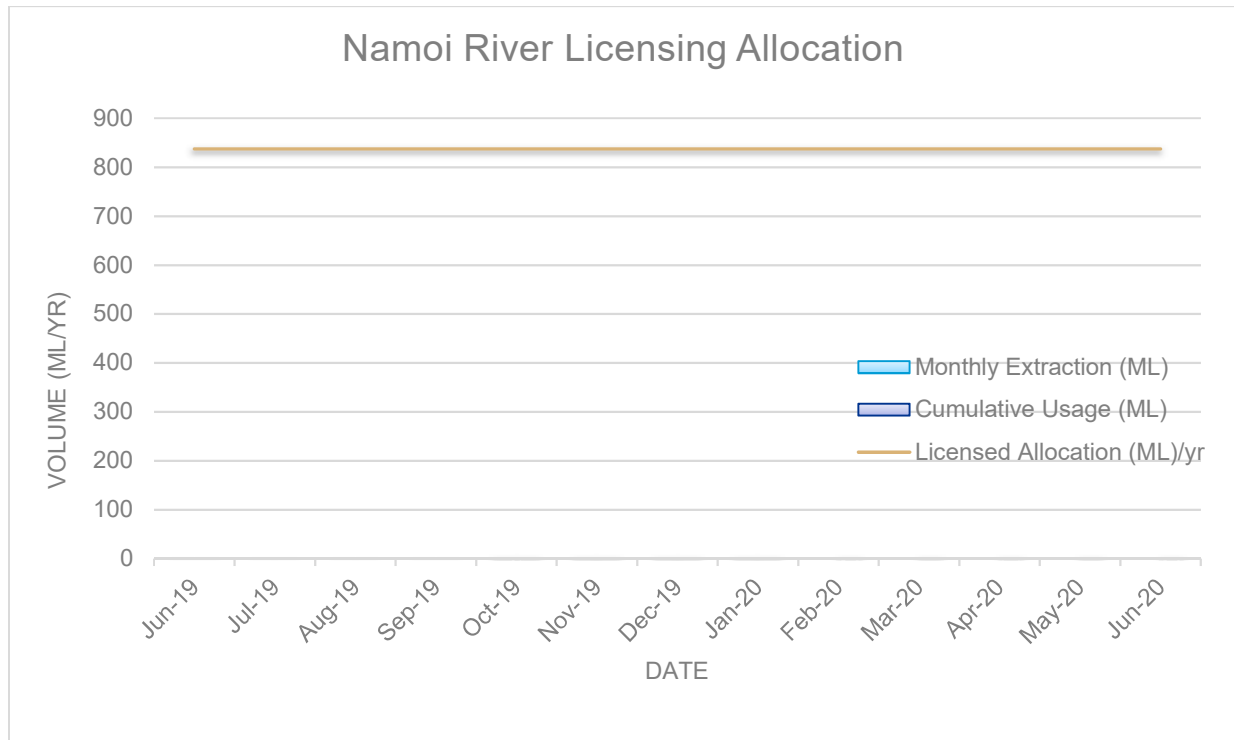
**Figure 5:** Namoi River usage over the Financial Year.

- 15ML High Security accessed 11-15 February
- 42ML General Security order approved 28 February

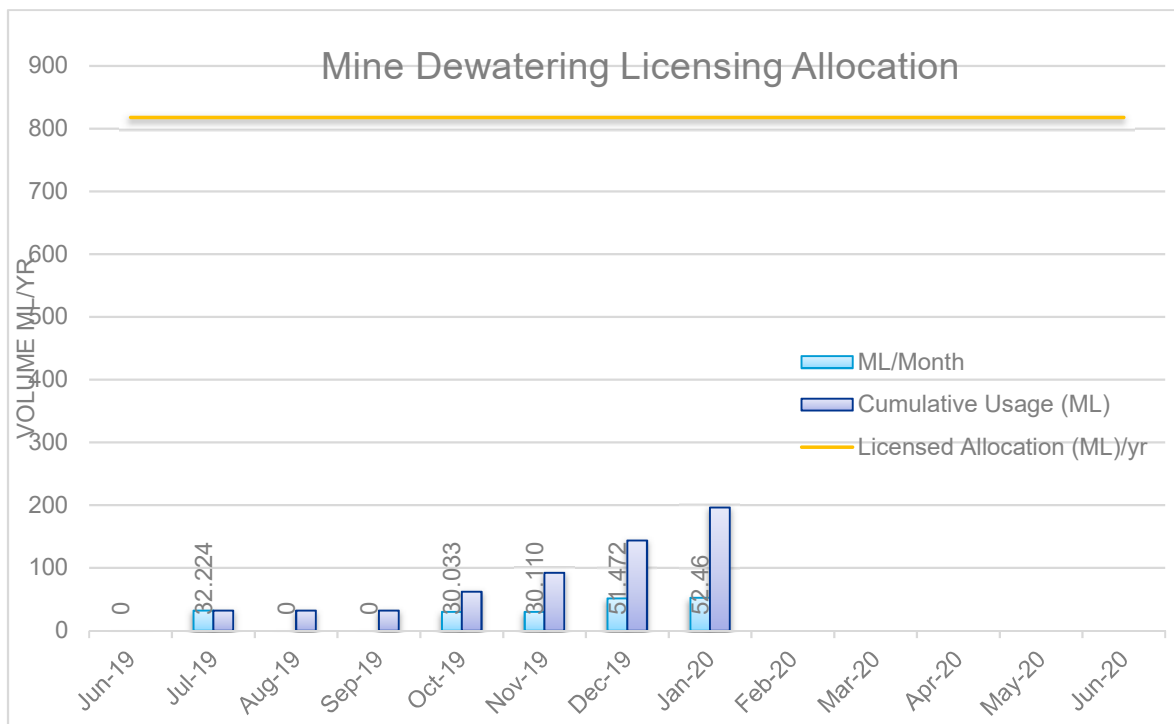
**Figure 6:** Mine dewatering licensed usage over the Financial Year.

**ACTION: BB to include more detail on Mine Dewatering licence usage chart for next meeting.**

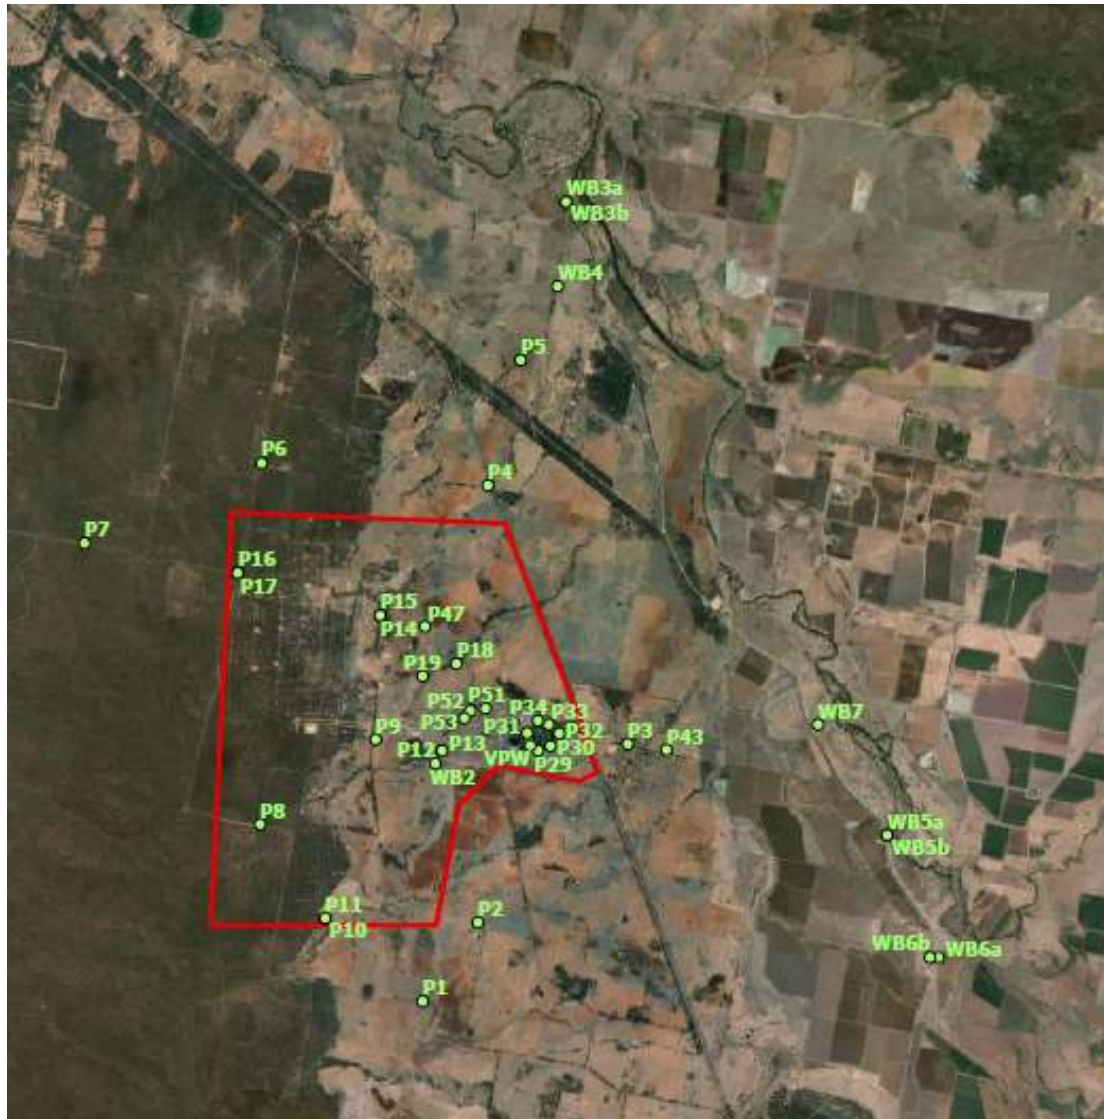
Figure 7: Ground water monitoring locations. Red shape is mining lease.

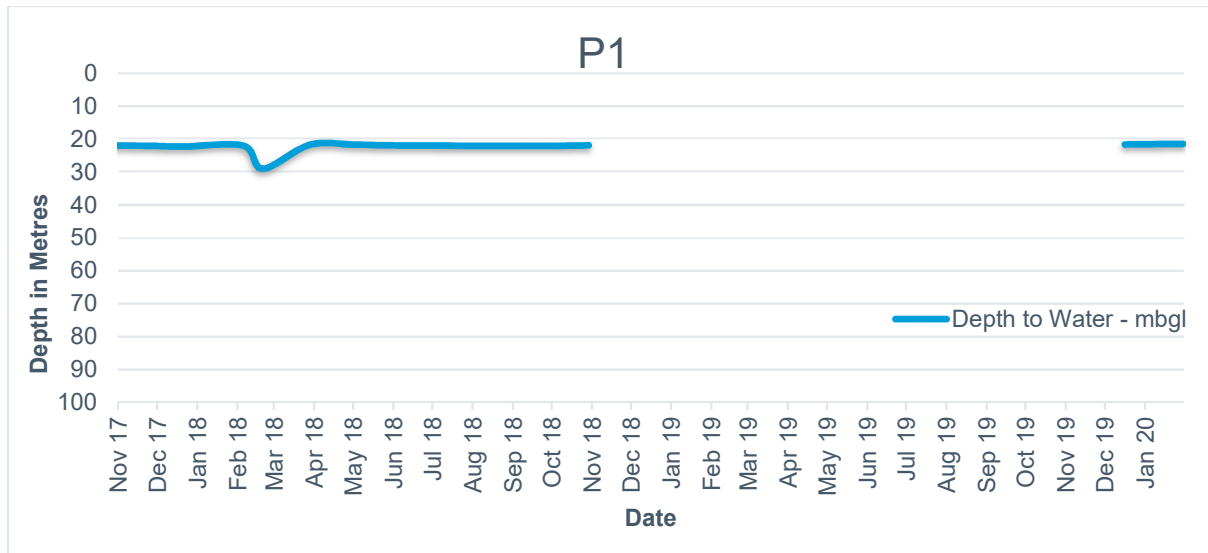
**NCO Monitoring bore ID:** P1

**Explanation:** Gap in data is due to land access issues.

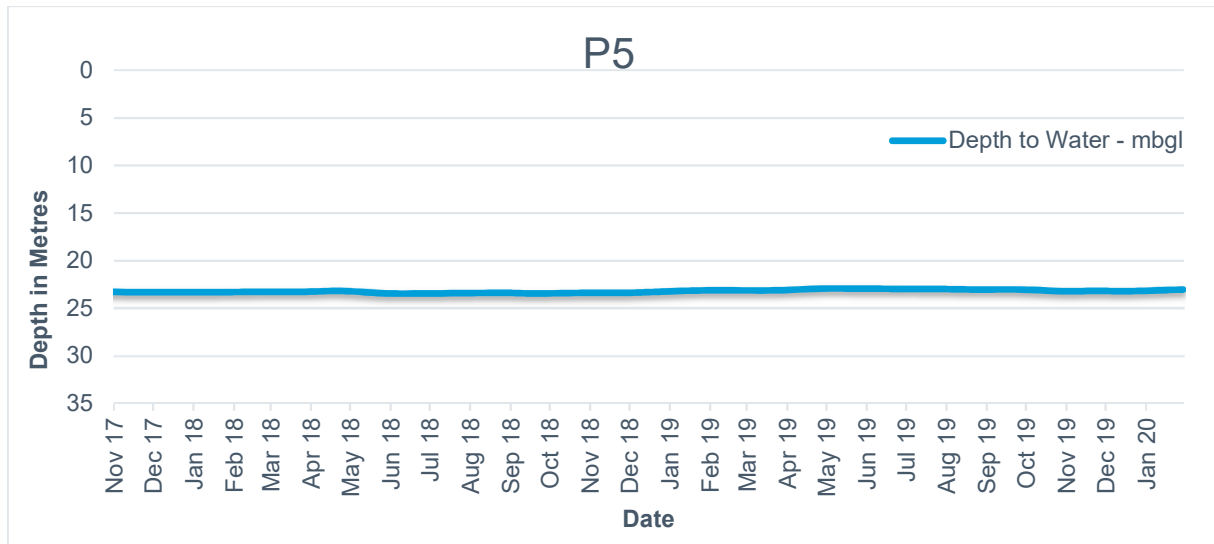
**NCO Monitoring bore ID:** P5

**Explanation:** Dry since 2012

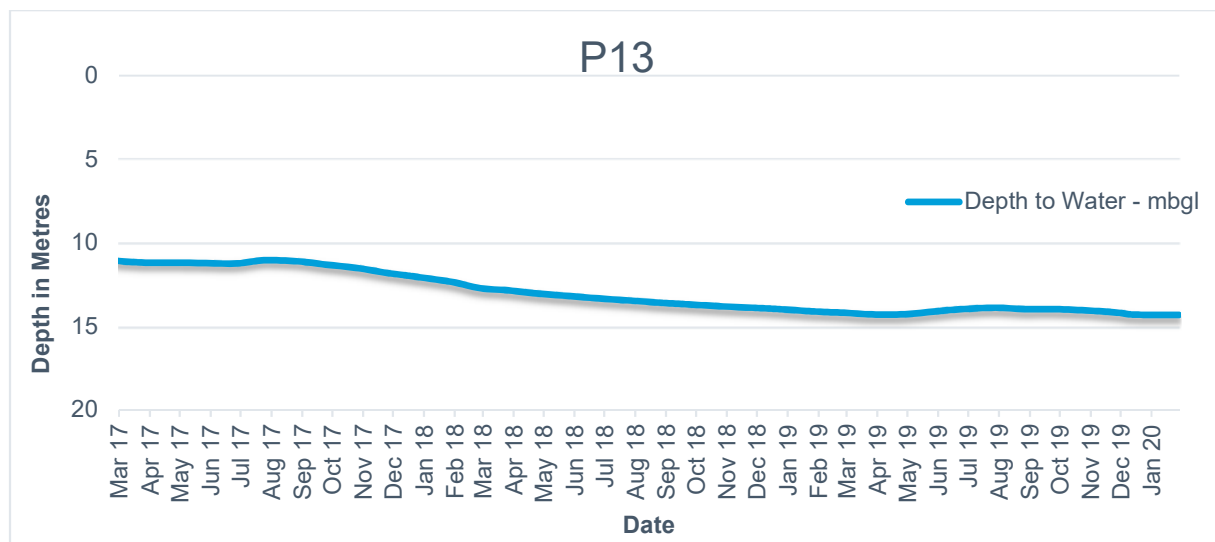
**NCO Monitoring bore ID:** P13

**Explanation:** Dry and blocked at 19m since 2016

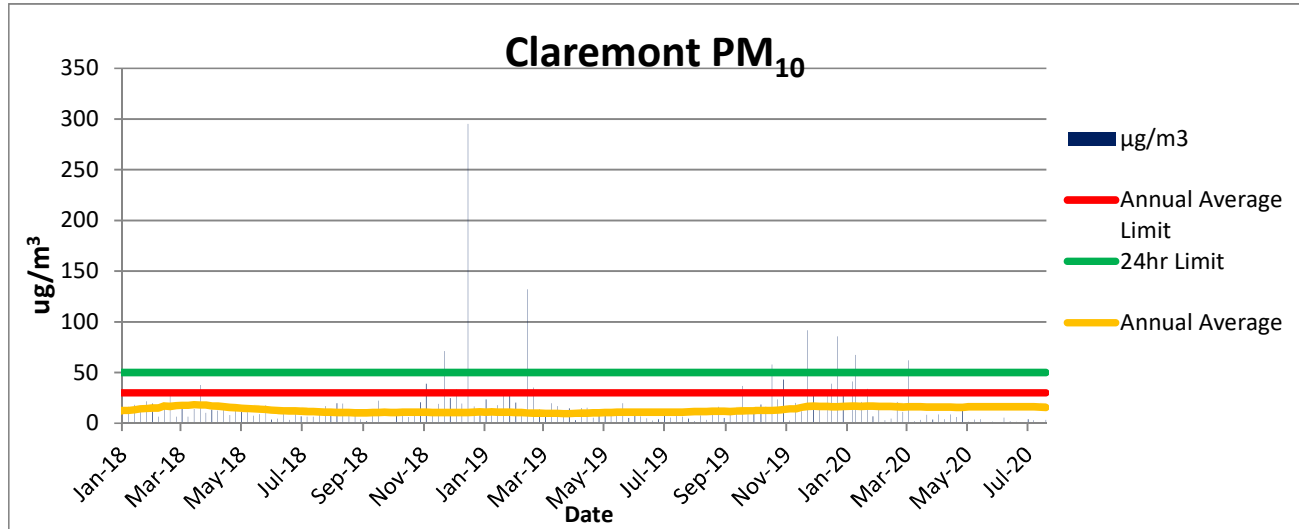
**Figure 1:** Claremont PM<sub>10</sub> High Volume Air Sampler results. Samples are collected over a 24 hour period once every week, with a (24hr) compliance limit of 50.0ug/m<sup>3</sup>.

The Claremont HVAS is returning an annual average of 15.72 µg/m<sup>3</sup>, which is below the annual average limit of 30 µg/m<sup>3</sup>. Results for the 24 hour sample period of 03 March 2020 were reported as 62 µg/m<sup>3</sup>, above the 24 hour average criteria of 50µg/m<sup>3</sup>. Report was submitted to DPI&E noting that the Claremont HVAS monitoring location is situated to the Southwest of the mine pit-top area, and that weather records for 03 March 2020 indicate dominant wind direction was from the South East. Therefore it is considered unlikely that the air quality recorded at ND9 is attributed to mining related impacts, and is likely related to agricultural activities being undertaken on properties south of the mine site.

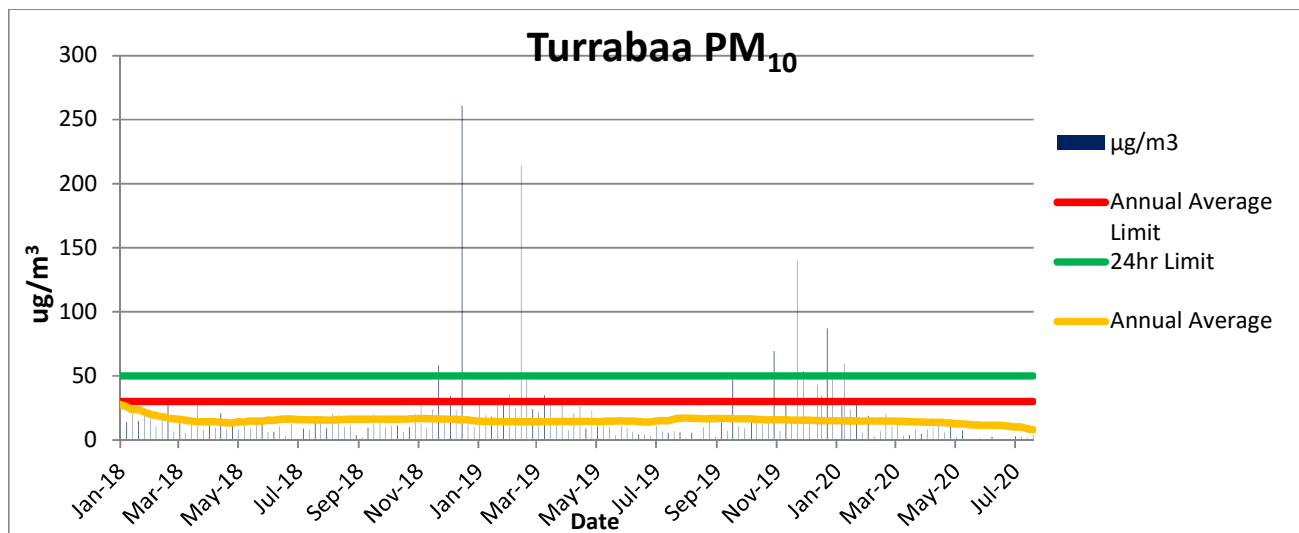
**Figure 2:** Turrabaa PM<sub>10</sub> High Volume Air Sampler results. Samples are collected over a 24 hour period once every week, with a (24hr) compliance limit of 50.0ug/m<sup>3</sup>.

The Turrabaa HVAS is returning an annual average of 8.04 µg/m<sup>3</sup>, which is below the annual average limit of 30 µg/m<sup>3</sup>. Since the previous CCC meeting there has been no new exceedances of the 24 hour limit of 50 µg/m<sup>3</sup>.

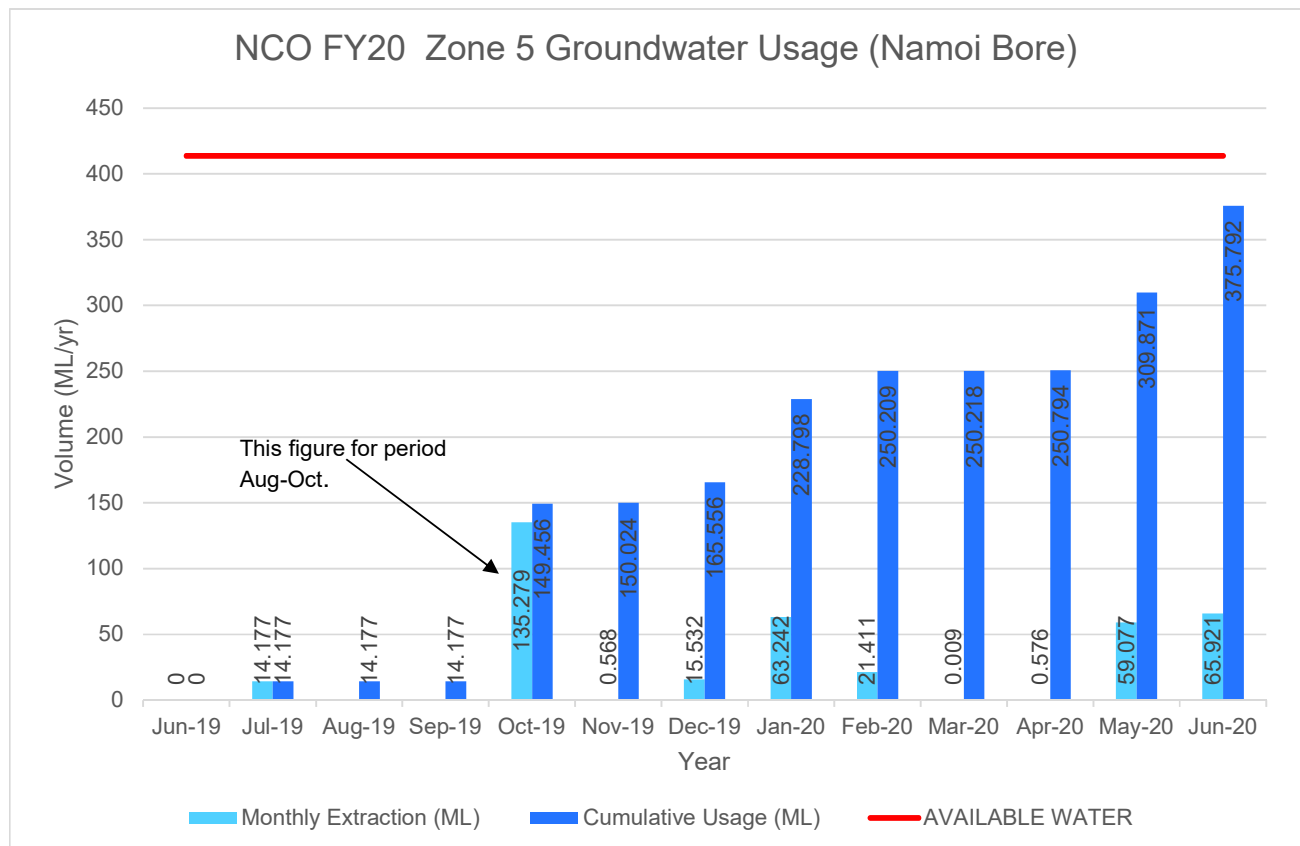
**Figure 5:** Zone 5 licensed groundwater usage from the Namoi Bore over the previous Financial (Water) Year.

- Approximately 14ML accessed from Namoi Bore during July 2020.

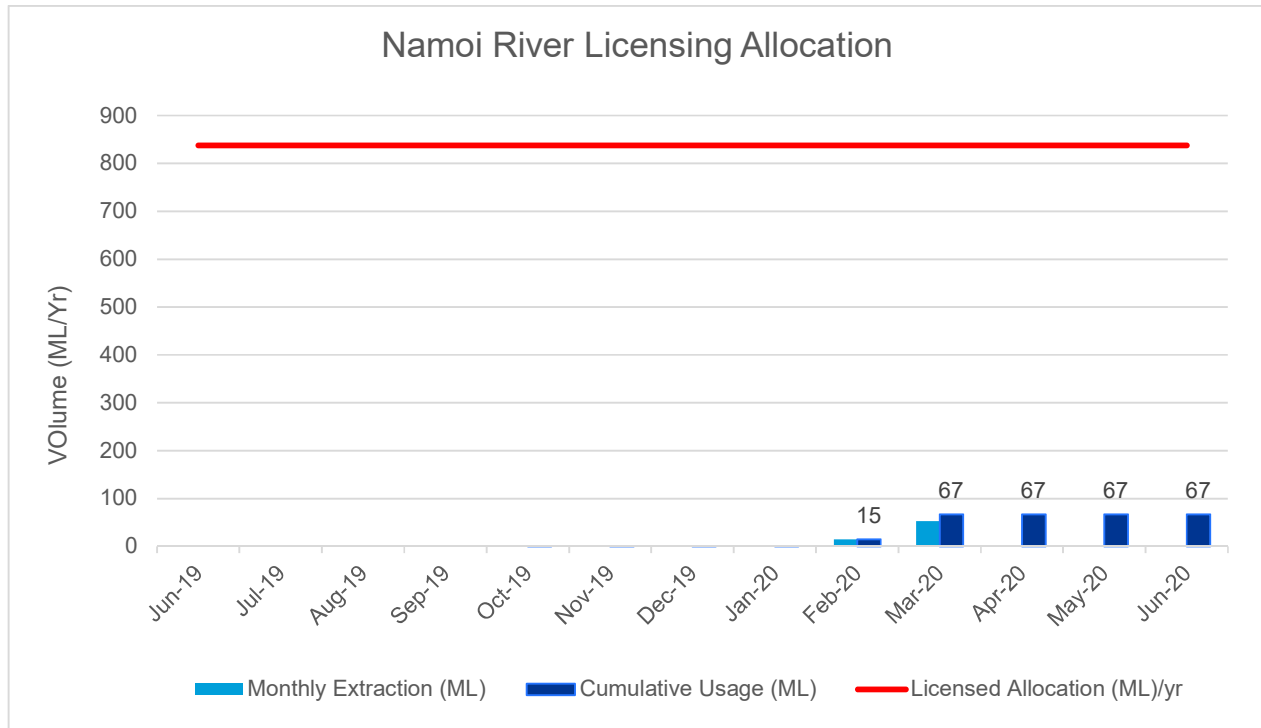
**Figure 6:** Namoi River usage over the previous Financial (Water) Year.

- Approximately 30ML accessed from Namoi River General Security licence during August 2020.

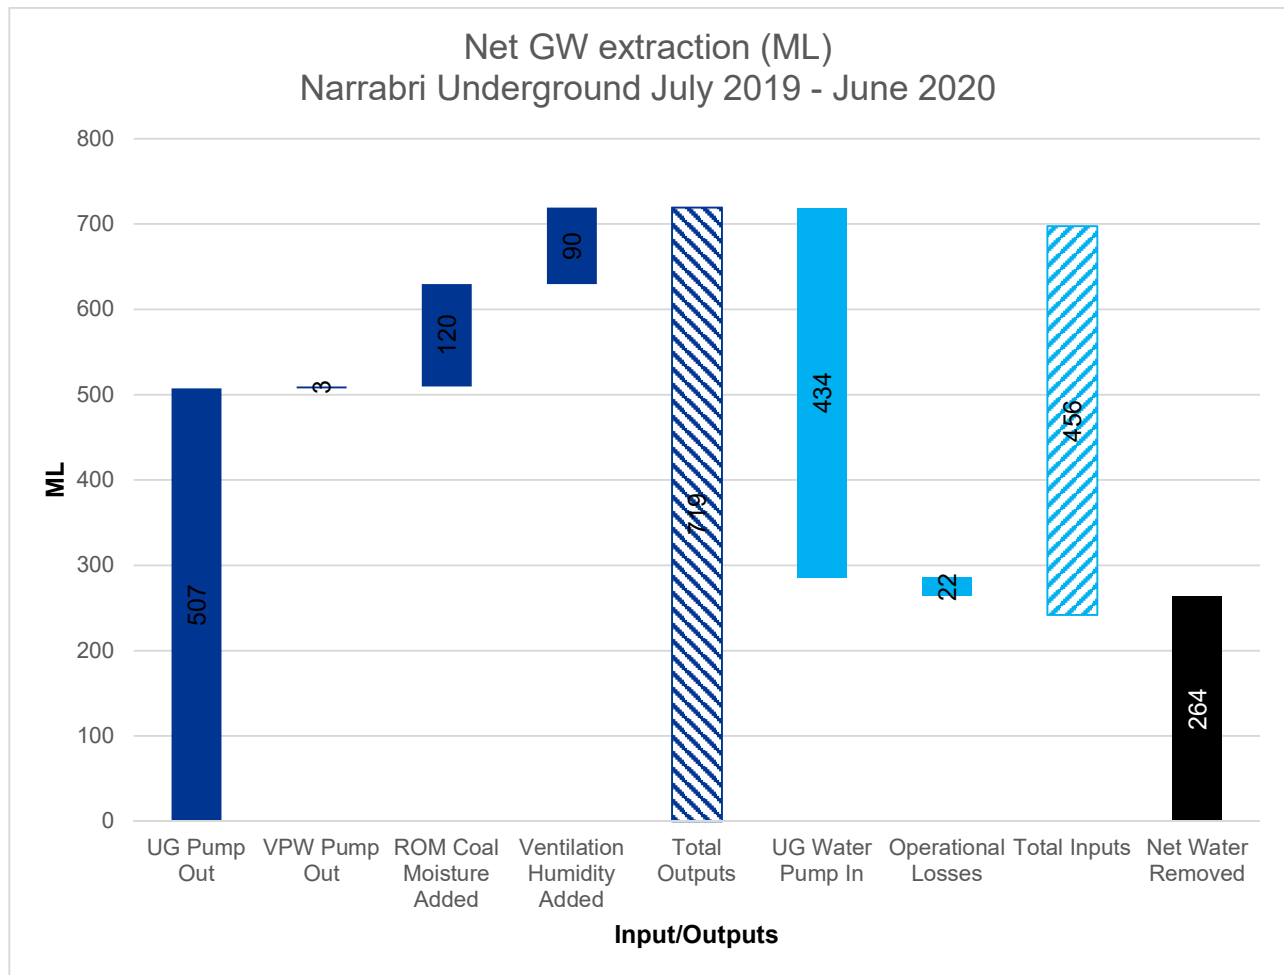
**Figure 7:** 'Waterfall chart' showing detail for net groundwater removal from the mine for previous Financial (Water) Year.

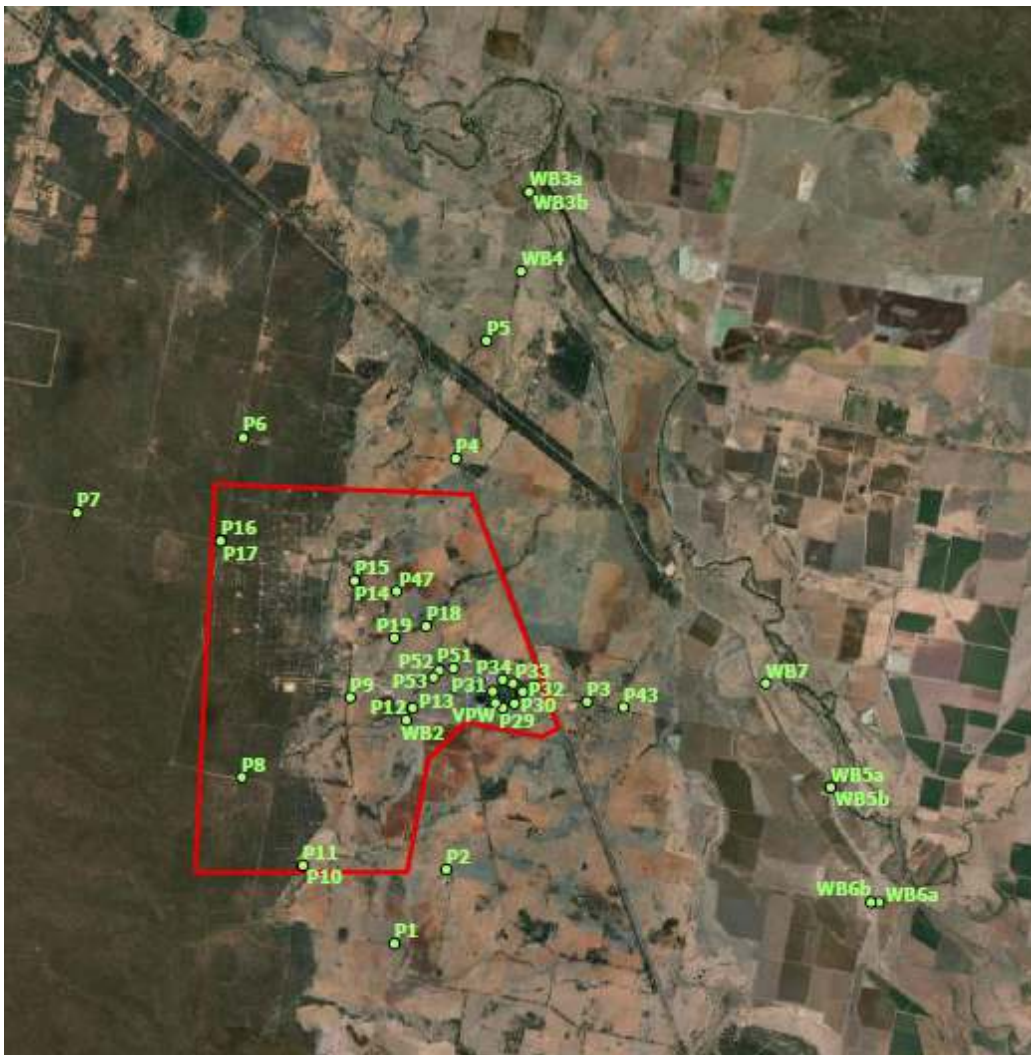
**Figure 8:** Ground water monitoring locations

- Significant depressurisation of the Hoskissons Coal Seam and the Arkarula Formation has been observed during and after extraction of longwall panels LW101 – LW108. This notable depressurisation was observed in numerous groundwater monitoring records and the pressure reductions observed are consistent with predictions that have been made.

- Rail Loop Dams
  - A notable change has been detected within the water monitoring network surrounding the evaporation / storage ponds. Most notable the rise in water level, although slight, and the significantly elevated salinity that has been recorded in P30. As P30 is adjacent to Storage Pond C (which stores brine concentrate) it can be inferred that a potential leak from Pond C may be contributing to the elevated salinity recorded in P30. Given the low rainfall trends that have been experienced in the past three years, there is a potential that the clay within the pond embankments may be experiencing cracking and increased hydraulic conductivity.

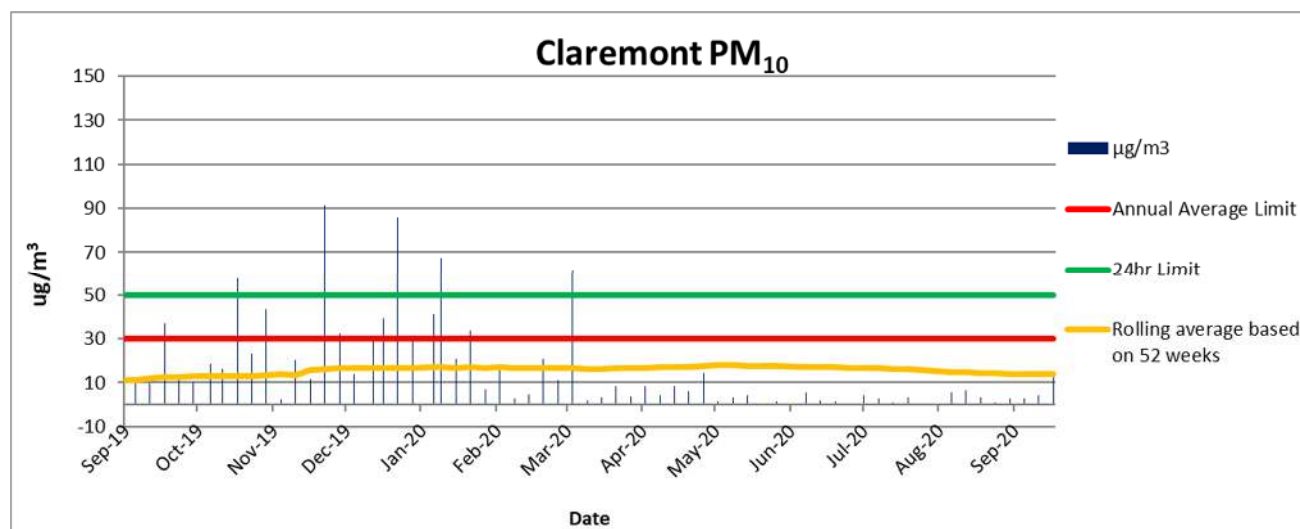
**Figure 1:** Claremont PM<sub>10</sub> High Volume Air Sampler results. Samples are collected over a 24 hour period once every week, with a (24hr) compliance limit of 50.0 µg/m<sup>3</sup>.

The Claremont HVAS is returning an annual average of 16.11 µg/m<sup>3</sup>, which is below the annual average limit of 30 µg/m<sup>3</sup>. Since the previous CCC meeting there has been no exceedances of the 24 hour limit of 50 µg/m<sup>3</sup>.

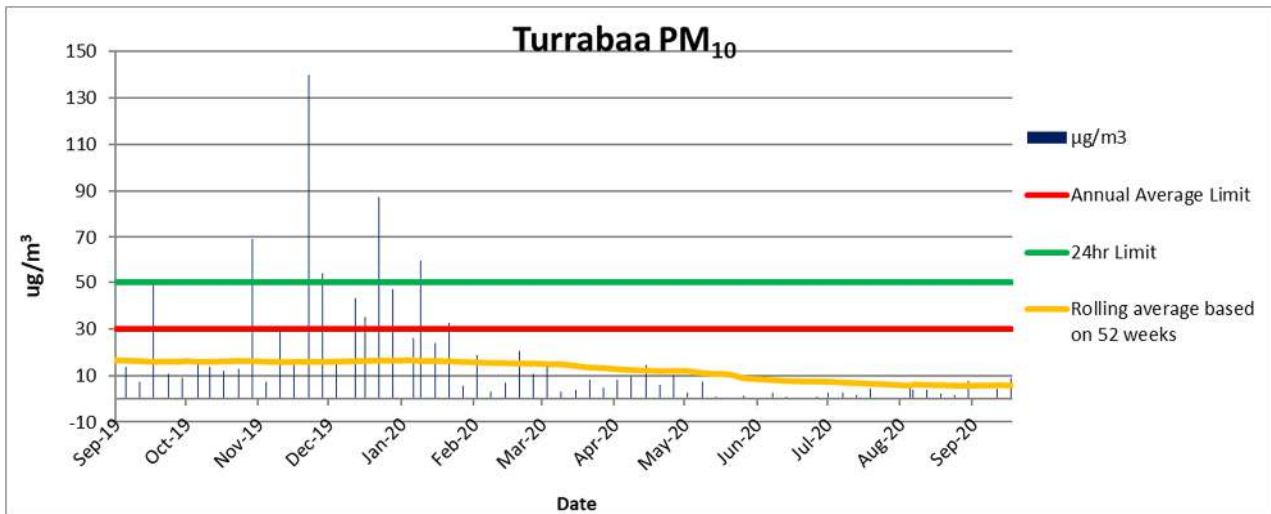
**Figure 2:** Turrabaa PM10 High Volume Air Sampler results. Samples are collected over a 24 hour period once every week, with a (24hr) compliance limit of 50.0 $\mu\text{g}/\text{m}^3$ .

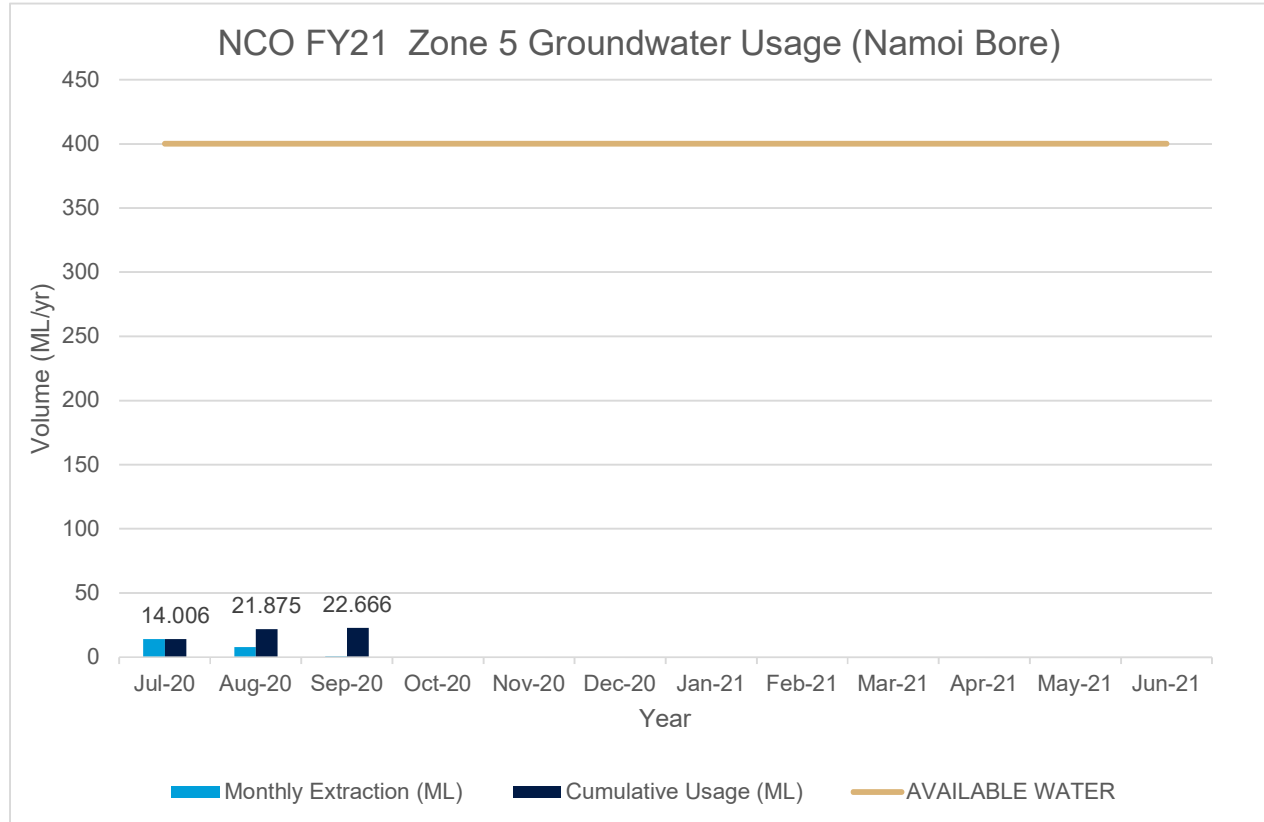
**Figure 4:** Zone 5 licensed groundwater usage from the Namoi Bore over the current Financial (Water) Year.

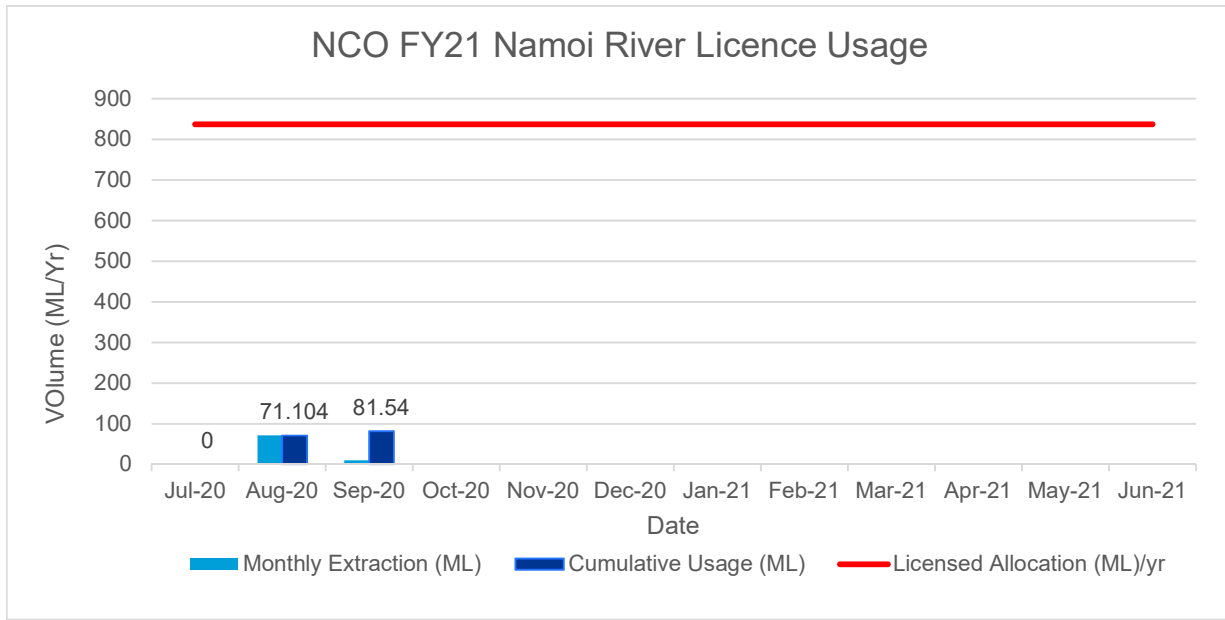
**Figure 5:** Namoi River usage over the current Financial (Water) year.

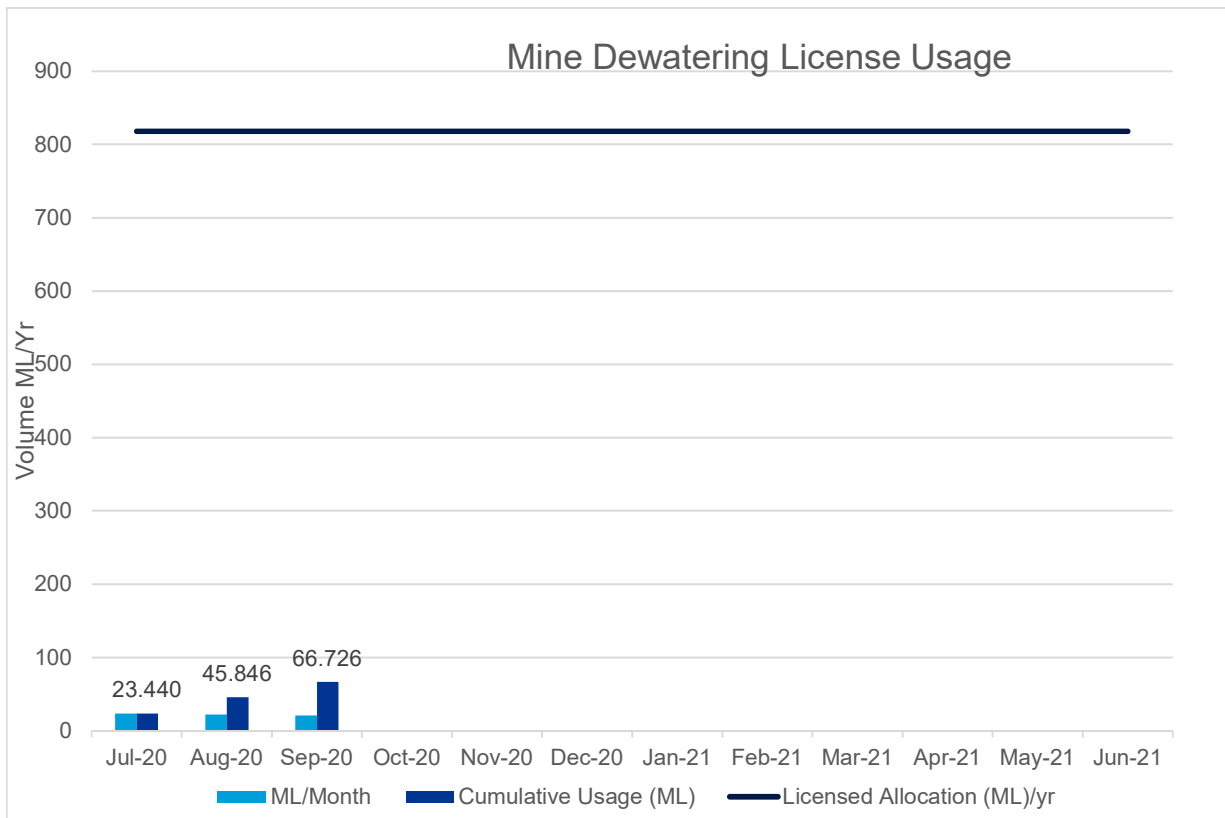
**Figure 8:** Box-cut pump usage over the current Financial (Water) year.

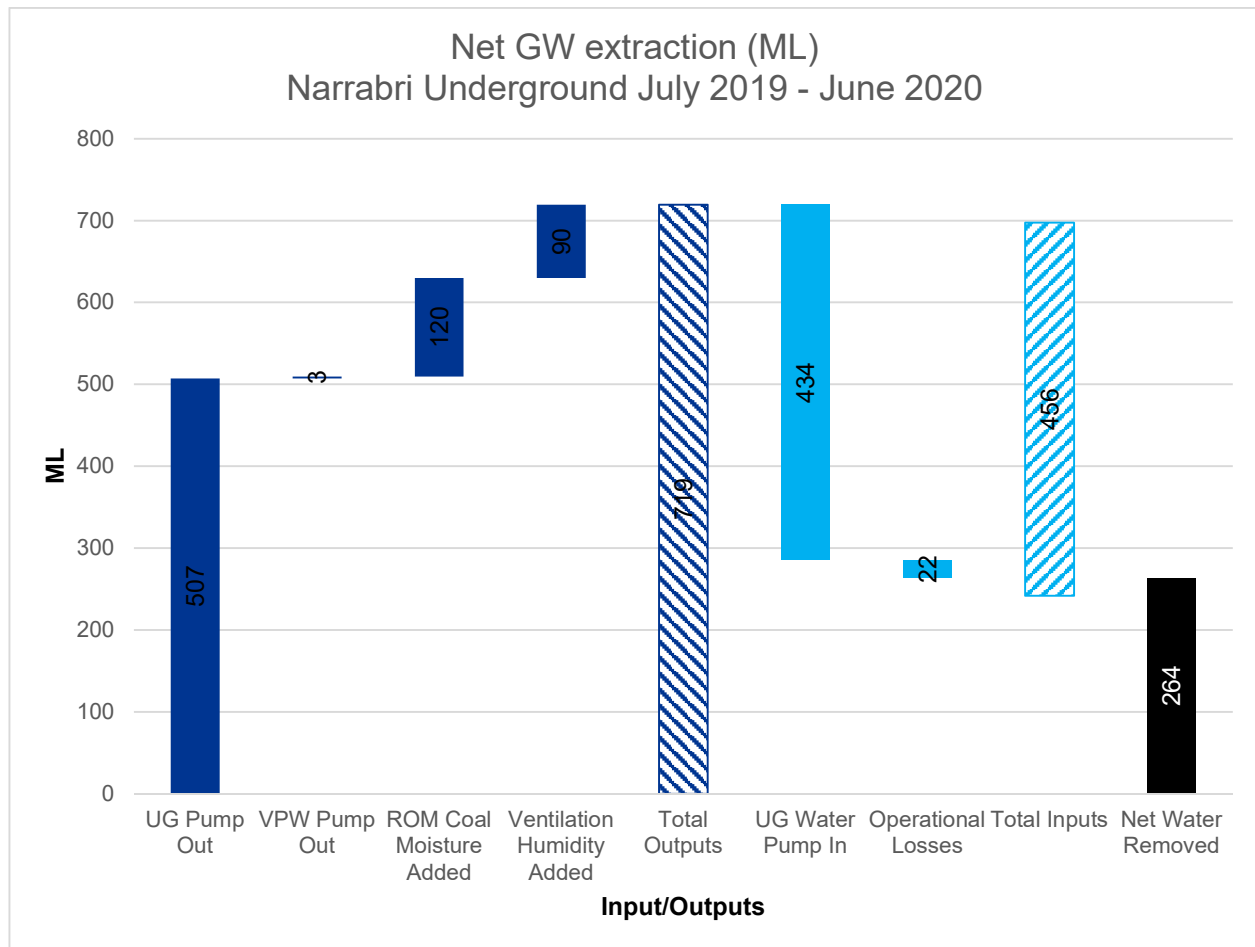
**Figure 9:** 'Waterfall chart' showing detail for net groundwater removal from the mine for previous Financial (Water) Year.

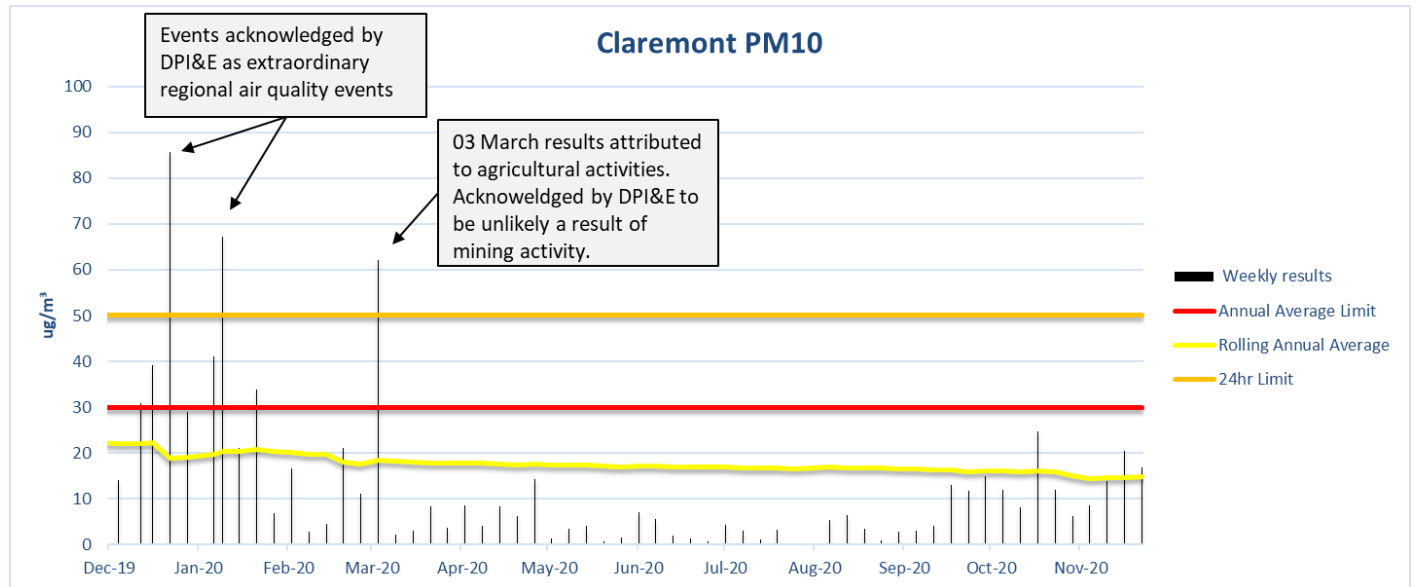
**Figure 1:** Claremont PM<sub>10</sub> High Volume Air Sampler results. Samples are collected over a 24 hour period once every week, with a (24hr) compliance limit of 50 µg/m<sup>3</sup>.

The Claremont HVAS is returning an annual average of 14.70 µg/m<sup>3</sup>, which is below the annual average limit of 30 µg/m<sup>3</sup>.

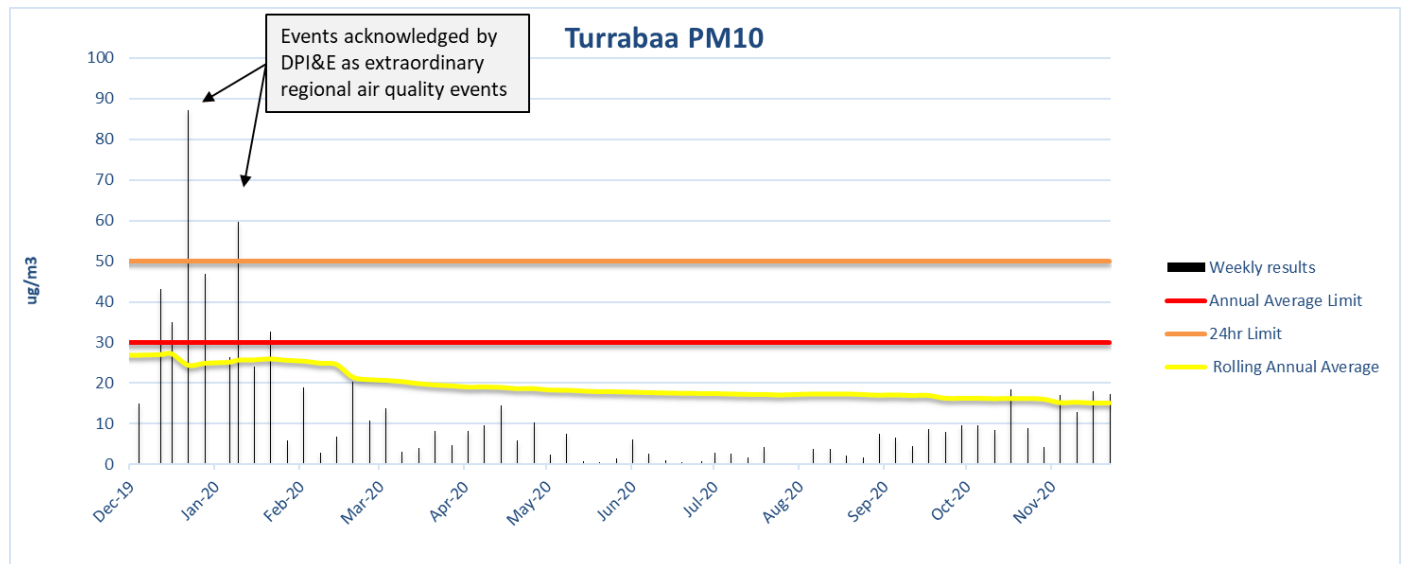
**Figure 2:** Turrabaa PM<sub>10</sub> High Volume Air Sampler results. Samples are collected over a 24 hour period once every week, with a (24hr) compliance limit of 50.0 µg/m<sup>3</sup>.
