**Narrabri Mine Community Consultative Committee Meeting #48****Date:** Tuesday 04<sup>th</sup> March 2020**Time:** 5:00pm**Location:** Narrabri Mine office

**Mine Progress Report (01 December 2019 – 29 February 2020)**

## 4. ENVIRONMENTAL MONITORING REPORT

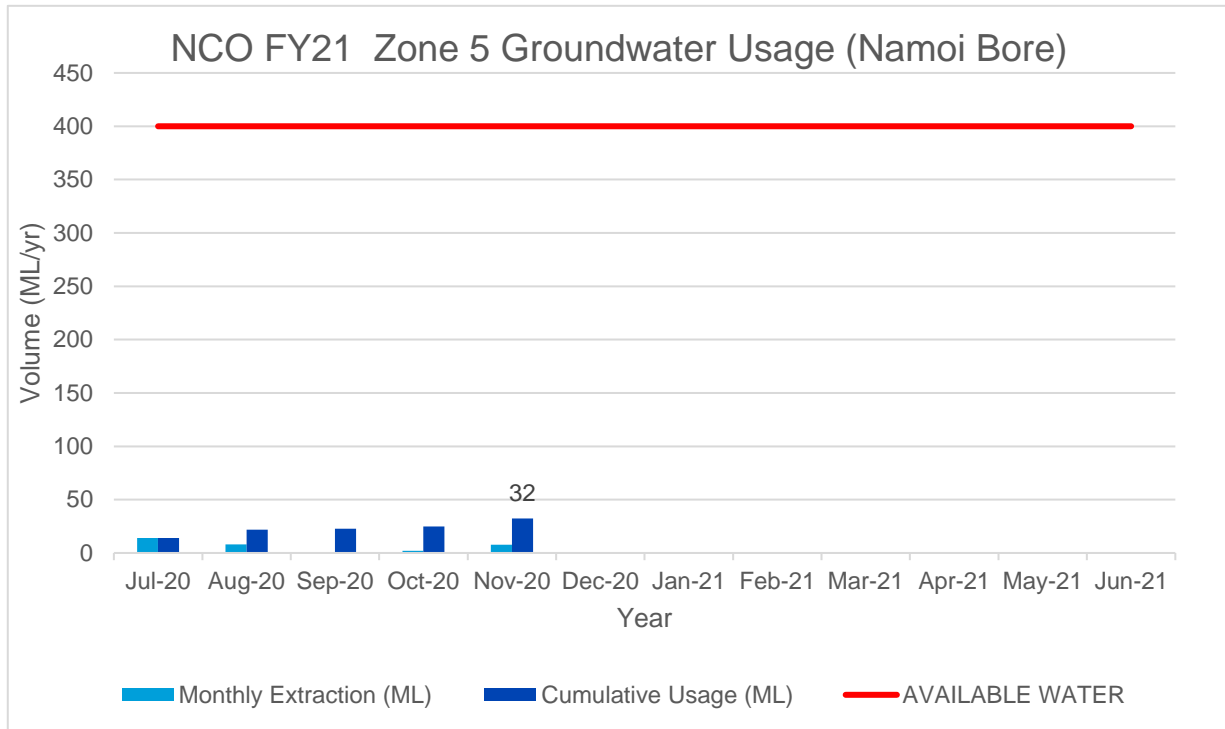
**Figure 3:** Zone 5 licensed groundwater usage from the Namoi Bore over the current Financial (Water) Year.

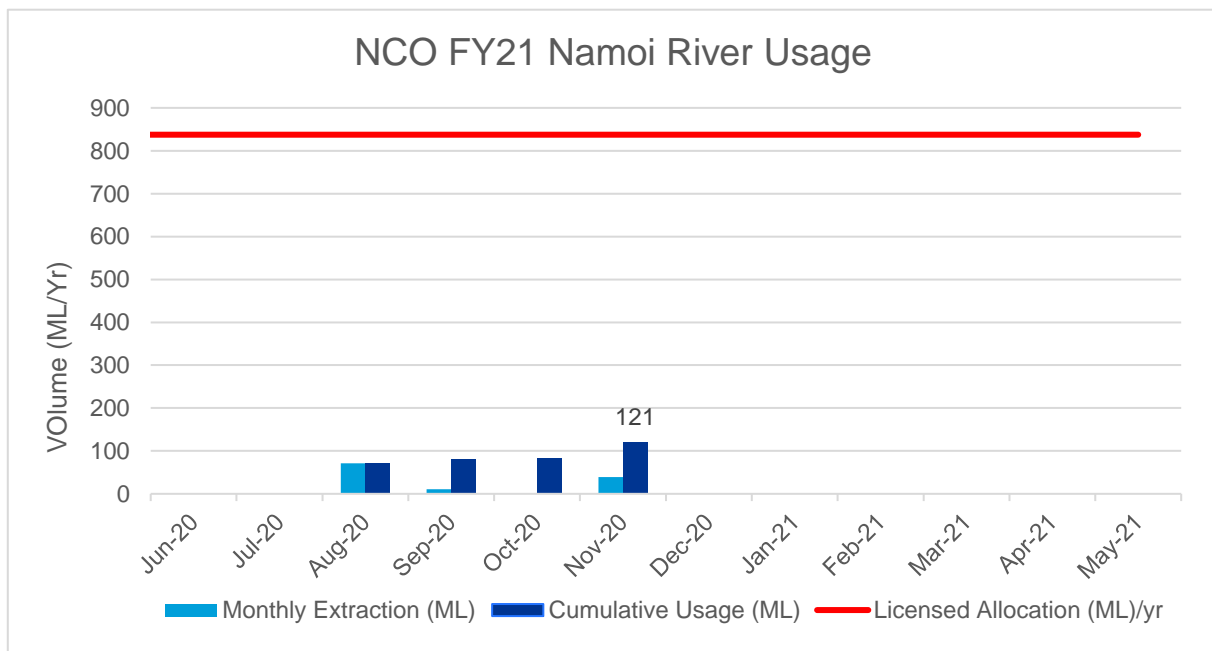
**Figure 4:** Namoi River usage over the current Financial (Water) year.

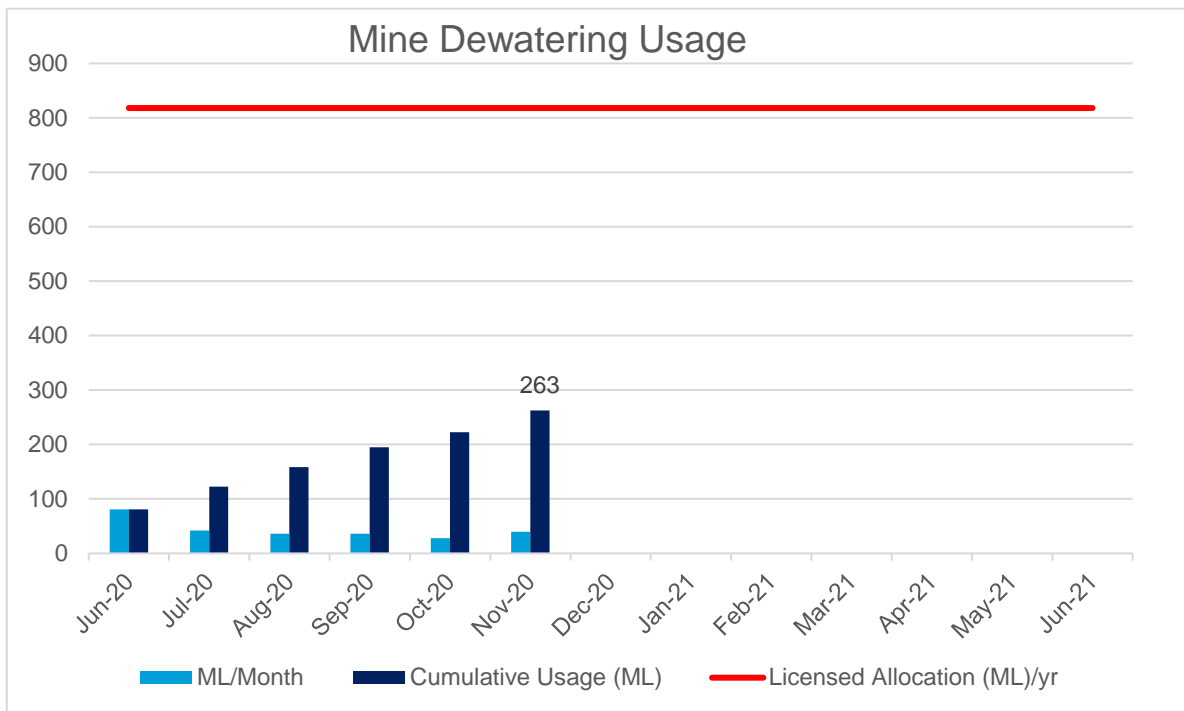
**Figure 8:** Dewatering from Box Cut over the current Financial (Water) year.

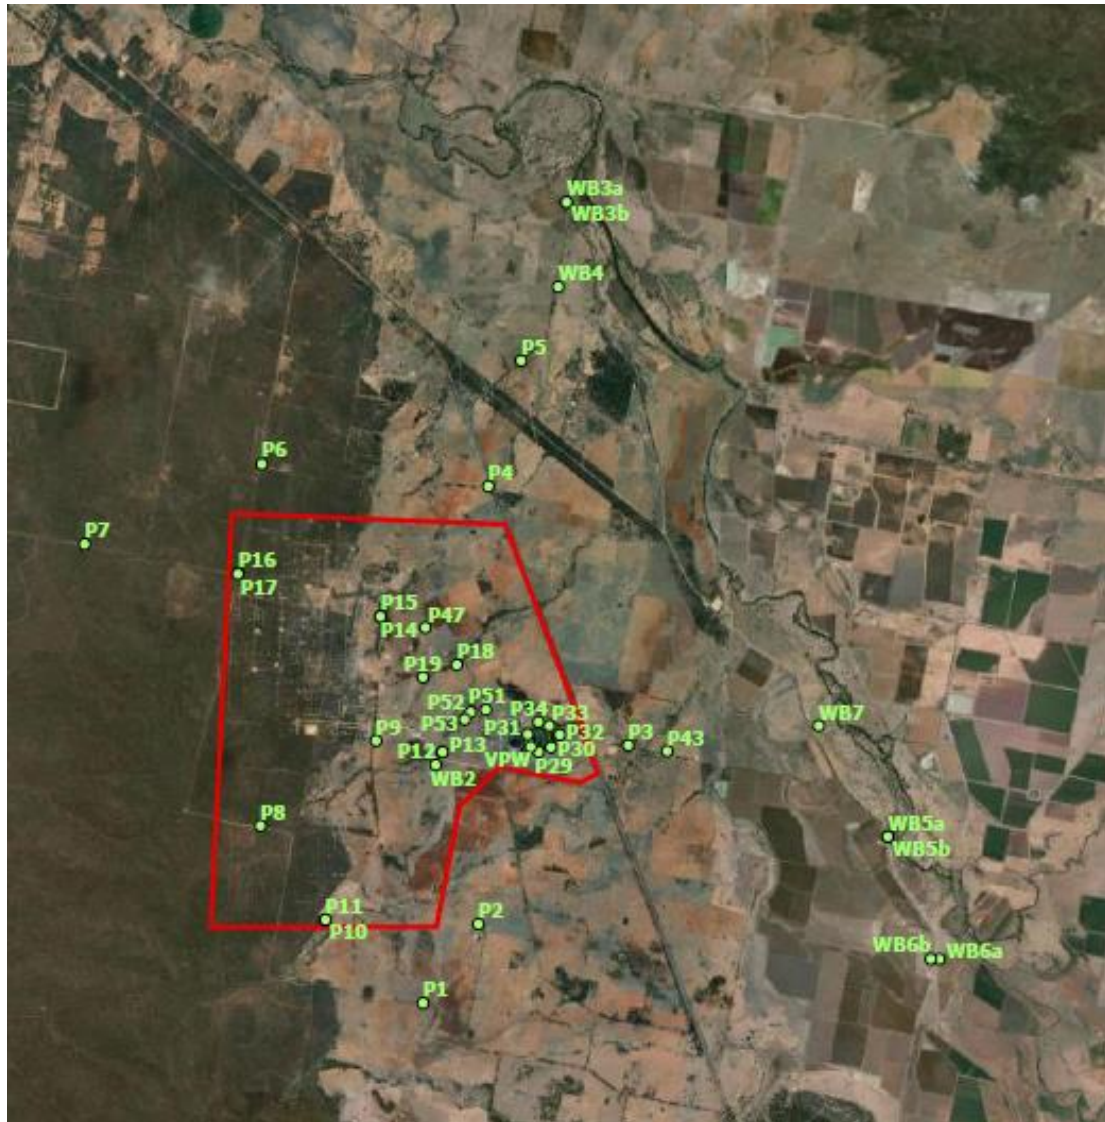
**Figure 9:** Location of groundwater monitoring wells

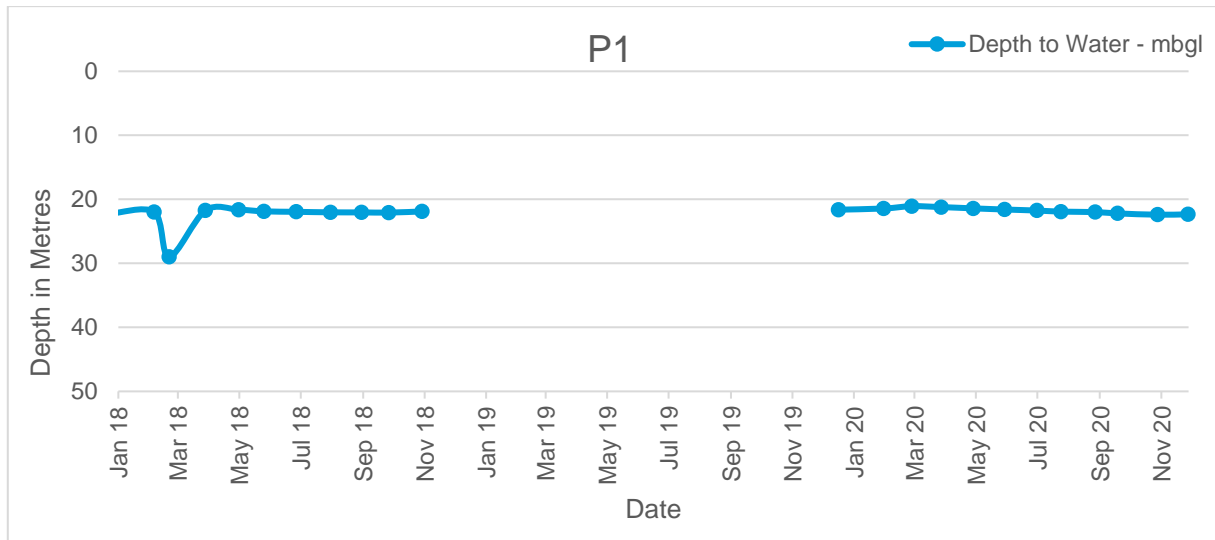
**NCO Monitoring bore ID: P1**

**Explanation:** Gap in data is due to land access issues.
