Narrabri Mine Community Consultative Committee Meeting #56

Date: Wednesday 16 March 2022

4. ENVIRONMENTAL MONITORING REPORT

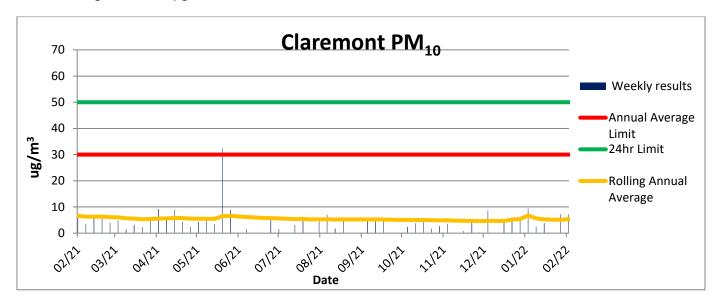
Figure 1: Claremont PM10 High Volume Air Sampler results for last 12 month period.

The Claremont HVAS is returning a rolling annual average of 5.35 μ g/m³, which is below the annual average limit of 30 μ g/m³. There have been no exceedances of the 24 hour compliance limit of 50 μ g/m³ within the last 12 month period.

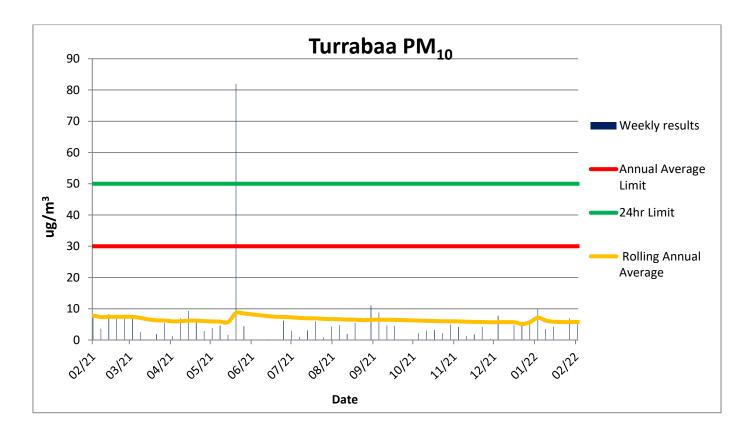
Figure 2: Turrabaa PM10 High Volume Air Sampler results for last 12 month period.

The Turrabaa HVAS is returning a rolling annual average of $5.79 \,\mu\text{g/m}^3$, which is below the annual average limit of $30 \,\mu\text{g/m}^3$. There has been one exceedance of the 24 hour compliance limit of $50 \,\mu\text{g/m}^3$ within the last 12 month period ($82 \,\mu\text{g/m}^3$ on 02/06/2021); this exceedance was communicated to DPI&E who acknowledged that the dust result was not related to mining operations and likely to be caused by roadwork activities on the Kamilaroi Highway.

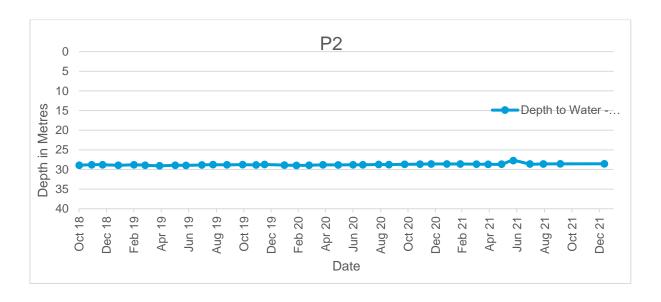
NCO Monitoring bore ID: P2

Location: Matilda

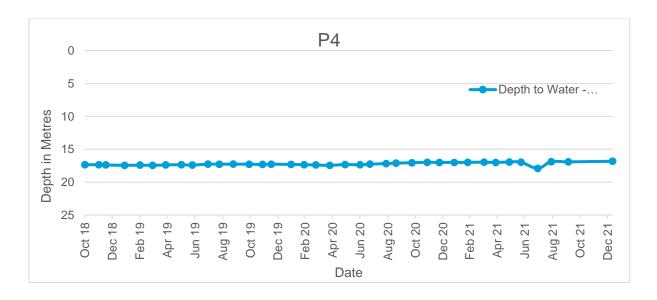
NCO Monitoring bore ID: P4

Location: North of Newhaven on Kamilaroi highway

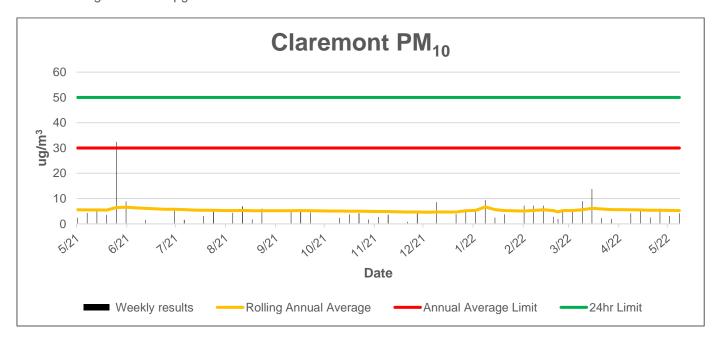
Figure 1: Claremont PM10 High Volume Air Sampler results for last 12 month period.

The Claremont HVAS is returning a rolling annual average of 5.25 μ g/m³, which is below the annual average limit of 30 μ g/m³. There have been no exceedances of the 24 hour compliance limit of 50 μ g/m³ within the last 12 month period.

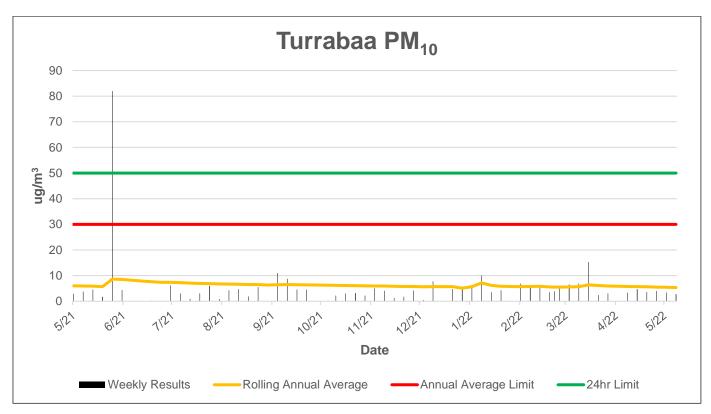
Figure 2: Turrabaa PM10 High Volume Air Sampler results for last 12 month period.

The Turrabaa HVAS is returning a rolling annual average of $5.32 \,\mu\text{g/m}^3$, which is below the annual average limit of $30 \,\mu\text{g/m}^3$. There has been one exceedance of the 24 hour compliance limit of $50 \,\mu\text{g/m}^3$ within the last 12 month period ($82 \,\mu\text{g/m}^3$ on 02/06/2021); this exceedance was communicated to DPI&E who acknowledged that the dust result was not related to mining operations and likely to be caused by roadwork activities on the Kamilaroi Highway.

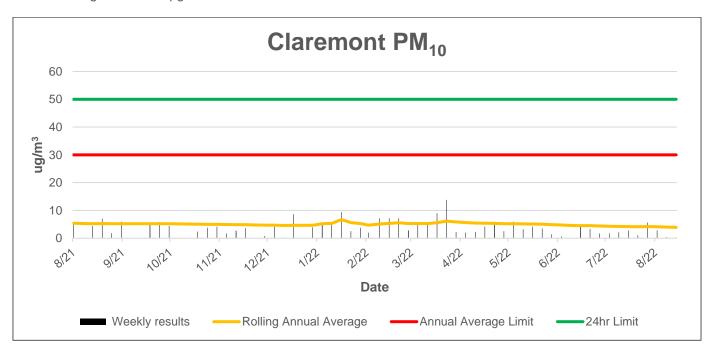
Figure 1: Claremont PM10 High Volume Air Sampler results for last 12-month period.

The Claremont HVAS (*Figure 1*) rolling annual average is $3.92 \,\mu\text{g/m}^3$, which is below the annual average limit of $30 \,\mu\text{g/m}^3$. There have been no exceedances of the 24-hour compliance limit of $50 \,\mu\text{g/m}^3$ within the last 12-month period.

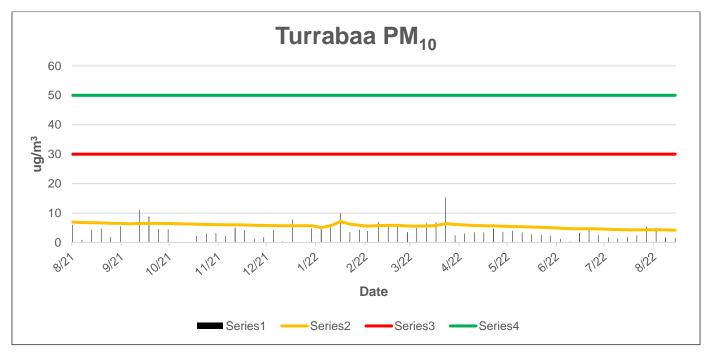
Figure 2: Turrabaa PM10 High Volume Air Sampler results for last 12-month period.

The Turrabaa HVAS (*Figure 2*) rolling annual average is 4.18 μ g/m³, which is below the annual average limit of 30 μ g/m³. There have been no exceedances of the 24-hour compliance limit of 50 μ g/m³ within the last 12-month period.

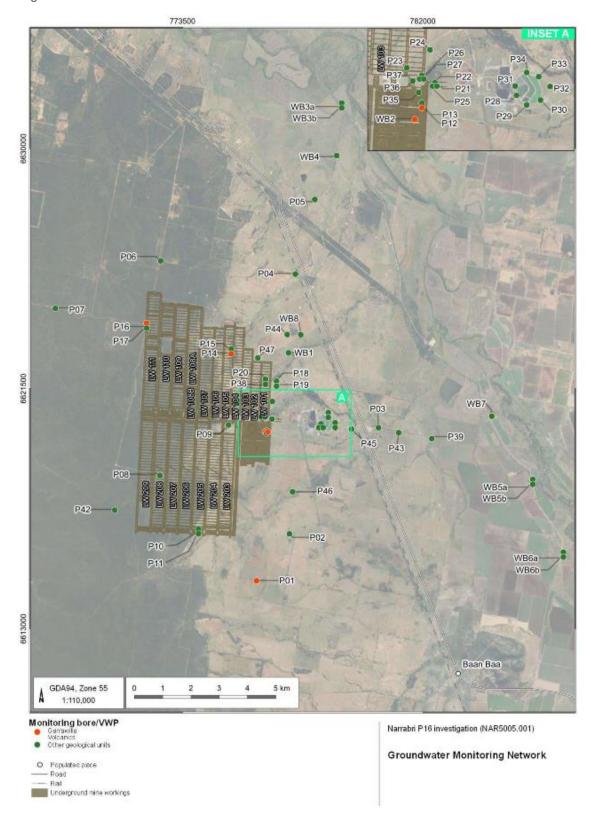
Figure 4 Narrabri Mine groundwater monitoring locations showing P16 location on the western edge of LW111

- as this is an isolated occurrence, no impact, as a result of the drawdown observed at the P16 location, is currently observed at any identified landholder bores identified during the Stage 2 groundwater assessment, additionally no external pumping occurs close to P16;

- Climate influence was assessed as having a likely low to moderate expected contribution (generally less than 3.2m):
- Based on analysis of the available data, the observed drawdown is considered most likely to be related to the mining of the nearby longwall panels. A stepped pattern is evident in the groundwater level for P16, whereby a series of steps can be observed which broadly coincide with the start of mining in each of the nearby longwall panels (Figure 3). It should also be noted that monitoring of water make within the mine has measured no significant increase in inflows to the mine workings and current inflows are significantly below those predicted by the GW model; and

As this is an isolated occurrence, no impact, as a result of the drawdown observed at the P16 location, is currently observed at any identified landholder bores identified during the Stage 2 groundwater assessment.

NCO will continue to monitor groundwater at P16 and other bores in the monitoring network in accordance with the Water Management Plan.

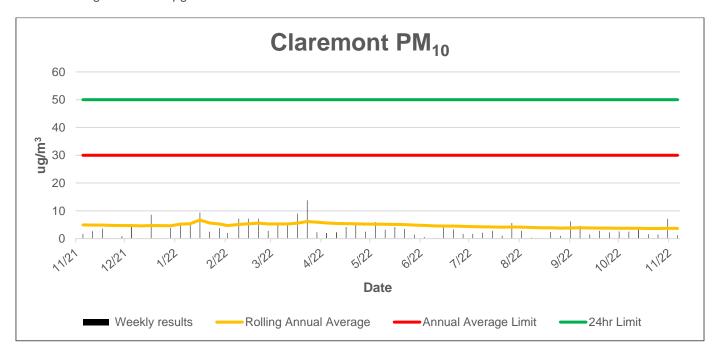
Figure 1: Claremont PM10 High Volume Air Sampler results for last 12-month period.

The Claremont HVAS (*Figure 1*) rolling annual average is 3.65 μ g/m³, which is below the annual average limit of 30 μ g/m³. There have been no exceedances of the 24-hour compliance limit of 50 μ g/m³ within the last 12-month period.

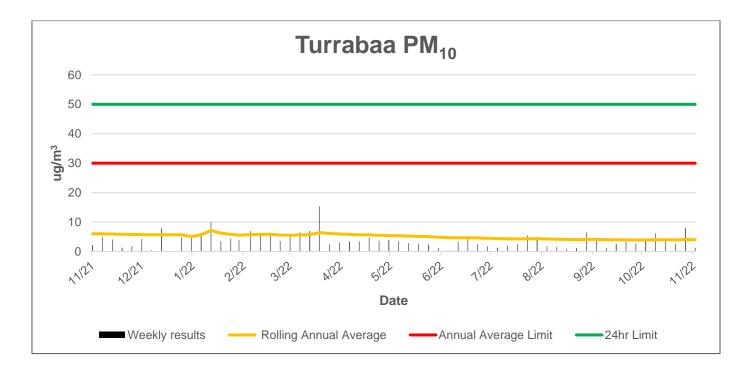
Figure 2: Turrabaa PM10 High Volume Air Sampler results for last 12-month period.

The Turrabaa HVAS (*Figure 2*) rolling annual average is 3.98 μ g/m³, which is below the annual average limit of 30 μ g/m³. There have been no exceedances of the 24-hour compliance limit of 50 μ g/m³ within the last 12-month period.
