NARRABRI MINE 2023 ANNUAL REVIEW

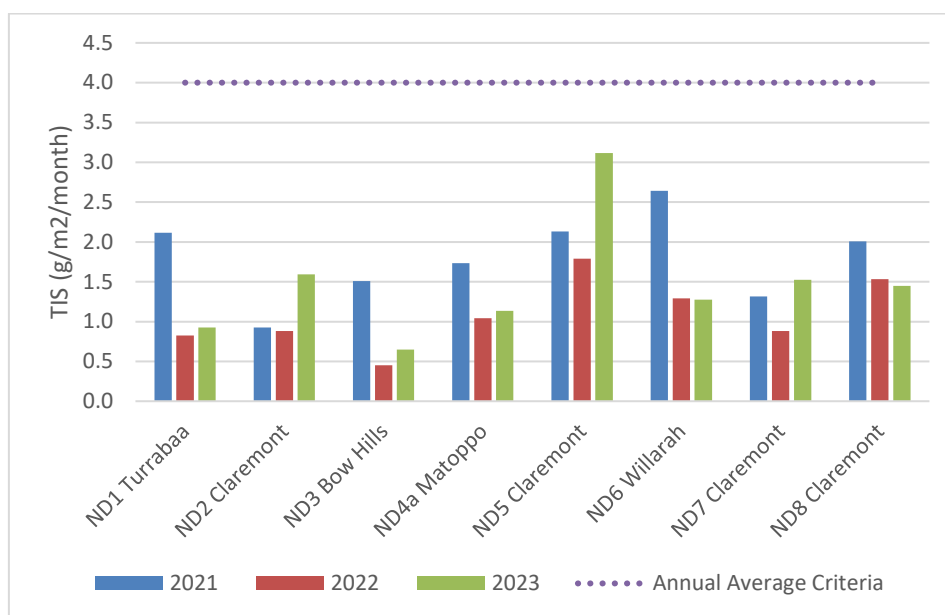
Figure 4: Deposited Dust Annual Mean 2021 - 2023

Deposited dust was generally higher during the Reporting Period than the previous Reporting Period (**Figure 4**). Higher results within the Reporting Period may be attributed to lower rainfall in 2023.

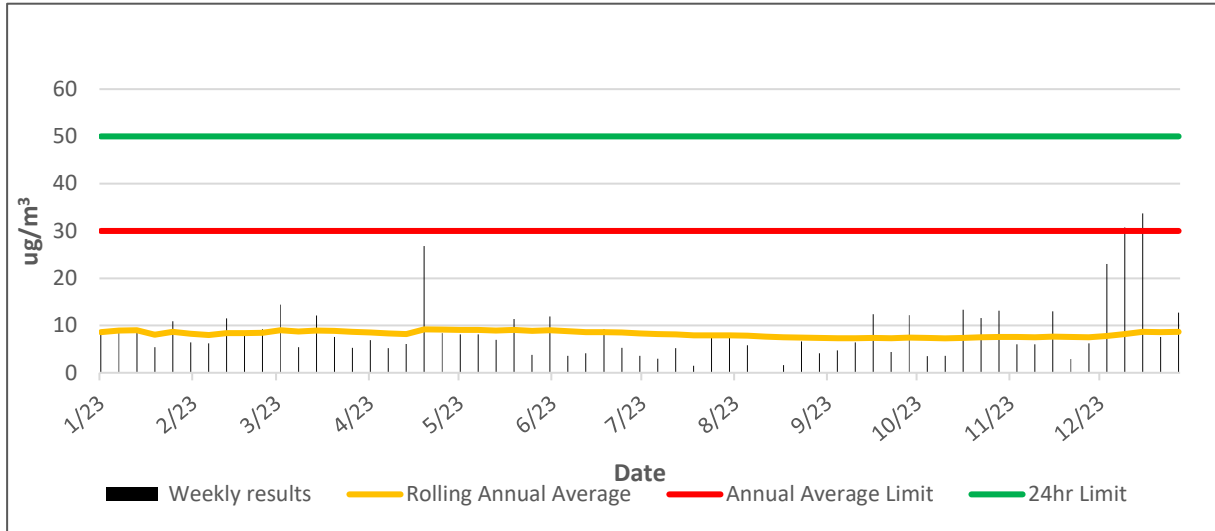
Figure 5: ND9 PM₁₀ Results Including Extraordinary Weather Events

Site ND10 was impacted by mechanical failure during the weeks of 23 April, 29 April, 29 May, and 4 June. The results from Site ND9 in the corresponding weeks do not show levels of concern; 26.8 µg/m³, 8.4 µg/m³, 3.8 µg/m³, and 11.9 µg/m³ respectively.

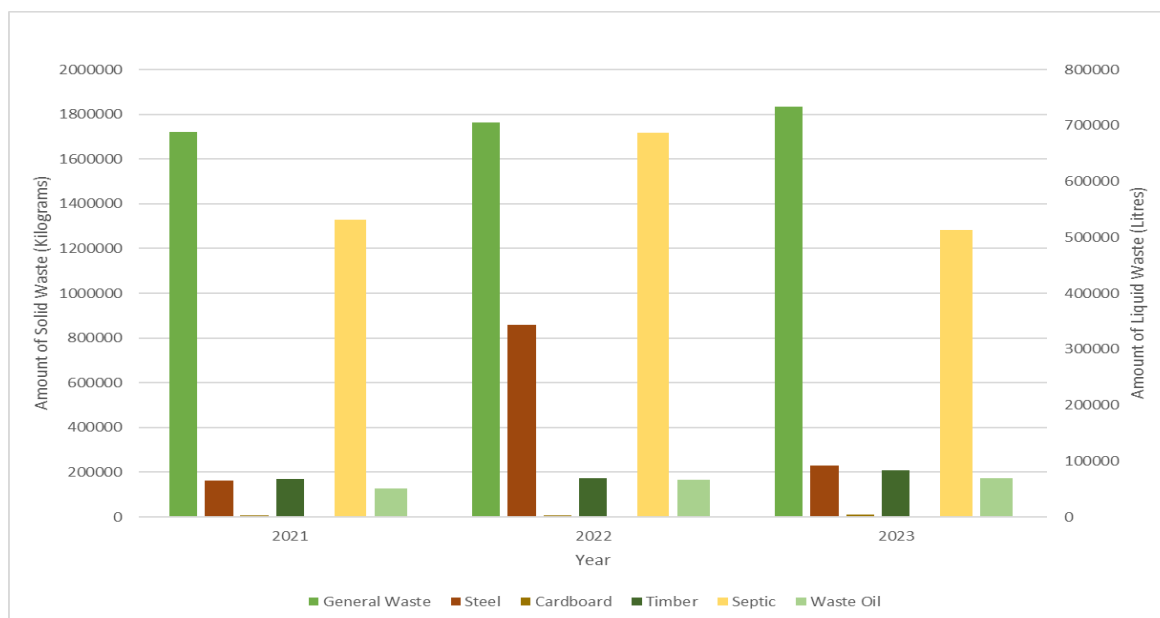
Figure 10: Comparison of Waste Streams Previous 3 Years

During the Reporting Period, NCOPL engaged a licenced contractor to transport waste from the Narrabri Mine to a licenced facility. NCOPL produced a approximately 1,834t of general waste. In addition, NCOPL produced recyclable material, consisting of approximately 11t of cardboard/paper, 210t of timber and 230t of steel, including approximately 69,900 Litres (L) of used oils. These figures are comparable to the previous 2 years, as shown in Figure 10.

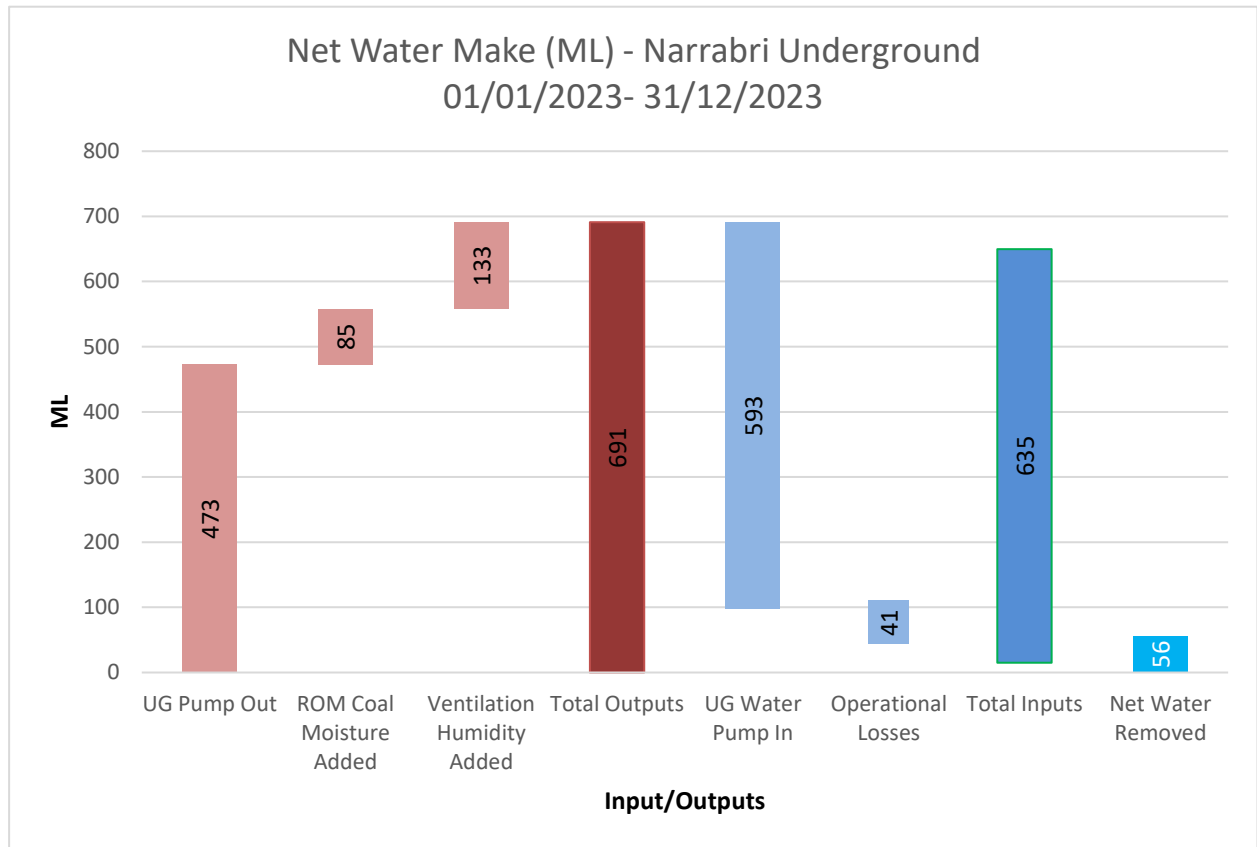
Figure 11: Waterfall Chart – Water Inputs/Outputs for Reporting Period

Table 16 summarises the water licences held by NCOPL to account for indirect take associated with mining, and water usage for operational purposes, during the Reporting Period. All water take for the Reporting Period is below current licence entitlements. Information on actual groundwater inflows is inferred from monitoring of the volume of water pumped underground and the volume of water returned via the box-cut dewatering pump. The calculated water take utilising inputs and losses of water within the mine are represented by the waterfall chart (**Figure 11**).

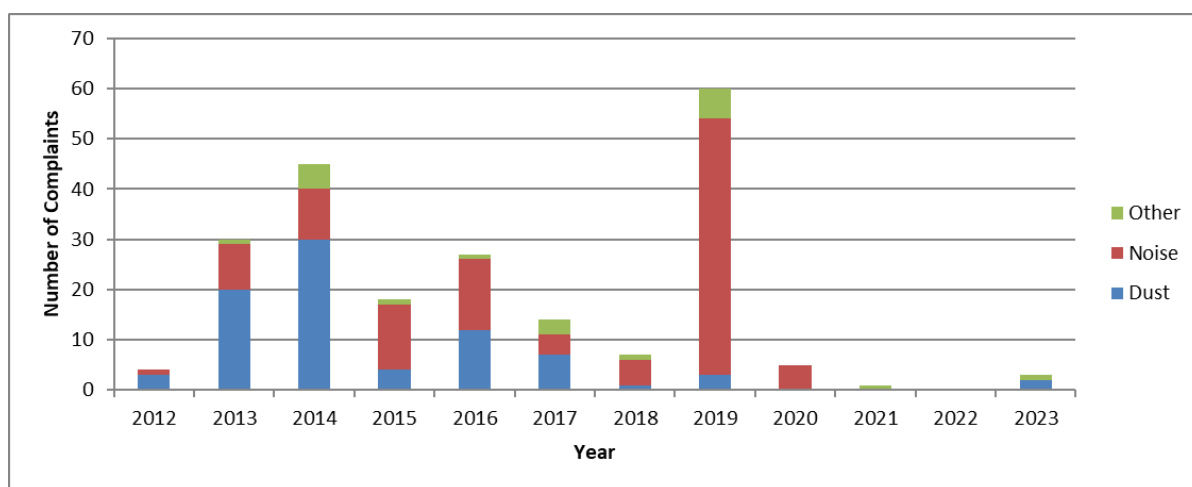
Figure 14: Complaints Trend Since Commencement of Operations

Three community complaints were received during the Reporting Period which is an increase from no complaints received during 2022 (Figure 14).

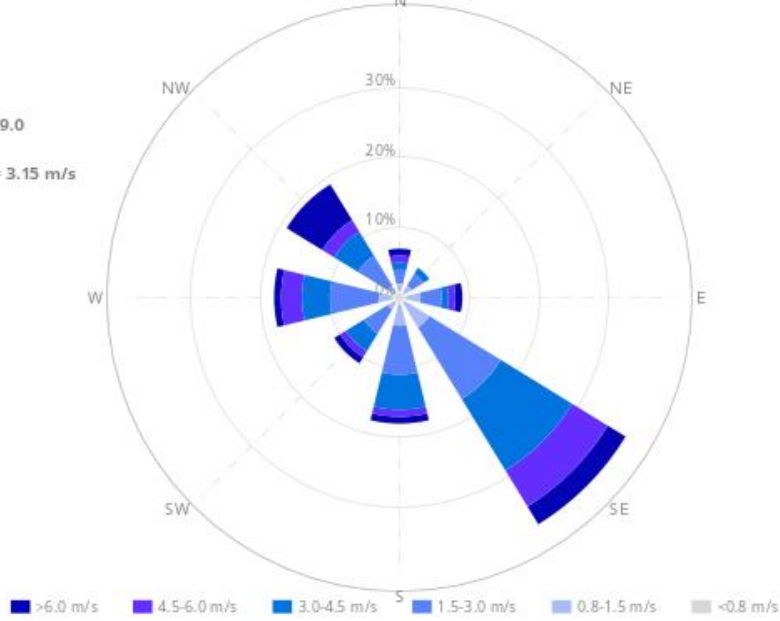
Wind Rose (Sentinex99-M4) : September 2023

Total Count = 7559.0
Calm = 8%
Avg Wind Speed = 3.15 m/s

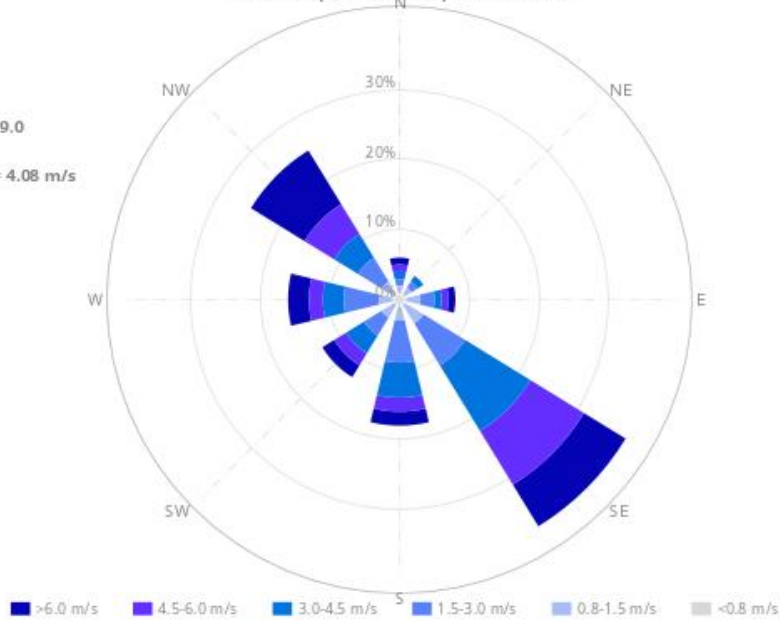
Wind Rose (Sentinex99-M4) : October 2023

Total Count = 7909.0
Calm = 8%
Avg Wind Speed = 4.08 m/s
