# NARRABRI MINE 2025 ANNUAL REVIEW

| Name of Operation | Narrabri Mine |
| Name of Operator | Narrabri Coal Operations Pty Ltd |

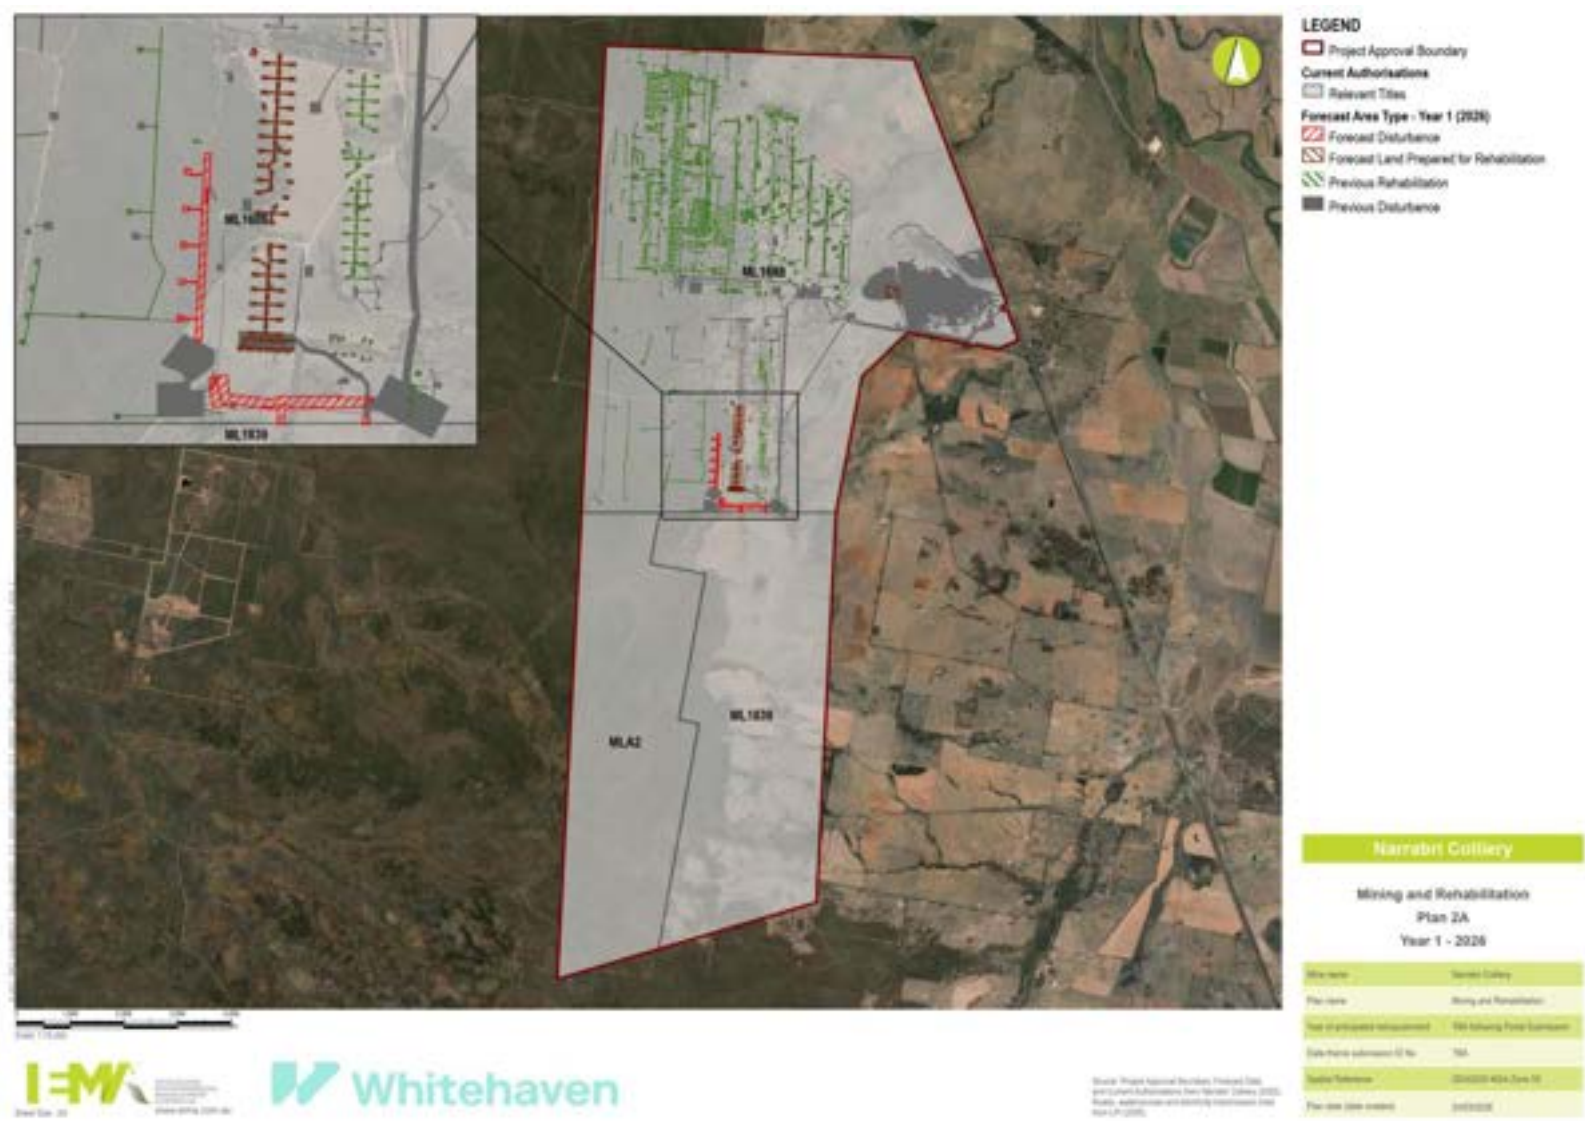
Figure 13: Rehabilitated Areas, Reporting Period 2025

**Figure 12** and **Figure 13** shows the status of rehabilitation at the Narrabri Mine.

Rehabilitation activities for 2026 will be carried out generally in accordance with the FWP and RMP subject to operational progress.

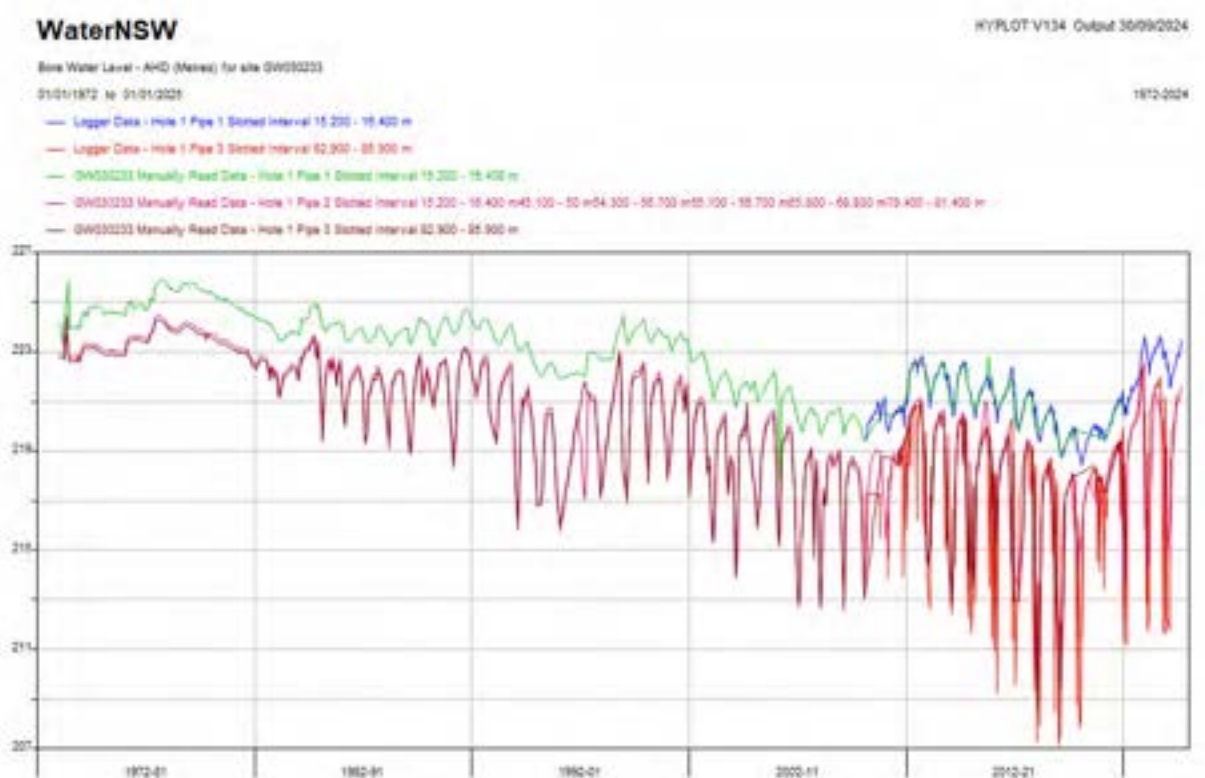
Figure 4.4 Groundwater bore installed northeast of mining near Namoi River

Regional groundwater level contours for the Namoi Alluvium indicate that groundwater flows generally south to north along the Namoi River, consistent with topography and flow direction of the river (Hydrosimulations, 2015). Intensive groundwater use for irrigation results in seasonal water table drawdown up to 15 m in areas of the Namoi Alluvium (Figure 4.4).

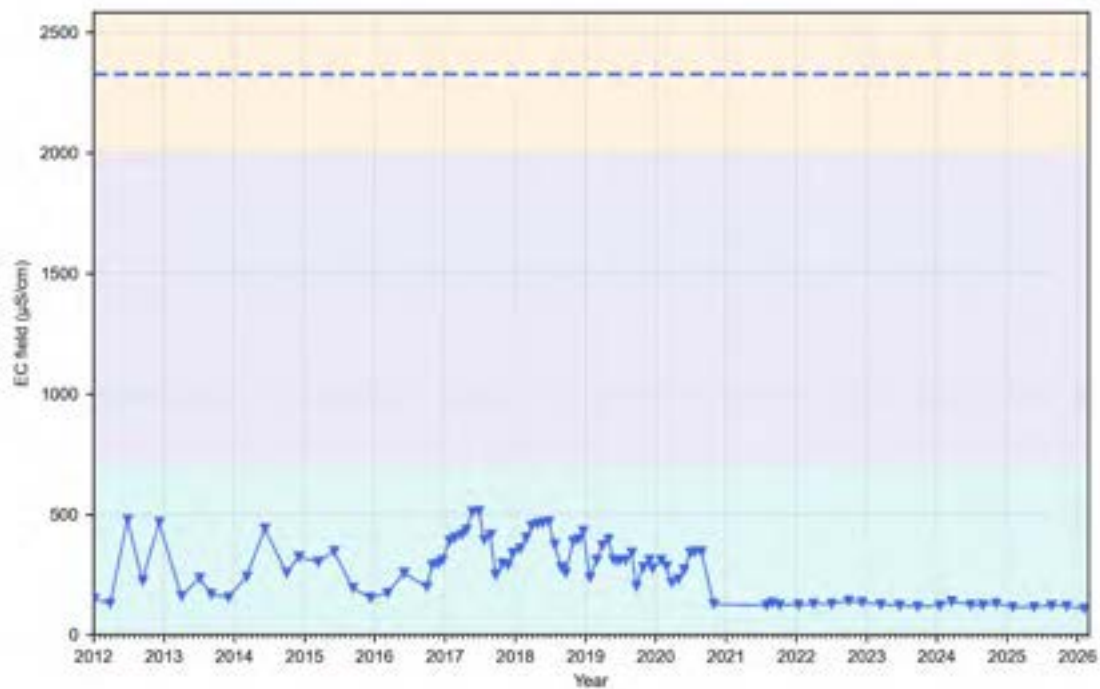
Figure 7.3 EC plot Pilliga Sandstone

A stable EC measurement has been recorded at P7 since 2021 (Figure 7.3). From late 2020 until mid-2024 pH decreased from 6.5 to 5.5 (Figure 7.4) thereby exceeding the pH trigger level of 6. This decrease in pH coincides with the high rainfall events that followed the Tinderbox Drought and are discussed further Appendix F.

Filled markers indicate values above limit of reporting, and  
Empty markers indicate values below limit of reporting.

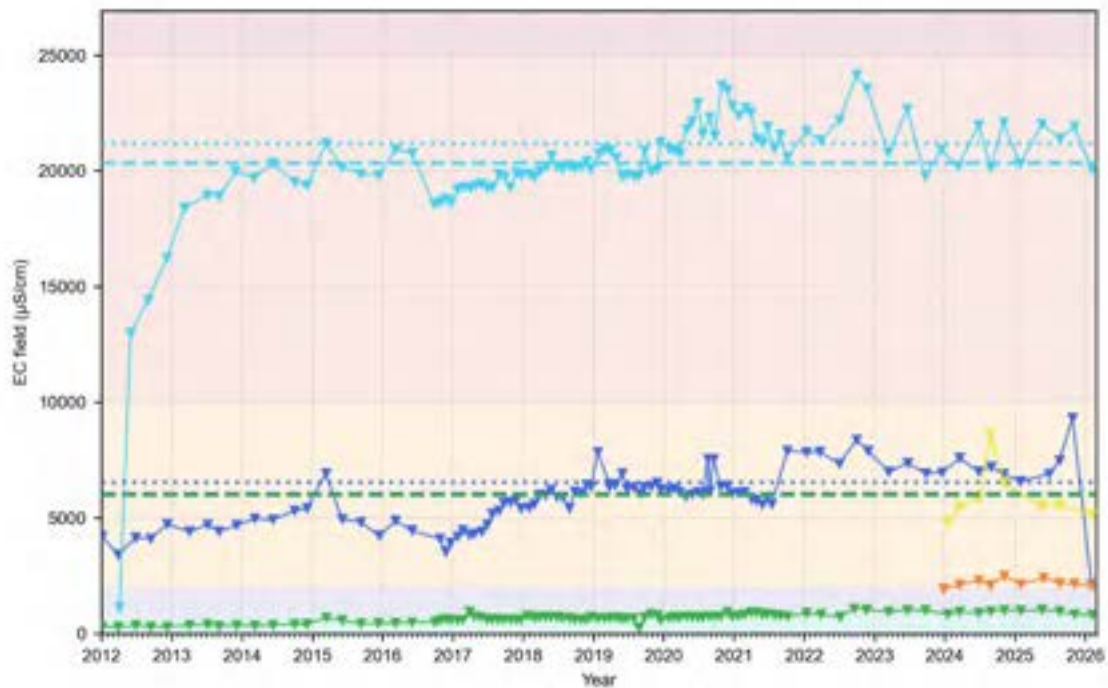
During the same period pH values fluctuate with greater ranges in consecutive measurements than previously recorded (Figure 7.6). pH generally ranges between 6 and 7.75 within ANZECC guideline ranges with the exception of P72 which has pH recorded above 7.75 on one occasion recorded after installation.

Filled markers indicate values above limit of reporting, and Empty markers indicate values below limit of reporting.

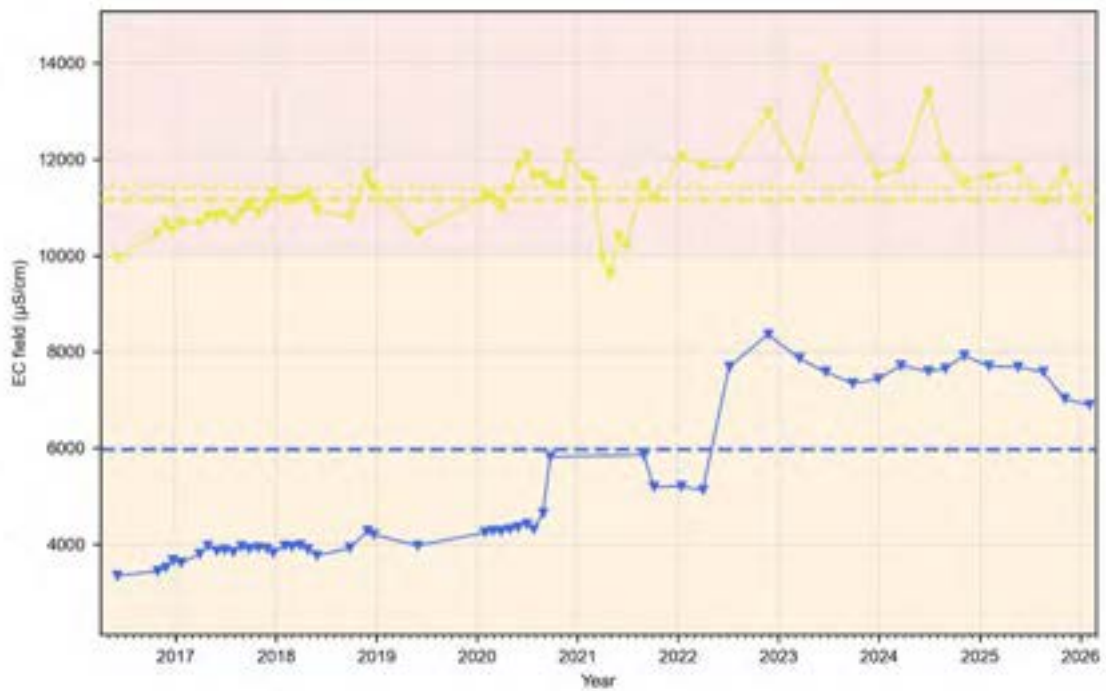
Figure 7.11 EC plot Watermark Formation

From 2016 to mid-2020 both bores experience a steadily increasing trend in salinity (Figure 7.11), from mid-2020 salinity increased more significantly at the same time both bores saw a drop in pH. P39A decreased in pH from approximately 8 to 7, at the same time P43 dropped from approximately 7.5 to 7. Both bores have recorded similar pH since mid-2020 (Figure 7.12).

Filled markers indicate values above limit of reporting, and Empty markers indicate values below limit of reporting.

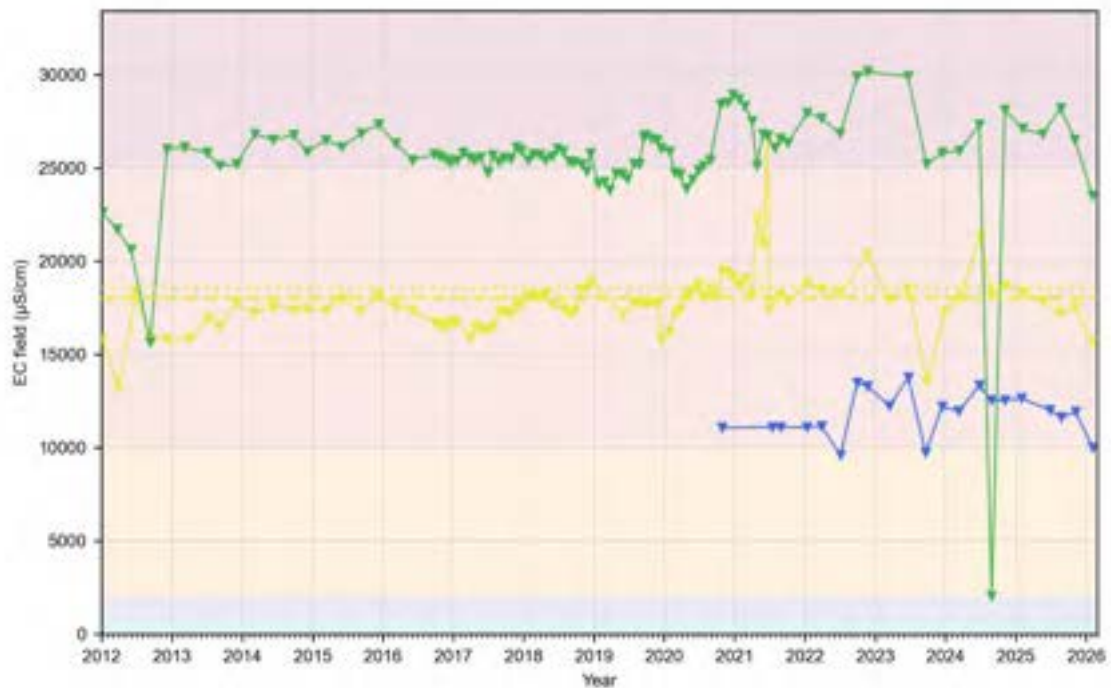
Figure 7.13 EC plot Pamboola Formation

Bores P3 and P5 have recorded stable EC and pH from 2012 to 2021 (Figure 7.13). From 2021 pH measurements become increasingly erratic and with an overall decreasing trend (Figure 7.14), during the same period EC began to increase and fluctuate. A similar trend has been noted in other formations; the trend generally coincides with the end of the Tinderbox Drought.

Filled markers indicate values above limit of reporting, and Empty markers indicate values below limit of reporting.

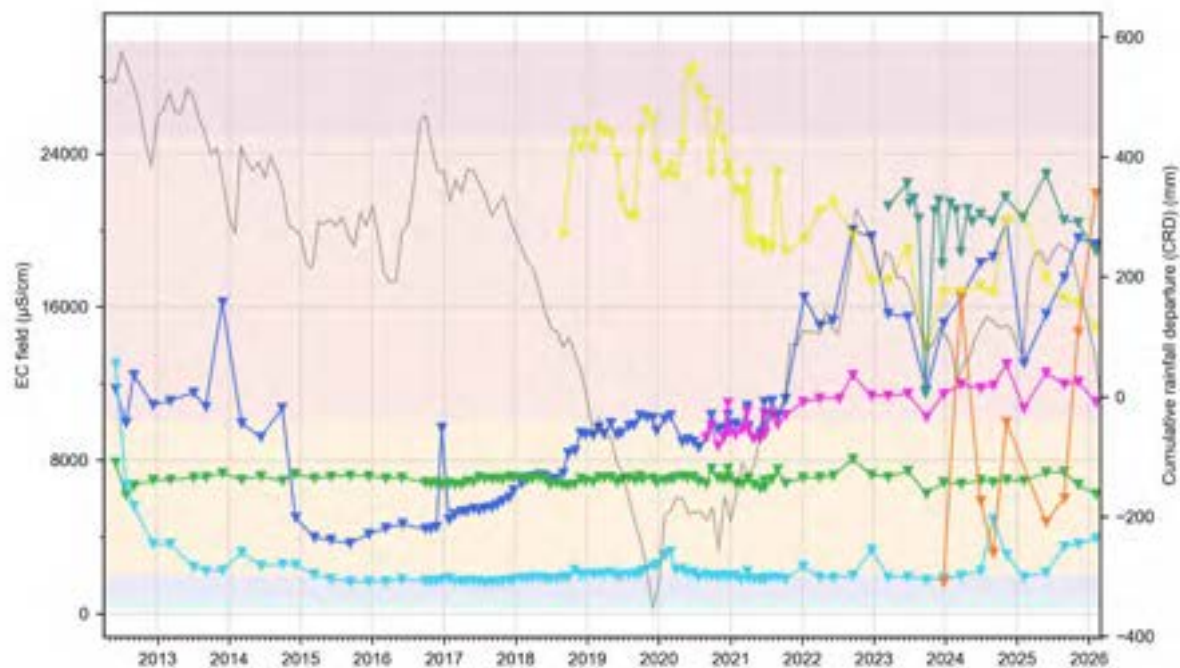
The Reject Emplacement Area (REA) is located immediately west of the box cut. Three shallow standpipe monitoring bores (P51, P52 and P53) are installed north of the REA. It is expected that 8.2 million tonnes (or approximately 5.7 million m<sup>3</sup>) will be managed within the REA over the 30-year mine life. SB3 is located north of the REA to capture surface water runoff. EC and pH plots for REA bores are plotted in Figure 8.1 and Figure 8.2 respectively.

*Ratios of major ions and EC measured at P53 and P52 indicate that the water types at the two bores) have become similar to each other since 2022. This could indicate that a source of water with a consistent composition is influencing the groundwater at both sites via mixing. The mechanism for this mixing is not clear; however, mixing trends identifiable in piper plots and Ca/Mg ratios indicate that water quality at P53 is becoming less similar to water types typical of mine inflow and coal seams. Mixing trends indicate that water is becoming more chloride rich relative to bicarbonate (or bicarbonate depleted), whereas water types of mine inflow, coal seams, or water affected by rejects would be expected to be more bicarbonate-dominant relative to chloride.*

Filled markers indicate values above limit of reporting, and Empty markers indicate values below limit of reporting.

No immediate remediation is recommended as changing water quality is likely due to mixing from other groundwater sources.

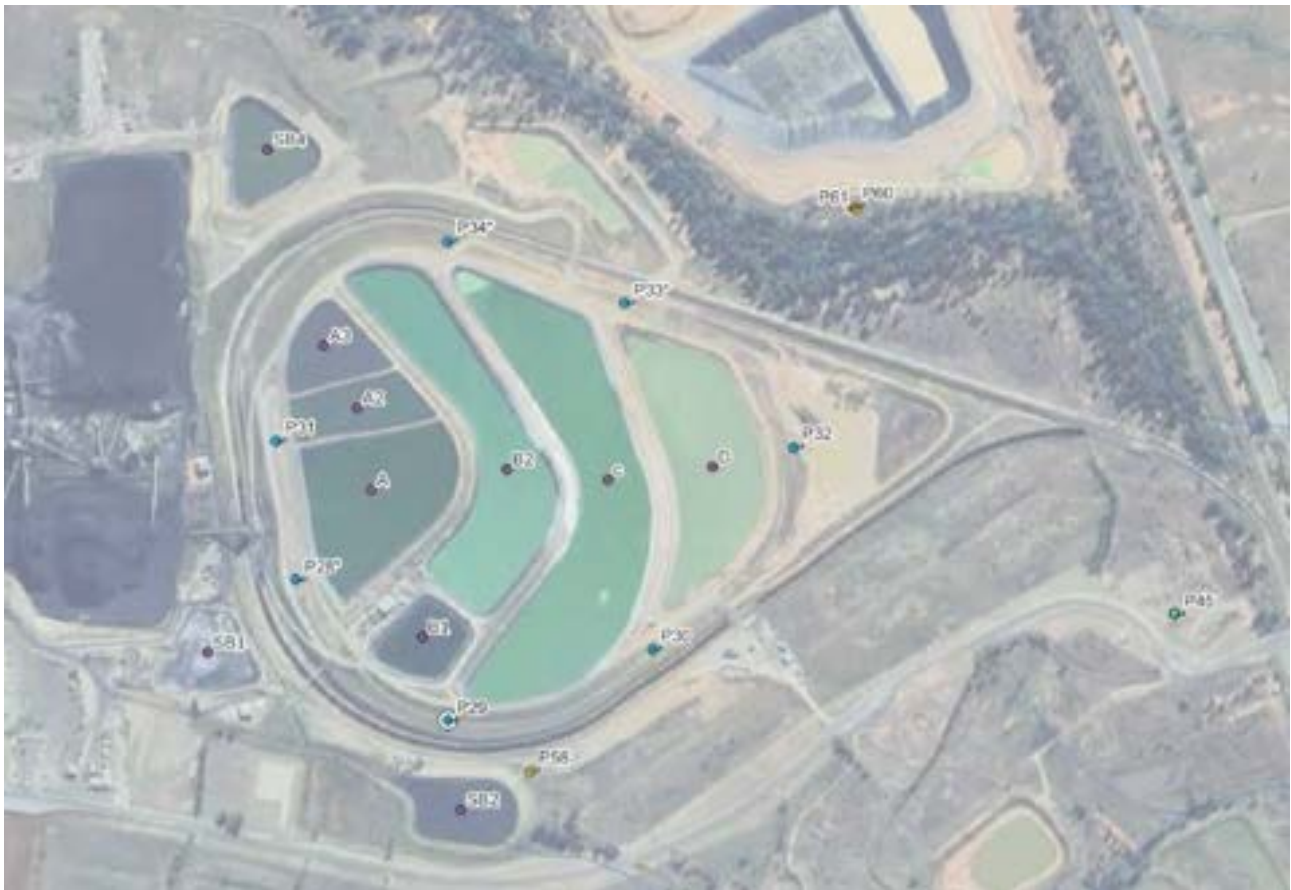
Figure 7.25 Seepage monitoring bore EC (anomalous data removed) and locations

Surrounding seepage monitoring bores installed in the Napperby Formation (Figure 7.25) do not follow similar EC trends of P29. P30, located about 280 m to the east of P29 and adjacent to storage dams D and C shows a declining EC trend (Figure 7.25), although the two bores now currently have similar EC of about 17,000  $\mu\text{S}/\text{cm}$ . The minimal correlation between bores and rainfall trends indicates natural climate variations are unlikely causing increasing trends in EC.

The hydraulic gradient at P29 indicates flow toward the mining zone, indicating that there is no viable pathway for solutes to reach P29, if they were being produced.
