## Environmental Event Report

### Narrabri Underground Mine Stage 3 Extension Project

Application number: EPBC 2019/8427  
Licensee/Proponent: Narrabri Coal Operations Pty Ltd  
Locked Bag 1002  
Narrabri NSW 2390

#### b) Outcomes of an investigation, including identification of the cause of the incident

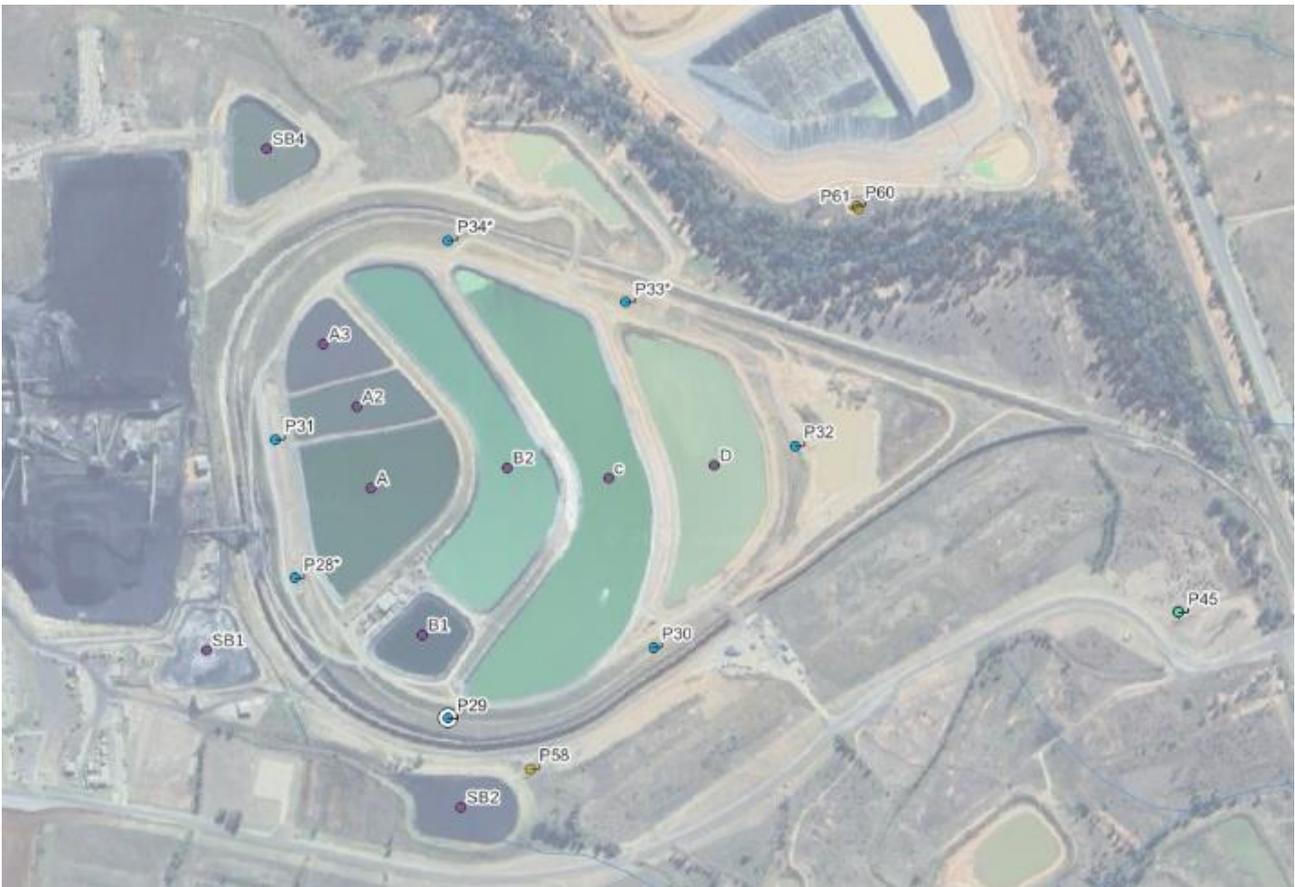
Figure 7.25 Seepage monitoring bore EC (anomalous data removed) and locations

The hydraulic gradient at P29 indicates flow toward the mining zone, indicating that there is no viable pathway for solutes to reach P29, if they were being produced.
