Environmental Event Report

Narrabri Underground Mine Stage 3 Extension Project

Narrabri Coal Mine- Hydrogeological Review of Monitoring Bore Exceedances Q3 2025

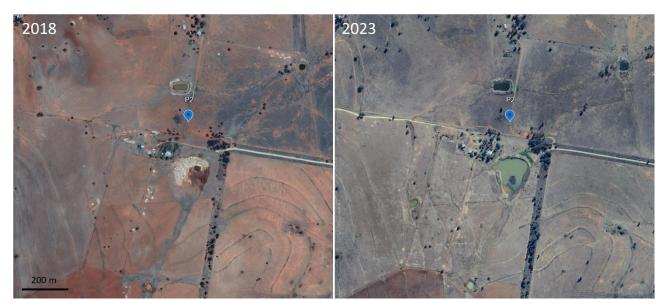
Figure 7.19 Comparison of area surrounding P2 between 2018 and 2023

Bore P2 is located between two dams, no hydrochemistry data is available for these dams; however, as the purpose is for stock and irrigation the salinity is expected to be low. As can be seen in Figure 7.19 no water was present in the southern dam during the Tinderbox drought, whereas water is present post drought. Seepage from the dams is unlikely given that P2 is installed at 44 m bgl within the very tight Napperby Formation.

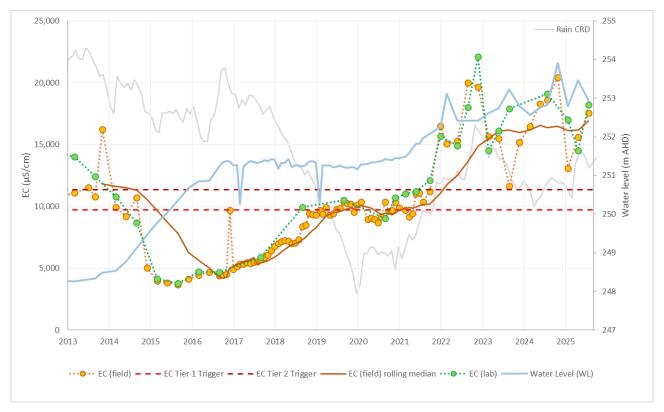
Figure 7.25 P29 EC field and laboratory measurements plotted with water levels

Bore P29 is a seepage monitoring bore located south of the rail loop dams (Figure 4.2), the bore is installed in Napperby Formation from 19 to 25 m bgl. The monitoring bore was installed in 2012 when the dams were installed. EC values initially declined after installation to mid-2015. Since 2015 values have fluctuated with an overall increase concurrent with an increase in water levels (Figure 7.25).
