NARRABRI WATER LEVEL HYDROGRAPHS

NARRABRI HYDRAULIC TEST DATA

SHORT TERM PUMP TEST - CLAREMONT

Prepared for Narrabri Coal

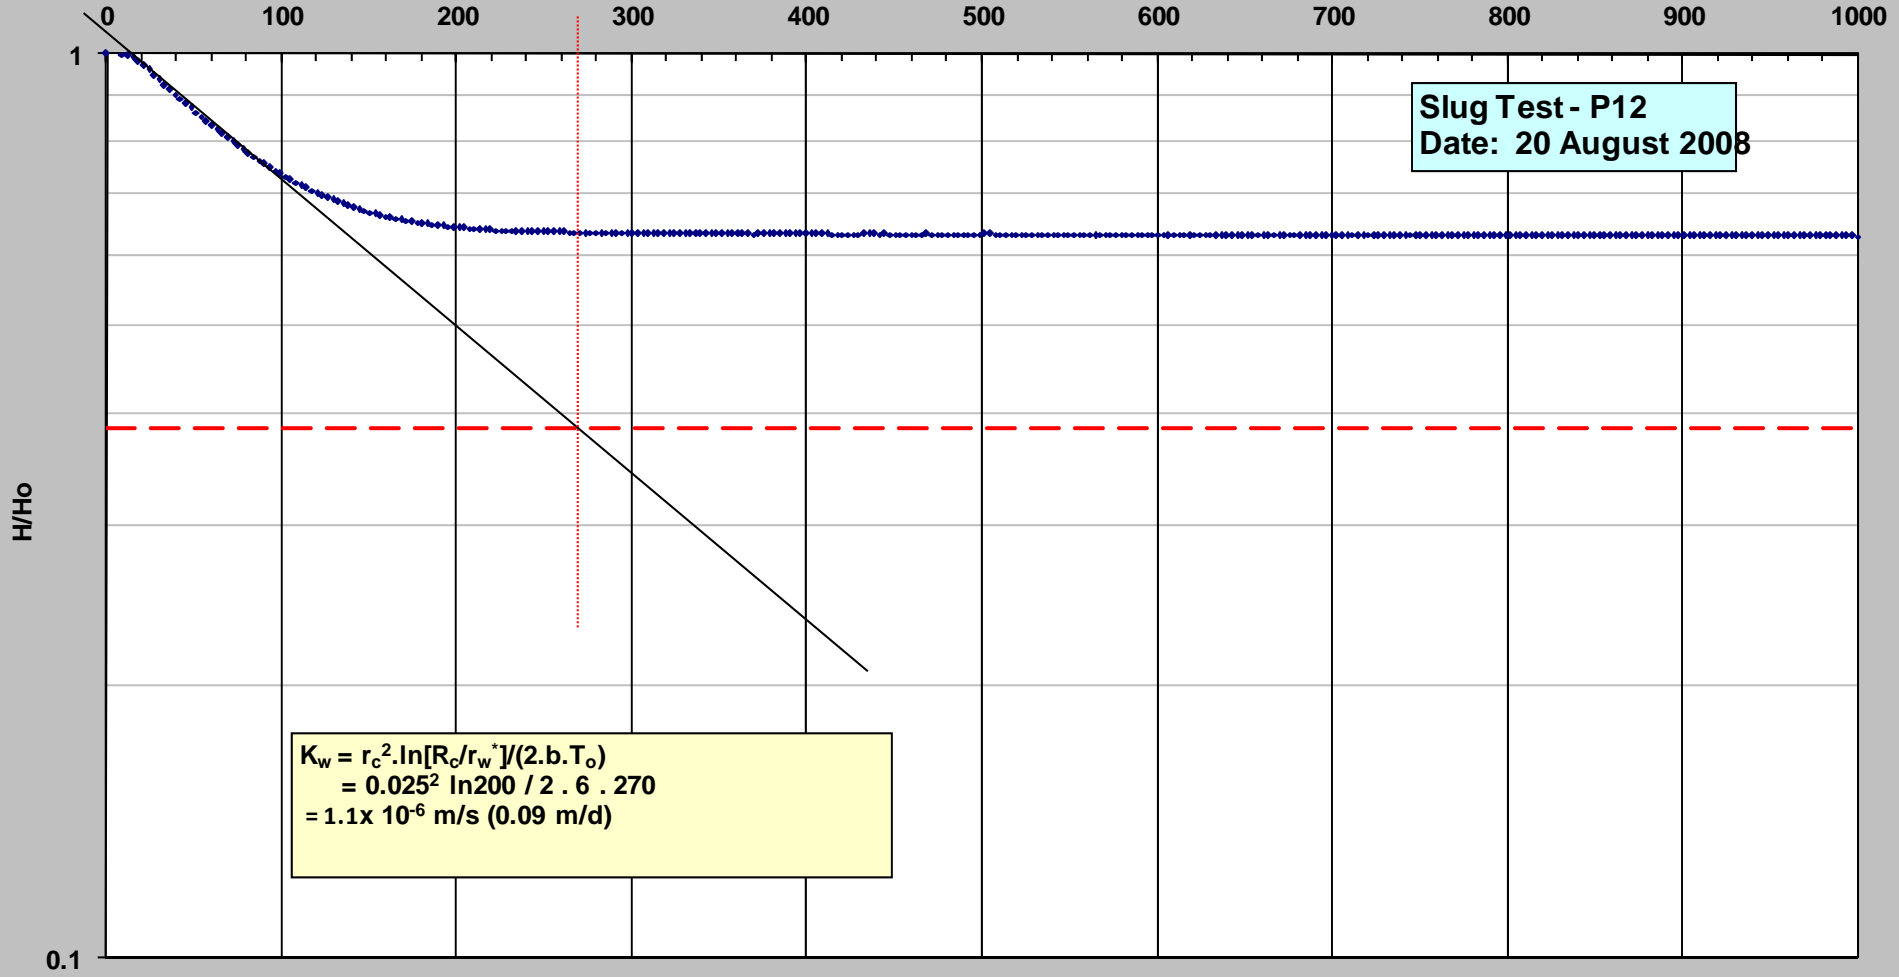
SLUG TEST - P12

Slug Test - P12
Date: 20 August 2008

$$\begin{aligned}
 K_w &= r_c^2 \cdot \ln[R_c/r_w^*] / (2 \cdot b \cdot T_o) \\
 &= 0.025^2 \ln 200 / 2 \cdot 6 \cdot 270 \\
 &= 1.1 \times 10^{-6} \text{ m/s (0.09 m/d)}
 \end{aligned}$$
