**Annual
Environmental
Management
Report**

**Rocglen Coal
Mine
(ML 1620)**

1 August 2010 – 31 July 2011

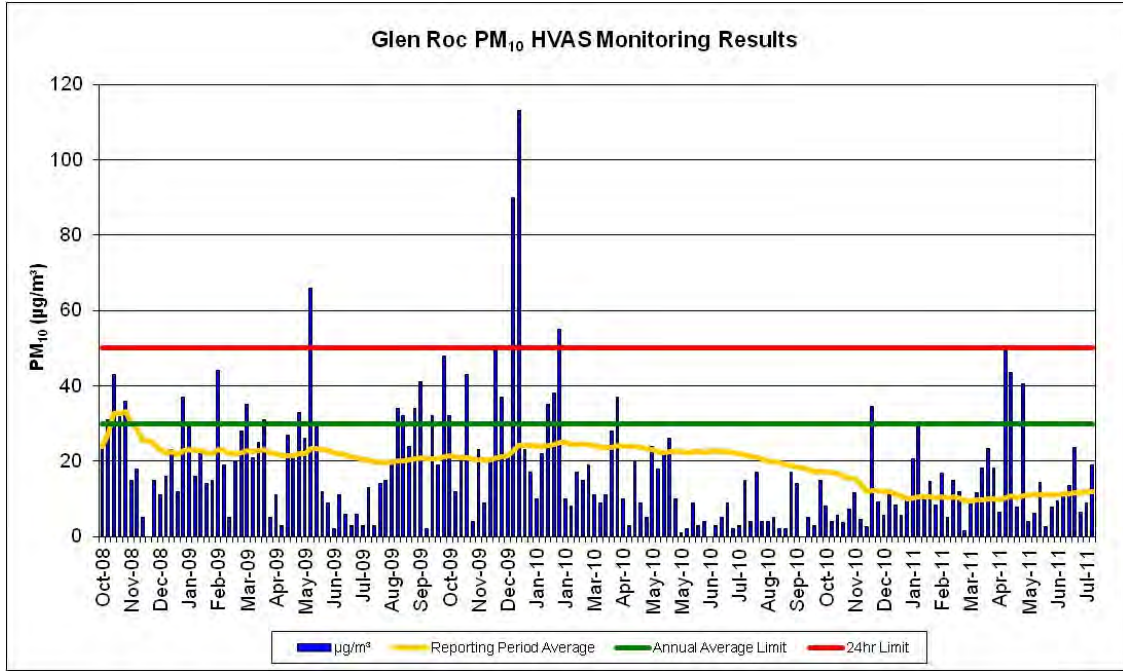
The long term PM₁₀ levels and averages are provided in Figure 5 and Figure 6. Both figures indicate a reduction in annual average PM₁₀ level. This is due to the exclusion of elevated results that no longer fall within the 12 month reporting period. These include those from September/October 2009 (from regional dusty conditions) and December 2009 (from the Kelvin Range bushfire).

Figure 5 - Glenroc HVAS PM₁₀ Data

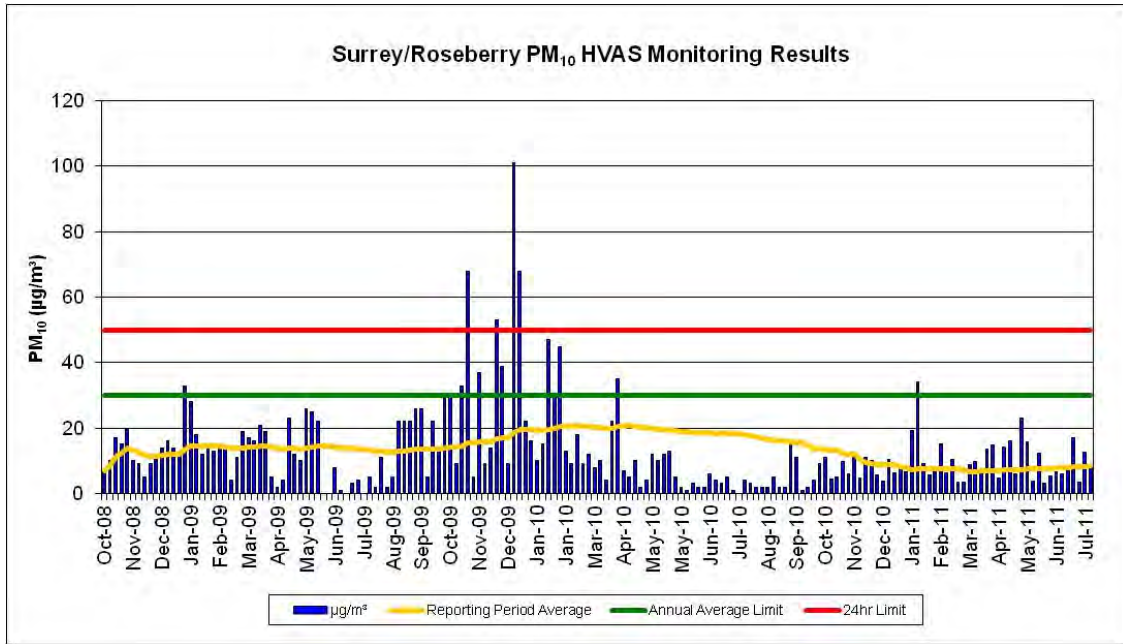
Figure 6 – Surrey/Roseberry HVAS PM₁₀ Data

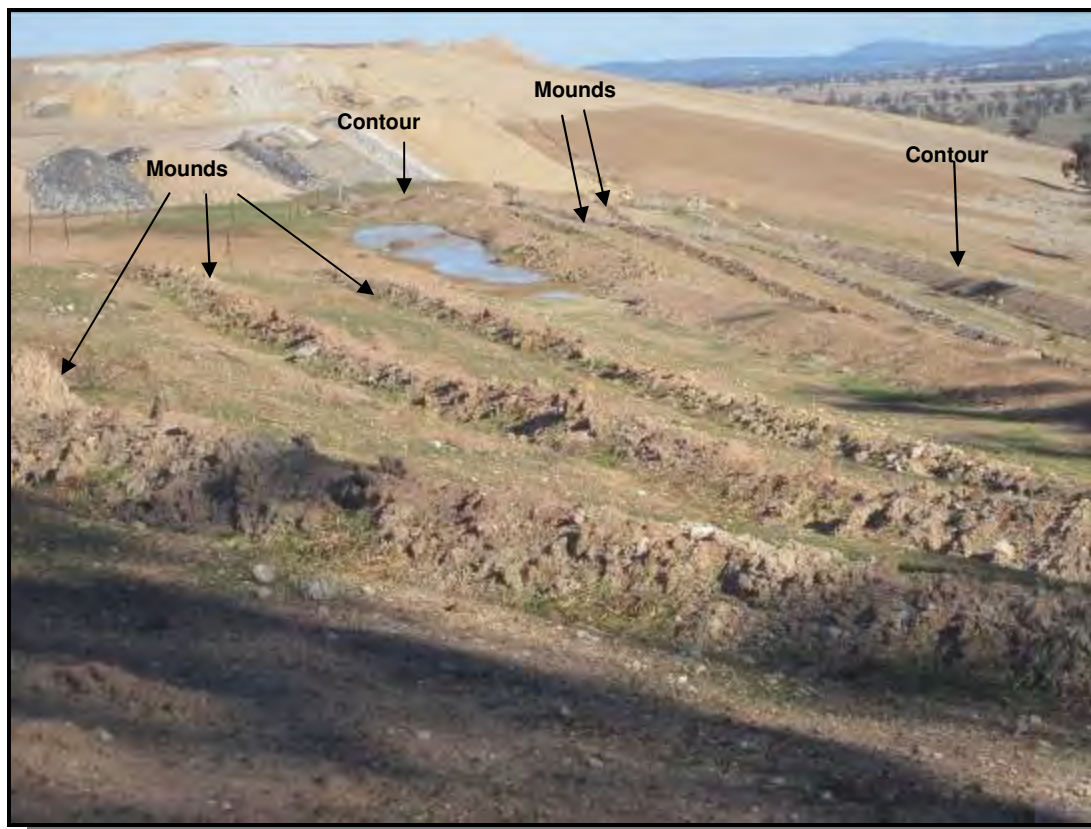
Plate 2 - Mounding used to catch runoff and minimise erosion

The site has maintained sediment fencing in appropriate locations throughout the reporting period, particularly at the two discharge locations. This incorporated the use of hay bales as additional sediment traps at these locations. Hay bales have also been utilised on rehabilitation slopes in order to 'patch' erosion channels through contours and mounds. Mounding was used as an alternative to rip lines with the aim to catch more water on-slope hence reducing runoff and erosion whilst aiding fast root establishment through increased moisture within the soil profile (Plate 2). Whilst the sampling results have indicated elevated sediment loads in the first half of the reporting period, site personnel have made every effort to try to minimise sediment loading in surface waters in difficult circumstances given the extent of regular rainfall.

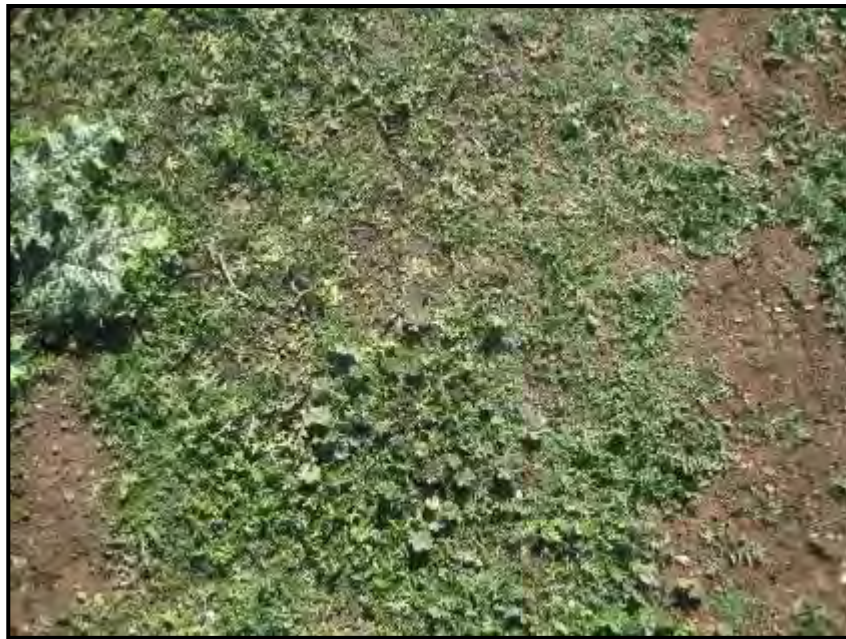
Plate 6 – Growth eight months after manure trial

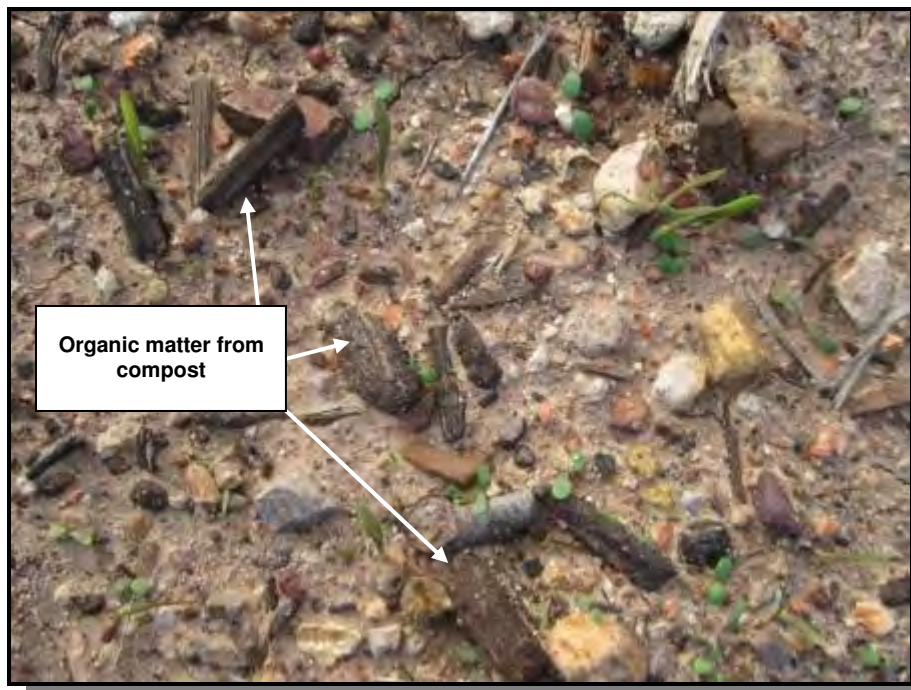
Plate 9 – Germination one month
