Annual Environmental Management Report & Annual Review

Name of Mine	Rocglen Coal Mine		
Titles/Mining Leases	ML 1620, ML 1662		
MOP Commencement Date	01-10-2011	MOP Completion Date	30-10-2015
AEMR Commencement Date	01-08-2014	AEMR Completion Date	31-07-2015
Name of Leaseholder	Whitehaven Coal Mining Pty Ltd		
Reporting Officer:	Jill Johnson		
Title:	Group Manager - Environment		
Signature:	_____		
Date:	_____

This is the seventh Annual Environmental Management Report (AEMR) produced for the Rocglen Coal Mine (RCM), and it has been prepared in accordance with Conditions 4 and 5 of Mining Lease (ML 1620) (Mining Act 1992), Condition 4 of Mining Lease (ML 1662) and Clause (c) of Environmental Monitoring and Reporting in the Statement of Commitments within PA 10_0015 MOD 1. The AEMR generally follows the format identified in the Department of Primary Industries Mineral Resources (DPI-MR) document entitled *“Guidelines to the Mining, Rehabilitation and Environmental Management Process”* Version 3, dated January 2006. It also addresses Condition 3 (Schedule 5) of PA 10_0015 MOD 1 which requires provision of an Annual Review and is herein referred to as an AEMR/Annual Review.

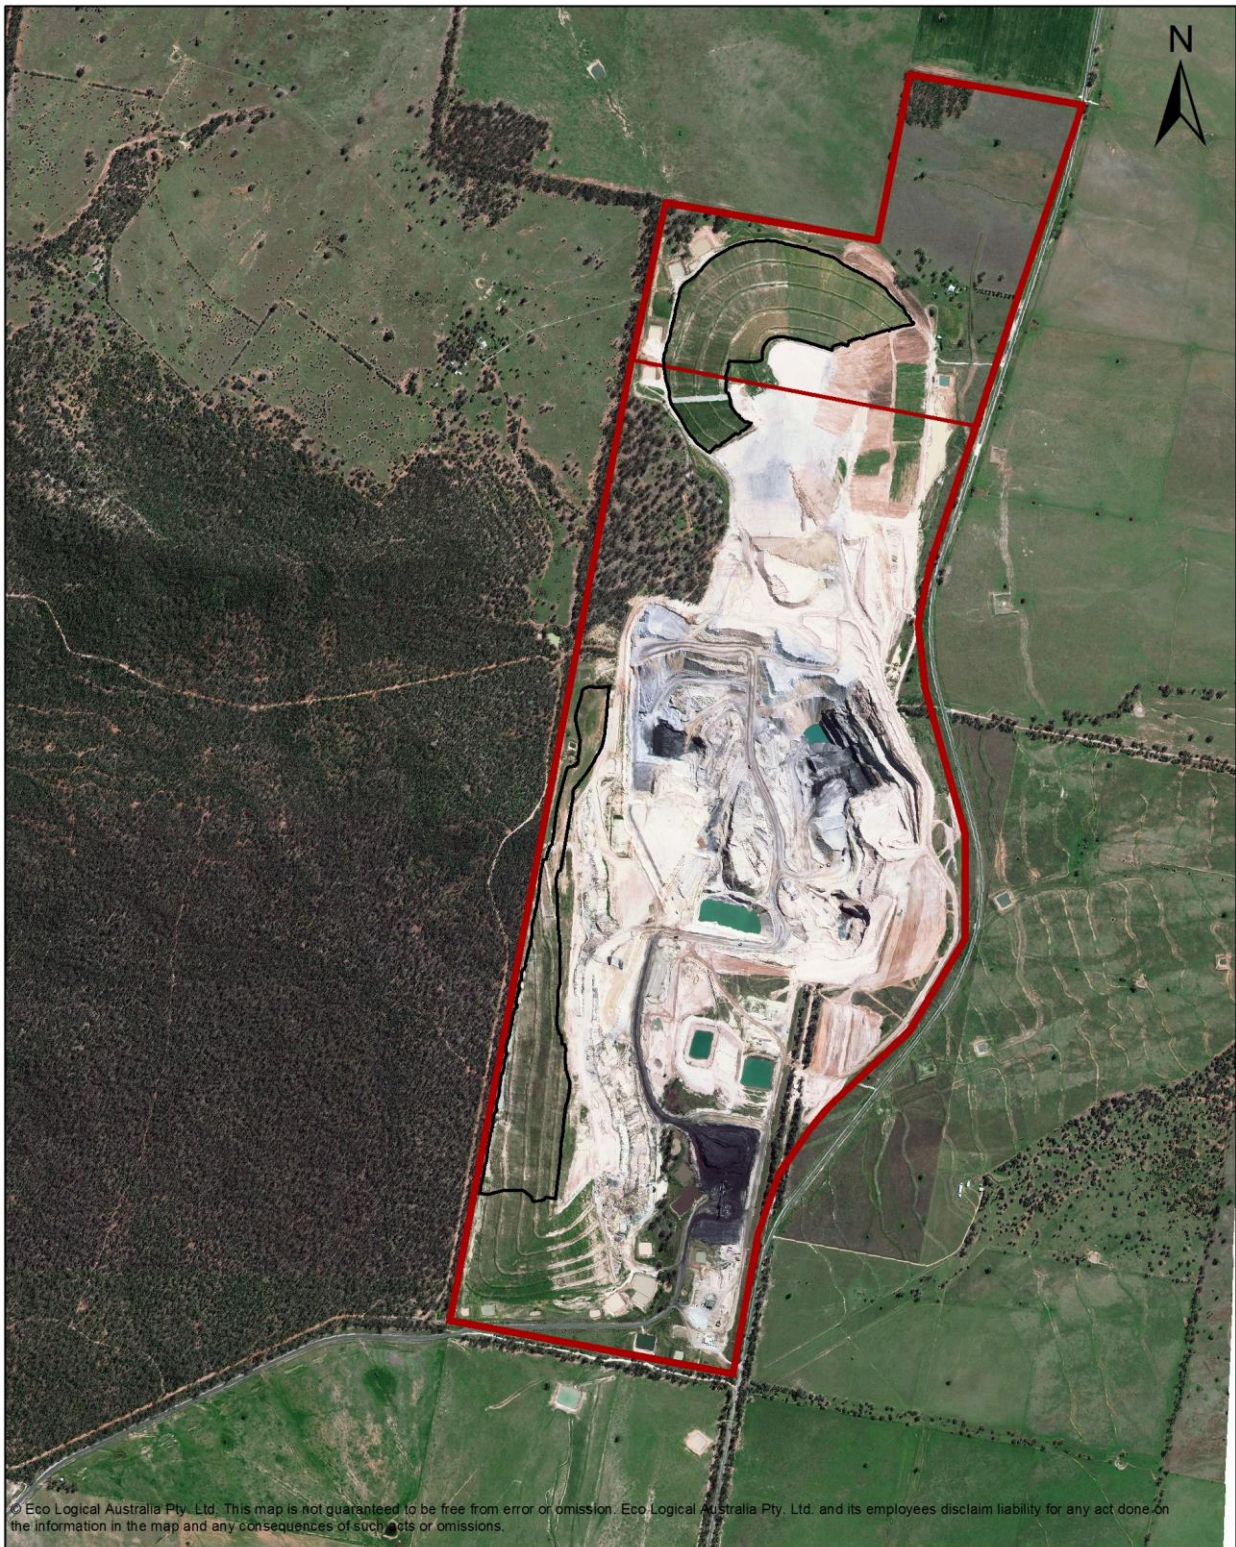
The true colour and false colour images indicate the extent and condition of each land cover type in the area. These images show similar vegetation cover across the control and rehabilitation pasture sites. In the woodland areas there is a greater vegetation cover at the control sites, given that tubestock planting in WR01 commenced in 2011.

Figure 5-1: Rocglen Mine - True Colour Image

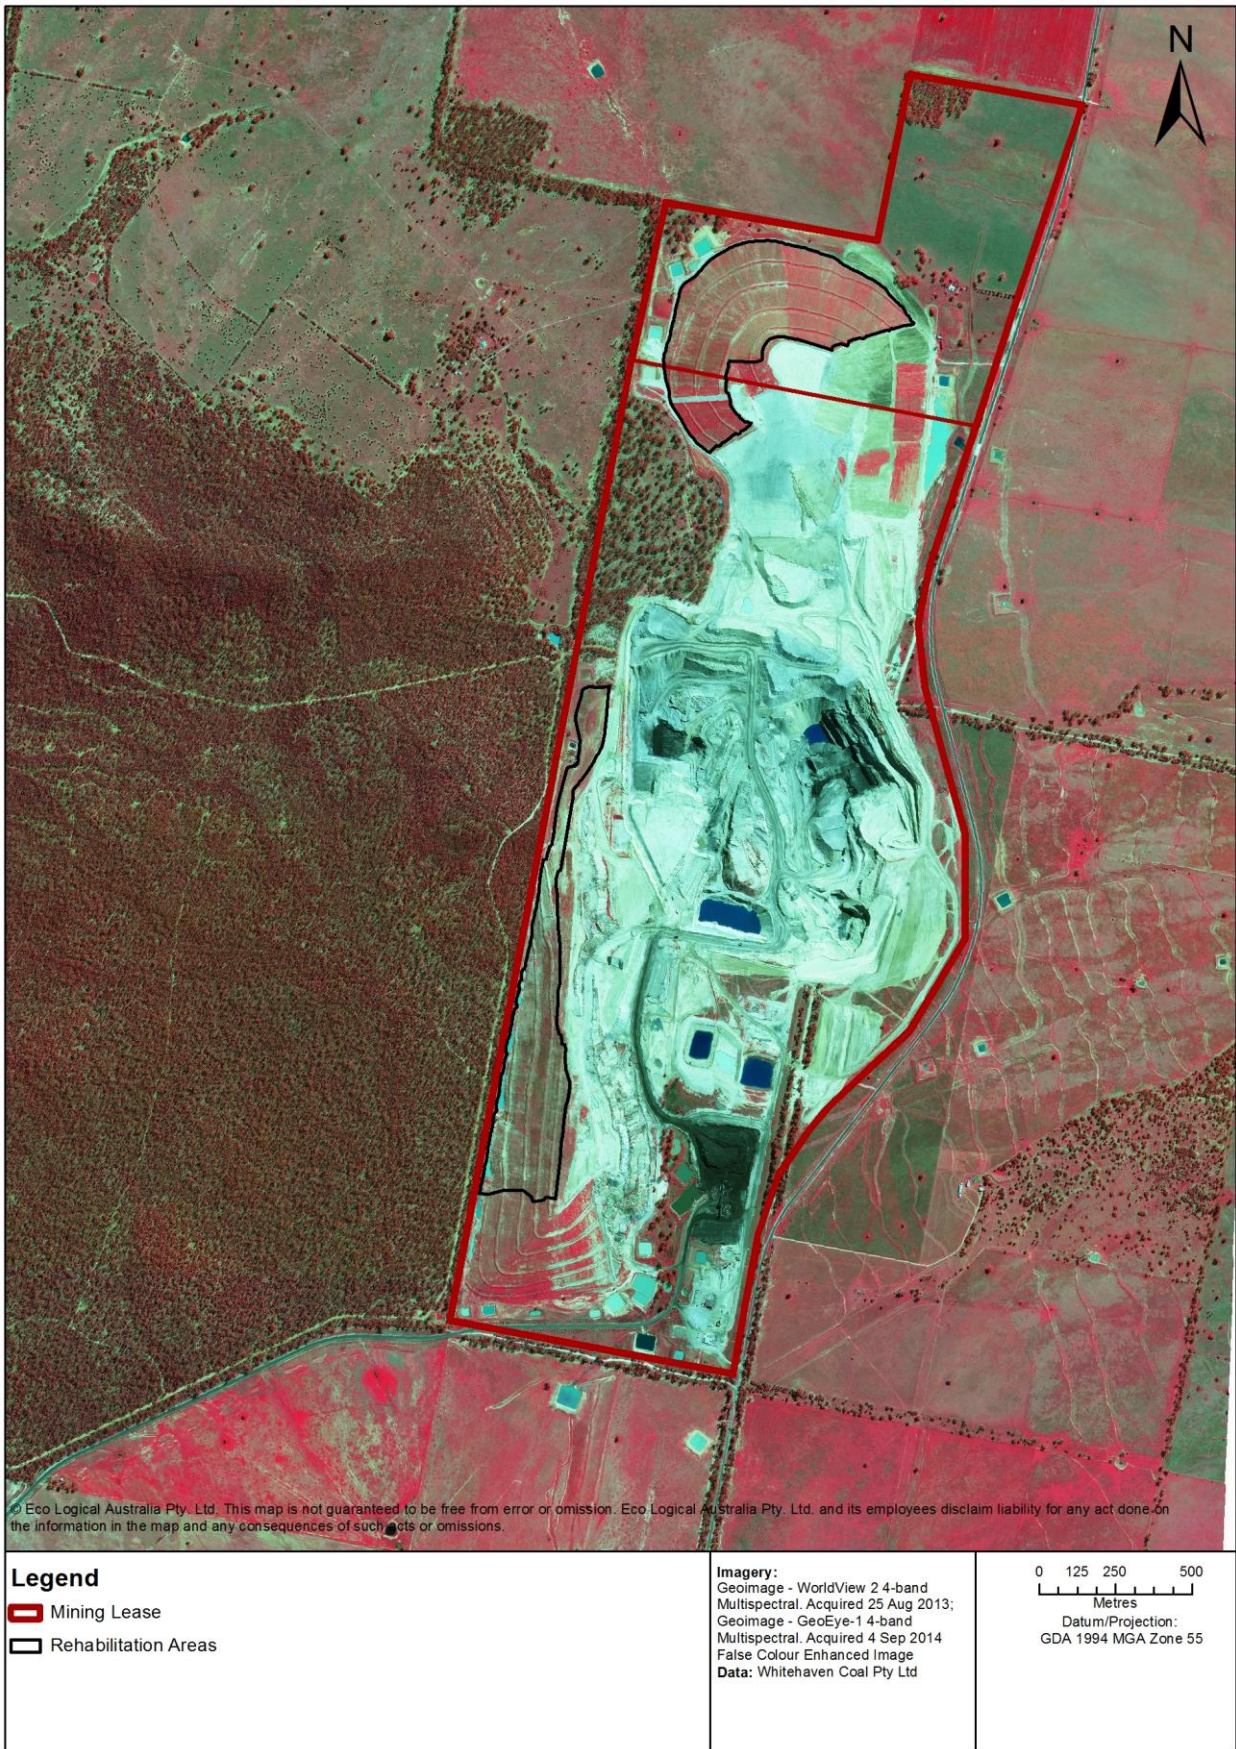
Figure 5-2: Rocglen Mine - False Colour Image
