Annual Review

Rocglen Coal Mine

Name of operation	Rocglen Coal Mine
Name of operator	Whitehaven Coal Mining Pty Ltd
Development consent/project approval number	PA 10_0015
Name of holder of development consent/project approval	Whitehaven Coal Mining Pty Ltd
Mining lease number	ML 1620, ML 1662
Name of holder of mining lease	Whitehaven Coal Mining Pty Ltd
Water licence number	WAL29461 and WAL 36758
Name of holder of water licence	Whitehaven Coal Mining Pty Ltd
RMP start date	2 August 2022, reported on calendar year
Annual review start date	1 January 2024
Annual review end date	31 December 2024
<p><i>I, Daryl Robinson, certify that this audit report is a true and accurate record of the compliance status of Rocglen Coal Mine for the period 1st January 2024 to 31st December 2024, and that I am authorised to make this statement on behalf of Whitehaven Coal Mining Pty Ltd.</i></p> <p><i>Note. a) The Annual Review is an 'environmental audit' for the purposes of section 122B (2) of the Environmental Planning and Assessment Act 1979. Section 122E provides that a person must not include false or misleading information (or provide information for inclusion in) an audit report produced to the

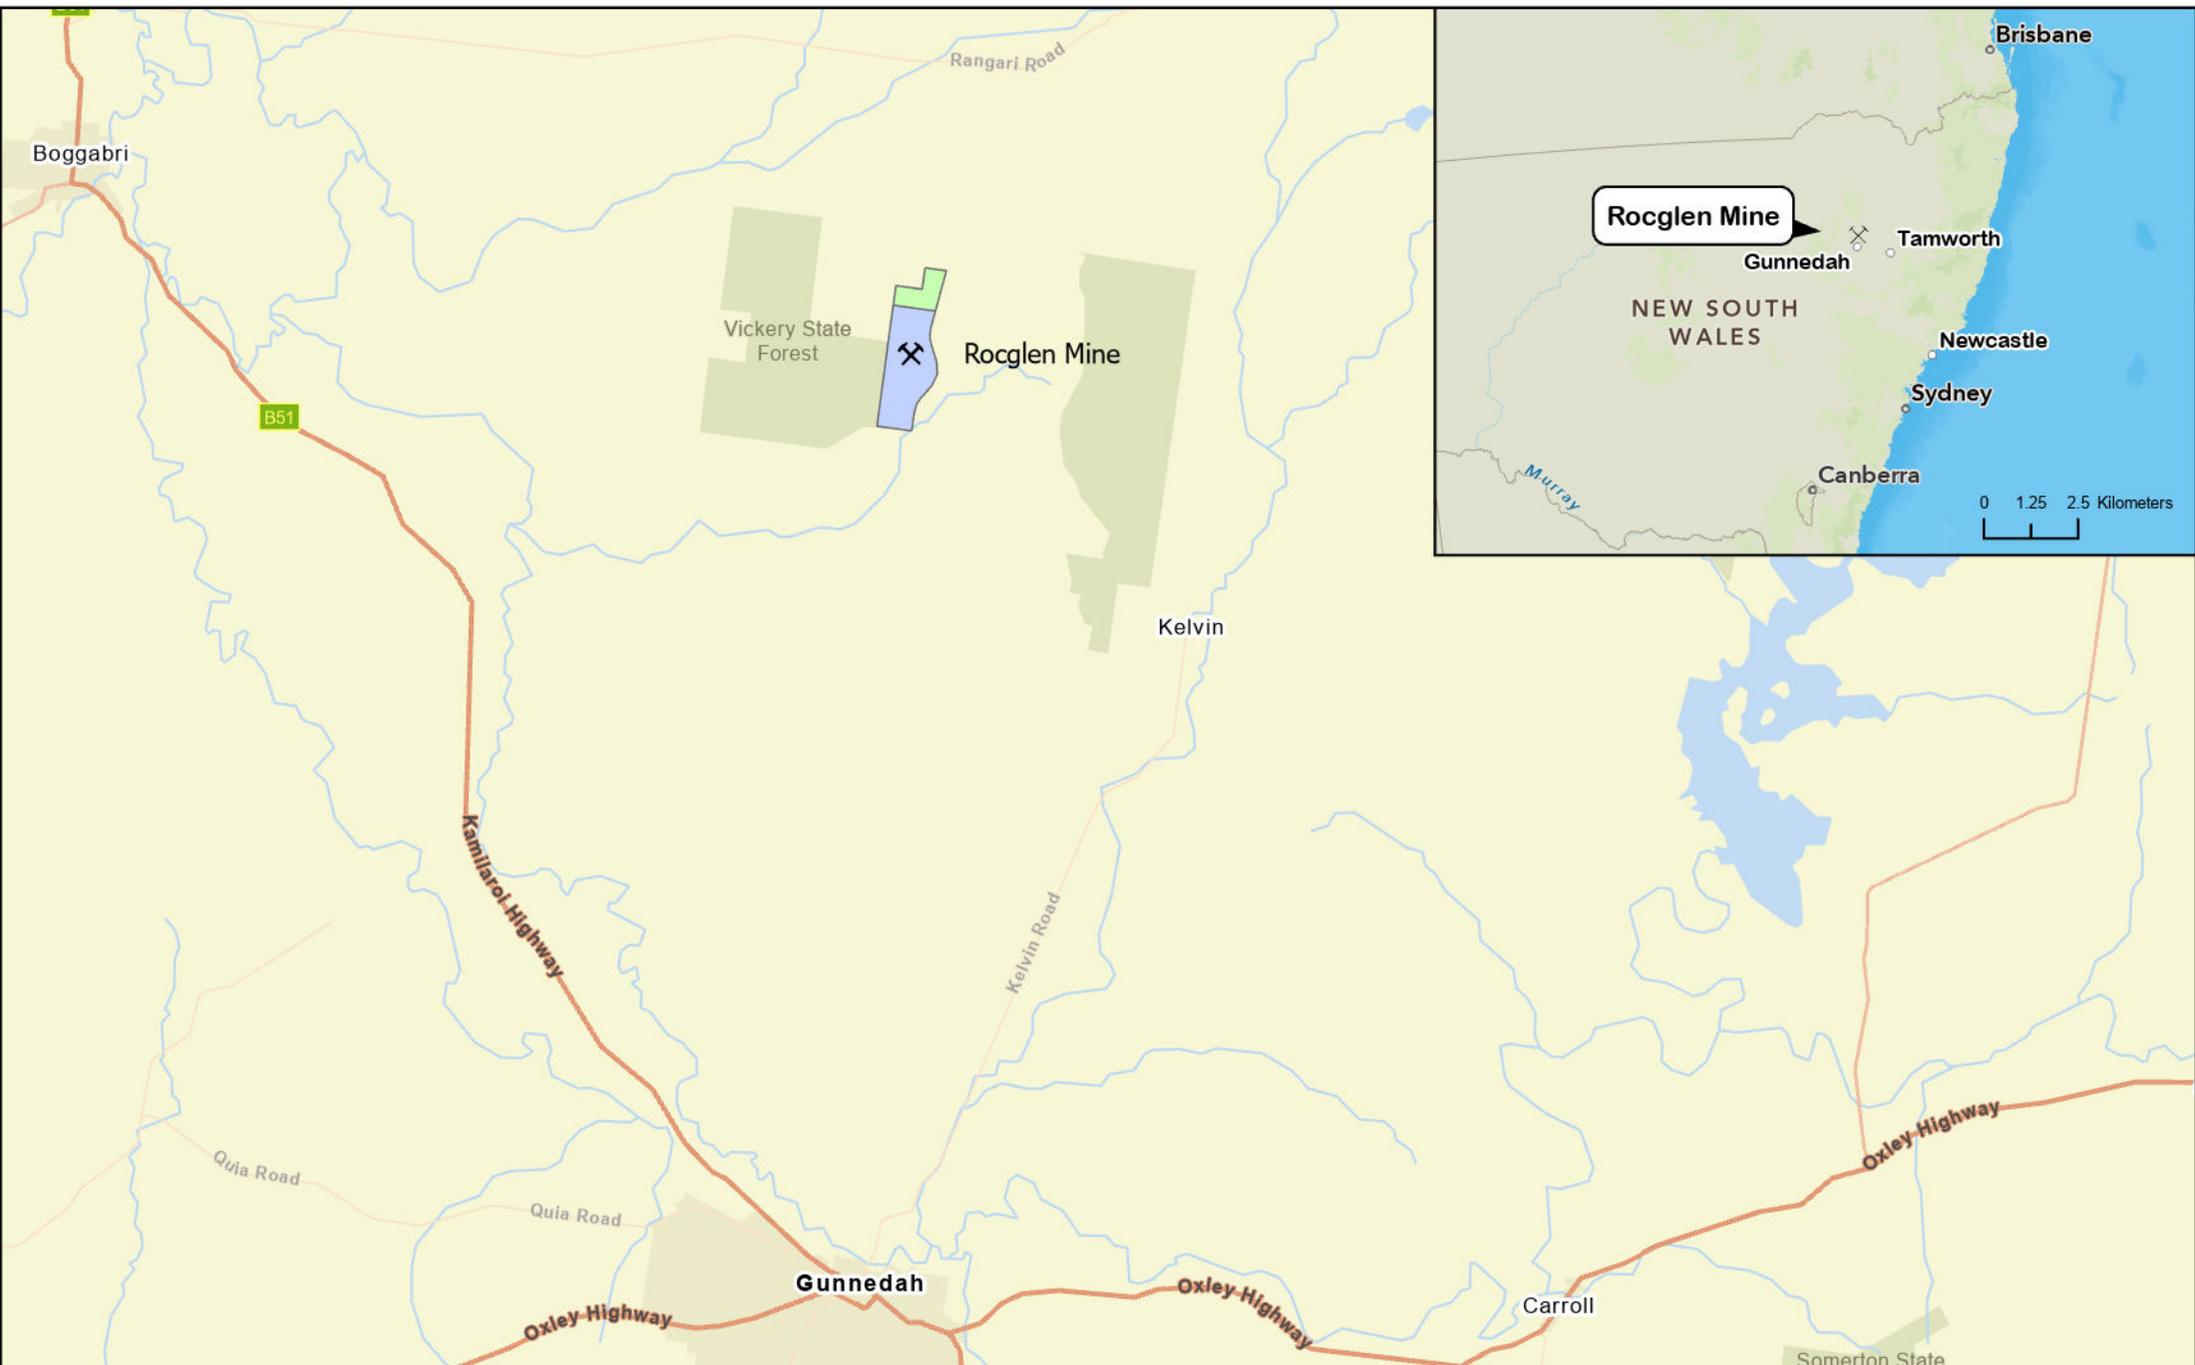
Rocglen Coal Mine Regional Locality

The RCM is located approximately 28km north of Gunnedah (refer **Figure 1**). The RCM is owned by Whitehaven Coal Limited (WCL) and operated by Whitehaven Coal Mining Pty Ltd (WCMPL).

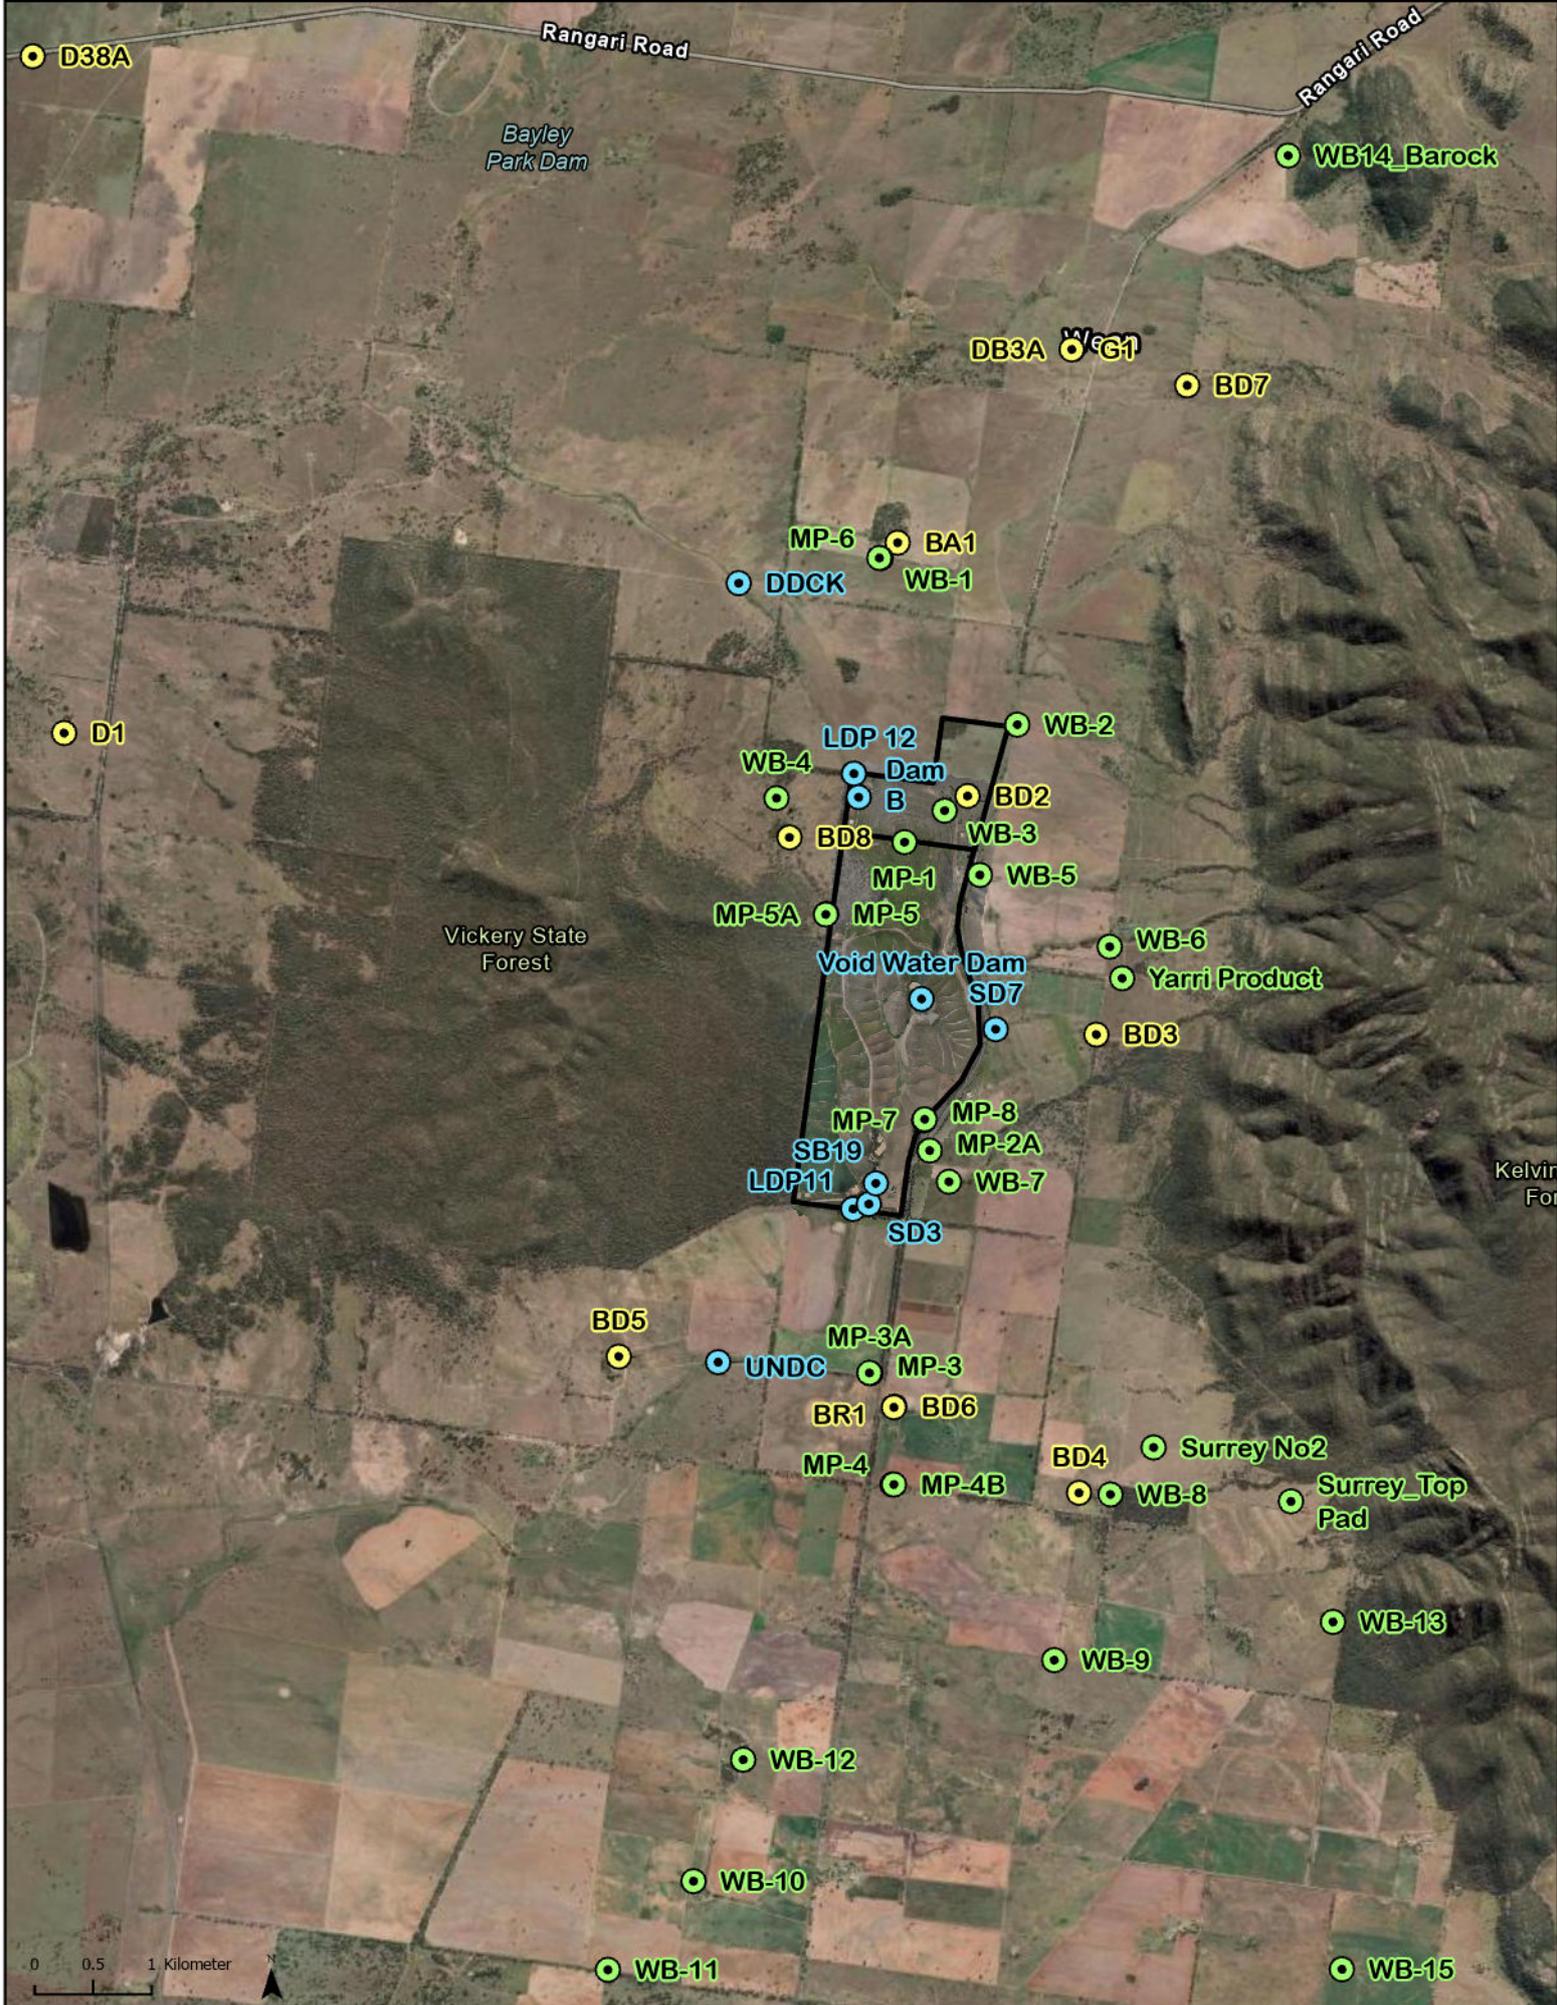
Rocglen Coal Mine Monitoring Locations

- Groundwater Bores
- Air Quality
- EPL Water Quality
- Mining Lease

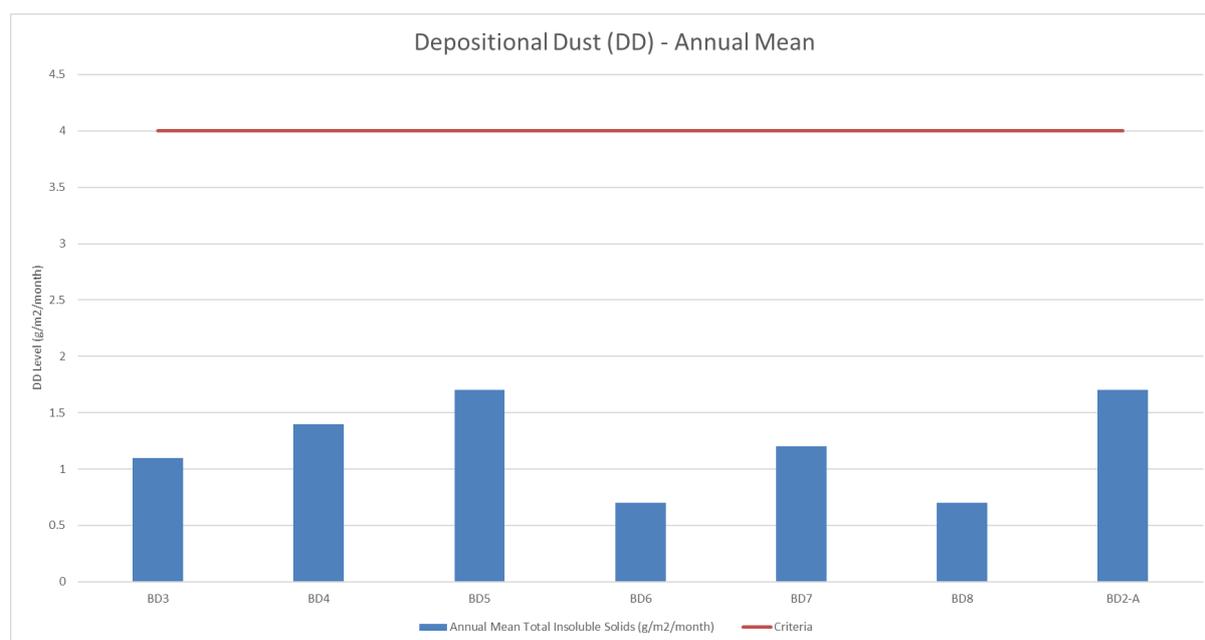
Figure 3 Annual Average of Depositional Dust across 7 monitoring sites

A review of the above, shows that the annual mean limit for deposited dust was below the set criteria at each monitoring site.

Monitoring of Deposited Dust is undertaken monthly, whilst PM₁₀ levels are monitored every 6 days. [Table 6.1.2a](#) and [Figure 3](#) below presents a summary of the Deposited Dust monitoring data.

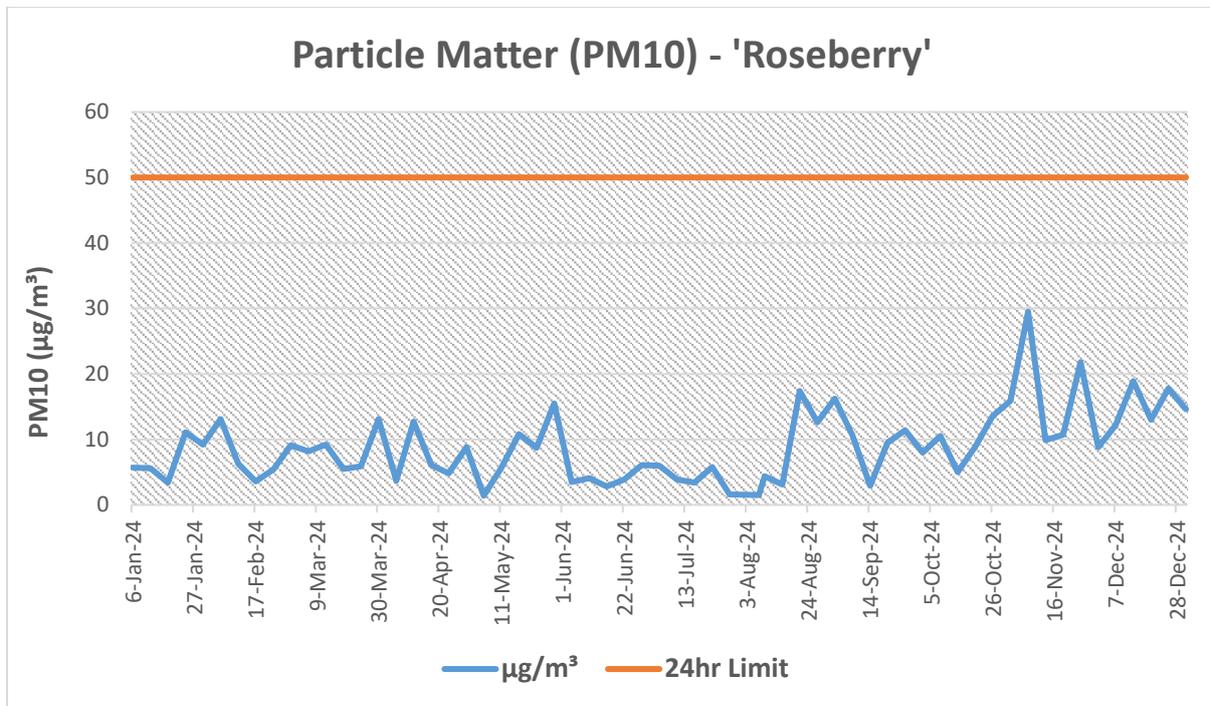
Figure 4 'Roseberry' Particulate Matter (PM10)

PM10 Summary		
Sites	Roseberry- Full data set	Roseberry- excluding extraordinary events
No. of readings	61	61
No. days above criteria	0	0
Maximum	29.5	29.5
Minimum	1.4	1.4
Mean	8.9	8.9
Comment

RCM had one licenced HVAS (EPL ID - 10) monitoring operation which is located to the south-east of the mine on 'Roseberry' (a privately owned property under private agreement) during the reporting period. [Figure 4](#) displays the PM₁₀ 24hr results for 'Roseberry'.

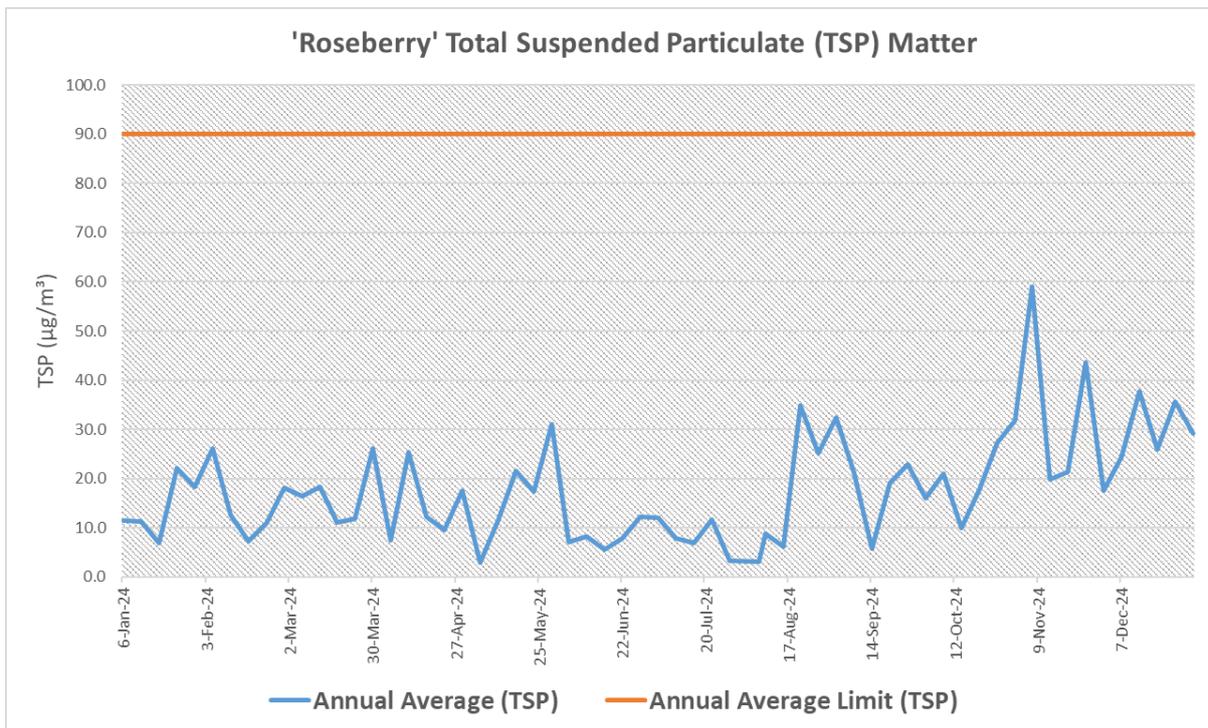
Figure 6 'Roseberry' TSP Annual Rolling Mean

Annual rolling mean for TSP and PM10 reported below limits.

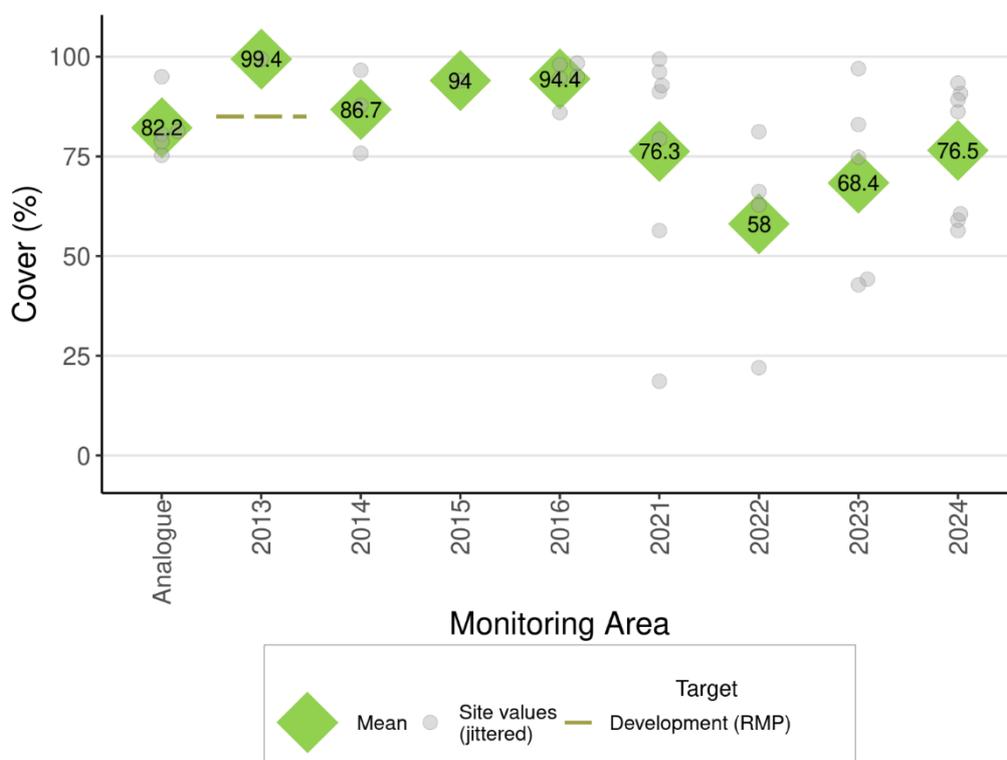
Figure 7 Woodland vegetation surface cover

In the 2024 monitoring year, all rehabilitation areas achieved the relevant phase-specific targets for surface cover. Phase-specific targets currently do not apply to the rehabilitation areas established from 2021 to 2024, which were the only areas below 85% surface cover. (Figure 3-35).

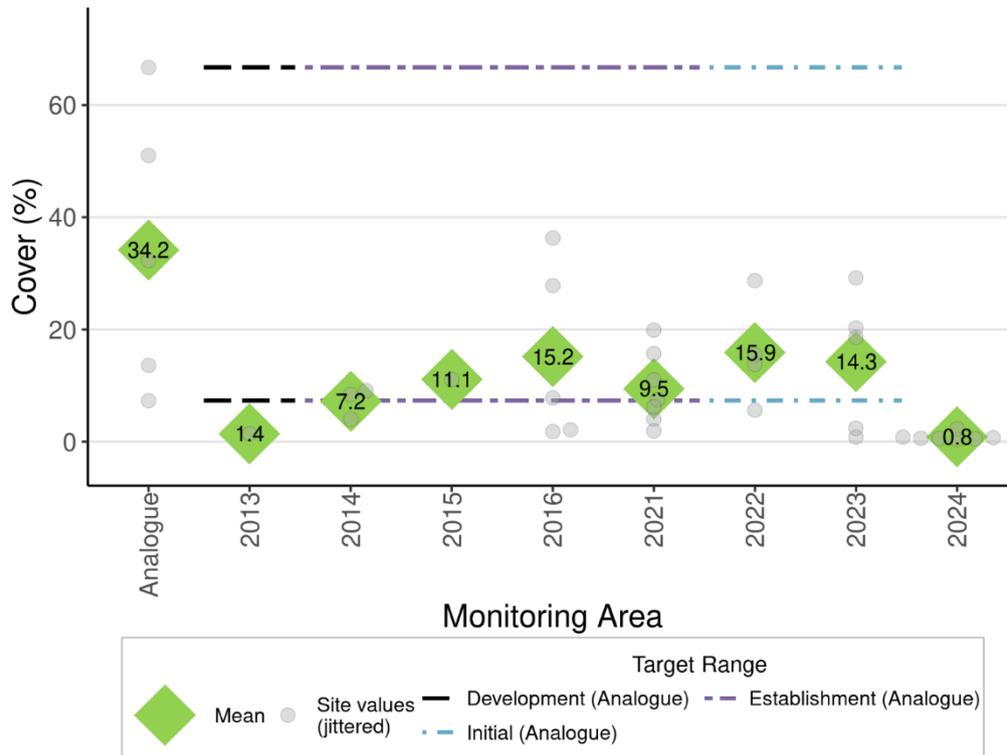
Figure 8 Woodland native vegetation groundcover at Rocglen Coal Mine and Analogue sites.

Five out of eight rehabilitation areas met the completion criterion target for native vegetation groundcover; however, the rehabilitation established in 2014 was only marginally outside of the required range, with a native vegetation groundcover value of 7.2% compared to the analogue 10th percentile of 7.3% (Figure 3-37).

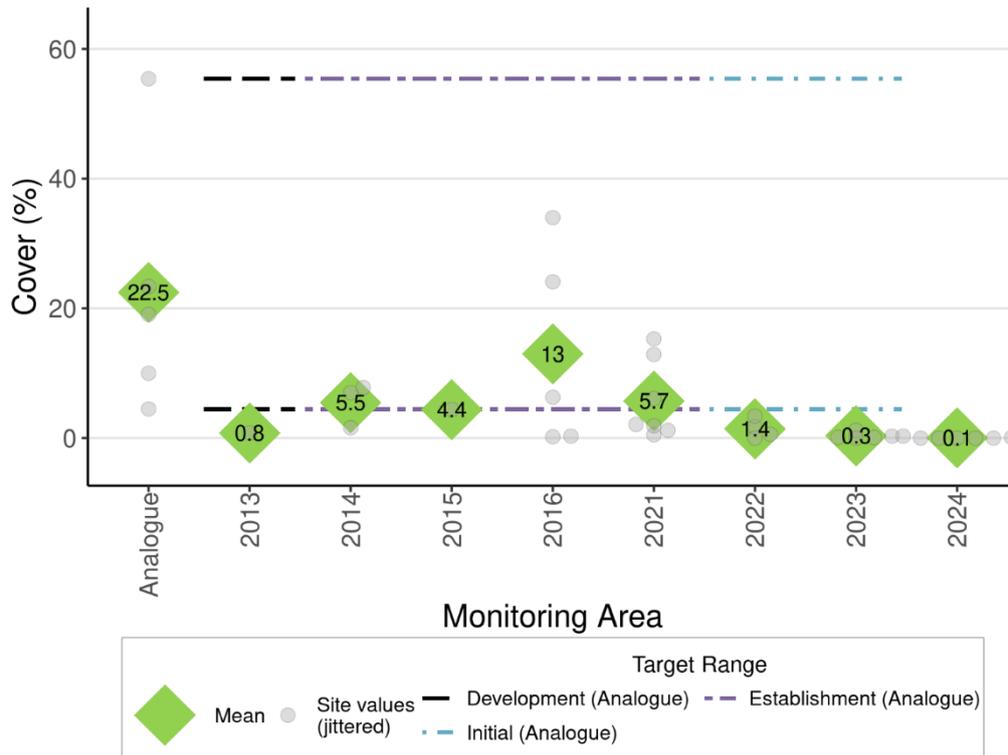
Figure 9 Woodland native grass cover at Rocglen Coal Mine and Analogue sites.

Only three out of eight rehabilitation areas met the completion criterion target for native grass cover; however, the rehabilitation established in 2015 was only marginally outside of the required range, with a native grass cover value of 4.4% compared to the analogue 10th percentile of 4.5% (Figure 3-39).

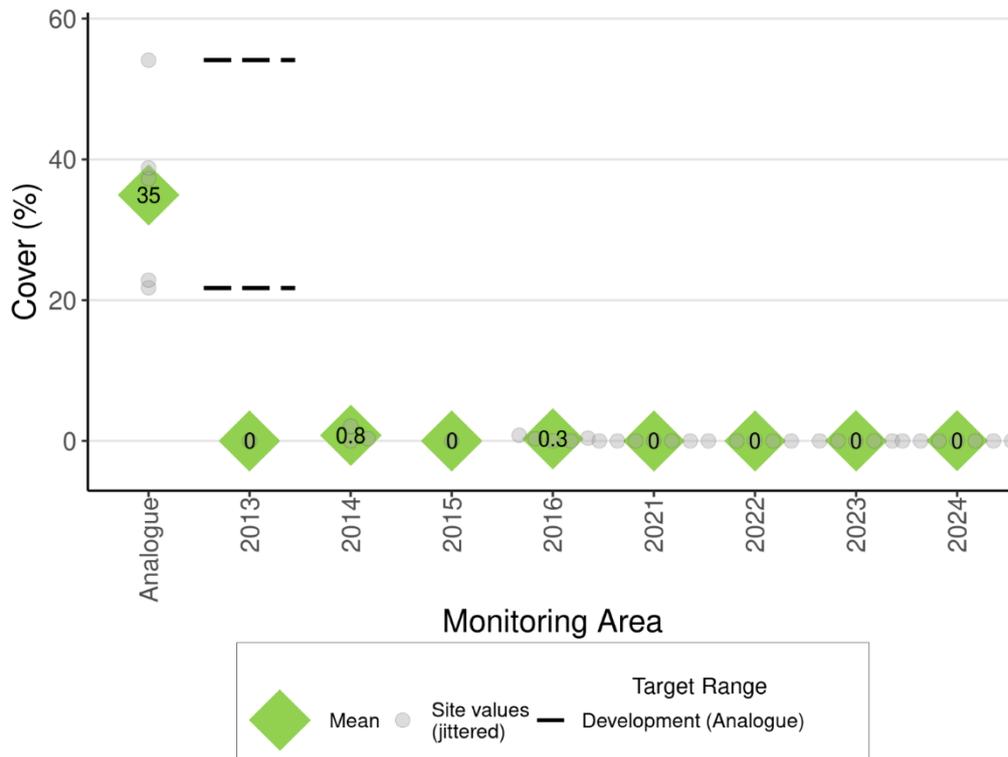
Figure 10 Woodland native mid-storey cover at Rocglen Coal Mine and Analogue sites.

The sole representative of the Ecosystem Development Phase, the rehabilitation established in 2013, did not meet the phase-specific completion criterion target for the indicator of native mid-storey cover (Figure 3-40).

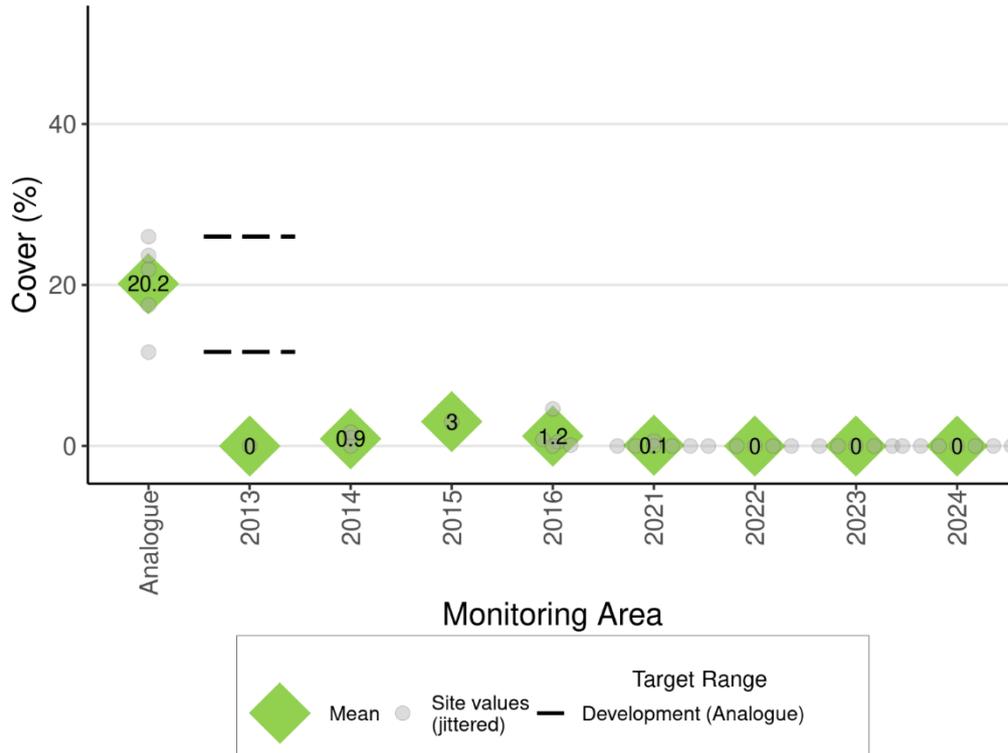
Figure 11 Woodland native overstorey cover at Rocglen Coal Mine and Analogue sites.

The sole representative of the Ecosystem Development Phase, the rehabilitation established in 2013, did not meet the phase-specific completion criterion target for the indicator of native overstorey cover (Figure 3-41).

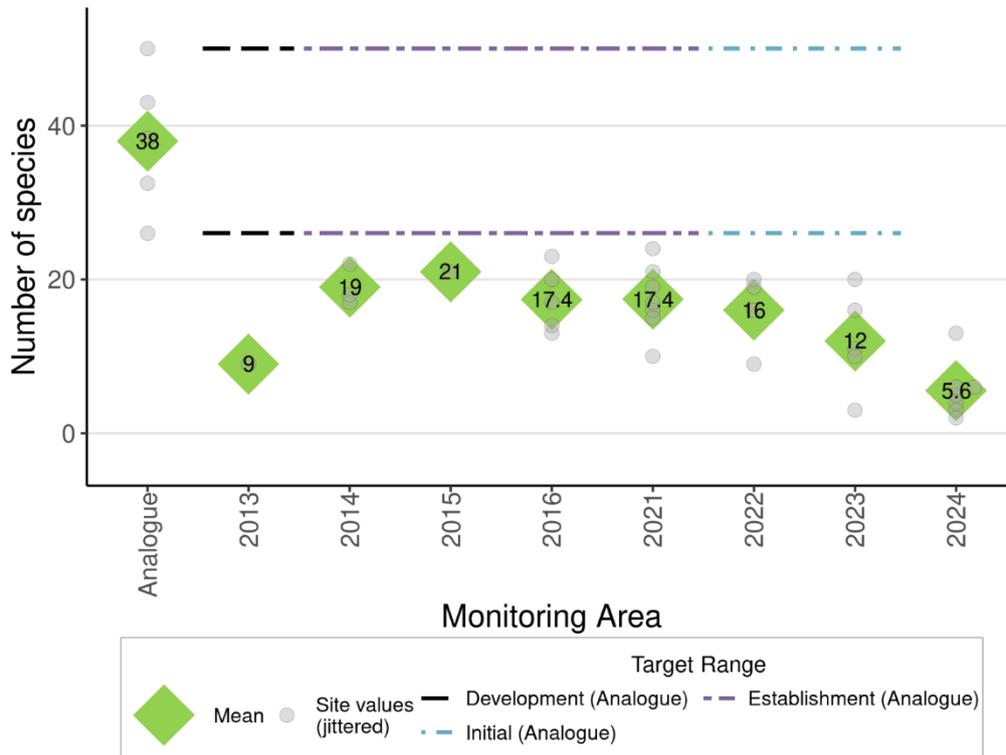
Figure 12 Woodland native species richness at Rocglen Coal Mine and Analogue sites.

The rehabilitation is yet to achieve the phase-specific completion criterion targets for the indicator of native species richness (**Figure 3-42**).

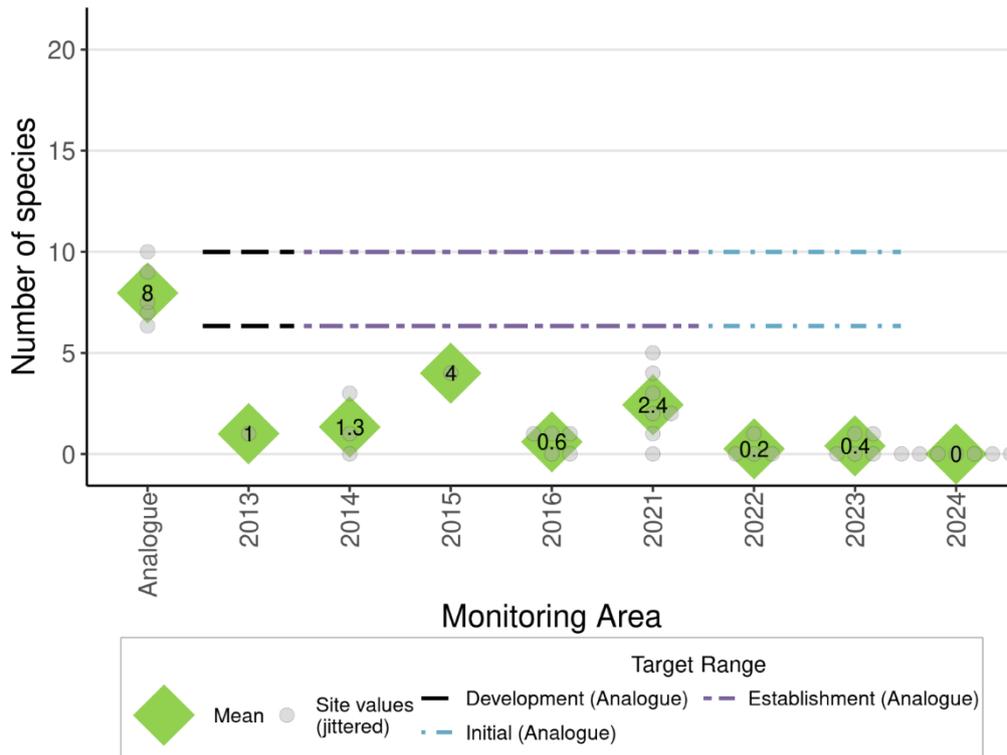
Figure 13 Woodland native shrub species richness at Rocglen Coal Mine and Analogue sites

Number of species that will contribute to native mid-storey cover serves as an indicator of the rehabilitation objective for woodland re-establishment. The metric for this indicator is native shrub species richness, with the caveat that some low-growing shrub species may not contribute to mid-storey cover. To achieve the completion criteria targets for this indicator, the rehabilitation must fall within the 10th and 90th percentile range of analogue site values. In the 2024 monitoring year, the analogue sites’ 10th–90th percentile range for native shrub species richness was 6.33–10 species. No rehabilitation areas achieved the completion criterion target for native shrub richness in 2024. The rehabilitation established in 2015 had the highest (four species), and the 2024 rehabilitation had the lowest (no species), native shrub richness (Figure 3-44).

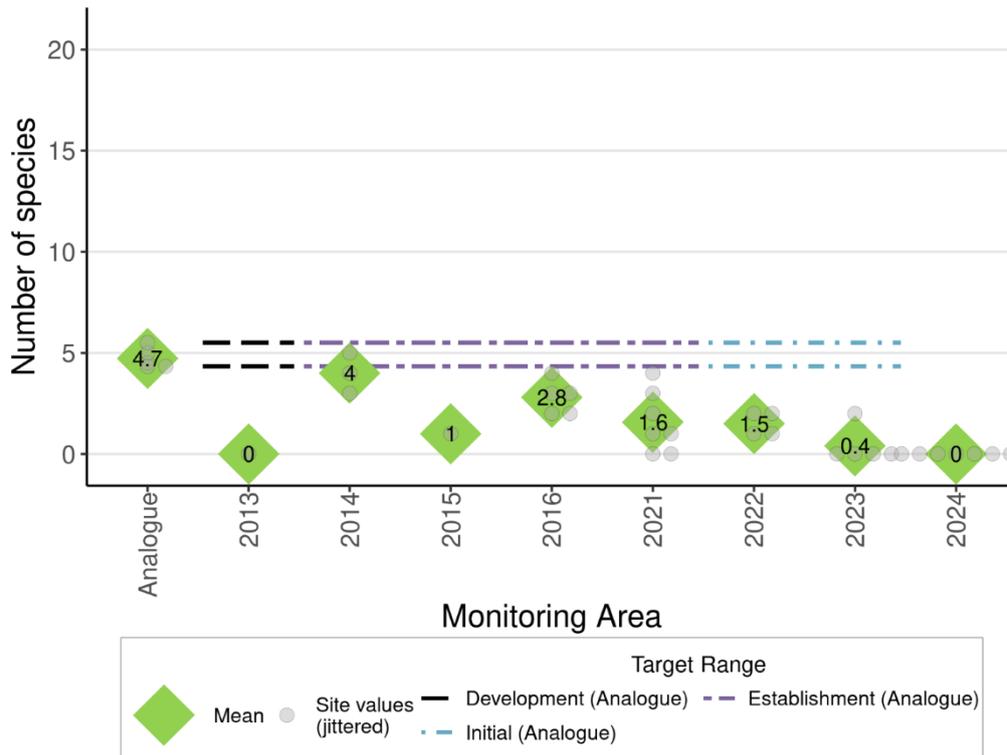
Figure 14 Woodland native tree species richness at Rocglen Coal Mine and Analogue sites

Number of species that will contribute to native overstorey cover serves as an indicator of the rehabilitation objective for woodland re-establishment. The metric for this indicator is native tree species richness. To achieve the completion criteria targets for this indicator, the rehabilitation must fall within the 10th and 90th percentile range of analogue site values. In the 2024 monitoring year, the analogue sites’ 10th–90th percentile range for native tree species richness was 4.33–5.5 species. No rehabilitation areas met the completion criterion target for native tree species richness; however, the rehabilitation established in 2024 was only marginally outside of the required range, with a value of 4 species compared to the analogue 9th percentile, of 4.3 species (Figure 3-45).

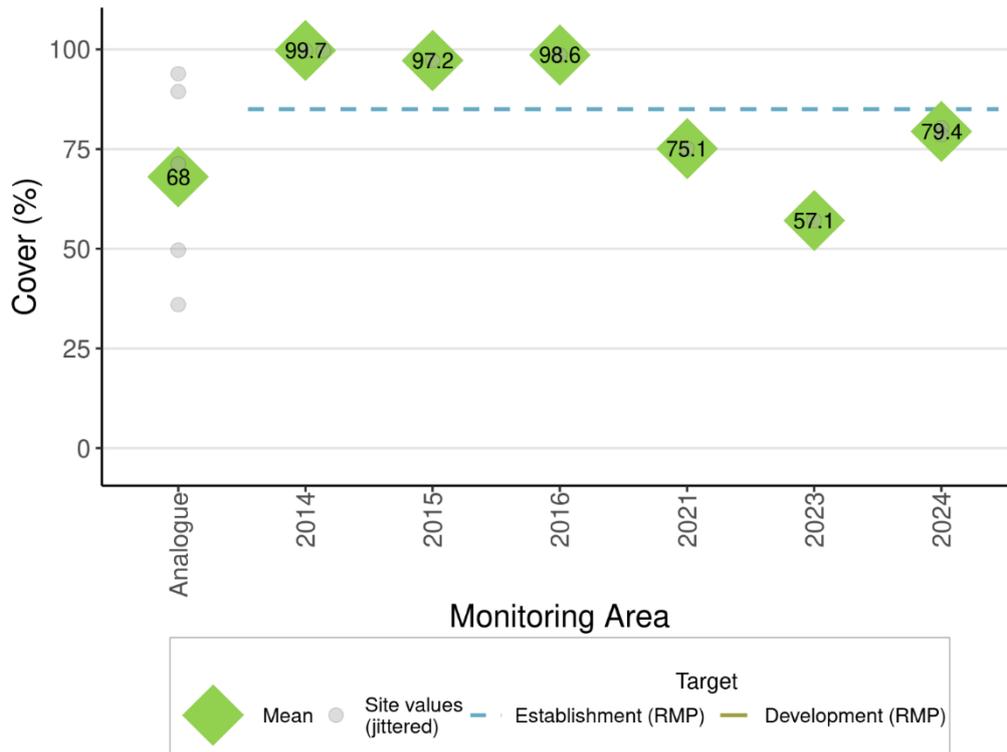
Figure 15 Pasture surface cover at Rocglen Coal Mine and Analogue sites

In the 2024 monitoring year, the 2014–2016 rehabilitation areas met the phase-specific completion criterion target for surface cover whilst those established in 2021–2024 did not (**Figure 3-57**). No large bare surfaces were observed in monitoring sites located in rehabilitation areas established prior to 2019.

- Weed management is undertaken to reduce perennial exotic grass abundance in the woodland rehabilitation;
- management actions are undertaken to prevent further increases in exotic cover within the 2021 woodland rehabilitation;
- ground plantings are initiated to increase the diversity of the woodland rehabilitation groundcover; and
- feral animals are controlled.

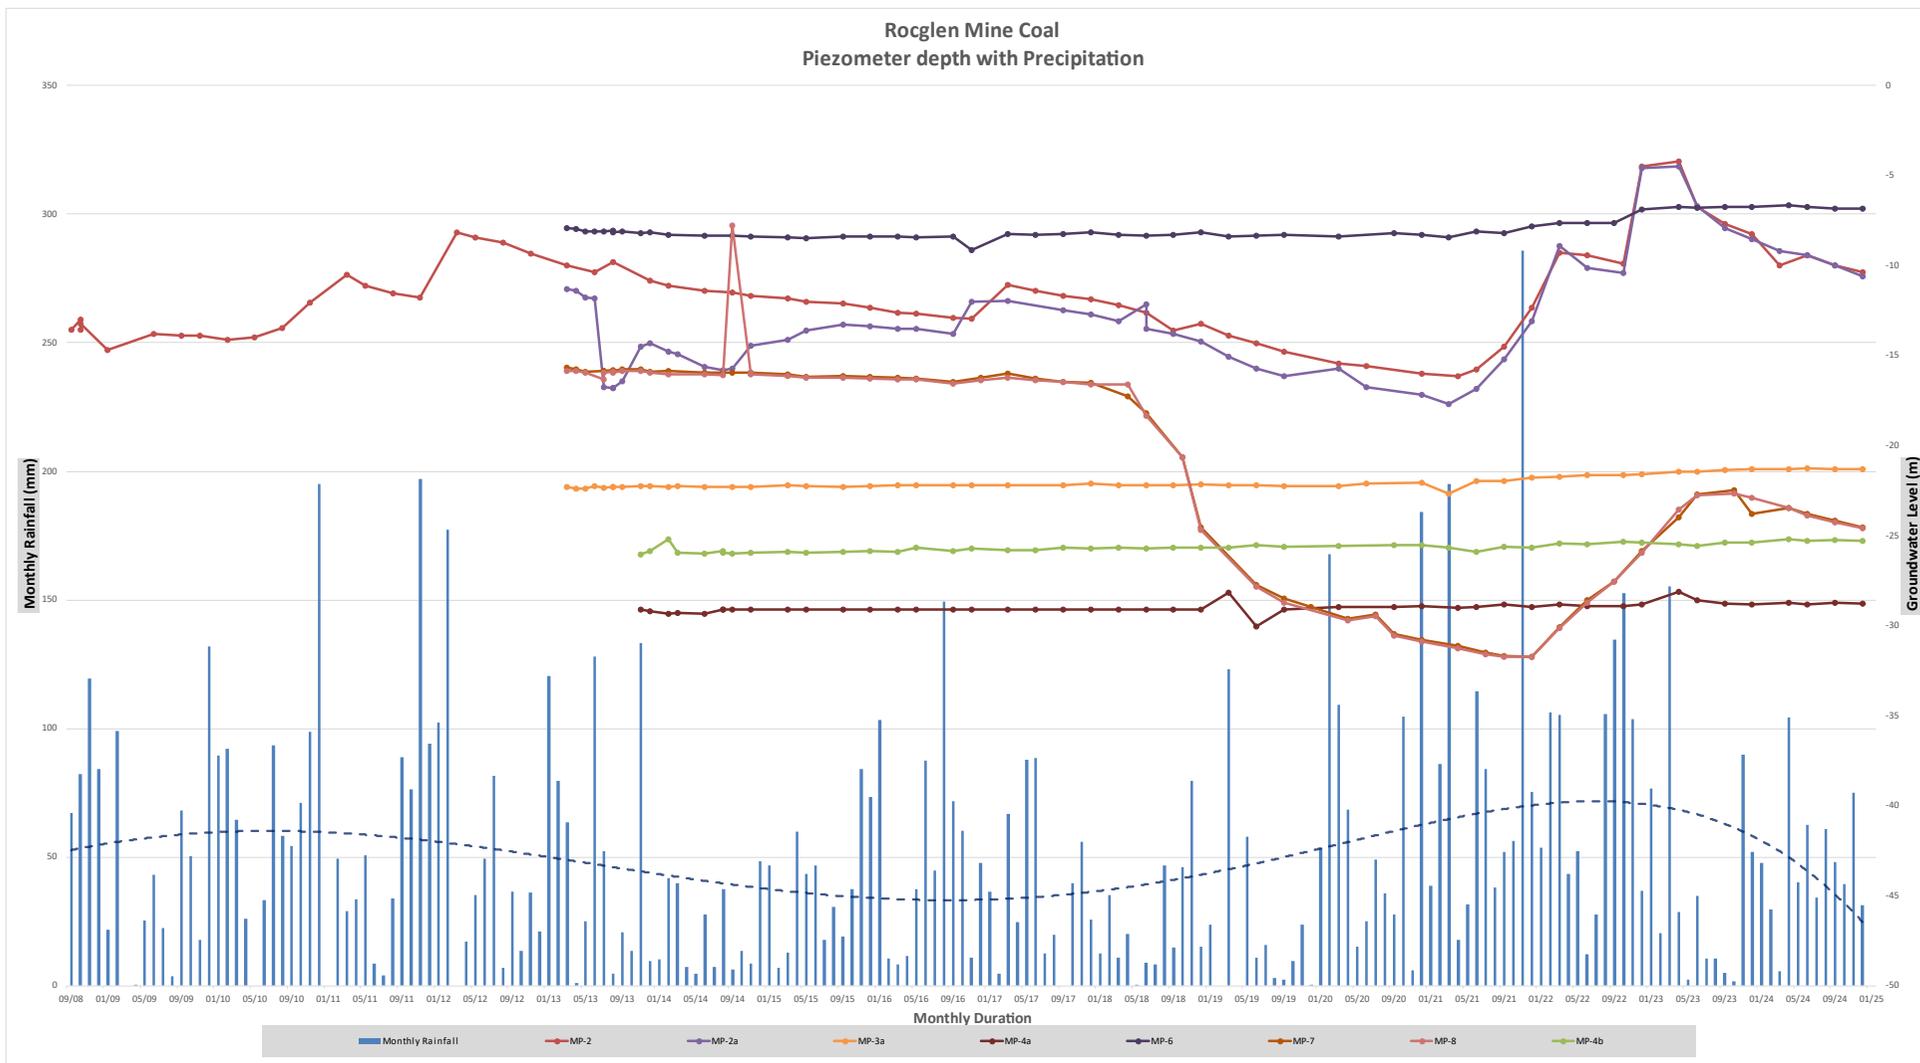
Figure 16 Rocglen Mine Groundwater Piezometer Depth

As discussed previously, groundwater from surrounding bores is monitored on a regular basis to detect and assess any changes in groundwater quality or level that may be attributable to the mine.
