Minutes of the 37th Meeting of the

Sunnyside Coal Mine Community Consultative Committee

Sunnyside Coal Mine Community Consultative Committee Meeting #37

Environmental Monitoring Report January 2023 – December 2024

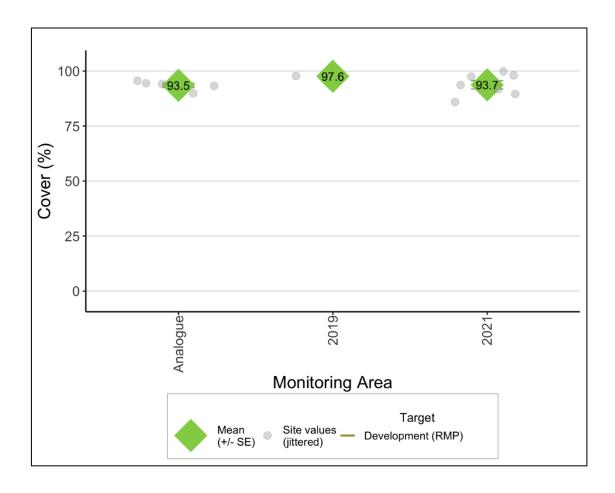
To achieve the completion criterion target for this indicator, surface cover is to be greater than 85% during the Ecosystem Development Phase (RMP tbl 12). Additionally, no bare surfaces greater than 20 m x 20 m in area or greater than 10 m in length down slope are to be present at year 5 following establishment (RMP tbl 12). No rehabilitation sites were recorded as having large bare surfaces. Pasture domain surface cover results shown in figure below.
