# WHITEHAVEN COAL

# SUNNYSIDE COAL MINE REHABILITATION MANAGEMENT PLAN

Summary Table		
Name of Mine         Sunnyside Coal Mine		
Rehabilitation Management Plan Commencement Date	July 2022	
Rehabilitation Management Plan Revision Date and Version Numbers	Version 3, January 2025	
Mining Leases and Expiry date	ML 1624, Expiry 5th November 2029	
Name of Authorisation holder(s)	Namoi Mining Pty Ltd	
Name of Mine Operator (if different)	Whitehaven Coal Mining Limited

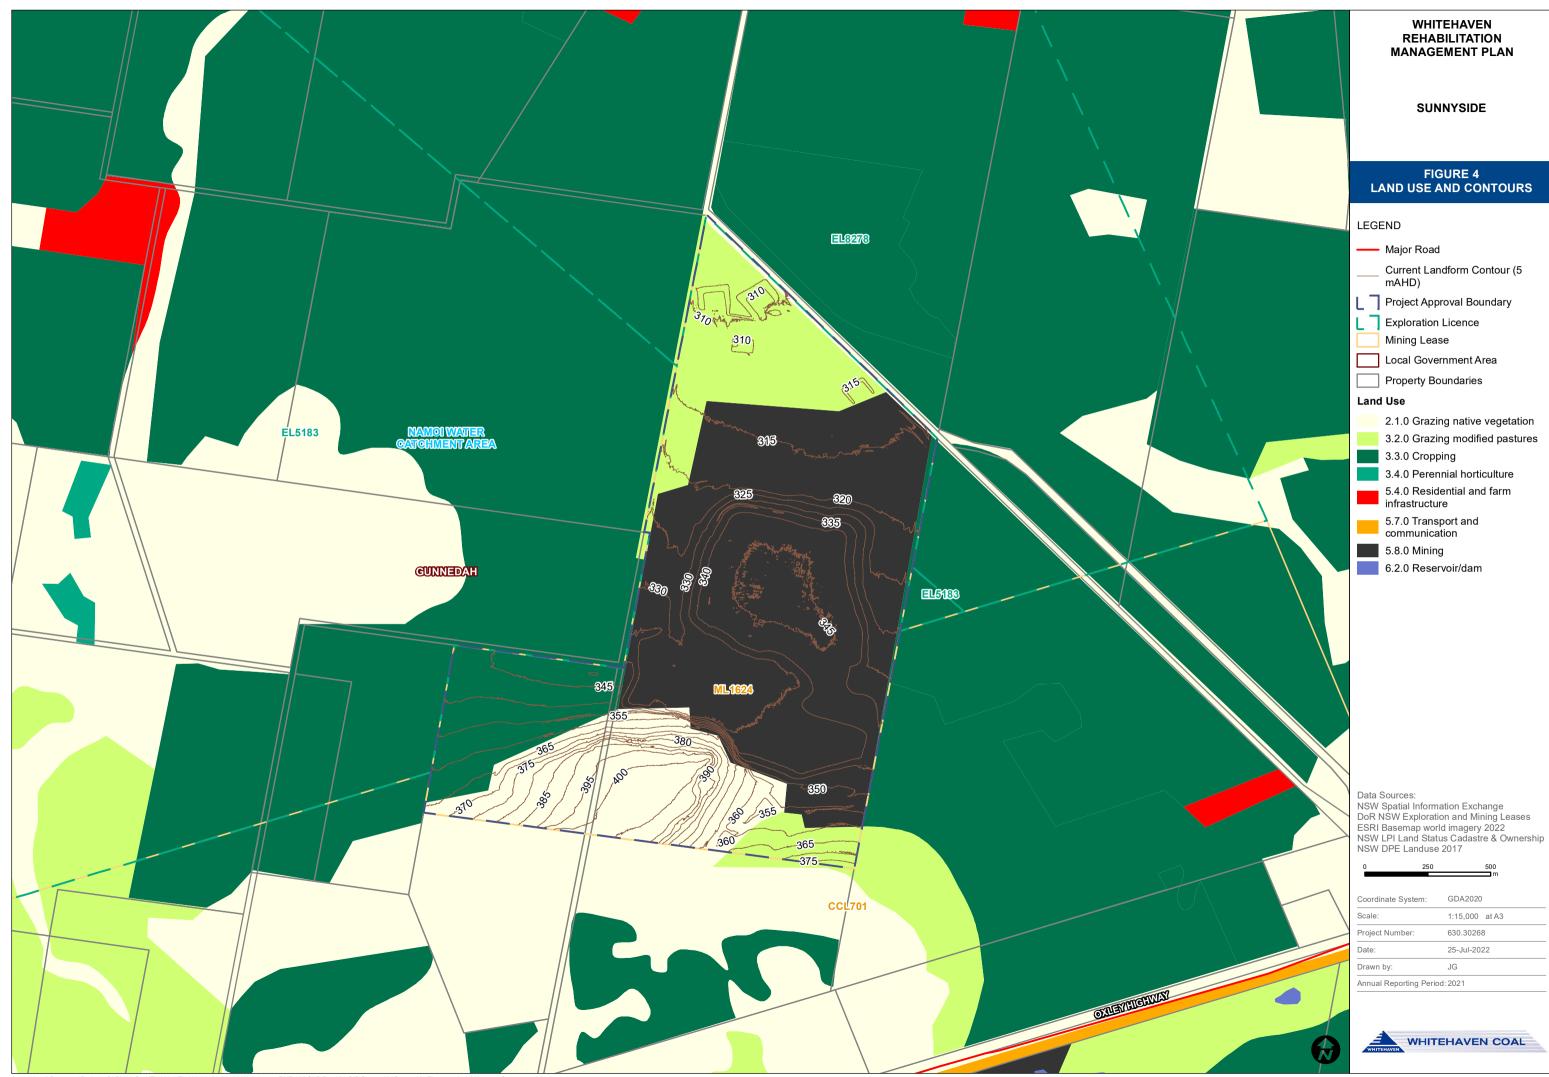
Nau.str.local/Corporate\Projects-SLR\630-SrvNTL\630-NTL\630.30268.00000 Whitehaven RMPs\06 SLR Data\01 GIS\Sunnyside\Sunnyside Figure 4 - Land Use and Control of the stand of

Prior to mining, the SCM had predominantly been cleared for agricultural cultivation and grazing and was vegetated with open grassland. Land use immediately surrounding the SCM is also predominantly cropping and pastoral land use. A rocky escarpment with remnant vegetation and regrowth is located immediately south of the SCM. This southern area is considered a valuable area of local habitat given the historical landscape clearing within the region and is proposed to be managed as Koala habitat.

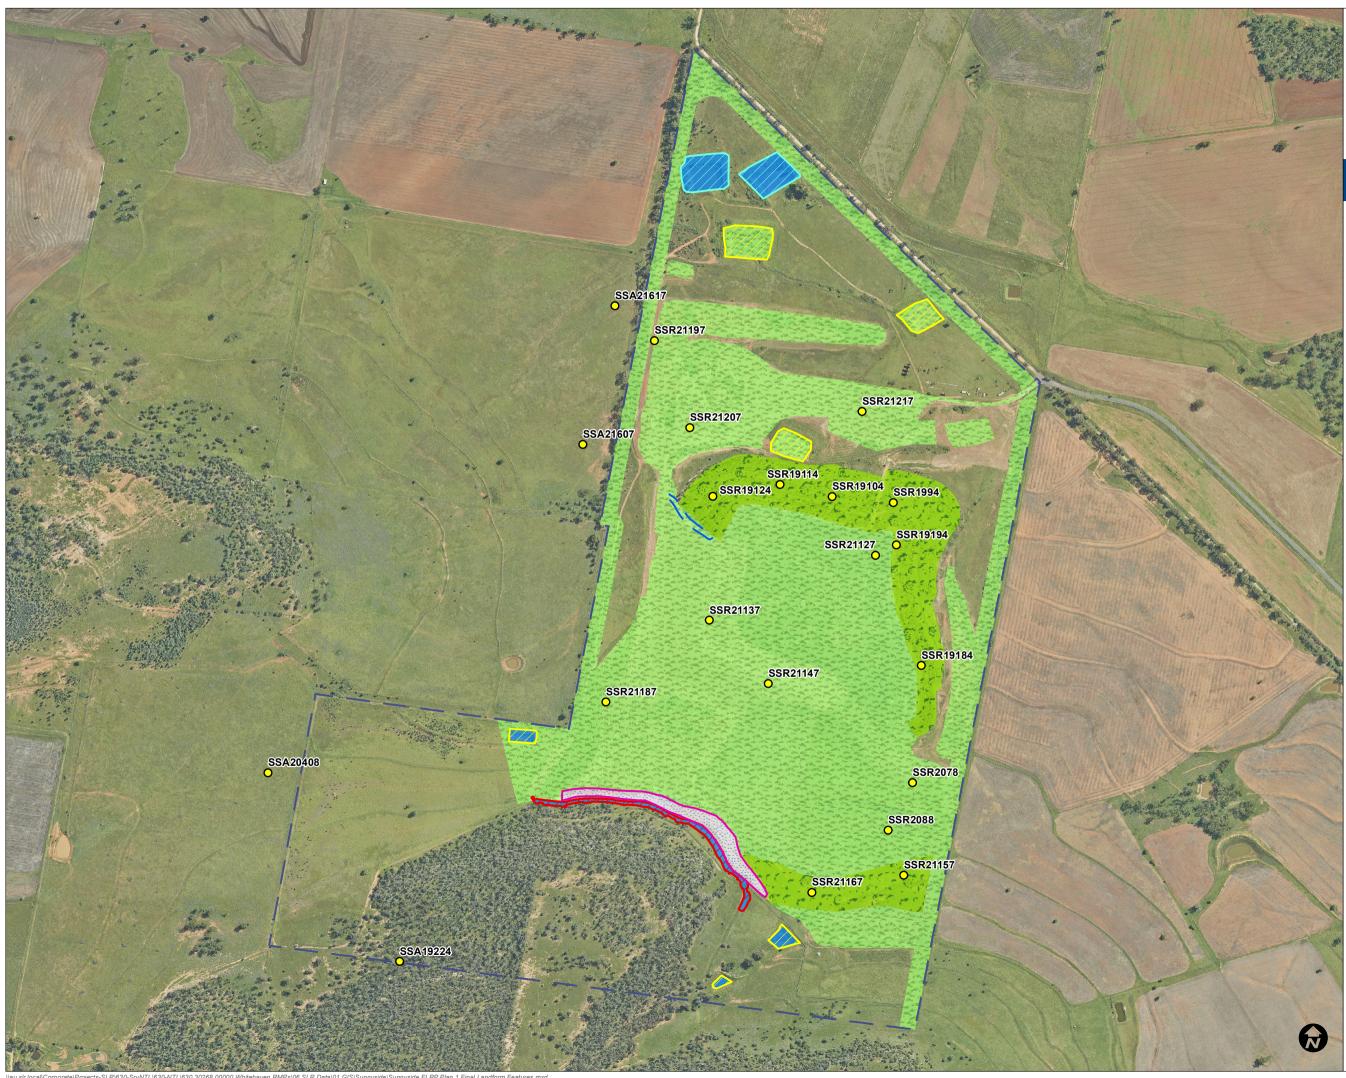
In accordance with the requirements of the *Form and Way: Rehabilitation Management Plan for Large Mines* (RR, 2021a) a *Final Landform and Rehabilitation Plan* has been prepared to show the proposed final land use and final landform for SCM (refer **Figure 6** Final Landform and Rehabilitation Plan 1 and **Figure 7** Final Landform and Rehabilitation Plan 2).
