Minutes of the 55th Meeting of the Tarrawonga Coal Mine Community Consultative Committee (TCCC)

Tarrawonga Coal Mine Community Consultative Committee Meeting #55

Quarterly Environmental Monitoring Report
1 November 2018 – 31 January 2019

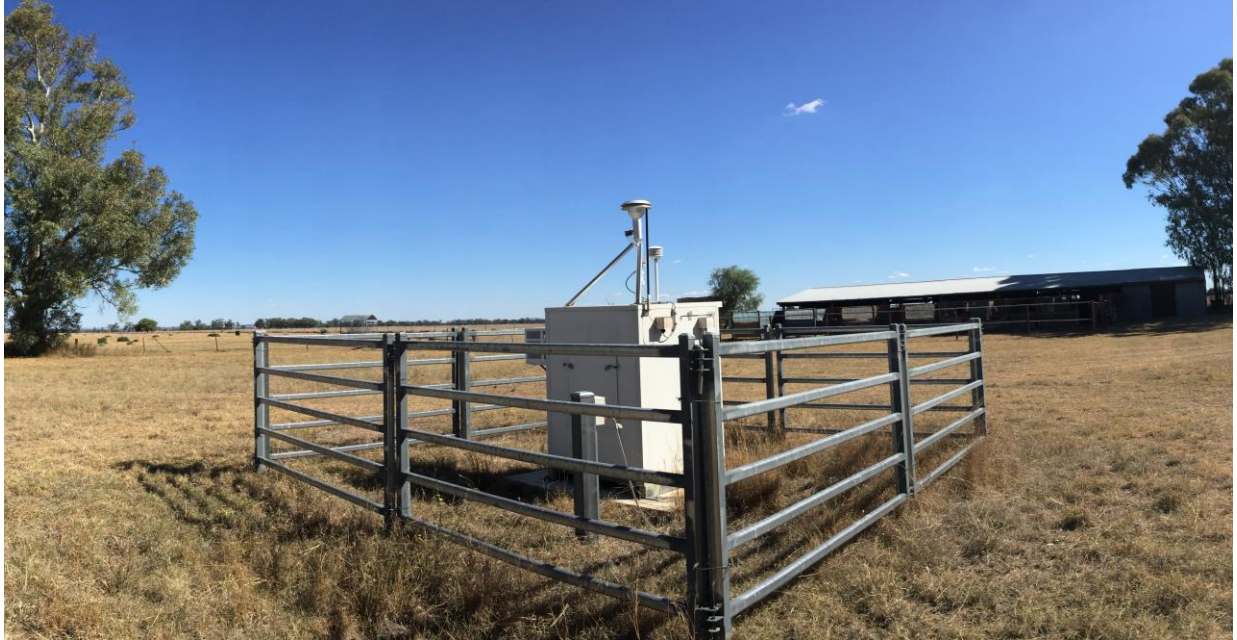
TEOM installed at Flixton property

According to the current Air Quality and Greenhouse gas Management Plan, the real time air quality unit (TEOM) installed at the “Flixton” property monitors PM₁₀ levels in ambient air. It is an operational management tool and dust levels nearing or reaching the nominated criteria will trigger actions onsite to assess the source of dust and modify operations if it is determined to be related to Tarrawonga operations.

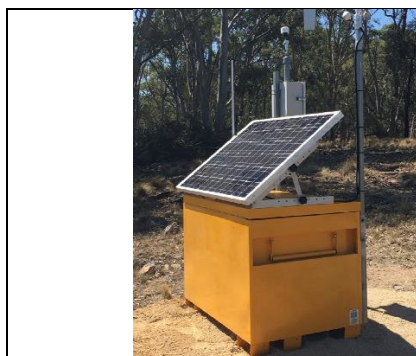
Two Portable dust (PM10) monitors have been ordered to upgrade the air monitoring network. They have been installed and record continuously data

Portable Dust monitor installed at TCM in November 2018

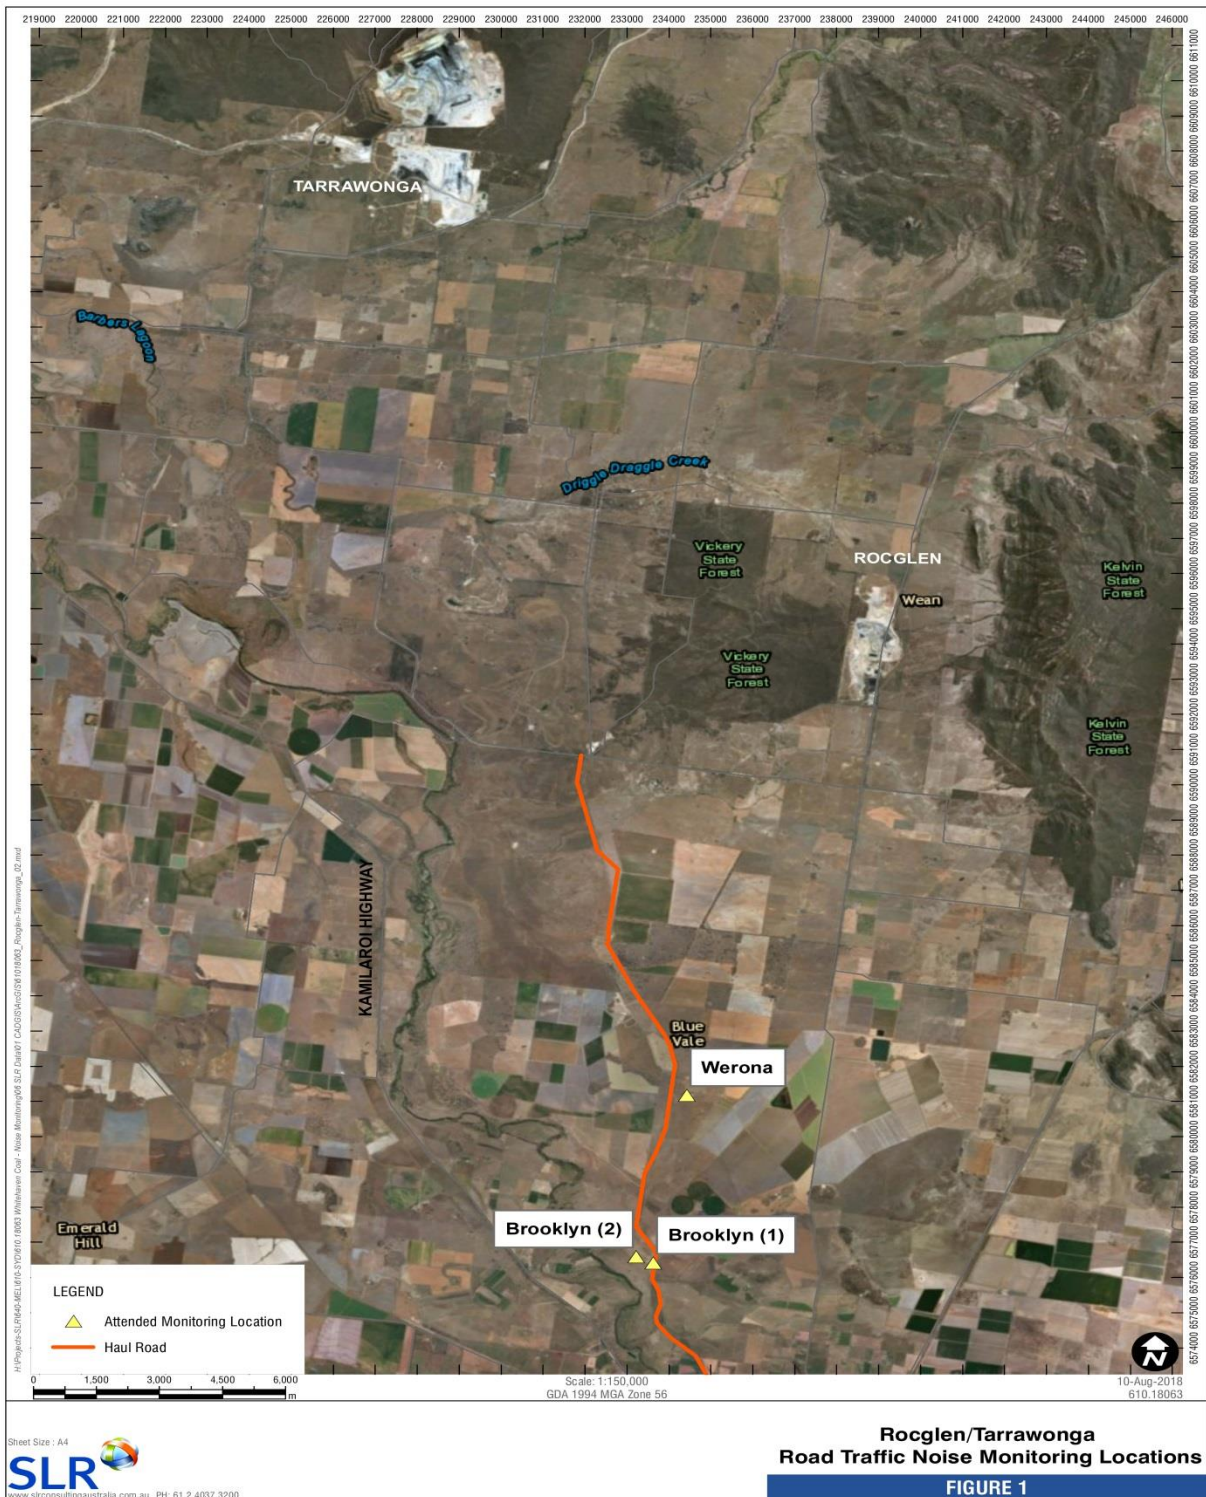
Figure 1 Attended Noise Monitoring Locations

The data collected during the operator attended noise monitoring was processed using Bruel & Kjaer Evaluator Type 7820-7821. Extraneous noise sources were filtered and an $L_{Aeq(1hour)}$ contribution of coal haulage only was calculated.

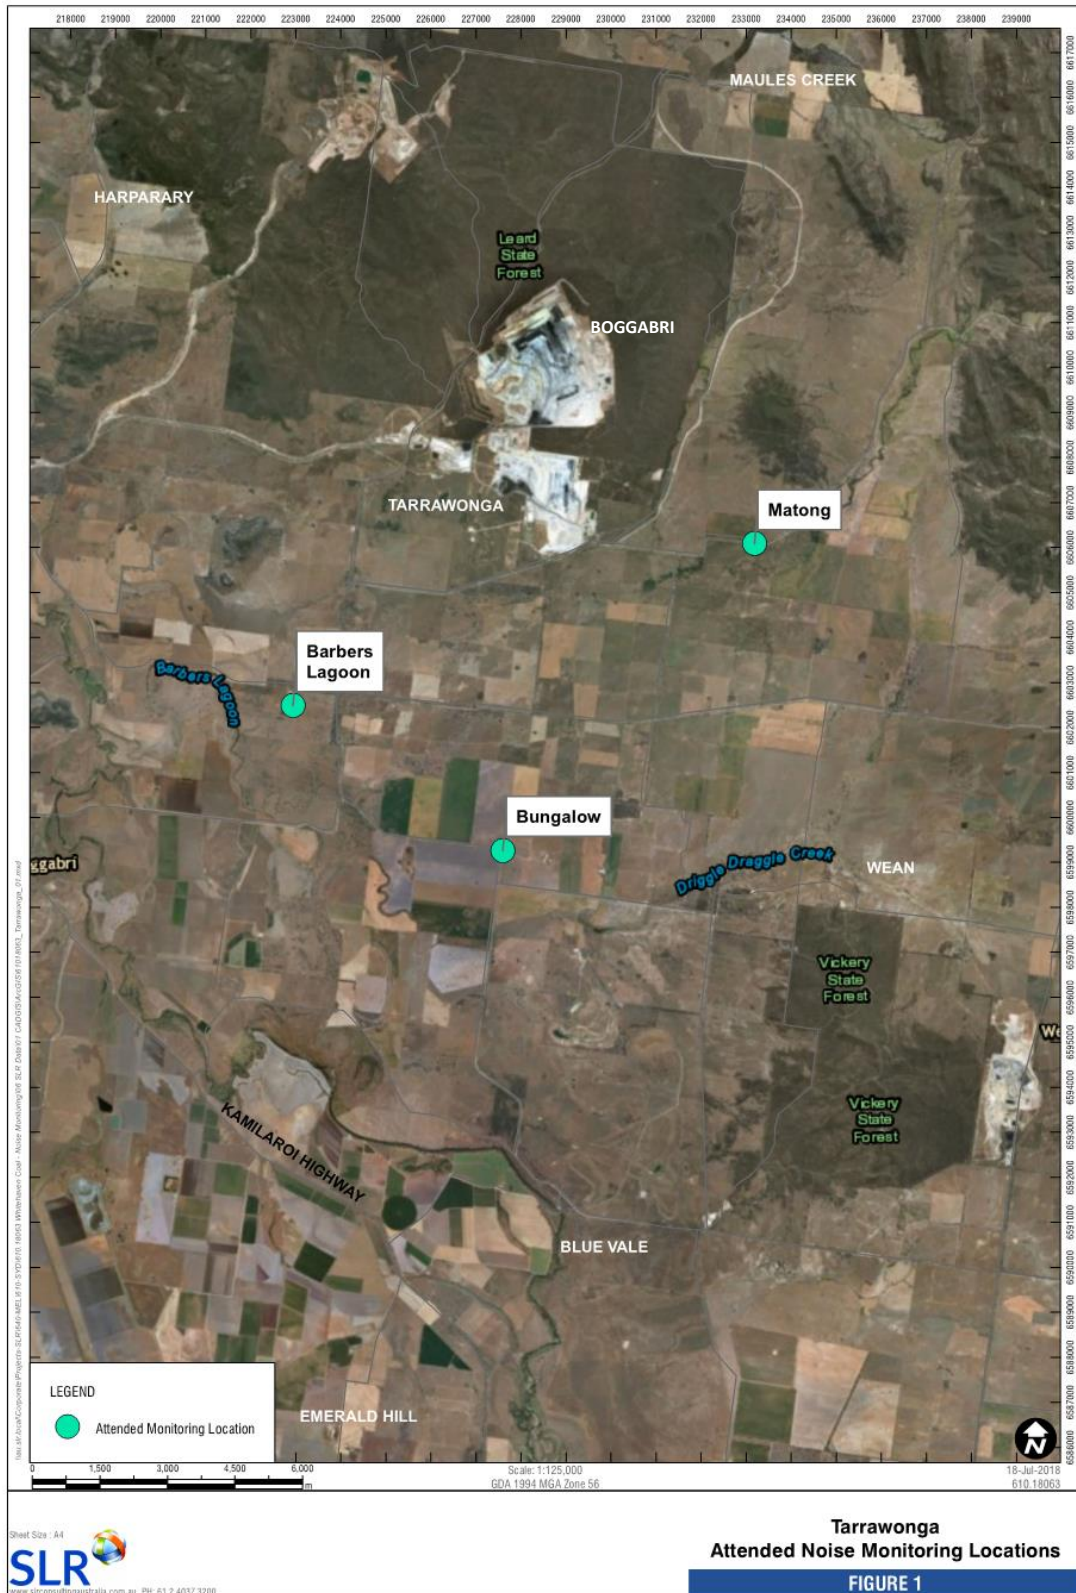
Figure 1 Tarrawonga Coal Mine Attended Noise Monitoring Locations

TCM will be undertaking Attended Noise monitoring on a quarterly basis at residential areas. The attended monitoring will take place at the following locations & can be found in **Figure 1**.

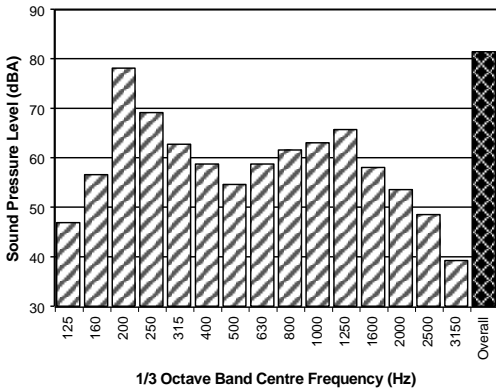
The following figure shows a 1/3 octave band frequency analysis where the noise is dominated by the 200 Hz band. Note that the indicated level of each individual band is less than the overall level, which is the logarithmic sum of the bands.

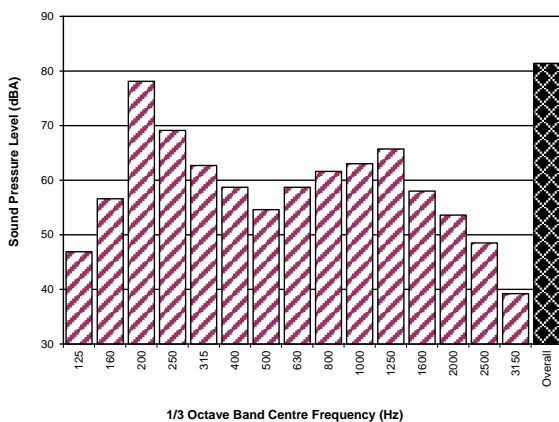
The following figure shows a 1/3 octave band frequency analysis where the noise is dominated by the 200 Hz band. Note that the indicated level of each individual band is less than the overall level, which is the logarithmic sum of the bands.

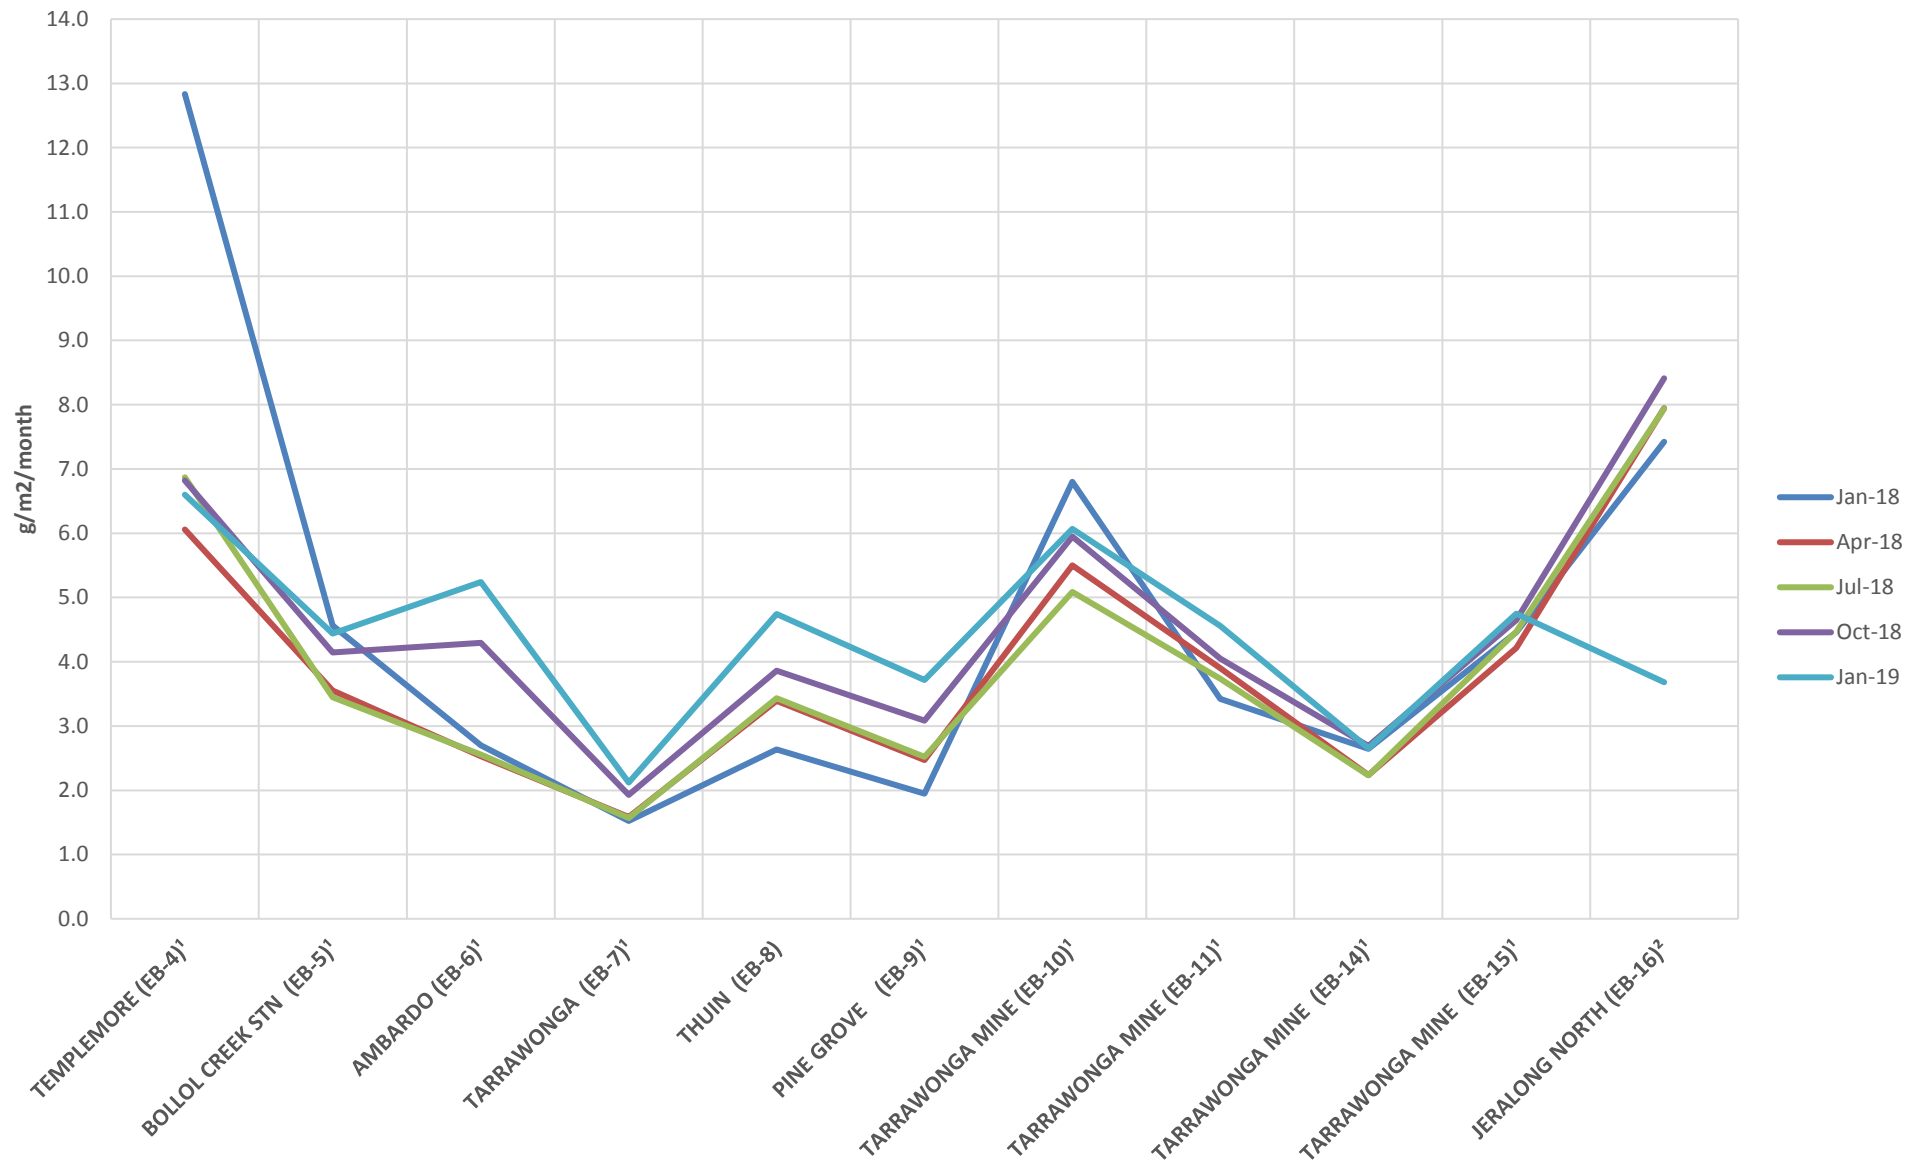
Deposited Dust Gauge Results- Quarterly rolling average [g/m²/month]

Table 3 shows deposited dust gauge results over 12 months. All the monitors are located on project related land; as such compliance criteria (**4g/m²/month**) do not apply. The weather conditions have been relatively dry, overall deposited dust trends are steady during the reporting period (refer graph in *Appendix C*). Note the elevated level recorded at EB14 (East side) in December 2018 returned to normal (or average level) in January 2018. ALS was responsible for sampling and analysis and conducted an investigation to determine potential reason behind that elevated result. They found that the samples was contaminated.

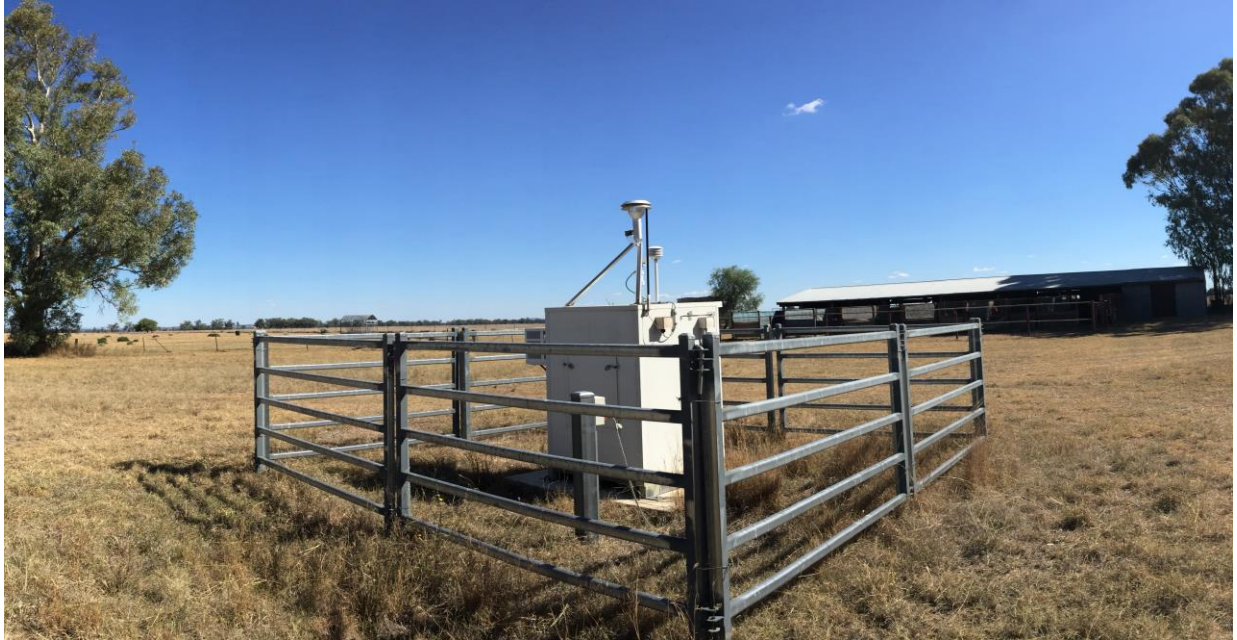
TEOM installed at Flixton property

According to the current Air Quality and Greenhouse gas Management Plan, the real time air quality unit (TEOM) installed at the “Flixton” property monitors PM₁₀ levels in ambient air. It is an operational management tool and dust levels nearing or reaching the nominated criteria will trigger actions onsite to assess the source of dust and modify operations if it is determined to be related to Tarrawonga operations.

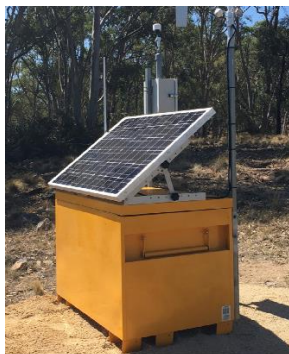
Two Portable dust (PM10) monitors have been ordered to upgrade the air monitoring network. They have been installed and record continuously data

Portable Dust monitor installed at TCM in November 2018

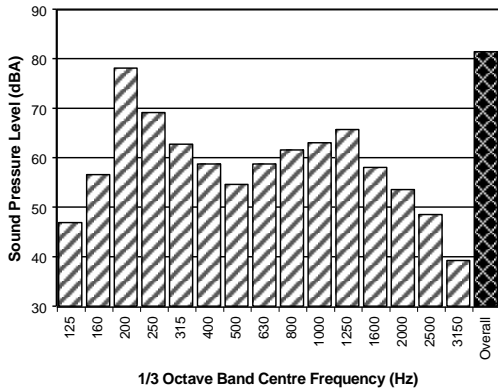
The following figure shows a 1/3 octave band frequency analysis where the noise is dominated by the 200 Hz band. Note that the indicated level of each individual band is less than the overall level, which is the logarithmic sum of the bands.

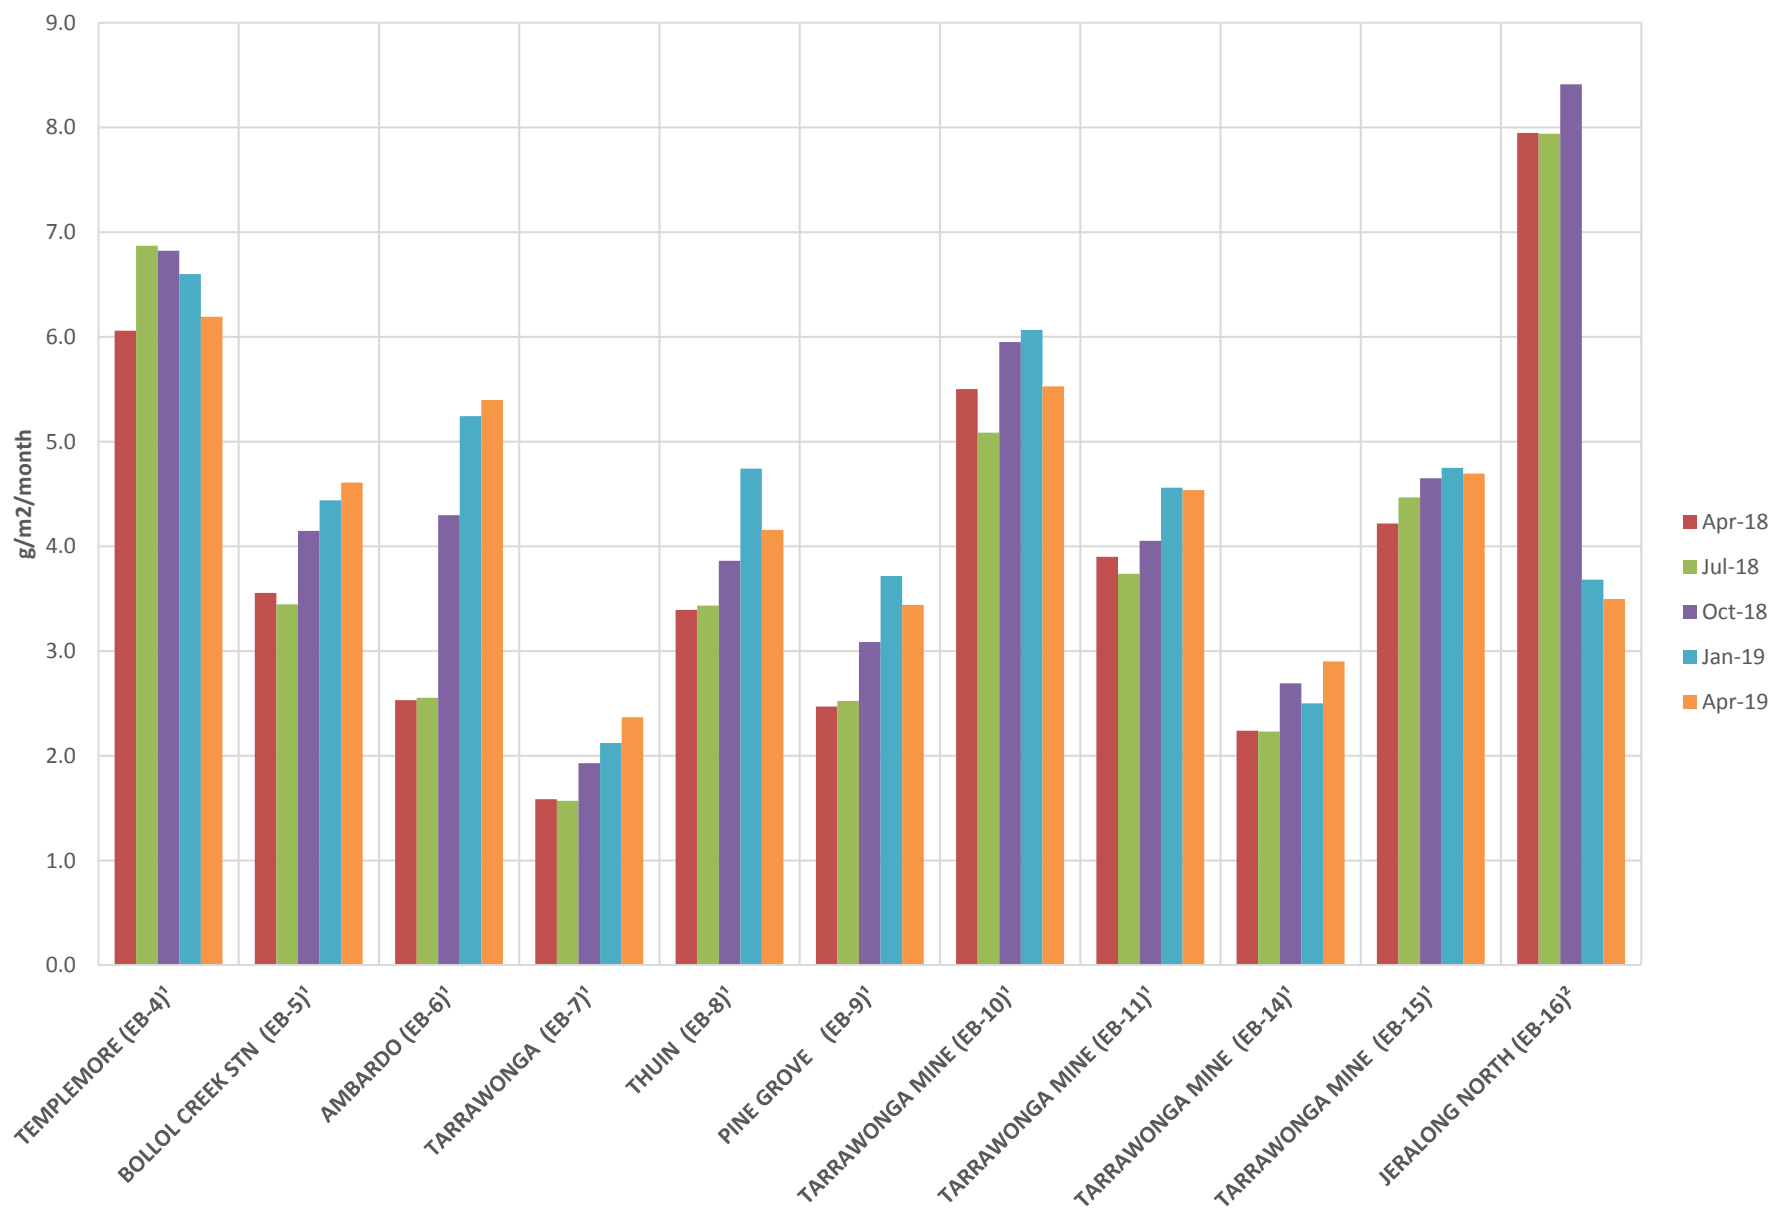
Deposited Dust Gauge Results- Quarterly rolling average [g/m²/month]

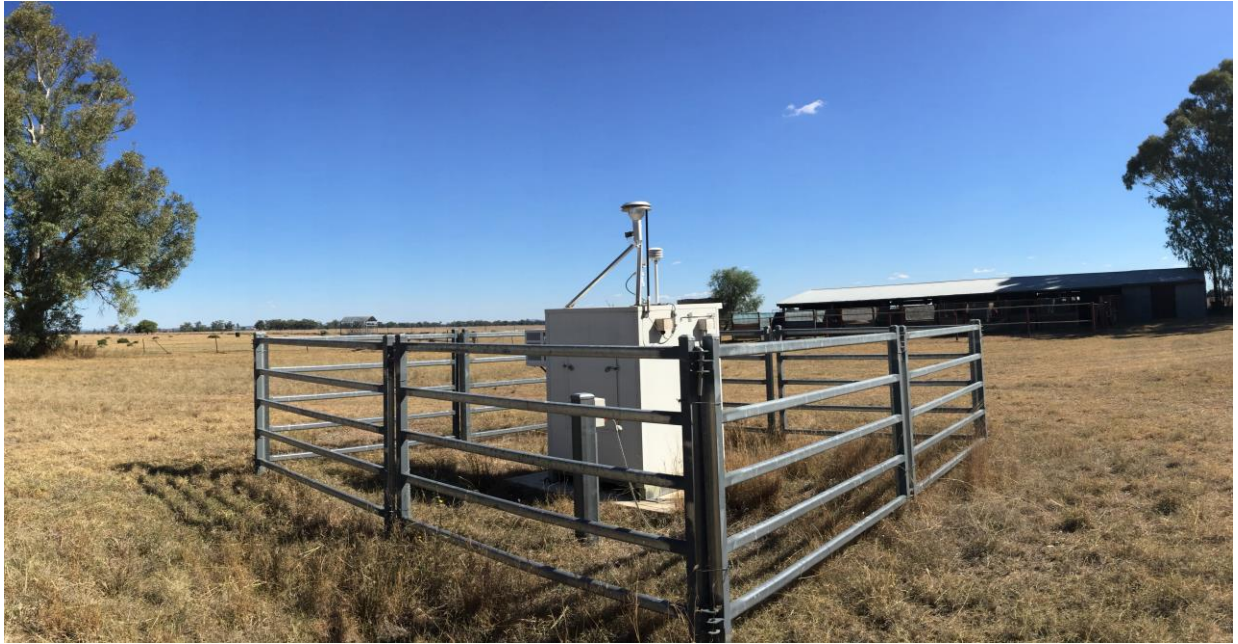
TEOM installed at Flixton property

According to the current Air Quality and Greenhouse gas Management Plan, the real time air quality unit (TEOM) installed at the “Flixton” property monitors PM₁₀ levels in ambient air. It is an operational management tool and dust levels nearing or reaching the nominated criteria will trigger actions onsite to assess the source of dust and modify operations if it is determined to be related to Tarrawonga operations.

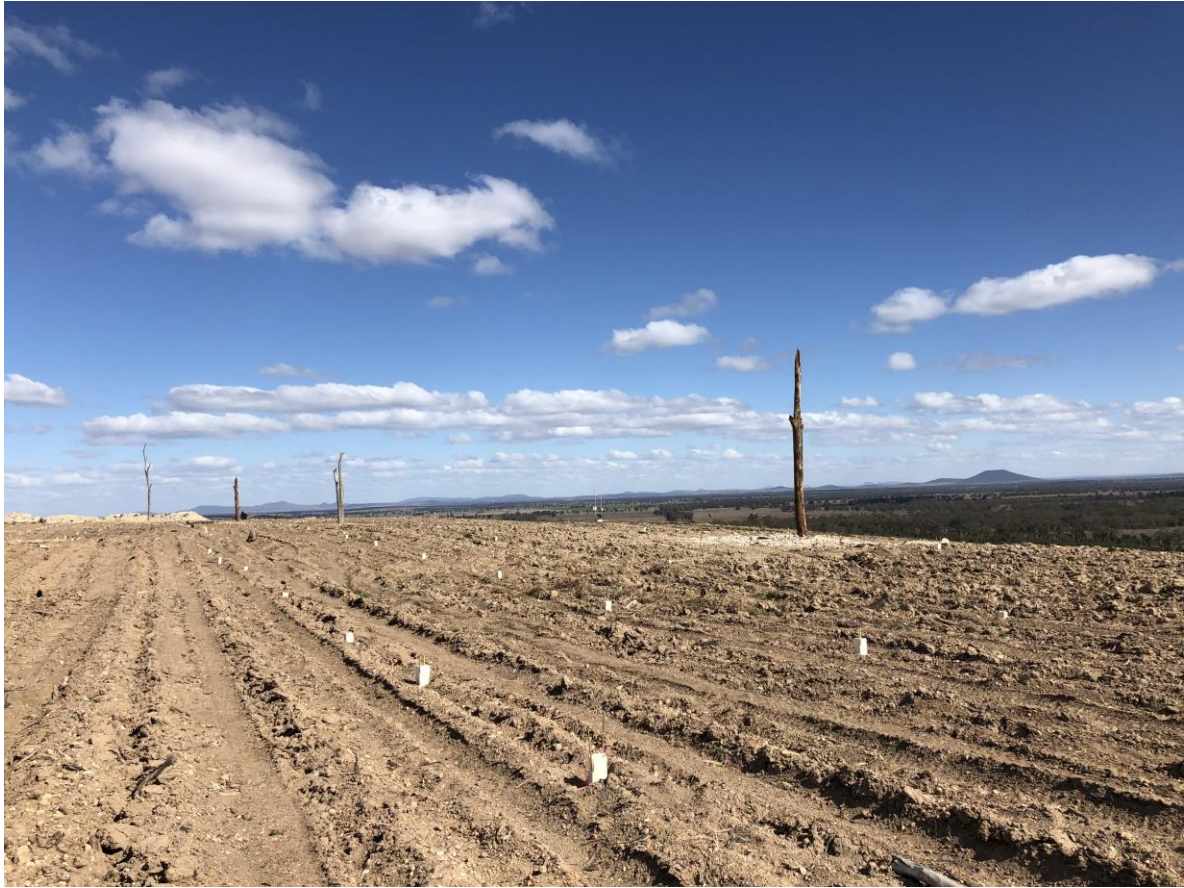
This year, TCM engaged the services of a specialised tree planting company to plant approximately 4,100 trees in the rehabilitation areas including Eucalyptus albens, Eucalyptus blakelyi, Eucalyptus crebra, Eucalyptus melliodora, Eucalyptus pilligaensis, Eucalyptus populanea, Eucalyptus macrocarpa, Eucalyptus Melanophloia, Eucalyptus Crebra, Eucalyptus Dealbata and Eucalyptus Dwyeriand. Native grass (ground cover) seeds were spread over approximately 40Ha and trials (including planting using fertilizers) were undertaken on approximately 2Ha at the southern emplacement area.

Section of the southern emplacement areas rehabilitated in July 2019

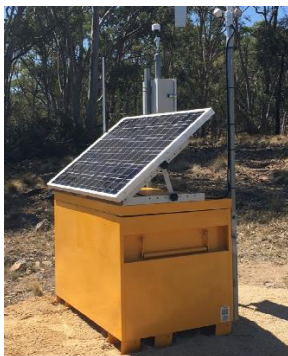
Three Portable dust (PM10) monitors have improved the real-time dust monitoring network and assist the operation to mitigate any potential dust generated by the operation.

Portable and real-time dust monitor installed at TCM in November 2018

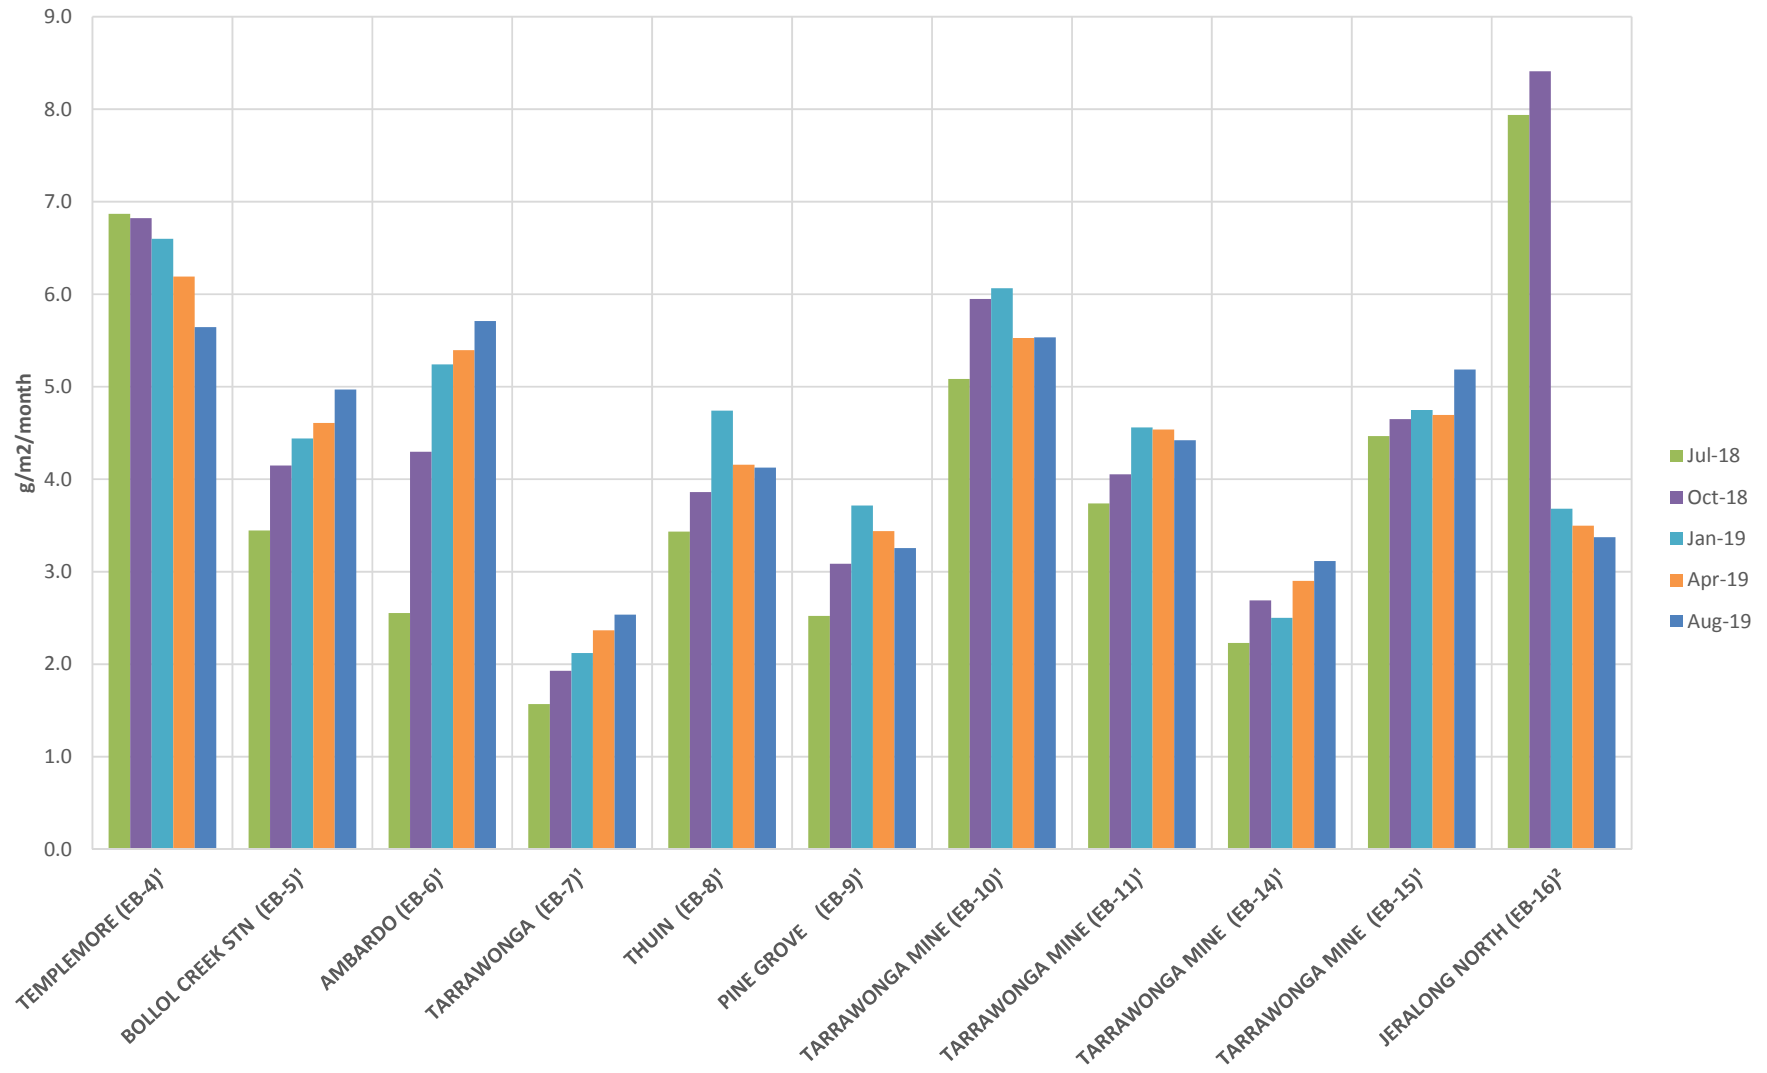
Deposited Dust Gauge Results- Quarterly rolling average [g/m2/month]

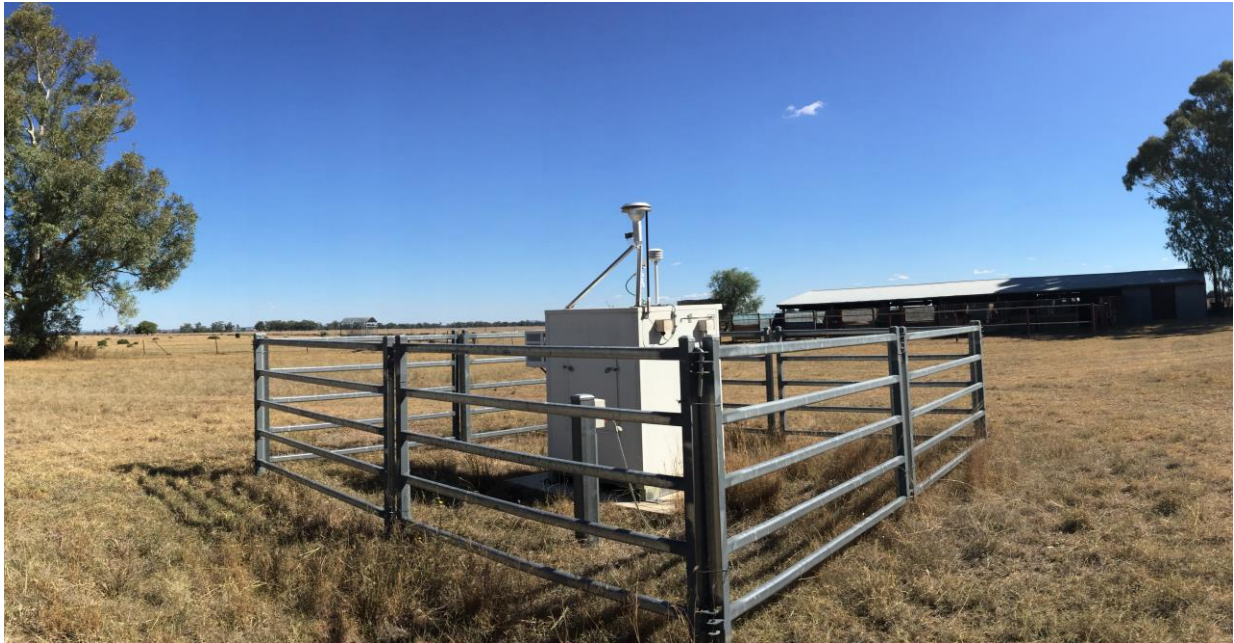
TEOM installed at Flixton property

According to the current Air Quality and Greenhouse gas Management Plan, the real time air quality unit (TEOM) installed at the “Flixton” property monitors PM₁₀ levels in ambient air. It is an operational management tool and dust levels nearing or reaching the nominated criteria will trigger actions onsite to assess the source of dust and modify operations if it is determined to be related to Tarrawonga operations.

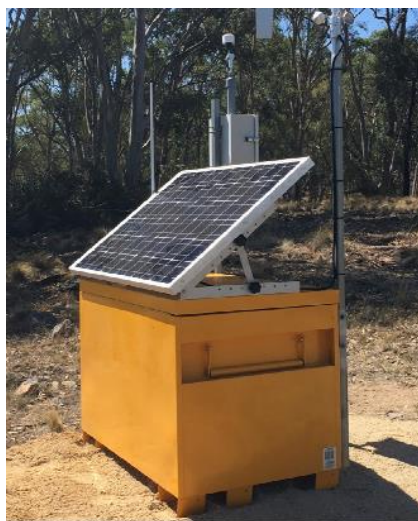
Three portable dust (PM₁₀) monitors have improved the real-time dust monitoring network and assist the operation to mitigate any potential dust generated by the operation.

Portable and real-time dust monitor installed at TCM in November 2018

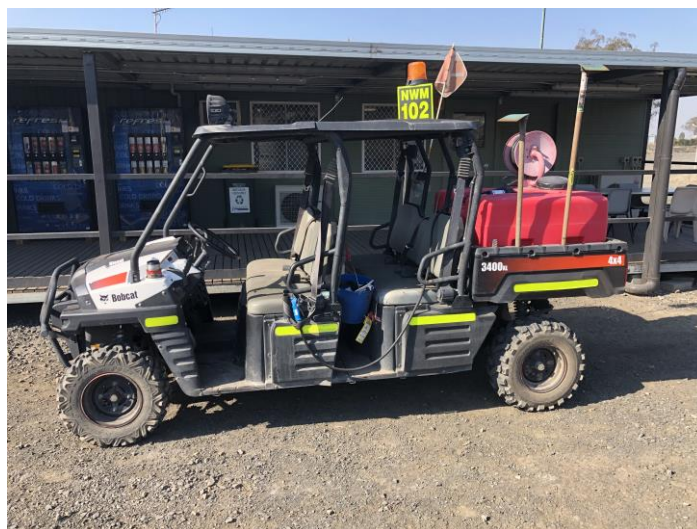
TCM continues to use an All-Terrain Vehicle (ATV) to water the rehabilitated areas and the trees recently planted. In 2018, that initiative allowed to achieve a high survival rate despite prolonged dry weather condition.

ATV used in the rehabilitation areas

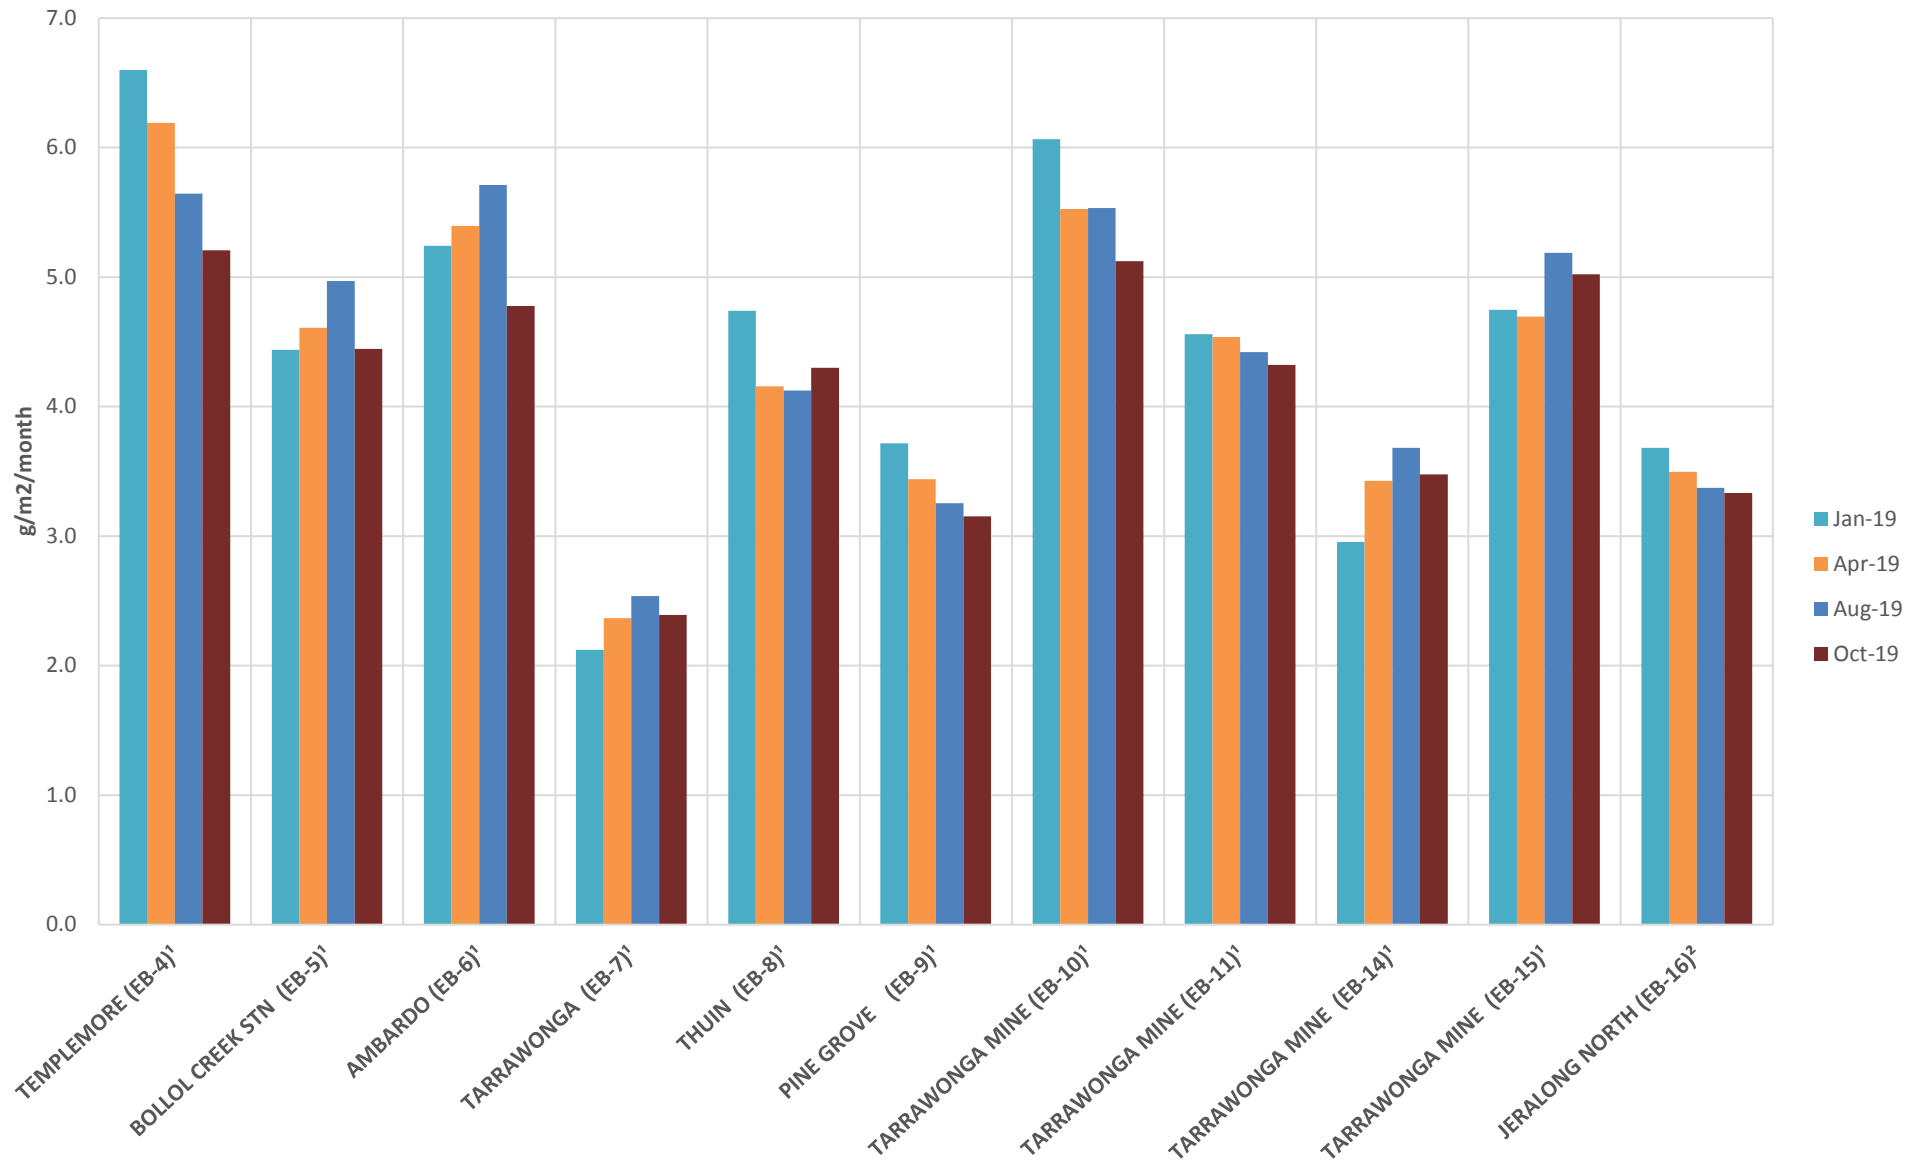
Deposited Dust Gauge Results- Quarterly rolling average [g/m2/month]
