Annual Review 2020

Tarrawonga Coal Mine

This Annual Review (AR) for Tarrawonga Coal Mine (TCM) has been prepared in accordance with Condition 3 of Mining Lease (ML) 1579, Condition 3 of ML 1685, Condition 4 of ML 1693 (Mining Act 1992) and Condition 4 (Schedule 5) of PA 11_0047, as modified.

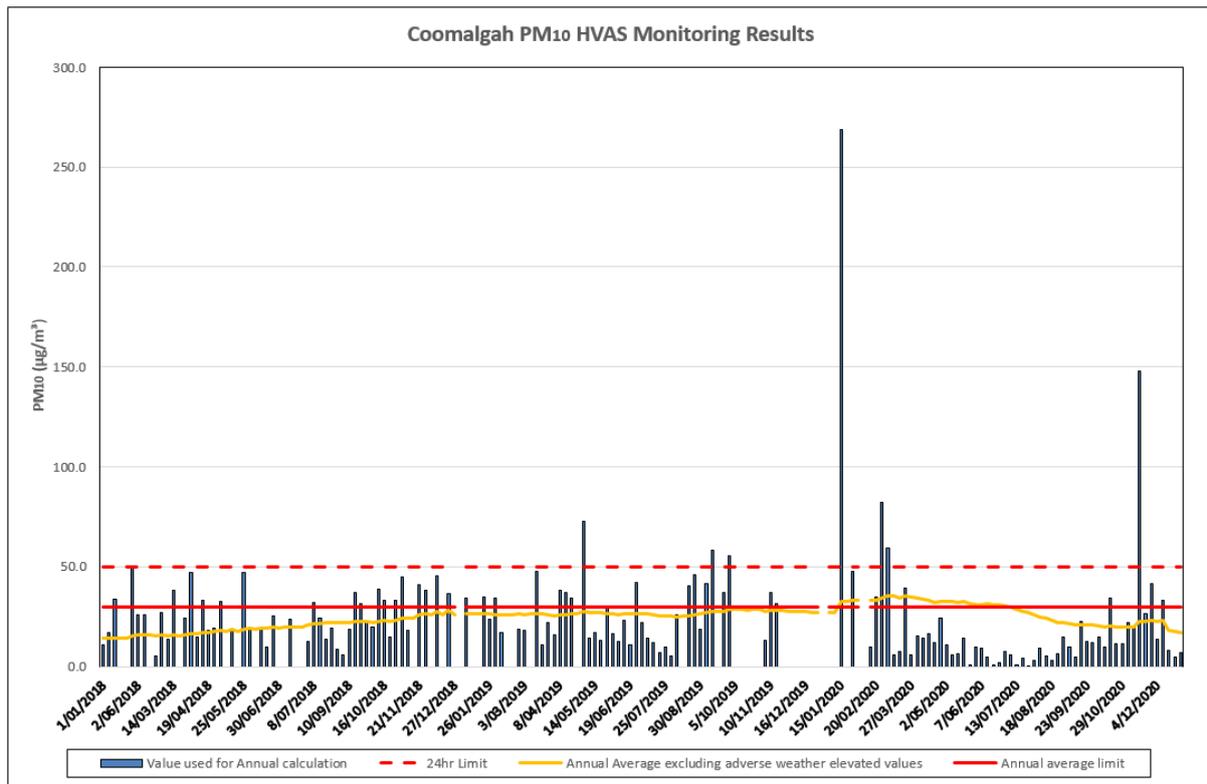
Figure 7- HVAS-PM₁₀ 24hr average monitoring data (2018-2020)

Excluding those PM₁₀ levels, the PM₁₀ annual average at Coomalgah was 19.5 µg/m³, which is below the 30 µg/m³ criterion specified in Schedule 3 condition 24.

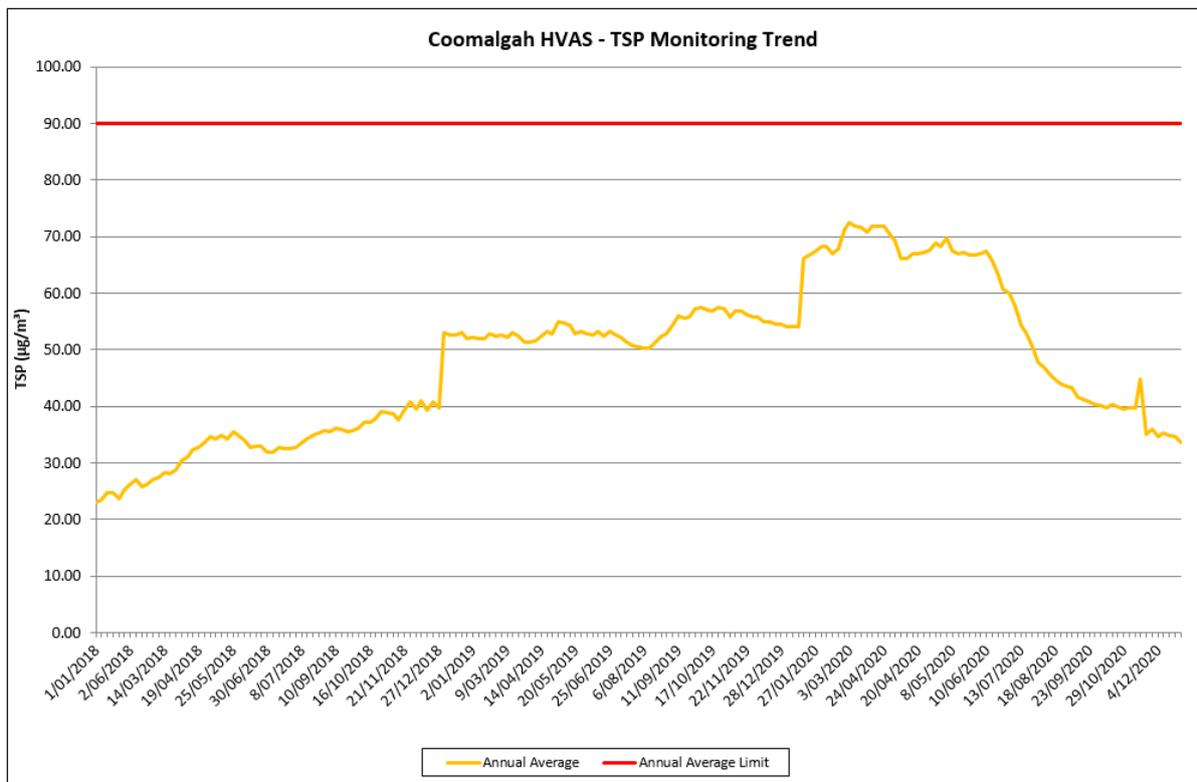
Figure 8 – Coomalgal HVAS- calculated TSP Monitoring Trend (2018- 2020)

Total Suspended Particulate (TSP) is inferred from the measured PM₁₀ data using monitoring conducted at the ‘Coomalgah’ HVAS. Results indicated the TSP rolling annual average remained below the applicable criteria of 90 $\mu\text{g}/\text{m}^3$ for the reporting period. These are illustrated in Figure 8.

The EA predicted no exceedance of the annual average TSP criterion. TSP results inferred from PM₁₀ data were consistent with the EA for the reporting period.

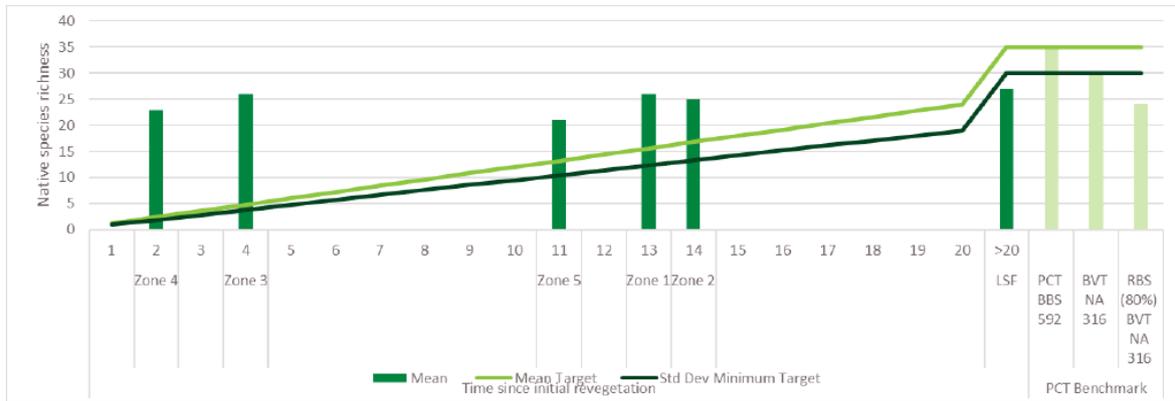
Figure 15. 1: Native Species richness vs benchmark.

Native species richness changed little from close to the time of establishment (1 to 2 years) through to 14 years of age. Native species richness is 65% to 75% of benchmark for Zones 1 to 4, whilst the zones vary in age from 2 years to 14 years. Zone 5 which is dominated by exotic grass and is recommended for being classified as Pasture has a native species richness of 62% of benchmark.

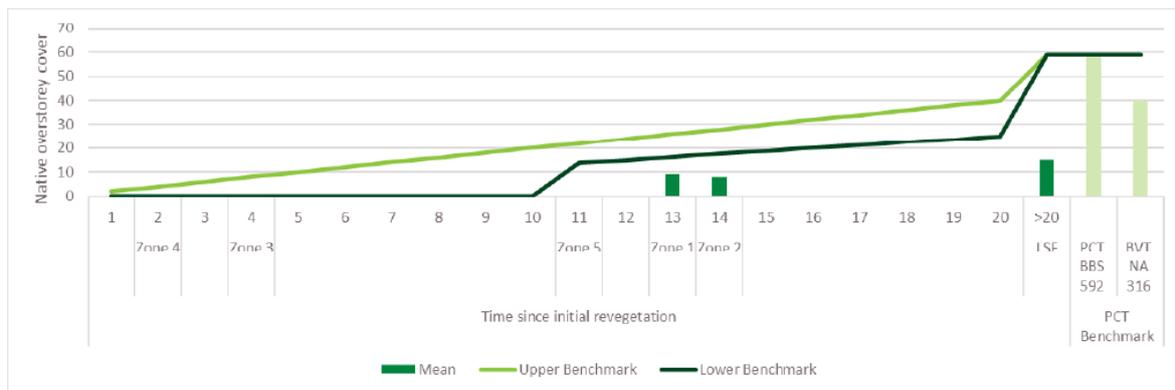
Figure 15. 2: Native overstorey vs benchmark

Canopy cover will increase with age, but was about 15% of benchmark by age 14, and even analogue areas in LSF were only 25% of target. Mid-storey data showed that age 14 cover was 30% of benchmark. Analogue sites in LSF was within 15% of benchmark. It is important to note that mid-storey (below 6m in height) data for younger zone included trees which will form the canopy in later years. Grass cover for all rehabilitation zones is below 20% of benchmark.

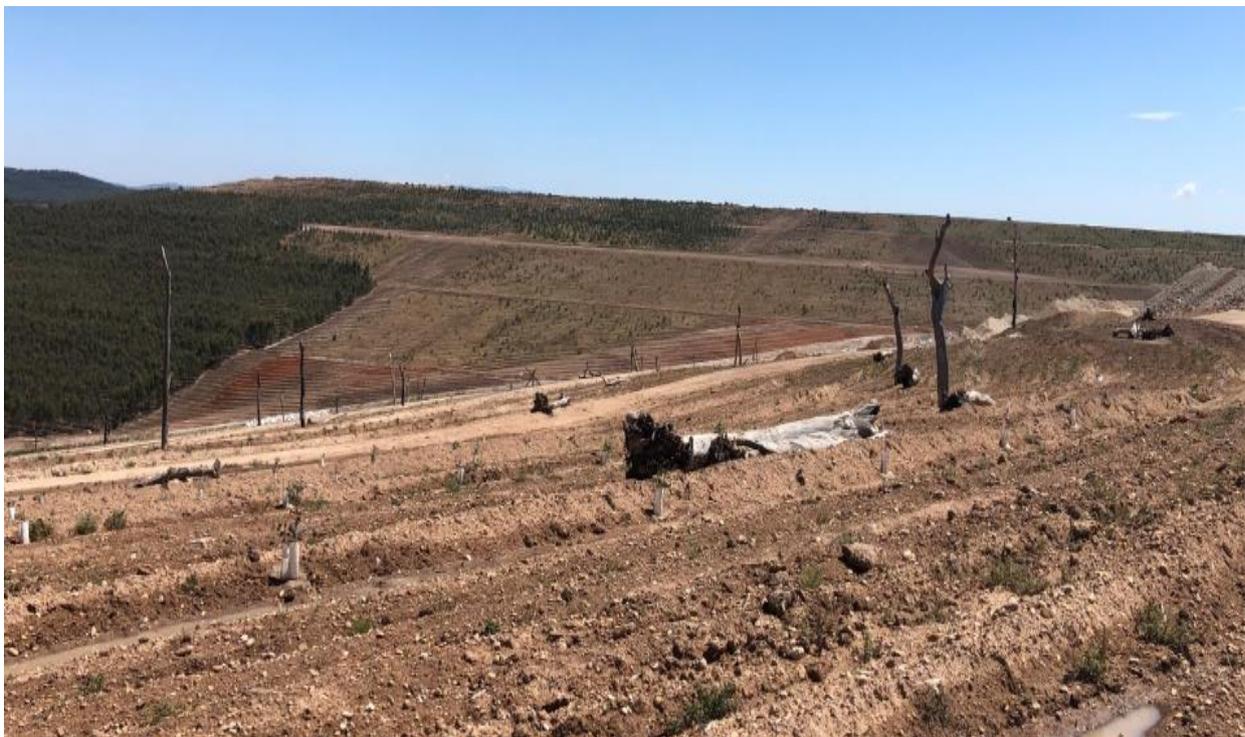
On TCM Northern and Southern Emplacements Rehabilitated areas, several dead trees salvaged from previous years clearing campaign were erected to create habitat for different bird species (Figure 16). Additional woody debris has been deposited on the ground during the rehabilitation process to generate habitat and protection for species.

Figure 16 - Photo: Salvaged trees laid down and erected in the Northern Rehabilitation area in 2020

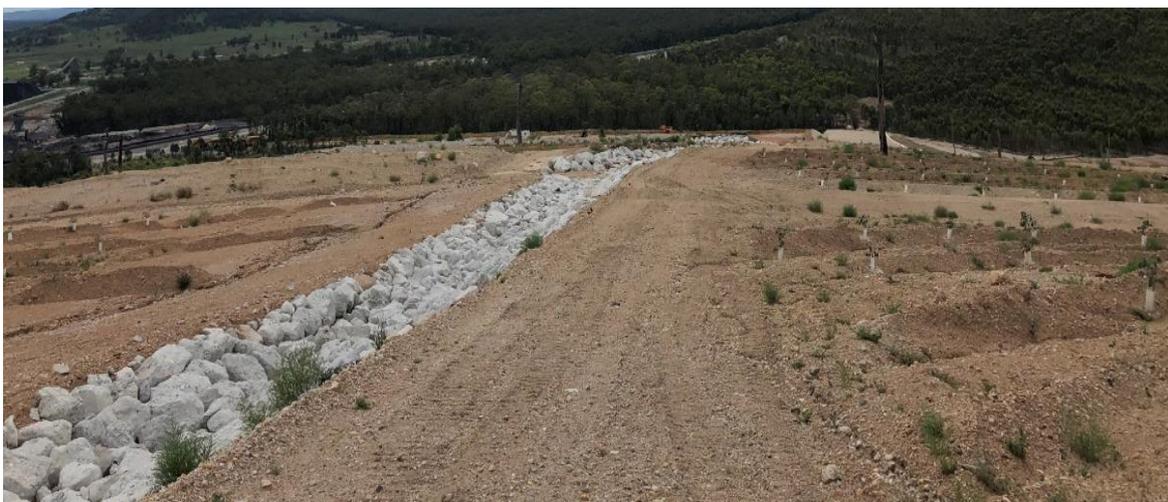
Several water infrastructures including sediment dams, drop structures, diversion drains and contour banks were designed and sized in accordance with the managing-urban-stormwater-soils and construction guide (volume-2E-fourth-edition). TCM constructed engineered drop structures in the Northern Rehabilitation area (Figure 17) and one dam was enlarged from 9ML to approximately 50ML near the Southern Emplacement area.

Figure 17 - Photo: Rocklined Drop structures on the Northern Rehabilitation area

Inlets and spillways of some of the sediment dams were repaired using geotextile fabric and armour rock and several of the sumps and drains were desilted.

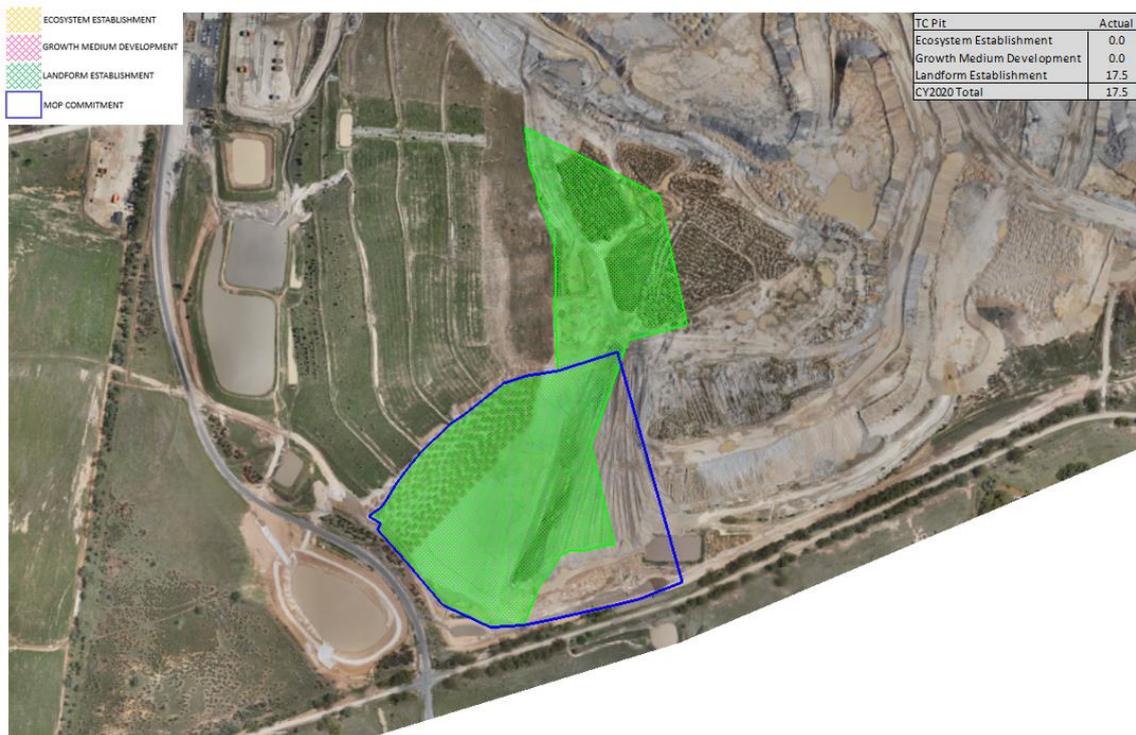
Approximately 17.5Ha of landform establishment was achieved on the Southern Emplacement Area and approximately 8.5Ha were rehabilitated on the Northern Emplacement Area. For this reason the polygons showing progressive rehabilitation in Plan 3F of MOP F are slightly different to the polygons showing the actual areas rehabilitated during 2020 as per Figure 18 and Figure 19.

Figure 18 - Southern Emplacement Area Rehabilitation at end of CY2020

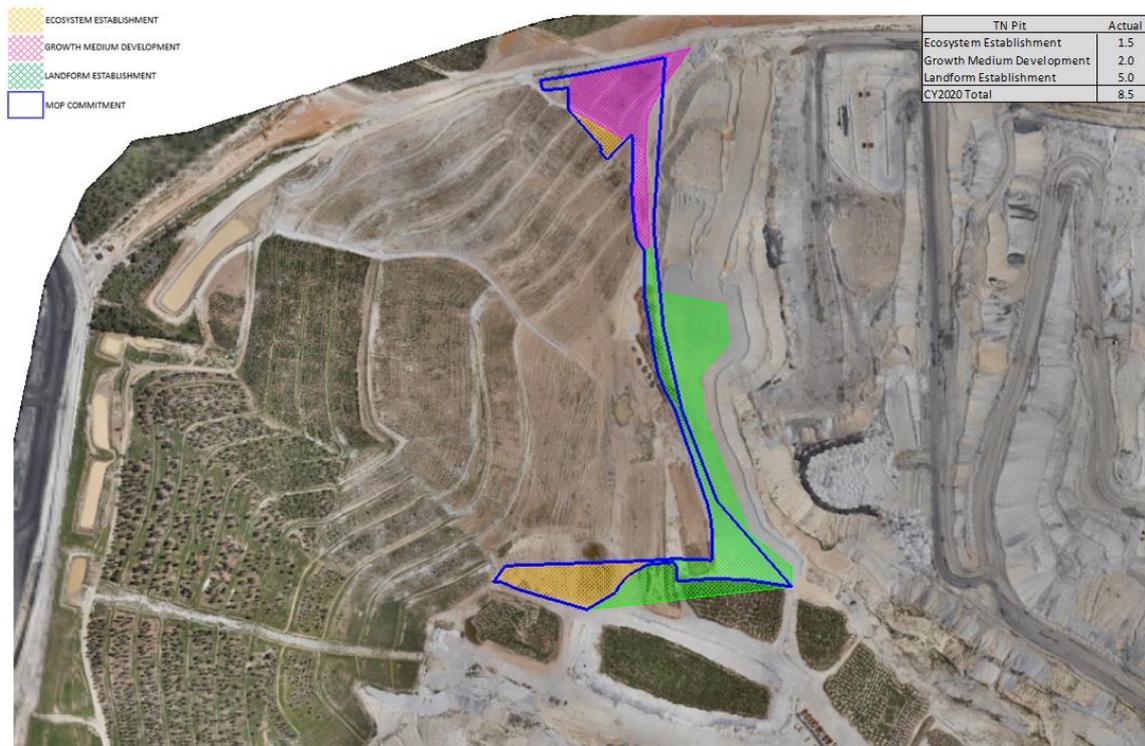
Figure 19 - Northern Emplacement Area Rehabilitation at end of CY2020

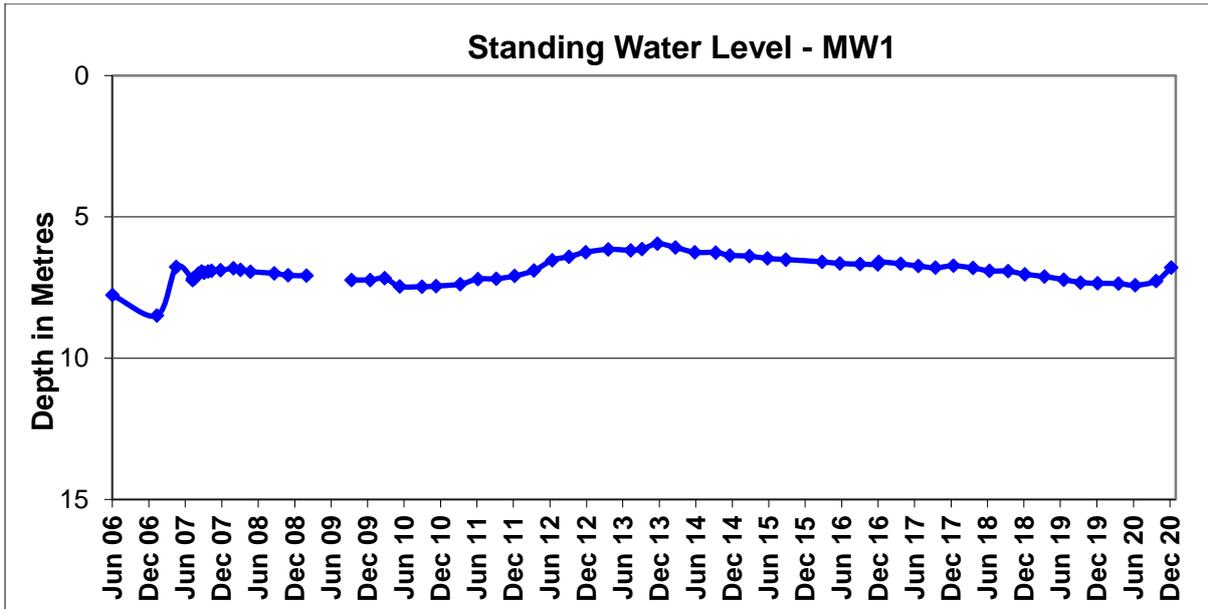
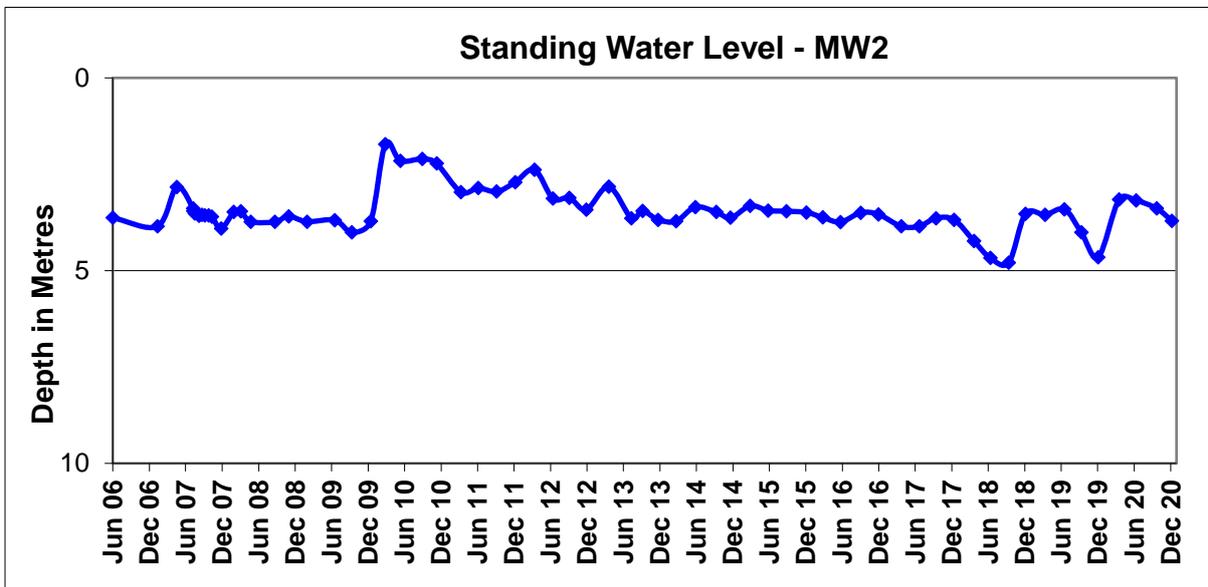
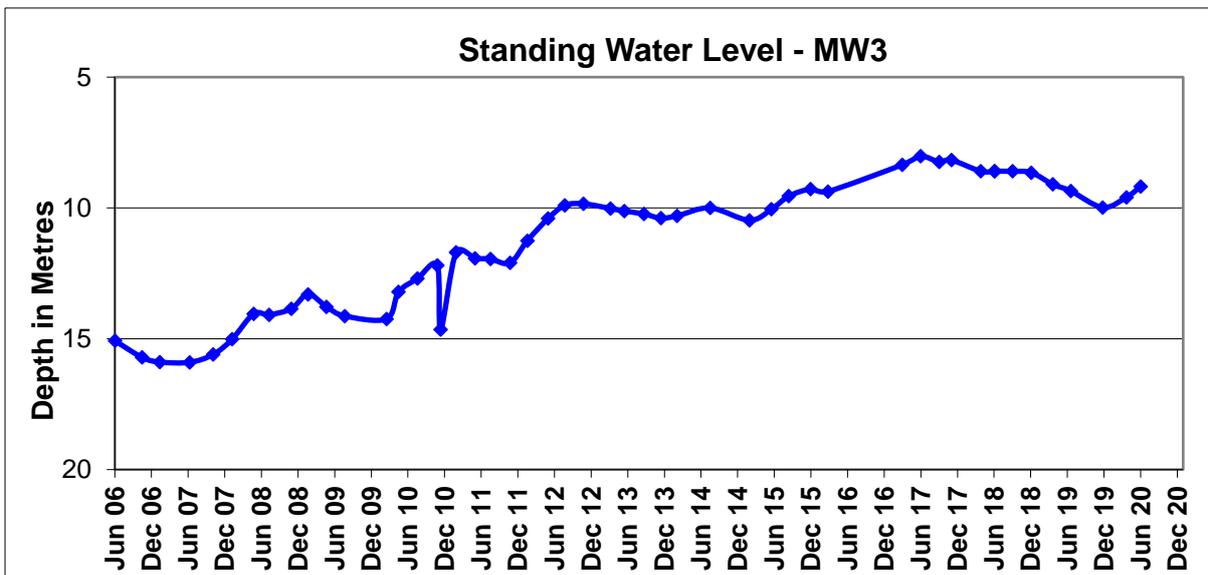
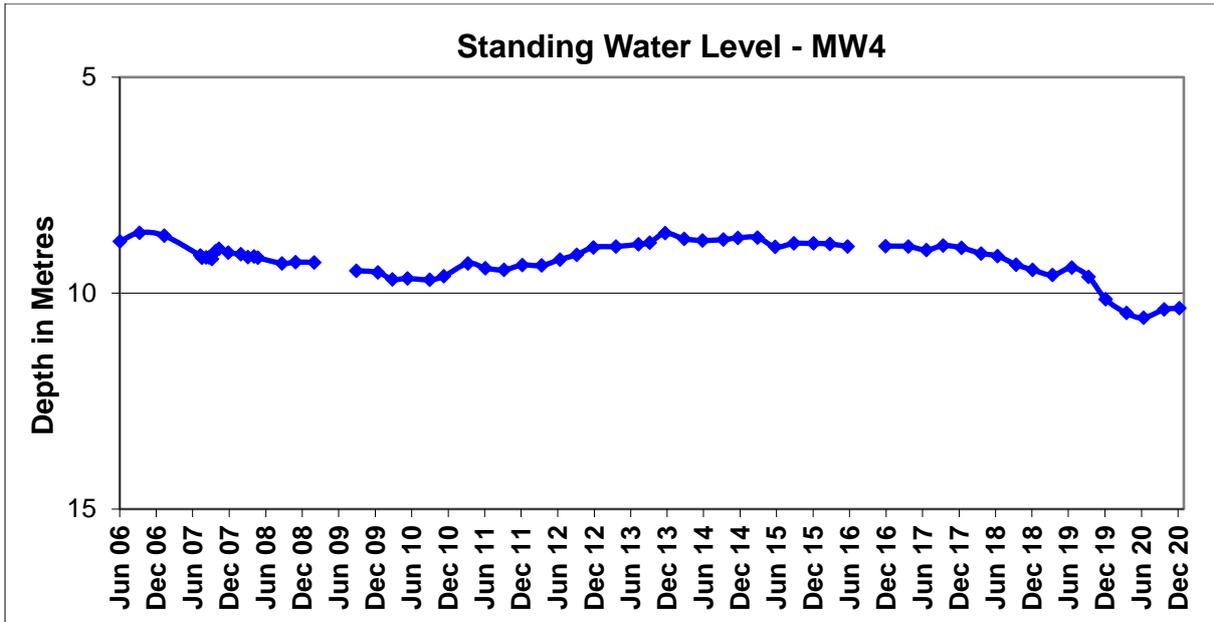
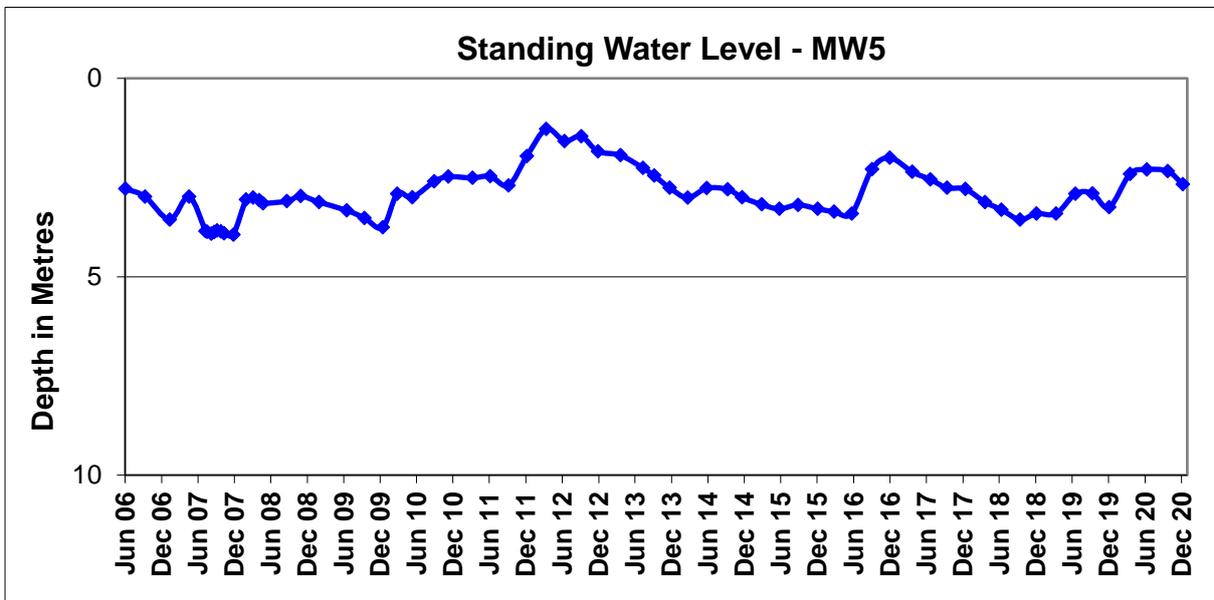
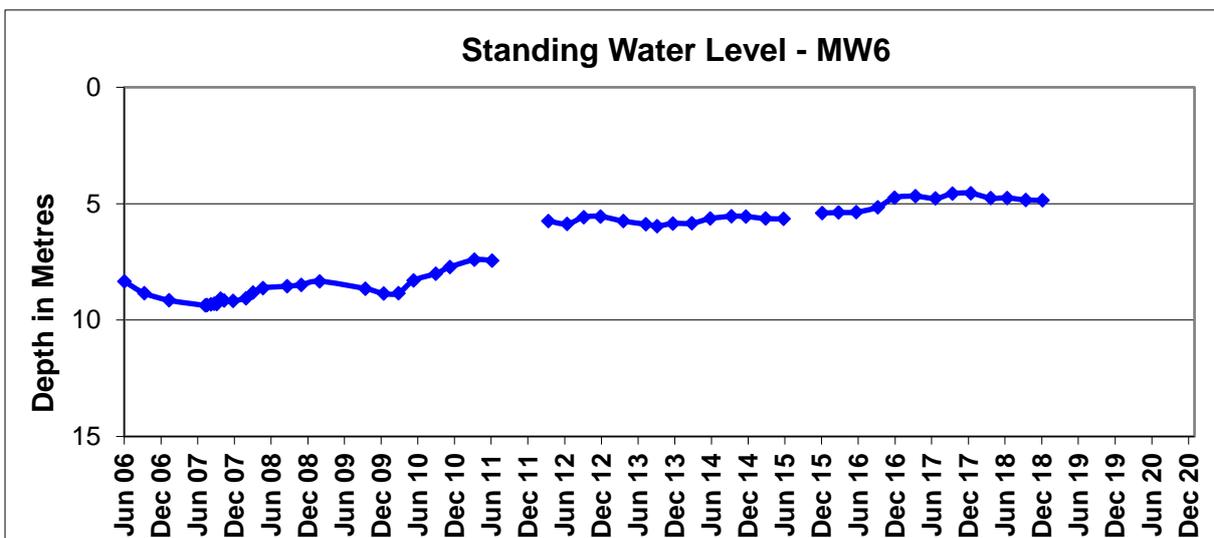
GROUNDWATER MONITORING DATA

Graphs available in Appendix 4 show that groundwater levels at the majority of nominated monitoring bores maintained a steady trend. Most of the bore levels show a significant increase, likely related to rainfall recorded over the year. Sampling and water levels have not been monitored at MW6 since the beginning of 2019, due to a broken casing. This bore is located on Boggabri Coal Mine property. MW3 was removed from the EPL12365 requirement and will not be monitored any more. Samples could not be collected at MW8 due to a damaged casing however, water level could regularly be checked for at that site.

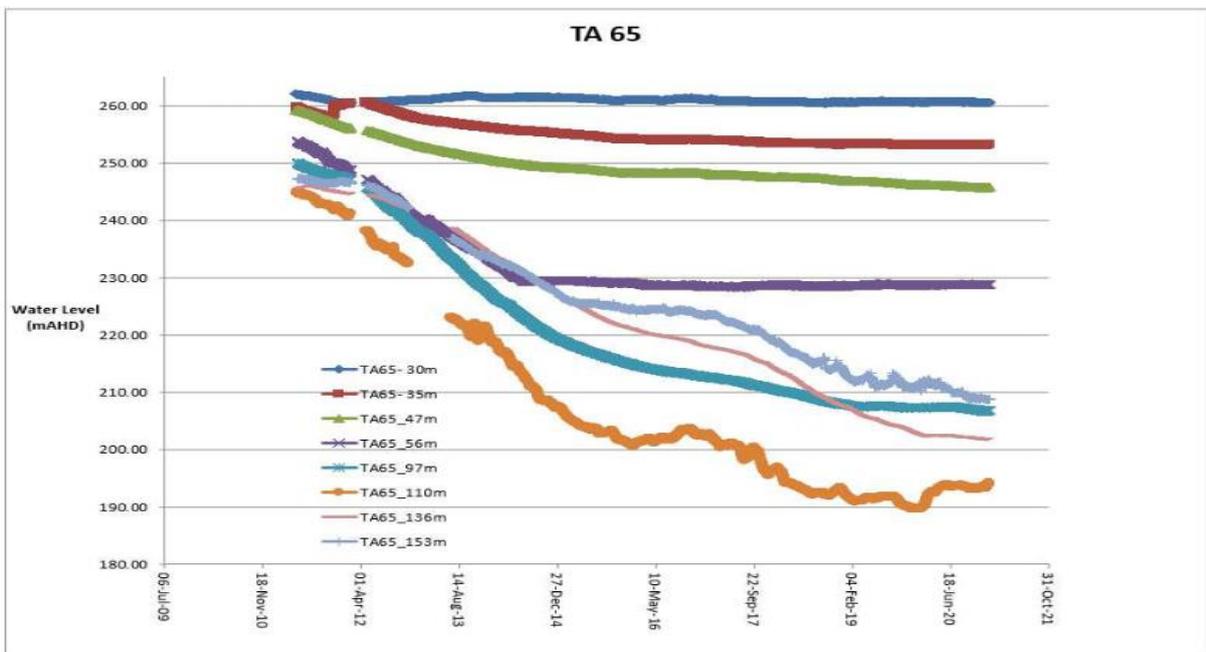
Vibrating Wire Piezometers:

The Vibrating Wire Piezometers (VWPs) installed at TA65 indicated general depressurisation increases with depth (at 110m, 136m and 153m intake). Excluding the 56m intake (which is likely to be faulty), depressurisation of all intakes continued throughout 2019, ranging from 0.04m in the 30m intake to a maximum of 4.81m in the 136m intake, reflecting changes consistent with the presence of an open cut mining operation in proximity to TA65.
