VICKERY EXTENSION PROJECT

LAND CONTAMINATION ASSESSMENT

Tier 1 Preliminary Site Investigation Vickery Extension Project

Whitehaven Coal Limited

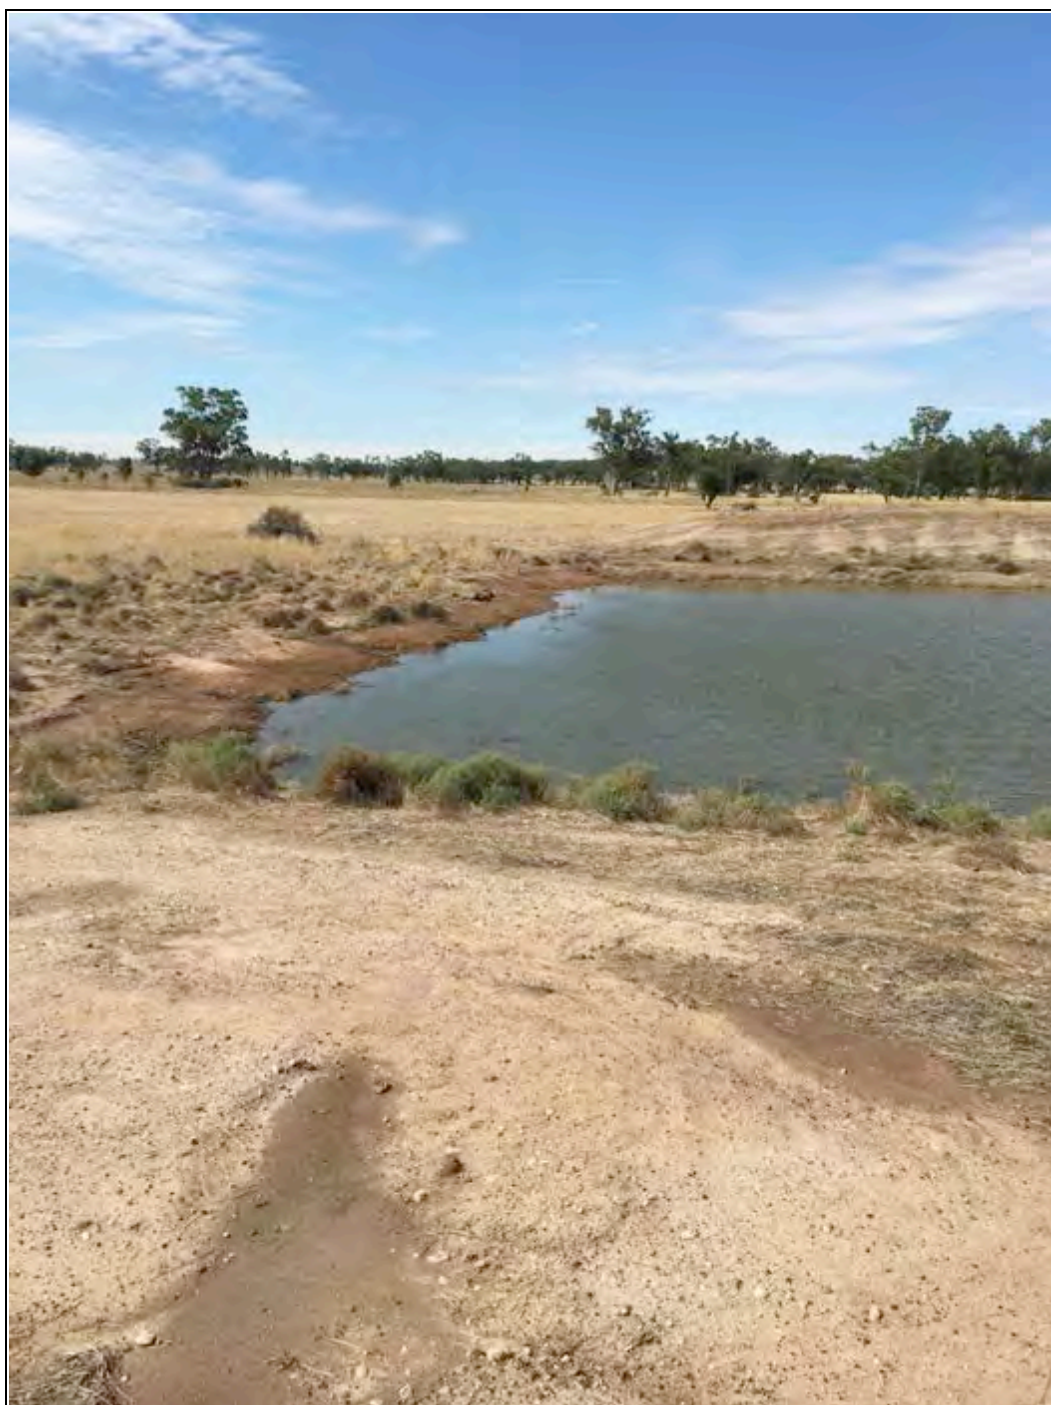
Photo
%

Feature 11- Dam.

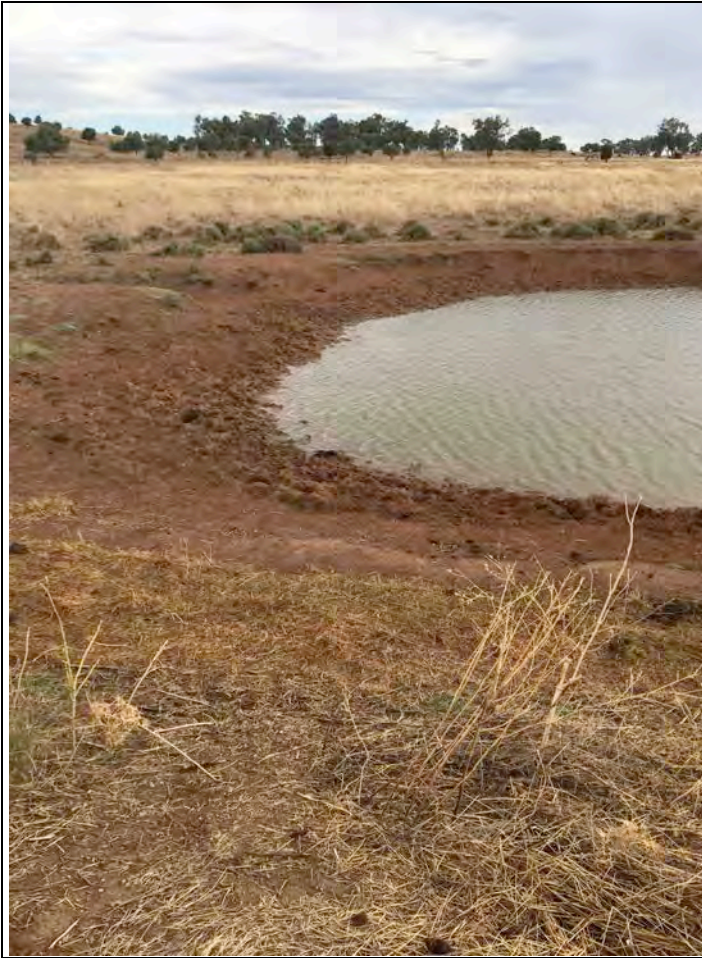
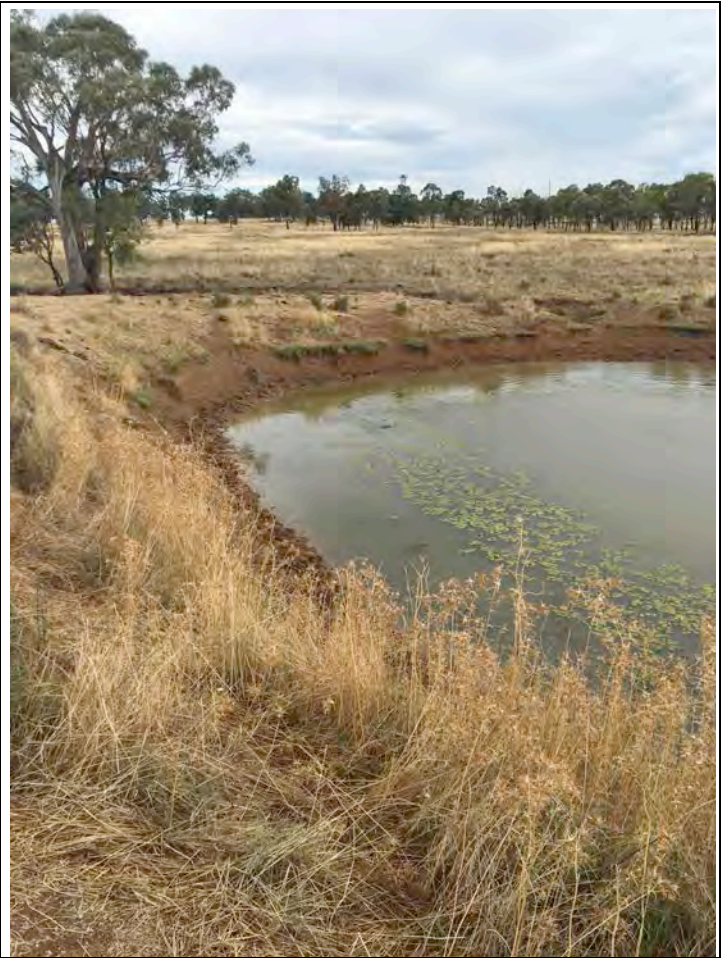
Photo % . Feature 12- Dam

Photo %. Feature -13 Dam.

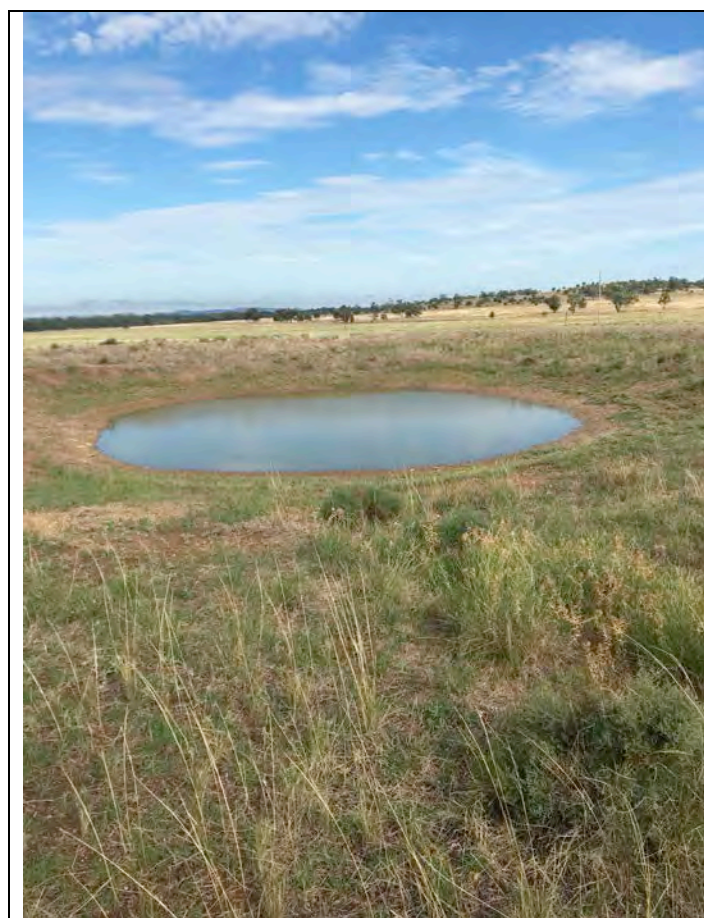
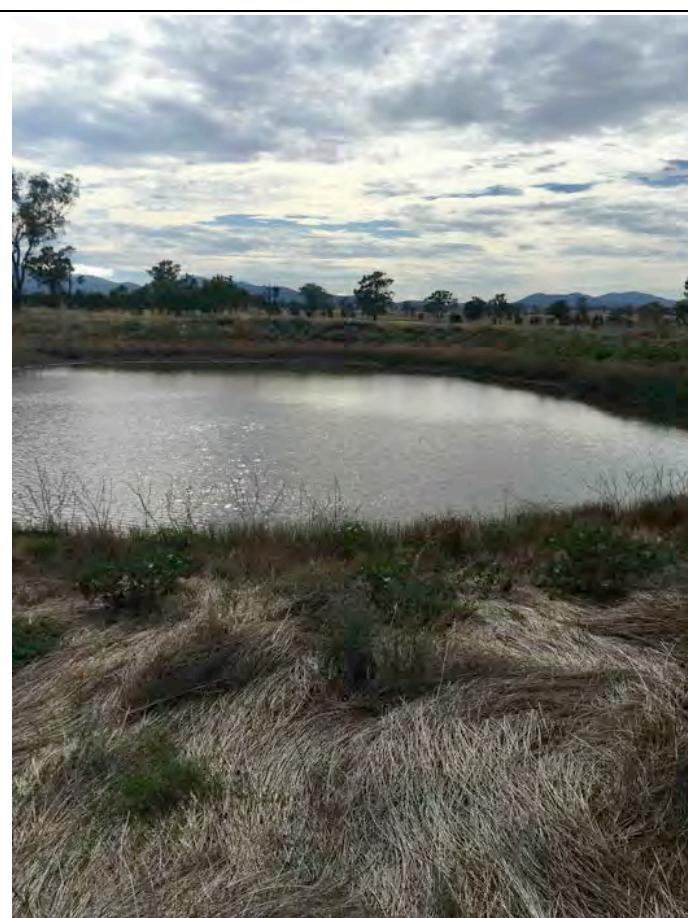
<p>Photo % .</p>	<p>Feature 14-Dam.</p>	<p>Photo % .</p>	<p>Feature 15- Dam.</p>
-------------------------	------------------------	-------------------------	-------------------------

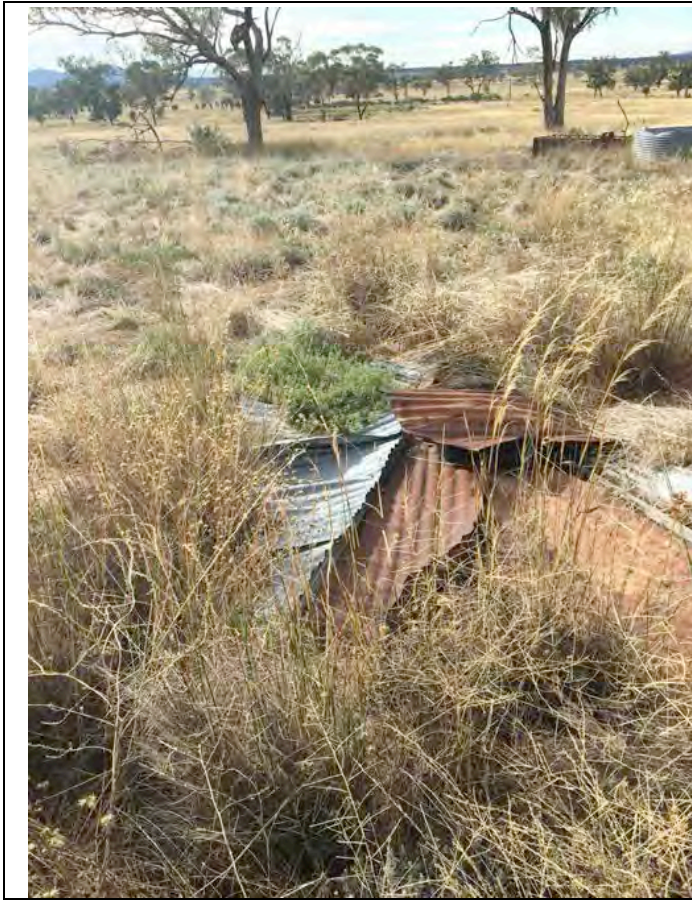
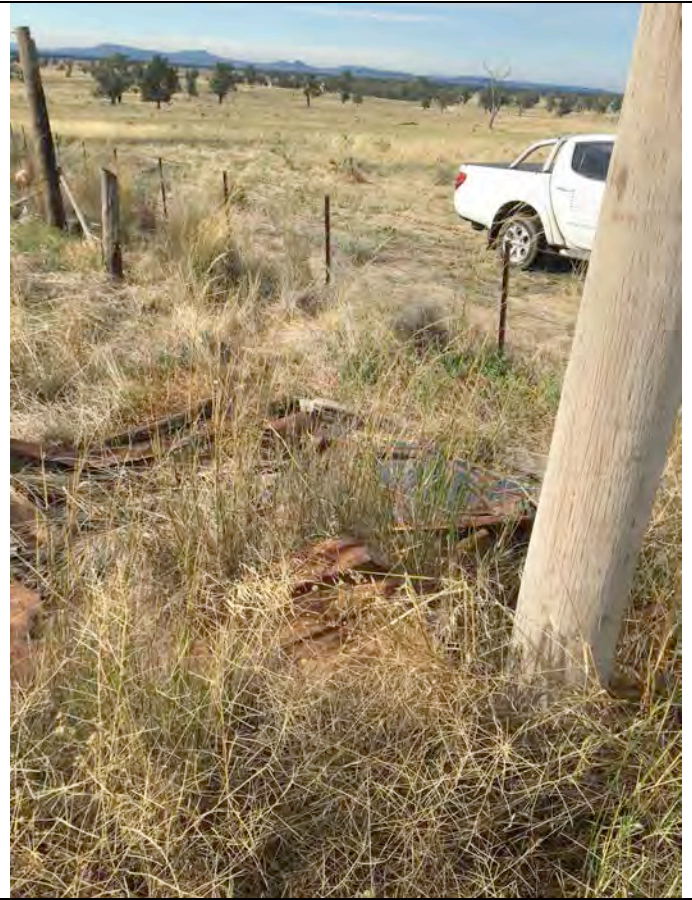
<p>Photo &\$.</p>	<p>Feature 16- Unconsolidated scrap pile-roofing and other material.</p>	<p>Photo &%.</p>	<p>Feature 16- Unconsolidated scrap pile.</p>
------------------------------	--	-----------------------------	---

Based on the features of interest inspected as part of this investigation, SESL recommends that further investigation is required to determine the presence and/or extent of the contamination present within the vicinity of these features. Further investigation should be conducted through the undertaking of a DSI. This investigation should include intrusive soil sampling & analysis, required to investigate the contaminants of potential concern associated with the features, as discussed above. Limited surface soil sampling should be conducted in low risk areas.

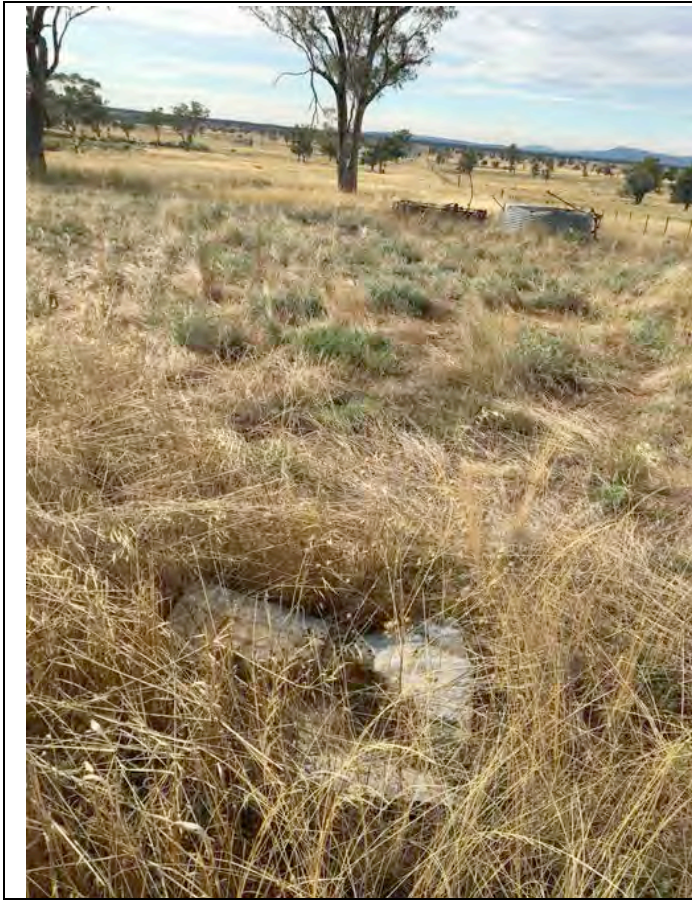
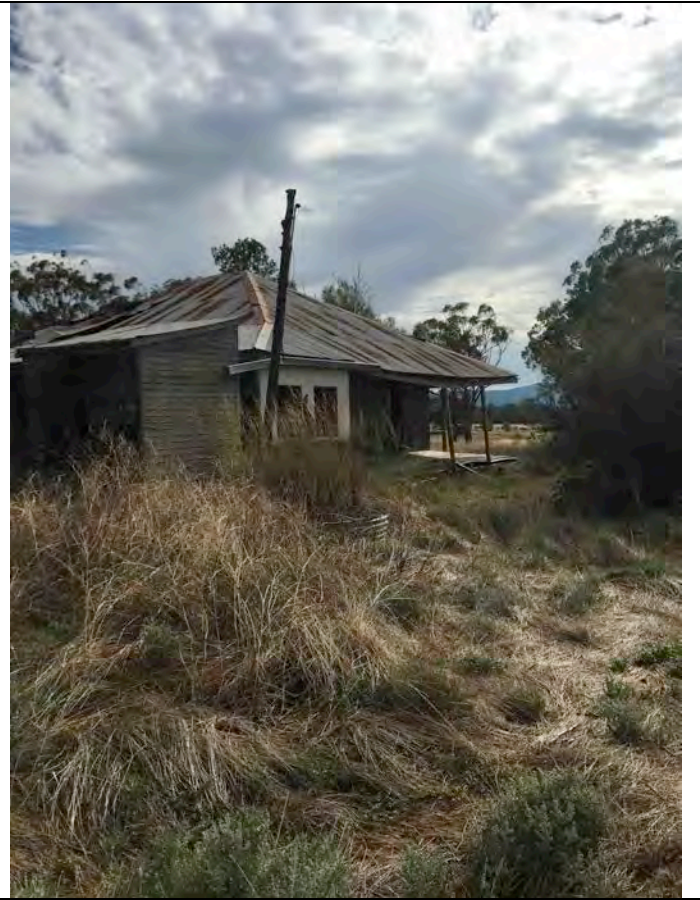
<p>Photo &&</p>	<p>Feature 16- Unconsolidated scrap pile, old agricultural equipment and tank.</p>	<p>Photo & .</p>	<p>Feature 16- Derelict house.</p>
--------------------------------	--	-----------------------------	------------------------------------

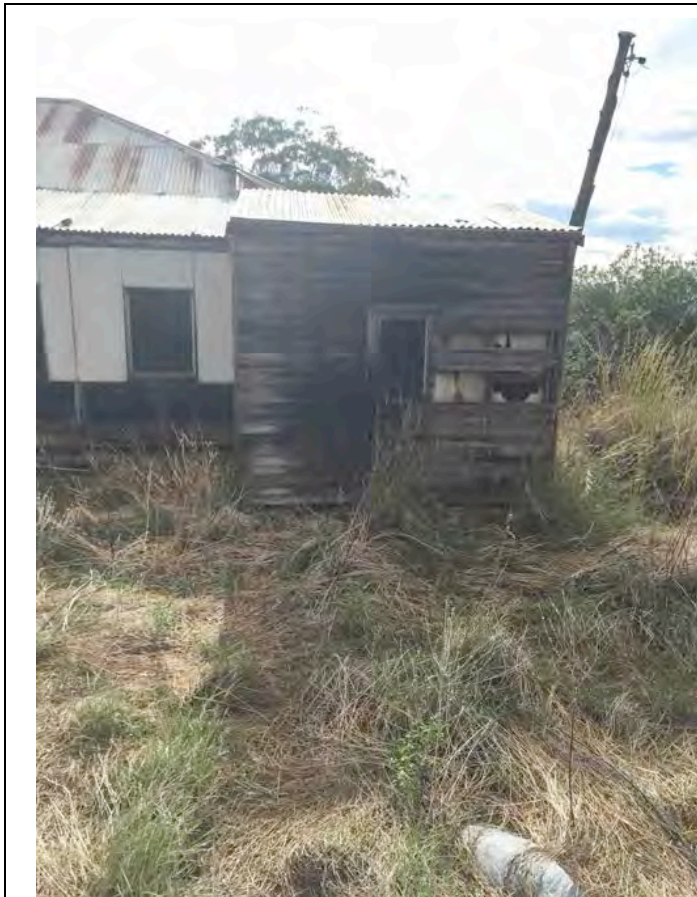
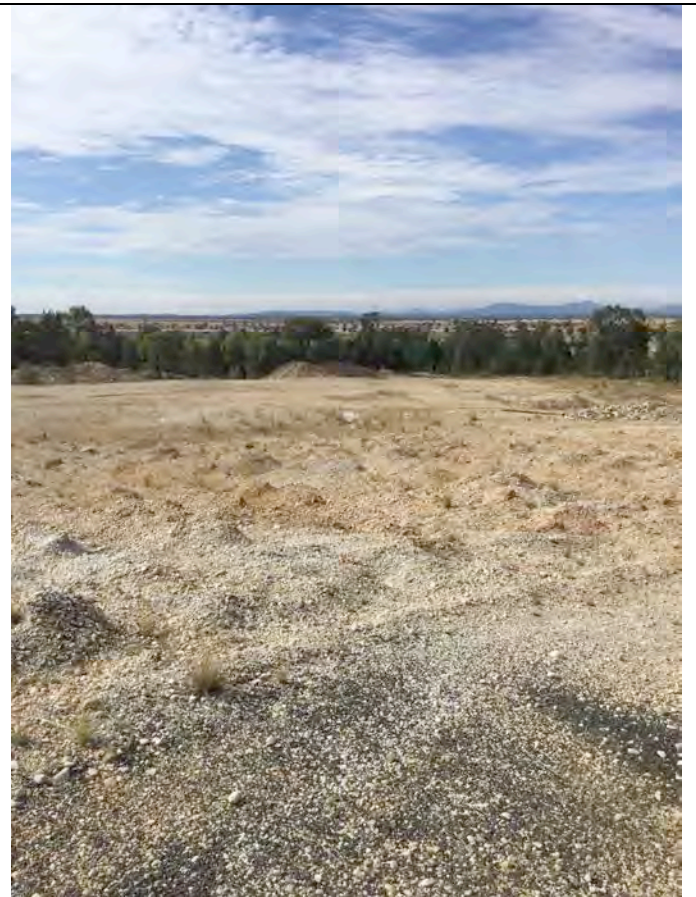
The feature is located partially inside the site extent (within the Mine Site Investigation Area [Figure 3a]). Inspection of this feature (25/01/2017) identified a quarry. The quarry is expected to have been a river stone/pebble quarry, based on the quantity of pebbles on the surface of the site. It is also expected to have involved the excavation of shallow rock deposits, as the disturbed areas tended to have only shallow excavations. No equipment associated with quarry activities were observed on the site. No evidence of landfilling was observed. Minor amounts of concrete waste were observed in one location, possibly due to opportunistic dumping, or the removal of former site infrastructure at the cessation of quarry activities. No land contamination concerns were identified.

<p>Photo & .</p>	<p>Feature 16-. Derelict house.</p>	<p>Photo & .</p>	<p>Feature 17- Quarry.</p>
-----------------------------	-------------------------------------	-----------------------------	----------------------------

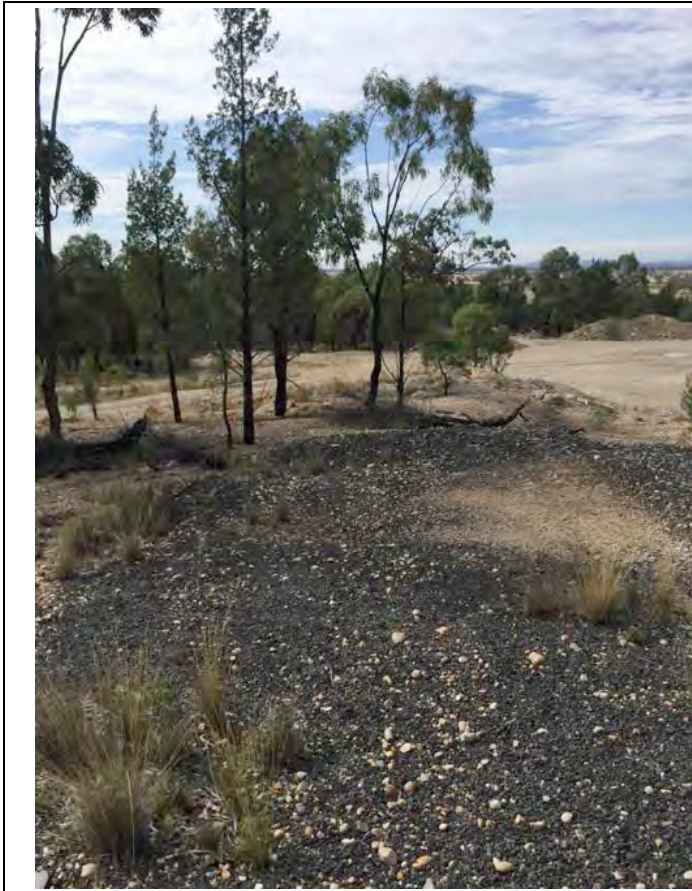
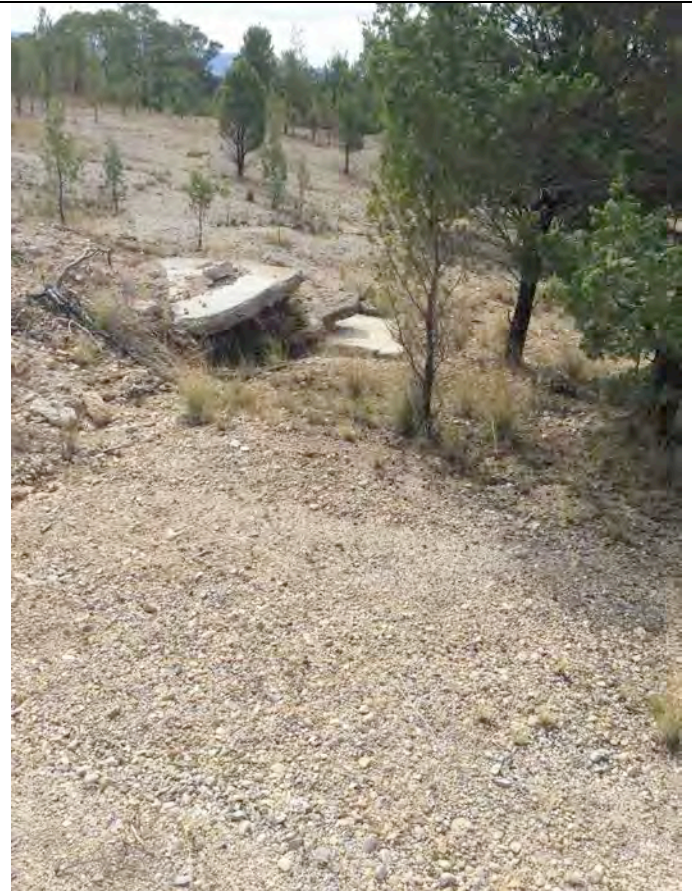
<p>Photo &*</p>	<p>Feature 17- Quarry.</p>	<p>Photo &+.</p>	<p>Feature 17- Quarry.</p>
----------------------------	----------------------------	-----------------------------	----------------------------

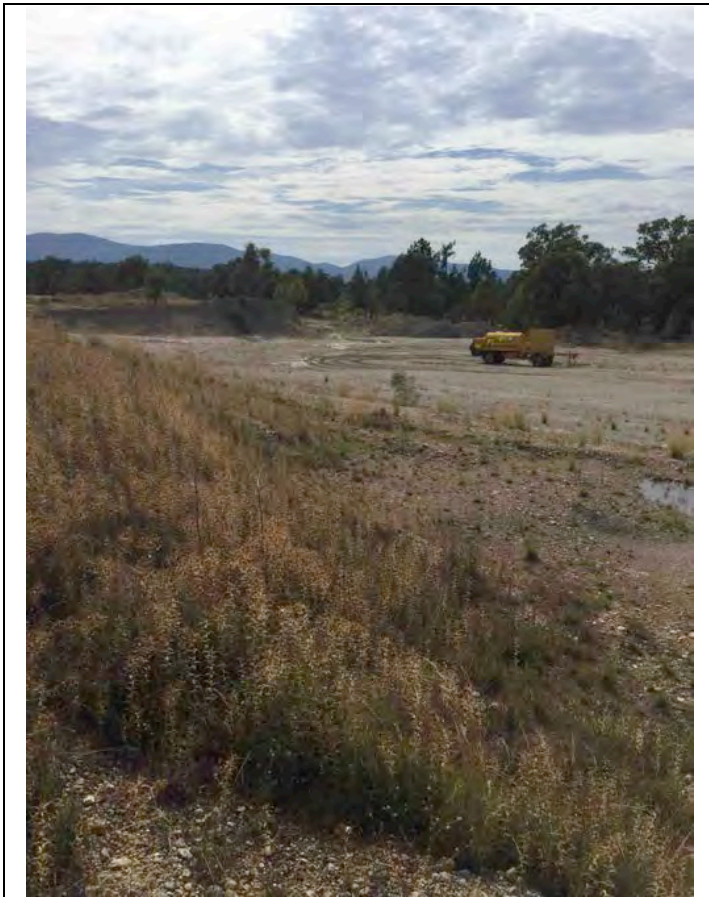
**Photo
& .**

Feature 17-Quarry with tanker trailer
