# Narrabri Mine Modification 5

# Environmental Assessment

### Aboriginal Cultural Heritage Assessment

September 2015

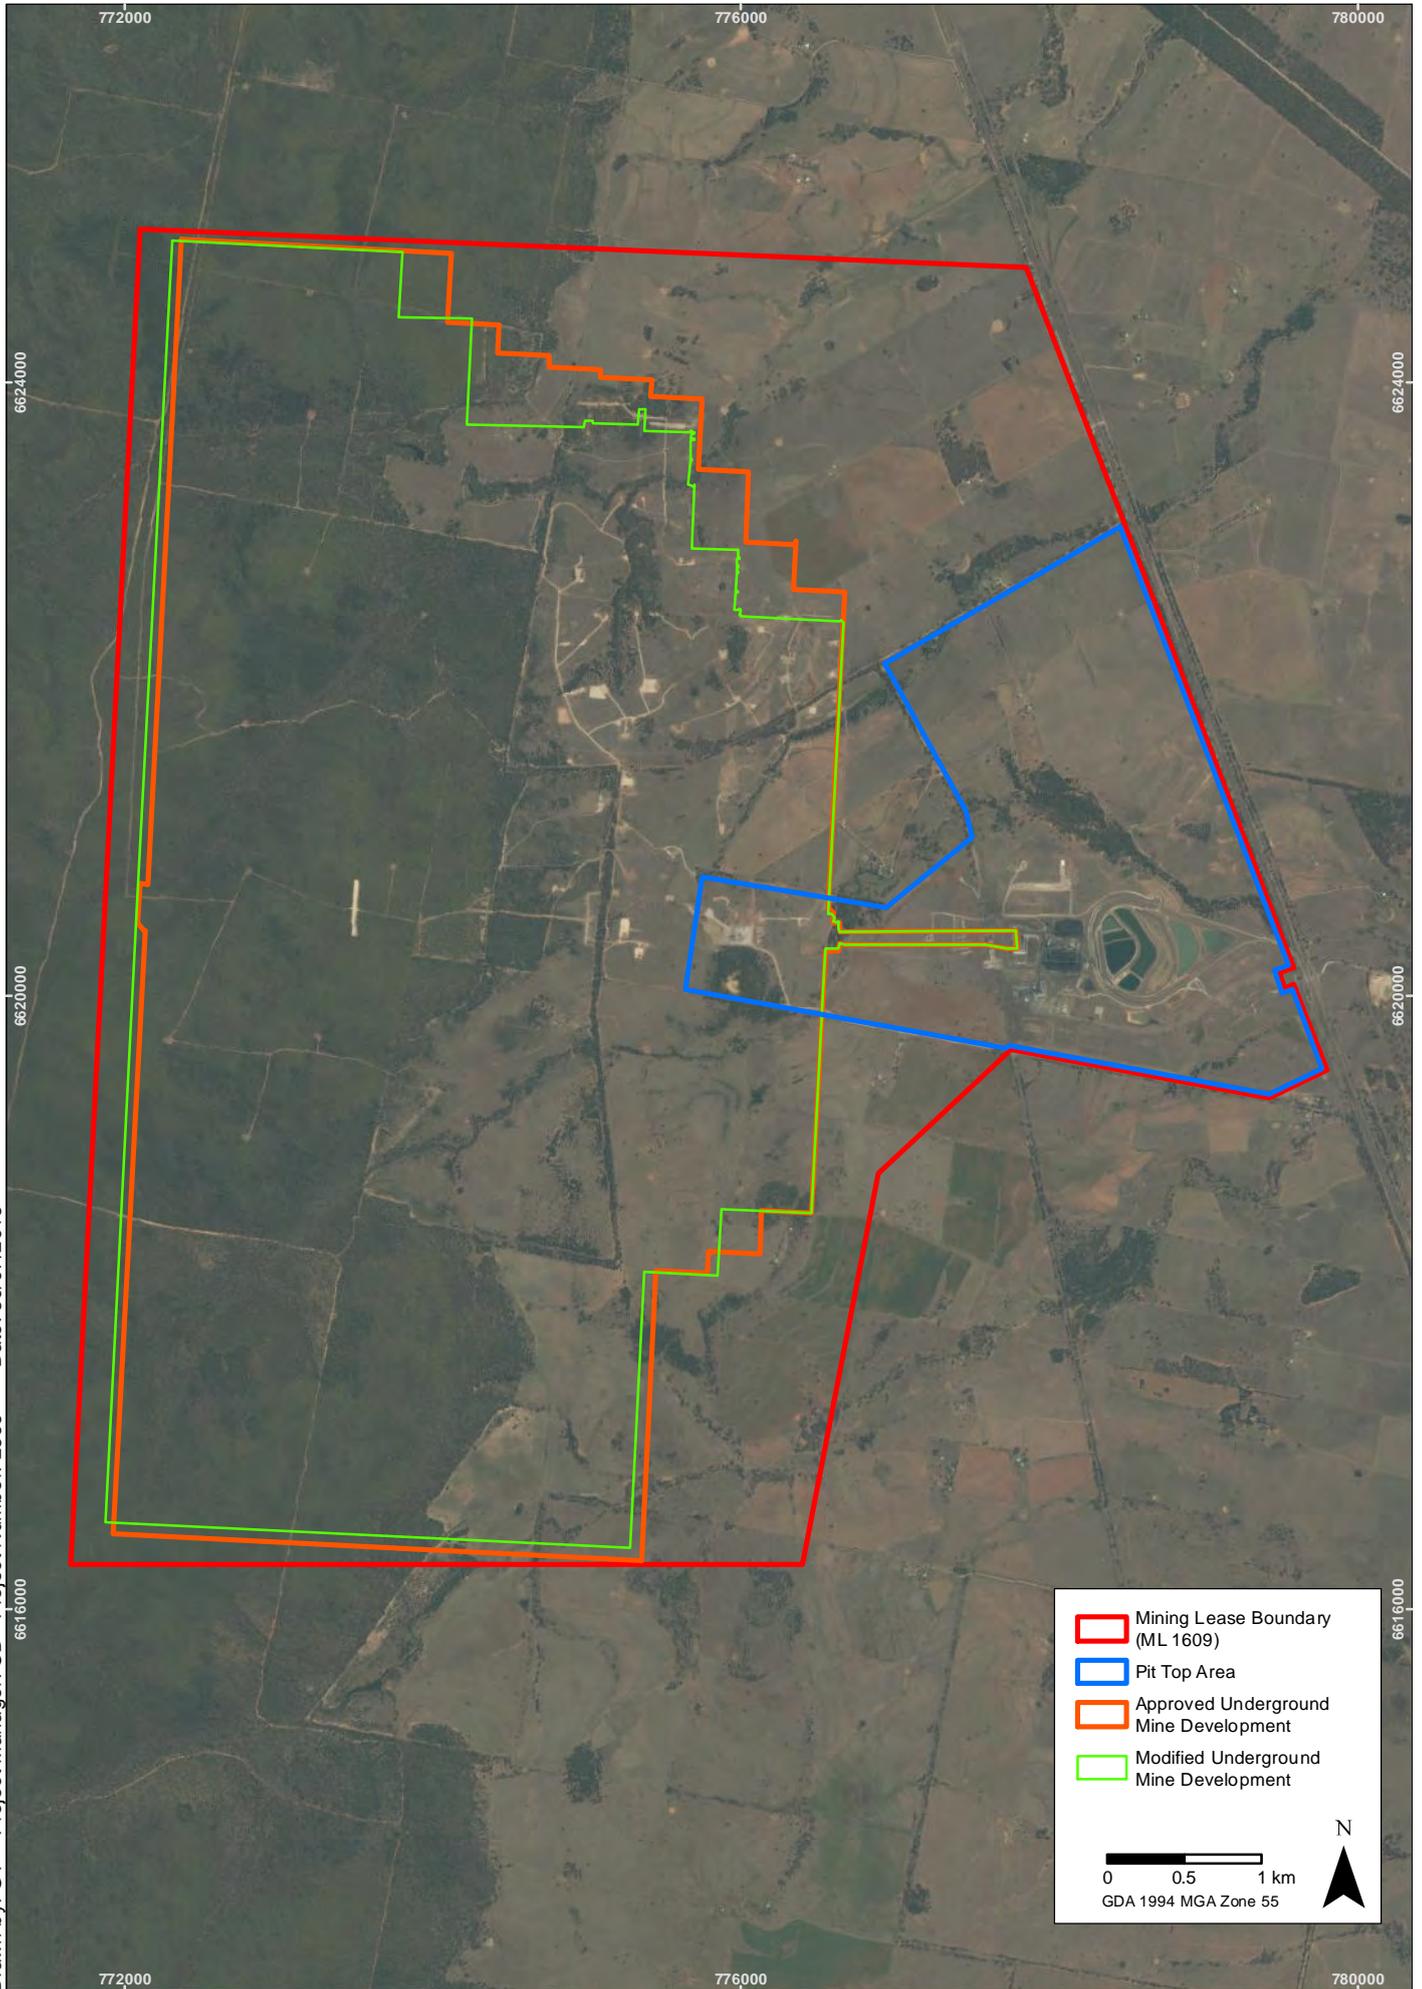
**FIGURE 2**

Modification Area  
Narrabri Mine Modification ACHA

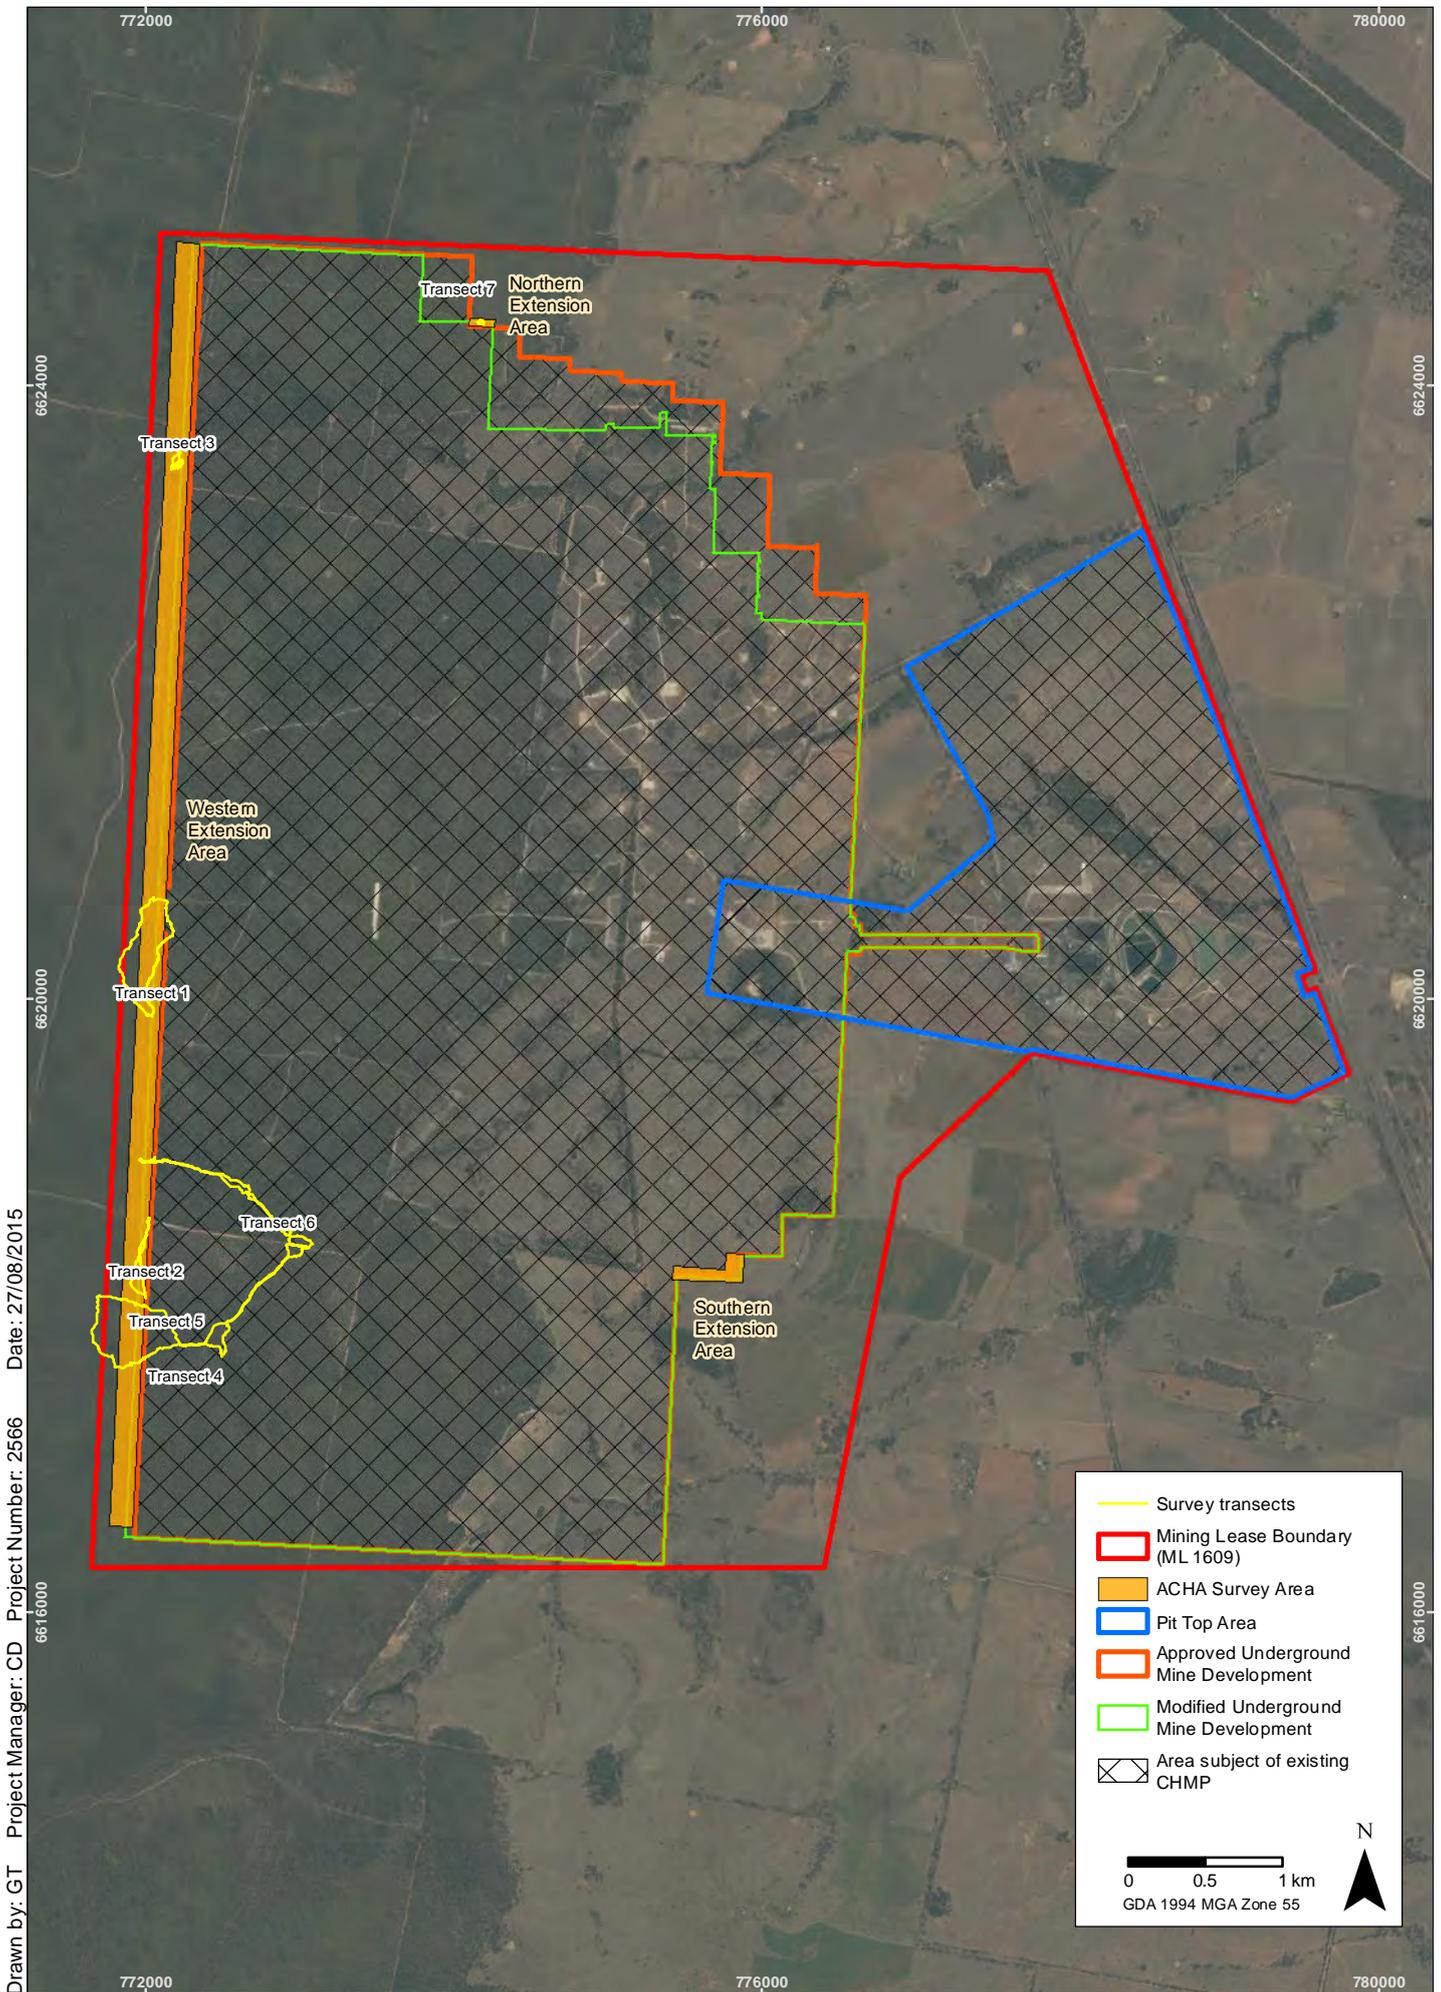
**FIGURE 3**

Survey Area  
Narrabri Mine Modification ACHA

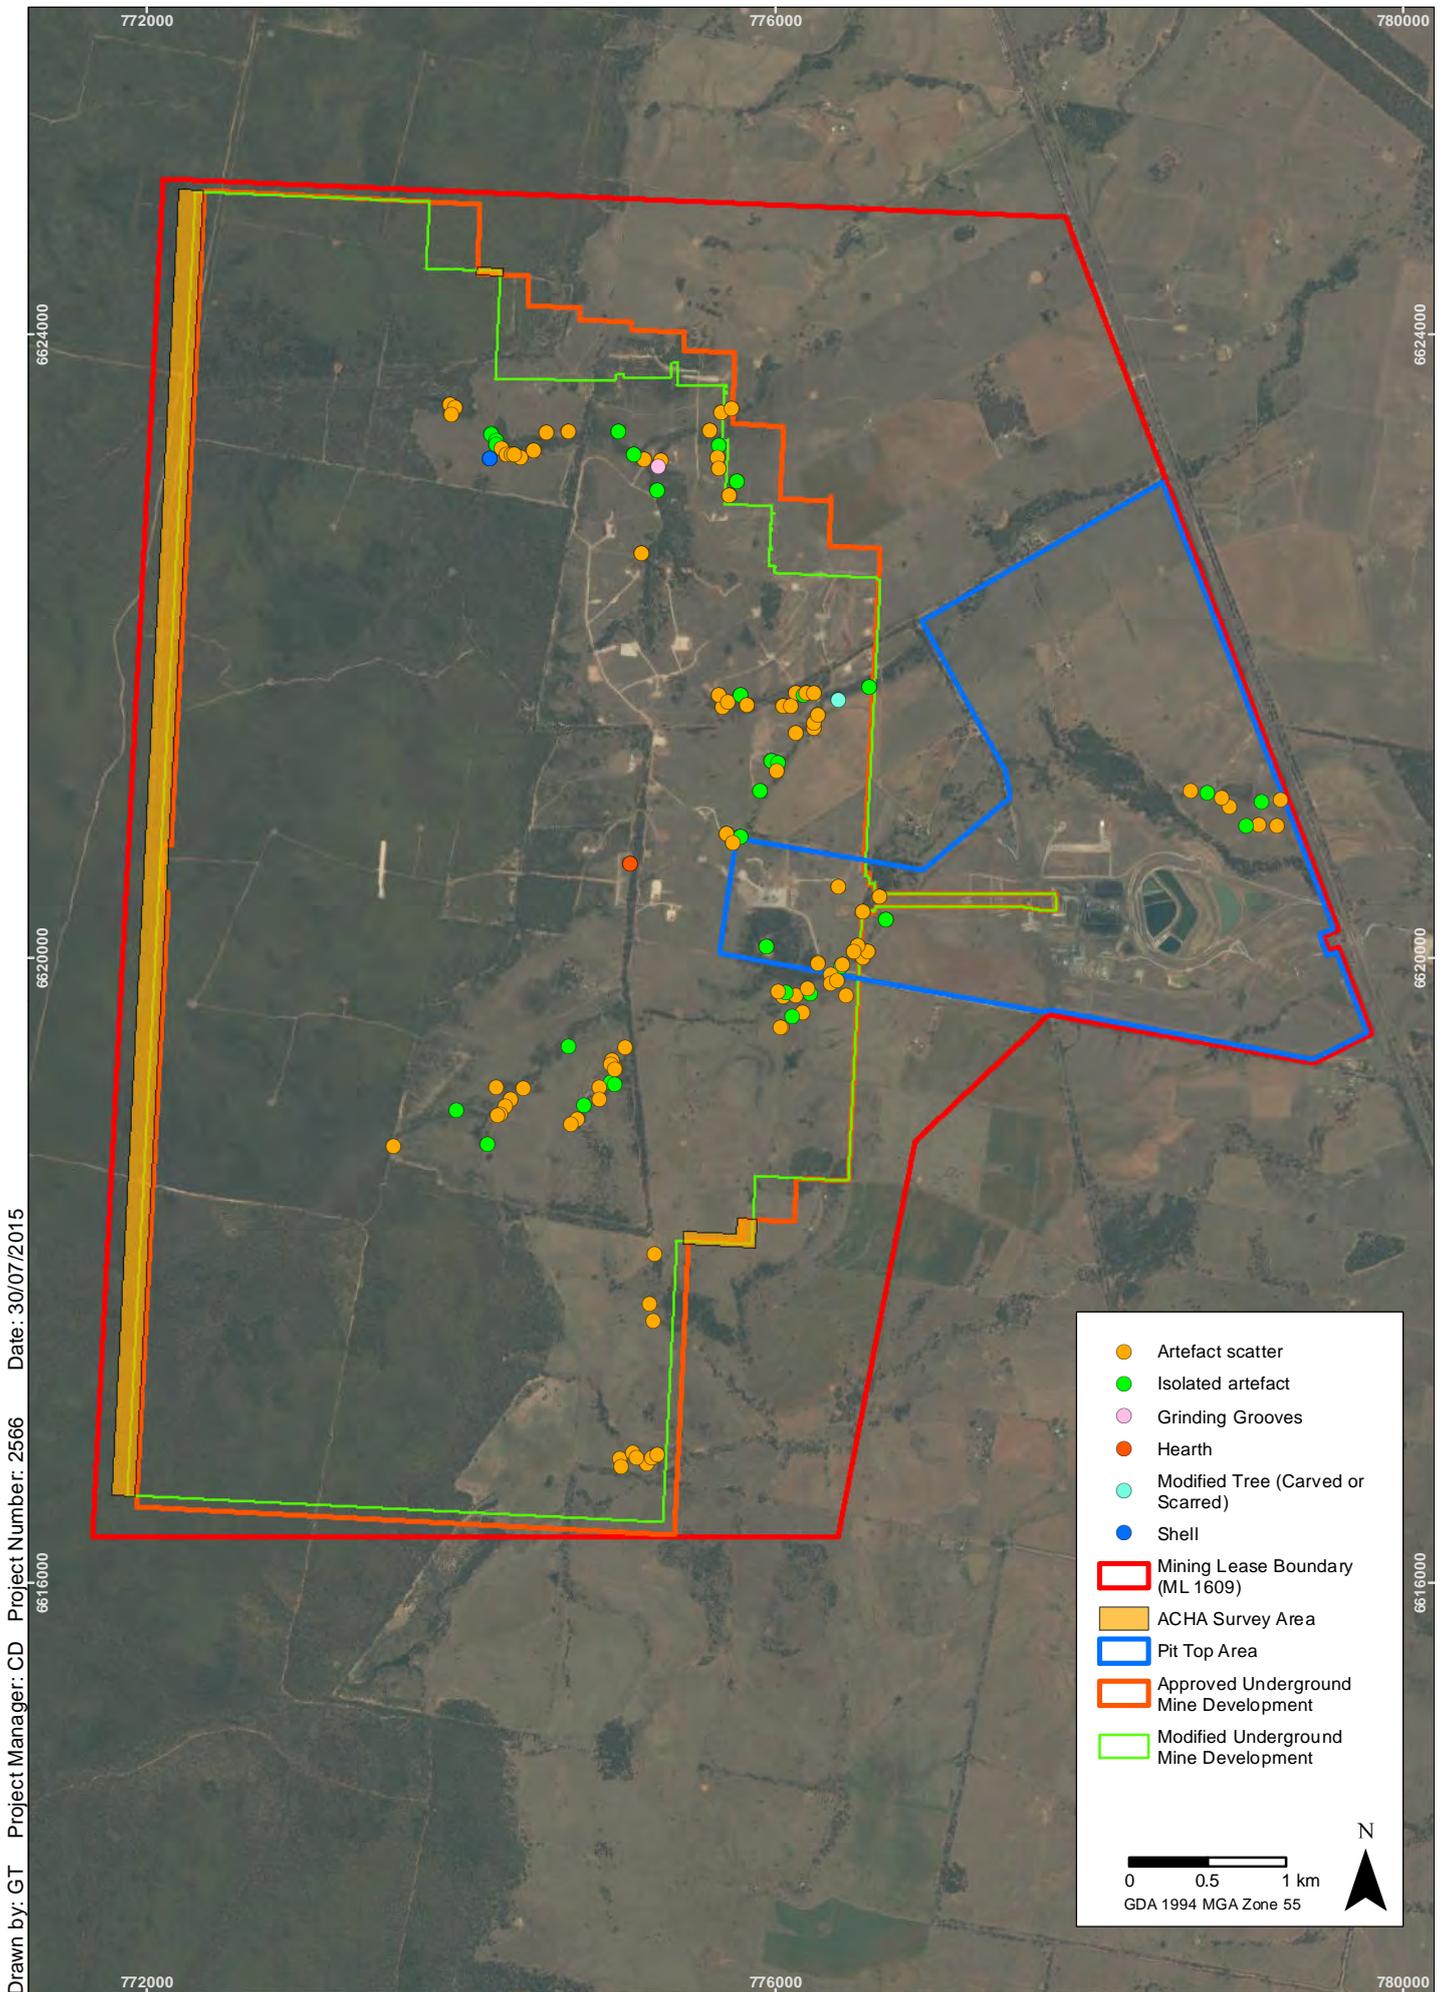
FIGURE 4

AHIMS search results  
Narrabri Mine Modification ACHA

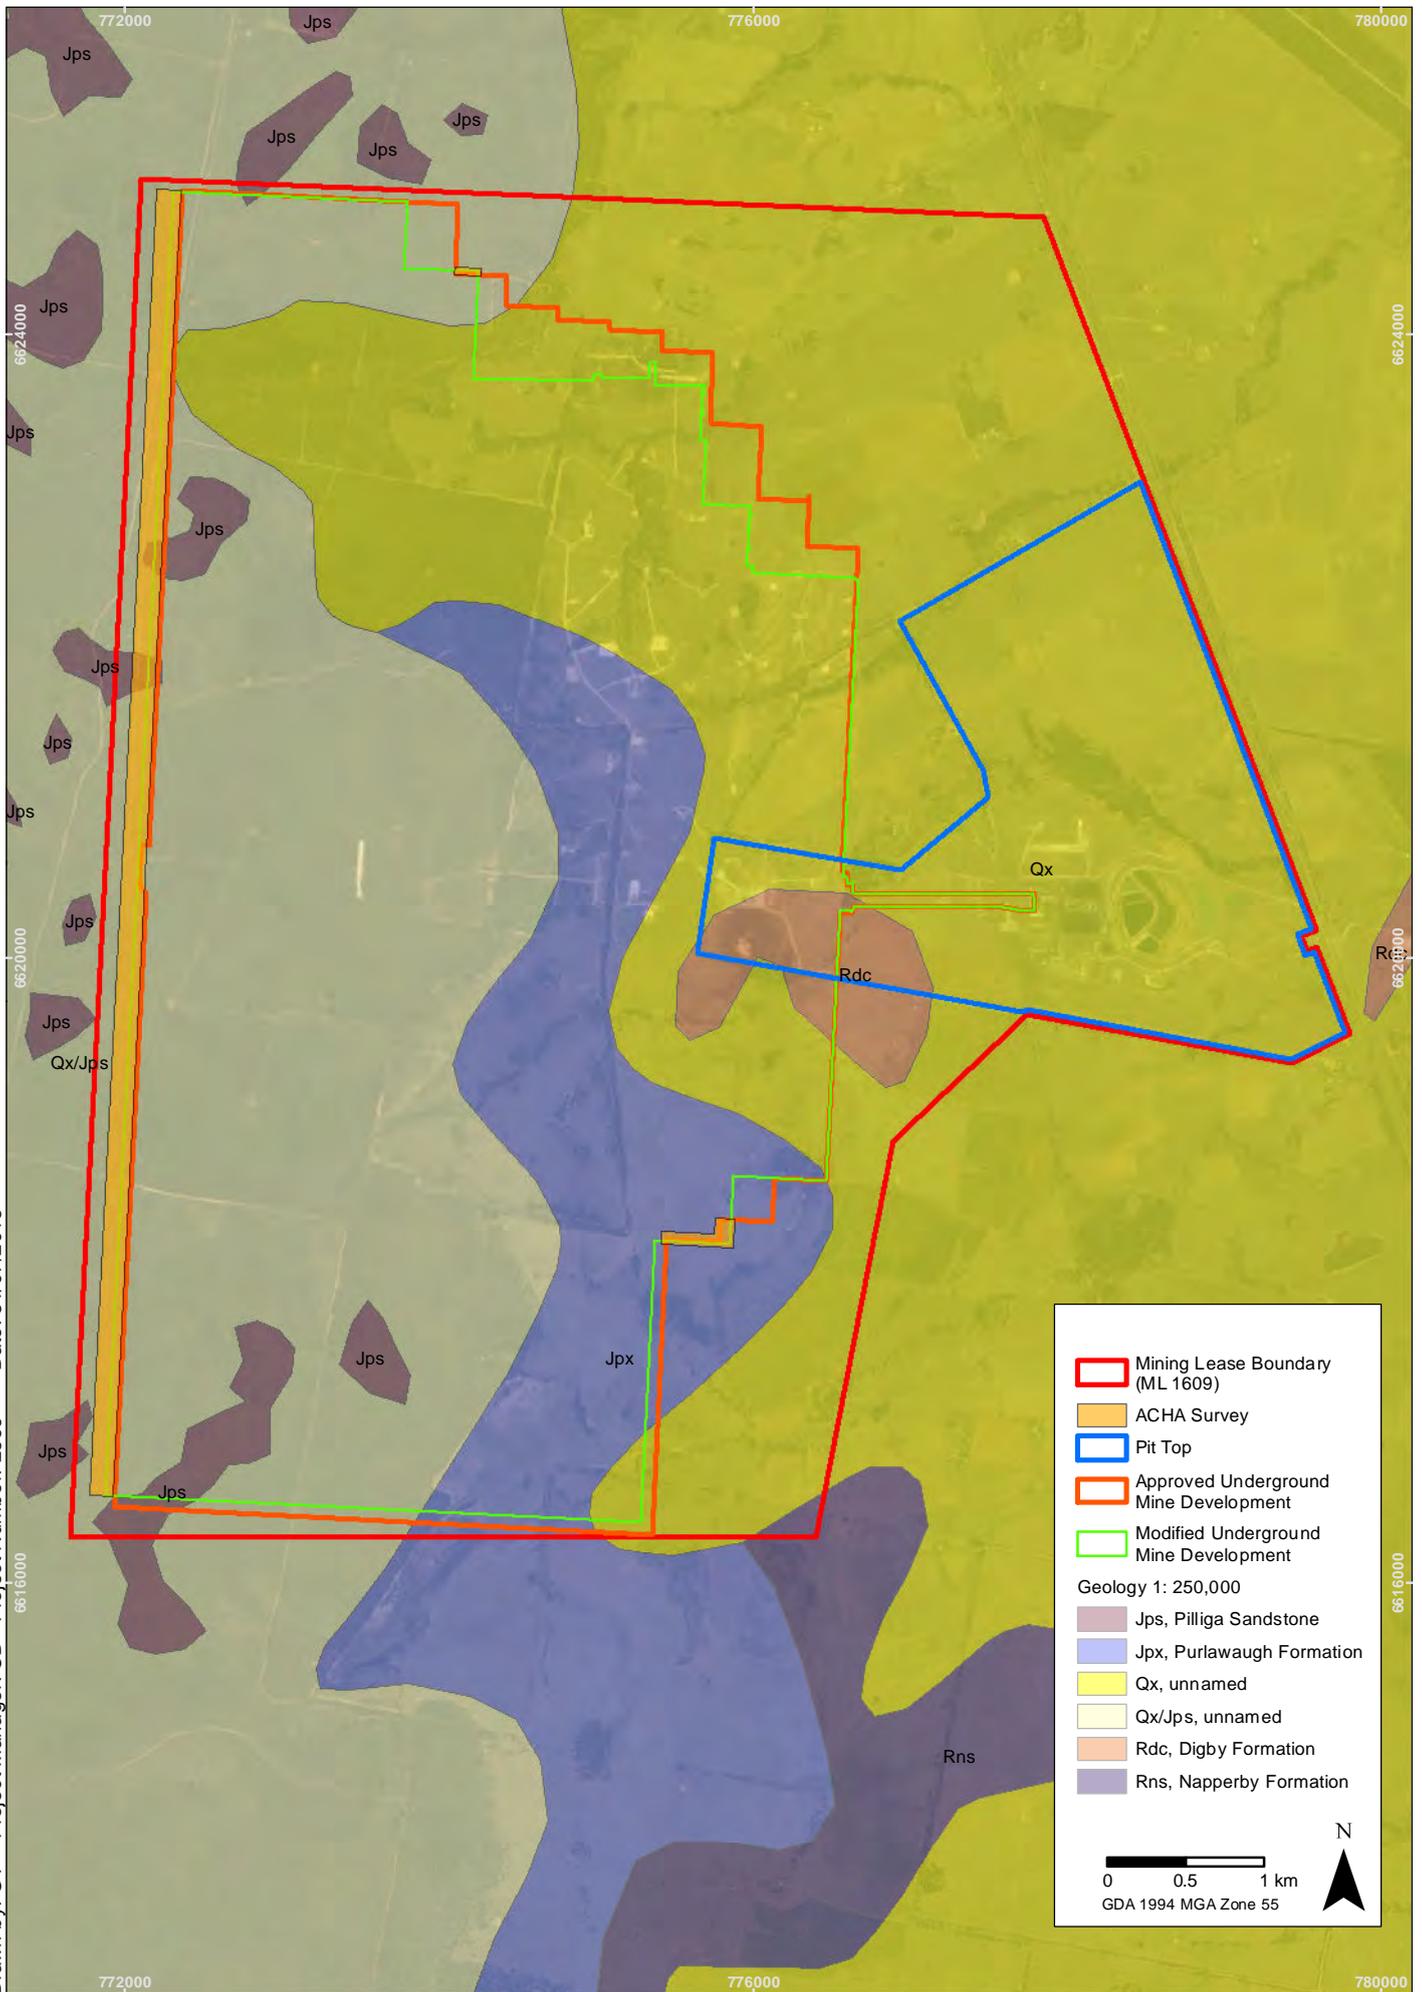
FIGURE 5

Geology of Modification Area  
Narrabri Mine Modification ACHA

The Gunnedah Basin Sequence is of the Permian to Triassic era. This contains the Napperby Formation which is up to 140 m thick coarsening up sequence of siltstone, sandstone, siltstone laminae and fine to medium grained quartz-lithic sandstone. An intrusive Basalt Sill exists in the lower part (i.e. 30 – 35 m above the base) of the Napperby Formation, varying in thickness between 0 – 30 m (typically 15 – 20 m thick). It does not continue into the surrounding rocks and is likely a result of cooling shrinkage. Within the basalt, strongly developed sub vertical fractures have been infilled with secondary chlorite and zeolite minerals (R.W. Corkery and Co Pty Ltd 2008).

The Digby Formation consists of two units, the lower Digby Conglomerate and the overlying Ulinda Sandstone (which does not occur in the Modification Subsidence Area). The Digby Conglomerate consists of thickly bedded, polymictic, lithic, pebble conglomerate with clasts of volcanic, meta sediment, and jasper in a lithic thick matrix which unconformably overlies the coal bearing Black Jack Group. Towards the top of the unit, sandstone beds are found. Within the Modification Subsidence Area, the Digby Conglomerate is between 15 – 20 m thick (R.W. Corkery and Co Pty Ltd 2008).

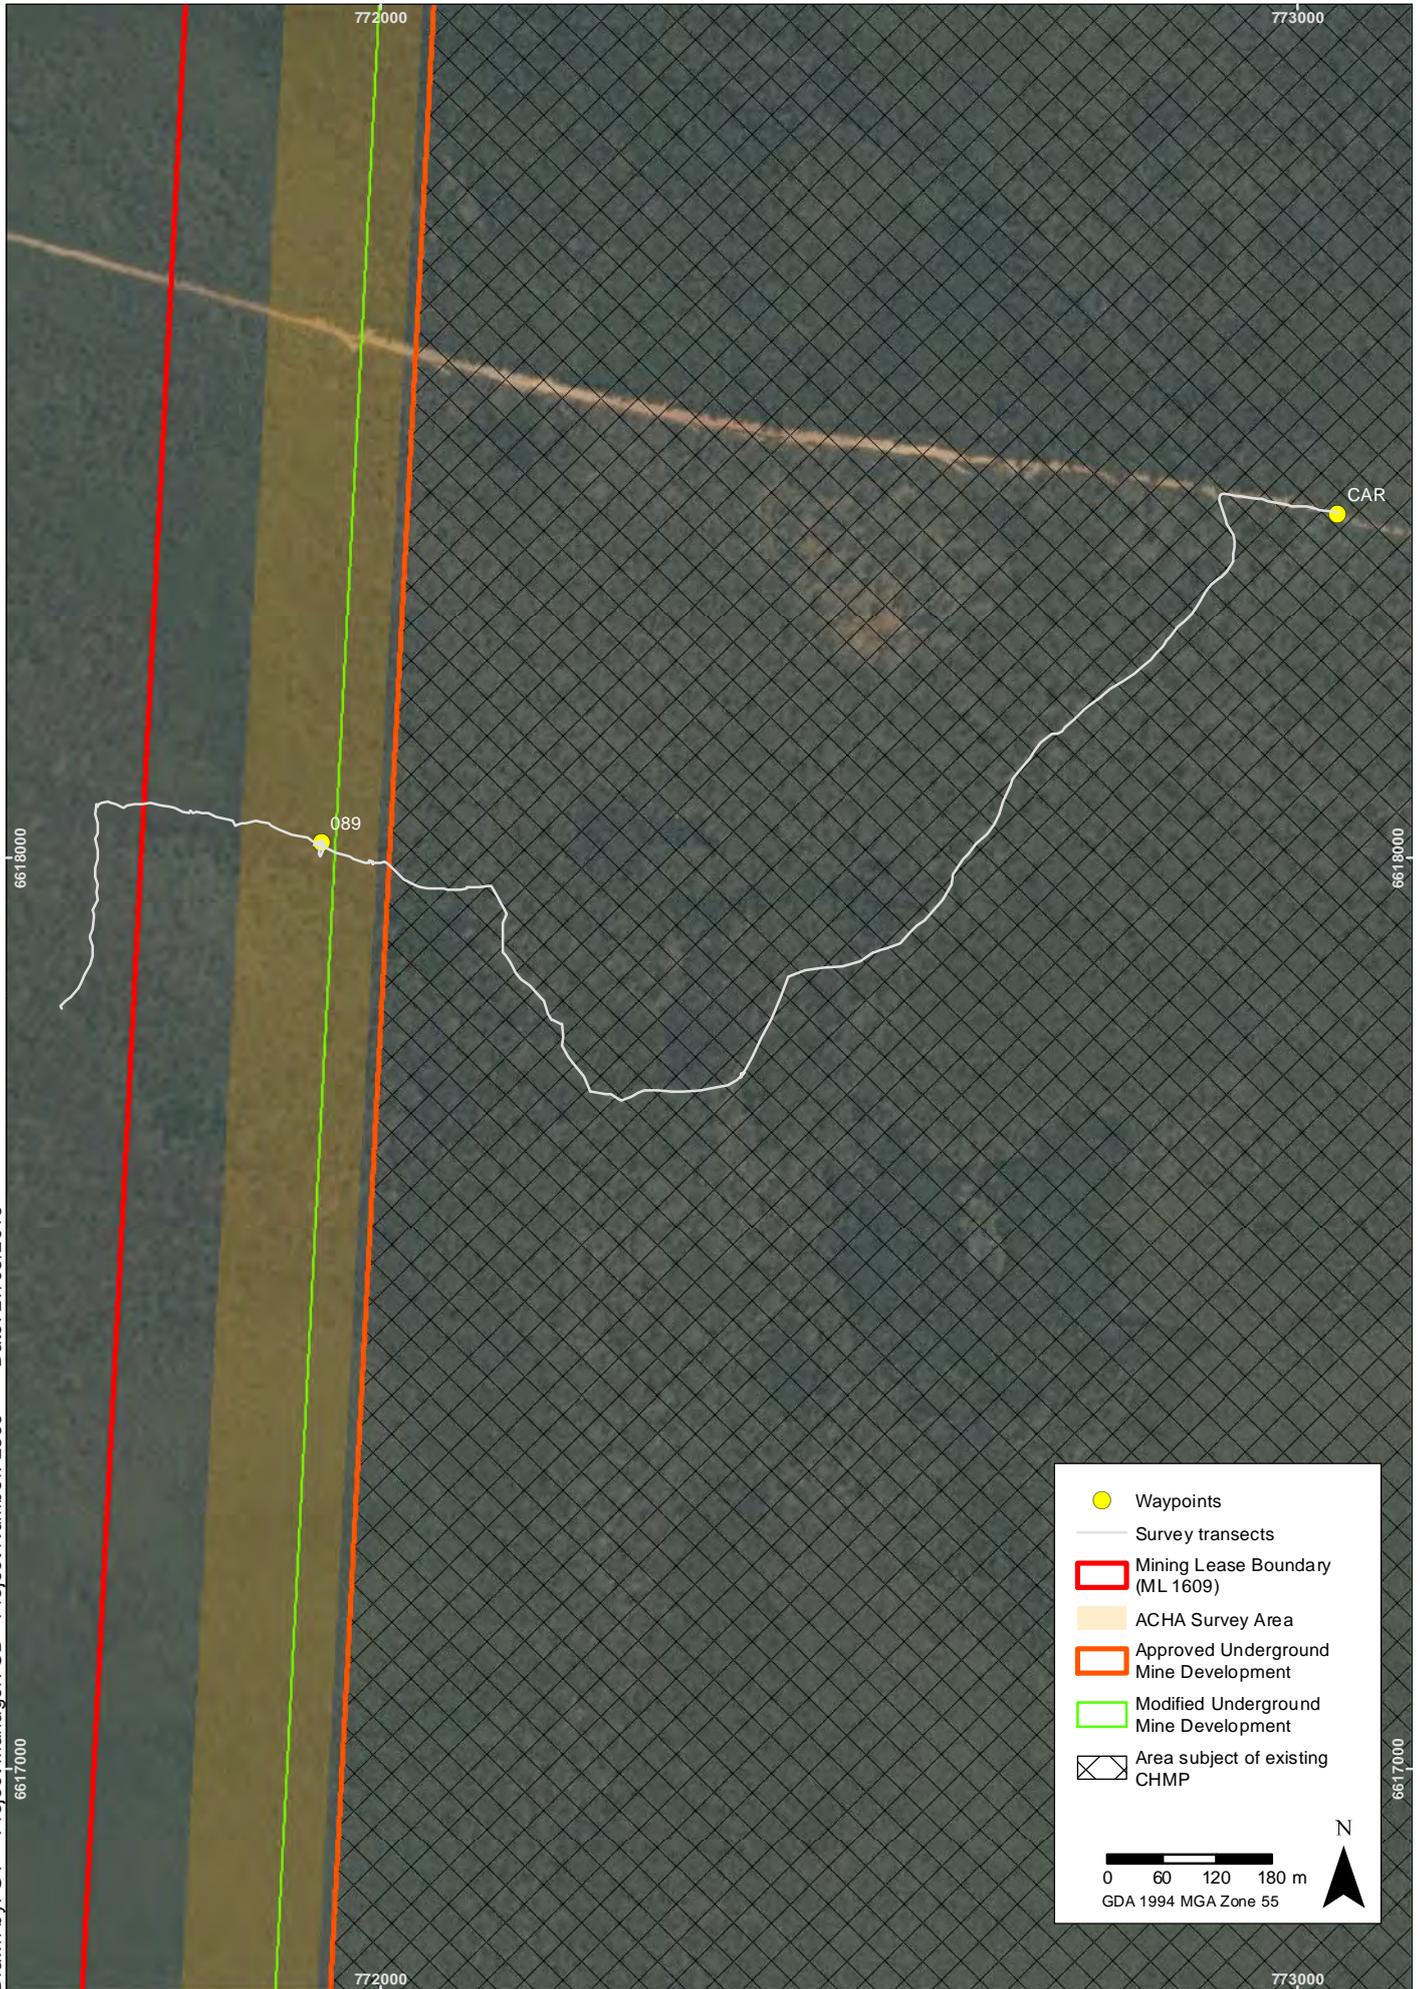
FIGURE 10

Transect 5

The landform in Transect 5 sloped downwards towards the east from a small hill, and a more clearly defined drainage depression was observed at the junction of the slopes with evidence of pooling in several locations along the depression. Vegetation included mature ironbark, Wilga (*Geijera parviflora*), Broombush, wattle, box trees, supplejack and Kurrajong (*Brachychiton populneus*) (Plate 12, Plate 13, Plate 14, Plate 15). Native grasses and leaf litter meant GSV was approximately 20 – 30% (Plate 16). No visible banks of the drainage feature were identified within the surveyed area, and it was concluded that water was not permanently available in this location.

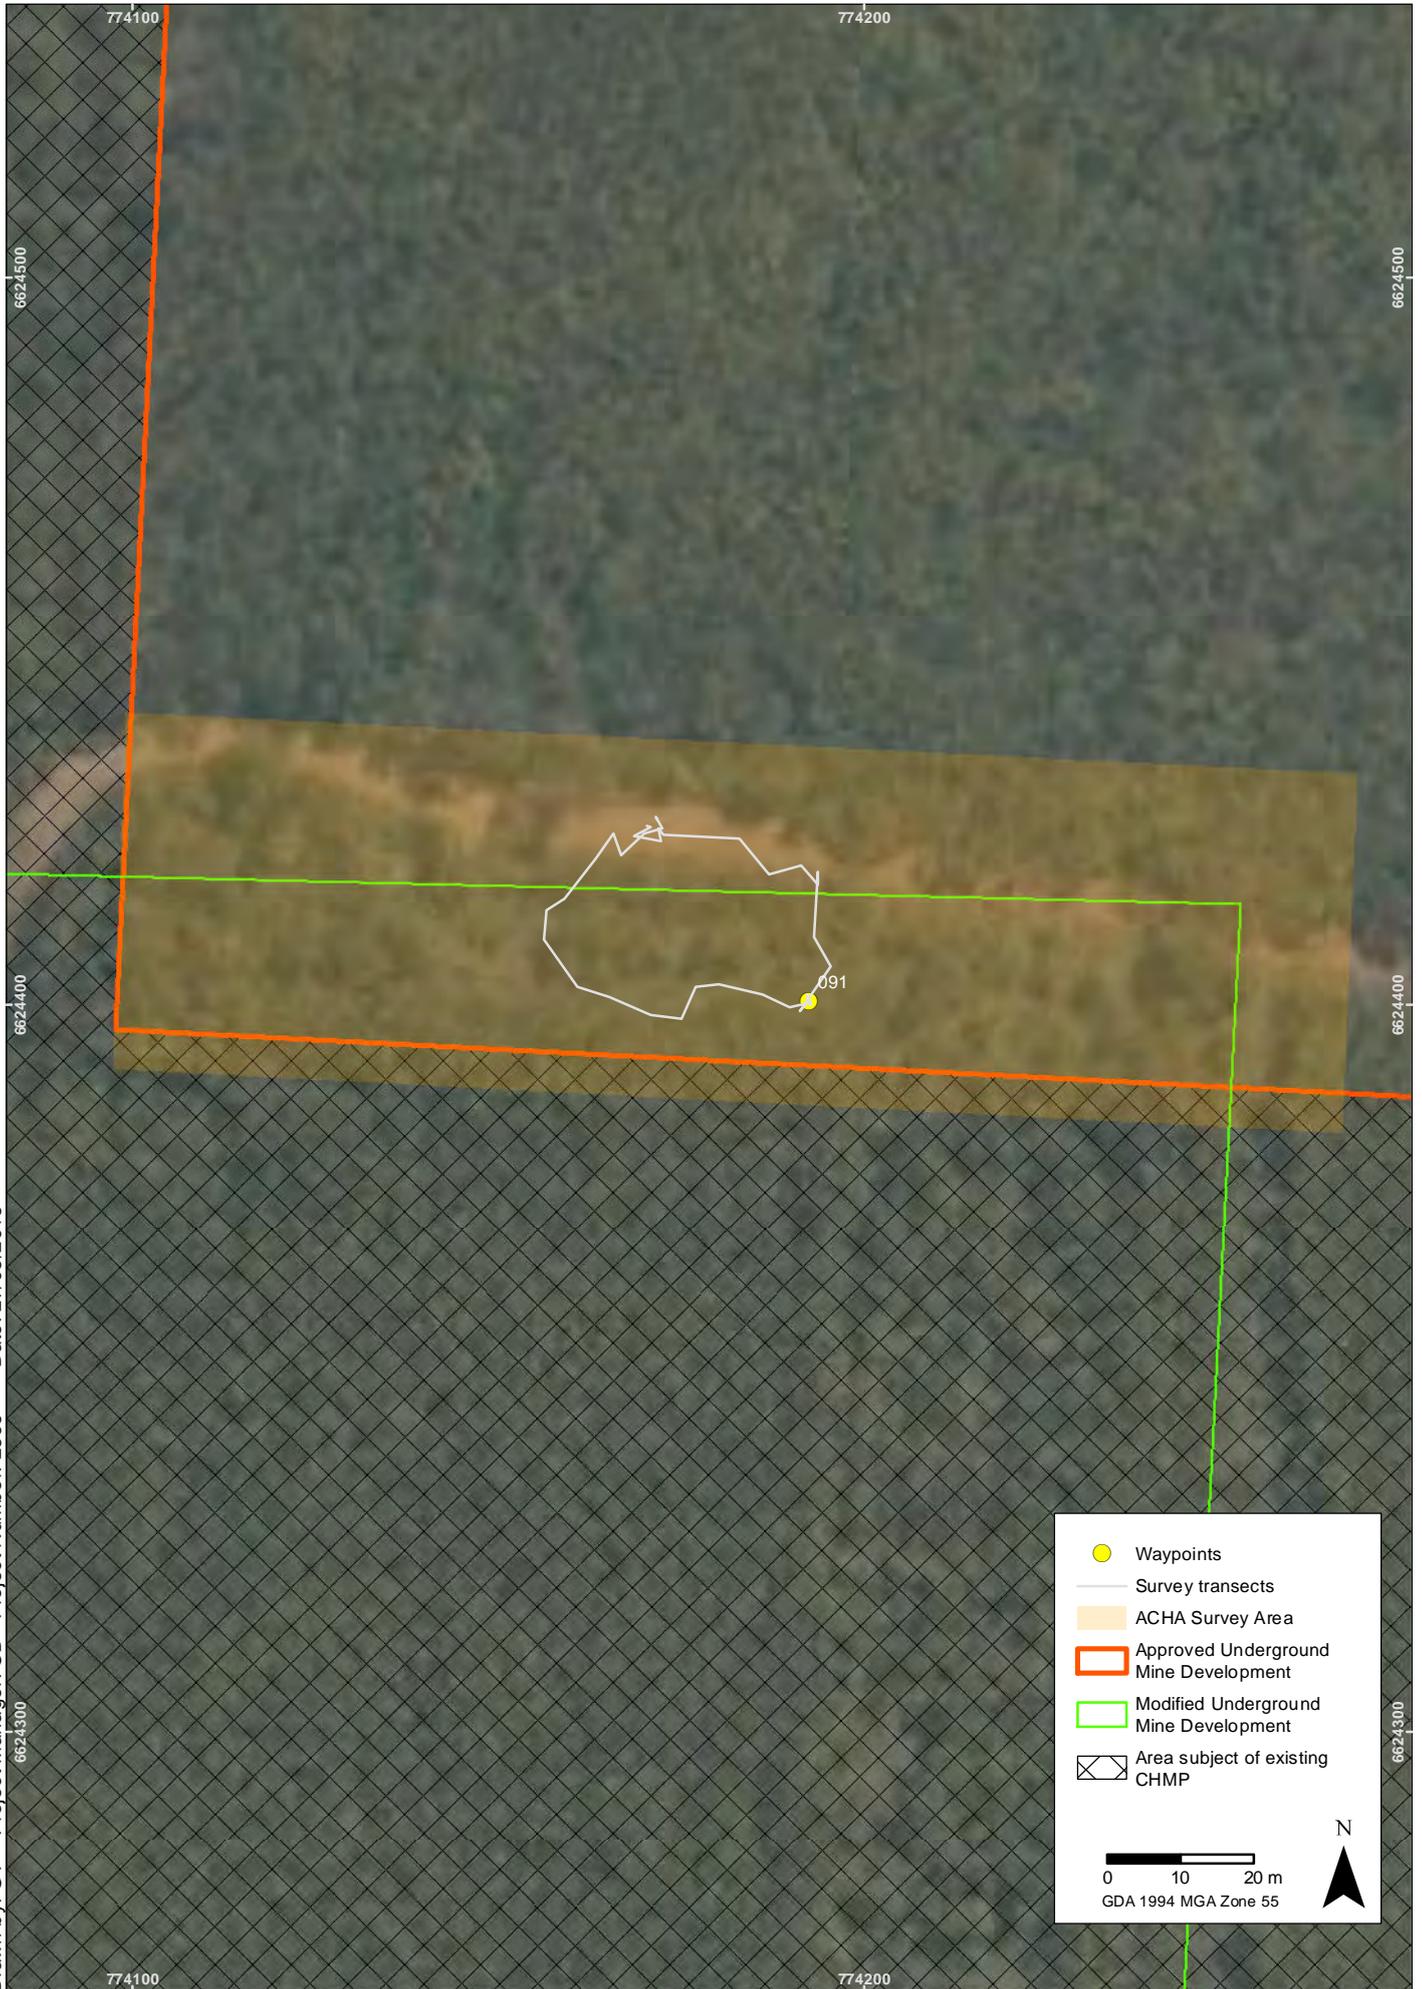
FIGURE 12

Transect 7

The terrain in Transect 7 was almost flat, with trees including immature ironbark, pine and Broombush (Plate 27, Plate 28, Plate 29, Plate 30). Native grasses and leaf litter on the loosely compacted soil reduced Ground Survey Visibility (GSV) to between 0 – 10% (Plate 31).
