Annual Review

Rocglen Coal Mine

Biobank Site Annual Report 2015-2016

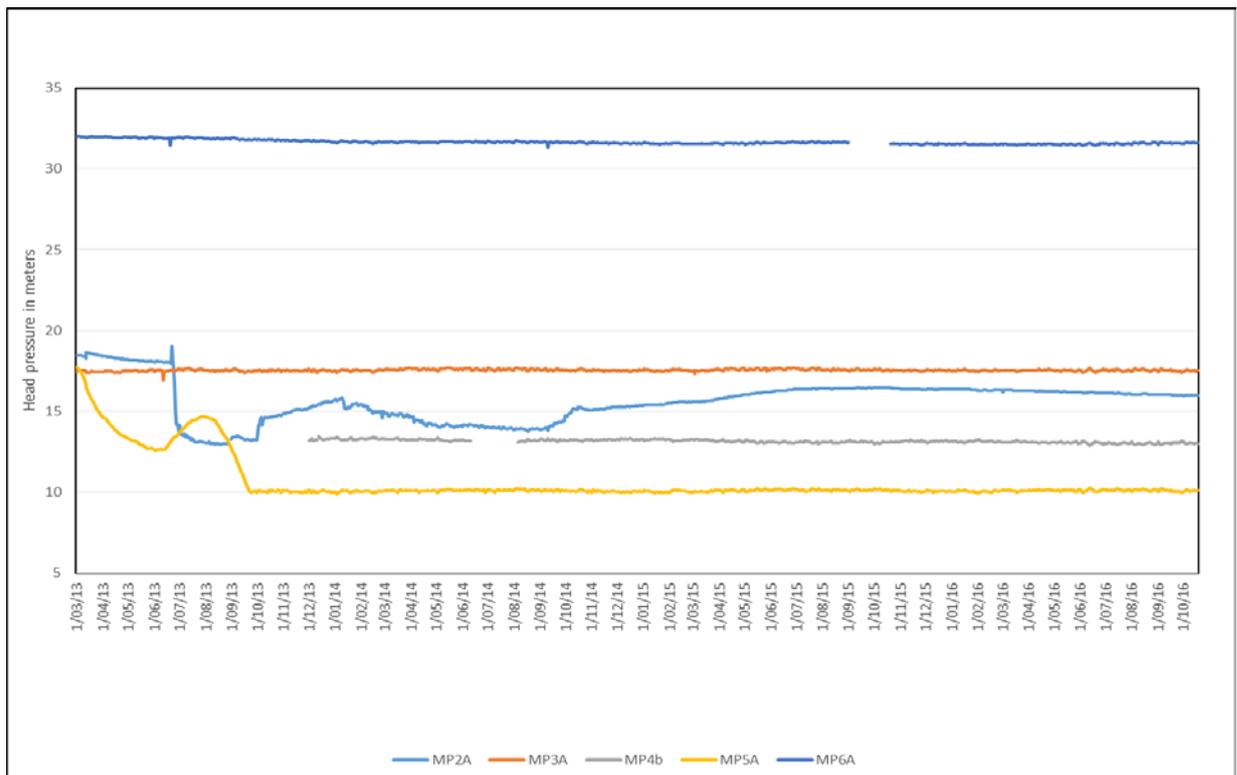
Figure 2 Rocglen VW Piezometers Ground Water Head Pressure

- WB5, located on the Roseberry property, and WB13 continue to show fluctuating levels associated with non-mining influences.
- MP-5a is a piezometer installed directly adjacent to MP-5. Since monitoring commenced in March 2013, it showed a reasonably consistent SWL until September 2013, where the SWL dropped 4.4m to 71.25m. The SWL dropped a further 5.3m in November 2013, where it remained consistent at around 76.6m. For the previous reporting period and this reporting period the bore has remained relatively consistent, dropping only 1.66m since the beginning of 2014. There remains insufficient data at this point to verify any ongoing trend, however being in relatively close proximity to the open cut pit (within 1km), drawdown is not unexpected.

The pressure transducers/loggers installed in monitoring bores on site in accordance with the EA show consistent groundwater levels at all 5 recording sites. These results are generally consistent with the results of quarterly monitoring undertaken in the reporting period for these monitoring bores. A summary of the pressure transducer monitoring data is provided in Figure 2.

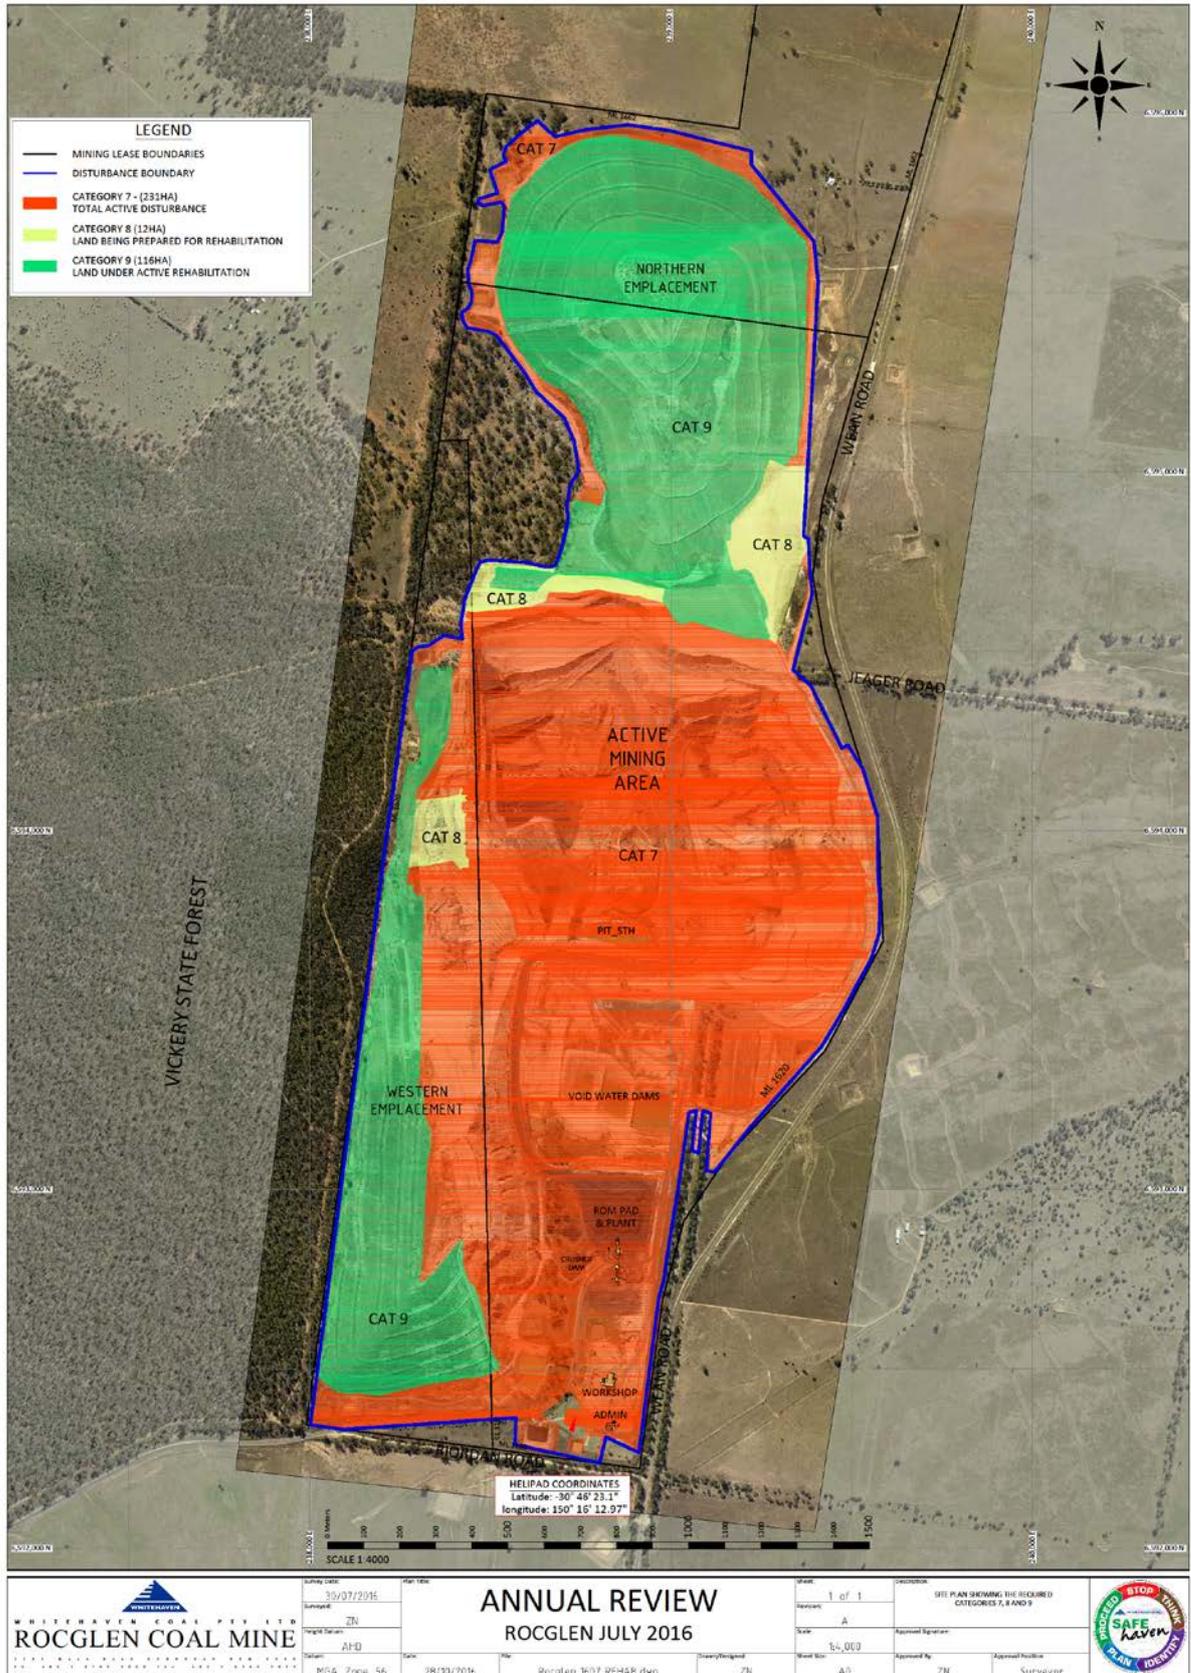
Figure 3 Rehabilitation and Mining Status

Mine Area Type ¹	Previous Reporting Period (Actual)	This Reporting Period (Actual)	Next Reporting Period (Forecast)
	2014/15 (ha)	2015/16 (ha)	2016/17 (ha)
A. Total Mine Footprint	360	360	360
B. Total Active Disturbance	NA	231.4	217.6
C. Land Being Prepared for Rehabilitation	NA	12.4	26.2
D. Land Under Active Rehabilitation	NA	116	116
E. Completed Rehabilitation	0	0	0

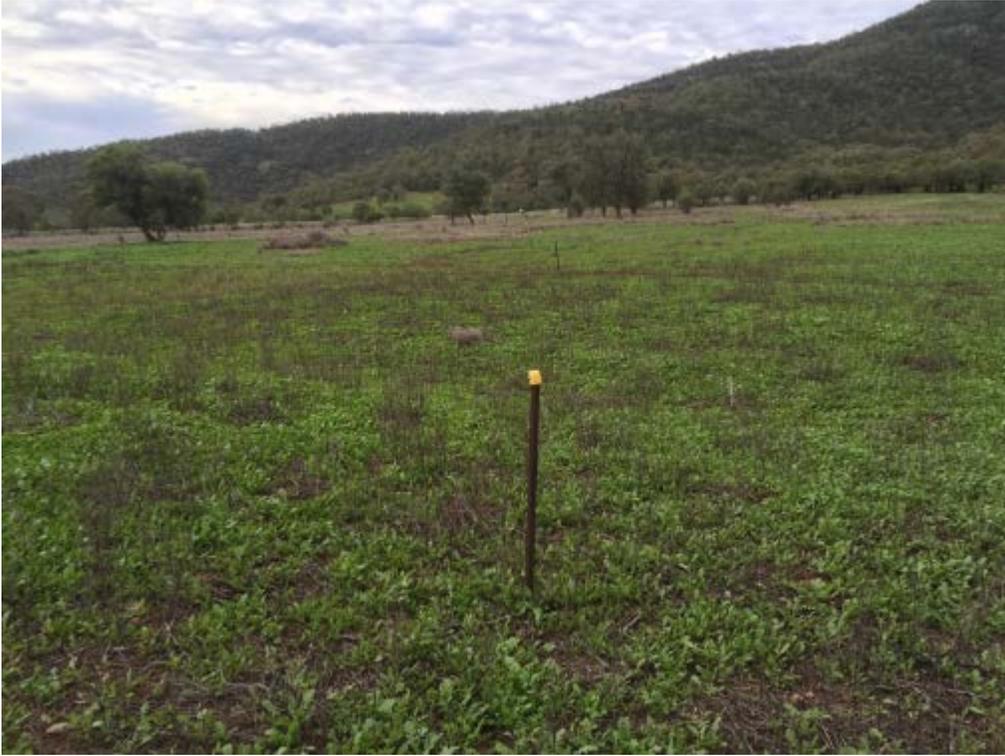
Photo Point 42	E240603	N6597014	24/07/16	3:31pm
----------------	---------	----------	----------	--------

Dam site that has been in-filled
From South West Corner
