Minutes of the 56th Meeting of the Tarrawonga Coal Mine Community Consultative Committee (TCCC)

Tarrawonga Coal Mine Community Consultative Committee Meeting #56

Quarterly Environmental Monitoring Report
1 February 2019 – 30 April 2019

WHITEHAVEN COAL OPERATIONAL NOISE MONITORING

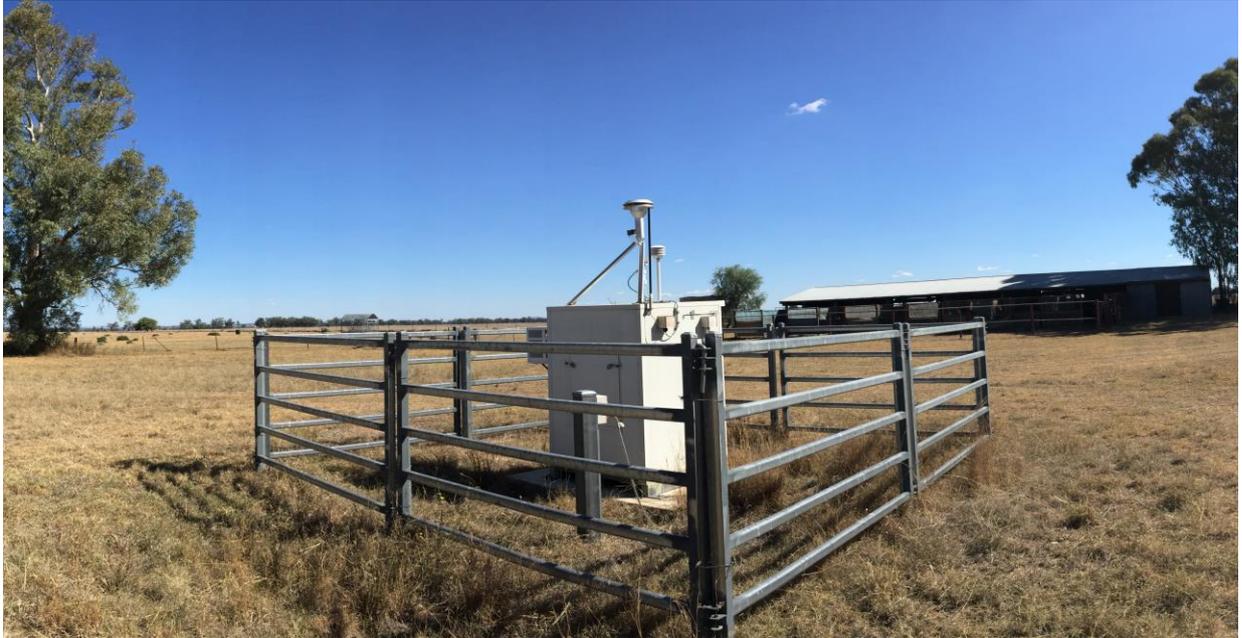
TEOM installed at Flixton property

According to the current Air Quality and Greenhouse gas Management Plan, the real time air quality unit (TEOM) installed at the “Flixton” property monitors PM₁₀ levels in ambient air. It is an operational management tool and dust levels nearing or reaching the nominated criteria will trigger actions onsite to assess the source of dust and modify operations if it is determined to be related to Tarrawonga operations.

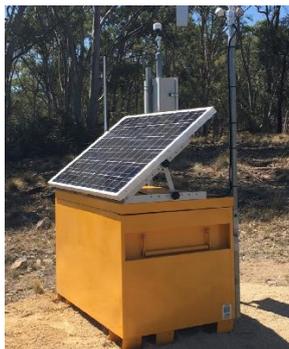
Portable Dust monitor installed at TCM in November 2018

Two Portable dust (PM10) monitors have been ordered to upgrade the air monitoring network. They have been installed and record continuously data

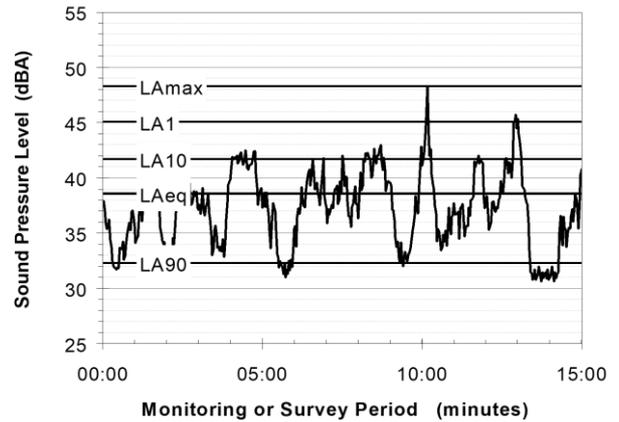
The following figure presents a hypothetical 15 minute noise survey, illustrating various common statistical indices of interest.

- LA1 The noise level exceeded for 1% of the 15 minute interval.
- LA10 The noise level exceeded for 10% of the 15 minute interval. This is commonly referred to as the average maximum noise level.
- LA90 The noise level exceeded for 90% of the sample period. This noise level is described as the average minimum background sound level (in the absence of the source under consideration), or simply the background level.
- LAeq The A-weighted equivalent noise level (basically the average noise level). It is defined as the steady sound level that contains the same amount of acoustical energy as the corresponding time-varying sound.

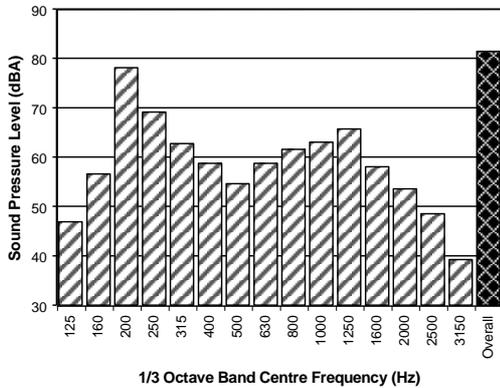
The following figure shows a 1/3 octave band frequency analysis where the noise is dominated by the 200 Hz band. Note that the indicated level of each individual band is less than the overall level, which is the logarithmic sum of the bands.

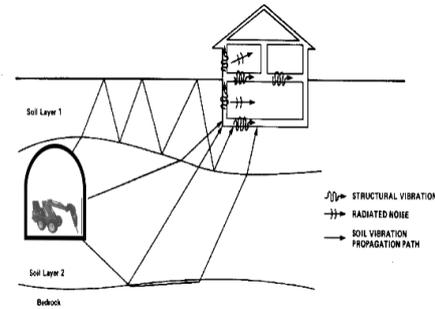
The following figure presents the various paths by which vibration and ground-borne noise may be transmitted between a source and receiver for construction activities occurring within a tunnel.
