# Appendix J

Soils and Land Suitability  
Assessment

## WINCHESTER SOUTH PROJECT Environmental Impact Statement

# Soils and Land Suitability Assessment

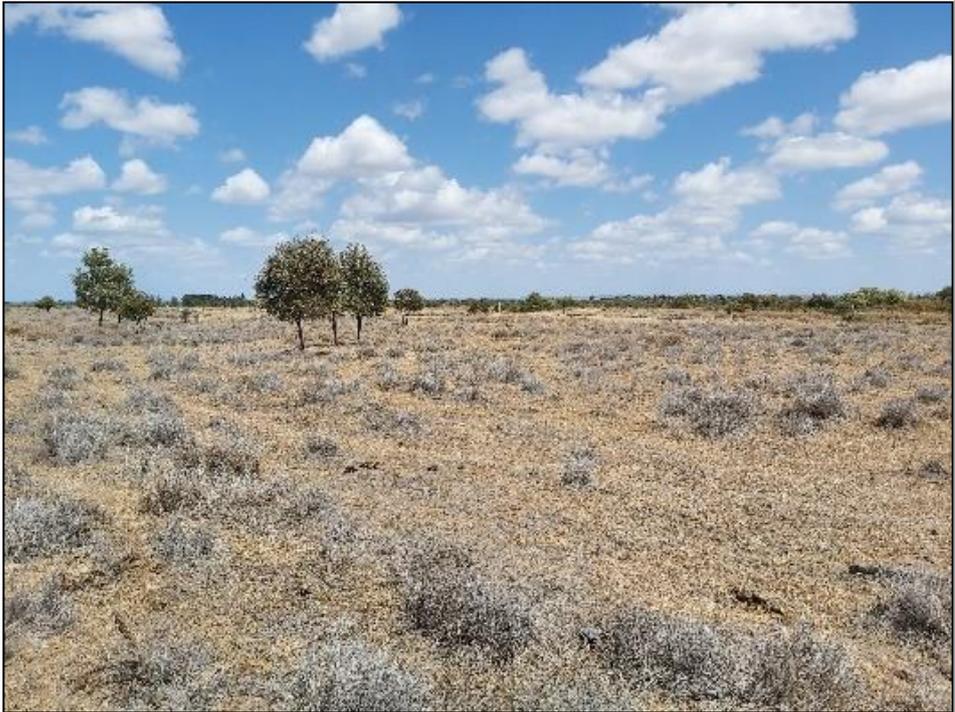
C1-BL soils in depression positions are firm, with a cracking and crusting surface, featuring uniform dark clays extending 1.0 m below the surface. Soils are dominant black clays with minor interfingering sub-dominant brown clays. Soils associated with mound positions are similar but with higher likelihood of poorer quality subsoils from increased salt, sodium and sodic attributes. This SMU is suitable for light grazing of native pastures.

<b>Location GDA94 ZONE 55</b>	638156 mE 7542869 mN
<b>Current land use</b>	Grazing
<b>Site survey type</b>	Detailed, 50 mm hand auger
<b>Vegetation</b>	Dawson Gum and Brigalow regrowth
<b>Disturbance</b>	Semi-disturbed
<b>Landform element /pattern</b>	Flat Plain
<b>Micro relief</b>	Melon hole 40% coverage, 3-10 m wide, 0.3-0.6 m deep
<b>Permeability</b>	Slowly permeable
<b>Drainage</b>	Moderate
<b>Erosion</b>	Nil erosion
<b>Slope (%)</b>	1.0%/<1.0%
<b>Surface coarse fragments</b>	Nil coarse fragments
<b>Surface condition</b>	Firm, cracking

<b>Soil quality for mine rehabilitation</b>	<p><b>Recommended topsoil strip depth:</b> 0.00-0.10 mbgl (mound positions). 0.00-0.30 mbgl (depression positions).</p> <p><b>Recommended topsoil use:</b> support establishment of native vegetation and grasses, or other appropriate species, on level plains.</p> <p><b>Recommended subsoil strip depth:</b> 0.00 mbgl.</p> <p><b>Recommended subsoil use:</b> no rehabilitation stripping recommendations for subsoils. Potential reuse as capping for waste rock due to limitations to a depth of 1.00 mbgl.</p>
<b>ASS/PASS field assessment</b>	<p>Low field indication of potential acid sulfate soil (PASS).</p> <p>No field indicators of actual acid sulfate soil (AASS).</p>
<b>Total area (ha)</b>	670

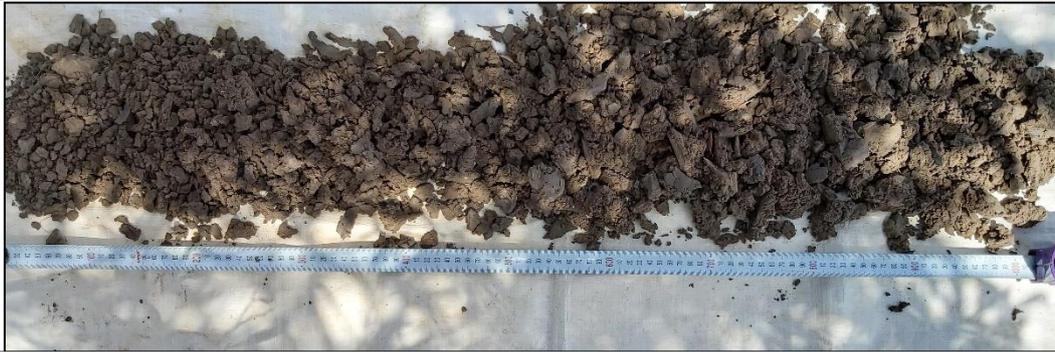
Site 2-m

**Table 4-3: Soil Profile Morphology Summary SMU C1-BL - Mound position**

Horizon Depth (m), Boundary	Field / Lab Texture	Structure Strength	Inclusions Segregations	Colour, Mottle, Bleaching	Moisture Drainage	Roots	Depth (m) / Field pH
A1 0.00-0.12 Abrupt	Medium clay / Silty clay	Moderate, very firm, subangular <10 mm	Nil	10YR3/2 Very dark greyish brown Nil mottles / bleaching	Dry, well to moderate	Common	0.05 / 5.5-6.0	0.00-0.10 0.20-0.30 0.50-0.60 0.70-0.80 0.90-1.00
B21 0.12-0.50 Abrupt	Medium heavy clay / Medium clay	Moderate, very firm, subangular <20 mm	Nil	10YR3/1 Very dark grey Nil mottles / bleaching	Dry, moderate	Few	0.30 / 5.5-6.0	
B22 0.50-100 End of Borehole (EOBH)	Medium heavy clay / Medium clay	Moderate, very firm, subangular <40 mm	Nil	10YR3/1 Very dark grey Nil mottles / bleaching	Dry, moderate	Few	0.60 / 5.5-6.0 0.90 / 5.5

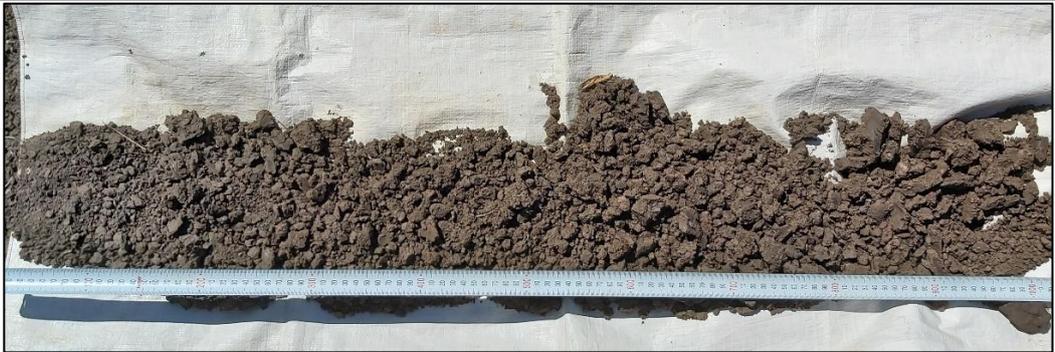
Site 2-d

**Table 4-4: Soil Profile Morphology Summary SMU C1-BL – Depression position**

Horizon Depth (m), Boundary	Field Texture / Lab Texture <sup>1</sup>	Structure Strength	Inclusions Segregations	Colour, Mottle, Bleaching	Moisture Drainage	Roots	Depth (m) / Field pH
A1 0.00-0.13 Abrupt	Medium clay / Silty clay	Weak, very firm, subangular <10 mm	Nil	10YR3/2 Very dark greyish brown Nil mottles / bleaching	Dry, well to moderate	Common	0.10 / 5.5-6.0	0.00-0.10 0.20-0.30 0.50-0.60 0.70-0.80 0.90-1.00
B21 0.13-0.61 Abrupt	Medium heavy clay / Medium clay	Moderate, very firm, subangular <20 mm	Nil	10YR3/1 Very dark grey Nil mottles / bleaching	Dry, moderate	Few	0.30 / 5.5-6.0	
B22 0.61-1.00 EOBH	Medium heavy clay / Medium clay	Moderate, very firm, subangular 10-30 mm	Nil	10YR3/1 Very dark grey Nil mottles / bleaching	Dry, moderate	Few	0.60 / 5.5-6.0 0.90 / 5.5

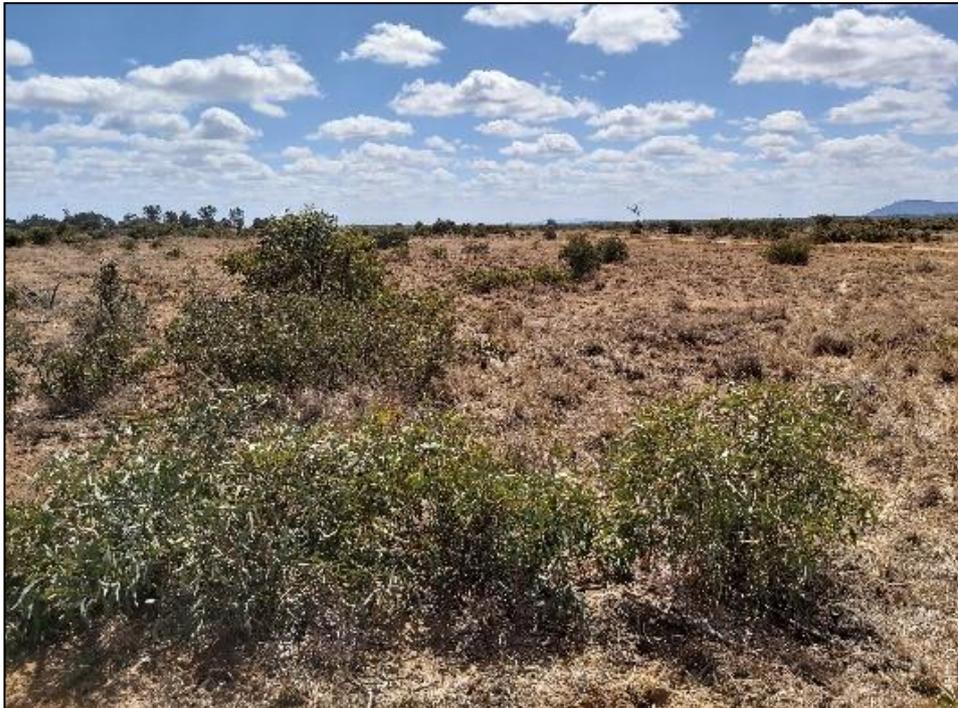
C1-BR soils in depression positions are firm, with a cracking and crusting surface, featuring uniform dark clays extending 1.0 m below the surface. Soils are dominant brown clays with minor interfingering sub-dominant black clays. Soils associated with mound positions are similar but with higher likelihood of poorer quality subsoils from increased salt, sodium and sodic attributes. This SMU is suitable for light grazing of native pastures.

<b>Location GDA94 ZONE 55</b>	635942 mE 7541225 mN
<b>Current land use</b>	Grazing
<b>Site survey type</b>	Detailed, 50 mm hand auger
<b>Vegetation</b>	Dawson Gum and Brigalow regrowth
<b>Disturbance</b>	Semi-disturbed
<b>Landform element /pattern</b>	Midslope
<b>Micro relief</b>	Melon hole 50% coverage, 3-6m wide, 0.2-0.4m deep
<b>Permeability</b>	Slowly permeable
<b>Drainage</b>	Moderate
<b>Erosion</b>	Nil erosion
<b>Slope (%)</b>	<2.0%/1.0%
<b>Surface coarse fragments</b>	Nil coarse fragments
<b>Surface condition</b>	Cracking
<b>ASC order (s)</b>	Brown Vertosol

<b>Soil quality for mine rehabilitation</b>	<p><b>Recommended topsoil strip depth:</b> 0.00-0.10 mbgl (mound positions), 0.30 mbgl (depression positions).</p> <p><b>Recommended topsoil use:</b> support establishment of native vegetation and grasses, or other appropriate species, on level plains.</p> <p><b>Recommended subsoil strip depth:</b> 0.00 mbgl.</p> <p><b>Recommended subsoil use:</b> no rehabilitation stripping recommendations for subsoils. Potential reuse as capping for waste rock due to limitations to a depth of 1.00 mbgl.</p>
<b>ASS/PASS field assessment</b>	<p>Low field indication of PASS.</p> <p>No field indicators of AASS.</p>
<b>Total area (ha)</b>	3,189

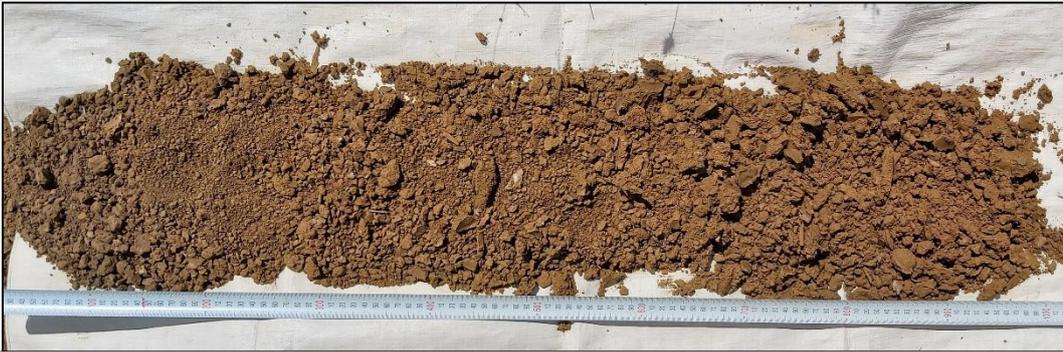
Site 9-m

Horizon Depth (m), Boundary	Field / Lab Texture	Structure Strength	Inclusions Segregations	Colour, Mottle, Bleaching	Moisture Drainage	Roots	Depth (m) / Field pH	Samples (m)
	A1 0.00-0.09 Abrupt	Light clay / Light medium clay	Weak, firm, subangular < 10 mm	<2% manganese nodules	10YR3/3 Dark brown Nil mottles / bleaching	Dry, well to moderate	Common	0.10 / 6.5	0.00-0.09 0.20-0.30 0.50-0.60 0.70-0.80 0.90-1.00
	B21 0.09-0.60 Abrupt	Light medium clay / Medium clay	Weak, firm, subangular < 10 mm	<1% manganese nodules	7.5YR4/3 Brown Nil mottles / bleaching	Dry, moderate	Few	0.30 / 7.5 0.60 / 7.5	
B22 0.60-1.00 EOBH	Light medium heavy clay / Medium clay	Weak, firm, subangular 10-20 mm	Nil	7.5YR4/3 Brown Nil mottles / bleaching	Dry, moderate	Few	0.90 / 6.5

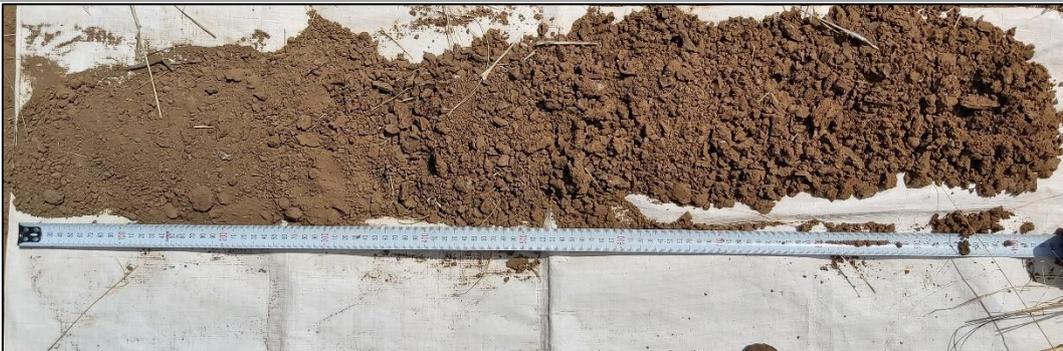
Site 9-d

**Table 4-9: Soil Profile Morphology Summary SMU C1-BR – Depression position**

Horizon Depth (m), Boundary	Field Texture/ Lab Texture <sup>1</sup>	Structure Strength	Inclusions Segregations	Colour, Mottle, Bleaching	Moisture Drainage	Roots	Depth (m) / Field pH	Samples (m)
	A1 0.00-0.12 Abrupt	Light clay / Light medium clay	Weak, weak, subangular < 10 mm	Nil	10YR3/4 Dark yellowish brown Nil mottles / bleaching	Dry, well to moderate	Common	0.10 / 4.5	0.00-0.10 0.20-0.30 0.50-0.60 0.70-0.80 0.90-1.00
	B21 0.12-0.38 Abrupt	Light medium clay / Medium clay	Moderate, weak, subangular < 10 mm	<1% manganese nodules	10YR3/4 Dark yellowish brown Nil mottles / bleaching	Dry, moderate	Few	0.30 / 5.5 0.60 / 5.5	
B22 0.38-1.00 EOBH	Medium clay / Medium clay	Moderate, firm, subangular 10-20 mm	Nil	10YR3/3 Dark brown Nil mottles / bleaching	Dry, moderate	Few	0.90 / 5.5

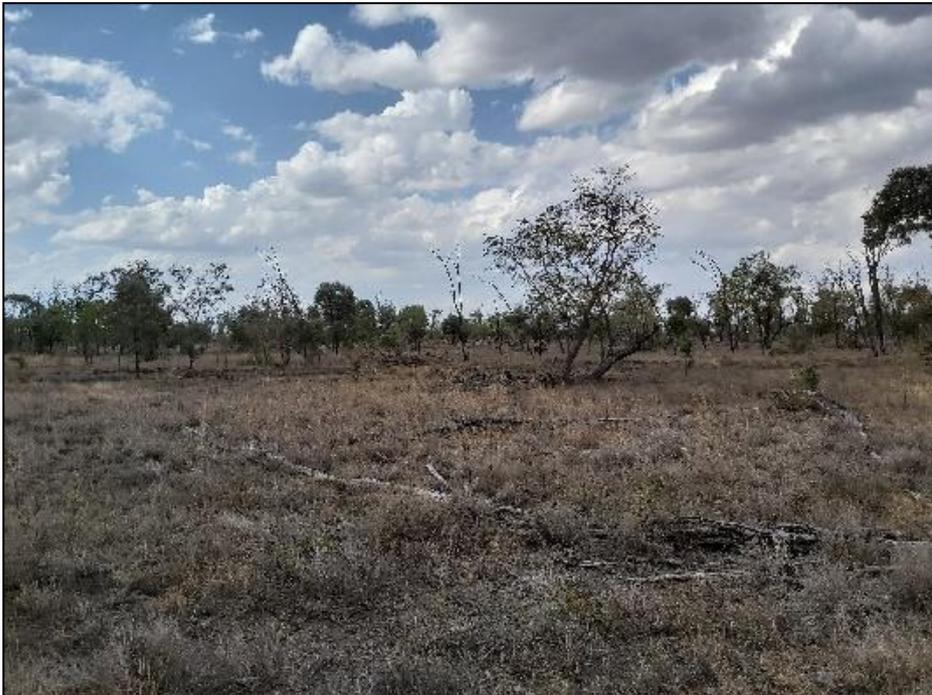
C3-BL soils are firm, with a cracking surface, featuring uniform dark clays with unmappable, very minor microrelief observed extending 1.0 m below the surface. Soils are dominant black clays with minor interfingering sub-dominant brown clays. Soils have dispersive attributes in subsoils with minor salinity attributes increasing with depth. This SMU is suitable for a wide range of current and potential broadacre and horticultural crops.

<b>Location GDA94 ZONE 55</b>	633162 mE 7547605 mN
<b>Current land use</b>	Grazing
<b>Site survey type</b>	Detailed, 50 mm hand auger
<b>Vegetation</b>	Native grassland
<b>Disturbance</b>	Semi-/Extensive disturbed
<b>Landform element /pattern</b>	Simple / mid slope
<b>Micro relief</b>	Nil
<b>Permeability</b>	Slowly permeable
<b>Drainage</b>	Moderately well drained
<b>Erosion</b>	Nil erosion
<b>Slope (%)</b>	1.0%-2.0%
<b>Surface coarse fragments</b>	White nodules <1%
<b>Surface condition</b>	Firm, cracking
<b>ASC order (s)</b>	Black Vertosol
<b>Land suitability summary</b>	<p><b>Plant Available Water Capacity (RPI 08/14 Soil Texture Table):</b> 114 mm/100 cm  <b>Identified Physical and/or Chemical Limitation:</b> Sodicity increasing at 0.60 mbgl  <b>Estimated effective rooting depth:</b> 1.00 mbgl  <b>Estimated soil water storage:</b> 114 mm  <b>Land Suitability (Cropping) Class:</b> 3  <b>Land Suitability (Grazing) Class:</b> 3  <b>Agricultural Land Class:</b> A1</p>

Item	Description
<b>Erosion potential</b>	<p>The assessment included reviewing the laboratory data and landform factors;</p> <ul style="list-style-type: none"> <li>• Texture: clays</li> <li>• Sodicty / ESP: non-sodic increasing to moderately sodic in subsoils at 0.50 mbgl</li> <li>• Ca:Mg: very high decreasing to high in subsoils;</li> <li>• R1 Dispersion: low levels throughout</li> <li>• K-factor: 0.025, moderate (Foster et al., 1981)</li> <li>• Landform: flat to gently undulating plains</li> <li>• Water Erosion - Topsoil (Regional Frameworks): 2</li> <li>• Erosion Hazard - Subsoils (Regional Frameworks): 3</li> </ul> <p>Erosion potential through dispersion is assessed as low to moderate in topsoil, increasing with subsoils. Appropriate management of bare earths should be considered when stockpiling and for reuse of this SMU for rehabilitation activities.</p>
<b>Soil quality for mine rehabilitation</b>	<p><b>Recommended topsoil strip depth:</b> 0.00-0.30 mbgl  <b>Recommended topsoil use:</b> support establishment of native vegetation and grasses, or other appropriate species.  <b>Recommended subsoil strip depth:</b> 0.00 mbgl  <b>Recommended subsoil use:</b> no rehabilitation stripping recommendations for subsoils. Potential reuse as capping for waste rock due to limitations to a depth of 1.00 mbgl.</p>

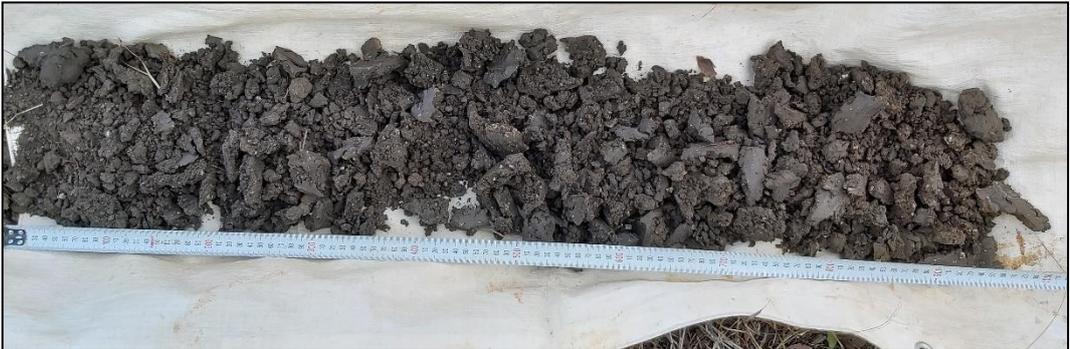
Site 51

**Table 4-13: Soil Profile Morphology Summary SMU C3-BL**

Horizon Depth (m), Boundary	Field / Lab Texture	Structure Strength	Inclusions Segregations	Colour, Mottle, Bleaching	Moisture Drainage	Roots	Depth (m) / Field pH	Samples (m)
A1 0.00-0.12 Abrupt	Light clay / Light clay	Weak, very firm, sub-rounded peds <10 mm	Nil	10YR3/2 Very dark greyish brown Nil mottles / bleaching	Dry, well drained	Common	0.05 / 6.5	0.00-0.10 0.20-0.30 0.50-0.60 0.70-0.80 0.90-1.00
B21 0.12-0.80 Abrupt	Light medium clay / Light to Medium clay	Moderate, very firm	<2% calcium carbonate	10YR3/1 Very dark grey Nil mottles / bleaching	Dry, well to moderately drained	Few	0.30 / 7.0 0.60 / 7.0	
B22 0.80-1.00 EOBH	Light medium clay / Medium clay	Moderate, very firm	Nil	10YR4/1 Dark grey Nil mottles / bleaching	Dry, moderately well drained	Few	0.90 / 7.0

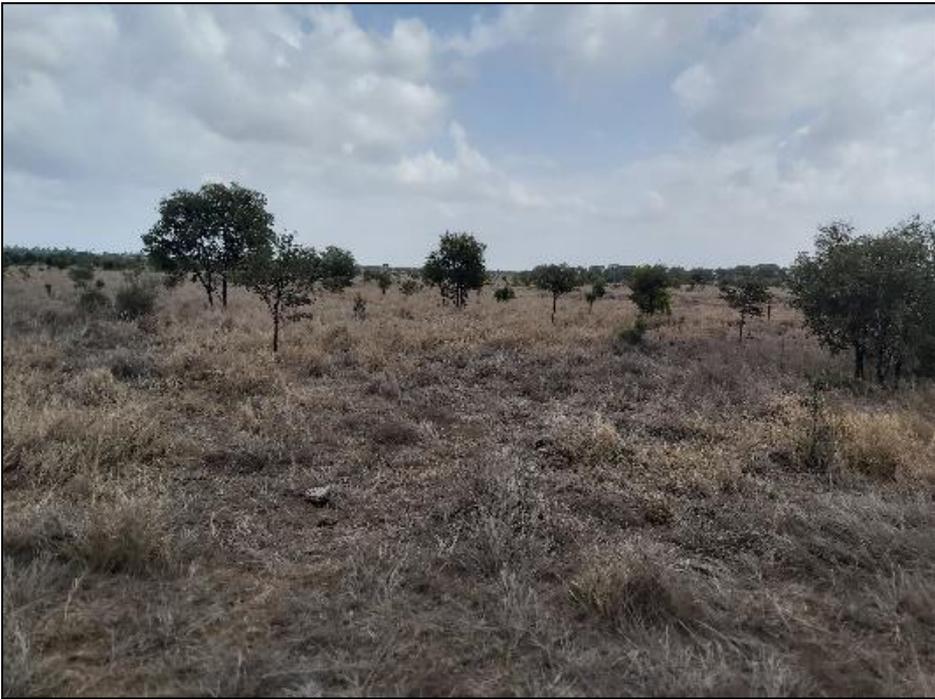
C3-BR soils are soft with a cracking surface, featuring uniform dark clays with unmappable, very minor microrelief observed extending 1.0 m below the surface. Soils are dominant brown clays with minor interfingering sub-dominant black clays. Soils have dispersive and salinity attributes in subsoils increasing with depth. This SMU is suitable for grazing native pastures, with or without the introduction of pasture species.

<b>Location GDA94 ZONE 55</b>	630899 mE 7545564 mN
<b>Current land use</b>	Grazing
<b>Site survey type</b>	Detailed, 50 mm hand auger
<b>Vegetation</b>	Exotic grassland
<b>Disturbance</b>	Semi-disturbed
<b>Landform element /pattern</b>	Lower slope
<b>Micro relief</b>	Nil
<b>Permeability</b>	Slowly permeable
<b>Drainage</b>	Moderately well drained
<b>Erosion</b>	Nil erosion
<b>Slope (%)</b>	2.0%
<b>Surface coarse fragments</b>	Nil
<b>Surface condition</b>	Soft, cracking with crust
<b>ASC order (s)</b>	Brown Vertosol
<b>Land suitability summary</b>	<p><b>Plant Available Water Capacity (RPI 08/14 Soil Texture Table):</b> 96 mm/100 cm  <b>Identified Physical and/or Chemical Limitation:</b> ESP at 17%, in sample depth 0.70-0.80 mbgl  <b>Estimated effective rooting depth:</b> 0.70 mbgl  <b>Estimated soil water storage:</b> 66 mm  <b>Land Suitability (Cropping) Class:</b> 5  <b>Land Suitability (Grazing) Class:</b> 3  <b>Agricultural Land Class:</b> C2</p>

<b>Soil quality for mine rehabilitation</b>	<p><b>Recommended topsoil strip depth:</b> 0.00-0.30 mbgl</p> <p><b>Recommended topsoil use:</b> support establishment of native vegetation and grasses, or other appropriate species.</p> <p><b>Recommended subsoil strip depth:</b> 0.00 mbgl</p> <p><b>Recommended subsoil use:</b> no rehabilitation stripping recommendations for subsoils. Potential reuse as capping for waste rock due to limitations to a depth of 1.00 mbgl.</p>
<b>ASS/PASS field assessment</b>	<p>Very low field indication of PASS.</p> <p>No field indicators of AASS.</p>
<b>Total area (ha)</b>	3,219

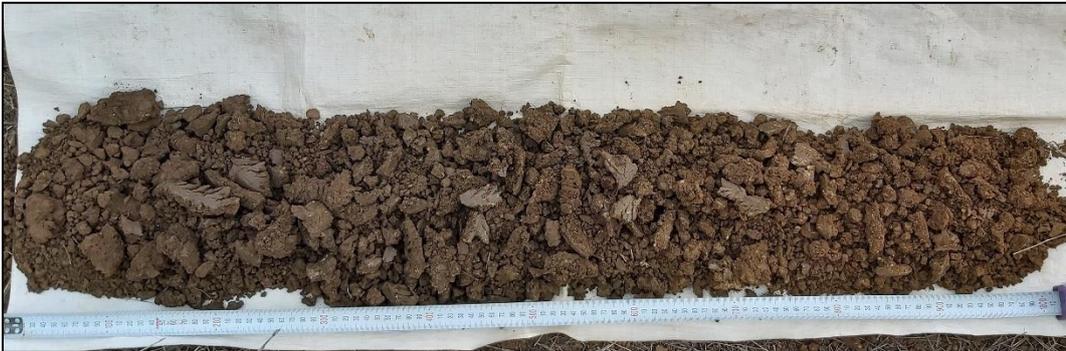
Horizon Depth (m), Boundary	Field / Lab Texture	Structure Strength	Inclusions Segregations	Colour, Mottle, Bleaching	Moisture Drainage	Roots	Depth (m) / Field pH	Samples (m)
A1 0.00-0.10 Abrupt	Light clay / Clay loam	Weak, firm, subangular peds <20 mm	Nil	10YR3/3 Dark brown Nil mottles / bleaching	Dry, well drained	Common	0.05 / 8.0	0.00-0.10 0.20-0.30 0.50-0.60 0.70-0.80 0.90-1.00
B21 0.10-0.63 Gradual	Light medium clay / Light medium to medium clay	Moderate, firm, angular peds 20-40 mm, slickensides	<2% calcium carbonate <1% <2 mm coarse fragments	10YR4/3 Brown Nil mottles / bleaching	Dry, moderately well drained	Few	0.30 / 7.0 0.55 / 7.0	
B22 0.63-1.00 EOBH	Light medium clay / Medium to light medium clay	Moderate, firm, angular peds 20-40 mm, slickensides	Nil	10YR5/3 Brown Nil mottles / bleaching	Dry, moderately well drained	Very few	0.90 / 7.0

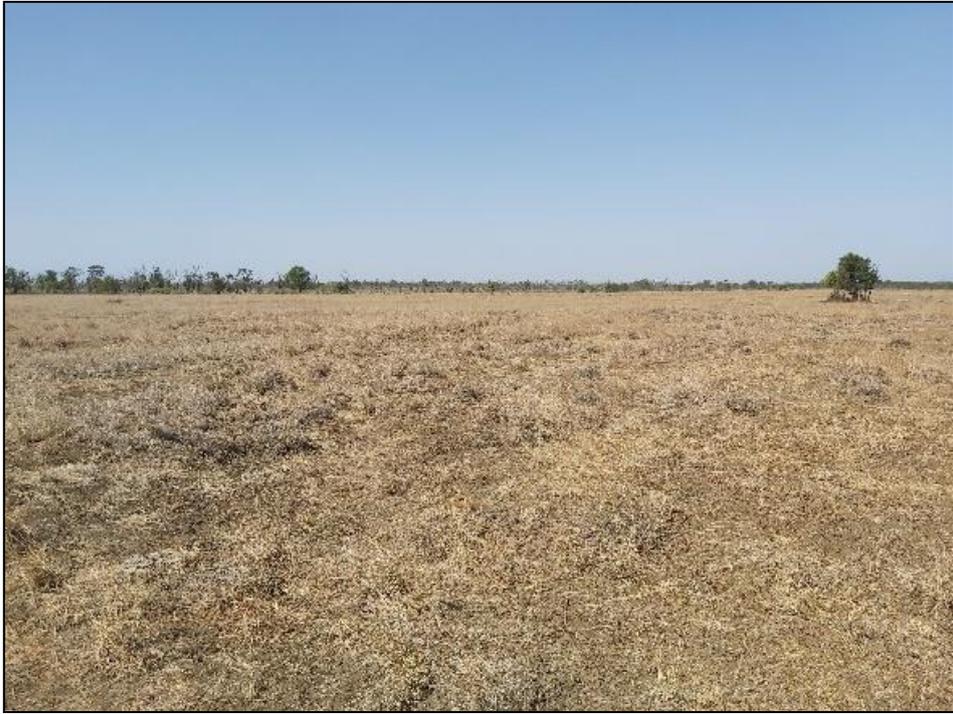
C4 soils are soft with a cracking surface, featuring uniform dark clays extending 1.0 m below the surface. Soils have dispersive and salinity attributes in subsoils increasing with depth. This SMU is suitable for a wide range of current and potential broadacre and horticultural crops.

<b>Location GDA94 ZONE 55</b>	623121 mE 7550243 mN
<b>Current land use</b>	Grazing
<b>Site survey type</b>	Detailed, 50 mm hand auger
<b>Vegetation</b>	Native grassland
<b>Disturbance</b>	Extensive disturbance
<b>Landform element /pattern</b>	Simple slope
<b>Micro relief</b>	Linear gilgai, 0.2 m deep, 40% coverage
<b>Permeability</b>	Slowly permeable
<b>Drainage</b>	Imperfectly drained
<b>Erosion</b>	Nil erosion
<b>Slope (%)</b>	2.0%/3.0%
<b>Surface coarse fragments</b>	Nil
<b>Surface condition</b>	Soft, cracking
<b>ASC order (s)</b>	Black Vertosol

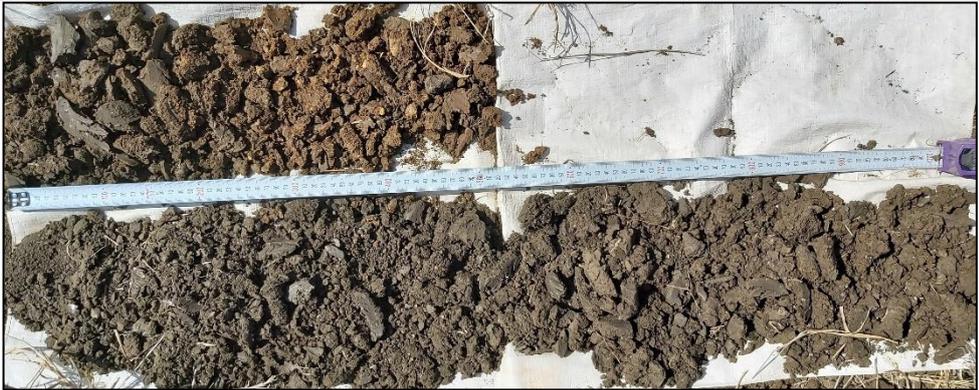
Horizon Depth (m), Boundary	Field / Lab Texture	Structure Strength	Inclusions Segregations	Colour, Mottle, Bleaching	Moisture Drainage	Roots	Depth (m) / Field pH	Samples (m)
A1 0.00-0.10 Abrupt	Light clay / Medium clay	Weak, moderate, sub-rounded peds <20 mm	Nil	10YR3/2 Very dark greyish brown Nil mottles / bleaching	Dry, well drained	Common	0.05 / 6.0	0.00-0.10 0.20-0.30 0.50-0.60 0.70-0.80 1.10-1.20 1.40-1.50
B21 0.10-0.42 Abrupt	Light medium clay / Medium to medium heavy clay	Moderate, firm, sub-angular peds <20 mm	Nil	10YR3/1 Very dark grey Nil mottles / bleaching	Dry, moderately well drained	Common	0.30 / 6.5	
B22 0.42-0.60 Clear	Medium clay / Medium heavy clay	Moderate, firm, sub-angular peds <20 mm	<2% calcium carbonate	10YR3/1 Very dark grey Nil mottles / bleaching	Dry, moderately well drained	Few	0.50 / 6.5	
B23 0.60-1.25 Gradual	Medium clay / Medium heavy clay	Moderate, firm, sub-angular peds <20 mm	<2% calcium carbonate	2.5YR3/2 Dusky red Nil mottles / bleaching	Dry, moderately well drained	Nil	0.90 / 6.5

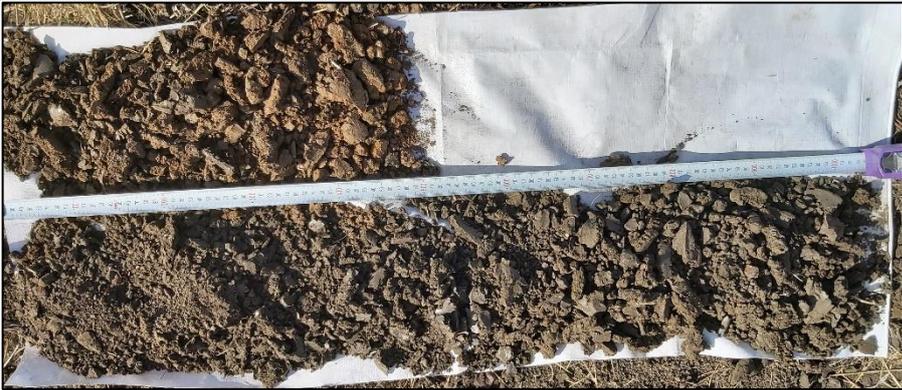
Site 35 - d

**Table 4-20: Soil Profile Morphology Summary SMU C4 - Depression position**

Horizon Depth (m), Boundary	Field / Lab Texture <sup>1</sup>	Structure Strength	Inclusions Segregations	Colour, Mottle, Bleaching	Moisture Drainage	Roots	Depth (m) / Field pH	Samples (m)
A1 0.00-0.10 Abrupt	Light clay / Medium clay	Weak, moderate, sub-rounded peds <20 mm	Nil	10YR3/2 Very dark greyish brown Nil mottles / bleaching	Dry, well drained	Common	0.05 / 6.0	0.00-0.10 0.20-0.30 0.50-0.60 0.80-0.90 1.10-1.20 1.40-1.50
B21 0.10-0.50 Abrupt	Light medium clay / Medium to medium heavy clay	Moderate, firm, sub-angular peds <20 mm	Nil	10YR3/1 Very dark grey Nil mottles / bleaching	Dry, moderately well drained	Common	0.30 / 6.0	
B22 0.50-0.65 Clear	Medium clay / Medium heavy clay	Moderate, firm, sub-angular peds <20 mm	<2% calcium carbonate	10YR3/1 Very dark grey Nil mottles / bleaching	Dry, moderately well drained	Few	0.50 / 6.5	
B23 0.65-1.30 Gradual	Medium clay / Medium heavy clay	Moderate, firm, sub-angular peds <20 mm	<2% calcium carbonate	2.5YR3/2 Dusky red Nil mottles / bleaching	Dry, moderately well drained	Nil	0.90 / 6.5

B24 1.30-1.50 EOBH	Medium clay / Medium heavy clay	Moderate, firm, sub-angular peds <20 mm	<2% calcium carbonate	7.5YR4.3 Brown 20% light brown mottle Nil bleaching	Dry, imperfectly drained	Nil	1.30 / 6.5

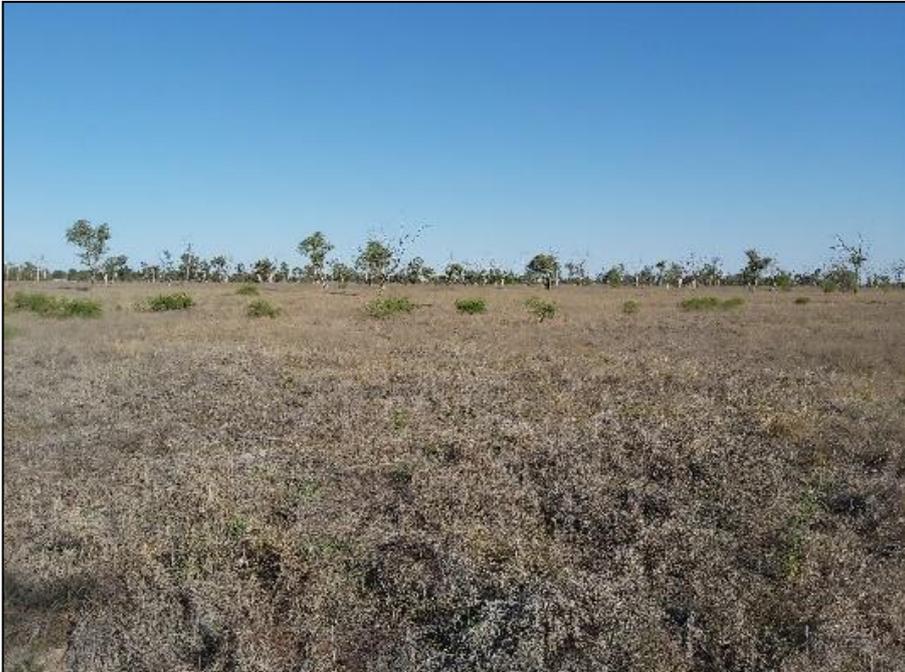
**Table 4-23: Land Summary SMU C5**

Item	Description
<b>Representative site</b>	70
<b>Representative site photograph</b>

<b>Location GDA94 ZONE 55</b>	630784 mE 7552235 MN
<b>Current land use</b>	Grazing
<b>Site survey type</b>	Detailed, 50 mm hand auger
<b>Vegetation</b>	Exotic grassland
<b>Disturbance</b>	Extensive disturbance
<b>Landform element /pattern</b>	Alluvial plain, flat wide depression
<b>Micro relief</b>	Nil
<b>Permeability</b>	Slowly permeable
<b>Drainage</b>	Imperfectly drained
<b>Erosion</b>	Nil
<b>Slope (%)</b>	-
<b>Surface coarse fragments</b>	Nil
<b>Surface condition</b>	Cracking with crust
<b>ASC order (s)</b>	Black Vertosol
<b>Land suitability summary</b>	<p><b>Plant Available Water Capacity (RPI 08/14 Soil Texture Table):</b> 114 mm/100 cm</p> <p><b>Identified Physical and/or Chemical Limitation:</b> Marginal dispersive attributes below 0.80 mbgl</p> <p><b>Estimated effective rooting depth:</b> 1.00 mbgl</p> <p><b>Estimated soil water storage:</b> 114 mm</p> <p><b>Land Suitability (Cropping) Class:</b> 4</p> <p><b>Land Suitability (Grazing) Class:</b> 3</p> <p><b>Agricultural Land Class:</b> C2</p>

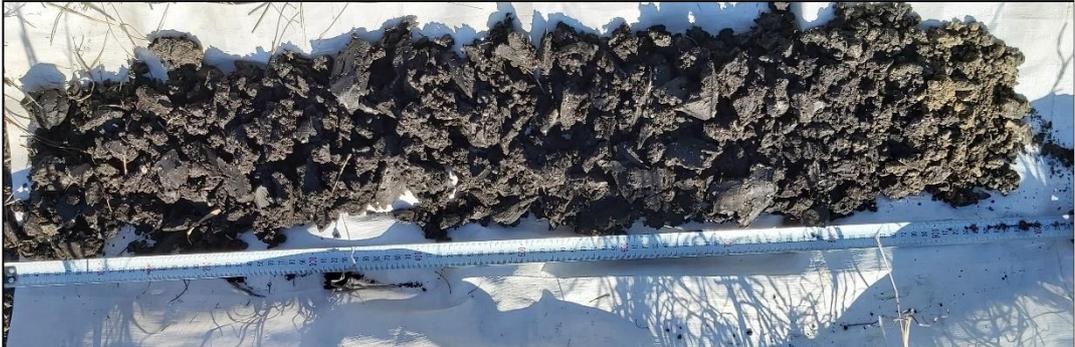
<b>Site 70</b>

**Table 4-24: Soil Profile Morphology Summary SMU C5**

Horizon Depth (m), Boundary	Field / Lab Texture <sup>1</sup>	Structure Strength	Inclusions Segregations	Colour, Mottle, Bleaching	Moisture Drainage	Roots	Depth (m) / Field pH	Samples (m)
A1 0.00-0.12 Abrupt	Medium clay / Light clay	Moderate, firm, subangular <20 mm	1% calcium carbonate	10YR3/1 Very dark grey Nil mottles / bleaching	Dry, well to moderate	Common	0.10 / 7.5	0.00-0.10 0.20-0.30 0.50-0.60 0.70-0.80 0.90-1.00
B21 0.12-0.88 Abrupt	Medium clay / Light to Medium clay	Moderate, firm, subangular 20-40 mm	2% calcium carbonate	10YR3/1 Very dark grey Nil mottles / bleaching	Dry, moderate	Few	0.30 / 7.5 0.60 / 7.5	
B22 0.88-1.00 EOBH	Medium clay / Medium clay	Moderate, very firm, subangular 20-40 mm	2% calcium carbonate	10YR3/1 Very dark grey Nil mottles / bleaching	Dry, moderate to imperfect	Nil	0.90 / 7.5

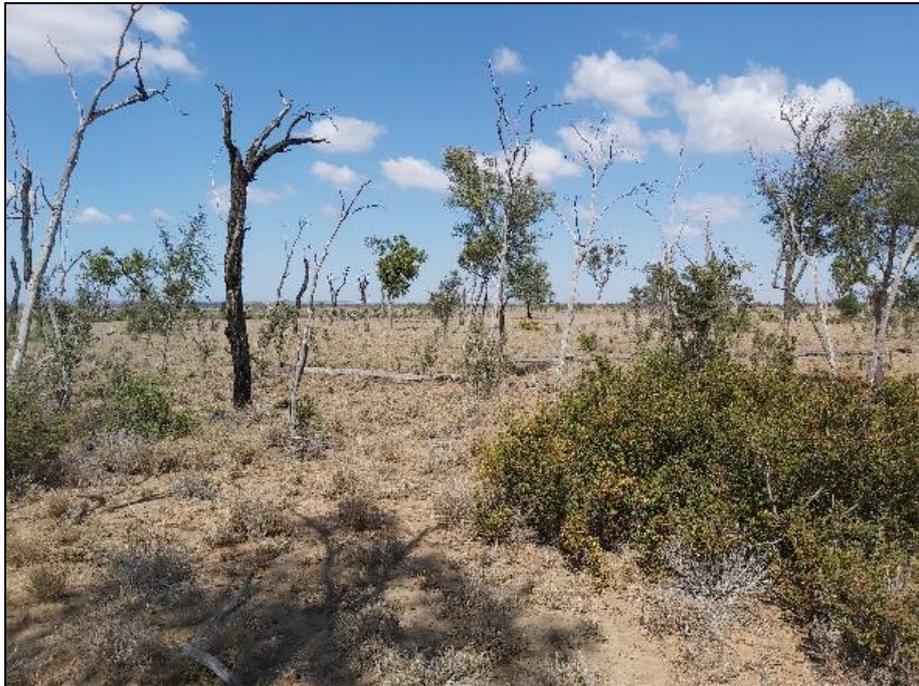
**Table 4-26: Land Summary SMU K1**

Item	Description
<b>Representative site</b>	55
<b>Representative site photograph</b>

<b>Location GDA94 ZONE 55</b>	630779 mE 7550077 mN
<b>Current land use</b>	Grazing
<b>Site survey type</b>	Detailed, 50 mm hand auger
<b>Vegetation</b>	Exotic grassland
<b>Disturbance</b>	Semi-disturbed
<b>Landform element /pattern</b>	Wide crest upper slope, 1-2%
<b>Micro relief</b>	Nil
<b>Permeability</b>	Highly permeable
<b>Drainage</b>	Rapid
<b>Erosion</b>	Nil erosion
<b>Slope (%)</b>	1.0%/2.0%
<b>Surface coarse fragments</b>	2% coarse fragments <10 mm
<b>Surface condition</b>	Firm
<b>ASC order (s)</b>	Very shallow Brown Tenosol
<b>Land suitability summary</b>	<p><b>Plant Available Water Capacity (RPI 08/14 Soil Texture Table):</b> 6 mm/100 cm</p> <p><b>Identified Physical and/or Chemical Limitation:</b> Soil depth at 0.11 mbgl</p> <p><b>Estimated effective rooting depth:</b> 0.10 mbgl</p> <p><b>Estimated soil water storage:</b> 6 mm</p> <p><b>Land Suitability (Cropping) Class:</b> 5</p> <p><b>Land Suitability (Grazing) Class:</b> 4</p> <p><b>Agricultural Land Class:</b> C2</p>

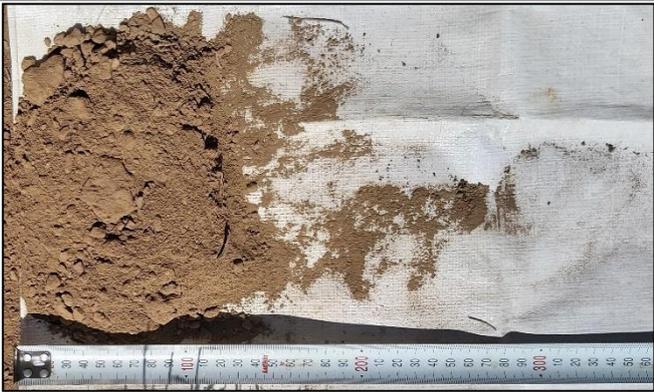
Site 55

**Table 4-27: Soil Profile Morphology Summary SMU K1**

Horizon Depth (m), Boundary	Field / Lab Texture	Structure Strength	Inclusions Segregations	Colour, Mottle, Bleaching	Moisture Drainage	Roots	Depth (m) / Field pH	Samples (m)	Observations
A1 0.00-0.11 EOBH	Sandy loam / Loam	Massive, loose	40% <10 mm coarse fragments 10% 10-20 mm coarse fragments	10YR3/4 Dark yellowish brown Nil mottles / bleaching	Dry, rapidly drained	Common	0.05 / 6.5	0.00-0.10	Auger refusal at 0.11 m, 5 attempts in the area

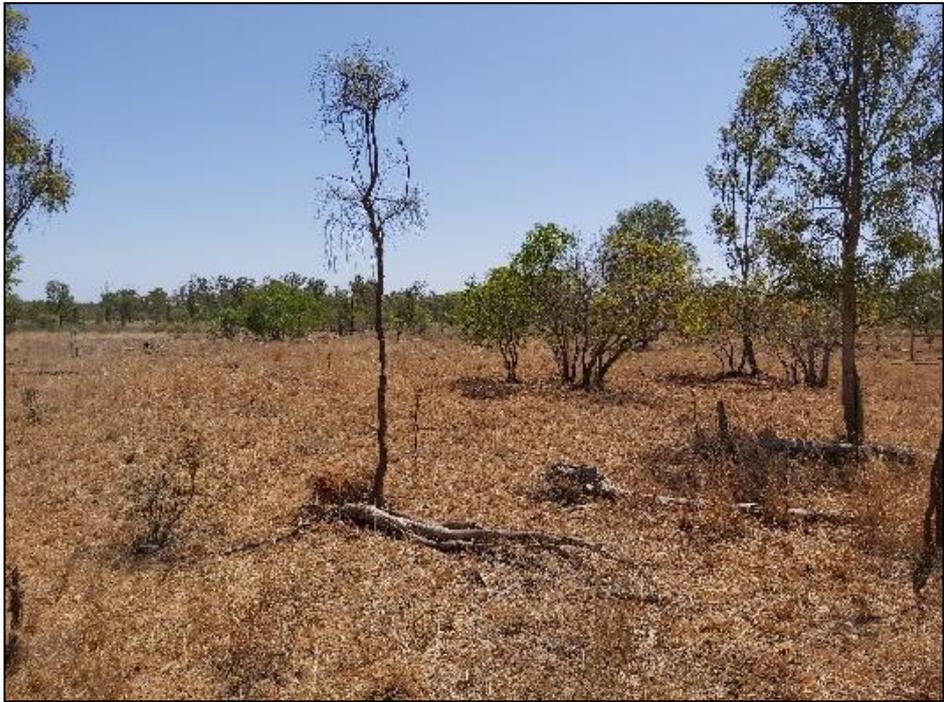
**Table 4-29: Land Summary SMU R3**

Item	Description
Representative site	31
Representative site photograph

<b>Location GDA94 ZONE 55</b>	638792 mE 7543714 mN
<b>Current land use</b>	Grazing
<b>Site survey type</b>	Detailed, 50 mm hand auger
<b>Vegetation</b>	Exotic grassland
<b>Disturbance</b>	Semi-disturbed
<b>Landform element /pattern</b>	Flat plain
<b>Micro relief</b>	Nil
<b>Permeability</b>	Slowly permeable
<b>Drainage</b>	Well drained
<b>Erosion</b>	Nil erosion
<b>Slope (%)</b>	<1.0%/1.0%
<b>Surface coarse fragments</b>	Nil coarse fragments
<b>Surface condition</b>	Firm
<b>ASC order (s)</b>	Red Kandosol
<b>Land suitability summary</b>	<p><b>Plant Available Water Capacity (RPI 08/14 Soil Texture Table):</b> 53 mm/100 cm</p> <p><b>Identified Physical and/or Chemical Limitation:</b> None identified</p> <p><b>Estimated effective rooting depth:</b> 1.00 mbgl</p> <p><b>Estimated soil water storage:</b> 53 mm</p> <p><b>Land Suitability (Cropping) Class:</b> 5</p> <p><b>Land Suitability (Grazing) Class:</b> 4</p> <p><b>Agricultural Land Class:</b> C2</p>

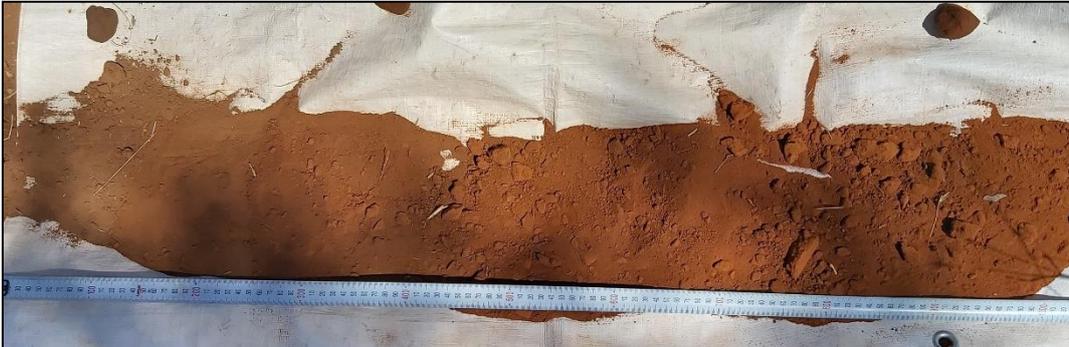
<b>Site 31</b>

**Table 4-30: Soil Profile Morphology Summary SMU R3**

Horizon Depth (m), Boundary	Field / Lab Texture	Structure Strength	Inclusions Segregations	Colour, Mottle, Bleaching	Moisture Drainage	Roots	Depth (m) / Field pH	Samples (m)
A11 0.00-0.12 Abrupt	Loamy sand / Loamy sand	Massive, loose	Nil	7.5YR3/3 Dark brown Nil mottles / bleaching	Dry, Rapid	Common	0.10 / 6.0	0.00-0.10 0.20-0.30 0.50-0.60 0.70-0.80
B21 0.12-0.45 Abrupt	Sandy loam / Sandy loam	Massive, loose	Nil	5YR3/4 Dark reddish brown Nil mottles / bleaching	Dry, Well	Few	0.30 / 6.0	0.90-1.00
B22 0.45-1.00 EOBH	Sandy clay loam / Sandy loam to loam	Massive, minor weak structure, loose	Nil	2.5YR3/4 Dark reddish brown Nil mottles / bleaching	Dry, Well	Nil	0.60 / 6.0 0.90 / 6.0

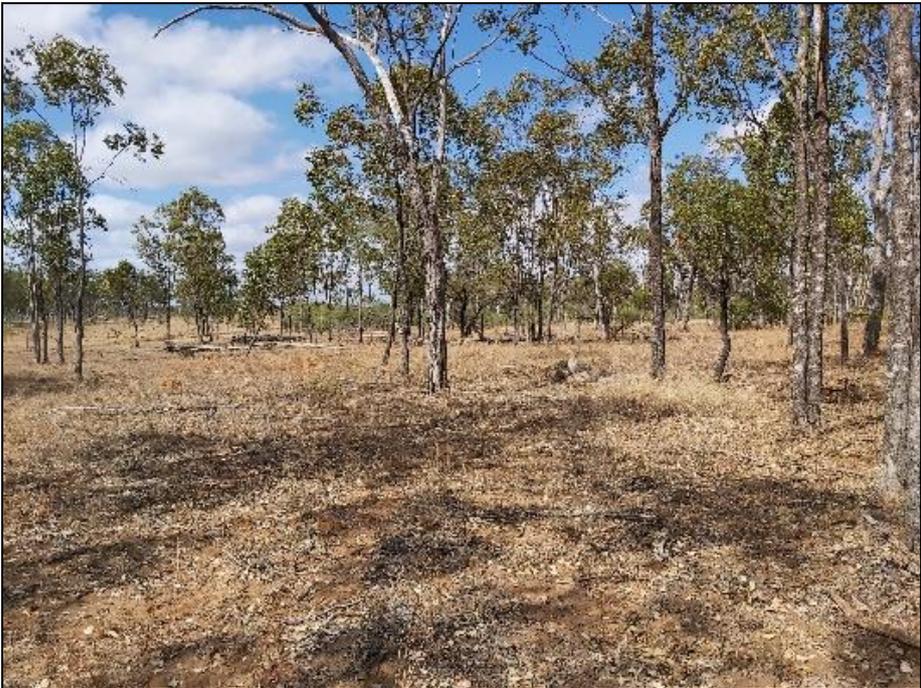
**Table 4-32: Land Summary SMU S1**

Item	Description
Representative site	1
Representative site photograph

<b>Location GDA94 ZONE 55</b>	638334 mE 7545005 mN
<b>Current land use</b>	Grazing
<b>Site survey type</b>	Detailed, 50 mm hand auger
<b>Vegetation</b>	Poplar Box
<b>Disturbance</b>	Semi-disturbed
<b>Landform element /pattern</b>	Gently undulating plain, simple slope
<b>Micro relief</b>	Nil
<b>Permeability</b>	Slowly permeable
<b>Drainage</b>	Imperfectly drained
<b>Erosion</b>	Nil erosion
<b>Slope (%)</b>	2.0%/2.0%
<b>Surface coarse fragments</b>	Coarse fragments <1% <5 mm
<b>Surface condition</b>	Soft
<b>ASC order (s)</b>	Brown Sodosol
<b>Land suitability summary</b>	<p><b>Plant Available Water Capacity (RPI 08/14 Soil Texture Table):</b> 73 mm/100 cm</p> <p><b>Identified Physical and/or Chemical Limitation:</b> Marginal dispersive attributes below 0.60 mbgl</p> <p><b>Estimated effective rooting depth:</b> 1.00 mbgl</p> <p><b>Estimated soil water storage:</b> 73 mm</p> <p><b>Land Suitability (Cropping) Class:</b> 5</p> <p><b>Land Suitability (Grazing) Class:</b> 4</p> <p><b>Agricultural Land Class:</b> C2</p>

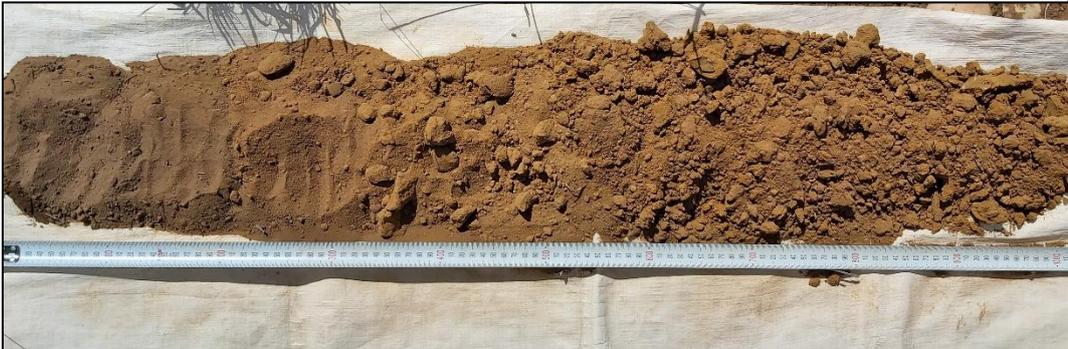
<b>Site 1</b>

**Table 4-33: Soil Profile Morphology Summary SMU S1**

Horizon Depth (m), Boundary	Field / Lab Texture	Structure Strength	Inclusions Segregations	Colour, Mottle, Bleaching	Moisture Drainage	Roots	Depth (m) / Field pH	Samples (m)
	A11 0.00-0.21 Abrupt	Loamy Sand / Loamy Sand	Loose, apedal	Nil	10YR4/3 Brown Nil mottles / bleaching	Dry, Rapid	Common	0.10 / 6.0	0.00-0.10 0.20-0.30 0.35-0.45 0.60-0.70
	A12 0.21-0.33 Abrupt	Loamy Sand / Loamy Sand	Loose, apedal	Nil	7.5YR4/3 Brown Nil mottles / bleaching	Dry, Rapid	Common	0.30 / 6.0	0.90-1.00
	A13 0.33-0.54 Abrupt	Loamy Sand / Loamy Sand	Massive 30% <20 mm peds	Nil	7.5YR4/3 Brown Nil mottles / bleaching	Dry, Well	Few	0.40 / 6.5	
B2 0.54-1.00 EOBH	Sandy clay loam / Light clay (sandy)	Weak to moderate, firm, angular <20 mm peds	<2% manganese nodules	10YR5/6 Yellowish brown Mottle <10% 10YR6/8 Brownish yellow Nil bleaching	Dry, moderate to imperfect	Fine	0.60 / 7.0

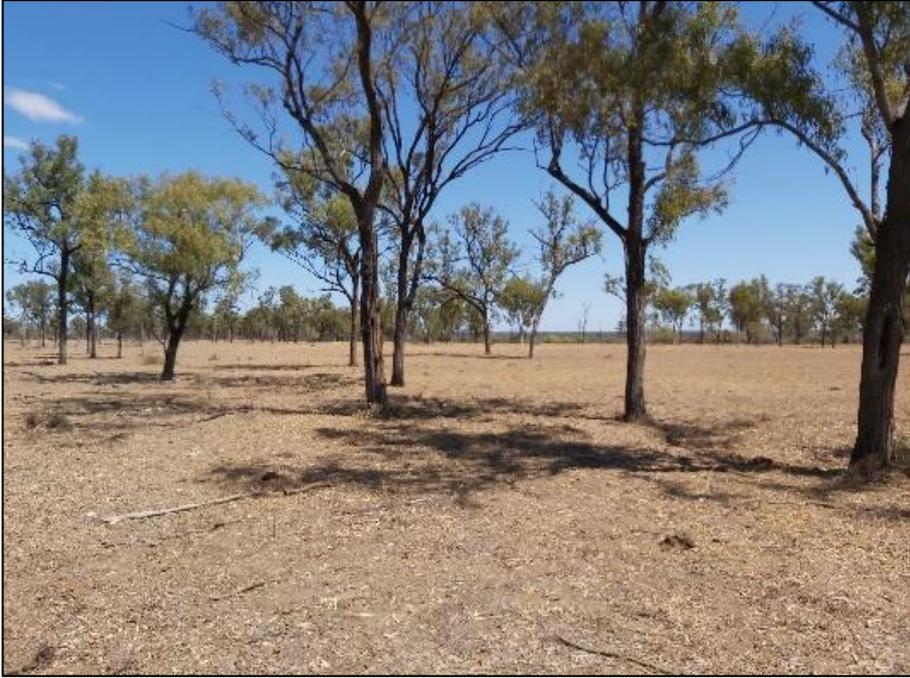
**Table 4-35: Land Summary SMU S3**

Item	Description
<b>Representative site</b>	10
<b>Representative site photograph</b>

<b>Location GDA94 ZONE 55</b>	636268 mE 7540681 mN
<b>Current land use</b>	Grazing
<b>Site survey type</b>	Detailed, 50 mm hand auger
<b>Vegetation</b>	Narrow-leaved Ironbark
<b>Disturbance</b>	Semi-disturbed
<b>Landform element /pattern</b>	Crest, wide flat plain
<b>Micro relief</b>	Nil
<b>Permeability</b>	Slowly permeable
<b>Drainage</b>	Moderately drained
<b>Erosion</b>	Nil erosion
<b>Slope (%)</b>	1.0%/1.0%
<b>Surface coarse fragments</b>	Coarse fragments 2% <5 mm
<b>Surface condition</b>	Firm
<b>ASC order (s)</b>	Brown Chromosol
<b>Land suitability summary</b>	<p><b>Plant Available Water Capacity (RPI 08/14 Soil Texture Table):</b> 100 mm/100 cm</p> <p><b>Identified Physical and/or Chemical Limitation:</b> None identified</p> <p><b>Estimated effective rooting depth:</b> 1.00 mbgl</p> <p><b>Estimated soil water storage:</b> 100 mm</p> <p><b>Land Suitability (Cropping) Class:</b> 4</p> <p><b>Land Suitability (Grazing) Class:</b> 3</p> <p><b>Agricultural Land Class:</b> C2</p>

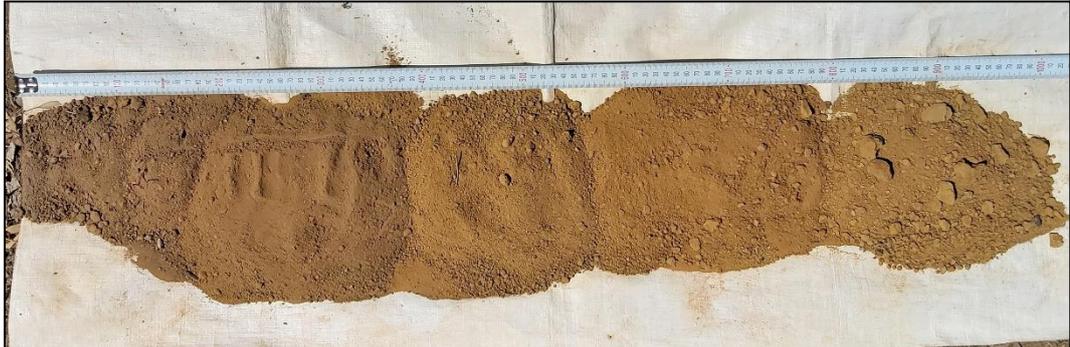
<p><b>Site 10</b></p>

**Table 4-36: Soil Profile Morphology Summary SMU S3**

<p><b>Horizon Depth (m), Boundary</b></p>	<p><b>Field / Lab Texture</b></p>	<p><b>Structure Strength</b></p>	<p><b>Inclusions Segregations</b></p>	<p><b>Colour, Mottle, Bleaching</b></p>	<p><b>Moisture Drainage</b></p>	<p><b>Roots</b></p>	<p><b>Depth (m) / Field pH</b></p>	<p><b>Samples (m)</b></p>
	<p>A1 0.00-0.11 Abrupt</p>	<p>Sandy loam / Silty loam</p>	<p>Massive, apedal</p>	<p>Nil</p>	<p>10YR4/2 Dark greyish brown Nil mottles / bleaching</p>	<p>Dry, well to moderate</p>	<p>Common</p>	<p>0.10 / 6.5</p>	<p>0.00-0.10 0.20-0.30 0.48-0.58 0.70-0.80 0.90-1.00</p>
	<p>B21 0.11-0.58 Abrupt</p>	<p>Clay loam / Light clay</p>	<p>Massive, apedal</p>	<p>&lt;2% coarse fragments &lt;5 mm</p>	<p>10YR3/4 Dark yellowish brown Nil mottles / bleaching</p>	<p>Dry, moderate</p>	<p>Few</p>	<p>0.30 / 6.5</p>	
	<p>B22 0.58-0.85 Abrupt</p>	<p>Light clay / Medium heavy clay</p>	<p>Massive, apedal</p>	<p>2% coarse fragments &lt;5 mm</p>	<p>7.5YR5/6 Strong brown Nil mottles / bleaching</p>	<p>Dry, moderate</p>	<p>Nil</p>	<p>0.60 / 7.0</p>

<p>B23 0.85-1.00 EOBH</p>	<p>Light clay / Medium heavy to medium clay</p>	<p>Massive, apedal</p>	<p>2% coarse fragments 10 mm</p>	<p>7.5YR5/6 Strong brown Nil mottles / bleaching</p>	<p>Dry, moderate</p>	<p>Nil</p>	<p>0.90 / 7.0</p>

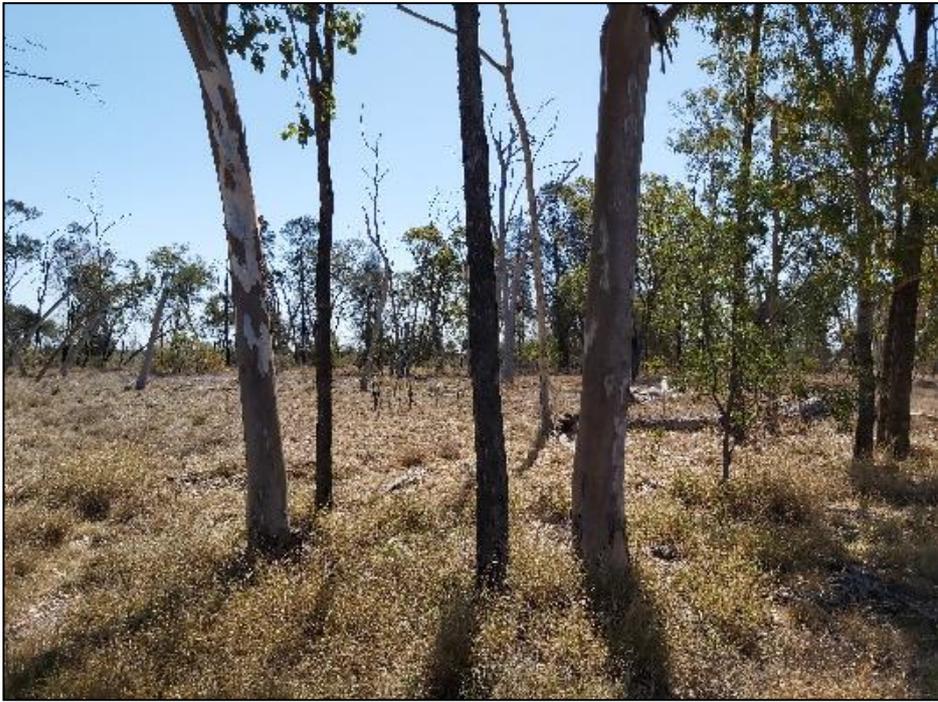
**Table 4-38: Land Summary SMU S4**

Item	Description
Representative site	68
Representative site photograph

<b>Location GDA94 ZONE 55</b>	628352 mE 7551956 mN
<b>Current land use</b>	Grazing
<b>Site survey type</b>	Detailed, 50 mm hand auger
<b>Vegetation</b>	Poplar Box
<b>Disturbance</b>	Nil
<b>Landform element /pattern</b>	Flat plain
<b>Micro relief</b>	Nil
<b>Permeability</b>	Highly permeable
<b>Drainage</b>	Rapid
<b>Erosion</b>	Nil erosion
<b>Slope (%)</b>	<1.0%/<1.0%
<b>Surface coarse fragments</b>	Nil
<b>Surface condition</b>	Soft
<b>ASC order (s)</b>	Brown Tenosol
<b>Land suitability summary</b>	<p><b>Plant Available Water Capacity (RPI 08/14 Soil Texture Table):</b> 40 mm/100 cm</p> <p><b>Identified Physical and/or Chemical Limitation:</b> None identified</p> <p><b>Estimated effective rooting depth:</b> 1.00 mbgl</p> <p><b>Estimated soil water storage:</b> 40 mm</p> <p><b>Land Suitability (Cropping) Class:</b> 5</p> <p><b>Land Suitability (Grazing) Class:</b> 4</p> <p><b>Agricultural Land Class:</b> C2</p>

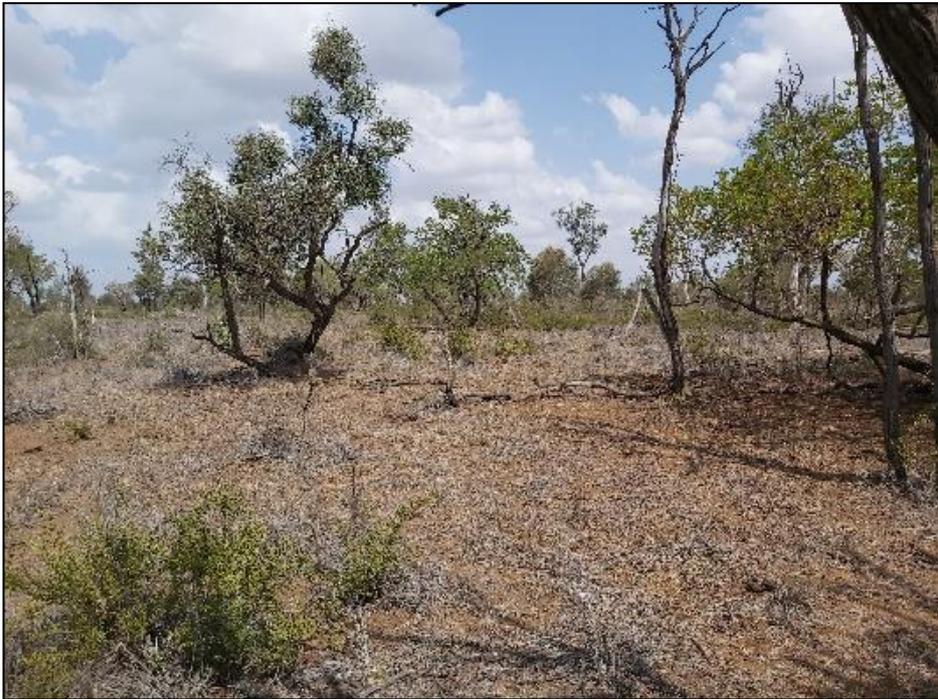
**Table 4-41: Land Summary SMU T1-B**

Item	Description
<b>Representative site</b>	42
<b>Representative site photograph</b>

<b>Location GDA94 ZONE 55</b>	630026 mE 7543369 mN
<b>Current land use</b>	Grazing
<b>Site survey type</b>	Detailed, 50 mm hand auger
<b>Vegetation</b>	Brigalow regrowth
<b>Disturbance</b>	Semi-disturbed
<b>Landform element /pattern</b>	Gently undulating plain, upper slope
<b>Micro relief</b>	Nil
<b>Permeability</b>	Slowly permeable
<b>Drainage</b>	Moderately drained
<b>Erosion</b>	Nil erosion
<b>Slope (%)</b>	1.0%/2.0%
<b>Surface coarse fragments</b>	Nil
<b>Surface condition</b>	Soft to firm
<b>ASC order (s)</b>	Brown Dermosol
<b>Land suitability summary</b>	<p><b>Plant Available Water Capacity (RPI 08/14 Soil Texture Table):</b> 75 mm/100 cm</p> <p><b>Identified Physical and/or Chemical Limitation:</b> Marginal, pH at 9.03, in sample depth 0.80-0.90 mbgl</p> <p><b>Estimated effective rooting depth:</b> 1.00 mbgl</p> <p><b>Estimated soil water storage:</b> 75 mm</p> <p><b>Land Suitability (Cropping) Class:</b> 4</p> <p><b>Land Suitability (Grazing) Class:</b> 3</p>

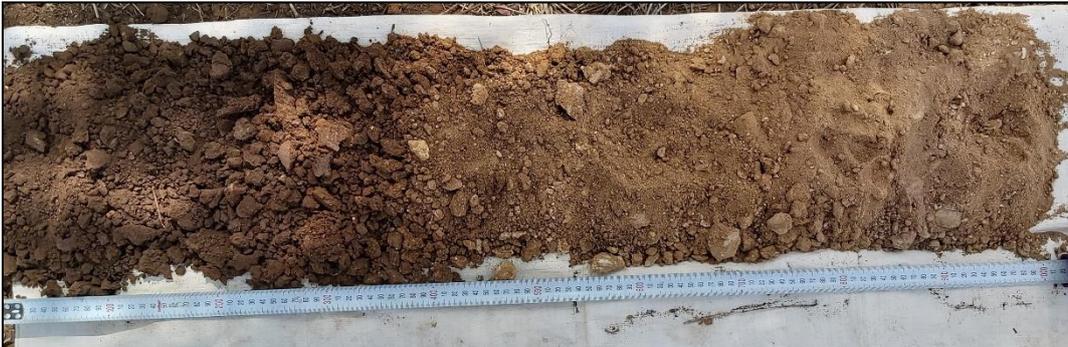
Site 42

**Table 4-42: Soil Profile Morphology Summary SMU T1-B**

Horizon Depth (m), Boundary	Field / Lab Texture	Structure Strength	Inclusions Segregations	Colour, Mottle, Bleaching	Moisture Drainage	Roots	Depth (m) / Field pH	Samples (m)
A11 0.00-0.09 Abrupt	Clay loam / Clay loam	Massive to weak, loose	Nil	7.5YR3/2 Dark brown Nil mottles / bleaching	Dry, well drained	Common	0.05 / 7.0	0.00-0.09 0.10-0.20 0.25-0.35 0.50-0.60
A12 0.09-0.24 Gradual	Clay loam / Clay loam	Weak, firm, sub-angular peds <10 mm	Nil	7.5YR3/4 Dark brown Nil mottles / bleaching	Dry, moderately well drained	Few	0.20 / 8.0	0.80-0.90
B21 0.24-0.37 Abrupt	Light clay / Light clay	Moderate, firm, sub-angular peds <10 mm	<2% calcium carbonate	7.5YR3/3 Dark brown Nil mottles / bleaching	Dry, moderately well drained	Few	0.28 / 7.5	
B31 0.37-0.70 Abrupt	Clay loam / Light clay to clay loam	Massive to weak, weak subangular peds <10 mm <2%	<2% calcium carbonate	7.5YR4/6 Strong brown Nil mottles / bleaching	Dry, moderate	Nil	0.50 / 8.0

B32 0.70-1.00 EOBH	Loam / Loam	Massive, loose	Nil	7.5YR4/4 Brown Nil mottles / bleaching	Dry, moderate	Nil	0.90 / 8.0	
--------------------------	----------------	----------------	-----	---	------------------	-----	------------	--

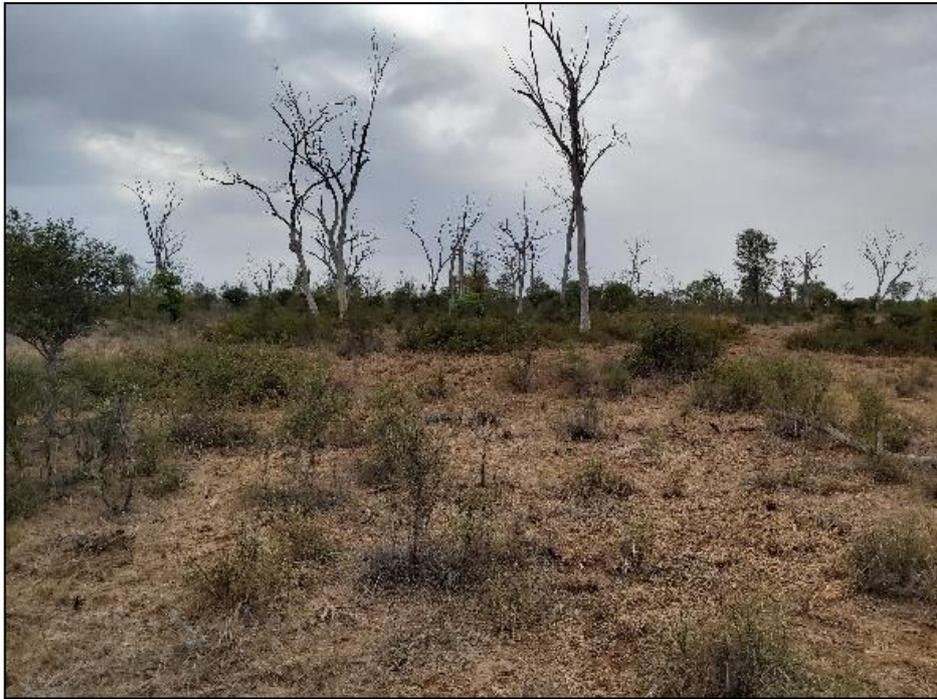
Item	Description
<b>Representative site</b>	36
<b>Representative site photograph</b>

<b>Location GDA94 ZONE 55</b>	624098 mE 7551284 mN
<b>Current land use</b>	Grazing
<b>Site survey type</b>	Detailed, 50 mm hand auger
<b>Vegetation</b>	Exotic grassland
<b>Disturbance</b>	Semi-disturbed
<b>Landform element /pattern</b>	Wide crest
<b>Micro relief</b>	Nil
<b>Permeability</b>	Slowly permeable
<b>Drainage</b>	Moderately drained
<b>Erosion</b>	Nil erosion
<b>Slope (%)</b>	<1.0%/<1.0%
<b>Surface coarse fragments</b>	Nil
<b>Surface condition</b>	Firm
<b>ASC order (s)</b>	Red Dermosol
<b>Land suitability summary</b>	<p><b>Plant Available Water Capacity (RPI 08/14 Soil Texture Table):</b> 75 mm/100 cm</p> <p><b>Identified Physical and/or Chemical Limitation:</b> Marginal, pH at 8.98, in sample depth 0.90-1.00 mbgl</p> <p><b>Estimated effective rooting depth:</b> 1.00 mbgl</p> <p><b>Estimated soil water storage:</b> 75 mm</p> <p><b>Land Suitability (Cropping) Class:</b> 4</p> <p><b>Land Suitability (Grazing) Class:</b> 3</p>
