# Appendix J

Soils and Land Suitability  
Assessment

## WINCHESTER SOUTH PROJECT Environmental Impact Statement

# Soils and Land Suitability Assessment

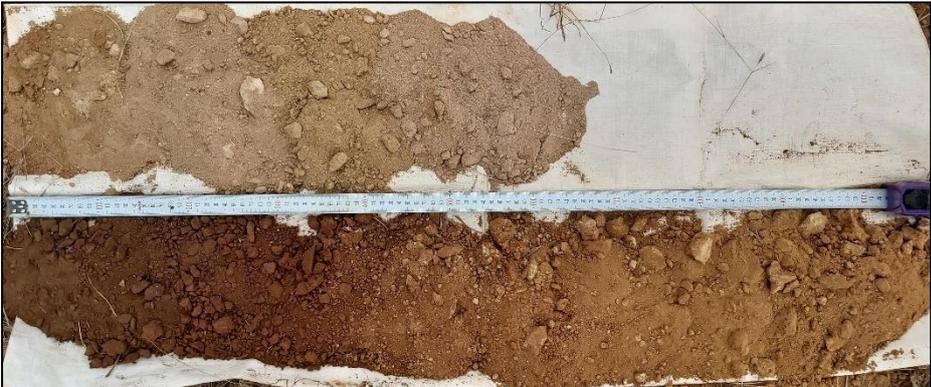
<b>Site 36</b>

<b>Horizon Depth (m), Boundary</b>	<b>Field / Lab<sup>1</sup> Texture</b>	<b>Structure Strength</b>	<b>Inclusions Segregations</b>	<b>Colour, Mottle, Bleaching</b>	<b>Moisture Drainage</b>	<b>Roots</b>	<b>Depth (m) / Field pH</b>
A11 0.00-0.08 Abrupt	Clay Loam / Clay loam	Massive, loose	Nil	10YR2/2 Very dark brown Nil mottles / bleaching	Dry, rapid	Common	0.05 / 6.5	0.00-0.08 0.10-0.20 0.20-0.30 0.50-0.60
A12 0.08-0.20 Abrupt	Clay loam / Clay loam	Weak, weak, sub-rounded 5-20 mm	<1% <2 mm coarse fragments	7.5YR3/2 Dark brown Nil mottles / bleaching	Dry, well	Few	0.15 / 6.5	0.90-1.00 1.40-1.50
B21 0.20-0.34 Abrupt	Light clay / Light clay	Moderate, weak, sub-rounded 5-20 mm	<1% <2 mm coarse fragments	5YR3/4 Dark reddish brown Nil mottles / bleaching	Dry, well	Few	0.30 / 7.0

B22 0.34-0.75 Abrupt	Silty clay loam / Light clay to clay loam	Weak, weak, sub-angular <20 mm	<5% <2 mm coarse fragments	5YR4/4 Reddish brown Nil mottles / bleaching	Dry, well to moderate	Nil	0.60 / 8.0
B23 0.75-1.05 Abrupt	Silty clay loam / Loam	Weak, weak, sub-angular <20 mm	<2% <2 mm coarse fragments	7.5YR4/6 Strong brown Nil mottles / bleaching	Dry, well to moderate	Nil	0.90 / 8.0
B3 1.05-1.60 EOBH	Loam	Massive, loose	Nil	7.5YR4/4 Brown Nil mottles / bleaching	Dry, moderate	Nil	1.20 / 8.5

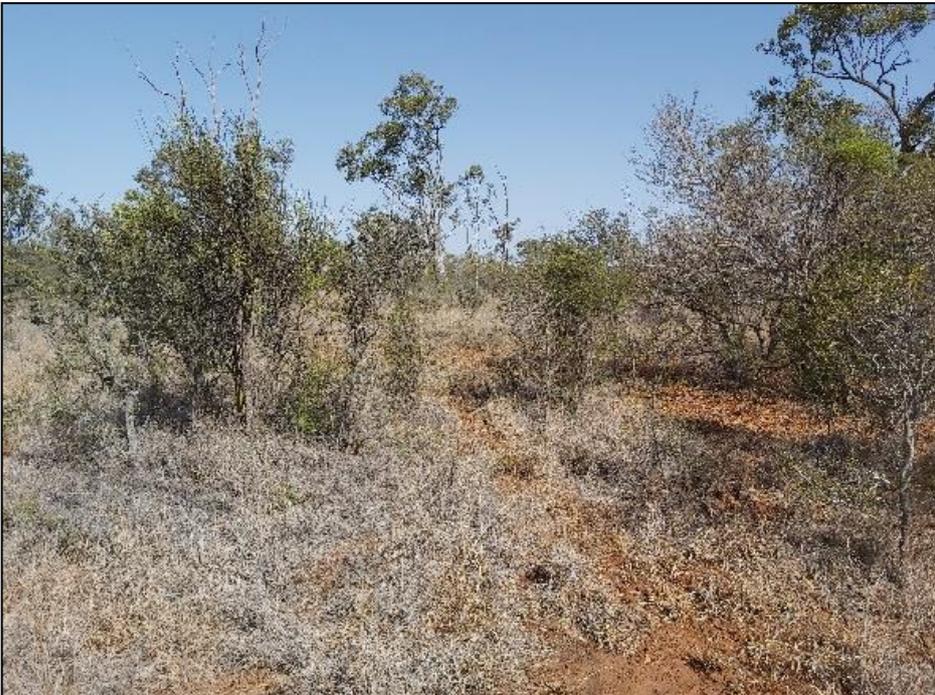
Item	Description
<b>Representative site</b>	75
<b>Representative site photograph</b>

<b>Location GDA94 ZONE 55</b>	627314 mE 7544935 mN
<b>Current land use</b>	Grazing
<b>Site survey type</b>	Detailed, 50 mm hand auger
<b>Vegetation</b>	Exotic grassland
<b>Disturbance</b>	Semi-disturbed
<b>Landform element /pattern</b>	Gently undulating plain, mid-slope
<b>Micro relief</b>	Nil
<b>Permeability</b>	Slowly permeable
<b>Drainage</b>	Moderately drained
<b>Erosion</b>	Nil erosion
<b>Slope (%)</b>	2.0%/2.0%
<b>Surface coarse fragments</b>	Nil
<b>Surface condition</b>	Firm
<b>ASC order (s)</b>	Red Kandosol
<b>Land suitability summary</b>	<p><b>Plant Available Water Capacity (RPI 08/14 Soil Texture Table):</b> 106 mm/100 cm</p> <p><b>Identified Physical and/or Chemical Limitation:</b> None identified</p> <p><b>Estimated effective rooting depth:</b> 1.00 mbgl</p> <p><b>Estimated soil water storage:</b> 106 mm</p> <p><b>Land Suitability (Cropping) Class:</b> 3</p> <p><b>Land Suitability (Grazing) Class:</b> 3</p> <p><b>Agricultural Land Class:</b> B</p>

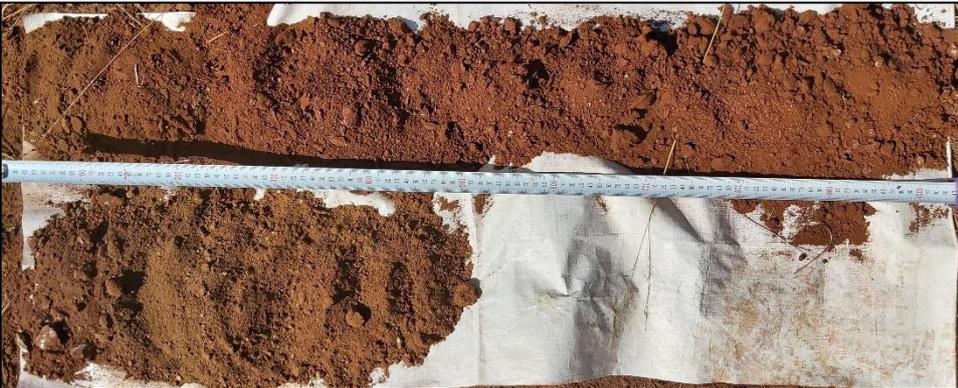
Site 75

Horizon Depth (m), Boundary	Field / Lab Texture	Structure Strength	Inclusions Segregations	Colour, Mottle, Bleaching	Moisture Drainage	Roots	Depth (m) / Field pH	Samples (m)
A1 0.00-0.10 Abrupt	Sandy clay loam / Silty loam	Massive to weak, form, peds <5 mm	<1% coarse fragments 5 mm	7.5YR3/3 Dark brown Nil mottles / bleaching	Dry, well drained	Common	0.05 / 6.5	0.00-0.10
A2 0.10-0.30 Abrupt	Clay loam / Silty clay loam	Massive to weak, form, peds <5 mm	<1% coarse fragments 5 mm	5YR4/3 Reddish brown Nil mottles / bleaching	Dry, well-moderate	Few	0.25 / 6.0	0.20-0.30
B21 0.30-0.88 Abrupt	Medium clay / Medium to light medium clay	Massive to weak, form, peds <2% <20 mm	Nil	2.5YR4/6 Red Nil mottles / bleaching	Dry, moderate	Few	0.60 / 6.5	0.50-0.60
B22 0.88-1.10 Abrupt	Medium clay / Medium heavy clay	Massive to weak, form, peds <10 mm	<1% coarse fragments <5 mm	2.5YR4/6 Red Nil mottles / bleaching	Dry, moderate	Nil	0.90 / 6.5	0.70-0.80

B23 1.10-1.50 EOBH	Clay loam / Clay loam	Massive to weak, form, peds <5 mm	<1% coarse fragments <5 mm	2.5YR4/6 Red Nil mottles / bleaching	Dry, moderate	Nil	1.20 / 7.0	0.90-1.00

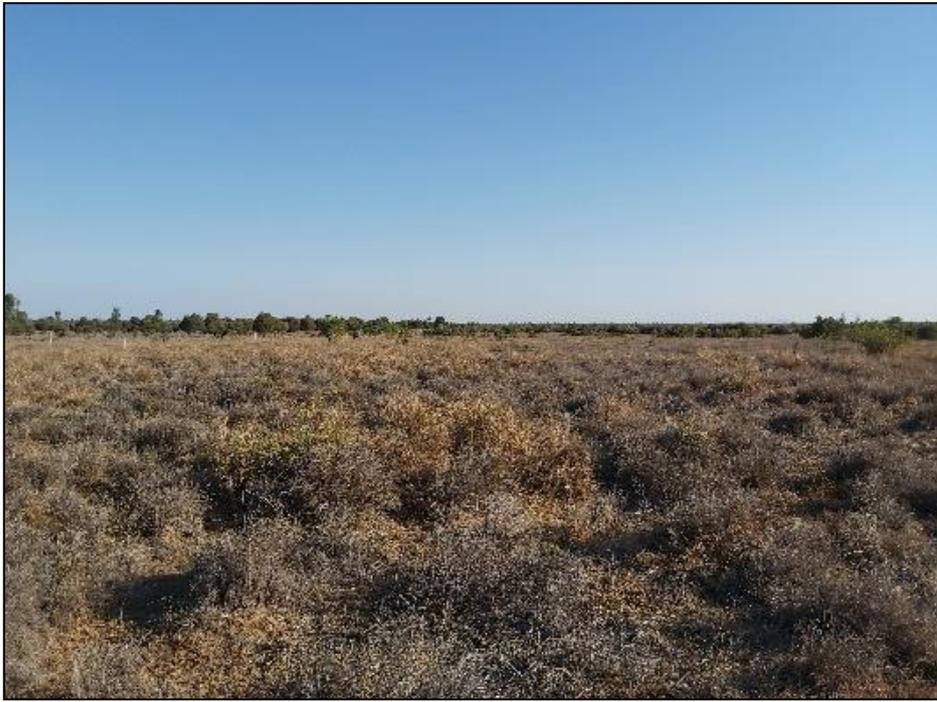
Item	Description
<b>Representative site</b>	6
<b>Representative site photograph</b>

<b>Location GDA94 ZONE 55</b>	637823 mE 7540836 mN
<b>Current land use</b>	Grazing
<b>Site survey type</b>	Detailed, 50 mm hand auger
<b>Vegetation</b>	Exotic grassland
<b>Disturbance</b>	Completely disturbed
<b>Landform element /pattern</b>	Gently undulating plain, flat plain
<b>Micro relief</b>	Nil
<b>Permeability</b>	Slowly permeable
<b>Drainage</b>	Moderately drained
<b>Erosion</b>	Nil erosion
<b>Slope (%)</b>	1.0%/1.0%
<b>Surface coarse fragments</b>	Nil
<b>Surface condition</b>	Firm, hard setting
<b>ASC order (s)</b>	Brown Chromosol
<b>Land suitability summary</b>	<p><b>Plant Available Water Capacity (RPI 08/14 Soil Texture Table):</b> 62 mm/100 cm  <b>Identified Physical and/or Chemical Limitation:</b> ESP at 21%, in sample depth 0.20-0.30 mbgl  <b>Estimated effective rooting depth:</b> 0.20 mbgl  <b>Estimated soil water storage:</b> 12 mm  <b>Land Suitability (Cropping) Class:</b> 5  <b>Land Suitability (Grazing) Class:</b> 4  <b>Agricultural Land Class:</b> C2</p>

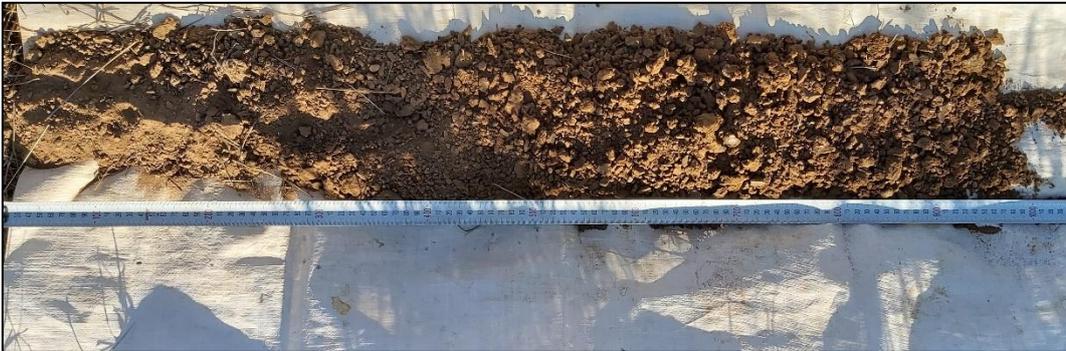
<b>Site 6</b>

Horizon Depth (m), Boundary	Field / Lab Texture	Structure Strength	Inclusions Segregation s	Colour, Mottle, Bleaching	Moisture Drainage	Roots	Depth (m) / Field pH	Samples (m)
A1 0.00-0.20 Abrupt	Silty loam / Silty loam	Massive, firm	<1% <5 mm coarse fragments	7.5YR3/3 Dark brown Nil mottles / bleaching	Dry, well to moderate	Common	0.10 / 6.5	0.00-0.10 0.20-0.30 0.50-0.57 0.65-0.75
B21 0.20-0.57 Abrupt	Silty clay loam / Silty clay loam to clay loam	Weak, firm, subangular <10 mm	Nil	7.5YR4/3 Brown Nil mottles / bleaching	Dry, moderate	Few	0.30 / 7.0	0.90-1.00
B22 0.57-0.76 Abrupt	Silty clay loam / Clay loam	Weak to moderate, firm, subangular <20 mm	Nil	7.5YR4/3 Brown Nil mottles / bleaching	Dry, moderate	Nil	0.60 / 8.0	
B23 0.76-100 EOBH	Silty clay loam / Clay loam	Moderate, firm, subangular <10 mm	Nil	10YR5/4 Yellowish brown Nil mottles / bleaching	Dry, moderate	Nil	0.90 / 8.0

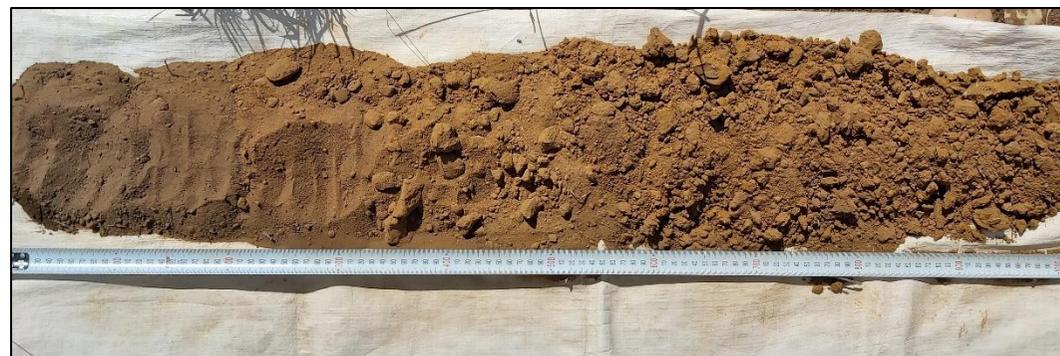
**Soil Profile**

Land use Landform Pattern, Element, Slope	Vegetation	Microrelief Disturbance Erosion	Surface condition, surface rock	Soil Profile Description									
				Horizon Depth (m), Boundary	Field Texture	Structure, Strength	Inclusions Segregations	Colour, Mottle, Bleaching	Moisture, Drainage	Roots	Depth (m) / Field pH	Sample (m)	Observations
Grazing, gently undulating plain, Simple Slope 2%/2%	Poplar Box	Nil microrelief, Semi disturbance Nil erosion	Soft, <1% coarse fragments <5mm	A11 0.00-0.21 Abrupt	Loamy Sand	Loose, apedal	Nil	10YR4/3 Brown Nil mottles / bleaching	Dry, Rapid	Common	0.10 / 6.0	0.00-0.10 0.20-0.30 0.35-0.45 0.60-0.70 0.90-1.00	Nil
				A12 0.21-0.33 Abrupt	Loamy Sand	Loose, apedal	Nil	7.5YR4/3 Brown Nil mottles / bleaching	Dry, Rapid	Common	0.30 / 6.0		
				A13 0.33-0.54 Abrupt	Loamy Sand	Massive 30% <20mm peds	Nil	7.5YR4/3 Brown Nil mottles / bleaching	Dry, Well	Few	0.40 / 6.5		
				B2 0.54-1.00 End of borehole (EOBH)	Sandy clay loam	Weak to moderate, firm, angular <20mm peds	<2% manganese nodules	10YR5/6 Yellowish brown Mottle <10% 10YR6/8 Brownish yellow Nil bleaching	Dry, moderate to imperfect	Fine	0.60 / 7.0

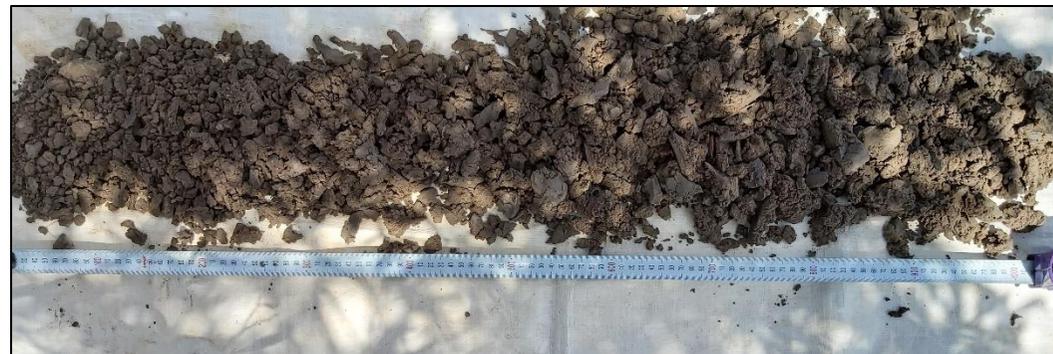
Land use Landform Pattern, Element, Slope	Vegetation	Microrelief Disturbance Erosion	Surface condition, surface rock	Soil Profile Description									
				Horizon Depth (m), Boundary	Field Texture	Structure, Strength	Inclusions Segregations	Colour, Mottle, Bleaching	Moisture, Drainage	Roots	Depth (m) / Field pH	Sample (m)	Observations
Grazing Flat Plain 1% / <1%	Dawson Gum and Brigalow regrowth	Melon hole 40% coverage, 3- 10m wide, 0.3-0.6m deep Semi disturbance	Firm, cracking Nil coarse fragments	A1 0.00-0.12 Abrupt	Medium clay	Moderate, very firm, subangular <10mm	Nil	10YR3/2 Very dark greyish brown Nil mottles / bleaching	Dry, well to moderate	Common	0.05 / 5.5-6.0	0.00-0.10 0.20-0.30 0.50-0.60 0.70-0.80 0.90-1.00	Borehole conducted on the mound
				B21 0.12-0.50 Abrupt	Medium heavy clay	Moderate, very firm, subangular <20mm	Nil	10YR3/1 Very dark grey Nil mottles / bleaching	Dry, moderate	Few	0.30 / 5.5-6.0

B22 0.50-1.00 EOBH	Medium heavy clay	Moderate, very firm, subangular <40mm	Nil	10YR3/1 Very dark grey Nil mottles / bleaching	Dry, moderate	Few	0.60 / 5.5-6.0 0.90m / 5.5

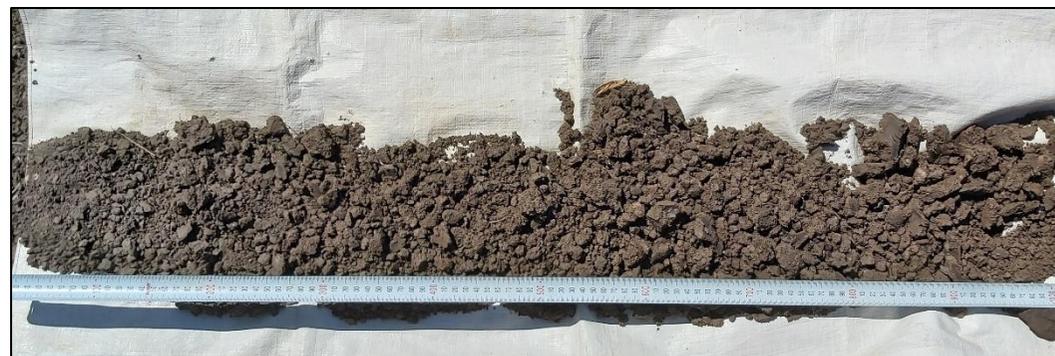
**Soil Profile**

Land use Landform Pattern, Element, Slope	Vegetation	Microrelief Disturbance Erosion	Surface condition, surface rock	Soil Profile Description									
				Horizon Depth (m), Boundary	Field Texture	Structure, Strength	Inclusions Segregations	Colour, Mottle, Bleaching	Moisture, Drainage	Roots	Depth (m) / Field pH	Sample (m)	Observations
Grazing Flat Plain 1% / <1%	Brigalow	Melon hole 40% coverage, 3- 10m wide, 0.3-0.6m deep Semi disturbance Nil erosion	Firm, cracking Nil coarse fragments	A1 0.00-0.13 Abrupt	Medium clay	Weak, very firm, subangular <10mm	Nil	10YR3/2 Very dark greyish brown Nil mottles / bleaching	Dry, well to moderate	Common	0.10 / 5.5- 6.0	0.00-0.10 0.20-0.30 0.50-0.60 0.70-0.80 0.90-1.00	Borehole conducted in depression
				B21 0.13-0.61 Abrupt	Medium heavy clay	Moderate, very firm, subangular <20mm	Nil	10YR3/1 Very dark grey Nil mottles / bleaching	Dry, moderate	Few	0.30 / 5.5- 6.0

B22 0.61-1.00 EOBH	Medium heavy clay	Moderate, very firm, subangular 10-30mm	Nil	10YR3/1 Very dark grey Nil mottles / bleaching	Dry, moderate	Few	0.60 / 5.5- 6.0 0.90 / 5.5

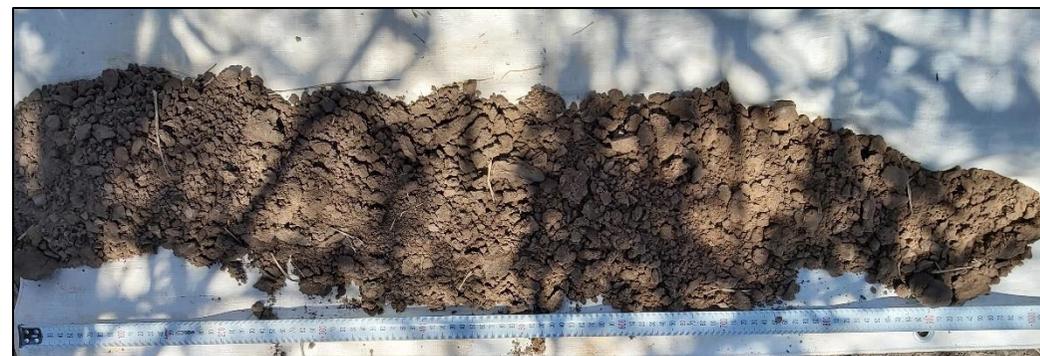
**Soil Profile**

Land use Landform Pattern, Element, Slope	Vegetation	Microrelief Disturbance Erosion	Surface condition, surface rock	Soil Profile Description									
				Horizon Depth (m), Boundary	Field Texture	Structure, Strength	Inclusions Segregations	Colour, Mottle, Bleaching	Moisture, Drainage	Roots	Depth (m) / Field pH	Sample (m)	Observations
Grazing Flat Plain 1% / <1%	Brigalow	Gilgai (normal to melon hole) Semi disturbed Nil erosion	Soft to firm Nil coarse fragments	A1 0.00-0.10 Abrupt	Light clay	Weak, strong, subangular <10mm	Nil	10YR3/2 Very dark greyish brown Nil mottles / bleaching	Dry, well to moderate	Common	0.10 / 6.0	Nil	Nil
				B21 0.10-0.68 Abrupt	Medium clay	Weak to moderate, very firm, subangular 10-20mm	<1% <20mm coarse fragments (coarse fragments)	10YR3/2 Very dark greyish brown Nil mottles / bleaching	Dry, moderate	Few	0.30 / 6.5 0.60 / 6.0		
				B22 0.68-1.00 EOBH	Medium clay	Weak to moderate, very firm, subangular 10-20mm	Nil	10YR3/2 Very dark greyish brown Nil mottles / bleaching	Dry, moderate	Few	0.90 / 5.5

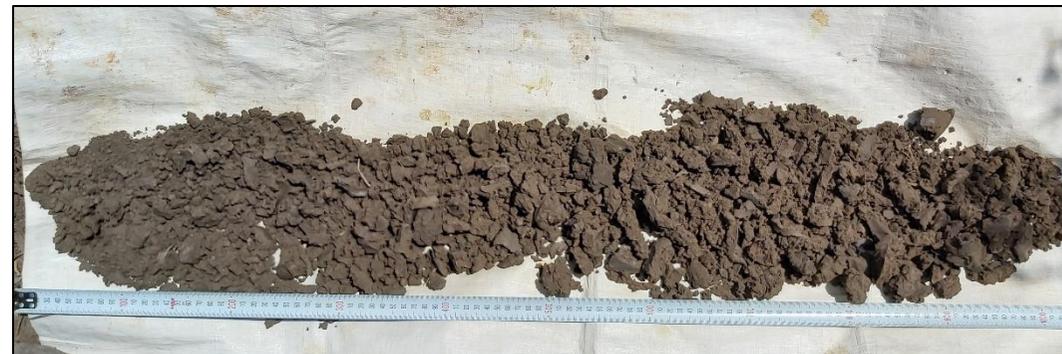
**Soil Profile**

Land use Landform Pattern, Element, Slope	Vegetation	Microrelief Disturbance Erosion	Surface condition, surface rock	Soil Profile Description									
				Horizon Depth (m), Boundary	Field Texture	Structure, Strength	Inclusions Segregations	Colour, Mottle, Bleaching	Moisture, Drainage	Roots	Depth (m) / Field pH	Sample (m)	Observations
Grazing Flat Plain 1% / <1%	Brigalow	Melon hole 40% coverage, 3- 10m wide, 0.3-0.6m deep Minor to semi disturbance Nil erosion	Firm, cracking Nil coarse fragments	A1 0.00-0.11 Abrupt	Medium clay	Moderate, very firm, subangular <10mm	Nil	10YR3/2 Very dark greyish brown Nil mottles / bleaching	Dry, well to moderate	Common	0.10 / 5.5- 6.0	Nil	Nil
				B21 0.11-0.48 Abrupt	Medium heavy clay	Moderate, very firm, subangular <20mm	Nil	10YR3/1 Very dark grey Nil mottles / bleaching	Dry, moderate	Few	0.30 / 5.5-6.0		
				B22 0.48-1.00 EOBH	Medium heavy clay	Moderate, very firm, subangular <40mm	Nil	10YR3/1 Very dark grey Nil mottles / bleaching	Dry, moderate	Few	0.60 / 5.5-6.0 0.90 / 5.5

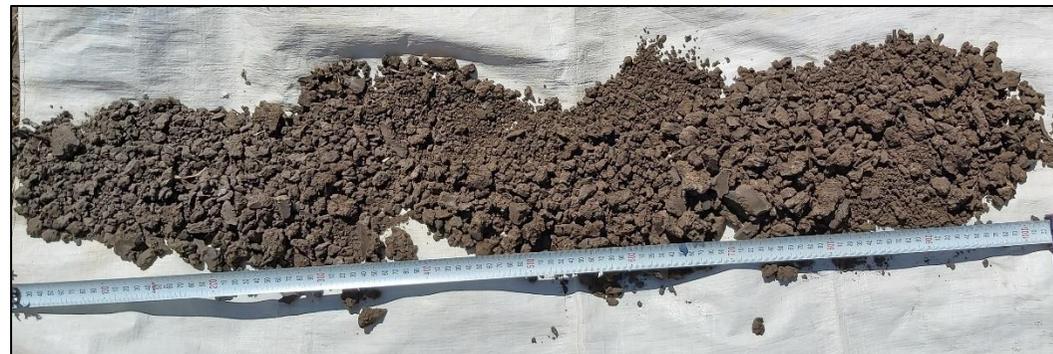
**Soil Profile**

Land use Landform Pattern, Element, Slope	Vegetation	Microrelief Disturbance Erosion	Surface condition, surface rock	Soil Profile Description									
				Horizon Depth (m), Boundary	Field Texture	Structure, Strength	Inclusions Segregations	Colour, Mottle, Bleaching	Moisture, Drainage	Roots	Depth (m) / Field pH	Sample (m)	Observations
Grazing Flat Plain 1% / <1%	Brigalow	Melon hole 40% coverage, 3- 10m wide, 0.3-0.6m deep Minor to semi disturbance Nil erosion	Firm, cracking Nil coarse fragments	A1 0.00-0.13 Abrupt	Medium clay	Weak, very firm, subangular <10mm	Nil	10YR3/2 Very dark greyish brown Nil mottles / bleaching	Dry, well to moderate	Common	0.10 / 5.5- 6.0	Nil	Nil
				B21 0.13-0.61 Abrupt	Medium heavy clay	Moderate, very firm, subangular <20mm	Nil	10YR3/1 Very dark grey Nil mottles / bleaching	Dry, moderate	Few	0.30 / 5.5- 6.0		
				B22 0.61-1.00 EOBH	Medium heavy clay	Moderate, very firm, subangular 10-30mm	Nil	10YR3/1 Very dark grey Nil mottles / bleaching	Dry, moderate	Few	0.60 / 5.5- 6.0 0.90 / 5.5

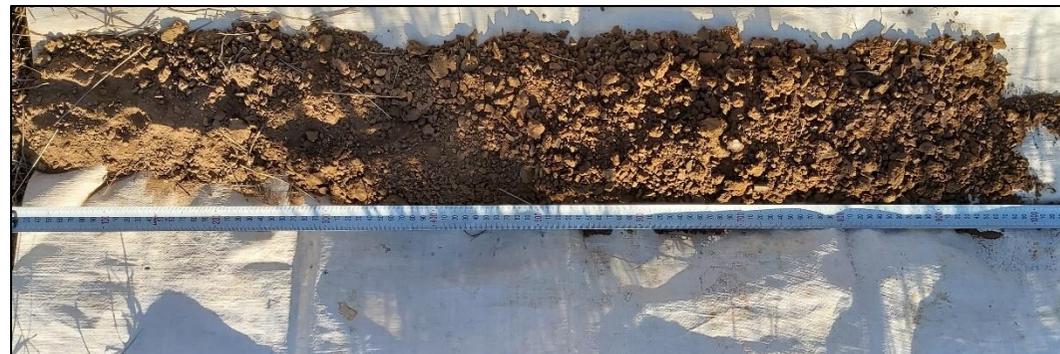
**Soil Profile**

Land use Landform Pattern, Element, Slope	Vegetation	Microrelief Disturbance Erosion	Surface condition, surface rock	Soil Profile Description									
				Horizon Depth (m), Boundary	Field Texture	Structure, Strength	Inclusions Segregations	Colour, Mottle, Bleaching	Moisture, Drainage	Roots	Depth (m) / Field pH	Sample (m)	Observations
Grazing, gently undulating plain, flat plain 1%/1%	Exotic grassland	Nil microrelief Completely disturbance Nil erosion	Firm, hard setting Nil coarse fragments	A1 0.00-0.21 Abrupt	Silty loam	Massive, firm	<1% <5mm coarse fragments	7.5YR3/3 Dark brown Nil mottles / bleaching	Dry, well to moderate	Common	0.10 / 6.5	0.00-0.10 0.20-0.30 0.50-0.57 0.65-0.75 0.90-1.00	Nil
				B21 0.20-0.57 Abrupt	Silty clay loam	Weak, firm, subangular <10mm	Nil	7.5YR4/3 Brown Nil mottles / bleaching	Dry, moderate	Few	0.30 / 7.0		
				B22 0.57-0.76 Abrupt	Silty clay loam	Weak to moderate, firm, subangular <20mm	Nil	7.5YR4/3 Brown Nil mottles / bleaching	Dry, moderate	Nil	0.60 / 8.0

B23 0.76-1.00 EOBH	Silty clay loam	Moderate, firm, subangular <10mm	Nil	10YR5/4 Yellowish brown Nil mottles / bleaching	Dry, moderate	Nil	0.90 / 8.0

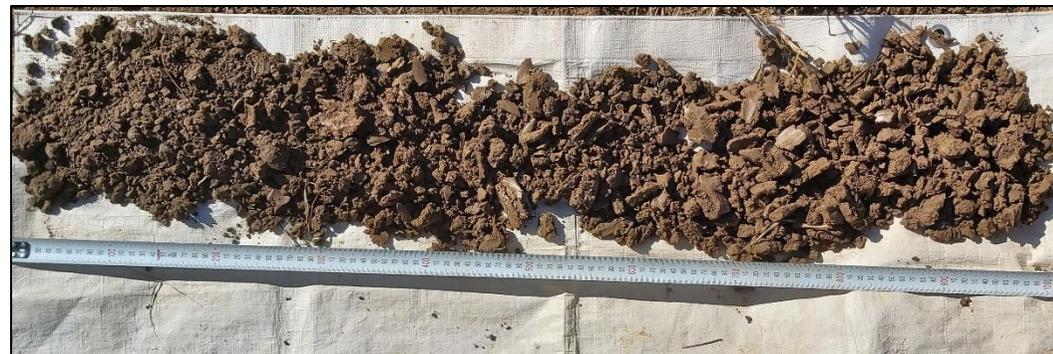
**Soil Profile**

Land use Landform Pattern, Element, Slope	Vegetation	Microrelief Disturbance Erosion	Surface condition, surface rock	Soil Profile Description									
				Horizon Depth (m), Boundary	Field Texture	Structure, Strength	Inclusions Segregations	Colour, Mottle, Bleaching	Moisture, Drainage	Roots	Depth (m) / Field pH	Sample (m)	Observations
Grazing Flat Plain 1% / <1%	Brigalow regrowth	Melon hole 30% coverage, 3- 6m wide, 0.2- 0.4m deep Minor to semi disturbance Nil erosion	Firm, hard setting Nil coarse fragments	A1 0.00-0.20 Abrupt	Light clay	Moderate, firm, subangular 10- 30mm	Nil	7.5YR3/2 Dark brown Nil mottles / bleaching	Dry, well to moderate	Common	0.10 / 6.5	Nil	Nil
				B21 0.20-0.65 Abrupt	Medium clay	Moderate, strong, subangular 20- 40mm	Nil	7.5YR3/2 Dark brown Nil mottles / bleaching	Dry, moderate	Few	0.30 / 7.0 0.60 / 8.0		
				B22 0.65-1.00 EOBH	Medium heavy clay	Moderate, strong, subangular 30- 50mm	Nil	7.5YR3/2 Dark brown Nil mottles / bleaching	Dry, moderate	Few	0.90 / 8.0

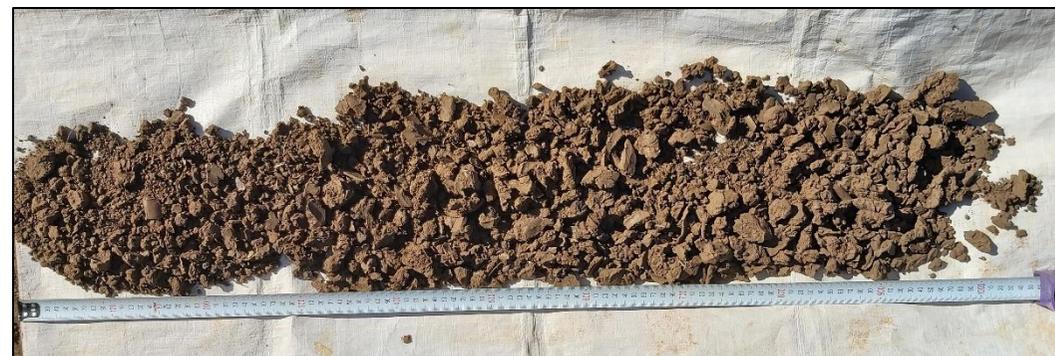
**Soil Profile**

Land use Landform Pattern, Element, Slope	Vegetation	Microrelief Disturbance Erosion	Surface condition, surface rock	Soil Profile Description									
				Horizon Depth (m), Boundary	Field Texture	Structure, Strength	Inclusions Segregations	Colour, Mottle, Bleaching	Moisture, Drainage	Roots	Depth (m) / Field pH	Sample (m)	Observations
Grazing Flat Plain 1%/1%	Brigalow regrowth	Melon hole 30% coverage, 3- 6m wide, 0.2- 0.4m deep Minor to semi disturbance Nil erosion	Firm, hard setting Nil coarse fragments	A1 0.00-0.22 Abrupt	Light clay	Moderate, firm, subangular 10- 30mm	Nil	7.5YR3/2 Dark brown Nil mottles / bleaching	Dry, well to moderate	Common	0.10 / 6.5	Nil	Nil
				B21 0.22-0.62 Abrupt	Medium clay	Moderate, strong, subangular 20- 40mm	Nil	7.5YR3/2 Dark brown Nil mottles / bleaching	Dry, moderate	Few	0.30 / 7.0 0.60 / 8.0		
				B22 0.62-1.00 EOBH	Medium heavy clay	Moderate, strong, subangular 30- 50mm	Nil	7.5YR3/2 Dark brown Nil mottles / bleaching	Dry, moderate	Few	0.90 / 8.0

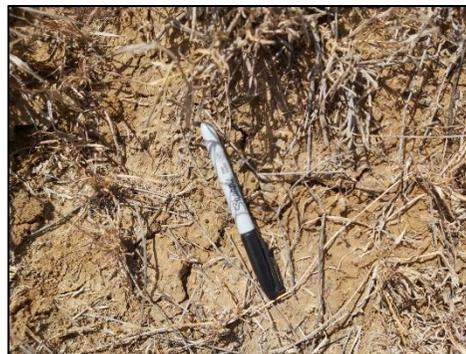
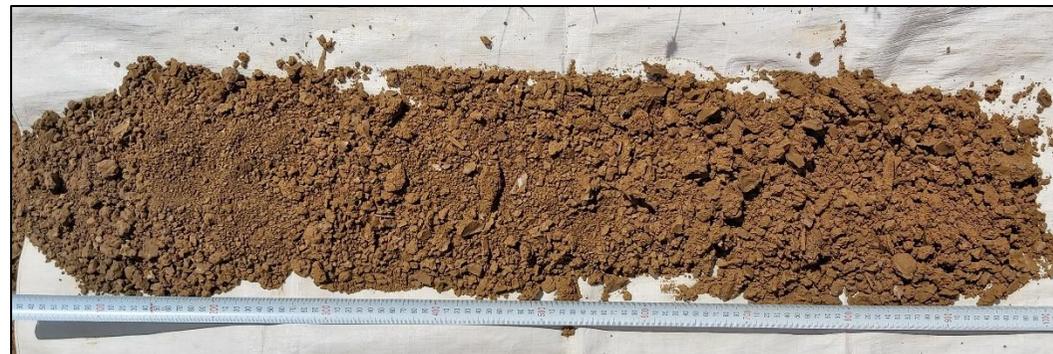
Land use Landform Pattern, Element, Slope	Vegetation	Microrelief Disturbance Erosion	Surface condition, surface rock	Soil Profile Description									
				Horizon Depth (m), Boundary	Field Texture	Structure, Strength	Inclusions Segregations	Colour, Mottle, Bleaching	Moisture, Drainage	Roots	Depth (m) / Field pH	Sample (m)	Observations
Grazing Midslope <2%/1%	Dawson Gum and Brigalow regrowth	Melon hole 50% coverage, 3- 6m wide, 0.2- 0.4m deep Semi disturbance Nil erosion	Cracking, Nil coarse fragments	A1 0.00-0.09 Abrupt	Light clay	Weak, firm, subangular <10mm	<2% manganese nodules	10YR3/3 Dark brown Nil mottles / bleaching	Dry, well to moderate	Common	0.10 / 6.5	0.00-0.09 0.20-0.30 0.50-0.60 0.70-0.80 0.90-1.00	Nil
				B21 0.09-0.60 Abrupt	Light medium clay	Weak, firm, subangular <10mm	<1% manganese nodules	7.5YR4/3 Brown Nil mottles / bleaching	Dry, moderate	Few	0.30 / 7.5 0.60 / 7.5		
				B22 0.60-1.00 EOBH	Light medium heavy clay	Weak, firm, subangular 10- 20mm	Nil	7.5YR4/3 Brown Nil mottles / bleaching	Dry, moderate	Few	0.90 / 6.5

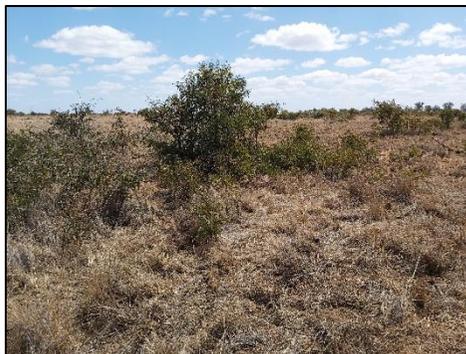
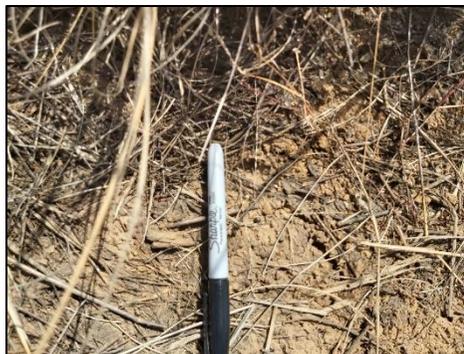
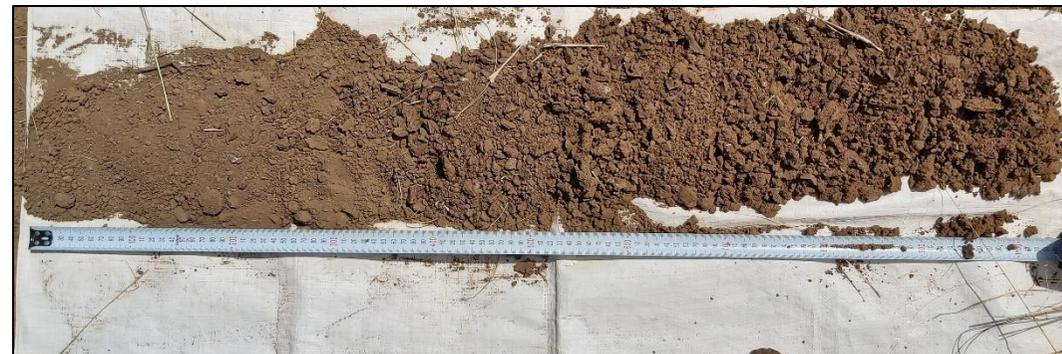
## SITE 9 - Depression

<b>Soil Mapping Unit:</b> C1-BR	<b>Location (GDA94 ZONE 55):</b> 635942 7541225	<b>Australian Soil Class:</b> Brown Vertosol	<b>Site Survey Type:</b> Detailed Hand Auger 50mm	<b>Survey Date:</b> 21/09/2019
------------------------------------	--	---	--	-----------------------------------

Land use Landform Pattern, Element, Slope	Vegetation	Microrelief Disturbance Erosion	Surface condition, surface rock	Soil Profile Description									
				Horizon Depth (m), Boundary	Field Texture	Structure, Strength	Inclusions Segregations	Colour, Mottle, Bleaching	Moisture, Drainage	Roots	Depth (m) / Field pH	Sample (m)	Observations
Grazing Midslope <2%/1%	Brigalow regrowth	Melon hole 50% coverage, 3- 6m wide, 0.2- 0.4m deep Semi disturbance Nil erosion	Cracking Nil coarse fragments	A1 0.00-0.12 Abrupt	Light clay	Weak, weak, subangular <10mm	Nil	10YR3/4 Dark yellowish brown Nil mottles / bleaching	Dry, well to moderate	Common	0.10 / 4.5	0.00-0.10 0.20-0.30 0.50-0.60 0.70-0.80 0.90-1.00	Nil
				B21 0.12-0.38 Abrupt	Light medium clay	Moderate, weak, subangular <10mm	<1% manganese nodules	10YR3/4 Dark yellowish brown Nil mottles / bleaching	Dry, moderate	Few	0.30 / 5.5 0.60 / 5.5		
				B22 0.38-1.00 EOBH	Medium clay	Moderate, firm, subangular 10- 20mm	Nil	10YR3/3 Dark brown Nil mottles / bleaching	Dry, moderate	Few	0.90 / 5.5

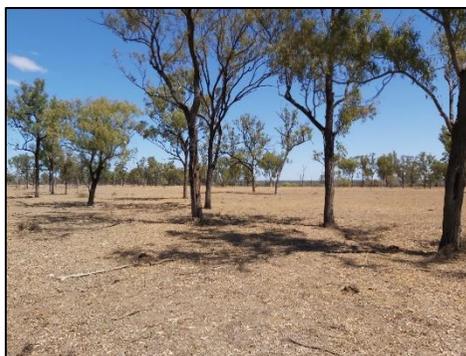
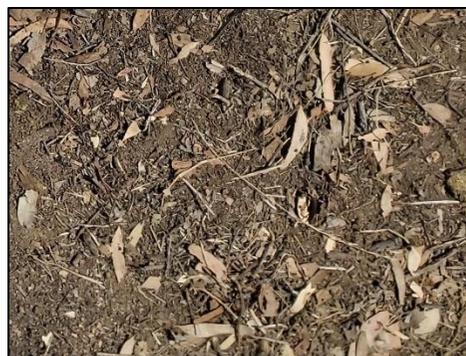
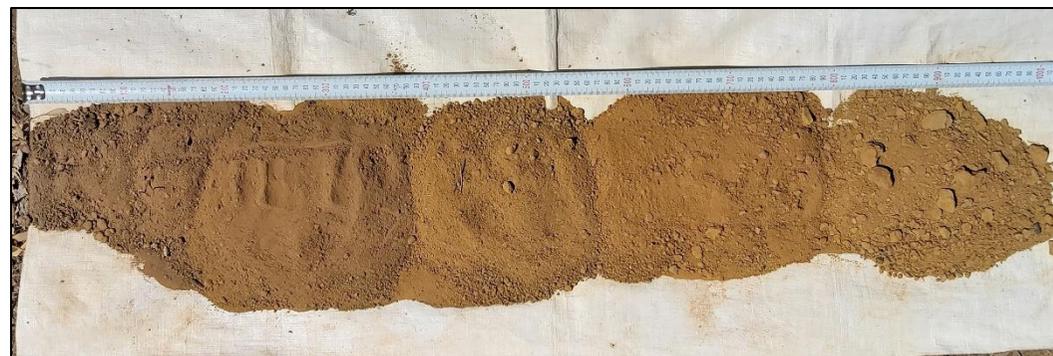
# SITE 10

<b>Soil Mapping Unit:</b> S3	<b>Location (GDA94 ZONE 55):</b> 636268 7540681	<b>Australian Soil Class:</b> Brown Chromosol	<b>Site Survey Type:</b> Detailed Hand Auger 50mm	<b>Survey Date:</b> 21/09/2019
---------------------------------	--	--	--	-----------------------------------

Land use Landform Pattern, Element, Slope	Vegetation	Microrelief Disturbance Erosion	Surface condition, surface rock	Soil Profile Description									
				Horizon Depth (m), Boundary	Field Texture	Structure, Strength	Inclusions Segregations	Colour, Mottle, Bleaching	Moisture, Drainage	Roots	Depth (m) / Field pH	Sample (m)	Observations
Grazing Crest, flat plain 1%/1%	Narrow-leaved Ironbark	Nil microrelief Semi disturbance Nil erosion	Firm, <2% coarse fragments <5mm	A1 0.00-0.11 Abrupt	Sandy loam	Massive, apedal	Nil	10YR4/2 Dark greyish brown Nil mottles / bleaching	Dry, well to moderate	Common	0.10 / 6.5	0.00-0.10 0.20-0.30 0.48-0.58 0.70-0.80 0.90-1.00	Nil
				B21 0.11-0.58 Abrupt	Clay loam	Massive, apedal	<2% coarse fragments <5mm	10YR3/4 Dark yellowish brown Nil mottles / bleaching	Dry, moderate	Few	0.30 / 6.5		
				B22 0.58-0.85 Abrupt	Light clay	Massive, apedal	2% coarse fragments <5mm	7.5YR5/6 Strong brown Nil mottles / bleaching	Dry, moderate	Nil	0.60 / 7.0

B23 0.85-1.00 EOBH	Light clay	Massive, apedal	2% coarse fragments 10mm	7.5YR5/6 Strong brown Nil mottles / bleaching	Dry, moderate	Nil	0.90 / 7.0

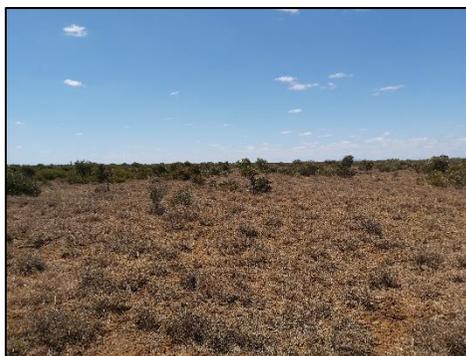
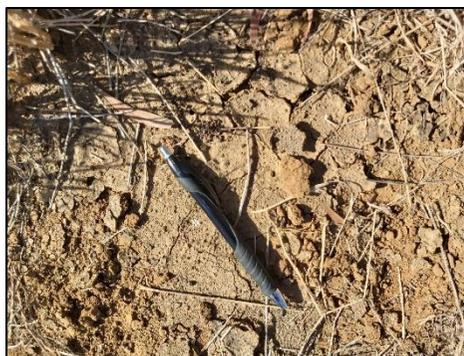
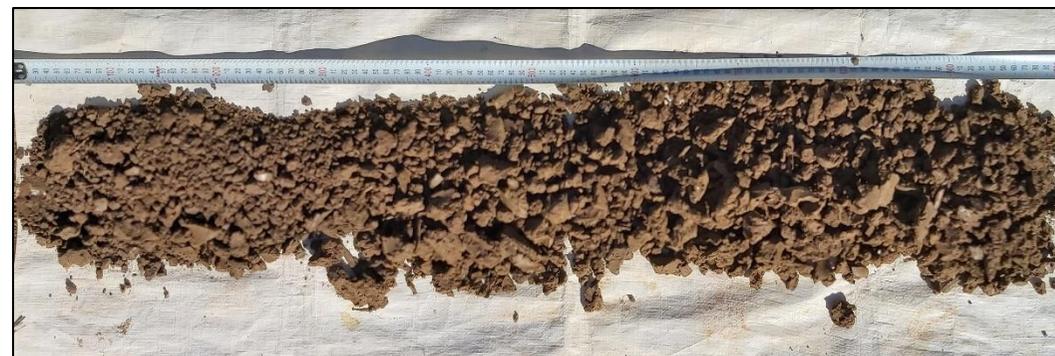
<b>Soil Mapping Unit:</b> C1-BR	<b>Location (GDA94 ZONE 55):</b> 636792 7540808	<b>Australian Soil Class:</b> Brown Vertosol	<b>Site Survey Type:</b> Detailed Hand Auger 50mm	<b>Survey Date:</b> 21/09/2019
------------------------------------	--	---	--	-----------------------------------

Land use Landform Pattern, Element, Slope	Vegetation	Microrelief Disturbance Erosion	Surface condition, surface rock	Soil Profile Description									
				Horizon Depth (m), Boundary	Field Texture	Structure, Strength	Inclusions Segregations	Colour, Mottle, Bleaching	Moisture, Drainage	Roots	Depth (m) / Field pH	Sample (m)	Observations
Grazing Flat Plain 1% / <1%	Brigalow regrowth	Melon hole 30% coverage, 3- 6m wide, 0.2- 0.4m deep Minor to semi disturbance Nil erosion	Firm, hard setting Nil coarse fragments	A1 0.00-0.20 Abrupt	Light clay	Moderate, firm, subangular 10- 30mm	Nil	7.5YR3/2 Dark brown Nil mottles / bleaching	Dry, well to moderate	Common	0.10 / 6.5	Nil	Nil
				B21 0.20-0.62 Abrupt	Medium clay	Moderate, strong, subangular 20- 40mm	Nil	7.5YR3/2 Dark brown Nil mottles / bleaching	Dry, moderate	Few	0.30 / 7.0 0.60 / 7.0		
				B22 0.62-1.00 EOBH	Medium heavy clay	Moderate, strong, subangular 30- 50mm	Nil	7.5YR3/2 Dark brown Nil mottles / bleaching	Dry, moderate	Few	0.90 / 8.0

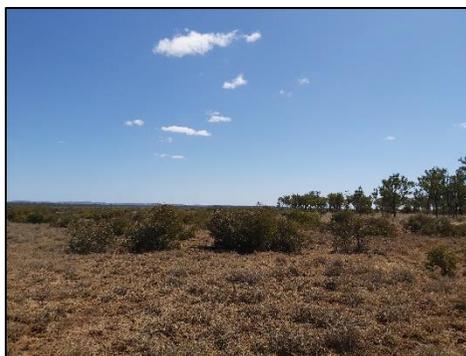
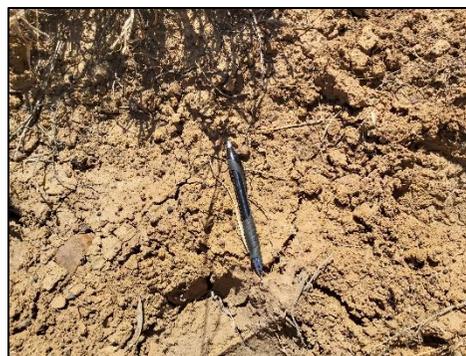
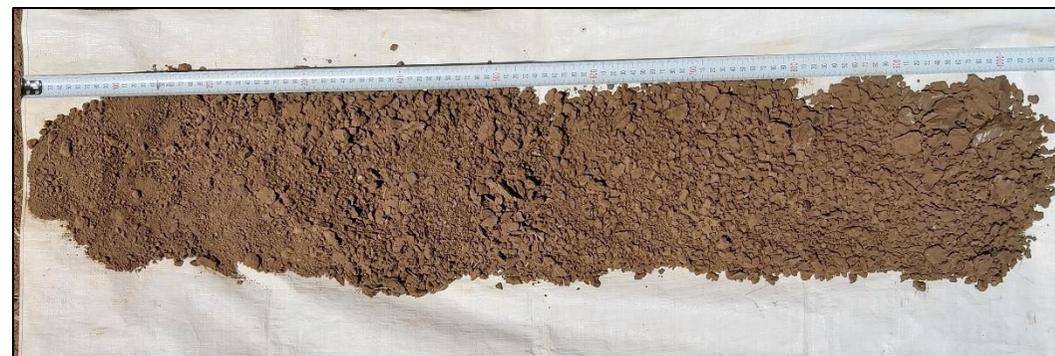
### SITE 12

<b>Soil Mapping Unit:</b> C1-BR	<b>Location (GDA94 ZONE 55):</b> 635884 7540395	<b>Australian Soil Class:</b> Brown Vertosol	<b>Site Survey Type:</b> Detailed Hand Auger 50mm	<b>Survey Date:</b> 21/09/2019
------------------------------------	--	---	--	-----------------------------------

Land use Landform Pattern, Element, Slope	Vegetation	Microrelief Disturbance Erosion	Surface condition, surface rock	Soil Profile Description									
				Horizon Depth (m), Boundary	Field Texture	Structure, Strength	Inclusions Segregations	Colour, Mottle, Bleaching	Moisture, Drainage	Roots	Depth (m) / Field pH	Sample (m)	Observations
Grazing Midslope <2%/1%	Brigalow regrowth	Melon hole 50% coverage, 3- 6m wide, 0.2- 0.4m deep Semi disturbance Nil erosion	Cracking, Nil coarse fragments	A1 0.00-0.14 Abrupt	Light clay	Weak, weak, subangular <10mm	Nil	10YR3/4 Dark yellowish brown Nil mottles / bleaching	Dry, well to moderate	Common	0.10 / 4.5	Nil	Nil
				B21 0.14-0.40 Abrupt	Light medium clay	Moderate, weak, subangular <10mm	<1% manganese nodules	10YR3/4 Dark yellowish brown Nil mottles / bleaching	Dry, moderate	Few	0.30 / 5.5 0.60 / 5.5		
				B22 0.40-1.00 EOBH	Medium clay	Moderate, firm, subangular 10- 20mm	Nil	10YR3/3 Dark brown Nil mottles / bleaching	Dry, moderate	Few	0.90 / 6.0

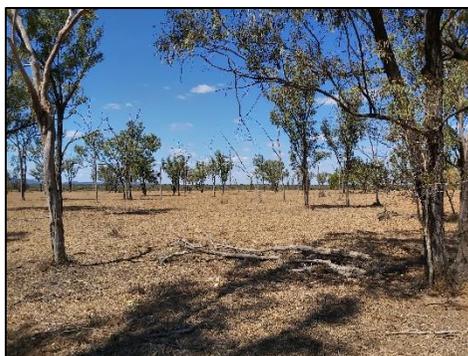
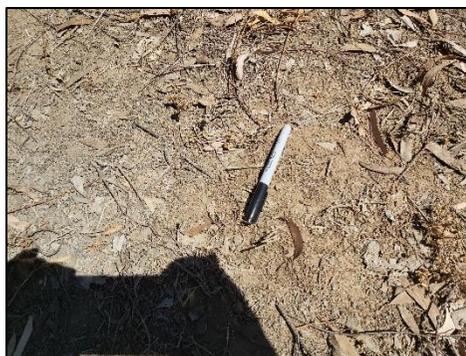
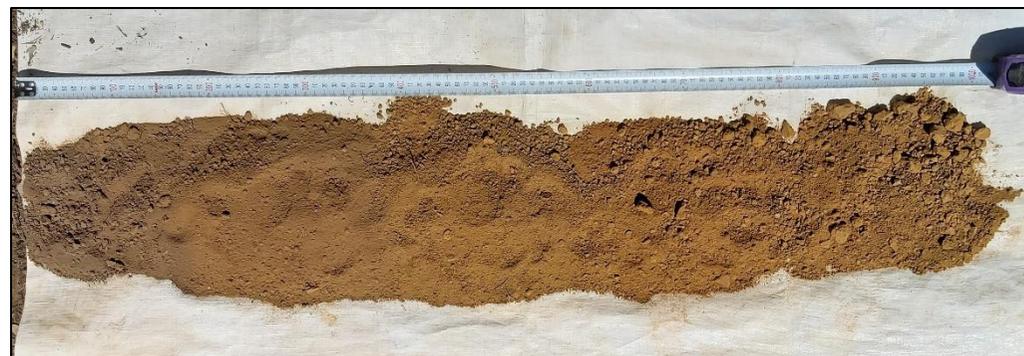
### SITE 13

<b>Soil Mapping Unit:</b> S3	<b>Location (GDA94 ZONE 55):</b> 636629 7540160	<b>Australian Soil Class:</b> Brown Chromosol	<b>Site Survey Type:</b> Detailed Hand Auger 50mm	<b>Survey Date:</b> 21/09/2019
---------------------------------	--	--	--	-----------------------------------

Land use Landform Pattern, Element, Slope	Vegetation	Microrelief Disturbance Erosion	Surface condition, surface rock	Soil Profile Description									
				Horizon Depth (m), Boundary	Field Texture	Structure, Strength	Inclusions Segregations	Colour, Mottle, Bleaching	Moisture, Drainage	Roots	Depth (m) / Field pH	Sample (m)	Observations
Grazing Flat plain 1%/1%	Narrow Leaf Ironbark	Nil microrelief Semi disturbance Nil erosion	Firm, <2% coarse fragments <5mm	A1 0.00-0.11 Abrupt	Sandy loam	Massive, apedal	Nil	10YR4/2 Dark greyish brown Nil mottles / bleaching	Dry, well to moderate	Common	0.10 / 6.5	Nil	Nil
				B21 0.11-0.50 Abrupt	Clay loam	Massive, apedal	<2% coarse fragments <5mm	10YR3/4 Dark yellowish brown Nil mottles / bleaching	Dry, moderate	Few	0.30 / 6.5		
				B22 0.50-0.85 Abrupt	Light clay	Weak, apedal	2% coarse fragments <5mm	7.5YR5/6 Strong brown Nil mottles / bleaching	Dry, moderate	Nil	0.60 / 7.0

B22 0.85-1.00 EOBH	Light clay	Weak, apedal	2% coarse fragments 10mm	7.5YR5/6 Strong brown Nil mottles / bleaching	Dry, moderate	Nil	0.90 / 7.0

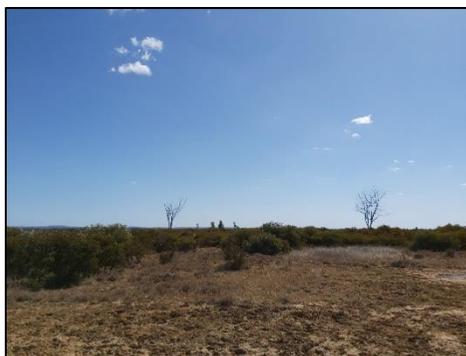
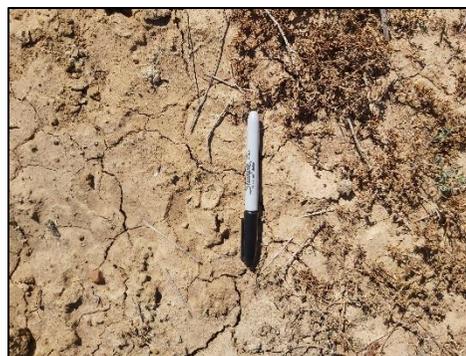
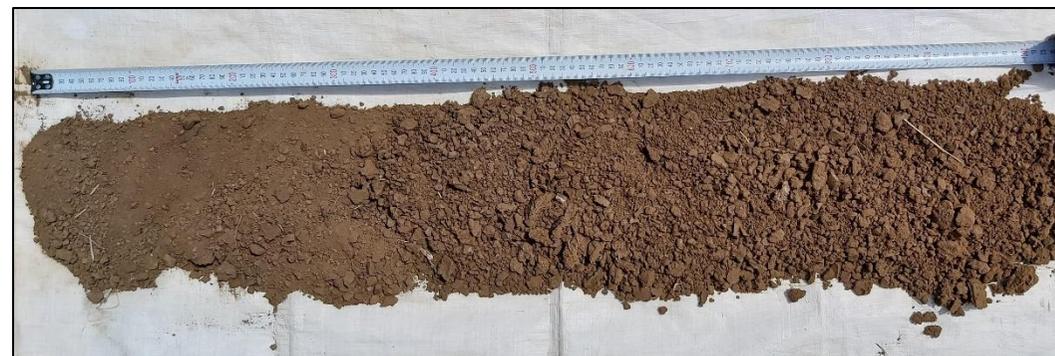
<b>Soil Mapping Unit:</b> C1-BR	<b>Location (GDA94 ZONE 55):</b> 635097 7541741	<b>Australian Soil Class:</b> Brown Vertosol	<b>Site Survey Type:</b> Detailed Hand Auger 50mm	<b>Survey Date:</b> 21/09/2019
------------------------------------	--	---	--	-----------------------------------

Land use Landform Pattern, Element, Slope	Vegetation	Microrelief Disturbance Erosion	Surface condition, surface rock	Soil Profile Description									
				Horizon Depth (m), Boundary	Field Texture	Structure, Strength	Inclusions Segregations	Colour, Mottle, Bleaching	Moisture, Drainage	Roots	Depth (m) / Field pH	Sample (m)	Observations
Grazing Midslope <2%/1%	Brigalow regrowth	Melon hole 50% coverage, 3- 6m wide, 0.2- 0.4m deep Semi disturbance Nil erosion	Cracking Nil coarse fragments	A1 0.00-0.09 Abrupt	Light clay	Weak, firm, subangular <10mm	<2% manganese nodules	10YR3/3 Dark brown Nil mottles / bleaching	Dry, well to moderate	Common	0.10 / 6.5	Nil	Nil
				B21 0.09-0.60 Abrupt	Light medium clay	Weak, firm, subangular <10mm	<1% manganese nodules	7.5YR4/3 Brown Nil mottles / bleaching	Dry, moderate	Few	0.30 / 7.5 0.60 / 7.5		
				B22 0.60-1.00 EOBH	Light medium heavy clay	Weak, firm, subangular 10- 20mm	Nil	7.5YR4/3 Brown Nil mottles / bleaching	Dry, moderate	Few	0.90 / 6.5

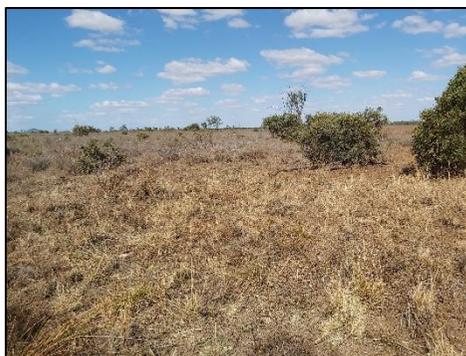
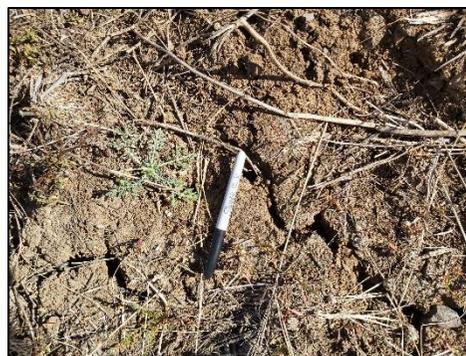
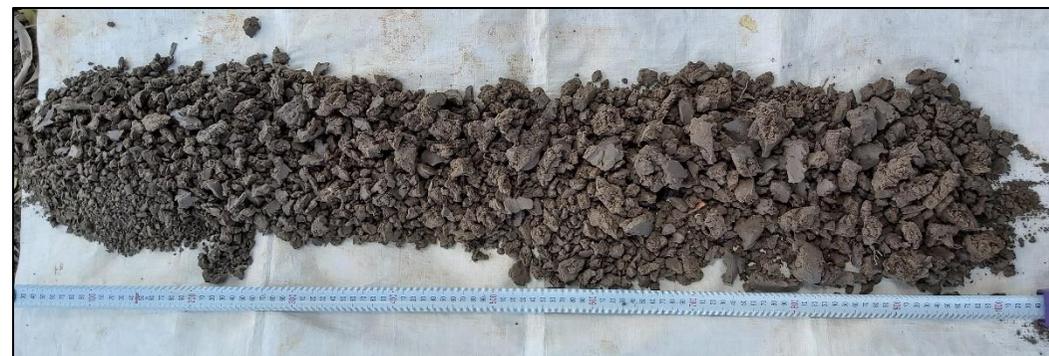
# SITE 15

<b>Soil Mapping Unit:</b> C1-BL	<b>Location (GDA94 ZONE 55):</b> 634851 7539279	<b>Australian Soil Class:</b> Black Vertosol	<b>Site Survey Type:</b> Detailed Hand Auger 50mm	<b>Survey Date:</b> 21/09/2019
------------------------------------	--	---	--	-----------------------------------

Land use Landform Pattern, Element, Slope	Vegetation	Microrelief Disturbance Erosion	Surface condition, surface rock	Soil Profile Description									
				Horizon Depth (m), Boundary	Field Texture	Structure, Strength	Inclusions Segregations	Colour, Mottle, Bleaching	Moisture, Drainage	Roots	Depth (m) / Field pH	Sample (m)	Observations
Grazing Flat Plain 1% / <1%	Brigalow	Melon hole 40% coverage, 3- 10m wide, 0.3-0.6m deep	Firm, cracking Nil coarse fragments	A1 0.00-0.12 Abrupt	Medium clay	Moderate, very firm, subangular <10mm	Nil	10YR3/2 Very dark greyish brown Nil mottles / bleaching	Dry, well to moderate	Common	0.10 / 5.5- 6.0	Nil	Nil
				B21 0.12-0.55 Abrupt	Medium heavy clay	Moderate, very firm, subangular <20mm	Nil	10YR3/1 Very dark grey Nil mottles / bleaching	Dry, moderate	Few	0.30 / 5.5-6.0		
				B22 0.55-1.00 EOBH	Medium heavy clay	Moderate, very firm, subangular <40mm	Nil	10YR3/1 Very dark grey Nil mottles / bleaching	Dry, moderate	Few	0.60 / 5.5-6.0 0.90 / 5.5

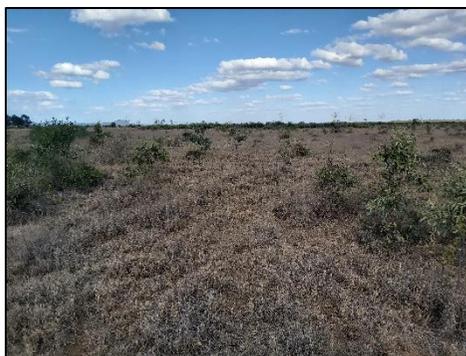
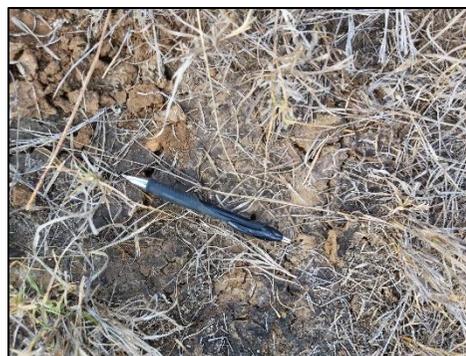
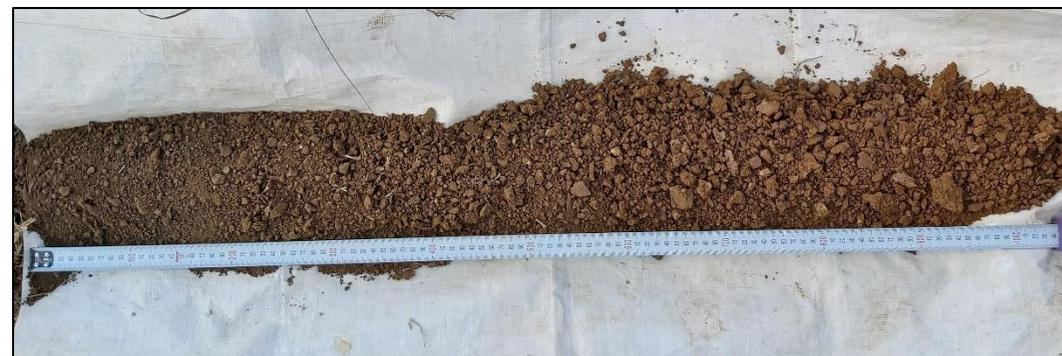
# SITE 16

<b>Soil Mapping Unit:</b> C3-BR	<b>Location (GDA94 ZONE 55):</b> 634514 7542109	<b>Australian Soil Class:</b> Brown Vertosol	<b>Site Survey Type:</b> Detailed Hand Auger 50mm	<b>Survey Date:</b> 21/09/2019
------------------------------------	--	---	--	-----------------------------------

Land use Landform Pattern, Element, Slope	Vegetation	Microrelief Disturbance Erosion	Surface condition, surface rock	Soil Profile Description									
				Horizon Depth (m), Boundary	Field Texture	Structure, Strength	Inclusions Segregations	Colour, Mottle, Bleaching	Moisture, Drainage	Roots	Depth (m) / Field pH	Sample (m)	Observations
Grazing Midslope 1%	Mixed regrowth	Nil microrelief Semi disturbance Nil erosion	Cracking Nil coarse fragments	A1 0.00-0.15 Abrupt	Light clay	Moderate, firm, subangular <10mm	Nil	7.5YR3/2 Dark brown Nil mottles / bleaching	Dry, well to moderate	Common	0.10 / 6.5	0.00-0.10 0.20-0.30 0.50-0.60 0.70-0.80 0.90-1.00	Site placed in small polygon with no microrelief, surrounding areas feature melon holes
				B21 0.15-0.80 Abrupt	Medium clay	Moderate, firm, subangular <10mm	Nil	7.5YR4/3 Brown Nil mottles / bleaching	Dry, moderate	Few	0.30 / 6.5 0.60 / 6.5		
				B22 0.80-1.00 EOBH	Medium clay	Moderate, firm, subangular 10- 20mm	Nil	7.5YR4/4 Brown Nil mottles / bleaching	Dry, moderate	Few	0.90 / 7.0

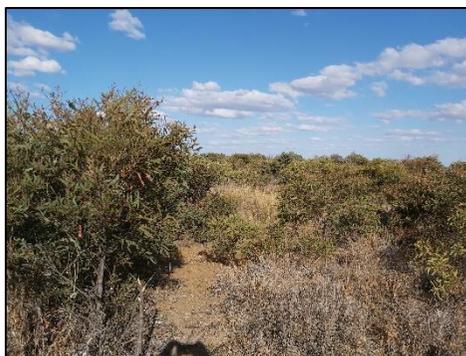
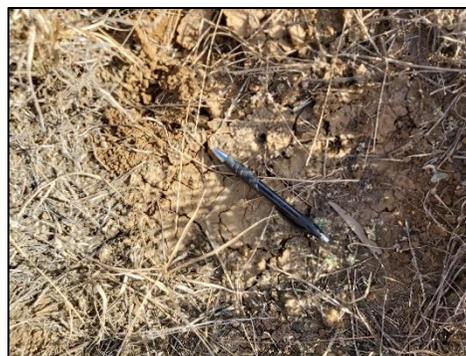
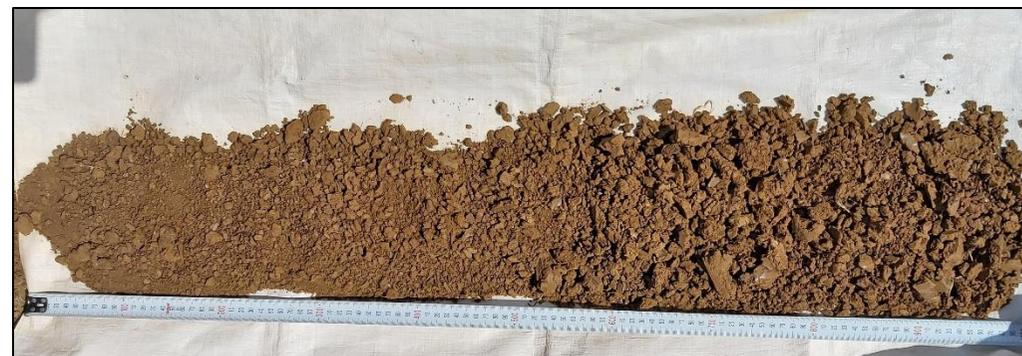
### SITE 17

<b>Soil Mapping Unit:</b> C1-BR	<b>Location (GDA94 ZONE 55):</b> 633642 7542147	<b>Australian Soil Class:</b> Brown Vertosol	<b>Site Survey Type:</b> Detailed Hand Auger 50mm	<b>Survey Date:</b> 21/09/2019
------------------------------------	--	---	--	-----------------------------------

Land use Landform Pattern, Element, Slope	Vegetation	Microrelief Disturbance Erosion	Surface condition, surface rock	Soil Profile Description									
				Horizon Depth (m), Boundary	Field Texture	Structure, Strength	Inclusions Segregations	Colour, Mottle, Bleaching	Moisture, Drainage	Roots	Depth (m) / Field pH	Sample (m)	Observations
Grazing Midslope <1%/1%	Brigalow regrowth	Melon hole 50% coverage, 3- 6m wide, 0.2- 0.4m deep Semi disturbance Nil erosion	Cracking, crust, Nil coarse fragments	A1 0.00-0.15 Abrupt	Light clay	Weak, weak, subangular <10mm	Nil	10YR3/4 Dark yellowish brown Nil mottles / bleaching	Dry, well to moderate	Common	0.10 / 6.0	Nil	Nil
				B21 0.15-0.45 Abrupt	Medium clay	Moderate, weak, subangular <10mm	Nil	10YR3/4 Dark yellowish brown Nil mottles / bleaching	Dry, moderate	Few	0.30 / 6.0 0.60 / 6.0		
				B22 0.45-1.00 EOBH	Medium clay	Moderate, firm, subangular 10- 20mm	Nil	7.5YR4/4 Brown Nil mottles / bleaching	Dry, moderate	Few	0.90 / 6.0

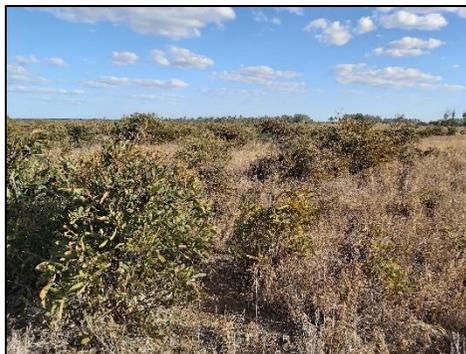
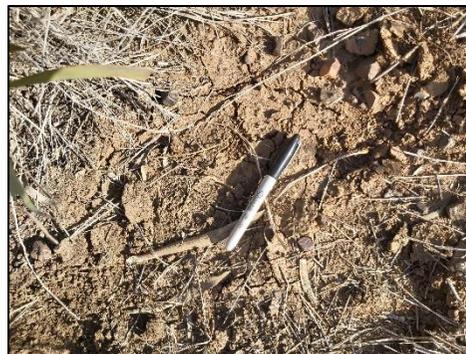
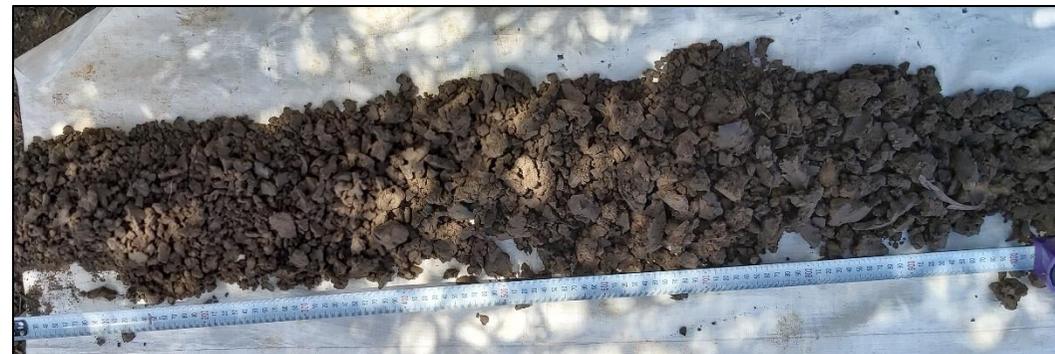
# SITE 18

<b>Soil Mapping Unit:</b> C1-BL	<b>Location (GDA94 ZONE 55):</b> 632695 7541423	<b>Australian Soil Class:</b> Black Vertosol	<b>Site Survey Type:</b> Detailed Hand Auger 50mm	<b>Survey Date:</b> 21/09/2019
------------------------------------	--	---	--	-----------------------------------

Land use Landform Pattern, Element, Slope	Vegetation	Microrelief Disturbance Erosion	Surface condition, surface rock	Soil Profile Description									
				Horizon Depth (m), Boundary	Field Texture	Structure, Strength	Inclusions Segregations	Colour, Mottle, Bleaching	Moisture, Drainage	Roots	Depth (m) / Field pH	Sample (m)	Observations
Grazing Flat Plain 1% / <1%	Brigalow	Melon hole 40-50% coverage, 3- 10m wide, 0.3-0.6m deep	Firm, cracking with crust Nil coarse fragments	A1 0.00-0.15 Abrupt	Medium clay	Moderate, very firm, subangular <10mm	Nil	10YR3/2 Very dark greyish brown Nil mottles / bleaching	Dry, well to moderate	Common	0.10 / 5.5	Nil	Nil
				B21 0.15-0.55 Abrupt	Medium clay	Moderate, very firm, subangular <20mm	Nil	10YR3/1 Very dark grey Nil mottles / bleaching	Dry, moderate	Few	0.30 / 6.0		
				B22 0.55-1.00 EOBH	Medium heavy clay	Moderate, very firm, subangular <40mm	Nil	10YR3/1 Very dark grey Nil mottles / bleaching	Dry, moderate	Few	0.60 / 6.0 0.90 / 5.5
