# Appendix J

Soils and Land Suitability  
Assessment

## WINCHESTER SOUTH PROJECT Environmental Impact Statement

# Soils and Land Suitability Assessment

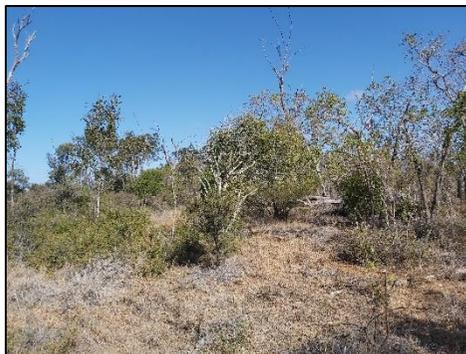
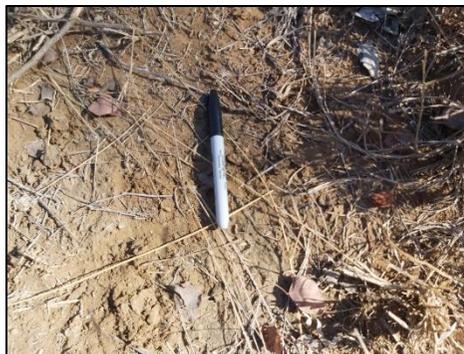
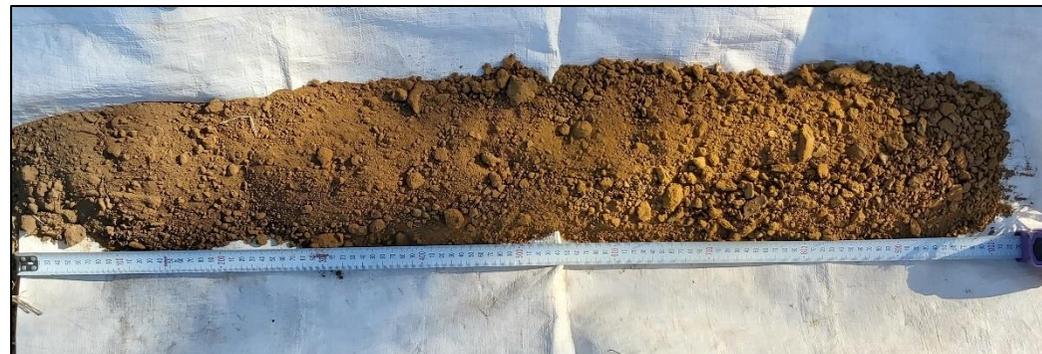
# SITE 19

<b>Soil Mapping Unit:</b> S1	<b>Location (GDA94 ZONE 55):</b> 637468 7544348	<b>Australian Soil Class:</b> Brown Sodosol	<b>Site Survey Type:</b> Detailed Hand Auger 50mm	<b>Survey Date:</b> 22/09/2019
---------------------------------	--	--	--	-----------------------------------

Land use Landform Pattern, Element, Slope	Vegetation	Microrelief Disturbance Erosion	Surface condition, surface rock	Soil Profile Description									
				Horizon Depth (m), Boundary	Field Texture	Structure, Strength	Inclusions Segregations	Colour, Mottle, Bleaching	Moisture, Drainage	Roots	Depth (m) / Field pH	Sample (m)	Observations
Grazing, gently undulating plain / flat plain 1%	Mixed vegetation with Poplar Box	Nil microrelief Semi disturbance Nil erosion	Hard setting, nil coarse fragments	A11 0.00-0.10 Abrupt	Loamy sand	Apedal, massive	Nil	10YR3/3 Dark brown Nil mottles / bleaching	Dry, rapidly drained	Common	0.10 / 6.0	Nil	Second attempt to reach 1m, first attempt no recovery at 0.70m
				A21 0.10-0.33 Abrupt	Clayey sand	Massive, weak, with parts firm subangular peds	Nil	10YR3/4 Dark yellowish brown Nil mottles / bleaching	Dry, rapidly drained	Common	0.25 / 7.0		
				A22 0.33-0.70 Abrupt	Clayey sand	Weak, firm, subangular peds	Nil	10YR3/6 Dark yellowish brown Nil mottles / bleaching	Dry, rapid/well drained	Few	0.60 / 7.0

B21 0.70-1.00 EOBH	Sandy clay loam	Moderate, very firm, subangular 10-20mm	<1% mg nodules <2mm	10YR4/6 Dark yellowish brown Nil mottles / bleaching	Dry, well drained	Few	0.90 / 7.5

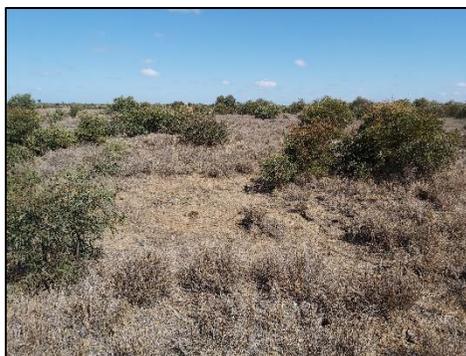
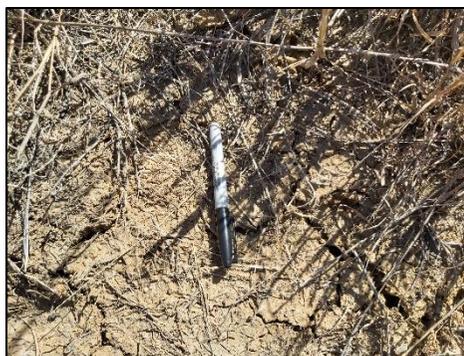
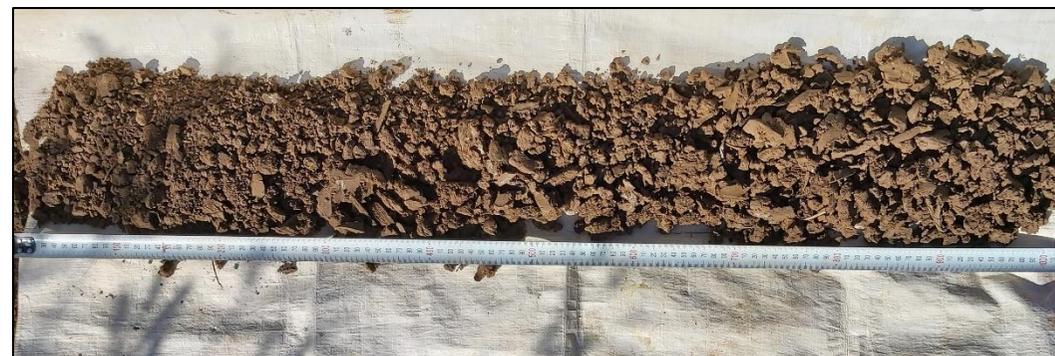
<b>Soil Mapping Unit:</b> C1-BR	<b>Location (GDA94 ZONE 55):</b> 636315 7544448	<b>Australian Soil Class:</b> Brown Vertosol	<b>Site Survey Type:</b> Detailed Hand Auger 50mm	<b>Survey Date:</b> 22/09/2019
------------------------------------	--	---	--	-----------------------------------

Land use Landform Pattern, Element, Slope	Vegetation	Microrelief Disturbance Erosion	Surface condition, surface rock	Soil Profile Description									
				Horizon Depth (m), Boundary	Field Texture	Structure, Strength	Inclusions Segregations	Colour, Mottle, Bleaching	Moisture, Drainage	Roots	Depth (m) / Field pH	Sample (m)	Observations
Grazing Flat Plain 1% / <1%	Brigalow regrowth	Melon hole 30% coverage, 3- 6m wide, 0.2- 0.4m deep Minor to semi disturbance Nil erosion	Firm, cracking Nil coarse fragments	A1 0.00-0.15 Abrupt	Light clay	Moderate, firm, subangular 10- 30mm	Nil	7.5YR3/2 Dark brown Nil mottles / bleaching	Dry, well to moderate	Common	0.10 / 6.5	Nil	Nil
				B21 0.15-0.60 Abrupt	Medium clay	Moderate, strong, subangular 20- 40mm	Nil	7.5YR3/2 Dark brown Nil mottles / bleaching	Dry, moderate	Few	0.30 / 6.5 0.55 / 6.5		
				B22 0.60-1.00 EOBH	Medium heavy clay	Moderate, strong, subangular 30- 50mm	Nil	7.5YR3/2 Dark brown Nil mottles / bleaching	Dry, moderate	Few	0.90 / 7.5

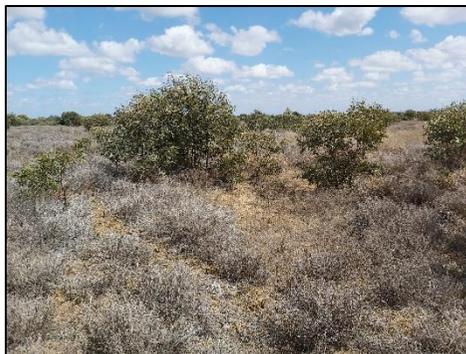
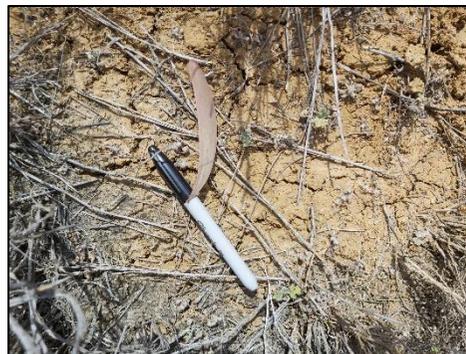
# SITE 21

<b>Soil Mapping Unit:</b> C1-BR	<b>Location (GDA94 ZONE 55):</b> 634457 7544037	<b>Australian Soil Class:</b> Brown Vertosol	<b>Site Survey Type:</b> Detailed Hand Auger 50mm	<b>Survey Date:</b> 22/09/2019
------------------------------------	--	---	--	-----------------------------------

Land use Landform Pattern, Element, Slope	Vegetation	Microrelief Disturbance Erosion	Surface condition, surface rock	Soil Profile Description									
				Horizon Depth (m), Boundary	Field Texture	Structure, Strength	Inclusions Segregations	Colour, Mottle, Bleaching	Moisture, Drainage	Roots	Depth (m) / Field pH	Sample (m)	Observations
Grazing Midslope 1%	Brigalow regrowth	Melon hole 40-50% coverage, 2- 5m wide, 0.2- 0.4m deep Semi disturbance Nil erosion	Cracking, Nil coarse fragments	A1 0.00-0.15 Abrupt	Light clay	Weak, weak, subangular <10mm	Nil	10YR3/4 Dark yellowish brown Nil mottles / bleaching	Dry, well to moderate	Common	0.10 / 5.5	Nil	Nil
				B21 0.15-0.38 Abrupt	Light medium clay	Moderate, weak, subangular <10mm	Nil	10YR3/4 Dark yellowish brown Nil mottles / bleaching	Dry, moderate	Few	0.30 / 6.5 0.60 / 6.5		
				B22 0.38-1.00 EOBH	Medium clay	Moderate, firm, subangular 10- 20mm	Nil	10YR3/3 Dark brown Nil mottles / bleaching	Dry, moderate	Few	0.90 / 6.5

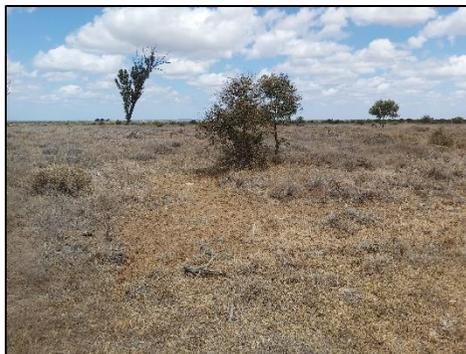
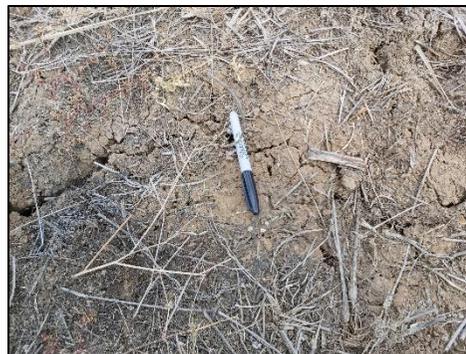
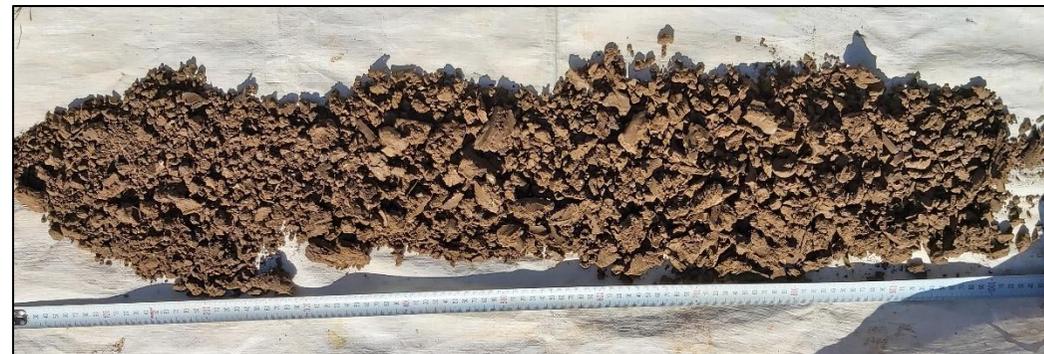
## SITE 22

<b>Soil Mapping Unit:</b> C1-BR	<b>Location (GDA94 ZONE 55):</b> 635436 7542867	<b>Australian Soil Class:</b> Brown Vertosol	<b>Site Survey Type:</b> Detailed Hand Auger 50mm	<b>Survey Date:</b> 22/09/2019
------------------------------------	--	---	--	-----------------------------------

Land use Landform Pattern, Element, Slope	Vegetation	Microrelief Disturbance Erosion	Surface condition, surface rock	Soil Profile Description									
				Horizon Depth (m), Boundary	Field Texture	Structure, Strength	Inclusions Segregations	Colour, Mottle, Bleaching	Moisture, Drainage	Roots	Depth (m) / Field pH	Sample (m)	Observations
Grazing, Flat Plain 1%	Sparse Brigalow regrowth	Melon hole 40% coverage, 3-5 m wide, 0.2- 0.4m deep Minor to semi disturbance Nil erosion	Firm, cracking, self-mulching Nil coarse fragments	A1 0.00-0.14 Abrupt	Light clay	Moderate, firm, subangular 10- 30mm	Nil	7.5YR3/2 Dark brown Nil mottles / bleaching	Dry, well to moderate	Common	0.10 / 6.0	Nil	Nil
				B21 0.14-0.62 Abrupt	Medium clay	Moderate, strong, subangular 20- 40mm	Nil	7.5YR3/2 Dark brown Nil mottles / bleaching	Dry, moderate	Few	0.30 / 6.5 0.60 / 6.5		
				B22 0.62-1.00 EOBH	Medium heavy clay	Moderate, strong, subangular 30- 50mm	Nil	7.5YR3/2 Dark brown Nil mottles / bleaching	Dry, moderate	Few	0.90 / 7.0

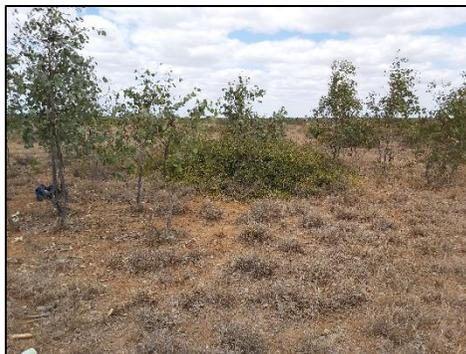
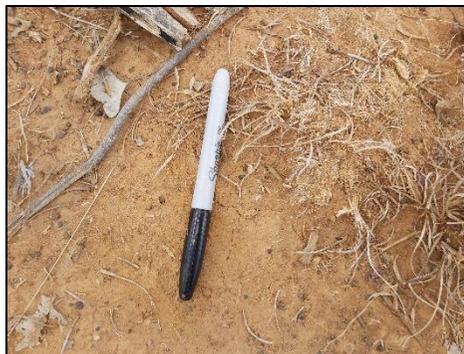
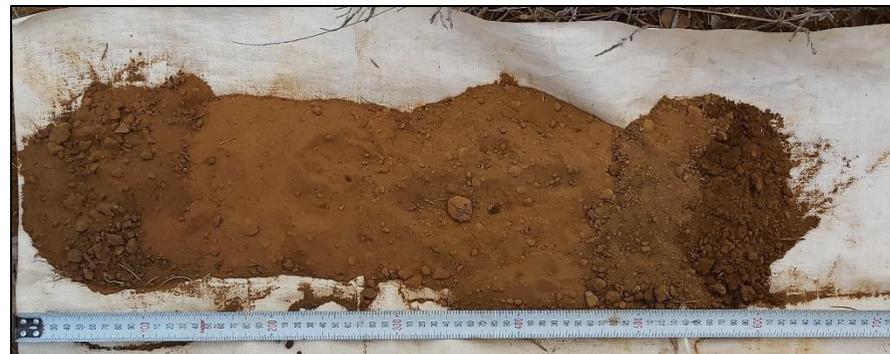
### SITE 23

<b>Soil Mapping Unit:</b> S3	<b>Location (GDA94 ZONE 55):</b> 636484 7542483	<b>Australian Soil Class:</b> Brown Chromosol	<b>Site Survey Type:</b> Detailed Hand Auger 50mm	<b>Survey Date:</b> 22/09/2019
---------------------------------	--	--	--	-----------------------------------

Land use Landform Pattern, Element, Slope	Vegetation	Microrelief Disturbance Erosion	Surface condition, surface rock	Soil Profile Description									
				Horizon Depth (m), Boundary	Field Texture	Structure, Strength	Inclusions Segregations	Colour, Mottle, Bleaching	Moisture, Drainage	Roots	Depth (m) / Field pH	Sample (m)	Observations
Flat plain <1%	Mixed regrowth with Poplar Box	Nil microrelief Semi disturbance Nil erosion	Firm to hard setting, <1% coarse fragments including Mg nodules	A1 0.00-0.10 Abrupt	Sandy loam	Weak, loose	2% coarse fragments 1-3mm	7.5YR2.5/3 Very dark brown Nil mottles / bleaching	Dry, rapidly drained	Common	0.10 / 6.0	0.00-0.10 0.20-0.30 0.50-0.60	No auger recovery at 0.60m, three attempts
				B21 0.10-0.60+	Clay loam	Massive, weak	2% coarse fragments 1-3mm	7.5YR4/4 Brown Nil mottles / bleaching	Dry, rapidly drained	Nil	0.30 / 5.5 0.60 / 5.5

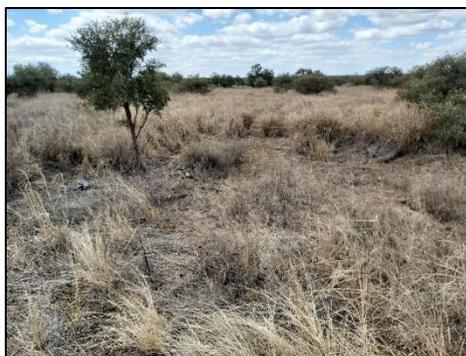
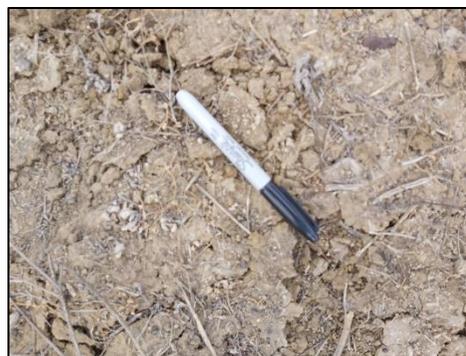
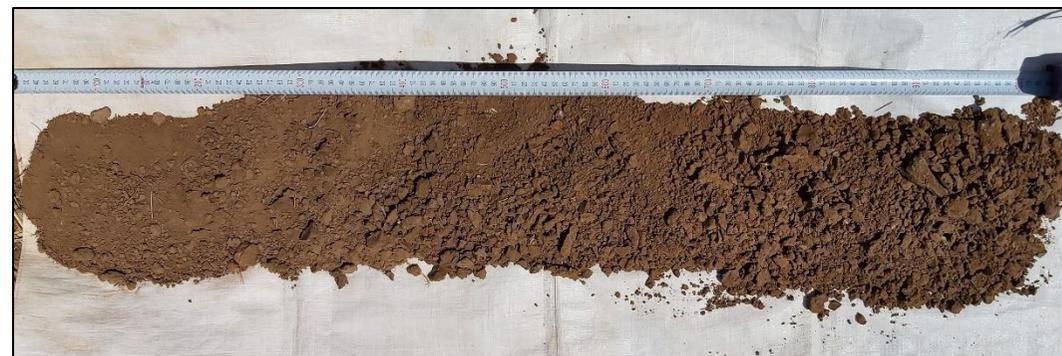
### SITE 24

<b>Soil Mapping Unit:</b> C1-BR	<b>Location (GDA94 ZONE 55):</b> 632797 7542537	<b>Australian Soil Class:</b> Brown Vertosol	<b>Site Survey Type:</b> Detailed Hand Auger 50mm	<b>Survey Date:</b> 22/09/2019
------------------------------------	--	---	--	-----------------------------------

Land use Landform Pattern, Element, Slope	Vegetation	Microrelief Disturbance Erosion	Surface condition, surface rock	Soil Profile Description									
				Horizon Depth (m), Boundary	Field Texture	Structure, Strength	Inclusions Segregations	Colour, Mottle, Bleaching	Moisture, Drainage	Roots	Depth (m) / Field pH	Sample (m)	Observations
Grazing, Flat Plain 1%	Brigalow regrowth	Melon hole 40% coverage, 3-5 m wide, 0.2- 0.4m deep Minor to semi disturbance Nil erosion	Firm, cracking self-mulching Nil coarse fragments	A1 0.00-0.18 Abrupt	Light clay	Moderate, firm, subangular 10- 30mm	Nil	7.5YR3/2 Dark brown Nil mottles / bleaching	Dry, well to moderate	Common	0.10 / 6.0	Nil	Nil
				B21 0.18-0.62 Abrupt	Medium clay	Moderate, strong, subangular 20- 40mm	Nil	7.5YR3/2 Dark brown Nil mottles / bleaching	Dry, moderate	Few	0.30 / 6.5 0.60 / 6.5		
				B22 0.62-1.00 EOBH	Medium clay	Moderate, strong, subangular 30- 50mm	Nil	7.5YR3/2 Dark brown Nil mottles / bleaching	Dry, moderate	Few	0.90 / 6.5

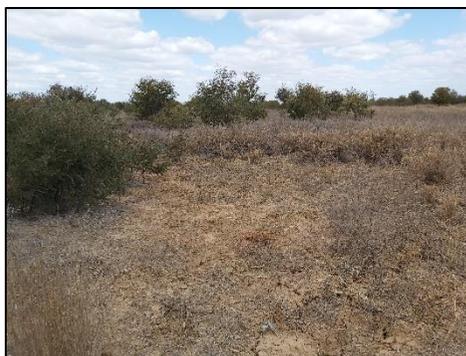
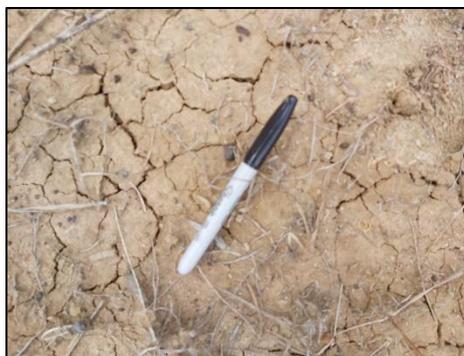
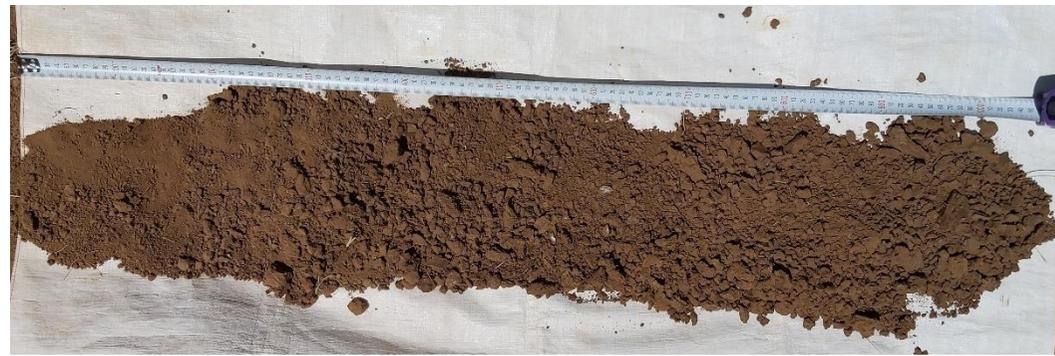
### SITE 25

<b>Soil Mapping Unit:</b> C1-BR	<b>Location (GDA94 ZONE 55):</b> 633001 7544031	<b>Australian Soil Class:</b> Brown Vertosol	<b>Site Survey Type:</b> Detailed Hand Auger 50mm	<b>Survey Date:</b> 22/09/2019
------------------------------------	--	---	--	-----------------------------------

Land use Landform Pattern, Element, Slope	Vegetation	Microrelief Disturbance Erosion	Surface condition, surface rock	Soil Profile Description									
				Horizon Depth (m), Boundary	Field Texture	Structure, Strength	Inclusions Segregations	Colour, Mottle, Bleaching	Moisture, Drainage	Roots	Depth (m) / Field pH	Sample (m)	Observations
Grazing Midslope <2%/1%	Brigalow regrowth	Melon hole 50% coverage, 3- 6m wide, 0.2- 0.4m deep Semi disturbance Nil erosion	Cracking Nil coarse fragments	A1 0.00-0.09 Abrupt	Light clay	Weak, firm, subangular <10mm	<2% manganese nodules	10YR3/3 Dark brown Nil mottles / bleaching	Dry, well to moderate	Common	0.10 / 6.5	Nil	Nil
				B21 0.09-0.66 Abrupt	Light medium clay	Weak, firm, subangular <10mm	Nil	7.5YR4/3 Brown Nil mottles / bleaching	Dry, moderate	Few	0.30 / 6.5 0.60 / 6.5		
				B22 0.66-1.00 EOBH	Light medium heavy clay	Weak, firm, subangular 10- 20mm	Nil	7.5YR4/3 Brown Nil mottles / bleaching	Dry, moderate	Few	0.90 / 7.0

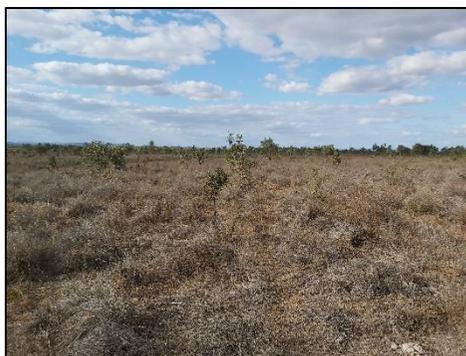
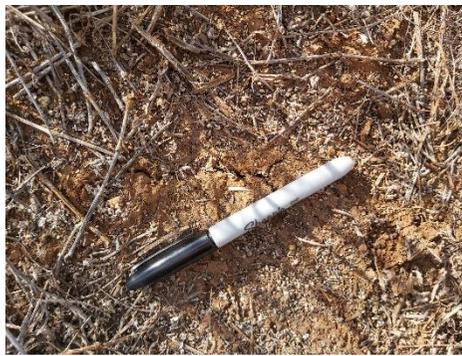
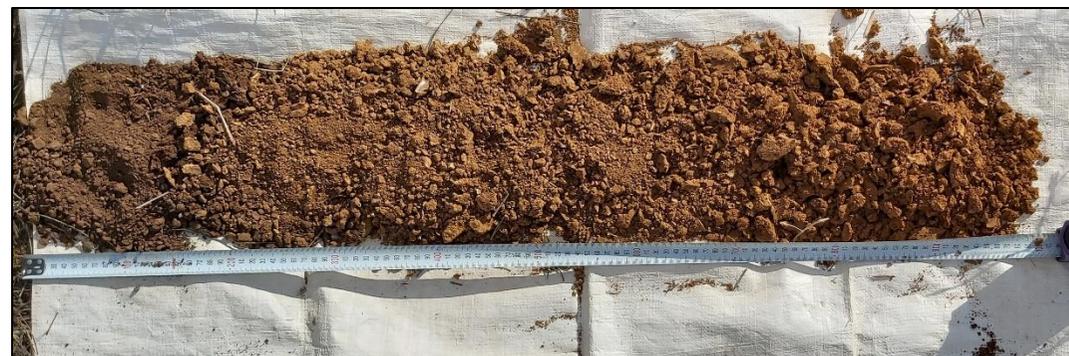
### SITE 26

<b>Soil Mapping Unit:</b> C3-BR	<b>Location (GDA94 ZONE 55):</b> 633122 7545375	<b>Australian Soil Class:</b> Brown Vertosol	<b>Site Survey Type:</b> Detailed Hand Auger 50mm	<b>Survey Date:</b> 22/09/2019
------------------------------------	--	---	--	-----------------------------------

Land use Landform Pattern, Element, Slope	Vegetation	Microrelief Disturbance Erosion	Surface condition, surface rock	Soil Profile Description									
				Horizon Depth (m), Boundary	Field Texture	Structure, Strength	Inclusions Segregations	Colour, Mottle, Bleaching	Moisture, Drainage	Roots	Depth (m) / Field pH	Sample (m)	Observations
Grazing, gently undulating plain, upper slope 1-2%	Grasses, nearby white/grey gums	Nil microrelief Semi disturbance Nil erosion	Firm, cracking nil coarse fragments	A1 0.00-0.18 Abrupt	Light clay	Weak, very firm peds <10mm	Nil	7.5YR3/3 Dark brown Nil mottles / bleaching	Dry, well drained	Common	0.10 / 6.0	Nil	Nil
				B21 0.18-0.68 Gradual	Light clay	Weak to moderate, firm, peds <20mm	<1% <2mm manganese nodules	7.5YR4/3 Brown Nil mottles / bleaching	Dry, moderately well drained	Few	0.30 / 6.5 0.60 / 6.5		
				B22 0.68-1.00 EOBH	Light medium clay	Moderate, very firm, peds 10- 20mm	<1% <2mm manganese nodules	10YR5/6 Yellowish brown Nil mottles / bleaching	Dry, moderately well drained	Nil	0.90 / 6.5

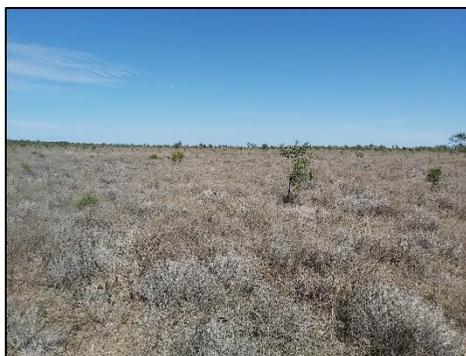
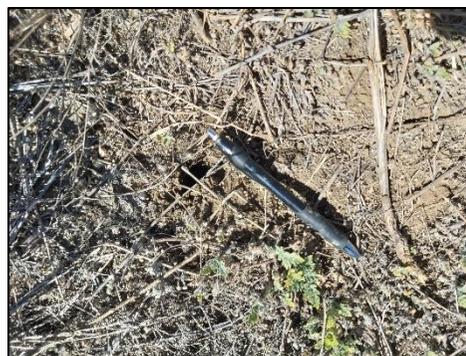
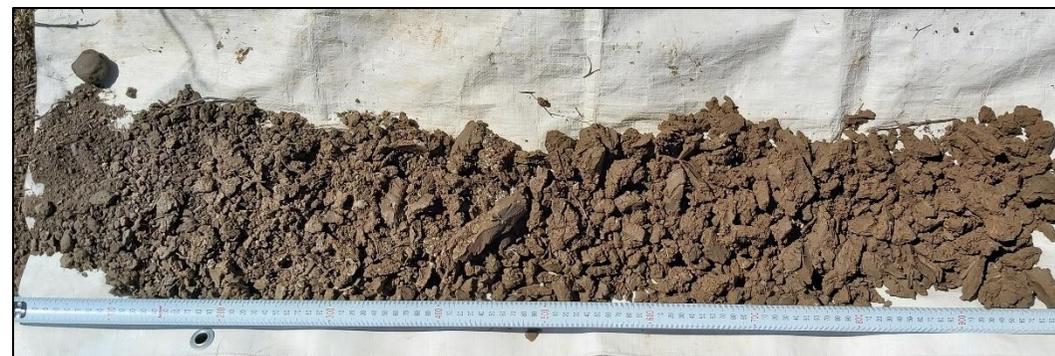
### SITE 27

<b>Soil Mapping Unit:</b> C3-BR	<b>Location (GDA94 ZONE 55):</b> 634901 7545803	<b>Australian Soil Class:</b> Brown Vertosol	<b>Site Survey Type:</b> Detailed Hand Auger 50mm	<b>Survey Date:</b> 23/09/2019
------------------------------------	--	---	--	-----------------------------------

Land use Landform Pattern, Element, Slope	Vegetation	Microrelief Disturbance Erosion	Surface condition, surface rock	Soil Profile Description									
				Horizon Depth (m), Boundary	Field Texture	Structure, Strength	Inclusions Segregations	Colour, Mottle, Bleaching	Moisture, Drainage	Roots	Depth (m) / Field pH	Sample (m)	Observations
Grazing, gently undulating plain, mid slope 2-3%	Grasses, nearby white/grey gums	1% normal gilgai in the area 0.2-0.3m deep Semi disturbance Nil erosion	Firm, cracking nil coarse fragments	A1 0.00-0.12 Abrupt	Light clay	Weak, firm	Nil	10YR4/2 Dark greyish brown Nil mottles / bleaching	Dry, well drained	Common	0.10 / 8.0	0.00-0.10 0.20-0.30 0.45-0.55 0.70-0.80 0.90-1.00	Nil
				B21 0.12-0.33 Abrupt	Medium clay	Weak, firm	<2% calcium carbonate	10YR4/3 Brown Nil mottles / bleaching	Dry, moderately well drained	Few	0.25 / 7.0		
				B22 0.33-0.55 Clear	Medium clay	Moderate, strong, subangular blocky	<2% calcium carbonate	10YR4/4 Dark yellowish brown Nil mottles / bleaching	Dry, moderately well drained	Few	0.50 / 7.0

B23 0.66-1.00 EOBH	Medium clay	Moderate, firm, subangular blocky	<1% manganese nodules	10YR4/4 Dark yellowish brown Nil mottles / bleaching	Dry, moderately well drained	Nil	0.90 / 7.5

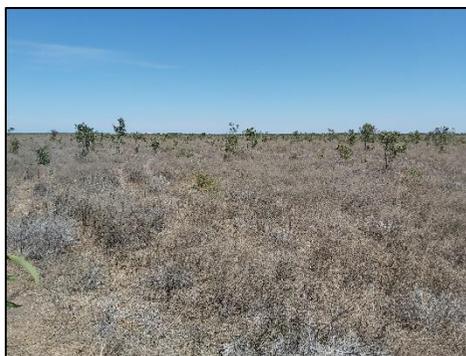
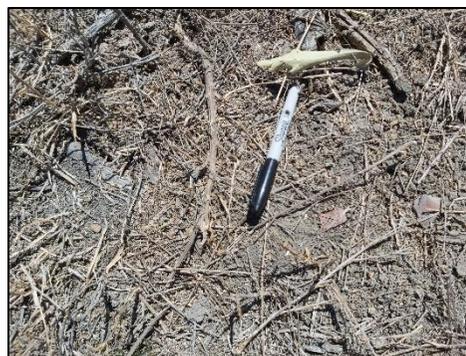
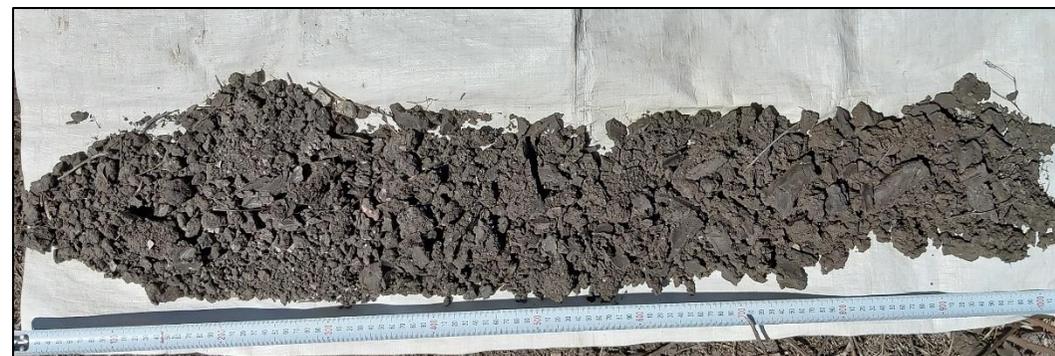
<b>Soil Mapping Unit:</b> C3-BL	<b>Location (GDA94 ZONE 55):</b> 635396 7546618	<b>Australian Soil Class:</b> Black Vertosol	<b>Site Survey Type:</b> Detailed Hand Auger 50mm	<b>Survey Date:</b> 23/09/2019
------------------------------------	--	---	--	-----------------------------------

Land use Landform Pattern, Element, Slope	Vegetation	Microrelief Disturbance Erosion	Surface condition, surface rock	Soil Profile Description									
				Horizon Depth (m), Boundary	Field Texture	Structure, Strength	Inclusions Segregations	Colour, Mottle, Bleaching	Moisture, Drainage	Roots	Depth (m) / Field pH	Sample (m)	Observations
Grazing, gently undulating plain, lower slope 1-2%	Grasses	Nil microrelief Extensive disturbance Nil erosion	Soft nil coarse fragments	A1 0.00-0.14 Abrupt	Light medium clay	Moderate, weak, sub-rounded	Nil	10YR3/1 Very dark grey Nil mottles / bleaching	Dry, well drained	Common	0.10 / 7.5	Nil	Nil
				B21 0.14-0.33 Abrupt	Light medium clay	Moderate, firm, subangular 10- 20mm peds	<2% calcium carbonate	10YR3/1 Very dark grey Nil mottles / bleaching	Dry, moderately well drained	Few	0.25 / 8.0		
				B22 0.33-0.78 Clear	Medium clay	Moderate, firm, subangular 10- 20mm peds	<1% calcium carbonate	10YR3/1 Very dark grey Nil mottles / bleaching	Dry, moderately well drained	Few	0.55 / 8.0

B23 0.78-1.00 EOBH	Medium clay	Moderate, firm, subangular 20- 40mm peds	Nil	10YR3/2 Very dark greyish brown Nil mottles / bleaching	Dry, moderately well drained	Nil	0.90 / 8.0

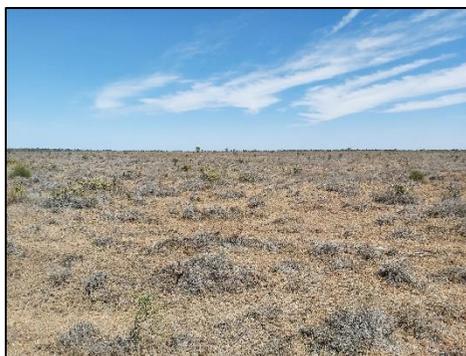
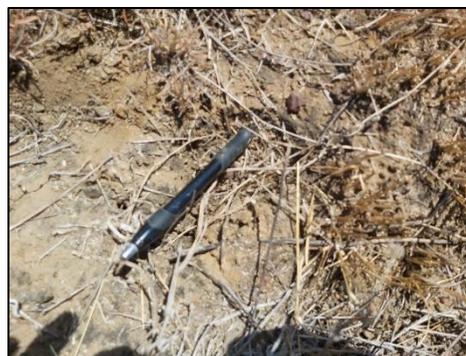
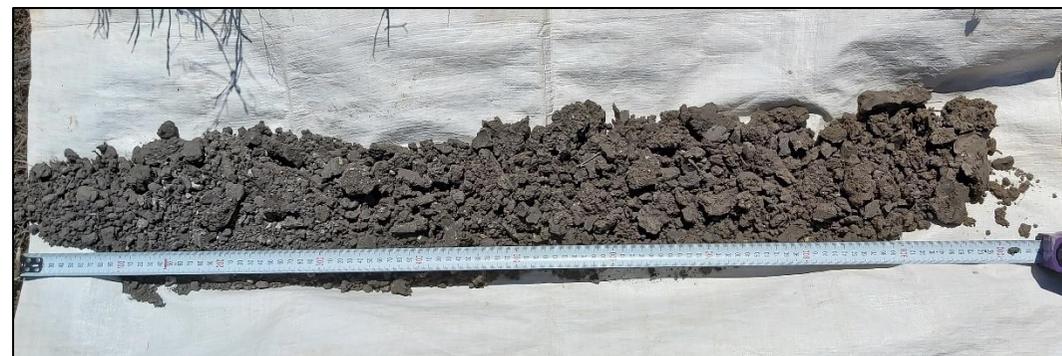
<b>Soil Mapping Unit:</b> C3-BL	<b>Location (GDA94 ZONE 55):</b> 635955 7547117	<b>Australian Soil Class:</b> Black Vertosol	<b>Site Survey Type:</b> Detailed Hand Auger 50mm	<b>Survey Date:</b> 23/09/2019
------------------------------------	--	---	--	-----------------------------------

Land use Landform Pattern, Element, Slope	Vegetation	Microrelief Disturbance Erosion	Surface condition, surface rock	Soil Profile Description									
				Horizon Depth (m), Boundary	Field Texture	Structure, Strength	Inclusions Segregations	Colour, Mottle, Bleaching	Moisture, Drainage	Roots	Depth (m) / Field pH	Sample (m)	Observations
Grazing, gently undulating plain, lower slope 1-2%	Grasses	Nil microrelief Extensive disturbance Nil erosion	Firm, cracking nil coarse fragments	A1 0.00-0.15 Abrupt	Light medium clay	Moderate, weak, sub-rounded	Nil	10YR3/1 Very dark grey Nil mottles / bleaching	Dry, well drained	Common	0.10 / 7.5	Nil	Nil
				B21 0.15-0.45 Abrupt	Light medium clay	Moderate, firm, subangular 10- 20mm peds	<2% calcium carbonate	10YR3/1 Very dark grey Nil mottles / bleaching	Dry, moderately well drained	Few	0.25 / 7.0		
				B22 0.45-1.00 EOBH	Medium clay	Moderate, firm, subangular 20- 40mm peds	Nil	10YR3/2 Very dark greyish brown Nil mottles / bleaching	Dry, moderately well drained	Few	0.60 / 7.5 0.90 / 7.5

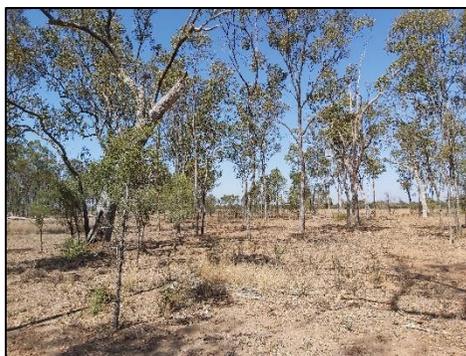
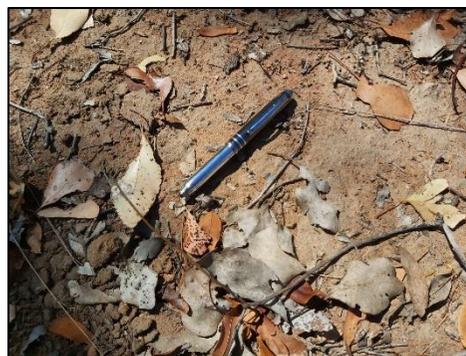
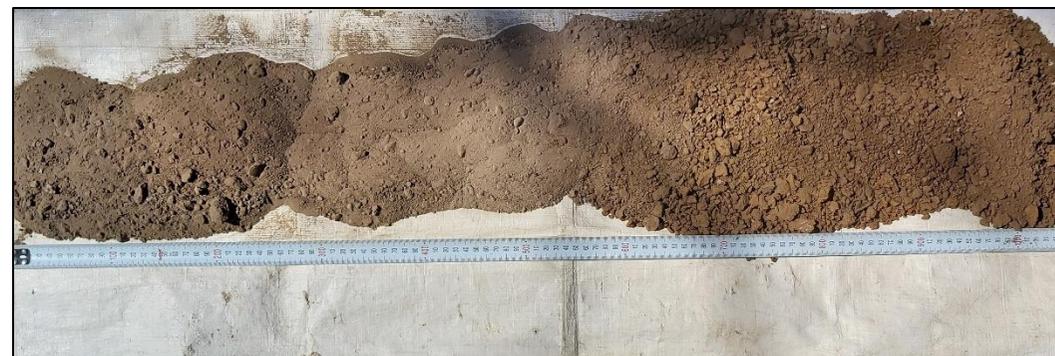
### SITE 30

<b>Soil Mapping Unit:</b> S1	<b>Location (GDA94 ZONE 55):</b> 638425 7542286	<b>Australian Soil Class:</b> Brown Sodosol	<b>Site Survey Type:</b> Detailed Hand Auger 50mm	<b>Survey Date:</b> 07/10/2019
---------------------------------	--	--	--	-----------------------------------

Land use Landform Pattern, Element, Slope	Vegetation	Microrelief Disturbance Erosion	Surface condition, surface rock	Soil Profile Description									
				Horizon Depth (m), Boundary	Field Texture	Structure, Strength	Inclusions Segregations	Colour, Mottle, Bleaching	Moisture, Drainage	Roots	Depth (m) / Field pH	Sample (m)	Observations
Grazing, gently undulating plain, mid slope 1-2%	Poplar Box	Nil microrelief Nil disturbance Nil erosion	Hard setting, 1% coarse fragments <2mm	A11 0.00-0.12 Diffuse	Loamy sand	Massive, loose	Nil	10YR3/3 Dark brown Nil mottles / bleaching	Dry, rapidly drained	Common	0.10 / 6.0	Nil	Nil
				A12 0.12-0.40 Abrupt	Loamy sand	Massive, loose	Nil	10YR5/3 Brown Nil mottles / bleaching	Dry, rapidly drained	Few	0.30 / 6.5		
				A13 0.40-0.60 Abrupt	Loamy sand	Massive, loose	<5% coarse fragments <1mm	10YR5/3 Brown Nil mottles / bleaching	Dry, rapidly drained	Nil	0.55 / 6.5

B2 0.60-1.00 EOBH	Sandy clay loam	Weak to moderate, firm, subangular	Nil	10YR4/4 Dark yellowish brown Nil mottles / bleaching	Dry, well drained	Nil	0.90 / 7.0

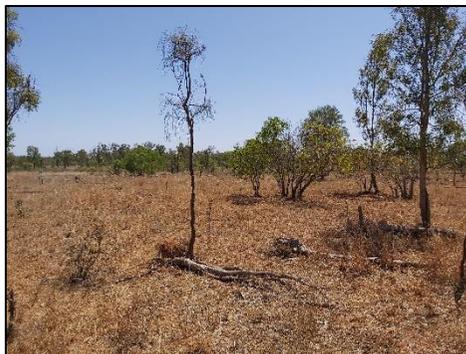
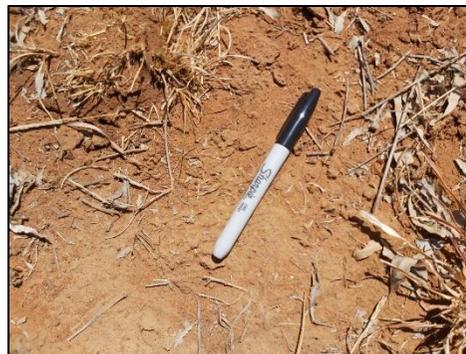
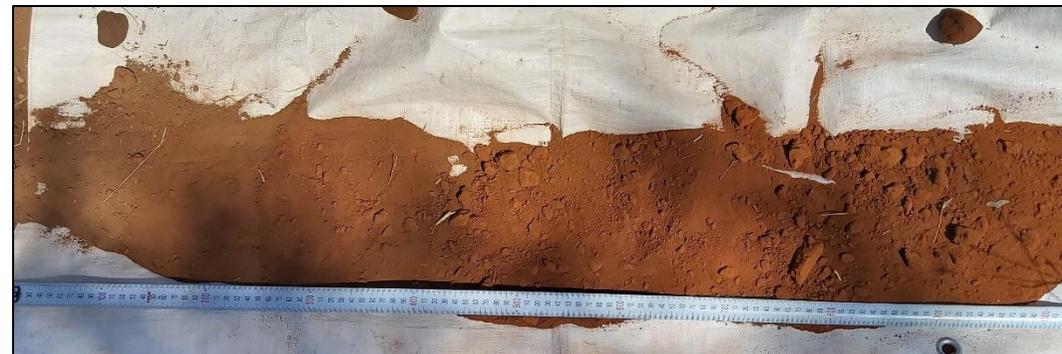
<b>Soil Mapping Unit:</b> R3	<b>Location (GDA94 ZONE 55):</b> 638792 7543714	<b>Australian Soil Class:</b> Red Kandosol	<b>Site Survey Type:</b> Detailed Hand Auger 50mm	<b>Survey Date:</b> 07/10/2019
---------------------------------	--	---	--	-----------------------------------

Land use Landform Pattern, Element, Slope	Vegetation	Microrelief Disturbance Erosion	Surface condition, surface rock	Soil Profile Description									
				Horizon Depth (m), Boundary	Field Texture	Structure, Strength	Inclusions Segregations	Colour, Mottle, Bleaching	Moisture, Drainage	Roots	Depth (m) / Field pH	Sample (m)	Observations
Grazing Flat Plain <1% / 1%	Exotic grassland	Nil microrelief Semi disturbance Nil erosion	Firm, Nil coarse fragments	A11 0.00-0.12 Abrupt	Loamy sand	Massive, loose	Nil	7.5YR3/3 Dark brown Nil mottles / bleaching	Dry, Rapid	Common	0.10 / 6.0	0.00-0.10 0.20-0.30 0.50-0.60 0.70-0.80 0.90-1.00	Nil
				B21 0.12-0.45 Abrupt	Sandy loam	Massive, loose	Nil	5YR3/4 Dark reddish brown Nil mottles / bleaching	Dry, Well	Few	0.30 / 6.0		
				B22 0.45-1.00 EOBH	Sandy clay loam	Massive, minor weak structure, loose	Nil	2.5YR3/4 Dark reddish brown Nil mottles / bleaching	Dry, Well	Nil	0.60 / 6.0 0.90 / 6.0

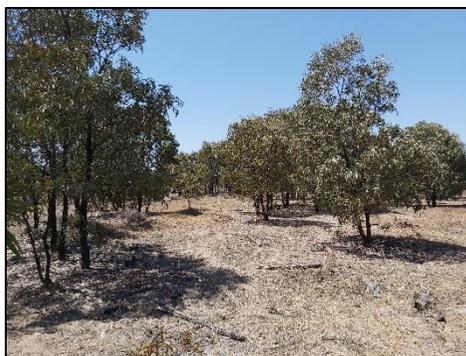
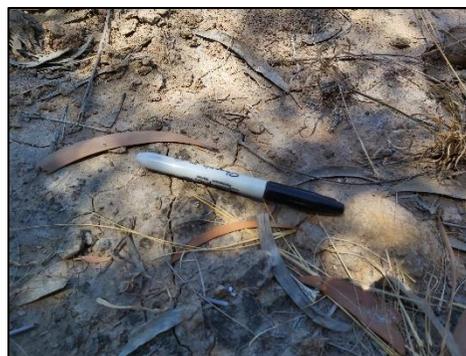
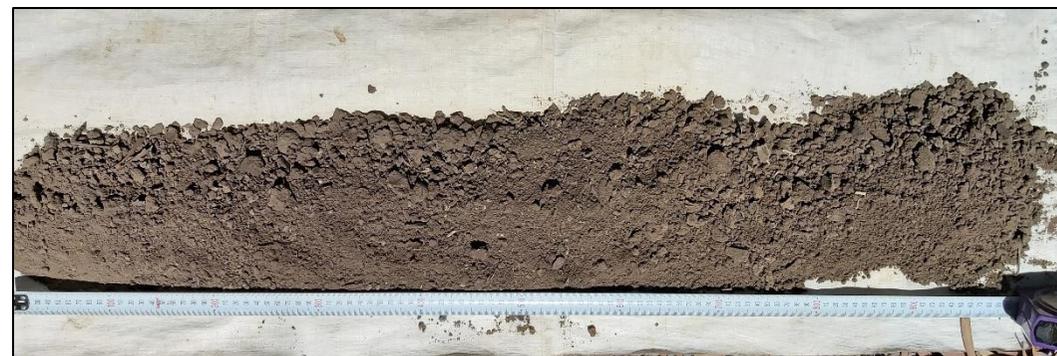
## SITE 32 - Mound

<b>Soil Mapping Unit:</b> C1-BL	<b>Location (GDA94 ZONE 55):</b> 638966 7543632	<b>Australian Soil Class:</b> Black Vertosol	<b>Site Survey Type:</b> Detailed Hand Auger 50mm	<b>Survey Date:</b> 07/10/2019
------------------------------------	--	---	--	-----------------------------------

Land use Landform Pattern, Element, Slope	Vegetation	Microrelief Disturbance Erosion	Surface condition, surface rock	Soil Profile Description									
				Horizon Depth (m), Boundary	Field Texture	Structure, Strength	Inclusions Segregations	Colour, Mottle, Bleaching	Moisture, Drainage	Roots	Depth (m) / Field pH	Sample (m)	Observations
Grazing, gently undulating plain, flat plain 1%	Brigalow	Gilgai 50% coverage depth 0.24- 0.29m disturbance Nil erosion	Hard setting, trampled, cracking and crust observed in area, nil coarse fragments	A1 0.00-0.12 Abrupt	Light medium clay	Weak, firm, angular <5mm peds	Nil	10YR4/1 Dark grey Nil mottles / bleaching	Dry, well drained	Common	0.10 / 7.0	0.00-0.10 0.20-0.30 0.50-0.60	Nil
				B21 0.12-0.75 Abrupt	Medium clay	Weak, firm, angular <10mm peds	Nil	10YR4/1 Dark grey Nil mottles / bleaching	Dry, well drained	Few	0.30 / 7.0 0.60 / 7.0	0.75-0.85 0.90-1.00	
				B22 0.75-1.00 EOBH	Medium clay	Weak, firm, angular <10mm peds	Nil	10YR4/2 Dark greyish brown Nil mottles / bleaching	Dry, well drained	Nil	0.90 / 7.5

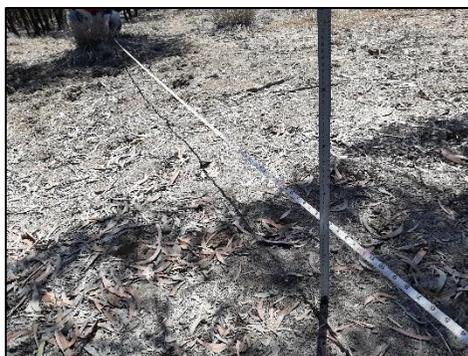
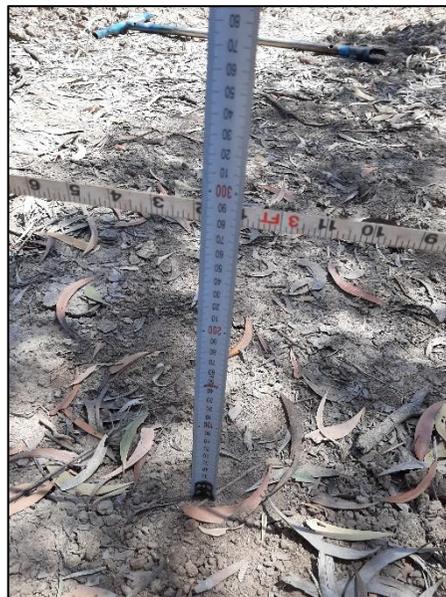
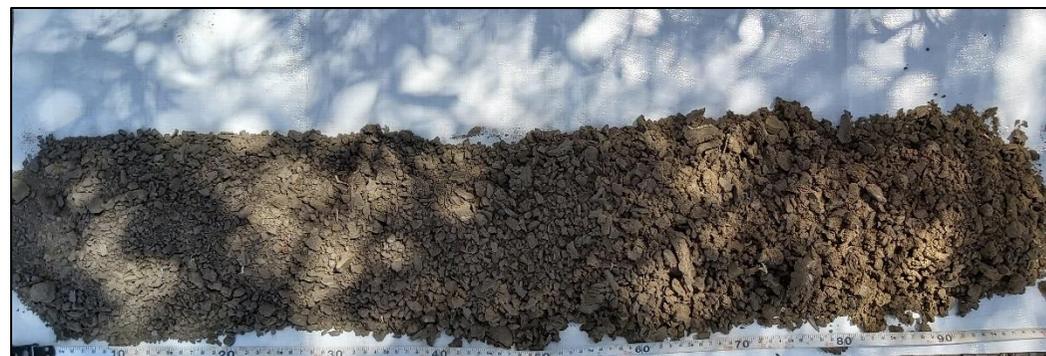
## SITE 32 - Depression

<b>Soil Mapping Unit:</b> C1-BL	<b>Location (GDA94 ZONE 55):</b> 638966 7543632	<b>Australian Soil Class:</b> Black Vertosol	<b>Site Survey Type:</b> Detailed Hand Auger 50mm	<b>Survey Date:</b> 07/10/2019
------------------------------------	--	---	--	-----------------------------------

Surface and depression depth

Land use Landform Pattern, Element, Slope	Vegetation	Microrelief Disturbance Erosion	Surface condition, surface rock	Soil Profile Description									
				Horizon Depth (m), Boundary	Field Texture	Structure, Strength	Inclusions Segregations	Colour, Mottle, Bleaching	Moisture, Drainage	Roots	Depth (m) / Field pH	Sample (m)	Observations
Grazing, gently undulating plain, flat plain 1%	Brigalow	Gilgai 50% coverage depth 0.29m Average for area 0.42- 0.29m disturbance Nil erosion	Hard setting, trampled, cracking, nil coarse fragments	A1 0.00-0.09 Abrupt	Light medium clay	Weak, firm, angular <5mm peds	Nil	10YR4/1 Dark grey Nil mottles / bleaching	Dry, well drained	Common	0.10 / 7.0	0.00-0.10 0.20-0.30 0.50-0.60 0.72-0.80 0.90-1.00	Nil
				B21 0.09-0.72 Abrupt	Medium clay	Moderate, firm, angular <10mm peds	Nil	10YR4/1 Dark grey Nil mottles / bleaching	Dry, well drained	Few	0.30 / 7.0 0.60 / 7.0		
				B22 0.72-1.00 EOBH	Medium clay	Moderate, firm, angular <10mm peds	Nil	10YR4/2 Dark greyish brown Nil mottles / bleaching	Dry, well drained	Nil	0.90 / 7.5

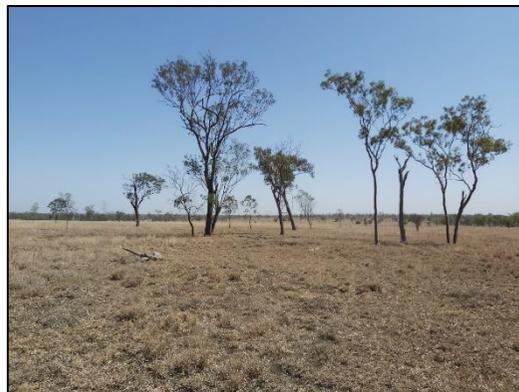
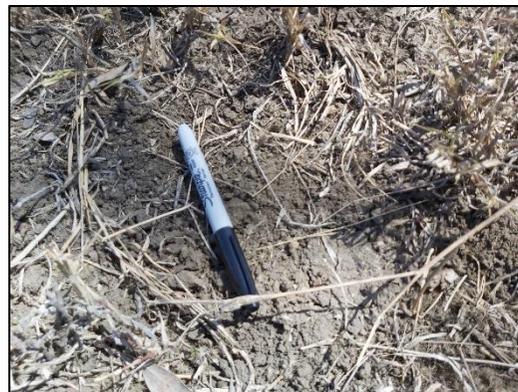
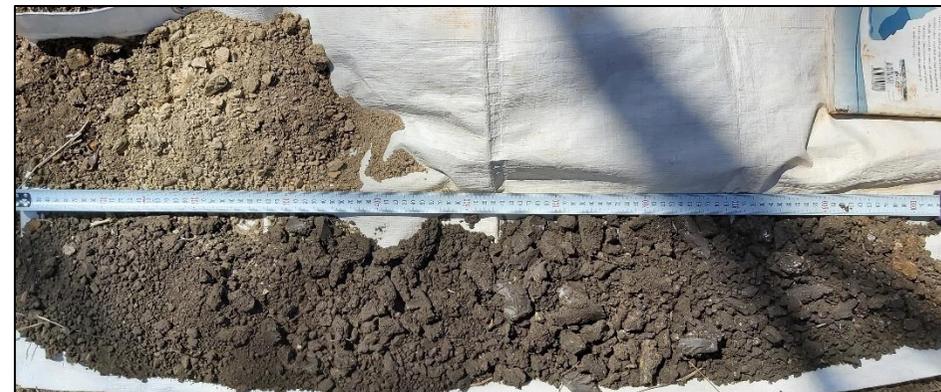
### SITE 33

<b>Soil Mapping Unit:</b> C4	<b>Location (GDA94 ZONE 55):</b> 621684 7548890	<b>Australian Soil Class:</b> Black Vertosol	<b>Site Survey Type:</b> Detailed Hand Auger 50mm	<b>Survey Date:</b> 09/10/2019
---------------------------------	--	---	--	-----------------------------------

Land use Landform Pattern, Element, Slope	Vegetation	Microrelief Disturbance Erosion	Surface condition, surface rock	Soil Profile Description									
				Horizon Depth (m), Boundary	Field Texture	Structure, Strength	Inclusions Segregations	Colour, Mottle, Bleaching	Moisture, Drainage	Roots	Depth (m) / Field pH	Sample (m)	Observations
Grazing, gently undulating plain, upper slope, 3%/3%	Sparse mixed vegetation	Minor linear gilgai observed in surrounding areas Semi disturbance Nil erosion	Soft, self- mulching, nil coarse fragments	A1 0.00-0.15 Abrupt	Light clay	Weak, weak, sub- rounded peds	Nil	10YR3/2 Very dark greyish brown Nil mottles / bleaching	Dry, well drained	Common	0.10 / 8.5	0.00-0.10 0.20-0.30 0.50-0.60 0.70-0.80 0.95-1.05	Nil
				B21 0.15-0.43 Gradual	Light clay	Moderate, form, sub-rounded peds	Nil	10YR2/2 Very dark brown Nil mottles / bleaching	Dry, moderately well drained	Few	0.30 / 8.5	1.22-1.32

B22 0.43-0.70 Abrupt	Light medium clay	Moderate, form, sub-angular peds	<2% calcium carbonate	10YR3/1 Very dark grey Nil mottles / bleaching	Dry, moderately well drained	Few	0.60 / 8.0		
				B23 0.70-0.95 Abrupt	Medium clay	Moderate, form, sub-angular peds	2-5% calcium carbonate	10YR3/1 Very dark grey Nil mottles / bleaching	Dry, moderately- imperfectly drained	Very few	0.90 / 8.0

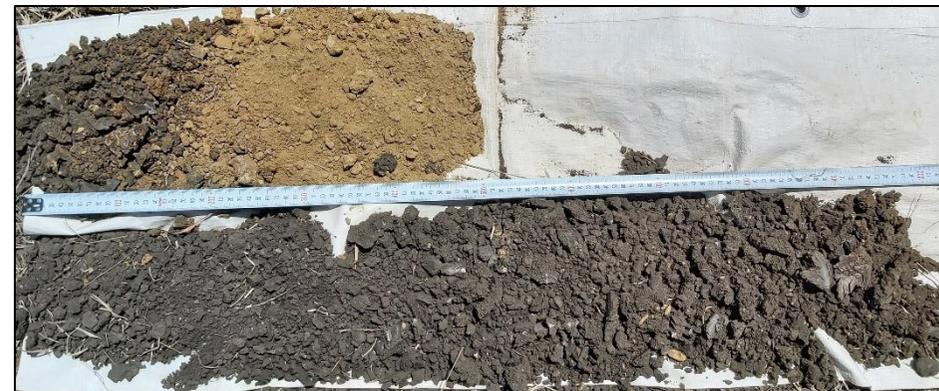
Land use Landform Pattern, Element, Slope	Vegetation	Microrelief Disturbance Erosion	Surface condition, surface rock	Soil Profile Description									
				Horizon Depth (m), Boundary	Field Texture	Structure, Strength	Inclusions Segregations	Colour, Mottle, Bleaching	Moisture, Drainage	Roots	Depth (m) / Field pH	Sample (m)	Observations
Grazing, gently undulating plain, midslope, simple slope, 2-3%	Buffel grass	Linear gilgai observed in surrounding areas, 0.15m deep Semi disturbance Nil erosion	Soft, cracking and crust nil coarse fragments	A1 0.00-0.11 Abrupt	Light clay	Weak, moderate, sub-rounded peds <20mm	Nil	10YR3/2 Very dark greyish brown Nil mottles / bleaching	Dry, well drained	Common	0.05 / 6.0	0.00-0.10 0.20-0.30 0.60-0.70 0.90-1.00	Nil
				B21 0.11-0.46 Abrupt	Light medium clay	Moderate, firm, sub-angular peds <20mm	<1% calcium carbonate	10YR3/1 Very dark grey Nil mottles / bleaching	Dry, moderately well drained	Common	0.30 / 6.0	1.10-1.20 1.30-1.40

B22 0.46-0.74 Abrupt	Light medium clay	Moderate, firm, sub-angular peds <20mm	<2% calcium carbonate	10YR3/1 Very dark grey Nil mottles / bleaching	Dry, moderately well drained	Few	0.60 / 6.0		
				B23 0.74-1.05 Gradual	Light medium clay	Moderate, firm, sub-angular peds <20mm	<2% calcium carbonate	10YR3/1 Very dark grey Nil mottles / bleaching	Dry, moderately well drained	Nil	0.90 / 6.0		
				BC 1.05-1.20 Abrupt	Silty loam	Massive, loose	<20% coarse fragments 5-20mm <10% coarse fragments <5mm	10YR3/3 Dark brown Nil mottles / bleaching	Dry, well drained	Nil	1.10 / 6.0

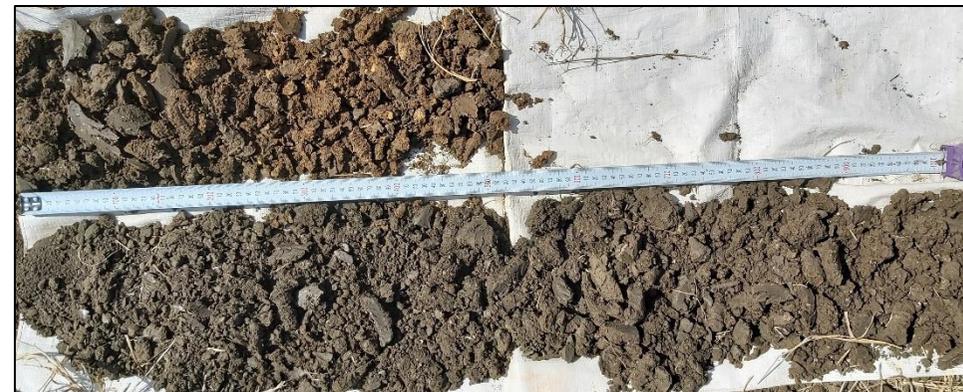
Land use Landform Pattern, Element, Slope	Vegetation	Microrelief Disturbance Erosion	Surface condition, surface rock	Soil Profile Description									
				Horizon Depth (m), Boundary	Field Texture	Structure, Strength	Inclusions Segregations	Colour, Mottle, Bleaching	Moisture, Drainage	Roots	Depth (m) / Field pH	Sample (m)	Observations
Grazing, gently undulating plain, mid slope, simple slope, 2-3%	Native grassland	Linear gilgai 0.2m deep, 40% coverage Extensive disturbance Nil erosion	Soft, cracking nil coarse fragments	A1 0.00-0.10 Abrupt	Light clay	Weak, moderate, sub-rounded peds <20mm	Nil	10YR3/2 Very dark greyish brown Nil mottles / bleaching	Dry, well drained	Common	0.05 / 6.0	0.00-0.10 0.20-0.30 0.50-0.60 0.70-0.80	Nil
				B21 0.10-0.42 Abrupt	Light medium clay	Moderate, firm, sub-angular peds <20mm	Nil	10YR3/1 Very dark grey Nil mottles / bleaching	Dry, moderately well drained	Common	0.30 / 6.5	1.10-1.20 1.40-1.50

B22 0.42-0.60 Clear	Medium clay	Moderate, firm, sub-angular peds <20mm	<2% calcium carbonate	10YR3/1 Very dark grey Nil mottles / bleaching	Dry, moderately well drained	Few	0.50 / 6.5		
				B23 0.60-1.25 Gradual	Medium clay	Moderate, firm, sub-angular peds <20mm	<2% calcium carbonate	2.5YR3/2 Dusky red Nil mottles / bleaching	Dry, moderately well drained	Nil	0.90 / 6.5		
				B24 1.25-1.50 EOBH	Medium clay	Moderate, firm, sub-angular peds <20mm	Nil	7.5YR4.3 20% light brown mottle Nil bleaching	Dry, imperfectly drained	Nil	1.30 / 6.5

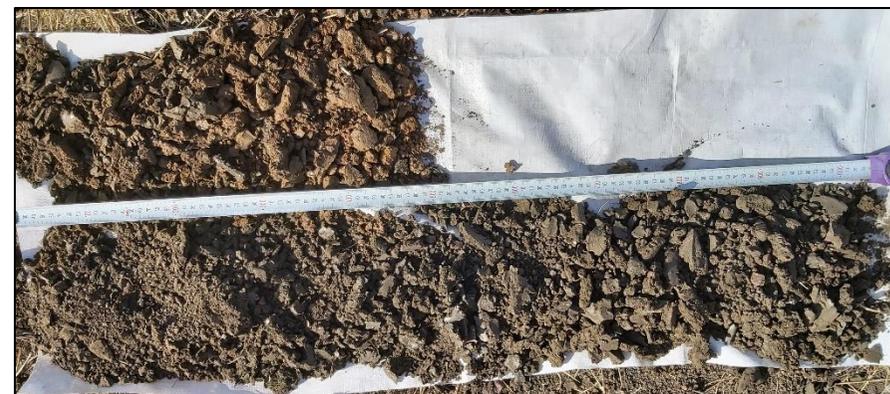
Land use Landform Pattern, Element, Slope	Vegetation	Microrelief Disturbanc e Erosion	Surface condition, surface rock	Soil Profile Description									
				Horizon Depth (m), Boundary	Field Texture	Structure, Strength	Inclusions Segregations	Colour, Mottle, Bleaching	Moisture, Drainage	Roots	Depth (m) / Field pH	Sample (m)	Observations
Grazing, gently undulating plain, mid slope, simple slope, 2-3%	Buffel grass	Linear gilgai 0.2m deep, 40% coverage Semi disturbance Nil erosion	Soft, cracking nil coarse fragments	A1 0.00-0.10 Abrupt	Light clay	Weak, moderate, sub-rounded peds <20mm	Nil	10YR3/2 Very dark greyish brown Nil mottles / bleaching	Dry, well drained	Common	0.05 / 6.0	0.00-0.10 0.20-0.30 0.50-0.60	Nil
				B21 0.10-0.50 Abrupt	Light medium clay	Moderate, firm, sub-angular peds <20mm	Nil	10YR3/1 Very dark grey Nil mottles / bleaching	Dry, moderately well drained	Common	0.30 / 6.0	0.80-0.90 1.10-1.20 1.40-1.50

B22 0.50-0.65 Clear	Medium clay	Moderate, firm, sub-angular peds <20mm	<2% calcium carbonate	10YR3/1 Very dark grey Nil mottles / bleaching	Dry, moderately well drained	Few	0.50 / 6.5		
				B23 0.65-1.30 Gradual	Medium clay	Moderate, firm, sub-angular peds <20mm	<2% calcium carbonate	2.5YR3/2 Dusky red Nil mottles / bleaching	Dry, moderately well drained	Nil	0.90 / 6.5		
				B24 1.30-1.50 EOBH	Medium clay	Moderate, firm, sub-angular peds <20mm	<2% calcium carbonate	7.5YR4.3 Brown 20% light brown mottle Nil bleaching	Dry, imperfectly drained	Nil	1.30 / 6.5

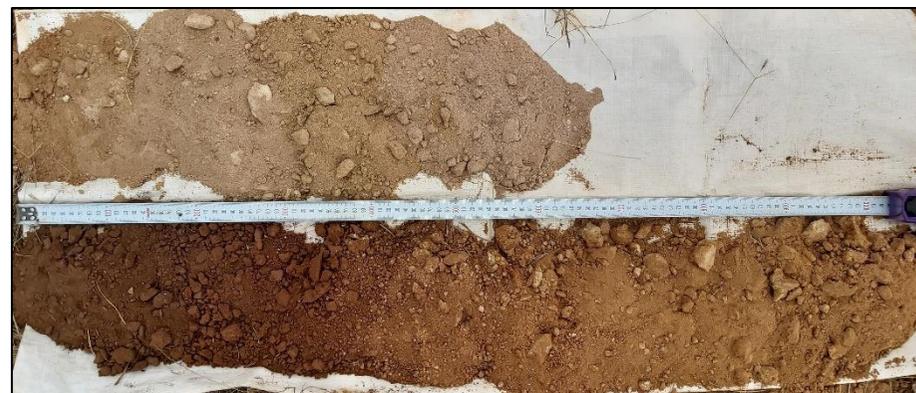
Land use Landform Pattern, Element, Slope	Vegetation	Microrelief Disturbance Erosion	Surface condition, surface rock	Soil Profile Description									
				Horizon Depth (m), Boundary	Field Texture	Structure, Strength	Inclusions Segregations	Colour, Mottle, Bleaching	Moisture, Drainage	Roots	Depth (m) / Field pH	Sample (m)	Observations
Grazing, Wide crest <1%/<1%	Exotic grassland	Nil microrelief Semi disturbed Nil erosion	Firm, Nil coarse fragments	A11 0.00-0.08 Abrupt	Clay Loam	Massive, loose	Nil	10YR2/2 Very dark brown Nil mottles / bleaching	Dry, rapid	Common	0.05 / 6.5	0.00-0.08 0.10-0.20 0.20-0.30 0.50-0.60	Nil
				A12 0.08-0.20 Abrupt	Clay loam	Weak, weak, sub- rounded 5-20mm	<1% <2mm coarse fragments	7.5YR3/2 Dark brown Nil mottles / bleaching	Dry, well	Few	0.15 / 6.5	0.90-1.00 1.40-1.50	
				B21 0.20-0.34 Abrupt	Light clay	Moderate, weak, sub-rounded 5- 20mm	<1% <2mm coarse fragments	5YR3/4 Dark reddish brown Nil mottles / bleaching	Dry, well	Few	0.30 / 7.0

B22 0.34-0.75 Abrupt	Silty clay loam	Weak, weak, sub- angular <20mm	<5% <2mm coarse fragments	5YR4/4 Reddish brown Nil mottles / bleaching	Dry, well to moderate	Nil	0.60 / 8.0		
				B23 0.75-1.05 Abrupt	Silty clay loam	Weak, weak, sub- angular <20mm	<2% <2mm coarse fragments	7.5YR4/6 Strong brown Nil mottles / bleaching	Dry, well to moderate	Nil	0.90 / 8.0

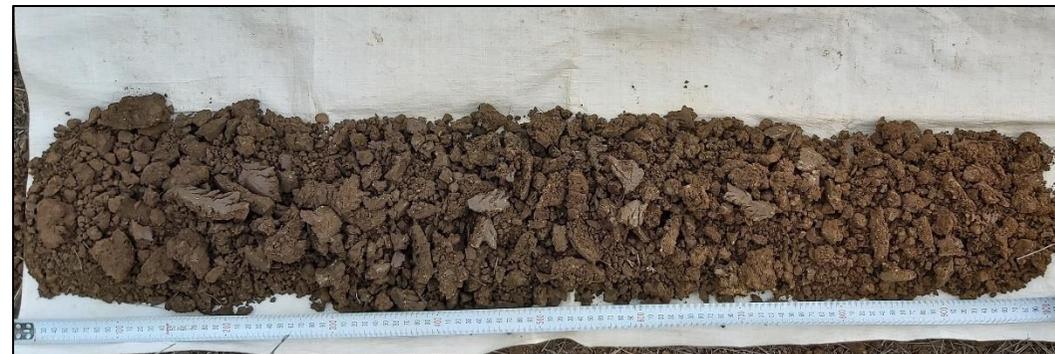
**Soil Profile**

Land use Landform Pattern, Element, Slope	Vegetation	Microrelief Disturbance Erosion	Surface condition, surface rock	Soil Profile Description									
				Horizon Depth (m), Boundary	Field Texture	Structure, Strength	Inclusions Segregations	Colour, Mottle, Bleaching	Moisture, Drainage	Roots	Depth (m) / Field pH	Sample (m)	Observations
Grazing, gently undulating plain, lower slope 2%	Exotic grassland	Nil microrelief Semi disturbed Nil erosion	Soft, cracking with crust Nil coarse fragments	A1 0.00-0.10 Abrupt	Light clay	Weak, firm, subangular peds <20mm	Nil	10YR3/3 Dark brown Nil mottles / bleaching	Dry, well drained	Common	0.05 / 8.0	0.00-0.10 0.20-0.30 0.50-0.60 0.70-0.80 0.90-1.00	Nil
				B21 0.10-0.63 Gradual	Light medium clay	Moderate, firm, angular peds 20- 40mm, slickensides	<2% calcium carbonate <1% <2mm coarse fragments	10YR4/3 Brown Nil mottles / bleaching	Dry, moderately well drained	Few	0.30 / 7.0 0.55 / 7.0

B22 0.63-1.00 EOBH	Light medium clay	Moderate, firm, angular peds 20- 40mm, slickensides	Nil	10YR5/3 Brown Nil mottles / bleaching	Dry, moderately well drained	Very few	0.90 / 7.0

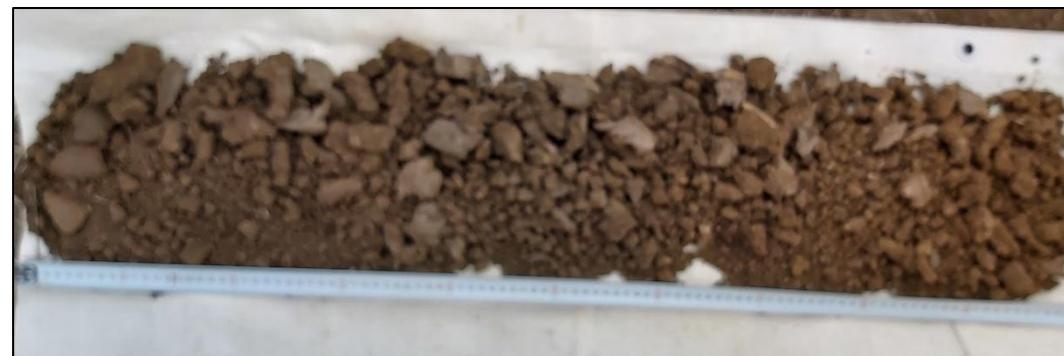
**Soil Profile**

Land use Landform Pattern, Element, Slope	Vegetation	Microrelief Disturbance Erosion	Surface condition, surface rock	Soil Profile Description									
				Horizon Depth (m), Boundary	Field Texture	Structure, Strength	Inclusions Segregations	Colour, Mottle, Bleaching	Moisture, Drainage	Roots	Depth (m) / Field pH	Sample (m)	Observations
Grazing, gently undulating plain, lower slope 2%	Spare regrowth, Brigalow in area	Nil microrelief Semi disturbed Nil erosion	Cracking with crust	A1 0.00-0.14 Abrupt	Light clay	Weak, firm, subangular peds <20mm	Nil	10YR3/3 Dark brown Nil mottles / bleaching	Dry, well drained	Common	0.05 / 8.0	Nil	Nil
				B21 0.14-0.66 Gradual	Light medium clay	Moderate, firm, angular peds 20- 40mm, slickensides	<2% calcium carbonate	10YR4/3 Brown Nil mottles / bleaching	Dry, moderately well drained	Few	0.30 / 7.0 0.55 / 7.0		
				B22 0.66-1.00 EOBH	Light medium clay	Moderate, firm, angular peds 20- 40mm, slickensides	Nil	10YR5/3 Brown Nil mottles / bleaching	Dry, moderately well drained	Very few	0.90 / 7.0

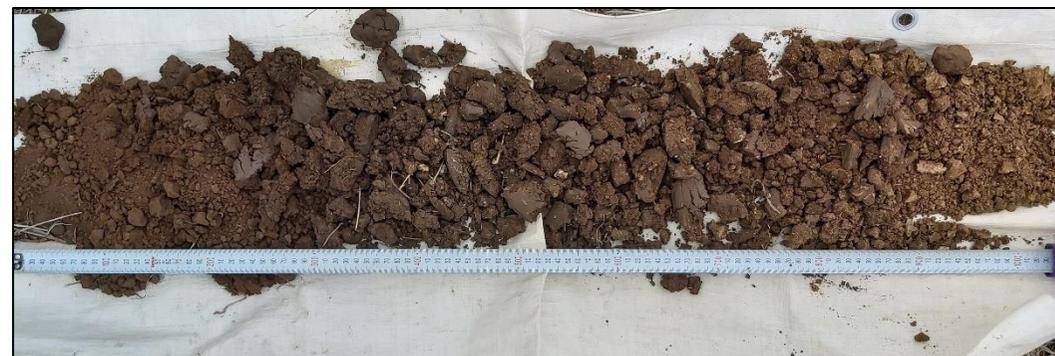
**Soil Profile**

Land use Landform Pattern, Element, Slope	Vegetation	Microrelief Disturbance Erosion	Surface condition, surface rock	Soil Profile Description									
				Horizon Depth (m), Boundary	Field Texture	Structure, Strength	Inclusions Segregations	Colour, Mottle, Bleaching	Moisture, Drainage	Roots	Depth (m) / Field pH	Sample (m)	Observations
Grazing, upper slope <2%	Very sparse, Brigalow approx. 100m away	Nil microrelief Semi disturbed Nil erosion	Firm, cracking observed in area	A1 0.00-0.12 Abrupt	Light clay	Weak, firm, subangular peds <20mm	Nil	7.5YR2.5/2 Very dark brown Nil mottles / bleaching	Dry, well drained	Common	0.10 / 7.0	Nil	Nil
				B21 0.12-0.25 Abrupt	Light medium clay	Moderate, firm, angular peds 20- 40mm	Nil	7.5YR2.5/2 Very dark brown Nil mottles / bleaching	Dry, moderately well drained	Common	0.20 / 7.0		
				B22 0.25-0.63 Clear	Medium clay	Moderate, firm, angular peds 20- 40mm	<1% calcium carbonate	7.5YR2.5/3 Very dark brown Nil mottles / bleaching	Dry, moderately well drained	Few	0.50 / 8.0

B23 0.63-0.85 Abrupt	Medium clay	Moderate, firm, angular peds 20- 40mm	Nil	7.5YR4/3 Brown Nil mottles / bleaching	Dry, moderately well drained	Nil	0.80 / 8.0		
				B3 0.85-1.00 EOBH	Medium clay	Moderate, firm, angular peds <20mm	10% coarse fragments and weathered rock	10YR4/3 Brown Nil mottles / bleaching	Dry, imperfectly drained	Nil	0.95 / 8.0
