# Appendix J

Soils and Land Suitability  
Assessment

## WINCHESTER SOUTH PROJECT Environmental Impact Statement

# Soils and Land Suitability Assessment

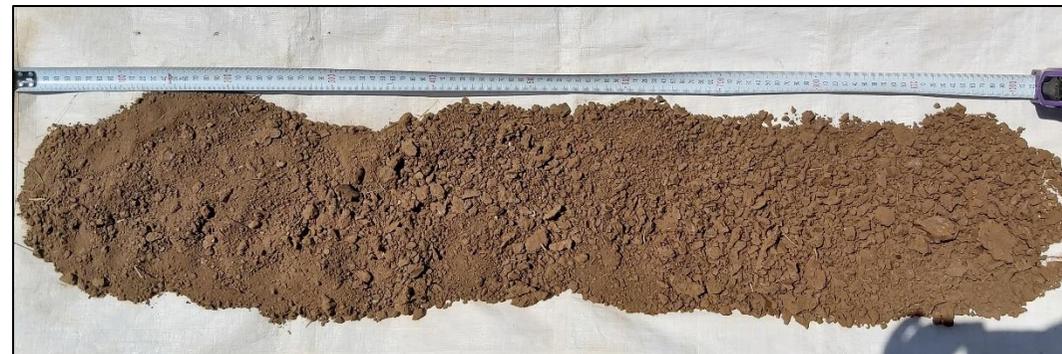
**Soil Profile**

Land use Landform Pattern, Element, Slope	Vegetation	Microrelief Disturbance Erosion	Surface condition, surface rock	Soil Profile Description									
				Horizon Depth (m), Boundary	Field Texture	Structure, Strength	Inclusions Segregations	Colour, Mottle, Bleaching	Moisture, Drainage	Roots	Depth (m) / Field pH	Sample (m)	Observations
Grazing Mid slope <2%/1%	Brigalow regrowth	Melon hole 50% coverage, 3- 6m wide, 0.2- 0.4m deep Semi disturbance Nil erosion	Cracking with crust observed in area, Nil coarse fragments	A1 0.00-0.10 Abrupt	Light clay	Weak, firm, subangular <10mm	Nil	10YR3/3 Dark brown Nil mottles / bleaching	Dry, well to moderate	Common	0.10 / 6.5	Nil	Nil
				B21 0.10-0.60 Abrupt	Light medium clay	Weak, firm, subangular <10mm	Nil	7.5YR4/3 Brown Nil mottles / bleaching	Dry, moderate	Few	0.30 / 7.5 0.60 / 7.5		
				B22 0.60-1.00 EOBH	Light medium heavy clay	Weak, firm, subangular 10- 20mm	Nil	7.5YR4/3 Brown Nil mottles / bleaching	Dry, moderate	Few	0.90 / 6.5

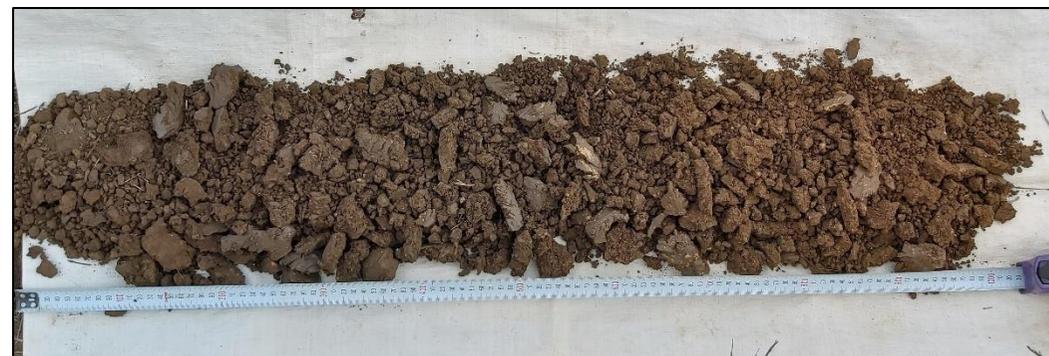
**Soil Profile**

Land use Landform Pattern, Element, Slope	Vegetation	Microrelief Disturbance Erosion	Surface condition, surface rock	Soil Profile Description									
				Horizon Depth (m), Boundary	Field Texture	Structure, Strength	Inclusions Segregations	Colour, Mottle, Bleaching	Moisture, Drainage	Roots	Depth (m) / Field pH	Sample (m)	Observations
Grazing, gently undulating plain, mid slope 1%	Brigalow regrowth	Nil microrelief Semi disturbed Nil erosion	Soft, cracking, crust observed in area	A1 0.00-0.12 Abrupt	Light clay	Weak, firm, subangular peds <20mm	Nil	10YR3/3 Dark brown Nil mottles / bleaching	Dry, well drained	Common	0.05 / 7.0	Nil	Nil
				B21 0.12-0.62 Gradual	Light medium clay	Moderate, firm, angular peds 20- 40mm, slickensides	<1% calcium carbonate	10YR4/3 Brown Nil mottles / bleaching	Dry, moderately well drained	Few	0.30 / 7.0 0.55 / 7.0		
				B22 0.62-1.00 EOBH	Light medium clay	Moderate, firm, angular peds 20- 40mm, slickensides	Nil	10YR5/3 Brown Nil mottles / bleaching	Dry, moderately well drained	Very few	0.90 / 7.0

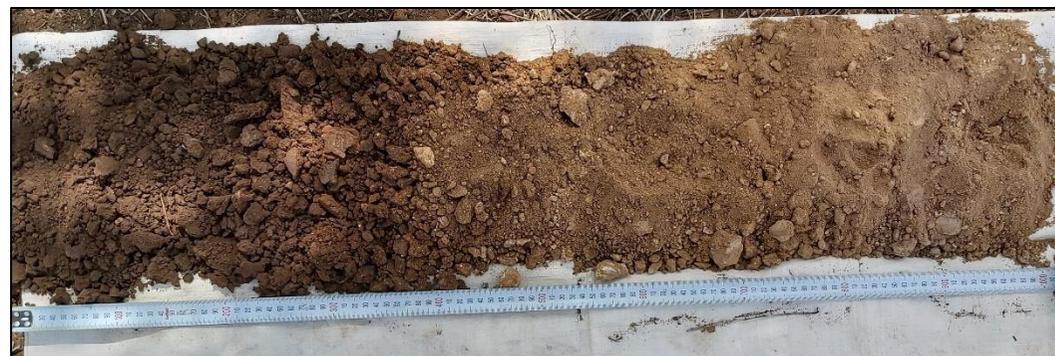
**Soil Profile**

Land use Landform Pattern, Element, Slope	Vegetation	Microrelief Disturbance Erosion	Surface condition, surface rock	Soil Profile Description									
				Horizon Depth (m), Boundary	Field Texture	Structure, Strength	Inclusions Segregations	Colour, Mottle, Bleaching	Moisture, Drainage	Roots	Depth (m) / Field pH	Sample (m)	Observations
Grazing, gently undulating plain, upper slope 1-2%	Brigalow regrowth	Nil microrelief Semi disturbed Nil erosion	Soft to firm, nil coarse fragments	A11 0.00-0.09 Abrupt	Clay loam	Massive to weak, loose	Nil	7.5YR3/2 Dark brown Nil mottles / bleaching	Dry, well drained	Common	0.05 / 7.0	0.00-0.10 0.10-0.20 0.25-0.35 0.50-0.60 0.80-0.90	Nil
				A12 0.09-0.24 Gradual	Clay loam	Weak, firm, sub- angular peds <10mm	Nil	7.5YR3/4 Dark brown Nil mottles / bleaching	Dry, moderately well drained	Few	0.20 / 8.0		
				B21 0.24-0.37 Abrupt	Light clay	Moderate, firm, sub-angular peds <10mm	<2% calcium carbonate	7.5YR3/3 Dark brown Nil mottles / bleaching	Dry, moderately well drained	Few	0.28 / 7.5

B31 0.37-0.70 Abrupt	Clay loam	Massive to weak, weak subangular peds <10mm <2%	<2% calcium carbonate	7.5YR4/6 Strong brown Nil mottles / bleaching	Dry, moderately well drained	Nil	0.50 / 8.0		
				B32 0.70-1.00 EOBH	Loam	Massive, loose	Nil	7.5YR4/4 Brown Nil mottles / bleaching	Dry, moderately well drained	Nil	0.90 / 8.0

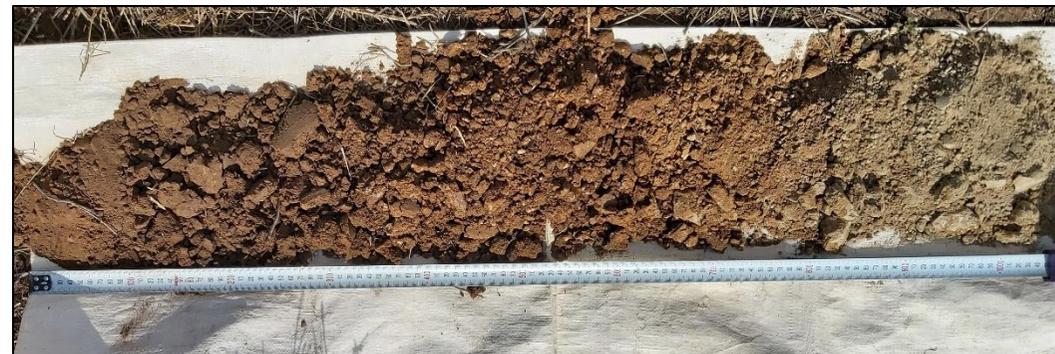
**Soil Profile**

Land use Landform Pattern, Element, Slope	Vegetation	Microrelief Disturbance Erosion	Surface condition, surface rock	Soil Profile Description									
				Horizon Depth (m), Boundary	Field Texture	Structure, Strength	Inclusions Segregations	Colour, Mottle, Bleaching	Moisture, Drainage	Roots	Depth (m) / Field pH	Sample (m)	Observations
Grazing, gently undulating plain, mid slope 1-2%	Mixed shrubs	Nil microrelief Semi disturbed Nil erosion	Hard setting, nil coarse fragments	A1 0.00-0.12 Abrupt	Sandy clay loam	Massive to weak, loose	Nil	7.5YR3/2 Dark brown Nil mottles / bleaching	Dry, well drained	Common	0.05 / 7.0	0.00-0.10 0.20-0.30 0.50-0.60 0.68-0.78 0.90-1.00	Nil
				B21 0.12-0.38 Gradual	Light clay	Weak, firm, sub- angular peds <10mm	<2% calcium carbonate	7.5YR3/4 Dark brown Nil mottles / bleaching	Dry, moderately well drained	Few	0.20 / 7.5		
				B22 0.38-0.60 Abrupt	Medium clay	Moderate, firm, sub-angular peds <10mm	Nil	7.5YR3/3 Dark brown Nil mottles / bleaching	Dry, moderately well drained	Few	0.28 / 7.5

B31 0.60-0.78 Abrupt	Clayey sand	Massive to weak, weak subangular peds <10mm <2%	5% weathered material	7.5YR4/6 Strong brown Nil mottles / bleaching	Dry, well drained	Nil	0.70 / 8.0		
				B32 0.78-1.00 EOBH	Clayey sand (increased sand content)	Massive, loose	5% weathered material	7.5YR4/4 Brown Nil mottles / bleaching	Dry, well drained	Nil	0.90 / 8.0

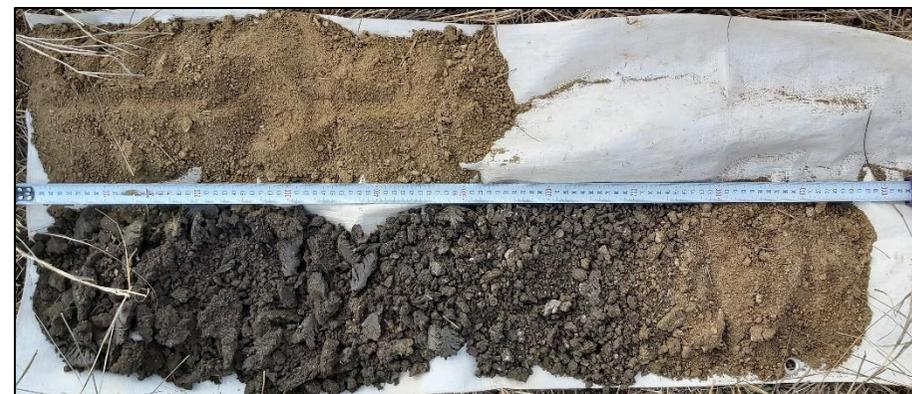
Land use Landform Pattern, Element, Slope	Vegetation	Microrelief Disturbance Erosion	Surface condition, surface rock	Soil Profile Description									
				Horizon Depth (m), Boundary	Field Texture	Structure, Strength	Inclusions Segregations	Colour, Mottle, Bleaching	Moisture, Drainage	Roots	Depth (m) / Field pH	Sample (m)	Observations
Grazing, gently undulating plain, lower slope 1-2%	Grass, sparse mixed vegetation	Nil microrelief extensively disturbed Nil erosion	Soft, self- mulching, <2% coarse fragments <5mm	A1 0.00-0.09 Abrupt	Light clay	Weak, firm, subangular peds 10-20mm	<2% coarse fragments <5mm	10YR3/2 Very dark greyish brown Nil mottles / bleaching	Dry, well drained	Coming	0.05 / 7.5	0.00-0.09 0.20-0.30 0.50-0.60 0.72-0.82	Nil
				B21 0.09-0.46 Abrupt	Light medium clay	Moderate, firm, subangular peds 10-20mm	Nil	10YR3/2 Very dark greyish brown Nil mottles / bleaching	Dry, well drained	Few	0.30 / 7.5	0.90-1.00 1.40-1.50

B22 0.46-0.72 Abrupt	Light medium clay	Moderate, firm, subangular peds 5-20mm	<2% coarse fragments <5mm	10YR4/1 Dark grey Nil mottles / bleaching	Dry, moderately well drained	Nil	0.60 / 8.0		
				BC 0.72-1.00 EOBH	Loamy sand	Massive, weak, <5% loose	<2% coarse fragments <5mm	10YR4/4 Dark yellowish brown Nil mottles / bleaching	Dry, rapidly drained	Nil	0.90 / 7.5

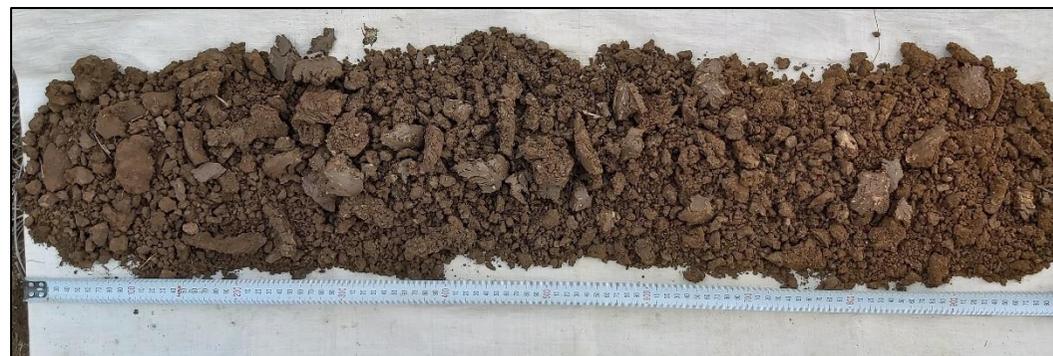
Land use Landform Pattern, Element, Slope	Vegetation	Microrelief Disturbance Erosion	Surface condition, surface rock	Soil Profile Description									
				Horizon Depth (m), Boundary	Field Texture	Structure, Strength	Inclusions Segregations	Colour, Mottle, Bleaching	Moisture, Drainage	Roots	Depth (m) / Field pH	Sample (m)	Observations
Grazing, gently undulating plain, lower slope <2%	Sparse Brigalow regrowth	Nil microrelief Semi disturbed Nil erosion	Soft, cracking	A1 0.00-0.10 Abrupt	Light clay	Weak, firm, subangular peds <20mm	Nil	10YR3/3 Dark brown Nil mottles / bleaching	Dry, well drained	Common	0.05 / 7.0	Nil	Nil
				B21 0.10-0.65 Gradual	Light medium clay	Moderate, firm, angular peds 20- 40mm	<1% <2mm coarse fragments	10YR4/3 Brown Nil mottles / bleaching	Dry, moderately well drained	Few	0.30 / 7.0 0.55 / 7.0		
				B22 0.65-1.00 EOBH	Light medium clay	Moderate, firm, angular peds 20- 40mm	<1% calcium carbonate	10YR5/3 Brown Nil mottles / bleaching	Dry, moderately well drained	Very few	0.90 / 7.5

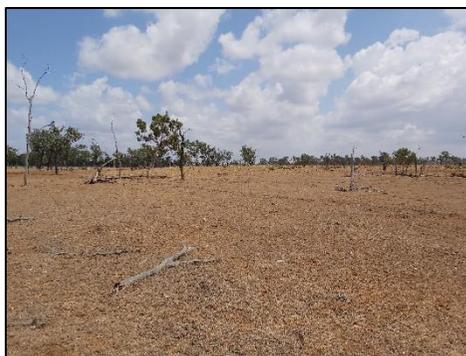
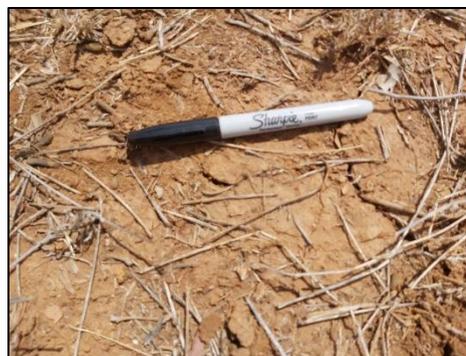
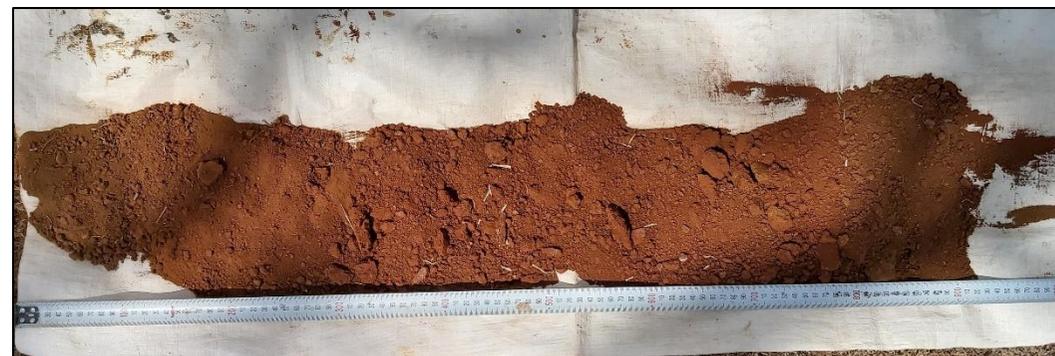
### SITE 46

<b>Soil Mapping Unit:</b> T2	<b>Location (GDA94 ZONE 55):</b> 627368 7546702	<b>Australian Soil Class:</b> Red Kandosol	<b>Site Survey Type:</b> Detailed Hand Auger 50mm	<b>Survey Date:</b> 11/10/2019
---------------------------------	--	---	--	-----------------------------------

Land use Landform Pattern, Element, Slope	Vegetation	Microrelief Disturbance Erosion	Surface condition, surface rock	Soil Profile Description									
				Horizon Depth (m), Boundary	Field Texture	Structure, Strength	Inclusions Segregations	Colour, Mottle, Bleaching	Moisture, Drainage	Roots	Depth (m) / Field pH	Sample (m)	Observations
Grazing, gently undulating plain, mid slope 1-2%	Sparse vegetation, gums	Nil microrelief Semi disturbed Nil erosion	Firm	A1 0.00-0.11 Abrupt	Sandy clay loam	Massive to weak, form, peds <5mm	<1% coarse fragments 5mm	7.5YR3/3 Dark brown Nil mottles / bleaching	Dry, well drained	Common	0.05 / 6.5	Nil	No recovery at 0.91 m
				B21 0.11-0.31 Abrupt	Clay loam	Massive to weak, form, peds <5mm	<1% coarse fragments 5mm	5YR4/3 Reddish brown Nil mottles / bleaching	Dry, well drained	Few	0.25 / 6.0		
				B22 0.31-0.80 Clear	Medium clay	Massive to weak, form, peds <2% <20mm	Nil	2.5YR4/4 Reddish brown Nil mottles / bleaching	Dry, well drained	Few	0.60 / 6.0

B23 0.80-0.91	Medium clay	Massive to weak, form, peds <5mm	Nil	5YR4/4 Reddish brown Nil mottles / bleaching	Dry, well drained	Nil	0.85 / 6.0

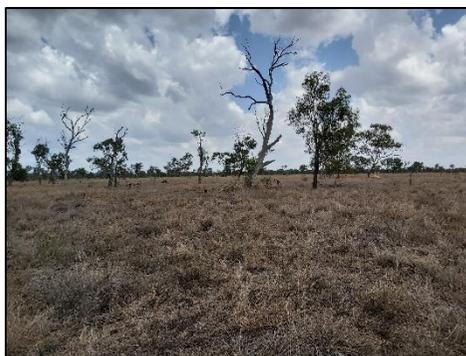
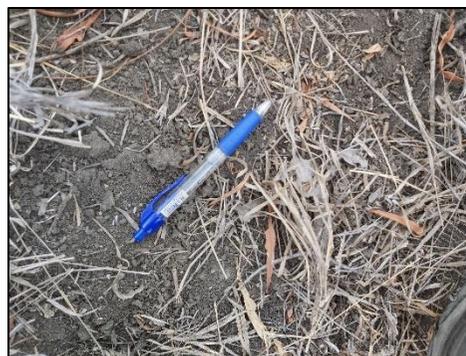
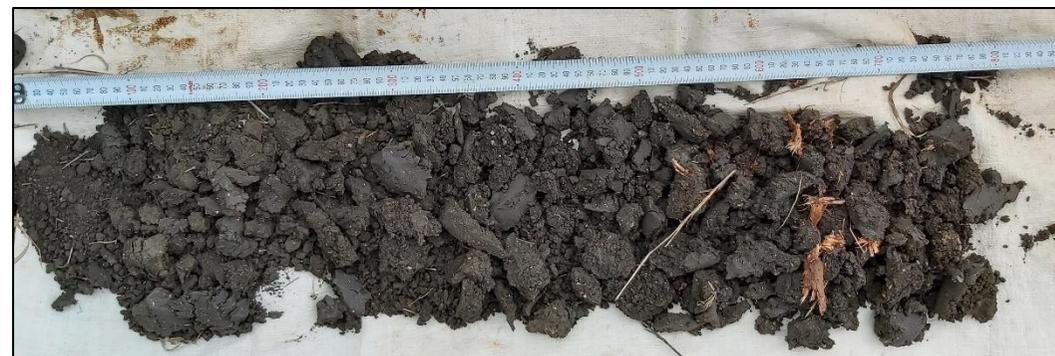
<b>Soil Mapping Unit:</b> C4	<b>Location (GDA94 ZONE 55):</b> 628379 7546548	<b>Australian Soil Class:</b> Black Vertosol	<b>Site Survey Type:</b> Detailed Hand Auger 50mm	<b>Survey Date:</b> 11/10/2019
---------------------------------	--	---	--	-----------------------------------

Land use Landform Pattern, Element, Slope	Vegetation	Microrelief Disturbance Erosion	Surface condition, surface rock	Soil Profile Description									
				Horizon Depth (m), Boundary	Field Texture	Structure, Strength	Inclusions Segregations	Colour, Mottle, Bleaching	Moisture, Drainage	Roots	Depth (m) / Field pH	Sample (m)	Observations
Gently undulating plain, lower slope 1-2%,	Sparse mixed vegetation	Linear gilgai, <0.1m deep, 50% coverage Semi disturbed Nil erosion	Self-mulching, nil coarse fragments	A1 0.00-0.08 Abrupt	Light clay	Moderate, weak, peds 5-20mm	Nil	10YR3/2 Very dark greyish brown Nil mottles / bleaching	Dry, well drained	Common	0.05 / 6.5	0.00-0.08 0.20-0.30 0.50-0.60	Auger refusal at 0.80m
				B21 0.08-0.80	Medium clay	Moderate, strong, subangular peds 20-50mm	Nil	10YR3/1 Very dark grey Nil mottles / bleaching	Dry, well drained	Few	0.30 / 6.5 0.75 / 6.5

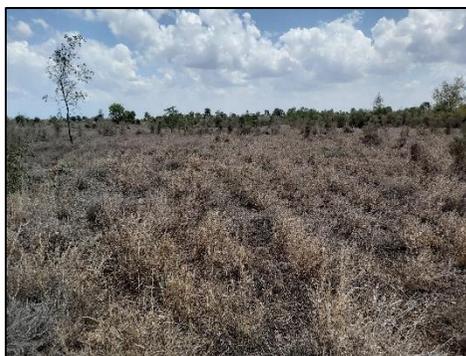
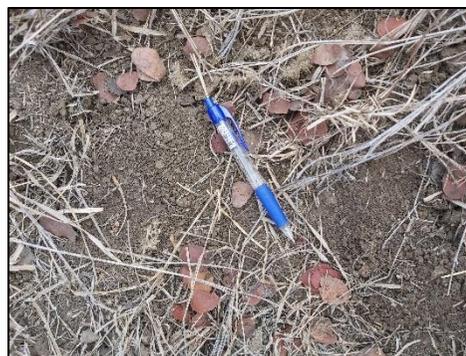
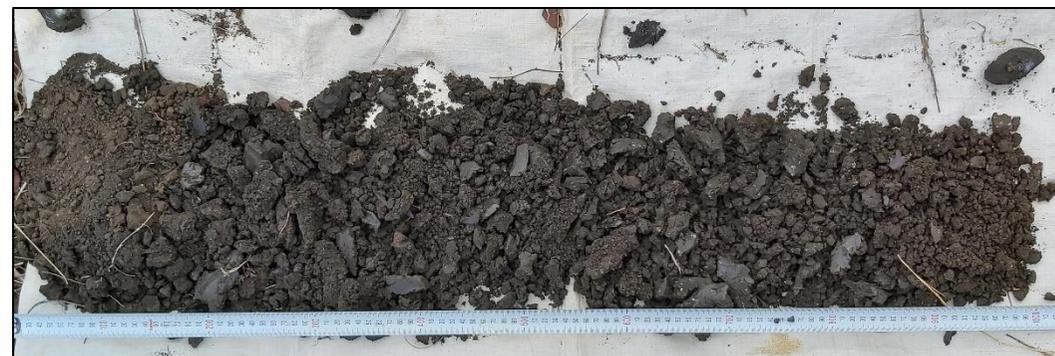
# SITE 48

<b>Soil Mapping Unit:</b> C3-BL	<b>Location (GDA94 ZONE 55):</b> 629619 7547139	<b>Australian Soil Class:</b> Black Vertosol	<b>Site Survey Type:</b> Detailed Hand Auger 50mm	<b>Survey Date:</b> 11/10/2019
------------------------------------	--	---	--	-----------------------------------

Land use Landform Pattern, Element, Slope	Vegetation	Microrelief Disturbance Erosion	Surface condition, surface rock	Soil Profile Description									
				Horizon Depth (m), Boundary	Field Texture	Structure, Strength	Inclusions Segregations	Colour, Mottle, Bleaching	Moisture, Drainage	Roots	Depth (m) / Field pH	Sample (m)	Observations
Grazing, gently undulating plain, mid slope 1-2%	Mixed	Nil microrelief Extensive disturbed Nil erosion	Soft, self- mulching	A1 0.00-0.10 Abrupt	Light clay	Weak, firm Sub- rounded peds <10mm	Nil	10YR3/2 Very dark greyish brown Nil mottles / bleaching	Dry, well drained	Common	0.05 / 6.5	Nil	Isolated area of C3-BL, surrounded by C3-BR
				B21 0.10-0.49 Abrupt	Light medium clay	Moderate, firm, subangular peds 20-40mm	Nil	10YR3/1 Very dark grey Nil mottles / bleaching	Dry, moderately well drained	Few	0.30 / 6.5		
				B22 0.49-0.88 Abrupt	Light medium clay	Moderate, firm, subangular peds 20-40mm	<10% calcium carbonate	10YR3/1 Very dark grey Nil mottles / bleaching	Dry, moderately well drained	Few	0.60 / 6.5

B23 0.88-1.00 EOBH	Light medium clay	Moderate, firm, subangular peds <10mm	Nil	10YR3/1 Very dark grey Nil mottles / bleaching	Dry, moderately well drained	Nil	0.95 / 6.5

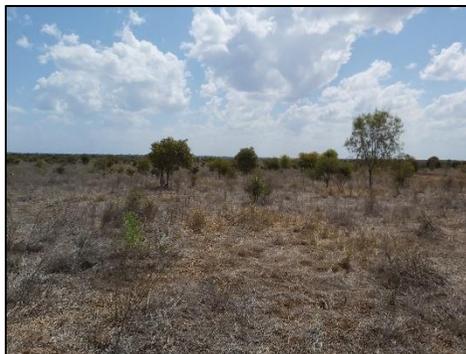
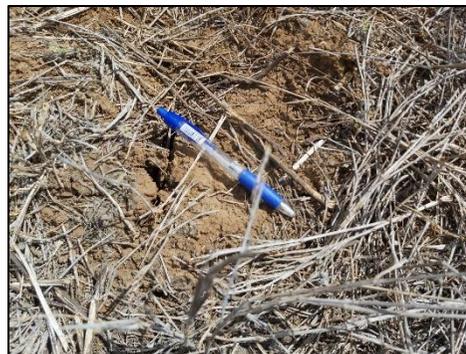
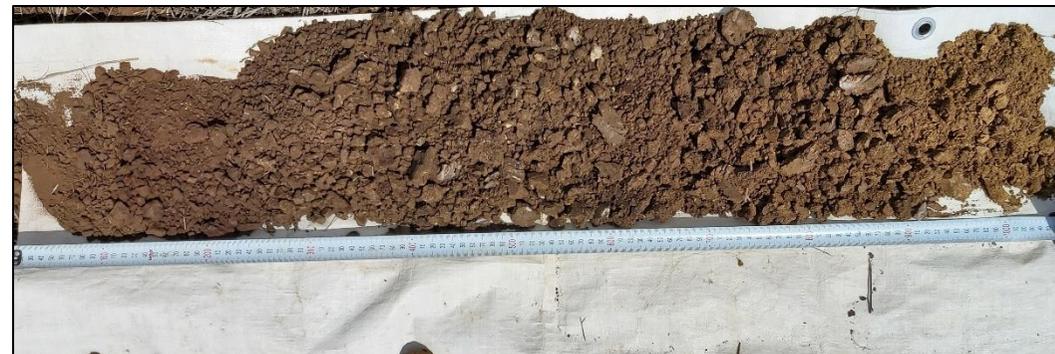
<b>Soil Mapping Unit:</b> C3-BR	<b>Location (GDA94 ZONE 55):</b> 631969 7546284	<b>Australian Soil Class:</b> Brown Vertosol	<b>Site Survey Type:</b> Detailed Hand Auger 50mm	<b>Survey Date:</b> 11/10/2019
------------------------------------	--	---	--	-----------------------------------

Land use Landform Pattern, Element, Slope	Vegetation	Microrelief Disturbance Erosion	Surface condition, surface rock	Soil Profile Description									
				Horizon Depth (m), Boundary	Field Texture	Structure, Strength	Inclusions Segregations	Colour, Mottle, Bleaching	Moisture, Drainage	Roots	Depth (m) / Field pH	Sample (m)	Observations
Grazing, mid slope 2/2%	Sparse mixed regrowth	Nil microrelief Semi disturbed Nil erosion	Soft, cracking, nil coarse fragments	A1 0.00-0.10 Abrupt	Light clay	Moderate, weak, peds 5-10mm	Nil	7.5YR3/2 Dark brown Nil mottles / bleaching	Dry, well drained	Common	0.05 / 7.0	Nil	Nil
				B21 0.10-0.35 Abrupt	Light clay	Moderate, firm, peds 10-20mm	Nil	7.5YR2.5/3 Very dark brown Nil mottles / bleaching	Dry, well drained	Common	0.25 / 7.5		
				B22 0.35-0.77 Abrupt	Medium clay	Moderate, very firm, subangular peds 10-40mm	<1% calcium carbonate	7.5YR3/3 Dark brown Nil mottles / bleaching	Dry, moderately well drained	Few	0.60 / 7.5

B23 0.77-1.00 EOBH	Medium clay	Moderate, weak, peds 10-20mm	Nil	7.5YR4/4 Brown Nil mottles / bleaching	Dry, moderately well drained	Nil	0.90 / 7.5

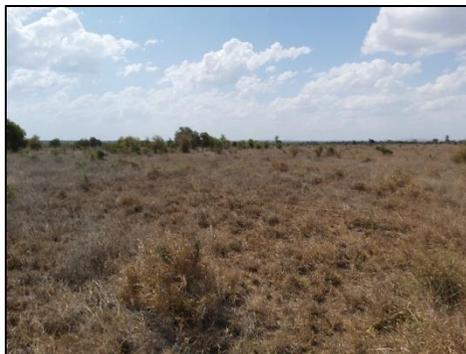
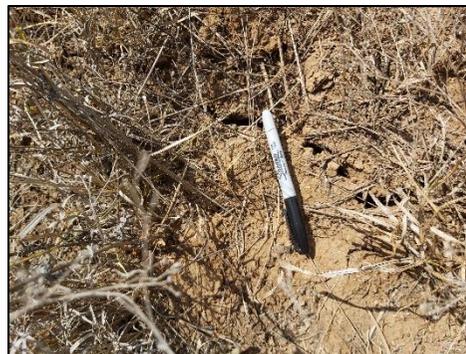
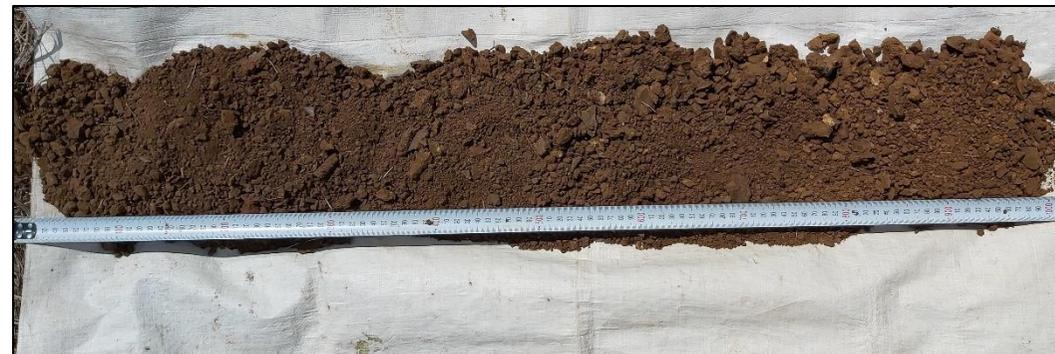
<b>Soil Mapping Unit:</b> C3-BR	<b>Location (GDA94 ZONE 55):</b> 633207 7546644	<b>Australian Soil Class:</b> Brown Vertosol	<b>Site Survey Type:</b> Detailed Hand Auger 50mm	<b>Survey Date:</b> 11/10/2019
------------------------------------	--	---	--	-----------------------------------

Land use Landform Pattern, Element, Slope	Vegetation	Microrelief Disturbance Erosion	Surface condition, surface rock	Soil Profile Description									
				Horizon Depth (m), Boundary	Field Texture	Structure, Strength	Inclusions Segregations	Colour, Mottle, Bleaching	Moisture, Drainage	Roots	Depth (m) / Field pH	Sample (m)	Observations
Grazing, mid slope 2%	Sparse mixed regrowth	Nil microrelief Semi disturbed Nil erosion	Soft, cracking nil coarse fragments	A1 0.00-0.12 Abrupt	Light clay	Moderate, weak, peds 5-10mm	Nil	7.5YR3/2 Dark brown Nil mottles / bleaching	Dry, well drained	Common	0.05 / 7.0	Nil	Nil
				B21 0.12-0.340 Abrupt	Light clay	Moderate, firm, peds 10-20mm	Nil	7.5YR2.5/3 Very dark brown Nil mottles / bleaching	Dry, well drained	Common	0.25 / 7.0		
				B22 0.40-0.75 Abrupt	Medium clay	Moderate, very firm, subangular peds 10-40mm	Nil	7.5YR3/3 Dark brown Nil mottles / bleaching	Dry, moderately well drained	Few	0.60 / 7.5

B23 0.75-1.00 EOBH	Medium clay	Moderate, weak, peds 10-20mm	Nil	7.5YR4/4 Brown Nil mottles / bleaching	Dry, moderately well drained	Nil	0.90 / 7.5

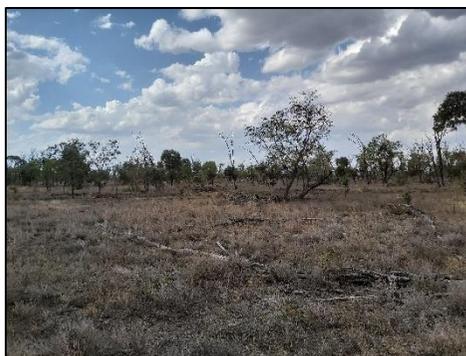
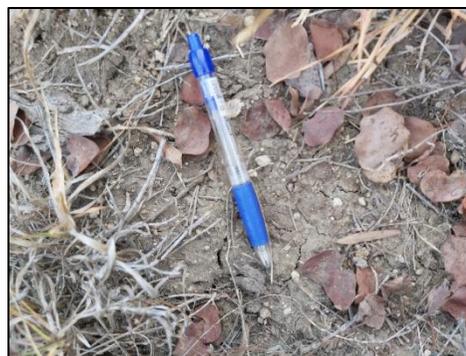
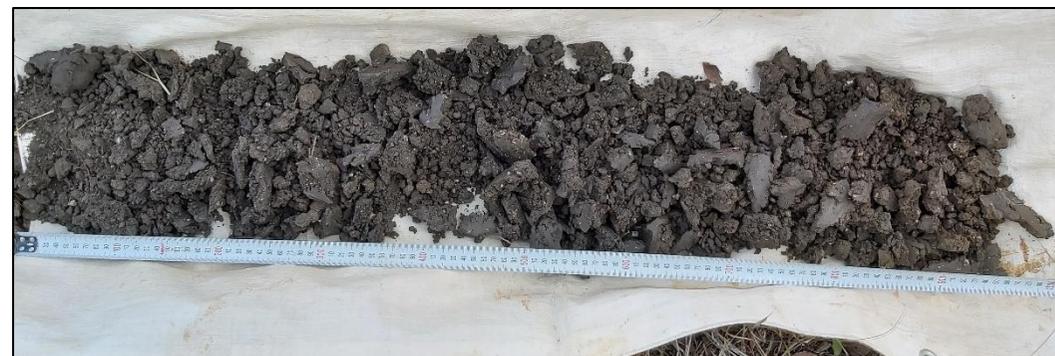
<b>Soil Mapping Unit:</b> C3-BL	<b>Location (GDA94 ZONE 55):</b> 633162 7547605	<b>Australian Soil Class:</b> Black Vertosol	<b>Site Survey Type:</b> Detailed Hand Auger 50mm	<b>Survey Date:</b> 11/10/2019
------------------------------------	--	---	--	-----------------------------------

Land use Landform Pattern, Element, Slope	Vegetation	Microrelief Disturbance Erosion	Surface condition, surface rock	Soil Profile Description									
				Horizon Depth (m), Boundary	Field Texture	Structure, Strength	Inclusions Segregations	Colour, Mottle, Bleaching	Moisture, Drainage	Roots	Depth (m) / Field pH	Sample (m)	Observations
Grazing, gently undulating plain, simple mid slope 1- 2%	Native vegetation	Nil microrelief Semi / Extensive disturbed Nil erosion	Firm, cracking, white nodules <1%	A1 0.00-0.12 Abrupt	Light clay	Weak, very firm, sub-rounded peds <10mm	Nil	10YR3/2 Very dark greyish brown Nil mottles / bleaching	Dry, well drained	Common	0.05 / 6.5	0.00-0.10 0.20-0.30 0.50-0.60 0.70-0.80 0.90-1.00	Nil
				B21 0.12-0.80 Abrupt	Light medium clay	Moderate, very firm	<2% calcium carbonate	10YR3/1 Very dark grey Nil mottles / bleaching	Dry, well to moderately drained	Few	0.30 / 7.0 0.60 / 7.0

B22 0.80-1.00 EOBH	Light medium clay	Moderate, very firm	Nil	10YR4/1 Dark grey Nil mottles / bleaching	Dry, moderately well drained	Few	0.90 / 7.0

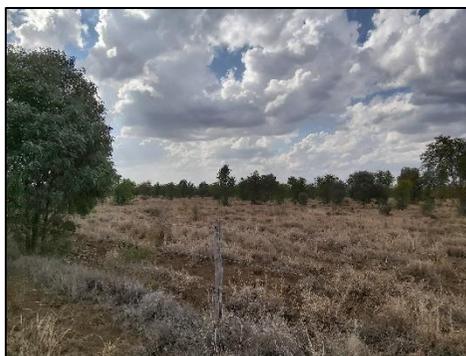
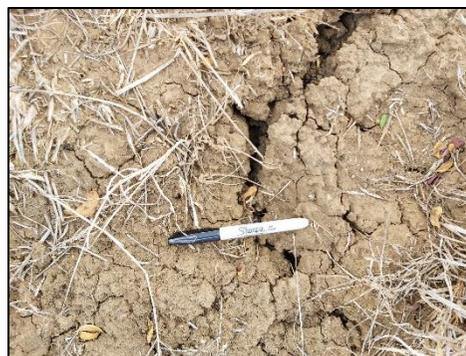
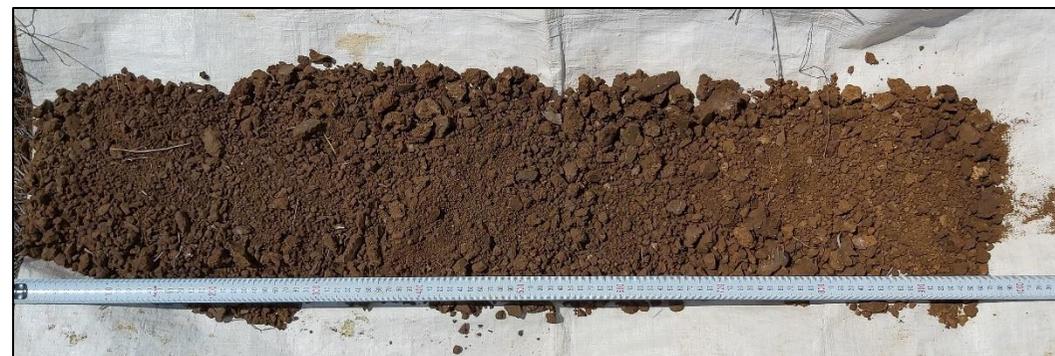
<b>Soil Mapping Unit:</b> C3-BR	<b>Location (GDA94 ZONE 55):</b> 631697 7547799	<b>Australian Soil Class:</b> Brown Vertosol	<b>Site Survey Type:</b> Detailed Hand Auger 50mm	<b>Survey Date:</b> 11/10/2019
------------------------------------	--	---	--	-----------------------------------

Land use Landform Pattern, Element, Slope	Vegetation	Microrelief Disturbance Erosion	Surface condition, surface rock	Soil Profile Description									
				Horizon Depth (m), Boundary	Field Texture	Structure, Strength	Inclusions Segregations	Colour, Mottle, Bleaching	Moisture, Drainage	Roots	Depth (m) / Field pH	Sample (m)	Observations
Grazing, mid slope 1-2%	Sparse mixed regrowth	Nil microrelief Semi disturbed Nil erosion	Soft, cracking nil coarse fragments	A1 0.00-0.08 Abrupt	Light clay	Moderate, weak, peds 5-10mm	Nil	7.5YR3/2 Dark brown Nil mottles / bleaching	Dry, well drained	Common	0.05 / 6.5	Nil	Nil
				B21 0.08-0.37 Abrupt	Light clay	Moderate, firm, peds 10-20mm	<1% calcium carbonate	7.5YR2.5/3 Very dark brown Nil mottles / bleaching	Dry, well drained	Common	0.25 / 6.5		
				B22 0.37-0.70 Abrupt	Medium clay	Moderate, very firm, subangular peds 10-40mm	<1% calcium carbonate	7.5YR3/3 Dark brown Nil mottles / bleaching	Dry, moderately well drained	Few	0.60 / 7.0

B23 0.70-1.00 EOBH	Medium clay	Moderate, weak, peds 10-20mm	Nil	7.5YR4/4 Brown Nil mottles / bleaching	Dry, moderately well drained	Nil	0.90 / 7.0

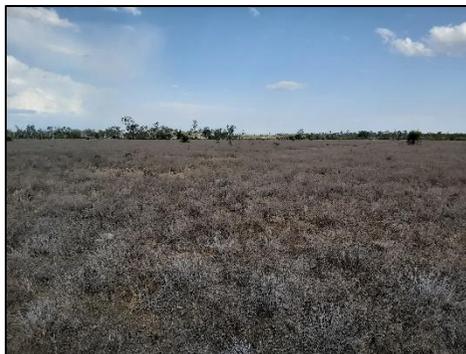
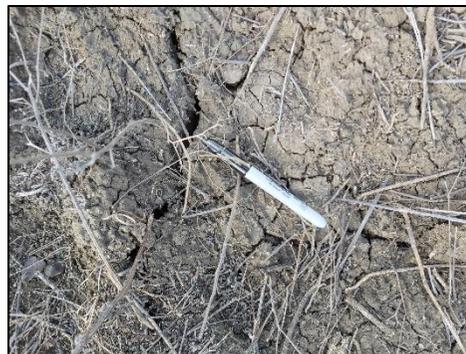
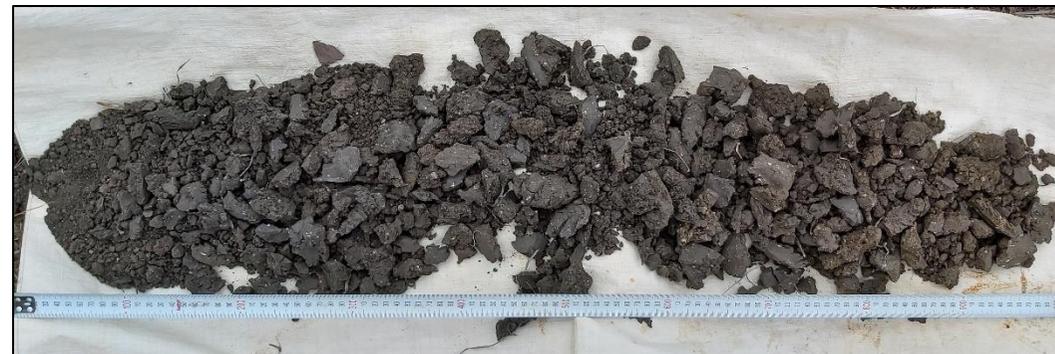
<b>Soil Mapping Unit:</b> C3-BL	<b>Location (GDA94 ZONE 55):</b> 629989 7548288	<b>Australian Soil Class:</b> Black Vertosol	<b>Site Survey Type:</b> Detailed Hand Auger 50mm	<b>Survey Date:</b> 11/10/2019
------------------------------------	--	---	--	-----------------------------------

Land use Landform Pattern, Element, Slope	Vegetation	Microrelief Disturbance Erosion	Surface condition, surface rock	Soil Profile Description									
				Horizon Depth (m), Boundary	Field Texture	Structure, Strength	Inclusions Segregations	Colour, Mottle, Bleaching	Moisture, Drainage	Roots	Depth (m) / Field pH	Sample (m)	Observations
Grazing, gently undulating plain, simple mid slope 1- 2%	Grass	Nil microrelief Extensively disturbed Nil erosion	Firm, cracking	A1 0.00-0.12 Abrupt	Light clay	Weak, very firm, sub-rounded peds <10mm	Nil	10YR3/2 Very dark greyish brown Nil mottles / bleaching	Dry, well drained	Common	0.05 / 6.5	Nil	Nil
				B21 0.12-0.78 Abrupt	Light medium clay	Moderate, very firm	<2% calcium carbonate	10YR3/1 Very dark grey Nil mottles / bleaching	Dry, well drained	Few	0.30 / 7.0 0.60 / 7.0		
				B22 0.78-1.00 EOBH	Light medium clay	Moderate, very firm	Nil	10YR4/1 Dark grey Nil mottles / bleaching	Dry, moderately well drained	Few	0.90 / 7.0

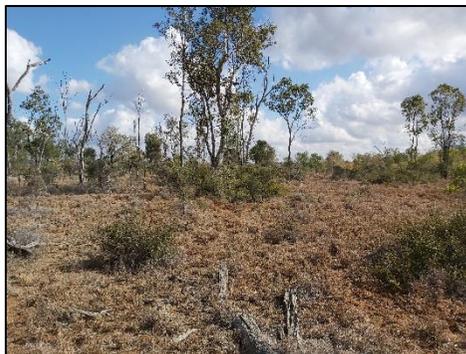
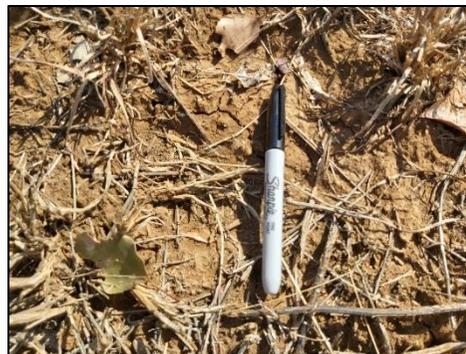
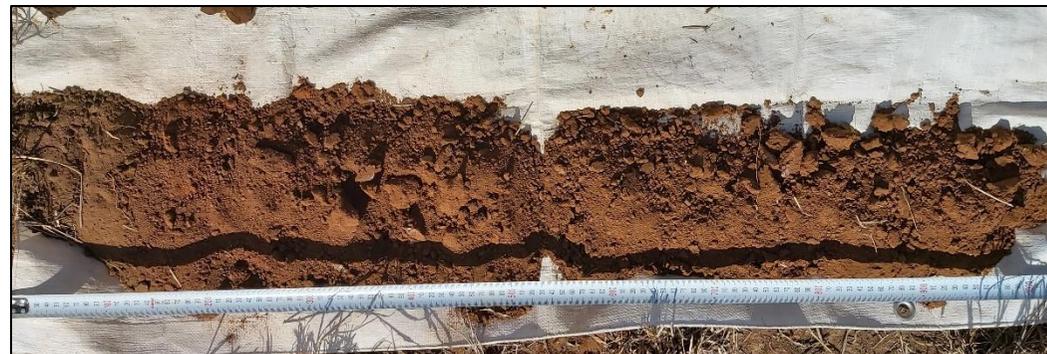
### SITE 54

<b>Soil Mapping Unit:</b> T3	<b>Location (GDA94 ZONE 55):</b> 630478 7548527	<b>Australian Soil Class:</b> Brown Chromosol	<b>Site Survey Type:</b> Detailed Hand Auger 50mm	<b>Survey Date:</b> 12/10/2019
---------------------------------	--	--	--	-----------------------------------

Land use Landform Pattern, Element, Slope	Vegetation	Microrelief Disturbance Erosion	Surface condition, surface rock	Soil Profile Description									
				Horizon Depth (m), Boundary	Field Texture	Structure, Strength	Inclusions Segregations	Colour, Mottle, Bleaching	Moisture, Drainage	Roots	Depth (m) / Field pH	Sample (m)	Observations
Grazing, gently undulating plain, upper slope 2%	Mixed woodlands, Poplar Box	Nil microrelief Semi disturbed Nil erosion	Firm, cracking, nil coarse fragments	A1 0.00-0.12 Abrupt	Loam	Massive, loose	Nil	7.5YR3/2 Dark brown Nil mottles / bleaching	Dry, well drained	Common	0.05 / 6.5	0.00-0.10 0.20-0.30 0.50-0.60 0.70-0.80 0.90-1.00	Nil
				B21 0.12-0.30 Gradual	Silty loam	Massive, weak	Nil	7.5YR3/4 Dark brown Nil mottles / bleaching	Dry, well drained	Few	0.25 / 6.5		
				B22 0.30-0.70 Gradual	Silty clay loam	Weak, weak, peds 5-30mm	<1% black nodules <1mm	7.5YR3/3 Dark brown Nil mottles / bleaching	Dry, well drained	Few	0.60 / 6.5

B23 0.70-1.00 EOBH	Silty clay loam	Weak, weak, peds 5-30mm	Nil	7.5YR3/4 Dark brown Nil mottles / bleaching	Dry, well drained	Nil	0.90 / 7.0

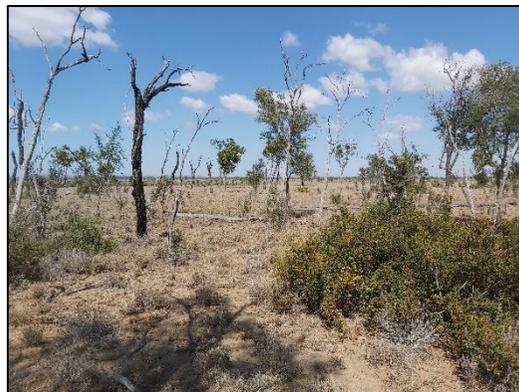
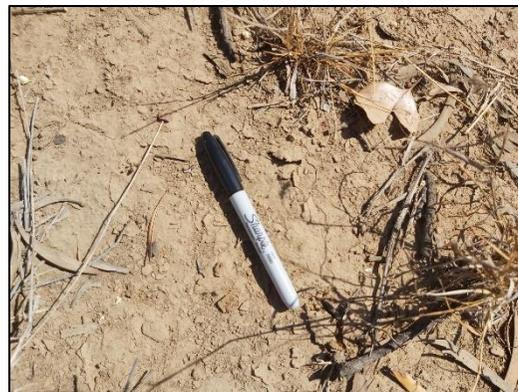
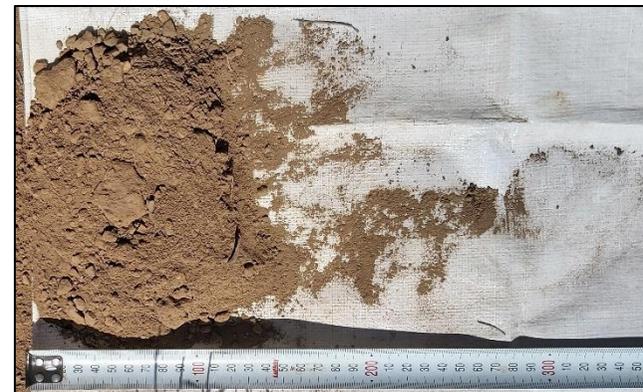
<b>Soil Mapping Unit:</b> K1	<b>Location (GDA94 ZONE 55):</b> 630779 7550077	<b>Australian Soil Class:</b> Very shallow Brown Tenosol	<b>Site Survey Type:</b> Detailed Hand Auger 50mm	<b>Survey Date:</b> 12/10/2019
---------------------------------	--	---	--	-----------------------------------

Land use Landform Pattern, Element, Slope	Vegetation	Microrelief Disturbance Erosion	Surface condition, surface rock	Soil Profile Description									
				Horizon Depth (m), Boundary	Field Texture	Structure, Strength	Inclusions Segregations	Colour, Mottle, Bleaching	Moisture, Drainage	Roots	Depth (m) / Field pH	Sample (m)	Observations
Grazing, wide crest upper slope, 1-2%	Exotic grassland	Nil microrelief Semi disturbed Nil erosion	Firm, 2% coarse fragments <10mm	A1 0.00-0.11 EOBH	Sandy loam	Massive, loose	40% <10mm coarse fragments 10% 10-20mm coarse fragments	10YR3/4 Dark yellowish brown Nil mottles / bleaching	Dry, rapidly drained	Common	0.05 / 6.5	0.00-0.10	Auger refusal at 0.11m, 5 attempts in the area

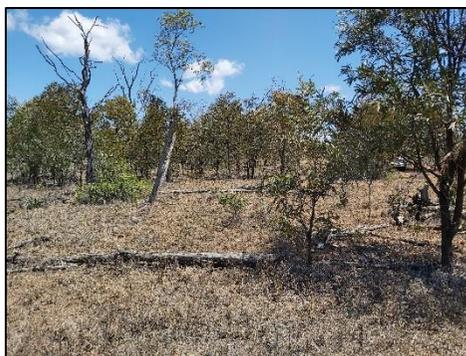
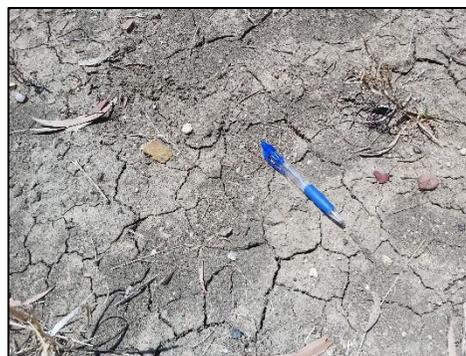
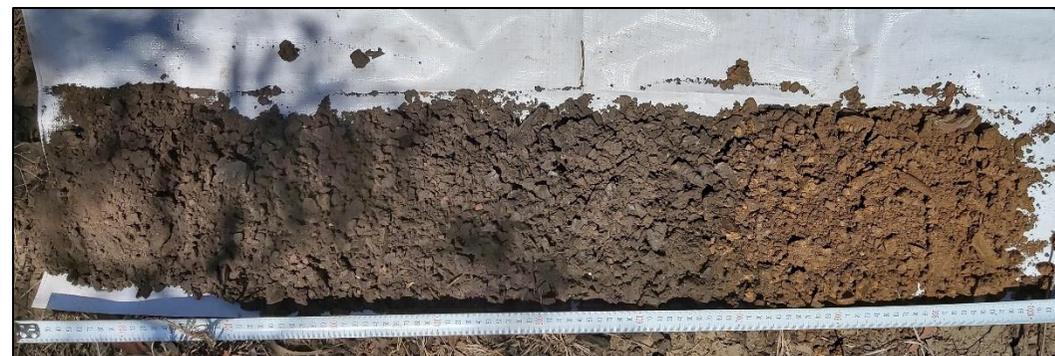
### SITE 56

<b>Soil Mapping Unit:</b> C3-BL	<b>Location (GDA94 ZONE 55):</b> 631455 7550363	<b>Australian Soil Class:</b> Black Vertosol	<b>Site Survey Type:</b> Detailed Hand Auger 50mm	<b>Survey Date:</b> 12/10/2019
------------------------------------	--	---	--	-----------------------------------

Land use Landform Pattern, Element, Slope	Vegetation	Microrelief Disturbance Erosion	Surface condition, surface rock	Soil Profile Description									
				Horizon Depth (m), Boundary	Field Texture	Structure, Strength	Inclusions Segregations	Colour, Mottle, Bleaching	Moisture, Drainage	Roots	Depth (m) / Field pH	Sample (m)	Observations
Grazing, lower slope, open flat plain	Brigalow	Very minor gilgai <1% coverage Semi disturbed Nil erosion	Soft, crust with cracking observed 5% coarse fragments <20mm	A1 0.00-0.12 Abrupt	Light clay	Weak, firm, subangular peds <10mm	<1% coarse fragments <5mm	10YR3/2 Very dark greyish brown Nil mottles / bleaching	Dry, well drained	Common	0.05 / 6.0	0.00-0.10 0.20-0.30 0.50-0.60 0.70-0.80 0.90-1.00	Nil
				B21 0.12-0.70 Abrupt	Light medium clay	Moderate, firm, subangular peds <20mm	<1% coarse fragments <5mm <2% coarse fragments <2mm	10YR3/1 Very dark grey Nil mottles / bleaching	Dry, well drained	Few	0.30 / 6.0 0.60 / 6.0

B22 0.70-1.00 EOBH	Light medium clay	Moderate, firm, subangular peds <20mm	<2% coarse fragments 2-5mm	10YR3/3 Dark brown Nil mottles / bleaching	Dry, well drained	Nil	0.90 / 6.0

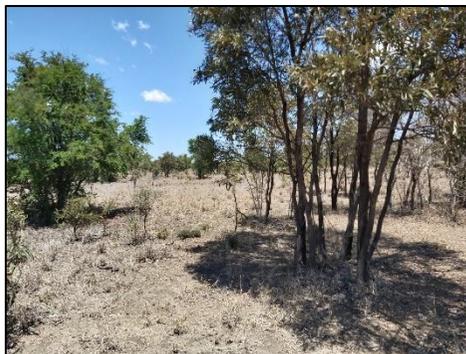
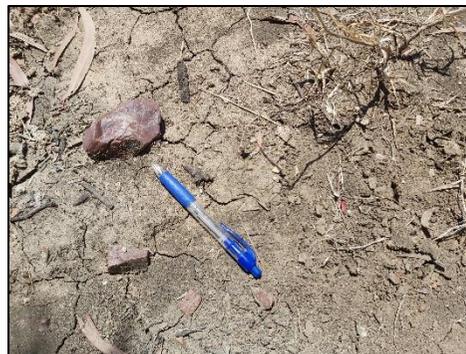
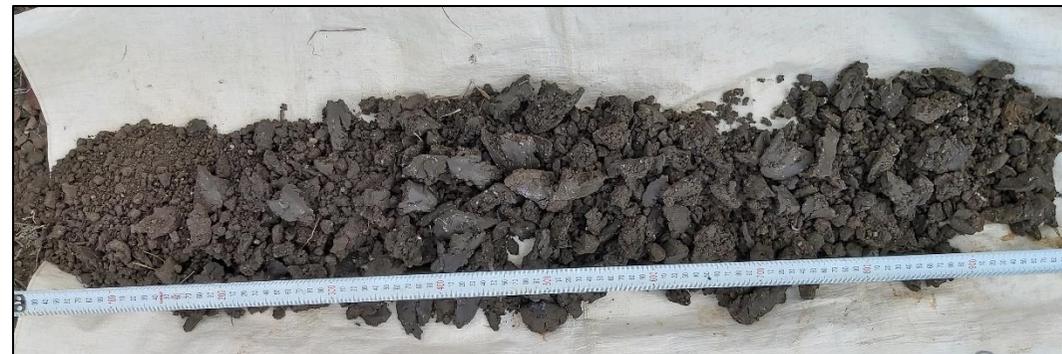
<b>Soil Mapping Unit:</b> C3-BL	<b>Location (GDA94 ZONE 55):</b> 632877 7550194	<b>Australian Soil Class:</b> Black Vertosol	<b>Site Survey Type:</b> Detailed Hand Auger 50mm	<b>Survey Date:</b> 12/10/2019
------------------------------------	--	---	--	-----------------------------------

Land use Landform Pattern, Element, Slope	Vegetation	Microrelief Disturbance Erosion	Surface condition, surface rock	Soil Profile Description									
				Horizon Depth (m), Boundary	Field Texture	Structure, Strength	Inclusions Segregations	Colour, Mottle, Bleaching	Moisture, Drainage	Roots	Depth (m) / Field pH	Sample (m)	Observations
Grazing, gently undulating plain, simple mid slope 1- 2%	Softwood scrub mixed vegetation	Nil microrelief Semi disturbed Nil erosion	Firm, crust with cracking white nodules <1%	A1 0.00-0.10 Abrupt	Light clay	Weak, very firm, sub-rounded peds <10mm	Nil	10YR3/2 Very dark greyish brown Nil mottles / bleaching	Dry, well drained	Common	0.05 / 6.5	Nil	Nil
				B21 0.10-0.68 Abrupt	Light medium clay	Moderate, very firm	<1% calcium carbonate	10YR3/1 Very dark grey Nil mottles / bleaching	Dry, well drained	Few	0.30 / 7.0 0.60 / 7.0		
				B22 0.68-1.00 EOBH	Light medium clay	Moderate, very firm	<2% calcium carbonate	10YR4/1 Dark grey Nil mottles / bleaching	Dry, moderately well drained	Few	0.90 / 7.0

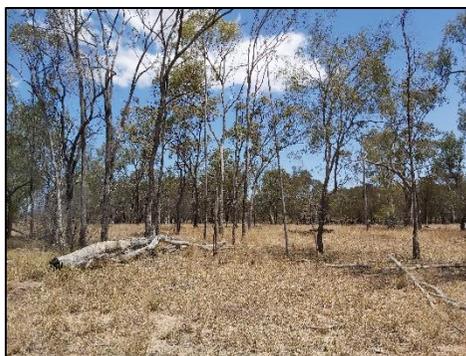
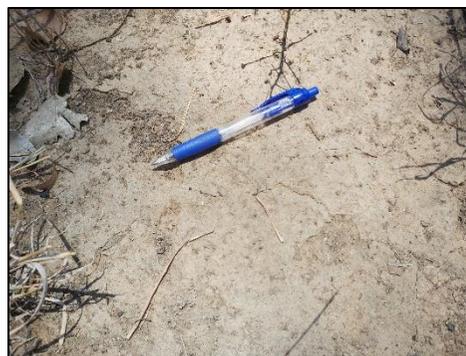
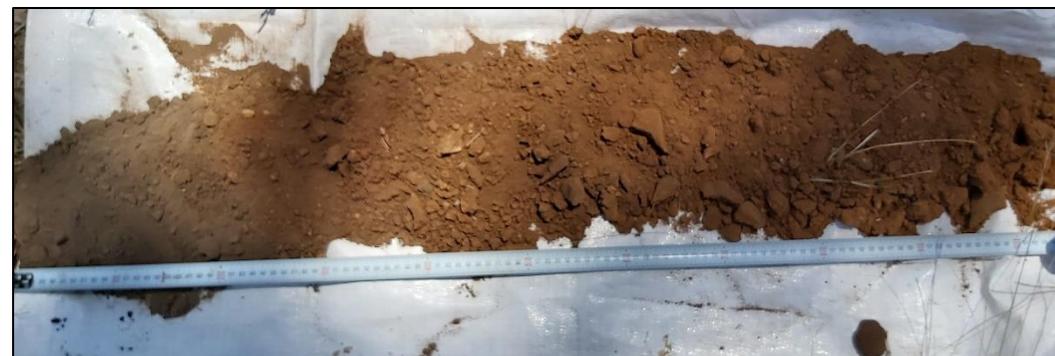
# SITE 58

<b>Soil Mapping Unit:</b> S1	<b>Location (GDA94 ZONE 55):</b> 633675 7550629	<b>Australian Soil Class:</b> Brown Sodosol	<b>Site Survey Type:</b> Detailed Hand Auger 50mm	<b>Survey Date:</b> 12/10/2019
---------------------------------	--	--	--	-----------------------------------

Land use Landform Pattern, Element, Slope	Vegetation	Microrelief Disturbance Erosion	Surface condition, surface rock	Soil Profile Description									
				Horizon Depth (m), Boundary	Field Texture	Structure, Strength	Inclusions Segregations	Colour, Mottle, Bleaching	Moisture, Drainage	Roots	Depth (m) / Field pH	Sample (m)	Observations
Grazing, mid slope 1-2%	Sparse mixed regrowth	Nil microrelief Semi disturbed Nil erosion	Soft, nil coarse fragments	A11 0.00-0.16 Abrupt	Loamy Sand	Massive, loose	Nil	7.5YR3/3 Dark brown Nil mottles / bleaching	Dry, Rapid	Common	0.10 / 6.0	0.00-0.10 0.20-0.30 0.50-0.60 0.70-0.80 0.90-1.00	
				A12 0.16-0.50 Abrupt	Clayey Sand	Massive, loose	Nil	7.5YR4/3 Brown Nil mottles / bleaching	Dry, Rapid	Few	0.30 / 6.0		
				B2 0.50-1.00 EOBH	Sandy clay Sand	Massive, loose, <10% <20mm weak peds	Nil	7.5YR3/4 Dark brown Nil mottles / bleaching	Dry, Well	Few	0.60 / 6.5 0.90 / 6.5

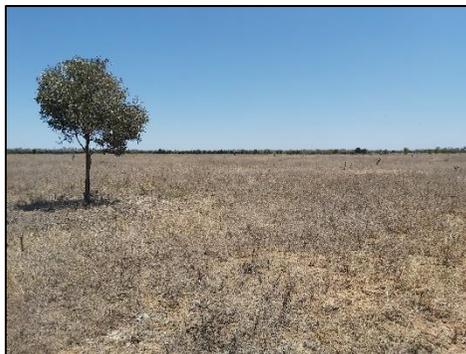
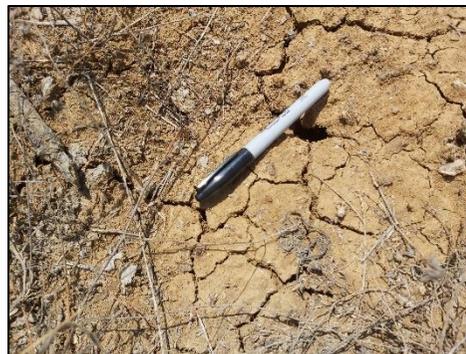
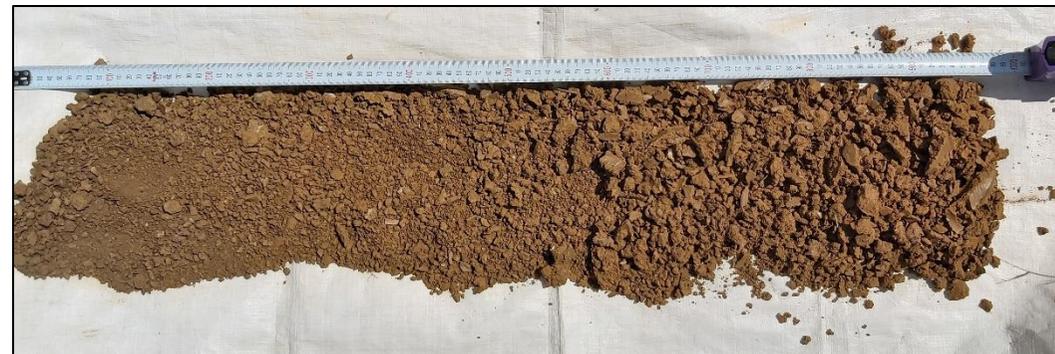
<b>Soil Mapping Unit:</b> C1-BR	<b>Location (GDA94 ZONE 55):</b> 633592 7550246	<b>Australian Soil Class:</b> Brown Vertosol	<b>Site Survey Type:</b> Detailed Hand Auger 50mm	<b>Survey Date:</b> 12/10/2019
------------------------------------	--	---	--	-----------------------------------

Land use Landform Pattern, Element, Slope	Vegetation	Microrelief Disturbance Erosion	Surface condition, surface rock	Soil Profile Description									
				Horizon Depth (m), Boundary	Field Texture	Structure, Strength	Inclusions Segregations	Colour, Mottle, Bleaching	Moisture, Drainage	Roots	Depth (m) / Field pH	Sample (m)	Observations
Grazing Flat plain	Very sparse Brigalow Grasses	Melon hole gilgai microrelief Extensive disturbance Nil erosion	Curst with cracking observed, soft to firm	A1 0.00-0.09 Abrupt	Light clay	Weak, firm, subangular <10mm	<2% manganese nodules	10YR3/3 Dark brown Nil mottles / bleaching	Dry, well to moderate	Common	0.10 / 6.5	Nil	Nil
				B21 0.09-0.59 Abrupt	Light medium clay	Weak, firm, subangular <10mm	<1% manganese nodules	7.5YR4/3 Brown Nil mottles / bleaching	Dry, moderate	Few	0.30 / 7.5 0.60 / 7.5		
				B22 0.59-1.00 EOBH	Light medium heavy clay	Weak, firm, subangular 10- 20mm	Nil	7.5YR4/3 Brown Nil mottles / bleaching	Dry, moderate	Few	0.90 / 6.5

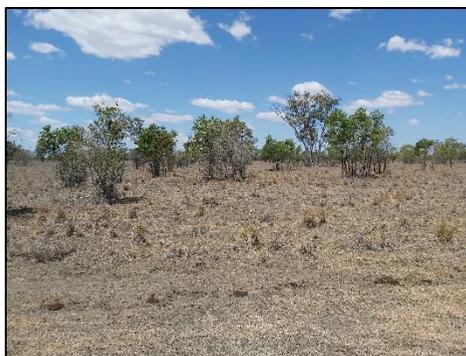
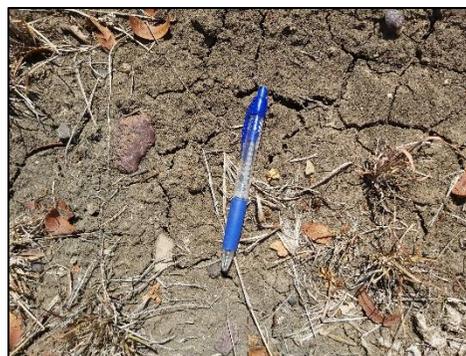
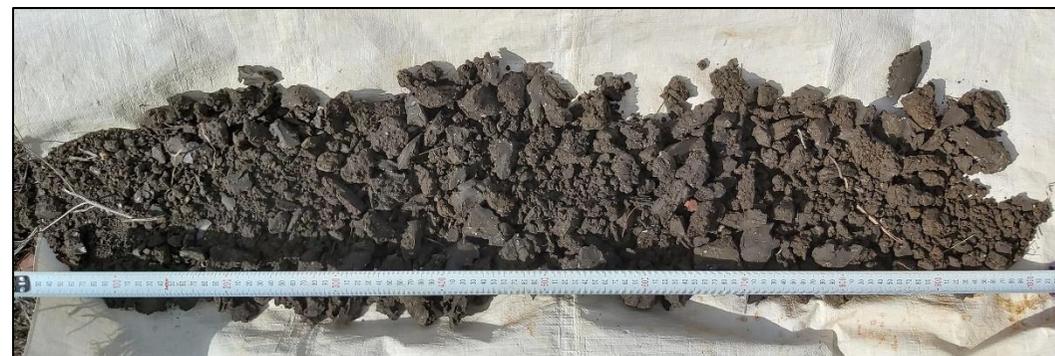
### SITE 60

<b>Soil Mapping Unit:</b> C3-BL	<b>Location (GDA94 ZONE 55):</b> 633443 7548576	<b>Australian Soil Class:</b> Black Vertosol	<b>Site Survey Type:</b> Detailed Hand Auger 50mm	<b>Survey Date:</b> 12/10/2019
------------------------------------	--	---	--	-----------------------------------

Land use Landform Pattern, Element, Slope	Vegetation	Microrelief Disturbance Erosion	Surface condition, surface rock	Soil Profile Description									
				Horizon Depth (m), Boundary	Field Texture	Structure, Strength	Inclusions Segregations	Colour, Mottle, Bleaching	Moisture, Drainage	Roots	Depth (m) / Field pH	Sample (m)	Observations
Grazing, gently undulating plain, mid- slope 2-3 %	Mixed vegetation including Brigalow and shrubs	Nil microrelief Semi disturbed Nil erosion	Cracking with crust nil coarse fragments	A1 0.00-0.11 Abrupt	Light clay	Weak, very firm, sub-rounded peds <10mm	Nil	10YR3/2 Very dark greyish brown Nil mottles / bleaching	Dry, well drained	Common	0.05 / 6.5	Nil	Nil
				B21 0.11-0.76 Abrupt	Light medium clay	Moderate, very firm	<2% calcium carbonate	10YR3/1 Very dark grey Nil mottles / bleaching	Dry, well drained	Few	0.30 / 7.0 0.60 / 7.0		
				B22 0.76-1.00 EOBH	Light medium clay	Moderate, very firm	Nil	10YR4/1 Dark grey Nil mottles / bleaching	Dry, moderately well drained	Few	0.90 / 7.0

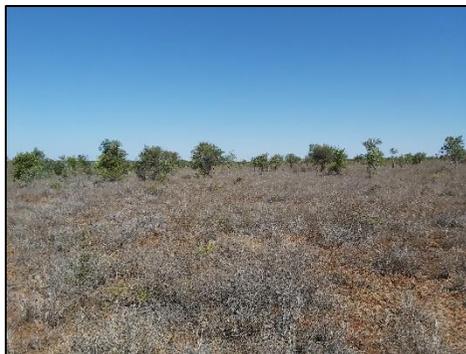
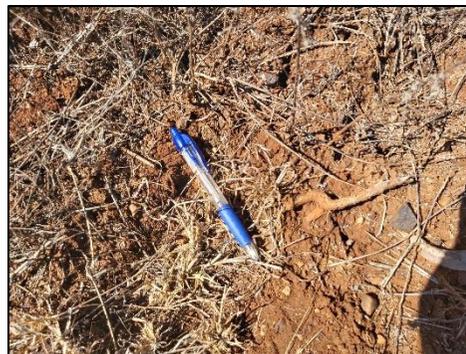
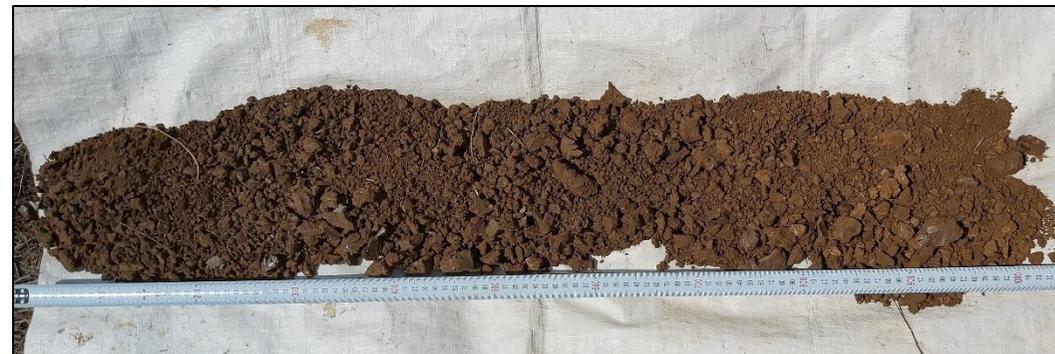
# SITE 61

<b>Soil Mapping Unit:</b> C3-BR	<b>Location (GDA94 ZONE 55):</b> 634364 7546987	<b>Australian Soil Class:</b> Brown Vertosol	<b>Site Survey Type:</b> Detailed Hand Auger 50mm	<b>Survey Date:</b> 12/10/2019
------------------------------------	--	---	--	-----------------------------------

Land use Landform Pattern, Element, Slope	Vegetation	Microrelief Disturbance Erosion	Surface condition, surface rock	Soil Profile Description									
				Horizon Depth (m), Boundary	Field Texture	Structure, Strength	Inclusions Segregations	Colour, Mottle, Bleaching	Moisture, Drainage	Roots	Depth (m) / Field pH	Sample (m)	Observations
Grazing, gently undulating plain, mid- slope 2 / 2%	Sparse mixed regrowth	Nil microrelief Semi disturbed Nil erosion	Crust cracking nil coarse fragments	A1 0.00-0.09 Abrupt	Light clay	Moderate, weak, peds 5-10mm	Nil	7.5YR3/2 Dark brown Nil mottles / bleaching	Dry, well drained	Common	0.05 / 7.0	Nil	Nil
				B21 0.09-0.27 Abrupt	Light clay	Moderate, firm, peds 10-20mm	Nil	7.5YR2.5/3 Very dark brown Nil mottles / bleaching	Dry, well drained	Common	0.25 / 7.5		
				B22 0.27-0.77 Abrupt	Medium clay	Moderate, very firm, subangular peds 10-40mm	<1% calcium carbonate	7.5YR3/3 Dark brown Nil mottles / bleaching	Dry, moderately well drained	Few	0.60 / 7.5

B23 0.77-1.00 EOBH	Medium clay	Moderate, weak, peds 10-20mm	Nil	7.5YR4/4 Brown Nil mottles / bleaching	Dry, moderately well drained	Nil	0.90 / 7.5
