# Appendix J

Soils and Land Suitability  
Assessment

## WINCHESTER SOUTH PROJECT Environmental Impact Statement

# Soils and Land Suitability Assessment

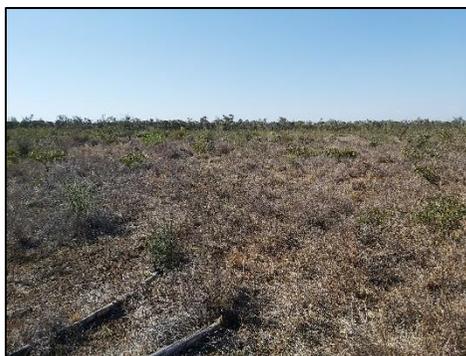
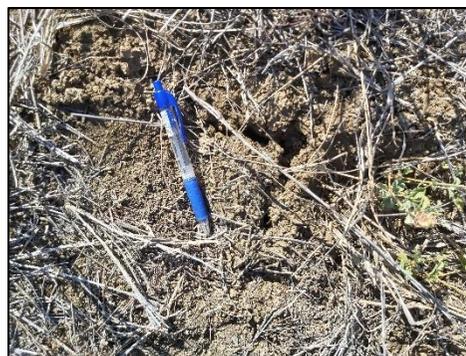
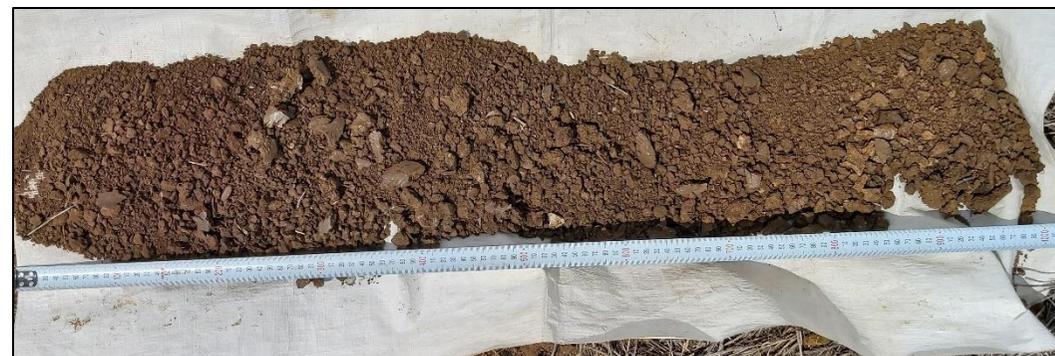
<b>Soil Mapping Unit:</b> C3-BR	<b>Location (GDA94 ZONE 55):</b> 627773 7550039	<b>Australian Soil Class:</b> Brown Vertosol	<b>Site Survey Type:</b> Detailed Hand Auger 50mm	<b>Survey Date:</b> 12/10/2019
------------------------------------	--	---	--	-----------------------------------

Land use Landform Pattern, Element, Slope	Vegetation	Microrelief Disturbance Erosion	Surface condition, surface rock	Soil Profile Description									
				Horizon Depth (m), Boundary	Field Texture	Structure, Strength	Inclusions Segregations	Colour, Mottle, Bleaching	Moisture, Drainage	Roots	Depth (m) / Field pH	Sample (m)	Observations
Grazing, gently undulating plain, mid- slope 2 / 2%	Grasses	Nil microrelief Semi disturbed Nil erosion	Cracking self- mulching, nil coarse fragments	A1 0.00-0.12 Abrupt	Light clay	Moderate, weak, peds 5-10mm	Nil	7.5YR3/2 Dark brown Nil mottles / bleaching	Dry, well drained	Common	0.05 / 7.0	Nil	Nil
				B21 0.12-0.25 Abrupt	Light clay	Moderate, firm, peds 10-20mm	<1% calcium carbonate	7.5YR2.5/3 Very dark brown Nil mottles / bleaching	Dry, well drained	Common	0.25 / 7.5		
				B22 0.25-0.71 Abrupt	Medium clay	Moderate, very firm, subangular peds 10-40mm	<1% calcium carbonate	7.5YR3/3 Dark brown Nil mottles / bleaching	Dry, moderately well drained	Few	0.60 / 7.5

B23 0.71-1.00 EOBH	Medium clay	Moderate, weak, peds 10-20mm	Nil	7.5YR4/4 Brown Nil mottles / bleaching	Dry, moderately well drained	Nil	0.90 / 7.5

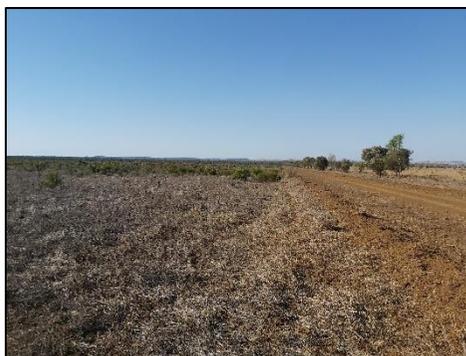
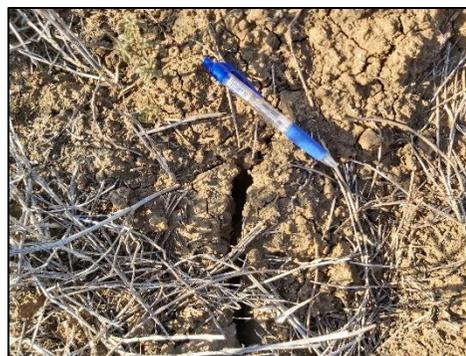
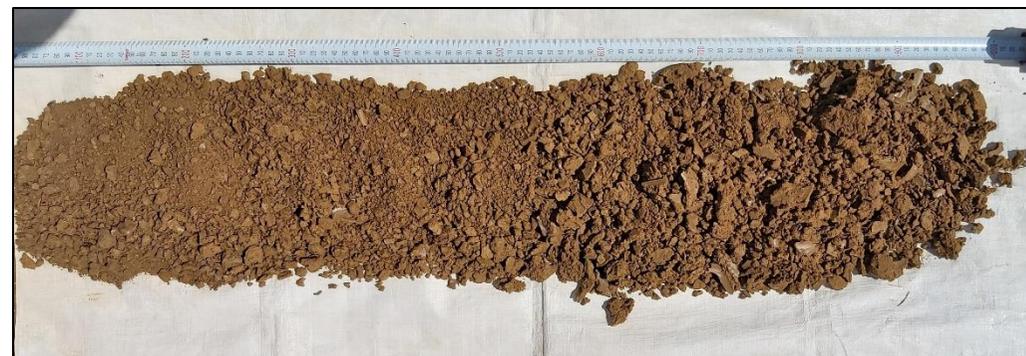
<b>Soil Mapping Unit:</b> C3-BR	<b>Location (GDA94 ZONE 55):</b> 627918 7548726	<b>Australian Soil Class:</b> Brown Vertosol	<b>Site Survey Type:</b> Detailed Hand Auger 50mm	<b>Survey Date:</b> 12/10/2019
------------------------------------	--	---	--	-----------------------------------

Land use Landform Pattern, Element, Slope	Vegetation	Microrelief Disturbance Erosion	Surface condition, surface rock	Soil Profile Description									
				Horizon Depth (m), Boundary	Field Texture	Structure, Strength	Inclusions Segregations	Colour, Mottle, Bleaching	Moisture, Drainage	Roots	Depth (m) / Field pH	Sample (m)	Observations
Grazing Midslope <2%/1%	Brigalow regrowth	Nil microrelief Semi disturbed Nil erosion	Cracking, self- mulching Nil coarse fragments	A1 0.00-0.11 Abrupt	Light clay	Weak, weak, subangular <10mm	Nil	10YR3/4 Dark yellowish brown Nil mottles / bleaching	Dry, well to moderate	Common	0.10m / 4.5	Nil	Nil
				B21 0.11-0.38 Abrupt	Light medium clay	Moderate, weak, subangular <10mm	<1% manganese nodules	10YR3/4 Dark yellowish brown Nil mottles / bleaching	Dry, moderate	Common	0.30m / 5.5 0.60m / 5.5		
				B22 0.53-1.00 EOBH	Medium clay	Moderate, firm, subangular 10- 20mm	Nil	10YR3/3 Dark brown Nil mottles / bleaching	Dry, moderate	Few	0.90m / 5.5

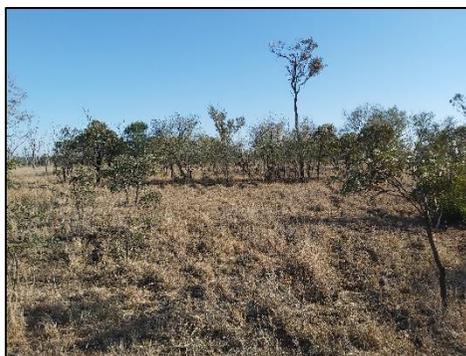
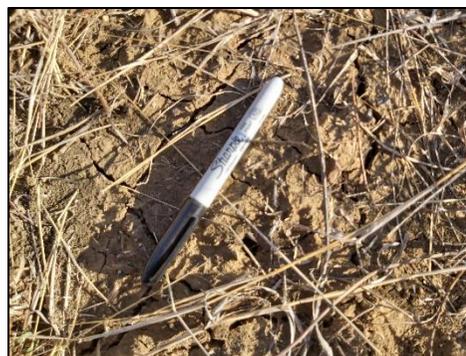
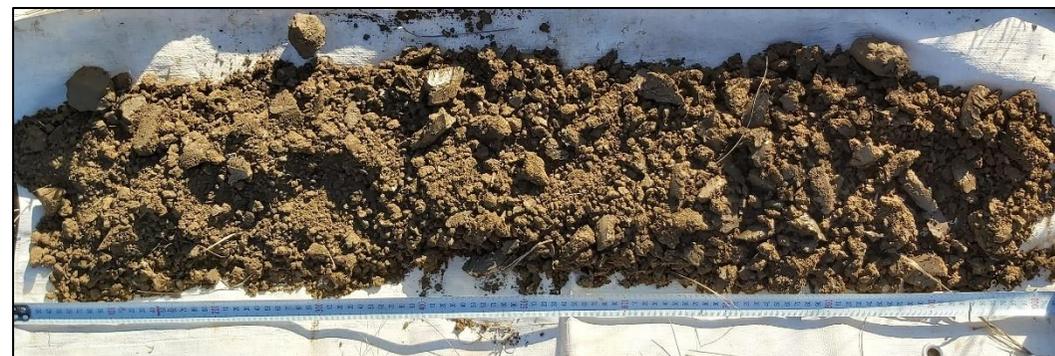
# SITE 64

<b>Soil Mapping Unit:</b> C3-BR	<b>Location (GDA94 ZONE 55):</b> 628992 7550731	<b>Australian Soil Class:</b> Brown Vertosol	<b>Site Survey Type:</b> Detailed Hand Auger 50mm	<b>Survey Date:</b> 13/10/2019
------------------------------------	--	---	--	-----------------------------------

Land use Landform Pattern, Element, Slope	Vegetation	Microrelief Disturbance Erosion	Surface condition, surface rock	Soil Profile Description									
				Horizon Depth (m), Boundary	Field Texture	Structure, Strength	Inclusions Segregations	Colour, Mottle, Bleaching	Moisture, Drainage	Roots	Depth (m) / Field pH	Sample (m)	Observations
Grazing, gently undulating plain, flat plain 1%/1%	Sparse Brigalow	Nil microrelief Semi disturbed Nil erosion	Cracking with crust Nil coarse fragments	A1 0.00-0.11 Abrupt	Light clay	Weak, weak, subangular <10mm	Nil	10YR3/4 Dark yellowish brown Nil mottles / bleaching	Dry, well to moderate	Common	0.10m / 4.5		
				B21 0.11-0.58 Abrupt	Light medium clay	Moderate, weak, subangular <10mm	<1% manganese nodules	10YR3/4 Dark yellowish brown Nil mottles / bleaching	Dry, moderate	Common	0.30m / 5.5 0.60m / 5.5		
				B22 0.58-1.00 EOBH	Medium clay	Moderate, firm, subangular 10- 20mm	Nil	10YR3/3 Dark brown Nil mottles / bleaching	Dry, moderate	Few	0.90m / 5.5

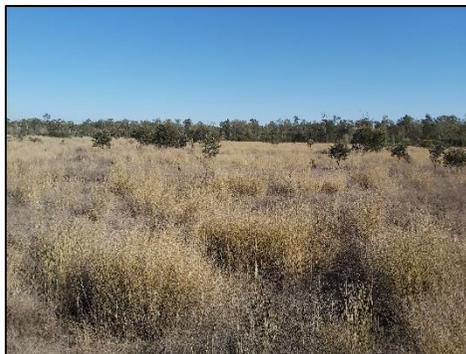
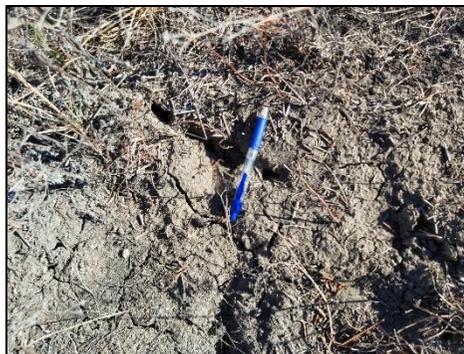
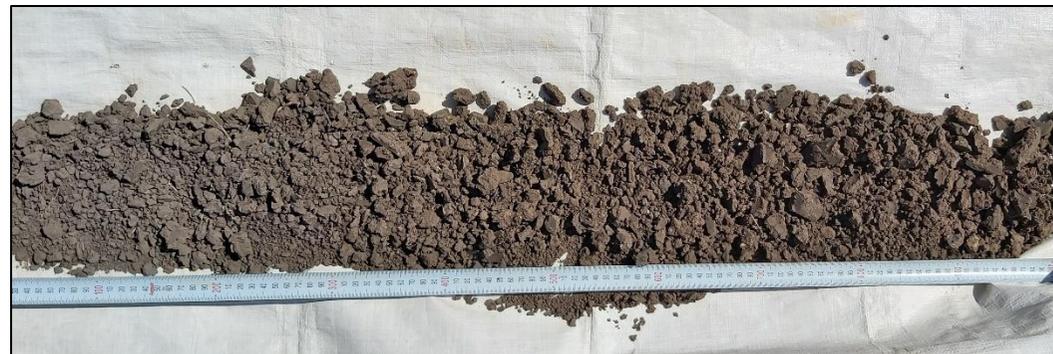
### SITE 65

<b>Soil Mapping Unit:</b> C1-BL	<b>Location (GDA94 ZONE 55):</b> 628719 7551638	<b>Australian Soil Class:</b> Black Vertosol	<b>Site Survey Type:</b> Detailed Hand Auger 50mm	<b>Survey Date:</b> 13/10/2019
------------------------------------	--	---	--	-----------------------------------

Land use Landform Pattern, Element, Slope	Vegetation	Microrelief Disturbance Erosion	Surface condition, surface rock	Soil Profile Description									
				Horizon Depth (m), Boundary	Field Texture	Structure, Strength	Inclusions Segregations	Colour, Mottle, Bleaching	Moisture, Drainage	Roots	Depth (m) / Field pH	Sample (m)	Observations
Grazing Flat Plain	Sparse Brigalow, grasses	Melon hole 50% coverage, 3- 6m wide, 0.2- 0.4m deep Semi disturbance Nil erosion	Cracking with crust Nil coarse fragments	A1 0.00-0.15 Abrupt	Medium clay	Weak, very firm, subangular <10mm	Nil	10YR3/2 Very dark greyish brown Nil mottles / bleaching	Dry, well to moderate	Common	0.10 / 5.5- 6.0	Nil	Nil
				B21 0.15-0.66 Abrupt	Medium heavy clay	Moderate, very firm, subangular <20mm	Nil	10YR3/1 Very dark grey Nil mottles / bleaching	Dry, moderate	Common	0.30 / 5.5- 6.0		
				B22 0.66-1.00 EOBH	Medium heavy clay	Moderate, very firm, subangular 10-30mm	Nil	10YR3/1 Very dark grey Nil mottles / bleaching	Dry, moderate	Few	0.60 / 5.5- 6.0 0.90 / 5.5

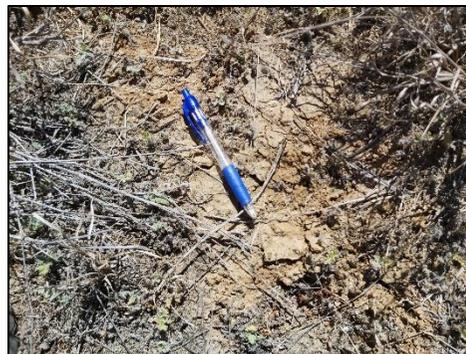
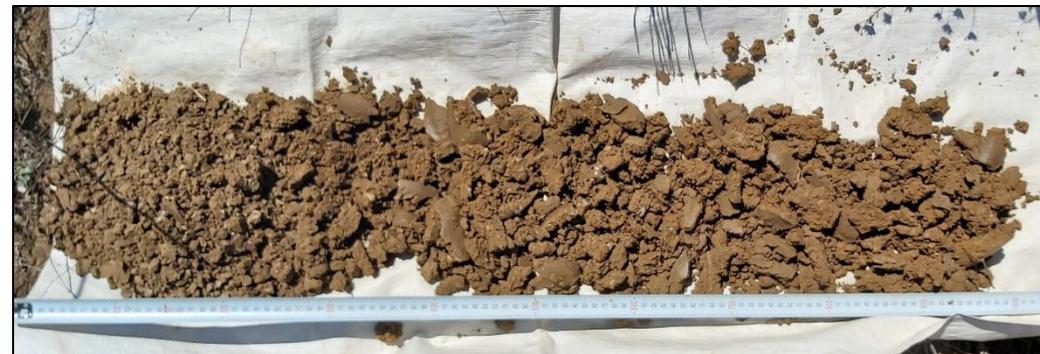
## SITE 66 - Mound

Land use Landform Pattern, Element, Slope	Vegetation	Microrelief Disturbance Erosion	Surface condition, surface rock	Soil Profile Description									
				Horizon Depth (m), Boundary	Field Texture	Structure, Strength	Inclusions Segregations	Colour, Mottle, Bleaching	Moisture, Drainage	Roots	Depth (m) / Field pH	Sample (m)	Observations
Grazing Mid-slope <1-1 %	Brigalow regrowth, sparse grasses	Melon hole 40% coverage, 3- 6m wide, 0.2- 0.4m deep extensive disturbance Nil erosion	Cracking with crust Nil coarse fragments	A1 0.00-0.17 Abrupt	Light medium clay	Weak, very firm, subangular <10mm	Nil	7.5YR3/2 Dark brown Nil mottles / bleaching	Dry, well to moderate	Common	0.10 / 7.0	Backup samples	Nil
				B21 0.17-0.50 Abrupt	Light medium clay	Moderate, very firm, subangular <20mm	Nil	10YR3/3 Dark brown Nil mottles / bleaching	Dry, moderate	Common	0.30 / 7.5		
				B22 0.50-0.66 Abrupt	Medium clay	Moderate, very firm, subangular <40mm	1% calcium carbonate	10YR4/4 Dark yellowish brown Nil mottles / bleaching	Dry, moderate	Few	0.60 / 7.5

B23 0.66-1.00 EOBH	Medium clay	Moderate, very firm, subangular <40mm	1% calcium carbonate / manganese nodules	10YR4/4 Dark yellowish brown Nil mottles / bleaching	Dry, moderate	Few	0.90 / 7.5

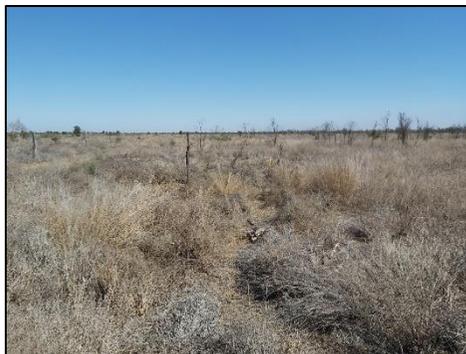
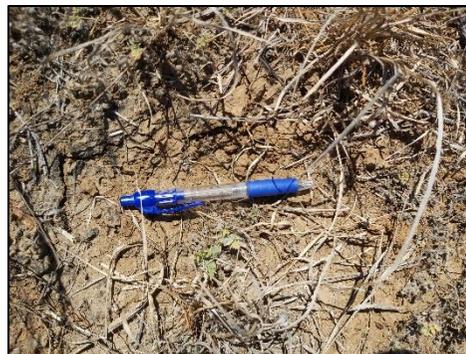
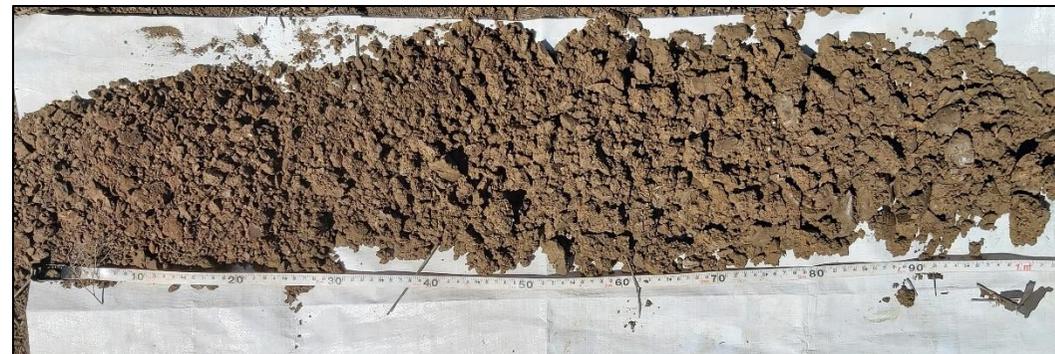
<b>Soil Mapping Unit:</b> C1-BR	<b>Location (GDA94 ZONE 55):</b> 627840 7551946	<b>Australian Soil Class:</b> Brown Vertosol	<b>Site Survey Type:</b> Detailed Hand Auger 50mm	<b>Survey Date:</b> 13/10/2019
------------------------------------	--	---	--	-----------------------------------

Land use Landform Pattern, Element, Slope	Vegetation	Microrelief Disturbance Erosion	Surface condition, surface rock	Soil Profile Description									
				Horizon Depth (m), Boundary	Field Texture	Structure, Strength	Inclusions Segregations	Colour, Mottle, Bleaching	Moisture, Drainage	Roots	Depth (m) / Field pH	Sample (m)	Observations
Grazing Mid-slope <1-1 %	Brigalow regrowth, sparse grasses	Melon hole 40% coverage, 3- 6m wide, 0.2- 0.4m deep extensive disturbance Nil erosion	Cracking with crust Nil coarse fragments	A1 0.00-0.11 Abrupt	Light medium clay	Weak, very firm, subangular <10mm	Nil	7.5YR3/2 Dark brown Nil mottles / bleaching	Dry, well to moderate	Common	0.10 / 7.0	Backup samples	Nil
				B21 0.11-0.43 Abrupt	Medium clay	Moderate, very firm, subangular <20mm	Nil	10YR3/3 Dark brown Nil mottles / bleaching	Dry, moderate	Few	0.30 / 7.5		
				B22 0.43-1.00 EOBH	Medium clay	Moderate, very firm, subangular <40mm	1% calcium carbonate	10YR4/4 Dark yellowish brown Nil mottles / bleaching	Dry, moderate	Few	0.60 / 7.5 0.90 / 7.5

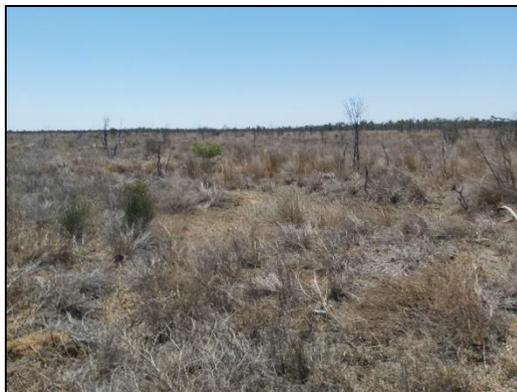
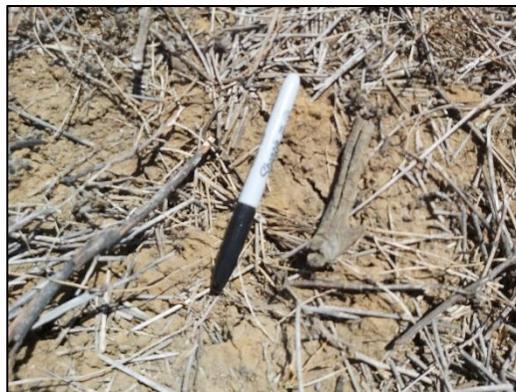
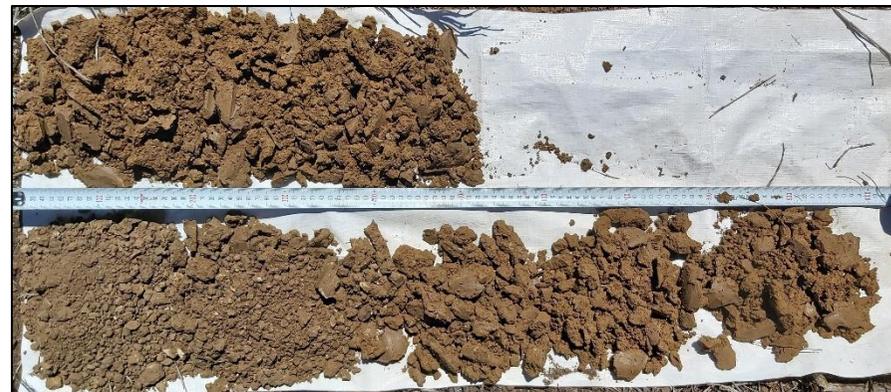
### SITE 67

<b>Soil Mapping Unit:</b> C1-BR	<b>Location (GDA94 ZONE 55):</b> 627369 7551873	<b>Australian Soil Class:</b> Brown Vertosol	<b>Site Survey Type:</b> Detailed Hand Auger 50mm	<b>Survey Date:</b> 13/10/2019
------------------------------------	--	---	--	-----------------------------------

Land use Landform Pattern, Element, Slope	Vegetation	Microrelief Disturbance Erosion	Surface condition, surface rock	Soil Profile Description									
				Horizon Depth (m), Boundary	Field Texture	Structure, Strength	Inclusions Segregations	Colour, Mottle, Bleaching	Moisture, Drainage	Roots	Depth (m) / Field pH	Sample (m)	Observations
Grazing Mid-slope <1-1 %	Brigalow regrowth, sparse grasses	Melon hole 40% coverage, 3- 6m wide, 0.2- 0.4m deep extensive disturbance Nil erosion	Cracking with crust Nil coarse fragments	A1 0.00-0.13 Abrupt	Light medium clay	Weak, very firm, subangular <10mm	Nil	7.5YR3/2 Dark brown Nil mottles / bleaching	Dry, well to moderate	Common	0.10 / 7.0	Nil	Nil
				B21 0.13-0.45 Abrupt	Medium clay	Moderate, very firm, subangular <20mm	Nil	10YR3/3 Dark brown Nil mottles / bleaching	Dry, moderate	Few	0.30 / 7.5		
				B22 0.43-1.22 Abrupt	Medium clay	Moderate, very firm, subangular <40mm	1% calcium carbonate	10YR4/4 Dark yellowish brown Nil mottles / bleaching	Dry, moderate	Very few	0.60 / 7.5 0.90 / 7.5

B22 1.22-1.50 EOBH	Medium clay	Moderate, very firm, subangular <40mm	2% calcium carbonate	10YR4/4 Dark yellowish brown Nil mottles / bleaching	Dry, moderate	Nil	1.20 / 7.5

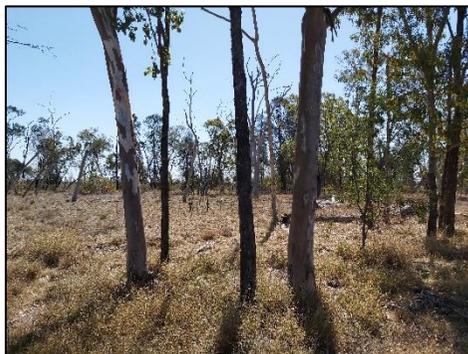
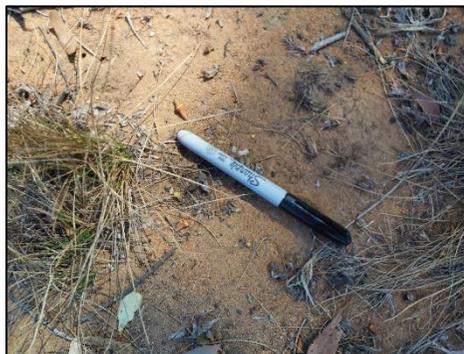
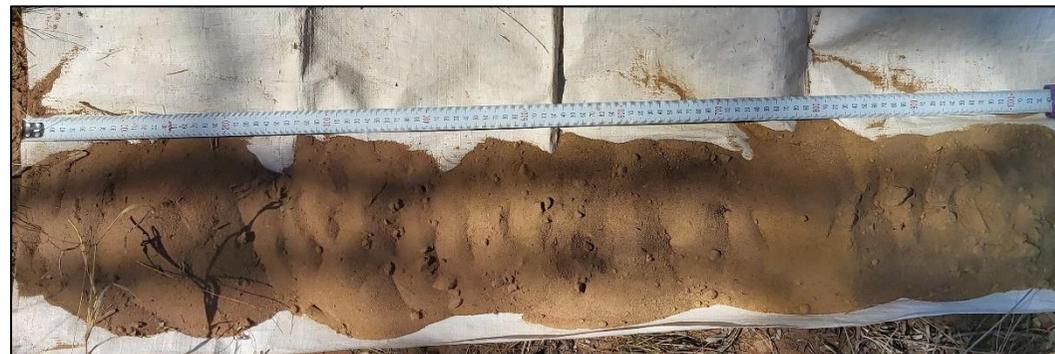
<b>Soil Mapping Unit:</b> S4	<b>Location (GDA94 ZONE 55):</b> 628352 7551956	<b>Australian Soil Class:</b> Brown Tenosol	<b>Site Survey Type:</b> Detailed Hand Auger 50mm	<b>Survey Date:</b> 13/10/2019
---------------------------------	--	--	--	-----------------------------------

Land use Landform Pattern, Element, Slope	Vegetation	Microrelief Disturbance Erosion	Surface condition, surface rock	Soil Profile Description									
				Horizon Depth (m), Boundary	Field Texture	Structure, Strength	Inclusions Segregations	Colour, Mottle, Bleaching	Moisture, Drainage	Roots	Depth (m) / Field pH	Sample (m)	Observations
Grazing Flat plain <1% / <1%	Poplar Box	Nil microrelief Nil disturbance Nil erosion	Soft, nil coarse fragments	A11 0.00-0.15 Abrupt	Loamy sand	Massive, loose	Nil	10YR3/3 Dark brown Nil mottles / bleaching	Dry, rapid	Common	0.10 / 6.0	0.00-0.10 0.20-0.30 0.50-0.60 0.70-0.80 0.90-1.00	Nil
				A12 0.15-0.70 Abrupt	Loamy sand	Massive, loose	Nil	10YR3/4 Dark yellowish brown Nil mottles / bleaching	Dry, rapid	Few	0.30 / 6.0 0.60 / 7.0		
				A13 0.70-1.00 EOBH	Loamy sand	Massive, loose	Nil	10YR4/6 Dark yellowish brown Nil mottles / bleaching	Dry, rapid	Nil	0.90 / 8.0

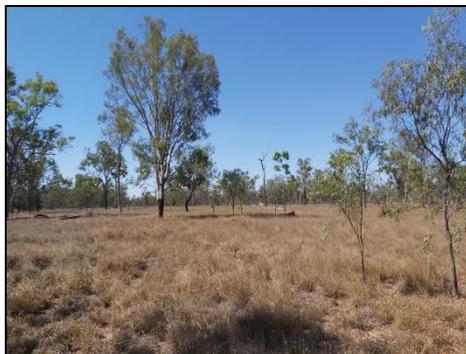
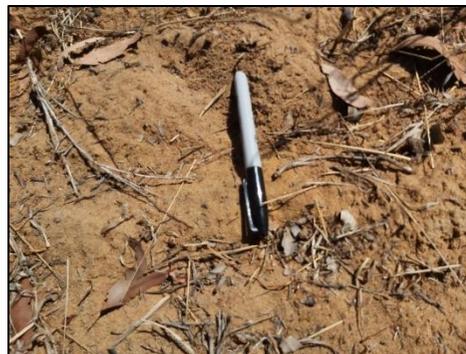
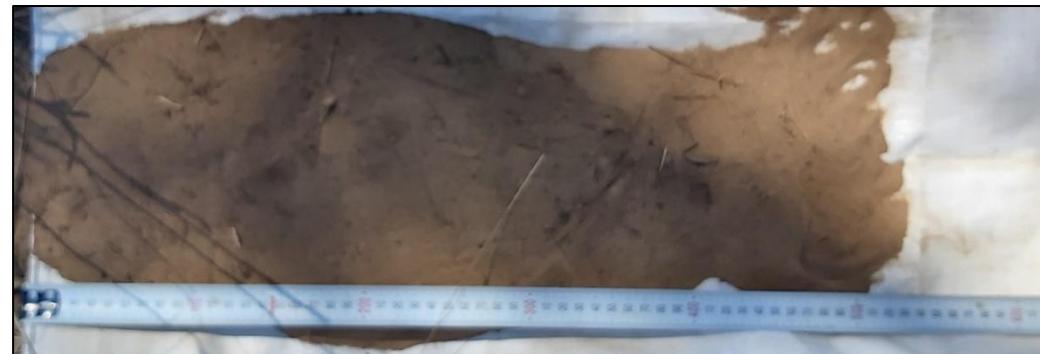
### SITE 69

<b>Soil Mapping Unit:</b> S2	<b>Location (GDA94 ZONE 55):</b> 628387 7552222	<b>Australian Soil Class:</b>	<b>Site Survey Type:</b> Detailed Hand Auger 50mm	<b>Survey Date:</b> 13/10/2019
---------------------------------	--	-------------------------------	--	-----------------------------------

Land use Landform Pattern, Element, Slope	Vegetation	Microrelief Disturbance Erosion	Surface condition, surface rock	Soil Profile Description									
				Horizon Depth (m), Boundary	Field Texture	Structure, Strength	Inclusions Segregations	Colour, Mottle, Bleaching	Moisture, Drainage	Roots	Depth (m) / Field pH	Sample (m)	Observations
Grazing Flat plain	Poplar box	Nil microrelief Nil disturbance Nil erosion	Soft, sandy	A11 0.00-0.10 Abrupt	Loamy sand	Apedal, loose	Nil	10YR3/3 Dark brown Nil mottles / bleaching	Dry, rapid	Nil	0.10 / 6.5	Nil	No recovery at 0.50 metres below ground level (mbgl)
				A12 0.10-0.50 EOBH	Loamy sand	Apedal, loose	Nil	10YR3/3 Dark brown Nil mottles / bleaching	Dry, rapid	Nil	0.30 / 6.5

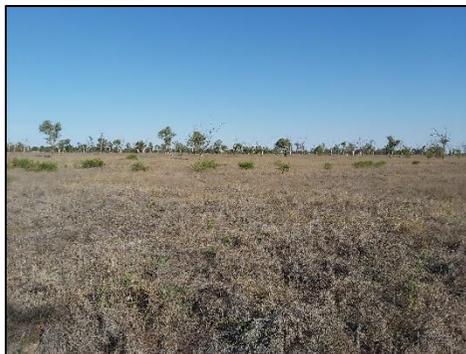
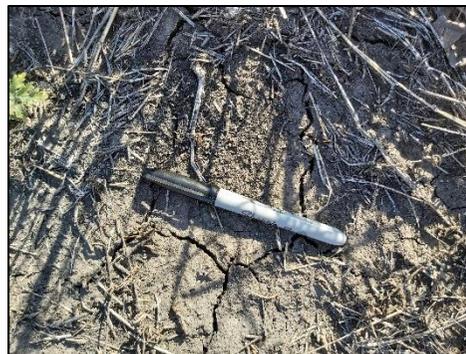
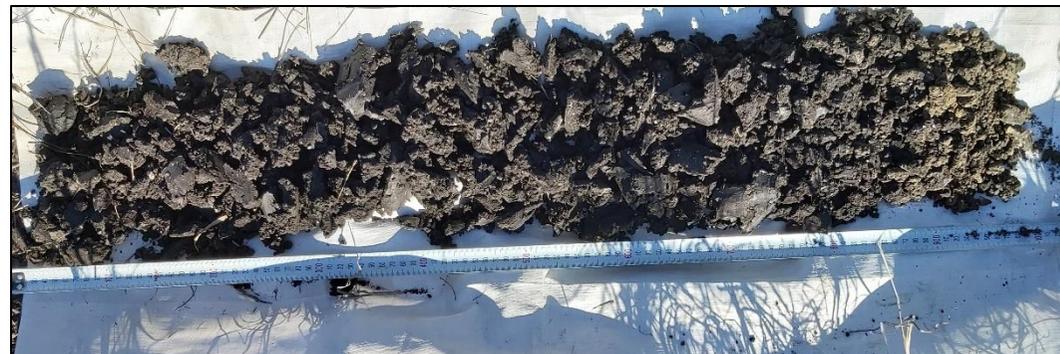
### SITE 70

<b>Soil Mapping Unit:</b> C5	<b>Location (GDA94 ZONE 55):</b> 630784 7552235	<b>Australian Soil Class:</b> Black Vertisol	<b>Site Survey Type:</b> Detailed Hand Auger 50mm	<b>Survey Date:</b> 13/10/2019
---------------------------------	--	---	--	-----------------------------------

Land use Landform Pattern, Element, Slope	Vegetation	Microrelief Disturbance Erosion	Surface condition, surface rock	Soil Profile Description									
				Horizon Depth (m), Boundary	Field Texture	Structure, Strength	Inclusions Segregations	Colour, Mottle, Bleaching	Moisture, Drainage	Roots	Depth (m) / Field pH	Sample (m)	Observations
Grazing Alluvial plain, flat wide depression	Exotic grassland	Nil microrelief Extensive disturbance Nil erosion	Cracking with crust Nil coarse fragments	A1 0.00-0.12 Abrupt	Medium clay	Moderate, firm, subangular <20mm	1% calcium carbonate	10YR3/1 Very dark grey Nil mottles / bleaching	Dry, well to moderate	Common	0.10 / 7.5	0.00-0.10 0.20-0.30 0.50-0.60 0.70-0.80 0.90-1.00	Nil
				B21 0.12-0.88 Abrupt	Medium clay	Moderate, firm, subangular 20- 40mm	2% calcium carbonate	10YR3/1 Very dark grey Nil mottles / bleaching	Dry, moderate	Few	0.30 / 7.5 0.60 / 7.5		
				B22 0.88-1.00 EOBH	Medium clay	Moderate, very firm, subangular 20-40mm	2% calcium carbonate	10YR3/1 Very dark grey Nil mottles / bleaching	Dry, moderate to imperfect	Nil	0.90 / 7.5

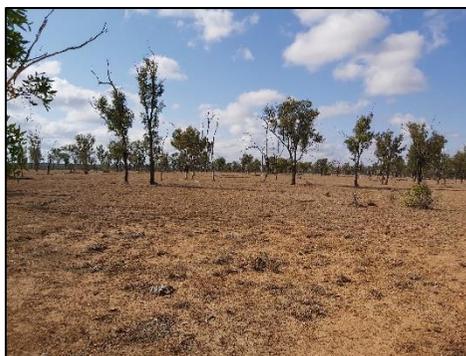
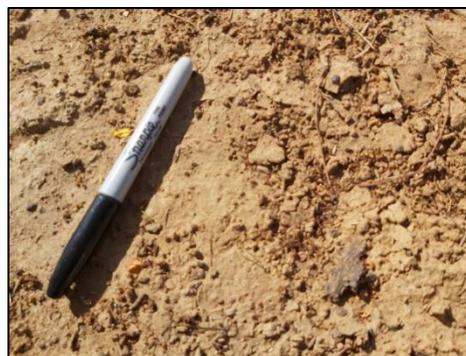
# SITE 71

<b>Soil Mapping Unit:</b> S3	<b>Location (GDA94 ZONE 55):</b> 636235 7540822	<b>Australian Soil Class:</b> Brown Chromosol	<b>Site Survey Type:</b> Detailed Hand Auger 50mm	<b>Survey Date:</b> 14/10/2019
---------------------------------	--	--	--	-----------------------------------

Land use Landform Pattern, Element, Slope	Vegetation	Microrelief Disturbance Erosion	Surface condition, surface rock	Soil Profile Description									
				Horizon Depth (m), Boundary	Field Texture	Structure, Strength	Inclusions Segregations	Colour, Mottle, Bleaching	Moisture, Drainage	Roots	Depth (m) / Field pH	Sample (m)	Observations
Grazing Flat plain 1%/1%	Narrow Leaf Ironbark	Nil microrelief Semi disturbance Nil erosion	Firm, <2% coarse fragments <5mm	A1 0.00-0.11 Abrupt	Sandy loam	Massive, apedal	Nil	10YR4/2 Dark greyish brown Nil mottles / bleaching	Dry, well to moderate	Common	0.10 / 6.5	Nil	Nil
				B21 0.11-0.50 Abrupt	Clay loam	Massive, apedal	<2% coarse fragments <5mm	10YR3/4 Dark yellowish brown Nil mottles / bleaching	Dry, moderate	Few	0.30 / 6.5		
				B22 0.50-0.85 Abrupt	Light clay	Massive, apedal	2% coarse fragments <5mm	7.5YR5/6 Strong brown Nil mottles / bleaching	Dry, moderate	Nil	0.60 / 7.0

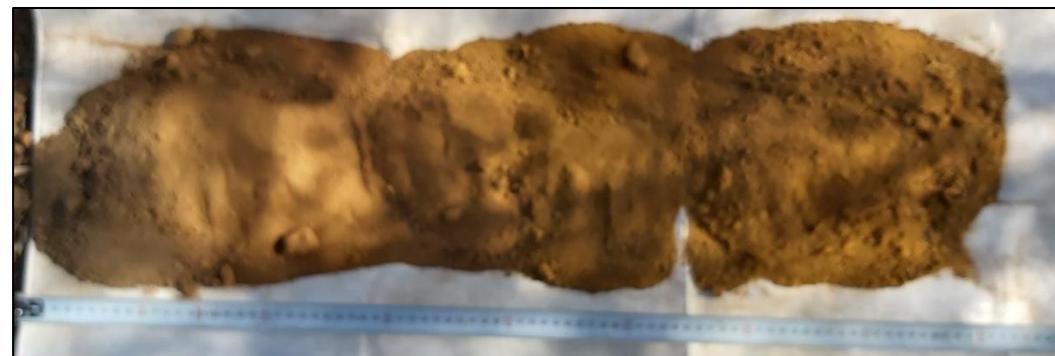
**Soil Profile**

B22 0.85-1.00 EOBH	Light clay	Massive, apedal	2% coarse fragments 10mm	7.5YR5/6 Strong brown Nil mottles / bleaching	Dry, moderate	Nil	0.90 / 7.0

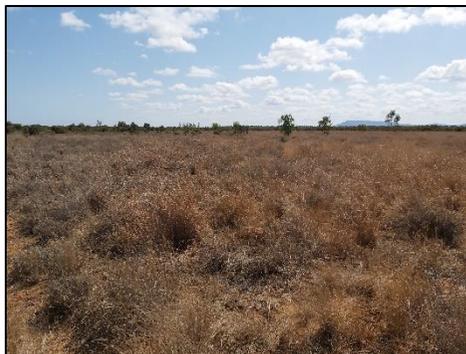
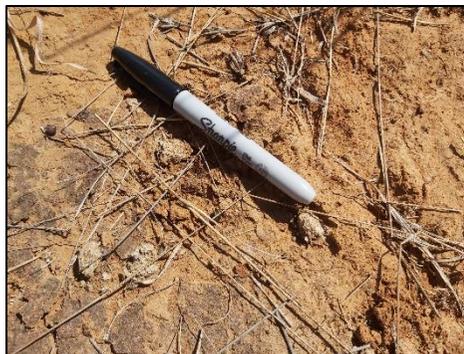
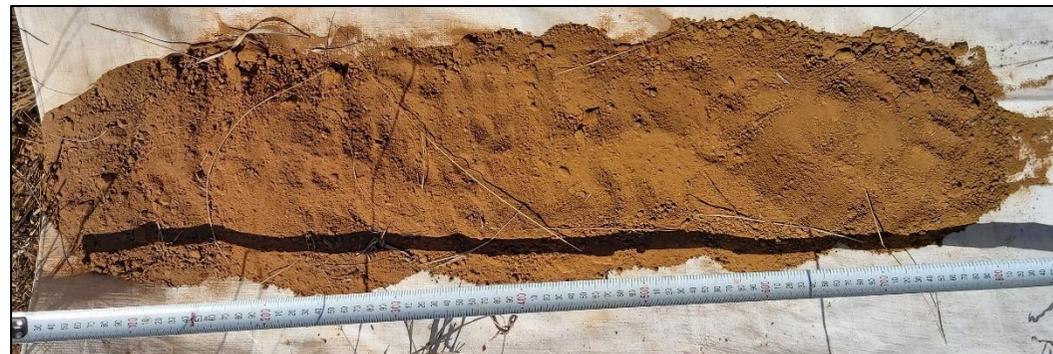
<b>Soil Mapping Unit:</b> S3	<b>Location (GDA94 ZONE 55):</b> 636966 7540450	<b>Australian Soil Class:</b> Brown Chromosol	<b>Site Survey Type:</b> Detailed Hand Auger 50mm	<b>Survey Date:</b> 14/10/2019
---------------------------------	--	--	--	-----------------------------------

Land use Landform Pattern, Element, Slope	Vegetation	Microrelief Disturbance Erosion	Surface condition, surface rock	Soil Profile Description									
				Horizon Depth (m), Boundary	Field Texture	Structure, Strength	Inclusions Segregations	Colour, Mottle, Bleaching	Moisture, Drainage	Roots	Depth (m) / Field pH	Sample (m)	Observations
Grazing, gently undulating plain, mid- slope <2%	Grasses	Nil microrelief Extensive disturbance Nil erosion	Hard Nil coarse fragments	A1 0.00-0.09 Abrupt	Clay loam	Massive, firm	Nil	7.5YR3/3 Dark brown Nil mottles / bleaching	Dry, Well	Common	0.10 / 6.0	Nil	No recovery at 0.8 mbgl
				B21 0.09-0.28 Abrupt	Silty loam	Massive, firm	<1% <5mm coarse fragments	7.5YR4/4 Brown Nil mottles / bleaching	Dry, moderate	Few	0.20 / 6.0		
				B22 0.28-0.80 Abrupt	Silty clay loam	Massive, firm	1% manganese nodules	7.5YR4/6 Strong brown Nil mottles / bleaching	Dry, moderate	Nil	0.60 / 6.0

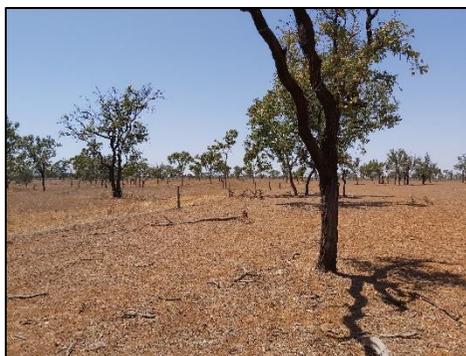
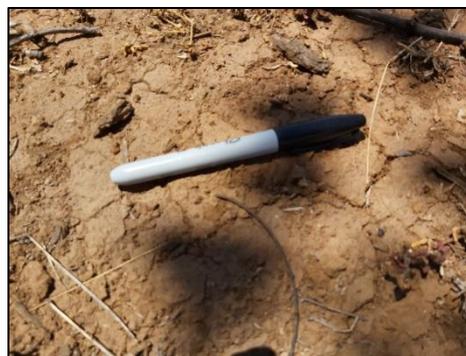
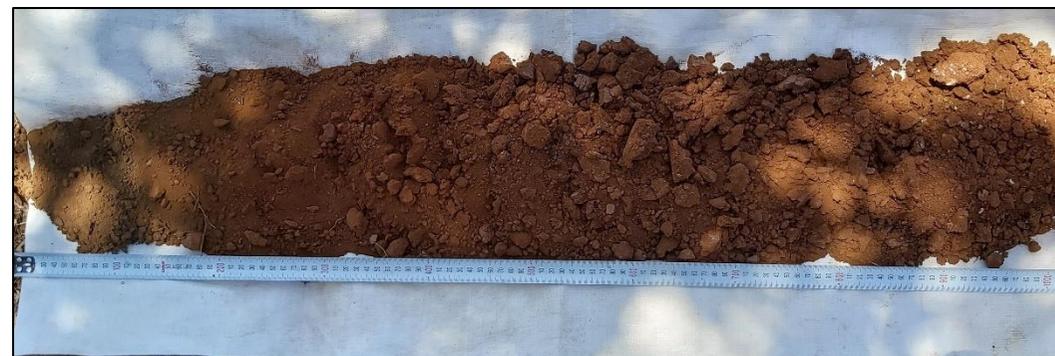
### SITE 73

<b>Soil Mapping Unit:</b> T2	<b>Location (GDA94 ZONE 55):</b> 627705 7546720	<b>Australian Soil Class:</b> Red Kandosol	<b>Site Survey Type:</b> Detailed Hand Auger 50mm	<b>Survey Date:</b> 14/10/2019
---------------------------------	--	---	--	-----------------------------------

Land use Landform Pattern, Element, Slope	Vegetation	Microrelief Disturbance Erosion	Surface condition, surface rock	Soil Profile Description									
				Horizon Depth (m), Boundary	Field Texture	Structure, Strength	Inclusions Segregations	Colour, Mottle, Bleaching	Moisture, Drainage	Roots	Depth (m) / Field pH	Sample (m)	Observations
Grazing, gently undulating plain, mid slope 1-2%	Sparse vegetation, gums	Nil microrelief Semi disturbed Nil erosion	Firm	A1 0.00-0.10 Abrupt	Sandy clay loam	Massive to weak, form, peds <5mm	<1% coarse fragments 5mm	7.5YR3/3 Dark brown Nil mottles / bleaching	Dry, well drained	Common	0.05 / 6.5	Nil	Nil
				B21 0.10-0.33 Abrupt	Clay loam	Massive to weak, form, peds <5mm	<1% coarse fragments 5mm	5YR4/3 Reddish brown Nil mottles / bleaching	Dry, well drained	Few	0.25 / 6.0		
				B22 0.33-0.80 Clear	Medium clay	Massive to weak, form, peds <2% <20mm	Nil	2.5YR4/4 Reddish brown Nil mottles / bleaching	Dry, well drained	Few	0.60 / 6.0

B23 0.80-1.00 EOBH	Medium clay	Massive to weak, form, peds <5mm	Nil	5YR4/4 Reddish brown Nil mottles / bleaching	Dry, well drained	Nil	0.85 / 6.0

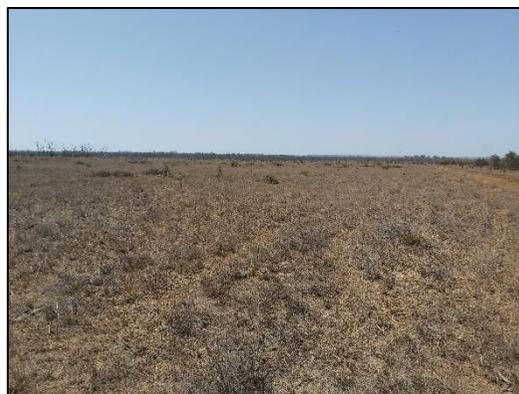
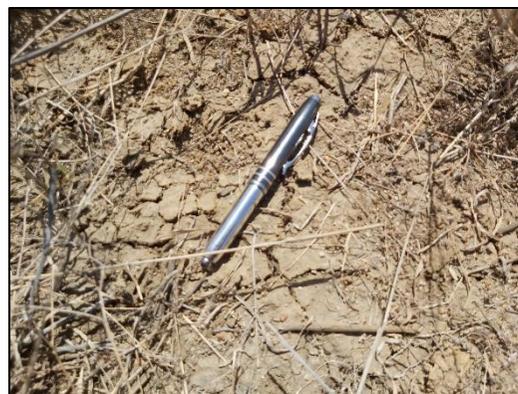
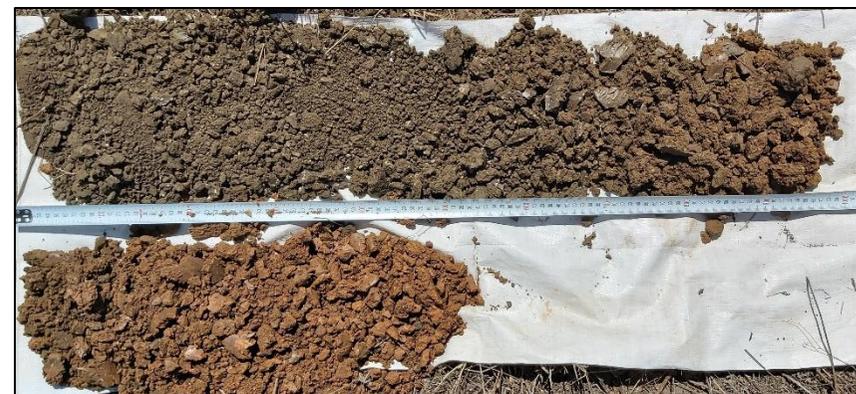
<b>Soil Mapping Unit:</b> C3-BL	<b>Location (GDA94 ZONE 55):</b> 625433 7551868	<b>Australian Soil Class:</b> Black Vertosol	<b>Site Survey Type:</b> Detailed Hand Auger 50mm	<b>Survey Date:</b> 14/10/2019
------------------------------------	--	---	--	-----------------------------------

Land use Landform Pattern, Element, Slope	Vegetation	Microrelief Disturbance Erosion	Surface condition, surface rock	Soil Profile Description									
				Horizon Depth (m), Boundary	Field Texture	Structure, Strength	Inclusions Segregations	Colour, Mottle, Bleaching	Moisture, Drainage	Roots	Depth (m) / Field pH	Sample (m)	Observations
Grazing, gently undulating plain, mid- slope 2%	Grasses	Nil microrelief Extensive disturbance Nil erosion	Firm to soft cracking with crust Nil coarse fragments	A11 0.00-0.12 Abrupt	Light clay	Weak to moderate, sub- angular <20mm	Nil	10YR3/2 Very dark greyish brown Nil mottles / bleaching	Dry, well	Common	-	Nil	Nil
				B21 0.12-0.80 Abrupt	Light medium clay	Weak to moderate, sub- angular <20mm	Nil	7.5YR3/2 Dark brown Nil mottles / bleaching	Dry, well to moderate	Common	-		
				B22 0.80-1.10 Abrupt	Light medium clay	Moderate, sub- angular <20mm	Nil	10YR4/4 Dark yellowish brown Nil mottles / bleaching	Dry, well to moderate	Nil	-

B23 1.10-1.50 EOBH	Medium clay	Moderate, sub- angular <20mm	Nil	7.5YR4/4 Brown Nil mottles / bleaching	Dry, moderate	Nil	-

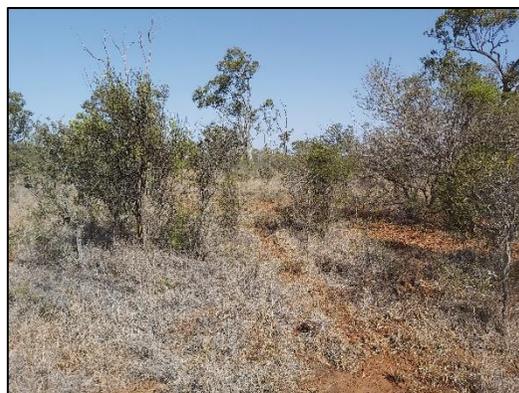
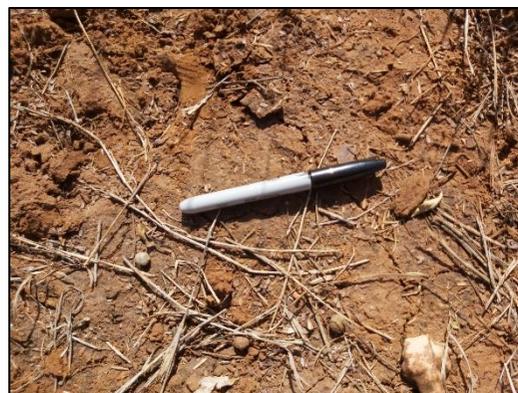
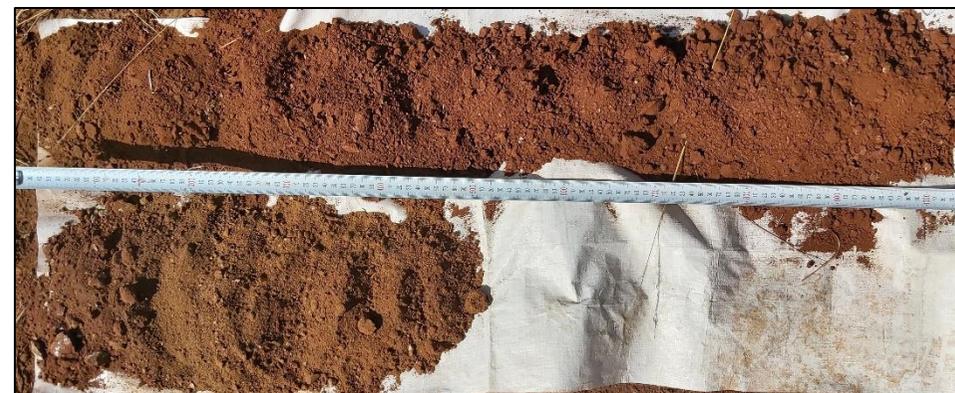
<b>Soil Mapping Unit:</b> T2	<b>Location (GDA94 ZONE 55):</b> 627314 7544935	<b>Australian Soil Class:</b> Red Kandosol	<b>Site Survey Type:</b> Detailed Hand Auger 50mm	<b>Survey Date:</b> 14/10/2019
---------------------------------	--	---	--	-----------------------------------

Land use Landform Pattern, Element, Slope	Vegetation	Microrelief Disturbance Erosion	Surface condition, surface rock	Soil Profile Description									
				Horizon Depth (m), Boundary	Field Texture	Structure, Strength	Inclusions Segregations	Colour, Mottle, Bleaching	Moisture, Drainage	Roots	Depth (m) / Field pH	Sample (m)	Observations
Grazing GUP mid- slope 2 / 2%	Mixed vegetation	Nil microrelief Semi disturbance Nil erosion	Firm, Nil coarse fragments	A1 0.00-0.10 Abrupt	Sandy clay loam	Massive to weak, form, peds <5mm	<1% coarse fragments 5mm	7.5YR3/3 Dark brown Nil mottles / bleaching	Dry, well drained	Common	0.05 / 6.5	0.00-0.10 0.20-0.30 0.50-0.60 0.70-0.80	Nil
				A2 0.10-0.30 Abrupt	Clay loam	Massive to weak, form, peds <5mm	<1% coarse fragments 5mm	5YR4/3 Reddish brown Nil mottles / bleaching	Dry, well – moderate	Few	0.25 / 6.0	0.90-1.00 1.40-1.50	
				B21 0.30-0.88 Abrupt	Medium clay	Massive to weak, form, peds <2% <20mm	Nil	2.5YR4/6 Red Nil mottles / bleaching	Dry, moderate	Few	0.60 / 6.5

B22 0.88-1.10 Abrupt	Medium clay	Massive to weak, form, peds <10mm	<1% coarse fragments <5mm	2.5YR4/6 Red Nil mottles / bleaching	Dry, moderate	Nil	0.90 / 6.5		
				B23 1.10-1.50 EOBH	Clay loam	Massive to weak, form, peds <5mm	<1% coarse fragments <5mm	2.5YR4/6 Red Nil mottles / bleaching	Dry, moderate	Nil	1.20 / 7.0

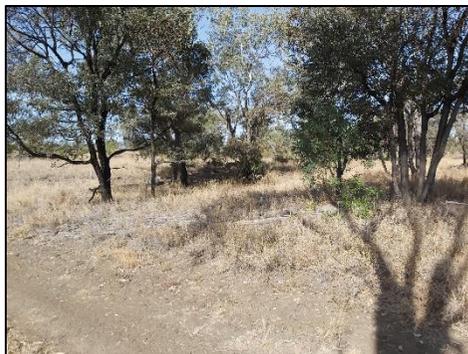
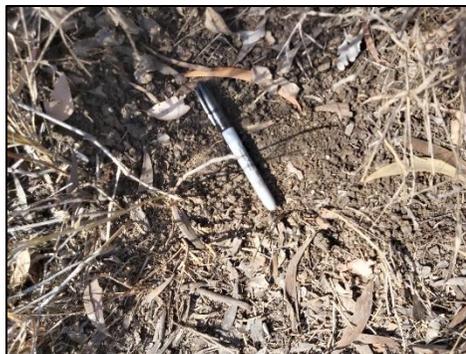
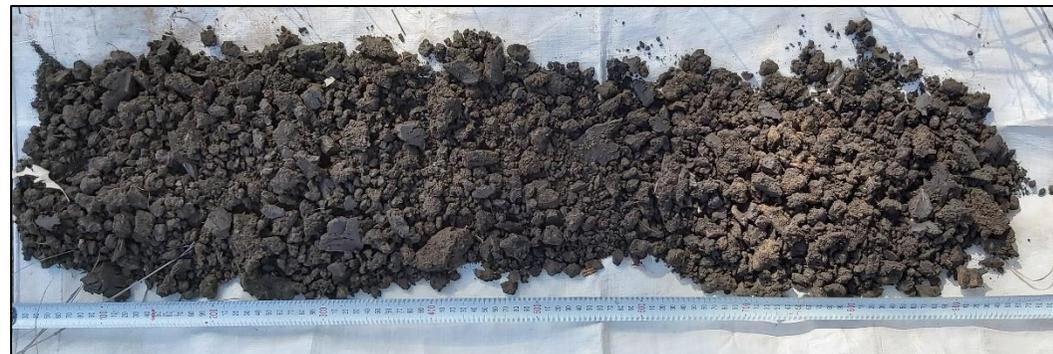
<b>Soil Mapping Unit:</b> C5	<b>Location (GDA94 ZONE 55):</b> 626770 7543936	<b>Australian Soil Class:</b> Black Vertosol	<b>Site Survey Type:</b> Detailed Hand Auger 50mm	<b>Survey Date:</b> 14/10/2019
---------------------------------	--	---	--	-----------------------------------

Land use Landform Pattern, Element, Slope	Vegetation	Microrelief Disturbance Erosion	Surface condition, surface rock	Soil Profile Description									
				Horizon Depth (m), Boundary	Field Texture	Structure, Strength	Inclusions Segregations	Colour, Mottle, Bleaching	Moisture, Drainage	Roots	Depth (m) / Field pH	Sample (m)	Observations
Alluvial plain, flat wide depression	Mount Coolibah	Nil microrelief Extensive disturbance Nil erosion	Cracking, Nil coarse fragments	A1 0.00-0.10 Abrupt	Medium clay	Moderate, firm, subangular <20mm	1% calcium carbonate	10YR3/1 Very dark grey Nil mottles / bleaching	Dry, well to moderate	Common	0.10 / 7.5	0.00-0.10 0.20-0.30 0.50-0.60 0.80-0.90	Nil
				B21 0.10-0.85 Abrupt	Medium clay	Moderate, firm, subangular 20- 40mm	2% calcium carbonate	10YR3/1 Very dark grey Nil mottles / bleaching	Dry, moderate	Few	0.30 / 7.5 0.60 / 7.5		
				B22 0.85-0.94 EOBH	Medium clay	Moderate, very firm, subangular 20-40mm	2% calcium carbonate	10YR3/1 Very dark grey Nil mottles / bleaching	Dry, moderate to imperfect	Nil	0.90 / 7.5

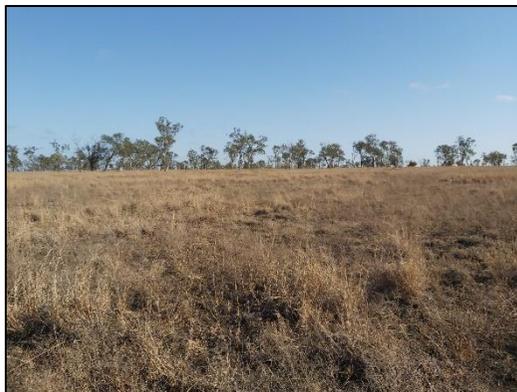
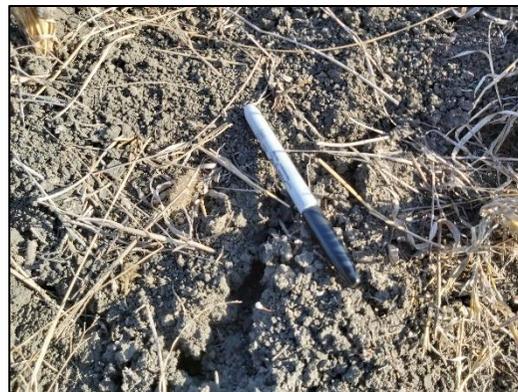
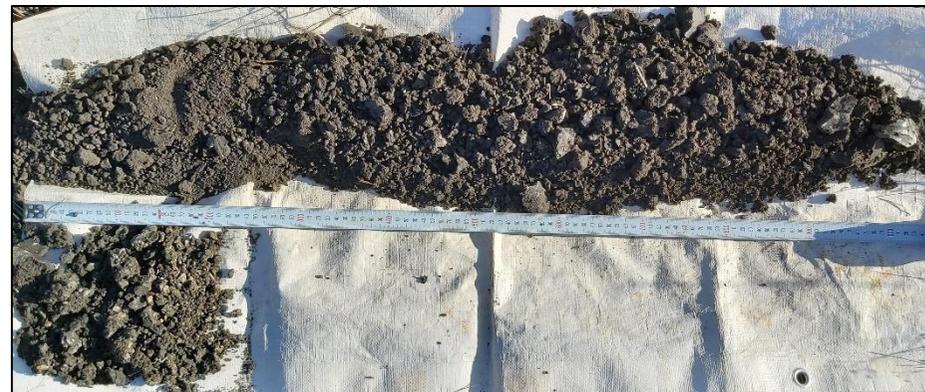
### SITE 77

<b>Soil Mapping Unit:</b> C4	<b>Location (GDA94 ZONE 55):</b> 620919 7548417	<b>Australian Soil Class:</b> Black Vertosol	<b>Site Survey Type:</b> Detailed Hand Auger 50mm	<b>Survey Date:</b> 15/10/2019
---------------------------------	--	---	--	-----------------------------------

Land use Landform Pattern, Element, Slope	Vegetation	Microrelief Disturbance Erosion	Surface condition, surface rock	Soil Profile Description									
				Horizon Depth (m), Boundary	Field Texture	Structure, Strength	Inclusions Segregations	Colour, Mottle, Bleaching	Moisture, Drainage	Roots	Depth (m) / Field pH	Sample (m)	Observations
Grazing GUP Mid-slope 3%	Grasses	Nil microrelief Extensive disturbance Nil erosion	Self-mulching, cracking Nil coarse fragments	A11 0.00-0.10 Abrupt	Light clay	Moderate, firm, sub-angular 5- 15mm	Nil	10YR3/2 Very dark greyish brown Nil mottles / bleaching	Dry, well	Common	-	Nil	Refusal encountered at 1.20 mbgl
				B21 0.10-0.33 Abrupt	Light medium clay	Moderate, firm, sub-angular 10- 20mm	Nil	10YR3/3 Dark brown Nil mottles / bleaching	Dry, moderate	Common	-		
				B22 0.33-1.05 Abrupt	Medium clay	Moderate, firm, sub-angular 10- 40mm	Nil	10YR3/2 Very dark greyish brown Nil mottles / bleaching	Dry, moderate	Few	-

B23 1.05-1.20 EOBH	Medium clay	Moderate, firm, sub-angular 10- 20mm	<2% coarse fragments	10YR3/2 Very dark greyish brown Mottles <2% 10YR4/2 Dark greyish brown Nil bleaching	Dry, moderate to imperfect	Nil	-

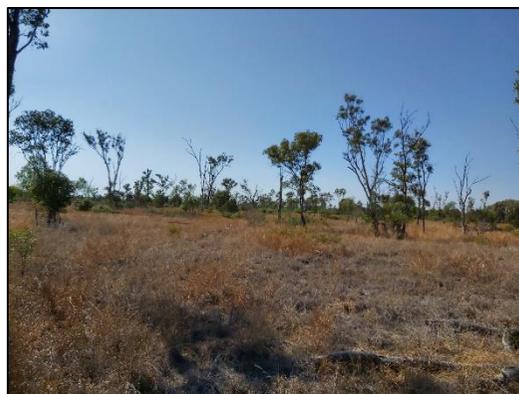
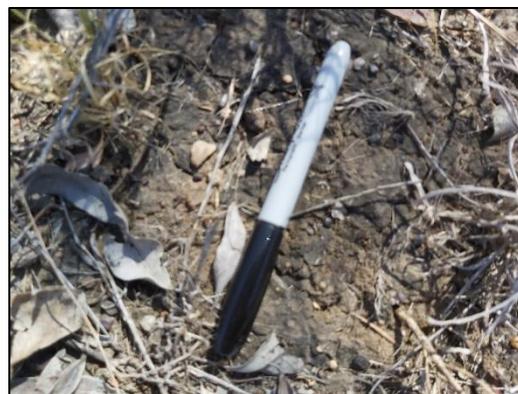
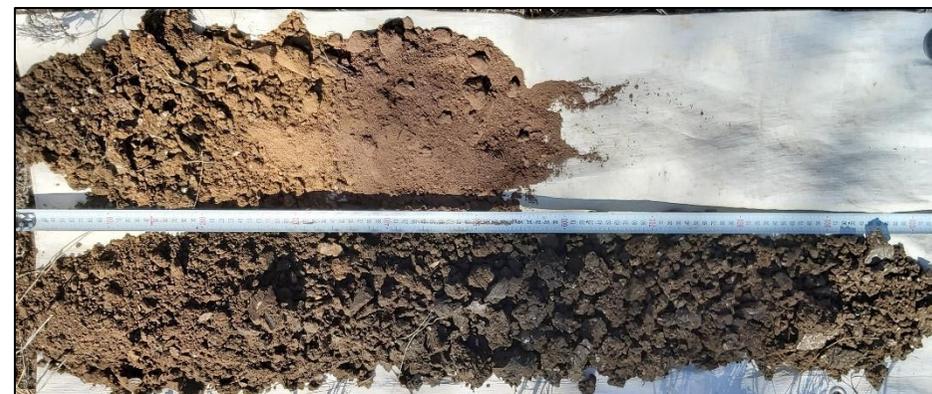
<b>Soil Mapping Unit:</b> T3	<b>Location (GDA94 ZONE 55):</b> 626510 7543191	<b>Australian Soil Class:</b> Brown Chromosol	<b>Site Survey Type:</b> Detailed Hand Auger 50mm	<b>Survey Date:</b> 15/10/2019
---------------------------------	--	--	--	-----------------------------------

Land use Landform Pattern, Element, Slope	Vegetation	Microrelief Disturbance Erosion	Surface condition, surface rock	Soil Profile Description									
				Horizon Depth (m), Boundary	Field Texture	Structure, Strength	Inclusions Segregations	Colour, Mottle, Bleaching	Moisture, Drainage	Roots	Depth (m) / Field pH	Sample (m)	Observations
Grazing GUP mid- slope 2%	Poplar box with minor Brigalow	Nil microrelief Semi disturbance Nil erosion	Firm to hard setting <1% coarse fragments < 5mm	A11 0.00-0.09 Abrupt	Silty clay	Weak, firm, sub- angular <10mm	Nil	10YR4/3 Brown Nil mottles / bleaching	Dry, Well	Common	0.05 / 7.5	Nil	Nil
				A12 0.09-0.23 Abrupt	Silty clay	Weak, firm, sub- angular <15mm	Nil	10YR4/3 Brown Nil mottles / bleaching	Dry, Well	Common	0.15 / 7.5		
				B21 0.23-0.41 Abrupt	Silty clay loam	Moderate, firm, sub-angular 10- 20mm	Nil	10YR4/3 Brown Nil mottles / bleaching	Dry, Well to moderate	Common	0.30 / 7.5

B22 0.41-0.53 Abrupt	Silty clay loam	Moderate, firm, sub-angular 10- 20mm	<1% calcium carbonate	10YR3/2 Very dark greyish brown Nil mottles / bleaching	Dry, Well to moderate	Few	0.45 / 8.0		
				B23 0.53-1.05 Abrupt	Light clay	Moderate, firm, sub-angular 10- 20mm	<2% calcium carbonate	10YR4/3 Brown Nil mottles / bleaching	Dry, Moderate	Few	0.60 / 8.0		
				B3 1.05-1.50 EOBH	Silty loam	Massive, weak	Nil	5YR3/3 Dark reddish brown Nil mottles / bleaching	Dry, Moderate	Nil	1.20 / 7.0

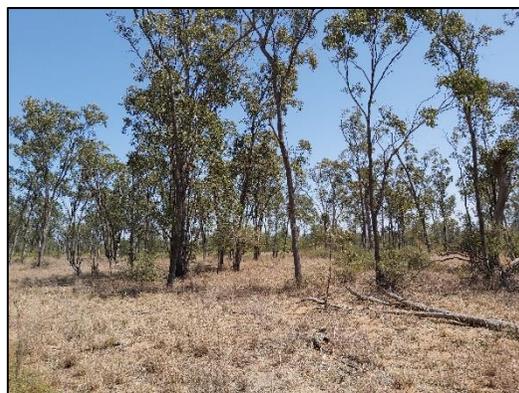
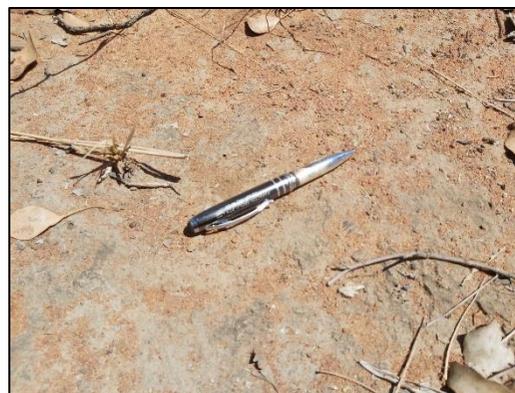
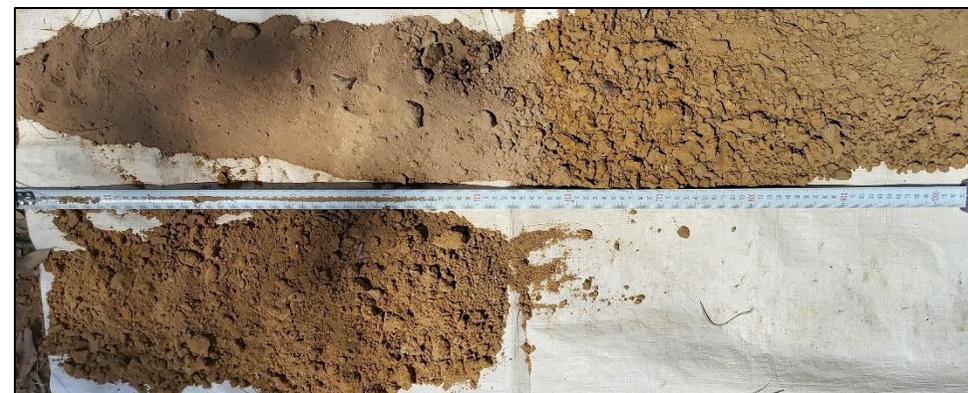
# SITE 80

<b>Soil Mapping Unit:</b> S1	<b>Location (GDA94 ZONE 55):</b> 627902 7541799	<b>Australian Soil Class:</b> Brown Sodosol	<b>Site Survey Type:</b> Detailed Hand Auger 50mm	<b>Survey Date:</b> 15/10/2019
---------------------------------	--	--	--	-----------------------------------

Land use Landform Pattern, Element, Slope	Vegetation	Microrelief Disturbance Erosion	Surface condition, surface rock	Soil Profile Description									
				Horizon Depth (m), Boundary	Field Texture	Structure, Strength	Inclusions Segregations	Colour, Mottle, Bleaching	Moisture, Drainage	Roots	Depth (m) / Field pH	Sample (m)	Observations
Grazing Flat plain	Tall woodlands including poplar box	Nil microrelief Nil disturbance Nil erosion	Hard setting Nil coarse fragments	A11 0.00-0.10 Abrupt	Clayey Sand	Massive, weak	Nil	10YR3/3 Dark brown Nil mottles / bleaching	Dry, Well	Common	0.10 / 6.0	Nil	Nil
				A12 0.10-0.45 Abrupt	Clayey Sand	Massive, weak	Nil	10YR4/4 Dark yellowish brown Nil mottles / bleaching	Dry, Well to moderate	Few	0.30 / 6.0		
				B21 0.45-0.90 Abrupt	Sandy clay loam	Moderate, firm 5- 20mm	<1% coarse fragments <5mm	10YR4/6 Dark yellowish brown Nil mottles / bleaching	Dry, Well to moderate	Nil	0.60 / 7.5

B22 0.90-1.50 EOBH	Sandy clay loam	Weak, weak	Nil	10YR4/6 Dark yellowish brown Nil mottles / bleaching	Dry, Moderate	Nil	1.20 / 7.5

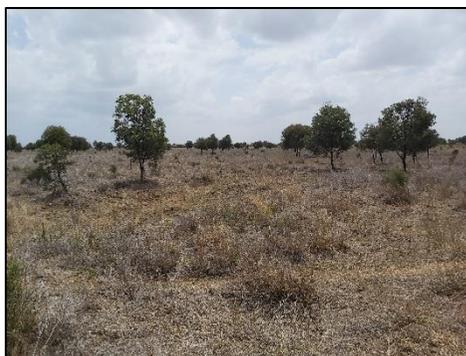
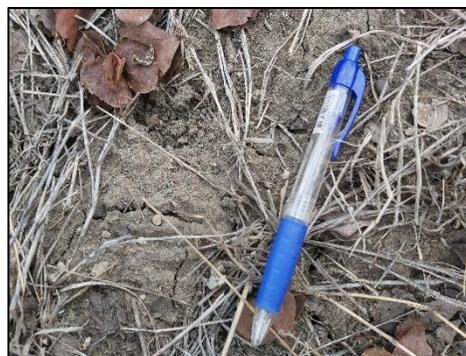
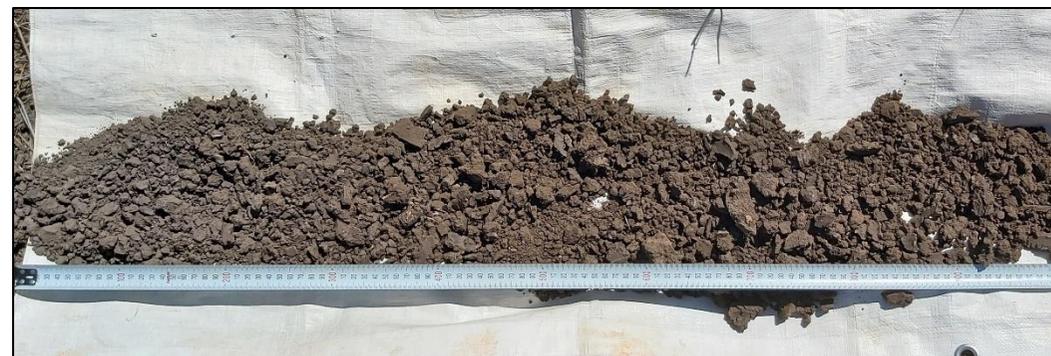
<b>Soil Mapping Unit:</b> C3-BL	<b>Location (GDA94 ZONE 55):</b> 629586 7542707	<b>Australian Soil Class:</b> Black Vertosol	<b>Site Survey Type:</b> Detailed Hand Auger 50mm	<b>Survey Date:</b> 15/10/2019
------------------------------------	--	---	--	-----------------------------------

Land use Landform Pattern, Element, Slope	Vegetation	Microrelief Disturbance Erosion	Surface condition, surface rock	Soil Profile Description									
				Horizon Depth (m), Boundary	Field Texture	Structure, Strength	Inclusions Segregations	Colour, Mottle, Bleaching	Moisture, Drainage	Roots	Depth (m) / Field pH	Sample (m)	Observations
Grazing, gently undulating plain, simple mid slope 1- 2%	Softwood scrub mixed vegetation	Nil microrelief Semi disturbed Nil erosion	Firm, cracking with crust, white nodules <1%	A1 0.00-0.11 Abrupt	Light clay	Weak, very firm, sub-rounded peds <10mm	Nil	10YR3/2 Very dark greyish brown Nil mottles / bleaching	Dry, well drained	Common	0.05 / 6.5	Nil	Nil
				B21 0.11-0.70 Abrupt	Light medium clay	Moderate, very firm	<2% calcium carbonate	10YR3/1 Very dark grey Nil mottles / bleaching	Dry, well drained	Few	0.30 / 7.0 0.60 / 7.0		
				B22 0.70-1.00 EOBH	Light medium clay	Moderate, very firm	Nil	10YR4/1 Dark grey Nil mottles / bleaching	Dry, moderately well drained	Few	0.90 / 7.0
