# Appendix J

Soils and Land Suitability  
Assessment

## WINCHESTER SOUTH PROJECT Environmental Impact Statement

# Soils and Land Suitability Assessment

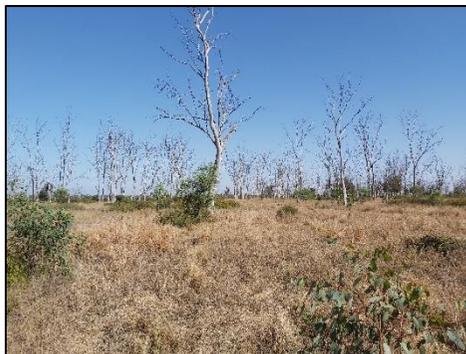
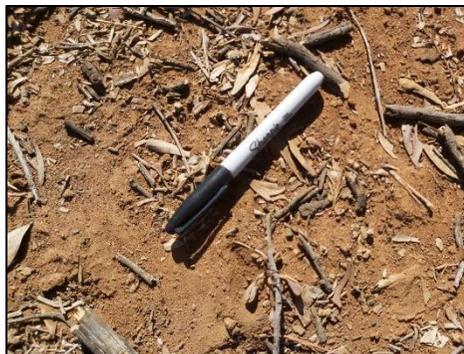
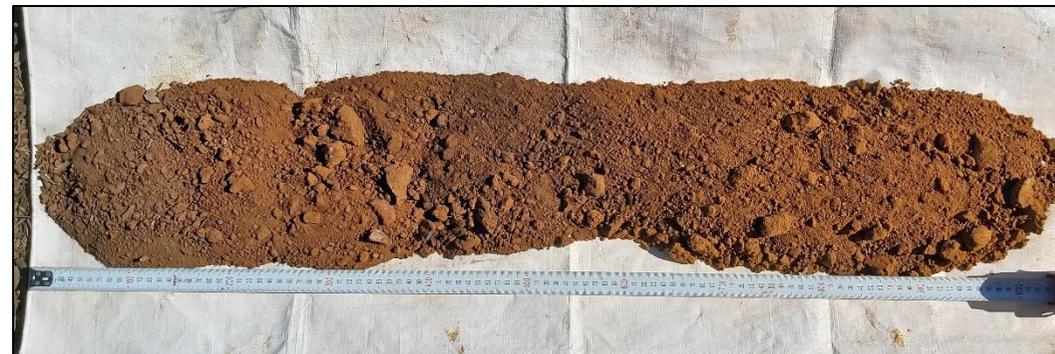
## SITE 82

<b>Soil Mapping Unit:</b> T2	<b>Location (GDA94 ZONE 55):</b> 630200 7541015	<b>Australian Soil Class:</b> Red Kandosol	<b>Site Survey Type:</b> Detailed Hand Auger 50mm	<b>Survey Date:</b> 15/10/2019
---------------------------------	--	---	--	-----------------------------------

Land use Landform Pattern, Element, Slope	Vegetation	Microrelief Disturbance Erosion	Surface condition, surface rock	Soil Profile Description									
				Horizon Depth (m), Boundary	Field Texture	Structure, Strength	Inclusions Segregations	Colour, Mottle, Bleaching	Moisture, Drainage	Roots	Depth (m) / Field pH	Sample (m)	Observations
Grazing, gently undulating plain, upper slope 1-2%	Tall woodlands	Nil microrelief Semi disturbance Nil erosion	Firm, Nil coarse fragments	A1 0.00-0.10 Abrupt	Clayey sand	Massive, loose	<2% coarse fragments <1mm	7.5YR3/2 Dark brown Nil mottles / bleaching	Dry, rapid	Common	-	Nil	Nil
				B21 0.10-0.38 Abrupt	Sandy clay loam	Weak, weak, sub- angular <20mm	Nil	7.5YR3/4 Dark brown Nil mottles / bleaching	Dry, well	Common	-		
				B22 0.38-0.68 Abrupt	Medium clay	Weak, weak, sub- angular <20mm	Nil	7.5YR3/3 Dark brown Nil mottles / bleaching	Dry, well	Few	-		
				B22 0.68-1.00 EOBH	Medium clay	Weak, weak, sub- angular <20mm	Nil	7.5YR4/4 Brown Nil mottles / bleaching	Dry, well	Nil	-

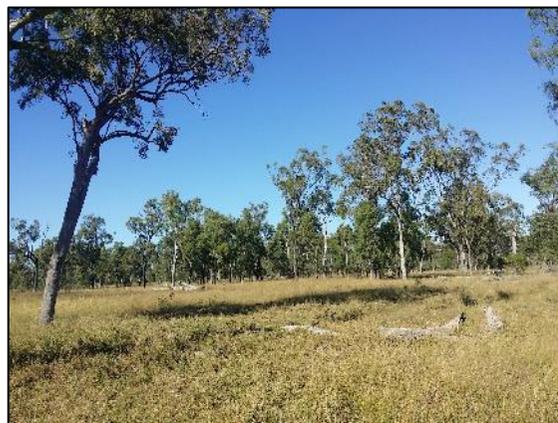
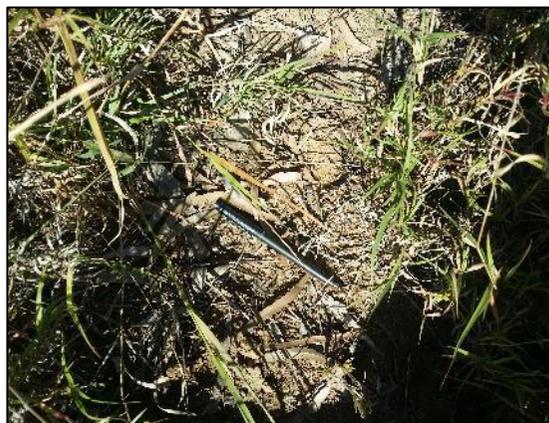
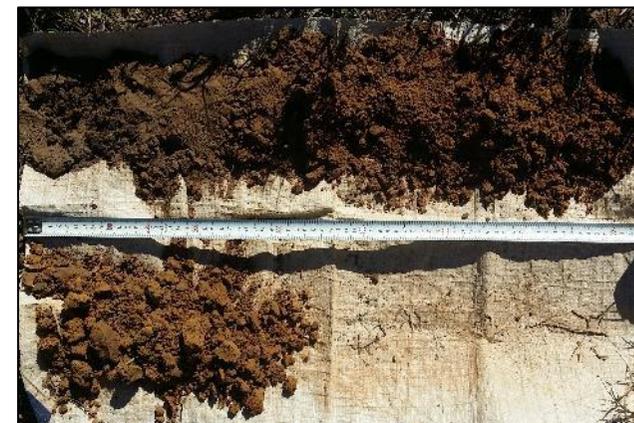
### SITE OD-15

<b>Soil Mapping Unit:</b> S1	<b>CSIRO Land Systems (Gunn et al 1967):</b> Somersby, Monteagle, Connors, Humboldt, Blackwater	<b>Location (GDA ZONE 55):</b> 639357 mE 7545231 mN	<b>Aust. Soil Class. :</b> Brown Sodosol	<b>Site Survey Type:</b> Detailed - 50mm hand auger	<b>Survey Date:</b> 20/6/2017
---------------------------------	--	--	---	--	----------------------------------

Land use Landform Pattern, Element, Slope	Natural Vegetation	Microrelief Disturbance Erosion	Surface condition, surface rock	Soil Profile Description									
				Horizon Depth (m), Boundary	Texture	Structure, Strength	Inclusions Segregations	Colour, Mottle	Moisture, Drainage	Roots	Depth (m) / Field pH	Sample (m)	Observations
Grazing, very gently undulating plains, 1%	Very Sparse, Moreton Bay Ash, Blackbutt	Semi cleared	Firm, nil coarse fragments	A11 0.0 – 0.22 Abrupt	Loamy sand	Massive, loose	Nil	10YR3/2 Very dark greyish brown Nil mottles / bleaching	Dry, rapid	Few, very fine	0.1 / 6.5	No samples taken	No additional observations
				A12 0.22 – 0.7 Abrupt	Clayey sand	Weak subangular peds 20mm, weak	Nil	10YR4/4 Dark yellowish brown Nil mottles / bleaching	Humid, well drained	Few, very fine	0.3 / 7.0 0.6 / 7.0		
				B2 0.7 – 1.0	Sandy clay loam	Weak subangular peds 40mm, weak	2% coarse fragments, 2- 10mm	7.5YR4/4 Brown Brown Mottle: 2.5YR4/6 Red Red Nil bleaching	Dry, imperfectly drained	Nil	0.9 / 7.0

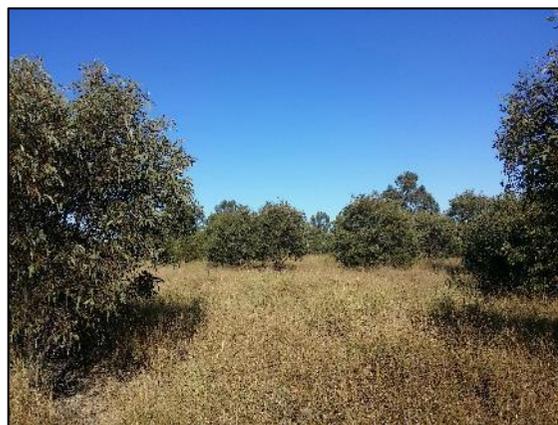
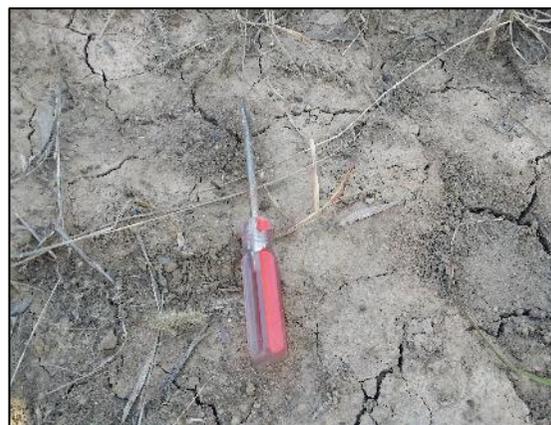
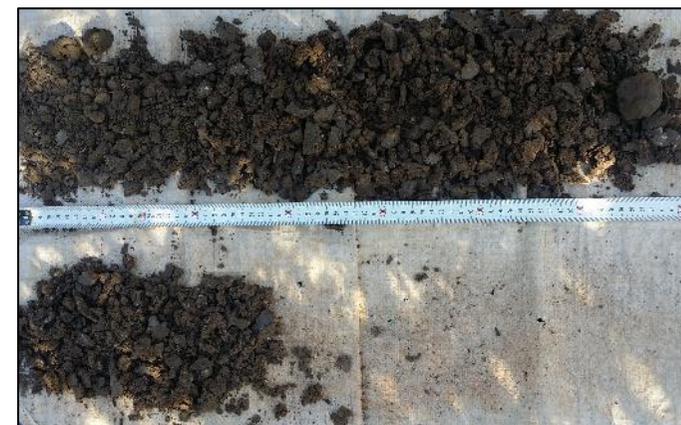
### SITE OD-26a

<b>Soil Mapping Unit:</b> C2 - C1-BR interfingering with C1-BL	<b>CSIRO Land Systems (Gunn et al 1967):</b> Someryby, Monteagle, Connors, Humboldt, Blackwater, Junee	<b>Location (GDA ZONE 55):</b> 640146 mE 7543555 mN	<b>Aust. Soil Class. :</b> Brown Vertosol	<b>Site Survey Type:</b> Detailed - 50mm hand auger	<b>Survey Date:</b> 22/6/2017
--	--	--	--	--	----------------------------------

Land use Landform Pattern, Element, Slope	Natural Vegetation	Microrelief Disturbance Erosion	Surface condition, surface rock	Soil Profile Description									
				Horizon Depth (m), Boundary	Texture	Structure, Strength	Inclusions Segregations	Colour, Mottle	Moisture, Drainage	Roots	Depth (m) / Field pH	Sample (m)	Observations
Grazing, very gently undulating plain, <1% slope	Tall Brigalow and Brigalow regrowth, semi sparse, limited clearing 20- 30% coverage	Normal gilgai, 30% coverage, <0.3m deep	Cracking, crust 5% coarse fragments <5mm	A1 0.00 – 0.19 Abrupt	Light medium clay	Weak, <10mm peds, subangular, strength- firm	2% coarse fragments	10YR4/2 Dark greyish brown Nil mottles / bleaching	Dry, well drained	Nil	0.00 / 6.5	0.00 – 0.10 0.30 – 0.40 0.60 – 0.70 0.90 – 1.00	Site located in gilgai depression
				B2 0.19 – 1.00	Medium clay	Strong structure <20mm, very firm strength	<2% black nodules <5mm <1% calcium carbonate	10YR4/3 Brown Nil mottles / bleaching	Dry, well drained	Nil	0.30 / 6.5 0.60 / 7.0 0.90 / 7.0

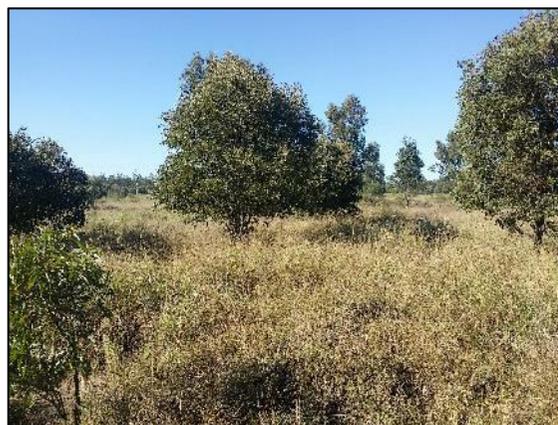
### SITE OD-26b

<b>Soil Mapping Unit:</b> C2 - C1-BR interfingering with C1-BL	<b>CSIRO Land Systems (Gunn et al 1967):</b> Somerby, Monteagle, Connors, Humboldt, Blackwater, Junee	<b>Location (GDA ZONE 55):</b> 640146 mE 7543555 mN	<b>Aust. Soil Class. :</b> Brown Vertosol	<b>Site Survey Type:</b> Detailed - 50mm hand auger	<b>Survey Date:</b> 22/6/2017
--	---	--	--	--	----------------------------------

Land use Landform Pattern, Element, Slope	Natural Vegetation	Microrelief Disturbance Erosion	Surface condition, surface rock	Soil Profile Description									
				Horizon Depth (m), Boundary	Texture	Structure, Strength	Inclusions Segregations	Colour, Mottle	Moisture, Drainage	Roots	Depth (m) / Field pH	Sample (m)	Observations
Grazing, very gently undulating plain, <1% slope	Tall Brigalow and Brigalow regrowth, semi sparse, limited clearing 20- 30% coverage	Normal gilgai, 30% coverage, <0.3m deep	Crust, 5% coarse fragments <5mm	A1 0.00 – 0.25 Abrupt	Light medium clay	Moderate, <10mm peds, subangular, strength- firm	2% coarse fragments	10YR4/2 Dark greyish brown Nil mottles / bleaching	Dry, well drained	Nil	0.00 / 6.5	0.00 – 0.10	Site located on gilgai mound
				B2 0.25 – 1.00	Medium clay	Strong structure <20mm, very firm strength	<2% black nodules <5mm <1% calcium carbonate	10YR4/3 Brown Nil mottles / bleaching	Dry, well drained	Nil	0.30 / 7.0 0.60 / 7.0 0.90 / 7.0

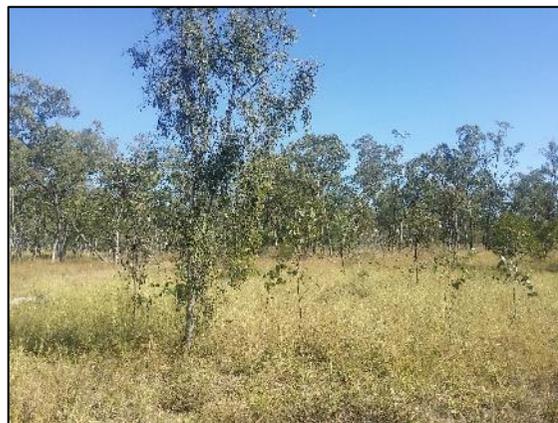
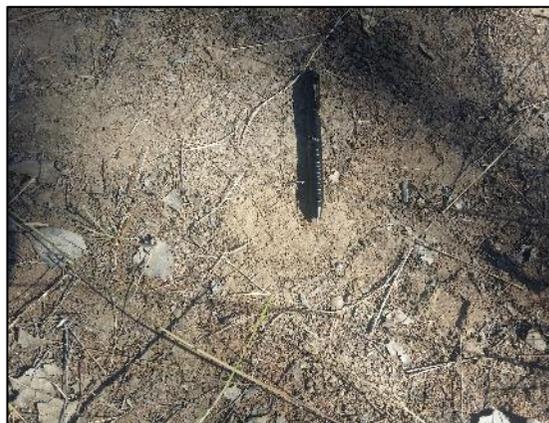
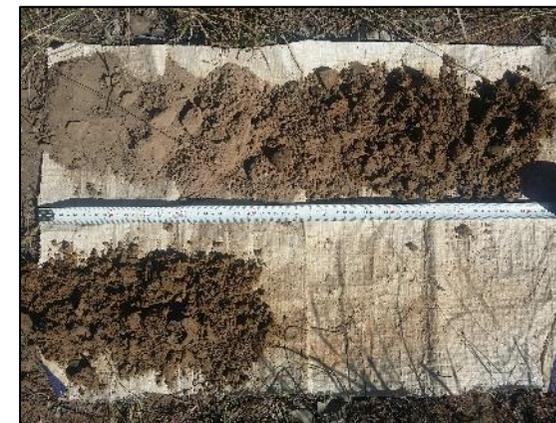
### SITE OD-28

<b>Soil Mapping Unit:</b> B1 interfingering / grading with S1	<b>CSIRO Land Systems (Gunn et al 1967):</b> Somersby, Monteagle, Humboldt	<b>Location (GDA ZONE 55):</b> 639637 mE 7542190 mN	<b>Aust. Soil Class. :</b> Subnatric Brown Sodosol	<b>Site Survey Type:</b> Detailed - 50mm hand auger	<b>Survey Date:</b> 22/6/2017
--	---	--	---	--	----------------------------------

Land use Landform Pattern, Element, Slope	Natural Vegetation	Microrelief Disturbance Erosion	Surface condition, surface rock	Soil Profile Description									
				Horizon Depth (m), Boundary	Texture	Structure, Strength	Inclusions Segregations	Colour, Mottle	Moisture, Drainage	Roots	Depth (m) / Field pH	Sample (m)	Observations
Grazing, very gently undulating plain, mid slope 1-2%	Ironbark, Poplar Box, Moreton Bay Ash	Nil	Hard setting, <5% coarse fragments <10mm	A11 0.00 – 0.30 Diffuse	Loamy sand	Massive, loose	Nil	10YR3/2 Very dark greyish brown Nil mottles / bleaching	Dry, rapid	Few, very fine	0.10 / 6.5	No samples taken	No additional observations
				A12 0.30 – 0.55 Clear	Loamy sand	Weak 0- 10mm peds subangular, Weak	<2% black/white nodules	10YR4/2 Dark greyish brown Nil mottles / bleaching	Dry, well drained	Nil	0.30 / 6.5		
				B21 0.55 – 1.00	Silty clay loam	Weak subangular, Moderate 6-10mm peds	<2% manganese nodules	10YR4/4 Dark yellowish brown Nil mottles / bleaching	Dry, well drained	Nil	0.60 / 7.0 0.90 / 7.0

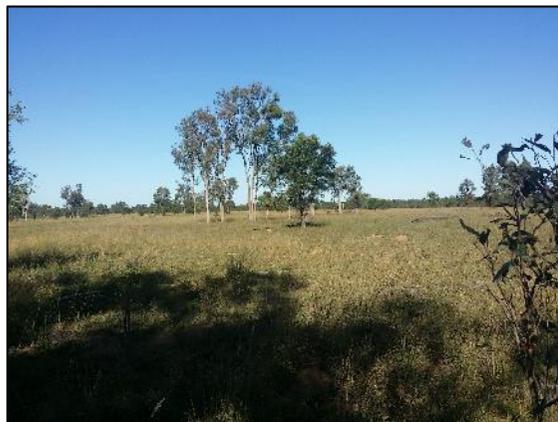
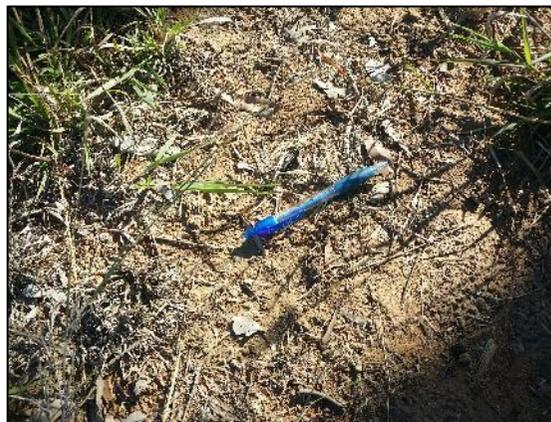
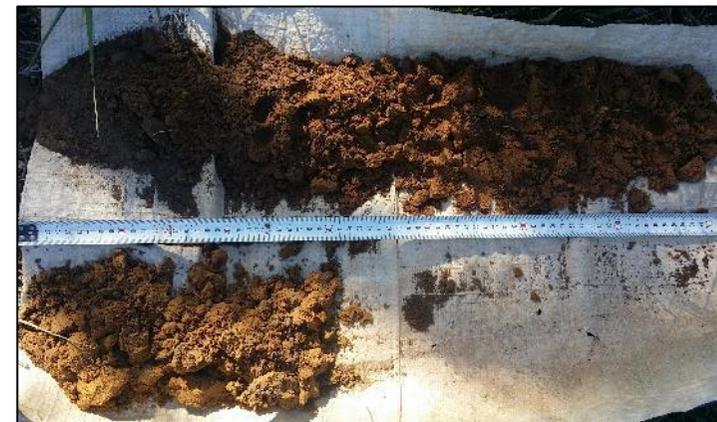
### SITE OD-31

<b>Soil Mapping Unit:</b> S2 grading into S4	<b>CSIRO Land Systems (Gunn et al 1967):</b> Somery, Monteagle, Connors, Humboldt, Blackwater	<b>Location (GDA ZONE 55):</b> 639834 mE 7541276 mN	<b>Aust. Soil Class. :</b> Haplic Brown Dermosol	<b>Site Survey Type:</b> Detailed - 50mm hand auger	<b>Survey Date:</b> 22/6/2017
---	---	--	---	--	----------------------------------

Land use Landform Pattern, Element, Slope	Natural Vegetation	Microrelief Disturbance Erosion	Surface condition, surface rock	Soil Profile Description									
				Horizon Depth (m), Boundary	Texture	Structure, Strength	Inclusions Segregations	Colour, Mottle	Moisture, Drainage	Roots	Depth (m) / Field pH	Sample (m)	Observations
Grazing, gently undulating plain, upper slope 1.5%	Very sparse Blackbutt and Ironbark	Extensive clearing	Firm, nil coarse fragments	A1 0.00 – 0.13 Abrupt	Clayey sand	Weak, peds 2-10mm, weak	Nil	10YR3/3 Dark brown Nil mottles / bleaching	Dry, rapid	Few, very fine	0.00 / 7.0	No samples taken	No additional observations
				B21 0.13 – 0.37 Clear	Loamy sand	Weak subangular peds 5- 20mm, weak	Nil	10YR4/3 Brown Nil mottles / bleaching	Dry, rapid	Nil	0.30 / 7.0		
				B22 0.37 – 1.00	Loamy sand	Weak subangular peds 10- 30mm, weak	<2% Coarse fragments 2- 5mm and red nodules	10YR4/4 Dark yellowish brown Nil mottles / bleaching	Moderately moist, rapid	Nil	0.60 / 7.0 0.90 / 7.0

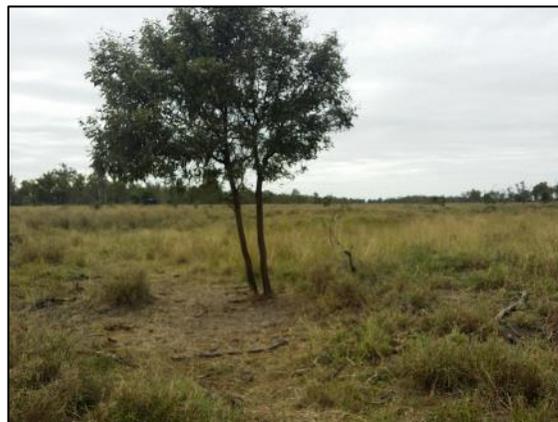
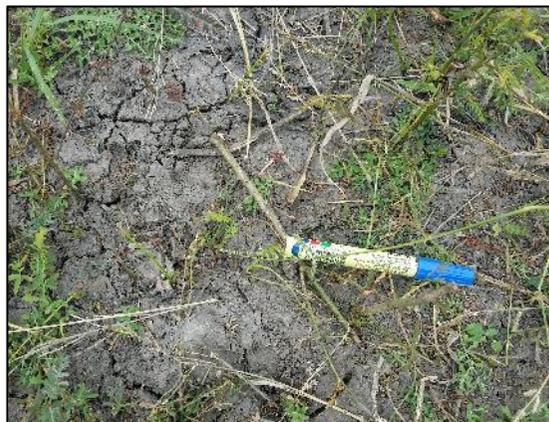
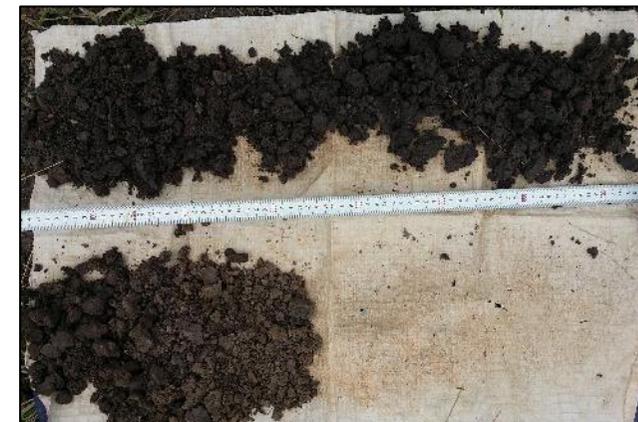
### SITE OD-34

<b>Soil Mapping Unit:</b> C2, grading into C3-BL	<b>CSIRO Land Systems (Gunn et al 1967):</b> Someryby, Monteagle, Connors, Humboldt, Blackwater, Junee	<b>Location (GDA ZONE 55):</b> 639343 mE 7540015 mN	<b>Aust. Soil Class. :</b> Brown Vertosol	<b>Site Survey Type:</b> Detailed - 50mm hand auger	<b>Survey Date:</b> 23/6/2017
---	---	--	--	--	----------------------------------

Land use Landform Pattern, Element, Slope	Natural Vegetation	Microrelief Disturbance Erosion	Surface condition, surface rock	Soil Profile Description									
				Horizon Depth (m), Boundary	Texture	Structure, Strength	Inclusions Segregations	Colour, Mottle	Moisture, Drainage	Roots	Depth (m) / Field pH	Sample (m)	Observations
Grazing, mid slope, very gently undulating plain, 1.5%	Brigalow regrowth	Extensive clearing, previously blade ploughed	Hard setting, cracking – fine to moderate cracks, <5% coarse fragments 2-4mm	A1 0.00 – 0.18 Clear	Light clay	Weak angular peds <10mm, firm	<2% coarse fragments 2-6mm	10YR3/1 Very dark grey Nil mottles / bleaching	Humid – moderately moist, well drained	Very fine, few	0.00 / 6.5	0.00 – 0.10 0.30 – 0.40 0.60 – 0.70 0.90 – 1.00	No additional observations
				B21 0.18 – 0.70 Diffuse	Medium clay	Moderate angular peds <20mm, firm	<5% coarse fragments 2-6mm and black nodules	10YR3/1 Very dark grey Nil mottles / bleaching	Moderately moist, well drained	Very fine, few	0.30 / 6.5

B22 0.70 – 0.81 Abrupt	Medium clay	Moderate angular peds <20mm, firm	Nil	10YR3/2 Very dark greyish brown Nil mottles / bleaching	Moderately moist, well to moderately drained	Nil	0.60 / 7.0

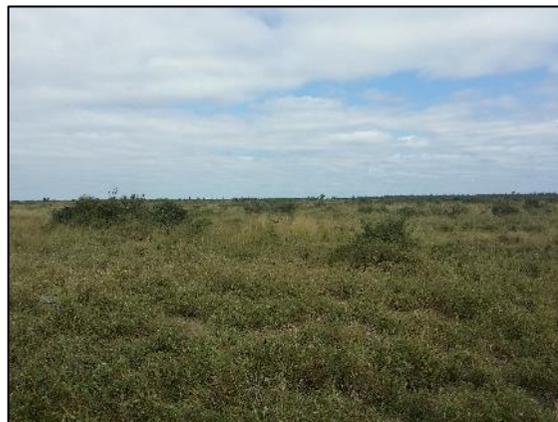
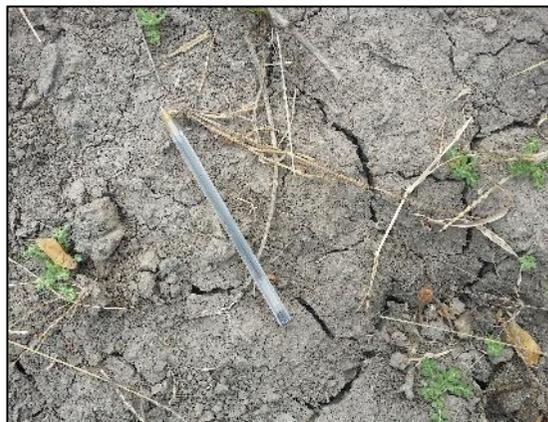
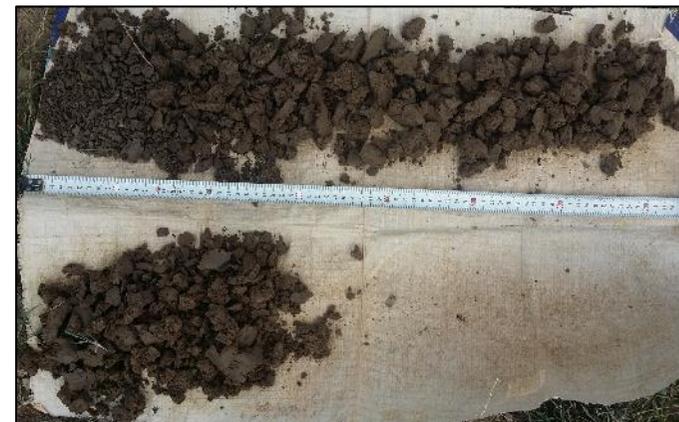
<b>Soil Mapping Unit:</b> C2, grading into C3-BL	<b>CSIRO Land Systems (Gunn et al 1967):</b> Sommerby, Monteagle, Connors, Humboldt, Blackwater, Junee	<b>Location (GDA ZONE 55):</b> 636346 mE 7538814 mN	<b>Aust. Soil Class. :</b> Brown Vertosol	<b>Site Survey Type:</b> Detailed - 50mm hand auger	<b>Survey Date:</b> 12/7/2017
---	---	--	--	--	----------------------------------

Land use Landform Pattern, Element, Slope	Natural Vegetation	Microrelief Disturbance Erosion	Surface condition, surface rock	Soil Profile Description									
				Horizon Depth (m), Boundary	Texture	Structure, Strength	Inclusions Segregations	Colour, Mottle	Moisture, Drainage	Roots	Depth (m) / Field pH	Sample (m)	Observations
Grazing, gently undulating plains, upper slope, 1.0%	Regrowth, shrubs	Shallow gilgai, Extensive clearing	Cracking, Nil coarse fragments	A1 0.00-0.10 Abrupt	Light clay	Weak, firm, <10mm sub- angular	Nil	10YR3/2 Very dark greyish brown Nil mottles / bleaching	Dry, well drained	Few, very fine	0.10 / 6.5	No samples taken	No additional observations
				B2 0.10-1.00	Light clay	Moderate, firm, <20mm sub- angular	Nil	10YR3/1 Very dark grey Nil mottles / bleaching	Dry, well drained	Very few, very fine	0.30 / 6.5 0.60 / 6.0 0.90 / 6.0

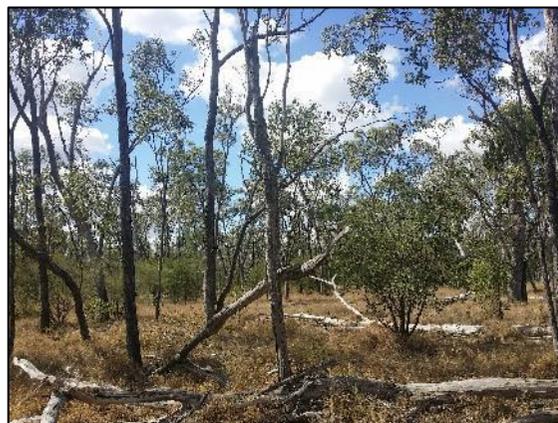
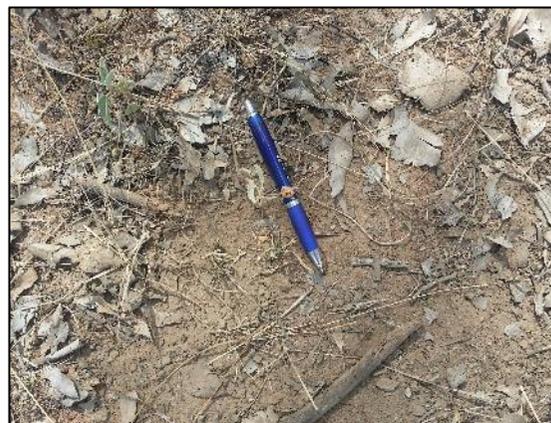
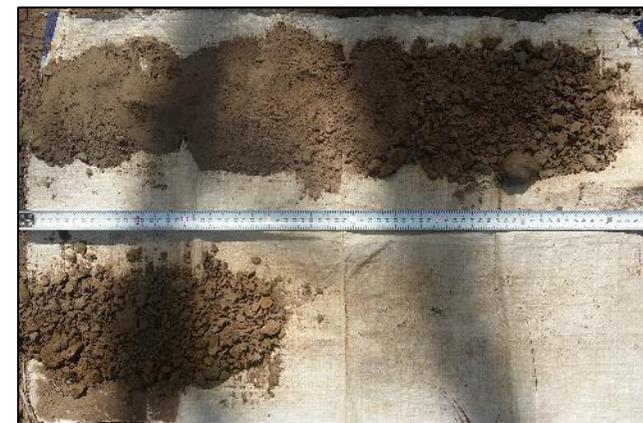
### SITE OD-170

<b>Soil Mapping Unit:</b> S1	<b>CSIRO Land Systems (Gunn et al 1967):</b> Someryby, Monteagle, Connors, Humboldt, Blackwater	<b>Location (GDA ZONE 55):</b> 637680 mE 7547045 mN	<b>Aust. Soil Class. :</b> Brown Sodosol	<b>Site Survey Type:</b> Detailed - 50mm hand auger	<b>Survey Date:</b> 4/8/2017
---------------------------------	---	--	---	--	---------------------------------

Land use Landform Pattern, Element, Slope	Natural Vegetation	Microrelief Disturbance Erosion	Surface condition, surface rock	Soil Profile Description									
				Horizon Depth (m), Boundary	Texture	Structure, Strength	Inclusions Segregations	Colour, Mottle	Moisture, Drainage	Roots	Depth (m) / Field pH	Sample (m)	Observations
Grazing, Gently undulating plain, mid- slope 1.0%	Poplar box, minor Ironbark	Nil	Soft to firm, nil coarse fragments	A1 0.00-0.38 Diffuse	Loamy sand	Massive, weak	Nil	10YR3/3 Dark Nil mottles / bleaching	Dry, rapid	Very fine, very few	0.10 / 6.5 0.30 / 6.5	No samples taken	No additional observations
				B2 0.38-1.00	Clay loam sand	Moderate, angular, 5- 20 weak	<2% coarse fragments 2mm	10YR4/3 Brown Brown Mottle 5% 10YR5/8 Yellowish brown	Dry, well drained	Nil	0.60 / 7.5 0.90 / 7.5

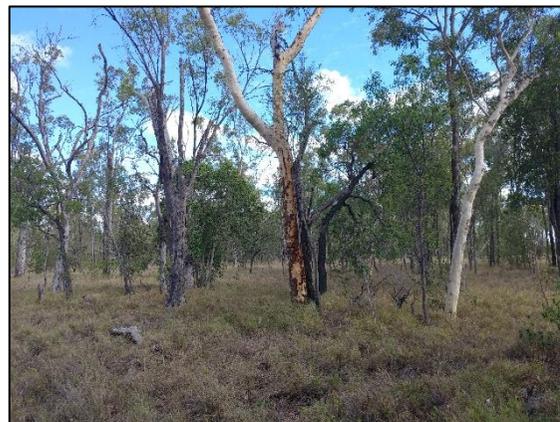
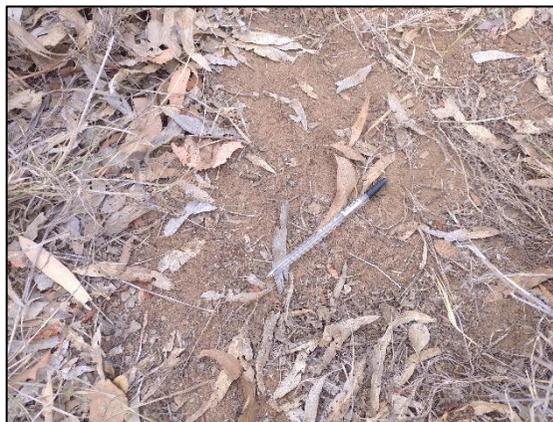
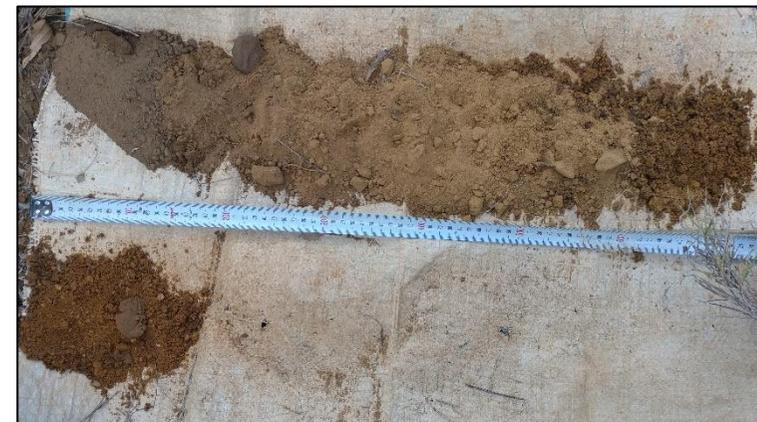
### SITE OD-180

<b>Soil Mapping Unit:</b> S1	<b>CSIRO Land Systems (Gunn et al 1967):</b> Somery, Monteagle, Connors, Humboldt, Blackwater	<b>Location (GDA ZONE 55):</b> 638448 mE 7545811 mN	<b>Aust. Soil Class. :</b> Brown Sodosol	<b>Site Survey Type:</b> Detailed - 50mm hand auger	<b>Survey Date:</b> 25/11/2017
---------------------------------	--	--	---	--	-----------------------------------

Land use Landform Pattern, Element, Slope	Natural Vegetation	Microrelief Disturbance Erosion	Surface condition, surface rock	Soil Profile Description									
				Horizon Depth (m), Boundary	Texture	Structure, Strength	Inclusions Segregations	Colour, Mottle	Moisture, Drainage	Roots	Depth (m) / Field pH	Sample (m)	Observations
Grazing, Gently undulating plain, lower slope <2.0%	Poplar box, minor Eucalypts	Nil	Soft, loose, nil coarse fragments	A11 0.00-0.12 Abrupt	Loamy sand	Massive, weak	Nil	10YR3/2 Very dark greyish brown Nil mottles / bleaching	Dry, rapid	Few, fine	0.10 / 6.5	No samples taken	No additional observations
				A12 0.12-0.32 Abrupt	Loamy sand	Massive, weak	Nil	10YR4/4 Dark yellowish brown Nil mottles / bleaching	Dry, rapid	Few, fine	0.30 / 6.5		
				A13 0.32-0.70 Abrupt	Loamy sand	Massive, weak	Nil	10YR4/6 Dark yellowish brown Nil mottles / bleaching	Dry, rapid	Very few, very fine	0.60 / 6.5

B2 0.70-0.85	Clay loam sandy	Weak, weak, <5mm sub- angular	Nil	10YR4/3 Brown Nil mottles / bleaching	Dry, Well drained	Nil	0.90 / 7.0

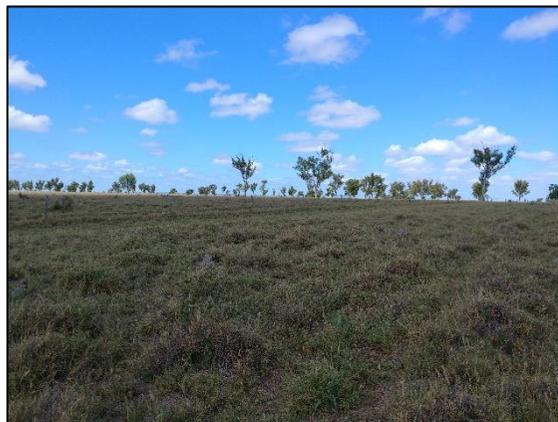
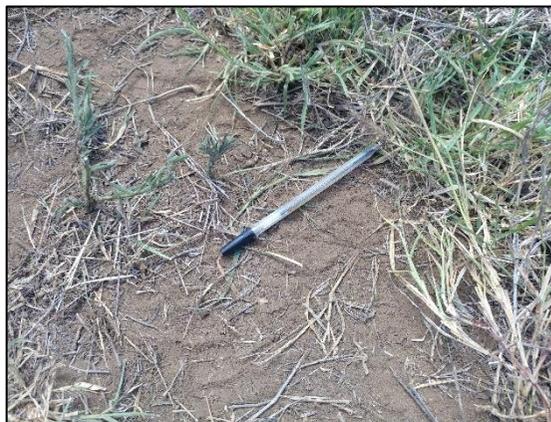
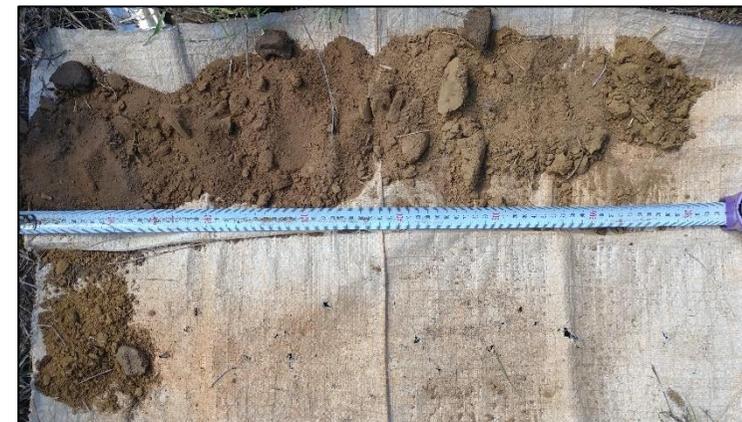
<b>Soil Mapping Unit:</b> S1	<b>CSIRO Land Systems (Gunn et al 1967):</b> Someryby, Monteagle, Connors, Humboldt, Blackwater	<b>Location (GDA ZONE 55):</b> 636937 mE 7547191 mN	<b>Aust. Soil Class. :</b> Brown Sodosol	<b>Site Survey Type:</b> Detailed - 50mm hand auger	<b>Survey Date:</b> 25/11/2017
---------------------------------	---	--	---	--	-----------------------------------

Land use Landform Pattern, Element, Slope	Natural Vegetation	Microrelief Disturbance Erosion	Surface condition, surface rock	Soil Profile Description									
				Horizon Depth (m), Boundary	Texture	Structure, Strength	Inclusions Segregation s	Colour, Mottle	Moisture, Drainage	Roots	Depth (m) / Field pH	Sample (m)	Observations
Grazing, Gently undulating plain, mid-slope <2.0%	Sparse Poplar box	Nil	Firm, nil coarse fragments	A1 0.00-0.10 Abrupt	Loamy sand	Massive, weak	Nil	10YR2/2 Very dark brown Nil mottles / bleaching	Dry, rapid	Very few, very fine	0.10 / 6.0	No samples taken	No recovery from 0.80m
				A2 0.10-0.44 Abrupt	Clayey sands	Massive, weak	Nil	10YR3/3 Dark brown Nil mottles / bleaching	Dry, rapid	Nil	0.30 / 6.5		
				A2 0.47-0.70 Abrupt	Clayey sand	Massive, weak	Nil	10YR4/4 Dark yellowish brown Nil mottles / bleaching	Dry, well drained	Nil	0.60 / 6.5		
				B2 0.70-0.80	Clay loam sand	Weak, weak, <5mm sub- angular	Nil	10YR4/3 Brown Nil mottles / bleaching	Dry, rapid	Nil	0.90 / 7.0

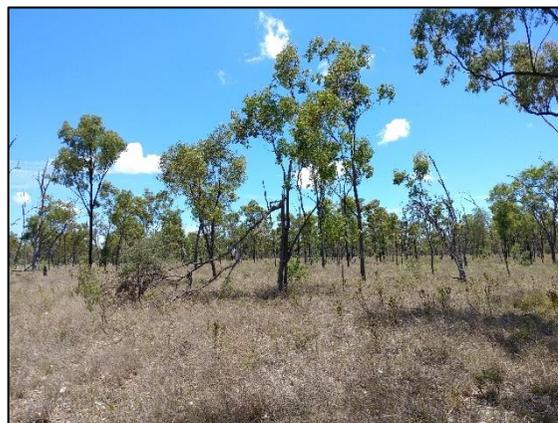
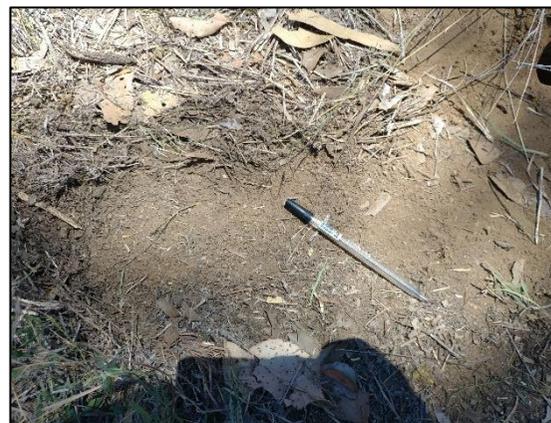
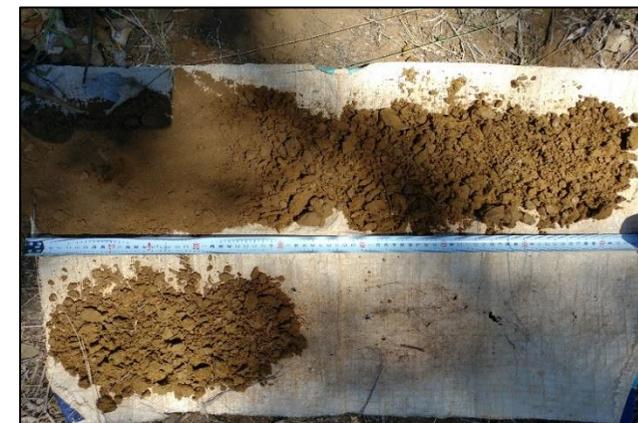
### SITE OD-182

<b>Soil Mapping Unit:</b> S1	<b>CSIRO Land Systems (Gunn et al 1967):</b> Somerby, Monteagle, Connors, Humboldt, Blackwater	<b>Location (GDA ZONE 55):</b> 635944 mE 7548438 mN	<b>Aust. Soil Class. :</b> Brown Sodosol	<b>Site Survey Type:</b> Detailed - 50mm hand auger	<b>Survey Date:</b> 25/11/2017
---------------------------------	---	--	---	--	-----------------------------------

Land use Landform Pattern, Element, Slope	Natural Vegetation	Microrelief Disturbance Erosion	Surface condition, surface rock	Soil Profile Description									
				Horizon Depth (m), Boundary	Texture	Structure, Strength	Inclusions Segregations	Colour, Mottle	Moisture, Drainage	Roots	Depth (m) / Field pH	Sample (m)	Observations
Grazing, Gently undulating plain, lower slope < 1.5%	Poplar box, Ironbark	Semi cleared, No microrelief No Erosion	Soft to firm, nil coarse fragments	A1 0.00-0.27 Abrupt	Loamy sand	Massive, weak	Nil	10YR3/3 Dark brown Nil mottles / bleaching	Dry, rapid	Few, fine	0.10 / 6.0	No samples taken	No additional observations
				B21 0.27-0.86 Abrupt	Clay loam sandy	Moderate, weak <10mm sub- angular	Nil	10YR4/4 Dark yellowish brown Nil mottles / bleaching	Dry, rapid	Nil	0.30 / 6.0 0.60 / 6.5		
				B22 0.86-1.00	Clay loam sandy	Moderate, weak, <10mm sub- angular	<2% calcium carbonate	10YR4/4 Dark yellowish brown Nil mottles / bleaching	Dry, well drained	Nil	0.90 / 7.0

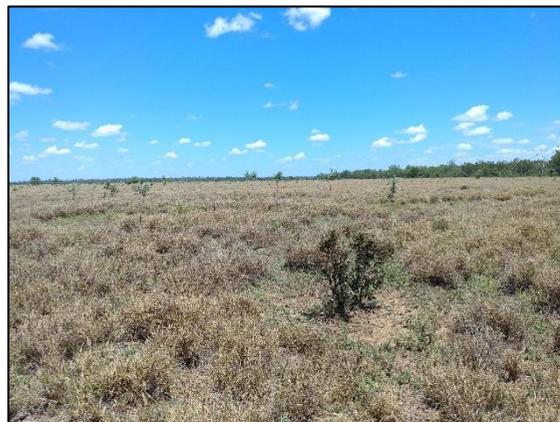
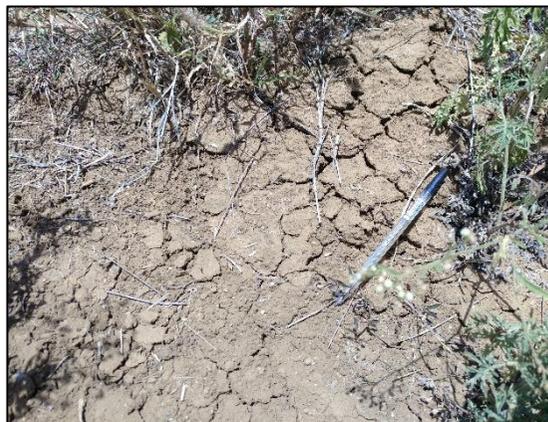
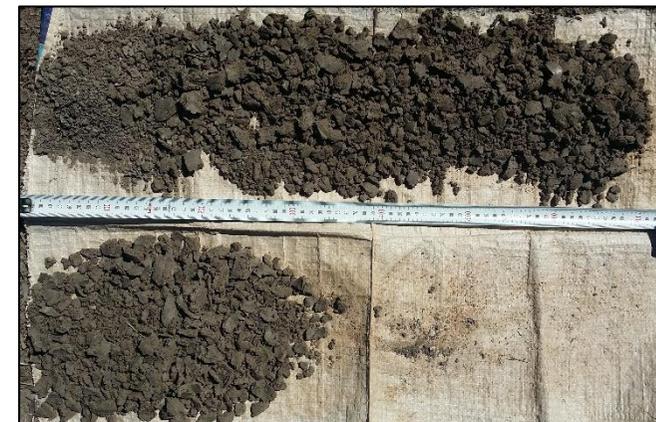
### SITE OD-183

<b>Soil Mapping Unit:</b> C2 grading into C1-BL	<b>CSIRO Land Systems (Gunn et al 1967):</b> Someryby, Monteagle, Connors, Humboldt, Blackwater	<b>Location (GDA ZONE 55):</b> 634838 mE 7549412 mN	<b>Aust. Soil Class. :</b> Brown Vertosol	<b>Site Survey Type:</b> Detailed - 50mm hand auger	<b>Survey Date:</b> 25/11/2017
--	--	--	--	--	-----------------------------------

Land use Landform Pattern, Element, Slope	Natural Vegetation	Microrelief Disturbance Erosion	Surface condition, surface rock	Soil Profile Description									
				Horizon Depth (m), Boundary	Texture	Structure, Strength	Inclusions Segregations	Colour, Mottle	Moisture, Drainage	Roots	Depth (m) / Field pH	Sample (m)	Observations
Grazing, Flat plain <0.5%	Brigalow regrowth	Extensive clearing, Minor normal gilgai <20% coverage 3- 5m wide and <0.30m in depth	Cracking with crust, firm	A1 0.00-0.11 Abrupt	Light clay	Weak, firm, 3-10mm sub- angular	Nil	10YR3/2 Very dark greyish brown Nil mottles / bleaching	Dry, well drained	Very few, very fine	0.10 / 7.0	No samples taken	No additional observations
				B2 0.11-1.00	Light clay	Moderate, firm, 20- 50mm sub- angular	Nil	10YR3/3 Dark brown Nil mottles / bleaching	Dry, well drained	Nil	0.30 / 7.0 0.60 / 7.0 0.90 / 7.0

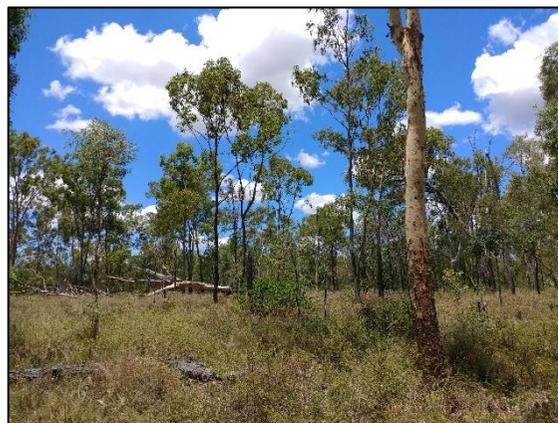
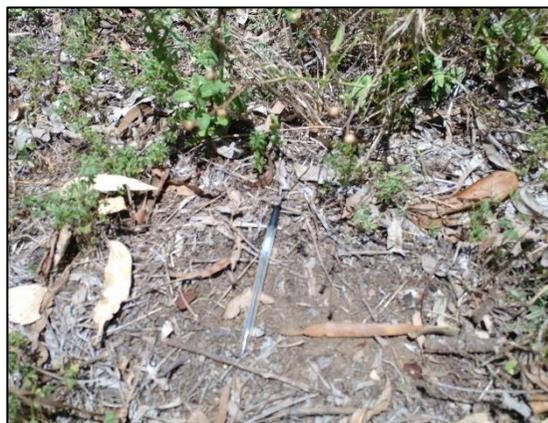
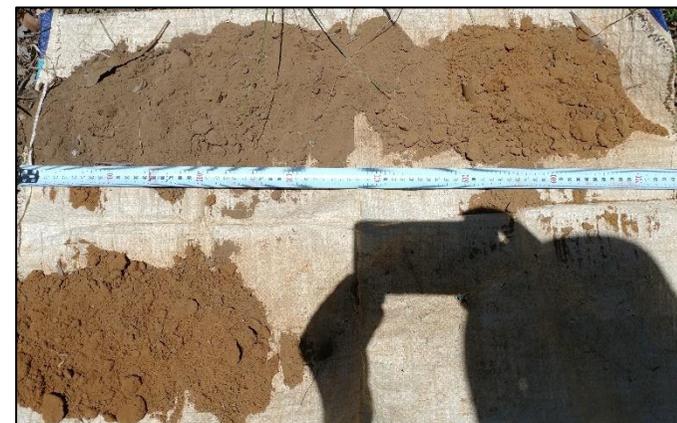
### SITE OD-184

<b>Soil Mapping Unit:</b> S2	<b>CSIRO Land Systems (Gunn et al 1967):</b> Somery, Monteagle, Connors, Humboldt, Blackwater	<b>Location (GDA ZONE 55):</b> 633712 mE 7550670 mN	<b>Aust. Soil Class. :</b> Haplic Brown Dermosol	<b>Site Survey Type:</b> Detailed - 50mm hand auger	<b>Survey Date:</b> 25/11/2017
---------------------------------	---	--	---	--	-----------------------------------

Land use Landform Pattern, Element, Slope	Natural Vegetation	Microrelief Disturbance Erosion	Surface condition, surface rock	Soil Profile Description									
				Horizon Depth (m), Boundary	Texture	Structure, Strength	Inclusions Segregations	Colour, Mottle	Moisture, Drainage	Roots	Depth (m) / Field pH	Sample (m)	Observations
Grazing, Gently undulating plain, lower slope 2.0%	Eucalypts Poplar box, minor Moreton Bay Ash	Nil	Firm, nil coarse fragments	A11 0.00-0.15 Abrupt	Loamy sand	Massive, weak	Nil	10YR3/3 Dark brown Nil mottles / bleaching	Dry, rapid	Very few, very fine	0.10 / 6.0	No samples taken	No additional observations
				A12 0.15-0.50 Abrupt	Loamy sand	Massive, weak	Nil	10YR3/4 Dark yellowish brown Nil mottles / bleaching	Dry, rapid	Very few, very fine	0.30 / 6.0		
				A13 0.50-1.00	Loamy sand	Massive, weak	Nil	10YR3/6 Dark yellowish brown Nil mottles / bleaching	Dry, rapid	Nil	0.60 / 6.0 0.90 / 6.0

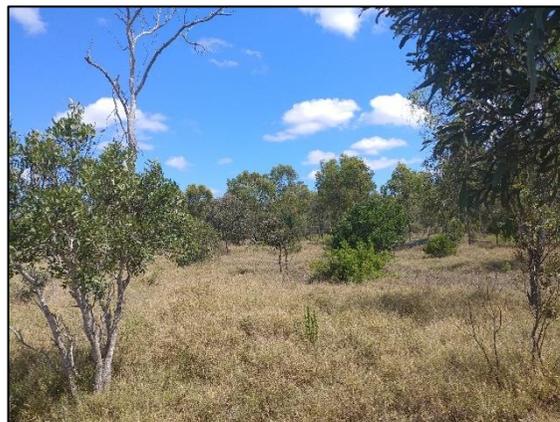
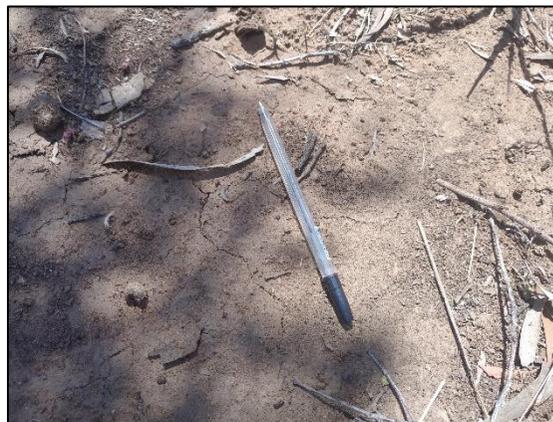
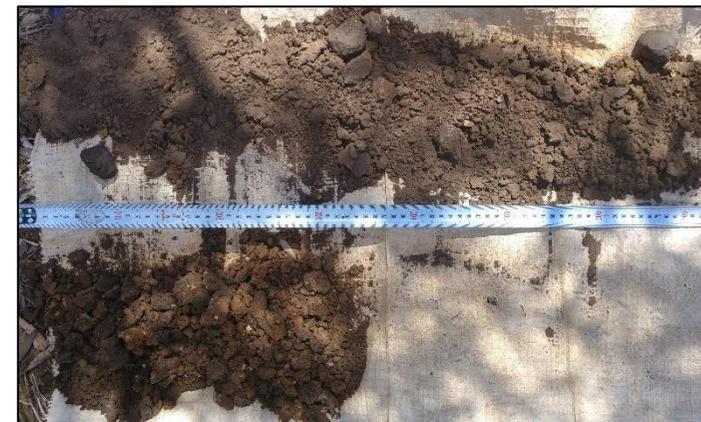
### SITE OD-187

<b>Soil Mapping Unit:</b> B2 grading into T3	<b>CSIRO Land Systems (Gunn et al 1967):</b> Someryby, Monteagle, Connors, Humboldt, Blackwater	<b>Location (GDA ZONE 55):</b> 632756 mE 7551848 mN	<b>Aust. Soil Class. :</b> Mesonatric Grey Sodosol	<b>Site Survey Type:</b> Detailed - 50mm hand auger	<b>Survey Date:</b> 26/11/2017
---	--	--	---	--	-----------------------------------

Land use Landform Pattern, Element, Slope	Natural Vegetation	Microrelief Disturbance Erosion	Surface condition, surface rock	Soil Profile Description									
				Horizon Depth (m), Boundary	Texture	Structure, Strength	Inclusions Segregations	Colour, Mottle	Moisture, Drainage	Roots	Depth (m) / Field pH	Sample (m)	Observations
Grazing, Very gently undulating plain, lower slope <1.0%	Mixed vegetation, Brigalow regrowth and Poplar Box	Nil	Firm to hard setting Nil coarse fragments	A11 0.00-0.10 Abrupt	Silty loam	Weak, weak	Nil	10YR2/2 Very dark brown Nil mottles / bleaching	Dry, rapid	Very few, very fine	0.05 / 6.5	No samples taken	No additional observations
				A12 0.10-0.60 Abrupt	Silty loam	Moderate, weak, 5-20mm	Nil	10YR2/2 Very dark brown Nil mottles / bleaching	Dry, rapid	Very few, very fine	0.30 / 6.5		
				B2 0.60-1.00	Light clay	Firm, sub- angular 10- 30mm	<2% calcium carbonate nodules	10YR2/2 Very dark brown Mottle 10YR3/6 Dark yellowish brown Dark yellowish brown 10-20% Nil bleaching	Dry, Imperfect	Nil	0.60 / 7.0 0.90 / 7.5

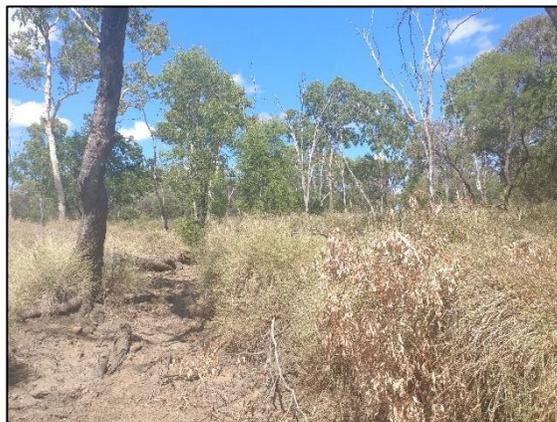
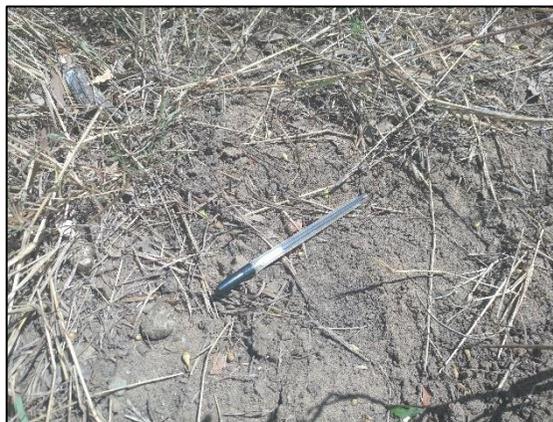
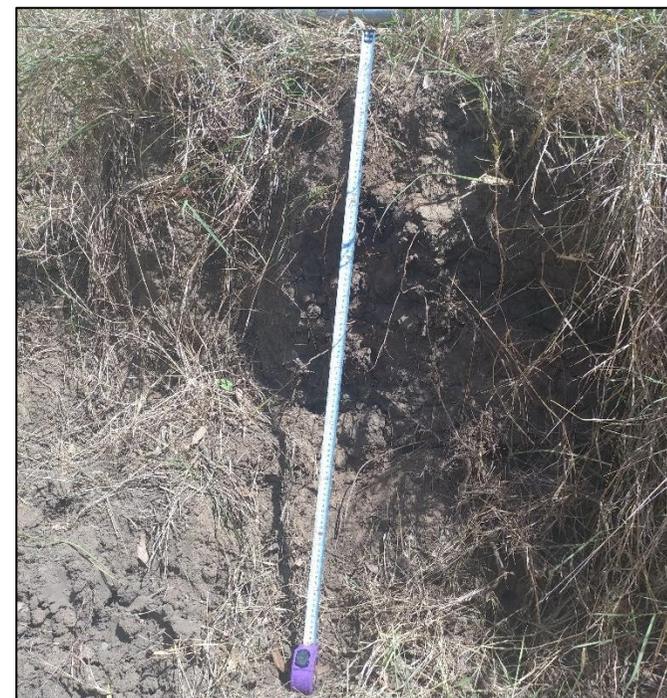
### SITE OD-188

<b>Soil Mapping Unit:</b> S2 grading to S4	<b>CSIRO Land Systems (Gunn et al 1967):</b> Somery, Monteagle, Connors, Humboldt, Blackwater	<b>Location (GDA ZONE 55):</b> 631308 mE 7552792 mN	<b>Aust. Soil Class. :</b> Haplic Brown Dermosol	<b>Site Survey Type:</b> Detailed - 50mm hand auger	<b>Survey Date:</b> 26/11/2017
---	--	--	---	--	-----------------------------------

Land use Landform Pattern, Element, Slope	Natural Vegetation	Microrelief Disturbance Erosion	Surface condition, surface rock	Soil Profile Description									
				Horizon Depth (m), Boundary	Texture	Structure, Strength	Inclusions Segregations	Colour, Mottle	Moisture, Drainage	Roots	Depth (m) / Field pH	Sample (m)	Observations
Grazing, Open Depression	Eucalypts, minor Brigalow	Gully erosion, No microrelief No disturbance	Loose, <5% <5mm coarse fragments	A11 0.00-0.40 Abrupt	Loamy sand	Massive, weak	Nil	10YR2/2 Very dark brown Nil mottles / bleaching	Dry, rapid	Few, fine	0.05 / 6.0	No samples taken	No additional observations
				A12 0.30-1.00 Abrupt	Loamy sand	Massive, weak	<10% coarse fragments <5mm	10YR6/3 Dark brown Nil mottles / bleaching	Dry, rapid	Few, fine	0.30 / 6.0

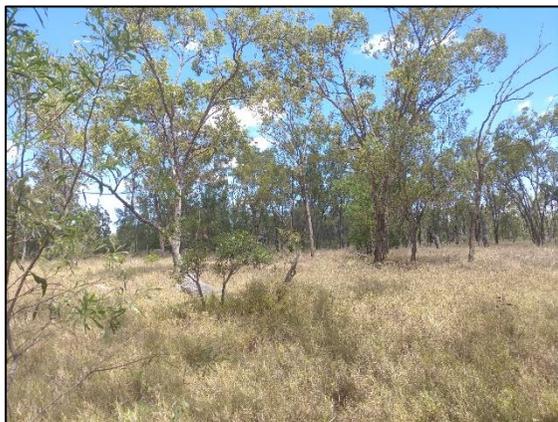
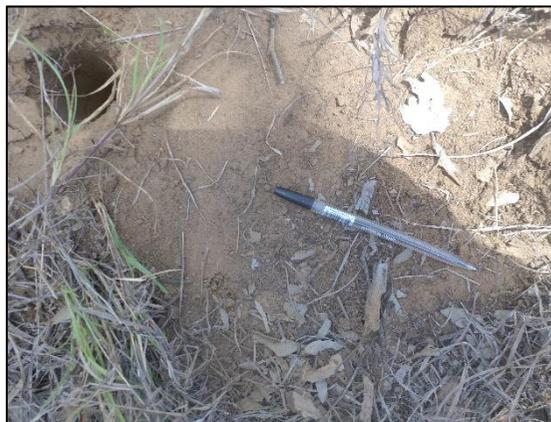
### SITE OD-189

<b>Soil Mapping Unit:</b> S1	<b>CSIRO Land Systems (Gunn et al 1967):</b> Somery, Monteagle, Connors, Humboldt, Blackwater	<b>Location (GDA ZONE 55):</b> 629781 mE 7553506 mN	<b>Aust. Soil Class. :</b> Brown Sodosol	<b>Site Survey Type:</b> Detailed - 50mm hand auger	<b>Survey Date:</b> 26/11/2017
---------------------------------	---	--	---	--	-----------------------------------

Land use Landform Pattern, Element, Slope	Natural Vegetation	Microrelief Disturbance Erosion	Surface condition, surface rock	Soil Profile Description									
				Horizon Depth (m), Boundary	Texture	Structure, Strength	Inclusions Segregations	Colour, Mottle	Moisture, Drainage	Roots	Depth (m) / Field pH	Sample (m)	Observations
Grazing, Very gently undulating plain, lower slope <1.0%	Poplar box	Nil	Firm, Nil coarse fragments	A11 0.00-0.28 Abrupt	Loamy sand	Massive, weak	Nil	10YR3/3 Dark brown Nil mottles / bleaching	Dry, rapid	Few, fine	0.10 / 6.0	No samples taken	No additional observations
				A12 0.28-0.54 Abrupt	Loamy sand	Massive, weak	Nil	7.5YR4/4 Brown Nil mottles / bleaching	Dry, rapid	Very few, fine	0.30 / 6.5		
				B2 0.54-1.00	Clay loam sandy	Moderate, weak, <10mm sub- angular	Nil	7.5YR4/4 Brown Mottle <2% 10YR5/8 Dark yellowish brown Nil bleaching	Dry, Imperfect	Nil	0.60 / 6.5 0.90 / 6.5

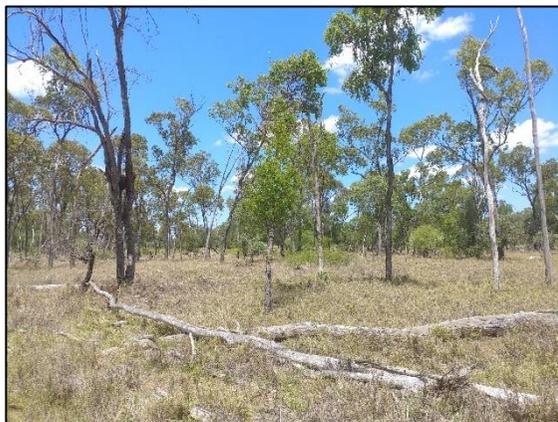
Landscape

### SITE OD-190

<b>Soil Mapping Unit:</b> S1	<b>CSIRO Land Systems (Gunn et al 1967):</b> Somery, Monteagle, Connors, Humboldt, Blackwater	<b>Location (GDA ZONE 55):</b> 627807 mE 7553767 mN	<b>Aust. Soil Class. :</b> Brown Sodosol	<b>Site Survey Type:</b> Detailed - 50mm hand auger	<b>Survey Date:</b> 26/11/2017
---------------------------------	--	--	---	--	-----------------------------------

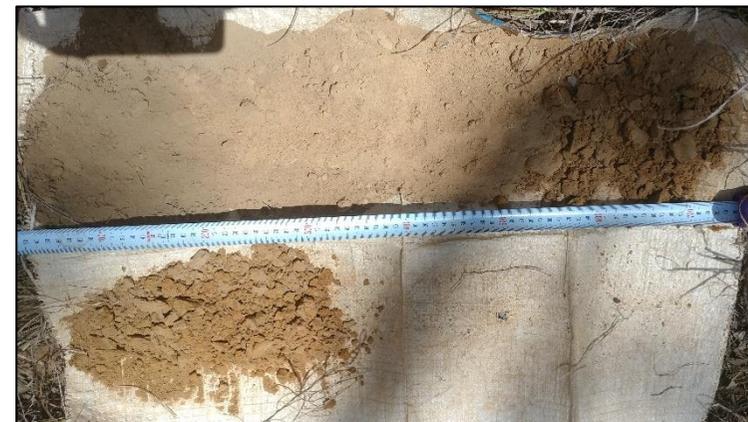
Land use Landform Pattern, Element, Slope	Natural Vegetation	Microrelief Disturbance Erosion	Surface condition, surface rock	Soil Profile Description									
				Horizon Depth (m), Boundary	Texture	Structure, Strength	Inclusions Segregations	Colour, Mottle	Moisture, Drainage	Roots	Depth (m) / Field pH	Sample (m)	Observations
Grazing, Flat plain <0.5%	Poplar box	Nil	Firm, Nil coarse fragments	A11 0.00-0.28 Abrupt	Loamy sand	Massive, weak	Nil	10YR3/3 Dark brown Nil mottles / bleaching	Dry, rapid	Few, fine	0.10 / 6.0	No samples taken	No additional observations
				A12 0.28-0.54 Abrupt	Loamy sand	Massive, weak	Nil	7.5YR4/4 Brown Nil mottles / bleaching	Dry, rapid	Very few, fine	0.30 / 6.5		
				B2 0.54-1.00	Clay loam sandy	Moderate, weak, <10mm sub- angular	Nil	7.5YR4/4 Brown Mottle <2% 10YR5/8 Dark yellowish brown Nil bleaching	Dry, Imperfect	Nil	0.60 / 6.5 0.90 / 6.5

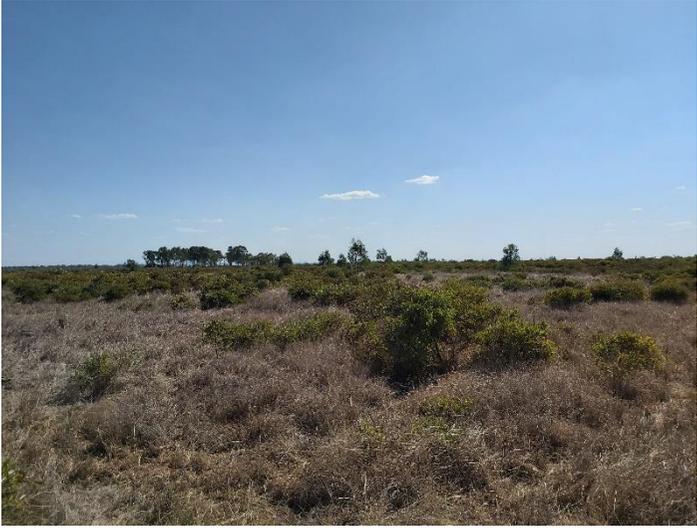
Site No.	Location - mE, mN (GDA94 Zone 55)	Soil Mapping Unit	Comments	Plates
C1	638193 7543626	C1-BL	Brigalow with small area nearby of Polpar Box Melonholes 0.3m deep	-
C2	638024 7542376	C1-BL	Grazing, flat plain, Brigalow, melonholes, cracking surface

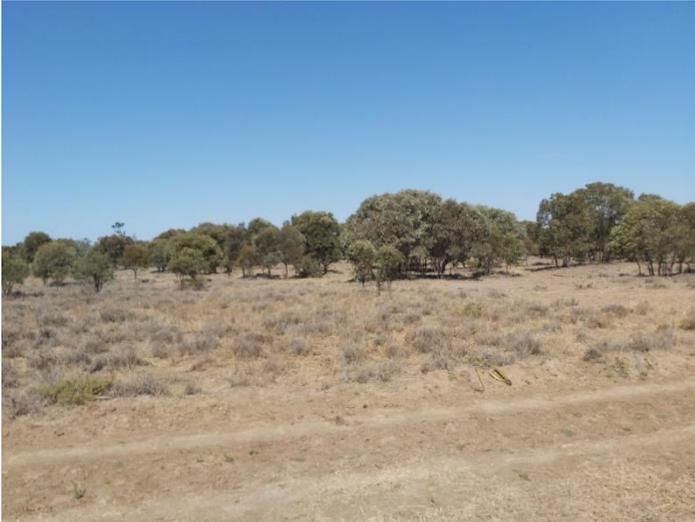
Site No.	Location - mE, mN (GDA94 Zone 55)	Soil Mapping Unit	Comments	Plates
C3	637791 7541963	C1-BR	Gently undulating plain, flat plain 1%, Brigalow Normal gilgai 0.2m deep with occasional melon holes 0.3-0.4m deep, 30% coverage Cracking surface

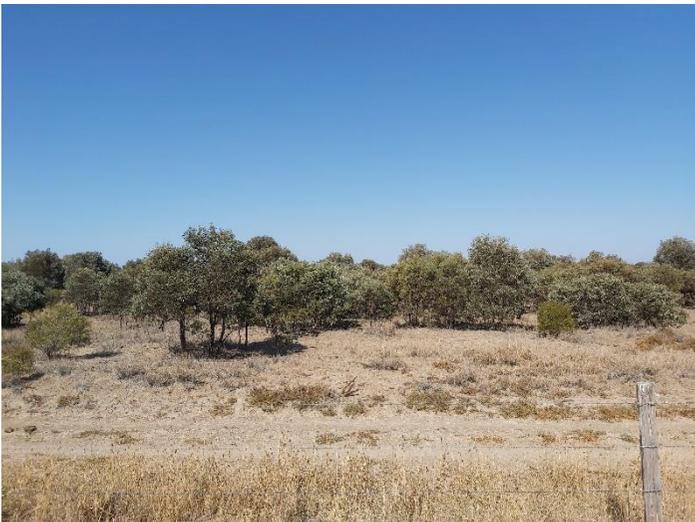
C4	637725 7539819	C1-BR	Gently undulating plain, flat plain 1%, Brigalow, melon holes, cracking surface

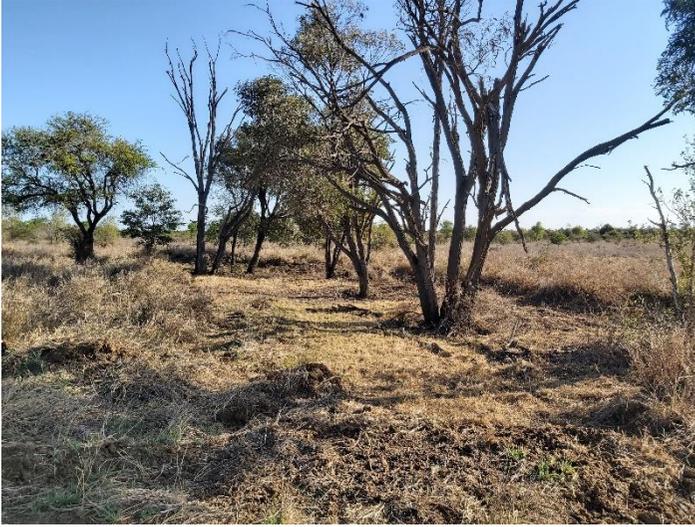
Site No.	Location - mE, mN (GDA94 Zone 55)	Soil Mapping Unit	Comments	Plates
C117	632021 7545698	C3-BR	Gently undulating plain, slope 1-2%, Brigalow regrowth, <2% melon holes 0.3 m deep in wider area, surface colour 10YR4/3 light clay	-
C118	630484 7545555	C3-BR	Narrow depression and drainage line, Narrow Leave Ironbark, gully erosion, surface light clay, 7.5YR3/2, cracking

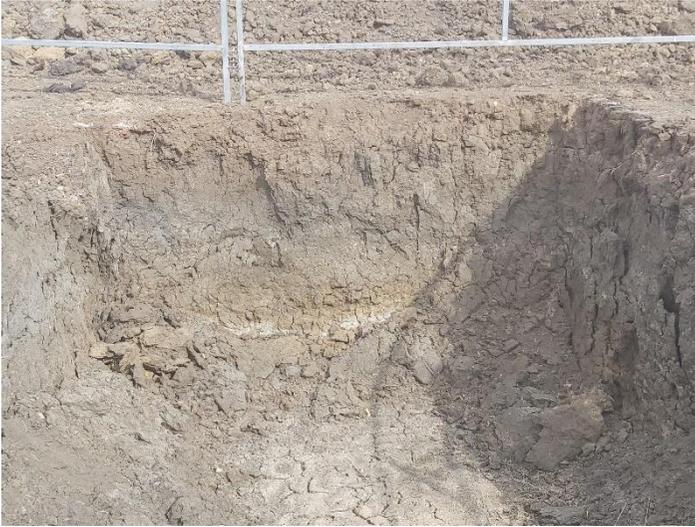
Site No.	Location - mE, mN (GDA94 Zone 55)	Soil Mapping Unit	Comments	Plates
C146	626865 7541097	C3-BL	Pit observed, suggests profile is uniform grey-black clay throughout Upper slope, Brigalow, linear gilgai observed, surface grey, self mulching

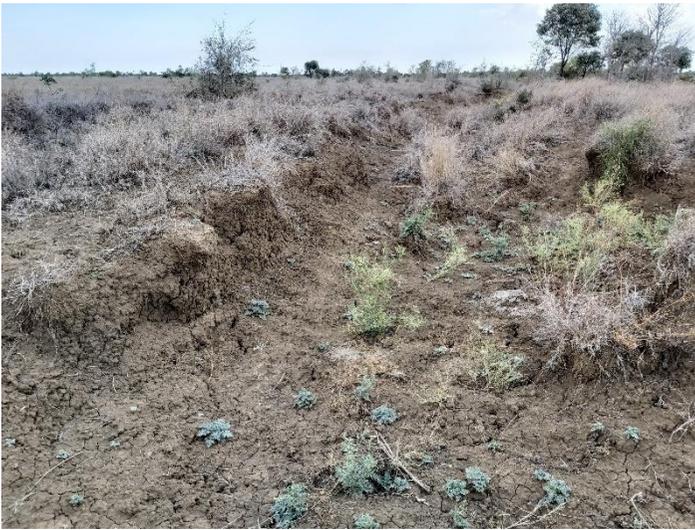
Site No.	Location - mE, mN (GDA94 Zone 55)	Soil Mapping Unit	Comments	Plates
C205	632799 7547676	C3-BL	Open depression with grass cover, gully erosion Surface grey, self mulching and cracking
