# Appendix J

Soils and Land Suitability  
Assessment

## WINCHESTER SOUTH PROJECT Environmental Impact Statement

# Soils and Land Suitability Assessment

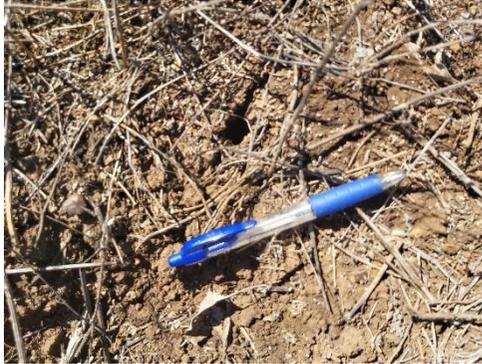
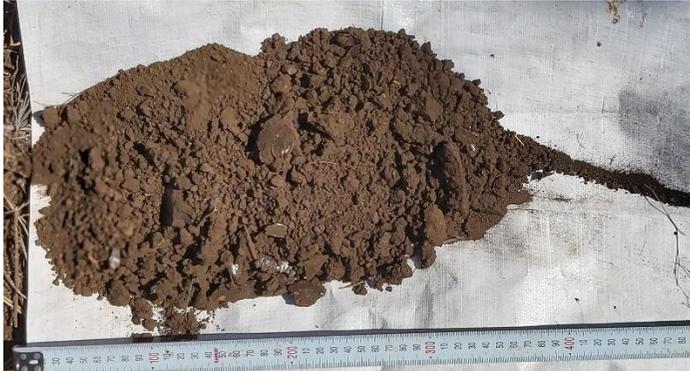
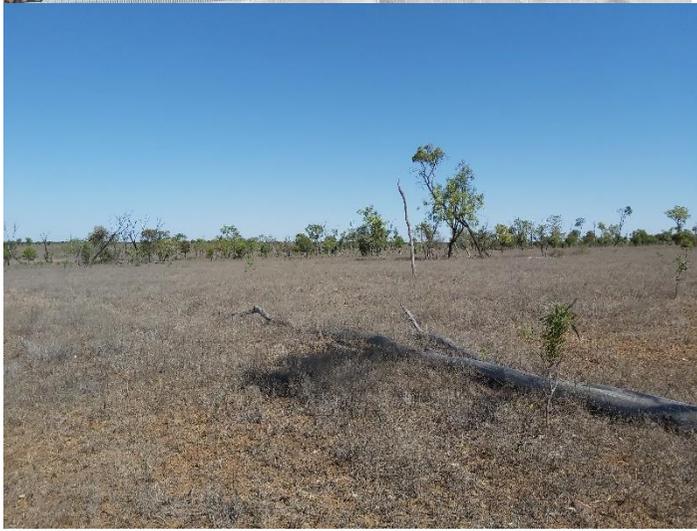
Site No.	Location - mE, mN (GDA94 Zone 55)	Soil Mapping Unit	Comments	Plates
C255	633598 7547130	C3-BR	<p>Crest, upper slope 2% Mixed veg., some Poplar Box nearby Surface soft, self mulching</p> <p>0.00-0.10 Light clay 10YR3/3 Weak</p> <p>0.10-0.30+ Light clay 10YR3/3 Moderate</p>

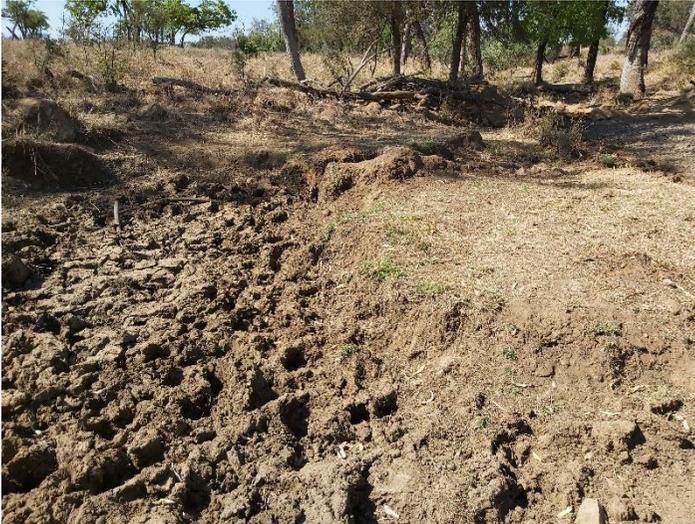
Site No.	Location - mE, mN (GDA94 Zone 55)	Soil Mapping Unit	Comments	Plates
C291	629161 7542391	C3-BL	Drepression, drainage line Gully erosion, gums Surface cracking light clay, grey

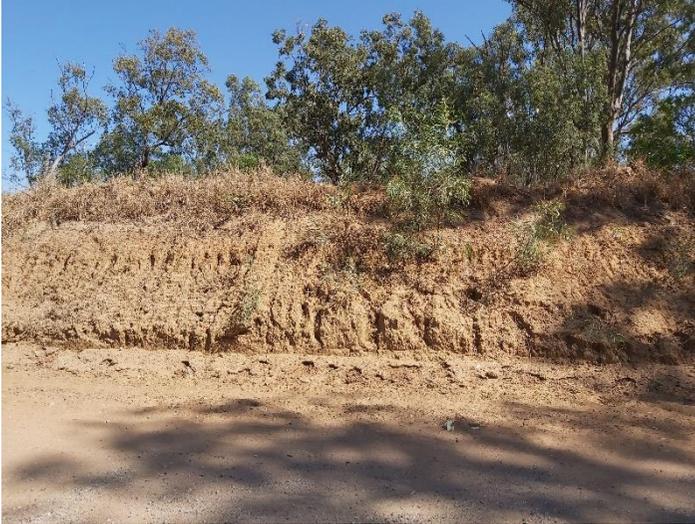
C292	627620 7541496	S1	Gully erosion, wide depression Mixed vegetation Soil profile sandy loam to sandy clay loam

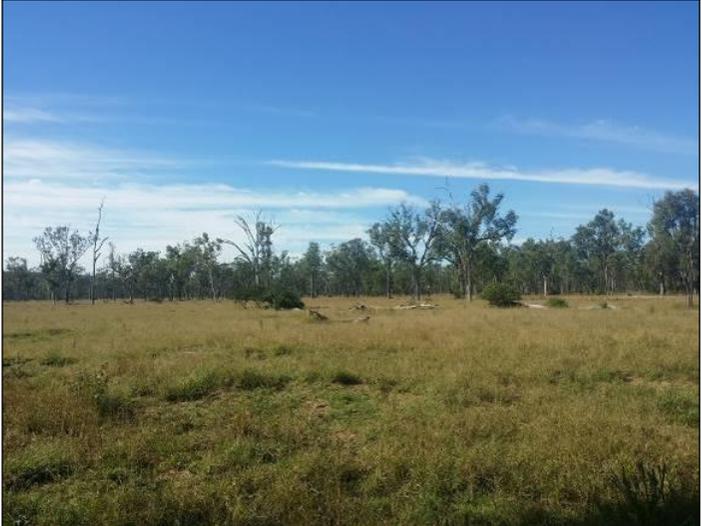
Site No.	Location - mE, mN (GDA94 Zone 55)	Soil Mapping Unit	Comments	Plates
OD-C129	639315 7540373	S4	Firm light brown surface, cleared
