WINCHESTER SOUTH PROJECT

Soils and Land Suitability Assessment Addendum

Winchester South Project
Whitehaven WS Pty Ltd

23 June 2022

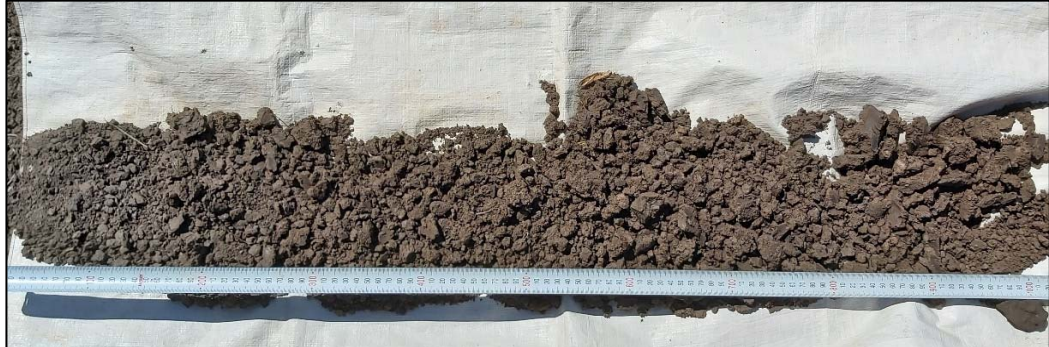
Site 2-d

Table 4-4: Soil Profile Morphology Summary SMU C1-BL – Depression Position

Horizon Depth (m), Boundary	Field Texture	Structure Strength	Inclusions Segregations	Colour, Mottle, Bleaching	Moisture Drainage	Roots	Depth (m) / Field pH	Samples (m)
	A1 0.00-0.13 Abrupt	Medium clay	Weak, very firm, subangular <10 mm	Nil	10YR3/2 Very dark greyish brown Nil mottles / bleaching	Dry, well to moderate	Common	0.10 / 5.5-6.0	0.00-0.10 0.20-0.30 0.50-0.60 0.70-0.80 0.90-1.00
	B21 0.13-0.61 Abrupt	Medium heavy clay	Moderate, very firm, subangular <20 mm Slickensides	Nil	10YR3/1 Very dark grey Nil mottles / bleaching	Dry, moderate	Few	0.30 / 5.5-6.0 0.60 / 5.5-6.0	
B22 0.61-1.00 EOBH	Medium heavy clay	Moderate, very firm, subangular 10-30 mm Slickensides	Nil	10YR3/1 Very dark grey Nil mottles / bleaching	Dry, moderate	Few	0.90 / 5.5

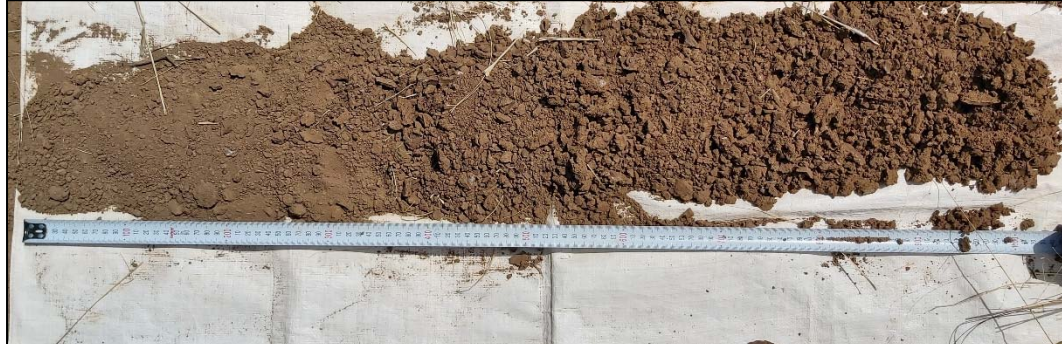
Site 9-d

Table 4-9: Soil Profile Morphology Summary SMU C1-BR – Depression Position

Horizon Depth (m), Boundary	Field Texture	Structure Strength	Inclusions Segregations	Colour, Mottle, Bleaching	Moisture Drainage	Roots	Depth (m) / Field pH	Samples (m)
	A1 0.00-0.12 Abrupt	Light clay	Weak, weak, subangular <10 mm	Nil	10YR3/4 Dark yellowish brown Nil mottles / bleaching	Dry, well to moderate	Common	0.10 / 4.5	0.00-0.10 0.20-0.30 0.50-0.60 0.70-0.80 0.90-1.00
	B21 0.12-0.38 Abrupt	Light medium clay	Moderate, weak, subangular <10 mm	<1% manganese nodules	10YR3/4 Dark yellowish brown Nil mottles / bleaching	Dry, moderate	Few	0.30 / 5.5	
	B22 0.38-1.00 EOBH	Medium clay	Moderate, firm, subangular 10-20 mm Slickensides	Nil	10YR3/3 Dark brown Nil mottles / bleaching	Dry, moderate	Few	0.60 / 5.5 0.90 / 5.5

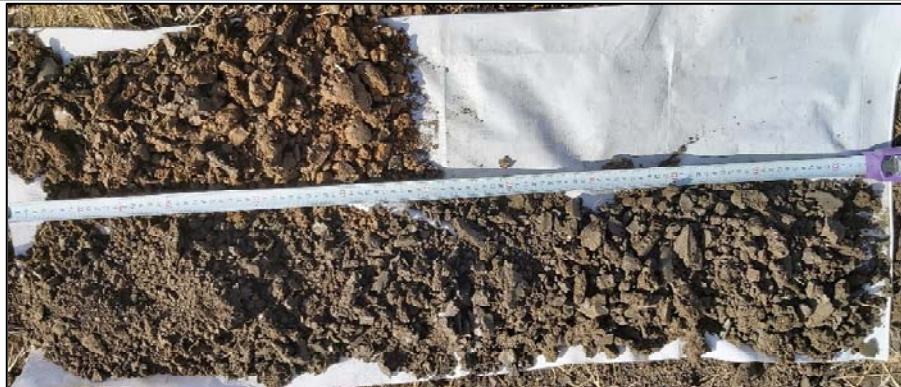
Site 35-d

Table 4-20: Soil Profile Morphology Summary SMU C4 - Depression Position

Horizon Depth (m), Boundary	Field Texture	Structure Strength	Inclusions Segregations	Colour, Mottle, Bleaching	Moisture Drainage	Roots	Depth (m) / Field pH	Samples (m)
A1 0.00-0.10 Abrupt	Light clay	Weak, moderate, sub-rounded peds <20 mm	Nil	10YR3/2 Very dark greyish brown Nil mottles / bleaching	Dry, well drained	Common	0.05 / 6.0	0.00-0.10 0.20-0.30 0.50-0.60 0.80-0.90 1.10-1.20 1.40-1.50
B21 0.10-0.50 Abrupt	Light medium clay	Moderate, firm, sub-angular peds <20 mm	Nil	10YR3/1 Very dark grey Nil mottles / bleaching	Dry, moderately well drained	Common	0.30 / 6.0	
B22 0.50-0.65 Clear	Medium clay	Moderate, firm, sub-angular peds <20 mm	<2% calcium carbonate	10YR3/1 Very dark grey Nil mottles / bleaching	Dry, moderately well drained	Few	0.50 / 6.5	
B23 0.65-1.30 Gradual	Medium clay	Moderate, firm, sub-angular peds <20 mm	<2% calcium carbonate	2.5YR3/2 Dusky red Nil mottles / bleaching	Dry, moderately well drained	Nil	0.90 / 6.5

B24 1.30-1.50 EOBH	Medium clay	Moderate, firm, sub-angular peds <20 mm	<2% calcium carbonate	7.5YR4.3 Brown 20% light brown mottle Nil bleaching	Dry, imperfectly drained	Nil	1.30 / 6.5

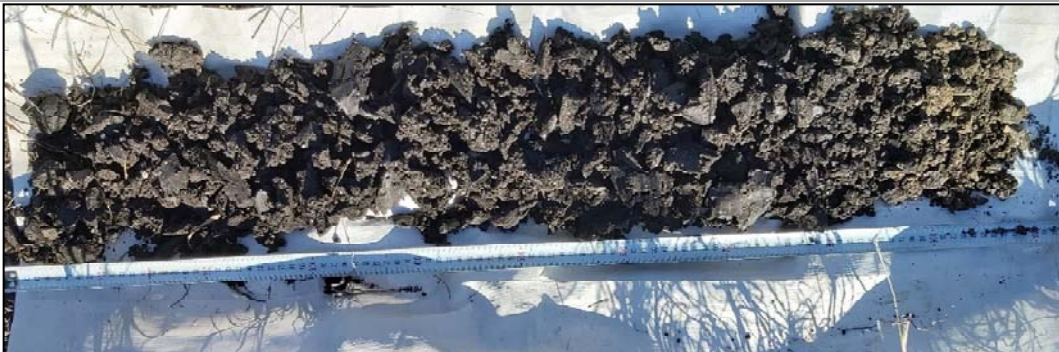
Site 70

Table 4-24: Soil Profile Morphology Summary SMU C5

Horizon Depth (m), Boundary	Field Texture	Structure Strength	Inclusions Segregations	Colour, Mottle, Bleaching	Moisture Drainage	Roots	Depth (m) / Field pH
	A1 0.00-0.12 Abrupt	Medium clay	Moderate, firm, subangular <20 mm	1% calcium carbonate	10YR3/1 Very dark grey Nil mottles / bleaching	Dry, well to moderate	Common	0.10 / 7.5
	B21 0.12-0.88 Abrupt	Medium clay	Moderate, firm, subangular 20-40 mm	2% calcium carbonate	10YR3/1 Very dark grey Nil mottles / bleaching	Dry, moderate	Few	0.30 / 7.5 0.60 / 7.5
	B22 0.88-1.00 EOBH	Medium clay	Moderate, very firm, subangular 20-40 mm	2% calcium carbonate	10YR3/1 Very dark grey Nil mottles / bleaching	Dry, moderate to imperfect	Nil	0.90 / 7.5

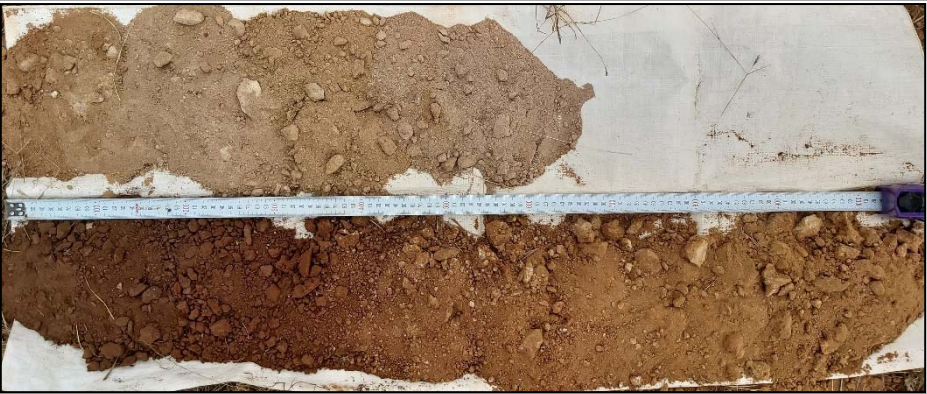
Site 36

Table 4-45: Soil Profile Morphology Summary SMU T1-R

Horizon Depth (m), Boundary	Field Texture	Structure Strength	Inclusions Segregations	Colour, Mottle, Bleaching	Moisture Drainage	Roots	Depth (m) / Field pH
A11 0.00-0.08 Abrupt	Clay Loam	Massive, loose	Nil	10YR2/2 Very dark brown Nil mottles / bleaching	Dry, rapid	Common	0.05 / 6.5	0.00-0.08 0.10-0.20 0.20-0.30 0.50-0.60 0.90-1.00 1.40-1.50
A12 0.08-0.20 Abrupt	Clay loam	Weak, weak, sub-rounded 5-20 mm	<1% <2 mm coarse fragments	7.5YR3/2 Dark brown Nil mottles / bleaching	Dry, well	Few	0.15 / 6.5	
B21 0.20-0.34 Abrupt	Light clay	Moderate, weak, sub-rounded 5-20 mm	<1% <2 mm coarse fragments	5YR3/4 Dark reddish brown Nil mottles / bleaching	Dry, well	Few	0.30 / 7.0	
B22 0.34-0.75 Abrupt	Silty clay loam	Weak, weak, sub-angular <20 mm	<5% <2 mm coarse fragments	5YR4/4 Reddish brown Nil mottles / bleaching	Dry, well to moderate	Nil	0.60 / 8.0	
B23 0.75-1.05 Abrupt	Silty clay loam	Weak, weak, sub-angular <20 mm	<2% <2 mm coarse fragments	7.5YR4/6 Strong brown Nil mottles / bleaching	Dry, well to moderate	Nil	0.90 / 8.0

Horizon Depth (m), Boundary	Field Texture	Structure Strength	Inclusions Segregations	Colour, Mottle, Bleaching	Moisture Drainage	Roots	Depth (m) / Field pH	
B3 1.05-1.60 EOBH	Loam	Massive, loose	Nil	7.5YR4/4 Brown Nil mottles / bleaching	Dry, moderate	Nil	1.20 / 8.5

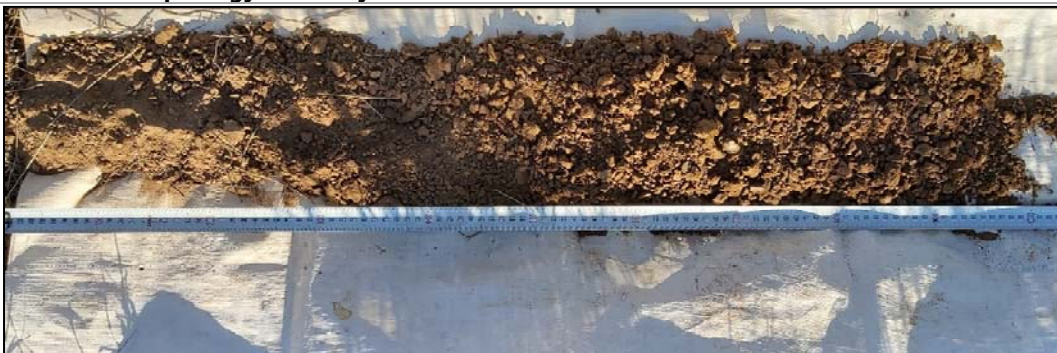
Site 6

Table 4-51: Soil Profile Morphology Summary SMU T3

Horizon Depth (m), Boundary	Field / Lab Texture	Structure Strength	Inclusions Segregations	Colour, Mottle, Bleaching	Moisture Drainage	Roots	Depth (m) / Field pH	Samples (m)
	A1 0.00-0.20 Abrupt	Silty loam / Silty loam	Massive, firm	<1% <5 mm coarse fragments	7.5YR3/3 Dark brown Nil mottles / bleaching	Dry, well to moderate	Common	0.10 / 6.5	0.00-0.10 0.20-0.30 0.50-0.57 0.65-0.75 0.90-1.00
	B21 0.20-0.57 Abrupt	Silty clay loam / Silty clay loam to clay loam	Weak to moderate, firm, subangular <10 mm	Nil	7.5YR4/3 Brown Nil mottles / bleaching	Dry, moderate	Few	0.30 / 7.0	
	B22 0.57-0.76 Abrupt	Silty clay loam / Clay loam	Weak to moderate, firm, subangular <20 mm	Nil	7.5YR4/3 Brown Nil mottles / bleaching	Dry, moderate	Nil	0.60 / 8.0	
B23 0.76-100 EOBH	Silty clay loam / Clay loam	Moderate, firm, subangular <10 mm	Nil	10YR5/4 Yellowish brown Nil mottles / bleaching	Dry, moderate	Nil	0.90 / 8.0

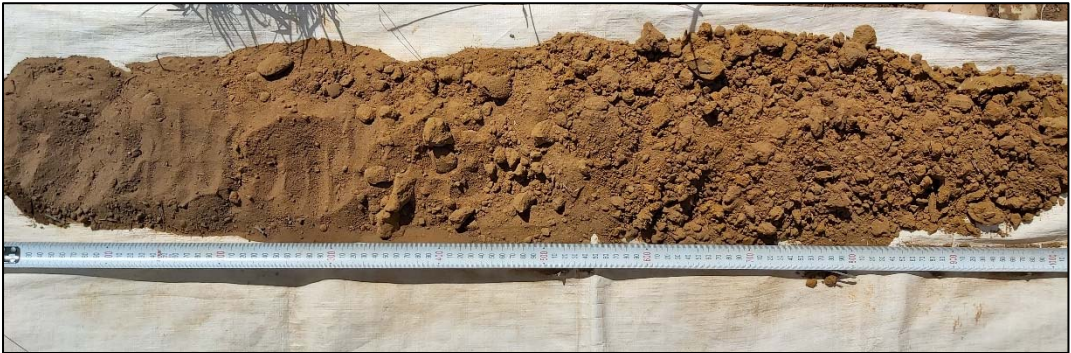
Land use Landform Pattern, Element, Slope	Vegetation	Microrelief Disturbance Erosion	Surface condition, surface rock	Soil Profile Description									
				Horizon Depth (m), Boundary	Field Texture	Structure, Strength, Cutans	Inclusions Segregations	Colour, Mottle, Bleaching	Moisture, Drainage	Roots	Depth (m) / Field pH	Sample (m)	Observations
Grazing, gently undulating plain, Simple Slope 2%/2%	Poplar Box	Nil microrelief, Semi disturbance Nil erosion	Soft, <1% coarse fragments <5mm	A11 0.00-0.21 Abrupt	Loamy Sand	Loose, apedal	Nil	10YR4/3 Brown Nil mottles / bleaching	Dry, Rapid	Common	0.10 / 6.0	0.00-0.10 0.20-0.30 0.35-0.45 0.60-0.70 0.90-1.00	Nil
				A12 0.21-0.33 Abrupt	Loamy Sand	Loose, apedal	Nil	7.5YR4/3 Brown Nil mottles / bleaching	Dry, Rapid	Common	0.30 / 6.0		
				A13 0.33-0.54 Abrupt	Loamy Sand	Massive 30% <20mm peds	Nil	7.5YR4/3 Brown Nil mottles / bleaching	Dry, Well	Few	0.40 / 6.5

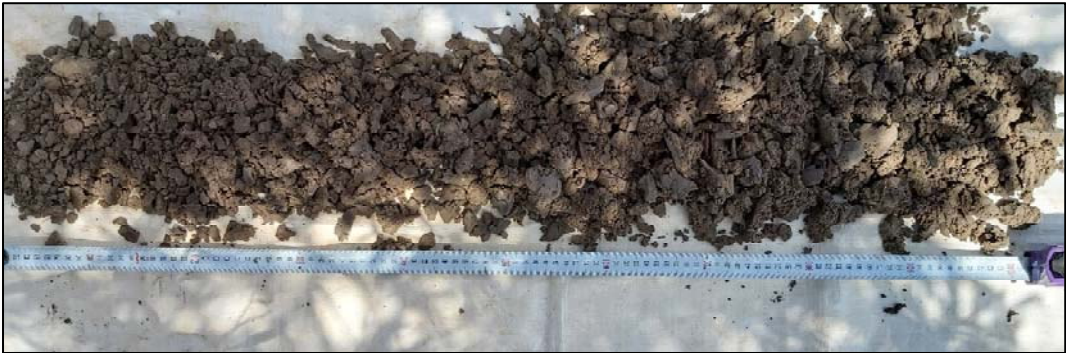
Land use Landform Pattern, Element, Slope	Vegetation	Microrelief Disturbance Erosion	Surface condition, surface rock	Soil Profile Description									
				Horizon Depth (m), Boundary	Field Texture	Structure, Strength, Cutans	Inclusions Segregations	Colour, Mottle, Bleaching	Moisture, Drainage	Roots	Depth (m) / Field pH	Sample (m)	Observations
Grazing Flat Plain 1% / <1%	Dawson Gum and Brigalow regrowth	Melon hole 40% coverage, 3- 10m wide, 0.3-0.6m deep Semi disturbance	Crust Nil coarse fragments	A1 0.00-0.12 Abrupt	Medium clay	Moderate, very firm, subangular <10mm	Nil	10YR3/2 Very dark greyish brown Nil mottles / bleaching	Dry, well to moderate	Common	0.05 / 5.5-6.0	0.00-0.10 0.20-0.30 0.50-0.60 0.70-0.80 0.90-1.00	Borehole conducted on the mound
				B21 0.12-0.50 Abrupt	Medium heavy clay	Moderate, very firm, subangular <20mm	Nil	10YR3/1 Very dark grey Nil mottles / bleaching	Dry, moderate	Few	0.30 / 5.5-6.0

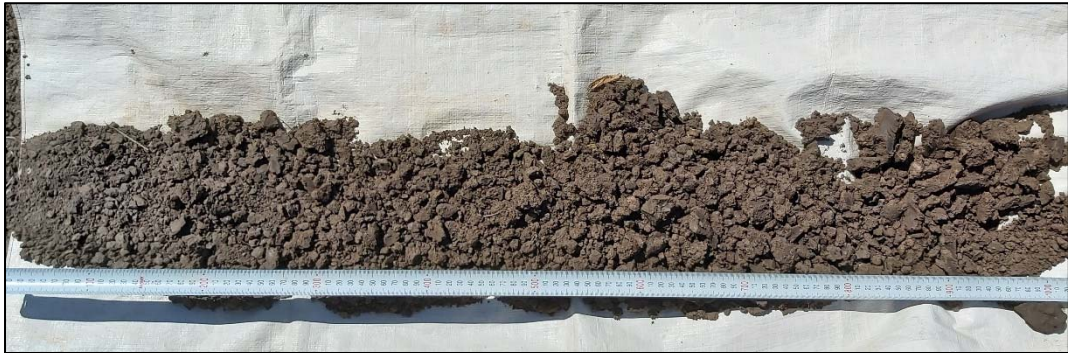
Land use Landform Pattern, Element, Slope	Vegetation	Microrelief Disturbance Erosion	Surface condition, surface rock	Soil Profile Description									
				Horizon Depth (m), Boundary	Field Texture	Structure, Strength, Cutans	Inclusions Segregations	Colour, Mottle, Bleaching	Moisture, Drainage	Roots	Depth (m) / Field pH	Sample (m)	Observations
Grazing Flat Plain 1% / <1%	Brigalow	Melon hole 40% coverage, 3- 10m wide, 0.3-0.6m deep Semi disturbance Nil erosion	Crust Nil coarse fragments	A1 0.00-0.13 Abrupt	Medium clay	Weak, very firm, subangular <10mm	Nil	10YR3/2 Very dark greyish brown Nil mottles / bleaching	Dry, well to moderate	Common	0.10 / 5.5- 6.0	0.00-0.10 0.20-0.30 0.50-0.60 0.70-0.80	Borehole conducted in depression
				B21 0.13-0.61 Abrupt	Medium heavy clay	Moderate, very firm, subangular <20mm	Nil	10YR3/1 Very dark grey Nil mottles / bleaching	Dry, moderate	Few	0.30 / 5.5- 6.0	0.90-1.00

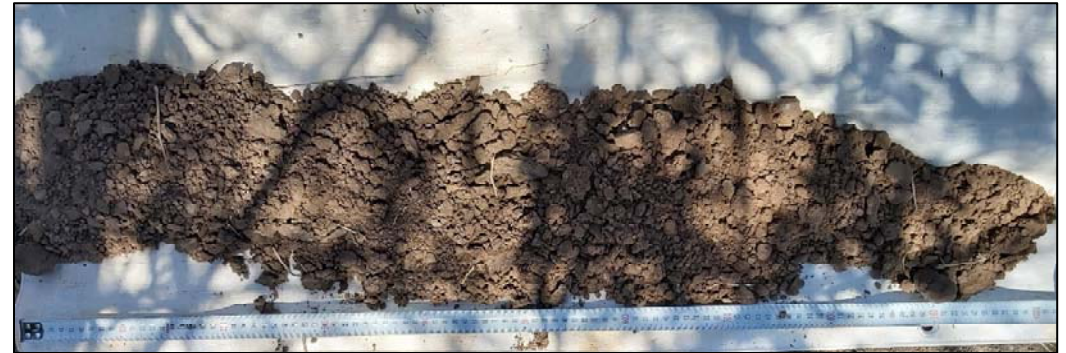
Land use Landform Pattern, Element, Slope	Vegetation	Microrelief Disturbance Erosion	Surface condition, surface rock	Soil Profile Description									
				Horizon Depth (m), Boundary	Field Texture	Structure, Strength, Cutans	Inclusions Segregations	Colour, Mottle, Bleaching	Moisture, Drainage	Roots	Depth (m) / Field pH	Sample (m)	Observations
Grazing Flat Plain 1% / <1%	Brigalow	Gilgai (normal to melon hole) Semi disturbed Nil erosion	Crust Nil coarse fragments	A1 0.00-0.10 Abrupt	Light clay	Weak, strong, subangular <10mm	Nil	10YR3/2 Very dark greyish brown Nil mottles / bleaching	Dry, well to moderate	Common	0.10 / 6.0	Nil	Nil
				B21 0.10-0.68 Abrupt	Medium clay	Weak to moderate, very firm, subangular 10-20mm	<1% <20mm coarse fragments (coarse fragments)	10YR3/2 Very dark greyish brown Nil mottles / bleaching	Dry, moderate	Few	0.30 / 6.5 0.60 / 6.0		
				B22 0.68-1.00 EOBH	Medium clay	Weak to moderate, very firm, subangular 10-20mm slickensides observed	Nil	10YR3/2 Very dark greyish brown Nil mottles / bleaching	Dry, moderate	Few	0.90 / 5.5

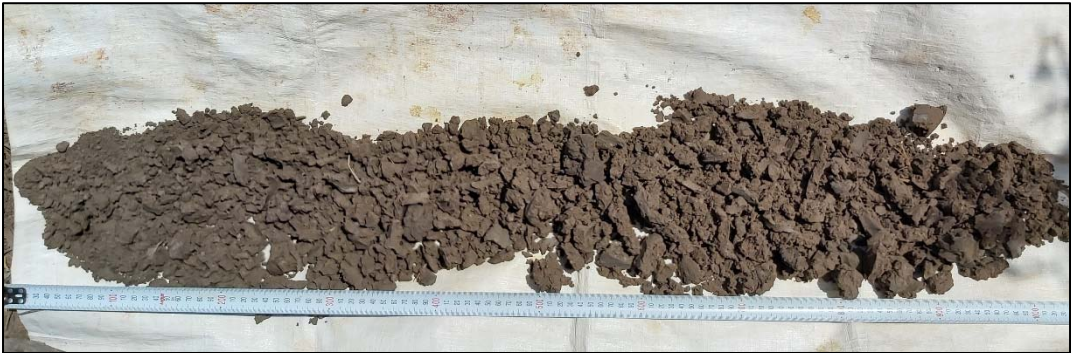
Land use Landform Pattern, Element, Slope	Vegetation	Microrelief Disturbance Erosion	Surface condition, surface rock	Soil Profile Description									
				Horizon Depth (m), Boundary	Field Texture	Structure, Strength, Cutans	Inclusions Segregations	Colour, Mottle, Bleaching	Moisture, Drainage	Roots	Depth (m) / Field pH	Sample (m)	Observations
Grazing Flat Plain 1% / <1%	Brigalow	Melon hole 40% coverage, 3- 10m wide, 0.3-0.6m deep Minor to semi disturbance Nil erosion	Crust Nil coarse fragments	A1 0.00-0.11 Abrupt	Medium clay	Moderate, very firm, subangular <10mm	Nil	10YR3/2 Very dark greyish brown Nil mottles / bleaching	Dry, well to moderate	Common	0.10 / 5.5- 6.0	Nil	Nil
				B21 0.11-0.48 Abrupt	Medium heavy clay	Moderate, very firm, subangular <20mm	Nil	10YR3/1 Very dark grey Nil mottles / bleaching	Dry, moderate	Few	0.30 / 5.5-6.0		
				B22 0.48-1.00 EOBH	Medium heavy clay	Moderate, very firm, subangular <40mm slickensides observed	Nil	10YR3/1 Very dark grey Nil mottles / bleaching	Dry, moderate	Few	0.60 / 5.5-6.0 0.90 / 5.5

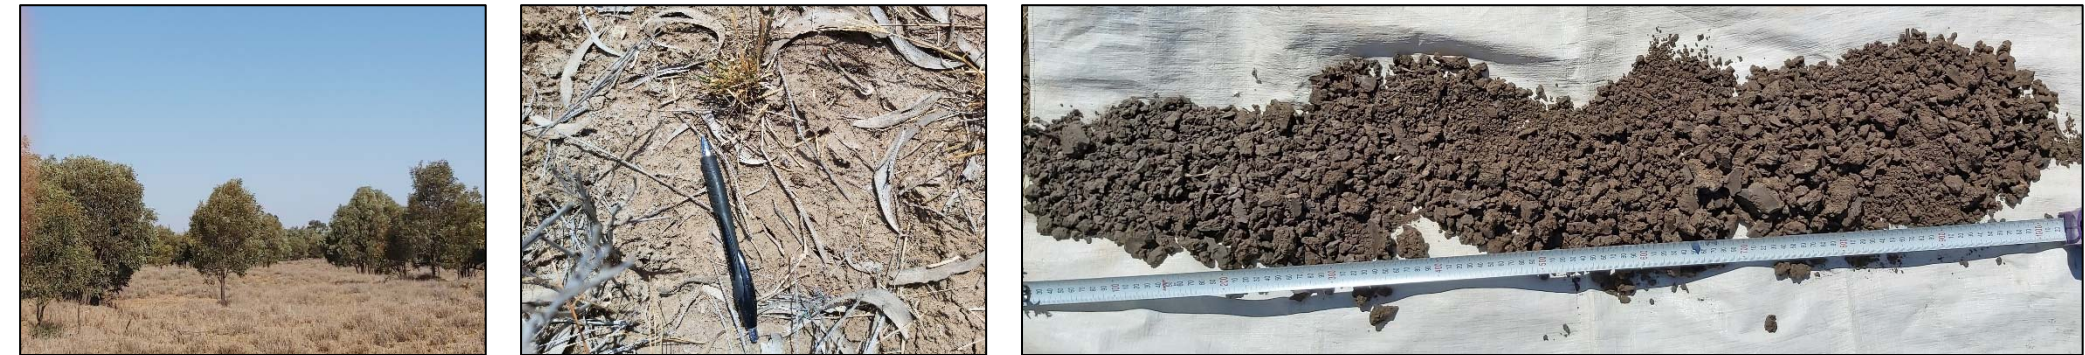
Land use Landform Pattern, Element, Slope	Vegetation	Microrelief Disturbance Erosion	Surface condition, surface rock	Soil Profile Description									
				Horizon Depth (m), Boundary	Field Texture	Structure, Strength, Cutans	Inclusions Segregations	Colour, Mottle, Bleaching	Moisture, Drainage	Roots	Depth (m) / Field pH	Sample (m)	Observations
Grazing Flat Plain 1% / <1%	Brigalow	Melon hole 40% coverage, 3- 10m wide, 0.3-0.6m deep Minor to semi disturbance Nil erosion	Firm, cracking Nil coarse fragments	A1 0.00-0.13 Abrupt	Medium clay	Weak, very firm, subangular <10mm	Nil	10YR3/2 Very dark greyish brown Nil mottles / bleaching	Dry, well to moderate	Common	0.10 / 5.5- 6.0	Nil	Nil
				B21 0.13-0.61 Abrupt	Medium heavy clay	Moderate, very firm, subangular <20mm	Nil	10YR3/1 Very dark grey Nil mottles / bleaching	Dry, moderate	Few	0.30 / 5.5- 6.0		
				B22 0.61-1.00 EOBH	Medium heavy clay	Moderate, very firm, subangular 10-30mm slickensides observed	Nil	10YR3/1 Very dark grey Nil mottles / bleaching	Dry, moderate	Few	0.60 / 5.5- 6.0 0.90 / 5.5

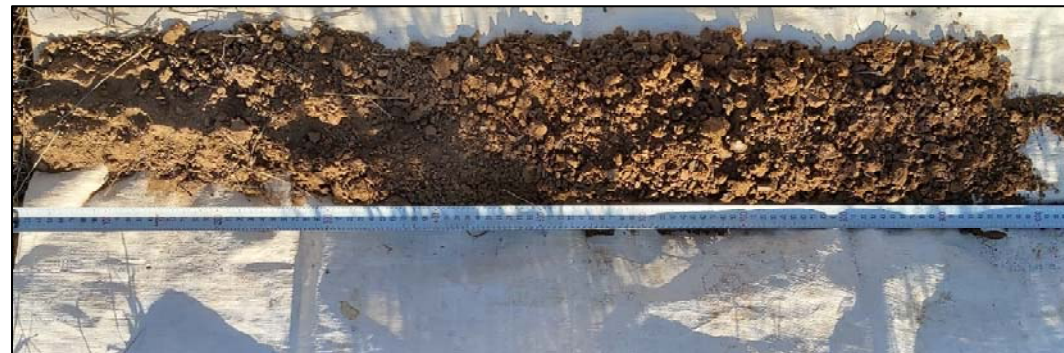
Land use Landform Pattern, Element, Slope	Vegetation	Microrelief Disturbance Erosion	Surface condition, surface rock	Soil Profile Description									
				Horizon Depth (m), Boundary	Field Texture	Structure, Strength, Cutans	Inclusions Segregations	Colour, Mottle, Bleaching	Moisture, Drainage	Roots	Depth (m) / Field pH	Sample (m)	Observations
Grazing, gently undulating plain, flat plain 1%/1%	Exotic grassland	Nil microrelief Completely disturbance Nil erosion	Firm, hard setting Nil coarse fragments	A1 0.00-0.21 Abrupt	Silty loam	Massive, firm	<1% <5mm coarse fragments	7.5YR3/3 Dark brown Nil mottles / bleaching	Dry, well to moderate	Common	0.10 / 6.5	0.00-0.10 0.20-0.30 0.50-0.57 0.65-0.75 0.90-1.00	Nil
				B21 0.20-0.57 Abrupt	Silty clay loam	Weak to moderate, firm, subangular <10mm	Nil	7.5YR4/3 Brown Nil mottles / bleaching	Dry, moderate	Few	0.30 / 7.0		
				B22 0.57-0.76 Abrupt	Silty clay loam	Weak to moderate, firm, subangular <20mm	Nil	7.5YR4/3 Brown Nil mottles / bleaching	Dry, moderate	Nil	0.60 / 8.0

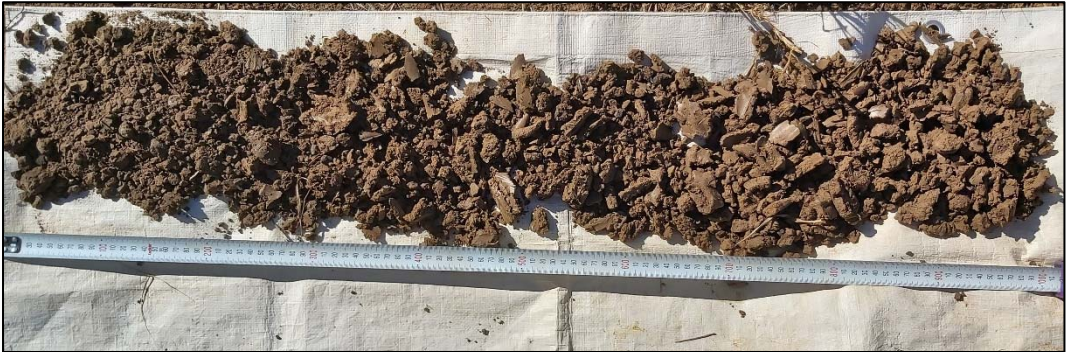
Land use Landform Pattern, Element, Slope	Vegetation	Microrelief Disturbance Erosion	Surface condition, surface rock	Soil Profile Description									
				Horizon Depth (m), Boundary	Field Texture	Structure, Strength, Cutans	Inclusions Segregations	Colour, Mottle, Bleaching	Moisture, Drainage	Roots	Depth (m) / Field pH	Sample (m)	Observations
Grazing Flat Plain 1% / <1%	Brigalow regrowth	Melon hole 30% coverage, 3- 6m wide, 0.2- 0.4m deep Minor to semi disturbance Nil erosion	Firm, hard setting Nil coarse fragments	A1 0.00-0.20 Abrupt	Light clay	Moderate, firm, subangular 10- 30mm	Nil	7.5YR3/2 Dark brown Nil mottles / bleaching	Dry, well to moderate	Common	0.10 / 6.5	Nil	Nil
				B21 0.20-0.65 Abrupt	Medium clay	Moderate, strong, subangular 20- 40mm	Nil	7.5YR3/2 Dark brown Nil mottles / bleaching	Dry, moderate	Few	0.30 / 7.0 0.60 / 8.0		
				B22 0.65-1.00 EOBH	Medium heavy clay	Moderate, strong, subangular 30- 50mm slickensides observed	Nil	7.5YR3/2 Dark brown Nil mottles / bleaching	Dry, moderate	Few	0.90 / 8.0

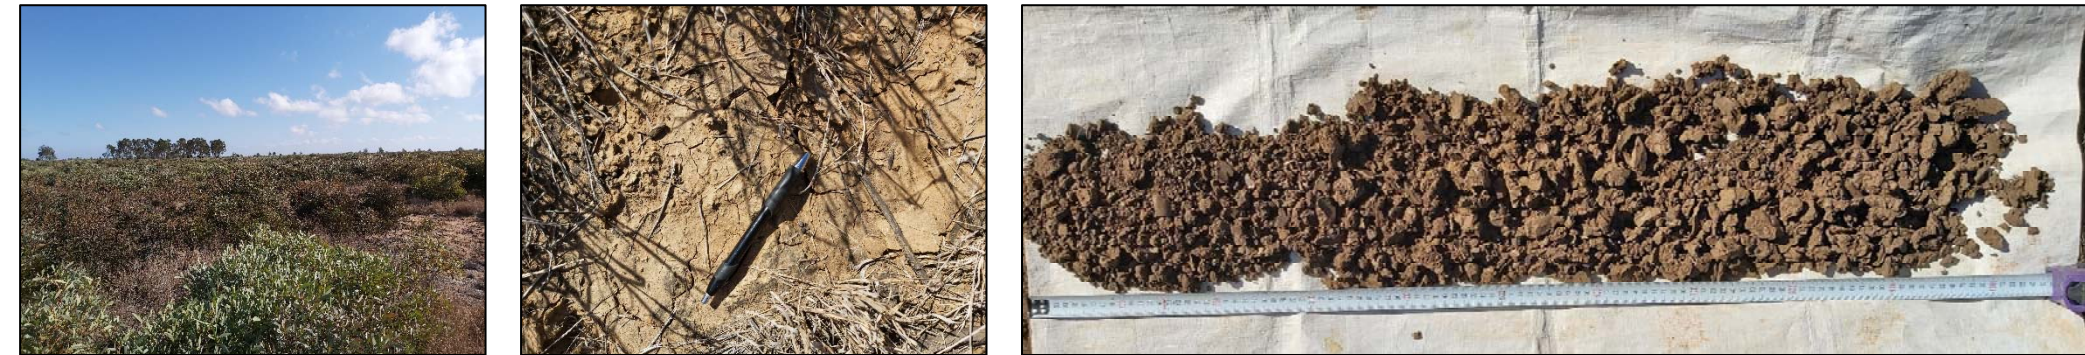
Land use Landform Pattern, Element, Slope	Vegetation	Microrelief Disturbance Erosion	Surface condition, surface rock	Soil Profile Description									
				Horizon Depth (m), Boundary	Field Texture	Structure, Strength, Cutans	Inclusions Segregations	Colour, Mottle, Bleaching	Moisture, Drainage	Roots	Depth (m) / Field pH	Sample (m)	Observations
Grazing Flat Plain 1%/1%	Brigalow regrowth	Melon hole 30% coverage, 3- 6m wide, 0.2- 0.4m deep Minor to semi disturbance Nil erosion	Firm, hard setting Nil coarse fragments	A1 0.00-0.22 Abrupt	Light clay	Moderate, firm, subangular 10- 30mm	Nil	7.5YR3/2 Dark brown Nil mottles / bleaching	Dry, well to moderate	Common	0.10 / 6.5	Nil	Nil
				B21 0.22-0.62 Abrupt	Medium clay	Moderate, strong, subangular 20- 40mm	Nil	7.5YR3/2 Dark brown Nil mottles / bleaching	Dry, moderate	Few	0.30 / 7.0 0.60 / 8.0		
				B22 0.62-1.00 EOBH	Medium heavy clay	Moderate, strong, subangular 30- 50mm slickensides observed	Nil	7.5YR3/2 Dark brown Nil mottles / bleaching	Dry, moderate	Few	0.90 / 8.0

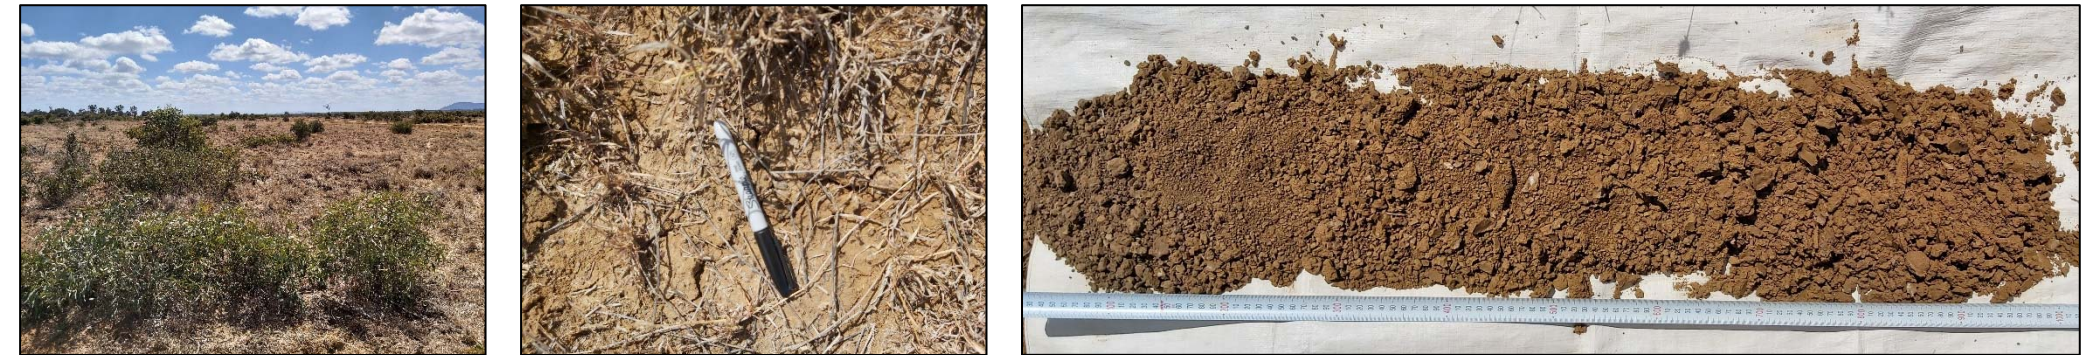
Land use Landform Pattern, Element, Slope	Vegetation	Microrelief Disturbance Erosion	Surface condition, surface rock	Soil Profile Description									
				Horizon Depth (m), Boundary	Field Texture	Structure, Strength, Cutans	Inclusions Segregations	Colour, Mottle, Bleaching	Moisture, Drainage	Roots	Depth (m) / Field pH	Sample (m)	Observations
Grazing Midslope <2%/1%	Dawson Gum and Brigalow regrowth	Melon hole 50% coverage, 3- 6m wide, 0.2- 0.4m deep Semi disturbance Nil erosion	Cracking, Nil coarse fragments	A1 0.00-0.09 Abrupt	Light clay	Weak, firm, subangular <10mm	<2% manganese nodules	10YR3/3 Dark brown Nil mottles / bleaching	Dry, well to moderate	Common	0.10 / 6.5	0.00-0.09 0.20-0.30 0.50-0.60 0.70-0.80 0.90-1.00	Nil
				B21 0.09-0.60 Abrupt	Light medium clay	Weak, firm, subangular <10mm	<1% manganese nodules	7.5YR4/3 Brown Nil mottles / bleaching	Dry, moderate	Few	0.30 / 7.5 0.60 / 7.5

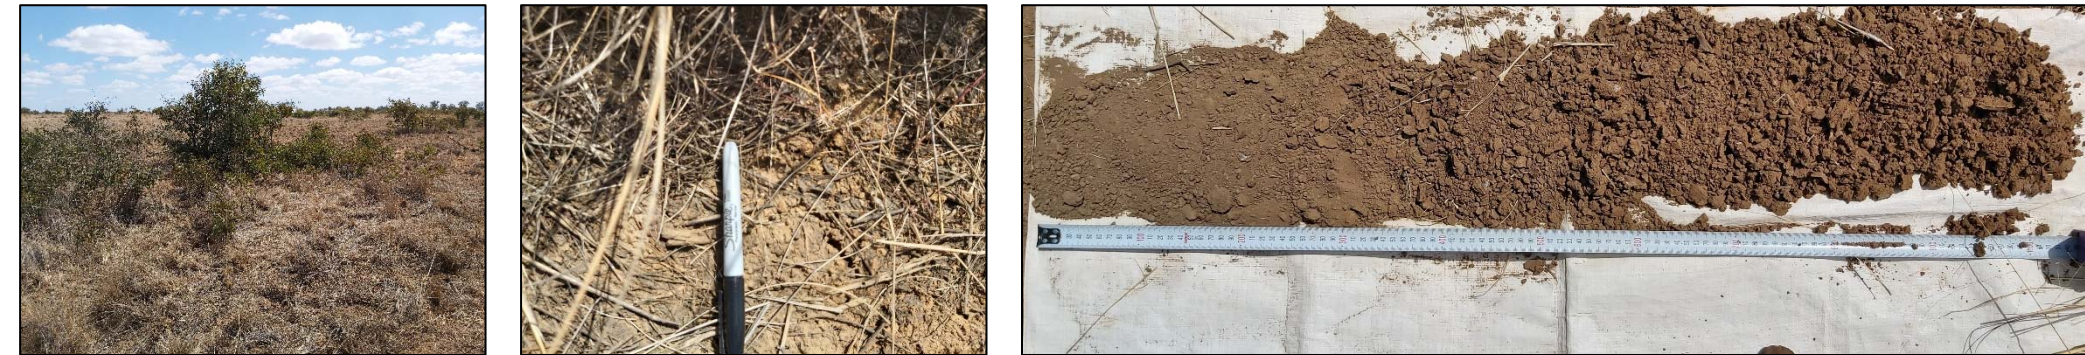
Land use Landform Pattern, Element, Slope	Vegetation	Microrelief Disturbance Erosion	Surface condition, surface rock	Soil Profile Description									
				Horizon Depth (m), Boundary	Field Texture	Structure, Strength, Cutans	Inclusions Segregations	Colour, Mottle, Bleaching	Moisture, Drainage	Roots	Depth (m) / Field pH	Sample (m)	Observations
Grazing Midslope <2%/1%	Brigalow regrowth	Melon hole 50% coverage, 3- 6m wide, 0.2- 0.4m deep Semi disturbance Nil erosion	Cracking Nil coarse fragments	A1 0.00-0.12 Abrupt	Light clay	Weak, weak, subangular <10mm	Nil	10YR3/4 Dark yellowish brown Nil mottles / bleaching	Dry, well to moderate	Common	0.10 / 4.5	0.00-0.10 0.20-0.30 0.50-0.60 0.70-0.80 0.90-1.00	Nil
				B21 0.12-0.38 Abrupt	Light medium clay	Moderate, weak, subangular <10mm	<1% manganese nodules	10YR3/4 Dark yellowish brown Nil mottles / bleaching	Dry, moderate	Few	0.30 / 5.5 0.60 / 5.5		
				B22 0.38-1.00 EOBH	Medium clay	Moderate, firm, subangular 10- 20mm slickensides observed	Nil	10YR3/3 Dark brown Nil mottles / bleaching	Dry, moderate	Few	0.90 / 5.5

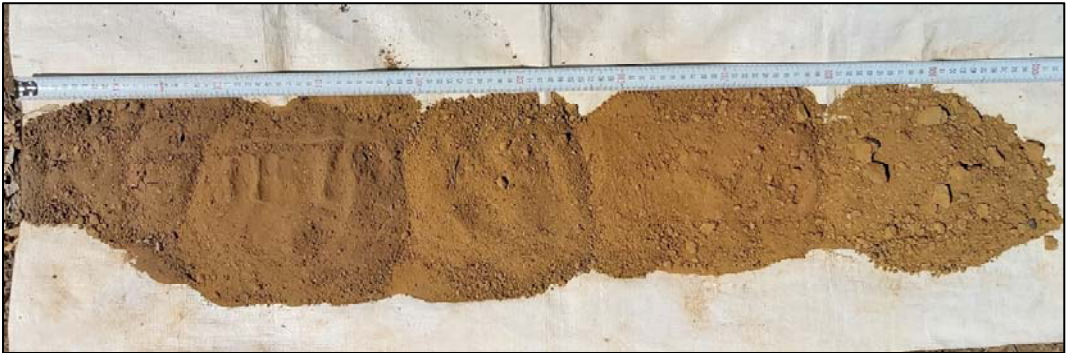
Land use Landform Pattern, Element, Slope	Vegetation	Microrelief Disturbance Erosion	Surface condition, surface rock	Soil Profile Description									
				Horizon Depth (m), Boundary	Field Texture	Structure, Strength, Cutans	Inclusions Segregations	Colour, Mottle, Bleaching	Moisture, Drainage	Roots	Depth (m) / Field pH	Sample (m)	Observations
Grazing Crest, flat plain 1%/1%	Narrow-leaved Ironbark	Nil microrelief Semi disturbance Nil erosion	Firm, <2% coarse fragments <5mm	A1 0.00-0.11 Abrupt	Sandy loam	Massive, apedal	Nil	10YR4/2 Dark greyish brown Nil mottles / bleaching	Dry, well to moderate	Common	0.10 / 6.5	0.00-0.10 0.20-0.30 0.48-0.58 0.70-0.80	Nil
				B21 0.11-0.58 Abrupt	Clay loam	Massive, apedal	<2% coarse fragments <5mm	10YR3/4 Dark yellowish brown Nil mottles / bleaching	Dry, moderate	Few	0.30 / 6.5	0.90-1.00	
				B22 0.58-0.85 Abrupt	Light clay	Massive, apedal	2% coarse fragments <5mm	7.5YR5/6 Strong brown Nil mottles / bleaching	Dry, moderate	Nil	0.60 / 7.0

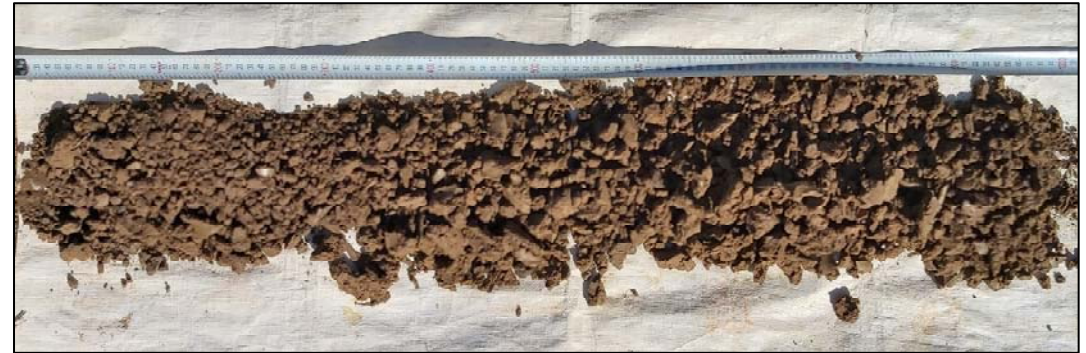
Land use Landform Pattern, Element, Slope	Vegetation	Microrelief Disturbance Erosion	Surface condition, surface rock	Soil Profile Description									
				Horizon Depth (m), Boundary	Field Texture	Structure, Strength, Cutans	Inclusions Segregations	Colour, Mottle, Bleaching	Moisture, Drainage	Roots	Depth (m) / Field pH	Sample (m)	Observations
Grazing Flat Plain 1% / <1%	Brigalow regrowth	Melon hole 30% coverage, 3- 6m wide, 0.2- 0.4m deep Minor to semi disturbance Nil erosion	Firm, hard setting Nil coarse fragments	A1 0.00-0.20 Abrupt	Light clay	Moderate, firm, subangular 10- 30mm	Nil	7.5YR3/2 Dark brown Nil mottles / bleaching	Dry, well to moderate	Common	0.10 / 6.5	Nil	Nil
				B21 0.20-0.62 Abrupt	Medium clay	Moderate, strong, subangular 20- 40mm	Nil	7.5YR3/2 Dark brown Nil mottles / bleaching	Dry, moderate	Few	0.30 / 7.0 0.60 / 7.0		
				B22 0.62-1.00 EOBH	Medium heavy clay	Moderate, strong, subangular 30- 50mm slickensides observed	Nil	7.5YR3/2 Dark brown Nil mottles / bleaching	Dry, moderate	Few	0.90 / 8.0

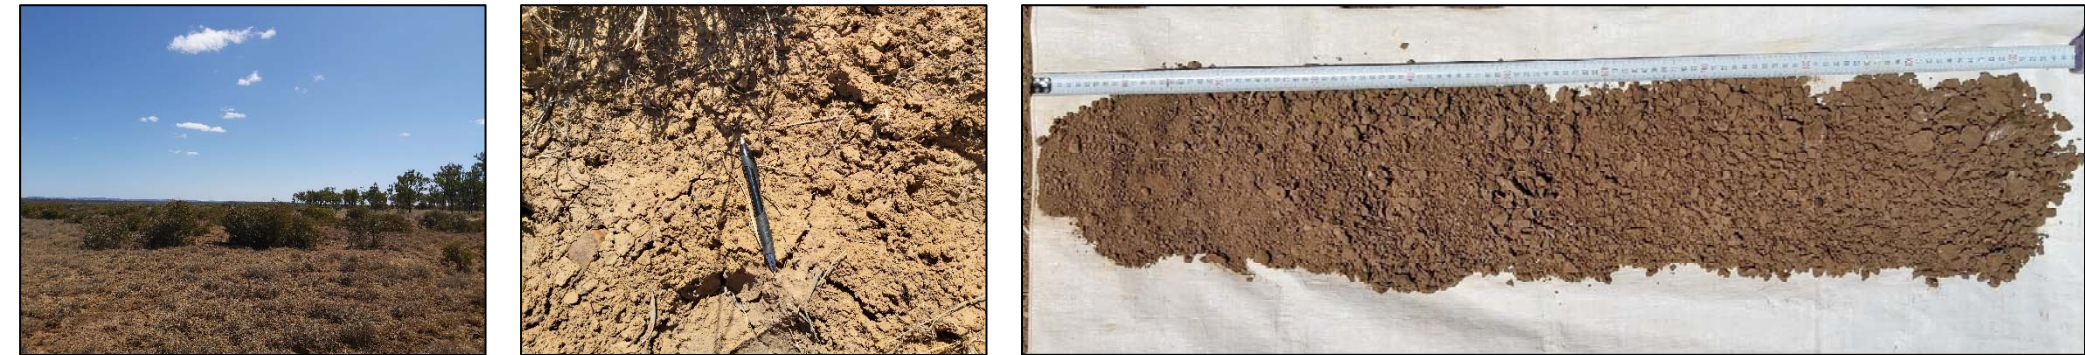
Land use Landform Pattern, Element, Slope	Vegetation	Microrelief Disturbance Erosion	Surface condition, surface rock	Soil Profile Description									
				Horizon Depth (m), Boundary	Field Texture	Structure, Strength, Cutans	Inclusions Segregations	Colour, Mottle, Bleaching	Moisture, Drainage	Roots	Depth (m) / Field pH	Sample (m)	Observations
Grazing Midslope <2%/1%	Brigalow regrowth	Melon hole 50% coverage, 3- 6m wide, 0.2- 0.4m deep Semi disturbance Nil erosion	Cracking, Nil coarse fragments	A1 0.00-0.14 Abrupt	Light clay	Weak, weak, subangular <10mm	Nil	10YR3/4 Dark yellowish brown Nil mottles / bleaching	Dry, well to moderate	Common	0.10 / 4.5	Nil	Nil
				B21 0.14-0.40 Abrupt	Light medium clay	Moderate, weak, subangular <10mm slickensides observed	<1% manganese nodules	10YR3/4 Dark yellowish brown Nil mottles / bleaching	Dry, moderate	Few	0.30 / 5.5 0.60 / 5.5		
				B22 0.40-1.00 EOBH	Medium clay	Moderate, firm, subangular 10- 20mm	Nil	10YR3/3 Dark brown Nil mottles / bleaching	Dry, moderate	Few	0.90 / 6.0

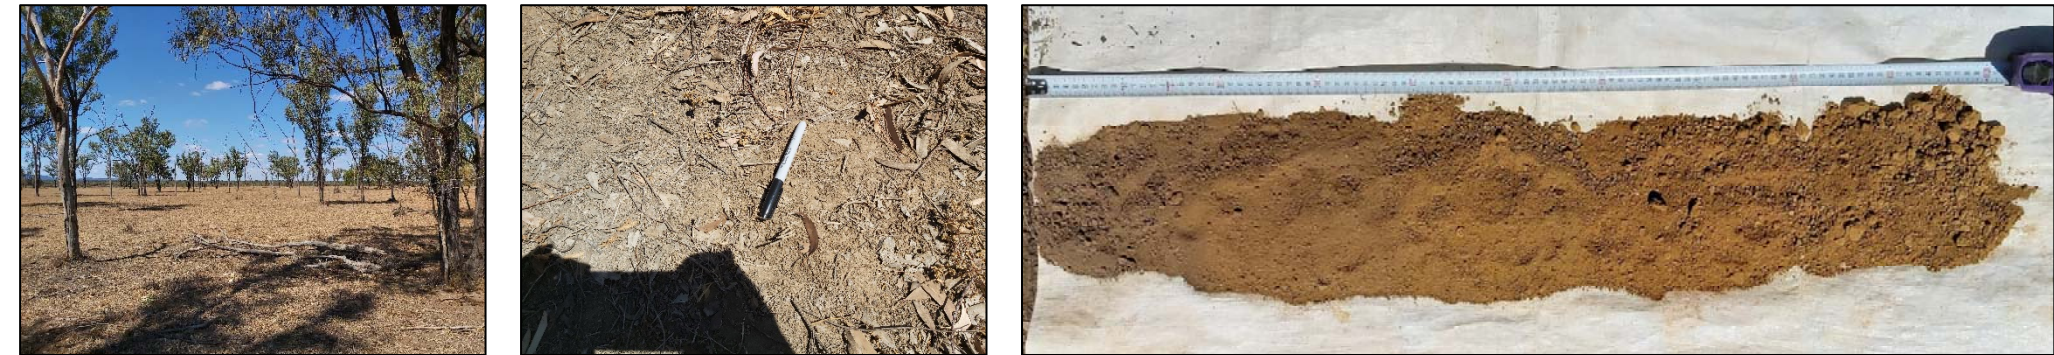
Land use Landform Pattern, Element, Slope	Vegetation	Microrelief Disturbance Erosion	Surface condition, surface rock	Soil Profile Description									
				Horizon Depth (m), Boundary	Field Texture	Structure, Strength, Cutans	Inclusions Segregations	Colour, Mottle, Bleaching	Moisture, Drainage	Roots	Depth (m) / Field pH	Sample (m)	Observations
Grazing Flat plain 1%/1%	Narrow Leaf Ironbark	Nil microrelief Semi disturbance Nil erosion	Firm, <2% coarse fragments <5mm	A1 0.00-0.11 Abrupt	Sandy loam	Massive, apedal	Nil	10YR4/2 Dark greyish brown Nil mottles / bleaching	Dry, well to moderate	Common	0.10 / 6.5	Nil	Nil
				B21 0.11-0.50 Abrupt	Clay loam	Massive, apedal	<2% coarse fragments <5mm	10YR3/4 Dark yellowish brown Nil mottles / bleaching	Dry, moderate	Few	0.30 / 6.5		
				B22 0.50-0.85 Abrupt	Light clay	Weak, apedal	2% coarse fragments <5mm	7.5YR5/6 Strong brown Nil mottles / bleaching	Dry, moderate	Nil	0.60 / 7.0

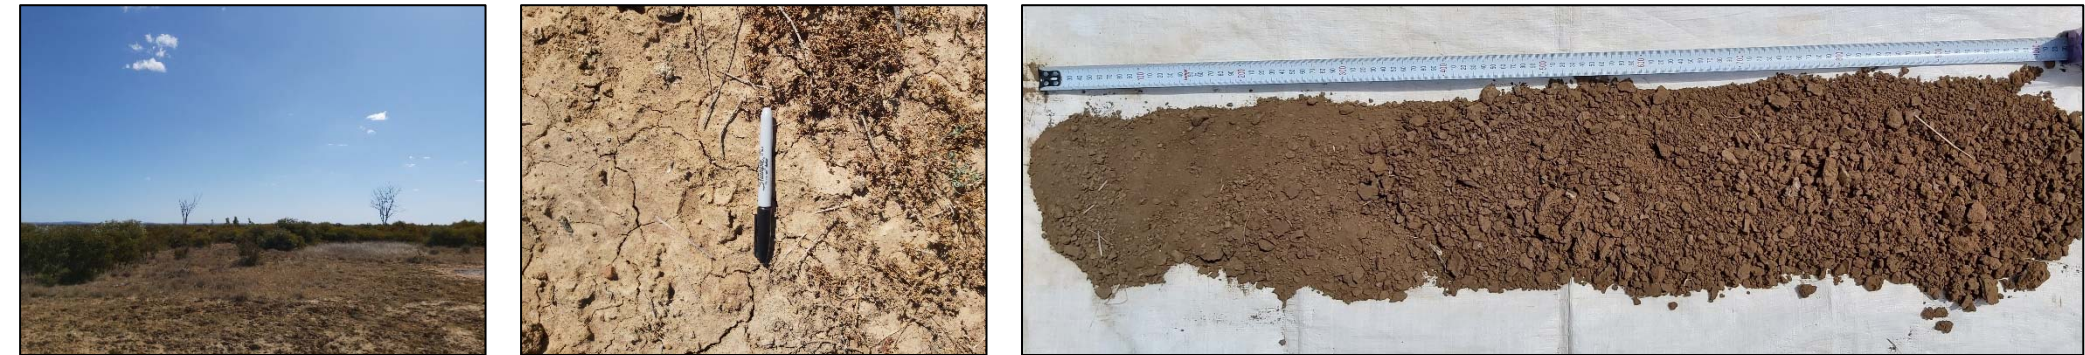
Land use Landform Pattern, Element, Slope	Vegetation	Microrelief Disturbance Erosion	Surface condition, surface rock	Soil Profile Description									
				Horizon Depth (m), Boundary	Field Texture	Structure, Strength, Cutans	Inclusions Segregations	Colour, Mottle, Bleaching	Moisture, Drainage	Roots	Depth (m) / Field pH	Sample (m)	Observations
Grazing Midslope <2%/1%	Brigalow regrowth	Melon hole 50% coverage, 3- 6m wide, 0.2- 0.4m deep Semi disturbance Nil erosion	Crust, Nil coarse fragments	A1 0.00-0.09 Abrupt	Light clay	Weak, firm, subangular <10mm	<2% manganese nodules	10YR3/3 Dark brown Nil mottles / bleaching	Dry, well to moderate	Common	0.10 / 6.5	Nil	Nil
				B21 0.09-0.60 Abrupt	Light medium clay	Weak, firm, subangular <10mm	<1% manganese nodules	7.5YR4/3 Brown Nil mottles / bleaching	Dry, moderate	Few	0.30 / 7.5 0.60 / 7.5		
				B22 0.60-1.00 EOBH	Light medium heavy clay	Weak, firm, subangular 10- 20mm slickensides observed	Nil	7.5YR4/3 Brown Nil mottles / bleaching	Dry, moderate	Few	0.90 / 6.5

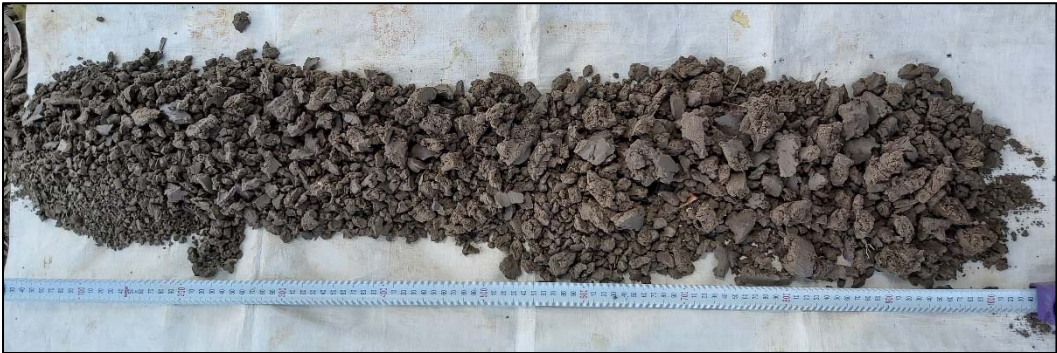
Soil Mapping Unit: C1-BL	Location (GDA94 ZONE 55): 634851 7539279	Australian Soil Class: Black Vertosol	Site Survey Type: Detailed Hand Auger 50mm	Survey Date: 21/09/2019
------------------------------------	--	---	--	-----------------------------------

Land use Landform Pattern, Element, Slope	Vegetation	Microrelief Disturbance Erosion	Surface condition, surface rock	Soil Profile Description									
				Horizon Depth (m), Boundary	Field Texture	Structure, Strength, Cutans	Inclusions Segregations	Colour, Mottle, Bleaching	Moisture, Drainage	Roots	Depth (m) / Field pH	Sample (m)	Observations
Grazing Flat Plain 1% / <1%	Brigalow	Melon hole 40% coverage, 3- 10m wide, 0.3-0.6m deep	Crust with cracking Nil coarse fragments	A1 0.00-0.12 Abrupt	Medium clay	Moderate, very firm, subangular <10mm	Nil	10YR3/2 Very dark greyish brown Nil mottles / bleaching	Dry, well to moderate	Common	0.10 / 5.5- 6.0	Nil	Nil
				B21 0.12-0.55 Abrupt	Medium heavy clay	Moderate, very firm, subangular <20mm	Nil	10YR3/1 Very dark grey Nil mottles / bleaching	Dry, moderate	Few	0.30 / 5.5-6.0		
				B22 0.55-1.00 EOBH	Medium heavy clay	Moderate, very firm, subangular <40mm slickensides observed	Nil	10YR3/1 Very dark grey Nil mottles / bleaching	Dry, moderate	Few	0.60 / 5.5-6.0 0.90 / 5.5

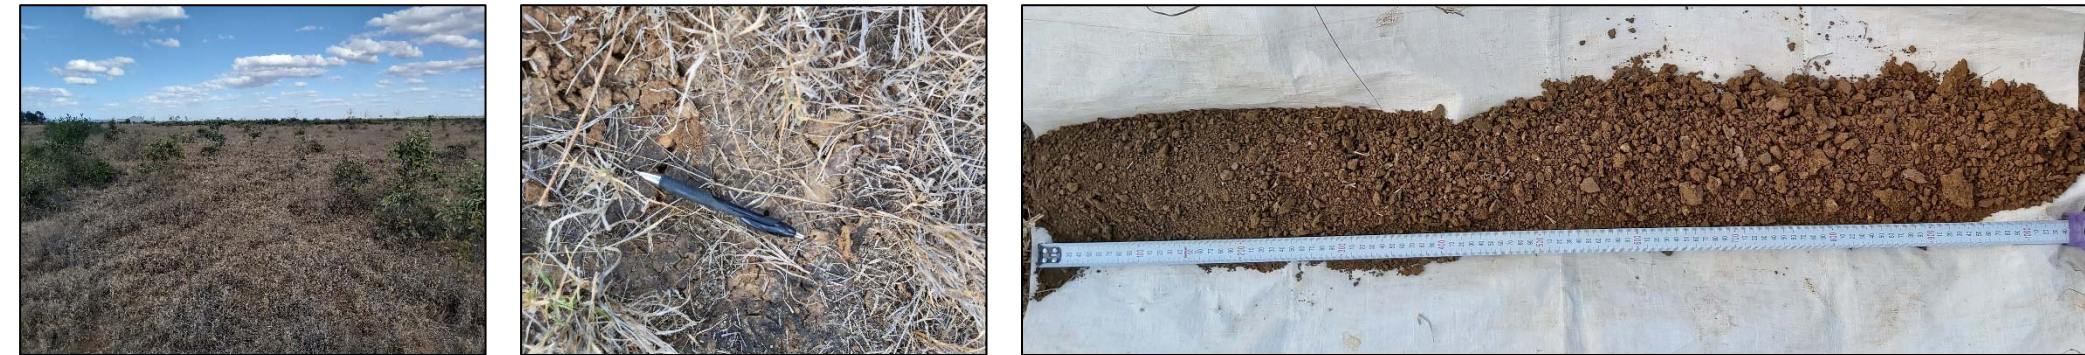
Land use Landform Pattern, Element, Slope	Vegetation	Microrelief Disturbance Erosion	Surface condition, surface rock	Soil Profile Description									
				Horizon Depth (m), Boundary	Field Texture	Structure, Strength, Cutans	Inclusions Segregations	Colour, Mottle, Bleaching	Moisture, Drainage	Roots	Depth (m) / Field pH	Sample (m)	Observations
Grazing Midslope 1%	Mixed regrowth	Nil microrelief Semi disturbance Nil erosion	Crust with cracking Nil coarse fragments	A1 0.00-0.15 Abrupt	Light clay	Moderate, firm, subangular <10mm	Nil	7.5YR3/2 Dark brown Nil mottles / bleaching	Dry, well to moderate	Common	0.10 / 6.5	0.00-0.10 0.20-0.30 0.50-0.60 0.70-0.80 0.90-1.00	Site placed in small polygon with no microrelief, surrounding areas feature melon holes
				B21 0.15-0.80 Abrupt	Medium clay	Moderate, firm, subangular <10mm	Nil	7.5YR4/3 Brown Nil mottles / bleaching	Dry, moderate	Few	0.30 / 6.5 0.60 / 6.5

B22 0.80-1.00 EOBH	Medium clay	Moderate, firm, subangular 10- 20mm slickensides observed	Nil	7.5YR4/4 Brown Nil mottles / bleaching	Dry, moderate	Few	0.90 / 7.0

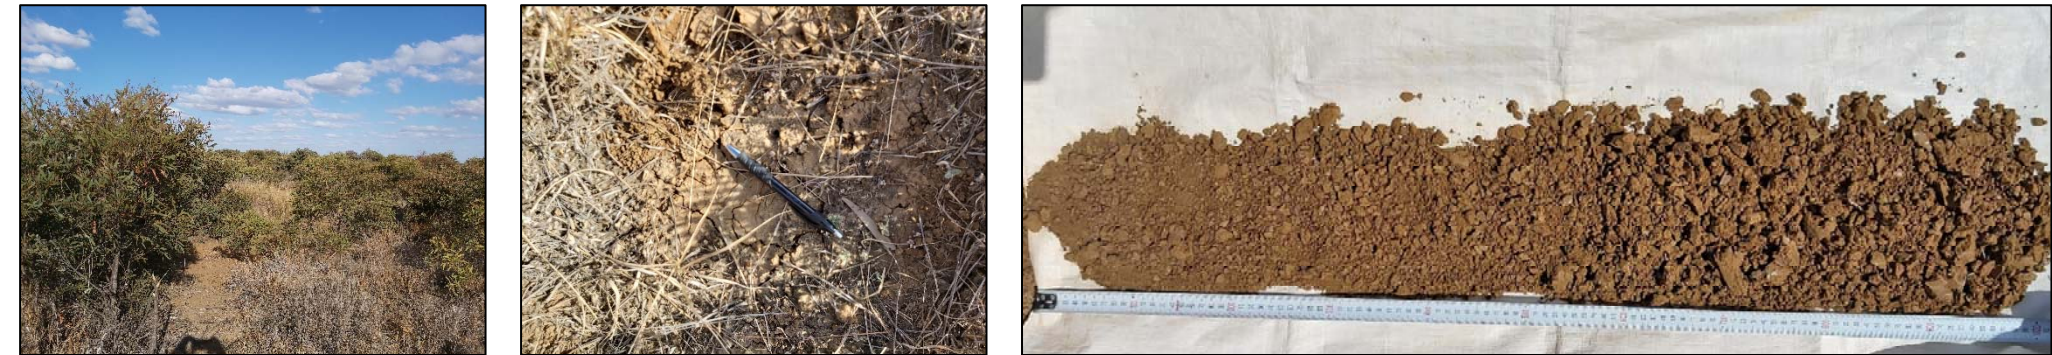
Land use Landform Pattern, Element, Slope	Vegetation	Microrelief Disturbance Erosion	Surface condition, surface rock	Soil Profile Description									
				Horizon Depth (m), Boundary	Field Texture	Structure, Strength, Cutans	Inclusions Segregations	Colour, Mottle, Bleaching	Moisture, Drainage	Roots	Depth (m) / Field pH	Sample (m)	Observations
Grazing Midslope <1%/1%	Brigalow regrowth	Melon hole 50% coverage, 3- 6m wide, 0.2- 0.4m deep Semi disturbance Nil erosion	Cracking, crust, Nil coarse fragments	A1 0.00-0.15 Abrupt	Light clay	Weak, weak, subangular <10mm	Nil	10YR3/4 Dark yellowish brown Nil mottles / bleaching	Dry, well to moderate	Common	0.10 / 6.0	Nil	Nil
				B21 0.15-0.45 Abrupt	Medium clay	Moderate, weak, subangular <10mm	Nil	10YR3/4 Dark yellowish brown Nil mottles / bleaching	Dry, moderate	Few	0.30 / 6.0 0.60 / 6.0		
				B22 0.45-1.00 EOBH	Medium clay	Moderate, firm, subangular 10- 20mm slickensides observed	Nil	7.5YR4/4 Brown Nil mottles / bleaching	Dry, moderate	Few	0.90 / 6.0

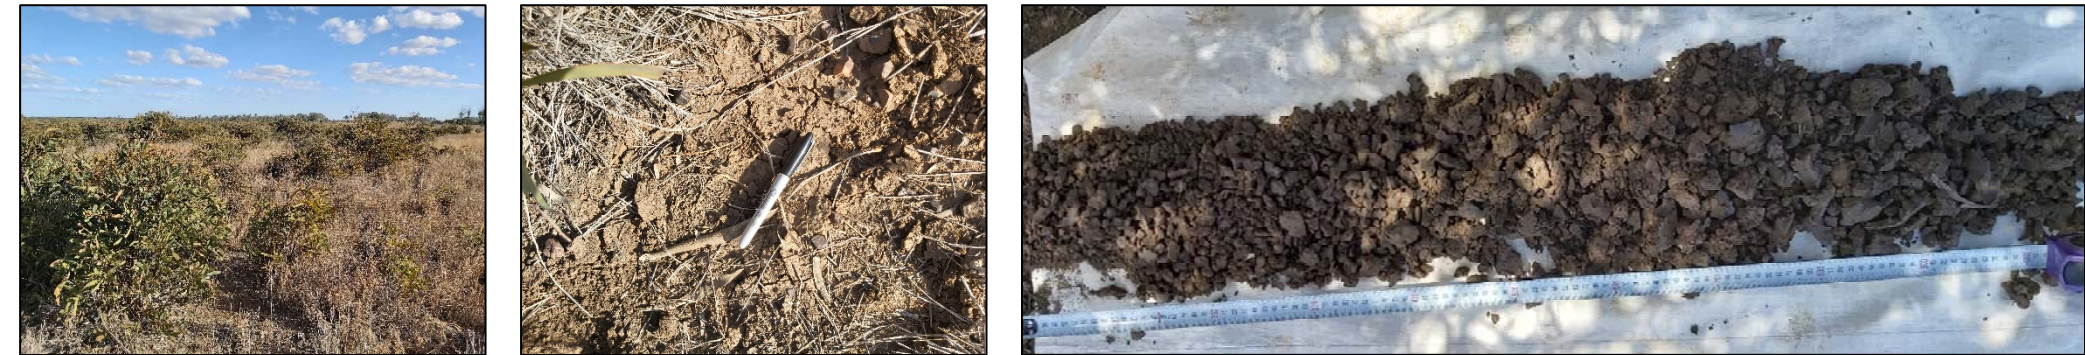
Land use Landform Pattern, Element, Slope	Vegetation	Microrelief Disturbance Erosion	Surface condition, surface rock	Soil Profile Description									
				Horizon Depth (m), Boundary	Field Texture	Structure, Strength, Cutans	Inclusions Segregations	Colour, Mottle, Bleaching	Moisture, Drainage	Roots	Depth (m) / Field pH	Sample (m)	Observations
Grazing Flat Plain 1% / <1%	Brigalow	Melon hole 40-50% coverage, 3- 10m wide, 0.3-0.6m deep	Crust with crust Nil coarse fragments	A1 0.00-0.15 Abrupt	Medium clay	Moderate, very firm, subangular <10mm	Nil	10YR3/2 Very dark greyish brown Nil mottles / bleaching	Dry, well to moderate	Common	0.10 / 5.5	Nil	Nil
				B21 0.15-0.55 Abrupt	Medium clay	Moderate, very firm, subangular <20mm	Nil	10YR3/1 Very dark grey Nil mottles / bleaching	Dry, moderate	Few	0.30 / 6.0		
				B22 0.55-1.00 EOBH	Medium heavy clay	Moderate, very firm, subangular <40mm slickensides observed	Nil	10YR3/1 Very dark grey Nil mottles / bleaching	Dry, moderate	Few	0.60 / 6.0 0.90 / 5.5

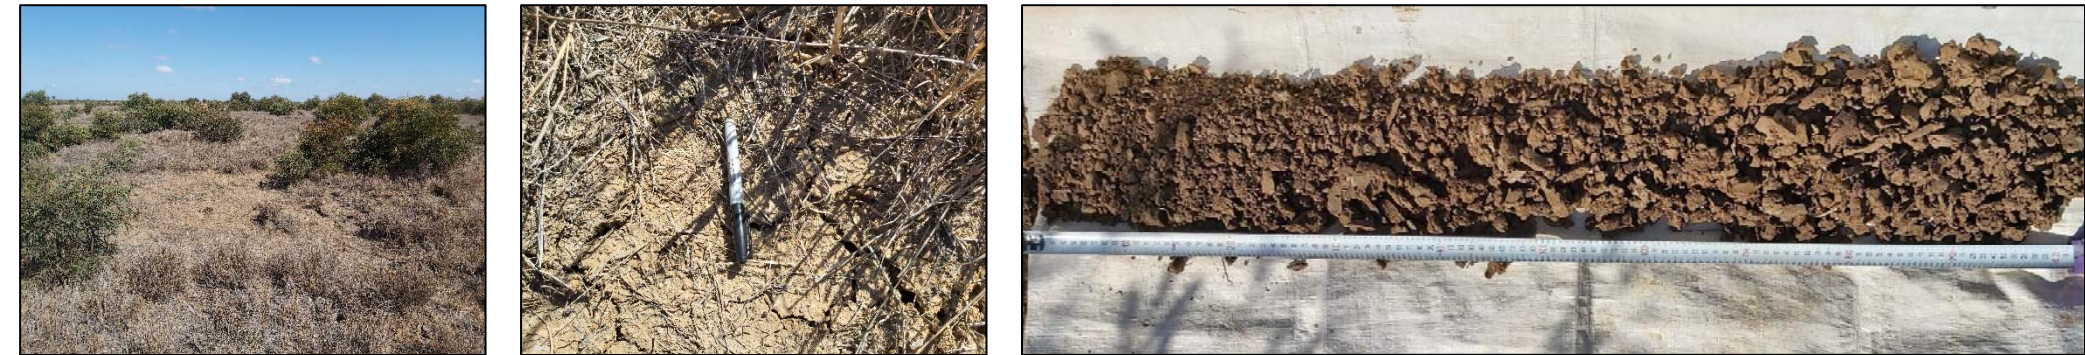
Land use Landform Pattern, Element, Slope	Vegetation	Microrelief Disturbance Erosion	Surface condition, surface rock	Soil Profile Description									
				Horizon Depth (m), Boundary	Field Texture	Structure, Strength, Cutans	Inclusions Segregations	Colour, Mottle, Bleaching	Moisture, Drainage	Roots	Depth (m) / Field pH	Sample (m)	Observations
Grazing Flat Plain 1% / <1%	Brigalow regrowth	Melon hole 30% coverage, 3- 6m wide, 0.2- 0.4m deep Minor to semi disturbance Nil erosion	Firm, cracking Nil coarse fragments	A1 0.00-0.15 Abrupt	Light clay	Moderate, firm, subangular 10- 30mm	Nil	7.5YR3/2 Dark brown Nil mottles / bleaching	Dry, well to moderate	Common	0.10 / 6.5	Nil	Nil
				B21 0.15-0.60 Abrupt	Medium clay	Moderate, strong, subangular 20- 40mm slickensides observed	Nil	7.5YR3/2 Dark brown Nil mottles / bleaching	Dry, moderate	Few	0.30 / 6.5 0.55 / 6.5		
				B22 0.60-1.00 EOBH	Medium heavy clay	Moderate, strong, subangular 30- 50mm slickensides observed	Nil	7.5YR3/2 Dark brown Nil mottles / bleaching	Dry, moderate	Few	0.90 / 7.5

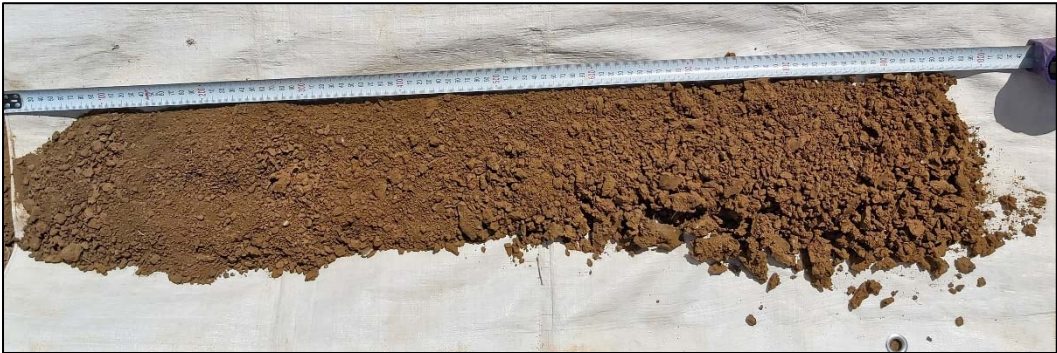
Soil Mapping Unit: C1-BR	Location (GDA94 ZONE 55): 634457 7544037	Australian Soil Class: Brown Vertosol	Site Survey Type: Detailed Hand Auger 50mm	Survey Date: 22/09/2019
------------------------------------	--	---	--	-----------------------------------

Land use Landform Pattern, Element, Slope	Vegetation	Microrelief Disturbance Erosion	Surface condition, surface rock	Soil Profile Description									
				Horizon Depth (m), Boundary	Field Texture	Structure, Strength, Cutans	Inclusions Segregations	Colour, Mottle, Bleaching	Moisture, Drainage	Roots	Depth (m) / Field pH	Sample (m)	Observations
Grazing Midslope 1%	Brigalow regrowth	Melon hole 40-50% coverage, 2- 5m wide, 0.2- 0.4m deep Semi disturbance Nil erosion	Cracking, Nil coarse fragments	A1 0.00-0.15 Abrupt	Light clay	Weak, weak, subangular <10mm	Nil	10YR3/4 Dark yellowish brown Nil mottles / bleaching	Dry, well to moderate	Common	0.10 / 5.5	Nil	Nil
				B21 0.15-0.38 Abrupt	Light medium clay	Moderate, weak, subangular <10mm	Nil	10YR3/4 Dark yellowish brown Nil mottles / bleaching	Dry, moderate	Few	0.30 / 6.5 0.60 / 6.5		
				B22 0.38-1.00 EOBH	Medium clay	Moderate, firm, subangular 10- 20mm slickensides observed	Nil	10YR3/3 Dark brown Nil mottles / bleaching	Dry, moderate	Few	0.90 / 6.5
