WINCHESTER SOUTH PROJECT

Soils and Land Suitability Assessment Addendum

Winchester South Project
Whitehaven WS Pty Ltd

23 June 2022

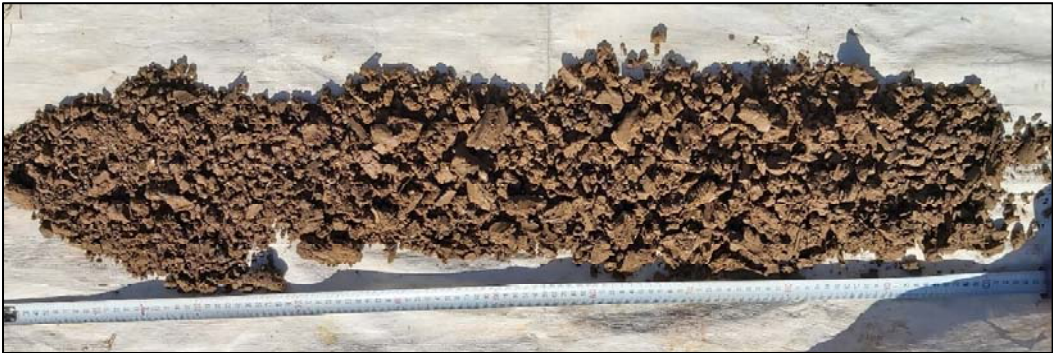
Soil Mapping Unit: C1-BR	Location (GDA94 ZONE 55): 635436 7542867	Australian Soil Class: Brown Vertosol	Site Survey Type: Detailed Hand Auger 50mm	Survey Date: 22/09/2019
------------------------------------	--	---	--	-----------------------------------

Land use Landform Pattern, Element, Slope	Vegetation	Microrelief Disturbance Erosion	Surface condition, surface rock	Soil Profile Description									
				Horizon Depth (m), Boundary	Field Texture	Structure, Strength, Cutans	Inclusions Segregations	Colour, Mottle, Bleaching	Moisture, Drainage	Roots	Depth (m) / Field pH	Sample (m)	Observations
Grazing, Flat Plain 1%	Sparse Brigalow regrowth	Melon hole 40% coverage, 3-5 m wide, 0.2- 0.4m deep Minor to semi disturbance Nil erosion	Firm, cracking, self-mulching Nil coarse fragments	A1 0.00-0.14 Abrupt	Light clay	Moderate, firm, subangular 10- 30mm	Nil	7.5YR3/2 Dark brown Nil mottles / bleaching	Dry, well to moderate	Common	0.10 / 6.0	Nil	Nil
				B21 0.14-0.62 Abrupt	Medium clay	Moderate, strong, subangular 20- 40mm slickensides observed	Nil	7.5YR3/2 Dark brown Nil mottles / bleaching	Dry, moderate	Few	0.30 / 6.5 0.60 / 6.5		
				B22 0.62-1.00 EOBH	Medium heavy clay	Moderate, strong, subangular 30- 50mm slickensides observed	Nil	7.5YR3/2 Dark brown Nil mottles / bleaching	Dry, moderate	Few	0.90 / 7.0

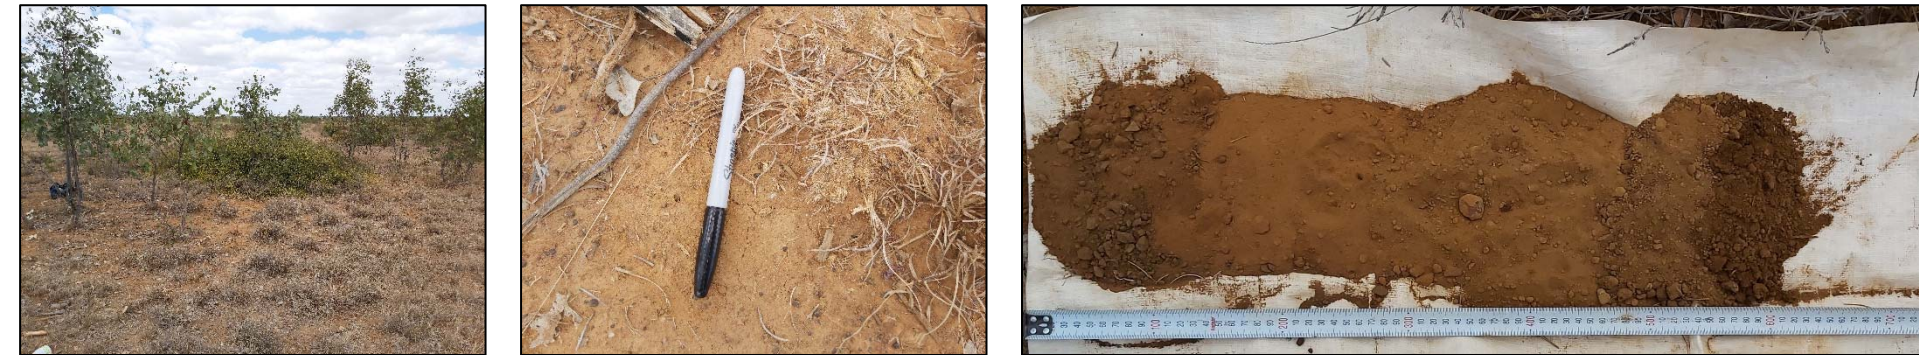
Land use Landform Pattern, Element, Slope	Vegetation	Microrelief Disturbance Erosion	Surface condition, surface rock	Soil Profile Description									
				Horizon Depth (m), Boundary	Field Texture	Structure, Strength, Cutans	Inclusions Segregations	Colour, Mottle, Bleaching	Moisture, Drainage	Roots	Depth (m) / Field pH	Sample (m)	Observations
Flat plain <1%	Mixed regrowth with Poplar Box	Nil microrelief Semi disturbance Nil erosion	Firm to hard setting, <1% coarse fragments including Mg nodules	A1 0.00-0.10 Abrupt	Sandy loam	Weak, loose	2% coarse fragments 1-3mm	7.5YR2.5/3 Very dark brown Nil mottles / bleaching	Dry, rapidly drained	Common	0.10 / 6.0	0.00-0.10 0.20-0.30 0.50-0.60	No auger recovery at 0.60m, three attempts
				B21 0.10-0.60+	Clay loam	Massive, weak	2% coarse fragments 1-3mm	7.5YR4/4 Brown Nil mottles / bleaching	Dry, rapidly drained	Nil	0.30 / 5.5 0.60 / 5.5

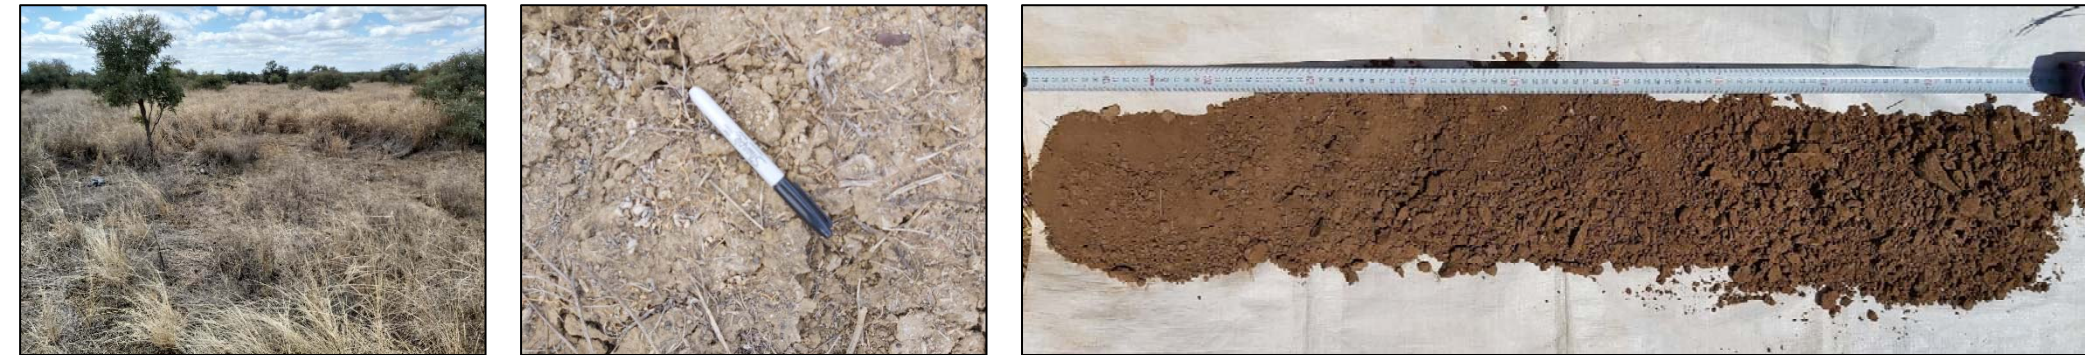
Land use Landform Pattern, Element, Slope	Vegetation	Microrelief Disturbance Erosion	Surface condition, surface rock	Soil Profile Description									
				Horizon Depth (m), Boundary	Field Texture	Structure, Strength, Cutans	Inclusions Segregations	Colour, Mottle, Bleaching	Moisture, Drainage	Roots	Depth (m) / Field pH	Sample (m)	Observations
Grazing, Flat Plain 1%	Brigalow regrowth	Melon hole 40% coverage, 3-5 m wide, 0.2- 0.4m deep Minor to semi disturbance Nil erosion	Firm, cracking self-mulching Nil coarse fragments	A1 0.00-0.18 Abrupt	Light clay	Moderate, firm, subangular 10- 30mm	Nil	7.5YR3/2 Dark brown Nil mottles / bleaching	Dry, well to moderate	Common	0.10 / 6.0	Nil	Nil
				B21 0.18-0.62 Abrupt	Medium clay	Moderate, strong, subangular 20- 40mm	Nil	7.5YR3/2 Dark brown Nil mottles / bleaching	Dry, moderate	Few	0.30 / 6.5 0.60 / 6.5		
				B22 0.62-1.00 EOBH	Medium clay	Moderate, strong, subangular 30- 50mm slickensides observed	Nil	7.5YR3/2 Dark brown Nil mottles / bleaching	Dry, moderate	Few	0.90 / 6.5

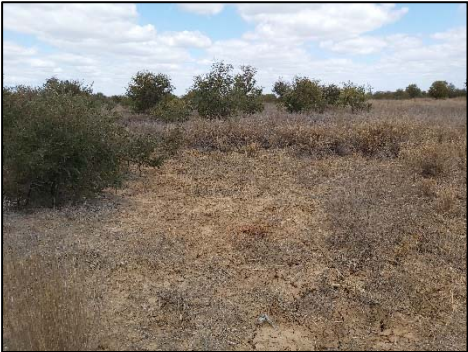
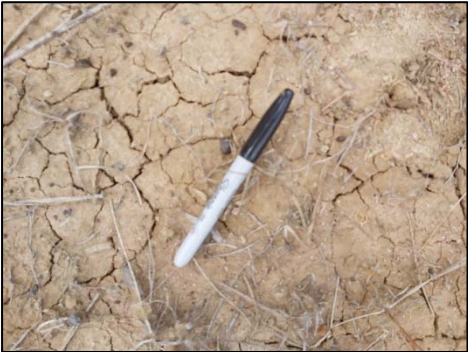
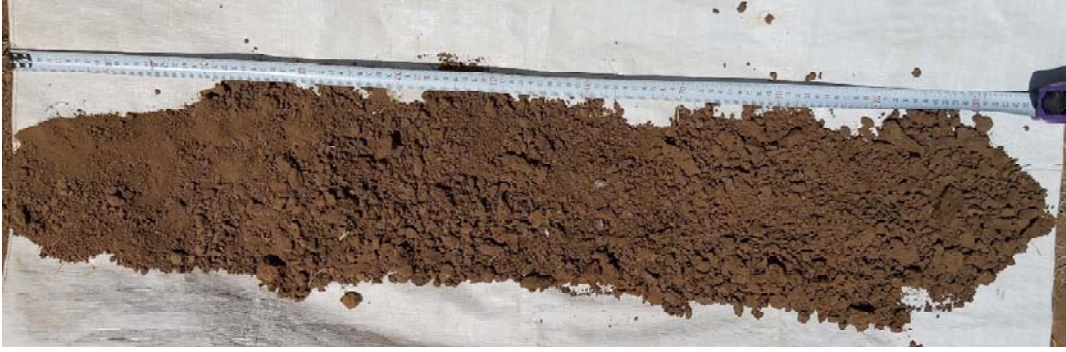
Land use Landform Pattern, Element, Slope	Vegetation	Microrelief Disturbance Erosion	Surface condition, surface rock	Soil Profile Description									
				Horizon Depth (m), Boundary	Field Texture	Structure, Strength, Cutans	Inclusions Segregations	Colour, Mottle, Bleaching	Moisture, Drainage	Roots	Depth (m) / Field pH	Sample (m)	Observations
Grazing Midslope <2%/1%	Brigalow regrowth	Melon hole 50% coverage, 3- 6m wide, 0.2- 0.4m deep Semi disturbance Nil erosion	Crust Nil coarse fragments	A1 0.00-0.09 Abrupt	Light clay	Weak, firm, subangular <10mm	<2% manganese nodules	10YR3/3 Dark brown Nil mottles / bleaching	Dry, well to moderate	Common	0.10 / 6.5	Nil	Nil
				B21 0.09-0.66 Abrupt	Light medium clay	Weak, firm, subangular <10mm	Nil	7.5YR4/3 Brown Nil mottles / bleaching	Dry, moderate	Few	0.30 / 6.5 0.60 / 6.5		
				B22 0.66-1.00 EOBH	Light medium clay	Weak, firm, subangular 10- 20mm, slickensides observed	Nil	7.5YR4/3 Brown Nil mottles / bleaching	Dry, moderate	Few	0.90 / 7.0

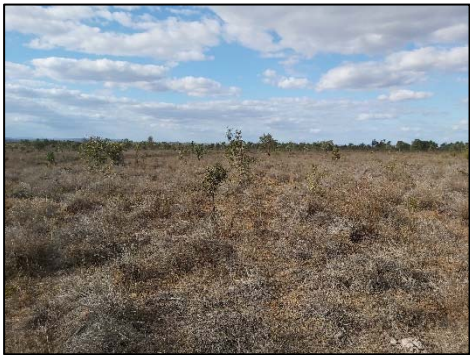
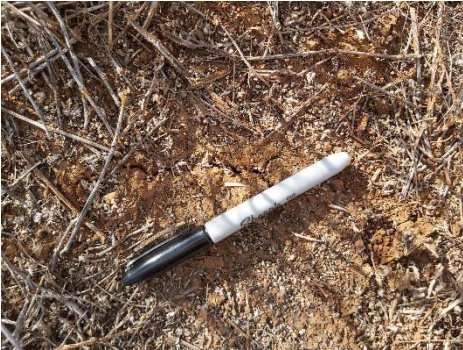
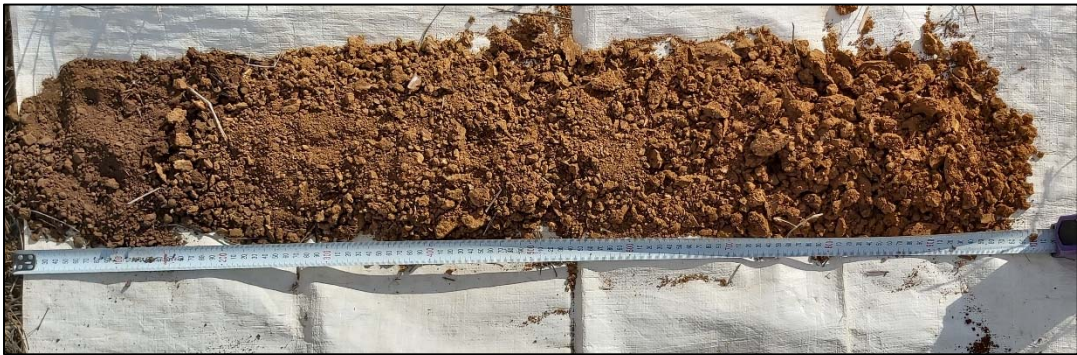
SITE 26

Soil Mapping Unit: C3-BR	Location (GDA94 ZONE 55): 633122 7545375	Australian Soil Class: Brown Dermosol (Sub-dominant within SPC Map Unit)	Site Survey Type: Detailed Hand Auger 50mm	Survey Date: 22/09/2019
------------------------------------	--	--	--	-----------------------------------

Land use Landform Pattern, Element, Slope	Vegetation	Microrelief Disturbance Erosion	Surface condition, surface rock	Soil Profile Description									
				Horizon Depth (m), Boundary	Field Texture	Structure, Strength, Cutans	Inclusions Segregations	Colour, Mottle, Bleaching	Moisture, Drainage	Roots	Depth (m) / Field pH	Sample (m)	Observations
Grazing, gently undulating plain, upper slope 1-2%	Grasses, nearby white/grey gums	Nil microrelief Semi disturbance Nil erosion	Crust with cracking nil coarse fragments	A1 0.00-0.18 Abrupt	Light clay	Weak, very firm peds <10mm	Nil	7.5YR3/3 Dark brown Nil mottles / bleaching	Dry, well drained	Common	0.10 / 6.0	Nil	Nil
				B21 0.18-0.68 Gradual	Light clay	Weak to moderate, firm, peds <20mm	<1% <2mm manganese nodules	7.5YR4/3 Brown Nil mottles / bleaching	Dry, moderately well drained	Few	0.30 / 6.5 0.60 / 6.5		
				B22 0.68-1.00 EOBH	Light medium clay	Moderate, very firm, peds 10- 20mm slickensides observed	<1% <2mm manganese nodules	10YR5/6 Yellowish brown Nil mottles / bleaching	Dry, moderately well drained	Nil	0.90 / 6.5

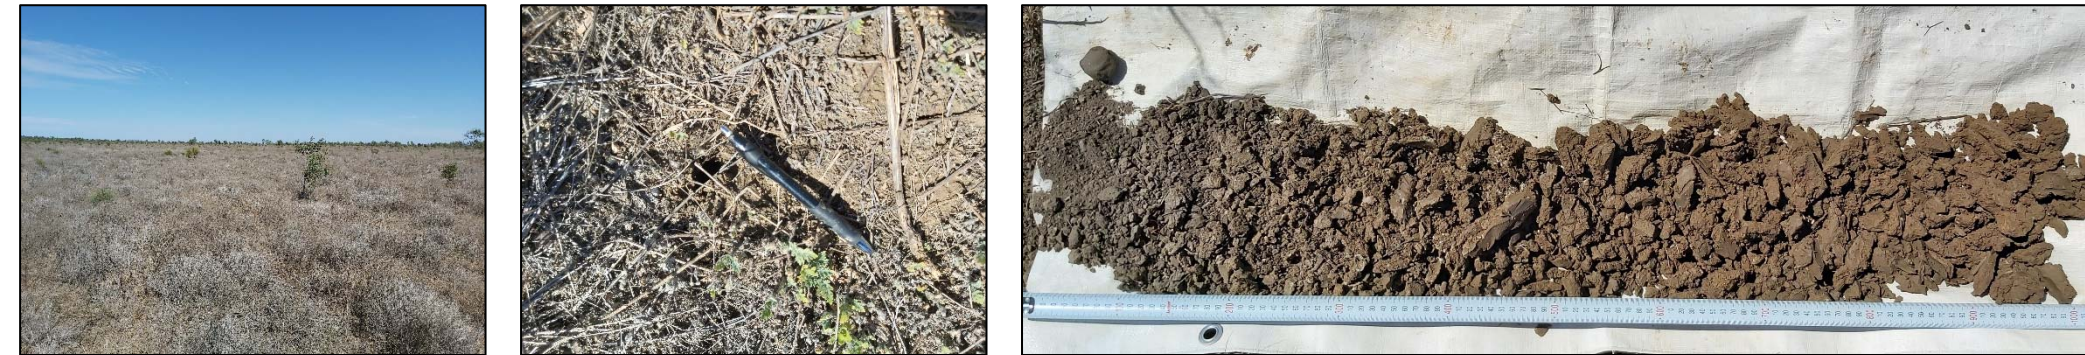
Land use Landform Pattern, Element, Slope	Vegetation	Microrelief Disturbance Erosion	Surface condition, surface rock	Soil Profile Description									
				Horizon Depth (m), Boundary	Field Texture	Structure, Strength, Cutans	Inclusions Segregations	Colour, Mottle, Bleaching	Moisture, Drainage	Roots	Depth (m) / Field pH	Sample (m)	Observations
Grazing, gently undulating plain, mid slope 2-3%	Grasses, nearby white/grey gums	1% normal gilgai in the area 0.2-0.3m deep Semi disturbance Nil erosion	Crust with cracking nil coarse fragments	A1 0.00-0.12 Abrupt	Light clay	Weak, firm	Nil	10YR4/2 Dark greyish brown Nil mottles / bleaching	Dry, well drained	Common	0.10 / 8.0	0.00-0.10 0.20-0.30 0.45-0.55 0.70-0.80 0.90-1.00	Nil
				B21 0.12-0.33 Abrupt	Medium clay	Weak, firm	<2% calcium carbonate	10YR4/3 Brown Nil mottles / bleaching	Dry, moderately well drained	Few	0.25 / 7.0		
				B22 0.33-0.55 Clear	Medium clay	Moderate, strong, subangular blocky slickensides observed	<2% calcium carbonate	10YR4/4 Dark yellowish brown Nil mottles / bleaching	Dry, moderately well drained	Few	0.50 / 7.0

B23 0.66-1.00 EOBH	Medium clay	Moderate, firm, subangular blocky	<1% manganese nodules	10YR4/4 Dark yellowish brown Nil mottles / bleaching	Dry, moderately well drained	Nil	0.90 / 7.5

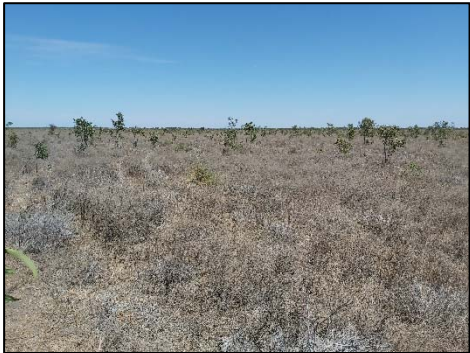
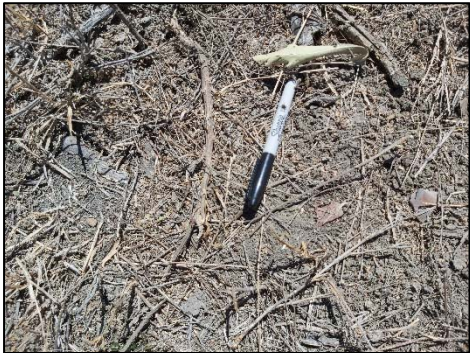
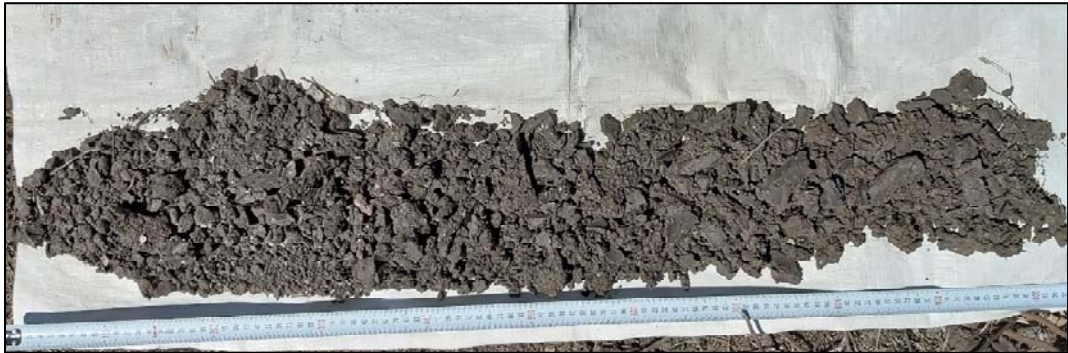
Land use Landform Pattern, Element, Slope	Vegetation	Microrelief Disturbance Erosion	Surface condition, surface rock	Soil Profile Description									
				Horizon Depth (m), Boundary	Field Texture	Structure, Strength, Cutans	Inclusions Segregations	Colour, Mottle, Bleaching	Moisture, Drainage	Roots	Depth (m) / Field pH	Sample (m)	Observations
Grazing, gently undulating plain, lower slope 1-2%	Grasses	Nil microrelief Extensive disturbance Nil erosion	Self mulching with cracking nil coarse fragments	A1 0.00-0.14 Abrupt	Light medium clay	Moderate, weak, sub-rounded	Nil	10YR3/1 Very dark grey Nil mottles / bleaching	Dry, well drained	Common	0.10 / 7.5	Nil	Nil
				B21 0.14-0.33 Abrupt	Light medium clay	Moderate, firm, subangular 10- 20mm peds	<2% calcium carbonate	10YR3/1 Very dark grey Nil mottles / bleaching	Dry, moderately well drained	Few	0.25 / 8.0		
				B22 0.33-0.78 Clear	Medium clay	Moderate, firm, subangular 10- 20mm peds	<1% calcium carbonate	10YR3/1 Very dark grey Nil mottles / bleaching	Dry, moderately well drained	Few	0.55 / 8.0

B23 0.78-1.00 EOBH	Medium clay	Moderate, firm, subangular 20- 40mm peds Slickensides observed	Nil	10YR3/2 Very dark greyish brown Nil mottles / bleaching	Dry, moderately well drained	Nil	0.90 / 8.0

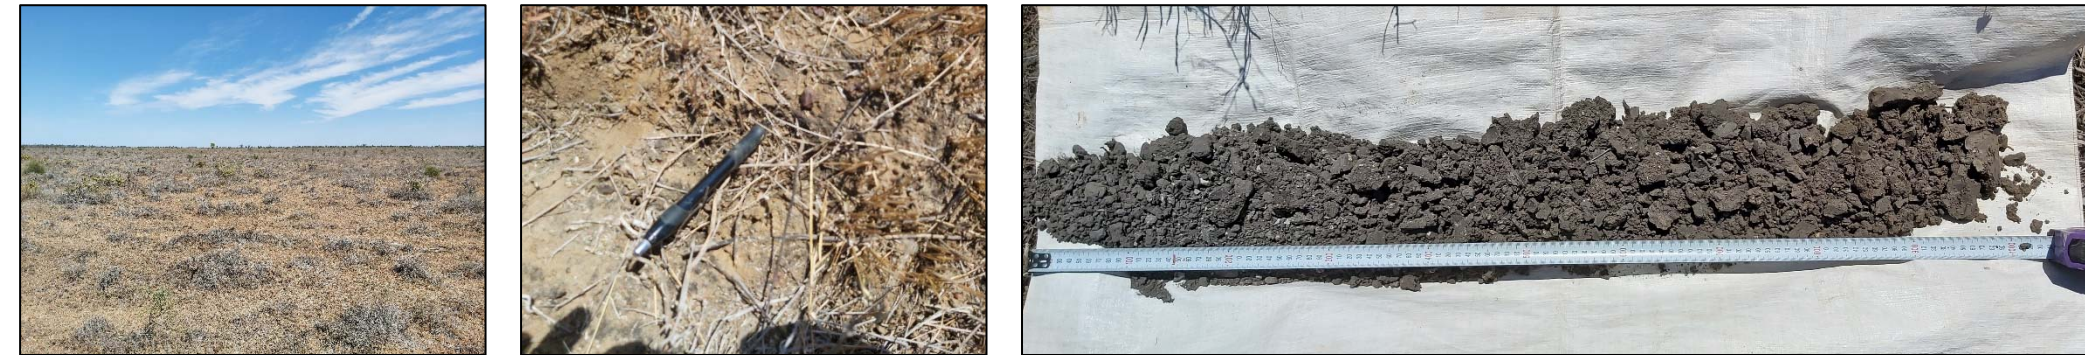
Land use Landform Pattern, Element, Slope	Vegetation	Microrelief Disturbance Erosion	Surface condition, surface rock	Soil Profile Description									
				Horizon Depth (m), Boundary	Field Texture	Structure, Strength, Cutans	Inclusions Segregations	Colour, Mottle, Bleaching	Moisture, Drainage	Roots	Depth (m) / Field pH	Sample (m)	Observations
Grazing, gently undulating plain, lower slope 1-2%	Grasses	Nil microrelief Extensive disturbance Nil erosion	Crust nil coarse fragments	A1 0.00-0.15 Abrupt	Light medium clay	Moderate, weak, sub-rounded	Nil	10YR3/1 Very dark grey Nil mottles / bleaching	Dry, well drained	Common	0.10 / 7.5	Nil	Nil
				B21 0.15-0.45 Abrupt	Light medium clay	Moderate, firm, subangular 10- 20mm peds	<2% calcium carbonate	10YR3/1 Very dark grey Nil mottles / bleaching	Dry, moderately well drained	Few	0.25 / 7.0		
				B22 0.45-1.00 EOBH	Medium clay	Moderate, firm, subangular 20- 40mm peds slickensides observed	Nil	10YR3/2 Very dark greyish brown Nil mottles / bleaching	Dry, moderately well drained	Few	0.60 / 7.5 0.90 / 7.5

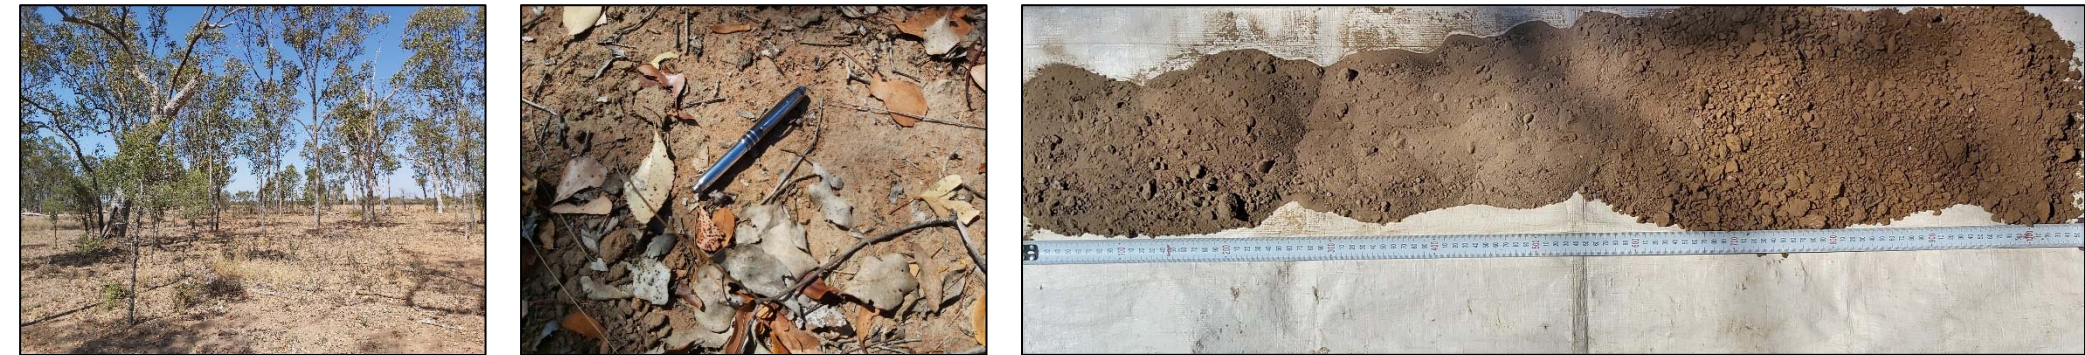
Land use Landform Pattern, Element, Slope	Vegetation	Microrelief Disturbance Erosion	Surface condition, surface rock	Soil Profile Description									
				Horizon Depth (m), Boundary	Field Texture	Structure, Strength, Cutans	Inclusions Segregations	Colour, Mottle, Bleaching	Moisture, Drainage	Roots	Depth (m) / Field pH	Sample (m)	Observations
Grazing, gently undulating plain, mid slope 1-2%	Poplar Box	Nil microrelief Nil disturbance Nil erosion	Hard setting, 1% coarse fragments <2mm	A11 0.00-0.12 Diffuse	Loamy sand	Massive, loose	Nil	10YR3/3 Dark brown Nil mottles / bleaching	Dry, rapidly drained	Common	0.10 / 6.0	Nil	Nil
				A12 0.12-0.40 Abrupt	Loamy sand	Massive, loose	Nil	10YR5/3 Brown Nil mottles / bleaching	Dry, rapidly drained	Few	0.30 / 6.5		
				A13 0.40-0.60 Abrupt	Loamy sand	Massive, loose	<5% coarse fragments <1mm	10YR5/3 Brown Nil mottles / bleaching	Dry, rapidly drained	Nil	0.55 / 6.5

B2 0.60-1.00 EOBH	Sandy clay loam	Weak to moderate, firm, subangular	Nil	10YR4/4 Dark yellowish brown Nil mottles / bleaching	Dry, well drained	Nil	0.90 / 7.0

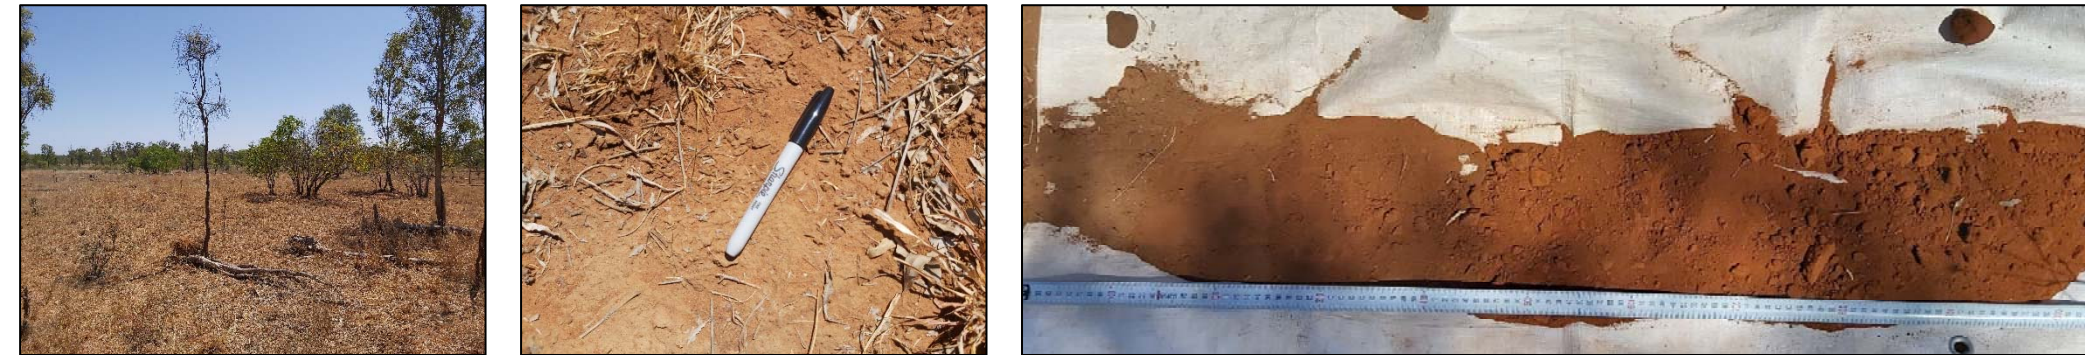
Land use Landform Pattern, Element, Slope	Vegetation	Microrelief Disturbance Erosion	Surface condition, surface rock	Soil Profile Description									
				Horizon Depth (m), Boundary	Field Texture	Structure, Strength, Cutans	Inclusions Segregations	Colour, Mottle, Bleaching	Moisture, Drainage	Roots	Depth (m) / Field pH	Sample (m)	Observations
Grazing Flat Plain <1% / 1%	Exotic grassland	Nil microrelief Semi disturbance Nil erosion	Firm, Nil coarse fragments	A11 0.00-0.12 Abrupt	Loamy sand	Massive, loose	Nil	7.5YR3/3 Dark brown Nil mottles / bleaching	Dry, Rapid	Common	0.10 / 6.0	0.00-0.10 0.20-0.30 0.50-0.60 0.70-0.80 0.90-1.00	Nil
				B21 0.12-0.45 Abrupt	Sandy loam	Massive, loose	Nil	5YR3/4 Dark reddish brown Nil mottles / bleaching	Dry, Well	Few	0.30 / 6.0		
				B22 0.45-1.00 EOBH	Sandy clay loam	Massive, minor weak structure, loose	Nil	2.5YR3/4 Dark reddish brown Nil mottles / bleaching	Dry, Well	Nil	0.60 / 6.0 0.90 / 6.0

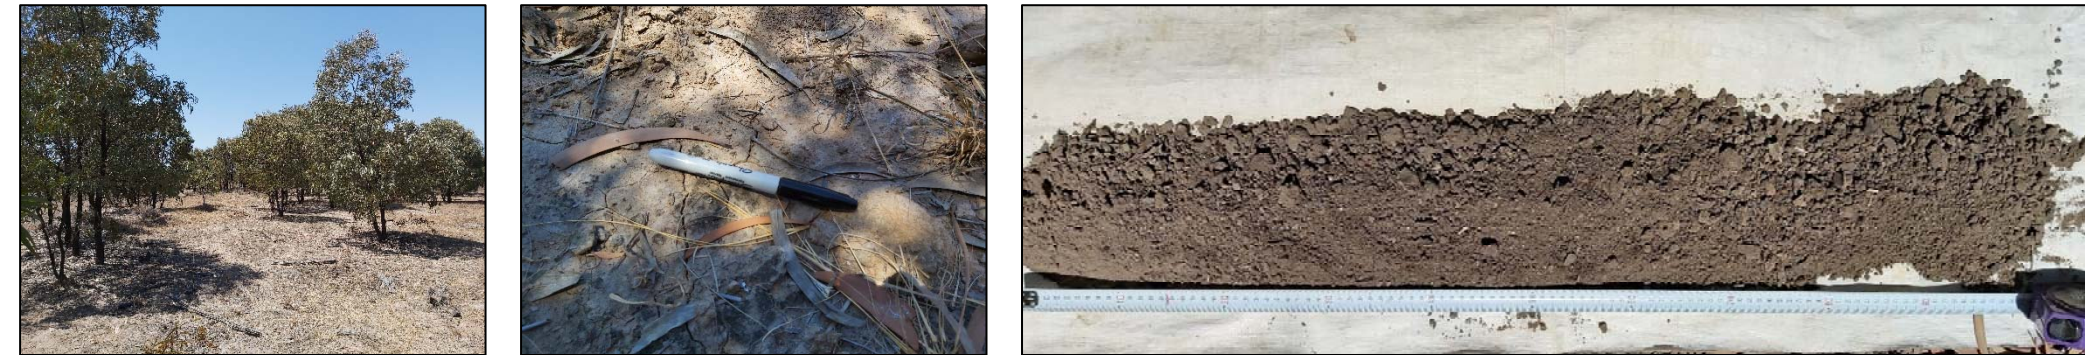
Land use Landform Pattern, Element, Slope	Vegetation	Microrelief Disturbance Erosion	Surface condition, surface rock	Soil Profile Description									
				Horizon Depth (m), Boundary	Field Texture	Structure, Strength, Cutans	Inclusions Segregations	Colour, Mottle, Bleaching	Moisture, Drainage	Roots	Depth (m) / Field pH	Sample (m)	Observations
Grazing, gently undulating plain, flat plain 1%	Brigalow	Gilgai 50% coverage depth 0.24- 0.29m disturbance Nil erosion	Crust wit cracking, observed in area, nil coarse fragments	A1 0.00-0.12 Abrupt	Light medium clay	Weak, firm, angular <5mm peds	Nil	10YR4/1 Dark grey Nil mottles / bleaching	Dry, well drained	Common	0.10 / 7.0	0.00-0.10	Nil
				B21 0.12-0.75 Abrupt	Medium clay	Weak, firm, angular <10mm peds	Nil	10YR4/1 Dark grey Nil mottles / bleaching	Dry, well drained	Few	0.30 / 7.0 0.60 / 7.0	0.50-0.60	
				B22 0.75-1.00 EOBH	Medium clay	Weak, firm, angular <10mm peds slickensides observed	Nil	10YR4/2 Dark greyish brown Nil mottles / bleaching	Dry, well drained	Nil	0.90 / 7.5	0.75-0.85 0.90-1.00

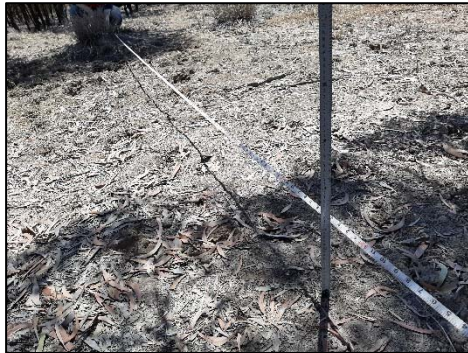
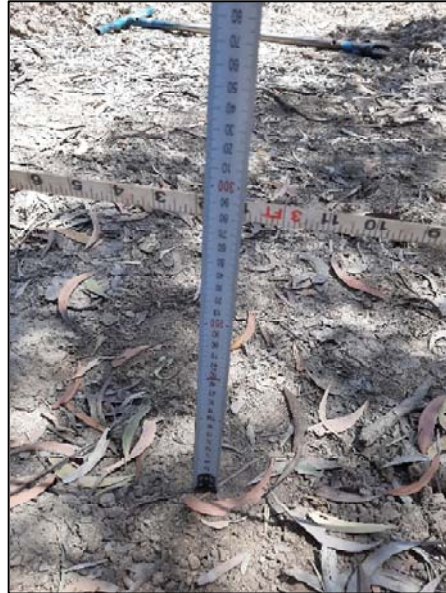
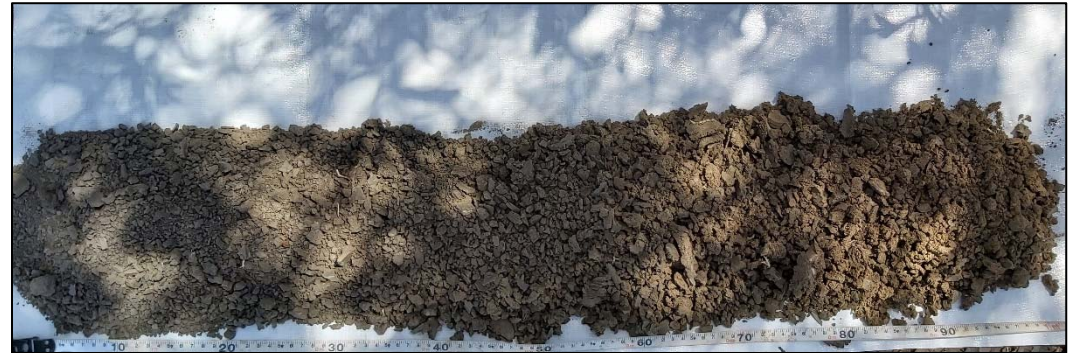
SITE 32 - Depression

Soil Mapping Unit: C1-BL	Location (GDA94 ZONE 55): 638966 7543632	Australian Soil Class: Black Vertosol	Site Survey Type: Detailed Hand Auger 50mm	Survey Date: 07/10/2019
------------------------------------	--	---	--	-----------------------------------

Land use Landform Pattern, Element, Slope	Vegetation	Microrelief Disturbance Erosion	Surface condition, surface rock	Soil Profile Description									
				Horizon Depth (m), Boundary	Field Texture	Structure, Strength, Cutans	Inclusions Segregations	Colour, Mottle, Bleaching	Moisture, Drainage	Roots	Depth (m) / Field pH	Sample (m)	Observations
Grazing, gently undulating plain, flat plain 1%	Brigalow	Gilgai 50% coverage depth 0.29m Average for area 0.42- 0.29m disturbance Nil erosion	Crust, nil coarse fragments	A1 0.00-0.09 Abrupt	Light medium clay	Weak, firm, angular <5mm peds	Nil	10YR4/1 Dark grey Nil mottles / bleaching	Dry, well drained	Common	0.10 / 7.0	0.00-0.10 0.20-0.30 0.50-0.60	Nil
				B21 0.09-0.72 Abrupt	Medium clay	Moderate, firm, angular <10mm peds	Nil	10YR4/1 Dark grey Nil mottles / bleaching	Dry, well drained	Few	0.30 / 7.0 0.60 / 7.0	0.72-0.80 0.90-1.00	
				B22 0.72-1.00 EOBH	Medium clay	Moderate, firm, angular <10mm peds slickensides observed	Nil	10YR4/2 Dark greyish brown Nil mottles / bleaching	Dry, well drained	Nil	0.90 / 7.5

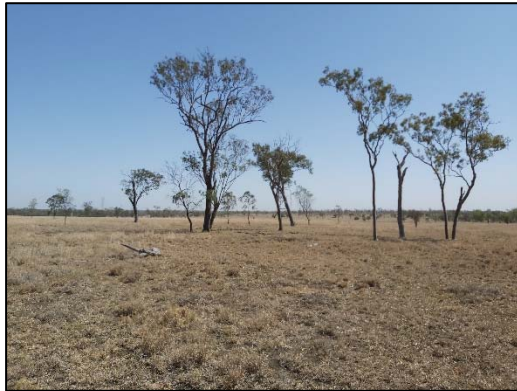
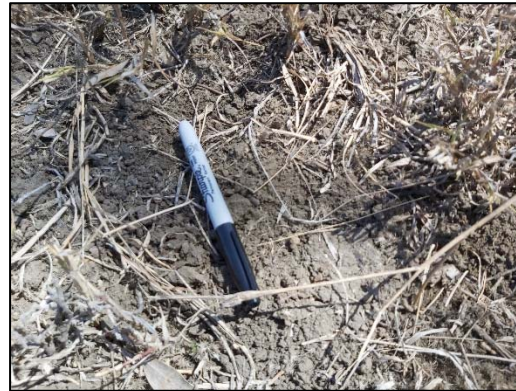
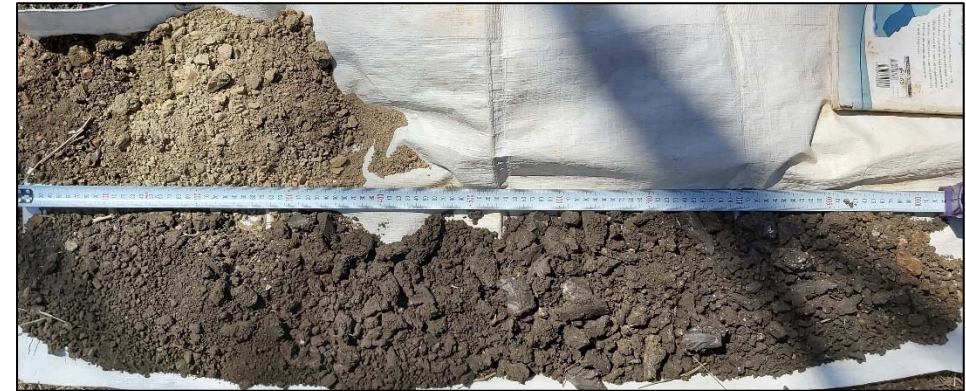
SITE 33

Soil Mapping Unit: C4	Location (GDA94 ZONE 55): 621684 7548890	Australian Soil Class: Black Vertosol	Site Survey Type: Detailed Hand Auger 50mm	Survey Date: 09/10/2019
---------------------------------	--	---	--	-----------------------------------

Land use Landform Pattern, Element, Slope	Vegetation	Microrelief Disturbance Erosion	Surface condition, surface rock	Soil Profile Description									
				Horizon Depth (m), Boundary	Field Texture	Structure, Strength, Cutans	Inclusions Segregations	Colour, Mottle, Bleaching	Moisture, Drainage	Roots	Depth (m) / Field pH	Sample (m)	Observations
Grazing, gently undulating plain, upper slope, 3%/3%	Sparse mixed vegetation	Minor linear gilgai observed in surrounding areas Semi disturbance Nil erosion	Self-mulching, nil coarse fragments	A1 0.00-0.15 Abrupt	Light clay	Weak, weak, sub- rounded peds	Nil	10YR3/2 Very dark greyish brown Nil mottles / bleaching	Dry, well drained	Common	0.10 / 8.5	0.00-0.10 0.20-0.30 0.50-0.60 0.70-0.80 0.95-1.05 1.22-1.32	Nil
				B21 0.15-0.43 Gradual	Light clay	Moderate, form, sub-rounded peds	Nil	10YR2/2 Very dark brown Nil mottles / bleaching	Dry, moderately well drained	Few	0.30 / 8.5

B22 0.43-0.70 Abrupt	Light medium clay	Moderate, form, sub-angular peds slickensides observed	<2% calcium carbonate	10YR3/1 Very dark grey Nil mottles / bleaching	Dry, moderately well drained	Few	0.60 / 8.0		
				B23 0.70-0.95 Abrupt	Medium clay	Moderate, form, sub-angular peds slickensides observed	2-5% calcium carbonate	10YR3/1 Very dark grey Nil mottles / bleaching	Dry, moderately- imperfectly drained	Very few	0.90 / 8.0

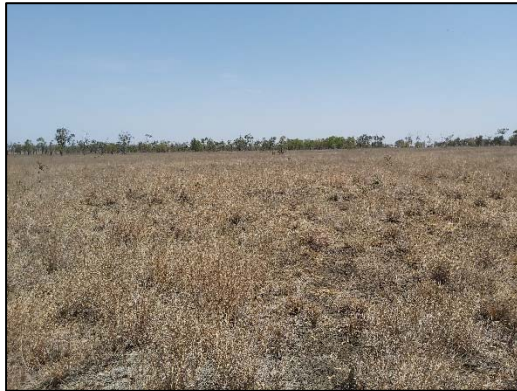
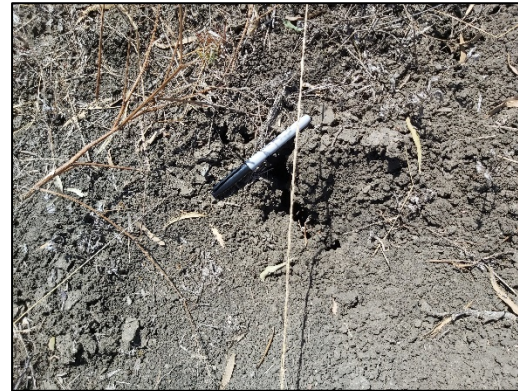
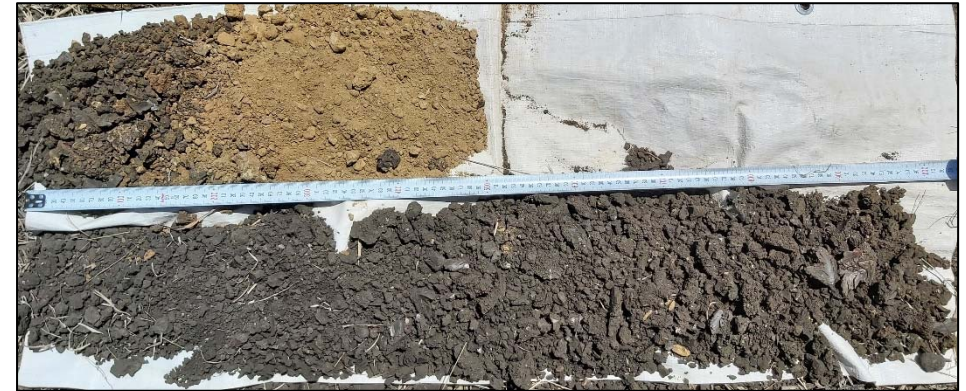
Soil Mapping Unit: C4	Location (GDA94 ZONE 55): 622486 7549684	Australian Soil Class: Black Vertosol	Site Survey Type: Detailed Hand Auger 50mm	Survey Date: 09/10/2019
---------------------------------	--	---	--	-----------------------------------

Land use Landform Pattern, Element, Slope	Vegetation	Microrelief Disturbance Erosion	Surface condition, surface rock	Soil Profile Description									
				Horizon Depth (m), Boundary	Field Texture	Structure, Strength, Cutans	Inclusions Segregations	Colour, Mottle, Bleaching	Moisture, Drainage	Roots	Depth (m) / Field pH	Sample (m)	Observations
Grazing, gently undulating plain, midslope, simple slope, 2-3%	Buffel grass	Linear gilgai observed in surrounding areas, 0.15m deep Semi disturbance Nil erosion	Self-mulching nil coarse fragments	A1 0.00-0.11 Abrupt	Light clay	Weak, moderate, sub-rounded peds <20mm	Nil	10YR3/2 Very dark greyish brown Nil mottles / bleaching	Dry, well drained	Common	0.05 / 6.0	0.00-0.10 0.20-0.30 0.60-0.70 0.90-1.00	Nil
				B21 0.11-0.46 Abrupt	Light medium clay	Moderate, firm, sub-angular peds <20mm	<1% calcium carbonate	10YR3/1 Very dark grey Nil mottles / bleaching	Dry, moderately well drained	Common	0.30 / 6.0	1.10-1.20 1.30-1.40

B22 0.46-0.74 Abrupt	Light medium clay	Moderate, firm, sub-angular peds <20mm	<2% calcium carbonate	10YR3/1 Very dark grey Nil mottles / bleaching	Dry, moderately well drained	Few	0.60 / 6.0		
				B23 0.74-1.05 Gradual	Light medium clay	Moderate, firm, sub-angular peds <20mm slickensides observed	<2% calcium carbonate	10YR3/1 Very dark grey Nil mottles / bleaching	Dry, moderately well drained	Nil	0.90 / 6.0		
				BC 1.05-1.20 Abrupt	Silty loam	Massive, loose	<20% coarse fragments 5-20mm	10YR3/3 Dark brown	Dry, well drained	Nil	1.10 / 6.0

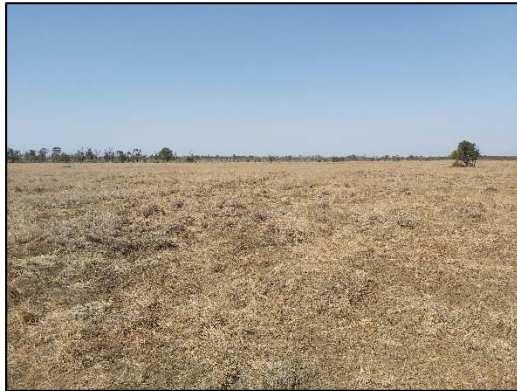
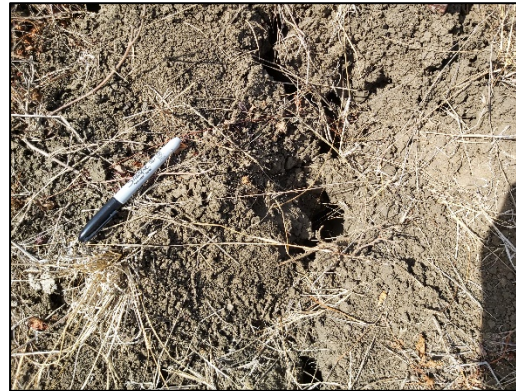
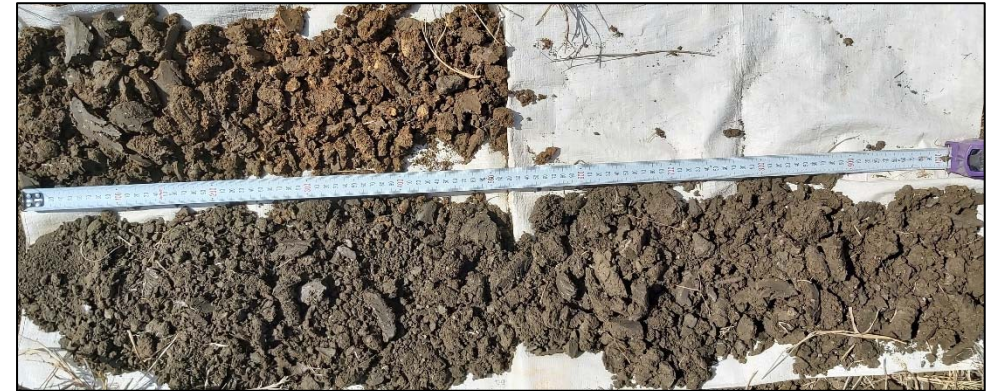
Soil Mapping Unit: C4	Location (GDA94 ZONE 55): 623121 7550243	Australian Soil Class: Black Vertosol	Site Survey Type: Detailed Hand Auger 50mm	Survey Date: 09/10/2019
---------------------------------	--	---	--	-----------------------------------

Land use Landform Pattern, Element, Slope	Vegetation	Microrelief Disturbance Erosion	Surface condition, surface rock	Soil Profile Description									
				Horizon Depth (m), Boundary	Field Texture	Structure, Strength, Cutans	Inclusions Segregations	Colour, Mottle, Bleaching	Moisture, Drainage	Roots	Depth (m) / Field pH	Sample (m)	Observations
Grazing, gently undulating plain, mid slope, simple slope, 2-3%	Native grassland	Linear gilgai 0.2m deep, 40% coverage Extensive disturbance Nil erosion	Self-mulching, cracking occasionally nil coarse fragments	A1 0.00-0.10 Abrupt	Light clay	Weak, moderate, sub-rounded peds <20mm	Nil	10YR3/2 Very dark greyish brown Nil mottles / bleaching	Dry, well drained	Common	0.05 / 6.0	0.00-0.10 0.20-0.30 0.50-0.60 0.70-0.80	Nil
				B21 0.10-0.42 Abrupt	Light medium clay	Moderate, firm, sub-angular peds <20mm	Nil	10YR3/1 Very dark grey Nil mottles / bleaching	Dry, moderately well drained	Common	0.30 / 6.5	1.10-1.20 1.40-1.50

B22 0.42-0.60 Clear	Medium clay	Moderate, firm, sub-angular peds <20mm	<2% calcium carbonate	10YR3/1 Very dark grey Nil mottles / bleaching	Dry, moderately well drained	Few	0.50 / 6.5		
				B23 0.60-1.25 Gradual	Medium clay	Moderate, firm, sub-angular peds <20mm slickensides observed	<2% calcium carbonate	2.5YR3/2 Dusky red Nil mottles / bleaching	Dry, moderately well drained	Nil	0.90 / 6.5		
				B24 1.25-1.50 EOBH	Medium clay	Moderate, firm, sub-angular peds <20mm	Nil	7.5YR4.3 20% light brown mottle	Dry, imperfectly drained	Nil	1.30 / 6.5

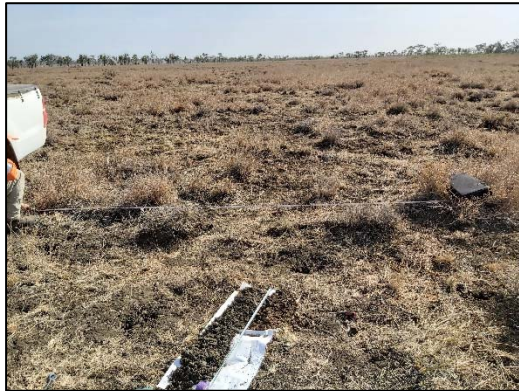
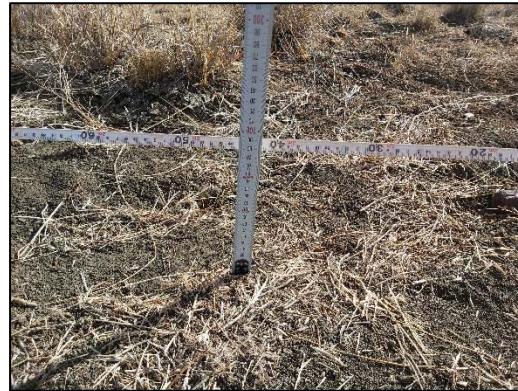
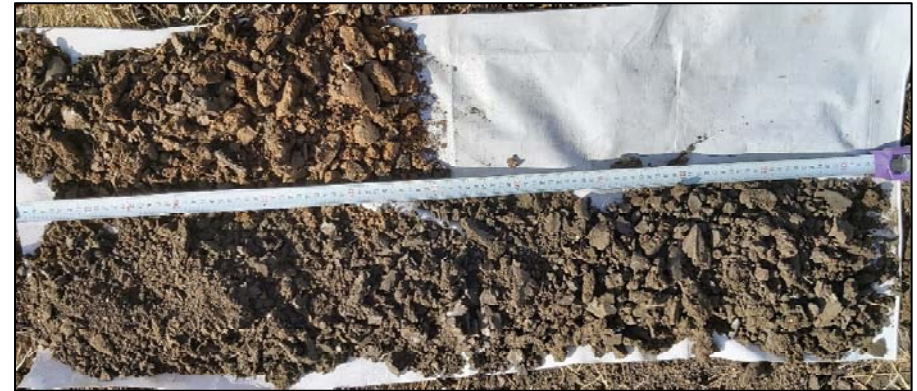
Soil Mapping Unit: C4	Location (GDA94 ZONE 55): 623121 7550243	Australian Soil Class: Black Vertosol	Site Survey Type: Detailed Hand Auger 50mm	Survey Date: 09/10/2019
---------------------------------	--	---	--	-----------------------------------

Land use Landform Pattern, Element, Slope	Vegetation	Microrelief Disturbanc e Erosion	Surface condition, surface rock	Soil Profile Description									
				Horizon Depth (m), Boundary	Field Texture	Structure, Strength, Cutans	Inclusions Segregations	Colour, Mottle, Bleaching	Moisture, Drainage	Roots	Depth (m) / Field pH	Sample (m)	Observations
Grazing, gently undulating plain, mid slope, simple slope, 2-3%	Buffel grass	Linear gilgai 0.2m deep, 40% coverage Semi disturbance Nil erosion	Self mulching nil coarse fragments	A1 0.00-0.10 Abrupt	Light clay	Weak, moderate, sub-rounded peds <20mm	Nil	10YR3/2 Very dark greyish brown Nil mottles / bleaching	Dry, well drained	Common	0.05 / 6.0	0.00-0.10	Nil
				B21 0.10-0.50 Abrupt	Light medium clay	Moderate, firm, sub-angular peds <20mm	Nil	10YR3/1 Very dark grey Nil mottles / bleaching	Dry, moderately well drained	Common	0.30 / 6.0	0.20-0.30	
				B22 0.50-0.65 Clear	Medium clay	Moderate, firm, sub-angular peds <20mm	<2% calcium carbonate	10YR3/1 Very dark grey Nil mottles / bleaching	Dry, moderately well drained	Few	0.50 / 6.5	0.50-0.60

B23 0.65-1.30 Gradual	Medium clay	Moderate, firm, sub-angular peds <20mm slickensides observed	<2% calcium carbonate	2.5YR3/2 Dusky red Nil mottles / bleaching	Dry, moderately well drained	Nil	0.90 / 6.5	0.80-0.90	
				B24 1.30-1.50 EOBH	Medium clay	Moderate, firm, sub-angular peds <20mm	<2% calcium carbonate	7.5YR4.3 Brown 20% light brown mottle Nil bleaching	Dry, imperfectly drained	Nil	1.30 / 6.5	1.10-1.20 1.40-1.50

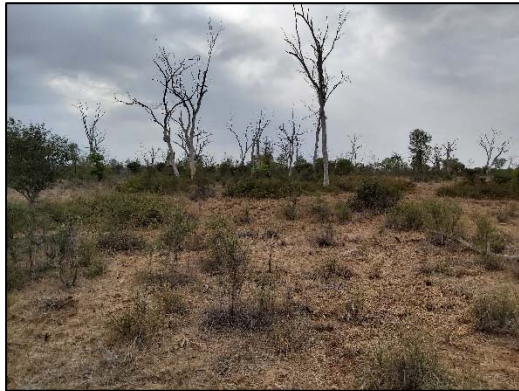
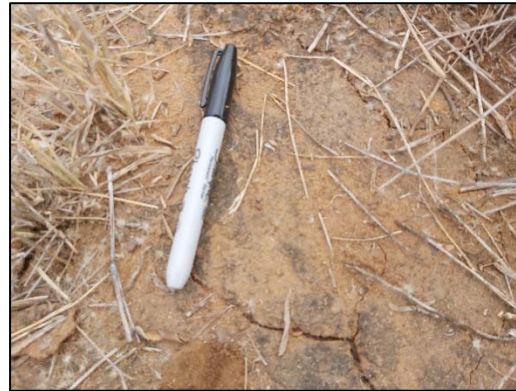
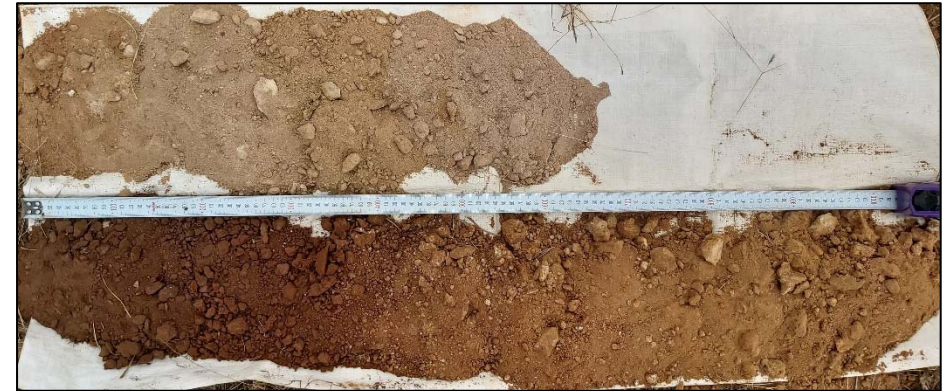
Soil Mapping Unit: T1-R	Location (GDA94 ZONE 55): 624098 7551284	Australian Soil Class: Red Dermosol	Site Survey Type: Detailed Hand Auger 50mm	Survey Date: 10/10/2019
-----------------------------------	--	---	--	-----------------------------------

Land use Landform Pattern, Element, Slope	Vegetation	Microrelief Disturbance Erosion	Surface condition, surface rock	Soil Profile Description									
				Horizon Depth (m), Boundary	Field Texture	Structure, Strength, Cutans	Inclusions Segregations	Colour, Mottle, Bleaching	Moisture, Drainage	Roots	Depth (m) / Field pH	Sample (m)	Observations
Grazing, Wide crest <1% / <1%	Exotic grassland	Nil microrelief Semi disturbed Nil erosion	Firm, Nil coarse fragments	A11 0.00-0.08 Abrupt	Clay Loam	Massive, loose	Nil	10YR2/2 Very dark brown Nil mottles / bleaching	Dry, rapid	Common	0.05 / 6.5	0.00-0.08	Nil
				A12 0.08-0.20 Abrupt	Clay loam	Weak, weak, sub- rounded 5-20mm	<1% <2mm coarse fragments	7.5YR3/2 Dark brown Nil mottles / bleaching	Dry, well	Few	0.15 / 6.5	0.10-0.20	
				B21 0.20-0.34 Abrupt	Light clay	Moderate, weak, sub-rounded 5- 20mm	<1% <2mm coarse fragments	5YR3/4 Dark reddish brown Nil mottles / bleaching	Dry, well	Few	0.30 / 7.0	0.20-0.30

B22 0.34-0.75 Abrupt	Silty clay loam	Weak, weak, sub- angular <20mm	<5% <2mm coarse fragments	5YR4/4 Reddish brown Nil mottles / bleaching	Dry, well to moderate	Nil	0.60 / 8.0	0.50-0.60	
				B23 0.75-1.05 Abrupt	Silty clay loam	Weak, weak, sub- angular <20mm	<2% <2mm coarse fragments	7.5YR4/6 Strong brown Nil mottles / bleaching	Dry, well to moderate	Nil	0.90 / 8.0	0.90-1.00 1.40-1.50

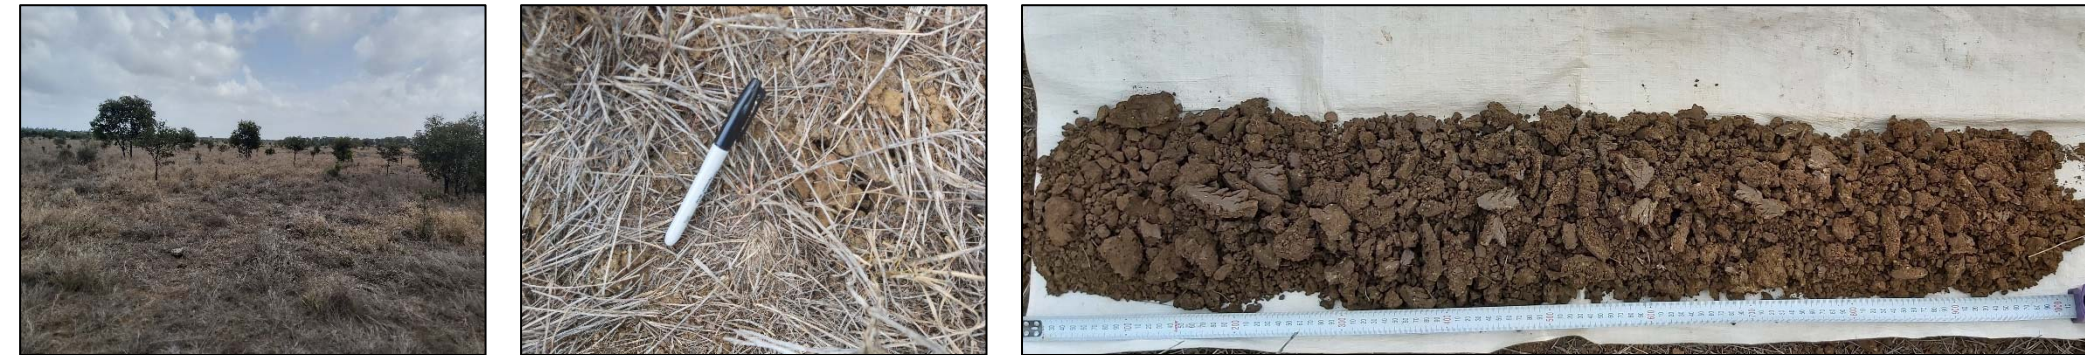
Land use Landform Pattern, Element, Slope	Vegetation	Microrelief Disturbance Erosion	Surface condition, surface rock	Soil Profile Description									
				Horizon Depth (m), Boundary	Field Texture	Structure, Strength, Cutans	Inclusions Segregations	Colour, Mottle, Bleaching	Moisture, Drainage	Roots	Depth (m) / Field pH	Sample (m)	Observations
Grazing, gently undulating plain, lower slope 2%	Exotic grassland	Nil microrelief Semi disturbed Nil erosion	Crust Nil coarse fragments	A1 0.00-0.10 Abrupt	Light clay	Weak, firm, subangular peds <20mm	Nil	10YR3/3 Dark brown Nil mottles / bleaching	Dry, well drained	Common	0.05 / 8.0	0.00-0.10 0.20-0.30 0.50-0.60 0.70-0.80 0.90-1.00	Nil
				B21 0.10-0.63 Gradual	Light medium clay	Moderate, firm, angular peds 20- 40mm, slickensides observed	<2% calcium carbonate <1% <2mm coarse fragments	10YR4/3 Brown Nil mottles / bleaching	Dry, moderately well drained	Few	0.30 / 7.0 0.55 / 7.0

B22 0.63-1.00 EOBH	Light medium clay	Moderate, firm, angular peds 20- 40mm, slickensides observed	Nil	10YR5/3 Brown Nil mottles / bleaching	Dry, moderately well drained	Very few	0.90 / 7.0

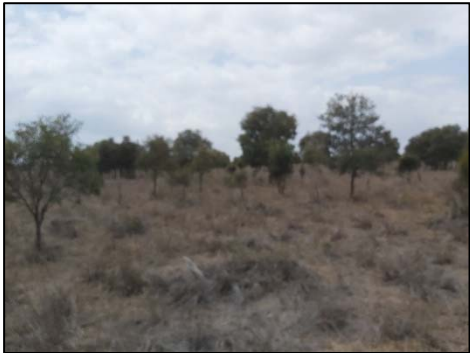
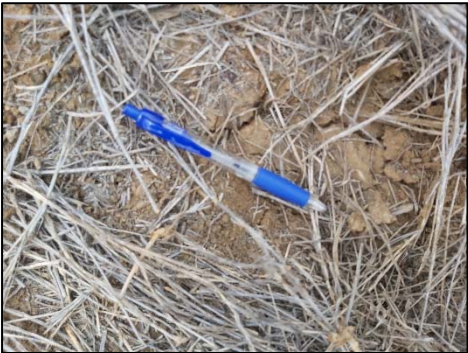
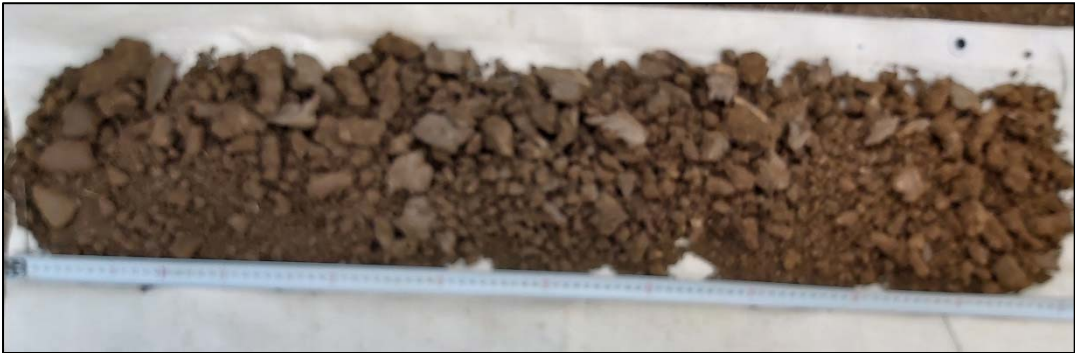
Soil Mapping Unit: C3-BR	Location (GDA94 ZONE 55): 630256 7544461	Australian Soil Class: Brown Vertosol	Site Survey Type: Detailed Hand Auger 50mm	Survey Date: 10/10/2019
------------------------------------	--	---	--	-----------------------------------

Land use Landform Pattern, Element, Slope	Vegetation	Microrelief Disturbance Erosion	Surface condition, surface rock	Soil Profile Description									
				Horizon Depth (m), Boundary	Field Texture	Structure, Strength, Cutans	Inclusions Segregations	Colour, Mottle, Bleaching	Moisture, Drainage	Roots	Depth (m) / Field pH	Sample (m)	Observations
Grazing, gently undulating plain, lower slope 2%	Spare regrowth, Brigalow in area	Nil microrelief Semi disturbed Nil erosion	Crust Nil coarse fragments	A1 0.00-0.14 Abrupt	Light clay	Weak, firm, subangular peds <20mm	Nil	10YR3/3 Dark brown Nil mottles / bleaching	Dry, well drained	Common	0.05 / 8.0	Nil	Nil
				B21 0.14-0.66 Gradual	Light medium clay	Moderate, firm, angular peds 20- 40mm, slickensides observed	<2% calcium carbonate	10YR4/3 Brown Nil mottles / bleaching	Dry, moderately well drained	Few	0.30 / 7.0 0.55 / 7.0		
				B22 0.66-1.00 EOBH	Light medium clay	Moderate, firm, angular peds 20- 40mm, slickensides observed	Nil	10YR5/3 Brown Nil mottles / bleaching	Dry, moderately well drained	Very few	0.90 / 7.0

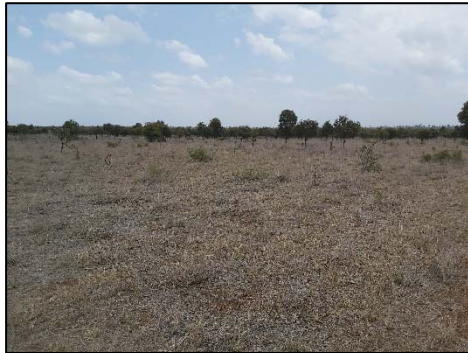
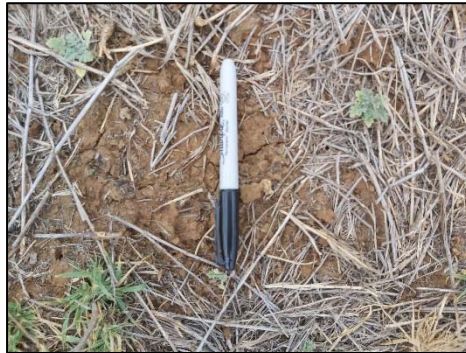
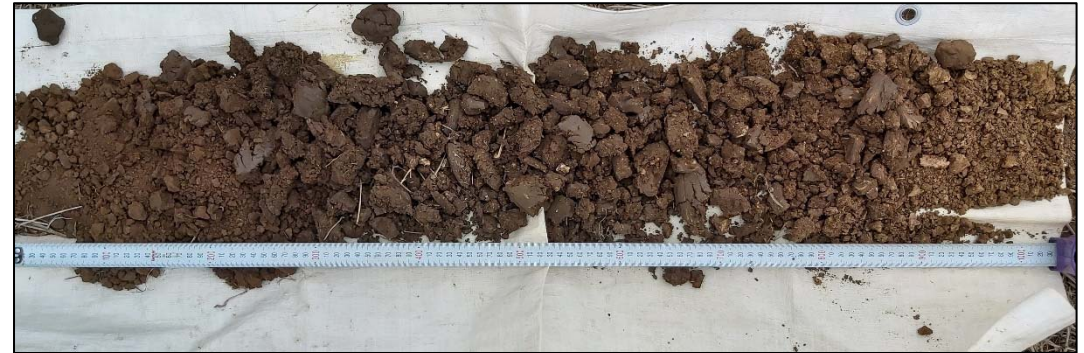
SITE 39

Soil Mapping Unit: C3-BR	Location (GDA94 ZONE 55): 631277 7544334	Australian Soil Class: Brown Dermosol	Site Survey Type: Detailed Hand Auger 50mm	Survey Date: 10/10/2019
------------------------------------	--	---	--	-----------------------------------

Land use Landform Pattern, Element, Slope	Vegetation	Microrelief Disturbance Erosion	Surface condition, surface rock	Soil Profile Description									
				Horizon Depth (m), Boundary	Field Texture	Structure, Strength, Cutans	Inclusions Segregations	Colour, Mottle, Bleaching	Moisture, Drainage	Roots	Depth (m) / Field pH	Sample (m)	Observations
Grazing, upper slope <2%	Very sparse, Brigalow approx. 100m away	Nil microrelief Semi disturbed Nil erosion	Firm, observed in area	A1 0.00-0.12 Abrupt	Light clay	Weak, firm, subangular peds <20mm	Nil	7.5YR2.5/2 Very dark brown Nil mottles / bleaching	Dry, well drained	Common	0.10 / 7.0	Nil	Nil
				B21 0.12-0.25 Abrupt	Light medium clay	Moderate, firm, angular peds 20- 40mm	Nil	7.5YR2.5/2 Very dark brown Nil mottles / bleaching	Dry, moderately well drained	Common	0.20 / 7.0		
				B22 0.25-0.63 Clear	Medium clay	Moderate, firm, angular peds 20- 40mm slickensides observed	<1% calcium carbonate	7.5YR2.5/3 Very dark brown Nil mottles / bleaching	Dry, moderately well drained	Few	0.50 / 8.0

B23 0.63-0.85 Abrupt	Medium clay	Moderate, firm, angular peds 20- 40mm slickensides observed	Nil	7.5YR4/3 Brown Nil mottles / bleaching	Dry, moderately well drained	Nil	0.80 / 8.0		
				B3 0.85-1.00 EOBH	Medium clay	Moderate, firm, angular peds <20mm	10% coarse fragments and weathered rock	10YR4/3 Brown Nil mottles / bleaching	Dry, imperfectly drained	Nil	0.95 / 8.0
