WINCHESTER SOUTH PROJECT

Soils and Land Suitability Assessment Addendum

Winchester South Project
Whitehaven WS Pty Ltd

23 June 2022

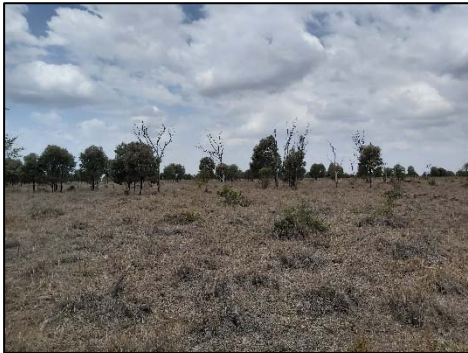
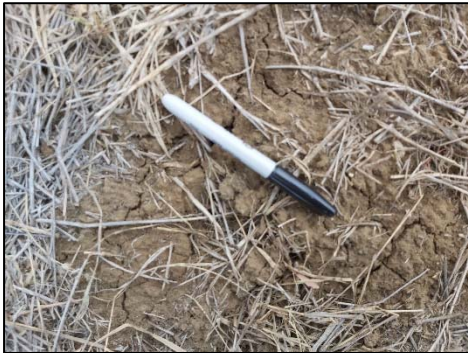
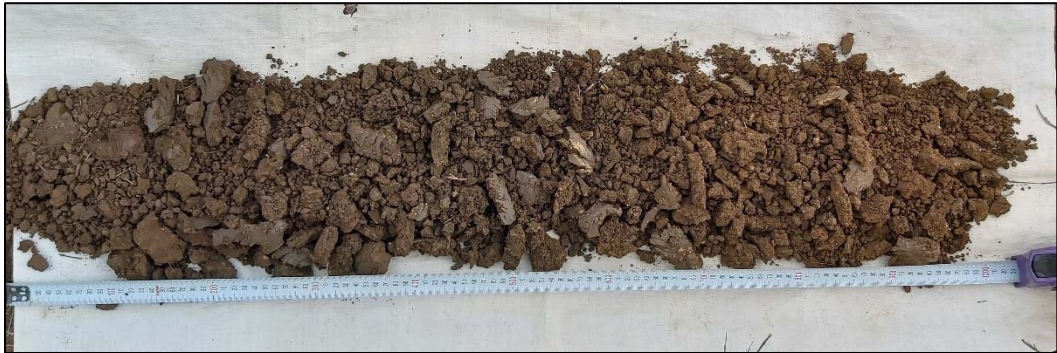
Land use Landform Pattern, Element, Slope	Vegetation	Microrelief Disturbance Erosion	Surface condition, surface rock	Soil Profile Description									
				Horizon Depth (m), Boundary	Field Texture	Structure, Strength, Cutans	Inclusions Segregations	Colour, Mottle, Bleaching	Moisture, Drainage	Roots	Depth (m) / Field pH	Sample (m)	Observations
Grazing, gently undulating plain, mid slope 1%	Brigalow regrowth	Nil microrelief Semi disturbed Nil erosion	Soft, cracking, crust observed in area	A1 0.00-0.12 Abrupt	Light clay	Weak, firm, subangular peds <20mm	Nil	10YR3/3 Dark brown Nil mottles / bleaching	Dry, well drained	Common	0.05 / 7.0	Nil	Nil
				B21 0.12-0.62 Gradual	Light medium clay	Moderate, firm, angular peds 20- 40mm, slickensides observed	<1% calcium carbonate	10YR4/3 Brown Nil mottles / bleaching	Dry, moderately well drained	Few	0.30 / 7.0 0.55 / 7.0		
				B22 0.62-1.00 EOBH	Light medium clay	Moderate, firm, angular peds 20- 40mm, slickensides observed	Nil	10YR5/3 Brown Nil mottles / bleaching	Dry, moderately well drained	Very few	0.90 / 7.0

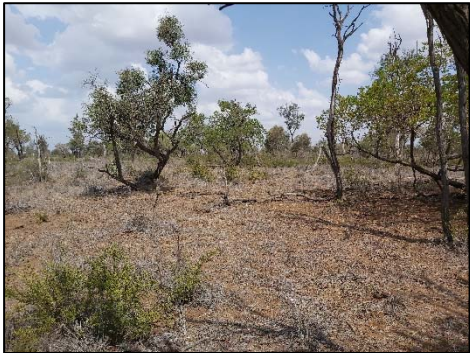
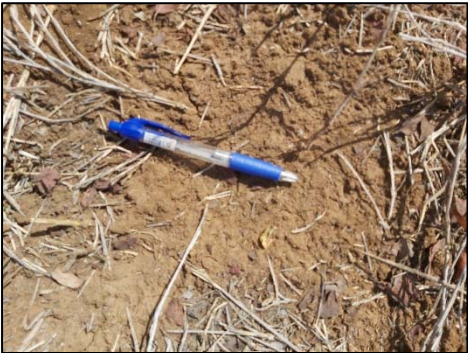
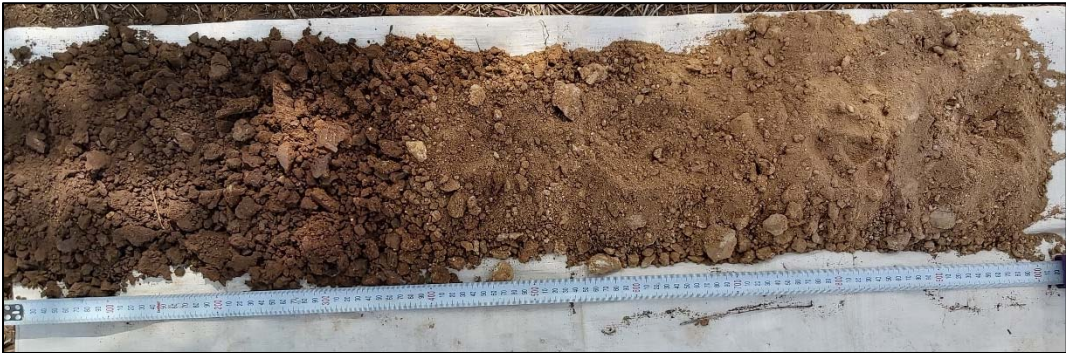
SITE 42

Soil Mapping Unit: T1-B	Location (GDA94 ZONE 55): 630026 7543369	Australian Soil Class: Brown Dermosol	Site Survey Type: Detailed Hand Auger 50mm	Survey Date: 10/10/2019
-----------------------------------	--	---	--	-----------------------------------

Land use Landform Pattern, Element, Slope	Vegetation	Microrelief Disturbance Erosion	Surface condition, surface rock	Soil Profile Description									
				Horizon Depth (m), Boundary	Field Texture	Structure, Strength, Cutans	Inclusions Segregations	Colour, Mottle, Bleaching	Moisture, Drainage	Roots	Depth (m) / Field pH	Sample (m)	Observations
Grazing, gently undulating plain, upper slope 1-2%	Brigalow regrowth	Nil microrelief Semi disturbed Nil erosion	Soft to firm, nil coarse fragments	A11 0.00-0.09 Abrupt	Clay loam	Massive to weak, loose	Nil	7.5YR3/2 Dark brown Nil mottles / bleaching	Dry, well drained	Common	0.05 / 7.0	0.00-0.10 0.10-0.20 0.25-0.35 0.50-0.60 0.80-0.90	Nil
				A12 0.09-0.24 Gradual	Clay loam	Weak, firm, sub- angular peds <10mm	Nil	7.5YR3/4 Dark brown Nil mottles / bleaching	Dry, moderately well drained	Few	0.20 / 8.0		
				B21 0.24-0.37 Abrupt	Light clay	Moderate, firm, sub-angular peds <10mm	<2% calcium carbonate	7.5YR3/3 Dark brown Nil mottles / bleaching	Dry, moderately well drained	Few	0.28 / 7.5

B31 0.37-0.70 Abrupt	Clay loam	Massive to weak, weak subangular peds <10mm <2%	<2% calcium carbonate	7.5YR4/6 Strong brown Nil mottles / bleaching	Dry, moderately well drained	Nil	0.50 / 8.0		
				B32 0.70-1.00 EOBH	Loam	Massive, loose	Nil	7.5YR4/4 Brown Nil mottles / bleaching	Dry, moderately well drained	Nil	0.90 / 8.0

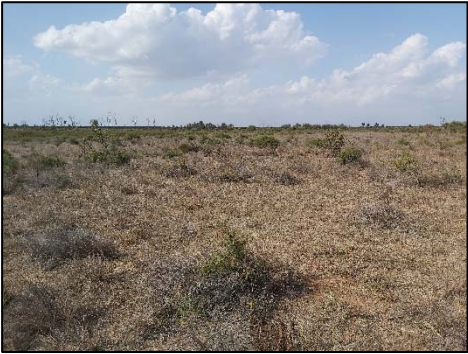
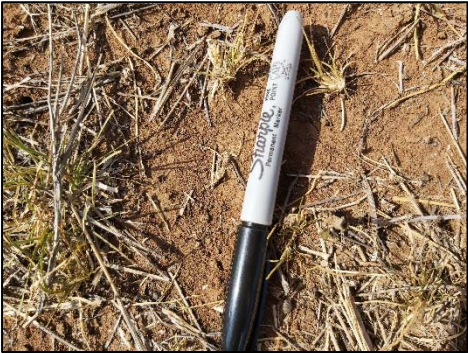
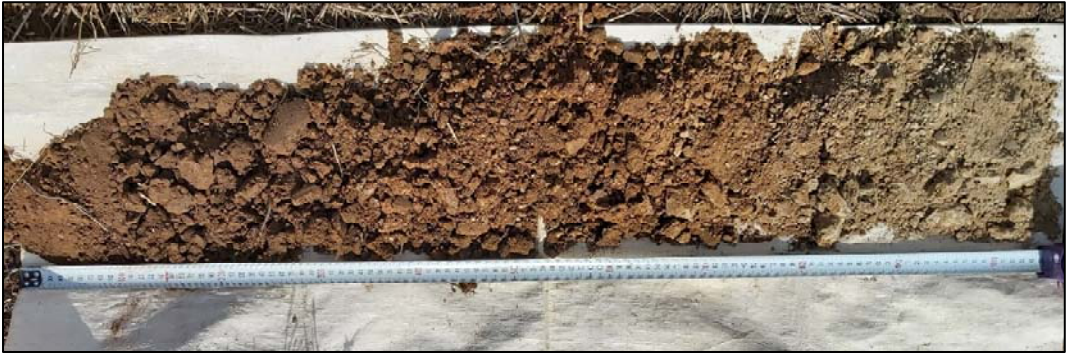
Land use Landform Pattern, Element, Slope	Vegetation	Microrelief Disturbance Erosion	Surface condition, surface rock	Soil Profile Description									
				Horizon Depth (m), Boundary	Field Texture	Structure, Strength, Cutans	Inclusions Segregations	Colour, Mottle, Bleaching	Moisture, Drainage	Roots	Depth (m) / Field pH	Sample (m)	Observations
Grazing, gently undulating plain, mid slope 1-2%	Mixed shrubs	Nil microrelief Semi disturbed Nil erosion	Hard setting, nil coarse fragments	A1 0.00-0.12 Abrupt	Sandy clay loam	Massive to weak, loose	Nil	7.5YR3/2 Dark brown Nil mottles / bleaching	Dry, well drained	Common	0.05 / 7.0	0.00-0.10 0.20-0.30 0.50-0.60 0.68-0.78 0.90-1.00	Nil
				B21 0.12-0.38 Gradual	Light clay	Weak, firm, sub- angular peds <10mm	<2% calcium carbonate	7.5YR3/4 Dark brown Nil mottles / bleaching	Dry, moderately well drained	Few	0.20 / 7.5		
				B22 0.38-0.60 Abrupt	Medium clay	Moderate, firm, sub-angular peds <10mm	Nil	7.5YR3/3 Dark brown Nil mottles / bleaching	Dry, moderately well drained	Few	0.28 / 7.5

B31 0.60-0.78 Abrupt	Clayey sand	Massive to weak, weak subangular peds <10mm <2%	5% weathered material	7.5YR4/6 Strong brown Nil mottles / bleaching	Dry, well drained	Nil	0.70 / 8.0		
				B32 0.78-1.00 EOBH	Clayey sand (increased sand content)	Massive, loose	5% weathered material	7.5YR4/4 Brown Nil mottles / bleaching	Dry, well drained	Nil	0.90 / 8.0

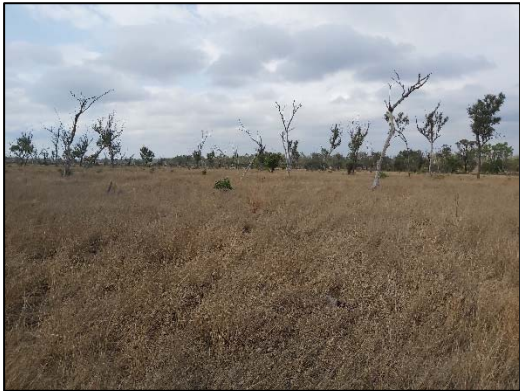
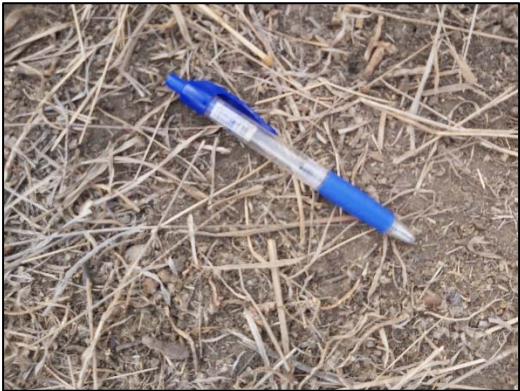
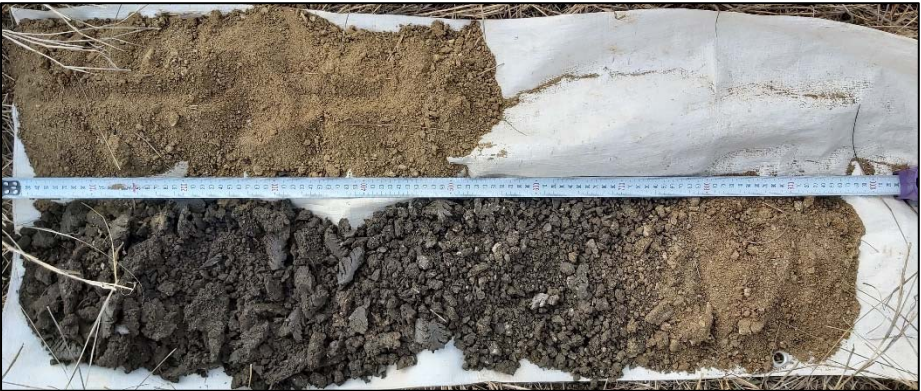
Soil Mapping Unit: C3-BL	Location (GDA94 ZONE 55): 629299 7542395	Australian Soil Class: Black Vertosol	Site Survey Type: Detailed Hand Auger 50mm	Survey Date: 11/10/2019
------------------------------------	--	---	--	-----------------------------------

Land use Landform Pattern, Element, Slope	Vegetation	Microrelief Disturbance Erosion	Surface condition, surface rock	Soil Profile Description									
				Horizon Depth (m), Boundary	Field Texture	Structure, Strength, Cutans	Inclusions Segregations	Colour, Mottle, Bleaching	Moisture, Drainage	Roots	Depth (m) / Field pH	Sample (m)	Observations
Grazing, gently undulating plain, lower slope 1-2%	Grass, sparse mixed vegetation	Nil microrelief extensively disturbed Nil erosion	Self-mulching, <2% coarse fragments <5mm	A1 0.00-0.09 Abrupt	Light clay	Weak, firm, subangular peds 10-20mm	<2% coarse fragments <5mm	10YR3/2 Very dark greyish brown Nil mottles / bleaching	Dry, well drained	Coming	0.05 / 7.5	0.00-0.09 0.20-0.30 0.50-0.60 0.72-0.82	Nil
				B21 0.09-0.46 Abrupt	Light medium clay	Moderate, firm, subangular peds 10-20mm Slickensides observed	Nil	10YR3/2 Very dark greyish brown Nil mottles / bleaching	Dry, well drained	Few	0.30 / 7.5	0.90-1.00 1.40-1.50

B22 0.46-0.72 Abrupt	Light medium clay	Moderate, firm, subangular peds 5-20mm	<2% coarse fragments <5mm	10YR4/1 Dark grey Nil mottles / bleaching	Dry, moderately well drained	Nil	0.60 / 8.0		
				BC 0.72-1.00 EOBH	Loamy sand	Massive, weak, <5% loose	<2% coarse fragments <5mm	10YR4/4 Dark yellowish brown Nil mottles / bleaching	Dry, rapidly drained	Nil	0.90 / 7.5

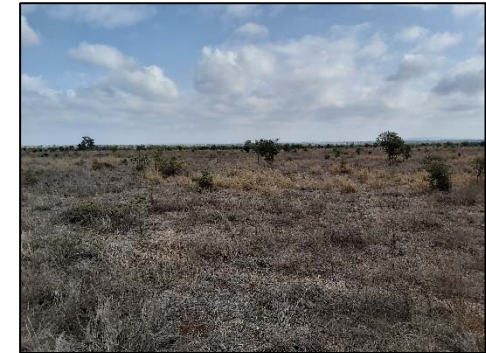
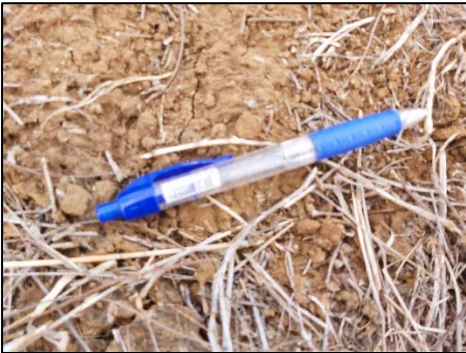
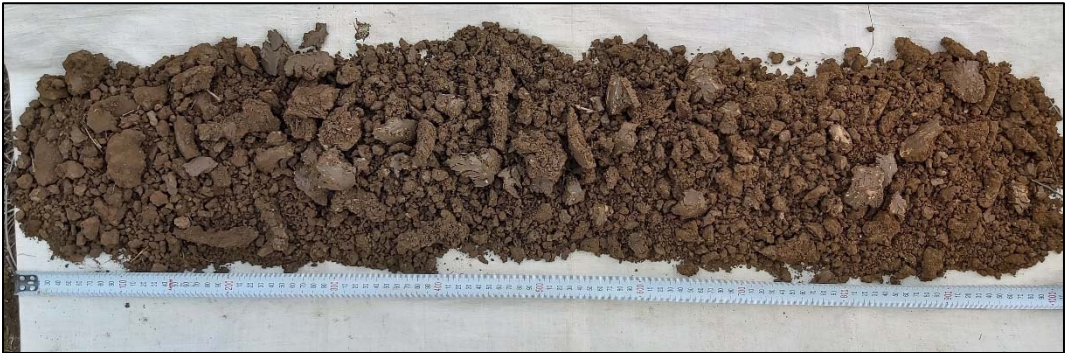
Soil Mapping Unit: C3-BR	Location (GDA94 ZONE 55): 630026 7546291	Australian Soil Class: Brown Vertosol	Site Survey Type: Detailed Hand Auger 50mm	Survey Date: 11/10/2019
-----------------------------	---	--	---	----------------------------

Land use Landform Pattern, Element, Slope	Vegetation	Microrelief Disturbance Erosion	Surface condition, surface rock	Soil Profile Description									
				Horizon Depth (m), Boundary	Field Texture	Structure, Strength, Cutans	Inclusions Segregations	Colour, Mottle, Bleaching	Moisture, Drainage	Roots	Depth (m) / Field pH	Sample (m)	Observations
Grazing, gently undulating plain, lower slope <2%	Sparse Brigalow regrowth	Nil microrelief Semi disturbed Nil erosion	Crust, nil coarse fragments	A1 0.00-0.10 Abrupt	Light clay	Weak, firm, subangular peds <20mm	Nil	10YR3/3 Dark brown Nil mottles / bleaching	Dry, well drained	Common	0.05 / 7.0	Nil	Nil
				B21 0.10-0.65 Gradual	Light medium clay	Moderate, firm, angular peds 20- 40mm	<1% <2mm coarse fragments	10YR4/3 Brown Nil mottles / bleaching	Dry, moderately well drained	Few	0.30 / 7.0 0.55 / 7.0		
				B22 0.65-1.00 EOBH	Light medium clay	Moderate, firm, angular peds 20- 40mm slickensides observed	<1% calcium carbonate	10YR5/3 Brown Nil mottles / bleaching	Dry, moderately well drained	Very few	0.90 / 7.5

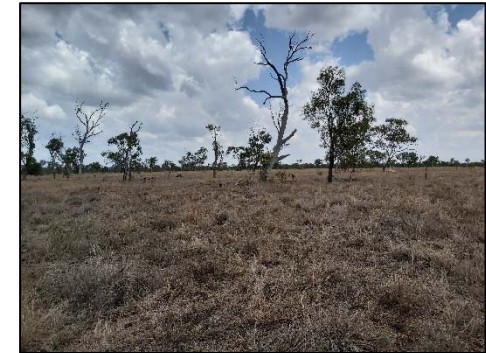
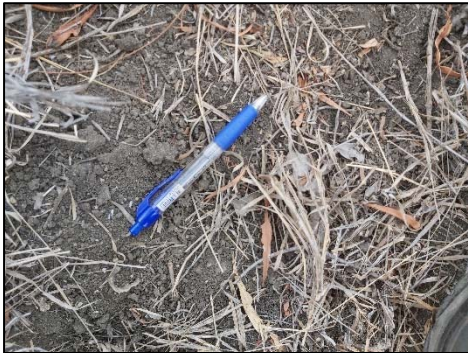
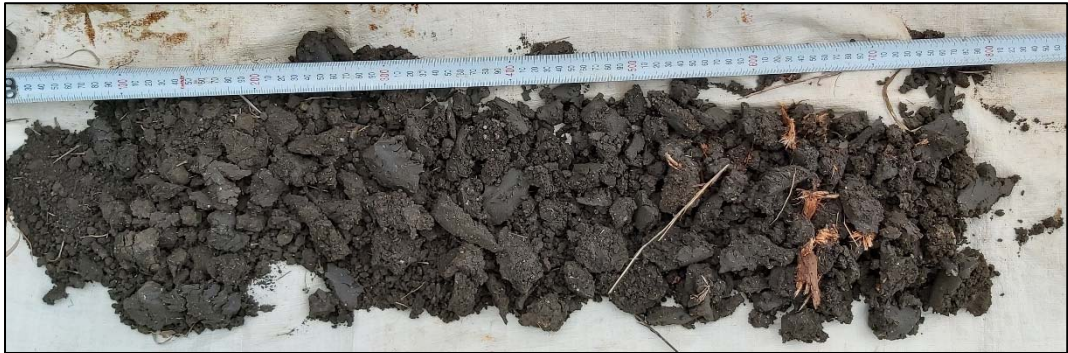
Soil Mapping Unit: C4	Location (GDA94 ZONE 55): 628379 7546548	Australian Soil Class: Black Vertosol	Site Survey Type: Detailed Hand Auger 50mm	Survey Date: 11/10/2019
---------------------------------	--	---	--	-----------------------------------

Land use Landform Pattern, Element, Slope	Vegetation	Microrelief Disturbance Erosion	Surface condition, surface rock	Soil Profile Description									
				Horizon Depth (m), Boundary	Field Texture	Structure, Strength, Cutans	Inclusions Segregations	Colour, Mottle, Bleaching	Moisture, Drainage	Roots	Depth (m) / Field pH	Sample (m)	Observations
Gently undulating plain, lower slope 1-2%,	Sparse mixed vegetation	Linear gilgai, <0.1m deep, 50% coverage Semi disturbed Nil erosion	Self-mulching, nil coarse fragments	A1 0.00-0.08 Abrupt	Light clay	Moderate, weak, peds 5-20mm	Nil	10YR3/2 Very dark greyish brown Nil mottles / bleaching	Dry, well drained	Common	0.05 / 6.5	0.00-0.08 0.20-0.30 0.50-0.60	Auger refusal at 0.80m
				B21 0.08-0.80	Medium clay	Moderate, strong, subangular peds 20-50mm slickensides observed	Nil	10YR3/1 Very dark grey Nil mottles / bleaching	Dry, well drained	Few	0.30 / 6.5 0.75 / 6.5

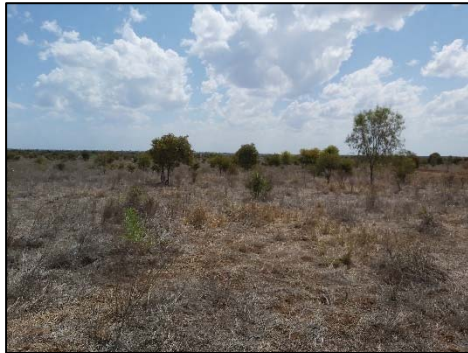
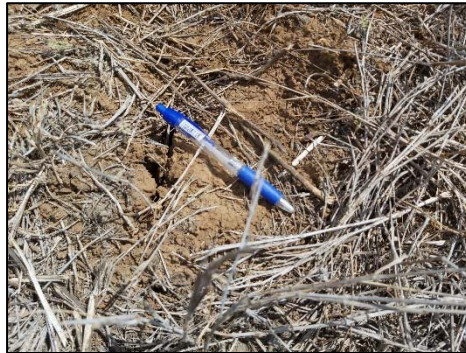
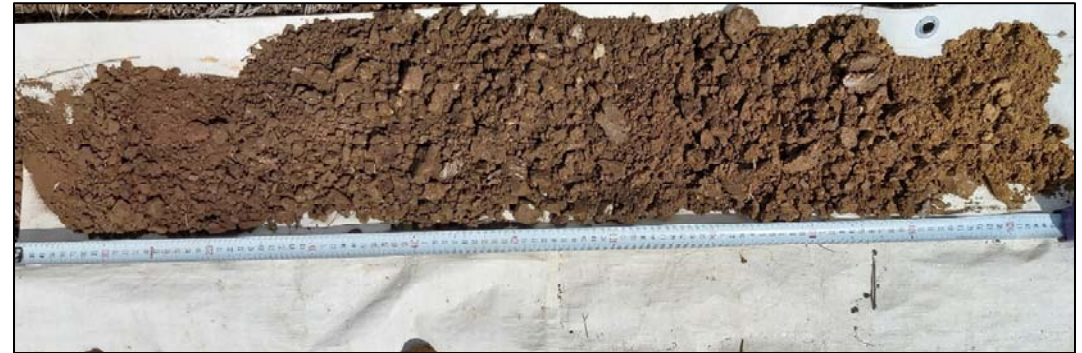
Soil Mapping Unit: C3-BR	Location (GDA94 ZONE 55): 631969 7546284	Australian Soil Class: Brown Vertosol	Site Survey Type: Detailed Hand Auger 50mm	Survey Date: 11/10/2019
------------------------------------	--	---	--	-----------------------------------

Land use Landform Pattern, Element, Slope	Vegetation	Microrelief Disturbance Erosion	Surface condition, surface rock	Soil Profile Description									
				Horizon Depth (m), Boundary	Field Texture	Structure, Strength, Cutans	Inclusions Segregations	Colour, Mottle, Bleaching	Moisture, Drainage	Roots	Depth (m) / Field pH	Sample (m)	Observations
Grazing, mid slope 2/2%	Sparse mixed regrowth	Nil microrelief Semi disturbed Nil erosion	Cracking, nil coarse fragments	A1 0.00-0.10 Abrupt	Light clay	Moderate, weak, peds 5-10mm	Nil	7.5YR3/2 Dark brown Nil mottles / bleaching	Dry, well drained	Common	0.05 / 7.0	Nil	Nil
				B21 0.10-0.35 Abrupt	Light clay	Moderate, firm, peds 10-20mm	Nil	7.5YR2.5/3 Very dark brown Nil mottles / bleaching	Dry, well drained	Common	0.25 / 7.5		
				B22 0.35-0.77 Abrupt	Medium clay	Moderate, very firm, subangular peds 10-40mm	<1% calcium carbonate	7.5YR3/3 Dark brown Nil mottles / bleaching	Dry, moderately well drained	Few	0.60 / 7.5

B23 0.77-1.00 EOBH	Medium clay	Moderate, weak, peds 10-20mm slickensides observed	Nil	7.5YR4/4 Brown Nil mottles / bleaching	Dry, moderately well drained	Nil	0.90 / 7.5

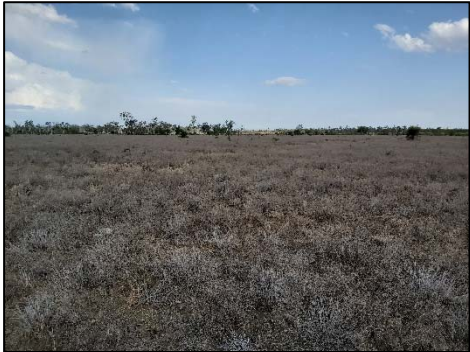
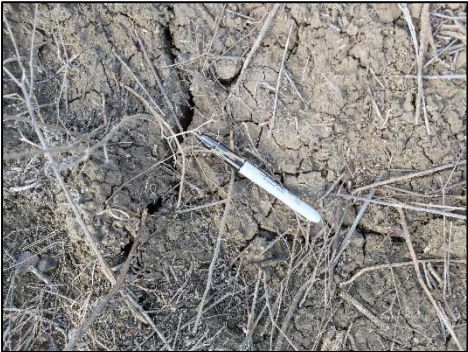
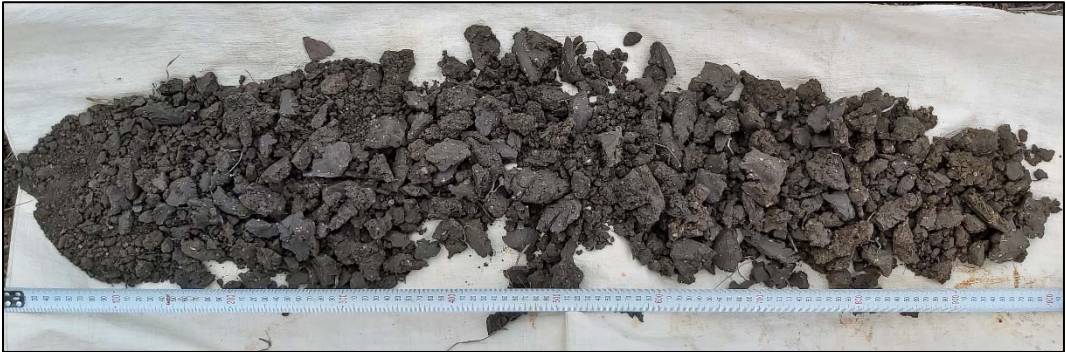
Soil Mapping Unit: C3-BL	Location (GDA94 ZONE 55): 629989 7548288	Australian Soil Class: Black Vertosol	Site Survey Type: Detailed Hand Auger 50mm	Survey Date: 11/10/2019
------------------------------------	--	---	--	-----------------------------------

Land use Landform Pattern, Element, Slope	Vegetation	Microrelief Disturbance Erosion	Surface condition, surface rock	Soil Profile Description									
				Horizon Depth (m), Boundary	Field Texture	Structure, Strength, Cutans	Inclusions Segregations	Colour, Mottle, Bleaching	Moisture, Drainage	Roots	Depth (m) / Field pH	Sample (m)	Observations
Grazing, gently undulating plain, simple mid slope 1- 2%	Grass	Nil microrelief Extensively disturbed Nil erosion	Cracking with crust occasionally nil coarse fragments	A1 0.00-0.12 Abrupt	Light clay	Weak, very firm, sub-rounded peds <10mm	Nil	10YR3/2 Very dark greyish brown Nil mottles / bleaching	Dry, well drained	Common	0.05 / 6.5	Nil	Nil
				B21 0.12-0.78 Abrupt	Light medium clay	Moderate, very firm slickensides observed	<2% calcium carbonate	10YR3/1 Very dark grey Nil mottles / bleaching	Dry, well drained	Few	0.30 / 7.0 0.60 / 7.0		
				B22 0.78-1.00 EOBH	Light medium clay	Moderate, very firm	Nil	10YR4/1 Dark grey Nil mottles / bleaching	Dry, moderately well drained	Few	0.90 / 7.0

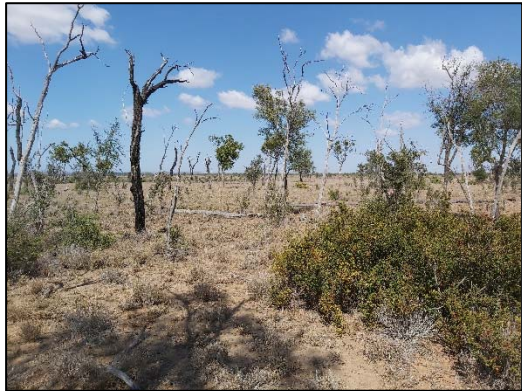
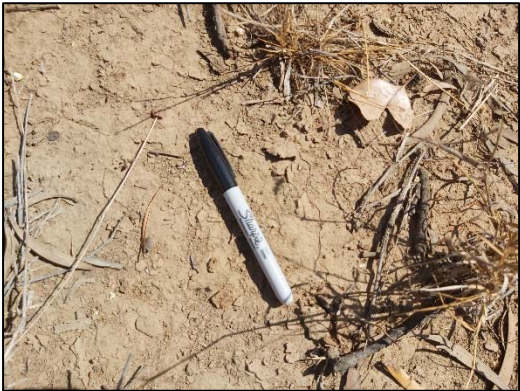
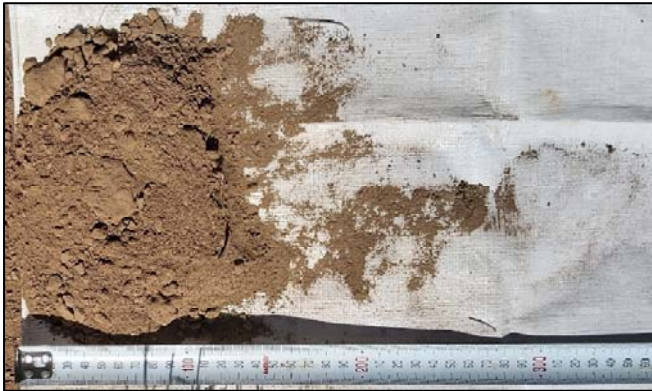
Land use Landform Pattern, Element, Slope	Vegetation	Microrelief Disturbance Erosion	Surface condition, surface rock	Soil Profile Description									
				Horizon Depth (m), Boundary	Field Texture	Structure, Strength, Cutans	Inclusions Segregations	Colour, Mottle, Bleaching	Moisture, Drainage	Roots	Depth (m) / Field pH	Sample (m)	Observations
Grazing, wide crest upper slope, 1-2%	Exotic grassland	Nil microrelief Semi disturbed Nil erosion	Firm, 2% coarse fragments <10mm	A1 0.00-0.11 EOBH	Sandy loam	Massive, loose	40% <10mm coarse fragments 10% 10-20mm coarse fragments	10YR3/4 Dark yellowish brown Nil mottles / bleaching	Dry, rapidly drained	Common	0.05 / 6.5	0.00-0.10	Auger refusal at 0.11m, 5 attempts in the area

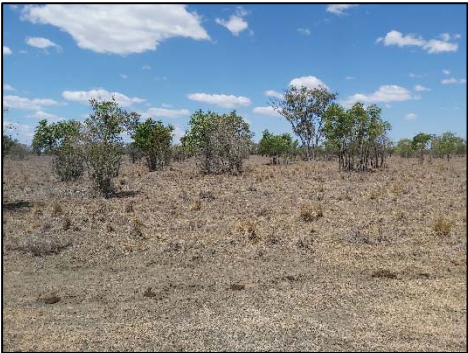
Landscape

SITE 60

Soil Mapping Unit: C3-BL	Location (GDA94 ZONE 55): 633443 7548576	Australian Soil Class: Black Vertosol	Site Survey Type: Detailed Hand Auger 50mm	Survey Date: 12/10/2019
------------------------------------	--	---	--	-----------------------------------

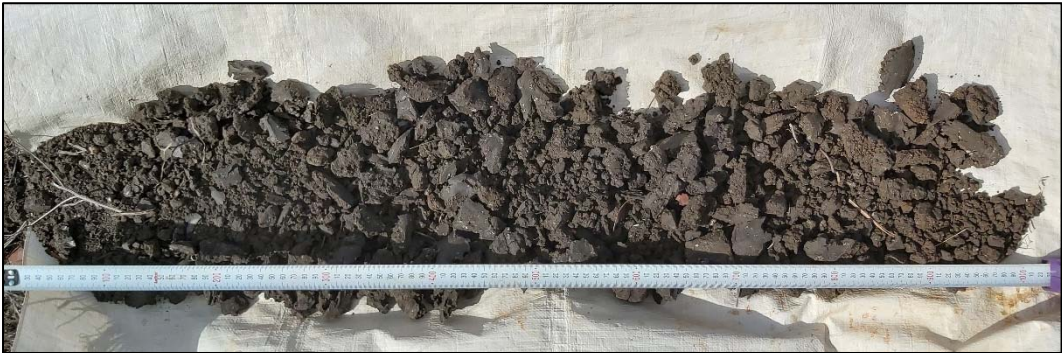
Land use Landform Pattern, Element, Slope	Vegetation	Microrelief Disturbance Erosion	Surface condition, surface rock	Soil Profile Description									
				Horizon Depth (m), Boundary	Field Texture	Structure, Strength, Cutans	Inclusions Segregations	Colour, Mottle, Bleaching	Moisture, Drainage	Roots	Depth (m) / Field pH	Sample (m)	Observations
Grazing, gently undulating plain, mid- slope 2-3 %	Mixed vegetation including Brigalow and shrubs	Nil microrelief Semi disturbed Nil erosion	Cracking with crust nil coarse fragments	A1 0.00-0.11 Abrupt	Light clay	Weak, very firm, sub-rounded peds <10mm	Nil	10YR3/2 Very dark greyish brown Nil mottles / bleaching	Dry, well drained	Common	0.05 / 6.5	Nil	Nil
				B21 0.11-0.76 Abrupt	Light medium clay	Moderate, very firm slickensides observed	<2% calcium carbonate	10YR3/1 Very dark grey Nil mottles / bleaching	Dry, well drained	Few	0.30 / 7.0 0.60 / 7.0		
				B22 0.76-1.00 EOBH	Light medium clay	Moderate, very firm	Nil	10YR4/1 Dark grey Nil mottles / bleaching	Dry, moderately well drained	Few	0.90 / 7.0

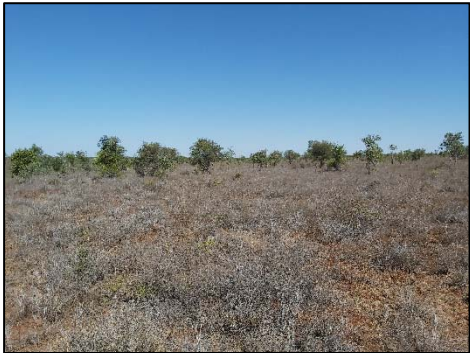
Landscape

SITE 61

Soil Mapping Unit: C3-BR	Location (GDA94 ZONE 55): 634364 7546987	Australian Soil Class: Brown Vertosol	Site Survey Type: Detailed Hand Auger 50mm	Survey Date: 12/10/2019
------------------------------------	--	---	--	-----------------------------------

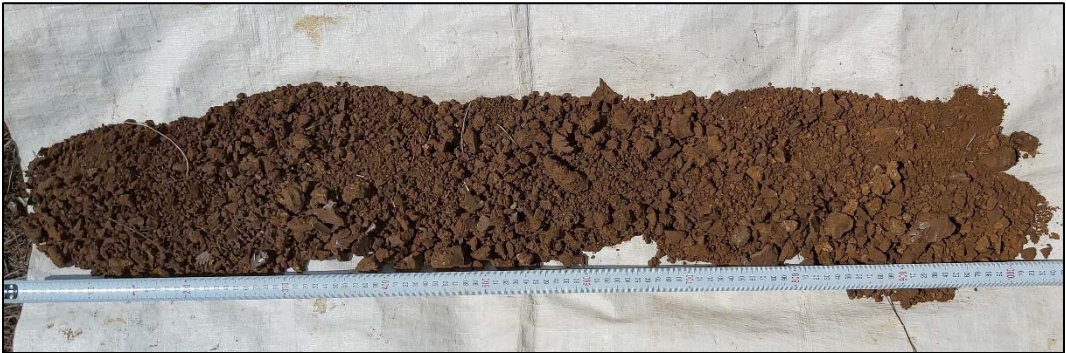
Land use Landform Pattern, Element, Slope	Vegetation	Microrelief Disturbance Erosion	Surface condition, surface rock	Soil Profile Description									
				Horizon Depth (m), Boundary	Field Texture	Structure, Strength, Cutans	Inclusions Segregations	Colour, Mottle, Bleaching	Moisture, Drainage	Roots	Depth (m) / Field pH	Sample (m)	Observations
Grazing, gently undulating plain, mid- slope 2 / 2%	Sparse mixed regrowth	Nil microrelief Semi disturbed Nil erosion	Crust with cracking nil coarse fragments	A1 0.00-0.09 Abrupt	Light clay	Moderate, weak, peds 5-10mm	Nil	7.5YR3/2 Dark brown Nil mottles / bleaching	Dry, well drained	Common	0.05 / 7.0	Nil	Nil
				B21 0.09-0.27 Abrupt	Light clay	Moderate, firm, peds 10-20mm	Nil	7.5YR2.5/3 Very dark brown Nil mottles / bleaching	Dry, well drained	Common	0.25 / 7.5		
				B22 0.27-0.77 Abrupt	Medium clay	Moderate, very firm, subangular peds 10-40mm slickensides observed	<1% calcium carbonate	7.5YR3/3 Dark brown Nil mottles / bleaching	Dry, moderately well drained	Few	0.60 / 7.5

B23 0.77-1.00 EOBH	Medium clay	Moderate, weak, peds 10-20mm slickensides observed	Nil	7.5YR4/4 Brown Nil mottles / bleaching	Dry, moderately well drained	Nil	0.90 / 7.5

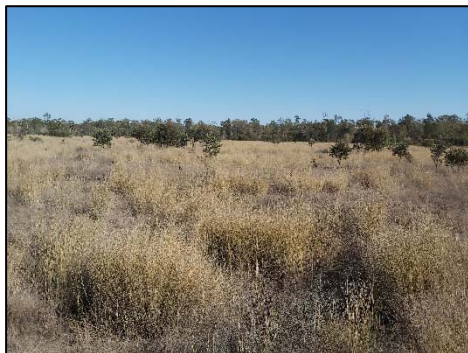
Landscape

SITE 66 - Mound

Soil Mapping Unit: C1-BR	Location (GDA94 ZONE 55): 627840 7551946	Australian Soil Class: Brown Vertosol	Site Survey Type: Detailed Hand Auger 50mm	Survey Date: 13/10/2019
------------------------------------	--	---	--	-----------------------------------

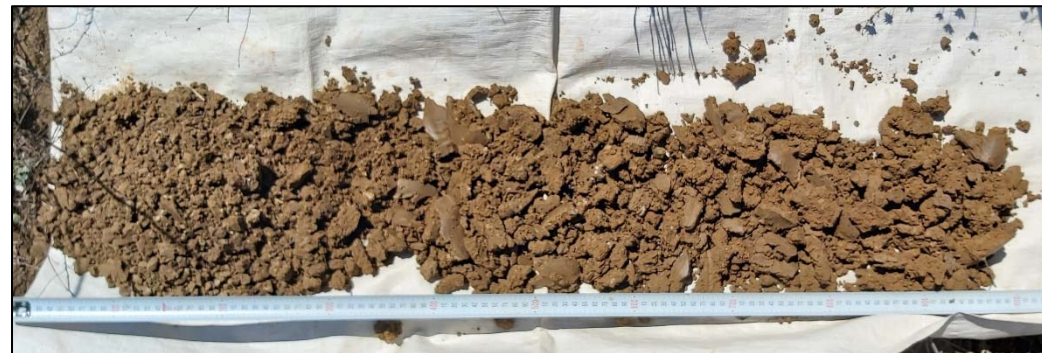
**Soil Profile**

Land use Landform Pattern, Element, Slope	Vegetation	Microrelief Disturbance Erosion	Surface condition, surface rock	Soil Profile Description									
				Horizon Depth (m), Boundary	Field Texture	Structure, Strength, Cutans	Inclusions Segregations	Colour, Mottle, Bleaching	Moisture, Drainage	Roots	Depth (m) / Field pH	Sample (m)	Observations
Grazing Mid-slope <1-1 %	Brigalow regrowth, sparse grasses	Melon hole 40% coverage, 3- 6m wide, 0.2- 0.4m deep extensive disturbance Nil erosion	Crust Nil coarse fragments	A1 0.00-0.17 Abrupt	Light medium clay	Weak, very firm, subangular <10mm	Nil	7.5YR3/2 Dark brown Nil mottles / bleaching	Dry, well to moderate	Common	0.10 / 7.0	Backup samples	Nil
				B21 0.17-0.50 Abrupt	Light medium clay	Moderate, very firm, subangular <20mm	Nil	10YR3/3 Dark brown Nil mottles / bleaching	Dry, moderate	Common	0.30 / 7.5		
				B22 0.50-0.66 Abrupt	Medium clay	Moderate, very firm, subangular <40mm slickensides observed	1% calcium carbonate	10YR4/4 Dark yellowish brown Nil mottles / bleaching	Dry, moderate	Few	0.60 / 7.5

B23 0.66-1.00 EOBH	Medium clay	Moderate, very firm, subangular <40mm slickensides observed	1% calcium carbonate / manganese nodules	10YR4/4 Dark yellowish brown Nil mottles / bleaching	Dry, moderate	Few	0.90 / 7.5

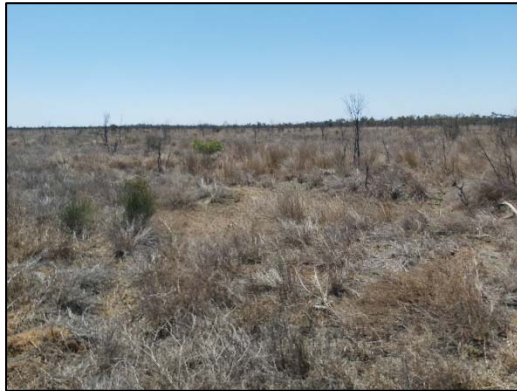
Landscape

SITE 67

Soil Mapping Unit: C1-BR	Location (GDA94 ZONE 55): 627369 7551873	Australian Soil Class: Brown Vertosol	Site Survey Type: Detailed Hand Auger 50mm	Survey Date: 13/10/2019
------------------------------------	--	---	--	-----------------------------------

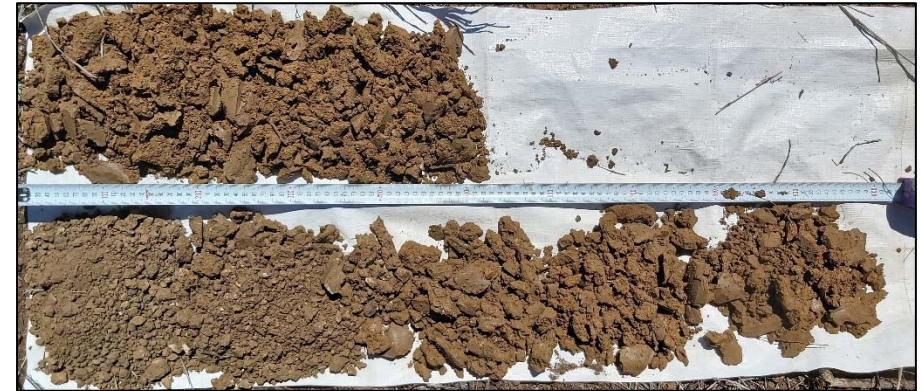
Land use Landform Pattern, Element, Slope	Vegetation	Microrelief Disturbance Erosion	Surface condition, surface rock	Soil Profile Description									
				Horizon Depth (m), Boundary	Field Texture	Structure, Strength, Cutans	Inclusions Segregations	Colour, Mottle, Bleaching	Moisture, Drainage	Roots	Depth (m) / Field pH	Sample (m)	Observations
Grazing Mid-slope <1-1 %	Brigalow regrowth, sparse grasses	Melon hole 40% coverage, 3- 6m wide, 0.2- 0.4m deep extensive disturbance Nil erosion	Crust Nil coarse fragments	A1 0.00-0.13 Abrupt	Light medium clay	Weak, very firm, subangular <10mm	Nil	7.5YR3/2 Dark brown Nil mottles / bleaching	Dry, well to moderate	Common	0.10 / 7.0	Nil	Nil
				B21 0.13-0.45 Abrupt	Medium clay	Moderate, very firm, subangular <20mm	Nil	10YR3/3 Dark brown Nil mottles / bleaching	Dry, moderate	Few	0.30 / 7.5		
				B22 0.43-1.22 Abrupt	Medium clay	Moderate, very firm, subangular <40mm Slickensides observed	1% calcium carbonate	10YR4/4 Dark yellowish brown Nil mottles / bleaching	Dry, moderate	Very few	0.60 / 7.5 0.90 / 7.5

B22 1.22-1.50 EOBH	Medium clay	Moderate, very firm, subangular <40mm Slickensides observed	2% calcium carbonate	10YR4/4 Dark yellowish brown Nil mottles / bleaching	Dry, moderate	Nil	1.20 / 7.5

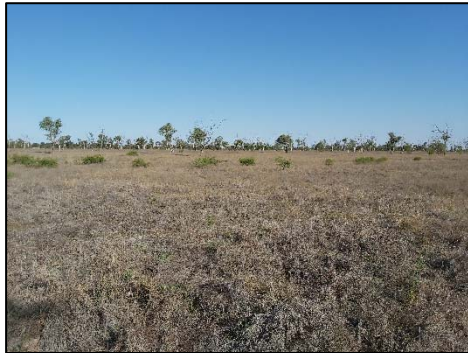
Landscape

SITE 70

Soil Mapping Unit: C5	Location (GDA94 ZONE 55): 630784 7552235	Australian Soil Class: Black Vertosol	Site Survey Type: Detailed Hand Auger 50mm	Survey Date: 13/10/2019
---------------------------------	--	---	--	-----------------------------------

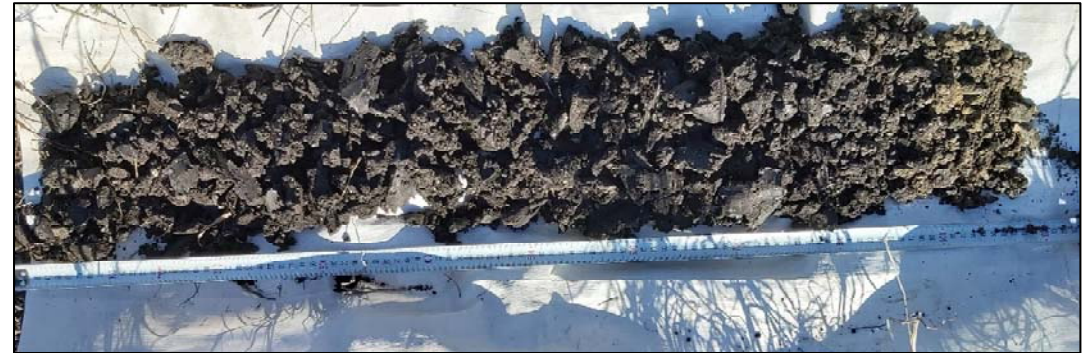
Land use Landform Pattern, Element, Slope	Vegetation	Microrelief Disturbance Erosion	Surface condition, surface rock	Soil Profile Description									
				Horizon Depth (m), Boundary	Field Texture	Structure, Strength, Cutans	Inclusions Segregations	Colour, Mottle, Bleaching	Moisture, Drainage	Roots	Depth (m) / Field pH	Sample (m)	Observations
Grazing Alluvial plain, flat wide depression	Exotic grassland	Nil microrelief Extensive disturbance Nil erosion	Crust Nil coarse fragments	A1 0.00-0.12 Abrupt	Medium clay	Moderate, firm, subangular <20mm	1% calcium carbonate	10YR3/1 Very dark grey Nil mottles / bleaching	Dry, well to moderate	Common	0.10 / 7.5	0.00-0.10 0.20-0.30 0.50-0.60 0.70-0.80 0.90-1.00	Nil
				B21 0.12-0.88 Abrupt	Medium clay	Moderate, firm, subangular 20- 40mm slickensides observed	2% calcium carbonate	10YR3/1 Very dark grey Nil mottles / bleaching	Dry, moderate	Few	0.30 / 7.5 0.60 / 7.5

B22 0.88-1.00 EOBH	Medium clay	Moderate, very firm, subangular 20-40mm	2% calcium carbonate	10YR3/1 Very dark grey Nil mottles / bleaching	Dry, moderate to imperfect	Nil	0.90 / 7.5

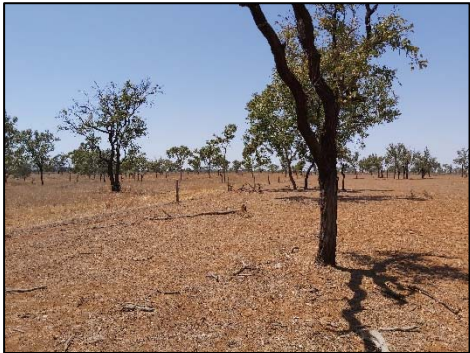
Landscape

SITE 73

Soil Mapping Unit: T2	Location (GDA94 ZONE 55): 627705 7546720	Australian Soil Class: Red Chromosol	Site Survey Type: Detailed Hand Auger 50mm	Survey Date: 14/10/2019
---------------------------------	--	--	--	-----------------------------------

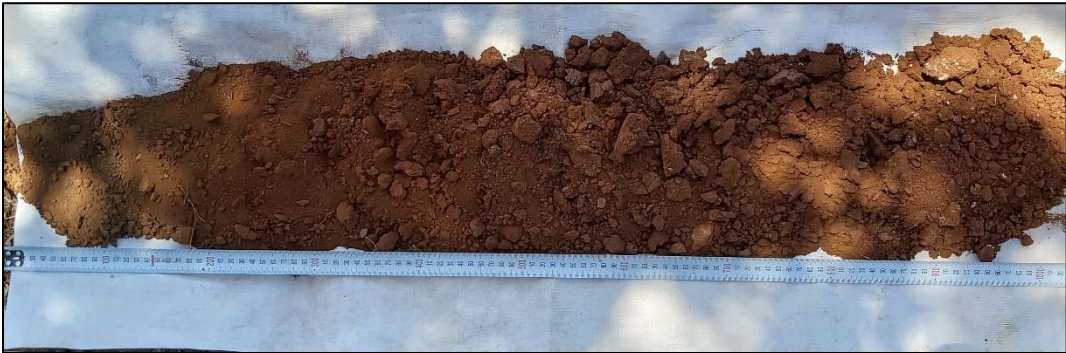
Land use Landform Pattern, Element, Slope	Vegetation	Microrelief Disturbance Erosion	Surface condition, surface rock	Soil Profile Description									
				Horizon Depth (m), Boundary	Field Texture	Structure, Strength, Cutans	Inclusions Segregations	Colour, Mottle, Bleaching	Moisture, Drainage	Roots	Depth (m) / Field pH	Sample (m)	Observations
Grazing, gently undulating plain, mid slope 1-2%	Sparse vegetation, gums	Nil microrelief Semi disturbed Nil erosion	Firm	A1 0.00-0.10 Abrupt	Sandy clay loam	Massive to weak, form, peds <5mm	<1% coarse fragments 5mm	7.5YR3/3 Dark brown Nil mottles / bleaching	Dry, well drained	Common	0.05 / 6.5	Nil	Nil
				B21 0.10-0.33 Abrupt	Clay loam	Massive to weak, form, peds <5mm	<1% coarse fragments 5mm	5YR4/3 Reddish brown Nil mottles / bleaching	Dry, well drained	Few	0.25 / 6.0		
				B22 0.33-0.80 Clear	Medium clay	Massive to weak, form, peds <2% <20mm	Nil	2.5YR4/4 Reddish brown Nil mottles / bleaching	Dry, well drained	Few	0.60 / 6.0

B23 0.80-1.00 EOBH	Medium clay	Massive to weak, form, peds <5mm	Nil	5YR4/4 Reddish brown Nil mottles / bleaching	Dry, well drained	Nil	0.85 / 6.0

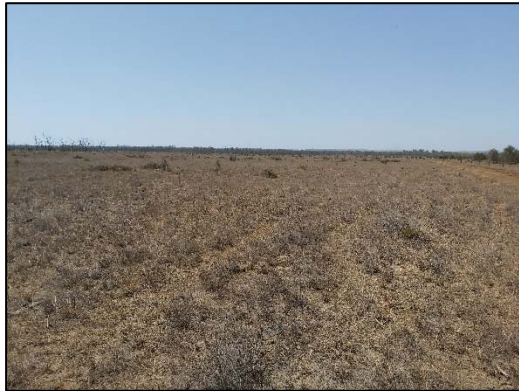
Landscape

Soil Mapping Unit: C3-BL	Location (GDA94 ZONE 55): 625433 7551868	Australian Soil Class: Black Vertosol	Site Survey Type: Detailed Hand Auger 50mm	Survey Date: 14/10/2019
------------------------------------	--	---	--	-----------------------------------

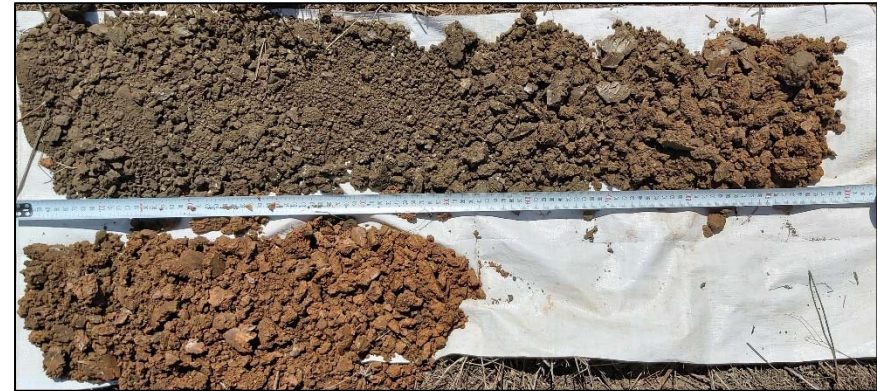
**Soil Profile**

Land use Landform Pattern, Element, Slope	Vegetation	Microrelief Disturbance Erosion	Surface condition, surface rock	Soil Profile Description									
				Horizon Depth (m), Boundary	Field Texture	Structure, Strength, Cutans	Inclusions Segregations	Colour, Mottle, Bleaching	Moisture, Drainage	Roots	Depth (m) / Field pH	Sample (m)	Observations
Grazing, gently undulating plain, mid- slope 2%	Grasses	Nil microrelief Extensive disturbance Nil erosion	Crust Nil coarse fragments	A11 0.00-0.12 Abrupt	Light clay	Weak to moderate, sub- angular <20mm	Nil	10YR3/2 Very dark greyish brown Nil mottles / bleaching	Dry, well	Common	-	Nil	Nil
				B21 0.12-0.80 Abrupt	Light medium clay	Weak to moderate, sub- angular <20mm slickensides observed	Nil	7.5YR3/2 Dark brown Nil mottles / bleaching	Dry, well to moderate	Common	-		
				B22 0.80-1.10 Abrupt	Light medium clay	Moderate, sub- angular <20mm	Nil	10YR4/4 Dark yellowish brown Nil mottles / bleaching	Dry, well to moderate	Nil	-

B23 1.10-1.50 EOBH	Medium clay	Moderate, sub- angular <20mm	Nil	7.5YR4/4 Brown Nil mottles / bleaching	Dry, moderate	Nil	-

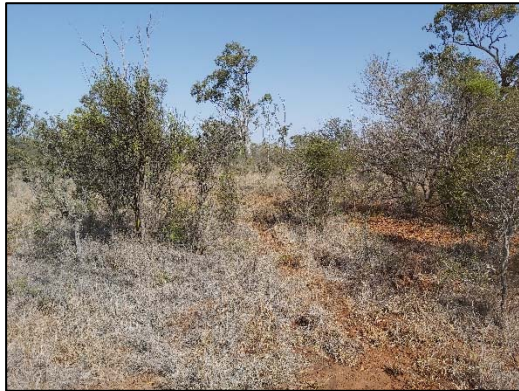
Landscape

Soil Mapping Unit: T2	Location (GDA94 ZONE 55): 627314 7544935	Australian Soil Class: Red Chromosol	Site Survey Type: Detailed Hand Auger 50mm	Survey Date: 14/10/2019
---------------------------------	--	--	--	-----------------------------------

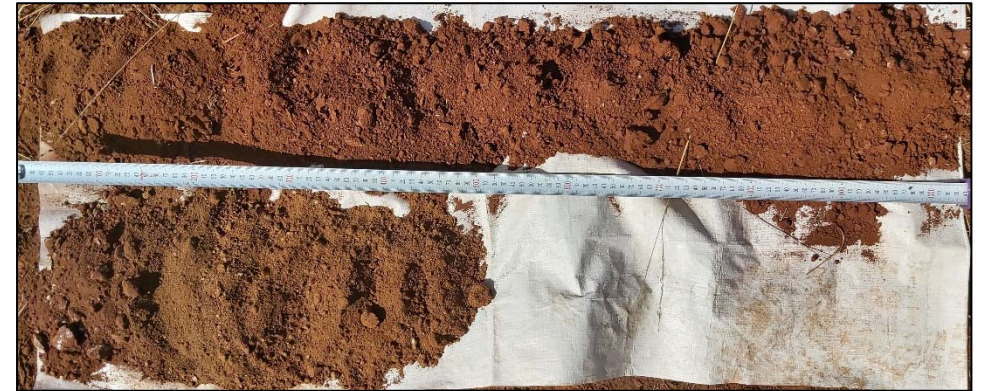
Land use Landform Pattern, Element, Slope	Vegetation	Microrelief Disturbance Erosion	Surface condition, surface rock	Soil Profile Description									
				Horizon Depth (m), Boundary	Field Texture	Structure, Strength, Cutans	Inclusions Segregations	Colour, Mottle, Bleaching	Moisture, Drainage	Roots	Depth (m) / Field pH	Sample (m)	Observations
Grazing GUP mid- slope 2 / 2%	Mixed vegetation	Nil microrelief Semi disturbance Nil erosion	Firm, Nil coarse fragments	A1 0.00-0.10 Abrupt	Sandy clay loam	Massive to weak, form, peds <5mm	<1% coarse fragments 5mm	7.5YR3/3 Dark brown Nil mottles / bleaching	Dry, well drained	Common	0.05 / 6.5	0.00-0.10	Nil
				A2 0.10-0.30 Abrupt	Clay loam	Massive to weak, form, peds <5mm	<1% coarse fragments 5mm	5YR4/3 Reddish brown Nil mottles / bleaching	Dry, well – moderate	Few	0.25 / 6.0	0.20-0.30	
				B21 0.30-0.88 Abrupt	Medium clay	Massive to weak, form, peds <2% <20mm	Nil	2.5YR4/6 Red Nil mottles / bleaching	Dry, moderate	Few	0.60 / 6.5	0.50-0.60

B22 0.88-1.10 Abrupt	Medium clay	Massive to weak, form, peds <10mm	<1% coarse fragments <5mm	2.5YR4/6 Red Nil mottles / bleaching	Dry, moderate	Nil	0.90 / 6.5	0.70-0.80	
				B23 1.10-1.50 EOBH	Clay loam	Massive to weak, form, peds <5mm	<1% coarse fragments <5mm	2.5YR4/6 Red Nil mottles / bleaching	Dry, moderate	Nil	1.20 / 7.0	0.90-1.00 1.40-1.50

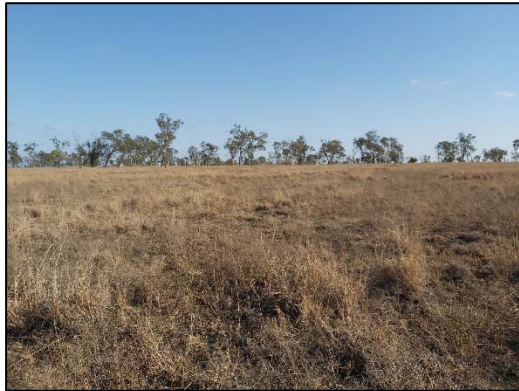
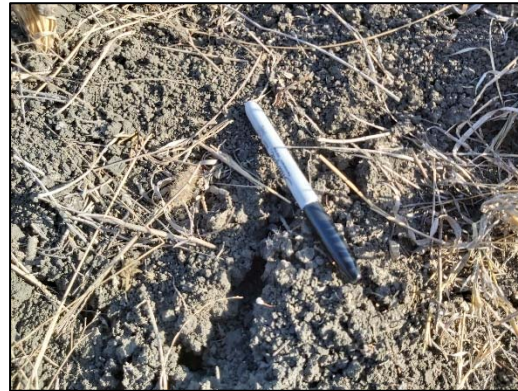
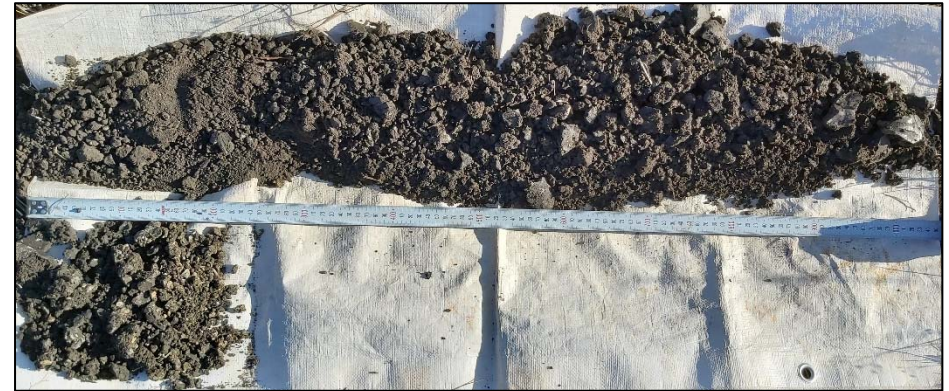
Soil Mapping Unit: C4	Location (GDA94 ZONE 55): 620919 7548417	Australian Soil Class: Black Vertosol	Site Survey Type: Detailed Hand Auger 50mm	Survey Date: 15/10/2019
---------------------------------	--	---	--	-----------------------------------

Land use Landform Pattern, Element, Slope	Vegetation	Microrelief Disturbance Erosion	Surface condition, surface rock	Soil Profile Description									
				Horizon Depth (m), Boundary	Field Texture	Structure, Strength, Cutans	Inclusions Segregations	Colour, Mottle, Bleaching	Moisture, Drainage	Roots	Depth (m) / Field pH	Sample (m)	Observations
Grazing GUP Mid-slope 3%	Grasses	Nil microrelief Extensive disturbance Nil erosion	Self-mulching, cracking Nil coarse fragments	A11 0.00-0.10 Abrupt	Light clay	Moderate, firm, sub-angular 5- 15mm	Nil	10YR3/2 Very dark greyish brown Nil mottles / bleaching	Dry, well	Common	-	Nil	Refusal encountered at 1.20 mbgl
				B21 0.10-0.33 Abrupt	Light medium clay	Moderate, firm, sub-angular 10- 20mm	Nil	10YR3/3 Dark brown Nil mottles / bleaching	Dry, moderate	Common	-		
				B22 0.33-1.05 Abrupt	Medium clay	Moderate, firm, sub-angular 10- 40mm slickensides observed	Nil	10YR3/2 Very dark greyish brown Nil mottles / bleaching	Dry, moderate	Few	-

B23 1.05-1.20 EOBH	Medium clay	Moderate, firm, sub-angular 10- 20mm	<2% coarse fragments	10YR3/2 Very dark greyish brown Mottles <2% 10YR4/2 Dark greyish brown Nil bleaching	Dry, moderate to imperfect	Nil	-

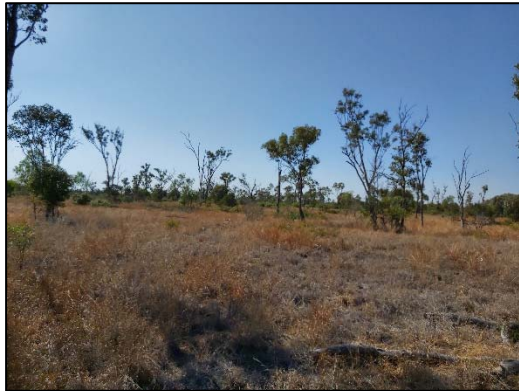
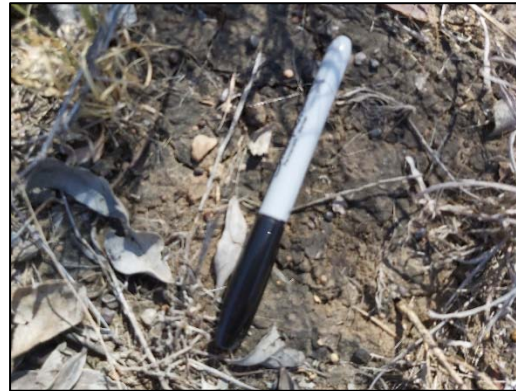
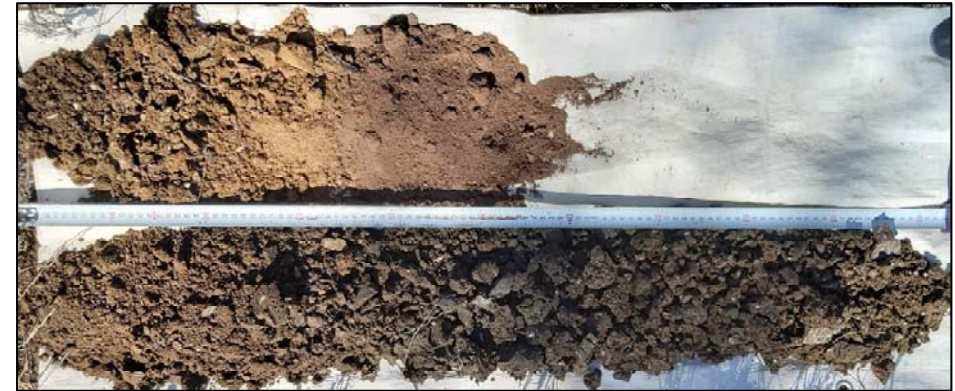
Soil Mapping Unit: T3	Location (GDA94 ZONE 55): 626510 7543191	Australian Soil Class: Brown Dermosol	Site Survey Type: Detailed Hand Auger 50mm	Survey Date: 15/10/2019
---------------------------------	--	---	--	-----------------------------------

Land use Landform Pattern, Element, Slope	Vegetation	Microrelief Disturbance Erosion	Surface condition, surface rock	Soil Profile Description									
				Horizon Depth (m), Boundary	Field Texture	Structure, Strength, Cutans	Inclusions Segregations	Colour, Mottle, Bleaching	Moisture, Drainage	Roots	Depth (m) / Field pH	Sample (m)	Observations
Grazing GUP mid- slope 2%	Poplar box with minor Brigalow	Nil microrelief Semi disturbance Nil erosion	Firm to hard setting <1% coarse fragments < 5mm	A11 0.00-0.09 Abrupt	Silty clay	Weak, firm, sub- angular <10mm	Nil	10YR4/3 Brown Nil mottles / bleaching	Dry, Well	Common	0.05 / 7.5	Nil	Nil
				A12 0.09-0.23 Abrupt	Silty clay	Weak, firm, sub- angular <15mm	Nil	10YR4/3 Brown Nil mottles / bleaching	Dry, Well	Common	0.15 / 7.5		
				B21 0.23-0.41 Abrupt	Silty clay loam	Moderate, firm, sub-angular 10- 20mm	Nil	10YR4/3 Brown Nil mottles / bleaching	Dry, Well to moderate	Common	0.30 / 7.5

B22 0.41-0.53 Abrupt	Silty clay loam	Moderate, firm, sub-angular 10- 20mm	<1% calcium carbonate	10YR3/2 Very dark greyish brown Nil mottles / bleaching	Dry, Well to moderate	Few	0.45 / 8.0		
				B23 0.53-1.05 Abrupt	Light clay	Moderate, firm, sub-angular 10- 20mm	<2% calcium carbonate	10YR4/3 Brown Nil mottles / bleaching	Dry, Moderate	Few	0.60 / 8.0		
				B3 1.05-1.50 EOBH	Silty loam	Massive, weak	Nil	5YR3/3 Dark reddish brown Nil mottles / bleaching	Dry, Moderate	Nil	1.20 / 7.0

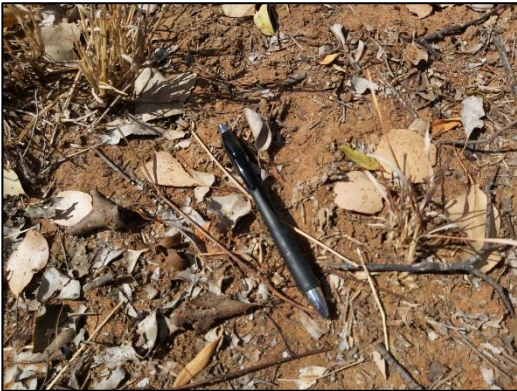
Soil Mapping Unit: S1	Location (GDA94 ZONE 55): 626206 7542633	Australian Soil Class: Brown Sodosol	Site Survey Type: Detailed exposed soil profile	Survey Date: 15/10/2019
---------------------------------	--	--	---	-----------------------------------

Land use Landform Pattern, Element, Slope	Vegetation	Microrelief Disturbance Erosion	Surface condition, surface rock	Soil Profile Description									
				Horizon Depth (m), Boundary	Field Texture	Structure, Strength, Cutans	Inclusions Segregations	Colour, Mottle, Bleaching	Moisture, Drainage	Roots	Depth (m) / Field pH	Sample (m)	Observations
Grazing GUP, lower slope near drainage line	Mixed Eucalyptus	Nil microrelief Semi disturbed Gully erosion	Hard Nil coarse fragments	A11 0.00-0.22 Abrupt	Clayey Sand	Weak	Nil	10YR3/3 Dark brown Nil mottles / bleaching	Dry, Well	Common	-	Nil	Exposed cutting profile
				A12 0.22-0.70 Abrupt	Clayey Sand	Weak	<1% coarse fragments <5mm	10YR3/3 Dark brown Nil mottles / bleaching	Dry, Well to moderate	Common	-		
				B2 0.70-1.00 EOBH	Sandy clay loam	Firm	<1% coarse fragments <5mm	10YR3/4 Dark yellowish brown Nil mottles / bleaching	Dry, Well to moderate	Few	-

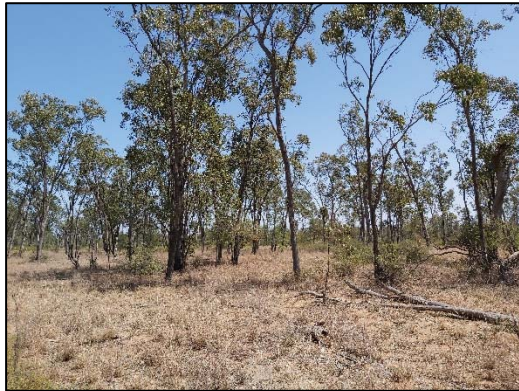
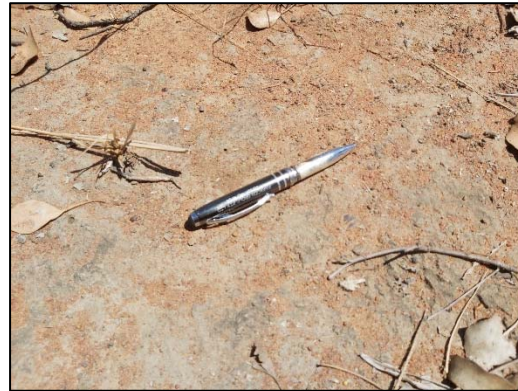
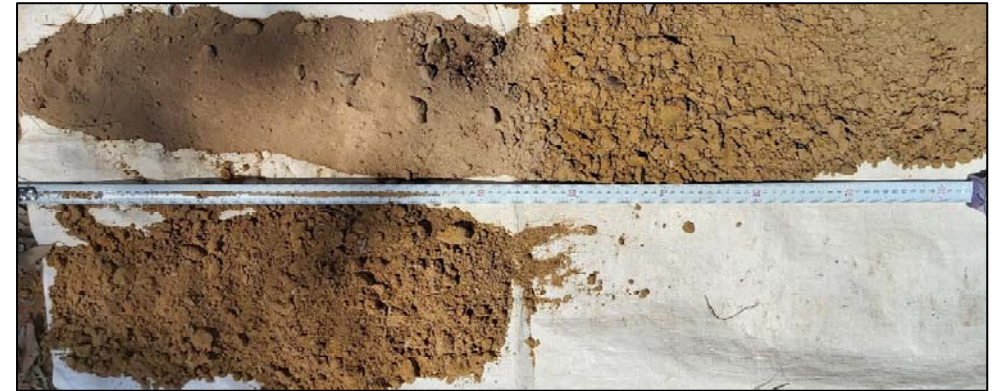
Soil Mapping Unit: S1	Location (GDA94 ZONE 55): 627902 7541799	Australian Soil Class: Brown Sodosol	Site Survey Type: Detailed Hand Auger 50mm	Survey Date: 15/10/2019
---------------------------------	--	--	--	-----------------------------------

Land use Landform Pattern, Element, Slope	Vegetation	Microrelief Disturbance Erosion	Surface condition, surface rock	Soil Profile Description									
				Horizon Depth (m), Boundary	Field Texture	Structure, Strength, Cutans	Inclusions Segregations	Colour, Mottle, Bleaching	Moisture, Drainage	Roots	Depth (m) / Field pH	Sample (m)	Observations
Grazing Flat plain	Tall woodlands including poplar box	Nil microrelief Nil disturbance Nil erosion	Hard setting Nil coarse fragments	A11 0.00-0.10 Abrupt	Clayey Sand	Massive, weak	Nil	10YR3/3 Dark brown Nil mottles / bleaching	Dry, Well	Common	0.10 / 6.0	Nil	Nil
				A12 0.10-0.45 Abrupt	Clayey Sand	Massive, weak	Nil	10YR4/4 Dark yellowish brown Nil mottles / bleaching	Dry, Well to moderate	Few	0.30 / 6.0		
				B21 0.45-0.90 Abrupt	Sandy clay loam	Moderate, firm 5- 20mm	<1% coarse fragments <5mm	10YR4/6 Dark yellowish brown Nil mottles / bleaching	Dry, Well to moderate	Nil	0.60 / 7.5

B22 0.90-1.50 EOBH	Sandy clay loam	Weak, weak	Nil	10YR4/6 Dark yellowish brown Nil mottles / bleaching	Dry, Moderate	Nil	1.20 / 7.5

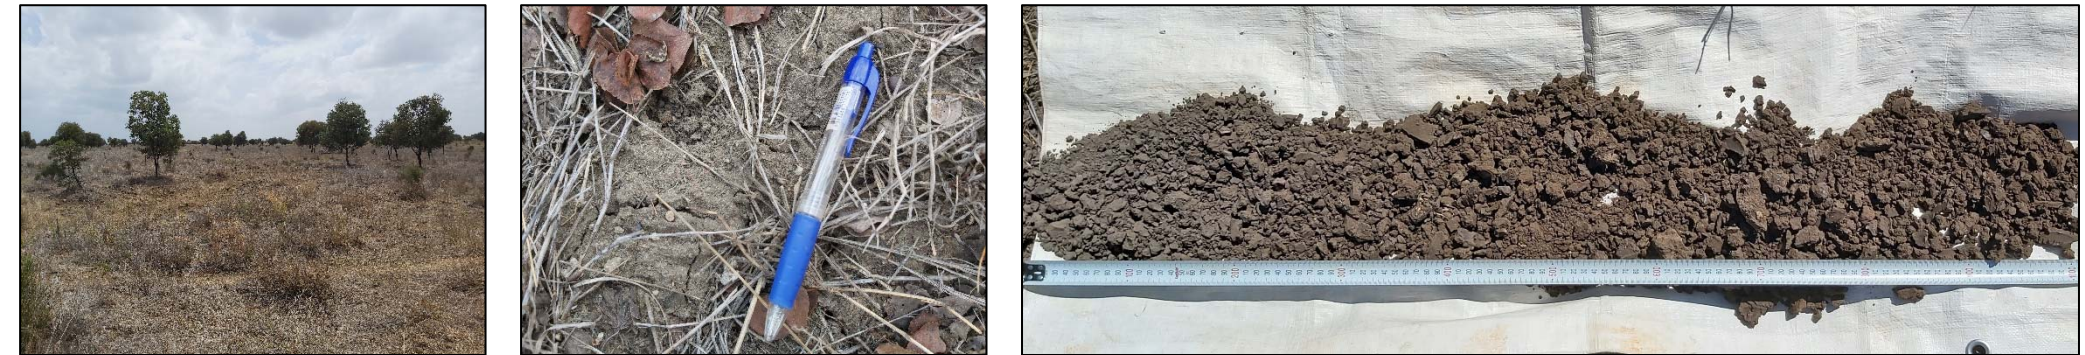
Land use Landform Pattern, Element, Slope	Vegetation	Microrelief Disturbance Erosion	Surface condition, surface rock	Soil Profile Description									
				Horizon Depth (m), Boundary	Field Texture	Structure, Strength, Cutans	Inclusions Segregations	Colour, Mottle, Bleaching	Moisture, Drainage	Roots	Depth (m) / Field pH	Sample (m)	Observations
Grazing, gently undulating plain, simple mid slope 1- 2%	Softwood scrub mixed vegetation	Nil microrelief Semi disturbed Nil erosion	Crust, white nodules <1%	A1 0.00-0.11 Abrupt	Light clay	Weak, very firm, sub-rounded peds <10mm	Nil	10YR3/2 Very dark greyish brown Nil mottles / bleaching	Dry, well drained	Common	0.05 / 6.5	Nil	Nil
				B21 0.11-0.70 Abrupt	Light medium clay	Moderate, very firm	<2% calcium carbonate	10YR3/1 Very dark grey Nil mottles / bleaching	Dry, well drained	Few	0.30 / 7.0 0.60 / 7.0		
				B22 0.70-1.00 EOBH	Light medium clay	Moderate, very firm slickensides observed	Nil	10YR4/1 Dark grey Nil mottles / bleaching	Dry, moderately well drained	Few	0.90 / 7.0
