WINCHESTER SOUTH PROJECT

Soils and Land Suitability Assessment Addendum

Winchester South Project
Whitehaven WS Pty Ltd

23 June 2022

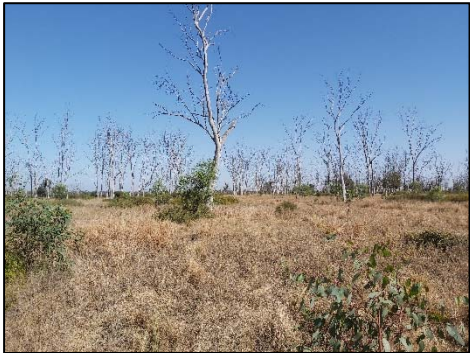
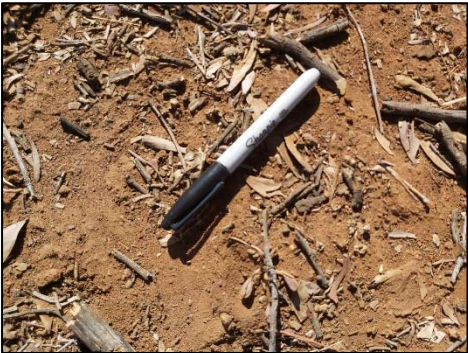
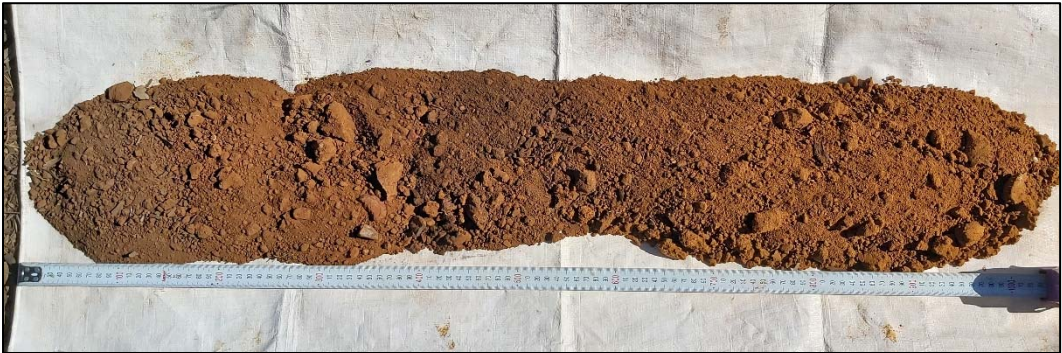
SITE 82

Soil Mapping Unit: T2	Location (GDA94 ZONE 55): 630200 7541015	Australian Soil Class: Red Chromosol	Site Survey Type: Detailed Hand Auger 50mm	Survey Date: 15/10/2019
---------------------------------	--	--	--	-----------------------------------

Land use Landform Pattern, Element, Slope	Vegetation	Microrelief Disturbance Erosion	Surface condition, surface rock	Soil Profile Description									
				Horizon Depth (m), Boundary	Field Texture	Structure, Strength, Cutans	Inclusions Segregations	Colour, Mottle, Bleaching	Moisture, Drainage	Roots	Depth (m) / Field pH	Sample (m)	Observations
Grazing, gently undulating plain, upper slope 1-2%	Tall woodlands	Nil microrelief Semi disturbance Nil erosion	Firm, Nil coarse fragments	A1 0.00-0.10 Abrupt	Clayey sand	Massive, loose	<2% coarse fragments <1mm	7.5YR3/2 Dark brown Nil mottles / bleaching	Dry, rapid	Common	-	Nil	Nil
				B21 0.10-0.38 Abrupt	Sandy clay loam	Weak, weak, sub- angular <20mm	Nil	7.5YR3/4 Dark brown Nil mottles / bleaching	Dry, well	Common	-		
				B22 0.38-0.68 Abrupt	Medium clay	Weak, weak, sub- angular <20mm	Nil	7.5YR3/3 Dark brown Nil mottles / bleaching	Dry, well	Few	-		
				B22 0.68-1.00 EOBH	Medium clay	Weak, weak, sub- angular <20mm	Nil	7.5YR4/4 Brown Nil mottles / bleaching	Dry, well	Nil	-

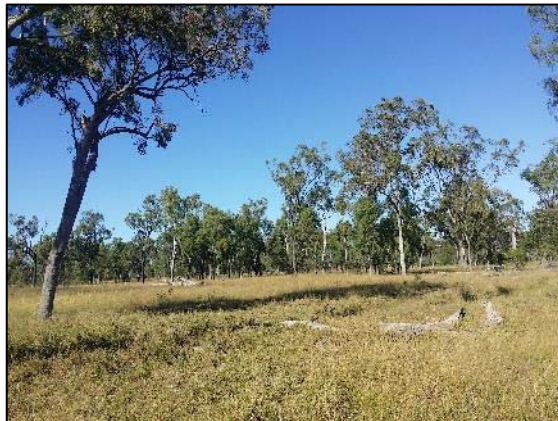
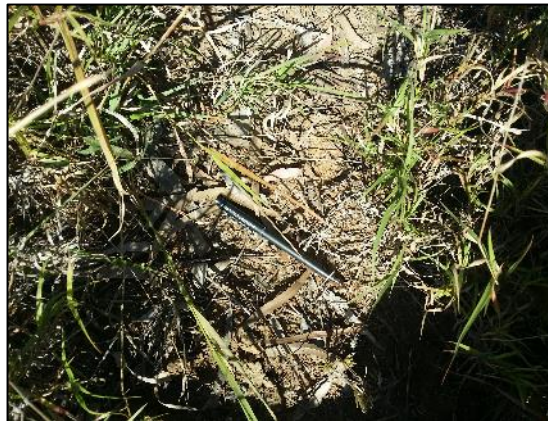
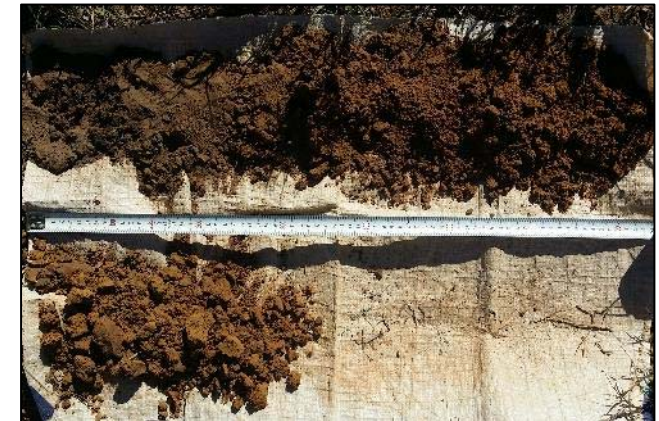
SITE OD-15

Soil Mapping Unit: S1	CSIRO Land Systems (Gunn et al 1967): Somerby, Monteagle, Connors, Humboldt, Blackwater	Location (GDA ZONE 55): 639357 mE 7545231 mN	Aust. Soil Class. : Brown Sodosol	Site Survey Type: Detailed - 50mm hand auger	Survey Date: 20/6/2017
---------------------------------	---	--	---	--	----------------------------------

Land use Landform Pattern, Element, Slope	Natural Vegetation	Microrelief Disturbance Erosion	Surface condition, surface rock	Soil Profile Description									
				Horizon Depth (m), Boundary	Texture	Structure, Strength, Cutans	Inclusions Segregations	Colour, Mottle	Moisture, Drainage	Roots	Depth (m) / Field pH	Sample (m)	Observations
Grazing, very gently undulating plains, 1%	Very Sparse, Moreton Bay Ash, Blackbutt	Semi cleared	Firm, nil coarse fragments	A11 0.0 – 0.22 Abrupt	Loamy sand	Massive, loose	Nil	10YR3/2 Very dark greyish brown Nil mottles / bleaching	Dry, rapid	Few, very fine	0.1 / 6.5	No samples taken	No additional observations
				A12 0.22 – 0.7 Abrupt	Clayey sand	Weak subangular peds 20mm, weak	Nil	10YR4/4 Dark yellowish brown Nil mottles / bleaching	Humid, well drained	Few, very fine	0.3 / 7.0 0.6 / 7.0		
				B2 0.7 – 1.0	Sandy clay loam	Weak subangular peds 40mm, weak	2% coarse fragments, 2- 10mm	7.5YR4/4 Brown Brown Mottle: 2.5YR4/6 Red Red Nil bleaching	Dry, imperfectly drained	Nil	0.9 / 7.0

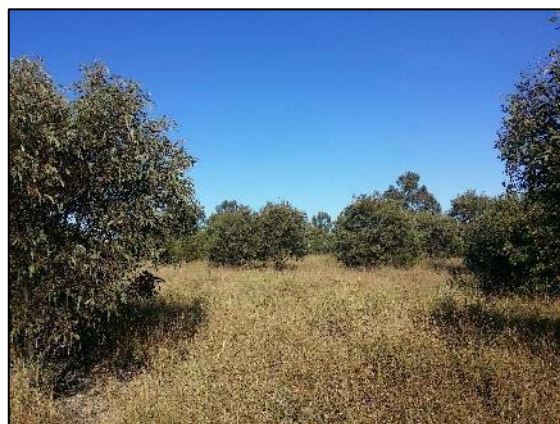
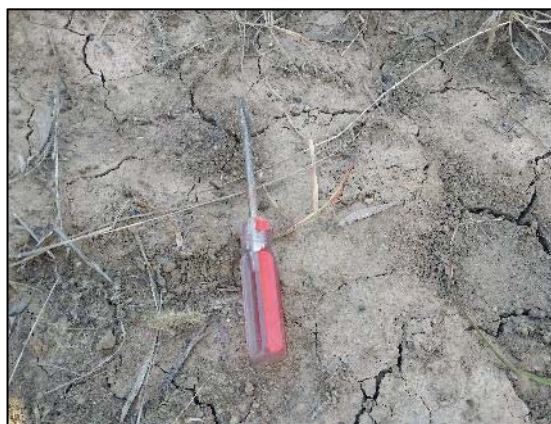
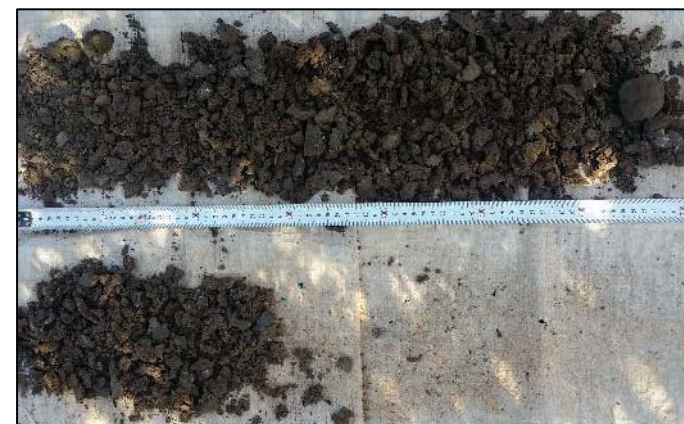
SITE OD-26a

Soil Mapping Unit: C2 - C1-BR interfingering with C1-BL	CSIRO Land Systems (Gunn et al 1967): Somerby, Monteagle, Connors, Humboldt, Blackwater, Junea	Location (GDA ZONE 55): 640146 mE 7543555 mN	Aust. Soil Class. : Brown Vertosol	Site Survey Type: Detailed - 50mm hand auger	Survey Date: 22/6/2017
--	---	--	--	--	----------------------------------

Land use Landform Pattern, Element, Slope	Natural Vegetation	Microrelief Disturbance Erosion	Surface condition, surface rock	Soil Profile Description									
				Horizon Depth (m), Boundary	Texture	Structure, Strength, Cutans	Inclusions Segregations	Colour, Mottle	Moisture, Drainage	Roots	Depth (m) / Field pH	Sample (m)	Observations
Grazing, very gently undulating plain, <1% slope	Tall Brigalow and Brigalow regrowth, semi sparse, limited clearing 20- 30% coverage	Normal gilgai, 30% coverage, <0.3m deep	Cracking, crust 5% coarse fragments <5mm	A1 0.00 – 0.19 Abrupt	Light medium clay	Weak, <10mm peds, subangular, strength- firm	2% coarse fragments	10YR4/2 Dark greyish brown Nil mottles / bleaching	Dry, well drained	Nil	0.00 / 6.5	0.00 – 0.10 0.30 – 0.40 0.60 – 0.70 0.90 – 1.00	Site located in gilgai depression
				B2 0.19 – 1.00	Medium clay	Strong structure <20mm, very firm strength slickensides observed	<2% black nodules <5mm <1% calcium carbonate	10YR4/3 Brown Nil mottles / bleaching	Dry, well drained	Nil	0.30 / 6.5 0.60 / 7.0 0.90 / 7.0

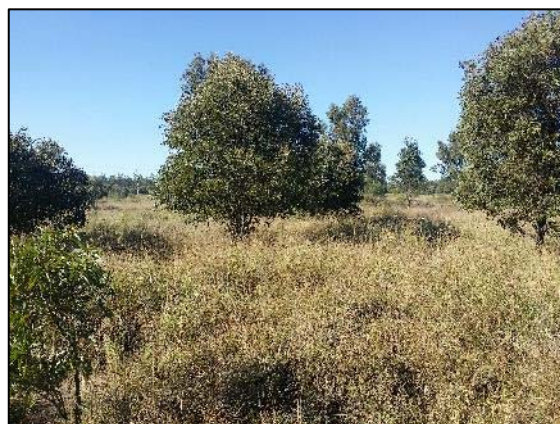
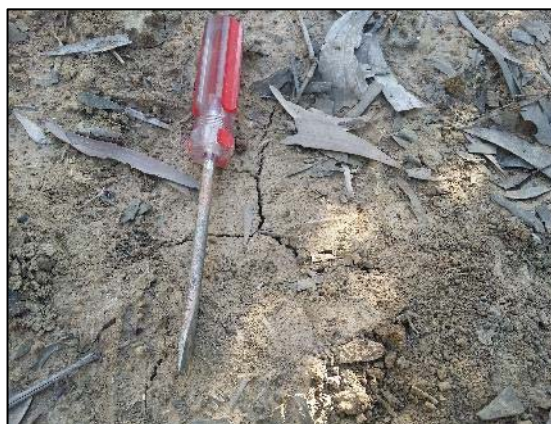
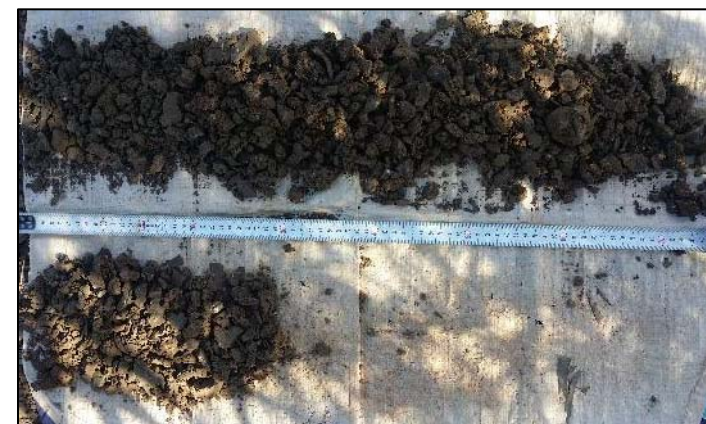
SITE OD-26b

Soil Mapping Unit: C2 - C1-BR interfingering with C1-BL	CSIRO Land Systems (Gunn et al 1967): Somerby, Monteagle, Connors, Humboldt, Blackwater, Junee	Location (GDA ZONE 55): 640146 mE 7543555 mN	Aust. Soil Class. : Brown Vertosol	Site Survey Type: Detailed - 50mm hand auger	Survey Date: 22/6/2017
--	---	--	--	--	----------------------------------

Land use Landform Pattern, Element, Slope	Natural Vegetation	Microrelief Disturbance Erosion	Surface condition, surface rock	Soil Profile Description									
				Horizon Depth (m), Boundary	Texture	Structure, Strength, Cutans	Inclusions Segregations	Colour, Mottle	Moisture, Drainage	Roots	Depth (m) / Field pH	Sample (m)	Observations
Grazing, very gently undulating plain, <1% slope	Tall Brigalow and Brigalow regrowth, semi sparse, limited clearing 20- 30% coverage	Normal gilgai, 30% coverage, <0.3m deep	Crust, 5% coarse fragments <5mm	A1 0.00 – 0.25 Abrupt	Light medium clay	Moderate, <10mm peds, subangular, strength- firm	2% coarse fragments	10YR4/2 Dark greyish brown Nil mottles / bleaching	Dry, well drained	Nil	0.00 / 6.5	0.00 – 0.10	Site located on gilgai mound
				B2 0.25 – 1.00	Medium clay	Strong structure <20mm, very firm strength slickensides observed	<2% black nodules <5mm <1% calcium carbonate	10YR4/3 Brown Nil mottles / bleaching	Dry, well drained	Nil	0.30 / 7.0 0.60 / 7.0 0.90 / 7.0	0.30 – 0.40 0.60 – 0.70 0.90 – 1.00

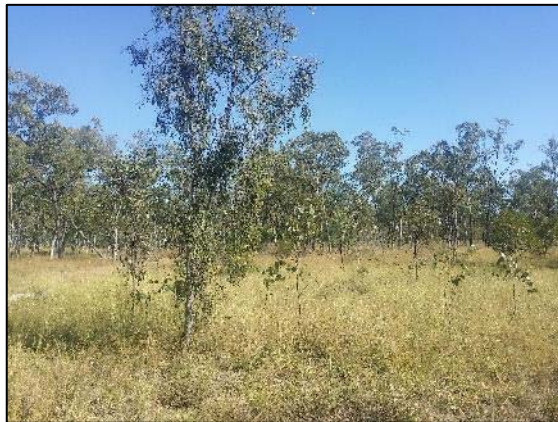
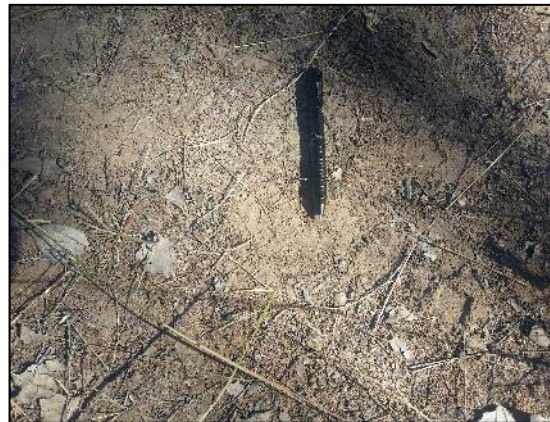
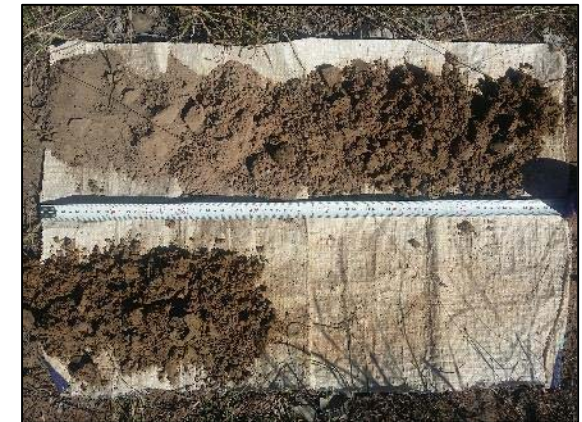
SITE OD-28

Soil Mapping Unit: B1 interfingering / grading with S1	CSIRO Land Systems (Gunn et al 1967): Somerby, Monteagle, Humboldt	Location (GDA ZONE 55): 639637 mE 7542190 mN	Aust. Soil Class. : Subnatric Brown Sodosol	Site Survey Type: Detailed - 50mm hand auger	Survey Date: 22/6/2017
--	--	--	---	--	----------------------------------

Land use Landform Pattern, Element, Slope	Natural Vegetation	Microrelief Disturbance Erosion	Surface condition, surface rock	Soil Profile Description									
				Horizon Depth (m), Boundary	Texture	Structure, Strength, Cutans	Inclusions Segregations	Colour, Mottle	Moisture, Drainage	Roots	Depth (m) / Field pH	Sample (m)	Observations
Grazing, very gently undulating plain, mid slope 1-2%	Ironbark, Poplar Box, Moreton Bay Ash	Nil	Hard setting, <5% coarse fragments <10mm	A11 0.00 – 0.30 Diffuse	Loamy sand	Massive, loose	Nil	10YR3/2 Very dark greyish brown Nil mottles / bleaching	Dry, rapid	Few, very fine	0.10 / 6.5	No samples taken	No additional observations
				A12 0.30 – 0.55 Clear	Loamy sand	Weak 0- 10mm peds subangular, Weak	<2% black/white nodules	10YR4/2 Dark greyish brown Nil mottles / bleaching	Dry, well drained	Nil	0.30 / 6.5		
				B21 0.55 – 1.00	Silty clay loam	Weak subangular, Moderate 6-10mm peds	<2% manganese nodules	10YR4/4 Dark yellowish brown Nil mottles / bleaching	Dry, well drained	Nil	0.60 / 7.0 0.90 / 7.0

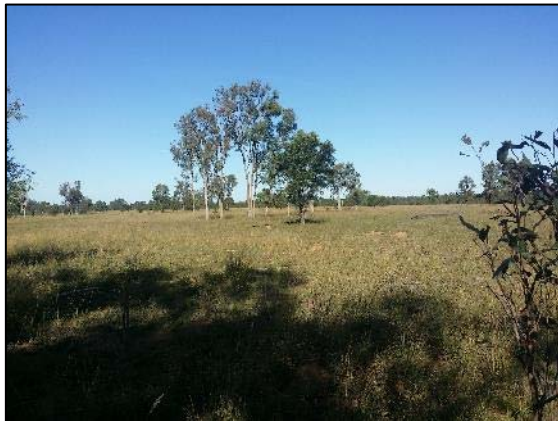
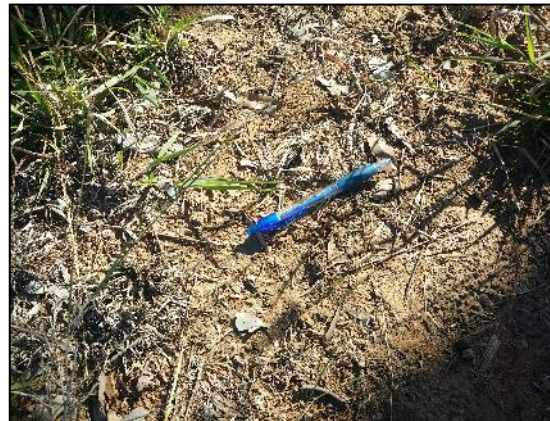
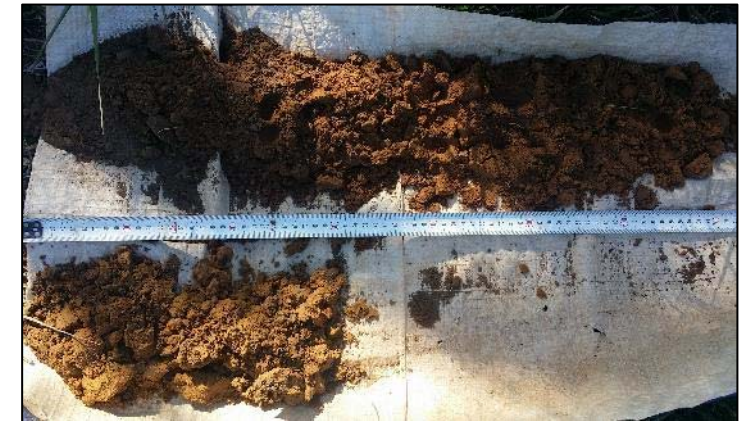
SITE OD-31

Soil Mapping Unit: S2 grading into S4	CSIRO Land Systems (Gunn et al 1967): Somerby, Monteagle, Connors, Humboldt, Blackwater	Location (GDA ZONE 55): 639834 mE 7541276 mN	Aust. Soil Class. : Haplic Brown Dermosol	Site Survey Type: Detailed - 50mm hand auger	Survey Date: 22/6/2017
---	--	--	---	--	----------------------------------

Land use Landform Pattern, Element, Slope	Natural Vegetation	Microrelief Disturbance Erosion	Surface condition, surface rock	Soil Profile Description									
				Horizon Depth (m), Boundary	Texture	Structure, Strength, Cutans	Inclusions Segregations	Colour, Mottle	Moisture, Drainage	Roots	Depth (m) / Field pH	Sample (m)	Observations
Grazing, gently undulating plain, upper slope 1.5%	Very sparse Blackbutt and Ironbark	Extensive clearing	Firm, nil coarse fragments	A1 0.00 – 0.13 Abrupt	Clayey sand	Weak, peds 2-10mm, weak	Nil	10YR3/3 Dark brown Nil mottles / bleaching	Dry, rapid	Few, very fine	0.00 / 7.0	No samples taken	No additional observations
				B21 0.13 – 0.37 Clear	Loamy sand	Weak subangular peds 5- 20mm, weak	Nil	10YR4/3 Brown Nil mottles / bleaching	Dry, rapid	Nil	0.30 / 7.0		
				B22 0.37 – 1.00	Loamy sand	Weak subangular peds 10- 30mm, weak	<2% Coarse fragments 2- 5mm and red nodules	10YR4/4 Dark yellowish brown Nil mottles / bleaching	Moderately moist, rapid	Nil	0.60 / 7.0 0.90 / 7.0

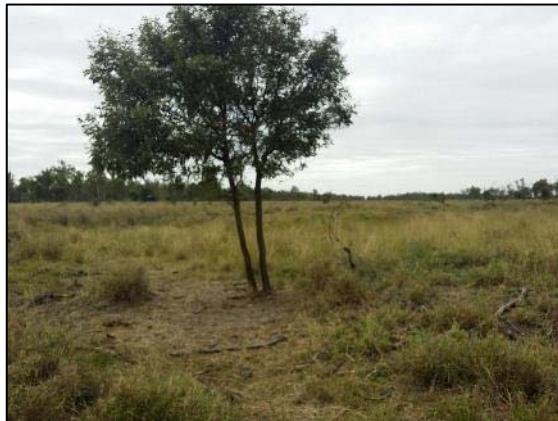
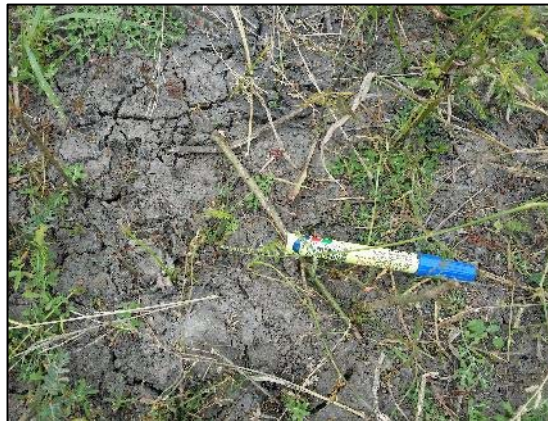
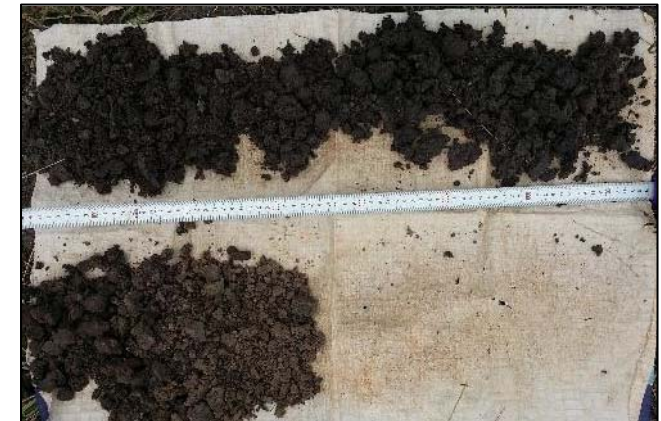
SITE OD-34

Soil Mapping Unit: C2, grading into C3-BL	CSIRO Land Systems (Gunn et al 1967): Somerby, Monteagle, Connors, Humboldt, Blackwater, Junea	Location (GDA ZONE 55): 639343 mE 7540015 mN	Aust. Soil Class. : Brown Vertosol	Site Survey Type: Detailed - 50mm hand auger	Survey Date: 23/6/2017
---	---	--	--	--	----------------------------------

Land use Landform Pattern, Element, Slope	Natural Vegetation	Microrelief Disturbance Erosion	Surface condition, surface rock	Soil Profile Description									
				Horizon Depth (m), Boundary	Texture	Structure, Strength, Cutans	Inclusions Segregations	Colour, Mottle	Moisture, Drainage	Roots	Depth (m) / Field pH	Sample (m)	Observations
Grazing, mid slope, very gently undulating plain, 1.5%	Brigalow regrowth	Extensive clearing, previously blade ploughed	Hard setting, cracking – fine to moderate cracks, <5% coarse fragments 2- 4mm	A1 0.00 – 0.18 Clear	Light clay	Weak angular peds <10mm, firm	<2% coarse fragments 2- 6mm	10YR3/1 Very dark grey Nil mottles / bleaching	Humid – moderately moist, well drained	Very fine, few	0.00 / 6.5	0.00 – 0.10 0.30 – 0.40 0.60 – 0.70 0.90 – 1.00	No additional observations
				B21 0.18 – 0.70 Diffuse	Medium clay	Moderate angular peds <20mm, firm	<5% coarse fragments 2- 6mm and black nodules	10YR3/1 Very dark grey Nil mottles / bleaching	Moderately moist, well drained	Very fine, few	0.30 / 6.5

B22 0.70 – 0.81 Abrupt	Medium clay	Moderate angular peds <20mm, firm slickensides observed	Nil	10YR3/2 Very dark greyish brown Nil mottles / bleaching	Moderately moist, well to moderately drained	Nil	0.60 / 7.0

Land use Landform Pattern, Element, Slope	Natural Vegetation	Microrelief Disturbance Erosion	Surface condition, surface rock	Soil Profile Description									
				Horizon Depth (m), Boundary	Texture	Structure, Strength, Cutans	Inclusions Segregations	Colour, Mottle	Moisture, Drainage	Roots	Depth (m) / Field pH	Sample (m)	Observations
				B23 0.81 – 1.05	Silty clay loam	Weak angular peds <10mm, firm	-	10YR4/2 Dark greyish brown Nil mottles / bleaching	Dry, moderately moist	-	0.90 / 7.0

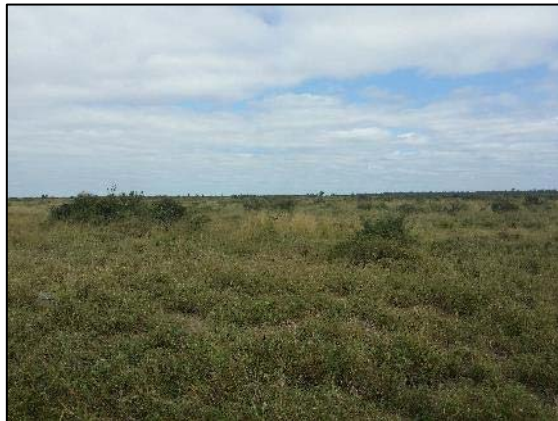
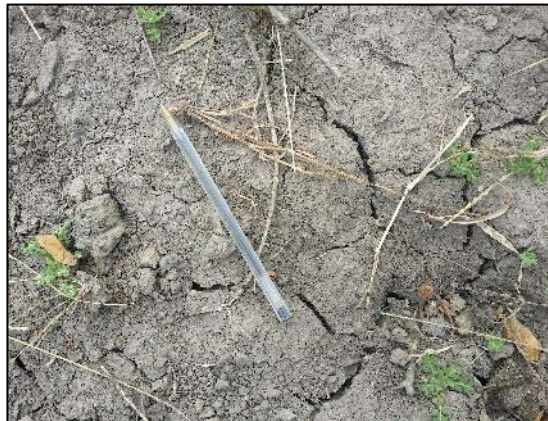
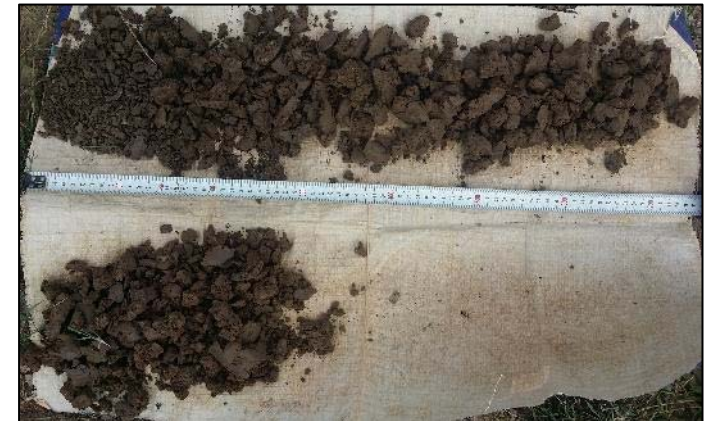
Soil Mapping Unit: C2, grading into C3-BL	CSIRO Land Systems (Gunn et al 1967): Somerby, Monteagle, Connors, Humboldt, Blackwater, Junea	Location (GDA ZONE 55): 636346 mE 7538814 mN	Aust. Soil Class. : Brown Vertosol	Site Survey Type: Detailed - 50mm hand auger	Survey Date: 12/7/2017
---	---	--	--	--	----------------------------------

Land use Landform Pattern, Element, Slope	Natural Vegetation	Microrelief Disturbance Erosion	Surface condition, surface rock	Soil Profile Description									
				Horizon Depth (m), Boundary	Texture	Structure, Strength, Cutans	Inclusions Segregations	Colour, Mottle	Moisture, Drainage	Roots	Depth (m) / Field pH	Sample (m)	Observations
Grazing, gently undulating plains, upper slope, 1.0%	Regrowth, shrubs	Shallow gilgai, Extensive clearing	Cracking, Nil coarse fragments	A1 0.00-0.10 Abrupt	Light clay	Weak, firm, <10mm sub- angular	Nil	10YR3/2 Very dark greyish brown Nil mottles / bleaching	Dry, well drained	Few, very fine	0.10 / 6.5	No samples taken	No additional observations
				B2 0.10-1.00	Light clay	Moderate, firm, <20mm sub- angular slickensides observed	Nil	10YR3/1 Very dark grey Nil mottles / bleaching	Dry, well drained	Very few, very fine	0.30 / 6.5 0.60 / 6.0 0.90 / 6.0

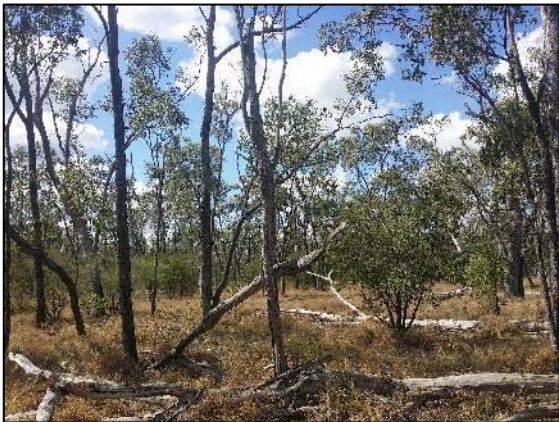
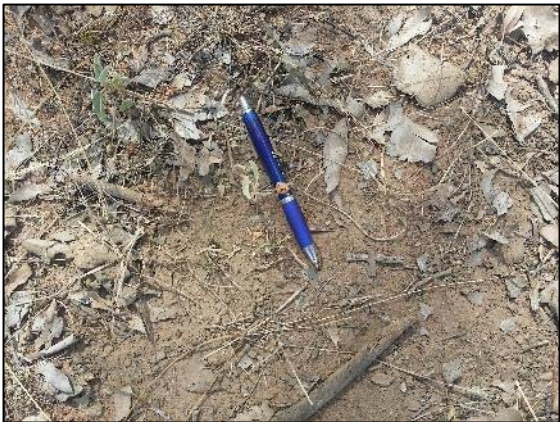
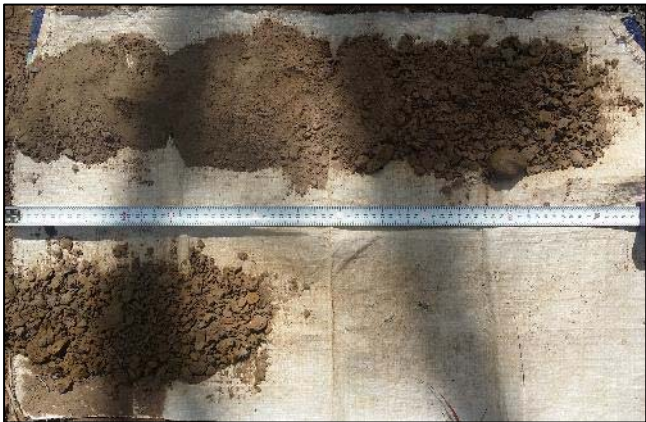
SITE OD-170

Soil Mapping Unit: S1	CSIRO Land Systems (Gunn et al 1967): Somerby, Monteagle, Connors, Humboldt, Blackwater	Location (GDA ZONE 55): 637680 mE 7547045 mN	Aust. Soil Class. : Brown Sodosol	Site Survey Type: Detailed - 50mm hand auger	Survey Date: 4/8/2017
---------------------------------	--	--	---	--	---------------------------------

Land use Landform Pattern, Element, Slope	Natural Vegetation	Microrelief Disturbance Erosion	Surface condition, surface rock	Soil Profile Description									
				Horizon Depth (m), Boundary	Texture	Structure, Strength, Cutans	Inclusions Segregations	Colour, Mottle	Moisture, Drainage	Roots	Depth (m) / Field pH	Sample (m)	Observations
Grazing, Gently undulating plain, mid- slope 1.0%	Poplar box, minor Ironbark	Nil	Soft to firm, nil coarse fragments	A1 0.00-0.38 Diffuse	Loamy sand	Massive, weak	Nil	10YR3/3 Dark Nil mottles / bleaching	Dry, rapid	Very fine, very few	0.10 / 6.5 0.30 / 6.5	No samples taken	No additional observations
				B2 0.38-1.00	Clay loam sand	Moderate, angular, 5- 20 weak	<2% coarse fragments 2mm	10YR4/3 Brown Brown Mottle 5% 10YR5/8 Yellowish brown	Dry, well drained	Nil	0.60 / 7.5 0.90 / 7.5

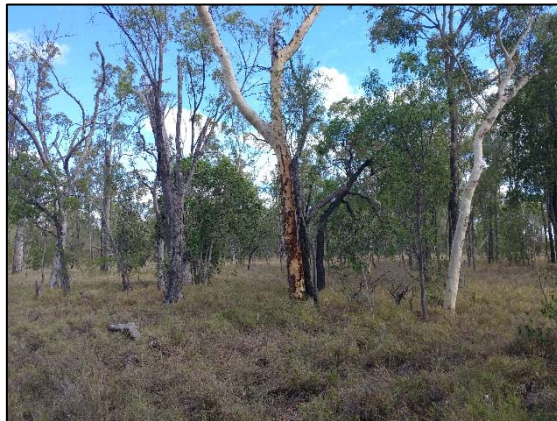
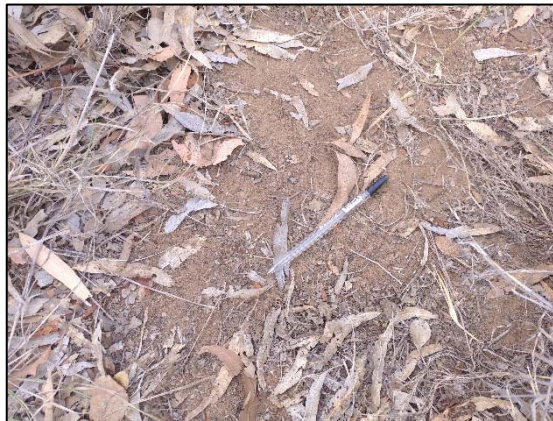
SITE OD-180

Soil Mapping Unit: S1	CSIRO Land Systems (Gunn et al 1967): Somerby, Monteagle, Connors, Humboldt, Blackwater	Location (GDA ZONE 55): 638448 mE 7545811 mN	Aust. Soil Class. : Brown Sodosol	Site Survey Type: Detailed - 50mm hand auger	Survey Date: 25/11/2017
---------------------------------	--	--	---	--	-----------------------------------

Land use Landform Pattern, Element, Slope	Natural Vegetation	Microrelief Disturbance Erosion	Surface condition, surface rock	Soil Profile Description									
				Horizon Depth (m), Boundary	Texture	Structure, Strength, Cutans	Inclusions Segregations	Colour, Mottle	Moisture, Drainage	Roots	Depth (m) / Field pH	Sample (m)	Observations
Grazing, Gently undulating plain, lower slope <2.0%	Poplar box, minor Eucalypts	Nil	Soft, loose, nil coarse fragments	A11 0.00-0.12 Abrupt	Loamy sand	Massive, weak	Nil	10YR3/2 Very dark greyish brown Nil mottles / bleaching	Dry, rapid	Few, fine	0.10 / 6.5	No samples taken	No additional observations
				A12 0.12-0.32 Abrupt	Loamy sand	Massive, weak	Nil	10YR4/4 Dark yellowish brown Nil mottles / bleaching	Dry, rapid	Few, fine	0.30 / 6.5		
				A13 0.32-0.70 Abrupt	Loamy sand	Massive, weak	Nil	10YR4/6 Dark yellowish brown Nil mottles / bleaching	Dry, rapid	Very few, very fine	0.60 / 6.5

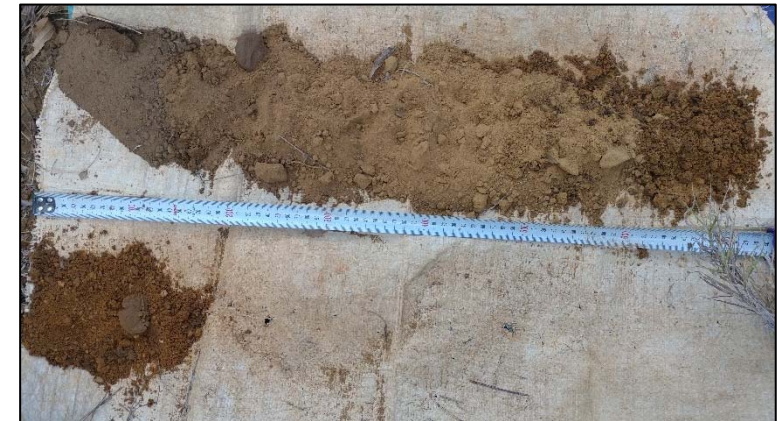
Soil Profile

B2 0.70-0.85	Clay loam sandy	Weak, weak, <5mm sub- angular	Nil	10YR4/3 Brown Nil mottles / bleaching	Dry, Well drained	Nil	0.90 / 7.0

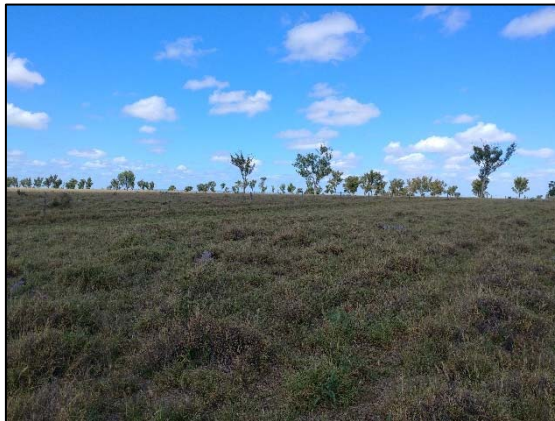
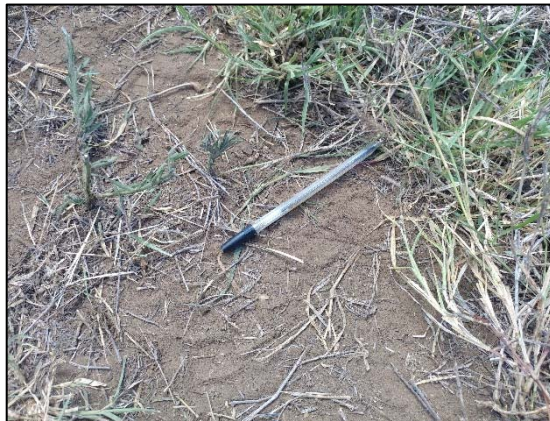
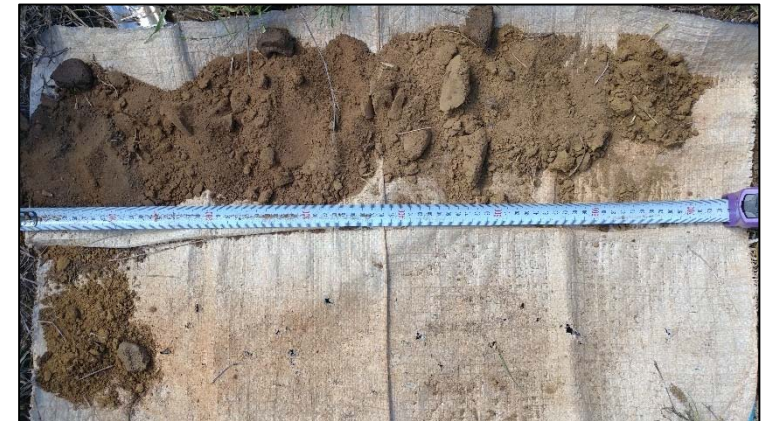
Land use Landform Pattern, Element, Slope	Natural Vegetation	Microrelief Disturbance Erosion	Surface condition, surface rock	Soil Profile Description									
				Horizon Depth (m), Boundary	Texture	Structure, Strength, Cutans	Inclusions Segregation s	Colour, Mottle	Moisture, Drainage	Roots	Depth (m) / Field pH	Sample (m)	Observations
Grazing, Gently undulating plain, mid-slope <2.0%	Sparse Poplar box	Nil	Firm, nil coarse fragments	A1 0.00-0.10 Abrupt	Loamy sand	Massive, weak	Nil	10YR2/2 Very dark brown Nil mottles / bleaching	Dry, rapid	Very few, very fine	0.10 / 6.0	No samples taken	No recovery from 0.80m
				A2 0.10-0.44 Abrupt	Clayey sands	Massive, weak	Nil	10YR3/3 Dark brown Nil mottles / bleaching	Dry, rapid	Nil	0.30 / 6.5		
				A2 0.47-0.70 Abrupt	Clayey sand	Massive, weak	Nil	10YR4/4 Dark yellowish brown Nil mottles / bleaching	Dry, well drained	Nil	0.60 / 6.5		
				B2 0.70-0.80	Clay loam sand	Weak, weak, <5mm sub- angular	Nil	10YR4/3 Brown Nil mottles / bleaching	Dry, rapid	Nil	0.90 / 7.0

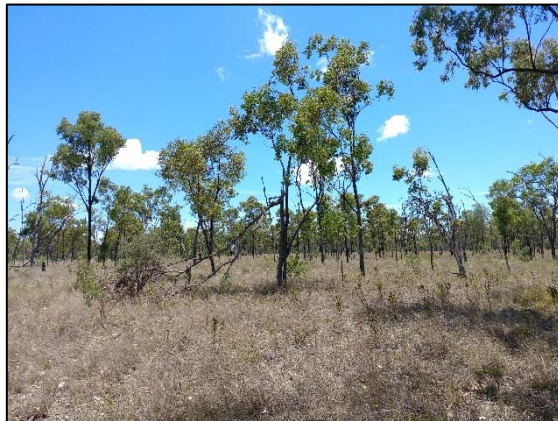
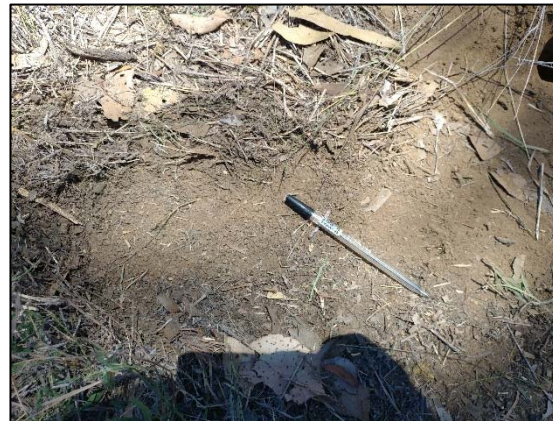
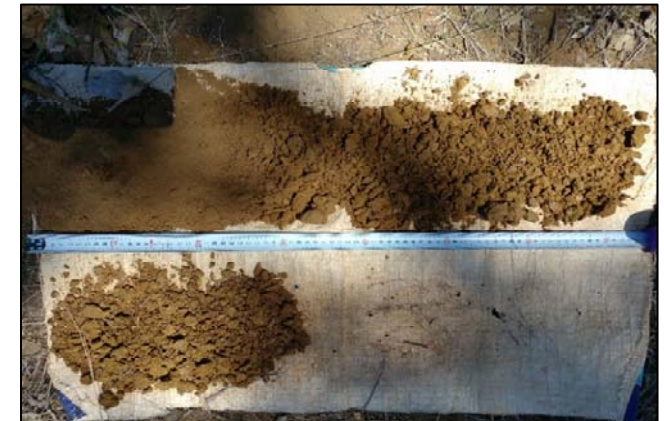
SITE OD-182

Soil Mapping Unit: S1	CSIRO Land Systems (Gunn et al 1967): Somerby, Monteagle, Connors, Humboldt, Blackwater	Location (GDA ZONE 55): 635944 mE 7548438 mN	Aust. Soil Class. : Brown Sodosol	Site Survey Type: Detailed - 50mm hand auger	Survey Date: 25/11/2017
---------------------------------	---	--	---	--	-----------------------------------

Land use Landform Pattern, Element, Slope	Natural Vegetation	Microrelief Disturbance Erosion	Surface condition, surface rock	Soil Profile Description									
				Horizon Depth (m), Boundary	Texture	Structure, Strength, Cutans	Inclusions Segregations	Colour, Mottle	Moisture, Drainage	Roots	Depth (m) / Field pH	Sample (m)	Observations
Grazing, Gently undulating plain, lower slope <1.5%	Poplar box, Ironbark	Semi cleared, No microrelief No Erosion	Soft to firm, nil coarse fragments	A1 0.00-0.27 Abrupt	Loamy sand	Massive, weak	Nil	10YR3/3 Dark brown Nil mottles / bleaching	Dry, rapid	Few, fine	0.10 / 6.0	No samples taken	No additional observations
				B21 0.27-0.86 Abrupt	Clay loam sandy	Moderate, weak <10mm sub- angular	Nil	10YR4/4 Dark yellowish brown Nil mottles / bleaching	Dry, rapid	Nil	0.30 / 6.0 0.60 / 6.5		
				B22 0.86-1.00	Clay loam sandy	Moderate, weak, <10mm sub- angular	<2% calcium carbonate	10YR4/4 Dark yellowish brown Nil mottles / bleaching	Dry, well drained	Nil	0.90 / 7.0

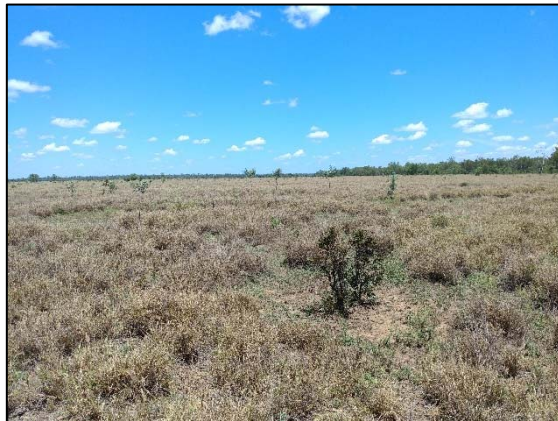
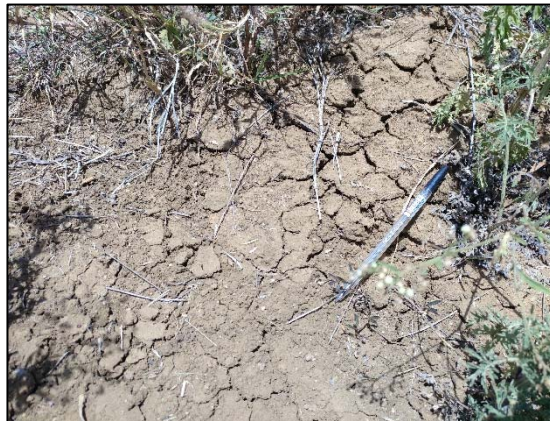
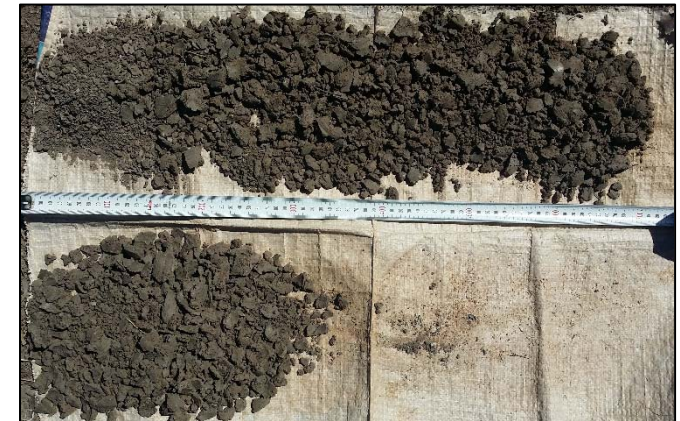
SITE OD-183

Soil Mapping Unit: C2 grading into C1-BL	CSIRO Land Systems (Gunn et al 1967): Somerby, Monteagle, Connors, Humboldt, Blackwater	Location (GDA ZONE 55): 634838 mE 7549412 mN	Aust. Soil Class. : Brown Vertosol	Site Survey Type: Detailed - 50mm hand auger	Survey Date: 25/11/2017
--	--	--	--	--	-----------------------------------

Land use Landform Pattern, Element, Slope	Natural Vegetation	Microrelief Disturbance Erosion	Surface condition, surface rock	Soil Profile Description									
				Horizon Depth (m), Boundary	Texture	Structure, Strength, Cutans	Inclusions Segregations	Colour, Mottle	Moisture, Drainage	Roots	Depth (m) / Field pH	Sample (m)	Observations
Grazing, Flat plain <0.5%	Brigalow regrowth	Extensive clearing, Minor normal gilgai <20% coverage 3- 5m wide and <0.30m in depth	Cracking with crust, firm	A1 0.00-0.11 Abrupt	Light clay	Weak, firm, 3-10mm sub- angular	Nil	10YR3/2 Very dark greyish brown Nil mottles / bleaching	Dry, well drained	Very few, very fine	0.10 / 7.0	No samples taken	No additional observations
				B2 0.11-1.00	Light clay	Moderate, firm, 20- 50mm sub- angular slickensides observed	Nil	10YR3/3 Dark brown Nil mottles / bleaching	Dry, well drained	Nil	0.30 / 7.0 0.60 / 7.0 0.90 / 7.0

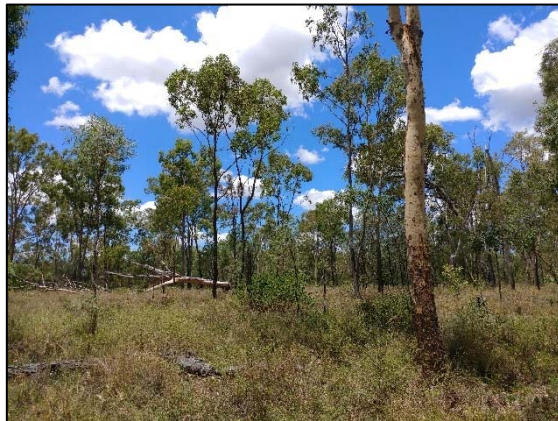
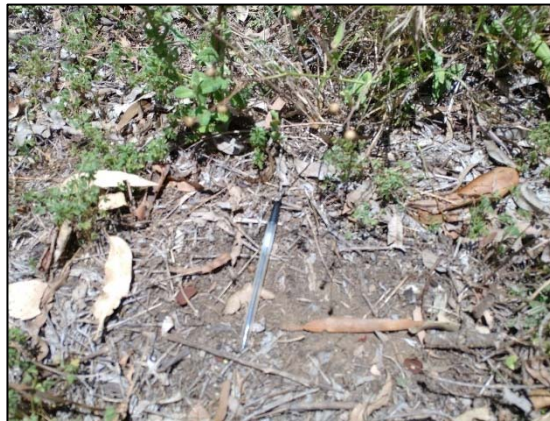
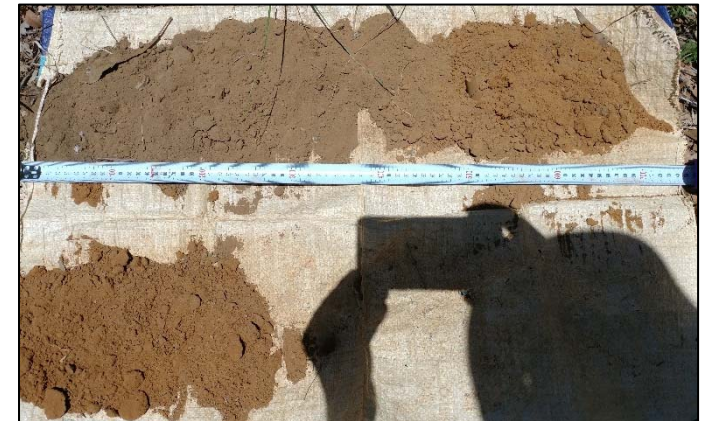
SITE OD-184

Soil Mapping Unit: S2	CSIRO Land Systems (Gunn et al 1967): Somerby, Monteagle, Connors, Humboldt, Blackwater	Location (GDA ZONE 55): 633712 mE 7550670 mN	Aust. Soil Class. : Haplic Brown Dermosol	Site Survey Type: Detailed - 50mm hand auger	Survey Date: 25/11/2017
---------------------------------	--	--	---	--	-----------------------------------

Land use Landform Pattern, Element, Slope	Natural Vegetation	Microrelief Disturbance Erosion	Surface condition, surface rock	Soil Profile Description									
				Horizon Depth (m), Boundary	Texture	Structure, Strength, Cutans	Inclusions Segregations	Colour, Mottle	Moisture, Drainage	Roots	Depth (m) / Field pH	Sample (m)	Observations
Grazing, Gently undulating plain, lower slope 2.0%	Eucalypts Poplar box, minor Moreton Bay Ash	Nil	Firm, nil coarse fragments	A11 0.00-0.15 Abrupt	Loamy sand	Massive, weak	Nil	10YR3/3 Dark brown Nil mottles / bleaching	Dry, rapid	Very few, very fine	0.10 / 6.0	No samples taken	No additional observations
				A12 0.15-0.50 Abrupt	Loamy sand	Massive, weak	Nil	10YR3/4 Dark yellowish brown Nil mottles / bleaching	Dry, rapid	Very few, very fine	0.30 / 6.0		
				A13 0.50-1.00	Loamy sand	Massive, weak	Nil	10YR3/6 Dark yellowish brown Nil mottles / bleaching	Dry, rapid	Nil	0.60 / 6.0 0.90 / 6.0

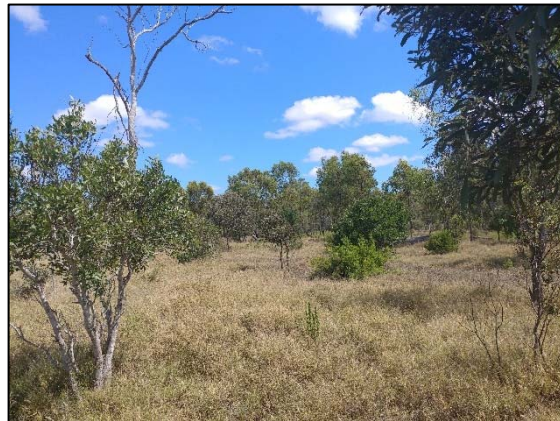
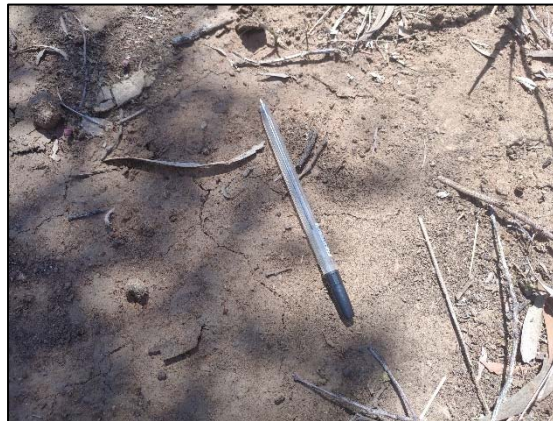
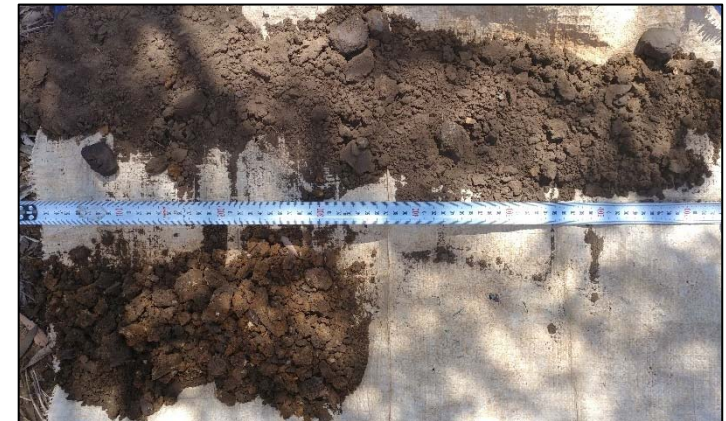
SITE OD-187

Soil Mapping Unit: B2 grading into T3	CSIRO Land Systems (Gunn et al 1967): Somerby, Monteagle, Connors, Humboldt, Blackwater	Location (GDA ZONE 55): 632756 mE 7551848 mN	Aust. Soil Class. : Mesonatric Grey Sodosol	Site Survey Type: Detailed - 50mm hand auger	Survey Date: 26/11/2017
---	---	--	---	--	-----------------------------------

Land use Landform Pattern, Element, Slope	Natural Vegetation	Microrelief Disturbance Erosion	Surface condition, surface rock	Soil Profile Description									
				Horizon Depth (m), Boundary	Texture	Structure, Strength, Cutans	Inclusions Segregations	Colour, Mottle	Moisture, Drainage	Roots	Depth (m) / Field pH	Sample (m)	Observations
Grazing, Very gently undulating plain, lower slope <1.0%	Mixed vegetation, Brigalow regrowth and Poplar Box	Nil	Firm to hard setting Nil coarse fragments	A11 0.00-0.10 Abrupt	Silty loam	Weak, weak	Nil	10YR2/2 Very dark brown Nil mottles / bleaching	Dry, rapid	Very few, very fine	0.05 / 6.5	No samples taken	No additional observations
				A12 0.10-0.60 Abrupt	Silty loam	Moderate, weak, 5-20mm	Nil	10YR2/2 Very dark brown Nil mottles / bleaching	Dry, rapid	Very few, very fine	0.30 / 6.5		
				B2 0.60-1.00	Light clay	Firm, sub- angular 10- 30mm	<2% calcium carbonate nodules	10YR2/2 Very dark brown Mottle 10YR3/6 Dark yellowish brown Dark yellowish brown 10-20% Nil bleaching	Dry, Imperfect	Nil	0.60 / 7.0 0.90 / 7.5

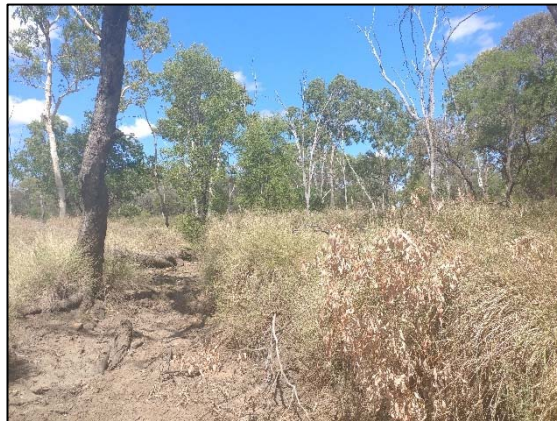
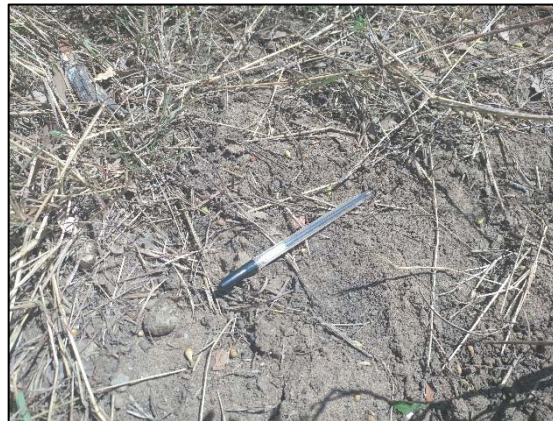
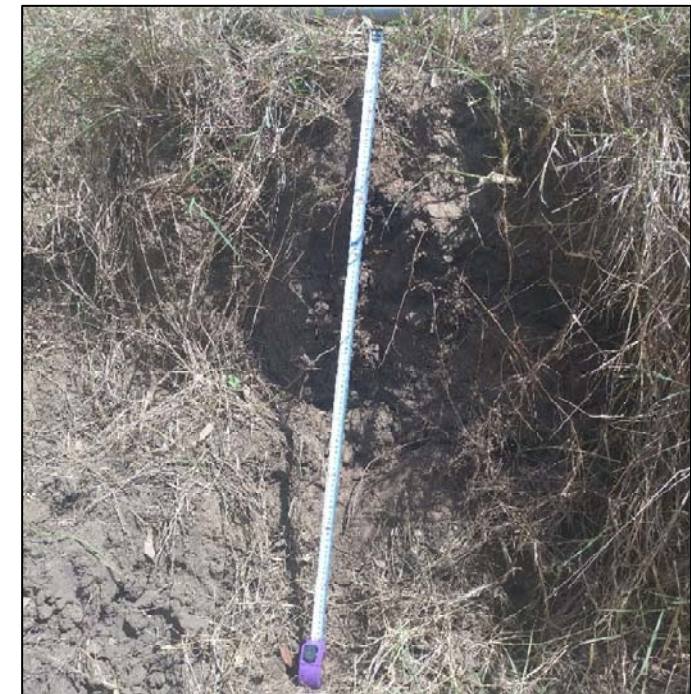
SITE OD-188

Soil Mapping Unit: S2 grading to S4	CSIRO Land Systems (Gunn et al 1967): Somerby, Monteagle, Connors, Humboldt, Blackwater	Location (GDA ZONE 55): 631308 mE 7552792 mN	Aust. Soil Class. : Haplic Brown Dermosol	Site Survey Type: Detailed - 50mm hand auger	Survey Date: 26/11/2017
---	--	--	---	--	-----------------------------------

Land use Landform Pattern, Element, Slope	Natural Vegetation	Microrelief Disturbance Erosion	Surface condition, surface rock	Soil Profile Description									
				Horizon Depth (m), Boundary	Texture	Structure, Strength, Cutans	Inclusions Segregations	Colour, Mottle	Moisture, Drainage	Roots	Depth (m) / Field pH	Sample (m)	Observations
Grazing, Open Depression	Eucalypts, minor Brigalow	Gully erosion, No microrelief No disturbance	Loose, <5% <5mm coarse fragments	A11 0.00-0.40 Abrupt	Loamy sand	Massive, weak	Nil	10YR2/2 Very dark brown Nil mottles / bleaching	Dry, rapid	Few, fine	0.05 / 6.0	No samples taken	No additional observations
				A12 0.30-1.00 Abrupt	Loamy sand	Massive, weak	<10% coarse fragments <5mm	10YR6/3 Dark brown Nil mottles / bleaching	Dry, rapid	Few, fine	0.30 / 6.0

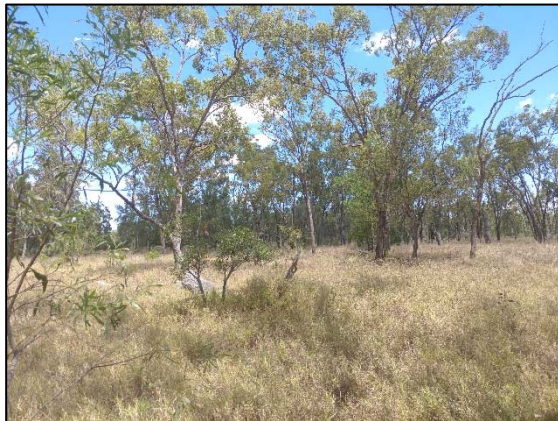
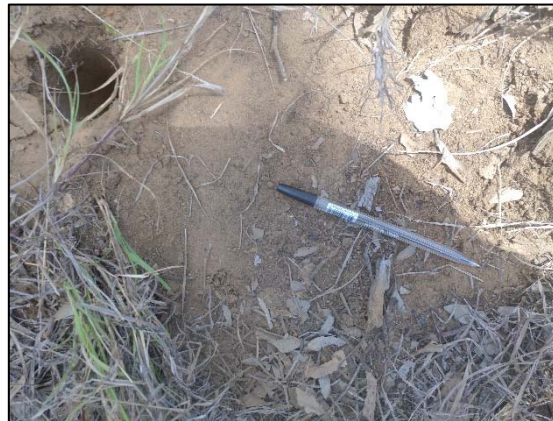
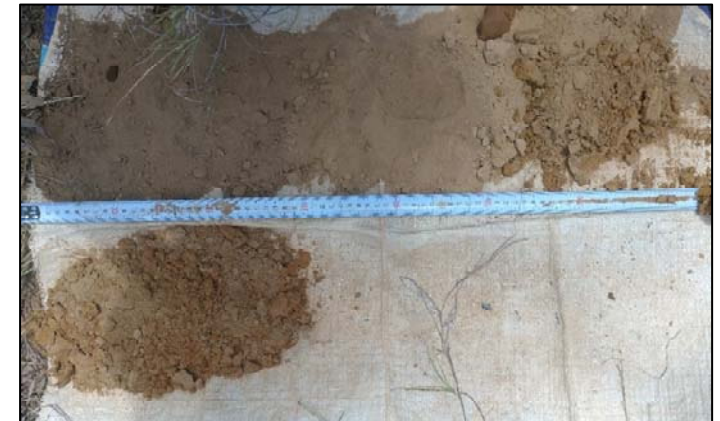
SITE OD-189

Soil Mapping Unit: S1	CSIRO Land Systems (Gunn et al 1967): Somerby, Monteagle, Connors, Humboldt, Blackwater	Location (GDA ZONE 55): 629781 mE 7553506 mN	Aust. Soil Class. : Brown Sodosol	Site Survey Type: Detailed - 50mm hand auger	Survey Date: 26/11/2017
---------------------------------	--	--	---	--	-----------------------------------

Land use Landform Pattern, Element, Slope	Natural Vegetation	Microrelief Disturbance Erosion	Surface condition, surface rock	Soil Profile Description									
				Horizon Depth (m), Boundary	Texture	Structure, Strength, Cutans	Inclusions Segregations	Colour, Mottle	Moisture, Drainage	Roots	Depth (m) / Field pH	Sample (m)	Observations
Grazing, Very gently undulating plain, lower slope <1.0%	Poplar box	Nil	Firm, Nil coarse fragments	A11 0.00-0.28 Abrupt	Loamy sand	Massive, weak	Nil	10YR3/3 Dark brown Nil mottles / bleaching	Dry, rapid	Few, fine	0.10 / 6.0	No samples taken	No additional observations
				A12 0.28-0.54 Abrupt	Loamy sand	Massive, weak	Nil	7.5YR4/4 Brown Nil mottles / bleaching	Dry, rapid	Very few, fine	0.30 / 6.5		
				B2 0.54-1.00	Clay loam sandy	Moderate, weak, <10mm sub- angular	Nil	7.5YR4/4 Brown Mottle <2% 10YR5/8 Dark yellowish brown Nil bleaching	Dry, Imperfect	Nil	0.60 / 6.5 0.90 / 6.5

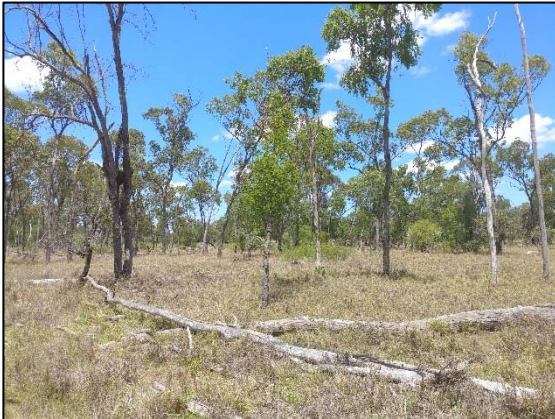
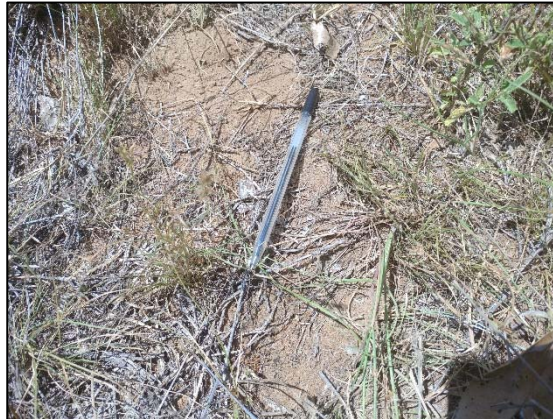
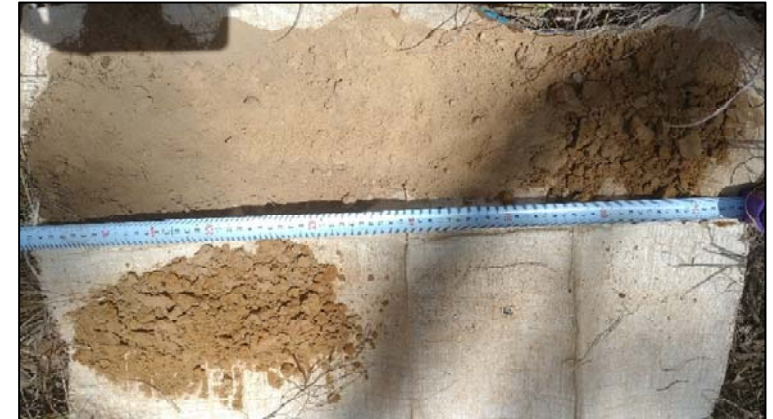
SITE OD-190

Soil Mapping Unit: S1	CSIRO Land Systems (Gunn et al 1967): Somerby, Monteagle, Connors, Humboldt, Blackwater	Location (GDA ZONE 55): 627807 mE 7553767 mN	Aust. Soil Class. : Brown Sodosol	Site Survey Type: Detailed - 50mm hand auger	Survey Date: 26/11/2017
---------------------------------	--	--	---	--	-----------------------------------

Land use Landform Pattern, Element, Slope	Natural Vegetation	Microrelief Disturbance Erosion	Surface condition, surface rock	Soil Profile Description									
				Horizon Depth (m), Boundary	Texture	Structure, Strength, Cutans	Inclusions Segregations	Colour, Mottle	Moisture, Drainage	Roots	Depth (m) / Field pH	Sample (m)	Observations
Grazing, Flat plain <0.5%	Poplar box	Nil	Firm, Nil coarse fragments	A11 0.00-0.28 Abrupt	Loamy sand	Massive, weak	Nil	10YR3/3 Dark brown Nil mottles / bleaching	Dry, rapid	Few, fine	0.10 / 6.0	No samples taken	No additional observations
				A12 0.28-0.54 Abrupt	Loamy sand	Massive, weak	Nil	7.5YR4/4 Brown Nil mottles / bleaching	Dry, rapid	Very few, fine	0.30 / 6.5		
				B2 0.54-1.00	Clay loam sandy	Moderate, weak, <10mm sub- angular	Nil	7.5YR4/4 Brown Mottle <2% 10YR5/8 Dark yellowish brown Nil bleaching	Dry, Imperfect	Nil	0.60 / 6.5 0.90 / 6.5
