# Blackwater Mine – North Extension Project

## Aquatic Ecology Impact Assessment

Prepared by **Ecological Service Professionals Pty Ltd**

**December 2023**

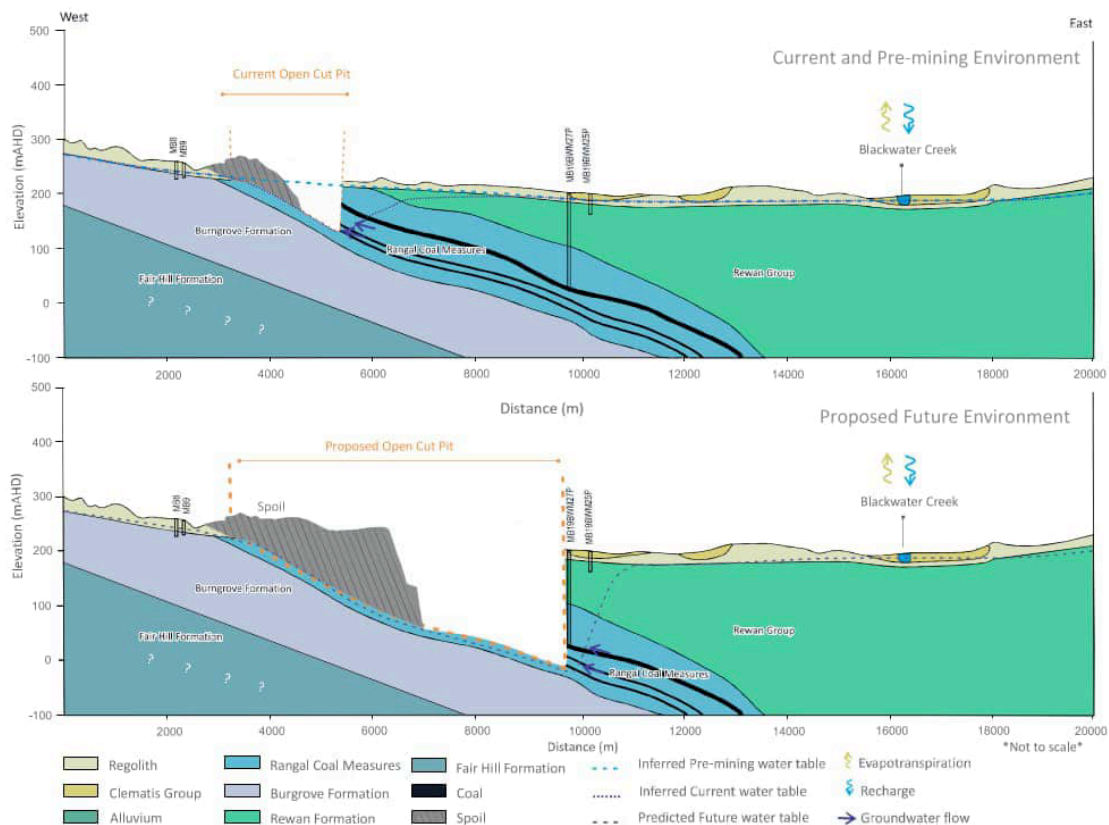
Figure 5.2 Conceptual hydrogeological section of the Project area. Source: SLR 2023c

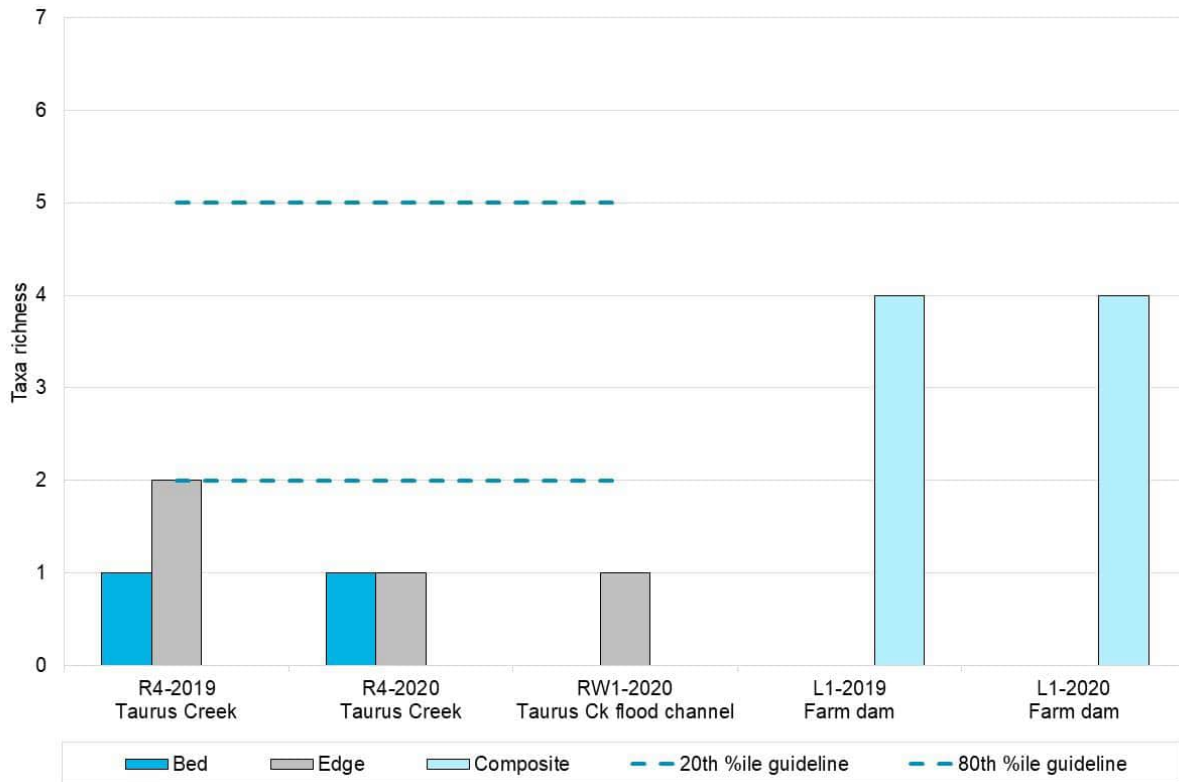
**Plate 5.3** PET taxa richness of aquatic macroinvertebrate samples collected from the study area, December 2019 and May 2020

richness fell below the guideline range in the bed habitat sample from site R4 in December 2019 and in the bed and edge habitat samples from sites R4 and RW1 in May 2020, reflecting poorer habitat complexity (Plate 5.3).

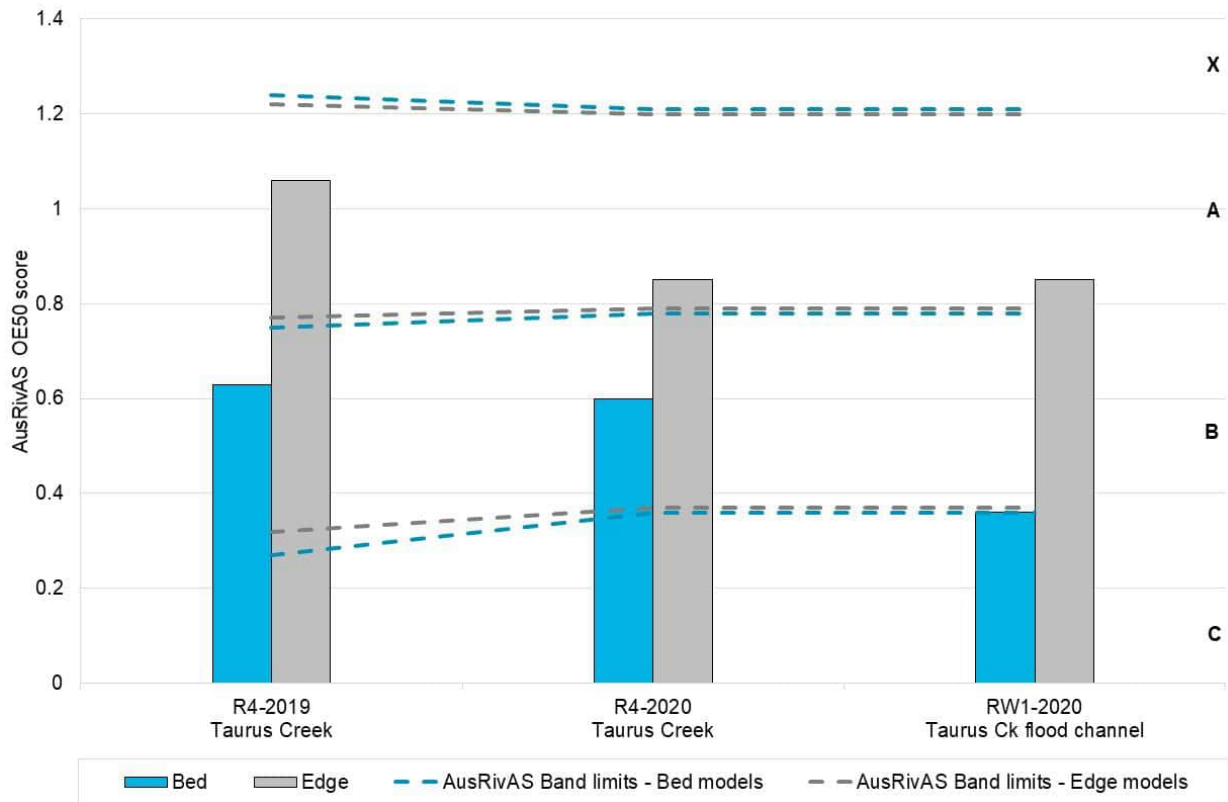
**Plate 5.6** AusRivAS OE50 scores for riverine macroinvertebrate samples collected from the study area, December 2019 and May 2020

The prevalence of wetted habitat is likely to be a key driver in macroinvertebrate community structure and ecosystem functioning, and caution is applied to the use of AusRivAS ratings in ephemeral systems. The lower (Band B and Band C) OE50 taxa scores for the bed habitat samples may be more reflective of seasonality than catchment impacts.

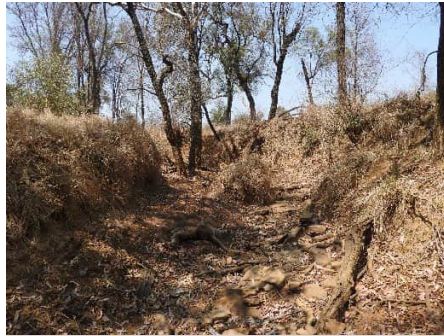
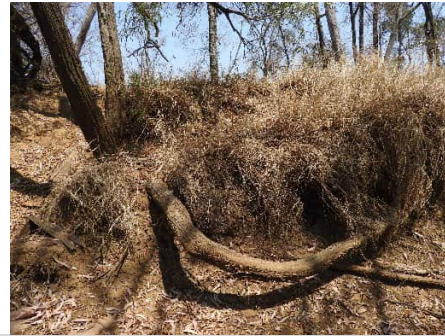
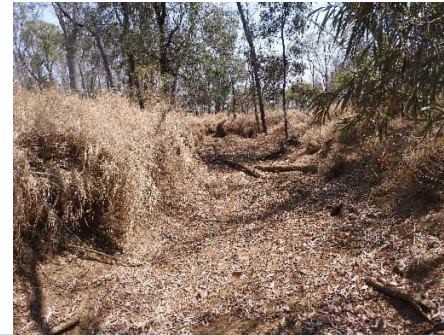
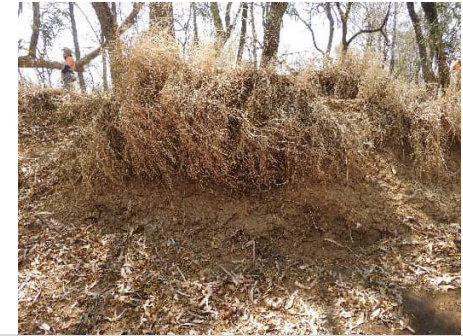
**Table 1** Sagittarius Creek – Dry

Site: R1 Property: Mountain View Stream order: 3 Latitude (GDA 94): -23.6017 Longitude (GDA 94): 148.8635 Date: 10/12/2019 Season: Dry

Upstream

Left bank

Downstream

Right bank

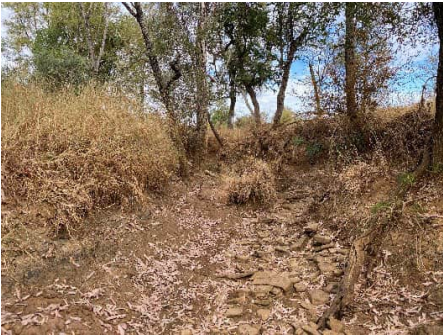
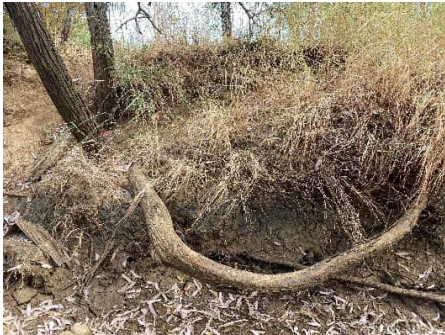
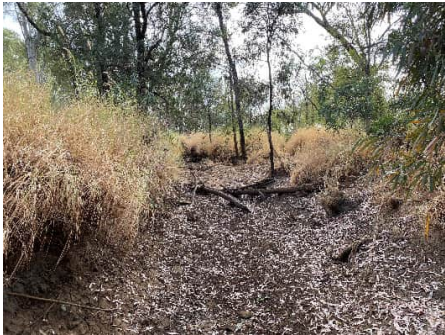
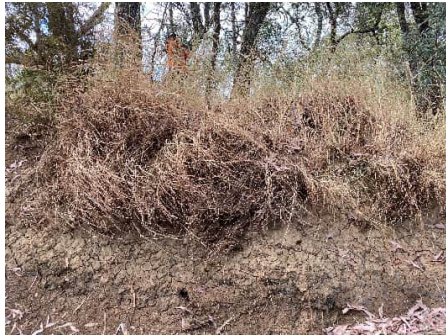
**Table 2** Sagittarius Creek – Late wet

Site: R1	Property: Mountain View	Stream order: 3	Latitude (GDA 94): -23.6017	Longitude (GDA 94): 148.8635	Date: 19/05/2020	Season: Late wet

Upstream	Left bank	Downstream	Right bank

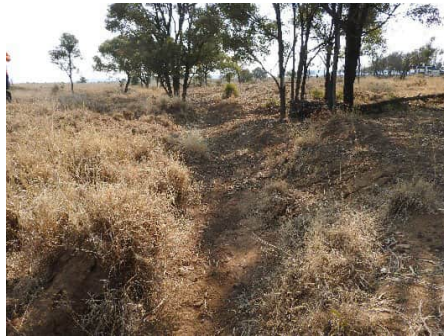
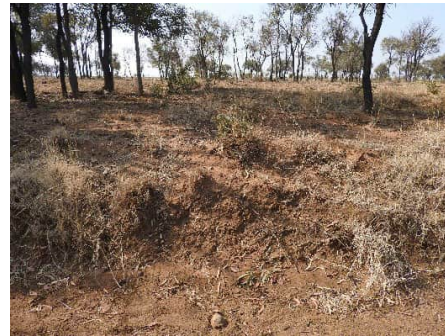
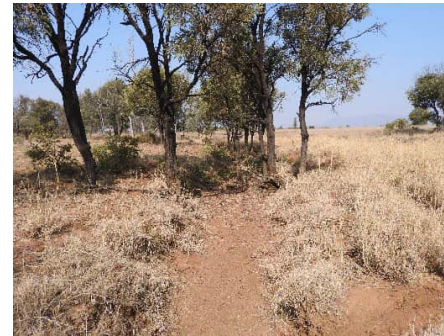
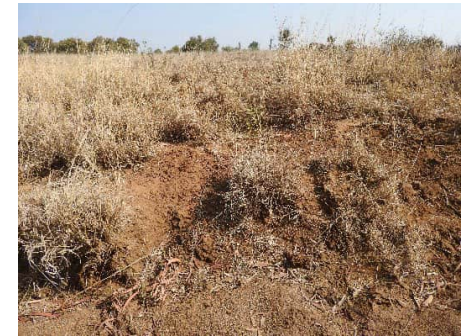
**Table 3** Sagittarius Creek – Dry

Site: R2 Property: Mountain View Stream order: 2 Latitude (GDA 94): -23.6527 Longitude (GDA 94): 148.8377 Date: 10/12/2019 Season: Dry

Upstream

Left bank

Downstream

Right bank

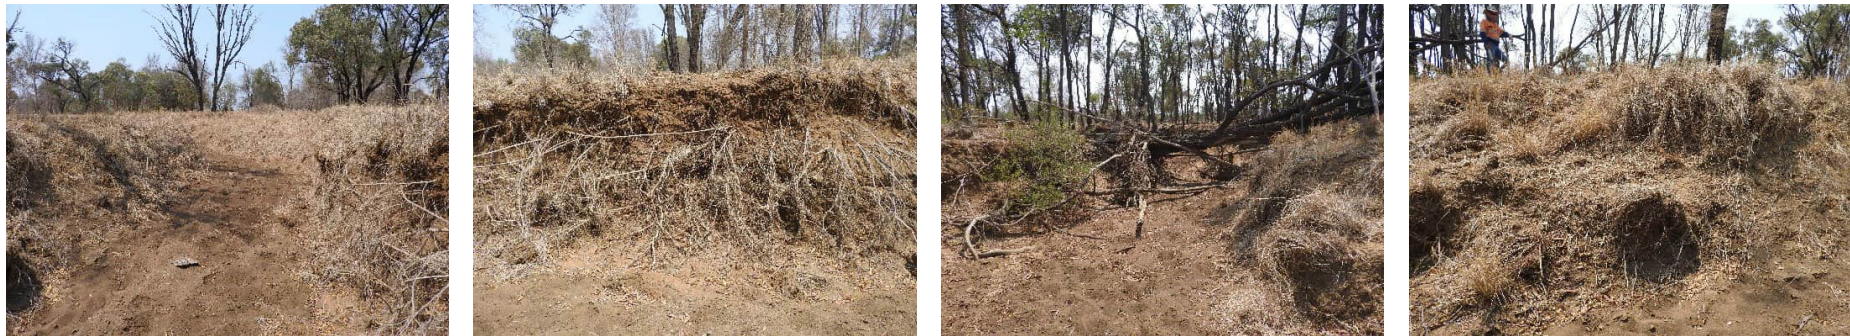
**Table 5** Unnamed tributary – Dry

Site: R3 Property: Taurus Stream order: 1 Latitude (GDA 94): -23.6933 Longitude (GDA 94): 148.8567 Date: 11/12/2019 Season: Dry

Upstream

Left bank

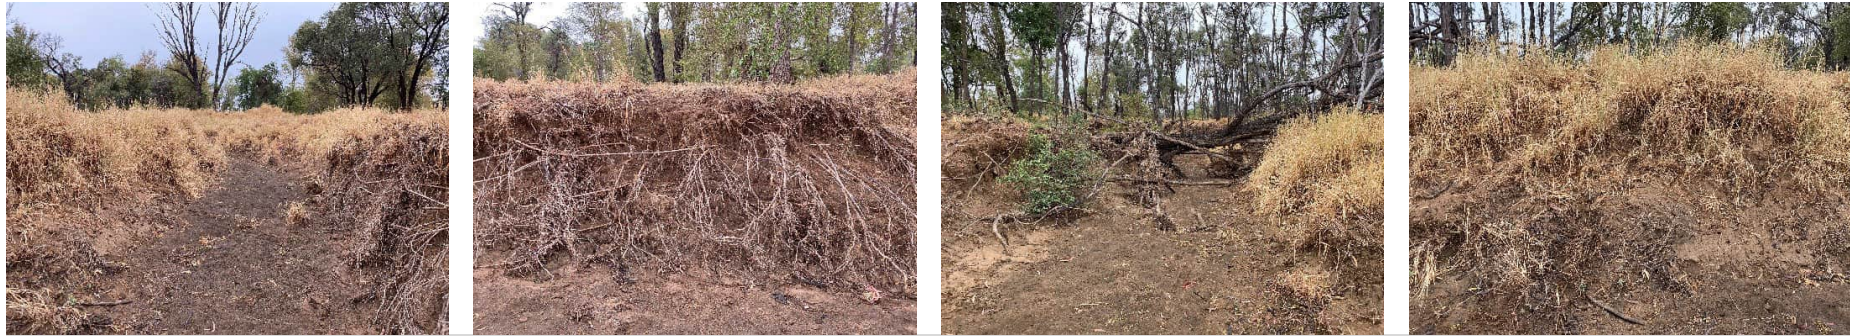
**Table 6 Unnamed tributary – Late wet**

**Site: R3 Property: Taurus Stream order: 1 Latitude (GDA 94): -23.6933 Longitude (GDA 94): 148.8567 Date: 21/05/2020 Season: Late wet**

Upstream

Left bank

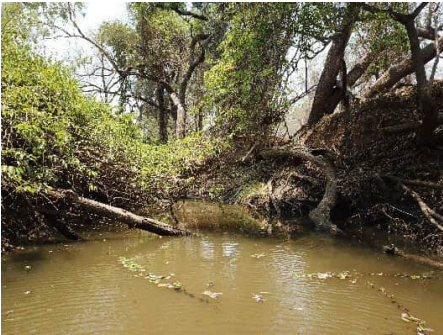
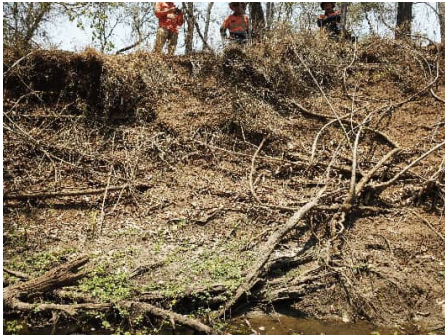
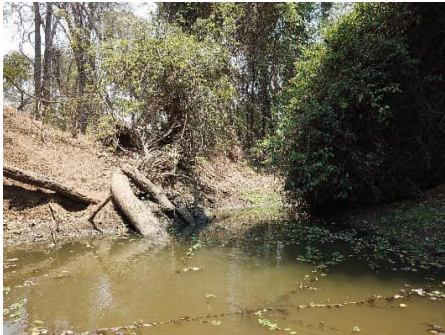
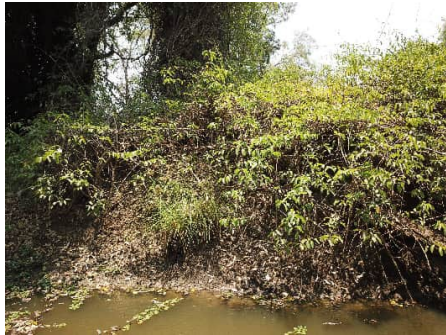
**Table 7** Taurus Creek – Dry

Site: R4	Property: Mountain View	Stream order: 4	Latitude (GDA 94): -23.6743	Longitude (GDA 94): 148.8671	Date: 11/12/2019	Season: Dry

Upstream	Left bank	Downstream	Right bank

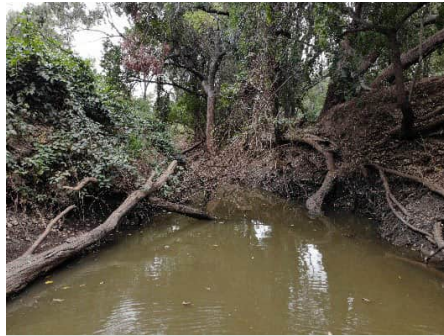
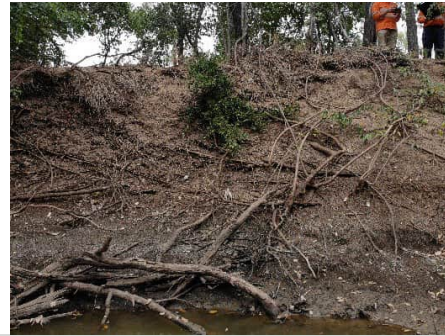
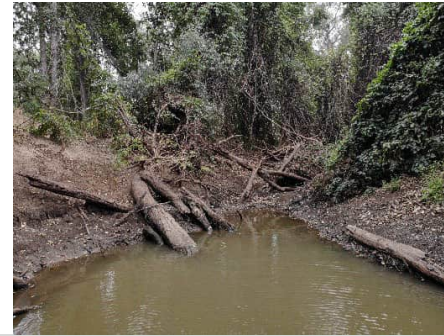
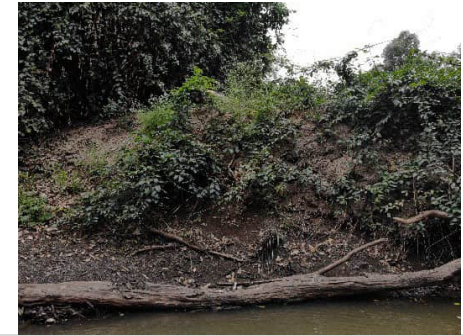
**Table 8** Taurus Creek – Late wet

Site: R4 Property: Mountain View Stream order: 4 Latitude (GDA 94): -23.6743 Longitude (GDA 94): 148.8671 Date: 20/05/2020 Season: Late wet

Upstream

Left bank

Downstream

Right bank

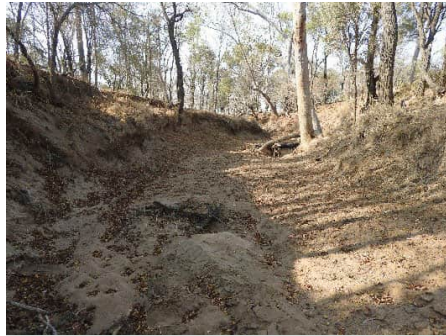
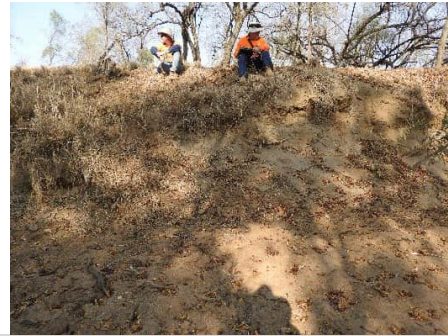
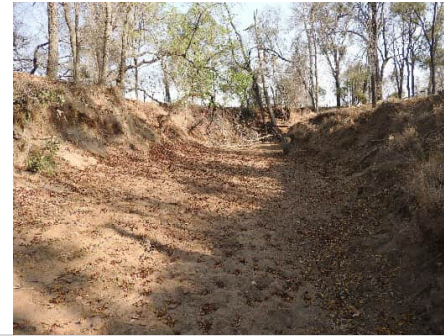
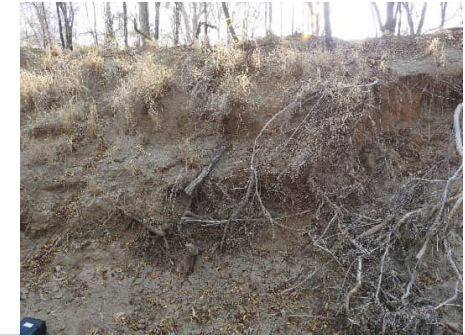
**Table 9** Taurus Creek – Dry

Site: R5 Property: Taurus Stream order: 3 Latitude (GDA 94): -23.7165 Longitude (GDA 94): 148.8544 Date: 12/12/2019 Season: Dry

Upstream

Left bank

Downstream

Right bank

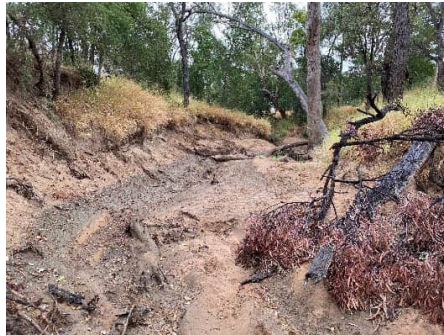
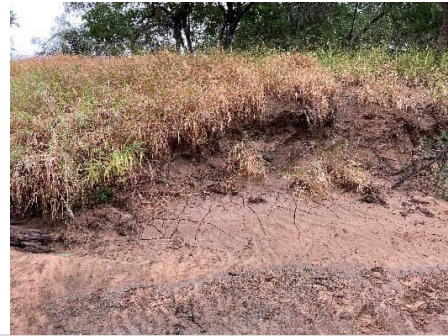
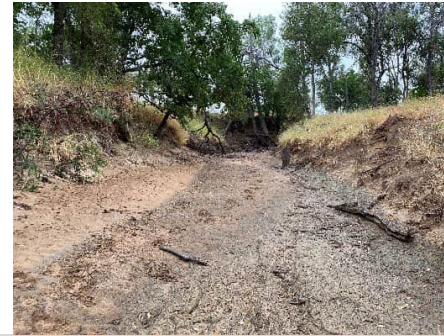
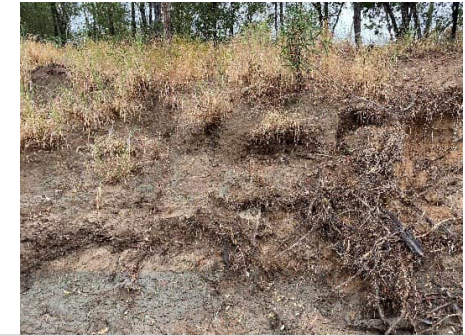
**Table10 Taurus Creek – Late wet**

Site: R5 Property: Taurus Stream order: 3 Latitude (GDA 94): -23.7165 Longitude (GDA 94): 148.8544 Date: 21/05/2020 Season: Late wet

Upstream

Left bank

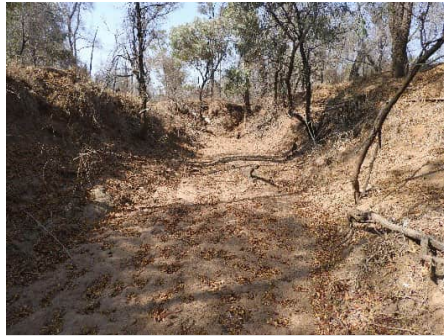
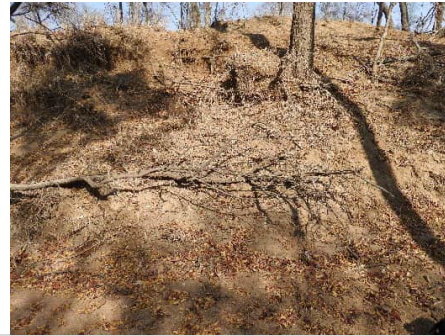
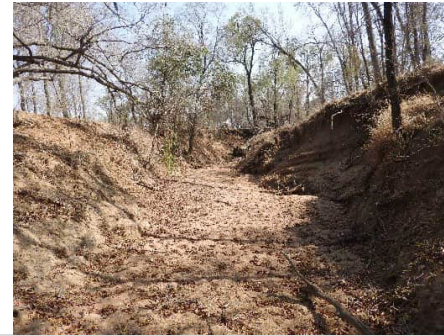
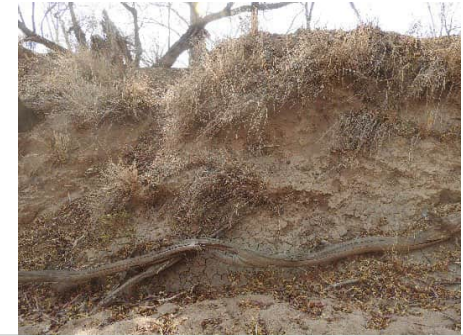
**Table 11** Two Mile Gully - Dry

Site: R6 Property: Taurus Stream order: 4 Latitude (GDA 94): -23.7309 Longitude (GDA 94): 148.8737 Date: 12/12/2019 Season: Dry

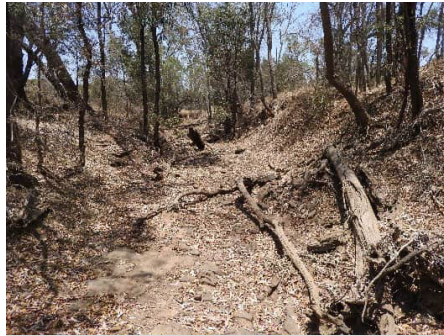
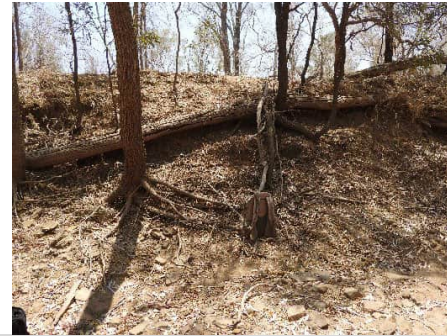
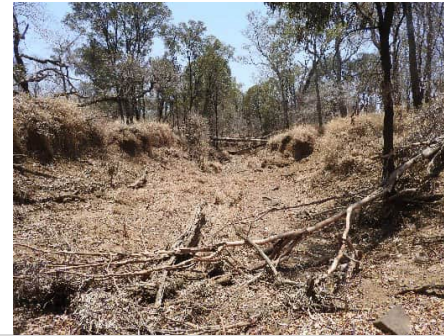
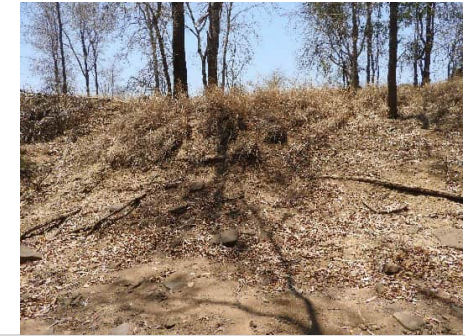
**Table 13** Taurus Creek – Dry

Site: R7 Property: Mountain View Stream order: 4 Latitude (GDA 94): -23.6717 Longitude (GDA 94): 148.8793 Date: 12/12/2019 Season: Dry

No aquatic fauna detected. May provide breeding and foraging habitat for fish in times of flow. No turtle or platypus breeding habitat detected. Freshwater crab and mussel shells observed.

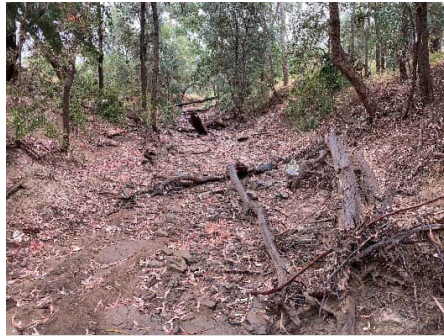
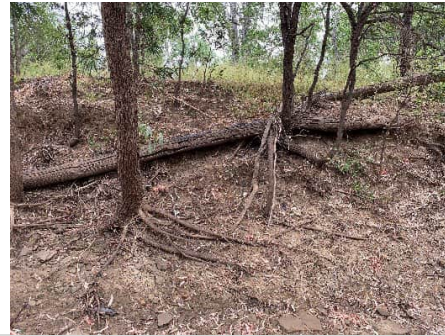
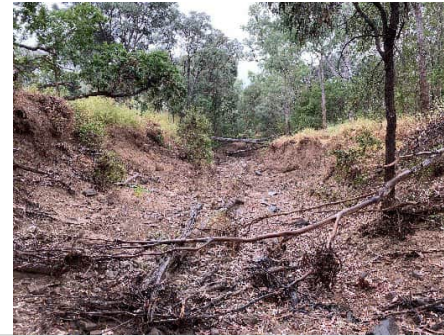
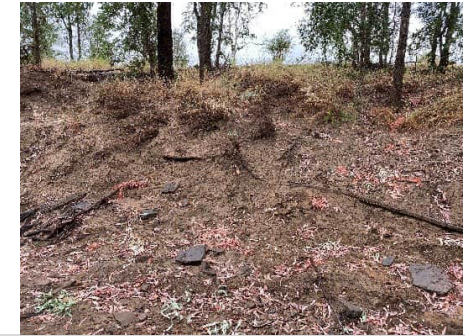
**Table 14 Taurus Creek – Late wet**

Site: R7 Property: Mountain View Stream order: 4 Latitude (GDA 94): -23.6717 Longitude (GDA 94): 148.8793 Date: 20/05/2020 Season: Late wet

No aquatic fauna detected. May provide breeding and foraging habitat for fish in times of flow. No turtle or platypus breeding habitat detected. Freshwater crab and mussel shells observed.

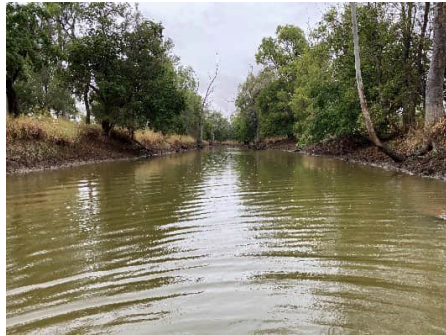
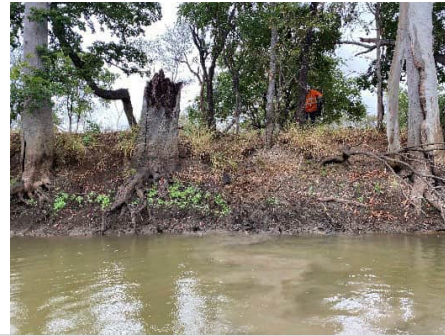
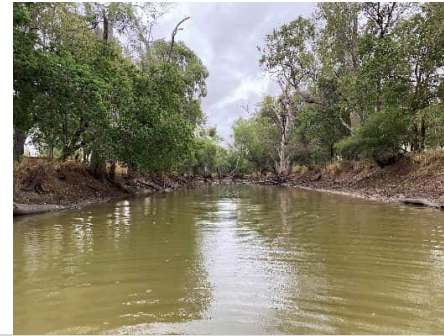
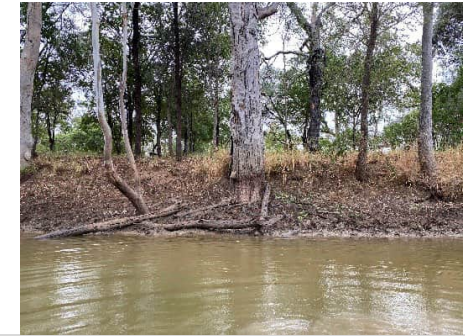
**Table 15** Flood-channel on Taurus Creek – Late wet

Site: RW1 Property: Mountain View Stream order: 3 Latitude (GDA 94): -23.6954 Longitude (GDA 94): 148.8653 Date: 21/05/2020 Season: Late wet

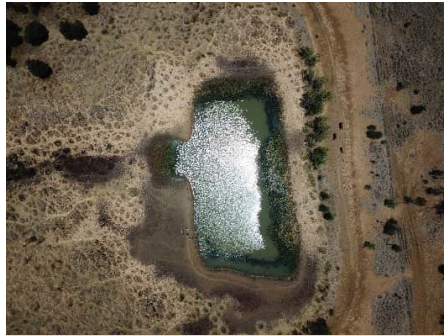
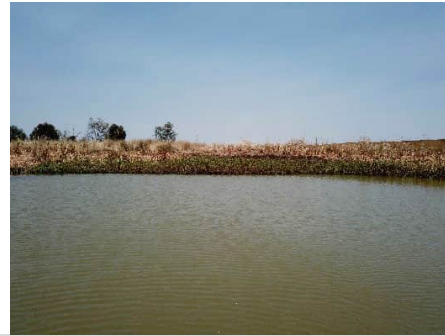
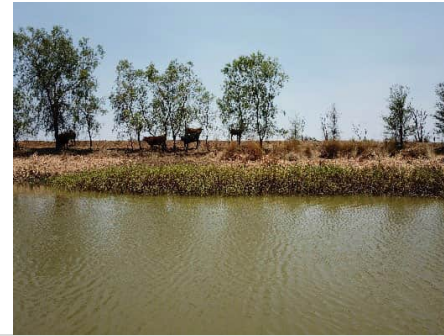
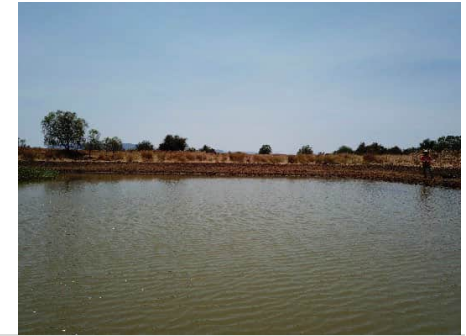
**Table16** Lacustrine wetland waterbody – Dry

Site: L1 Property: Mountain View Stream order: 2 Latitude (GDA 94): -23.6417 Longitude (GDA 94): 148.8591 Date: 10/12/2019 Season: Dry

Assessment site positioned within agricultural grassland State-mapped as non-remnant in the RE mapping; field-verified as non-remnant; fringing vegetation included a low (4–5 m) sparse (15%) tree layer dominated by brigalow (*Acacia harpophylla*), with occasional red bauhinia (*Lysiphyllum carronii*), whitewood (*Atalaya hemiglauca*), sally wattle (*Acacia salicina*) and yellowwood (*Terminalia oblongata*); very sparse shrub layer including currant bush (*Carissa ovata*) and warrior bush (*Apophyllum anomalum*); ground layer dominated by buffel grass (*Cenchrus ciliaris*)\*, with frequent bluegrass (*Bothriochloa* sp.) and occasional Harrisia cactus (*Harrisia martinii*)\*; submerged macrophytes included moderate (50–75%) cover of curly pondweed (*Potamogeton crispus*) and little (1–10%) swamp lily (*Ottelia ovalifolia*); emergent macrophytes included moderate (50–75%) cover of smartweed (*Persicaria attenuata*) and some (10–50%) cumbungi (*Typha domingensis*); fringing macrophytes included little (1–10%) umbrella canegrass (*Leptochloa digitata*), willow primrose (*Ludwigia octovalvis*) and dwarf sedge (*Cyperus pygmaeus*).

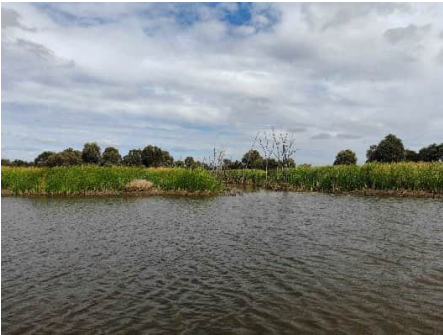
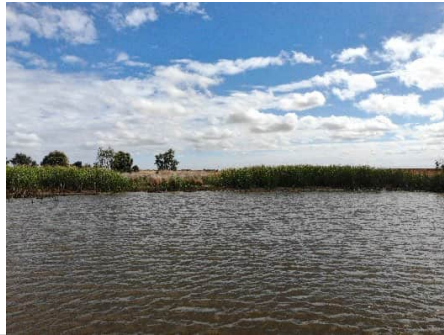
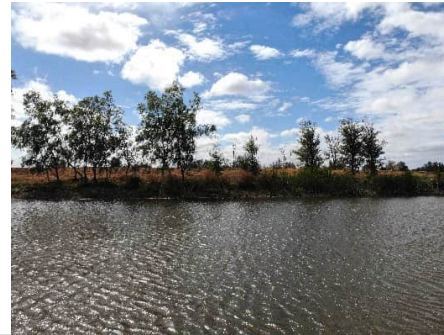
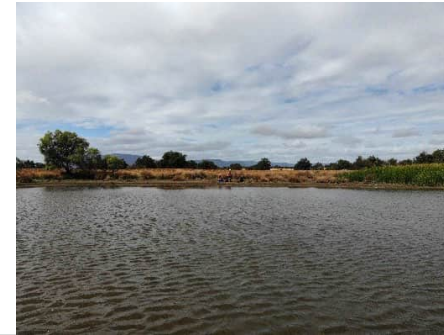
**Table 17** Lacustrine wetland waterbody – Late wet

Site: L1	Property: Mountain View	Stream order: 2	Latitude (GDA 94): -23.6417	Longitude (GDA 94): 148.8591	Date: 19/05/2020	Season: Late wet

Upstream	Left bank	Downstream	Right bank
<b>General Site Description</b>							
<b>Site attributes</b>							
Small unmapped lacustrine waterbody (farm dam) on Sagittarius Creek; 0.25 ha; little local catchment erosion, including rill erosion; >1.5 m deep; clay banks; in-stream habitat included shallow (<0.5 m) pool, deep pool and macrophytes; bed substrates comprised 100% silt/clay (<0.05 mm); upstream and adjacent land use includes moderate cattle grazing on land predominantly cleared of native vegetation.							
<b>Aquatic and riparian vegetation</b>							
Assessment site positioned within agricultural grassland State-mapped as non-remnant in the RE mapping; field-verified as non-remnant; fringing vegetation included a low (4–5 m) sparse (15%) tree layer dominated by brigalow ( <i>Acacia harpophylla</i> ), with occasional red bauhinia ( <i>Lysiphyllum carronii</i> ), whitewood ( <i>Atalaya hemiglauca</i> ), sally wattle ( <i>Acacia salicina</i> ) and yellowwood ( <i>Terminalia oblongata</i> ); very sparse shrub layer including currant bush ( <i>Carissa ovata</i> ) and warrior bush ( <i>Apophyllum anomalum</i> ); ground layer dominated by buffel grass ( <i>Cenchrus ciliaris</i> )*, with frequent bluegrass ( <i>Bothriochloa</i> sp.) and occasional Harrisia cactus ( <i>Harrisia martinii</i> )*; submerged macrophytes included moderate (50–75%) cover of curly pondweed ( <i>Potamogeton crispus</i> ) and little (1–10%) swamp lily ( <i>Ottelia ovalifolia</i> ); emergent macrophytes included moderate (50–75%) cover of cumbungi ( <i>Typha domingensis</i> ); fringing macrophytes included little (1–10%) <i>Cyperus betchei</i> , <i>C. concinnus</i> , rice sedge ( <i>C. difformis</i> ), tall flatsedge ( <i>C. exaltatus</i> ), dwarf sedge ( <i>C. pygmaeus</i> ), pale knotweed ( <i>Persicaria lapathifolia</i> ), umbrella canegrass ( <i>Leptochloa digitata</i> ), willow primrose ( <i>Ludwigia octovalvis</i> ), water primrose ( <i>L. peploides</i> ), brown beetle grass ( <i>Diplachne fusca fusca</i> ), white eclipta ( <i>Eclipta prostrata</i> )*.

<b>Aquatic fauna, including breeding habitat</b>							
The waterbody provides potential foraging and breeding habitat for fish and common turtle species. No suitable platypus breeding habitat detected. Aquatic fauna detected by backpack electrofishing and overnight deployment of two baited fyke nets and five baited box traps included gudgeon ( <i>Hypseleotris galii</i> / sp. 1), eastern rainbowfish ( <i>Melanotaenia splendida</i> ), Rendahl's tandan ( <i>Porochilus rendahli</i> ), Hyrtl's tandan ( <i>Neosilurus hyrtlii</i> ), Agassiz's glassfish ( <i>Ambassis agassizii</i> ), spangled perch ( <i>Leiopotherapon unicolor</i> ), bony bream ( <i>Nematalosa erebi</i> ), purple-spotted gudgeon ( <i>Mogurnda adspersa</i> ), mosquitofish ( <i>Gambusia holbrooki</i> )*.							
<b>Critically Endangered, Endangered, Vulnerable, Near Threatened (CEEVNT), Special Least Concern (SLC), or Priority flora and fauna</b>

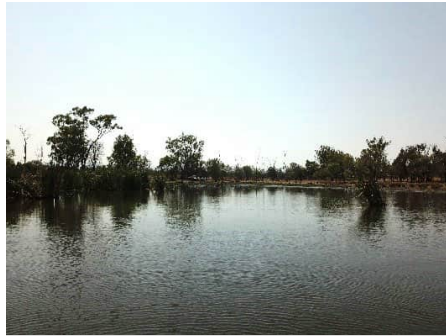
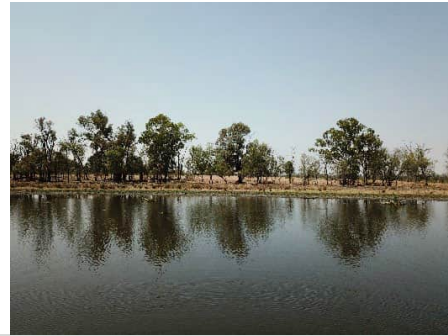
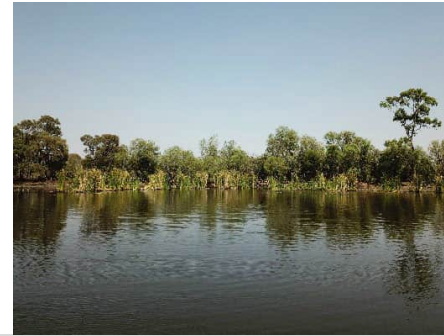
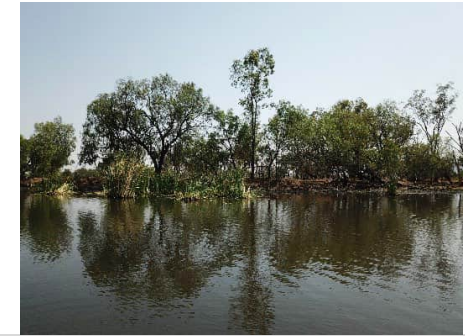
**Table 18** Lacustrine wetland waterbody – Dry

Site: L2 Property: Taurus Stream order: 1 Latitude (GDA 94): -23.7142 Longitude (GDA 94): 148.8777 Date: 12/12/2019 Season: Dry

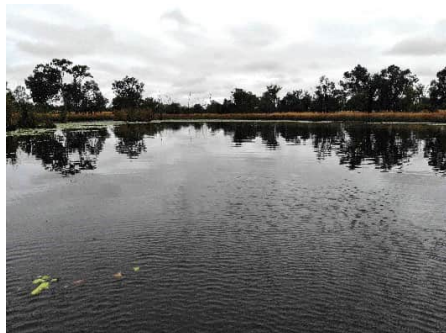
**Table 19 Lacustrine wetland waterbody – Late wet**

Site: L2 Property: Taurus Stream order: 1 Latitude (GDA 94): -23.7142 Longitude (GDA 94): 148.8777 Date: 21/05/2020 Season: Dry

Approximate 1.5 ha mapped lacustrine waterbody (farm dam) on a first order tributary of Two Mile Gully, and subsequently Taurus Creek; the farm dam is located downstream of the Cook Colliery Coal Handling and Processing Facility (CHPP); in-stream habitat included shallow (<0.5 m) pool, deep pool and macrophytes; adjacent land use includes moderate cattle grazing on land predominantly cleared of native vegetation. Bed substrate noted to display coal fines.

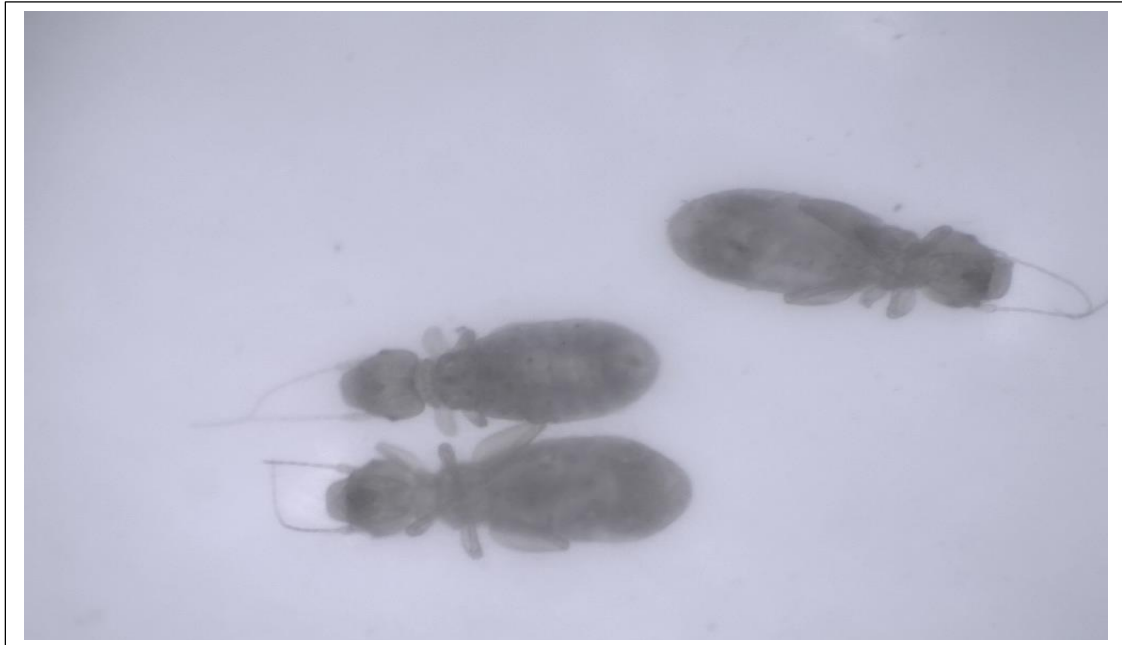
**Figure 1: Isoptera (termites) recorded from Bore MB19BWM03P in December 2020 (Photo: Chris Pietsch).**

Figure 1 shows the presence of Isoptera from groundwater bore MB19BWM03P in December 2020 and Figure 2 shows the presence of Thysanoptera and Collembola from bores MB19BWM25P and MB19BWM04R in May 2021.
