Aquatic Ecology Assessment Report

Daunia West Infrastructure Project

Whitehaven Daunia Pty Ltd

SLR Consulting Australia

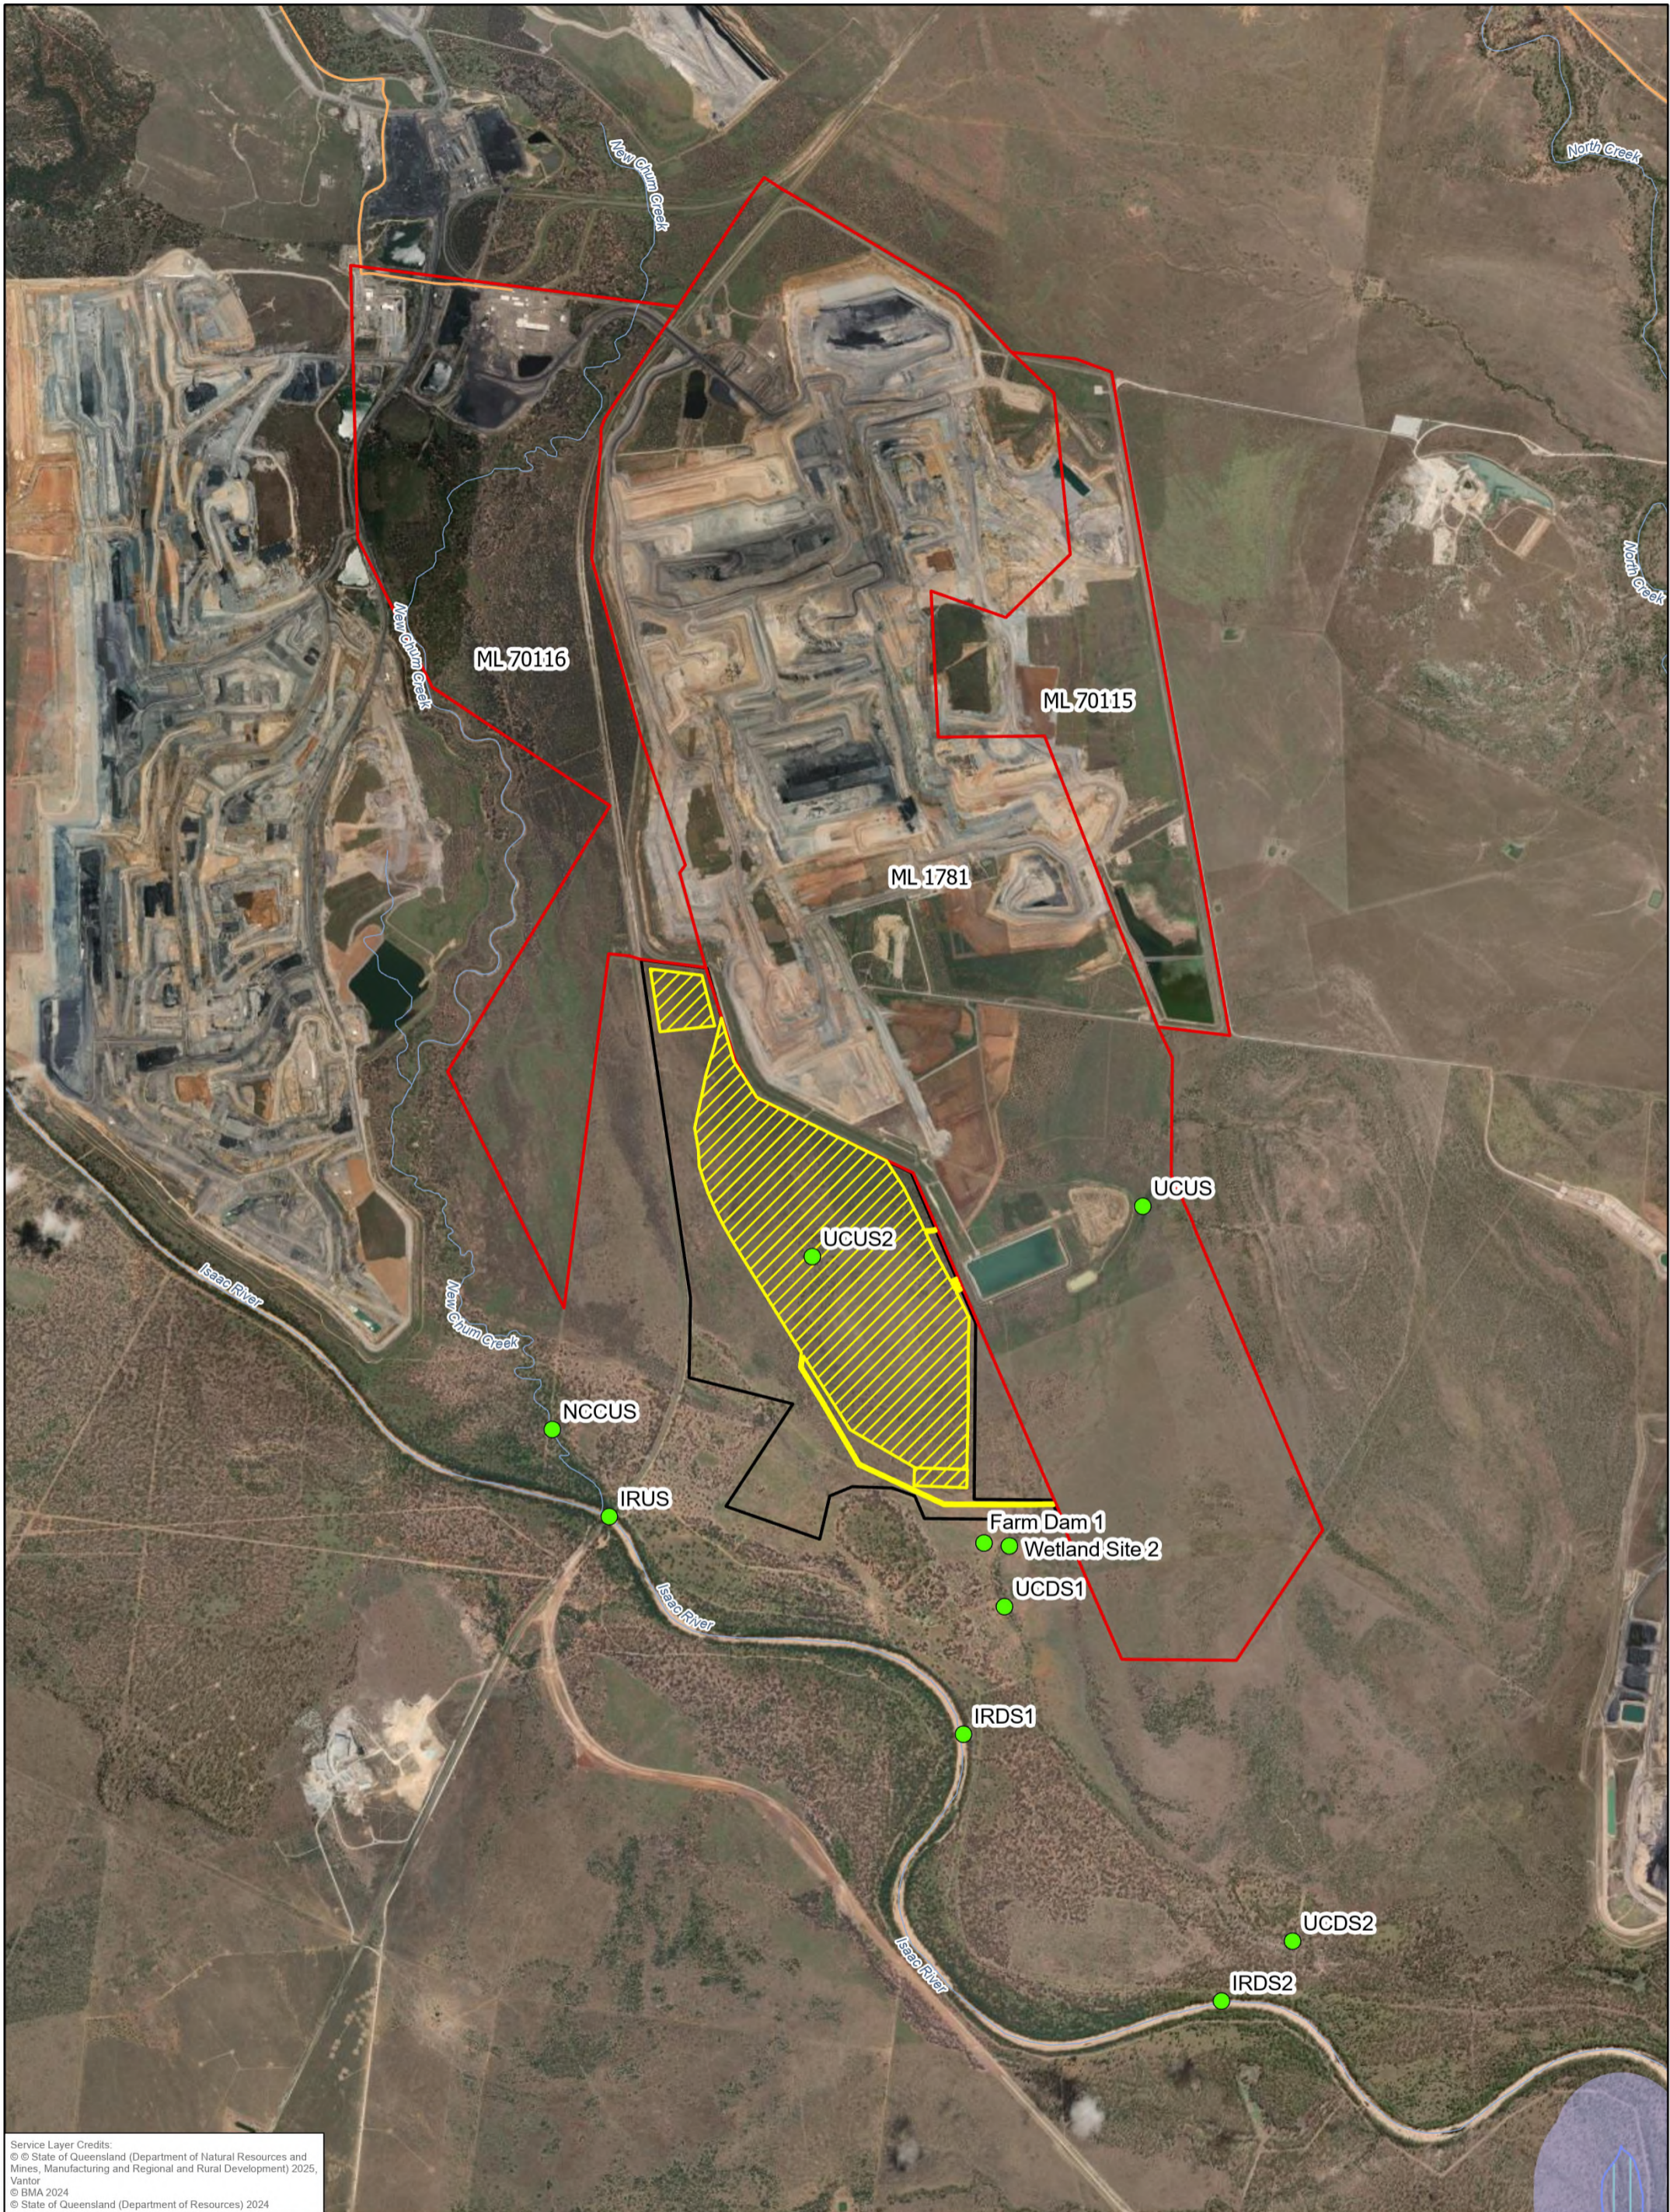
FIGURE 4-1

The Isaac River is a stream order 6 system with tributaries and upper reaches being 1 to 3 stream order systems, New Chum Creek an order 3 system, and the Unnamed Creek an order 2 system (Figure 4-1). Therefore, riparian vegetation from 10 m to 50 m to either side of the waterways within the Project Area, depending on their stream order, is a MSES relevant to aquatic ecology.

Regulated vegetation within 100 m of a wetland does not occur in the Project Area (Figure 4-1).

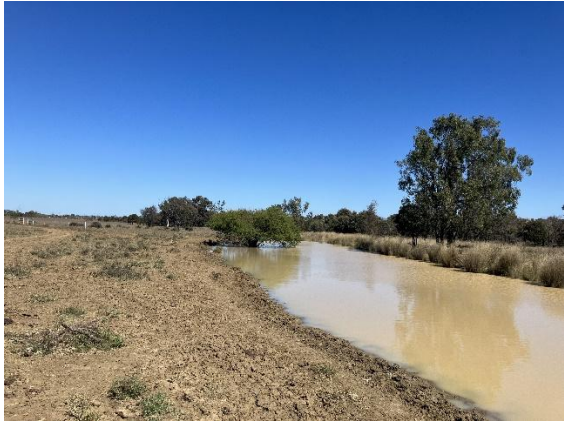
Table 4-1 Waterway description of unnamed waterway 1

| Waterway Description | Site Photos |
|---|---|
| <p>Site: Unnamed Waterway 1 (UW1)</p> <p>Defined bed and banks? Majority of the waterway did not have defined bed or banks, with the exception of one upstream site. The upstream site held significant water and was an isolated pool of roughly 100 m length with defined bank and beds.</p> <p>Fish habitat at/or upstream of site? There is no clear fish passage along the water way. No upstream or downstream connectivity most of the year would limit time when sufficient water would be present for fish passage. Dry channels look to be braided swampy channels that in times of high flow likely create wetland potentially leaving remnant pools.</p> <p>Evidence of flow adequacy? Non-flowing and dry the majority of the year.</p> <p>Other Observations:</p> | <p style="text-align: center;"><i>Downstream reach July 2024</i></p> |

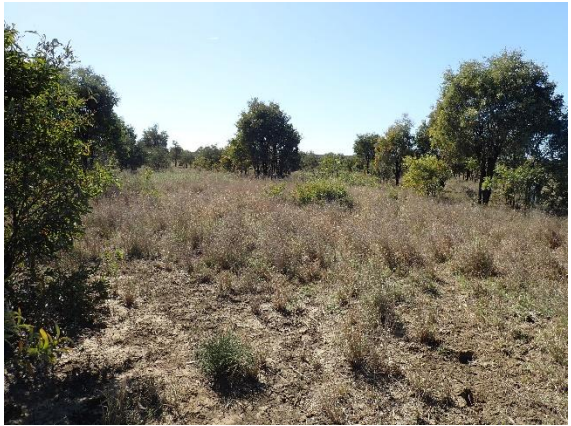
| Waterway Description | Site Photos |
|--|---|
| <p>No aquatic plants were observed along the waterway, the surrounding forest is dominated by Eucalyptus and Melaleuca, and Acacia in some sections.</p> <p>Survey date: 29/07/2024</p> | <p style="text-align: center;"><i>Upstream reach July 2024</i></p> |

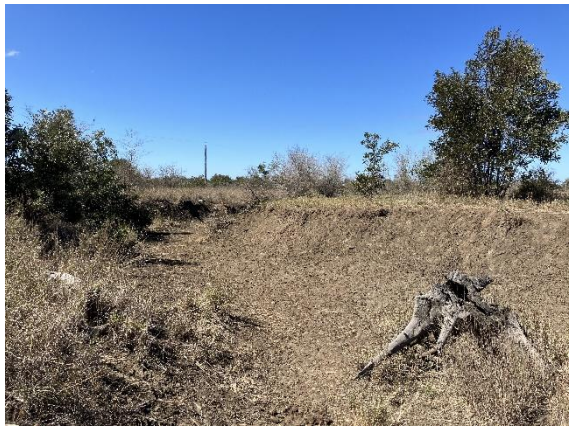
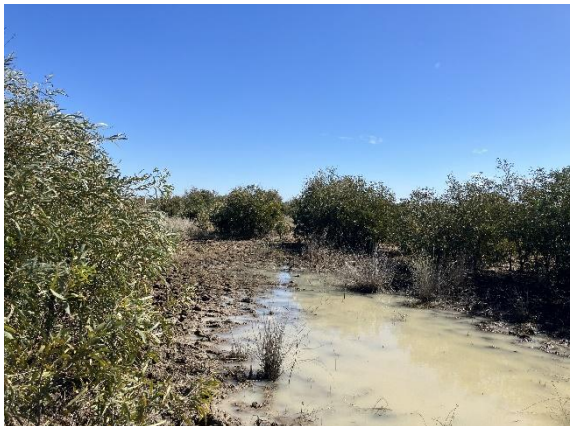
Table 4-2 Waterway description of unnamed waterway 2

| Waterway Description | Site Photos |
|---|--|
| <p>Site: Unnamed Waterway 2 (UW2)</p> <p>Defined bed and banks?</p> <p>Defined bed and banks were present along sections of the waterway, particularly at and upstream of UCUS2, in addition to isolated pools. However, the majority of downstream section of the waterway did not have defined bed or banks. Some braiding of channels observed.</p> <p>Fish habitat at/or upstream of site?</p> <p>Limited upstream or downstream connectivity most of the year would limit time when sufficient water would be present for fish passage, however habitat adequate for fish (and fish present at site) in May 2025. Rare times of flow would provide fish habitat but there is limited opportunity for movement throughout the year.</p> <p>Evidence of flow adequacy?</p> <p>Non-flowing and dry the majority of the year, however UCUS2 holding water and providing fish habitat in May 2025.</p> <p>Other Observations:</p> <p>Sedges were observed along the waterway. Surrounding forest is dominated by Eucalyptus and Melaleuca, and Acacia in some sections. Freshwater mussel and crab shells were observed along dry banks of the waterway. A box culvert at a road crossing in upstream reach but was dry. Site UCUS2 at</p> | <p style="text-align: center;"><i>Upstream reach July 2024</i></p> <p style="text-align: center;"><i>Downstream reach July 2024</i></p> |

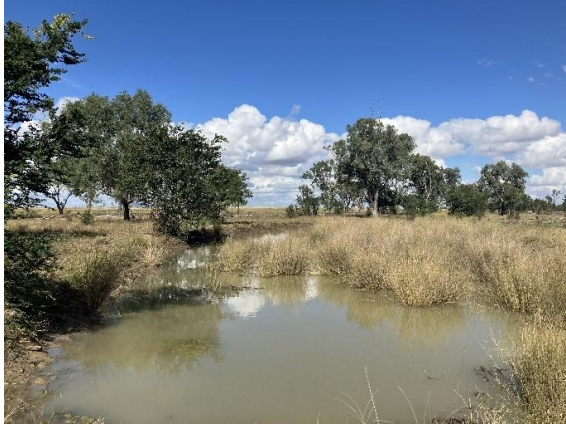
| Waterway Description | Site Photos |
|---|--|
| <p>site of OOPD accessible in May 2025, holding water with native fish present (Agassizi’s glassfish, common gudgeon and spangled perch) and limited aquatic plants present (submerged algae: <i>Chara</i> sp.).</p> <p>Survey date: 29/07/2024 and 15/05/2025</p> | <p style="text-align: center;"><i>UCUS2 (middle reach) May 2025</i></p> |

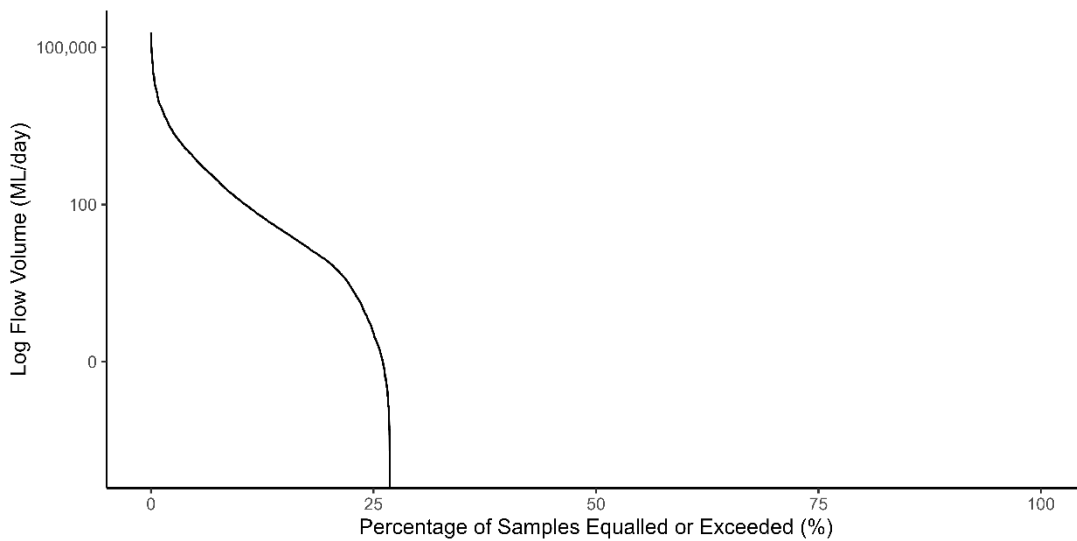
Figure 4-6 Daily flow (ML/day) recorded at the Queensland Government gauging station at Deverill (130410A).

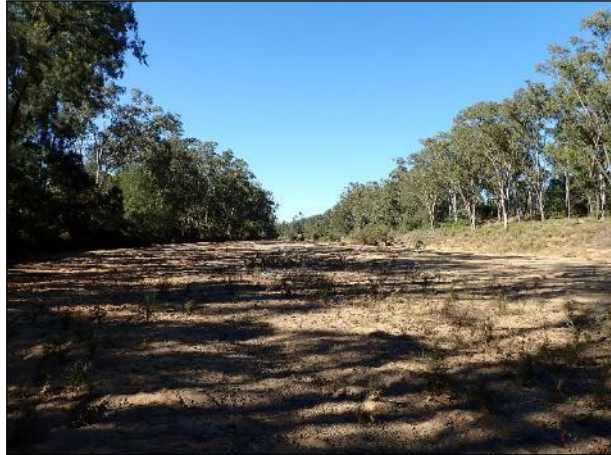
| Site | IRUS Isaac River Upstream | | Region | Isaac River catchment |

| Date surveyed: | 30/7/24 | | Habitat Bioassessment Score | 30 (poor) |
| | Downstream view | | Upstream view | Left bank view |

- Sites on the Isaac River (i.e. IRUS, IRDS1, IRDS2) had shallow (<0.3 m) flowing water at the time of survey, and consisted of poor aquatic habitat, dominated by sandy substrate, with some woody debris, tree roots, and leaves and twigs that may provide limited habitat at times when these sites hold water after significant rainfall events. Site disturbances include clearing for grazing, erosion and weeds (such as lantana and castor plant). Suitable nesting habitat for common turtle species was observed at all sites.
- The site on New Chum Creek (i.e. NCCUS) consisted of a narrow silty channel, with no water at the time of survey. Steep, heavily eroded banks were observed with minimal aquatic plants and habitat present at the time of survey. Site disturbances include clearing for grazing, erosion and high grass cover. The site had been recently graded.

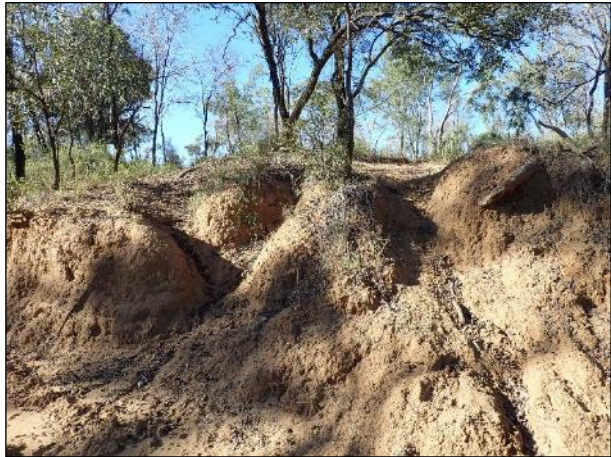
| Site | NCCUS New Chum Creek | | Region | Isaac River catchment |

| Date surveyed: | 29/7/24 | | Habitat Bioassessment Score | Dry (not assessed) |
| | Downstream view | Upstream view | Left bank view | Right bank view |

- The site on New Chum Creek (i.e. NCCUS), consisted of a narrow silty channel, with no water at the time of survey. Steep, heavily eroded banks were observed with minimal aquatic plants and habitat present at the time of survey. Site disturbances included clearing for grazing, erosion and high grass cover.

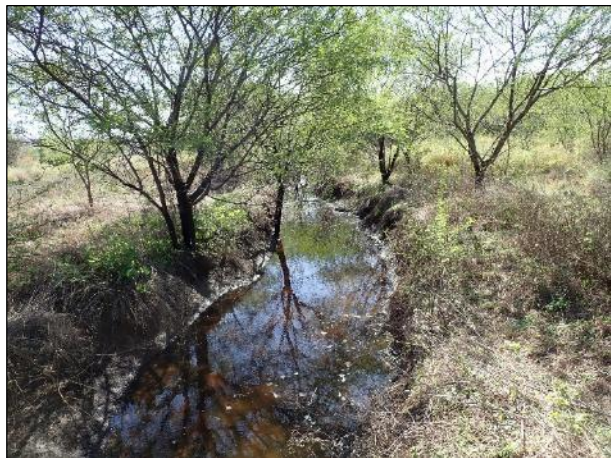
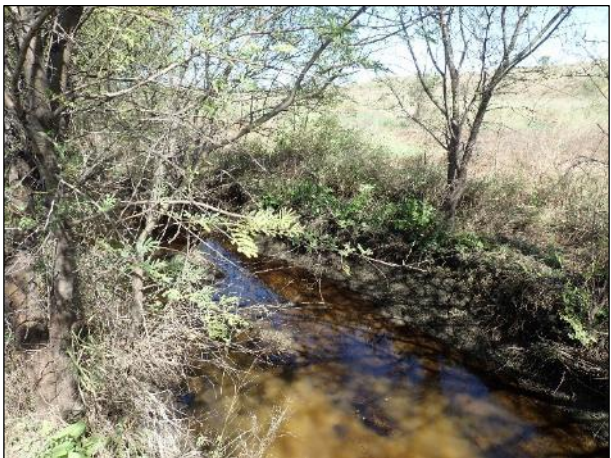
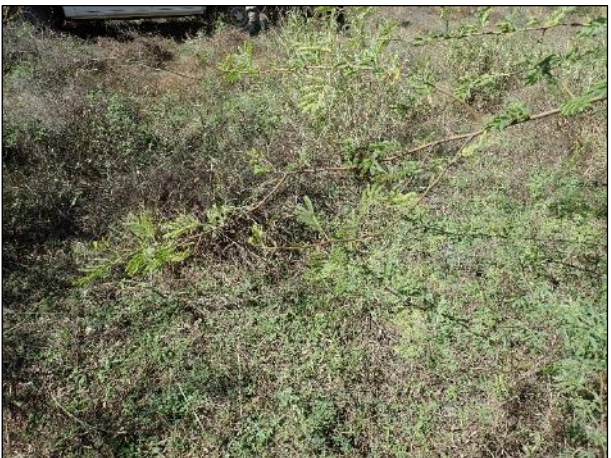
| Site | UCUS Unnamed Creek Upstream 1 | | Region | Isaac River catchment |

| Date surveyed: | 31/7/24 | | Habitat Bioassessment Score | 33 (poor) |
| | Downstream view | | Upstream view | Left bank view |

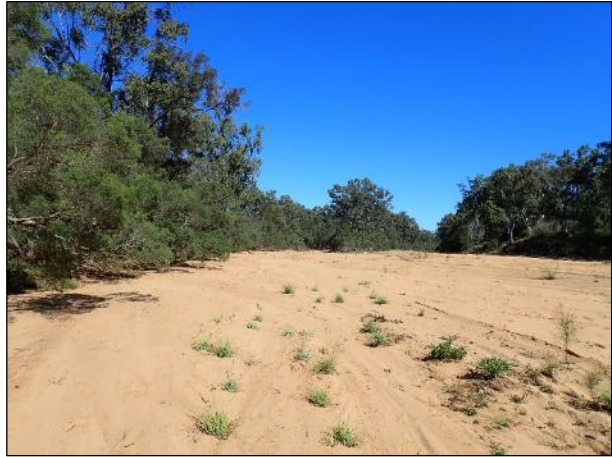
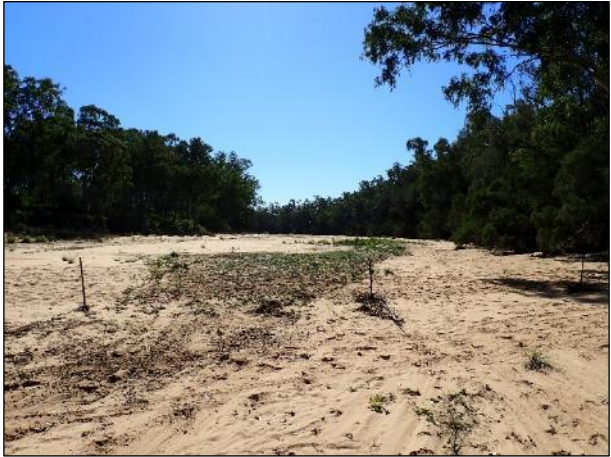
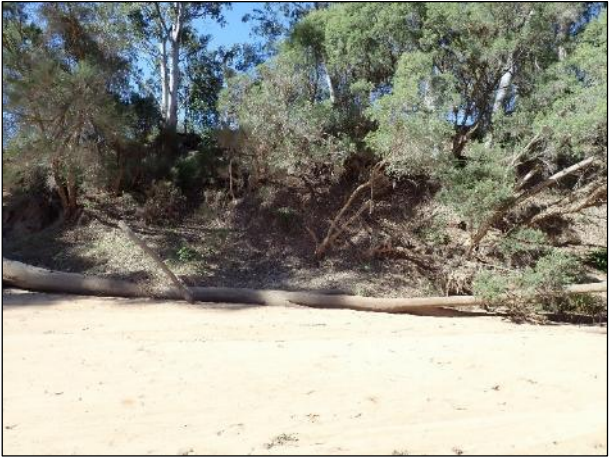
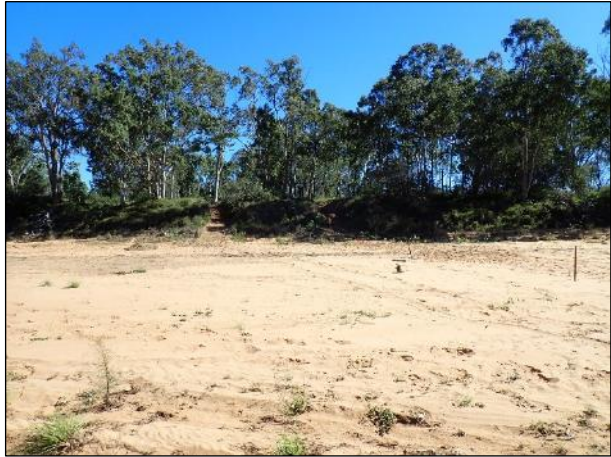
| Site | IRDS1 Isaac River Downstream | Region | Isaac River catchment |

| Date surveyed: | 29/7/24 | Habitat Bioassessment Score | Dry (not assessed) |
| Downstream view | Upstream view | Left bank view | Right bank view |

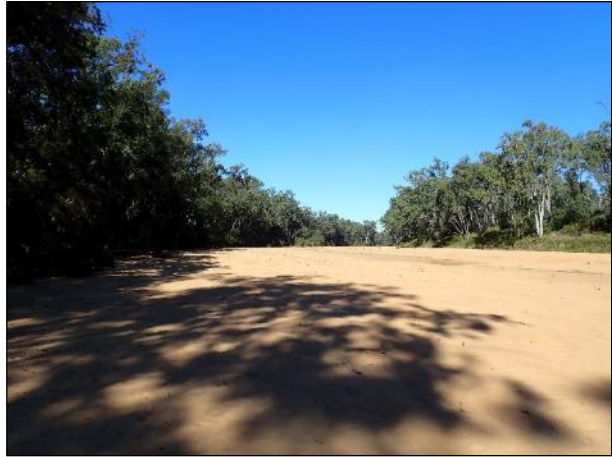
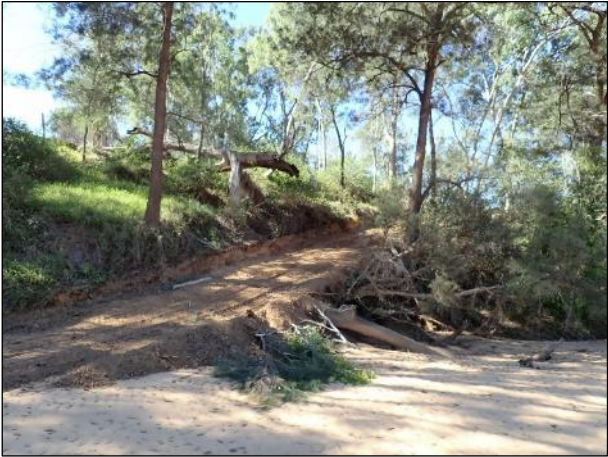
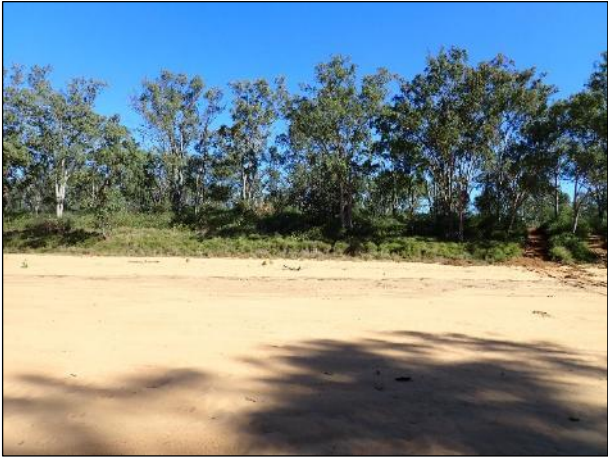
| Site | IRDS2 Isaac River Downstream | Region | Isaac River catchment |

| Date surveyed: | 29/7/24 | Habitat Bioassessment Score | Dry (not assessed) |
| Downstream view | Upstream view | Left bank view | Right bank view |

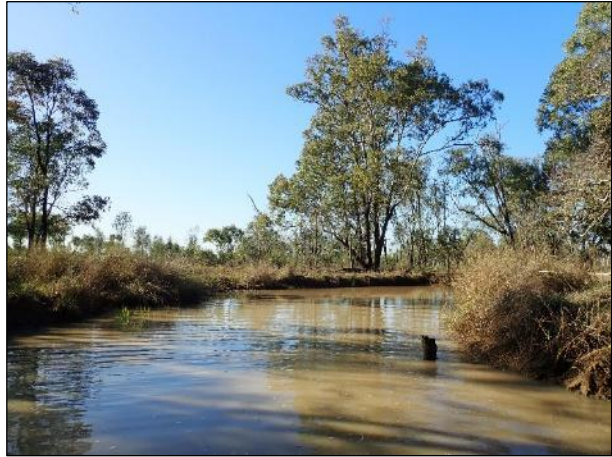
| Site | UCDS1 Unnamed Creek Downstream 1 | Region | Isaac River catchment |

| Date surveyed: | 31/7/24 | Habitat Bioassessment Score | 37 (poor) |
| Downstream view | Upstream view | Left bank view | Right bank view |

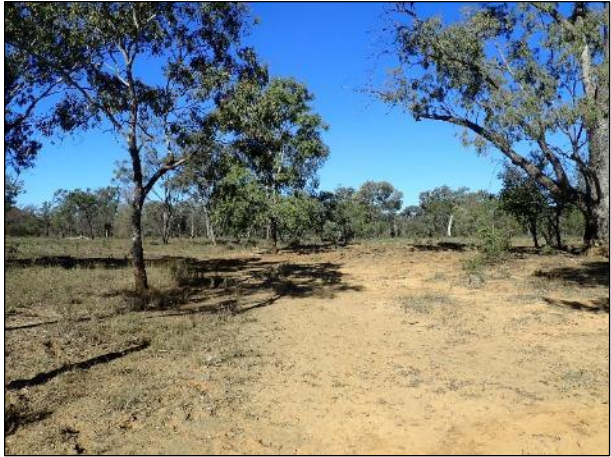
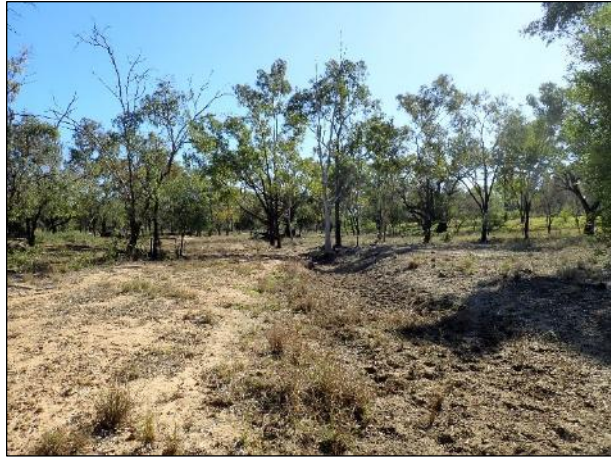
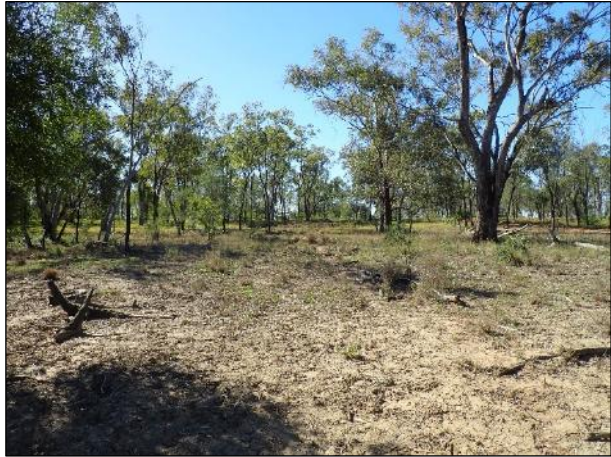
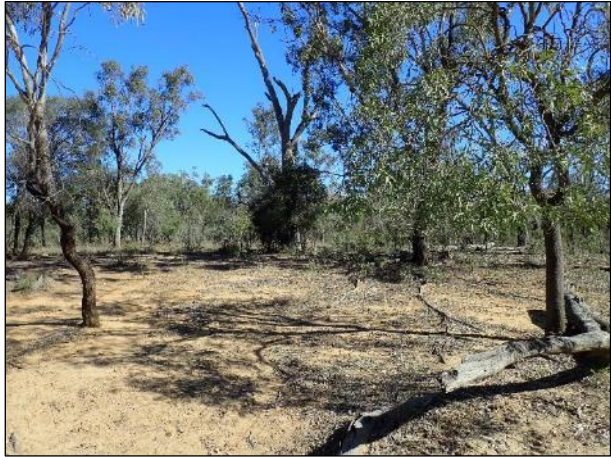
| Site | UCDS2 Unnamed Creek Downstream 2 | Region | Isaac River catchment |

| Date surveyed: | 29/7/24 | Habitat Bioassessment Score | Dry (not assessed) |
| | Downstream view | Upstream view | Left bank view |

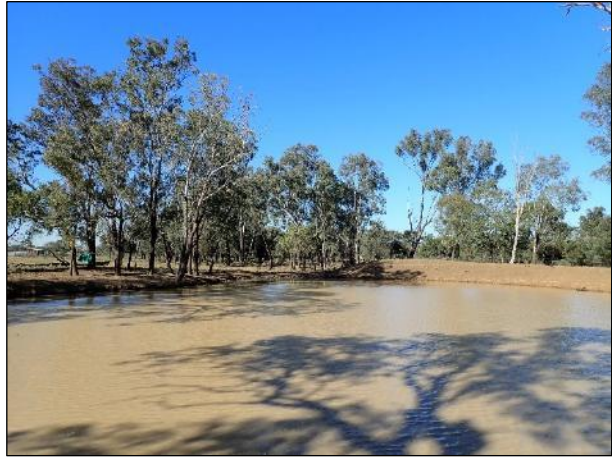
| Site | FD1 Farm Dam 1 | Region | Isaac River catchment |

| Date surveyed: | 31/7/24 | Habitat Bioassessment Score | 15 (poor) |
| Downstream view | Upstream view | Left bank view | Right bank view |

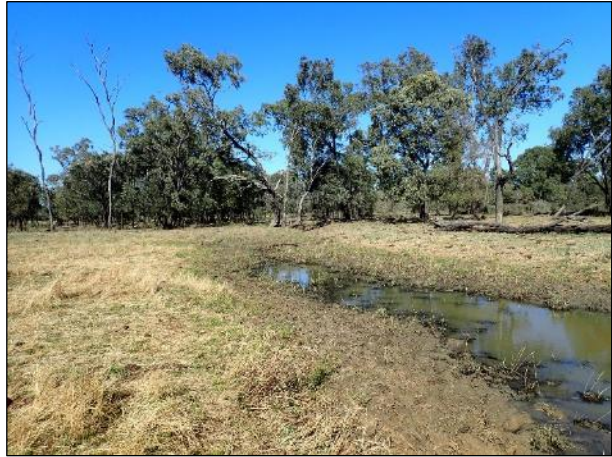
| Site | WS2 Wetland Site 2 | Region | Isaac River catchment |

| Date surveyed: | 31/7/24 | Habitat Bioassessment Score | 9 (poor) |
| Downstream view | Upstream view | Left bank view | Right bank view |

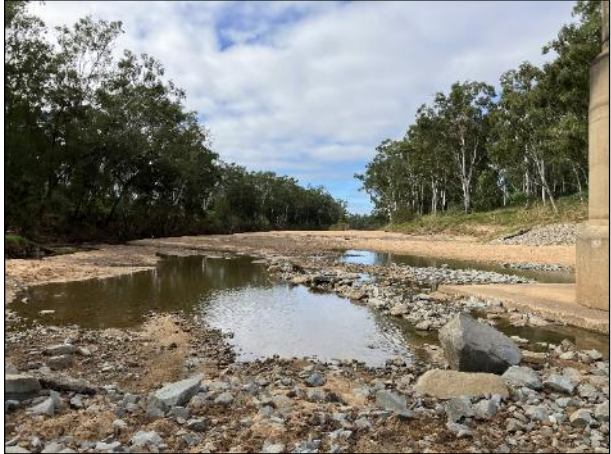
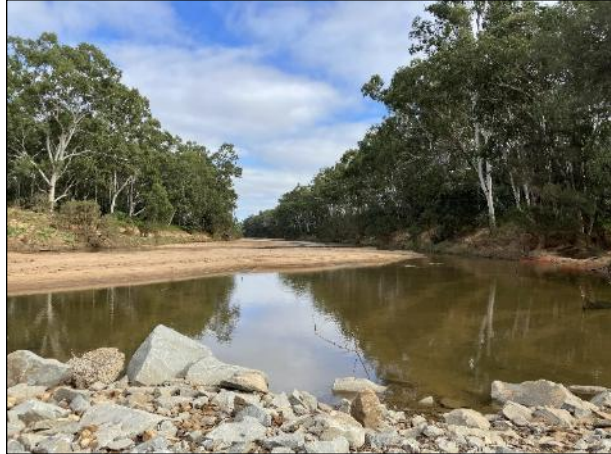
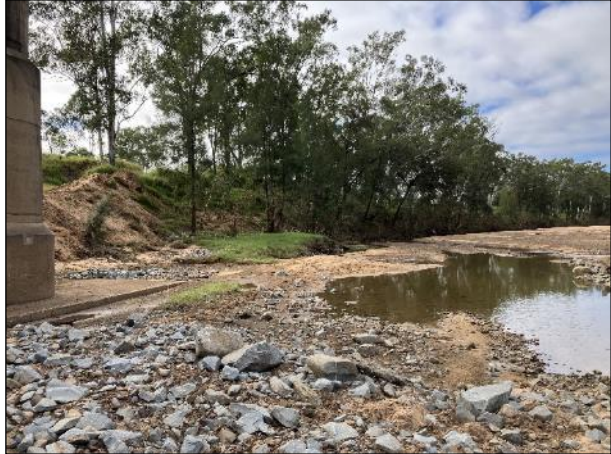
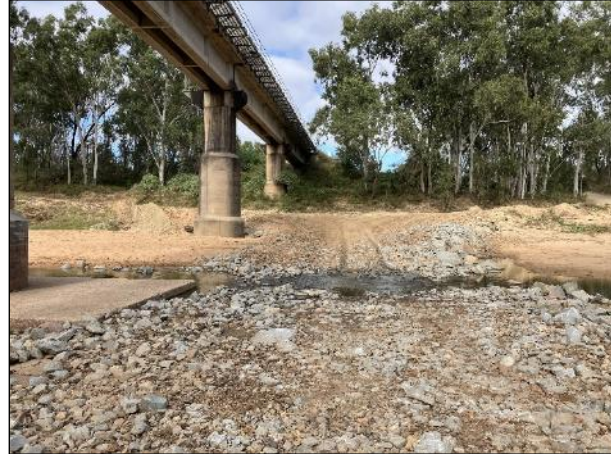
| | Downstream view | Upstream view | Left bank view |

| Site | IRUS Isaac River Upstream | Region | Isaac River catchment |
| Date surveyed: | 13/5/25 | Habitat Bioassessment Score | 50 (Moderate) |

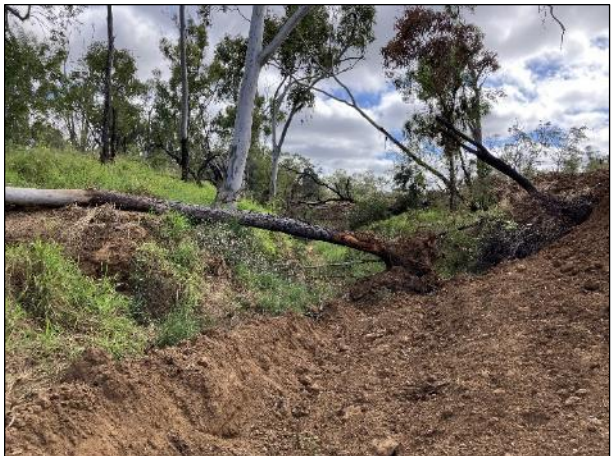
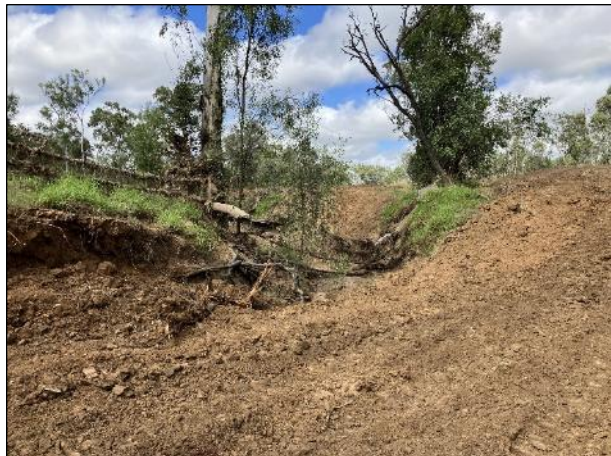
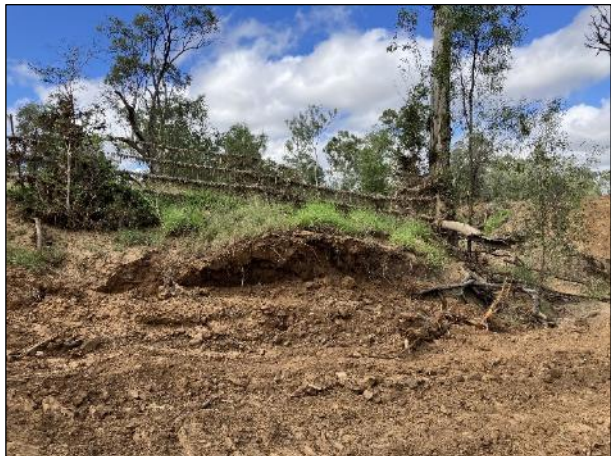
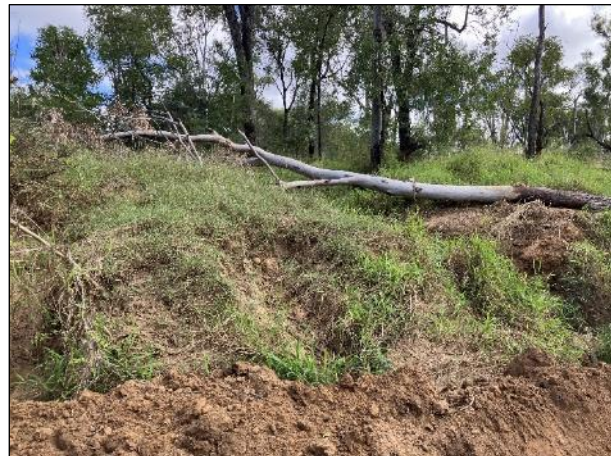
| Site | NCCUS New Chum Creek | Region | Isaac River catchment |

| Date surveyed: | 13/5/25 | Habitat Bioassessment Score | Dry (not assessed) |
| Downstream view | Upstream view | Left bank view | Right bank view |

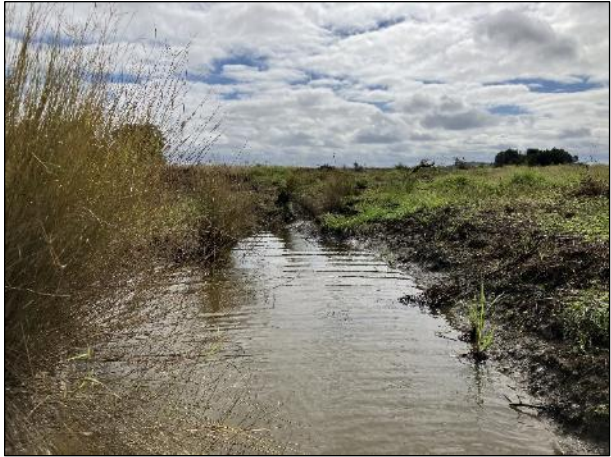
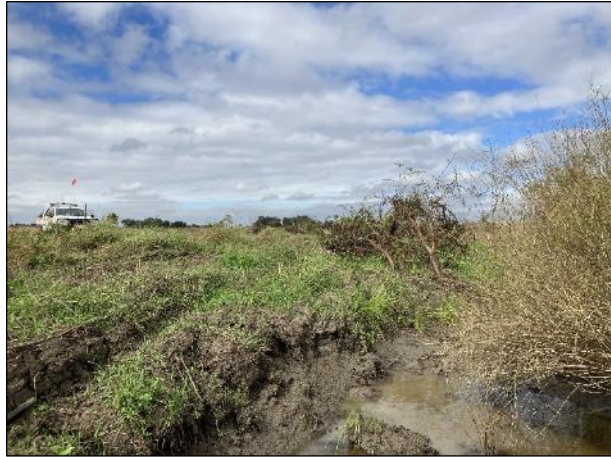
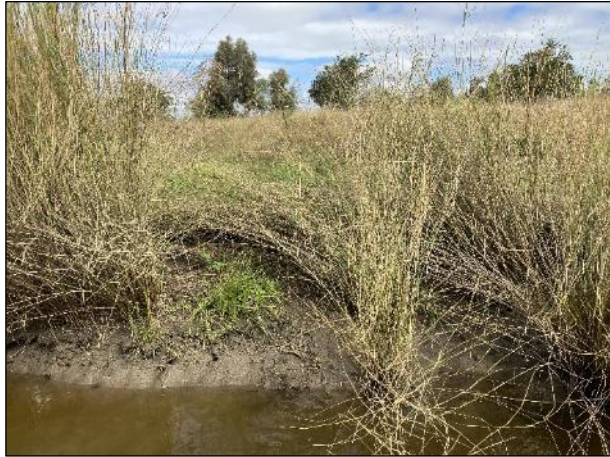
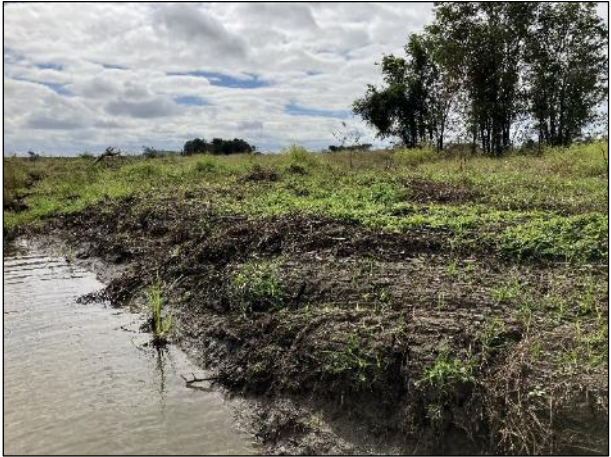
| Site | UCUS Unnamed Creek Upstream 1 | Region | Isaac River catchment |

| Date surveyed: | 15/5/25 | Habitat Bioassessment Score | 24 (Poor) |
| | Downstream view | Upstream view | Left bank view |

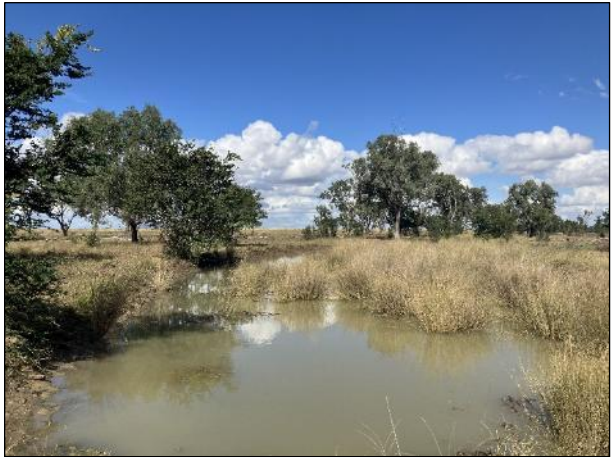
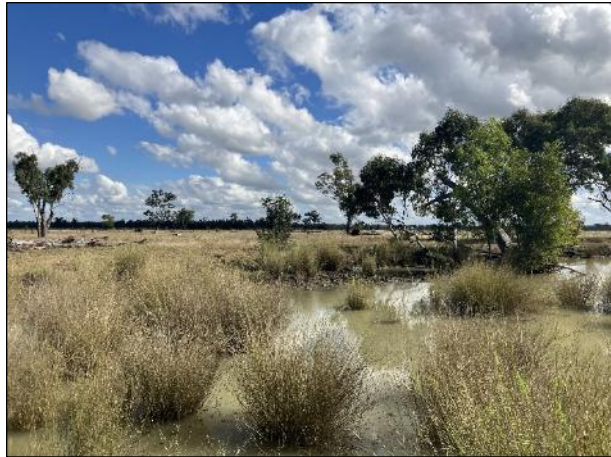
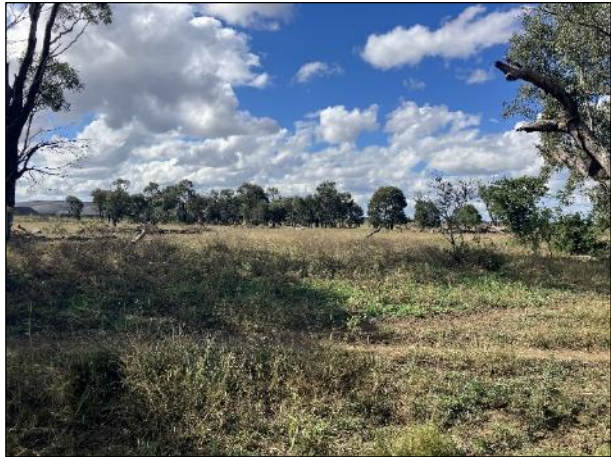
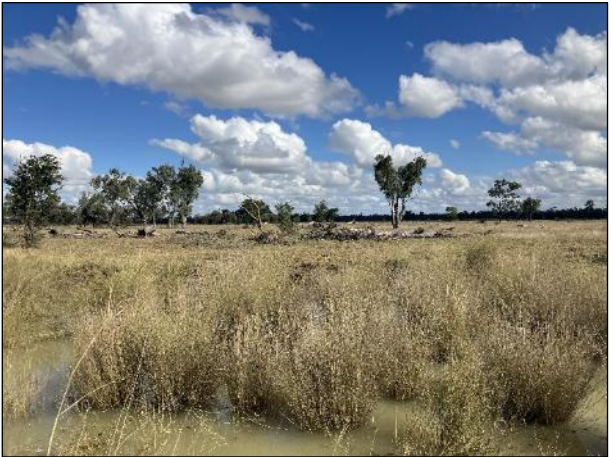
| Site | UCUS2 Unnamed Creek Upstream 2 | Region | Isaac River catchment |

| Date surveyed: | 15/5/25 | Habitat Bioassessment Score | 38 (Poor) |
| | Downstream view | Upstream view | Left bank view |

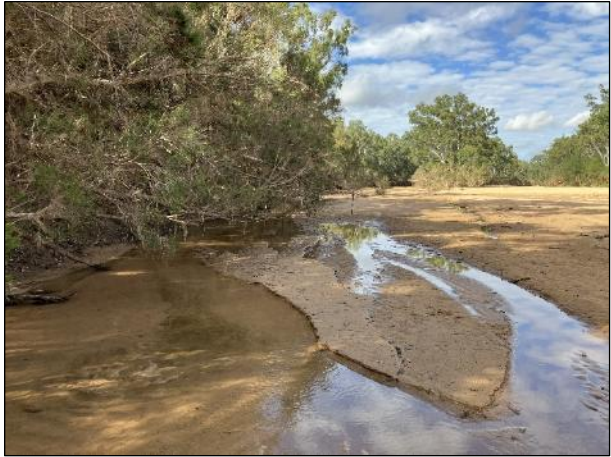
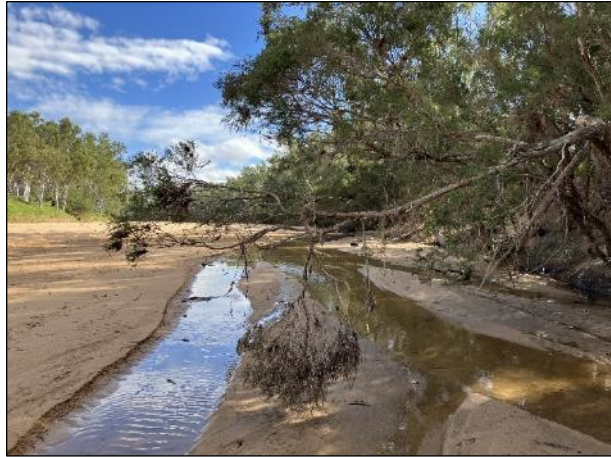
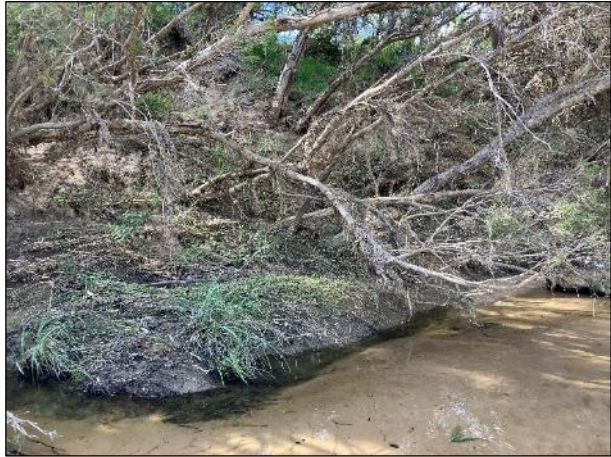
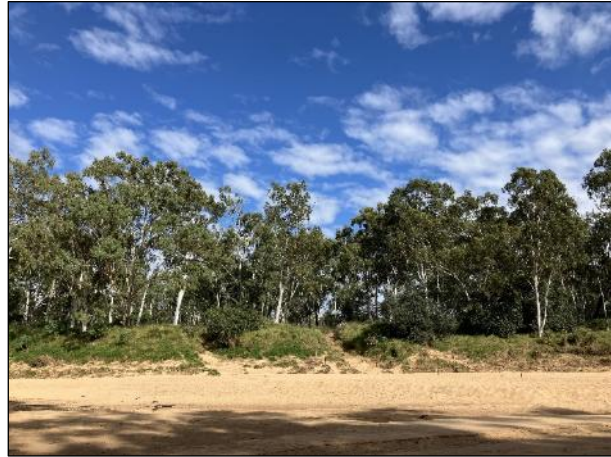
| Site | IRDS1 Isaac River Downstream | Region | Isaac River catchment |

| Date surveyed: | 14/5/25 | Habitat Bioassessment Score | 48 (Moderate) |
| Downstream view | Upstream view | Left bank view | Right bank view |

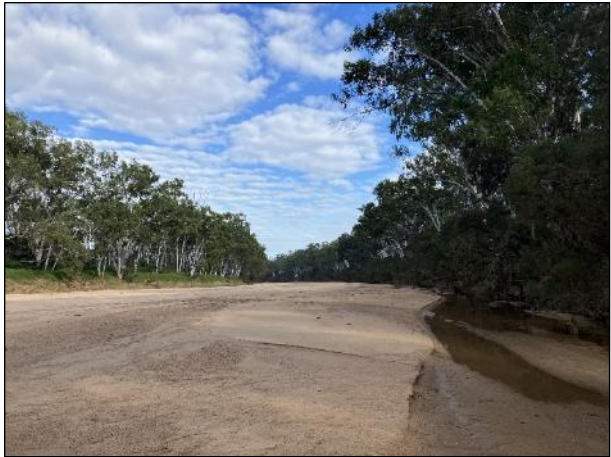
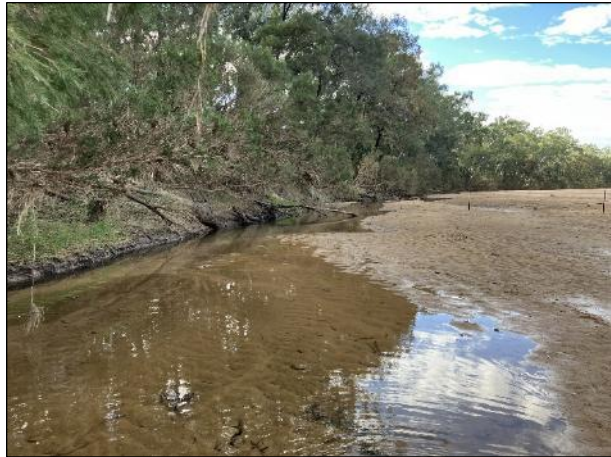
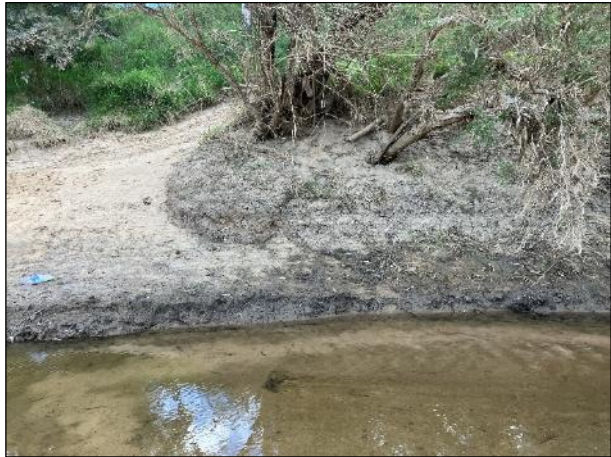
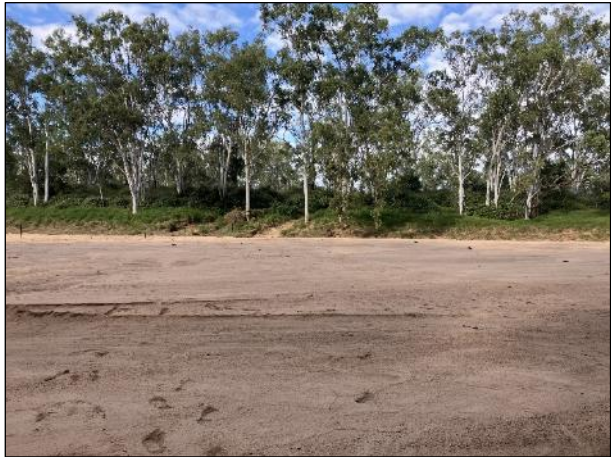
| Site | IRDS2 Isaac River Downstream | Region | Isaac River catchment |

| Date surveyed: | 14/5/25 | Habitat Bioassessment Score | 46 (Moderate) |
| Downstream view | Upstream view | Left bank view | Right bank view |

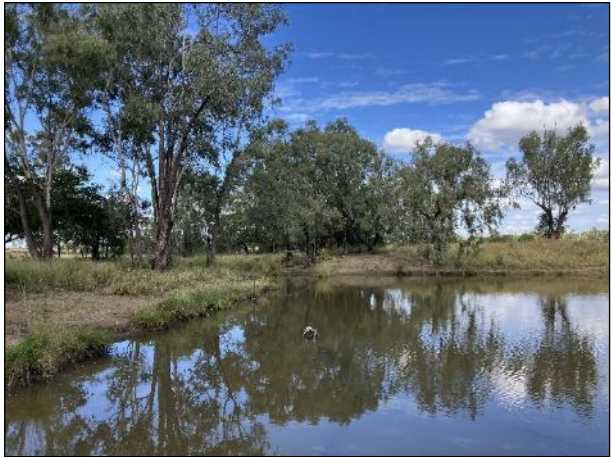
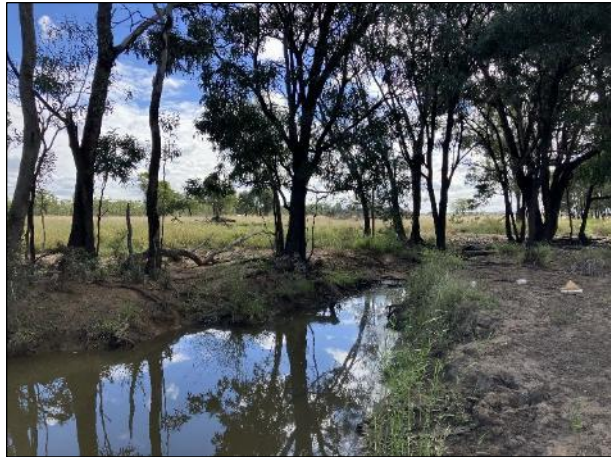
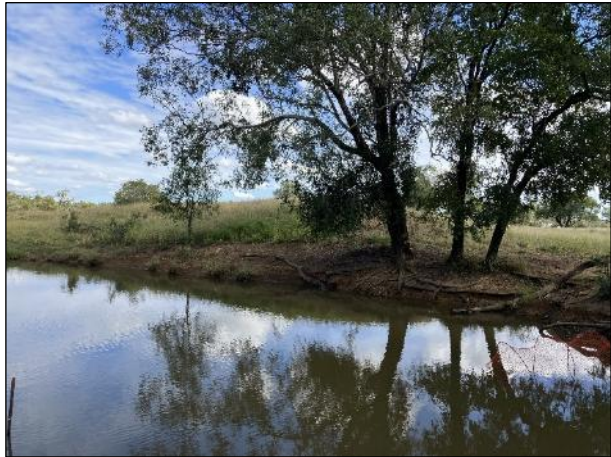
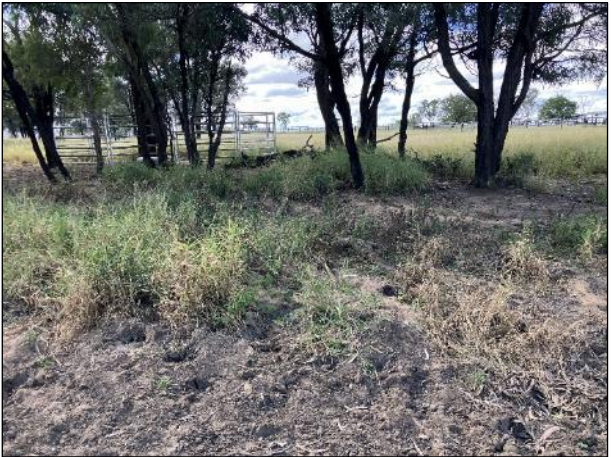
| Site | UCDS1 Unnamed Creek Downstream 1 | Region | Isaac River catchment |

| Date surveyed: | 14/5/25 | Habitat Bioassessment Score | 35 (Poor) |
| Downstream view | Upstream view | Left bank view | Right bank view |

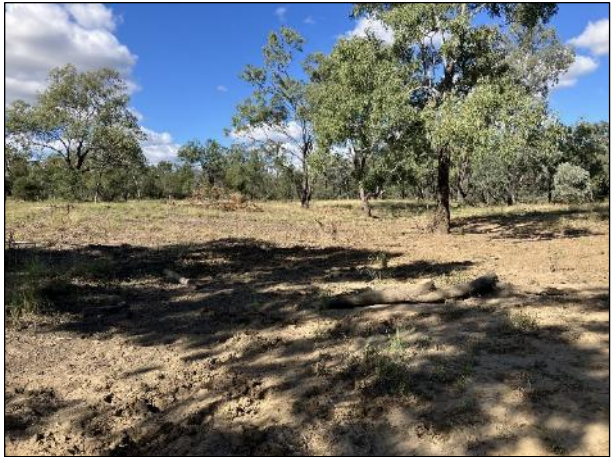
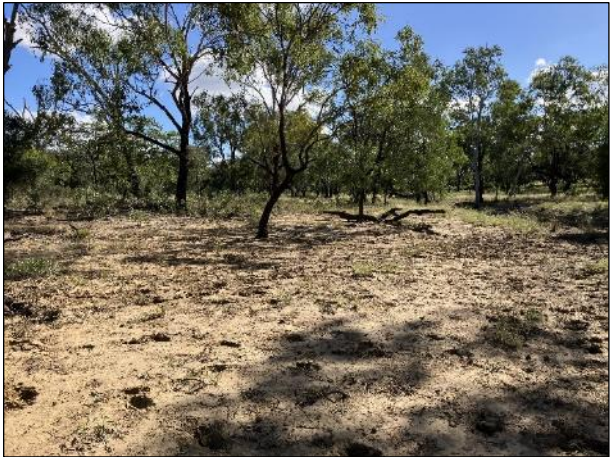
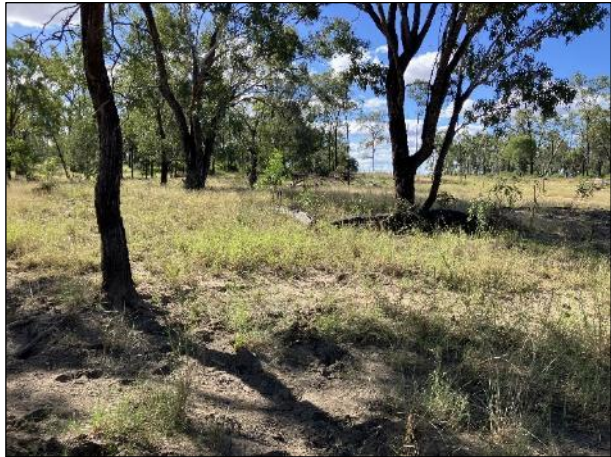
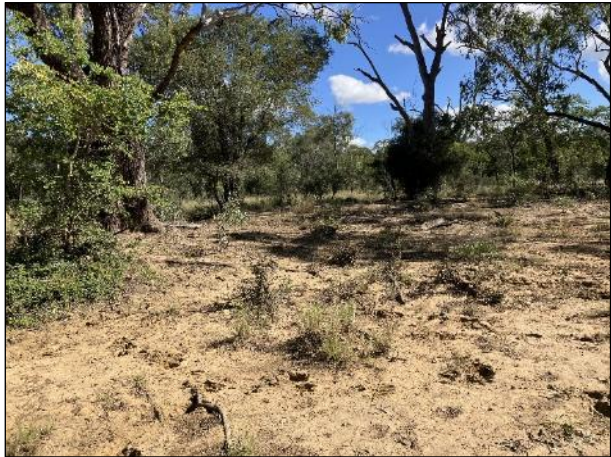
| Site | UCDS2 Unnamed Creek Downstream 2 | Region | Isaac River catchment |

| Date surveyed: | 13/5/25 | Habitat Bioassessment Score | Dry (not assessed) |
| Downstream view | Upstream view | Left bank view | Right bank view |
