Aquatic Ecology Assessment Report

Daunia West Infrastructure Project

Whitehaven Daunia Pty Ltd

SLR Consulting Australia

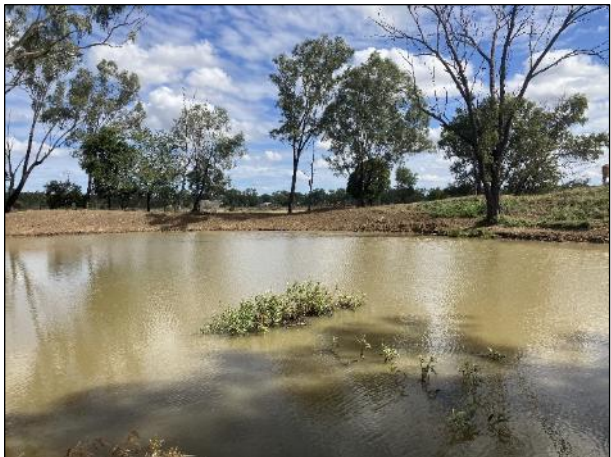
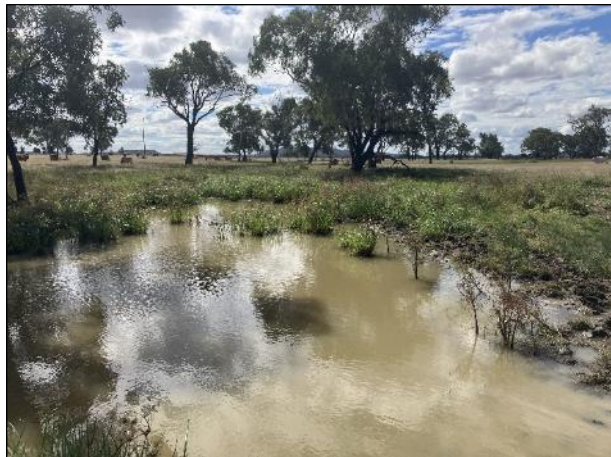
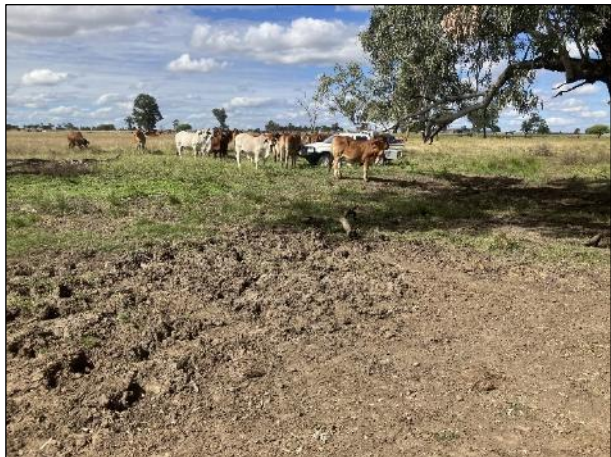
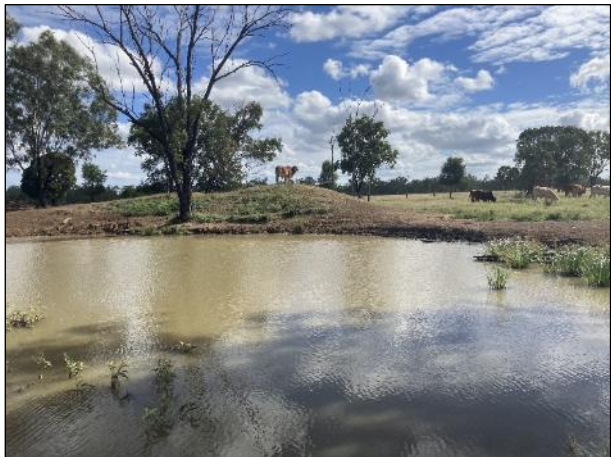
| Site | FD1 Farm Dam 1 | Region | Isaac River catchment |

| Date surveyed: | 14/5/25 | Habitat Bioassessment Score | 27 (Poor) |
| Downstream view | Upstream view | Left bank view | Right bank view |

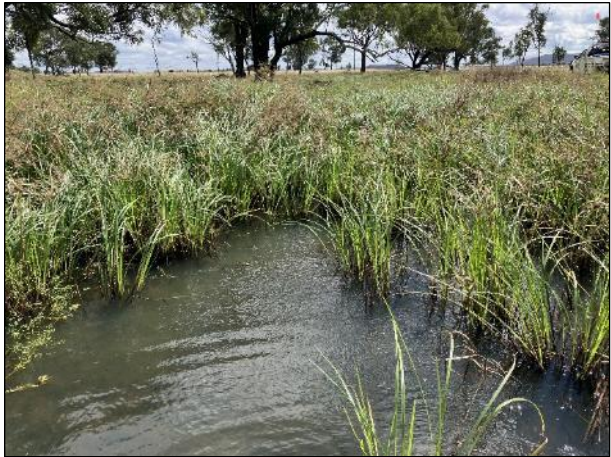
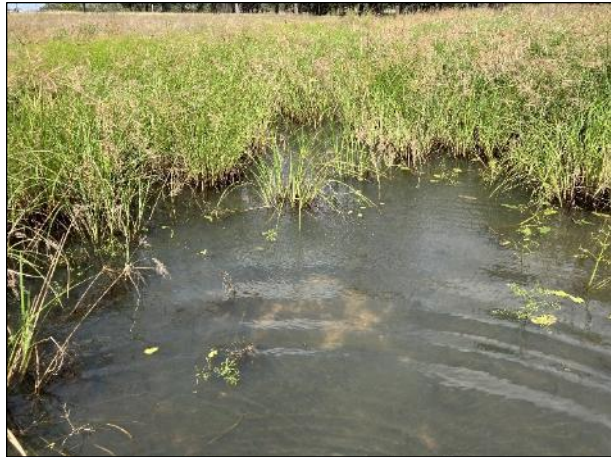
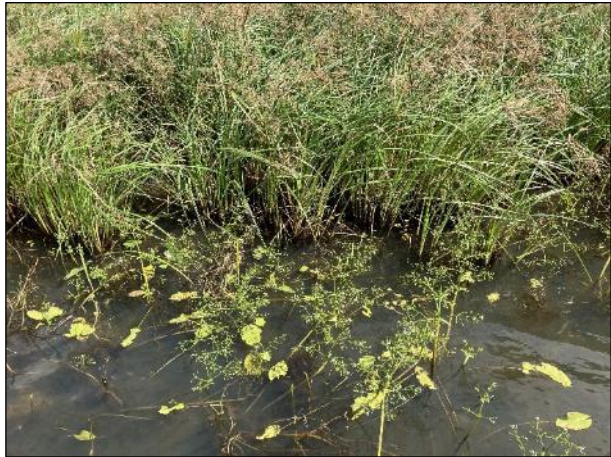
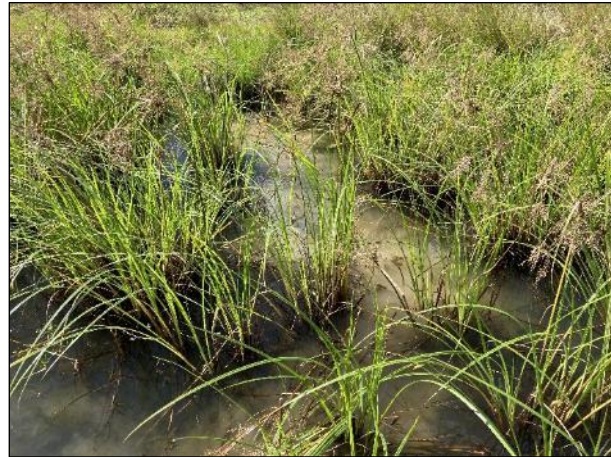
| Site | WS2 Wetland Site 2 | | Region | Isaac River catchment |

| Date surveyed: | 14/5/25 | | Habitat Bioassessment Score | Not assessed |
| | Downstream view | | Upstream view | Left bank view |
