Closure Plan Update/Annual Environmental Management Report

Canyon Coal Mine (MLs 1464 and 1471)

01 July 2012 – 30 June 2013

**Whitehaven Coal Mining Limited
Mine Closure Progress Report
for the
Canyon Coal Mine
(MLs 1464 and 1471)**

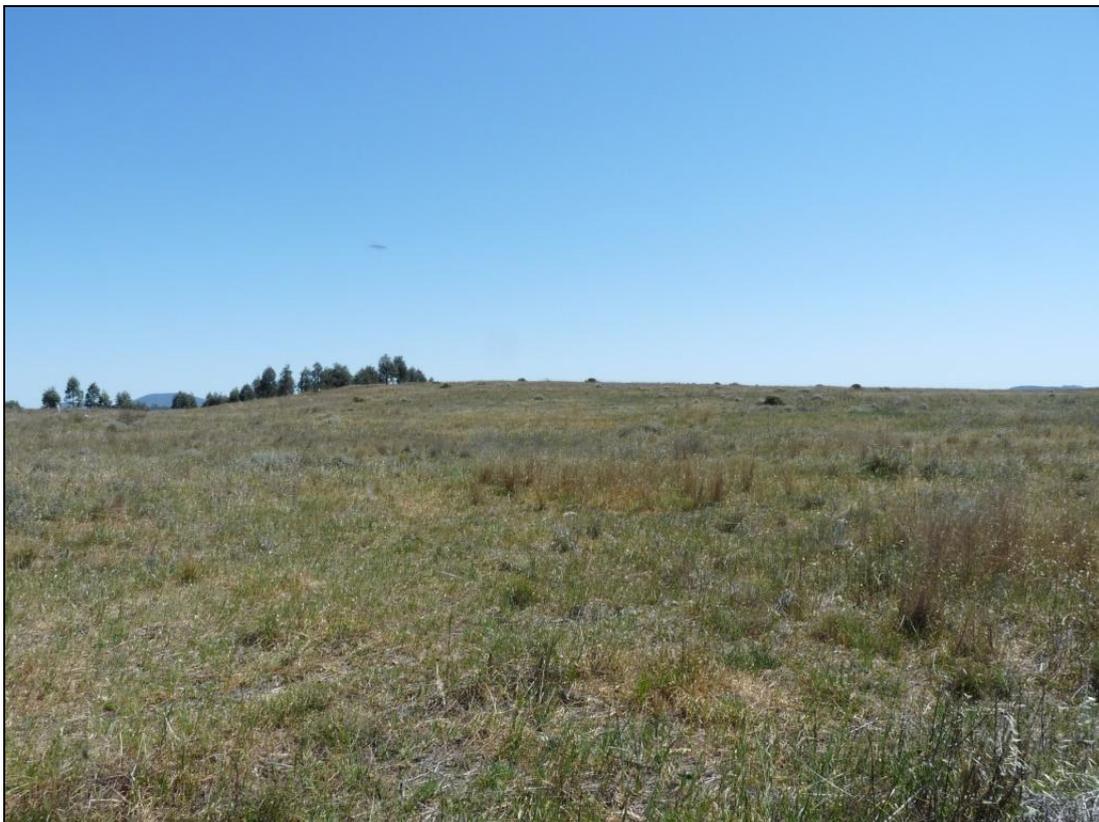
Plate 7 - Zone 2(a) - Pasture Zone 1

Three clumps, comprising 2 tubestock each of 12 different tree or understorey species, were planted in February 2013 on the plateau identified as 2(a) Pasture Zone 1.

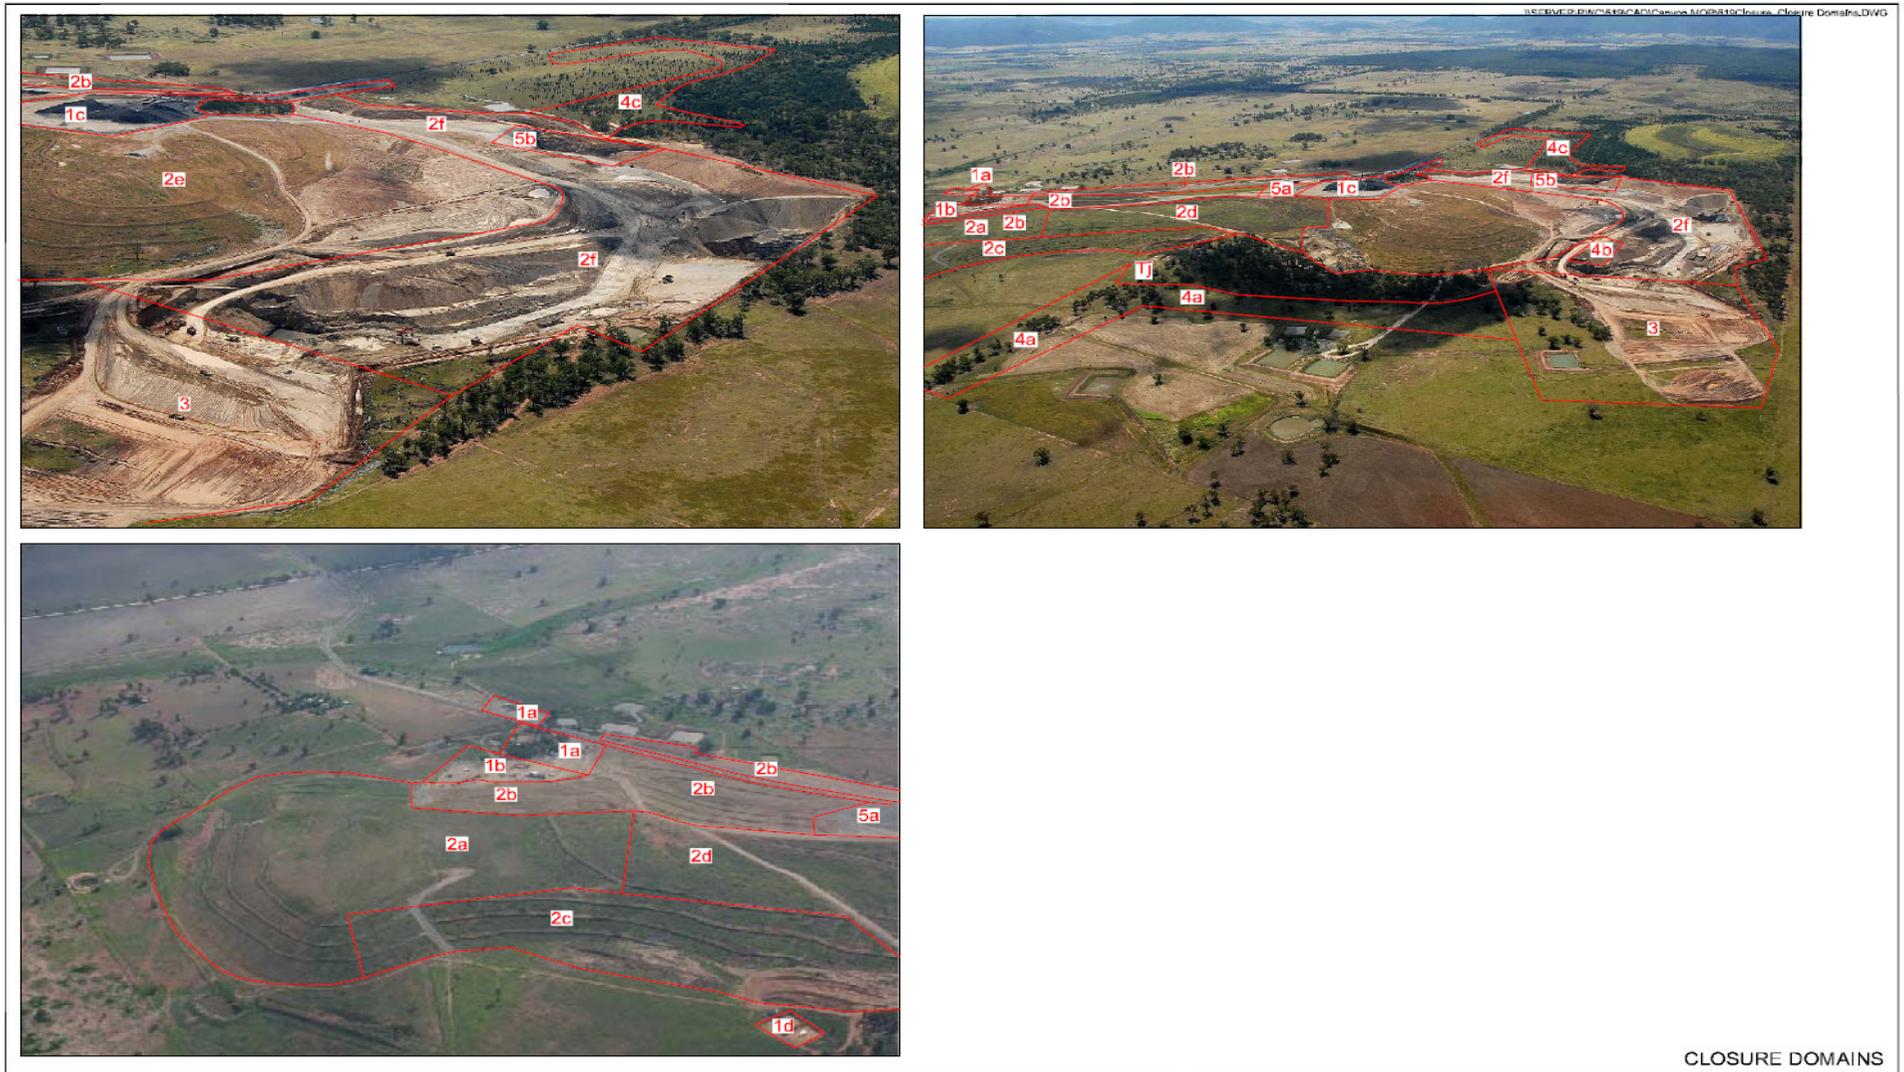
Plate 18 – Closure Domain Areas

The following sub-sections provide a more detailed summary of the progress within each domain (as shown in Plate 18). Table 2 at the end of this section provides an updated schedule of works, with revised timeframes, where required.
