**Closure Plan Update/Annual
Environmental Management Report**

**Canyon Coal Mine
(MLs 1464 and 1471)**

01 July 2013 – 30 June 2014

**Whitehaven Coal Mining Limited
Mine Closure Progress Report
for the
Canyon Coal Mine
(MLs 1464 and 1471)**

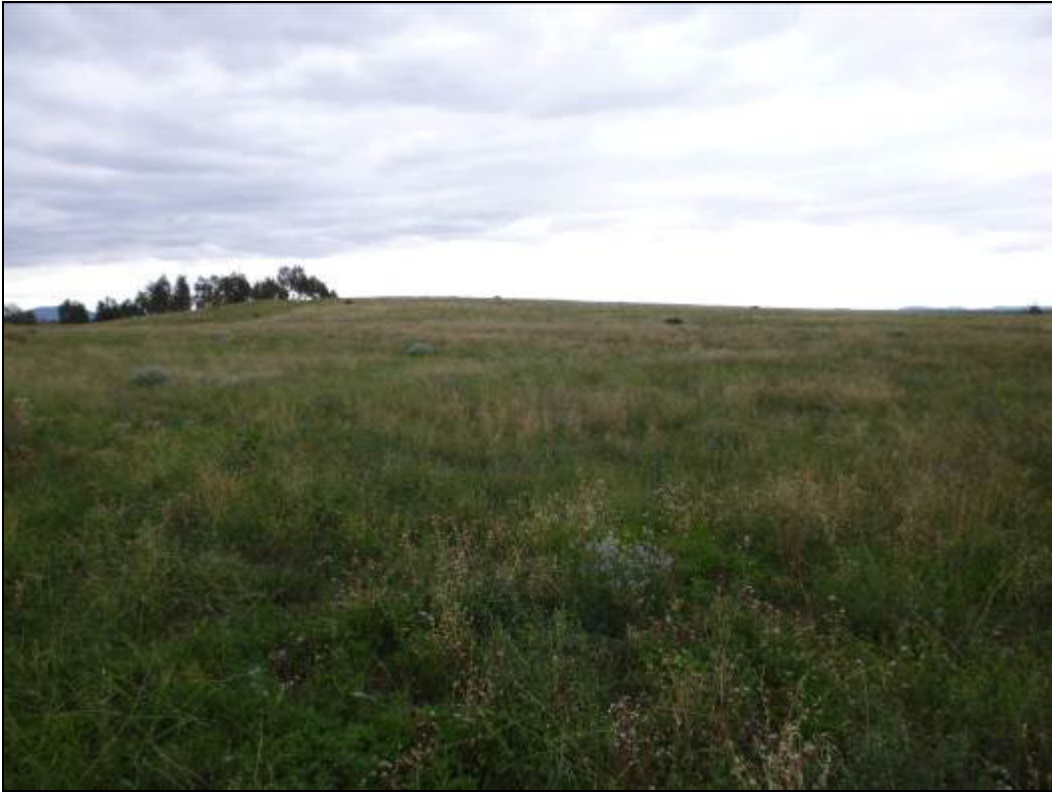
Plate 7 - Zone 2(a) - Pasture Zone 1

Three clumps, comprising 2 tubestock each of 12 different tree or understorey species, were planted in February 2013 on the plateau identified as 2(a) Pasture Zone 1.

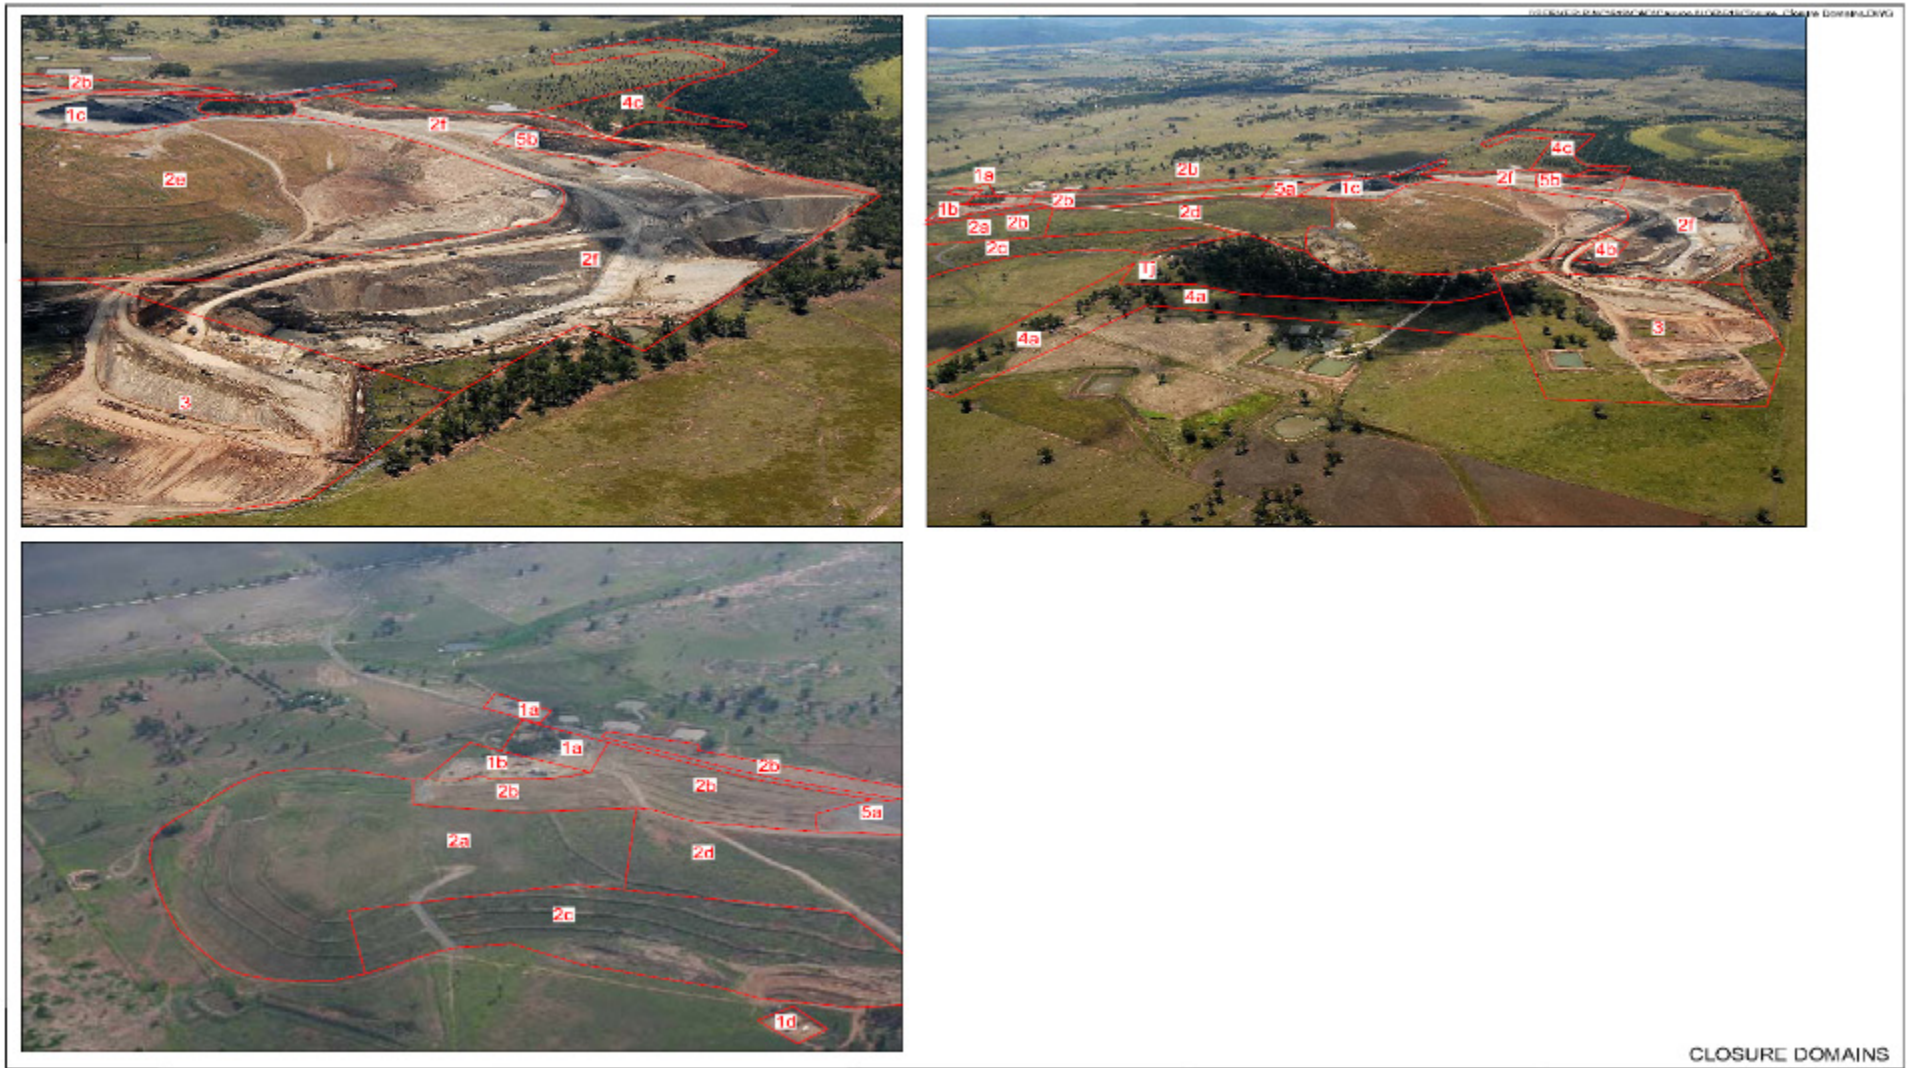
Plate 18 – Closure Domain Areas

The following sub-sections provide a more detailed summary of the progress within each domain (as shown in Plate 18). Table 2 at the end of this section provides an updated schedule of works, with revised timeframes, where required.
