## Environmental Event Report

### Narrabri Underground Mine Stage 3 Extension Project

### Surface Water Trigger Investigation Report – May 2026

Narrabri Coal Operations Pty Ltd

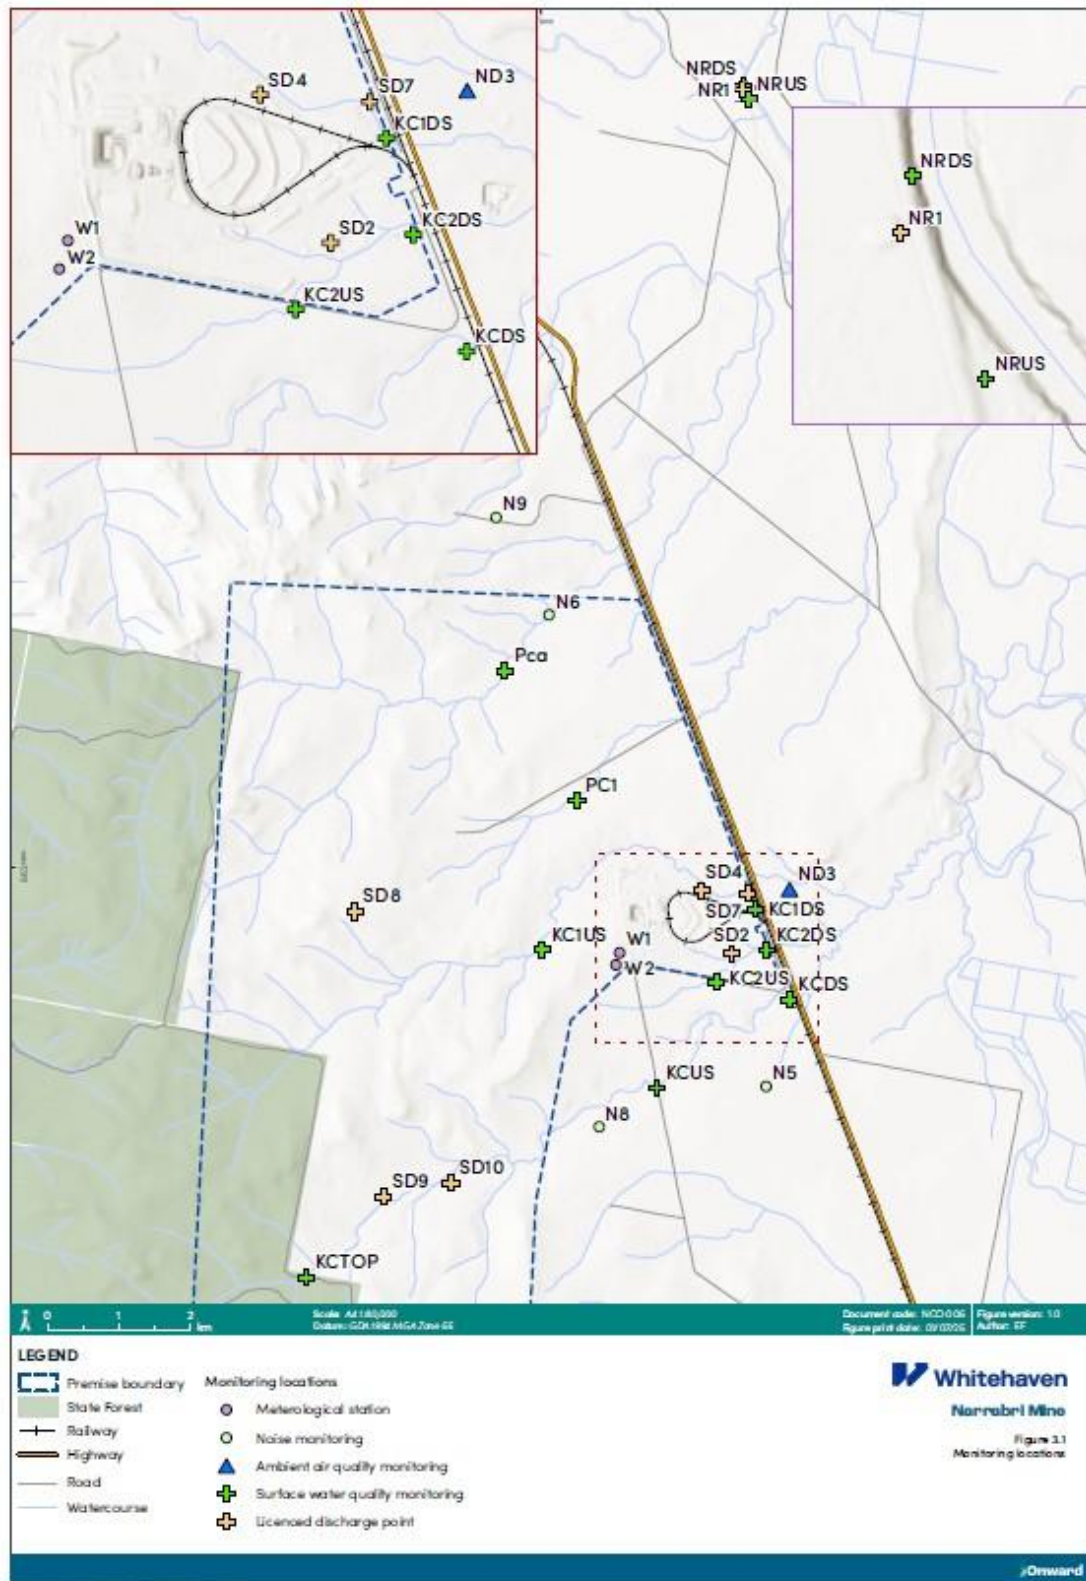
**Figure 1.1 – Locality plan**

The locations of the site monitoring points are shown in Figure 1.1.

Ponding may occur in the LW101 subsidence area, upstream of PC1. No subsidence has or will occur over the LW201 panel upstream of KC1DS, due to the cut and fill methods used in this location. Hence, no ponding due to mining operations is expected to occur upstream of KC1DS. Refer to Figure 1.1 for locations.
