## WINCHESTER SOUTH PROJECT

Environmental Impact Statement

# **Winchester South Project EIS**

## **Aquatic Ecology and Stygofauna, Additional Information**

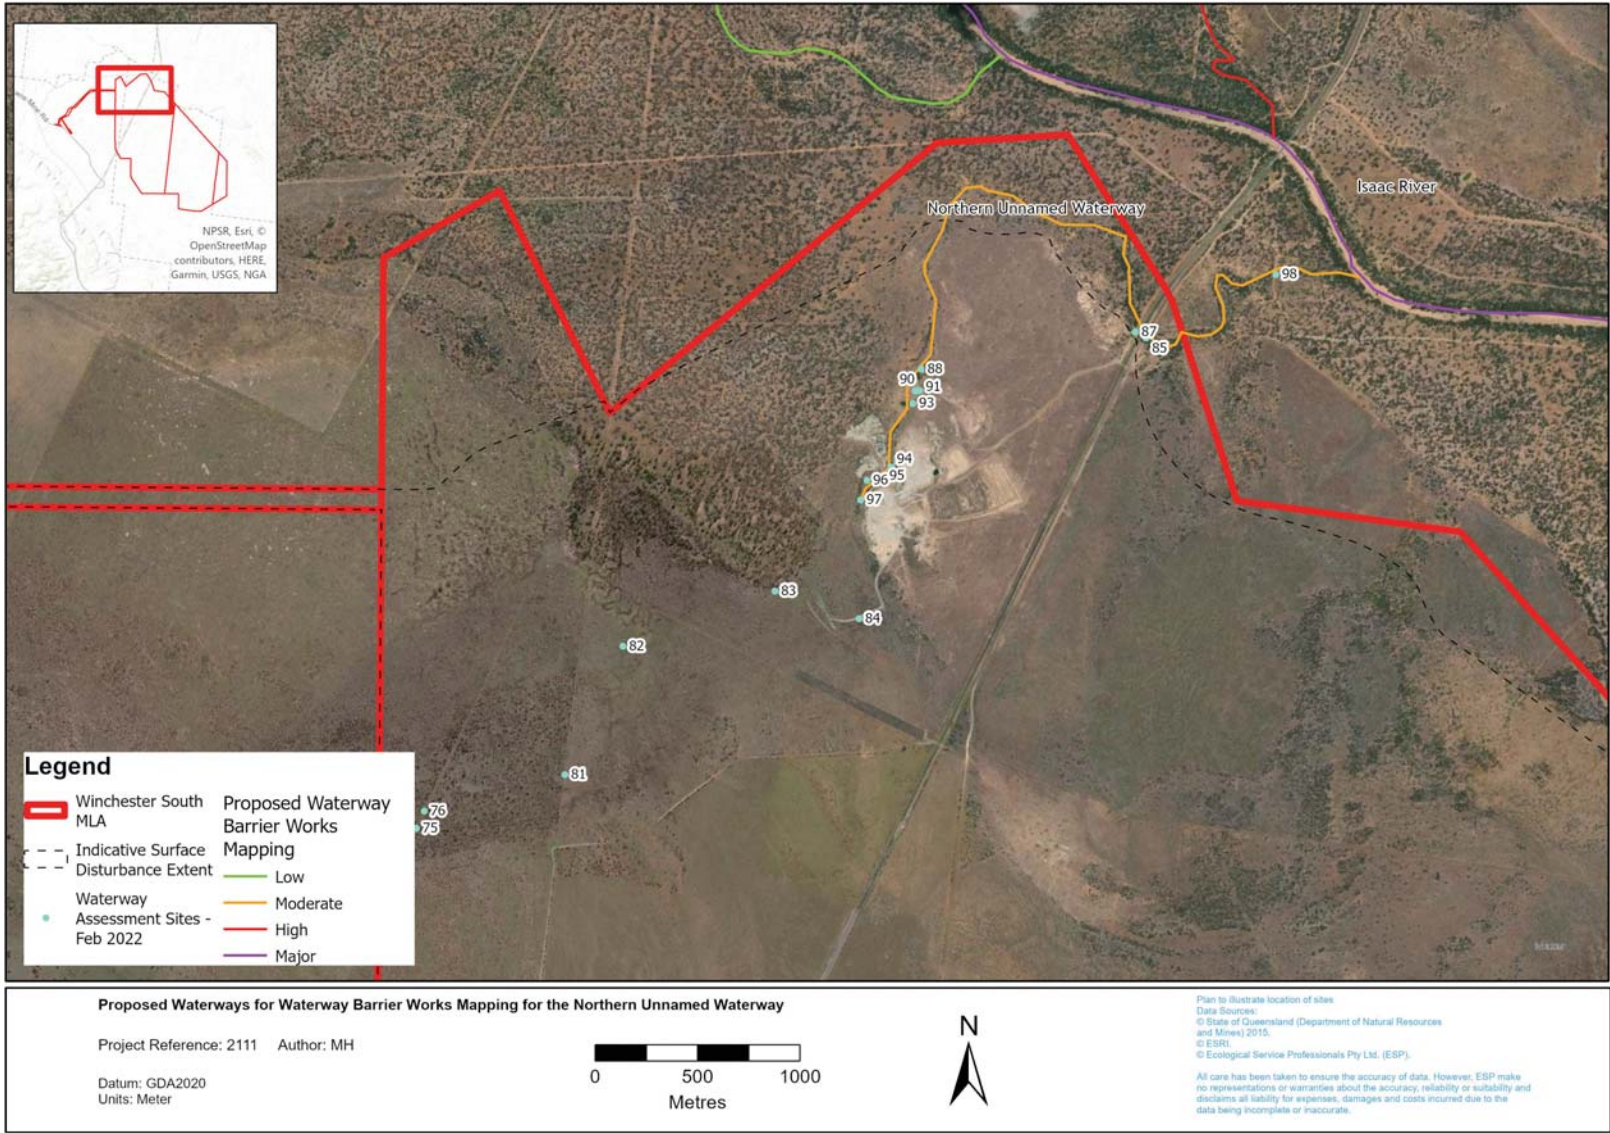
Figure 3.5 Proposed mapping change to the WWBW mapping for the northern unnamed waterway

The northern unnamed waterway contained 4.5 km of waterway providing for fish passage. Of this, 1.52 km (constituting 2.45 ha) is within the proposed surface disturbance extent of the Project.

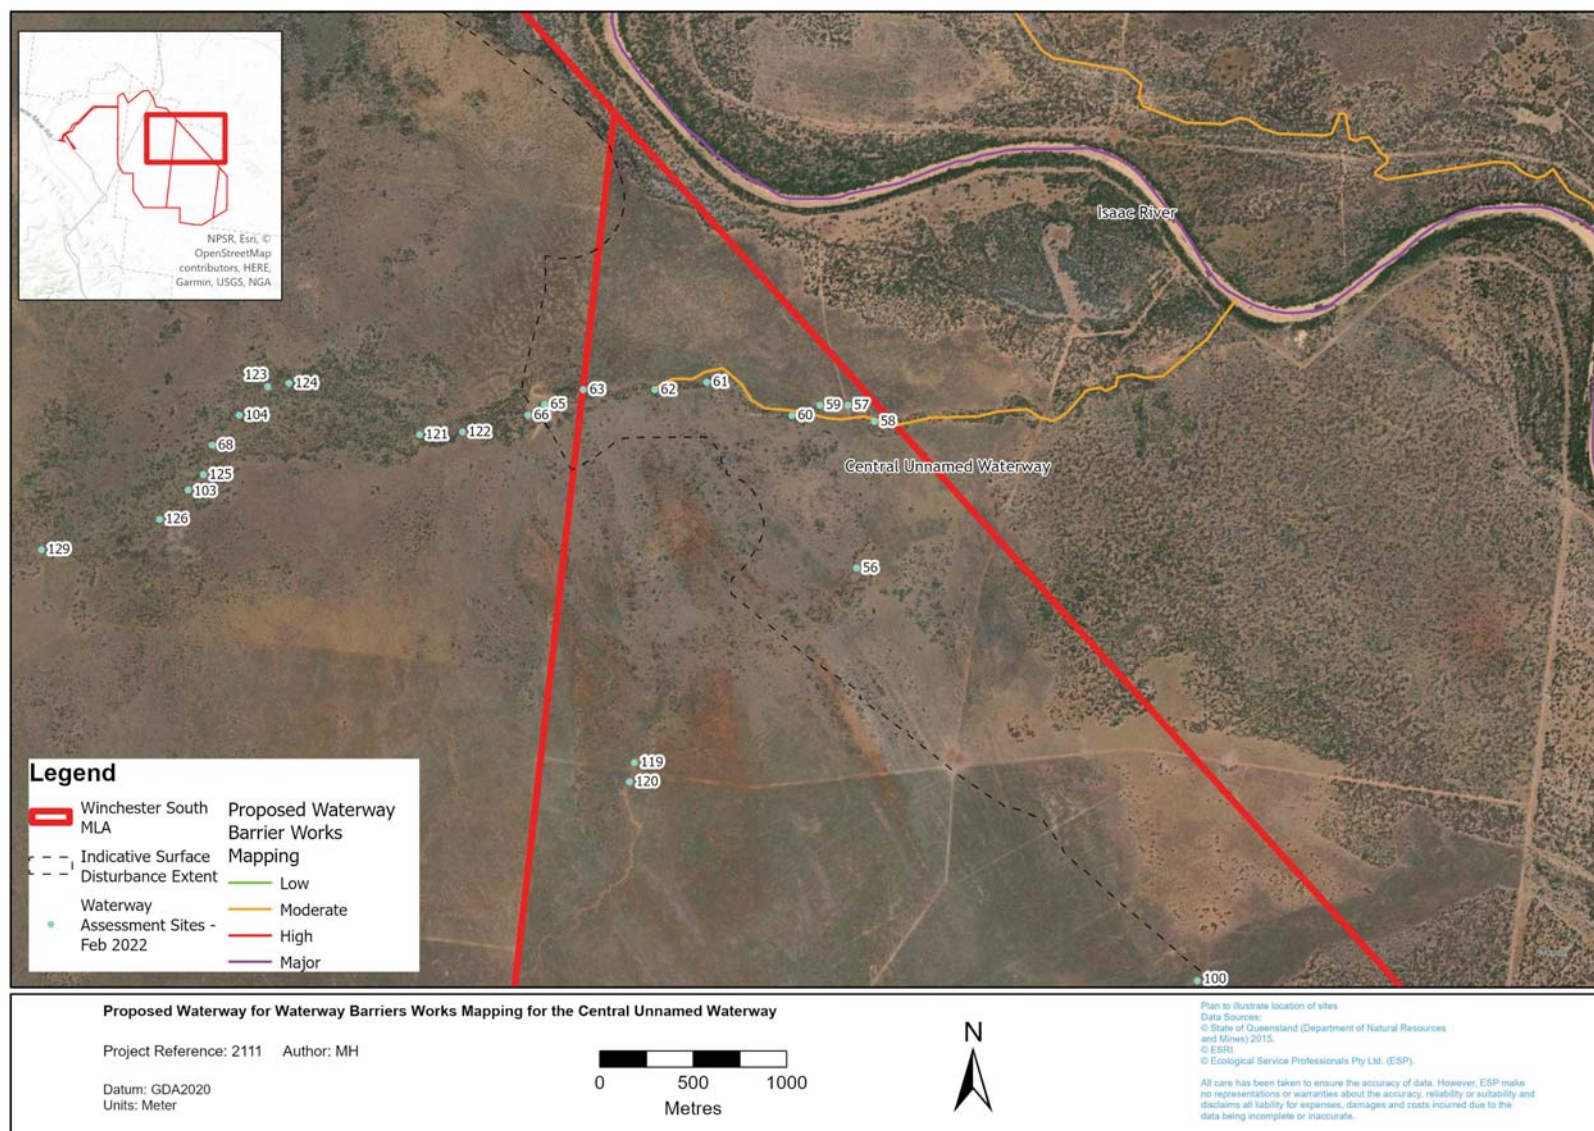
Figure 3.6 Proposed mapping change to the WWBW mapping for the central unnamed waterway

The central unnamed waterway contained 3.54 km of waterway providing for fish passage, with 1.37 km (constituting 2.12 ha) within the boundary of the Winchester South MLA; however, the waterway does not extend into the proposed surface disturbance extent. As such, for the purposes of this Project, it is not a waterway providing for fish passage MSES as defined under the EO Regulation.

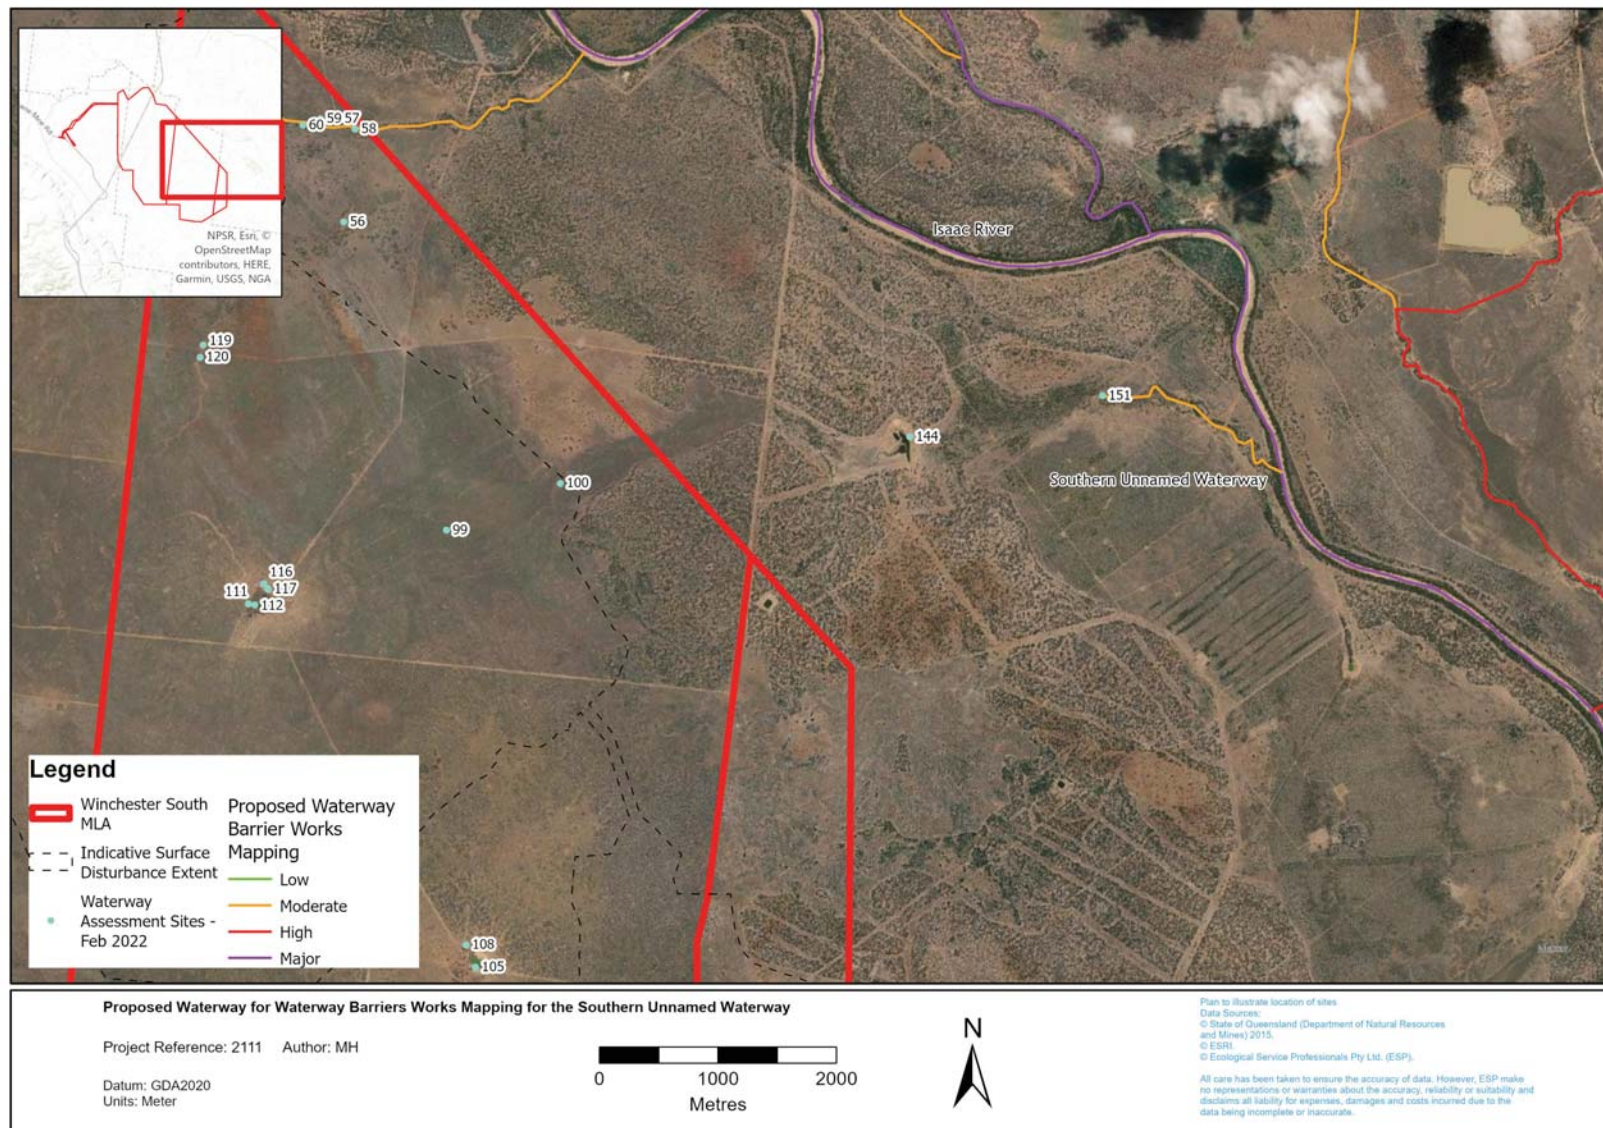
Figure 3.7 Proposed mapping change to the WWBW mapping for the southern unnamed waterway

The southern unnamed waterway, upstream from Site 151, lacks the features of a waterway providing for fish passage. Downstream of Site 151 (which is downstream of the proposed surface disturbance extent), the waterway exhibits the qualities of a waterway, as defined by DAF (2022). However, as this is a drainage feature under the Water Act, it is not a waterway providing for fish passage MSES as defined under the EO Regulation.

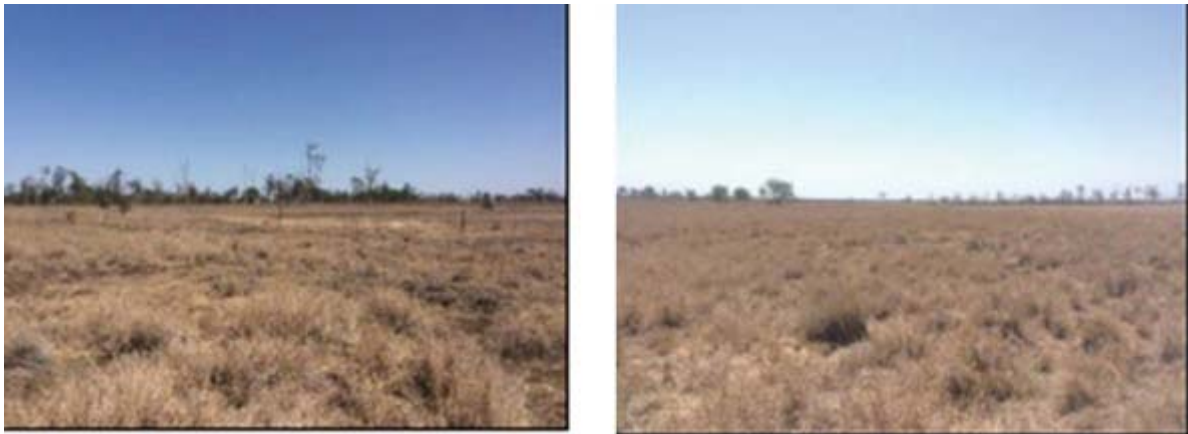
Figure 6.1 Site U3a (Photos from EIS; ESP 2021)

Site U3a is a drainage depression (Figure 6.1). There are no defined bed or banks, or any other waterway features. There is no visible standing water. The depression appears to be a drainage feature that funnels immediate localised rainfall and would not likely provide flow beyond the duration of a rain event.

The lack of defined bed and banks, in combination with insufficient water availability to sustain basic ecological processes and habitats, and the lack of riparian vegetation, suggest this reach of the mapped feature is not a waterway providing for fish passage.

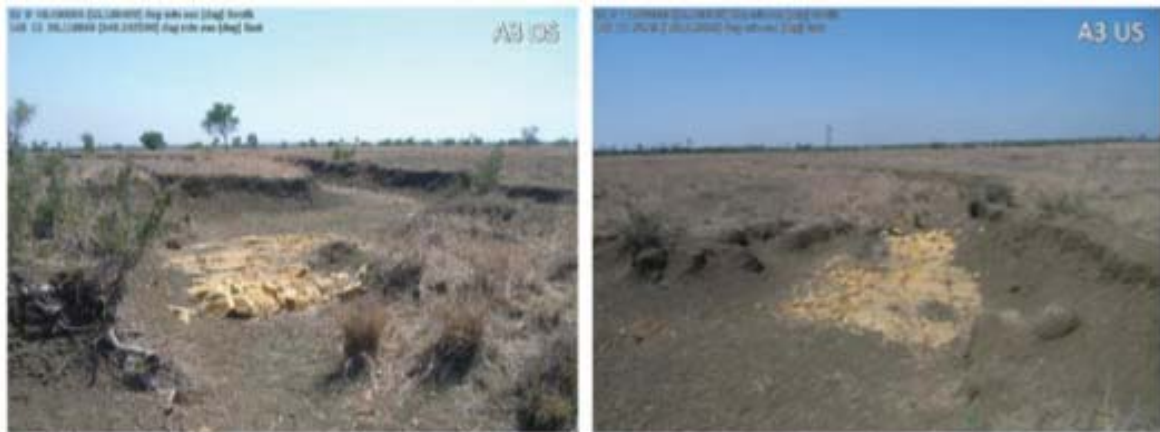
Figure 6.4 Site A3 (from Geomorphology Assessment; Fluvial Systems 2020)

Site A3 appears to be an eroded drainage feature (Figure 6.4). There is no evidence of previous standing water and no aquatic plants visible. The feature appears to funnel immediate localised rainfall and would not likely provide adequate flow beyond the duration of a rain event. This section of the waterway does not appear to provide fish habitat or for fish passage.

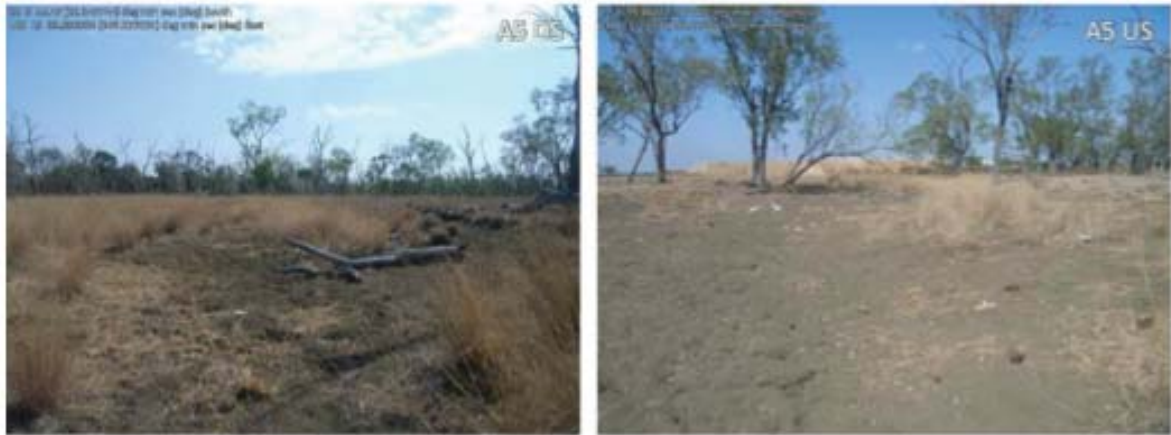
Figure 6.6 Site A5 (from Geomorphology Assessment; Fluvial Systems 2020)

at Site A5 and immediately upstream at Site A3, suggesting this section of the waterway does not provide for fish passage.

Due to the lack of a channel with defined bed and banks, no riparian vegetation, lack of fish habitat or passage opportunities, Site A5 is not considered a waterway providing for fish passage.

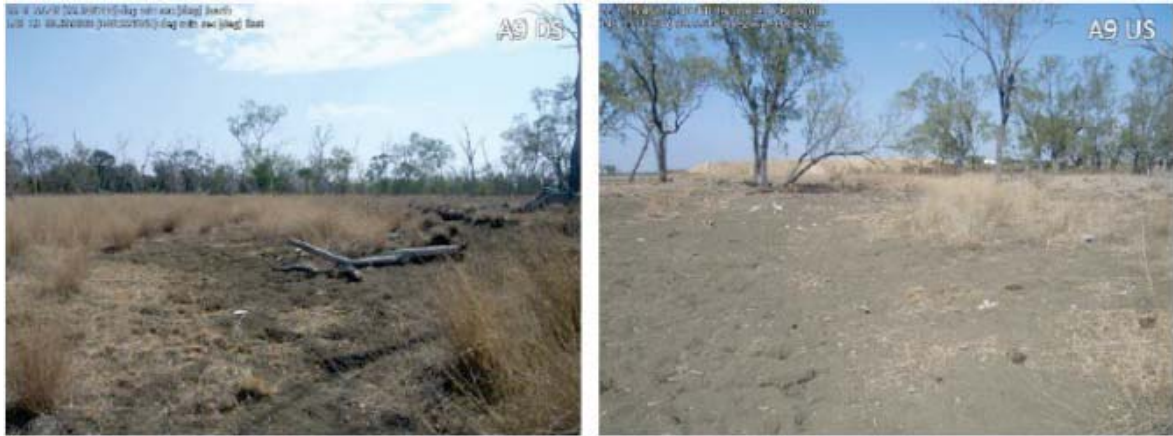
Figure 6.8 Site A9 (from Geomorphology Assessment; Fluvial Systems 2020)

Site A9 appears to be a drainage feature lacking the features of a waterway providing for fish passage (Figure 6.8). The drainage feature is flat, with no defined bed and banks. Terrestrial vegetation can be seen growing across the feature. This section of the mapped waterway would not provide adequate flow beyond an immediate rainfall event. There are no fish habitat or fish passage opportunities at this site, or at sites further upstream.

Due to the lack of a channel with defined bed and banks, no riparian vegetation, and a lack of fish habitat and connectivity for fish passage, Site A9 is not considered a waterway providing for fish passage.

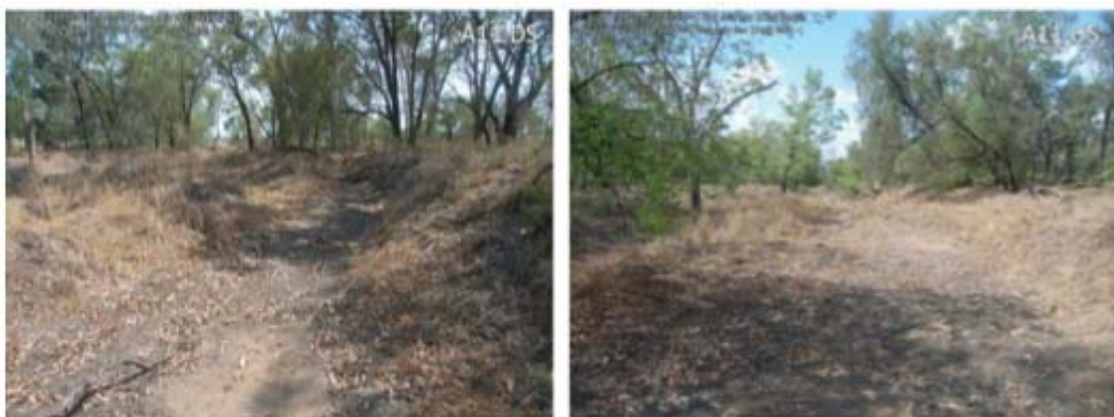
Figure 6.12 Site A11 (from Geomorphology Assessment; Fluvial Systems 2020)

This section of the waterway appears as a wide, deep channel that may provide fish passage opportunities during periods of flow from upstream catchments (Figure 6.12). There appears to be a defined bed and banks at both sites. It is a waterway providing for fish passage.

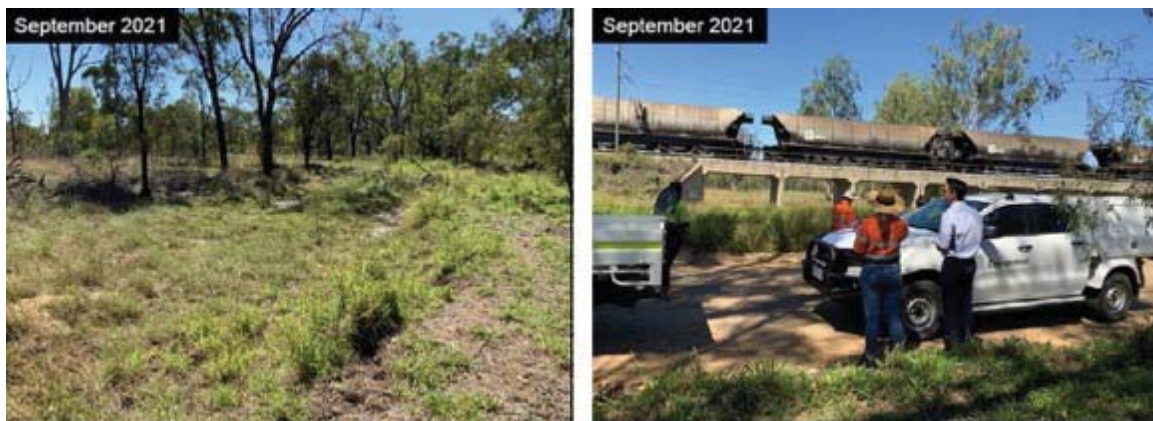
Figure 6.13 Site 2 and Site 3 (from site inspections; Whitehaven Coal 2021)

Our assessment of Sites 2 and 3 found the sites appear to be located in the vicinity of a rail bridge crossing, immediately downstream from Site A11 (Figure 6.13). The feature at Site 2 appears to be a wide flat channel, with a low bank. Terrestrial vegetation is growing across the feature.

The images of these sites do not allow for an adequate assessment to determine if these sites are a waterway providing for fish passage. However, our assessments of sites upstream and downstream of Site 2 and 3 in February 2022 found this section of the mapped waterway met the DAF requirements to be classified as a waterway providing for fish passage (see Appendix B).

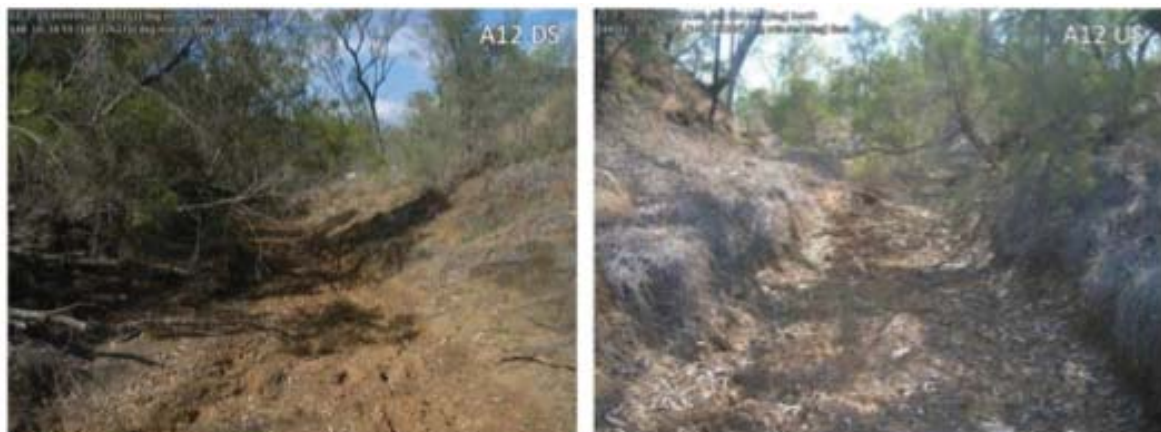
Figure 6.14 Site A12 (from Geomorphology Assessment; Fluvial Systems 2020)

This section of the waterway appears as a deep channel that may provide fish passage opportunities during periods of flow from upstream catchments (Figure 6.14). There appears to be a defined bed and banks with overhanging vegetation, offering habitat opportunities during periods of flow. It is therefore a waterway providing for fish passage.

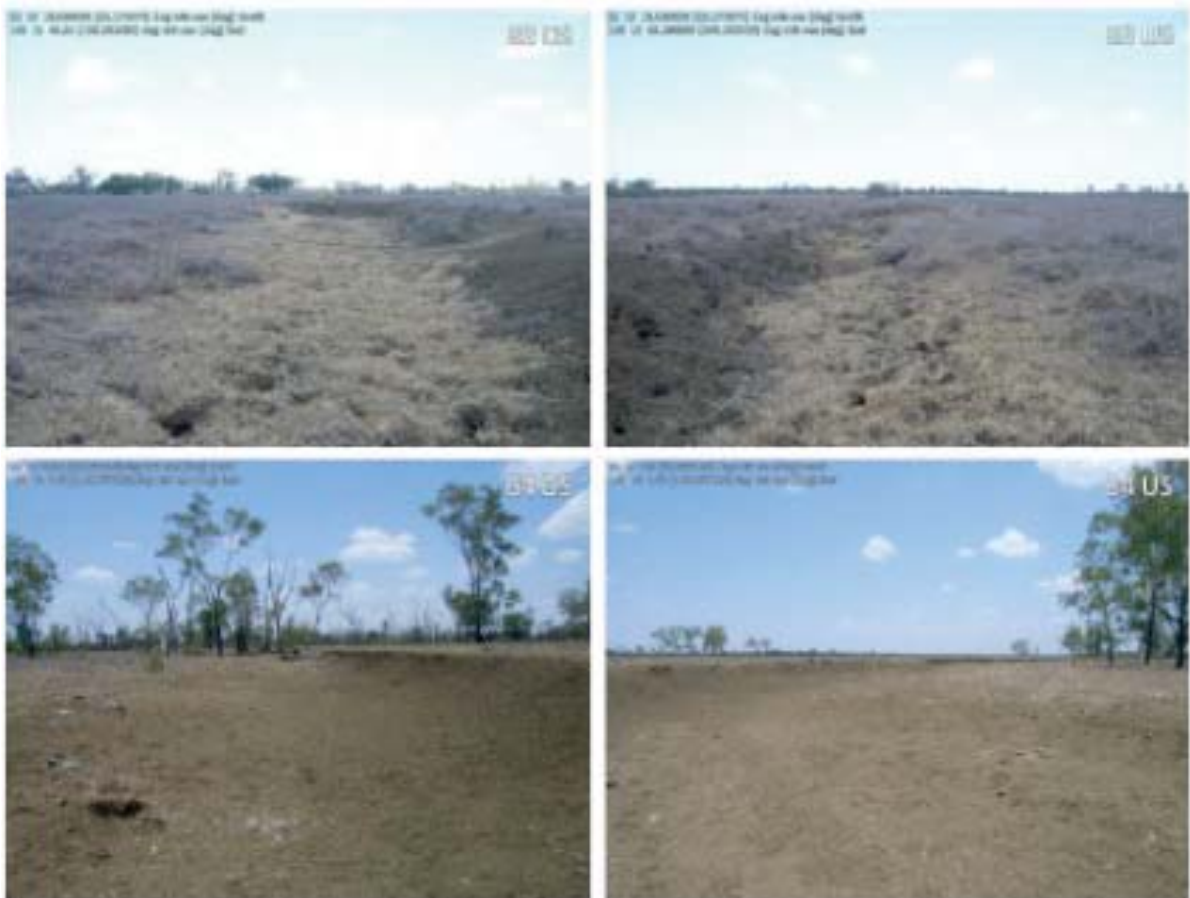
Figure 6.24 Sites B3 and B4 (Photos from Geomorphology Assessment; Fluvial Systems 2020)

Sites B3 and B4 are drainage depressions or gullies and lack features of a waterway providing for fish passage (Figure 6.24). These sites do not have a defined bed and banks, and do not appear that they would provide adequate flow other than in times of localised rainfall. There appears to be some erosion along the edges of some drainage channels; however, this is likely from short high velocity flows during periods of high localised rainfall.

The mapped feature at Sites B3 and B4 did not exhibit any of the qualities of a waterway as defined by DAF, and as such, is not considered a waterway providing for fish passage.

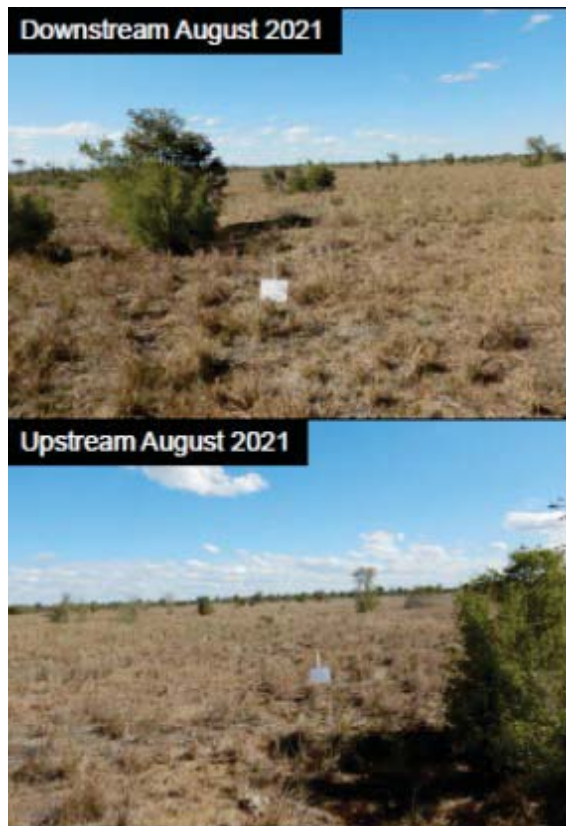
Figure 6.29 Site D2 (Photos from site inspections; Whitehaven Coal 2021)

Site D2 is a drainage feature / overland flow path (Figure 6.29). The drainage feature does not provide fish passage or habitat opportunities and does not appear to have defined bed and banks. This section of the mapped feature would not provide adequate flow beyond an immediate rainfall event. Terrestrial vegetation can be seen growing across the feature.

Due to the lack of a channel with defined bed and banks, no riparian vegetation, and a lack of fish habitat and connectivity for fish passage, Site D2 is not considered a waterway providing for fish passage.

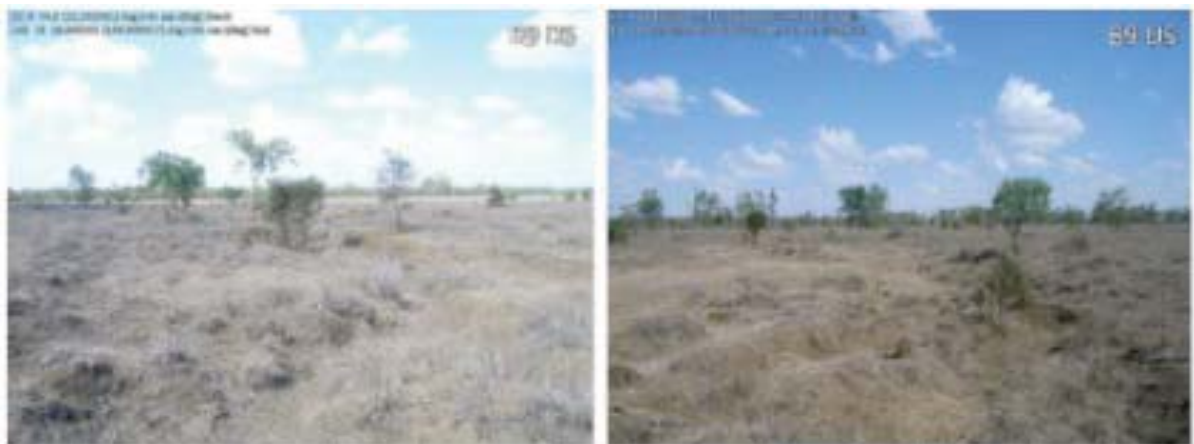
Figure 6.31 Site B9, showing upstream and downstream of the assessment site (Photos from Geomorphology Assessment; Fluvial Systems 2020)

Site B9 is a drainage depression (Figure 6.31). The depression does not have a continuously defined bed and banks, and would not provide adequate flow beyond an immediate rainfall event. The drainage feature does not provide fish passage or habitat opportunities, and lacks the features of a waterway providing for fish passage. Terrestrial vegetation, particularly grasses, can be seen growing across the depression.

The mapped feature at Site B9 does not exhibit any of the qualities of a waterway as defined by DAF, and as such, is not considered a waterway providing for fish passage.

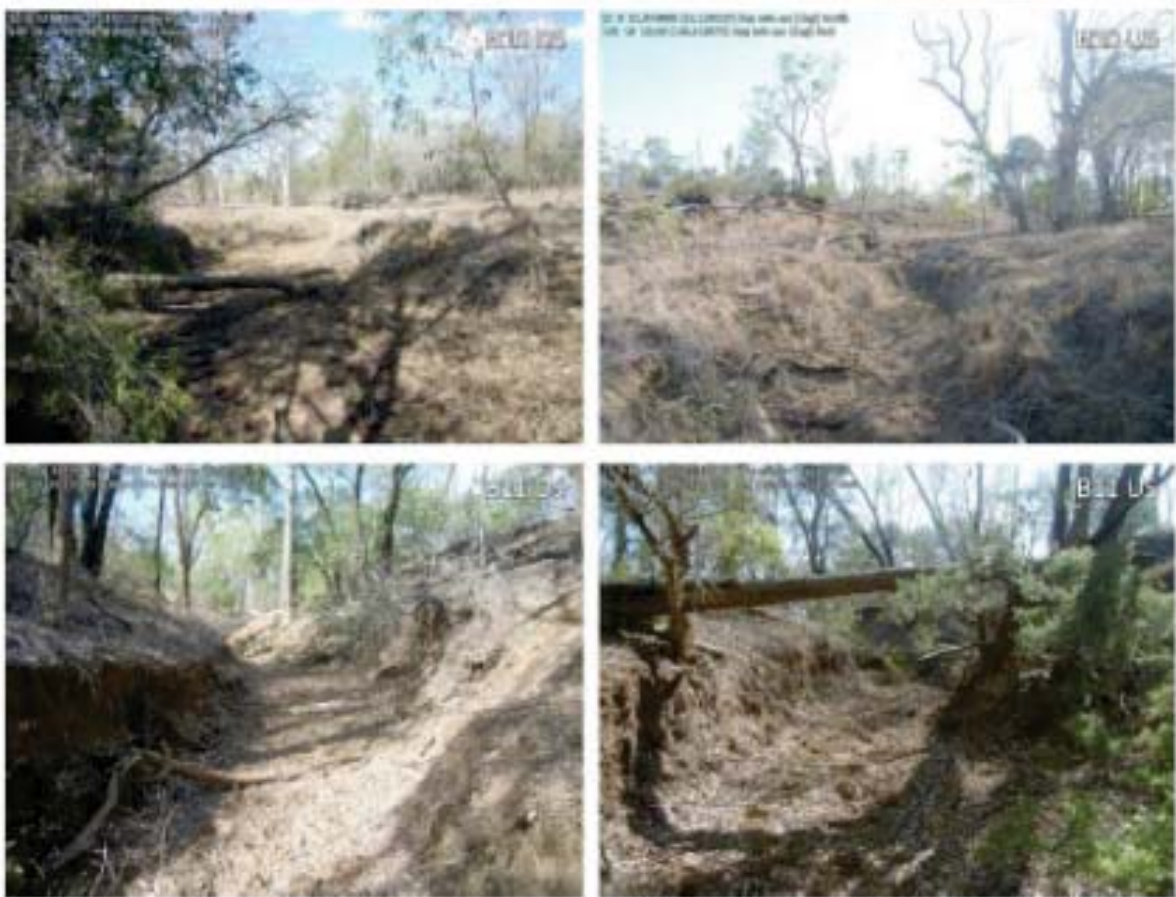
Figure 6.32 Sites B10 and B11 (Photos from Geomorphology Assessment; Fluvial Systems 2020)

This section of the waterway appears as a wide, deep channel that may provide fish passage opportunities during periods of flow from upstream catchments (Figure 6.32). There appears to be a defined bed and banks at both sites. However, the channel is narrow with high banks,

suggesting flow velocity may be high and may not provide adequate flow beyond an immediate rainfall event.

The mapped feature at Sites B10 and B11 exhibits some qualities of a waterway as defined by DAF, and may be considered a waterway providing for fish passage.

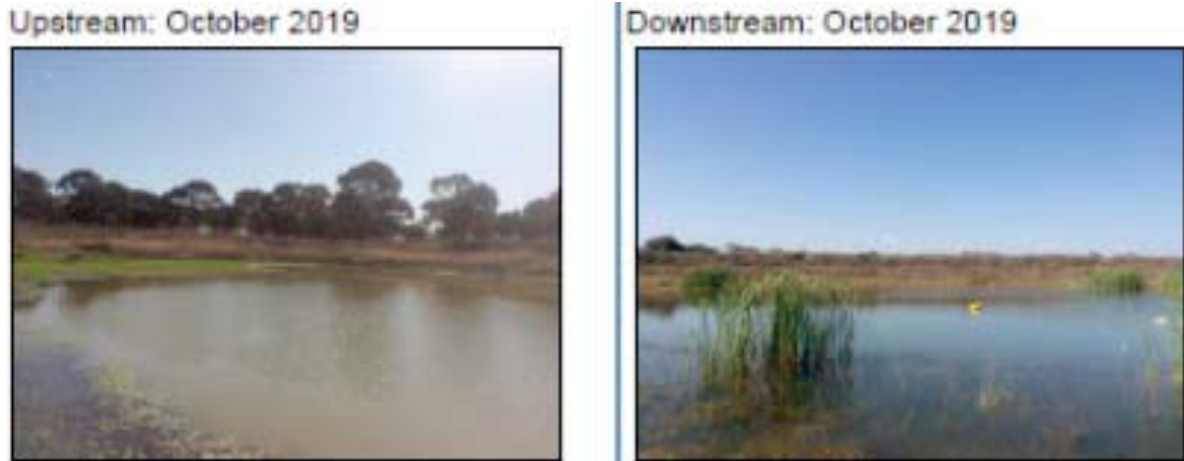
Figure 6.33 Site FD4, constructed dam (Photos from EIS; ESP 2021)

Site FD4 is a large, constructed dam (Figure 6.33). Dam walls are approximately 5 m in height. Aquatic vegetation is growing within the dam, providing fish habitat opportunities. Fish have been captured during previous fish surveys at this site (see Section 3.2.1 for details). However, the steep, high dam walls act as a barrier to fish passage and prevent connectivity to upstream and downstream reaches.

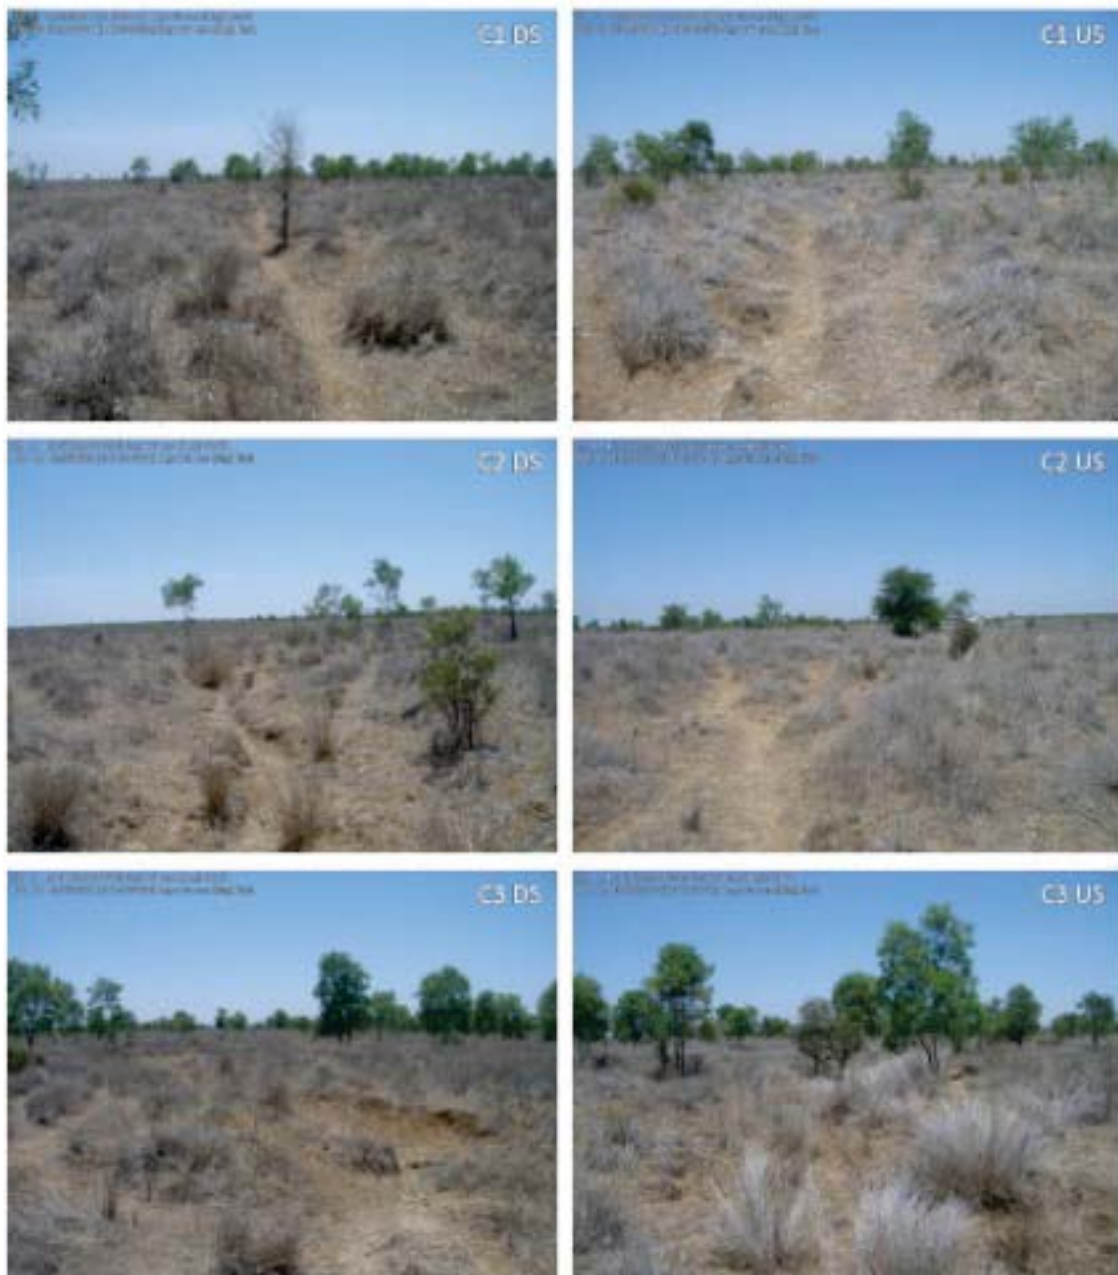
Figure 6.34 Sites C1, C2, C3 (Photos from Geomorphology Assessment; Fluvial Systems 2020)

Our assessment found Sites C1 through to C5 appear to be a drainage depression that lack the features of a waterway providing for fish passage (Figure 6.34 and Figure 6.35). There are no continuous defined bed and banks, and the feature appears to be broken sections of a drainage line. These sites do not appear that they would provide adequate flow beyond an immediate rainfall event. There are no fish habitat or fish passage opportunities.

The mapped feature from Site C1 through to Site C5 do not exhibit any of the qualities of a waterway as defined by DAF, and as such, is not considered a waterway providing for fish passage.

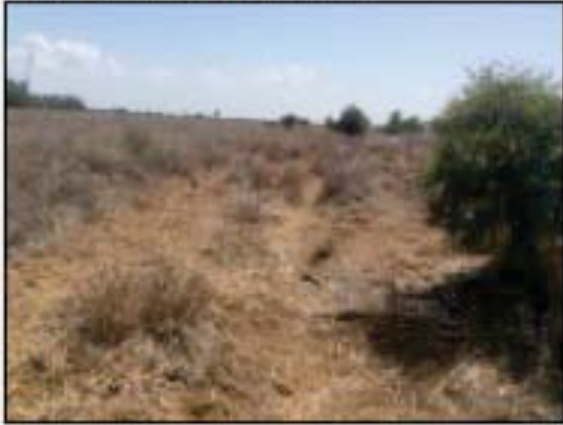
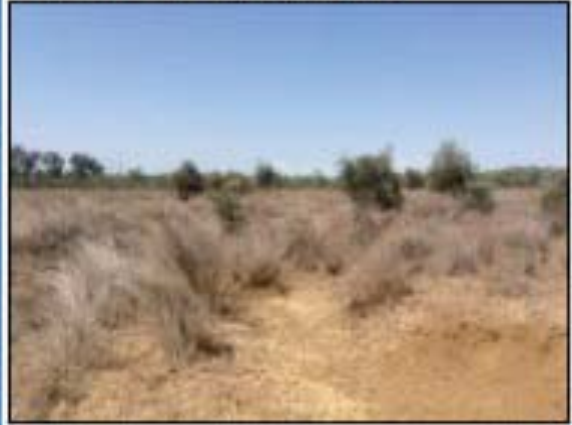
Figure 6.36 Site U5, showing upstream and downstream in October 2019 (Photos from EIS; ESP 2021)

Site U5 is a drainage depression, immediately downstream from Site C6. The drainage depression does not have defined bed or banks and appears that the mapped feature would not provide adequate flow beyond an immediate rainfall event (Figure 6.36). The drainage depression at Site U5 is not a waterway providing habitat or fish passage opportunities.

Due to the lack of a channel with defined bed and banks, no riparian vegetation, and a lack of fish habitat and connectivity for fish passage, Site U5 is not considered a waterway providing for fish passage.

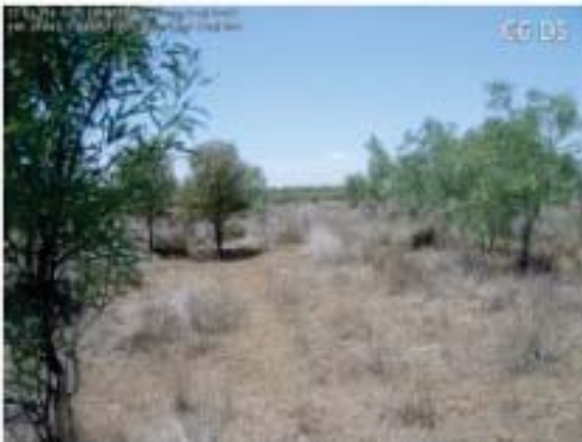
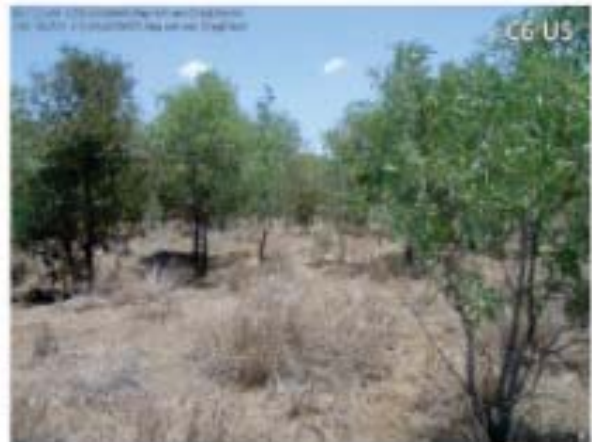
Figure 6.37 Site C6 (Photos from Geomorphology Assessment; Fluvial Systems 2020)

Site C6 (R18 in Olive Downs EIS) is a drainage depression that lacks the features of a waterway providing for fish passage. There are no defined bed and banks or suitable habitat features (Figure 6.37 and Figure 6.38).

The mapped feature does not exhibit any of the qualities of a waterway as defined by DAF, and as such, is not considered a waterway providing for fish passage.

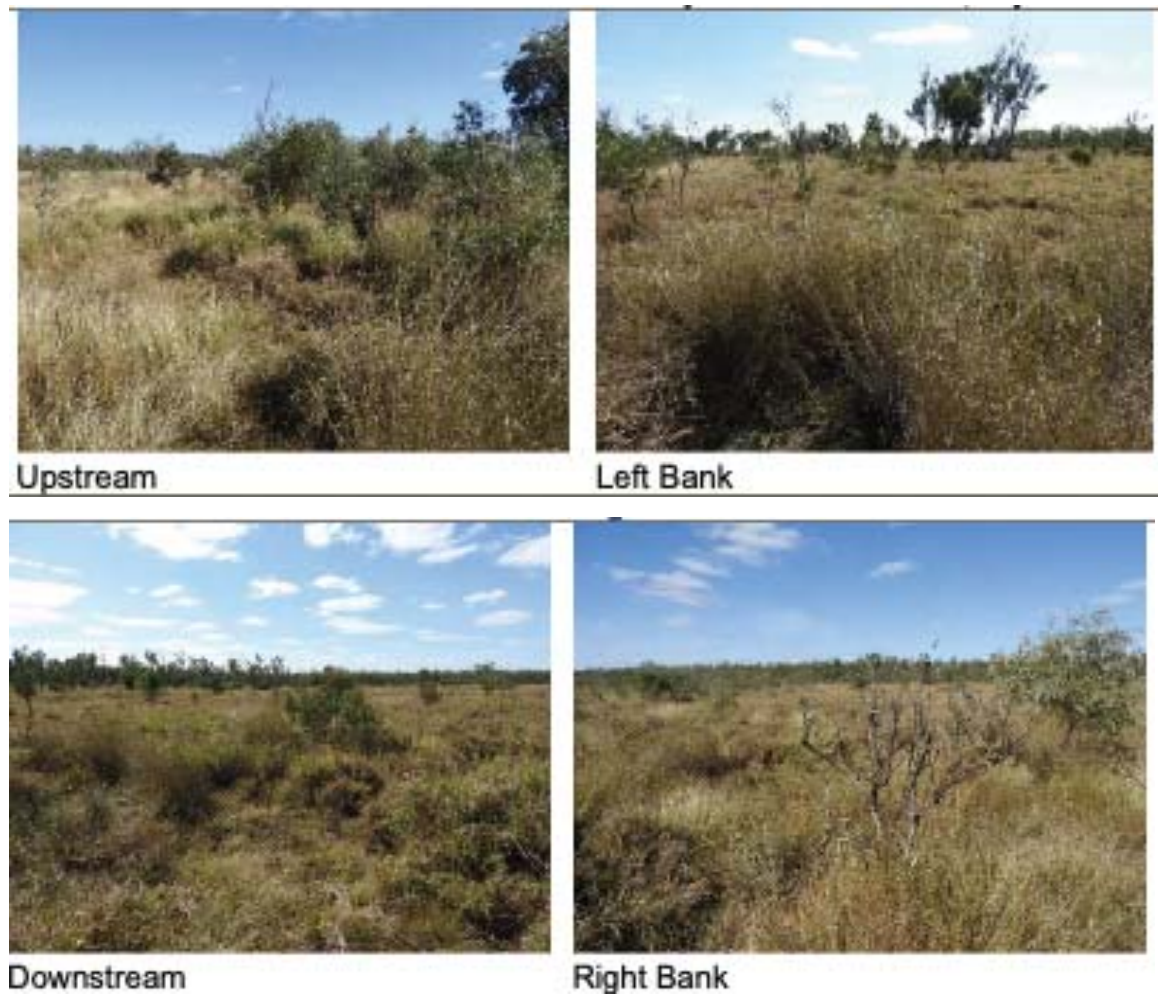
Figure 6.39 Site R20 (Photos from Olive Downs EIS, DPM Envirosiences 2018)

Site R20 is an ephemeral drainage line that lacks the features of a waterway providing for fish passage. There are no defined bed and banks or suitable habitat features (Figure 6.39).

The mapped feature does not exhibit any of the qualities of a waterway as defined by DAF, and as such, is not considered a waterway providing for fish passage.

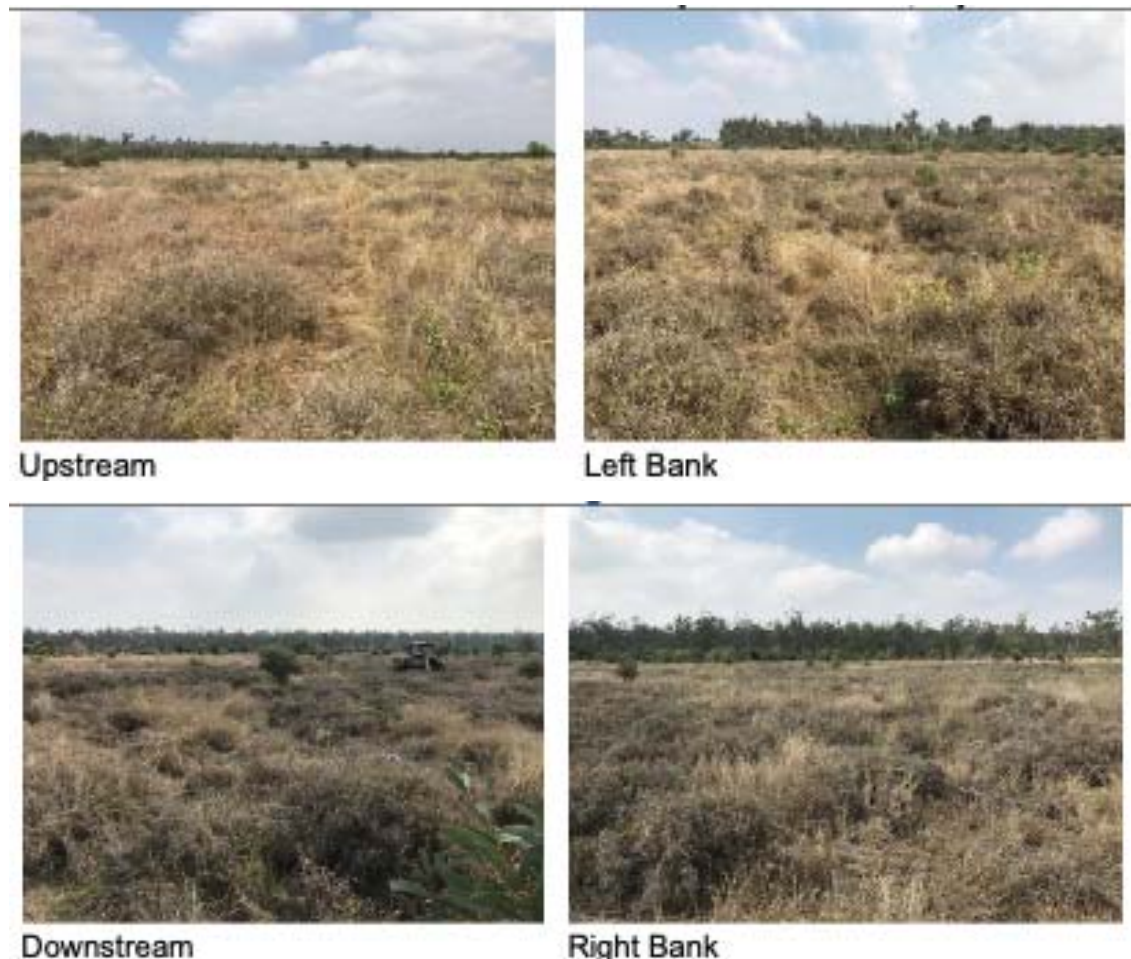
Figure 6.40 Site R22 (Photos from Olive Downs EIS, DPM Envirosiences 2018)

Site R22 is an ephemeral drainage depression that lacks the features of a waterway providing for fish passage. There are no defined bed and banks or suitable habitat features (Figure 6.40).

The mapped feature does not exhibit any of the qualities of a waterway as defined by DAF, and as such, is not considered a waterway providing for fish passage.

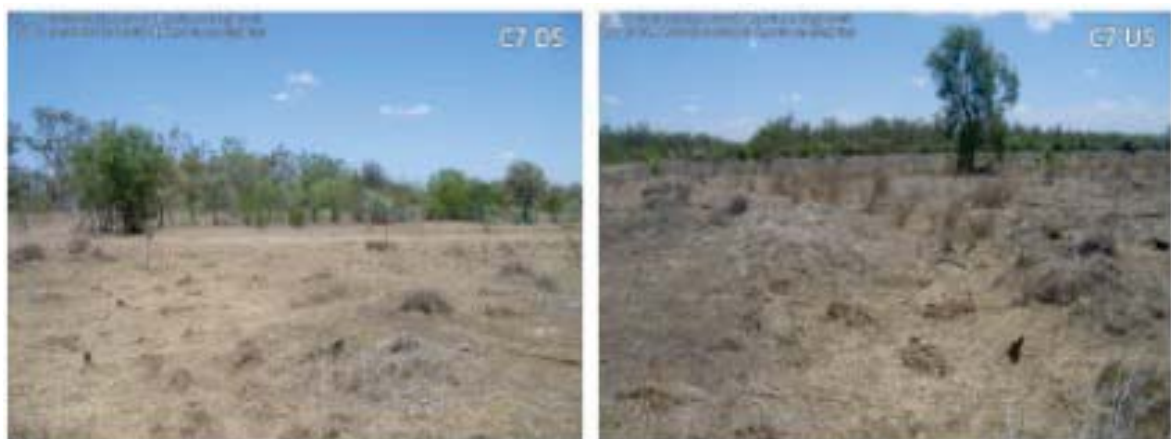
Figure 6.41 Site C7 (Photos from Geomorphology Assessment; Fluvial Systems 2020)

Site C7 is a drainage depression that lacks the features of a waterway providing for fish passage. There are no defined bed and banks or suitable habitat features (Figure 6.41).

Due to the lack of a channel with defined bed and banks, no riparian vegetation, and a lack of fish habitat and connectivity for fish passage, Site C7 is not considered a waterway providing for fish passage.

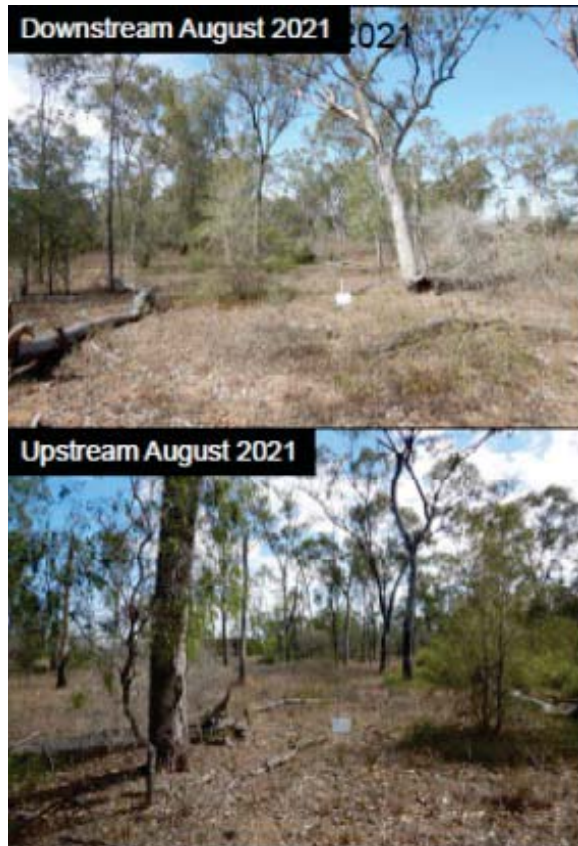
Figure 6.42 Site D6 (Photos from site inspections; Whitehaven Coal 2021)

Our assessment found Site D6 is a drainage corridor that lacks the features of a waterway providing for fish passage (Figure 6.42). There are no defined bed and banks or suitable habitat features.

The mapped feature does not exhibit any of the qualities of a waterway as defined by DAF, and as such, is not considered a waterway providing for fish passage.

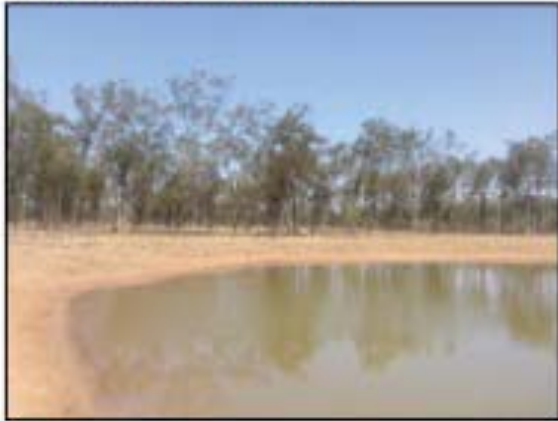
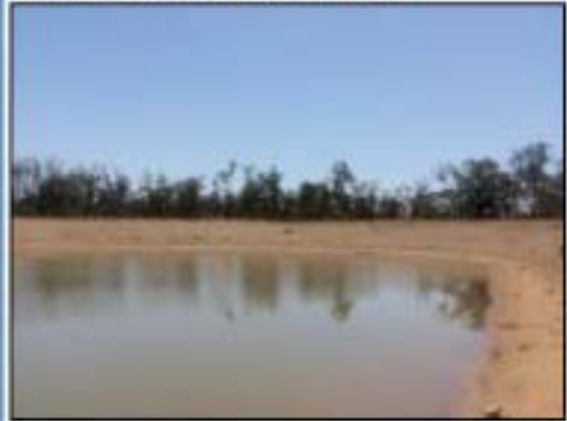
Figure 6.43 Site FD7, constructed dam, showing upstream and downstream in October 2019  
(Photos from EIS; ESP 2021)

Site FD7 is a large, constructed dam (Figure 6.43). The downstream side of the dam appears to have a moderately steep bank of approximately 3 m in height above the water level in the dam. Vegetation surrounding the dam appears to be terrestrial grasses with some shrubs and trees set further back from the dam edge.

While the dam may provide fish habitat opportunities, there is a lack of connectivity to suitable habitat upstream and particularly downstream due to the high dam wall.

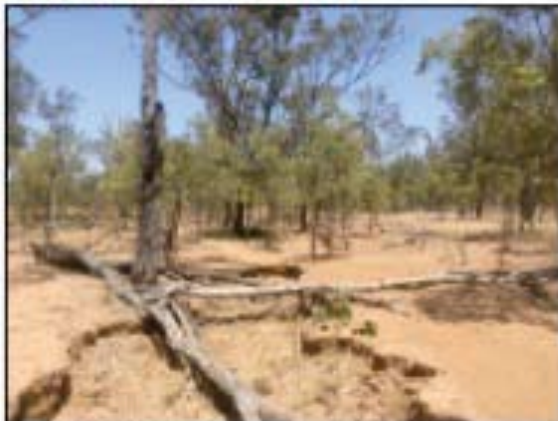
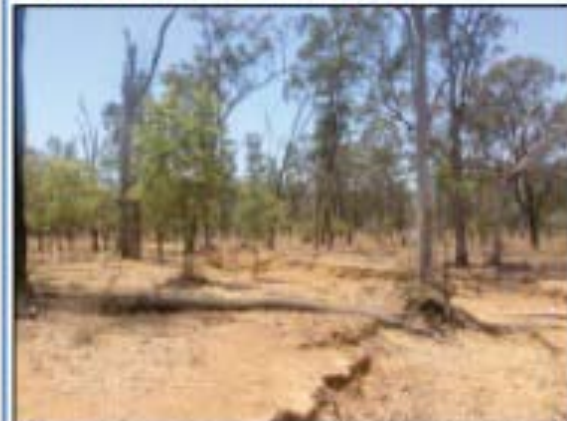
Figure 6.44 Site U6 (Photos from EIS; ESP 2021)

Site U6 is a drainage depression or gully that lacks the features of a waterway providing for fish passage (Figure 6.44). While there is some erosion along the edges of a broken gully, there is no continuous bed and banks, or suitable habitat features.

The mapped feature does not exhibit any of the qualities of a waterway as defined by DAF, and as such, is not considered a waterway providing for fish passage.
