## WINCHESTER SOUTH PROJECT

Environmental Impact Statement

# **Winchester South Project EIS**

## **Aquatic Ecology and Stygofauna, Additional Information**

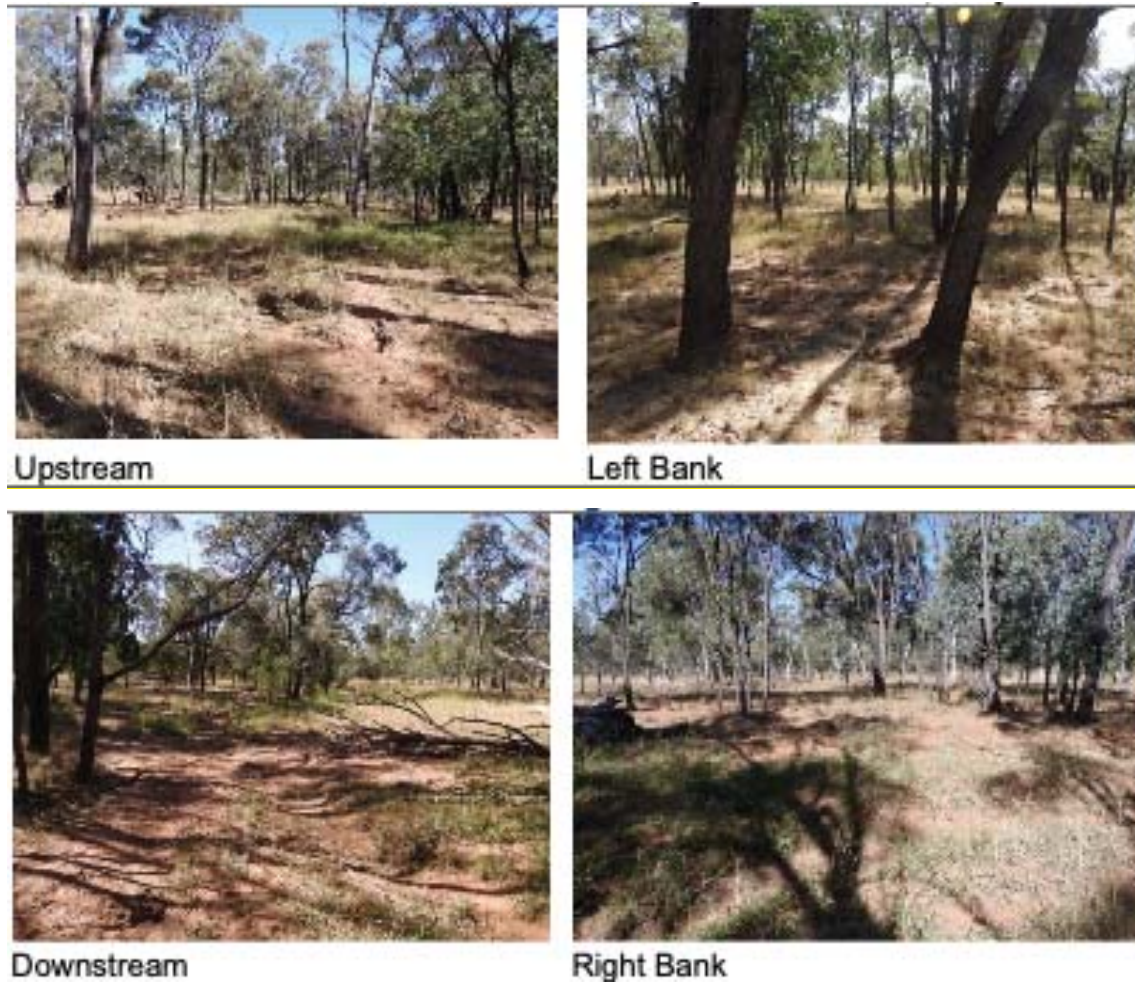
Figure 6.45 Site R15 (Photos from Olive Downs EIS, DPM Envirosiences 2018)

Site R15 is an ephemeral drainage line that lacks the features of a waterway providing for fish passage. There are no defined bed and banks or suitable habitat features (Figure 6.45).

The mapped feature does not exhibit any of the qualities of a waterway as defined by DAF, and as such, is not considered a waterway providing for fish passage.

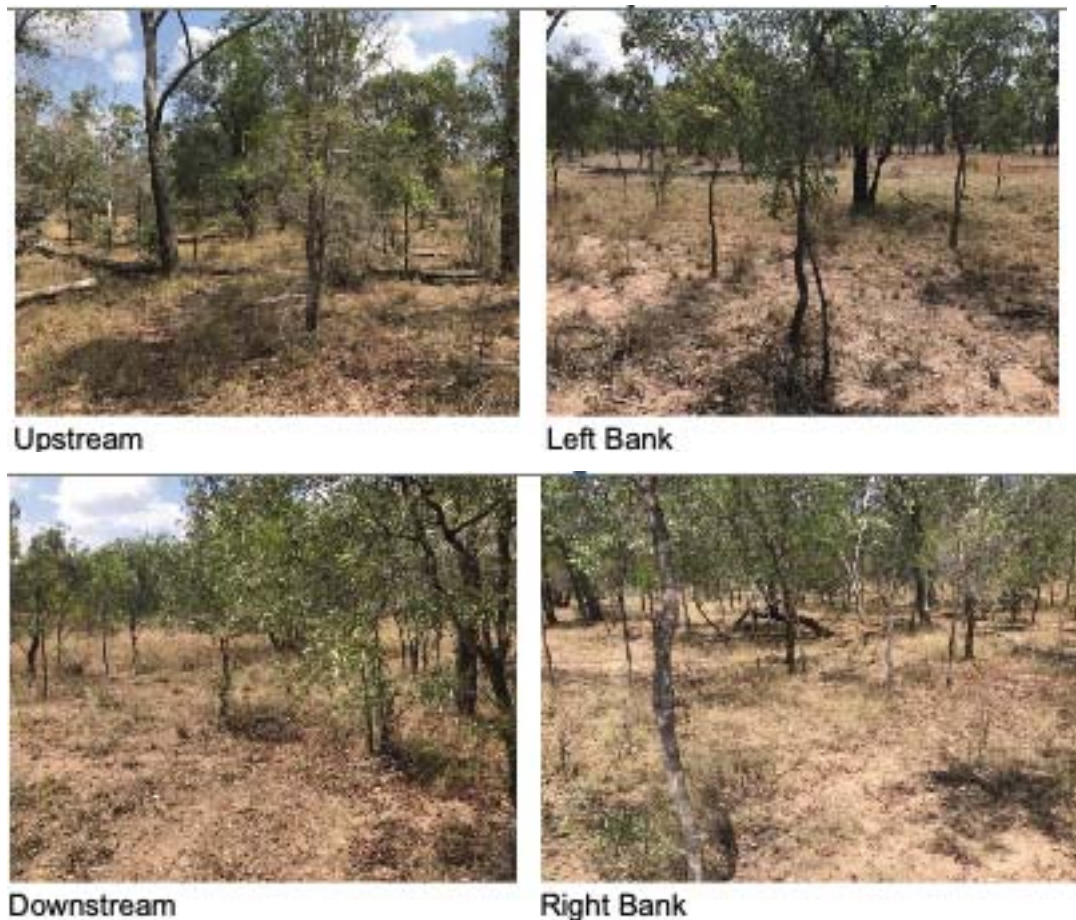
Figure 6.46 Site R21 (Photos from Olive Downs EIS, DPM Envirosiences 2018)

Site R21 is an ephemeral drainage line that lacks the features of a waterway providing for fish passage. There are no defined bed and banks or suitable habitat features (Figure 6.46).

The mapped feature does not exhibit any of the qualities of a waterway as defined by DAF, and as such, is not considered a waterway providing for fish passage.

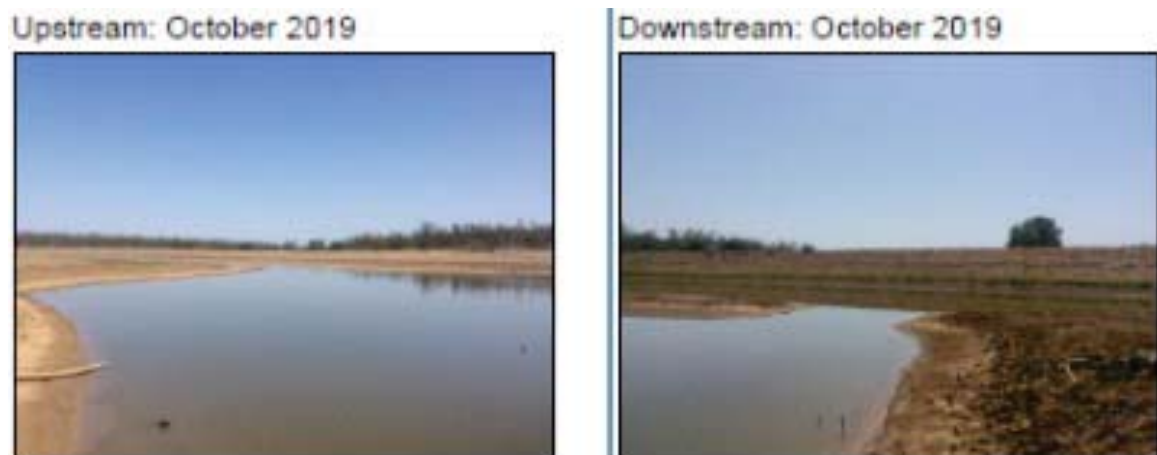
Figure 6.47 Site LW5, constructed dam, showing upstream and downstream in October 2019 (Photos from EIS; ESP 2021)

Site LW5 is a large, constructed dam (Figure 6.47). The dam walls are approximately 3 m in height, and act to restrict connectivity to upstream and downstream reaches. Aquatic plants are present in the dam. There is no riparian vegetation or shading, and a lack of habitat features. There appears to be no connectivity to upstream and downstream reaches.

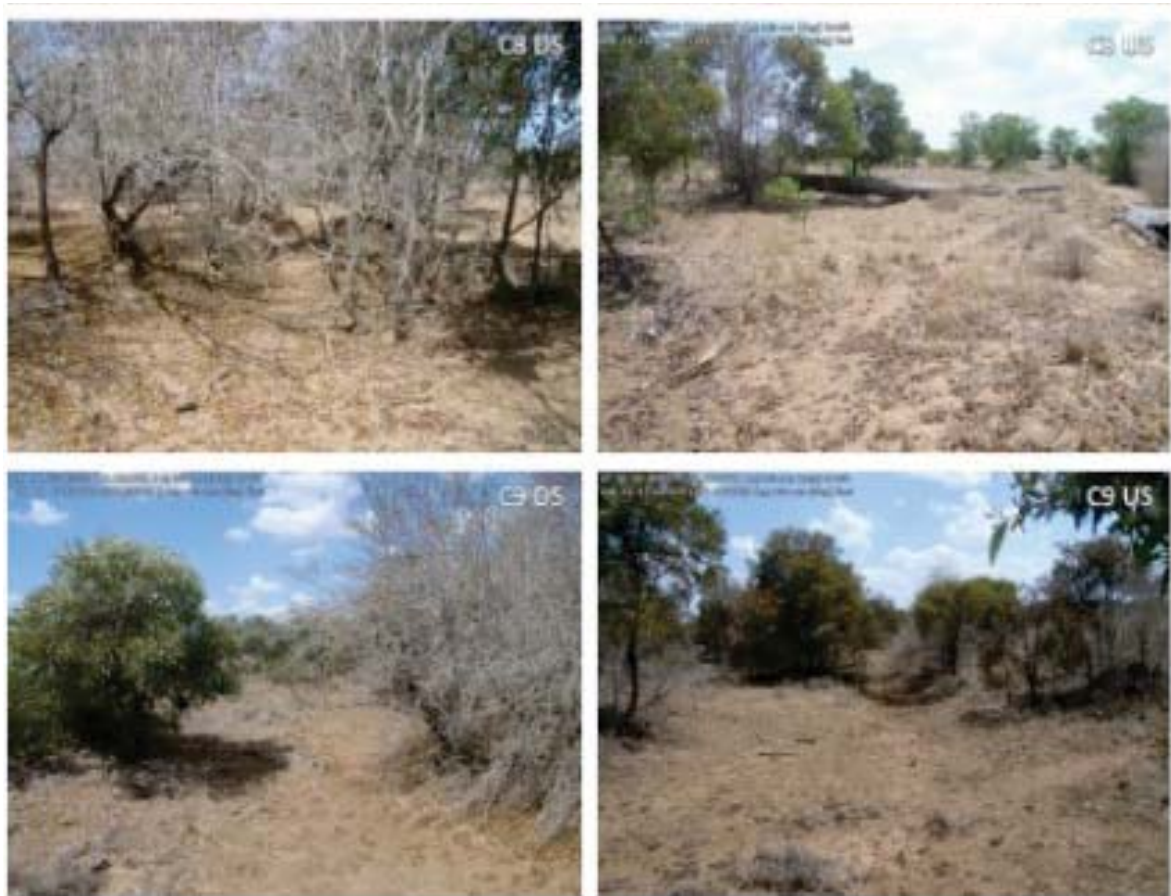
Figure 6.48 Sites C8 and C9 (Photos from Geomorphology Assessment; Fluvial Systems 2020)

Sites C8 through to C13 appear to be a drainage gully that lack the features of a waterway providing for fish passage (Figure 6.48, Figure 6.49 and Figure 6.50). These sites do not appear that they would provide adequate flow beyond an immediate rainfall event. There are no fish habitat or fish passage opportunities. The gully at Site C13 appears to narrow, deepen and become steeper, suggesting high velocity flow as it travels down a steep gradient toward the Isaac River.

The mapped feature from Site C8 through to Site C13 does not exhibit any of the qualities of a waterway as defined by DAF, and as such, is not considered a waterway providing for fish passage.

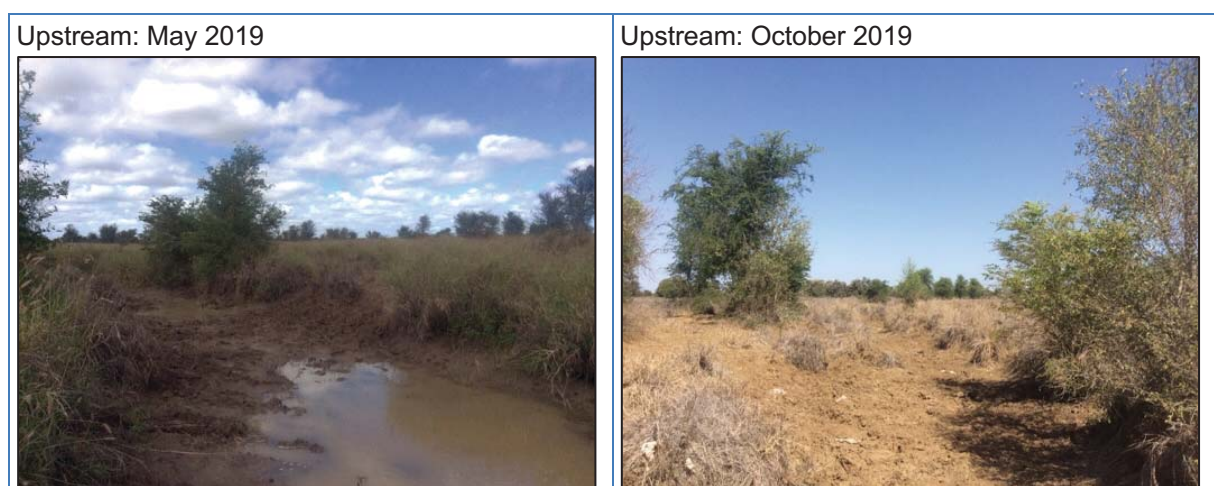
Figure 6.51 Site U4 (ESP 2021)

Our assessment found Site U4 is an unmapped drainage depression with highly eroded channel features (Figure 6.51). In October 2019 there was a small pool of water within the depression, about 2 m wide at its widest point. However, it appears that this pool was small and shallow and would not hold water for any length of time and that the water was only temporary; that is, it is likely to dry up within days without further rainfall.

While the upstream image from October 2019 does appear to show a defined bed and banks on the eroding outside bend of a channel, the image from May 2019 captures a larger area of the feature and indicates the channel is made up of broken sections of a drainage feature or gully.

Additionally, no fish or macrocrustaceans were captured at this site during fish surveys for the Draft EIS in May 2019 (the site was dry in October 2019) (ESP 2021; see Section 3.2.1 for fish survey details). This indicates a lack of connectivity to downstream fish habitat, and that the feature is not providing for fish passage.

Site U4 does not possess the features necessary to be considered a waterway providing fish passage.

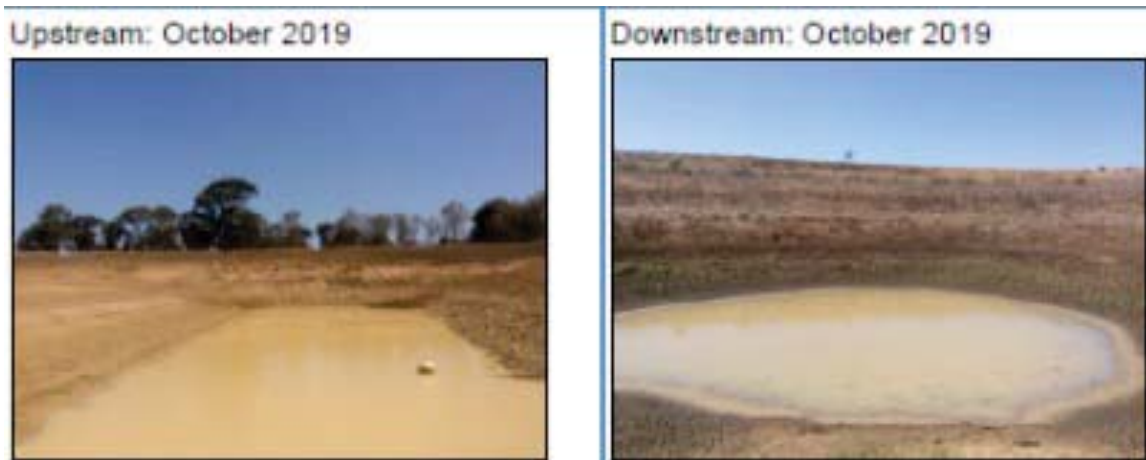
Figure 6.52 Site LW3, constructed dam (Photos from EIS; ESP 2021)

Site LW3 is a constructed 'turkey's nest' dam with 7 m high dam walls (Figure 6.52). The dam wall heights are a barrier to fish passage and restrict any possible fish movement from

downstream. The water is highly turbid. There is no riparian vegetation, no shading, and a lack of habitat features. There is no connectivity to upstream and downstream reaches. There is no evidence of a waterway providing for fish passage at this location.

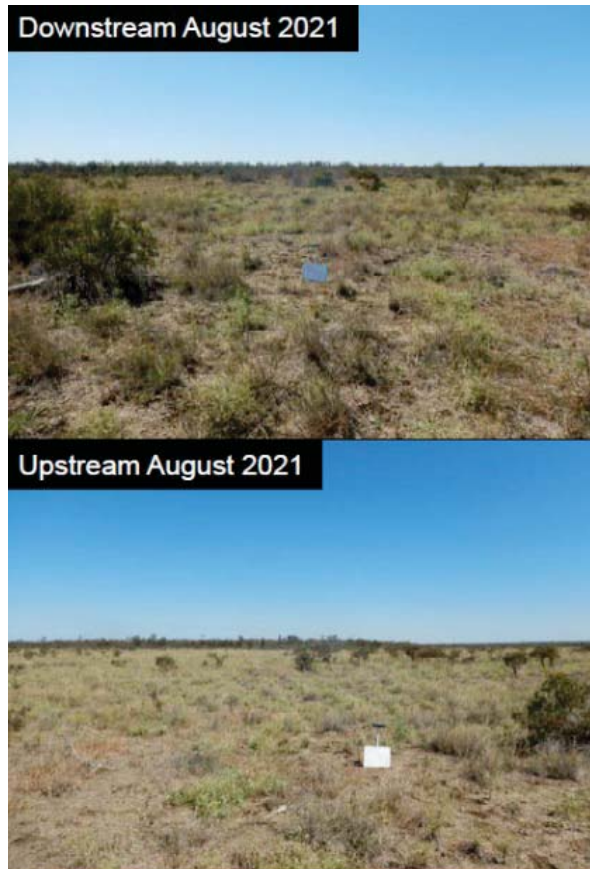
Figure 6.53 Site D4 (from site inspections; Whitehaven Coal 2021)

Due to the lack of a channel with continuously defined bed and banks, no riparian vegetation, and a lack of fish habitat and connectivity for fish passage, Site D4 is not considered a waterway providing for fish passage (Figure 6.53). This is consistent with the assessment by DAF.

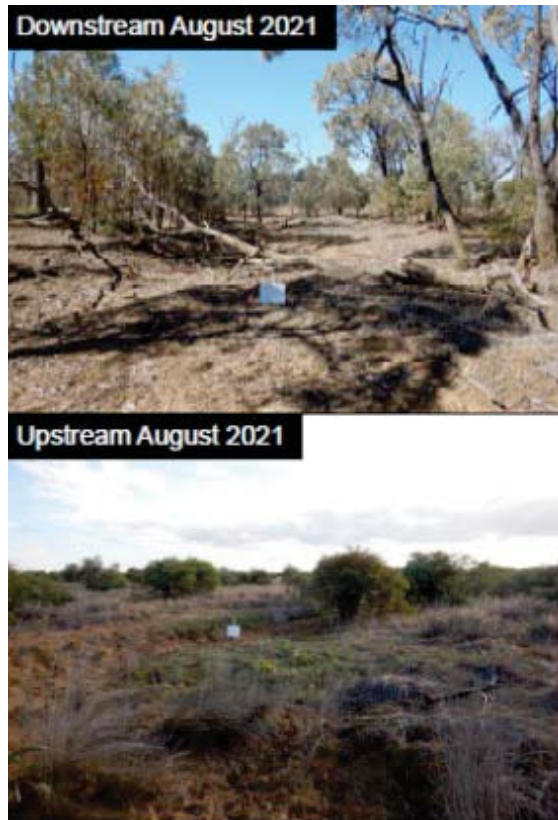
Figure 6.54 Site D7 (Photos from site inspections; Whitehaven Coal 2021)

Site D7 is an unmapped drainage feature. The feature appears to consist of broken sections of a depression that funnels water from localised rainfall events (Figure 6.54). It does not appear that the depression holds water for any length of time and that available water would be temporary; that is, it is likely to dry up within days without further rainfall.

The depression does not have continuous bed and banks, nor does it appear that it would provide adequate flow to provide for fish passage, or habitat opportunities.

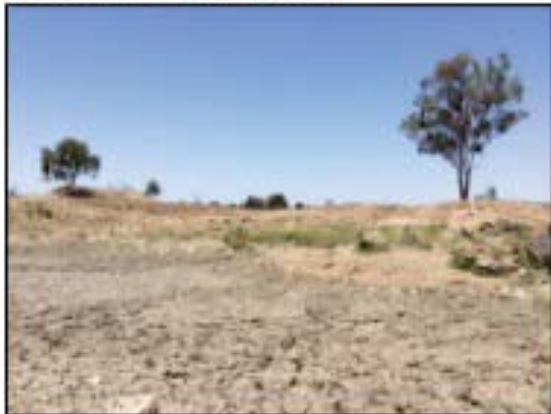
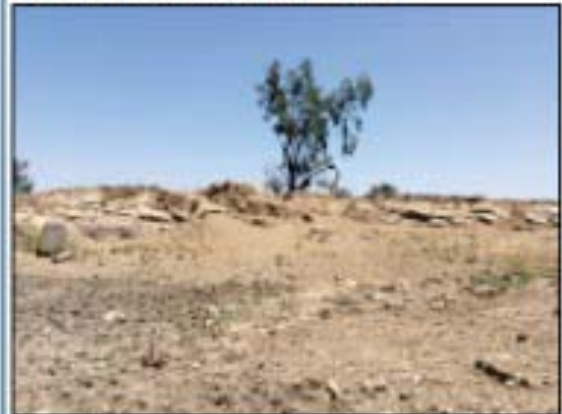
Figure 6.56 Site LW2 (Photos from EIS; ESP 2021)

Site LW2 is a dry constructed dam (Figure 6.56). There is no riparian vegetation and no shading. There does not appear to be any fish habitat.

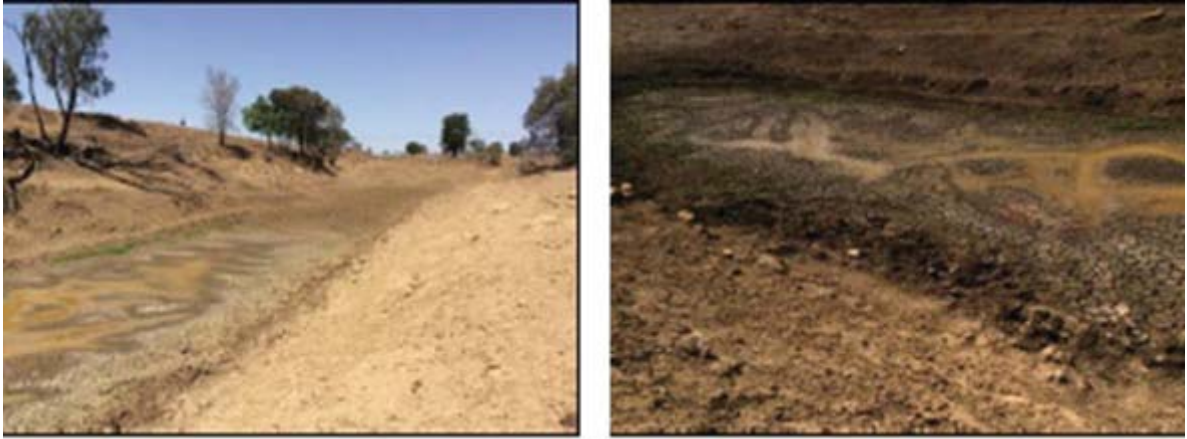
Figure 6.57 Aquatic habitat features at site LW7, showing a) upstream and b) downstream (Photos from EIS; ESP 2021)

Site LW7 appears to be a constructed dam (Figure 6.57). The dam has steep dam walls, approximately 8 m in height, which would act as a barrier to fish movement. There are no habitat features and no aquatic vegetation.

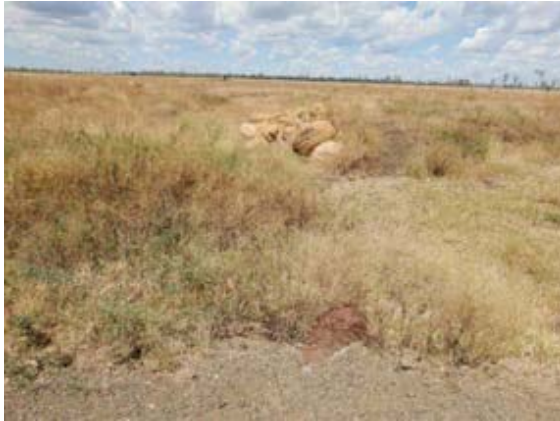
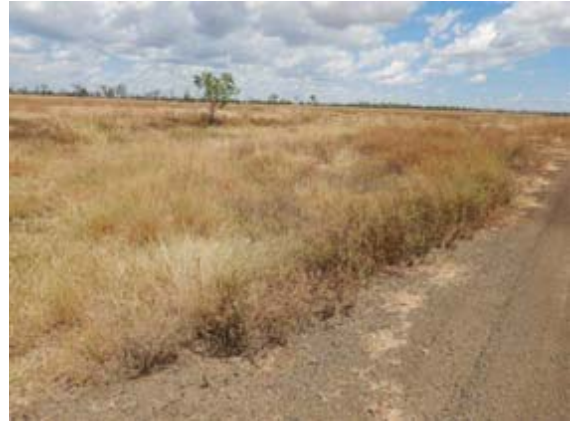
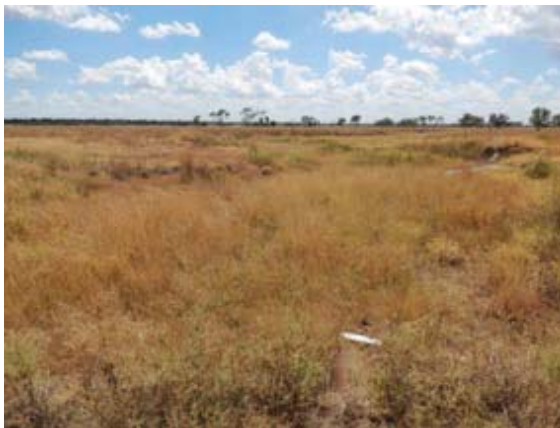
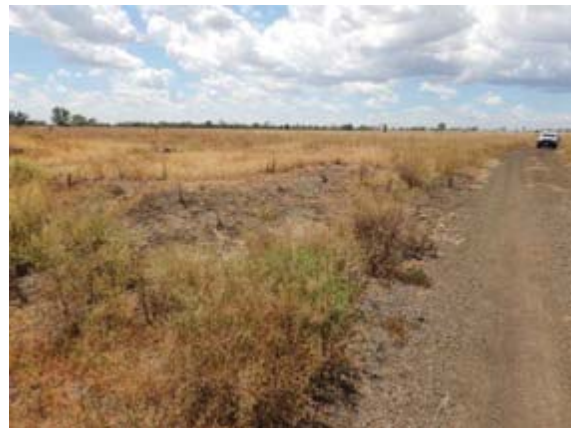
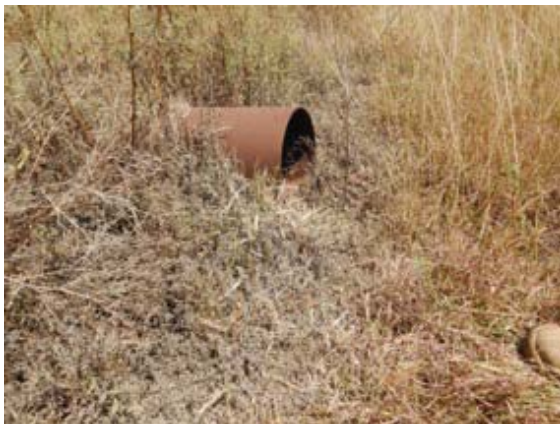
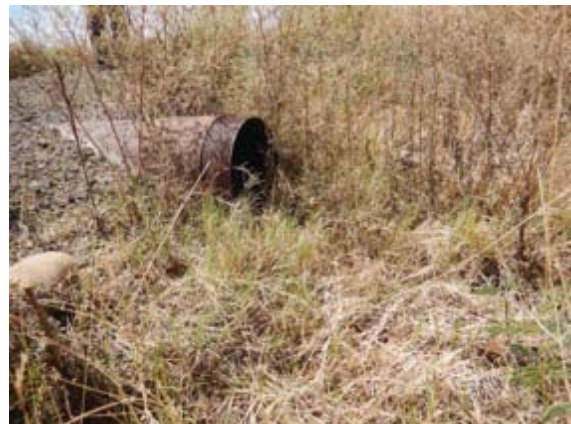
Figure 6.58 Site 79 (U3 in previous surveys) showing a) upstream, b) left bank, c) downstream, d) right bank, e) upstream culvert entrance, and f) downstream culvert entrance

Site 79 (U3 in previous assessments; see Appendix A) is a drainage gully passing through a dirt road. A pipe culvert (~40 cm diameter) passes under the road but does not start within or discharge to a channel with defined bed and banks. The upstream gully banks are broken and undulating with several flow paths converging at the culvert entrance. Rocks have been placed on the outside of the bed as an erosion control. Downstream of the culvert, eroding banks are on the outside of a bend from high velocity flows, likely during periods of localised heavy rainfall.

The drainage gully is not well formed and has likely been created during periods of heavy localised rain events (Figure 6.58). It does not appear that flows would persist for any extended period.

Due to the lack of a channel with defined bed and banks, no riparian vegetation, and a lack of fish habitat and connectivity for fish passage, Site 79 is not considered a waterway providing for fish passage.

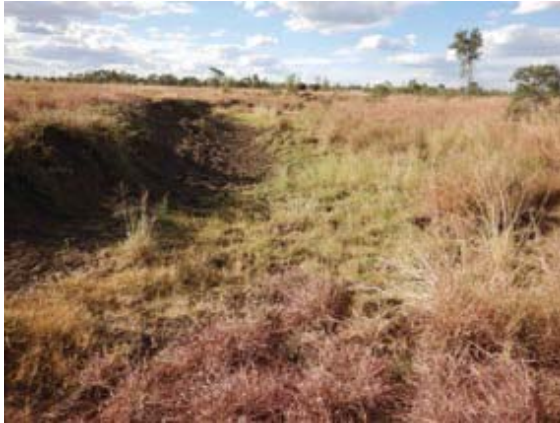
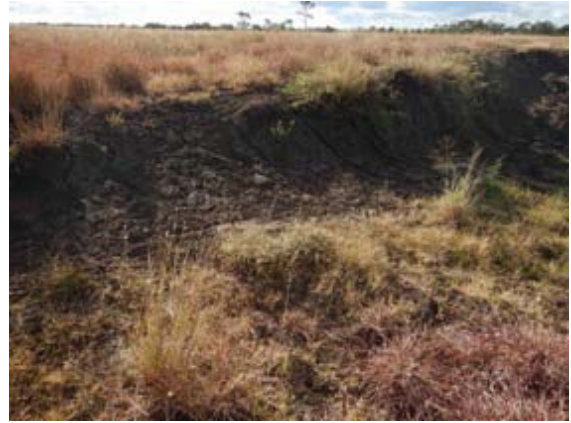
Figure 6.59 Site 166 showing a) upstream, b) left bank, c) downstream, d) right bank, and e) unconsolidated/cracking soils with no evidence of aquatic flora or fauna

Our assessment found Sites 166 and 165 are drainage depressions or gullies that lack features of a waterway providing for fish passage (Figure 6.59 and Figure 6.60). There appears to be some erosion along the edges of some of the depressions. However, these sections do not have a continuous defined bed and banks, and instead consist of broken sections of a drainage gully, particularly along straight sections of the channel. The drainage

depression at these sites would not flow other than in times of localised rainfall. Flow is not sufficient to maintain aquatic ecological processes. There was no evidence of aquatic flora or fauna presence at these sites, including a lack of dead sedges or evidence of aquatic fauna such as mollusc shells. Due to the lack of a channel with continuously defined bed and banks, no riparian vegetation, and a lack of fish habitat and connectivity for fish passage, Sites 166 and 165 are not considered waterways providing for fish passage.

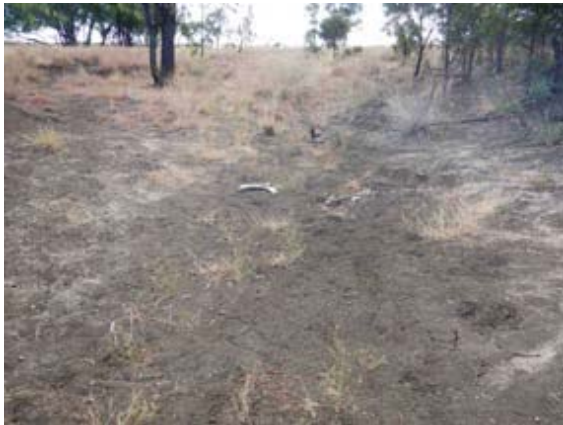
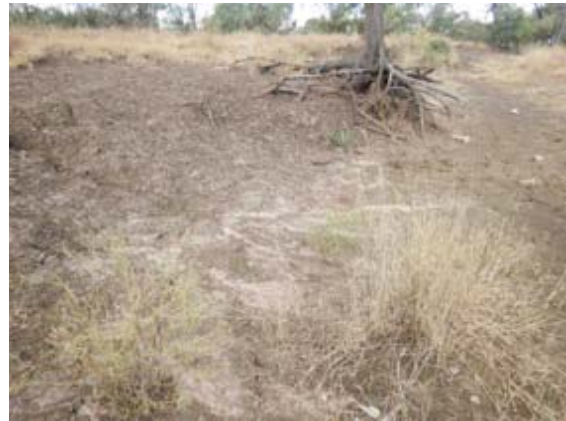
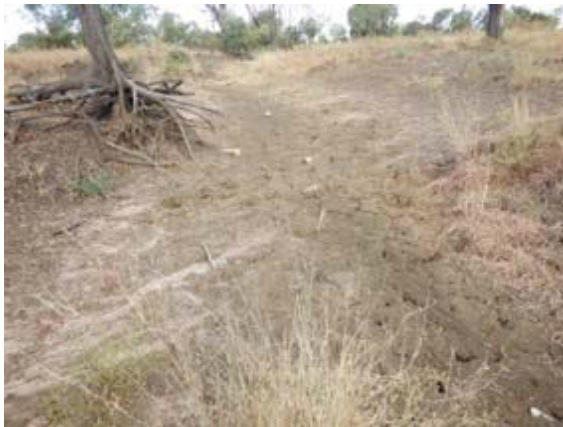
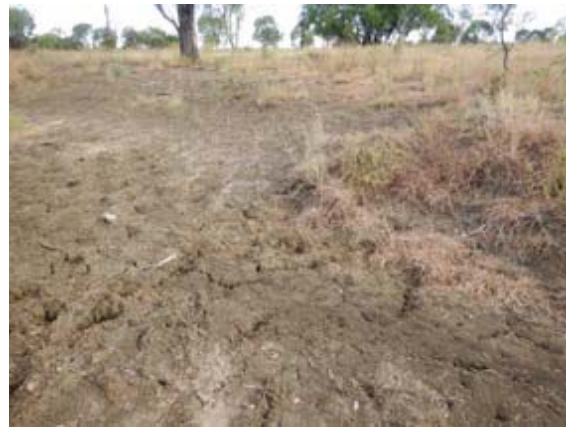
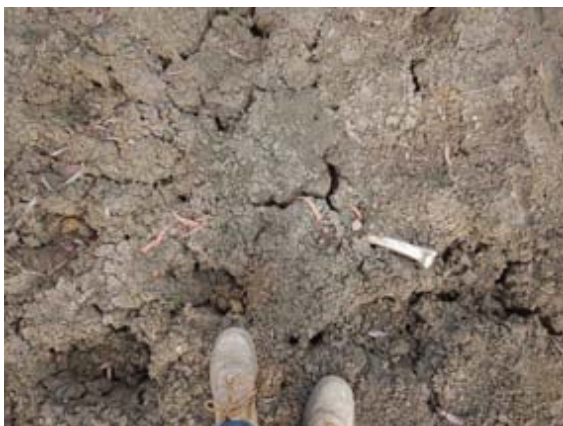
Figure 6.60 Site 165 showing a) upstream, b) left bank, c) downstream, d) right bank, and e) unconsolidated/cracking soils with no evidence of aquatic flora and fauna

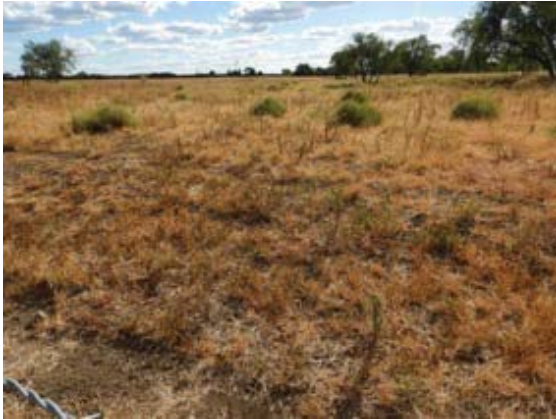
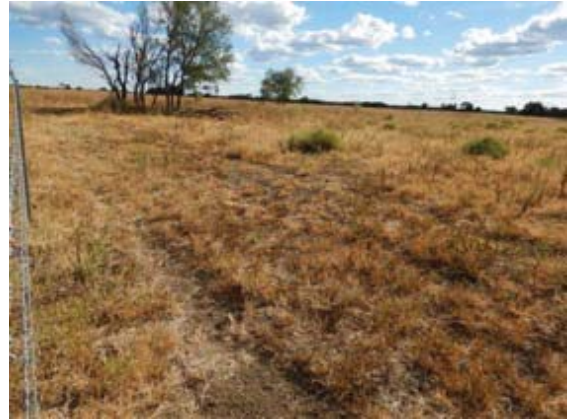
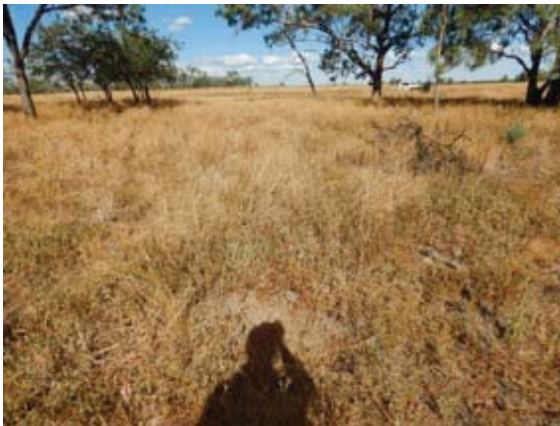
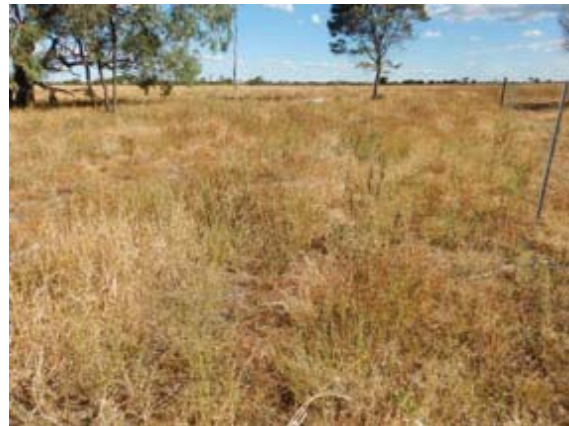
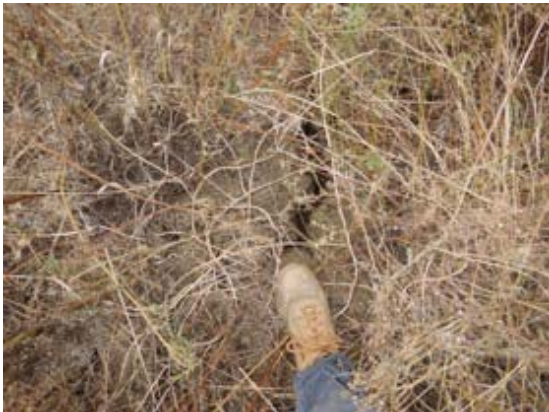
Site 161 is a drainage depression, immediately upstream of a 'turkey's nest' dam (Site 160). The drainage depression does not have continuously defined bed or banks, and there was no evidence that it would provide adequate flow beyond an immediate rainfall event (Figure 6.61). There was no riparian vegetation or fish habitat present. The drainage depression at Site 161 is not a waterway providing for fish passage.

Figure 6.61 Site 161 showing a) upstream, b) left bank, c) downstream, d) right bank, and e) unconsolidated/cracking soils with no evidence of aquatic flora or fauna

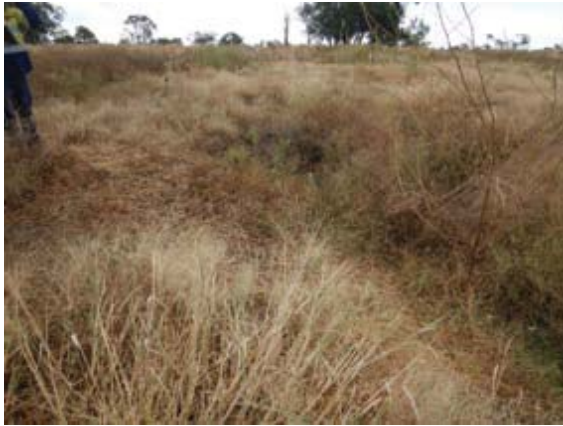
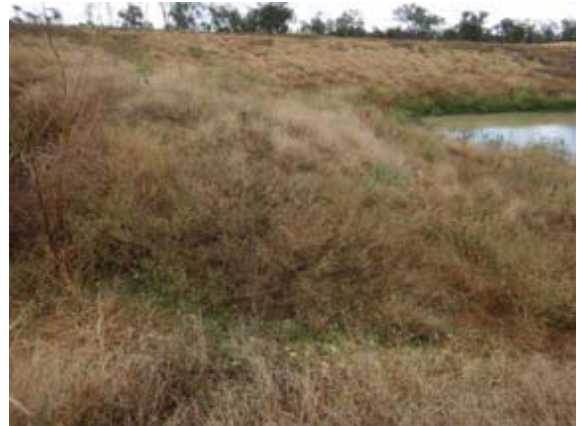
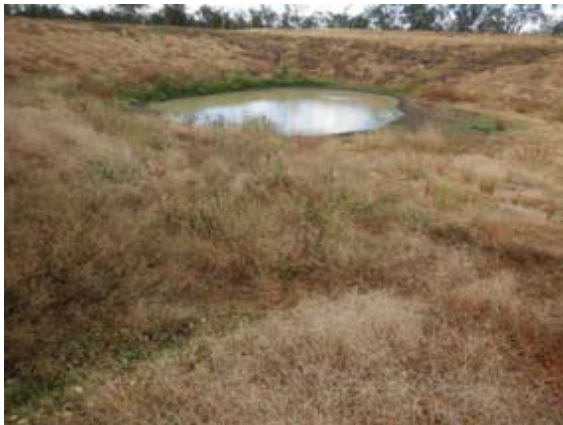
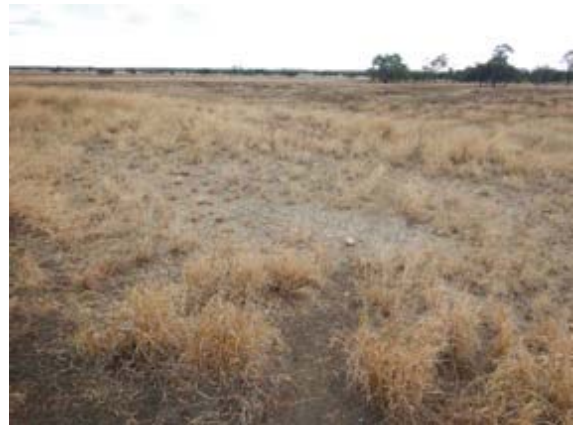
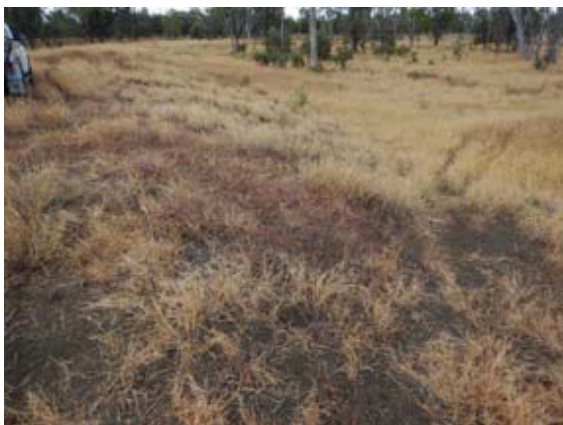
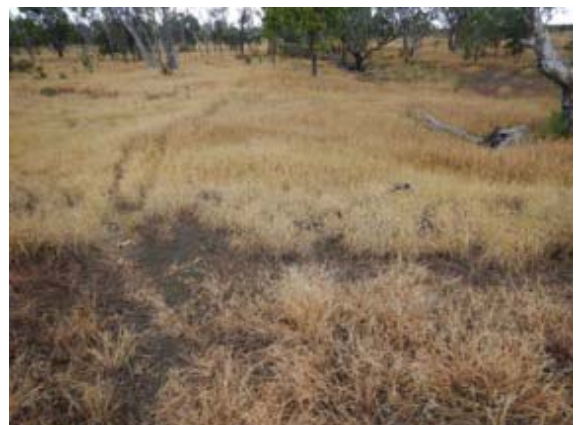
Site 160 is a constructed dam (Figure 6.62). The dam walls are approximately 10 m in height, and prevent connectivity, and there is no evidence of a waterway channel downstream of the dam (Figure 6.62e,f). The dam wall along the downstream extent of the dam extends away from the dam to the north, which appears designed to direct overland flows into the dam, but may also operate as the dam overflow. There is a drainage channel

that funnels overland flows into the dam. There is no riparian vegetation or shading, and a lack of habitat features. The dam at Site 160 acts as a barrier to fish passage.

Figure 6.62 Site 160 showing a) upstream of dam, b) left bank, c) downstream to dam, d) right bank, e) dam wall extending away from dam, and f) downstream of dam

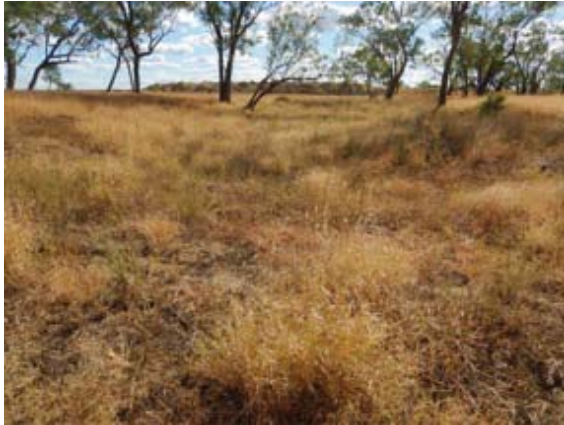
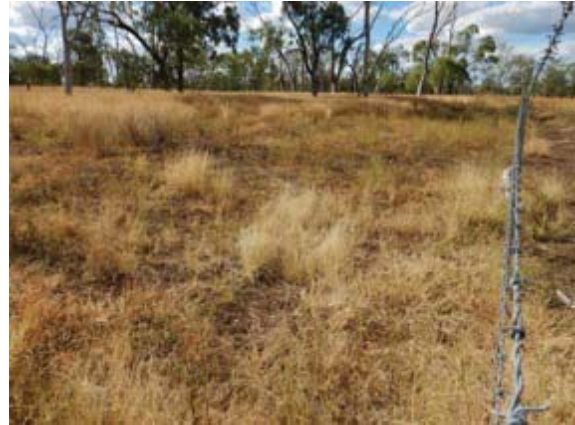
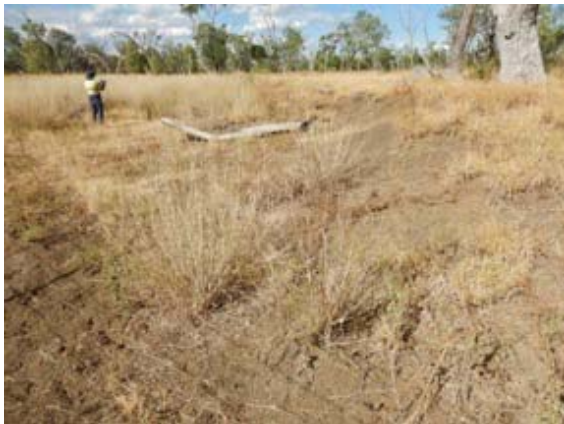
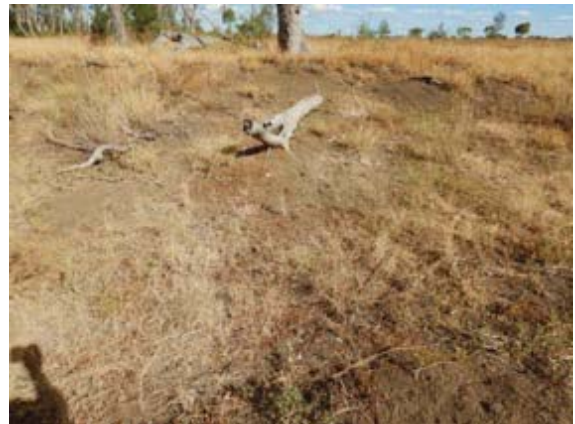
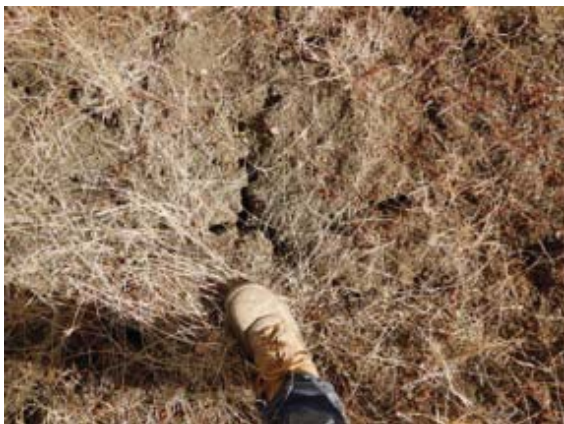
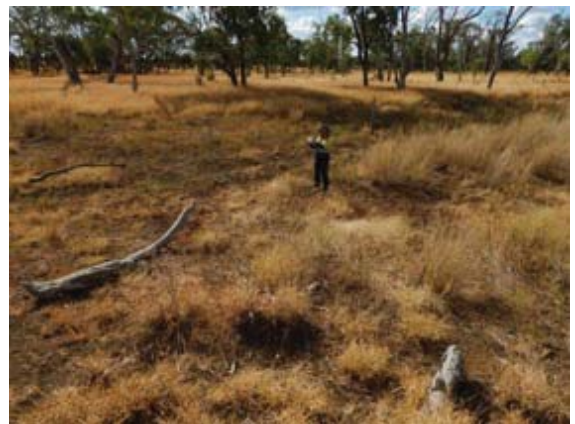
(Figure 6.63). The bed and banks are not well defined, are highly eroded, and consist of loose silty soil. Due to the high dam wall immediately upstream, Site 159 is unlikely to provide adequate flow beyond the duration of a rainfall event. Due to the lack of a channel with continuously defined bed and banks, no riparian vegetation, lack of fish habitat or passage opportunities, Site 159 is not considered a waterway providing for fish passage.

Figure 6.63 Site 159 showing a) upstream, b) left bank, c) downstream, d) right bank, e) unconsolidated/cracking soils, and f) a wider view of the feature, looking downstream

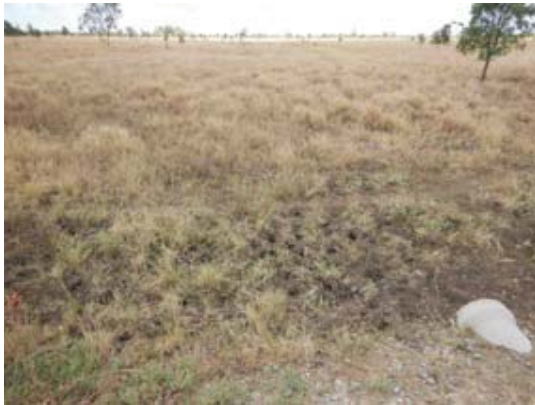
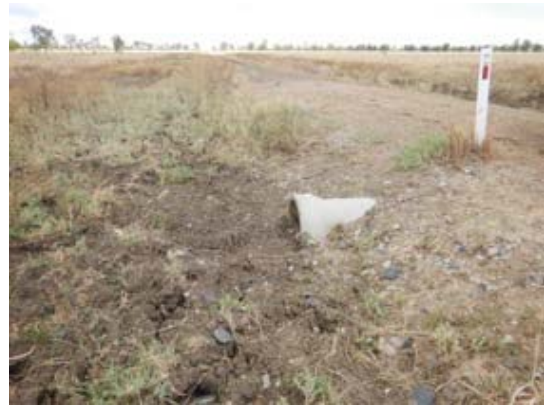
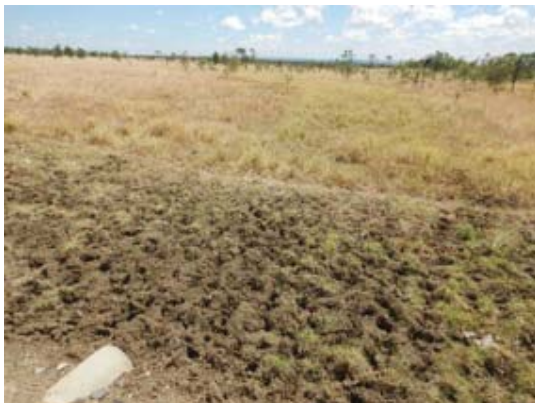
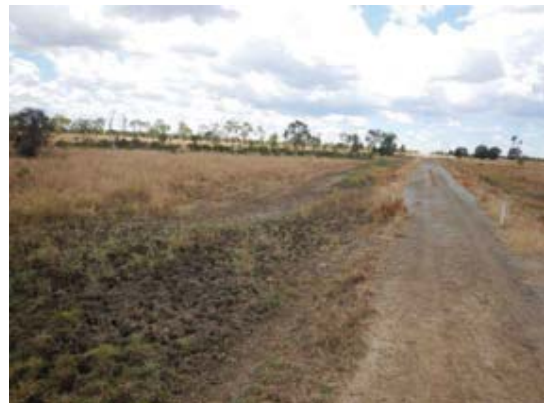
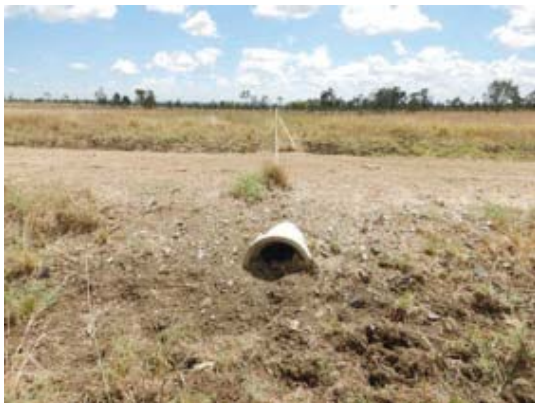
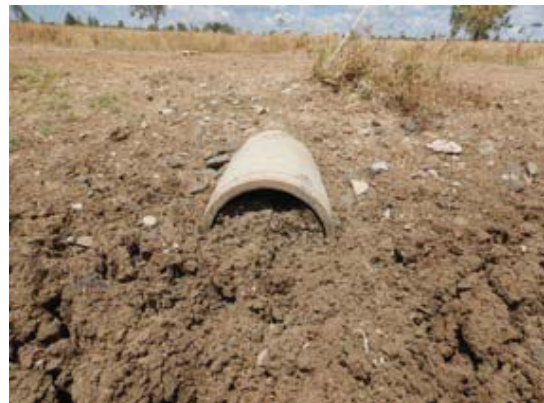
Site 80 is a drainage depression passing through a dirt road (Figure 6.64). A cement pipe culvert (~40 cm diameter) passes under the road. The road is elevated above the natural ground level, and the pipe culvert is largely blocked with soil. The drainage feature at Site 80 is flat, with no defined bed and banks. Terrestrial vegetation can be seen growing across the feature. This section of the mapped waterway would not provide adequate flow beyond an immediate rainfall event. There is no fish habitat at this site, or at sites further upstream. Site 80 is not a waterway providing for fish passage.

Figure 6.64 Site 80 showing a) upstream, b) left bank, c) downstream, d) right bank, e) upstream culvert entrance, and f) downstream culvert entrance

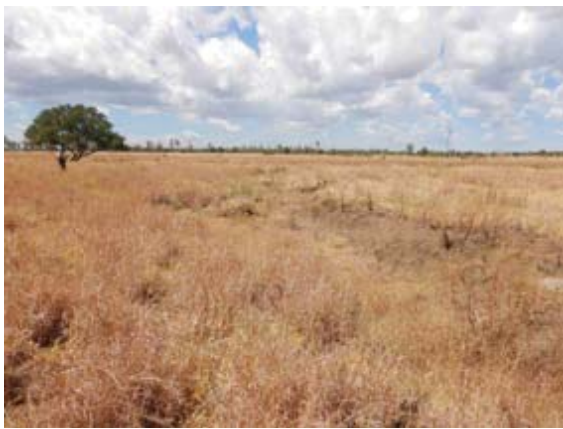
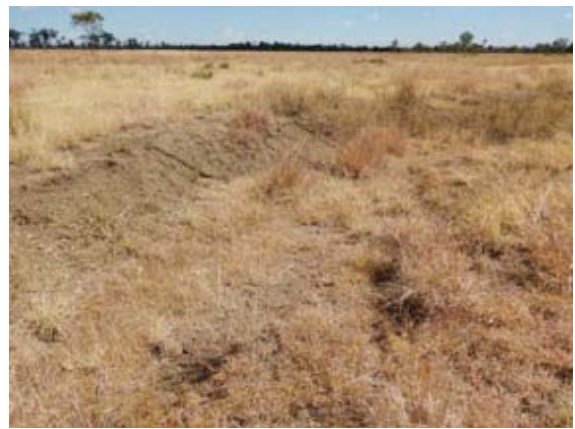
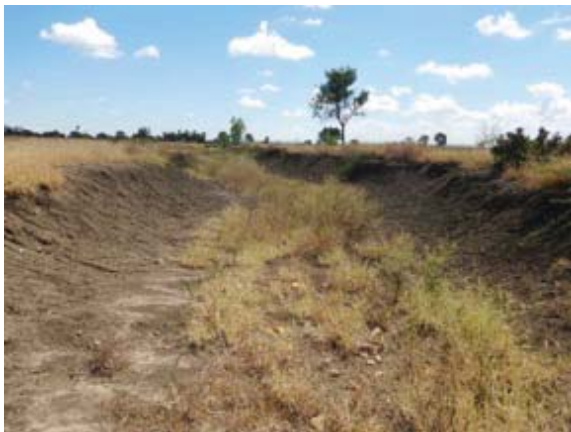
Site 78 (A3 in previous assessments, see Appendix A) is a drainage gully. There is significant erosion along the edges of parts of the feature, particularly on the outside of bends (Figure 6.65). The highly eroded banks are likely to confine flows in times of localised rainfall. However, there was no evidence that flows were sufficient to maintain aquatic ecological processes.

The upstream section of Site 78 flattens out and does not have a continuous defined bed and banks. Due to the lack of a channel with continuously defined bed and banks, no riparian vegetation, and a lack of fish habitat and connectivity for fish passage, Site 78 is not a waterway providing for fish passage.

Figure 6.65 Site 78 (A3) showing a) upstream, b) left bank, and c) downstream

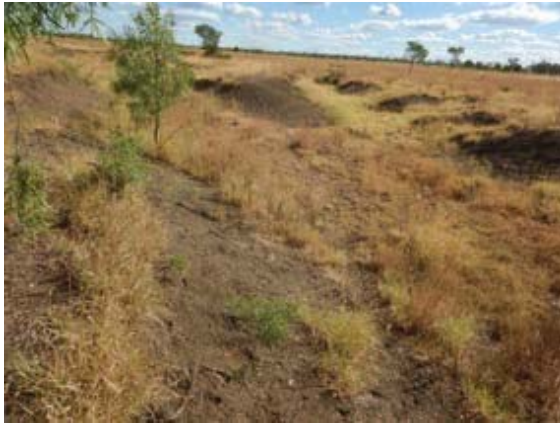
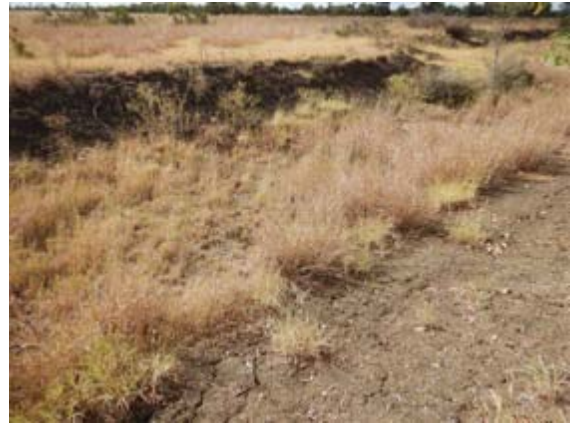
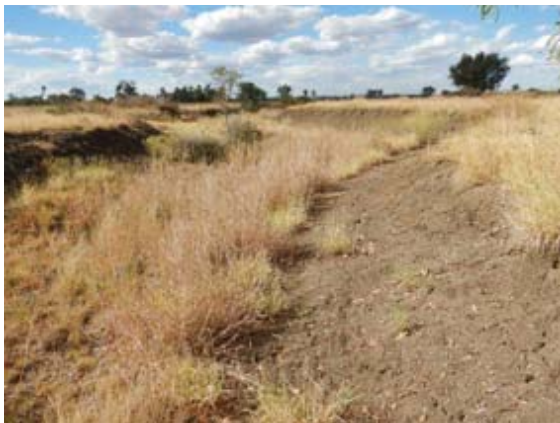
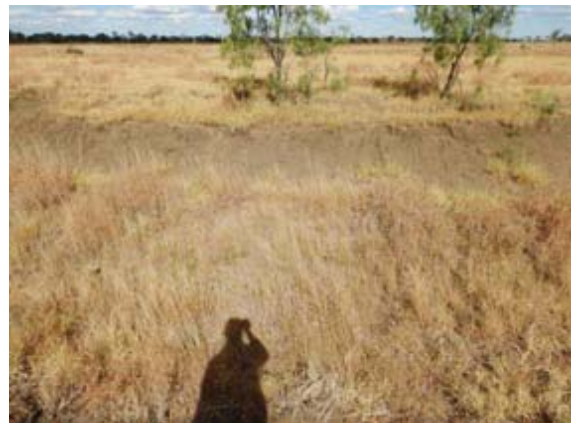
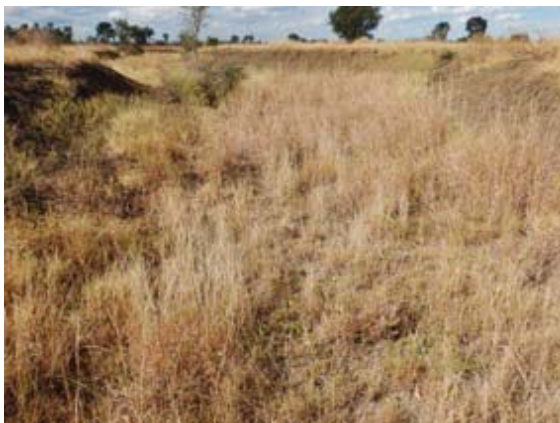
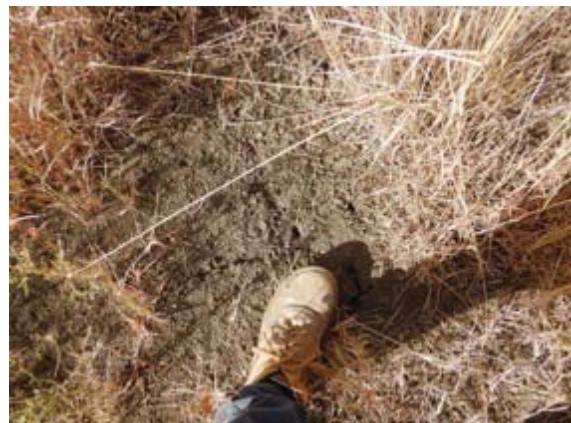
Site 158 is downstream of Site 78. Here, the feature consists of broken sections of a drainage depression, with no standing water (Figure 6.66). There is significant erosion in places, particularly on the outside of bends. The highly eroded banks are likely to confine flows, and a shallow depression within the gully, indicated by taller grasses, carries flow during rainfall events.

Due to the lack of a main channel with continuously defined bed and banks, no riparian vegetation, lack of fish habitat or passage opportunities, Site 158 is not considered a waterway providing for fish passage.

Figure 6.66 Site 158 showing a) upstream, b) left bank, c) downstream, d) right bank, e) main channel gully indicated by long grasses, and f) unconsolidated/cracks soils

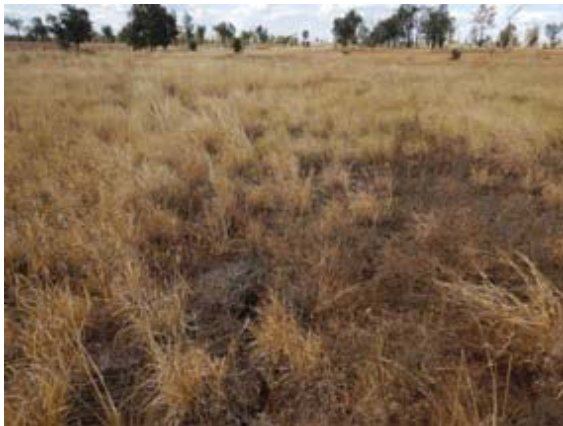
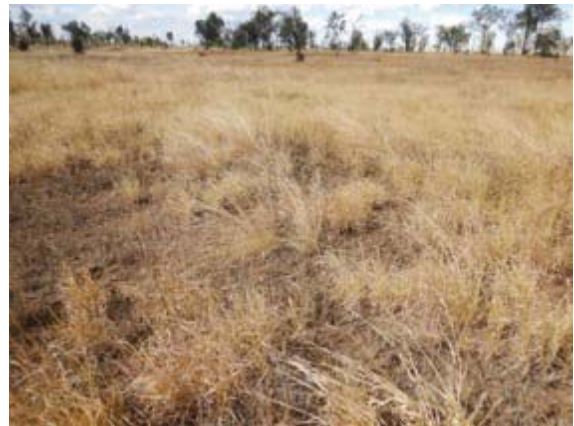
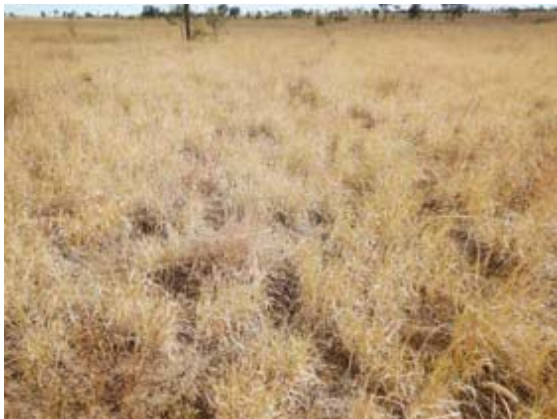
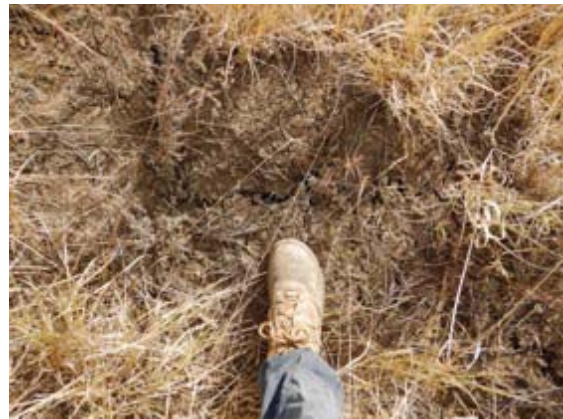
Site 156 is a flat drainage feature with no defined bed and banks (Figure 6.67). Terrestrial vegetation can be seen growing across the feature. This section of the mapped feature would not provide adequate flow beyond an immediate rainfall event. There are no fish habitat or fish passage opportunities at this site.

The lack of defined bed and banks, in combination with insufficient water availability to sustain basic aquatic ecological processes and habitats, and the lack of riparian vegetation, means this reach is not a waterway providing for fish passage.

Figure 6.67 Site 156 showing a) upstream, b) left bank, c) downstream, and d) unconsolidated/cracked soils
