## WINCHESTER SOUTH PROJECT

Environmental Impact Statement

# **Winchester South Project EIS**

## **Aquatic Ecology and Stygofauna, Additional Information**

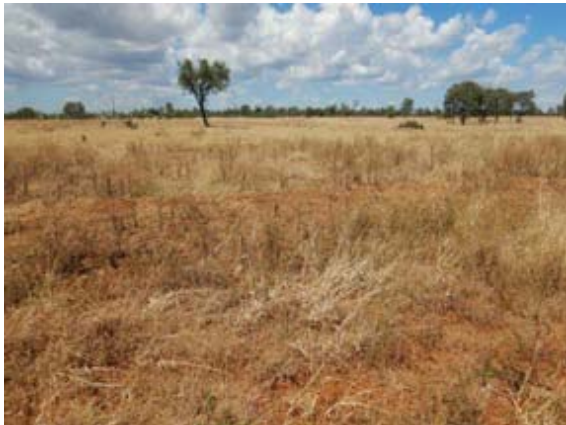
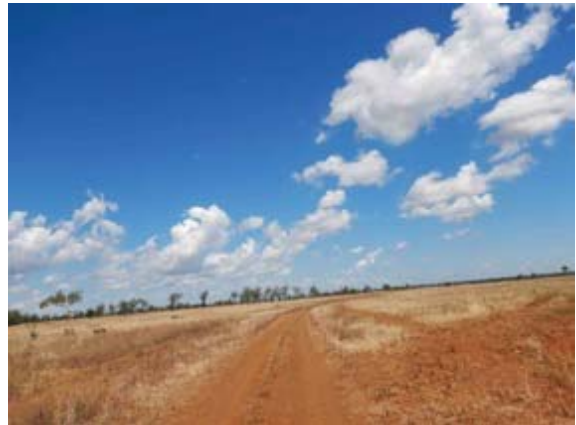
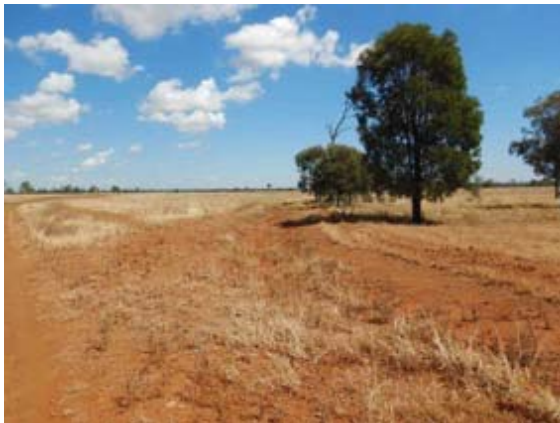
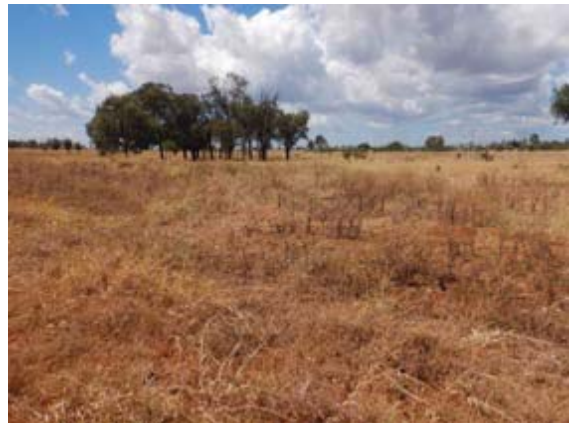
### Site 77 (A4)

Site 77 (A4 in previous assessments; see Appendix A) is a flat drainage feature, with no defined bed and banks (Figure 6.68). A road cuts across the feature and the downstream section appears to have been graded to direct overland flows away from the road. Terrestrial vegetation can be seen growing across the feature.

This reach of the mapped feature is not a waterway providing for fish passage.

Figure 6.68 Site 77 showing a) upstream, b) left bank and road crossing, c) downstream, and d) right bank

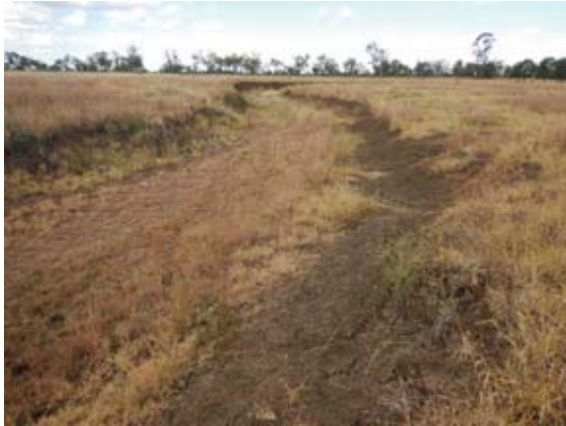
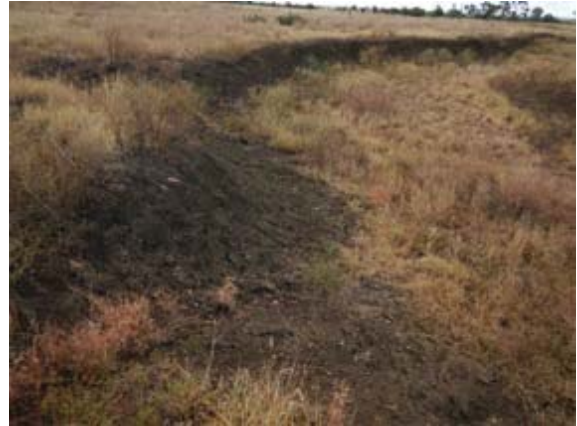
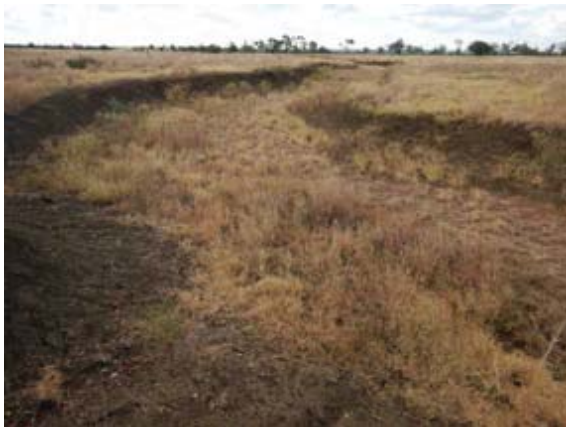
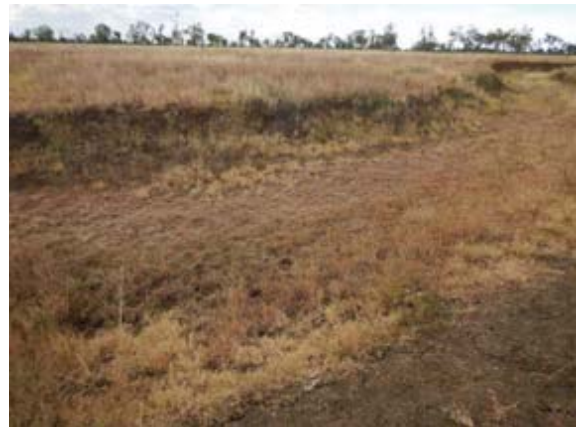
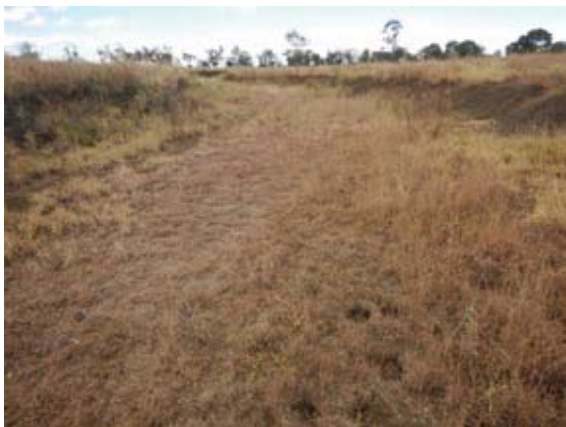
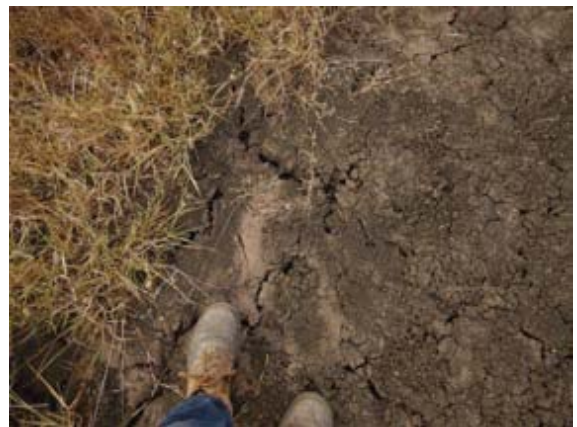
### Site 157

Site 157 is a wide drainage channel with highly eroded areas, particularly on the outside bends (Figure 6.69). The soil is silty and unconsolidated. A shallow depression within the gully would carry flows during rainfall events, but it is unlikely to provide adequate flow beyond the duration of a rainfall event. There is a complete lack of fish habitat, suggesting this section of the waterway does not provide fish passage opportunities.

Due to the lack of a main channel with continuously defined bed and banks, and lack of fish habitat or passage opportunities, Site 157 is not considered a waterway providing for fish passage.

Figure 6.69 Site 157 showing a) upstream, b) left bank, c) downstream, d) right bank, e) main channel gully indicated by long grasses, and f) unconsolidated/cracks soils

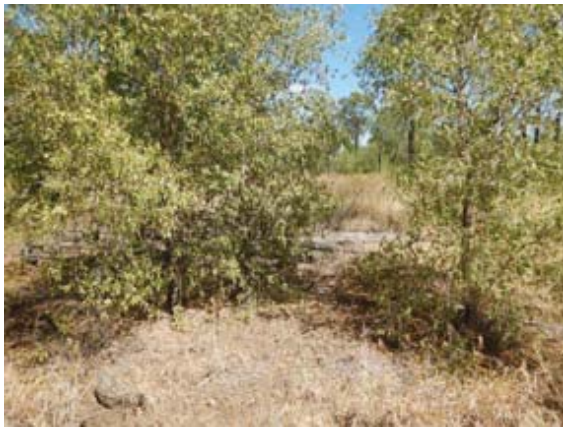
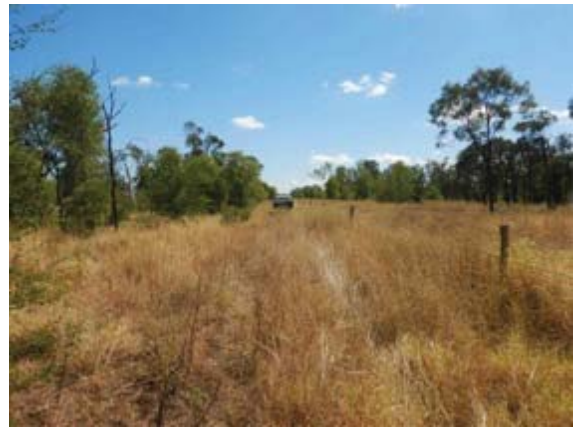
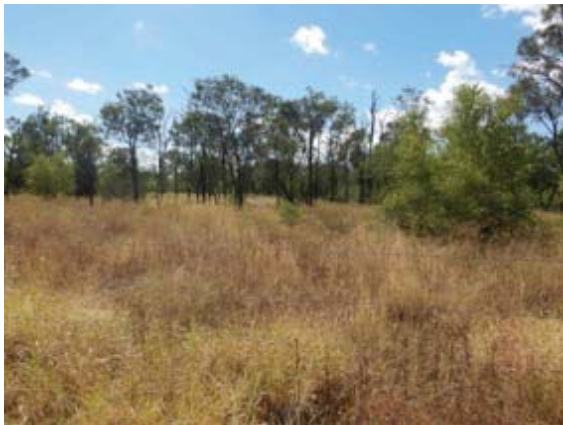
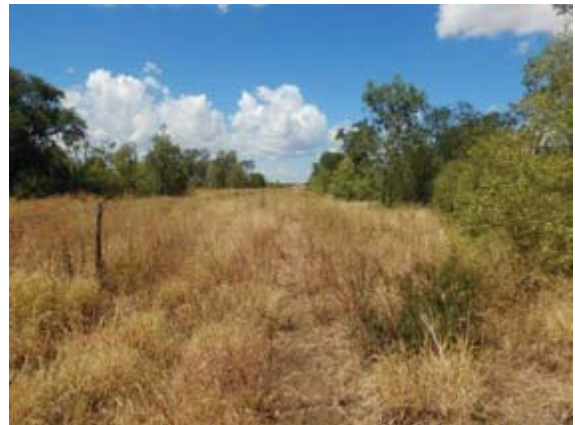
Sites 75 and 76 (Sites A6 and A7, respectively, in previous assessments; see Appendix A) are homogenous with surrounding terrain, with no drainage feature present at either site. A search of the area failed to find a drainage feature present within 250 m of each site.

Due to the lack of a waterway with any waterway features, Sites 75 and 76 are not considered a waterway providing for fish passage (Figure 6.70 and Figure 6.71). This further suggests that there is no opportunity for fish passage from the downstream reaches of the mapped amber feature to the upstream mapped green tributaries.

Figure 6.70 Site 75 (A6) showing a) upstream, b) left bank, c) downstream, and d) right bank

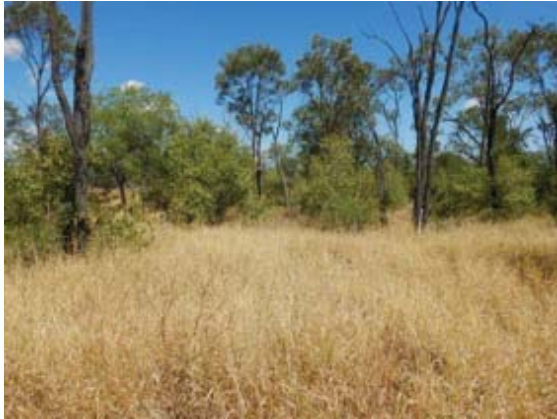
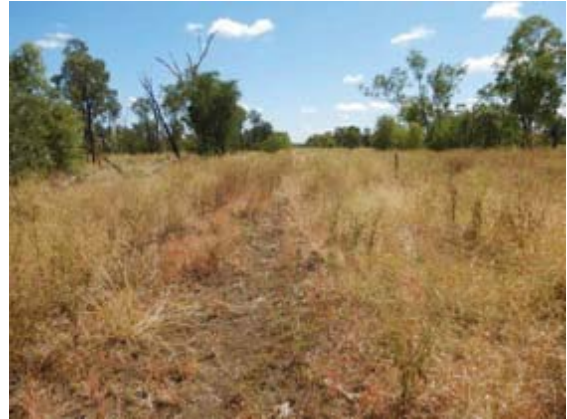
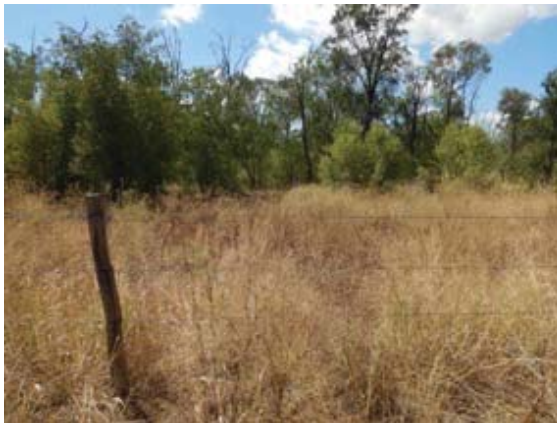
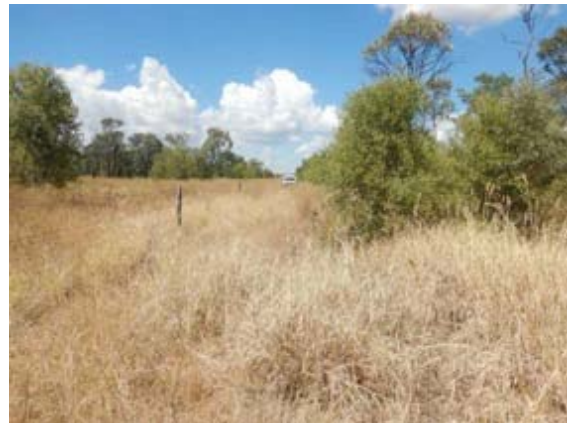
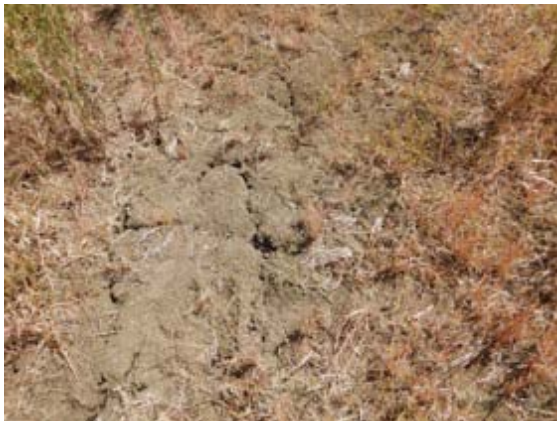
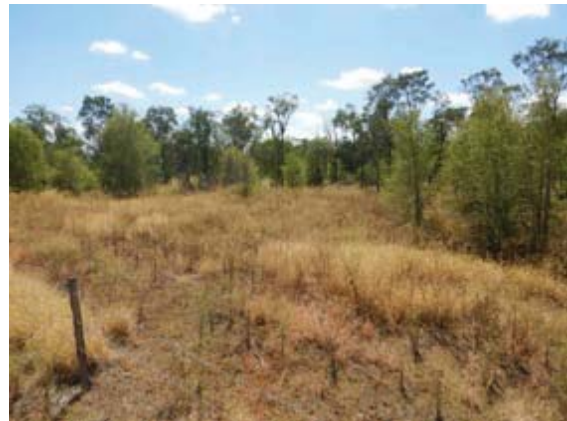
Figure 6.71 Site 76 (A7) showing a) upstream, b) left bank, c) downstream, d) right bank, e) unconsolidated/cracks soils, and f) wider view of downstream terrain

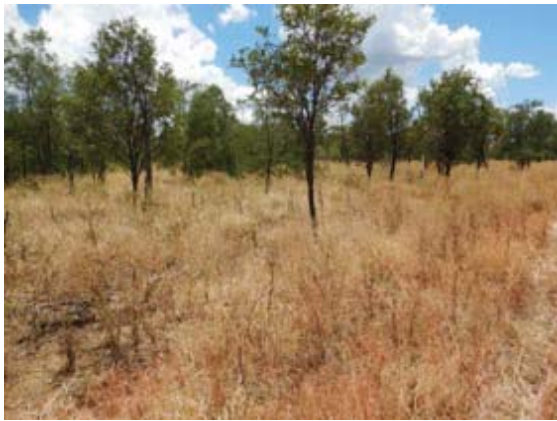
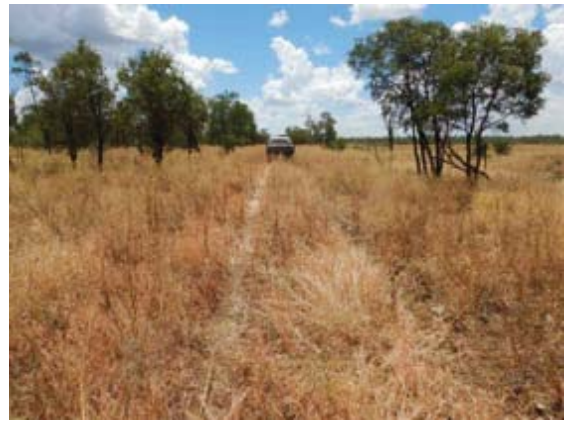
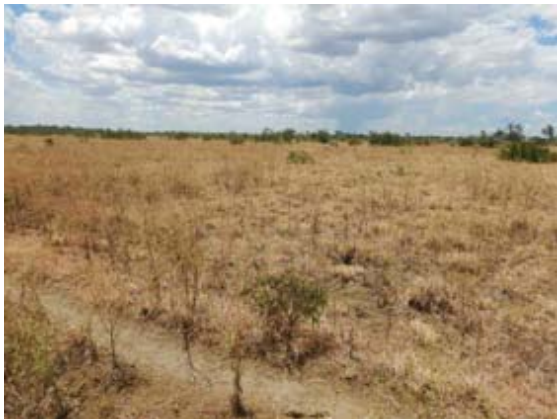
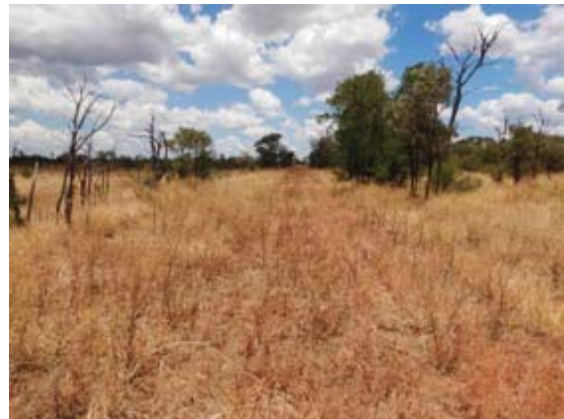
### Site 81 (A8)

No drainage feature was found at Site 81 (A8 in previous assessments; see Appendix A). A 1 km search along the fence line in a north-south direction failed to find any waterway features crossing the dirt track (Figure 6.72).

Due to the lack of a waterway with any waterway features, Site 81 is not considered a waterway providing for fish passage. This further reinforces that there is no opportunity for fish passage along large sections of the mapped amber feature.

Figure 6.72 Site 81 showing a) upstream, b) left bank with road crossing, c) downstream, and d) right bank with road crossing

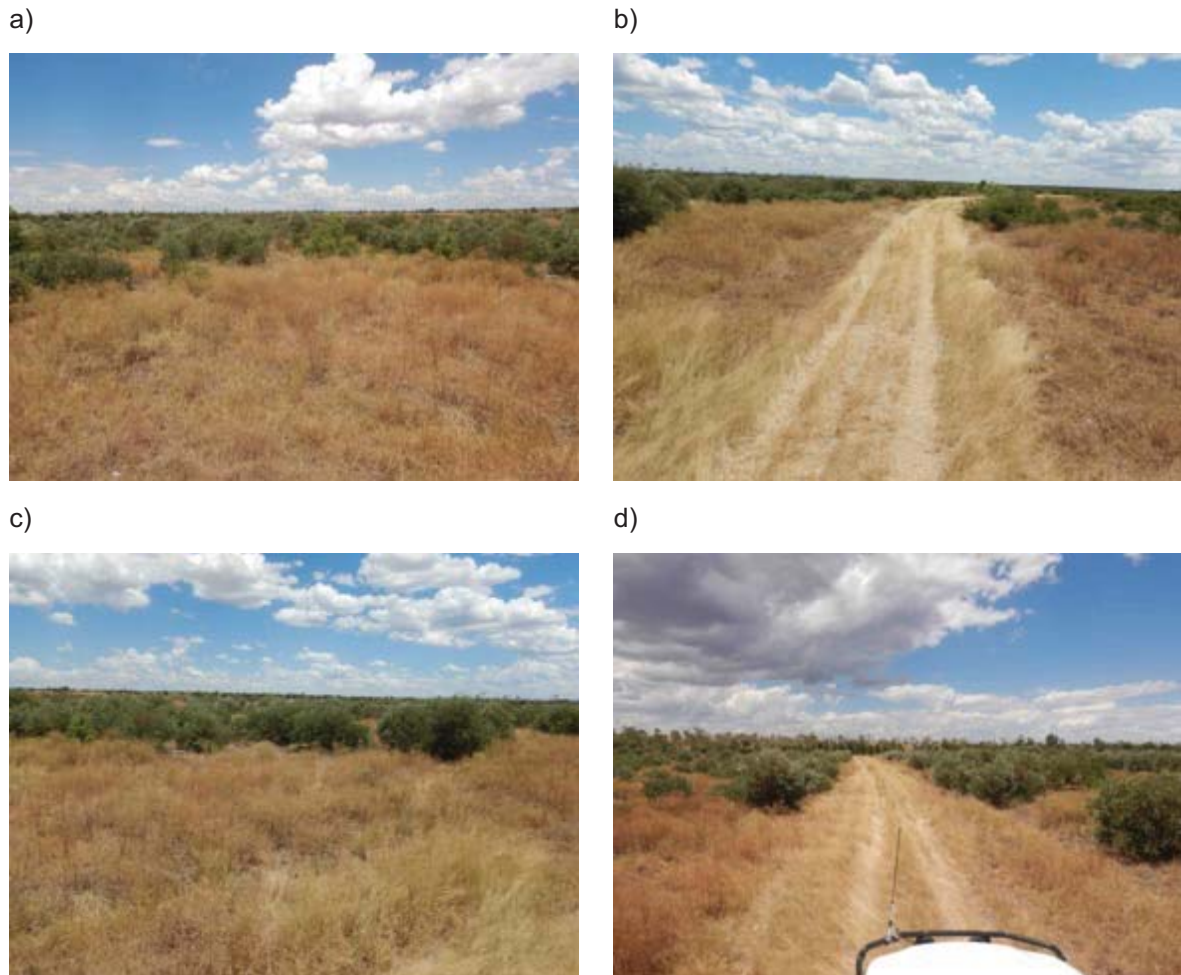
#### Site 84

No waterway could be identified in area of the amber mapped feature, or within 250 m in either direction along the east to west track. A small drainage channel was identified approximately 500 m further to the west (see Unmapped Features section below).

Due to the lack of a waterway with any waterway features, Site 84 is not considered a waterway providing for fish passage (Figure 6.73).

Figure 6.73 Site 84 showing a) upstream, b) left bank with road crossing, c) downstream, and d) right bank with road crossing

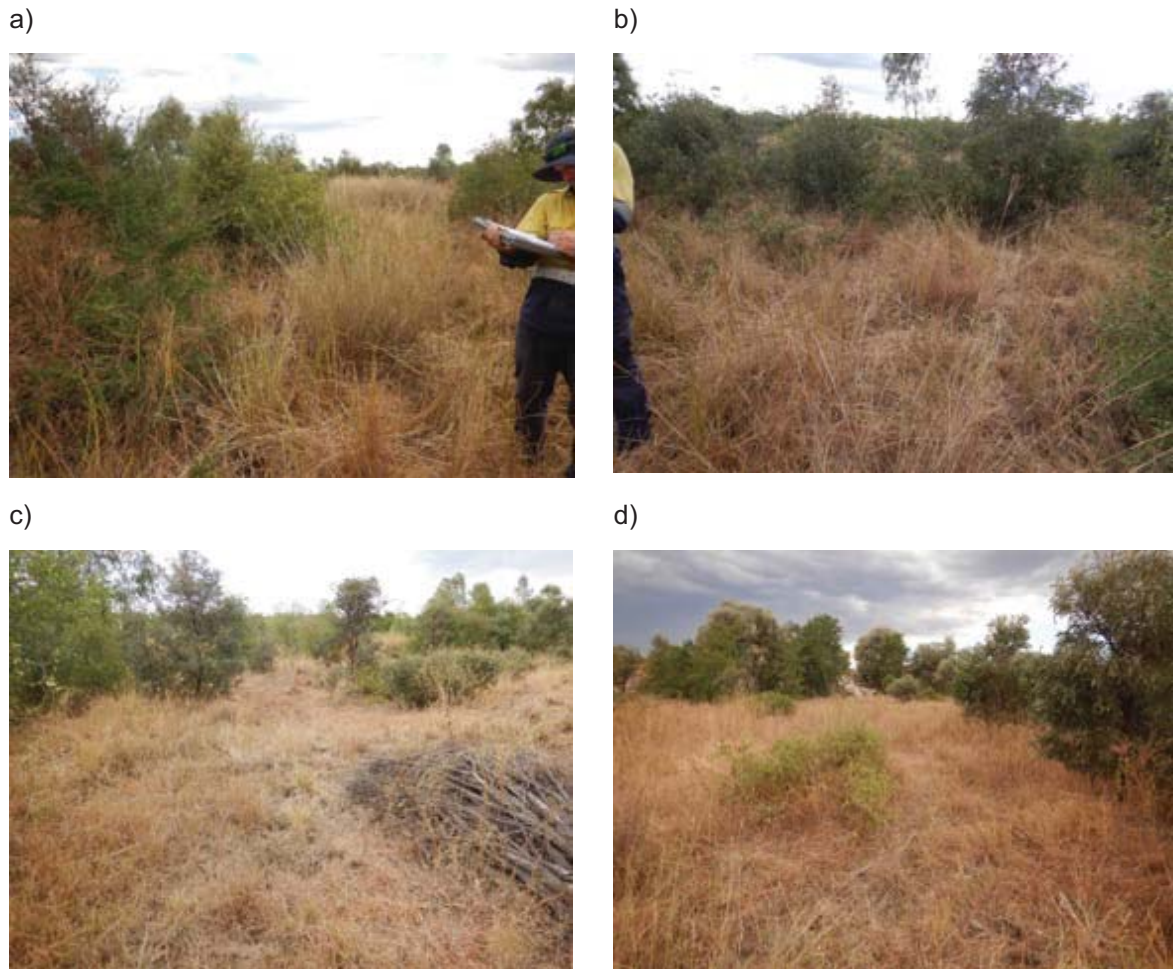
#### Site 97 – Upstream End of Discernible Waterway

Site 97 contains discontinuous bed banks forming broken sections of a drainage feature (Figure 6.74). There are no riparian plants, with terrestrial grasses, weeds and shrubs throughout. The terrain is undulating, and described as a slight depression between the constructed quarry rock wall and flat farming land further to the west.

A search 100 m across from the quarry wall to the farming land to the west failed to find a defined waterway.

Due to the complete lack of any waterway features, Site 97 is not considered a waterway providing for fish passage.

Site 97 is the upstream limit of the waterway providing for fish passage along the northern mapped feature.

Figure 6.74 Site 97 showing a) upstream, b) left bank, c) downstream, and d) right bank

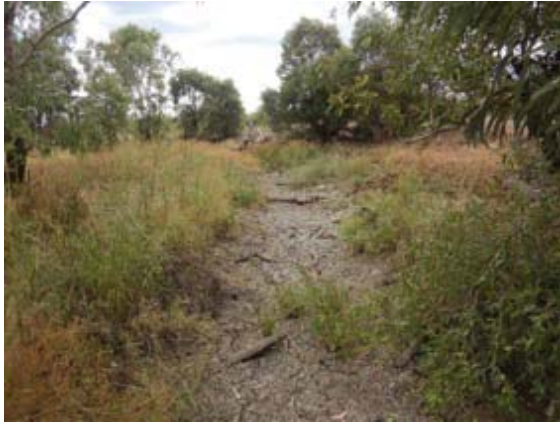
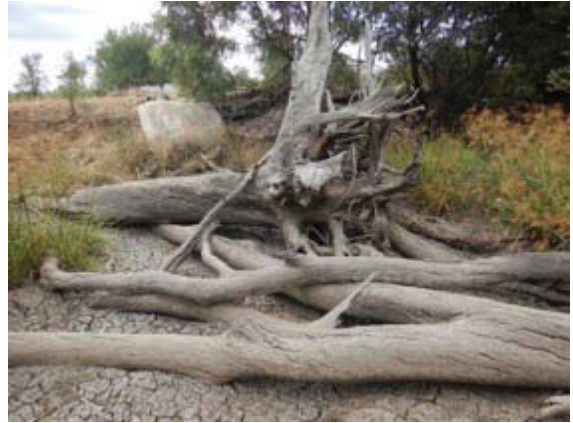
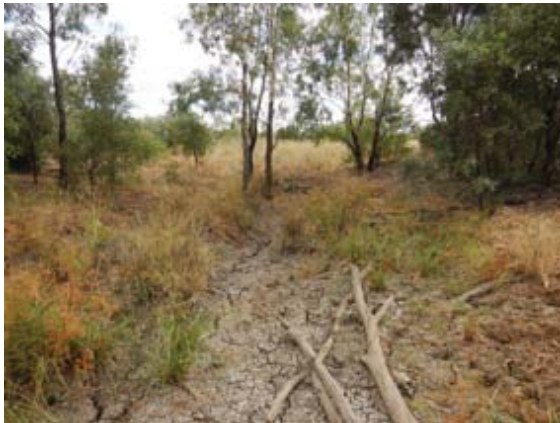
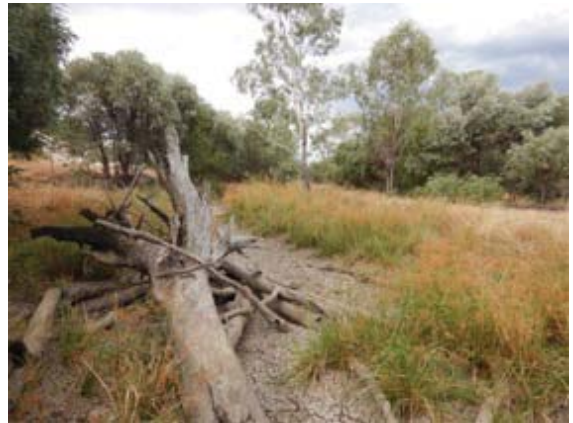
### Site 96

Site 96 is a wide, shallow gully with low banks (Figure 6.75). The bed was cracked and dry in February 2022, but the nature of the cracked soils was indicative of previous water ponding. Further, aquatic plants (sedges (*Cyperus* spp.)) were abundant at this site, suggesting water may occur at Site 96 for an extended period following rainfall. These sedges and large woody debris provides fish habitat.

Site 96 is a waterway providing for fish passage.

Figure 6.75 Site 96 showing a) upstream, b) left bank, c) downstream, and d) right bank

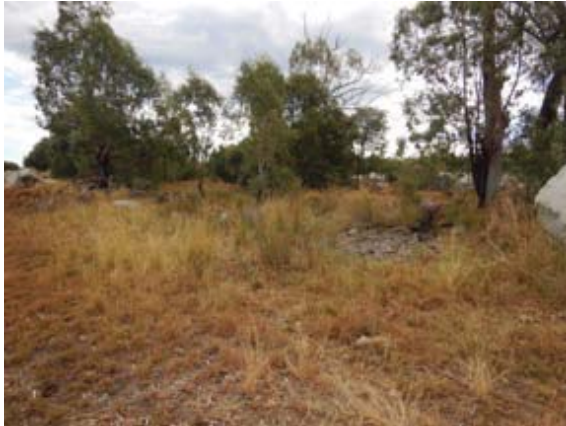
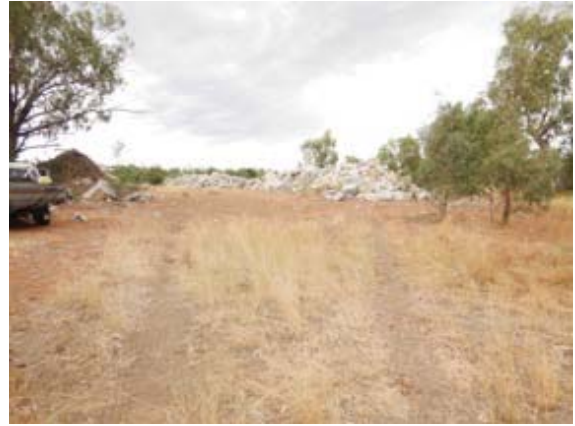
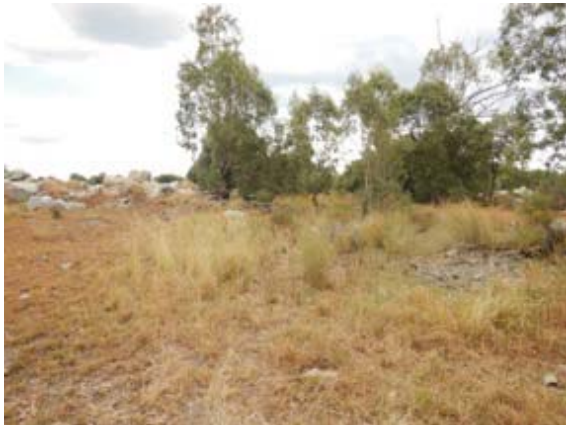
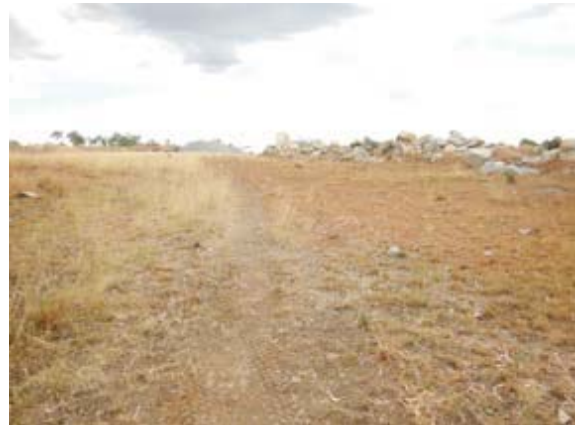
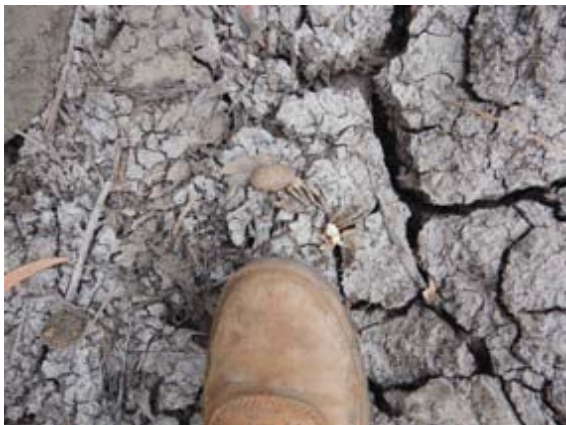
### Site 95

Site 95, immediately downstream of Site 96, is located at a road crossing (Figure 6.76). The road is approximately 0.4 m above the adjoining channel bed, creating a significant barrier to fish passage. Immediately upstream of Site 95, the channel is a depression with dry, cracked beds, indicating water is likely pooling up against the road. While not visible at the time of the assessment, it appears pooled water would eventually overtop the road and flow downstream to lower reaches.

Figure 6.76 Site 95 showing a) upstream, b) left bank road crossing, c) downstream, d) right bank road crossing, and e) unconsolidated/cracks soils with a deceased crab located on upstream side of road

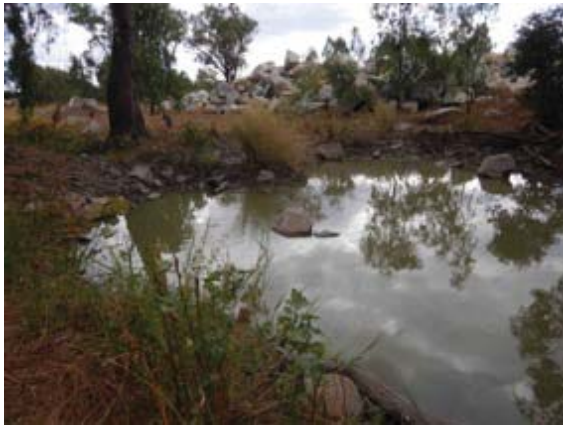
#### Site 94

Site 94 is a waterway providing for fish passage.

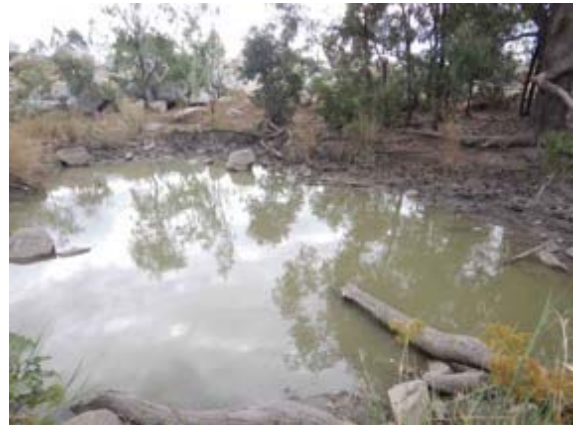
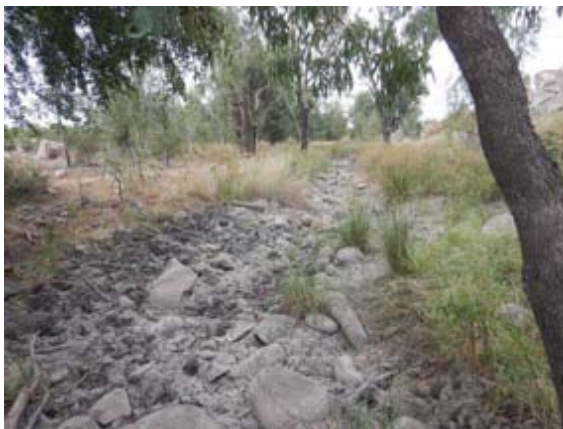
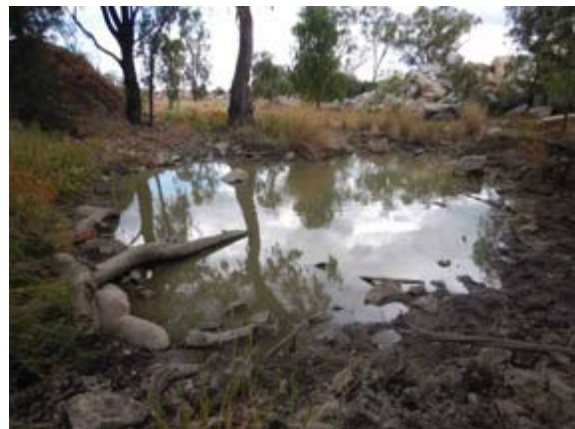
Site 94 is a small, 12 m wide, shallow pool of water (Figure 6.77). The pool has low banks and connectivity to upstream and downstream reaches. The channel flowing into the pool is not well defined and appears to be directing overland flows from the dirt road described at

Figure 6.77 Site 94 showing a) upstream side of pond, b) left bank of pond, c) downstream channel, and d) wider view of pond looking upstream

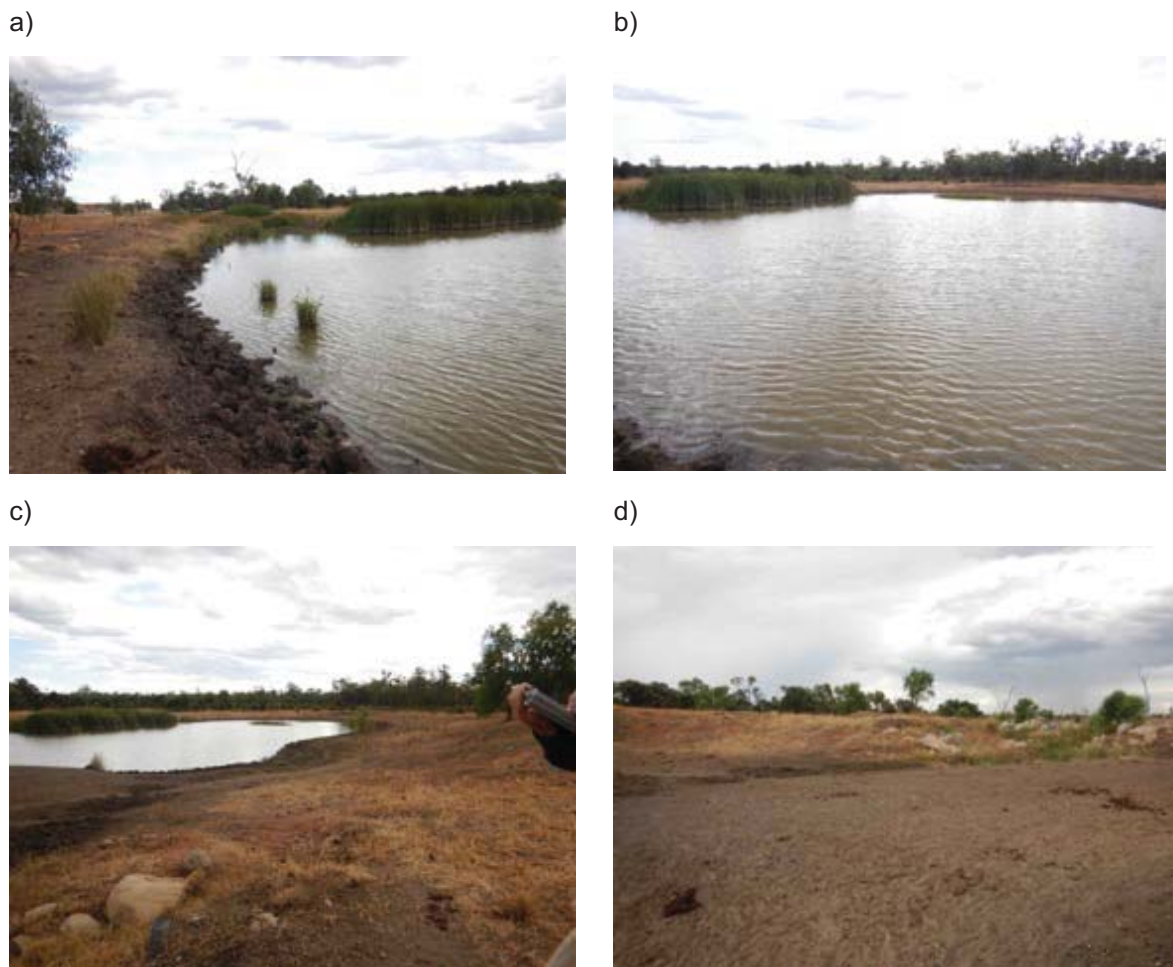
Site 93 is a large, constructed dam (Figure 6.78). The dam has low banks, approximately 1 m in height above the water level in the dam. Vegetation surrounding the dam appears to be mostly terrestrial grasses with some aquatic plants, including bull rush (*Typha orientalis*) and knotweed (*Persicaria* sp.) growing within the shallow areas of the dam.

There is connectivity to upstream and downstream reaches during periods of flow. The upstream channel flowing into the dam contains bull rush and likely only conveys flows during periods of rainfall. The downstream connectivity is via the dam overflow, which is separated from the dam by a wide flat section of bare land used by cattle as a track. The overflow connects to a constructed channel (described below).

Fish were captured within the dam as part of the fish survey (see Section 3.2.2, Site Q1).  
Site 93 is a waterway for fish passage during periods of flow to upstream reaches.

Figure 6.78 Site 93 showing a) upstream extent of dam , b) left bank of dam, c) downstream extent of dam, and d) looking downstream toward dam overflow

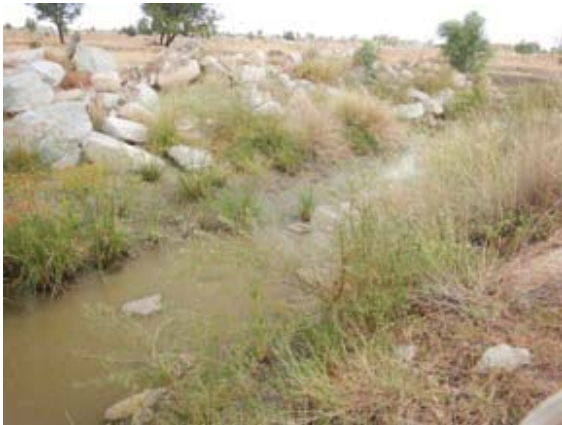
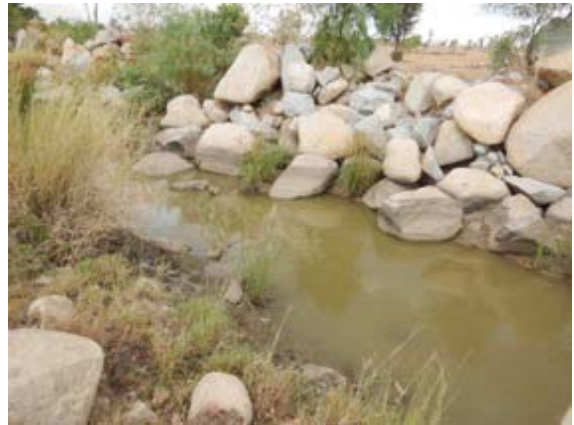
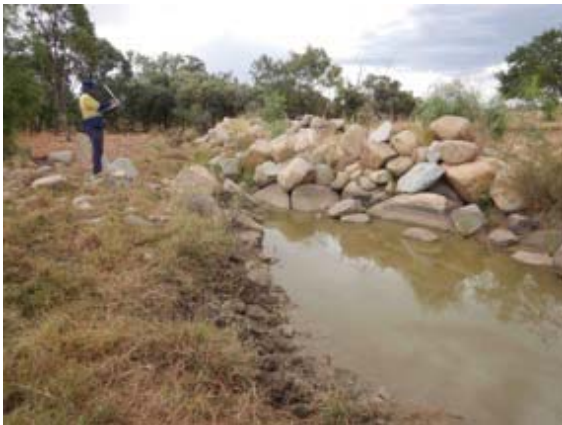
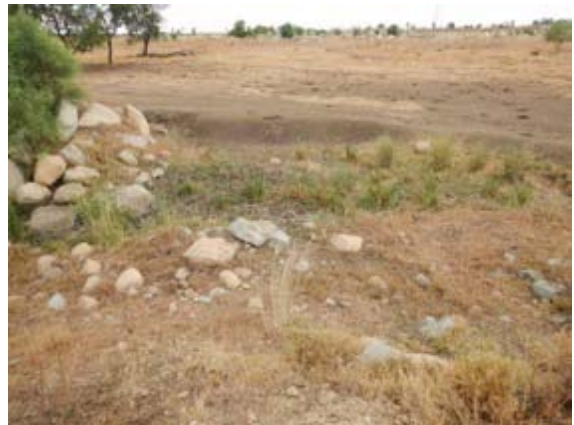
Site 91 appears to have been constructed and lined with rocks to provide dam overflow passage to downstream reaches of the mapped feature (Figure 6.79).

The channel contains defined bed and banks, with aquatic plants (sedges) present. Fish were observed swimming in the channel but were not able to be captured due to the shallow rocky conditions.

Site 91 is a waterway providing for fish passage.

Figure 6.79 Site 91 showing a) upstream, b) left bank, c) downstream, and d) dam overflow

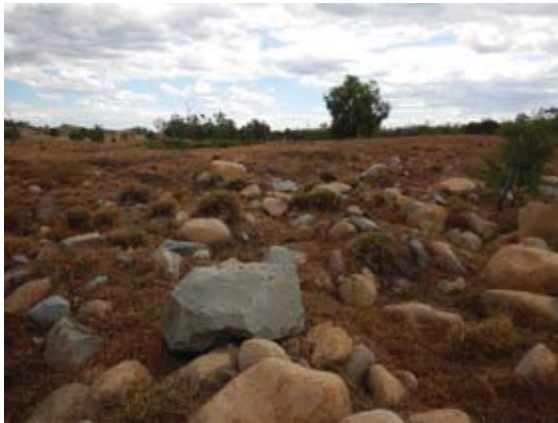
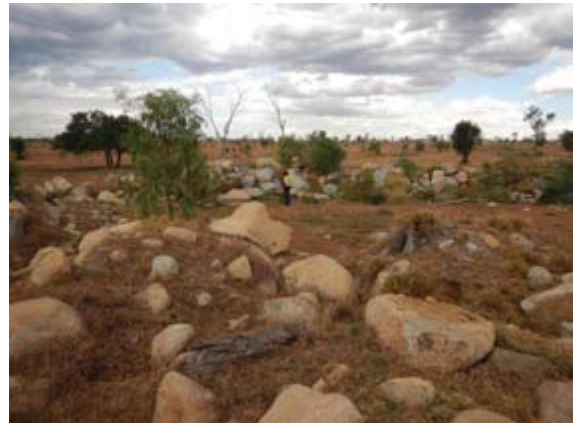
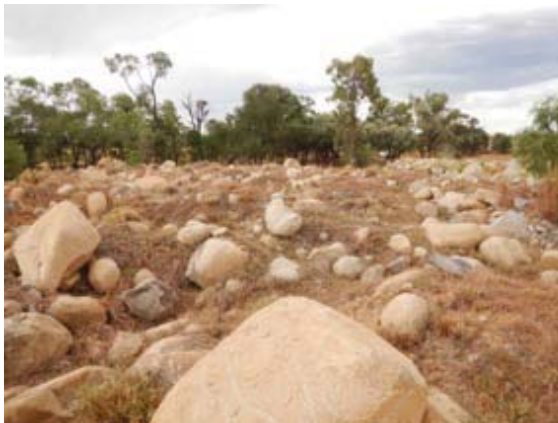
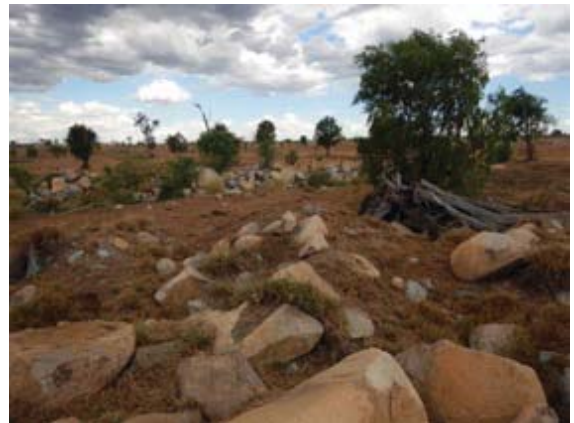
Site 90 is a wide rocky constructed barrier located between Sites 93 and 89 (Figure 6.80). The barrier is approximately 2 m above the natural ground level and does not provide any fish habitat or fish passage opportunities. The constructed channel at Site 91 appears to have been created to allow flows around Site 90.

Figure 6.80 Site 90 showing a) across constructed barrier toward upstream dam, b) looking west, c) toward downstream, and d) looking east

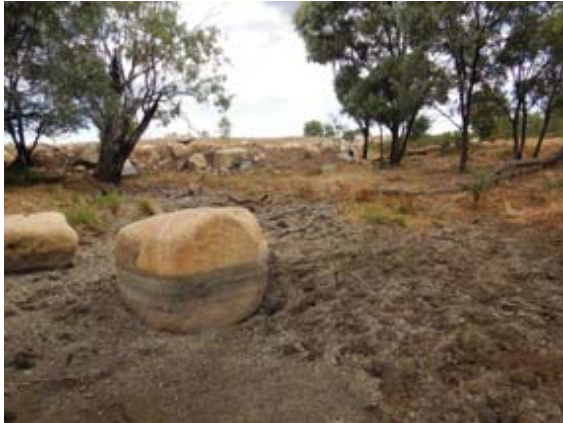
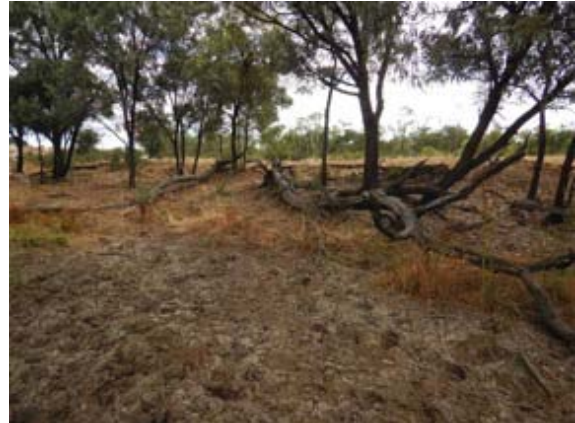
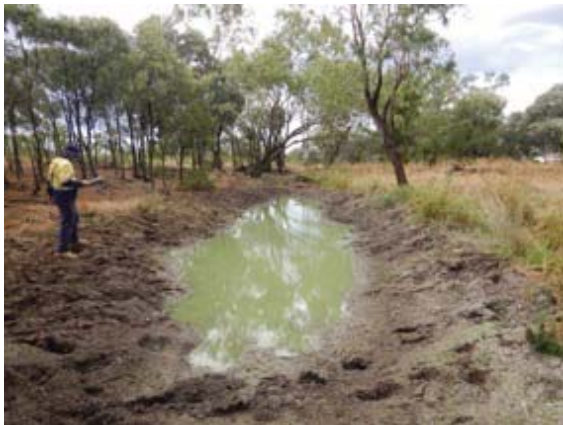
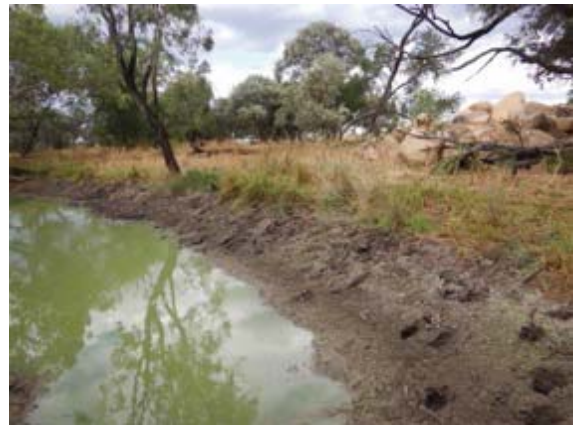
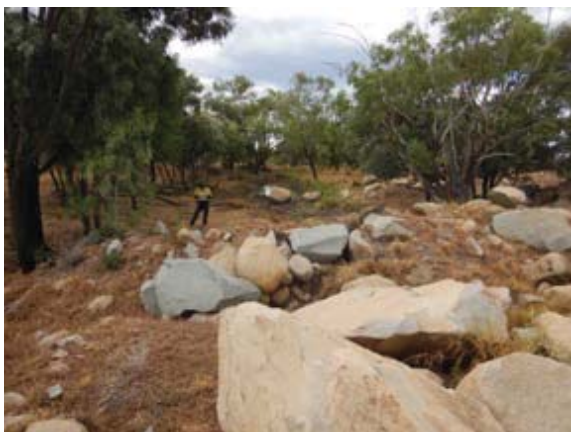
Site 89 is a small channel with defined bed and banks, immediately downstream of the constructed barrier at Site 90 (Figure 6.81). At the time of the assessment in February 2022, there was a small pool of green-coloured water. Aquatic plants (sedges) were present but sparse.

Figure 6.81 Site 89 showing a) upstream of pond, b) left bank, c) looking downstream across pond, d) right bank, and e) looking downstream toward pond from constructed rock barrier

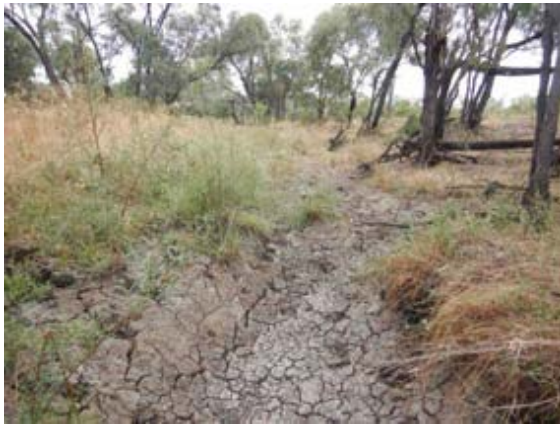
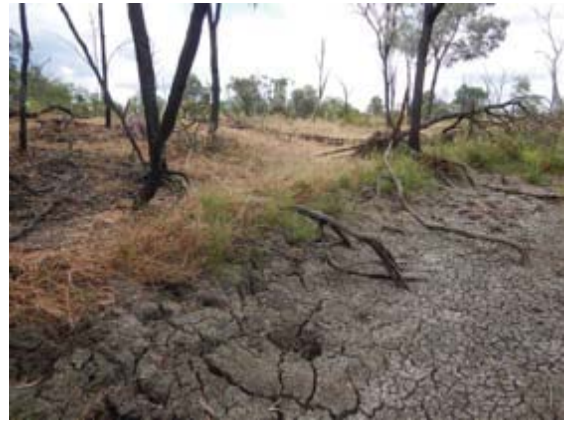
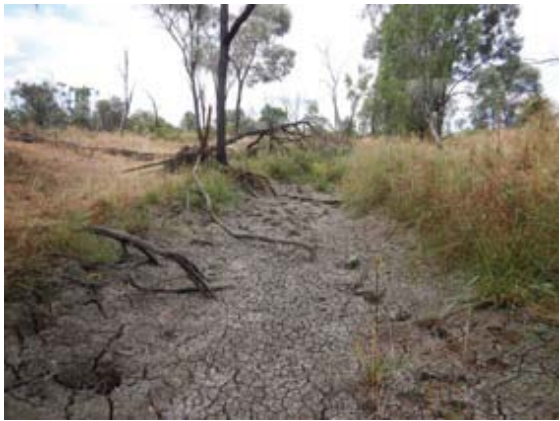
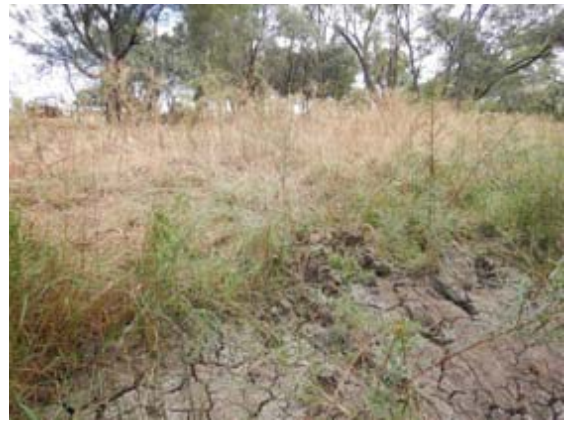
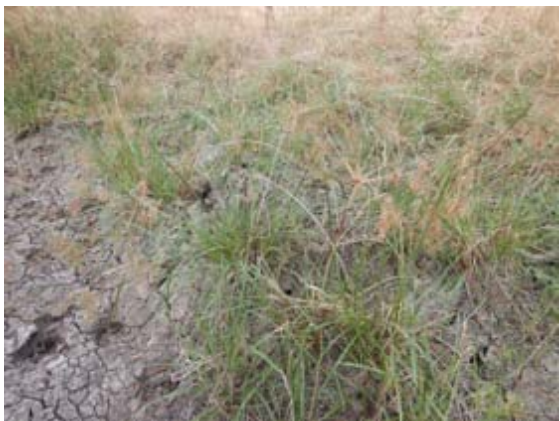
Site 88 (D5 in previous assessments; see Appendix A) is a waterway providing for fish passage. The channel contains defined bed and banks, with aquatic plants (sedges and rushes (*Juncus* sp.)) present (Figure 6.82). The nature of the cracked soils was indicative of previous water ponding.

Connectivity to upstream reaches would occur during periods of flow from the dam overflow.

Figure 6.82 Site 88 (D5) showing a) upstream, b) left bank, c) downstream, d) right bank, and e) aquatic plants, with cracked soils

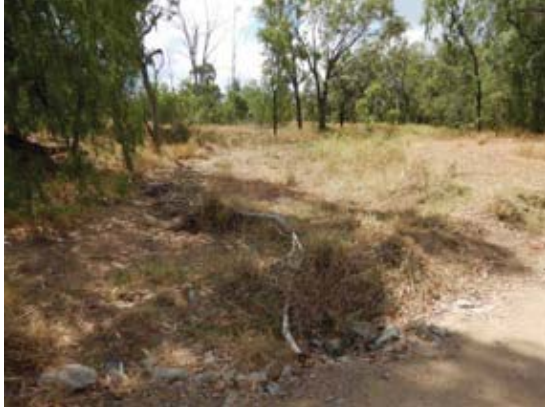
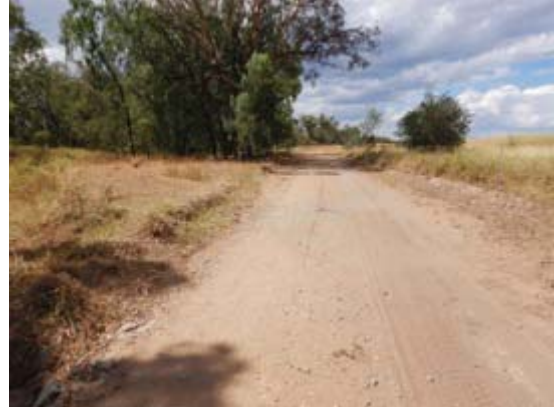
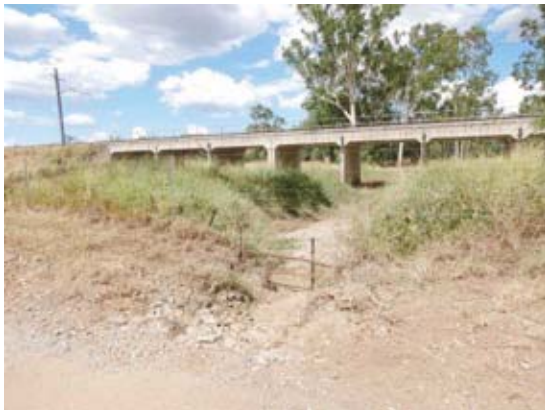
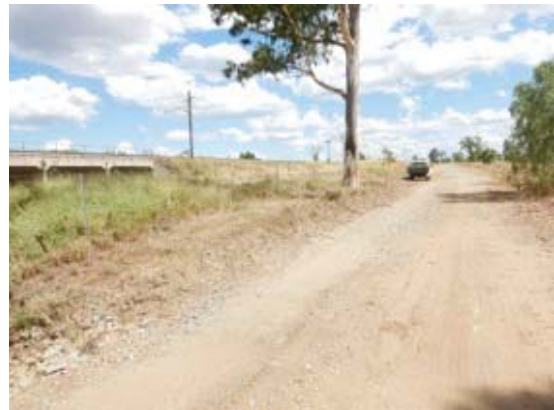
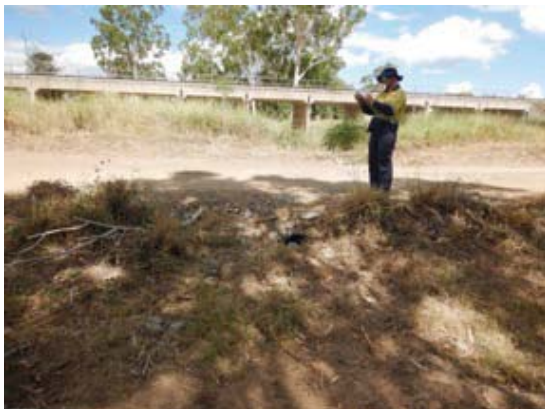
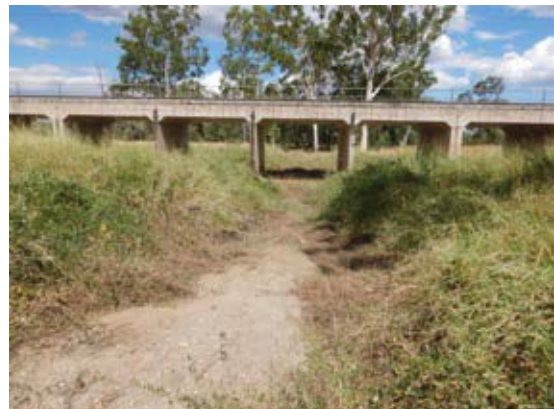
Site 87 (Site 2 and Site 3 in previous assessments; see Appendix A) is immediately upstream of a rail bridge with a large box culvert. A dirt road also crosses the channel with a narrow (0.4 m diameter) pipe culvert passing under the road (Figure 6.83). There was a rabbit inhabiting the pipe culvert suggesting flows had not occurred within this reach of the

Site 87 is a waterway providing for fish passage.

Figure 6.83 Site 87 (2 and 3) showing a) upstream, b) left bank with road crossing, c) downstream toward rail box culvert, d) right bank with road crossing, e) looking downstream showing blocked pipe culvert under road, and f) downstream narrow channel toward rail culvert

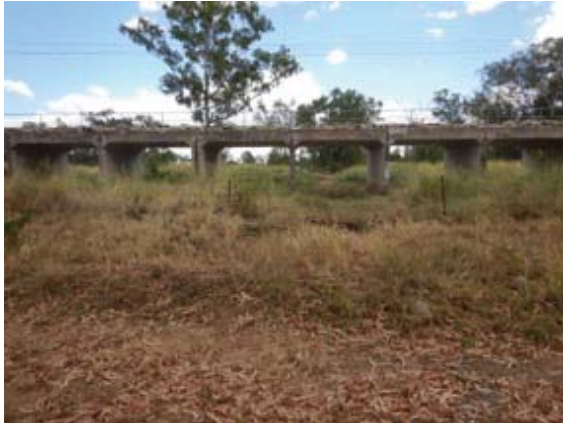
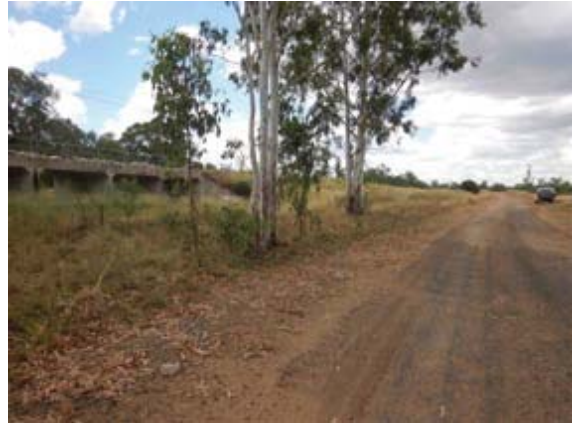
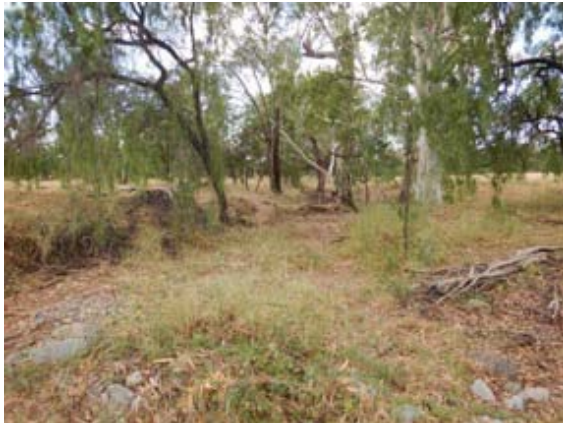
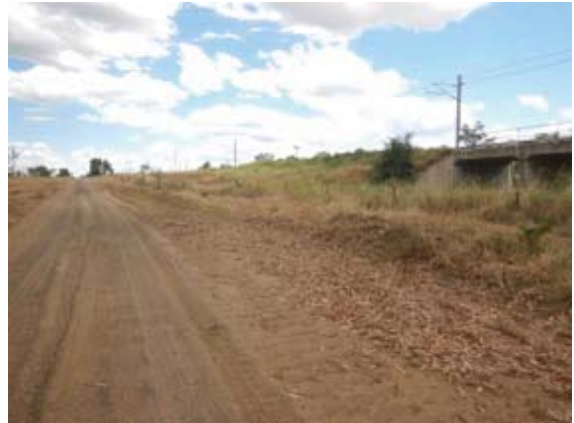
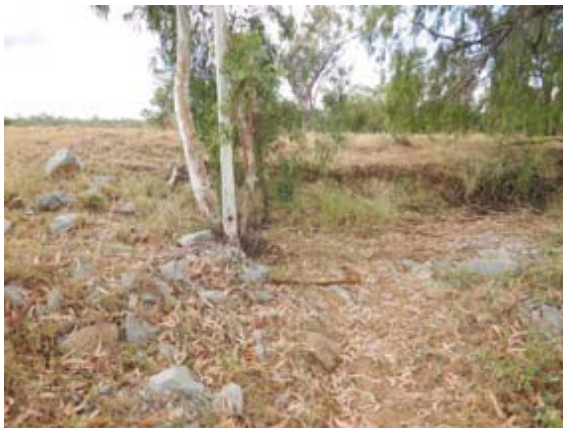
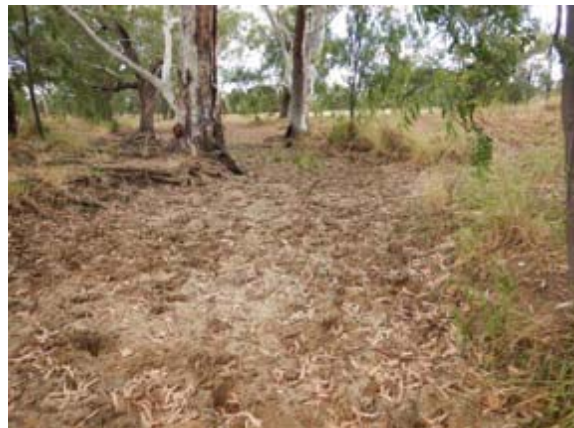
Site 85 is immediately downstream of the rail bridge with a large box culvert, described above. A dirt road crosses the channel (Figure 6.84). There is no culvert passing under the road. The channel downstream of the dirt road was wide and flat, with relatively low banks. Large *Eucalyptus* trees line the banks. Aquatic plants (sedge and rushes) were present.

Site 85 is a waterway providing for fish passage.

Figure 6.84 Site 85 showing a) upstream toward rail box culvert, b) left bank with road crossing, c) downstream, d) right bank with road crossing, e) left bank downstream of road crossing, and f) downstream of road crossing
