## WINCHESTER SOUTH PROJECT

Environmental Impact Statement

# **Winchester South Project EIS**

## **Aquatic Ecology and Stygofauna, Additional Information**

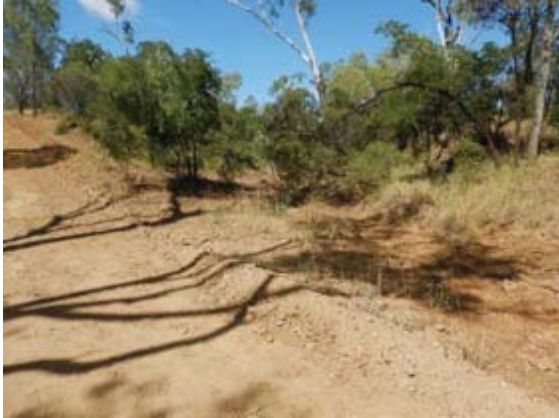
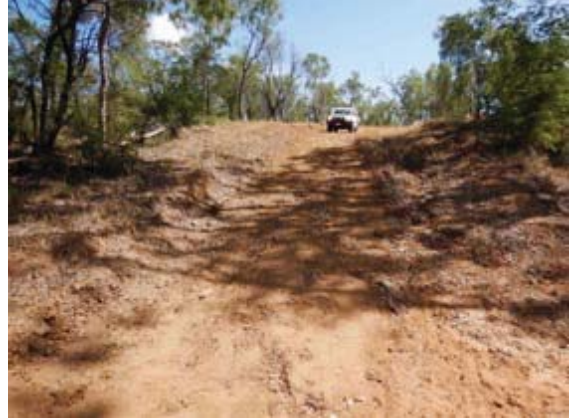
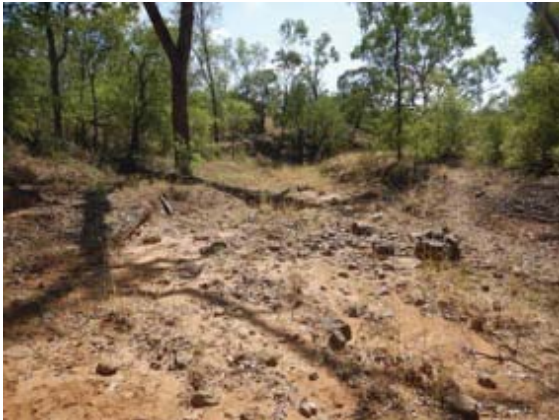
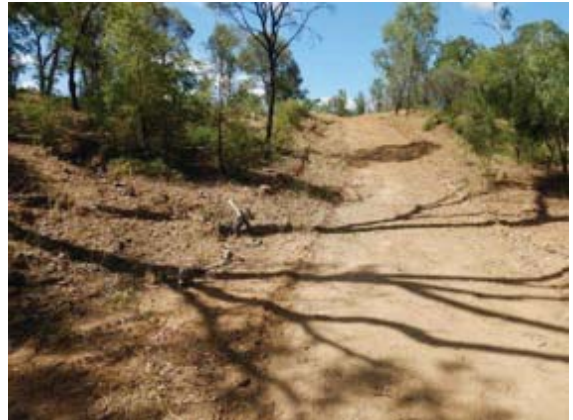
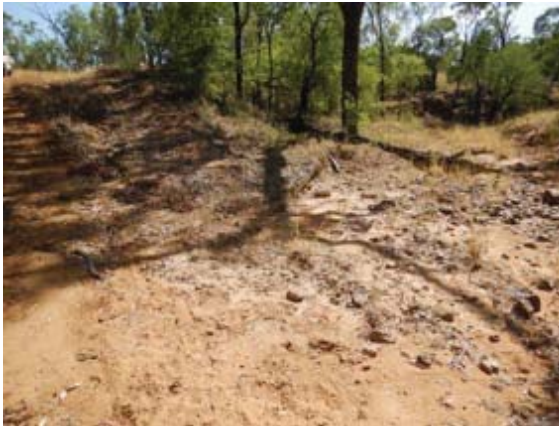
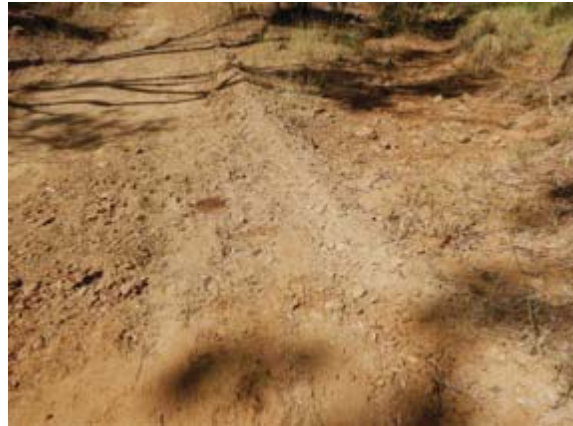
Site 98 (A12 in previous assessments; see Appendix B) is approximately 400 m upstream of the confluence with the Isaac River. A dirt road crosses the channel. The dirt road is at the same level as the channel bed, with no culvert passing under the road. Recent grading of the road has produced shallow banks of dirt across the channel creating possible barriers to fish passage (Figure 6.85).

Site 98 is a waterway providing for fish passage.

Figure 6.85 Site 98 showing a) upstream, b) left bank with road crossing, c) downstream, d) right bank with road crossing, e) left bank downstream of road, and f) unconsolidated soils with indications of recent grading across channel bed

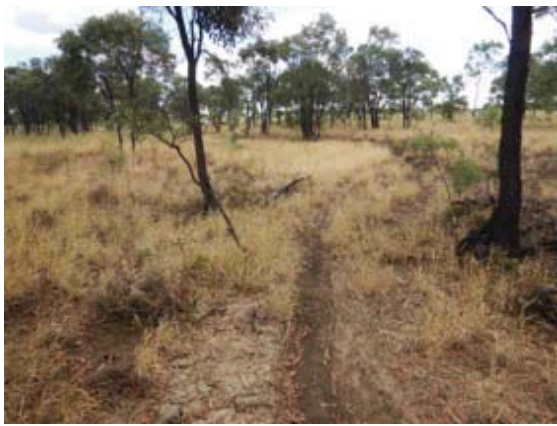
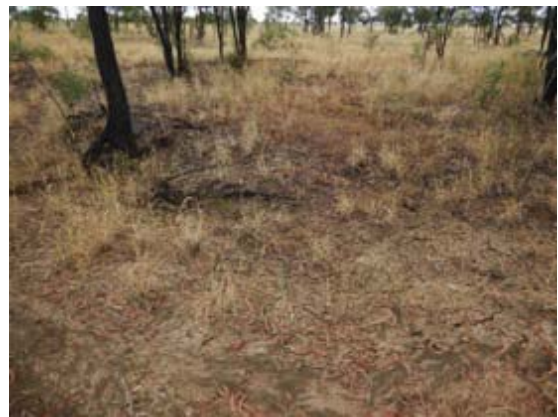
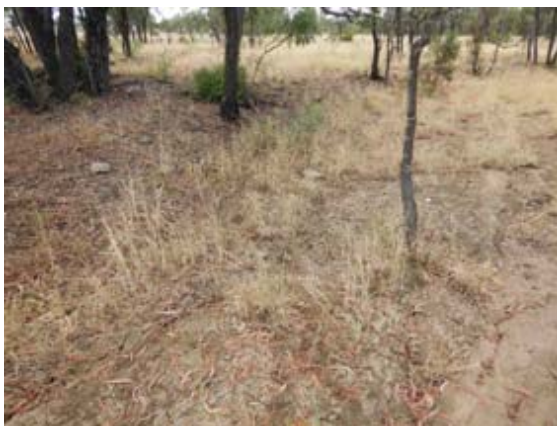
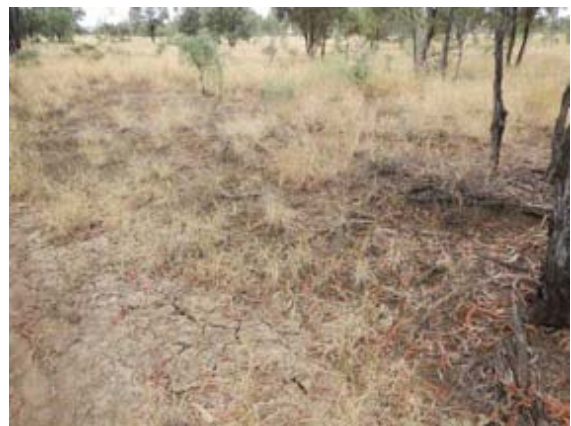
Sites 155 and 154 lack defined bed and banks and are indicative of overland flow paths that funnel immediate localised rainfall, and would not provide flow beyond the duration of a rain event (Figure 6.86 and Figure 6.87). Erosion is minimal suggesting flow velocities are low. Vegetation appears to be terrestrial grasses, with no aquatic plants. The soils are not indicative of previous water ponding.

This section of the mapped feature is not a waterway providing for fish passage.

Figure 6.86 Site 155 showing a) upstream, b) left bank, c) downstream, and d) right bank

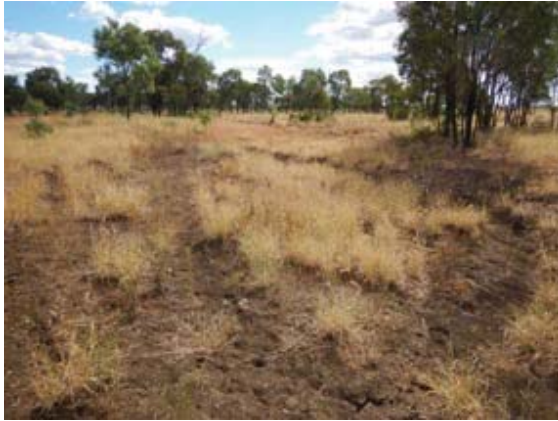
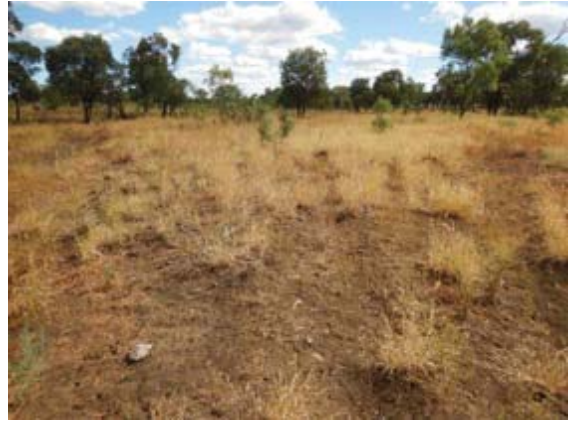
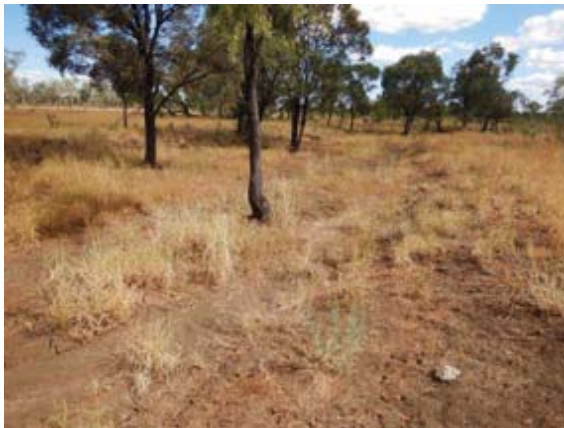
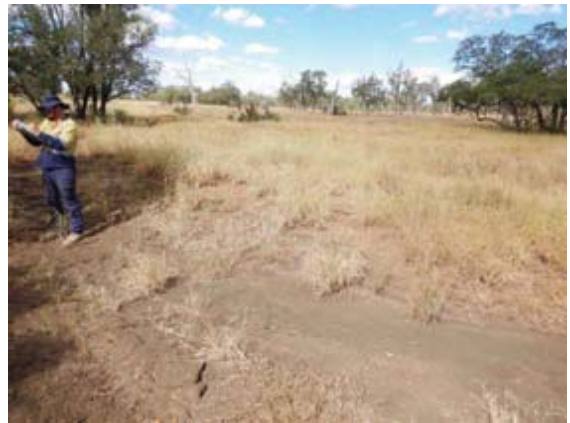
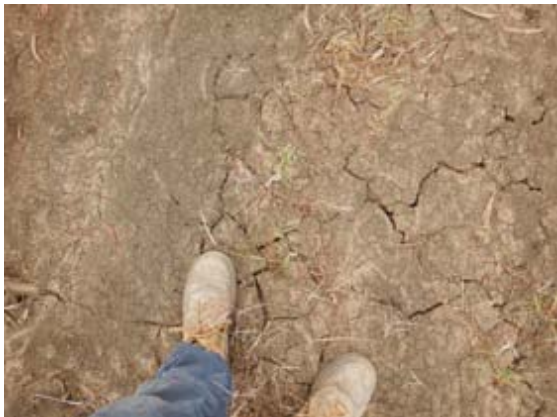
Figure 6.87 Site 154 showing a) upstream, b) left bank, c) downstream, d) right bank, and e) unconsolidated/cracks soils

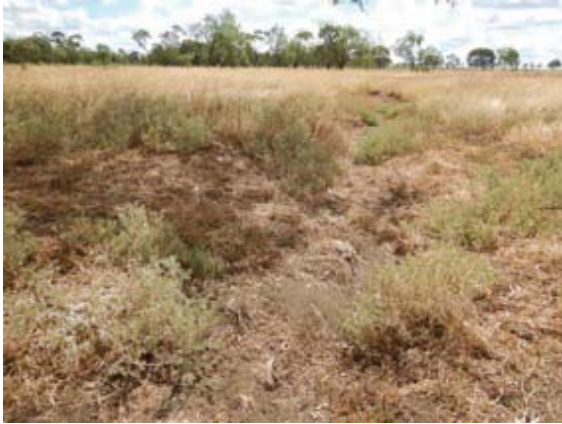
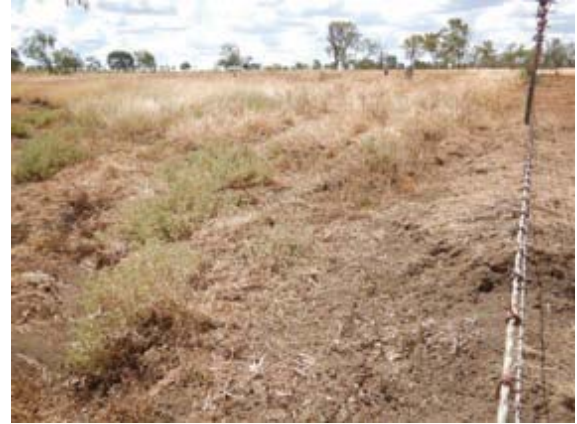
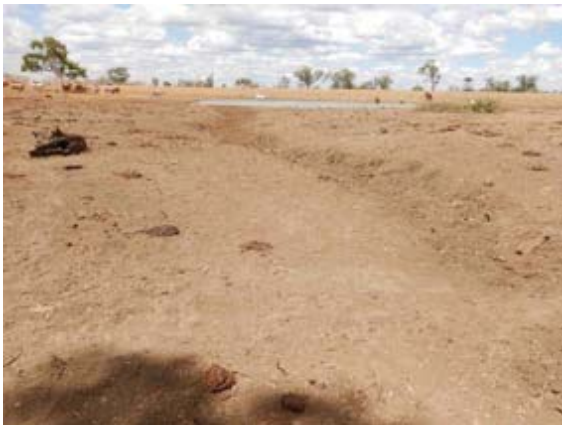
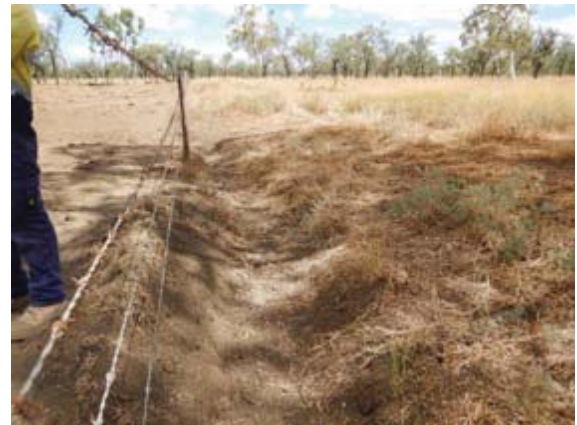
Site 137 is a narrow drainage gully directing flows toward a large, constructed dam and would not provide flow beyond the duration of a rain event (Figure 6.88). There is no riparian vegetation, aquatic plants or any other evidence of standing water.

The lack of defined bed and banks, in combination with insufficient water availability to sustain basic aquatic ecological processes and habitats, and the lack of riparian vegetation, suggests this reach of the mapped feature is not a waterway providing for fish passage.

Figure 6.88 Site 137 showing a) upstream, b) left bank, c) downstream, and d) right bank

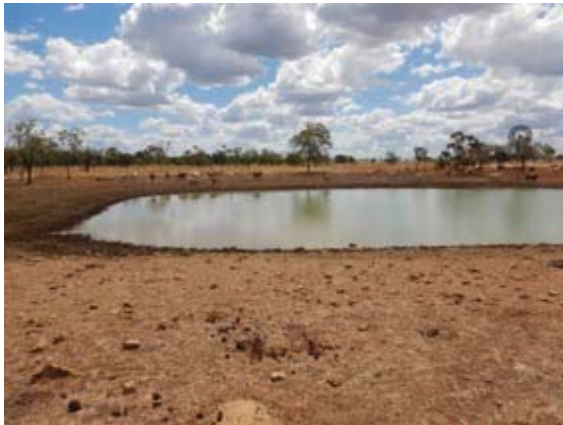
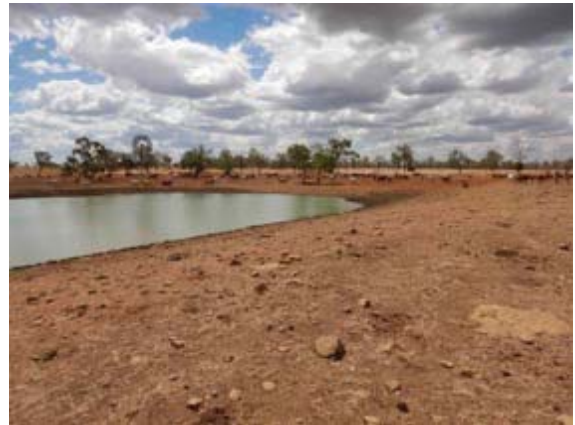
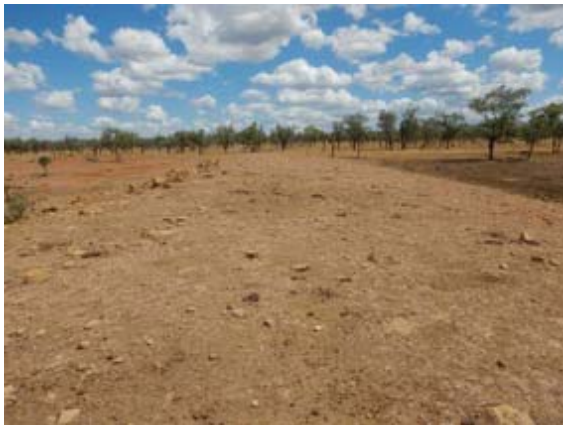
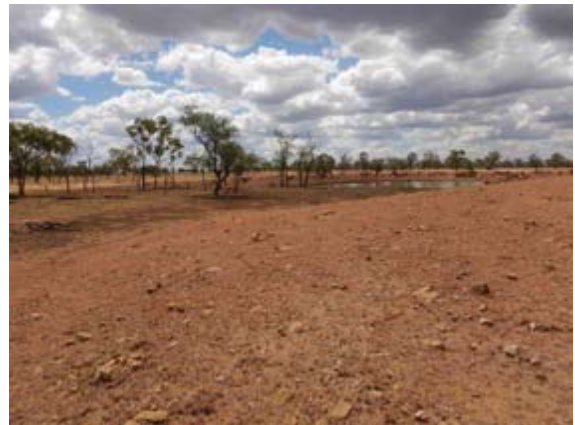
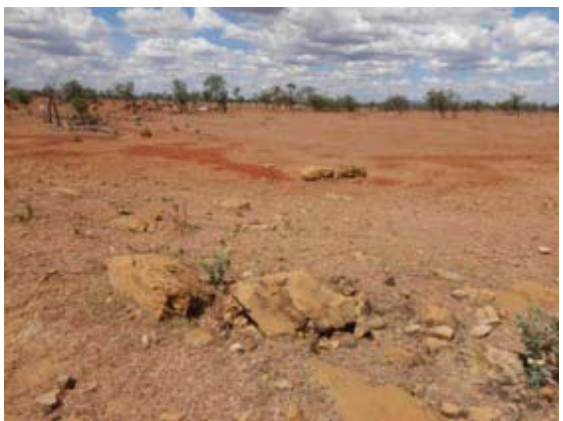
Site 135 (FD1 in previous assessments; see Appendix A) is a large, constructed dam (Figure 6.89). The dam walls are approximately 7 m high and act to restrict connectivity to downstream reaches. The dam wall along the downstream extent of the dam extends away from the dam to the south, which appears designed to direct dam overflows.

The dam at Site 135 acts as a barrier to fish passage and there is no waterway providing for fish passage upstream (see Site 137 described above) or downstream (Figure 6.89e).

Figure 6.89 Site 135 showing a) upstream across dam, b) left bank of dam, c) downstream, toward dam overflow, d) toward dam from dam overflow, and e) looking downstream from dam overflow

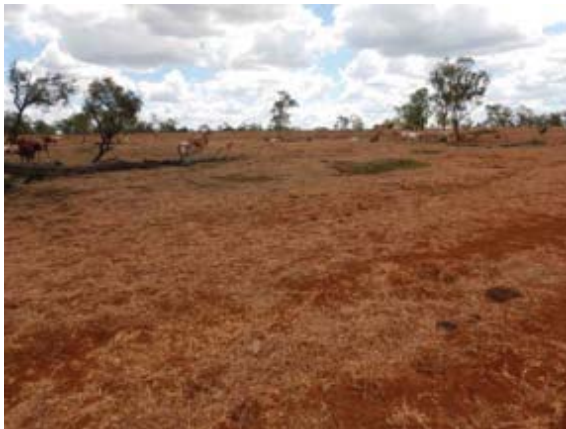
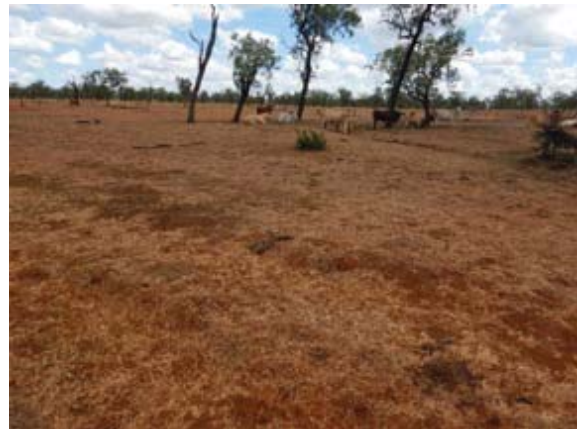
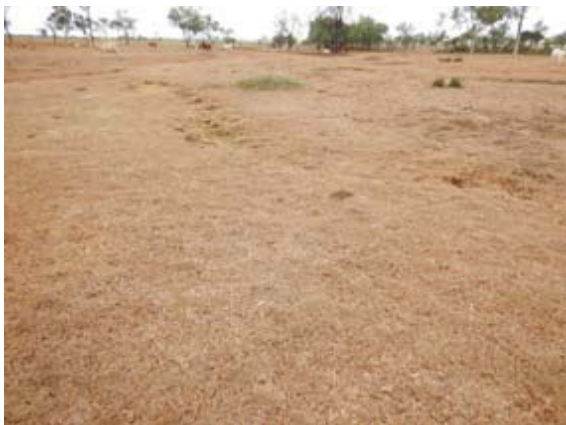
Sites 133 (Site 6 in previous assessments; see Appendix A) and 134 are small drainage depressions, downstream of the large constructed dam, that lack features of a waterway providing for fish passage (Figure 6.90 and Figure 6.91).

There are several small drainage lines running through Site 133, converging downstream at Site 134. There is some erosion along the edges of the drainage lines, particularly on the outside of bends. Sections of the depressions do not have a continuous defined bed and banks, and instead consist of broken sections of a drainage gully, particularly along straight sections of the channel. The drainage depression at these sites would not likely provide adequate flow other than in times of localised rainfall.

Due to the lack of a channel with continuously defined bed and banks, no riparian vegetation, and a lack of fish habitat and connectivity for fish passage, Sites 133 and 134 are not waterways providing for fish passage.

Figure 6.90 Site 133 showing a) upstream toward dam b) left bank, with multiple drainage lines, and c) downstream, away from dam

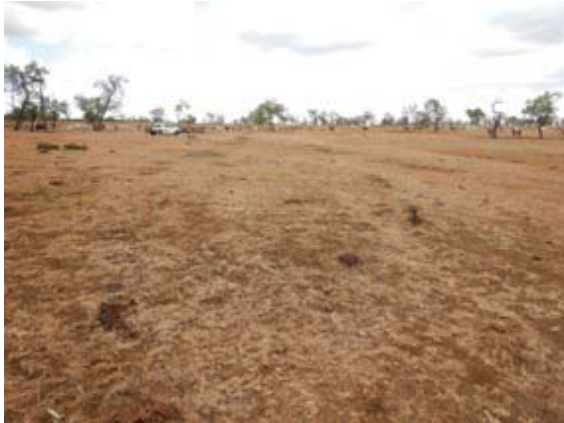
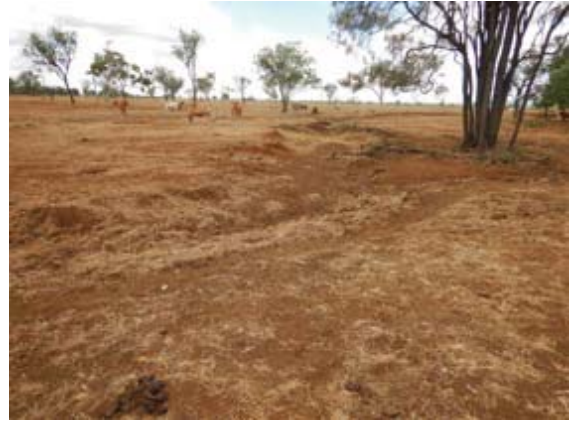
Figure 6.91 Site 134 showing a) upstream toward dam with several drainage lines visible, and b) downstream

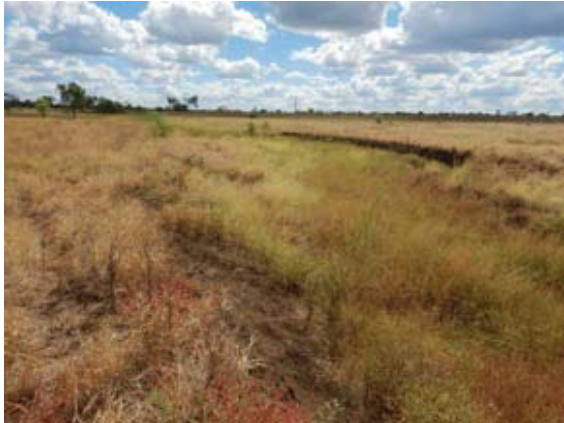
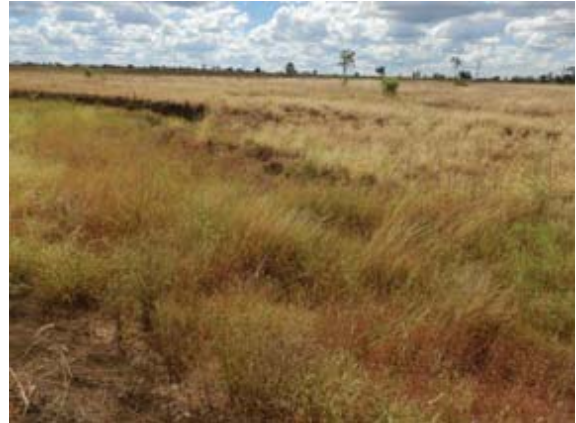
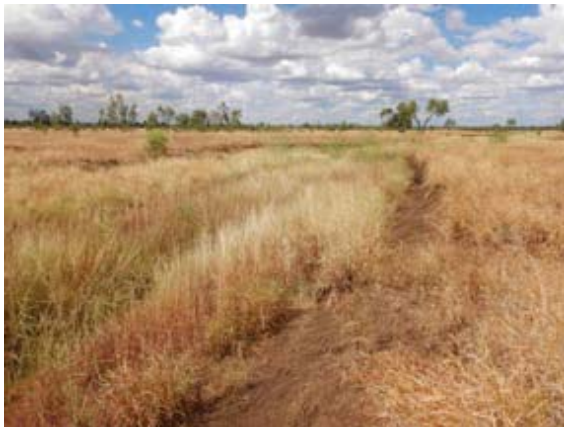
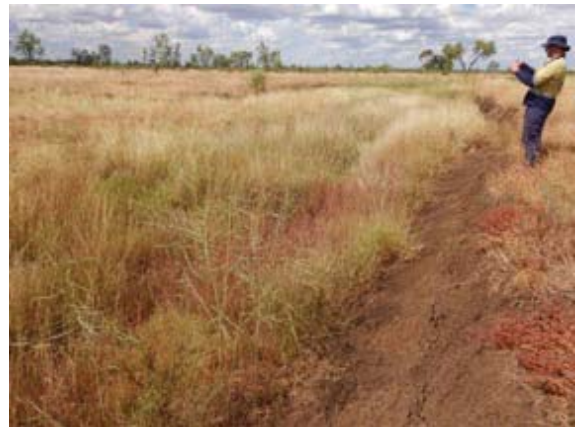
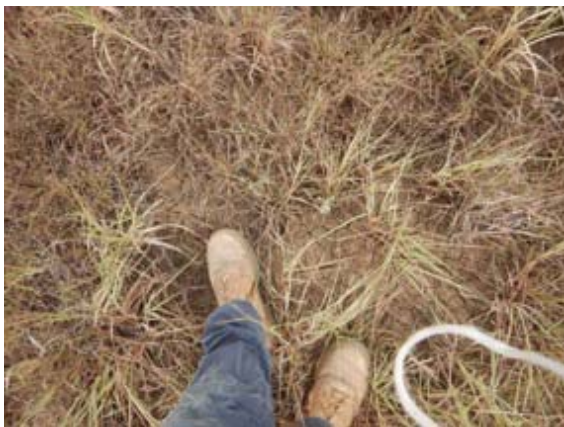
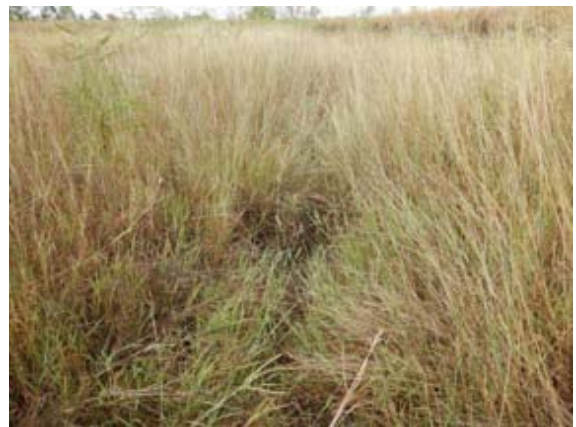
Site 138 is a wide flat drainage gully, with no standing water or evidence of previous standing water (Figure 6.92). There is significant erosion along the edges of some of the gullies, particularly on the outside of bends.

Due to the lack of a main channel with continuously defined bed and banks, no riparian vegetation, lack of fish habitat or passage opportunities, Site 138 is not considered a waterway providing for fish passage.

Figure 6.92 Site 138 showing a) upstream, b) left bank, c) downstream, d) right bank, e) unconsolidated/cracks soils, and f) vegetated gully floor

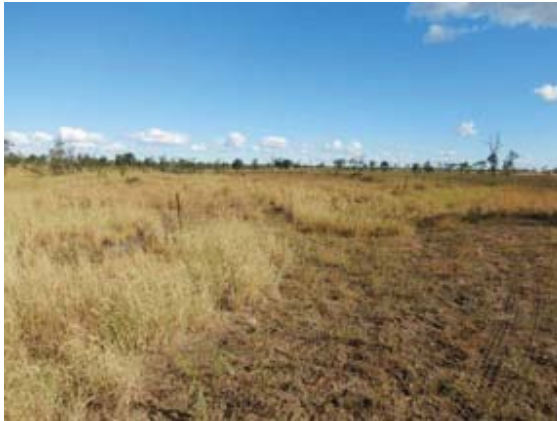
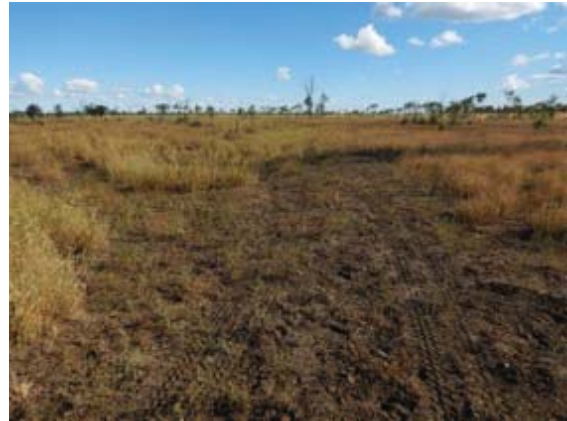
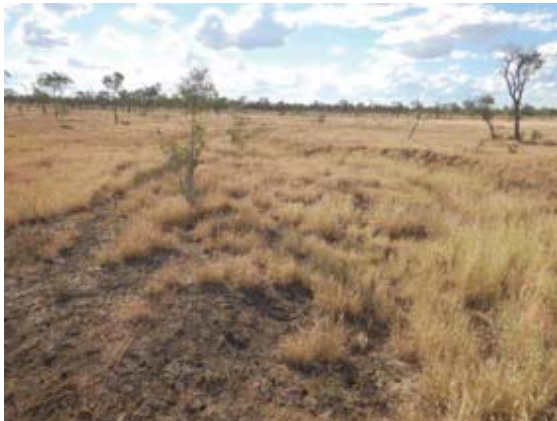
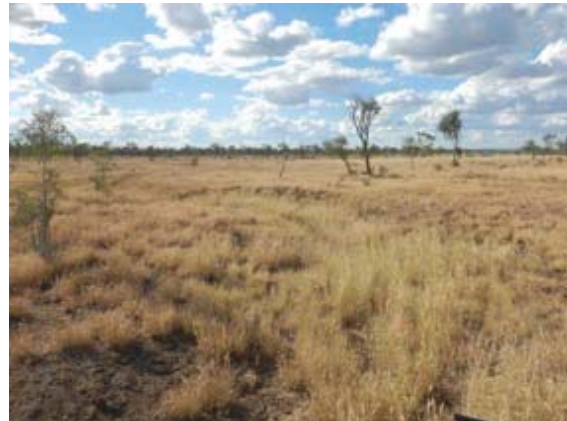
Site 139 is a drainage feature/overland flow path. The area is mostly flat, with no continuously defined bed and banks; rather, there are broken sections of a drainage line (Figure 6.93).

Due to the lack of a channel with continuously defined bed and banks, no riparian vegetation, and a lack of fish habitat and connectivity for fish passage, Site 139 is not a waterway providing for fish passage.

Figure 6.93 Site 139 showing a) upstream, b) left bank, c) downstream, and d) right bank

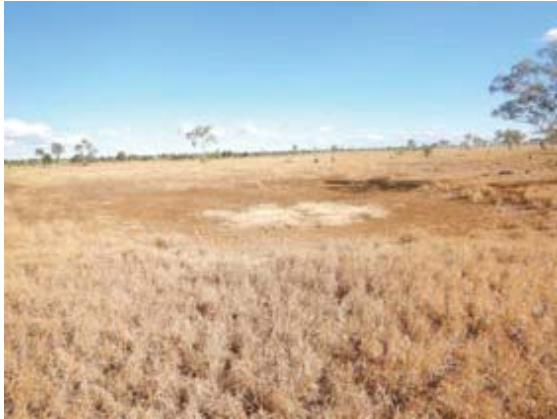
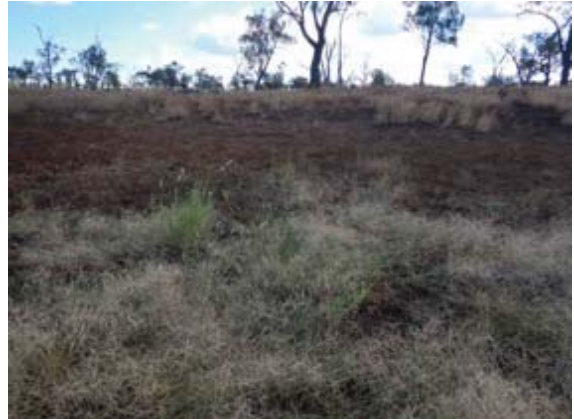
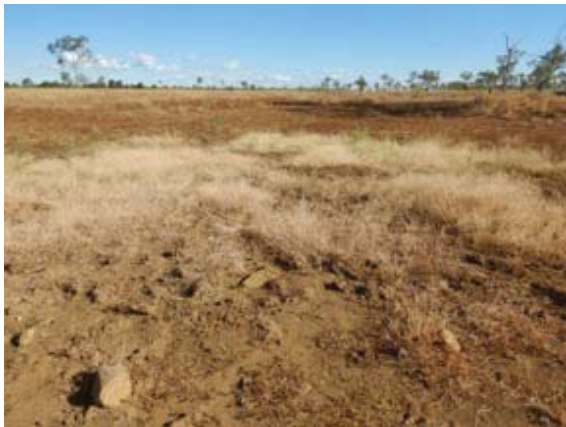
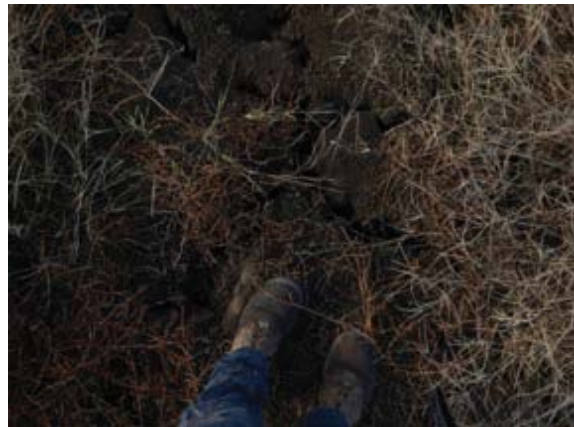
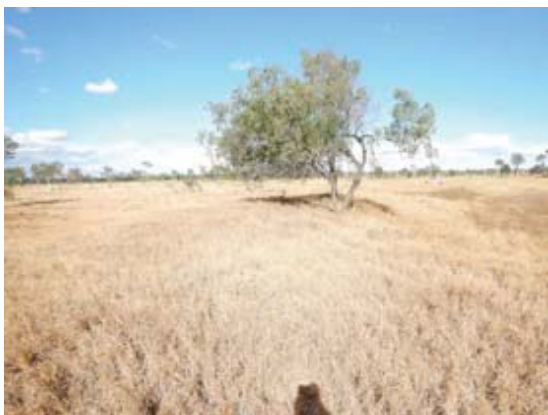
Site 140 is a constructed dam (Figure 6.94). There was no water within the dam during the February 2022 site assessment. The dam walls are approximately 3 m in height and restrict connectivity to downstream reaches. The dam wall along the downstream extent of the dam extends away from the dam to the east, providing the dam overflow. The dam overflow is approximately 1.5 m above the base of the dam.

The dam at Site 140 acts as a barrier to fish passage.

Figure 6.94 Site 140 showing a) upstream toward dam, b) left bank of dam, c) downstream from dam, d) unconsolidated/cracks soils, and e) looking along dam wall toward dam overflow

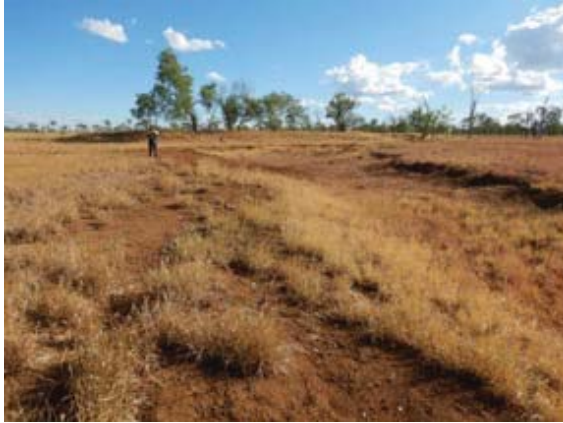
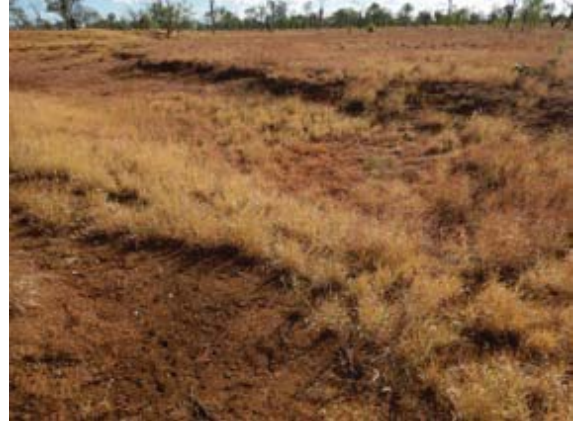
Terrestrial vegetation is growing across the drainage depression. The drainage depression flattens out further downstream from the dam, forming of broken sections of a drainage gully.

Due to the lack of a channel with continuously defined bed and banks, no riparian vegetation, and a lack of fish habitat and connectivity for fish passage, this site is not considered a waterway providing for fish passage.

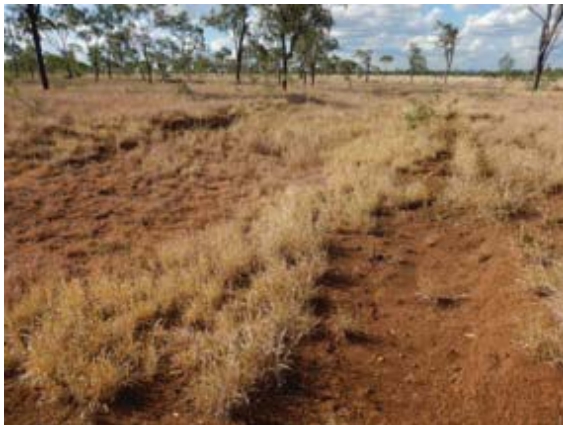
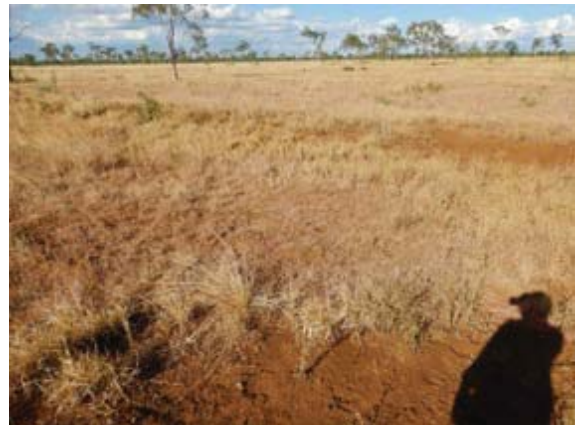
Figure 6.95 Site 143 showing a) upstream toward dam, b) left bank, c) downstream, and d) right bank

Site 143 is a wide flat drainage depression downstream of the dry constructed dam (Figure 6.95). There is erosion in places, particularly along outer bends.

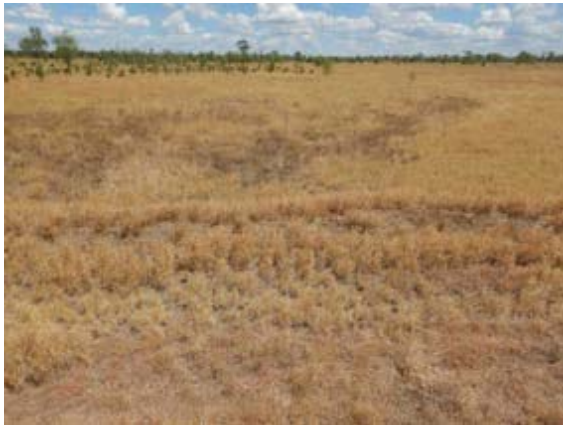
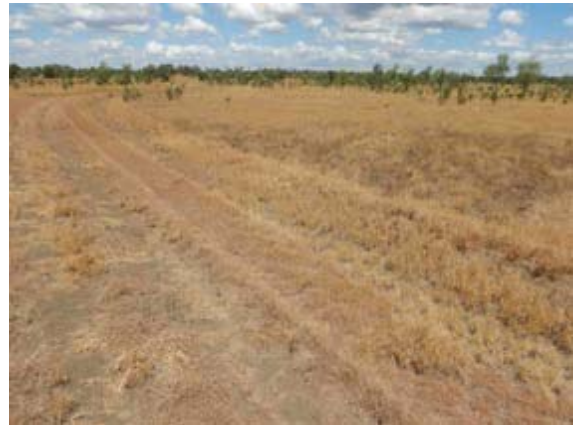
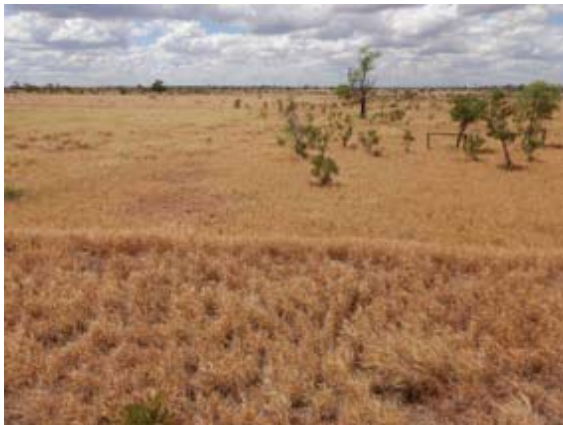
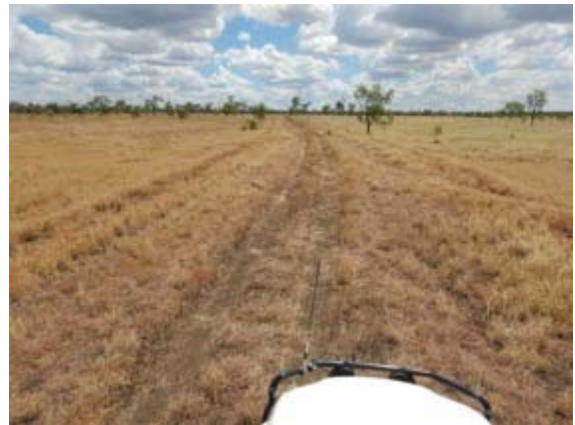
Figure 6.96 Site 132 showing a) upstream, b) left bank with road crossing, c) downstream, and d) right bank with road crossing

Site 132 (Site 5 in previous assessments; see Appendix A) is a flat overland flow area, with no defined bed and banks (Figure 6.96). A road cuts across the feature, with no culvert. Terrestrial vegetation can be seen growing across the feature.

Due to a lack of any evidence of a waterway channel, this reach of the mapped feature is not a waterway providing for fish passage.

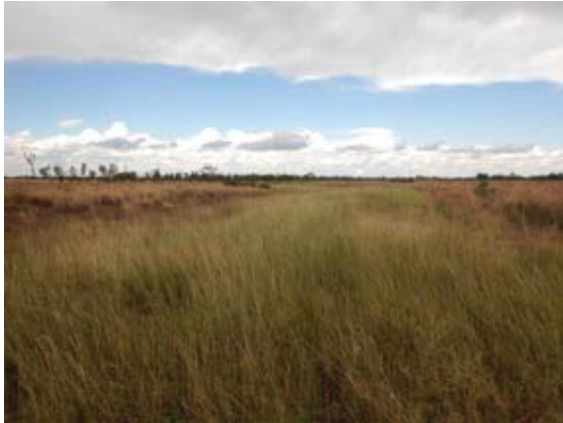
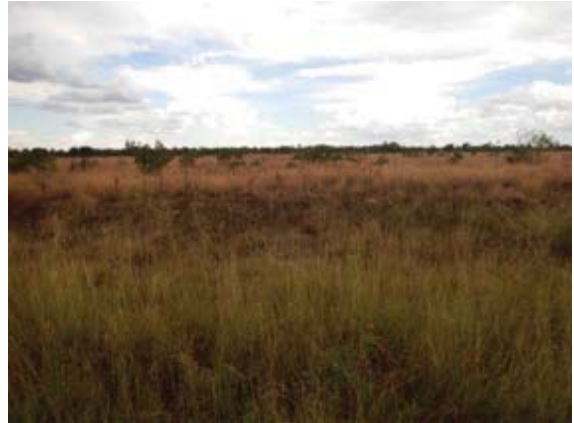
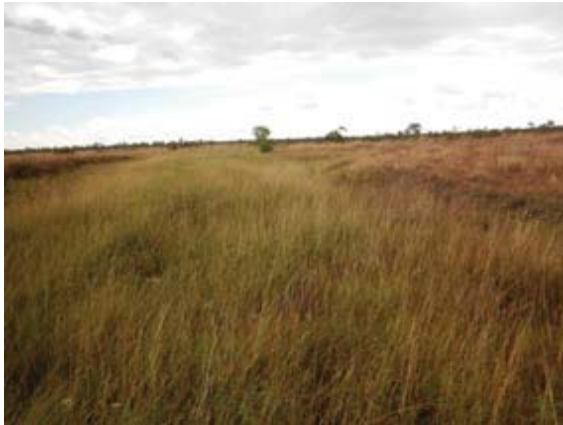
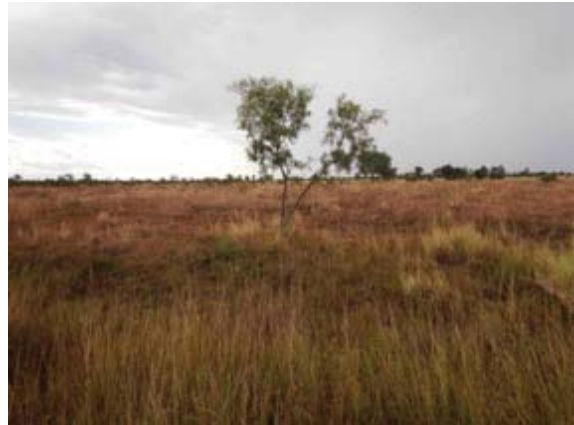
Figure 6.97 Site 73 showing a) upstream, b) left bank, c) downstream, and d) right bank

Sites 73 and 72 (B2 in previous assessments; see Appendix A) are wide flat drainage gullies, with no standing water in February 2022 (Figure 6.97 and Figure 6.98). There is significant erosion along the edges of some of the gullies, particularly on the outside of bends. There is a shallow vegetated depression within the gully with terrestrial vegetation, indicating that it is unlikely to provide adequate flow beyond the duration of a rainfall event. There are no aquatic plants or fish habitat.

Due to the lack of a main channel with continuously defined bed and banks, no riparian vegetation, lack of fish habitat or passage opportunities, Sites 73 and 72 are not considered a waterway providing for fish passage.

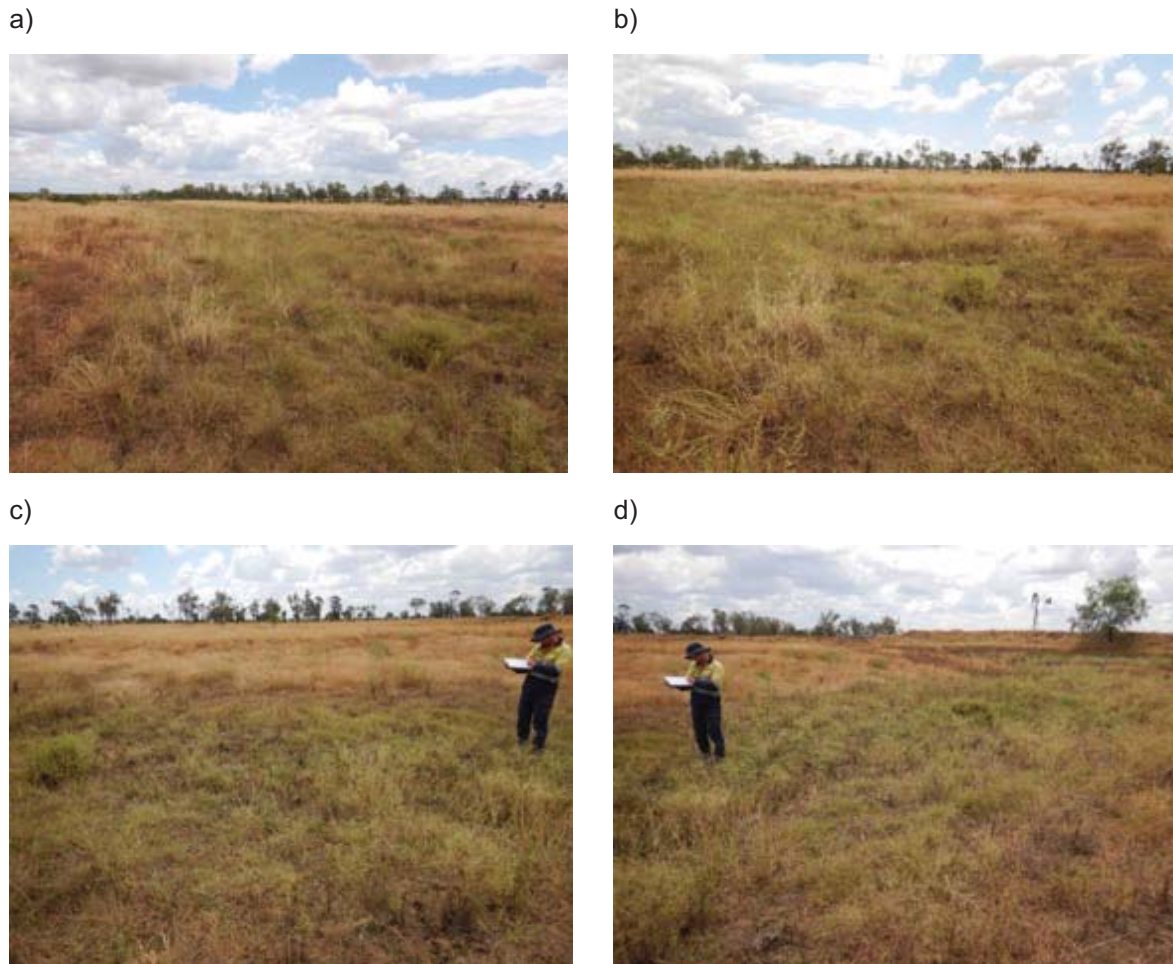
Figure 6.99 Site 102 showing a) upstream, b) left bank, c) downstream, and d) right bank

Site 102 is a wide flat overland flow area, immediately upstream of a large, constructed dam (Figure 6.99).

There are no continuously defined bed and banks; instead, there are broken sections of a drainage depression in places, particularly along straight sections of the channel. The drainage depression at these sites would not likely provide adequate flow other than in times of localised rainfall.

Due to the lack of a channel with continuously defined bed and banks, no riparian vegetation, lack of fish habitat or passage opportunities, Site 102 is not a waterway providing for fish passage.

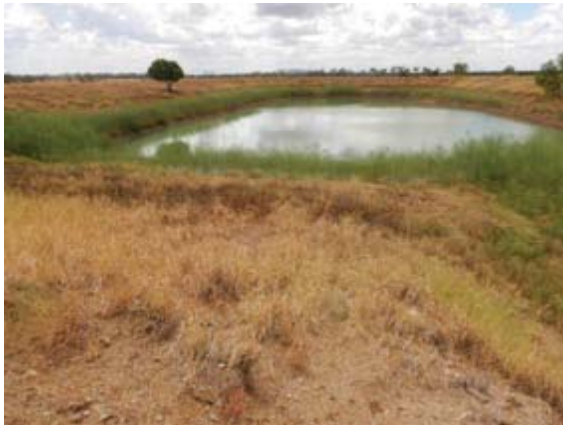
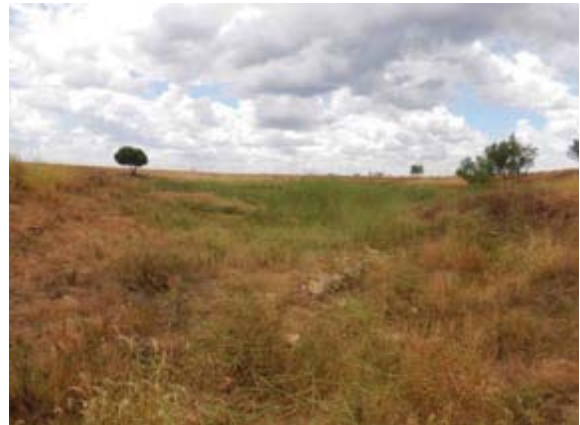
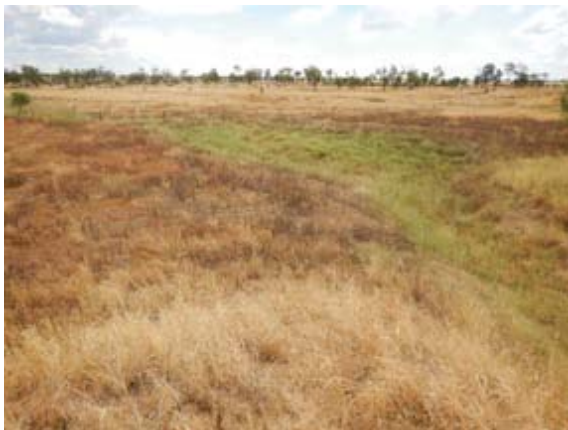
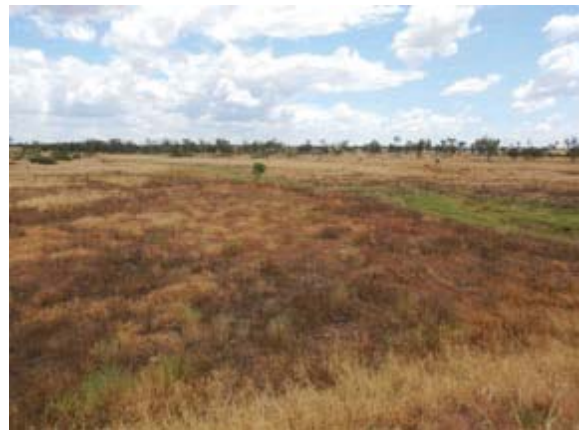
Figure 6.100 Site 101 showing a) downstream toward dam, b) looking downstream direction into dam entrance, c) looking upstream away from dam entrance, and d) looking upstream away from dam

Site 101 (FD2 in previous assessments; see Appendix A) is a constructed dam (Figure 6.100). The dam walls are approximately 8 m high and restrict connectivity to downstream reaches. There is no dam overflow on the downstream extent of the dam wall. There is a small drainage channel that funnels flow into the dam from upstream reaches (Site 102, discussed above). There is no shading and a lack of habitat features. There appears to be no connectivity to downstream reaches.

The dam at Site 101 acts as a barrier to fish passage.

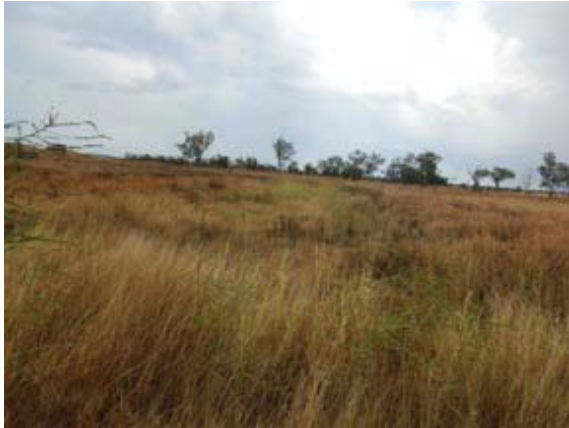
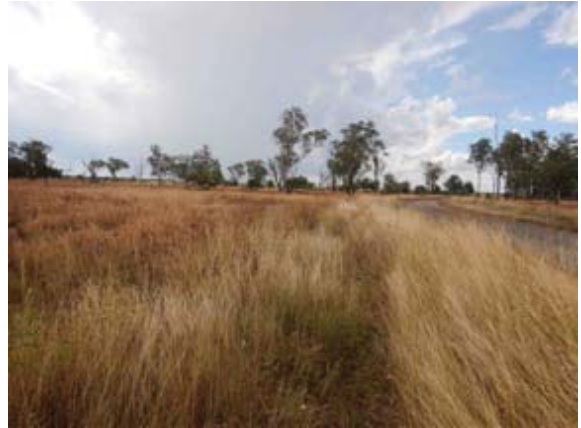
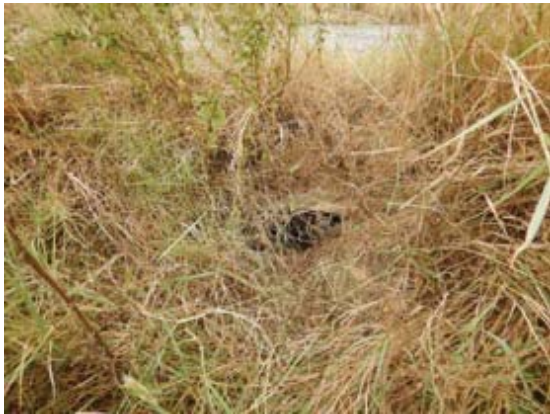
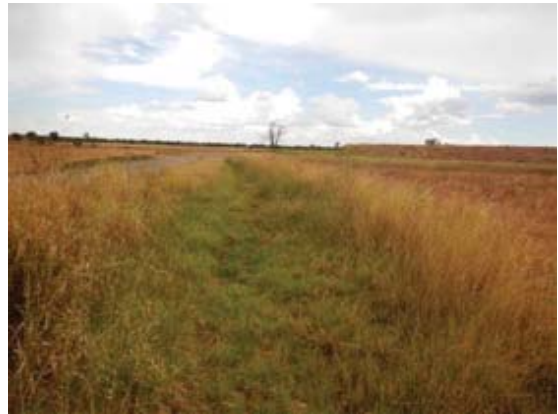
Figure 6.101 Site 71 showing a) upstream, b) left bank with road crossing, c) downstream, road pipe culvert, and d) right bank with road crossing

Sites 71 and 70 are drainage gullies, with ill-defined bed and banks, and instead, consist of broken sections of a drainage channel (Figure 6.101 and Figure 6.102).

This section of the mapped feature is not a waterway providing for fish passage.

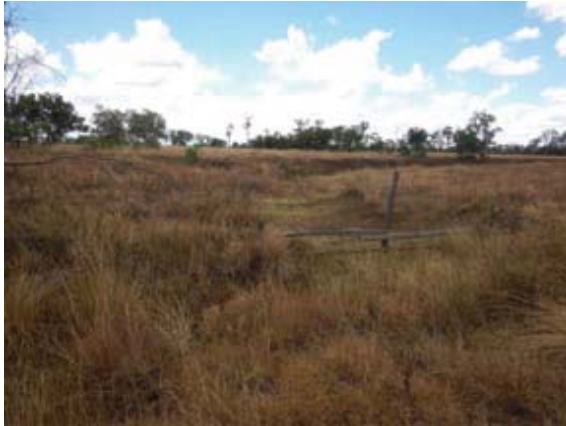
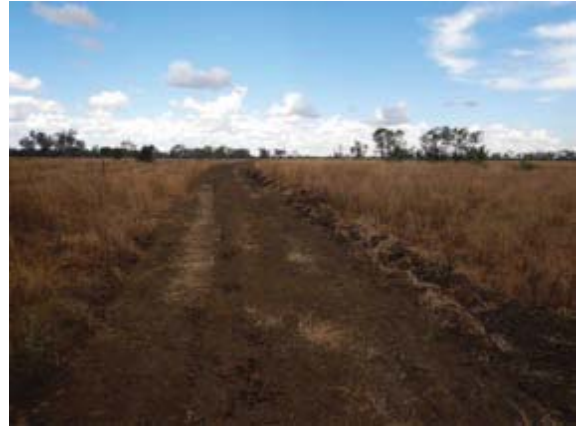
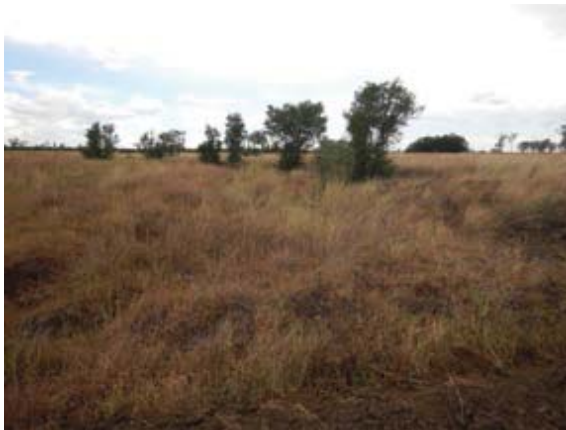
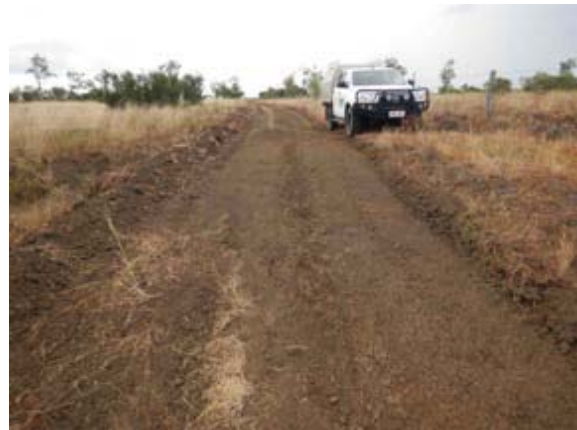
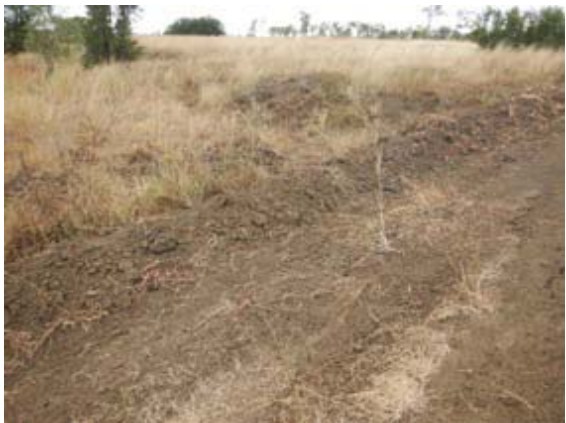
Figure 6.103 Site 69 showing a) upstream, b) left bank, c) downstream, d) right bank and e) recent grading across channel

Site 69 is a drainage depression crossed by a dirt track, with no culvert passing under the track (Figure 6.103).

There appears to be some erosion along the edges of the depression, particularly on the outside of bends. However, straight sections of the depression do not have a continuous defined bed and banks, and instead consist of broken sections of a drainage gully. The drainage depression would only flow in times of localised rainfall.

Due to the lack of a channel with continuously defined bed and banks, no riparian vegetation, and a lack of fish habitat and connectivity for fish passage, Site 69 is not a waterway providing for fish passage.

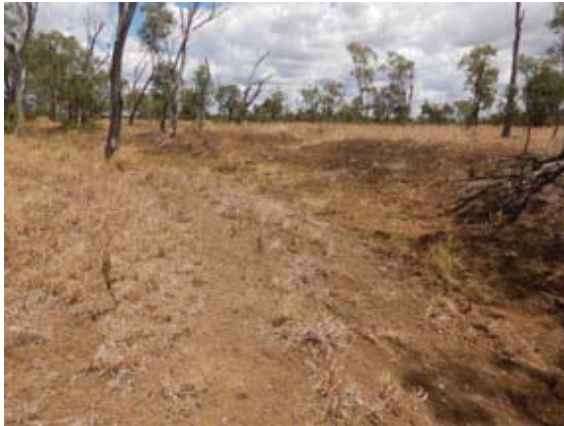
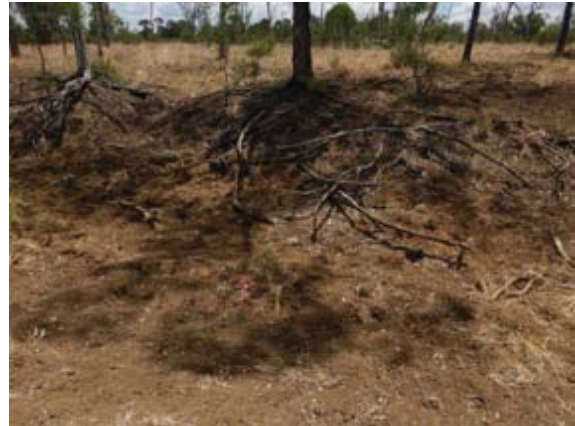
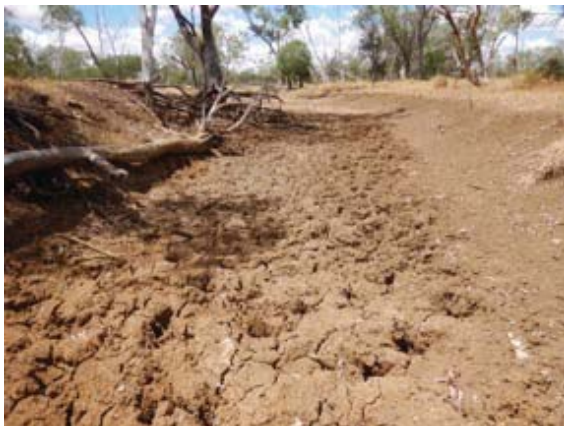
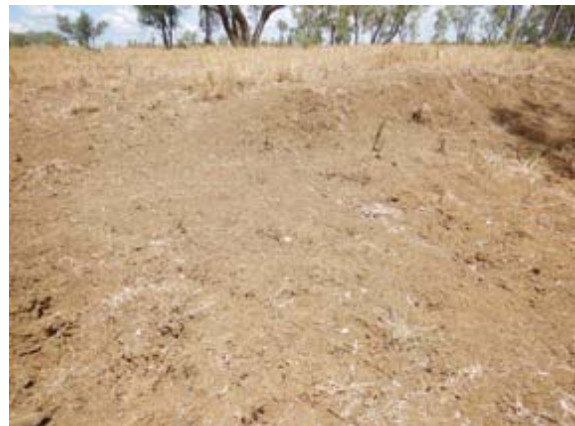
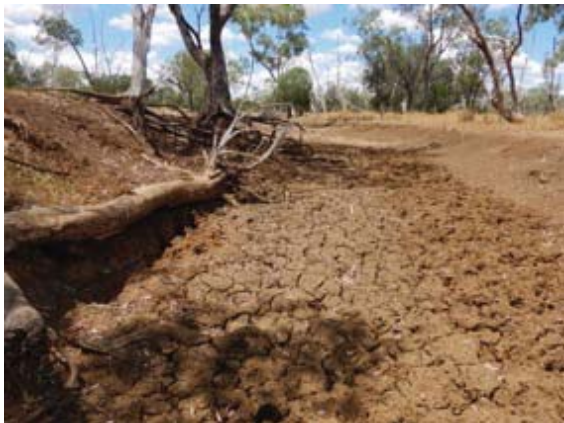
Figure 6.104 Site 129 showing a) upstream, b) left bank, c) downstream, d) right bank, and e) dried, cracked bed in depression

Site 129 is a wide drainage gully, with no visible standing water in February 2022 (Figure 6.104). A small depression within the gully contained cracked soils that were indicative of some pooling of water after periods of flow. However, the depression appears to be a gully that funnels immediate localised rainfall that would not likely provide flow beyond the duration of a rain event. There was no evidence of aquatic flora or fauna (such as dead aquatic plants

This section of the waterway is not a waterway providing for fish passage.
